## The Whitelands Leather Works, Ashton- under-Lyne, Tameside

An Archaeological Building Survey of the 1868 Complex

A Report By: Dr M Nevell & S Bell  
Report No: 03/2009

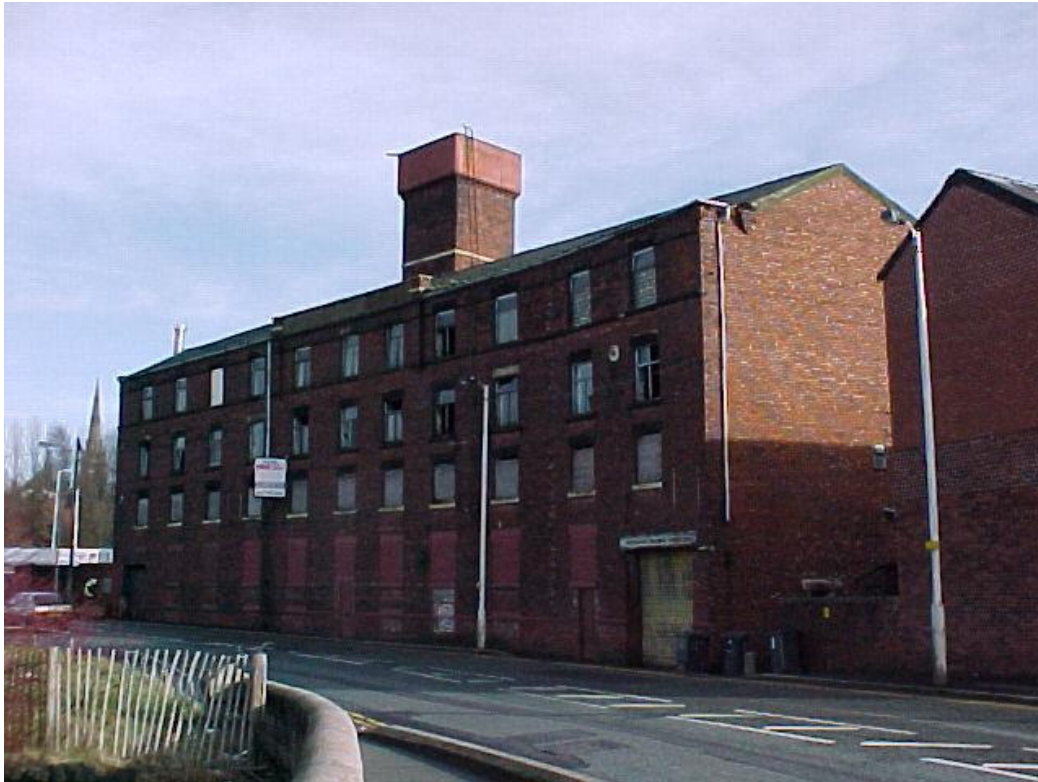
The west facing elevation was constructed from machine made red brick in English Garden Wall Bond (EGWB). Four entrances were visible, two situated to the south, one to the centre and one to the north of the building (*Fig. 10*). The southern entrance had a cast iron lintel bearing the name 'Whitelands Leather Works 1868', with a corrugated door curtain (*Fig. 11*). Under the second bay ground floor window was a smaller doorway. To the north was a similar corrugated door curtain. The ground floor window of the sixth bay from the south was higher in elevation, with the central doorway located directly beneath it. The building was eleven bays long, with the basement windows in-filled with brick and the ground floor windows in-filled with breeze blocks (*Fig. 12*). The windows had stone lintels and sills; the lintels used for the basement windows had a slight curve. The eaves consisted of a brick cornice returned at the gable, which served as a gutter (*Fig. 10*).

The water tower projected from the eastern side of the roof. This consisted of a red brick structure with an iron holding tank and single window, with an arched lintel on the east facing elevation (*Fig. 16*). An external ladder was visible against the south facing elevation of the tower (*Fig. 10*)

*Figure 10. General view of the works and water tower, from the south east*

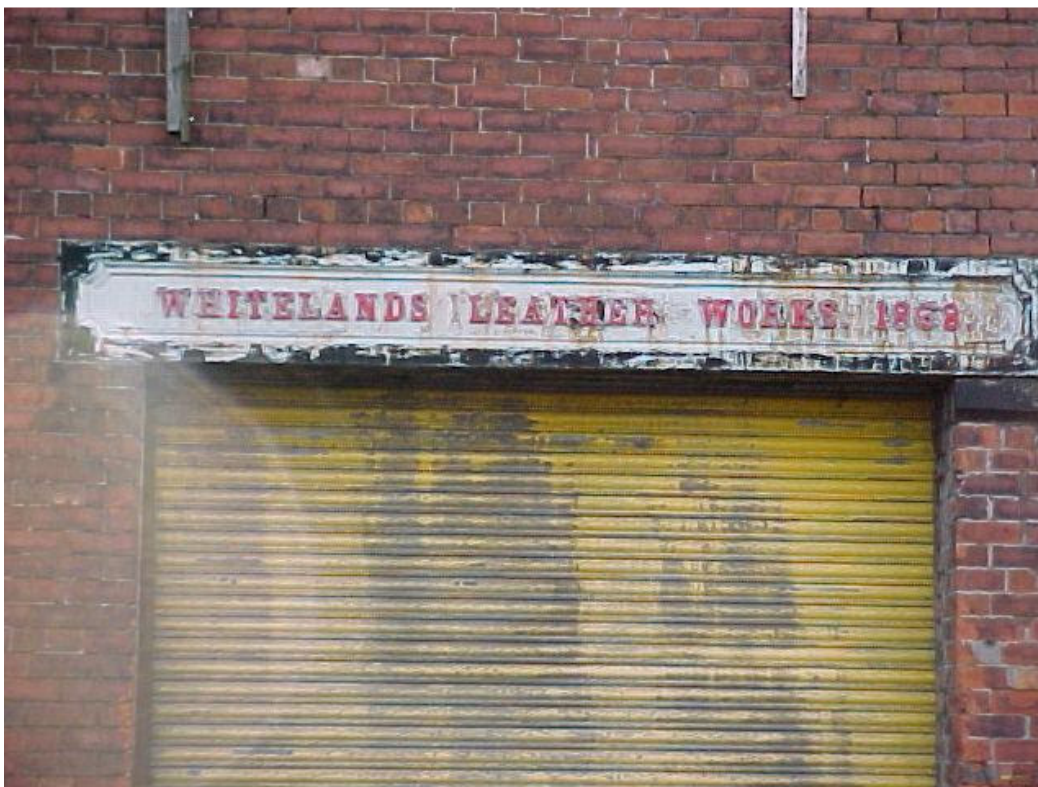
The structural iron lintel inscribed with ‘Whitelands Leather Works 1868’ and changes to the southern extent of the main works does indicate that either a major rebuild took place or that the existing works was remodelled.

*Figure 11. Detail of building entrance in the west facing elevation, showing 'Whitelands Leather Works. 1868' raised on an iron lintel*

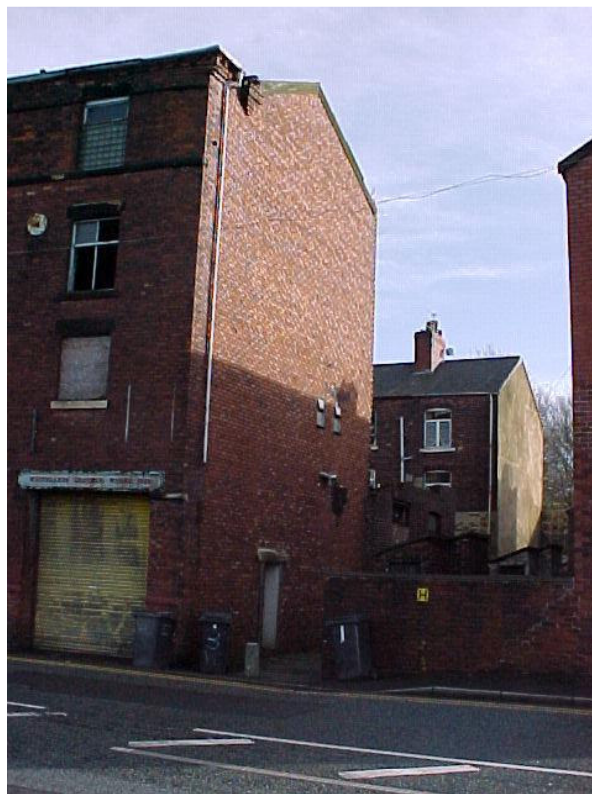
The south facing elevation was constructed from EGWB in red brick, with a single doorway (*Fig. 13*).

*Figure 13. General shot of south facing elevation of works*

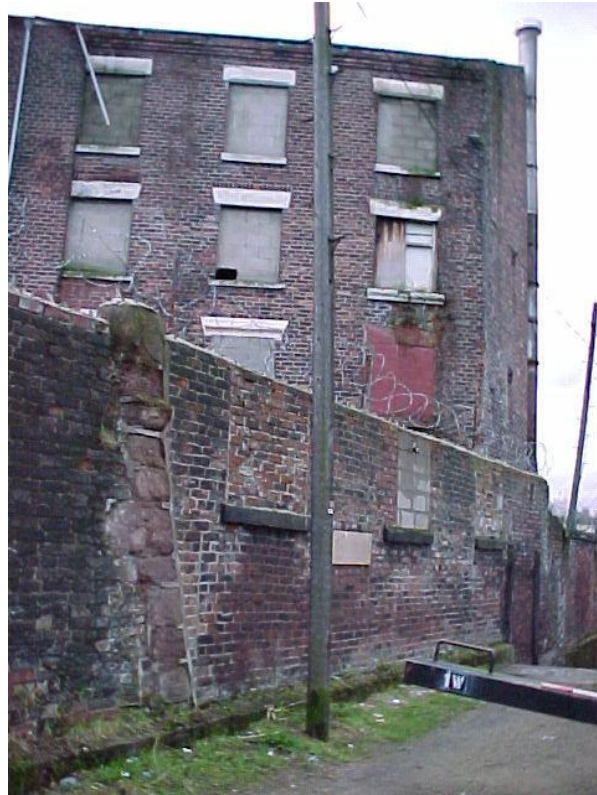
The north facing elevation was irregular, with a change in angle and a recess to allow for a cylindrical chimney vent (*Fig. 14*). There was a single doorway to the west of the wall.

*Figure 14. North east facing elevation and towpath/shed wall*

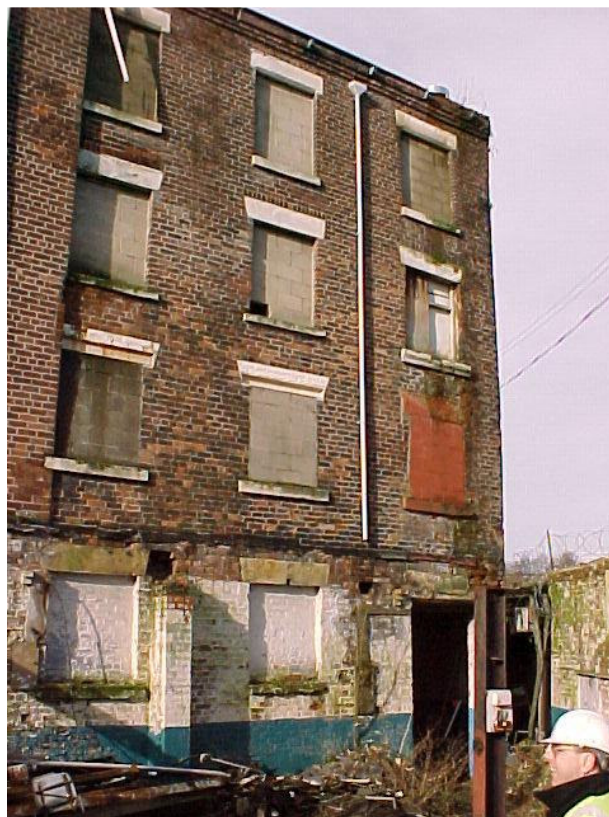
The east facing elevation was eleven bays long, with a notably wider distance between the third and fourth bays from the north. These last three bays were recessed,

with a slanting change in the brickwork after the third bay (*Fig. 15*). The windows of the ground floor were in-filled with brick, those on the second floor and most of the third and fourth floors were in-filled with breeze blocks. Beneath the seventh bay, from the north, was a three story flat roofed extension which housed an external staircase (*Fig. 16*); this appeared to be a later addition. There were three entrances also situated to the south, centre and north of the building. The southern entrance was an open doorway with a cast iron lintel (*Fig. 17*). The central entrance, situated to the north of the external staircase was in-filled with brick (*Fig. 18*). The entrance to the north opened out into Shed 1 (*Fig. 19*). To the east of the building were two sheds, one to the north (Shed 1) and one to the south (Shed 2).

*Figure 15. East facing elevation of northern end of works*

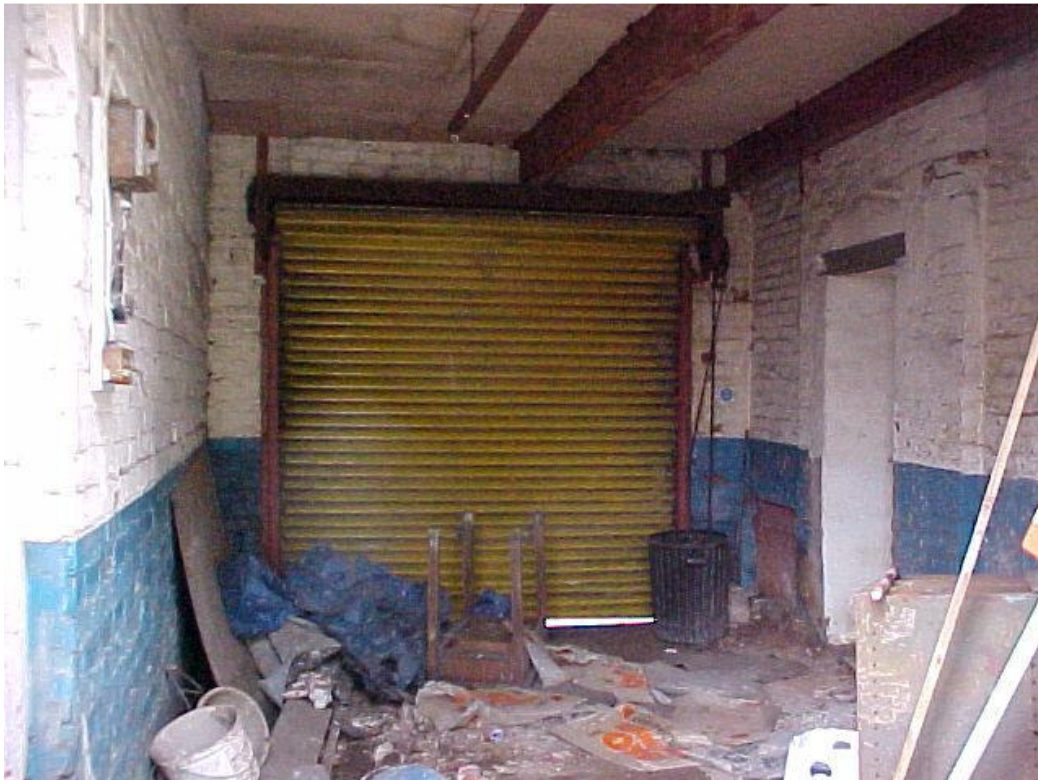
To the south and north of the ground floor were entrances, both with corrugated door curtains (*Fig. 20, northern entrance*). Where visible the ceiling supports consisted of RSJs orientated east west. Areas of the floor level were elevated by c.0.50m (*Fig. 19*). Stairway provided access to the basement level and the second floor. Apart from a leather punching machine (*Fig. 21*) there were no other fittings or features associated with the use of this area.

*Figure 20. Detail shot of interior of main entrance*

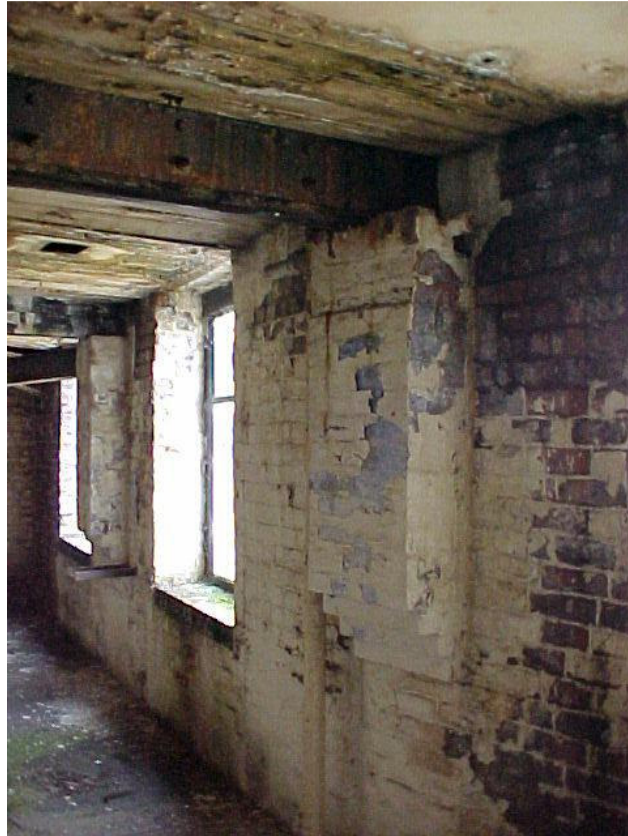
The third floor was also devoid of any work associated fittings or features. This floor consisted of a single large room, with a stair to the fourth floor situated against the eastern wall adjacent to the opening into the external staircase (*Fig. 27*). To the north was a hatchway to the second floor (*Fig. 28*). The ceiling beams were supported by various forms of brick pilaster. Thick brick pilasters were noted near the centre of the room on both sides. These thick pilasters primarily supported the beams along the eastern wall (*Fig. 29 & 30*), to the west two corbelled pilasters were located at the southern end of the room (*Fig. 31*). The wooden ceiling was supported by RSJs.

*Figure 31. Detail shot of corbelled brick support for RSJ beam, third floor*

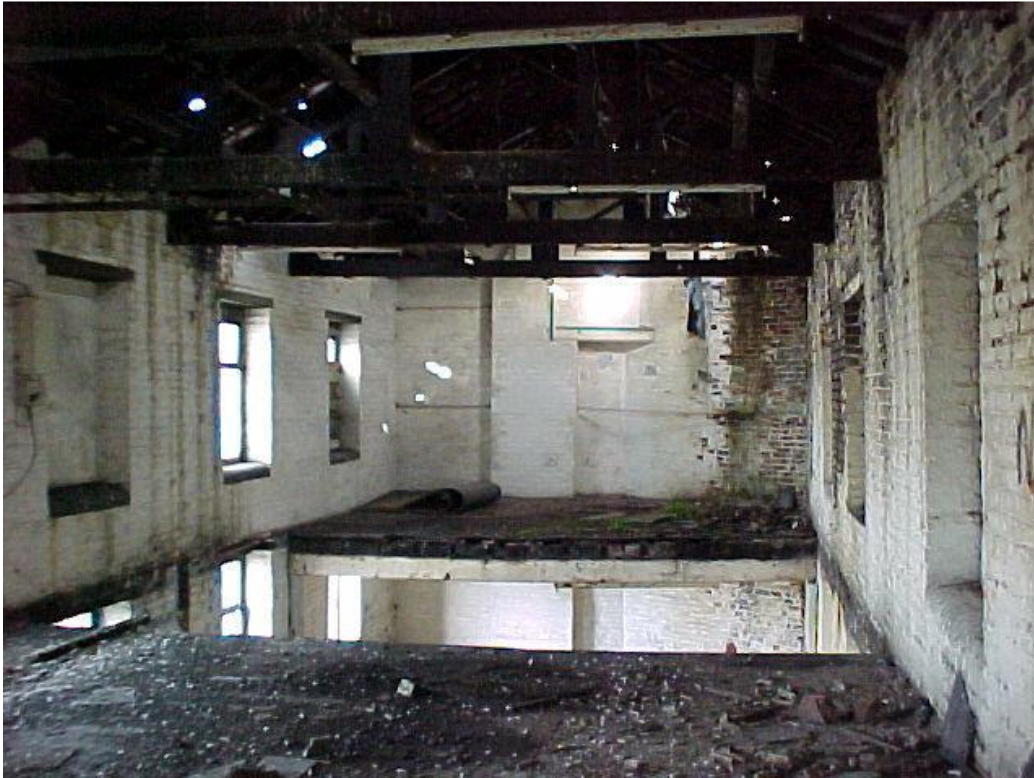
The fourth floor did not contain any fittings or features relating to its use. Part of the floor to the north of the room was missing (*Fig. 33*). The room was accessed via a single stairway from the third floor. The slate roof was supported by Kingpost trusses (*Fig. 34*), which also partially supported the base of the water tower (*Fig. 35*).

*Figure 33. General shot of northern end of room, fourth floor*

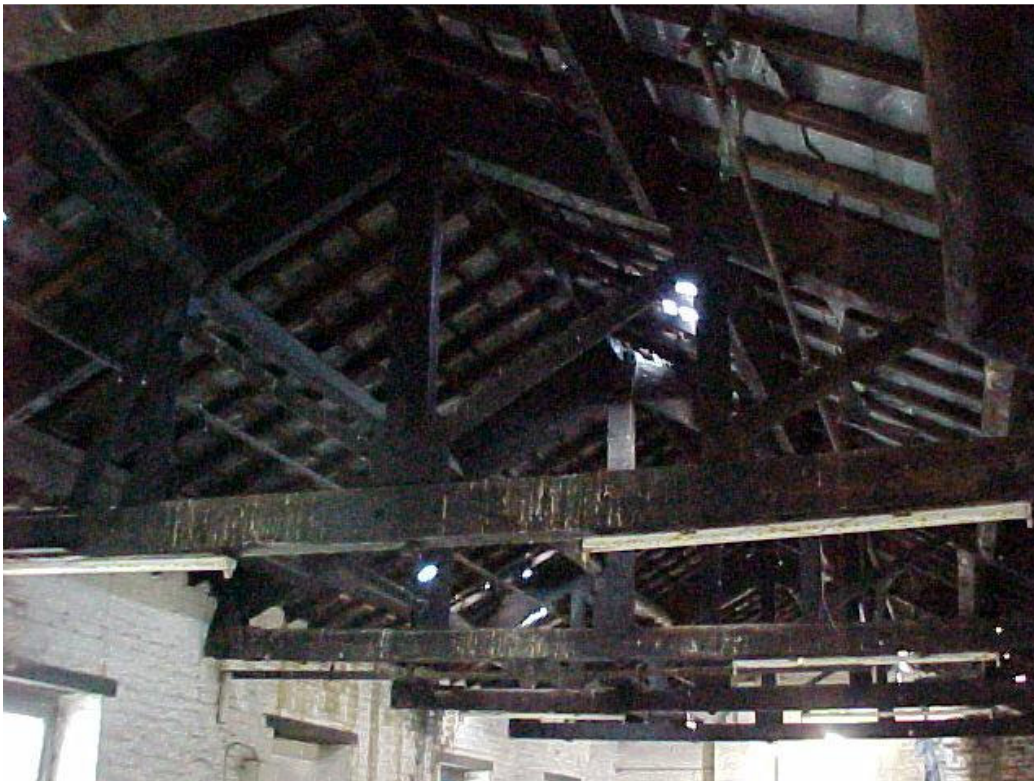
*Figure 34. Detail of kingpost trusses, fourth floor*

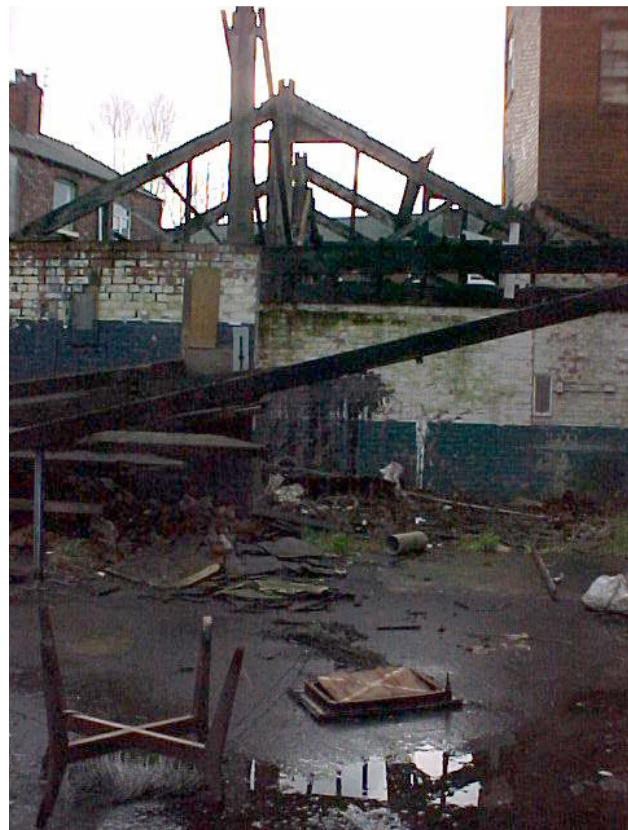
To the east of the works were the remains of a subsidiary building which had a gabled roof, supported by king post trusses. The sheds were separated by a brick wall, which abutted the external staircase (*Fig. 36*). There was no obvious access between the two sheds.

*Figure 36. General shot of north facing elevation in partially demolished sheds*

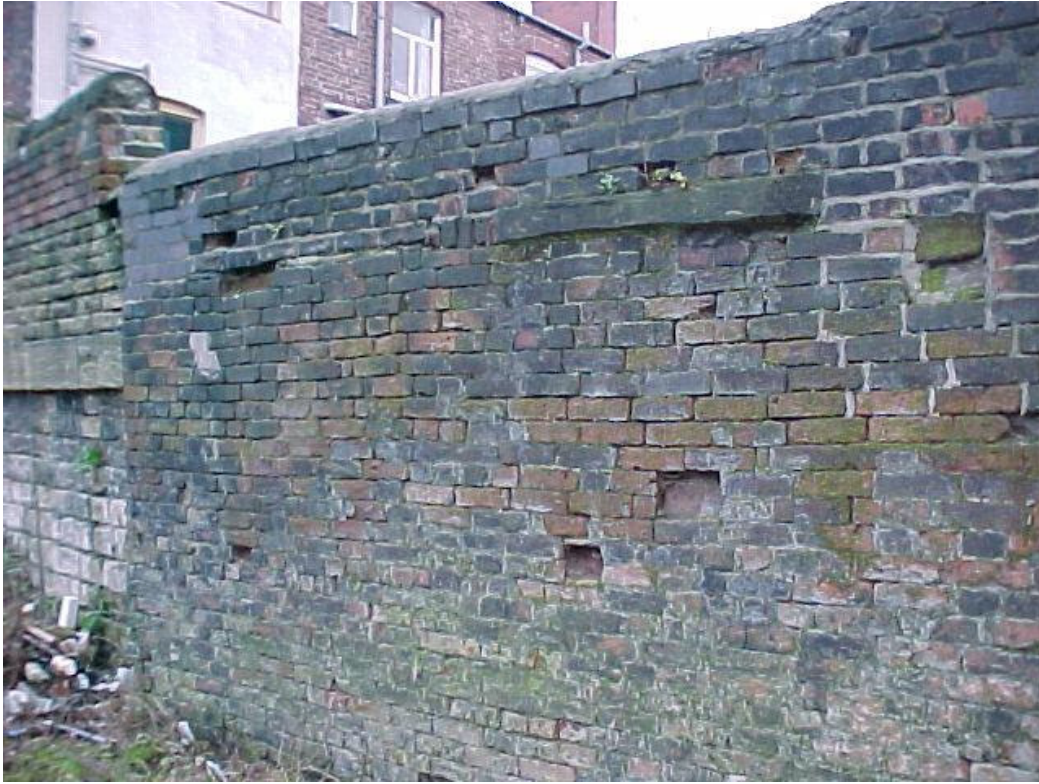
There was little to suggest that any of the works complex dating to this period remained. The towpath wall may have been the only exception with the stretch of wall constructed of handmade brickwork possibly dating to the earlier half of the 19<sup>th</sup> century (*Fig. 43*).

*Figure 43. Detail of towpath/yard wall*

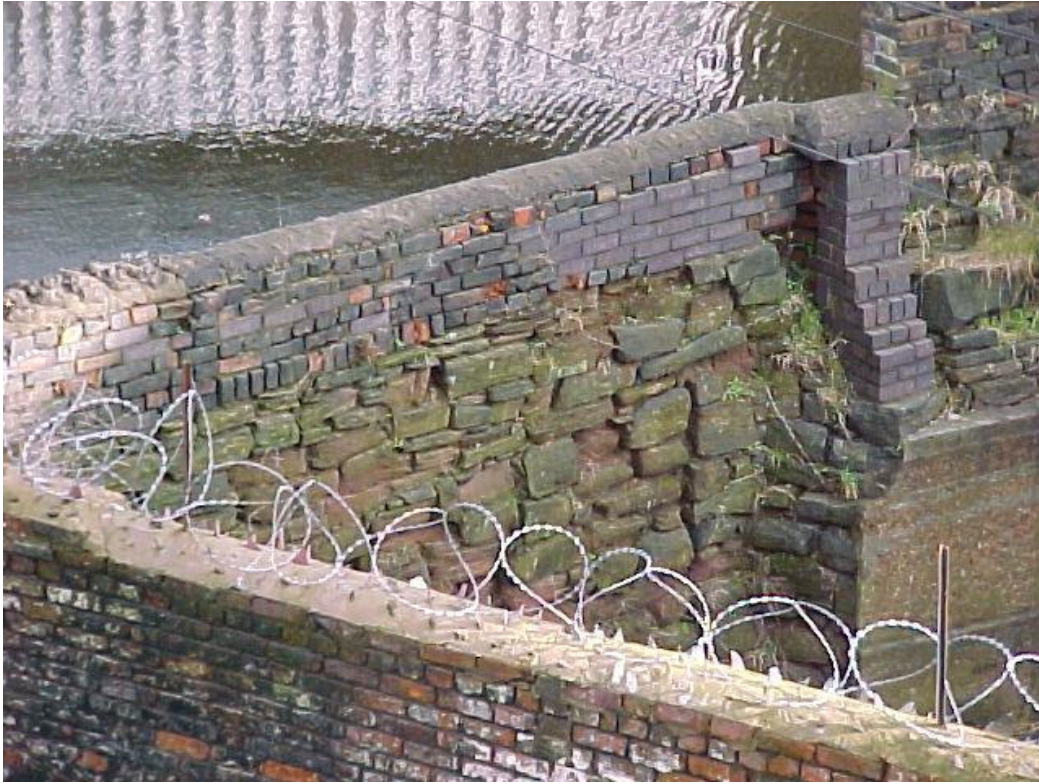
sandstone and roughly constructed brickwork, which appeared to extend to the phase break noted above (*Fig.45*).

*Figure 45. Detail shot of towpath/shed wall*

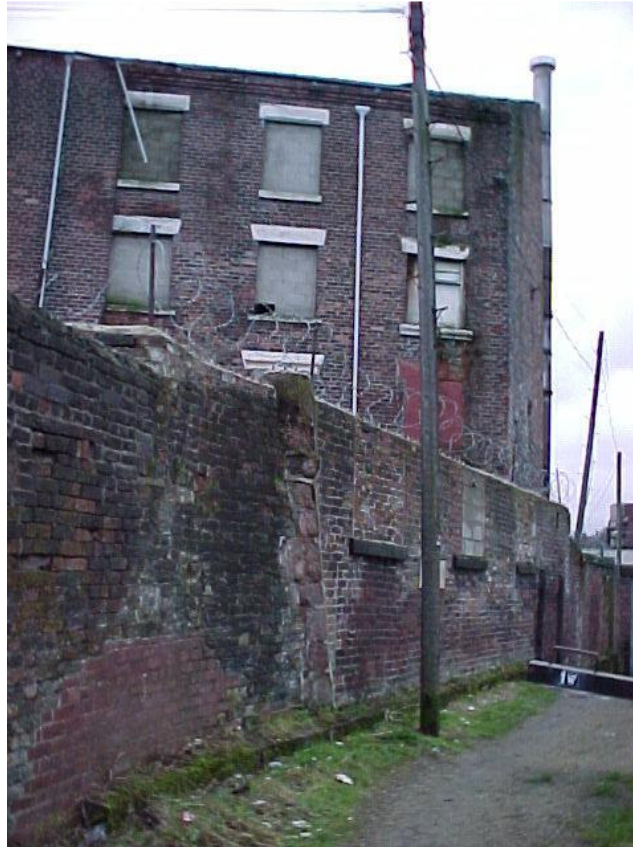
The central section of the towpath/shed wall primarily consisted of red brick in EGWB (*Fig. 46*). This section of wall had been partially demolished, which cut through the three windows set into this part of the elevation. The windows were evenly spaced, with stone lintels and were in-filled with a combination of brick and breeze block.

*Figure 46. General shot of towpath/yard wall*
