**Archaeological  
Building Survey:**

Woods Mill, The  
Narrow Spinning  
Mill, Glossop

**Report No:**  
2015/25

**Document Type:** Archaeological Building Survey

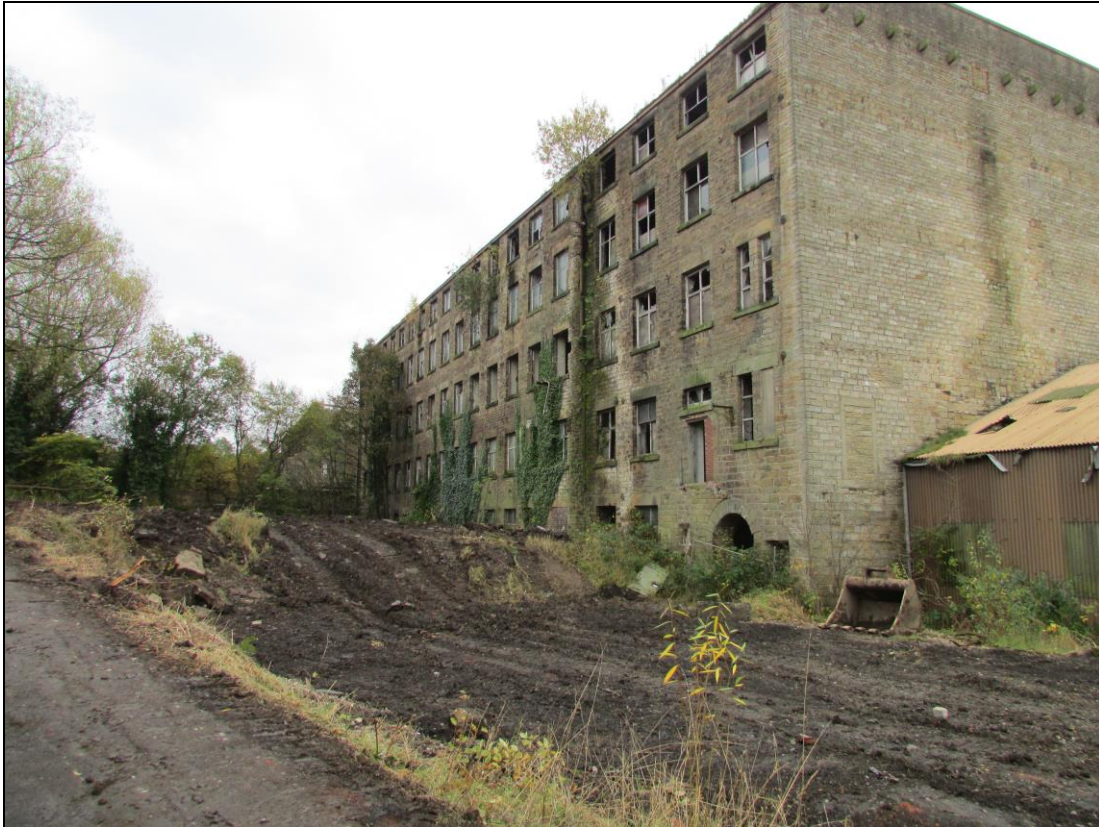
**Plate 1 Oblique shot of the northern elevation**

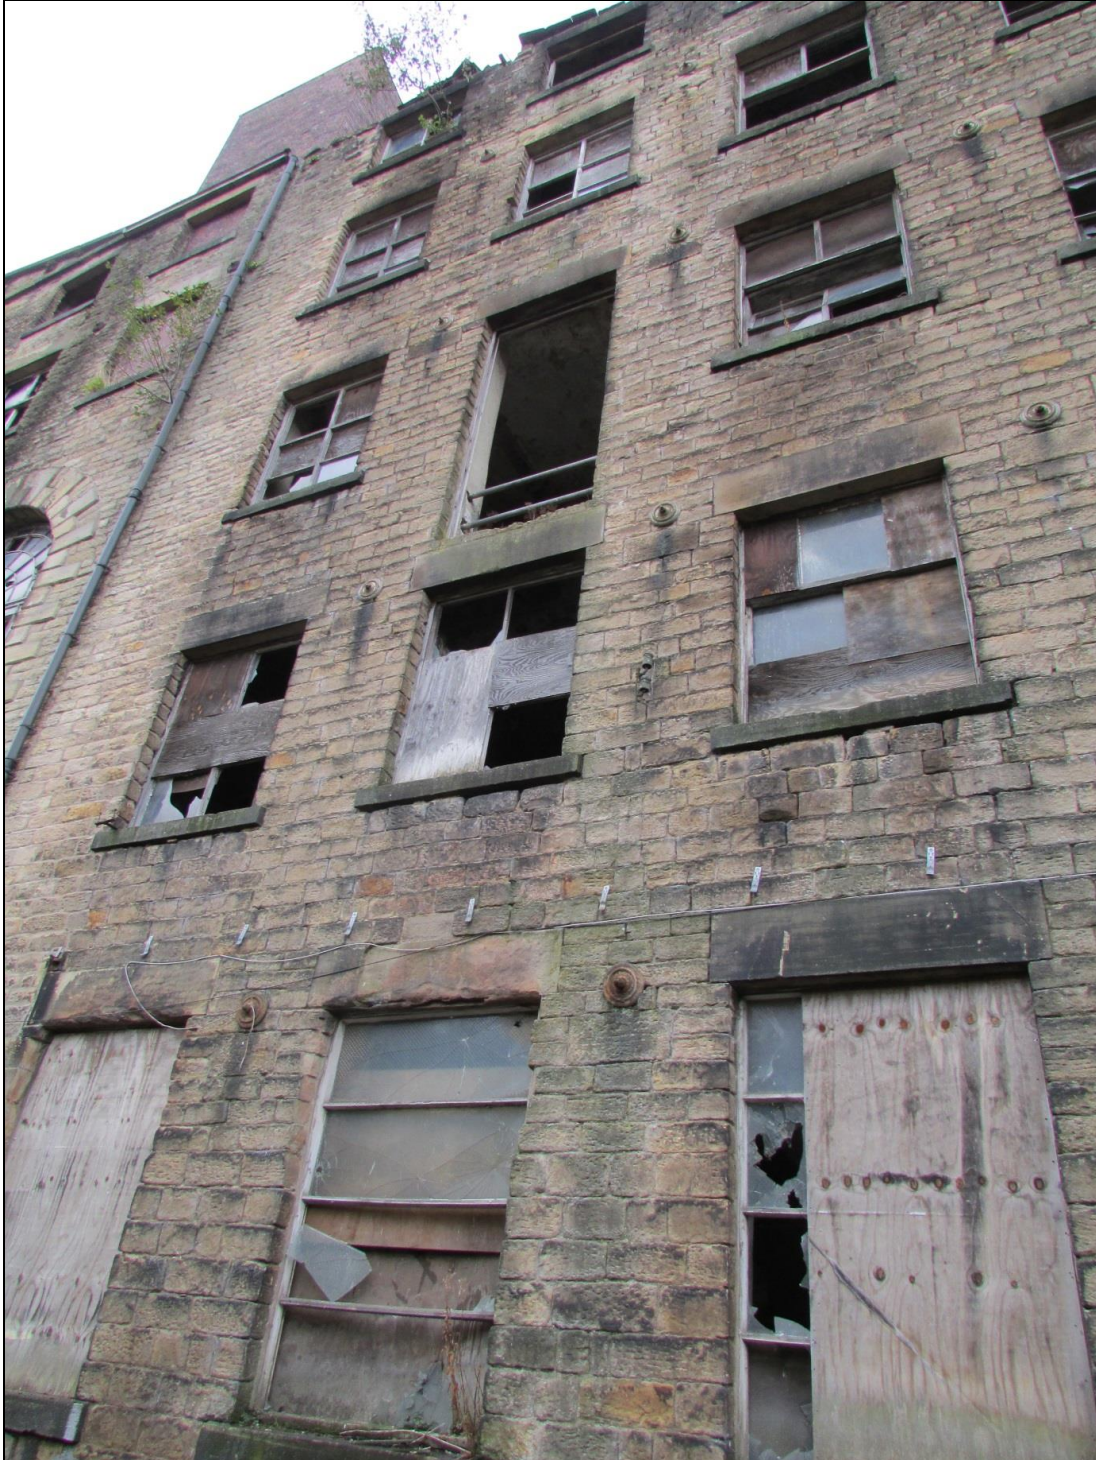
**Plate 2 The modified second-floor window (in the middle)**

and metal lining and located immediately west of the westernmost ground-floor window. The second window from the west on the second-floor appears to have been modified into a possible taking-in door (Plate 2). The change in mortar around where the sill should be indicates this modification. The third window from the east on the ground-floor has also been modified into an entrance (Plate 3). The original entrance to the building is located within the covered archway at the eastern end of the building (described below as part of the office block) and consists of a chamfered stone surround with a step up (Plate 4). Overall, the entrance measures 2.60 x 2.00m (including chamfering) and the door frame was wooden. This also appears to have been modified with the addition of a possible sliding door, although only part of a wooden frame was evident.

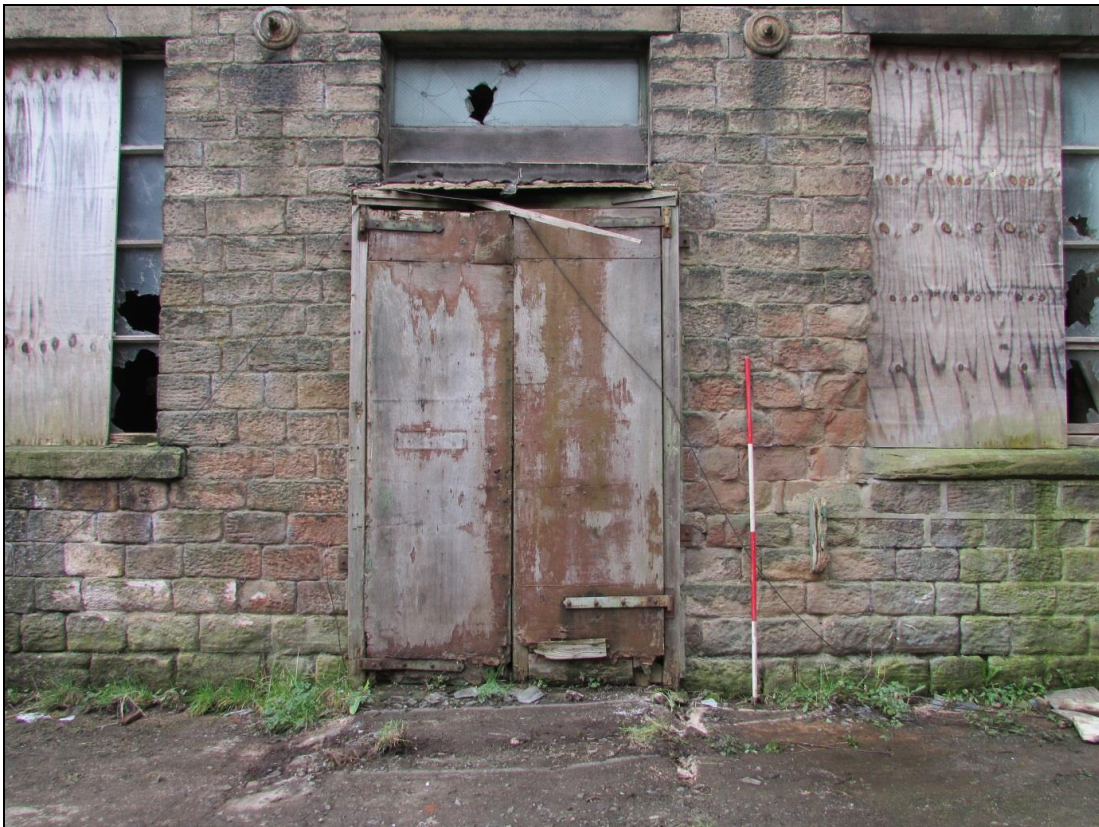
**Plate 3 Window on the ground-floor of the mill, later modified into a door**

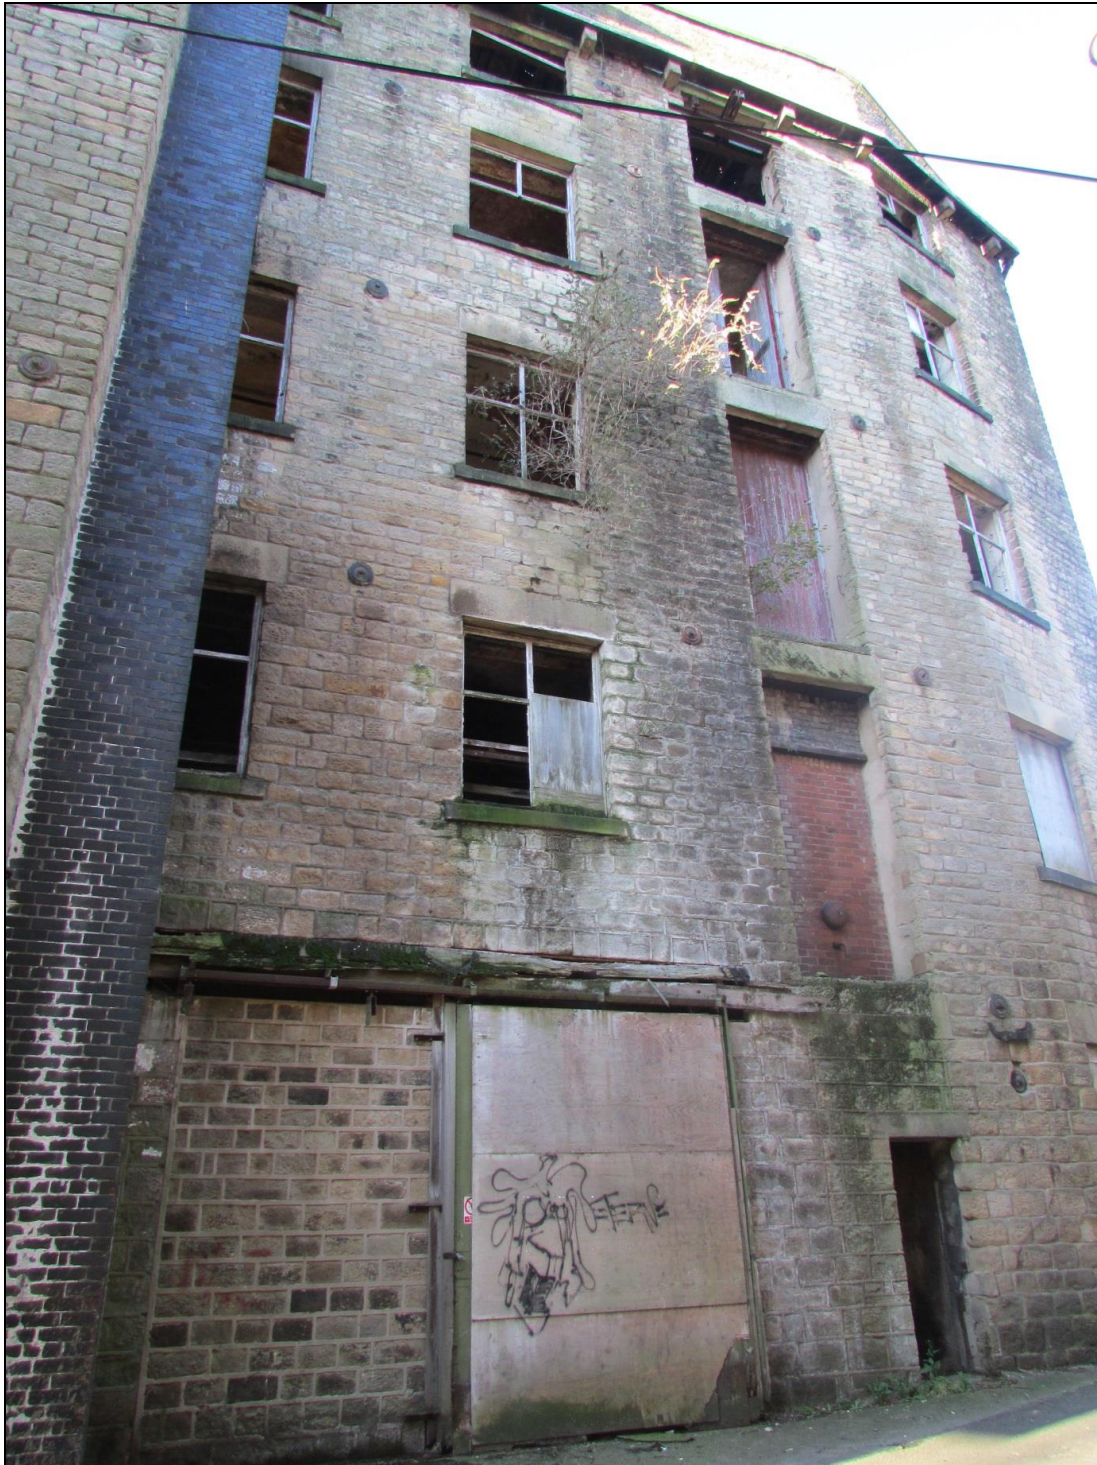
**Plate 5 Eastern elevation with taking-in doors and modified ground-floor entrance**

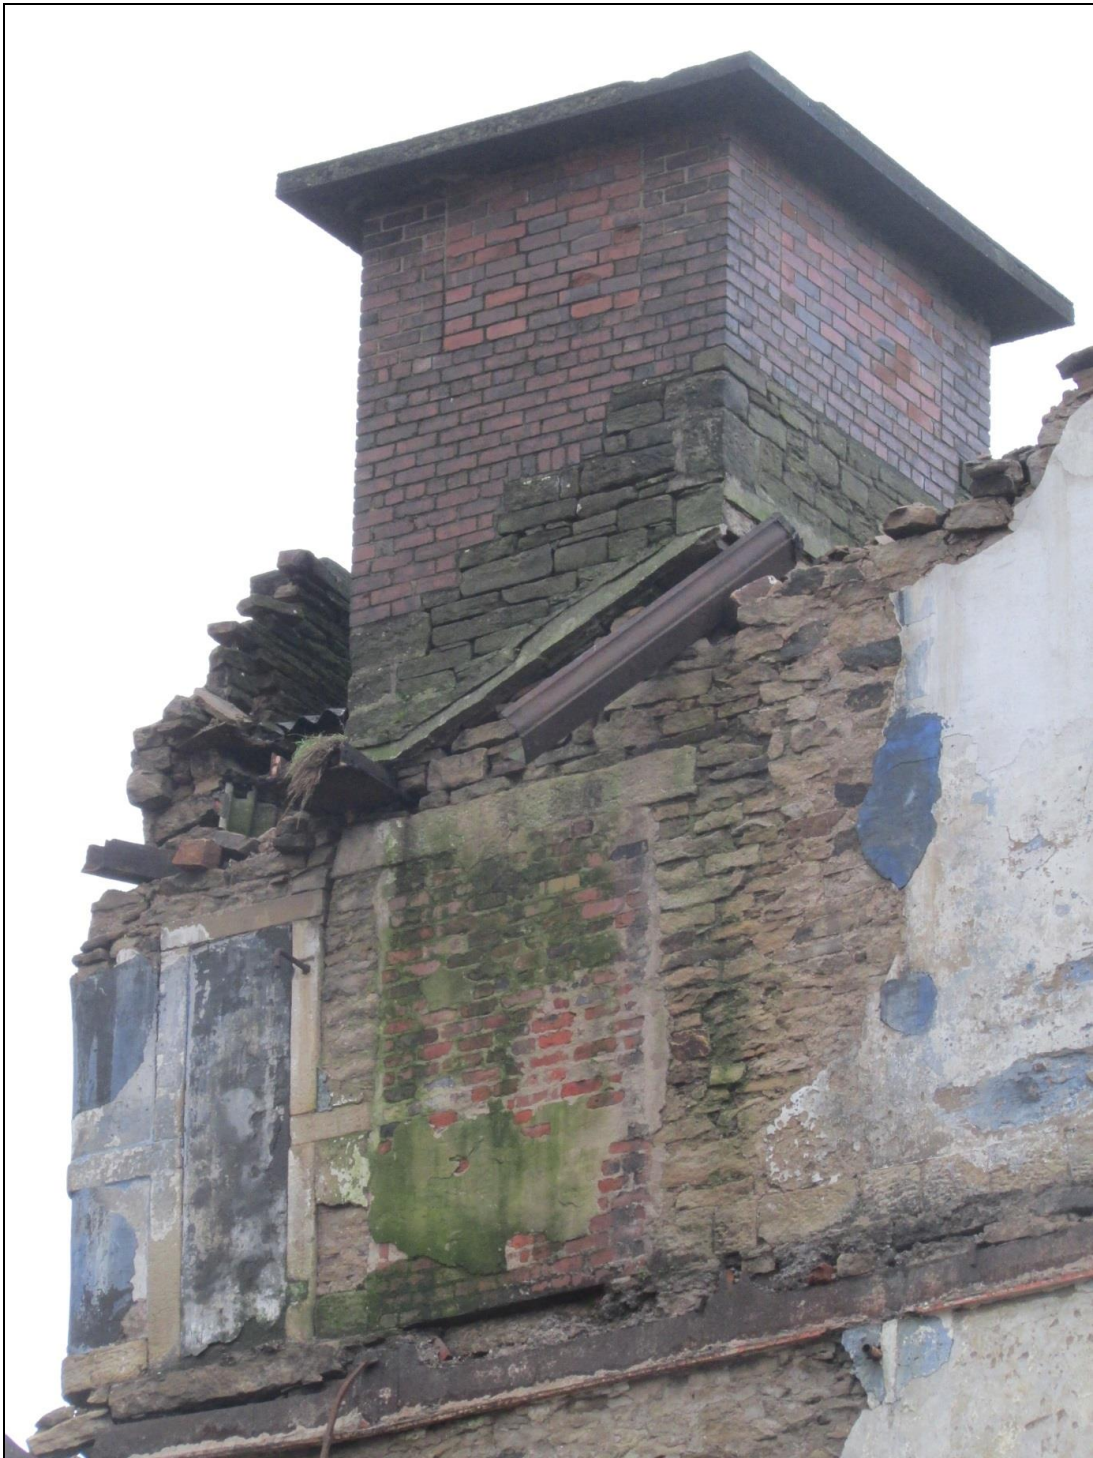
brick, with blocked apertures (Plate 6). The southernmost bay in the east elevation consists of ten windows (measuring 1.20 x 1.00m) in two parallel lengths, offset from each other.

**Plate 6 Close-up of the eastern lift shaft headgear shows the partial reconstruction in brick, as well as subsequent blocking of apertures**

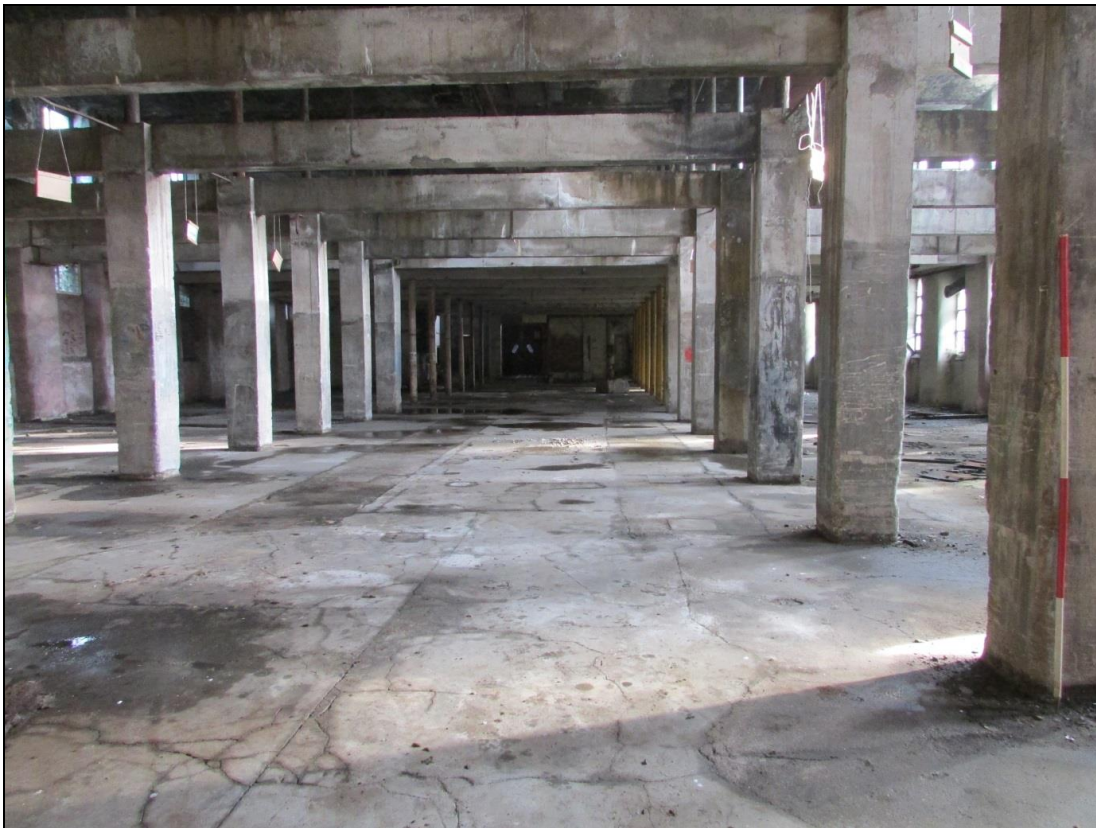
**Plate 7** The iron columns at the western end of the mill were encased in concrete

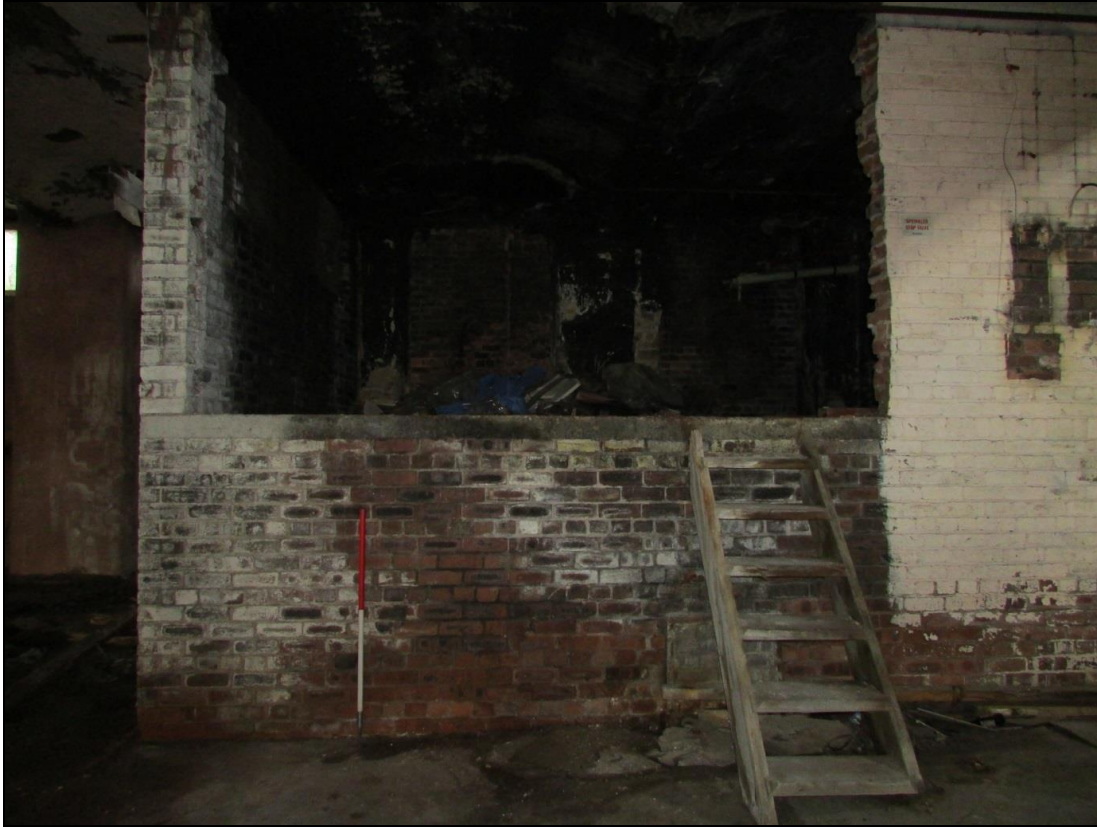
**Plate 9 Later machine made brick sub-divisions in the north-east corner of the mill included this storage area and a toilet block to the east**

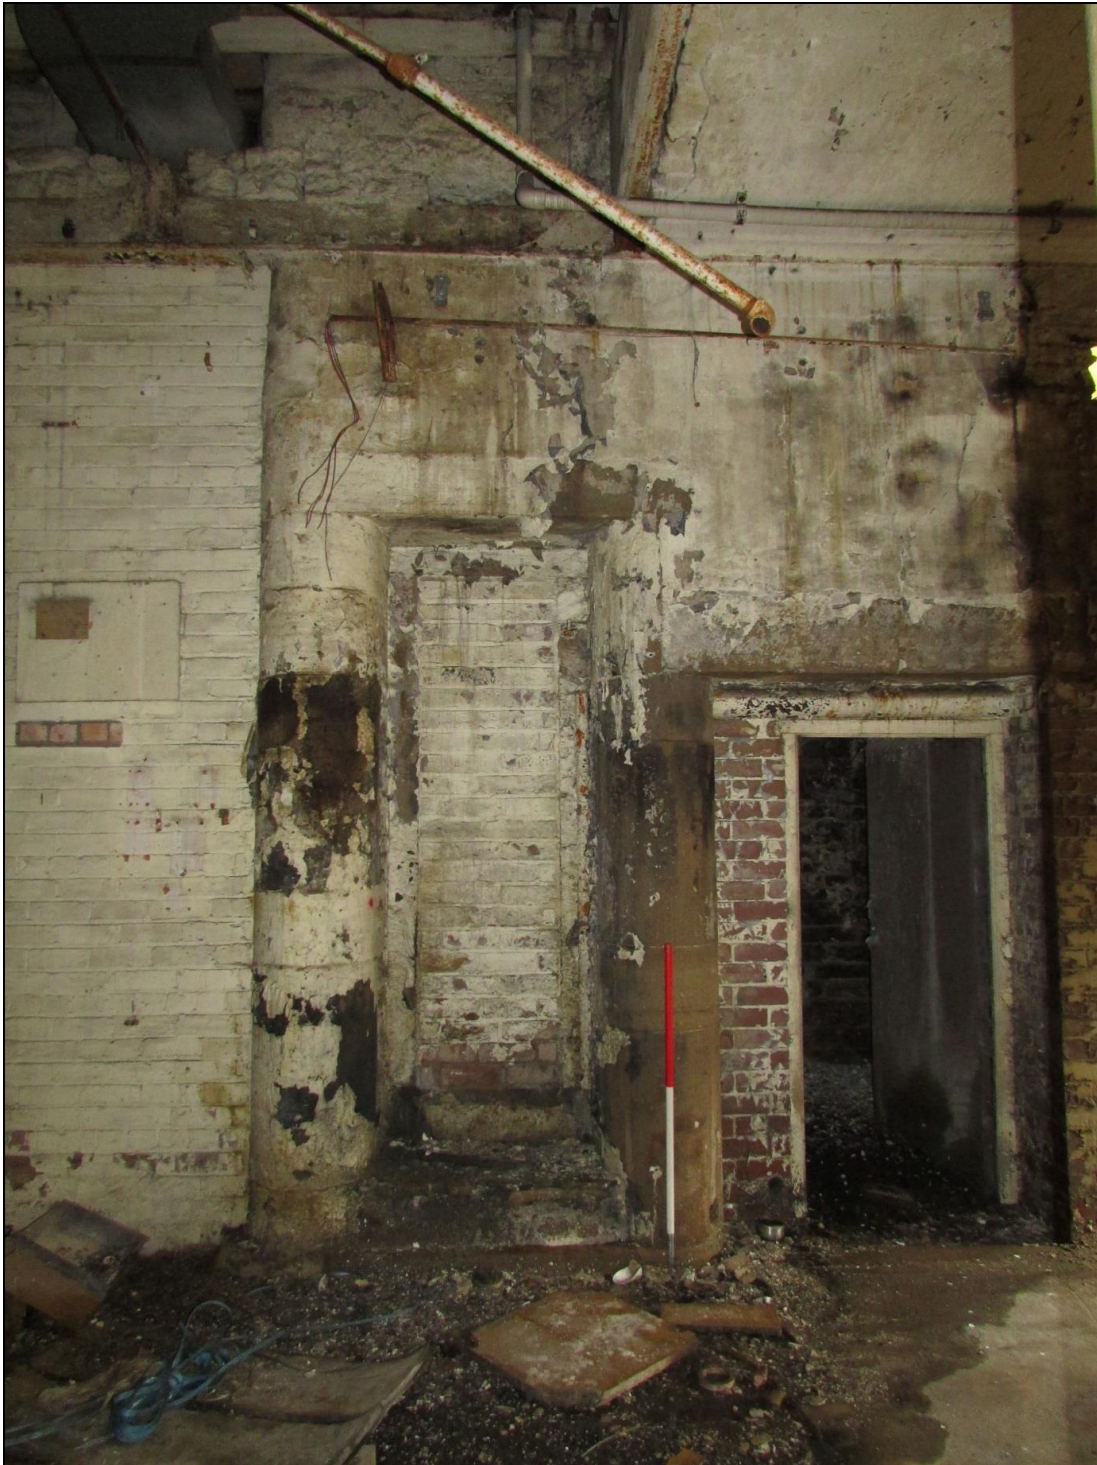
Where the eastern elevation steps out, this is evidenced by a blocked entrance into what was the privy tower (Plate 10) The entrance frame was almost column-like with two steps visible before the machine-made brick blocking is evident. Immediately south of this entrance was the entrance to another small room (which was not accessed due to health and safety issues). A stone lintel had been inserted and truncated the southern privy entrance column. This entrance was modified later still using machine-made brick, supporting a wooden frame.

**Plate 10 Blocked entrance into the former privy tower, with the later entrance to the lift shaft on the right, subsequently made smaller**

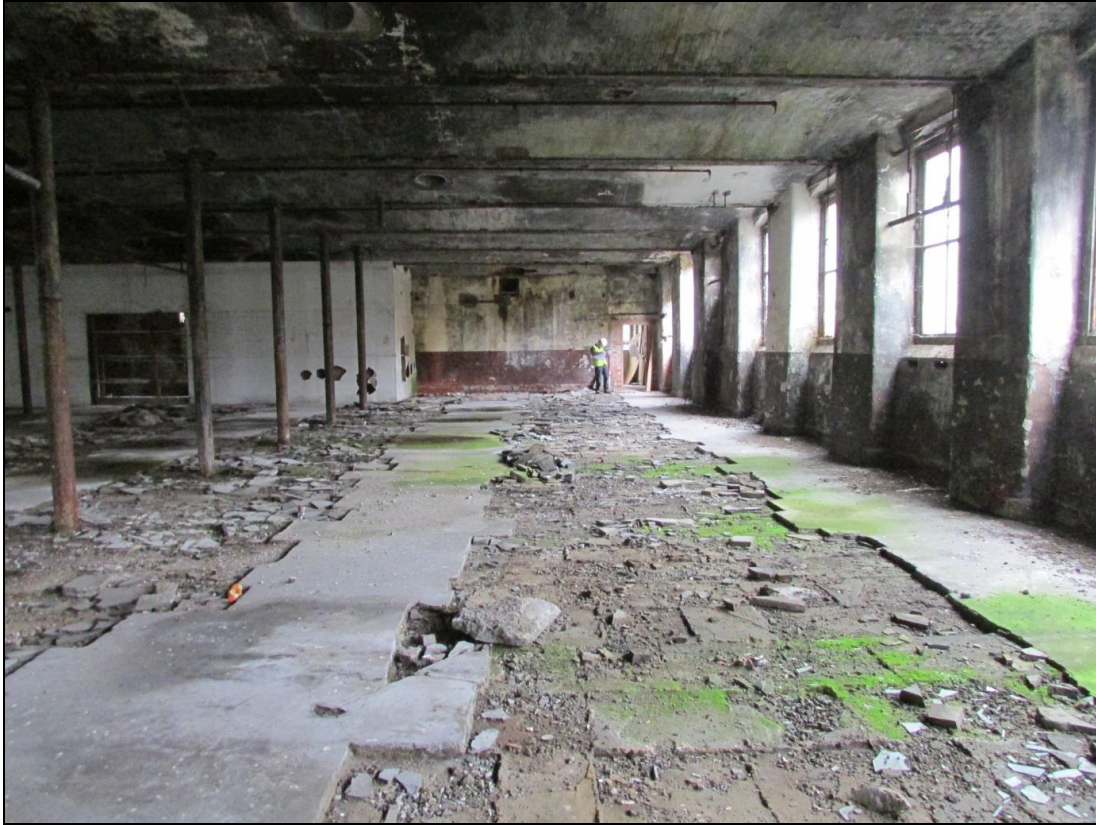
**Plate 13 Robbed out flagged flooring on the first-floor**

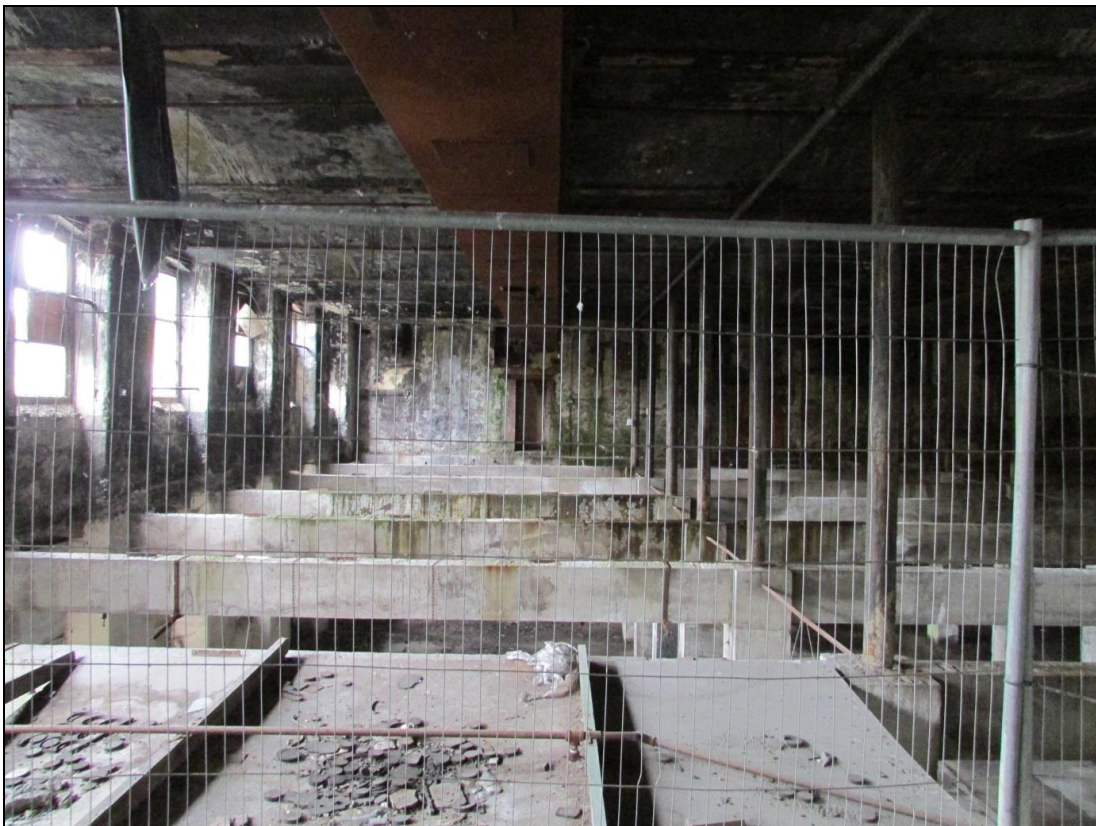
**Plate 14 The first-floor in the western half of the mill was removed at a later stage**

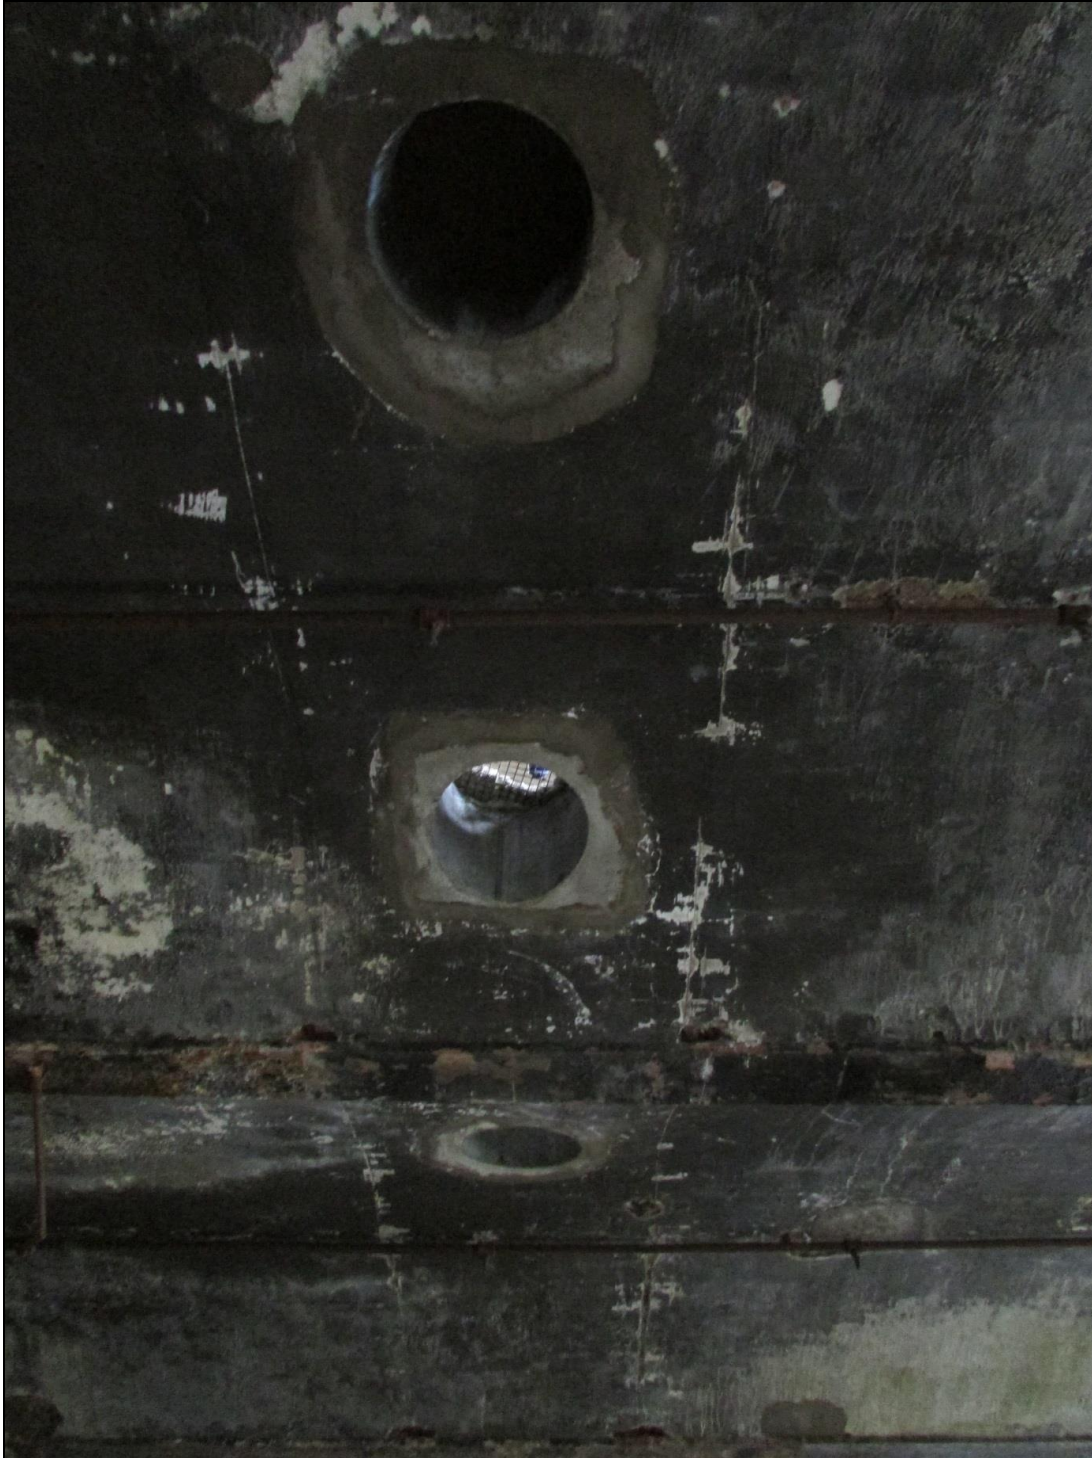
**Plate 15 Small circular apertures inserted at a later date into the first-floor ceiling**

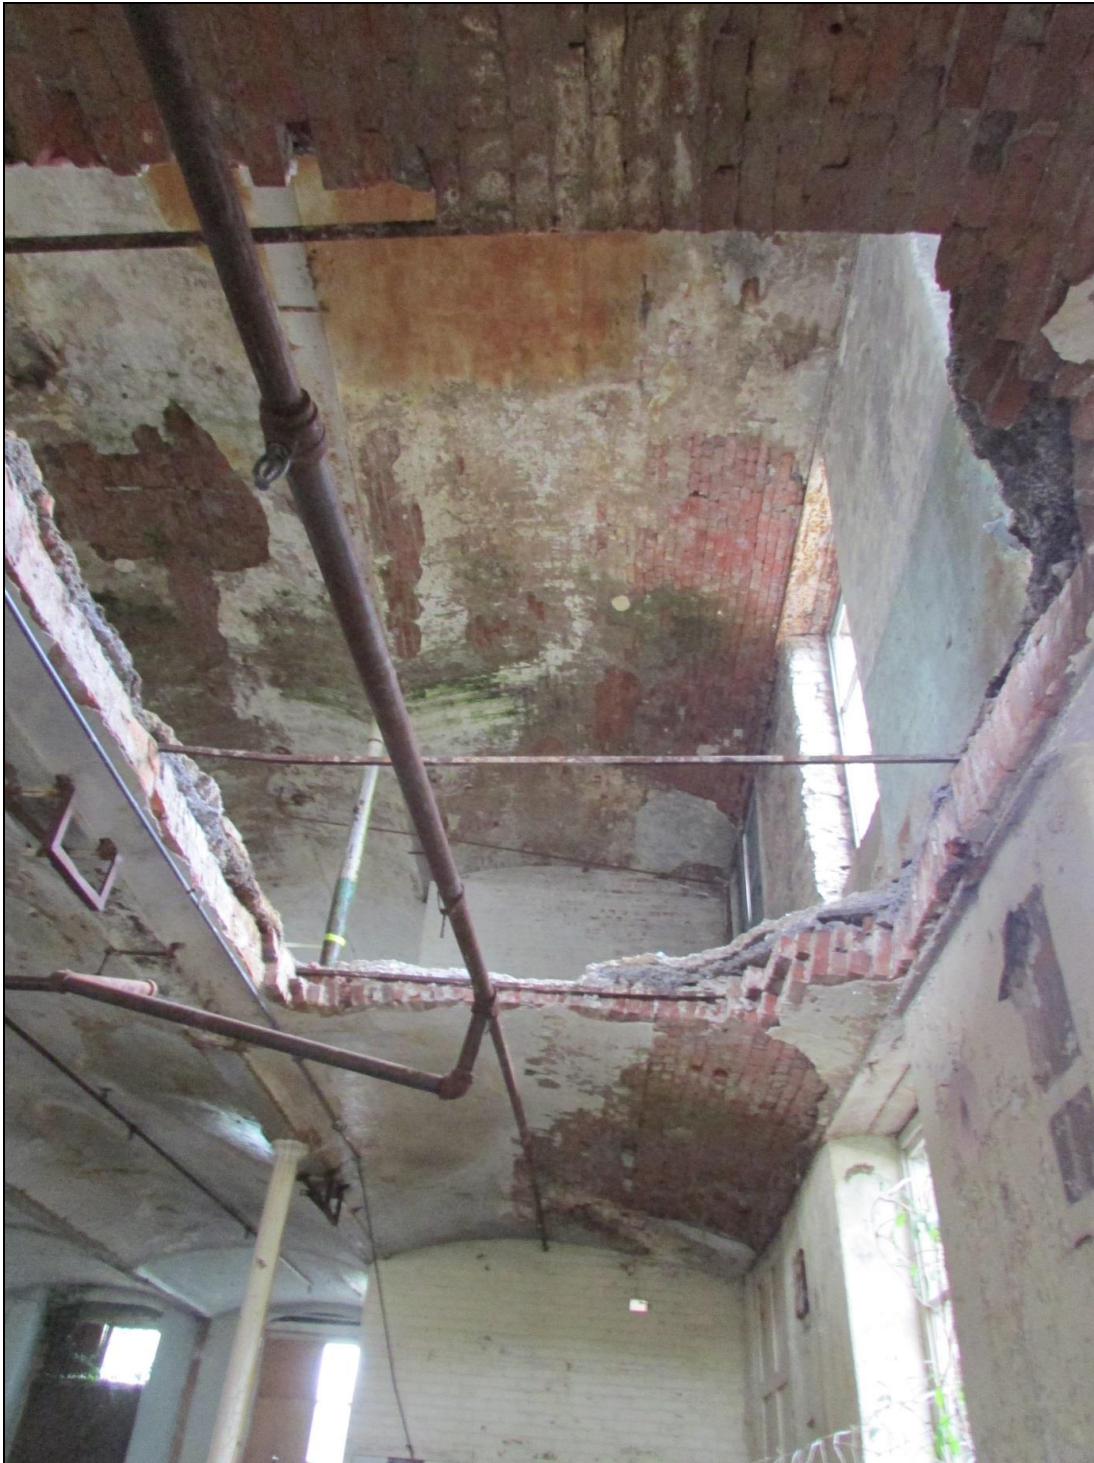
**Plate 17 A small part of the second-floor ceiling had collapsed within the eastern part of the mill, exposing the metal tie-beams integral to the fireproof arches' structure**

(Plate 17). The columns continued in the same pattern as seen on other floors (30 in two rows of 15) and the fireproof ceiling was the same as seen on other floors. There was plaster on the ceiling, which was generally in good condition although there was blackening along the north line of columns.

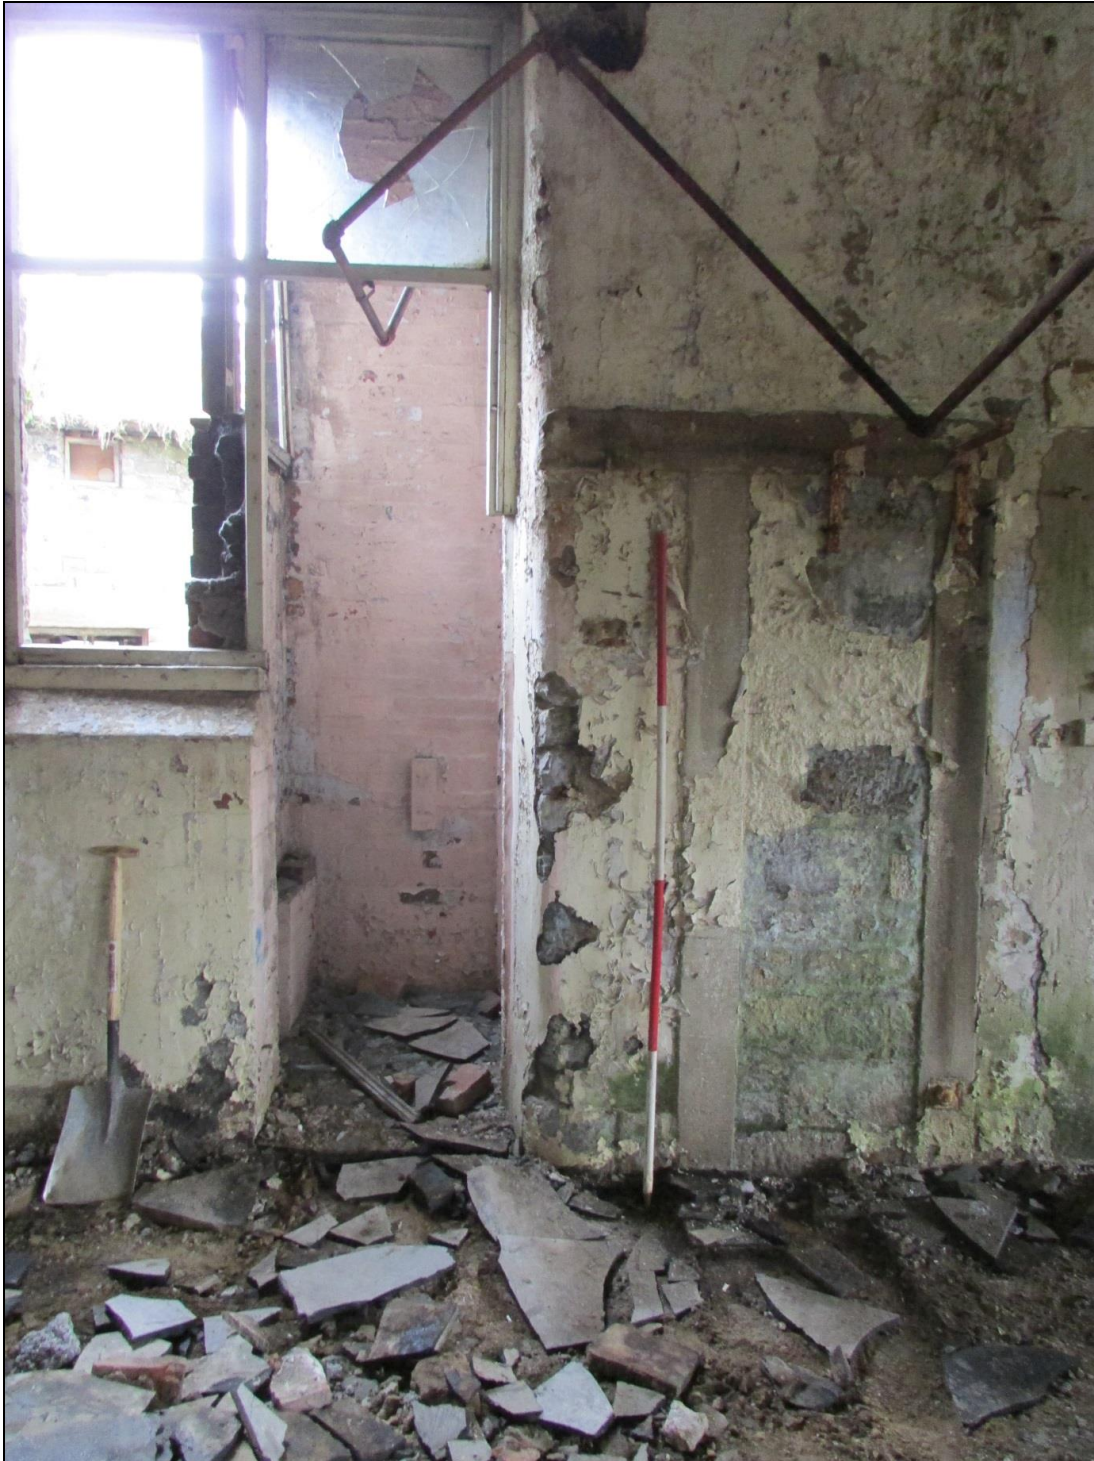
**Plate 21** The entrance on the left leads into the privy tower extension and the blocked entrance led originally into the privy tower

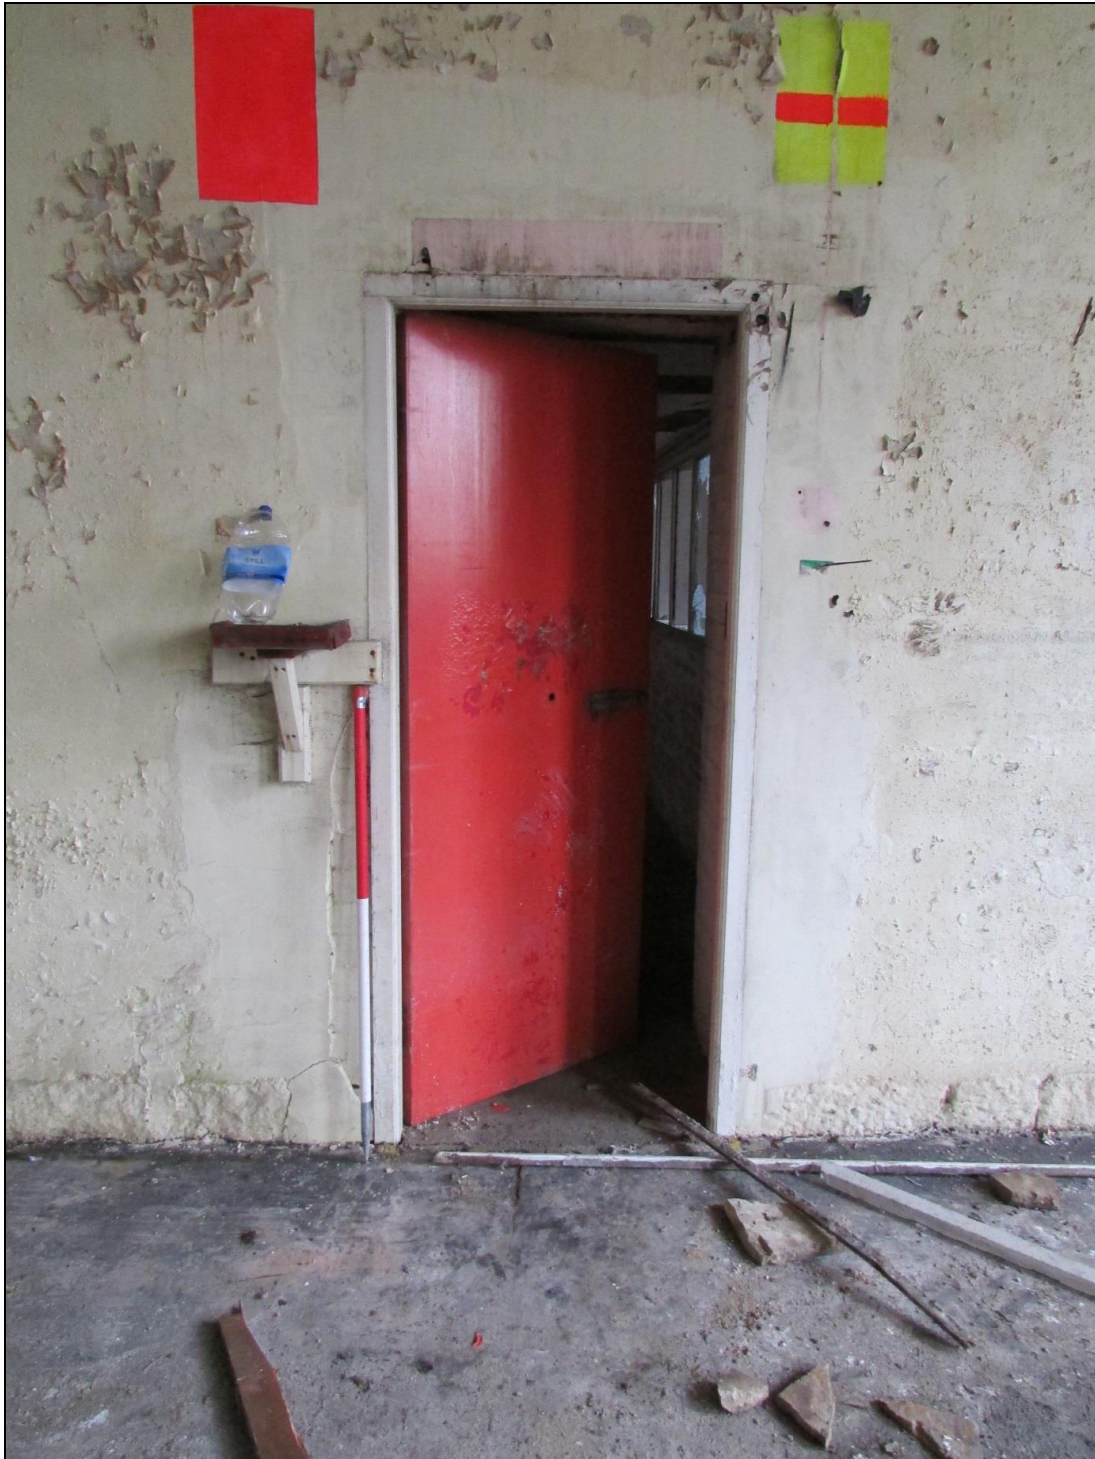
**Plate 24** Later inserted entrance into the northern part of the engine house on the second-floor

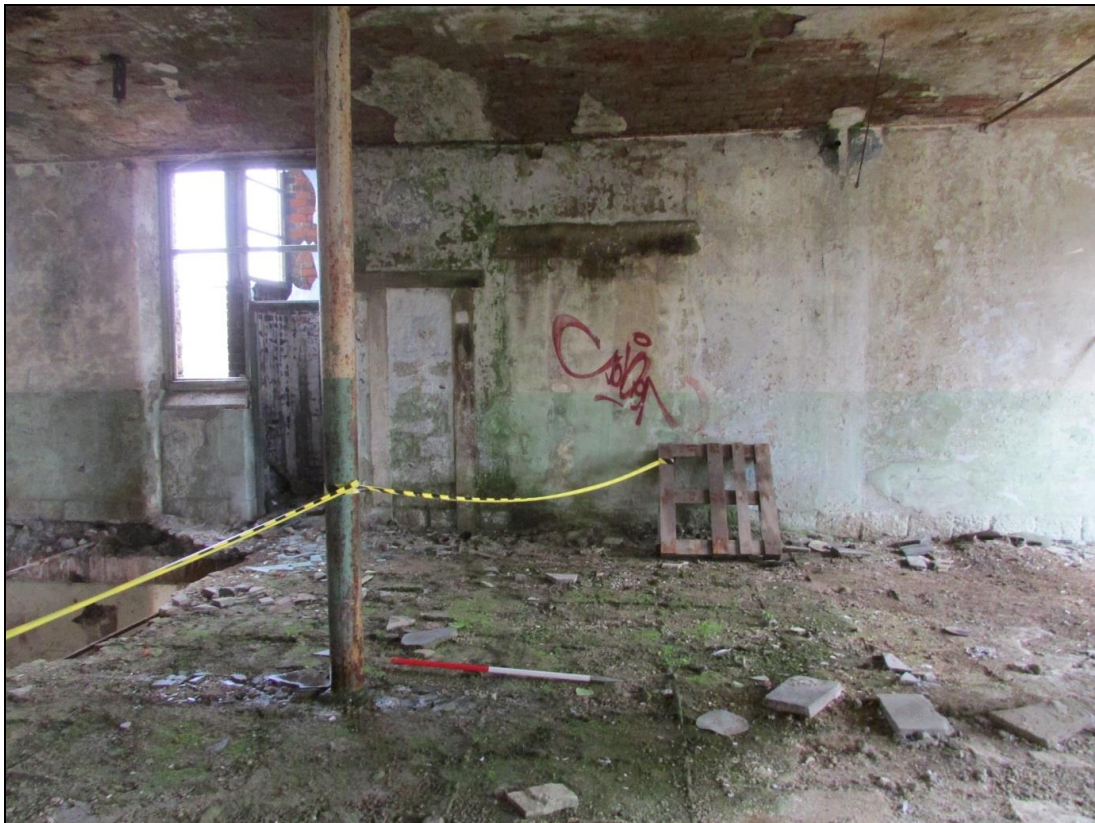
A small toilet block, constructed from machine-made brick was located at the north-eastern corner. A wooden taking-in door was located within the eastern elevation immediately south of the toilet block. As seen on the second-floor, there was a later entrance into the privy tower extension which had truncated a window and its sill. Immediately south were two blocked entrances, with the southerly most one wider although due to the floor collapse (Plate 25).

**Plate 25** The later entrance to the privy tower extension is evident to the left, with two former entrances blocked to the right

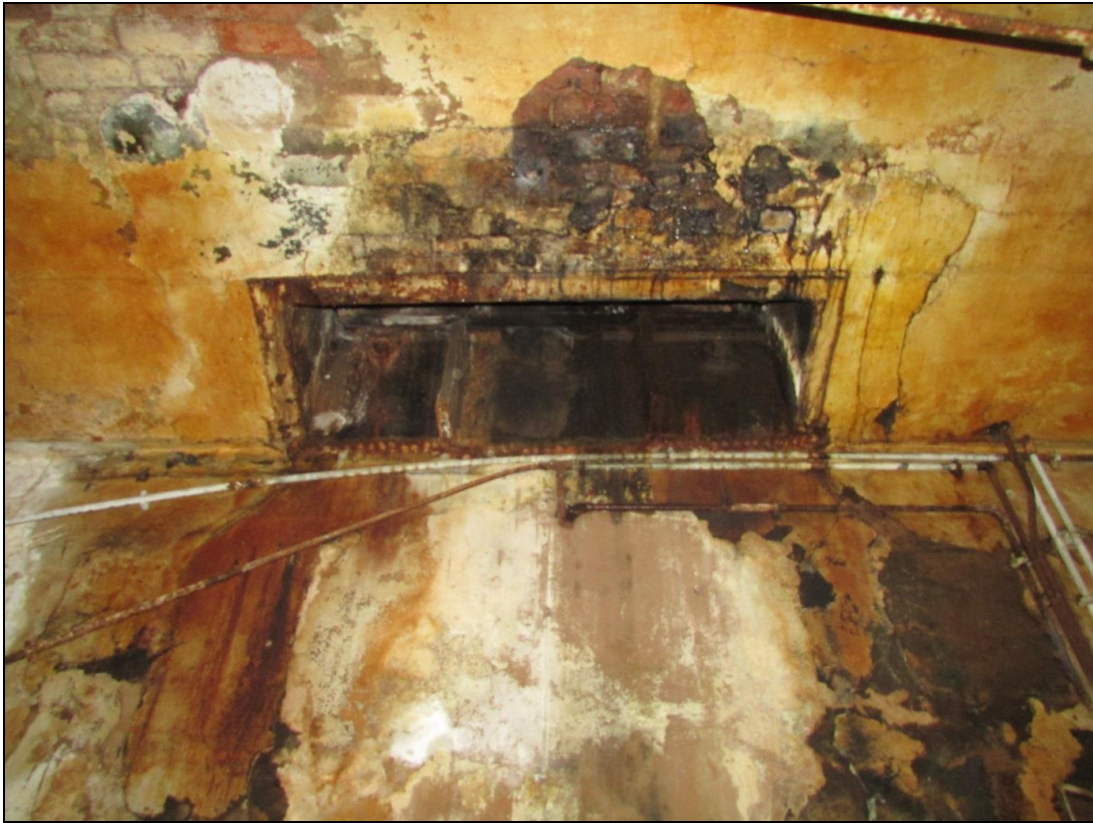
**Plate 26 A metal lined aperture inserted into the ceiling on the third-floor**

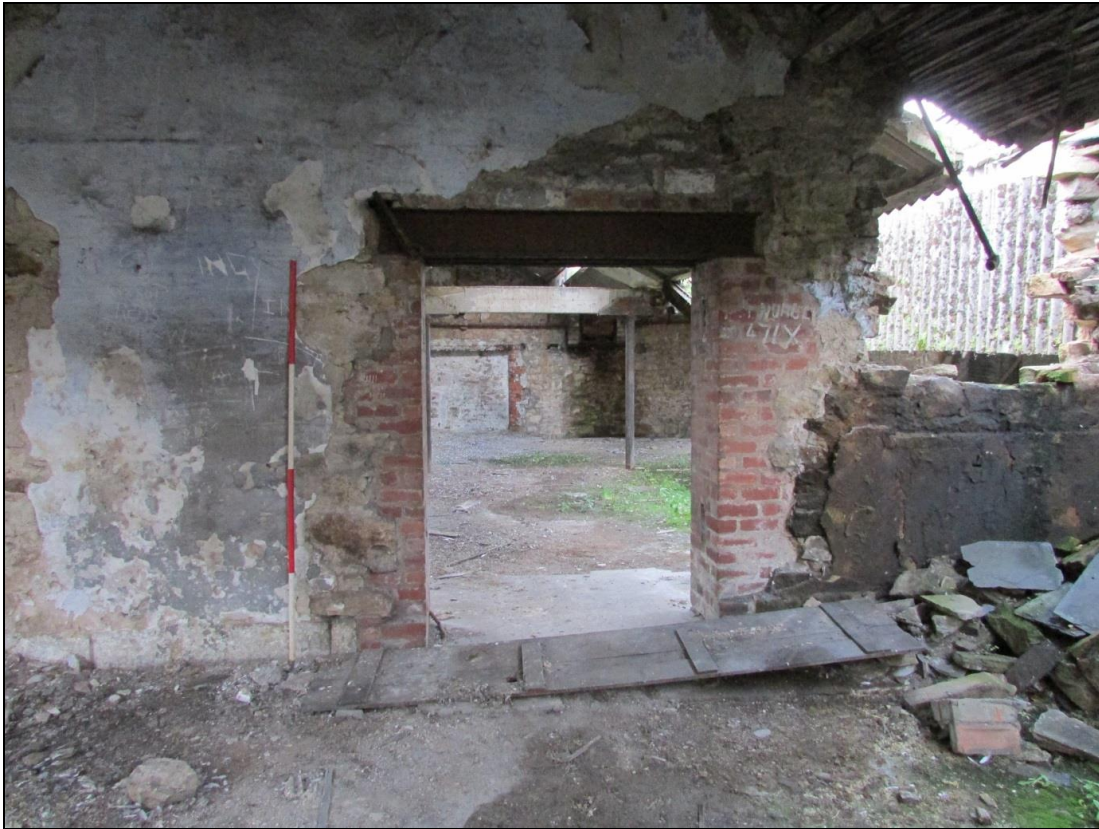
**Plate 30 An inserted entrance into the engine house and position of robbed out top steady bracket (to the right)**

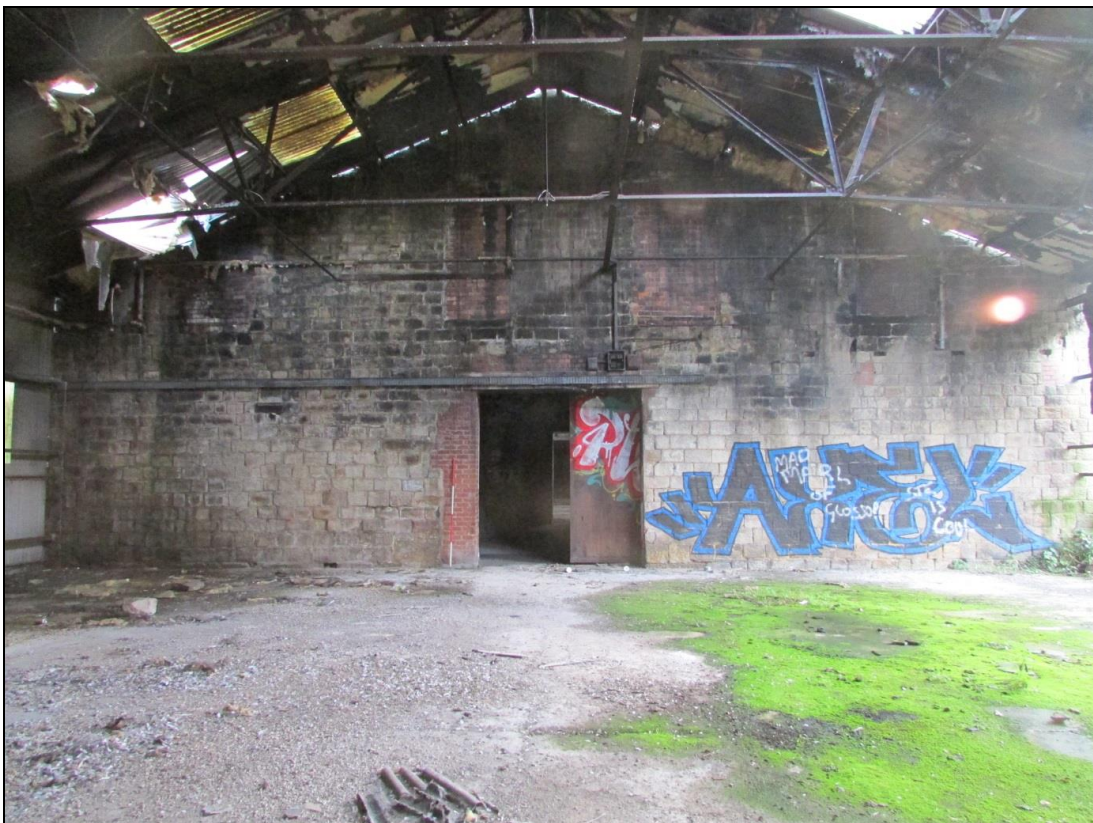
**Plate 33** Close up of inserted ground floor entrance and blocked entrances on the first-floor
