**Archaeological  
Building Survey:**

Woods Mill, The  
Narrow Spinning  
Mill, Glossop

**Report No:**  
2015/25

**Document Type:** Archaeological Building Survey

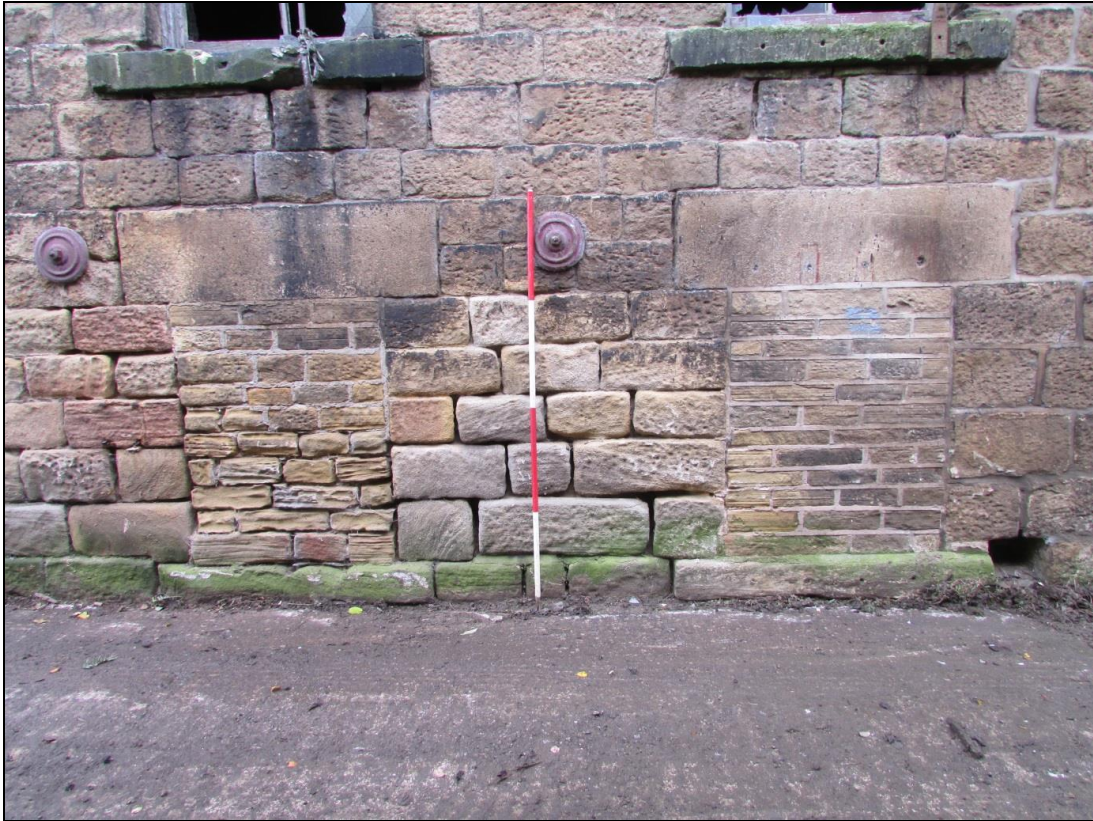
The two ground-floor bays in the western side contain four windows with plain flat stone lintels and slightly projecting sills. The two lower windows have been blocked with undressed regularly coursed sandstone (Plate 36). The two windows on the first-floor are the same as observed on the southern elevation of the mill. On the second-floor, the bay immediately west of the fanlight is taller and has a projecting I-section RSJ cat head retaining an *in situ* block. The westernmost bay differs again, with a smaller four-light bay below an aperture 0.30m wide with a dressed stone surround, possibly for an earlier hoist. This has a wooden taking-in door with an iron

**Plate 36 Two former windows blocked up on the ground-floor of the engine house**

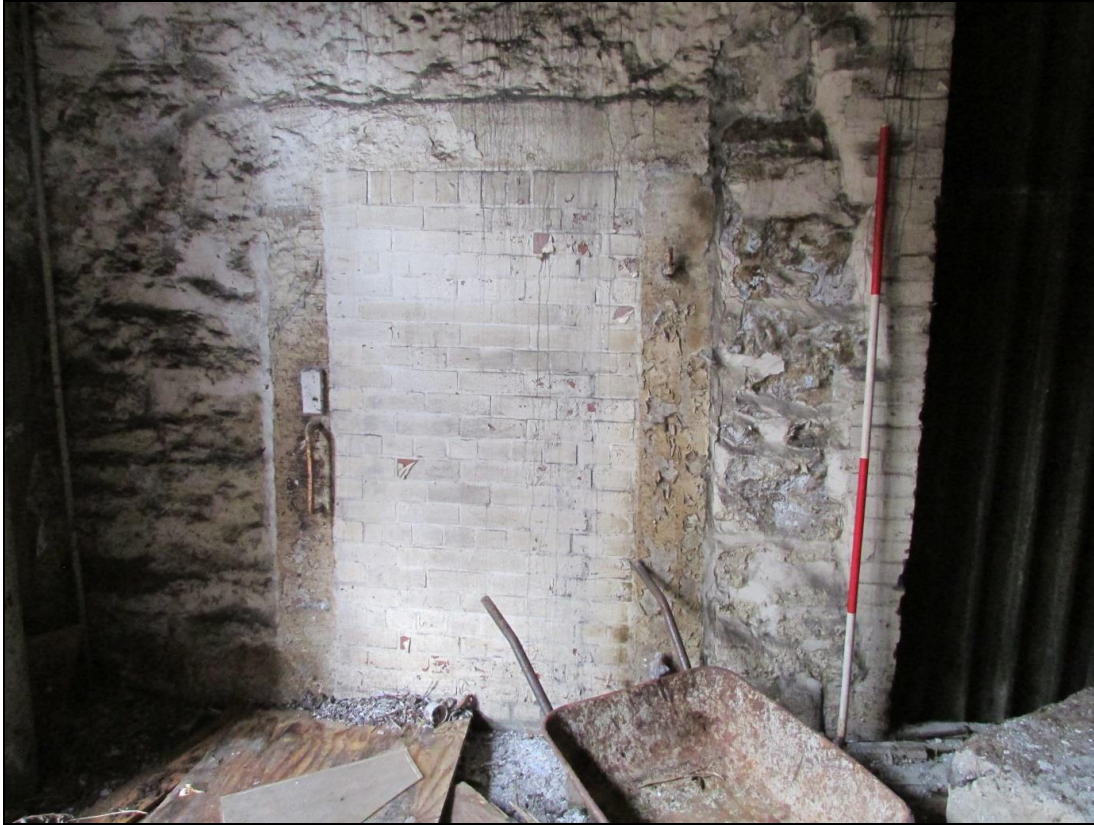
**Plate 39 Blocked entrance located within the engine house dividing wall**

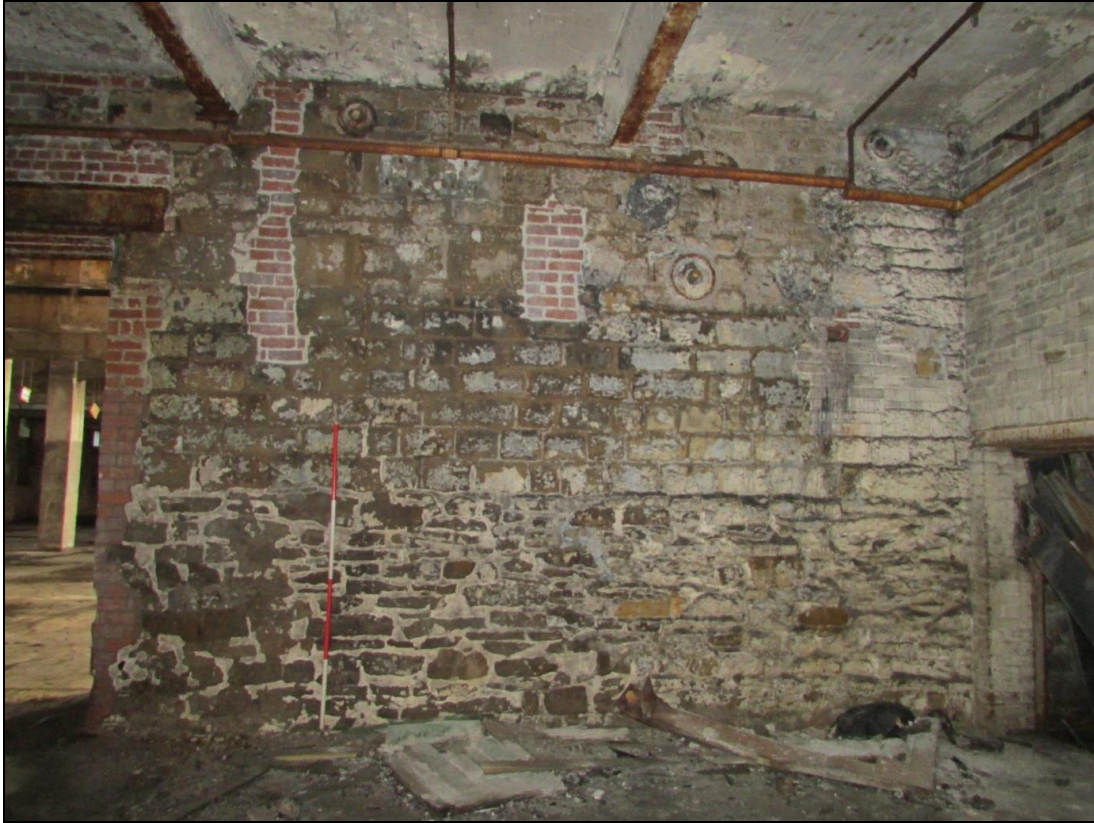
The gearing wall located between the engine house and the mill is a mix of coursed rough ashlar stones and uncoursed random rubble. There are several possible repairs using machine-made brick (Plate 40). The south-east room had a flat roof, possibly constructed of timber although this was obscured by white plaster, with iron beams running east/west (Plate 41). A machine-made brick lift shaft was inserted in the south-east corner which crosses all floors (Plate 42). Built into the gearing wall are very large rough ashlar blocks with a machine-made brick blocking a bearing box. There appears to be two phases as the mortar used between the upper and lower parts are different (Plate 43). Opposite this in the dividing wall was another blocked bearing box (Plate 38).

**Plate 40** Examples of later brick repairs within the gearing wall, possibly after removal of the engine

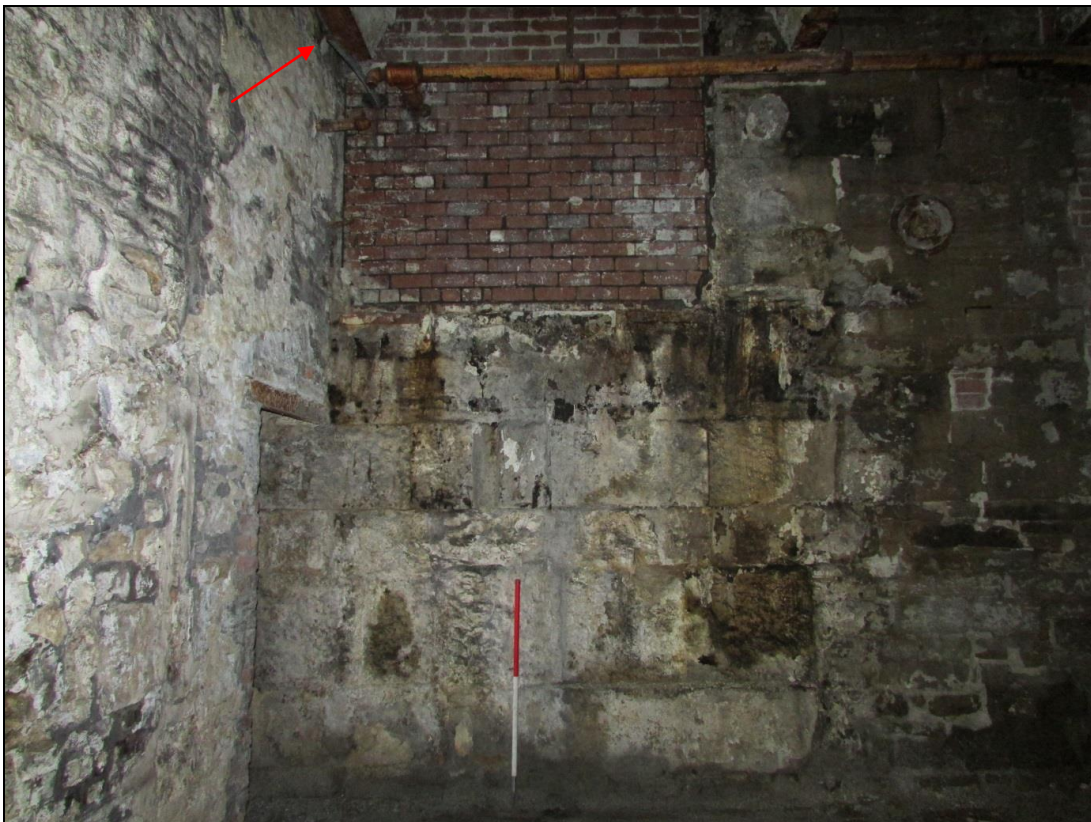
**Plate 43 Blocked footstep bearing, with part of the later ceiling visible (the beam (arrowed) abuts the brick blocking)**

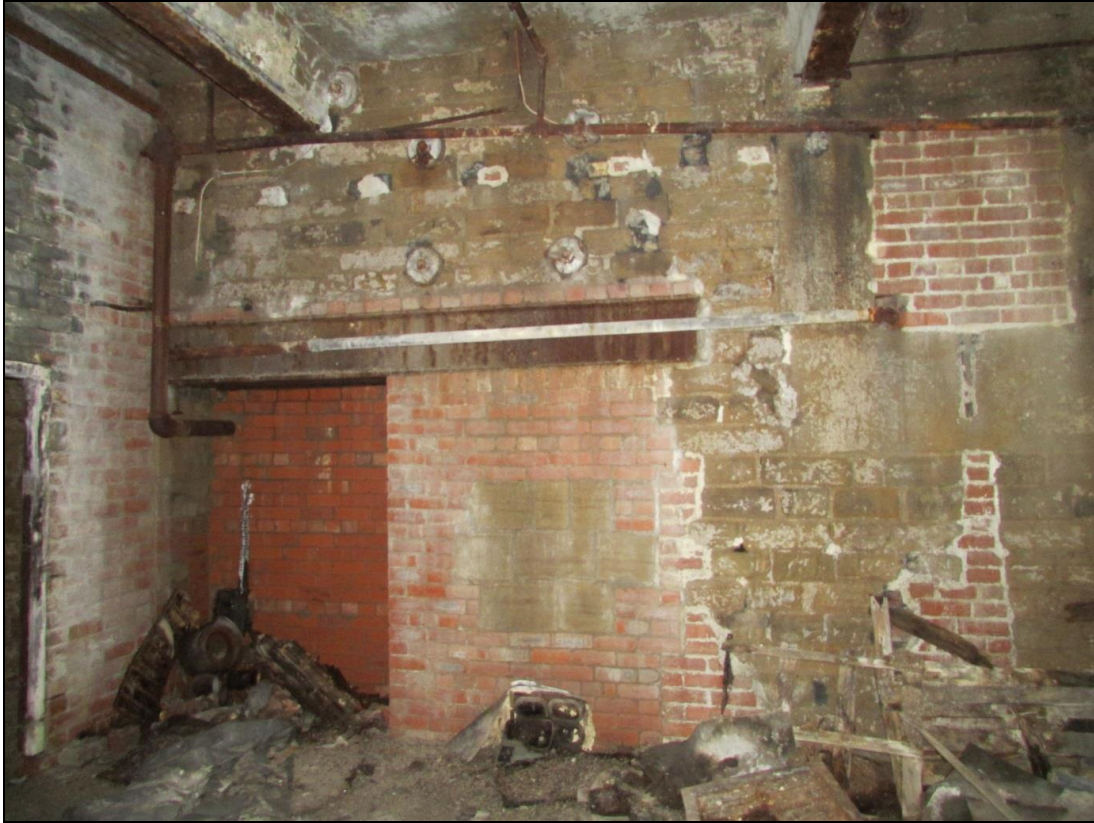
The south-east room had a flat ceiling with east/west metal beams supporting it, but due to the plastering, the material used for construction could not be ascertained. The room had also been subdivided with a machine-made brick division and a number of alterations were noted within the gearing wall. A number of localised infilling of stonework using machine-made brick were noted, including a large square aperture with dressed sandstone surround which was blocked with machine-made brick at a later stage. Immediately north of this was an entrance which was punched through the stonework and an RSJ lintel inserted above. Machine-made brick was then used to square off the entrance, which was then narrowed utilising a mix of machine-made brick and undressed coursed ashlar stones. The resulting entrance was blocked off at an even later stage, and metal piping inserted through it (Plate 48).

**Plate 48** Later inserted doorway, which was then blocked and a blocked footstep bearing for another upright shaft (see also Plate 16 for the bracket on the other side of the gearing wall)

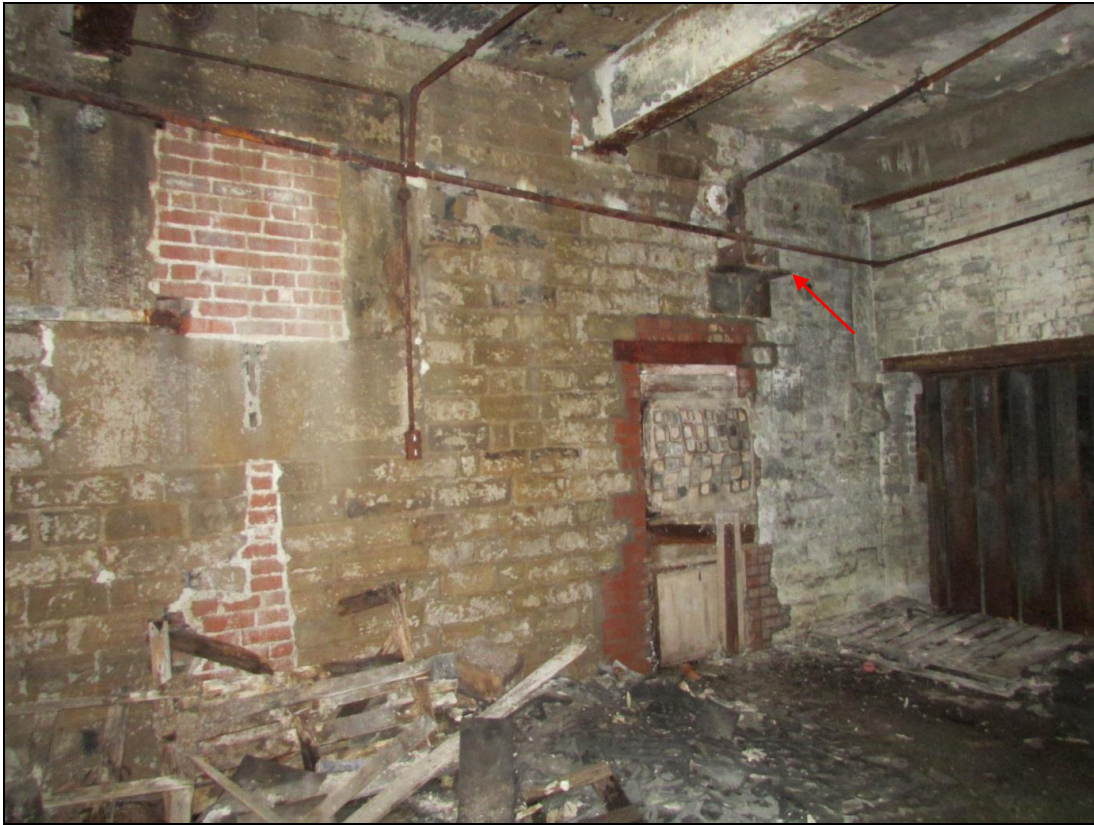
**Plate 49** Another inserted doorway had been blocked subsequently with a mixture of unknown materials. An original engine fitting is visible above (arrowed)

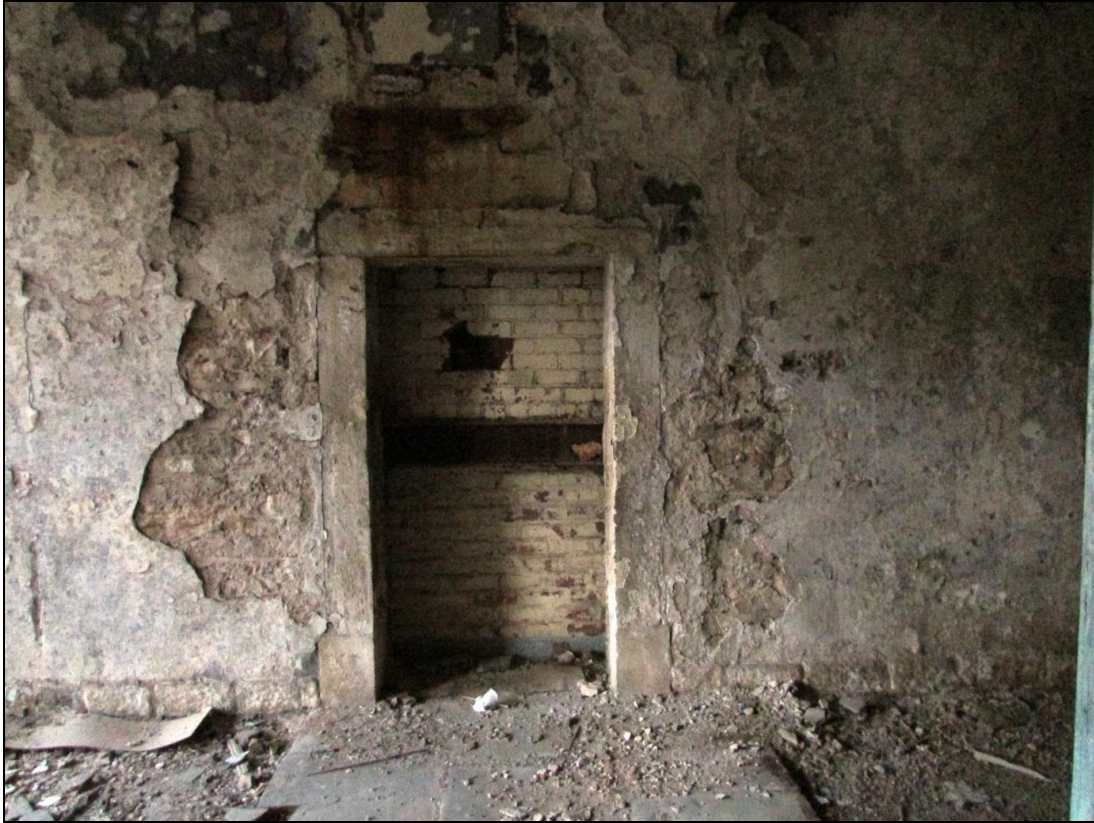
**Plate 50 Blocked entrance which would have connected the engine house with the other spinning mill**

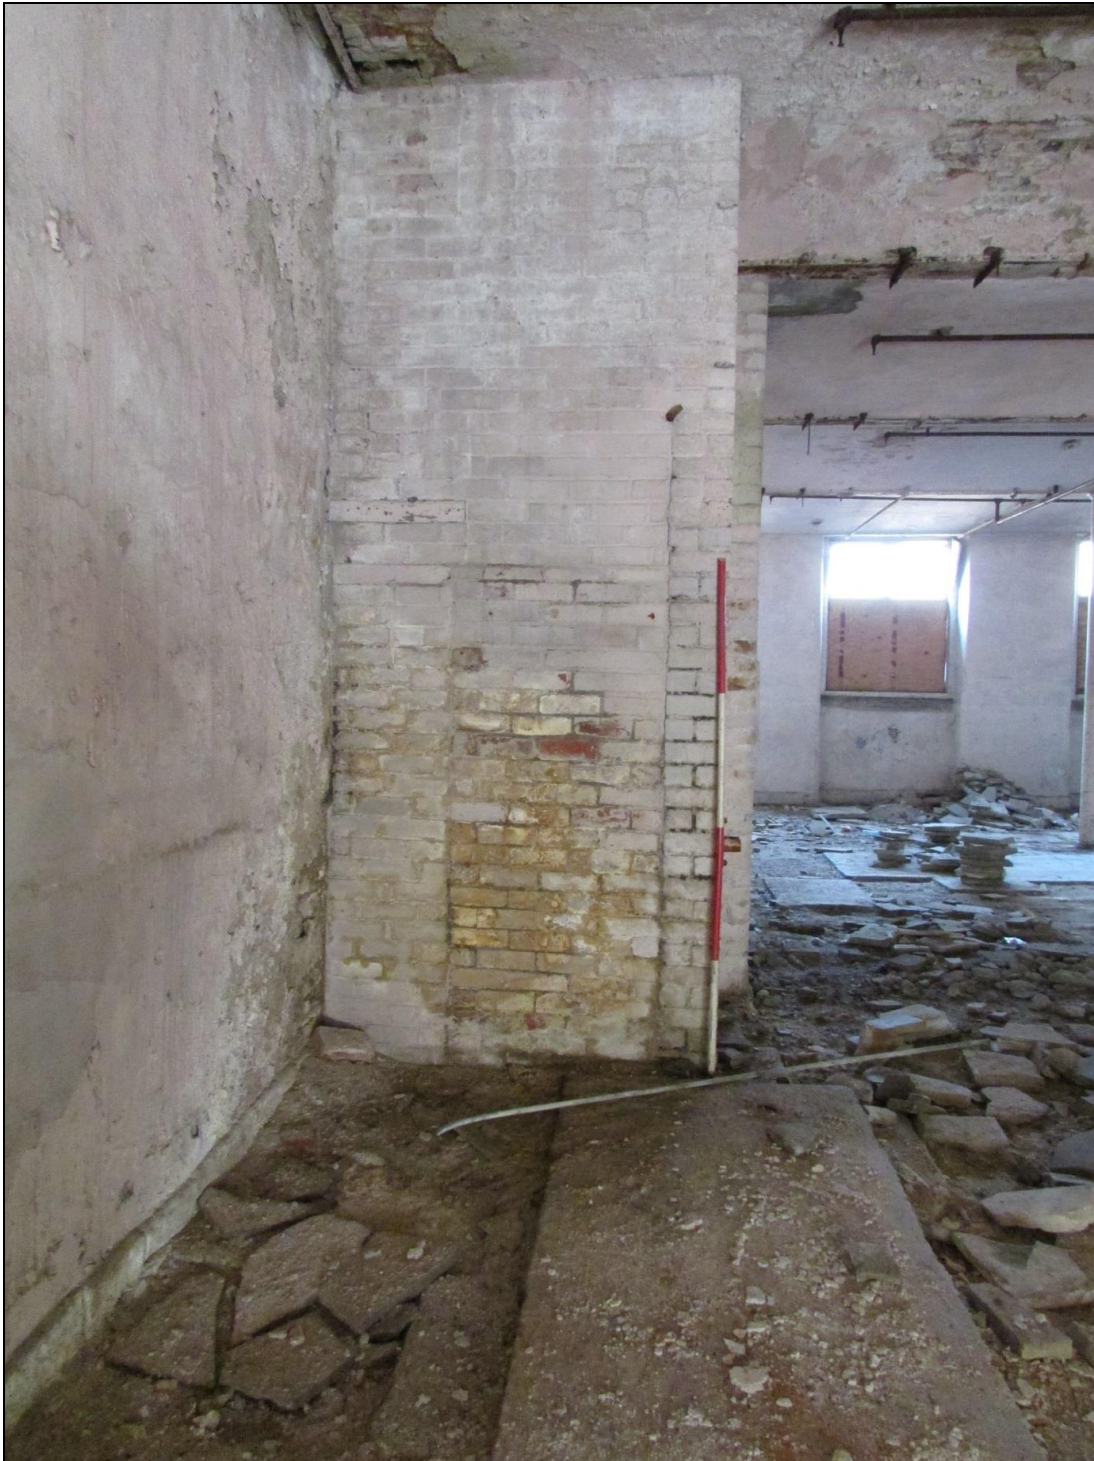
**Plate 52 Blocked entrance into a later sub-division, creating a void behind which could not be accessed**

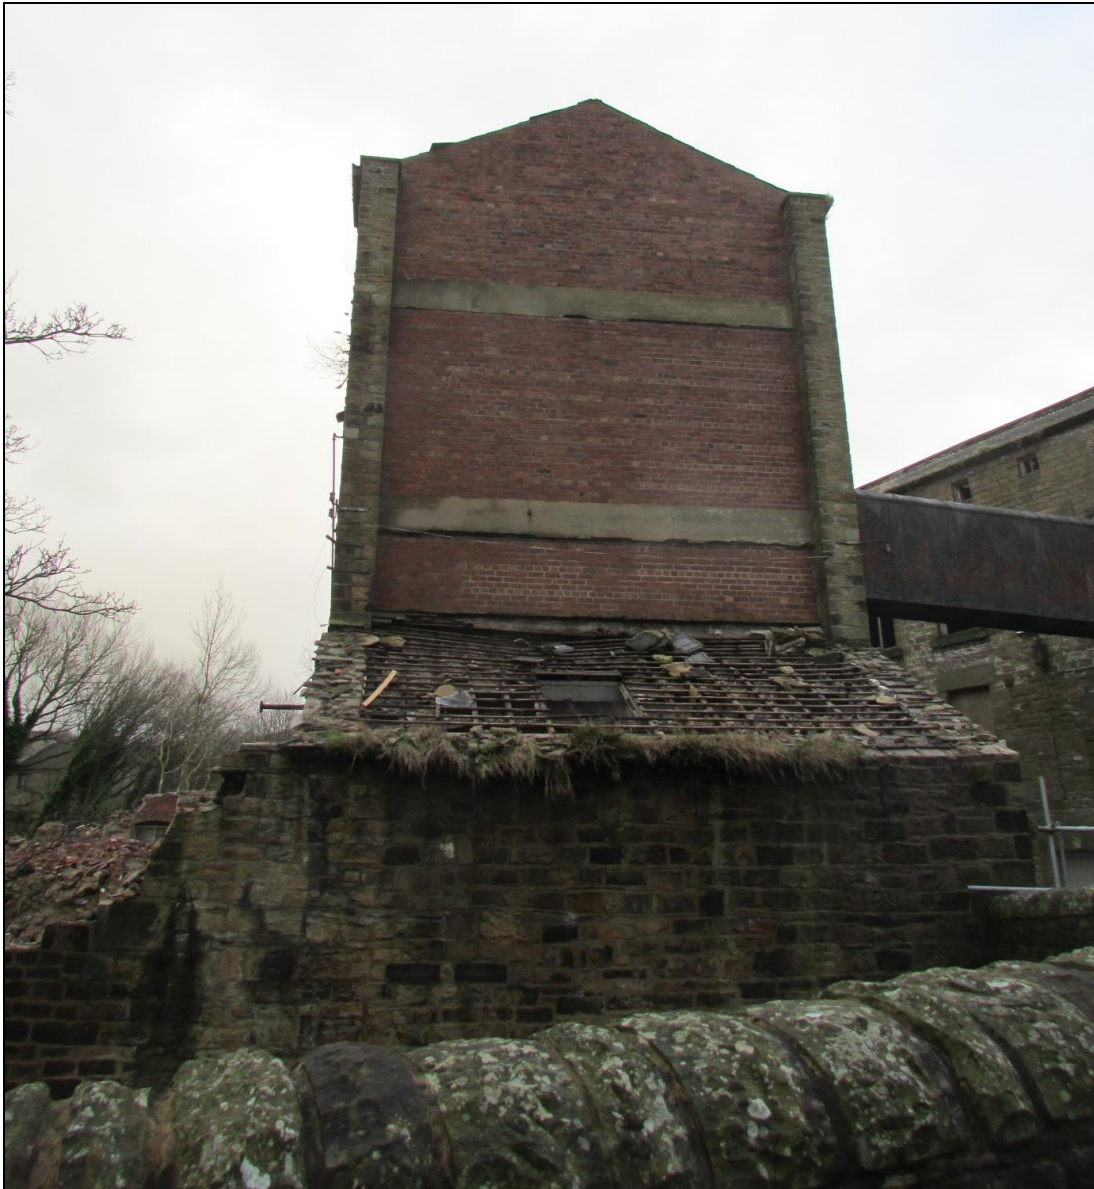
**Plate 66 South elevation of the office block, which appears to have been rebuilt along with the stone lean-to on the ground-floor level**

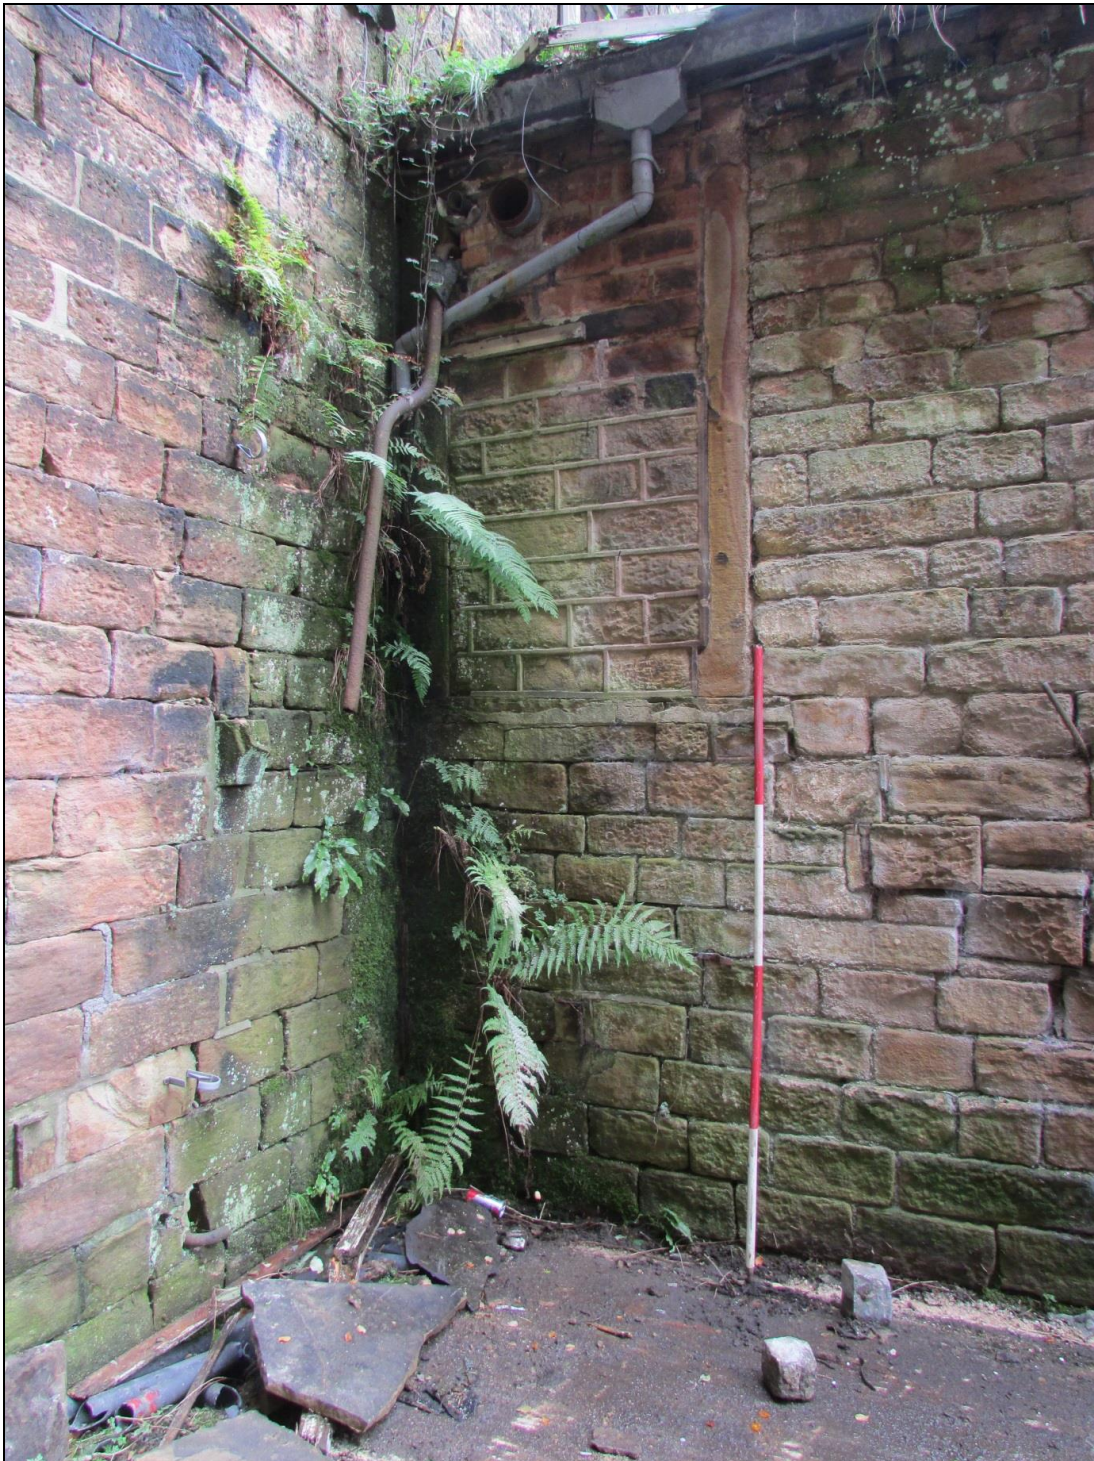
**Plate 76 Blocked window within the northern elevation of the east shed**

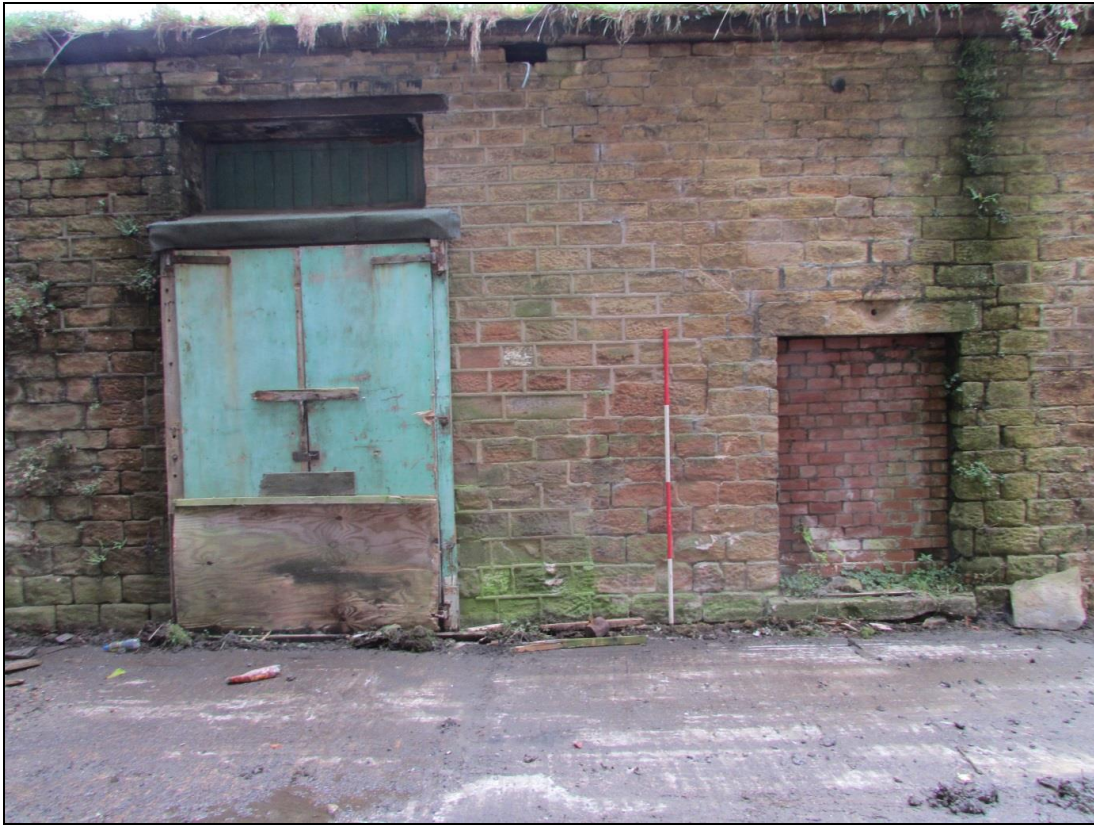
**Plate 77 A door was inserted into the northern elevation of the east shed (left) and a window was also blocked at a later stage**

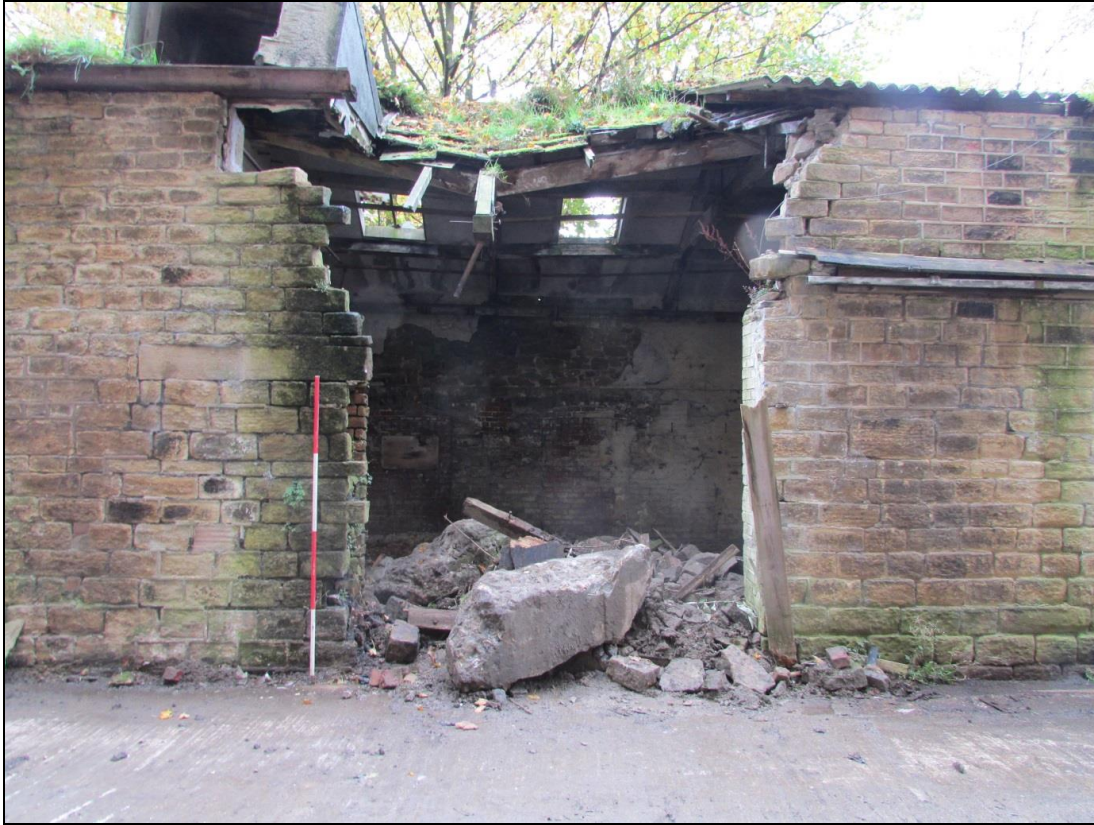
To the west of this was a gap which appeared to have been the position of a former sliding door. Part of a wooden frame and canopy was partially preserved which indicated this however the area had been damaged by partial collapse of the roof (Plate 78). It is probably an inserted entrance, as further to the west was a former entrance with a dressed stone surround, blocked subsequently with coursed stone. Just below the roof level there were also a series of small square apertures and containing windows (Plate 79). Just below this level, and west of the inserted doorway, was a small circular aperture which had been blocked subsequently with coursed stone.

**Plate 78** There appears to have been an entrance located here into the east shed, however roof collapse has damaged this area

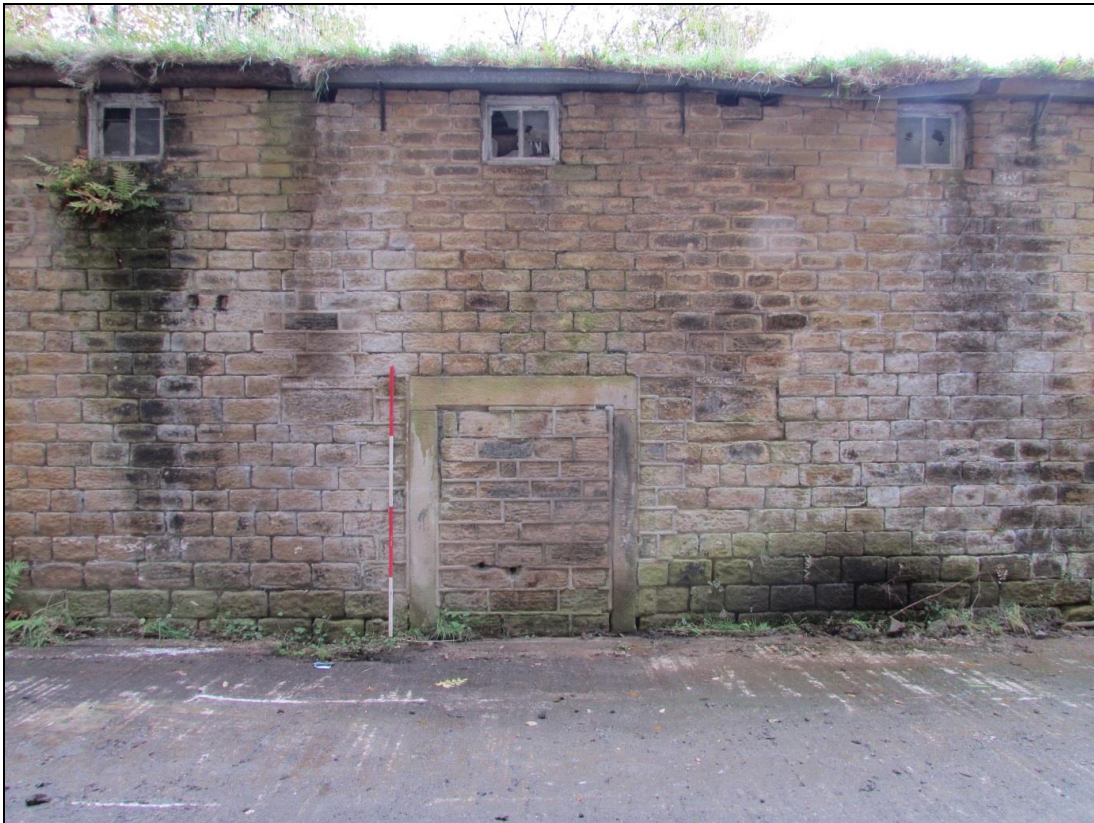
**Plate 79** Blocked entrance in East Shed

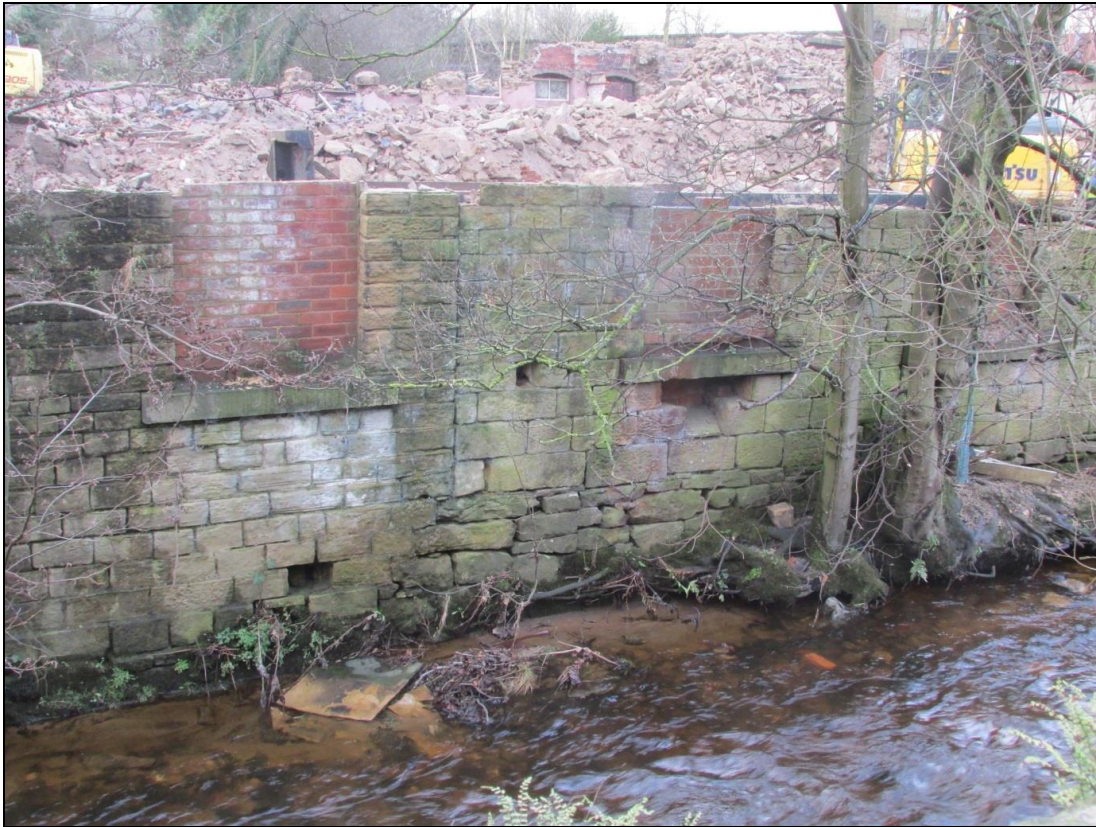
This elevation abutted the eastern shed and is partly built onto the foundations of this shed, suggesting that it is later in date. The stonework slightly differs although it generally consists of small random coursed stones. There are six windows in this elevation with flat stone sills and lintels, each blocked with machine-made brick. The roof is gable with a later metal vent inserted. Above the western window was a brick-sided platform supported on decorative iron corbels and fish-bellied beams, likely a hoist gantry into the upper floor (Wild 2007, 16). This was not visible at the time of the survey, but was observed during the previous Buildings Assessment (Wild 2007).

**Plate 82** The butt joint between the earlier shed (east) and the later shed (west) is clearly visible, as well as where the later shed partly used the drystone foundations of the earlier building
