**The Influence of Fire on the Design of Polymer  
Composite Pipes and Panels  
for Offshore Structures**

**Volume 2 of 2**

**APPENDIX A - DEVELOPMENT OF A NEW FURNACE LINING MATERIAL**

The following text contains detailed descriptions of the methodologies used and experiments performed in the development of a new, non-fibrous, highly efficient furnace lining.

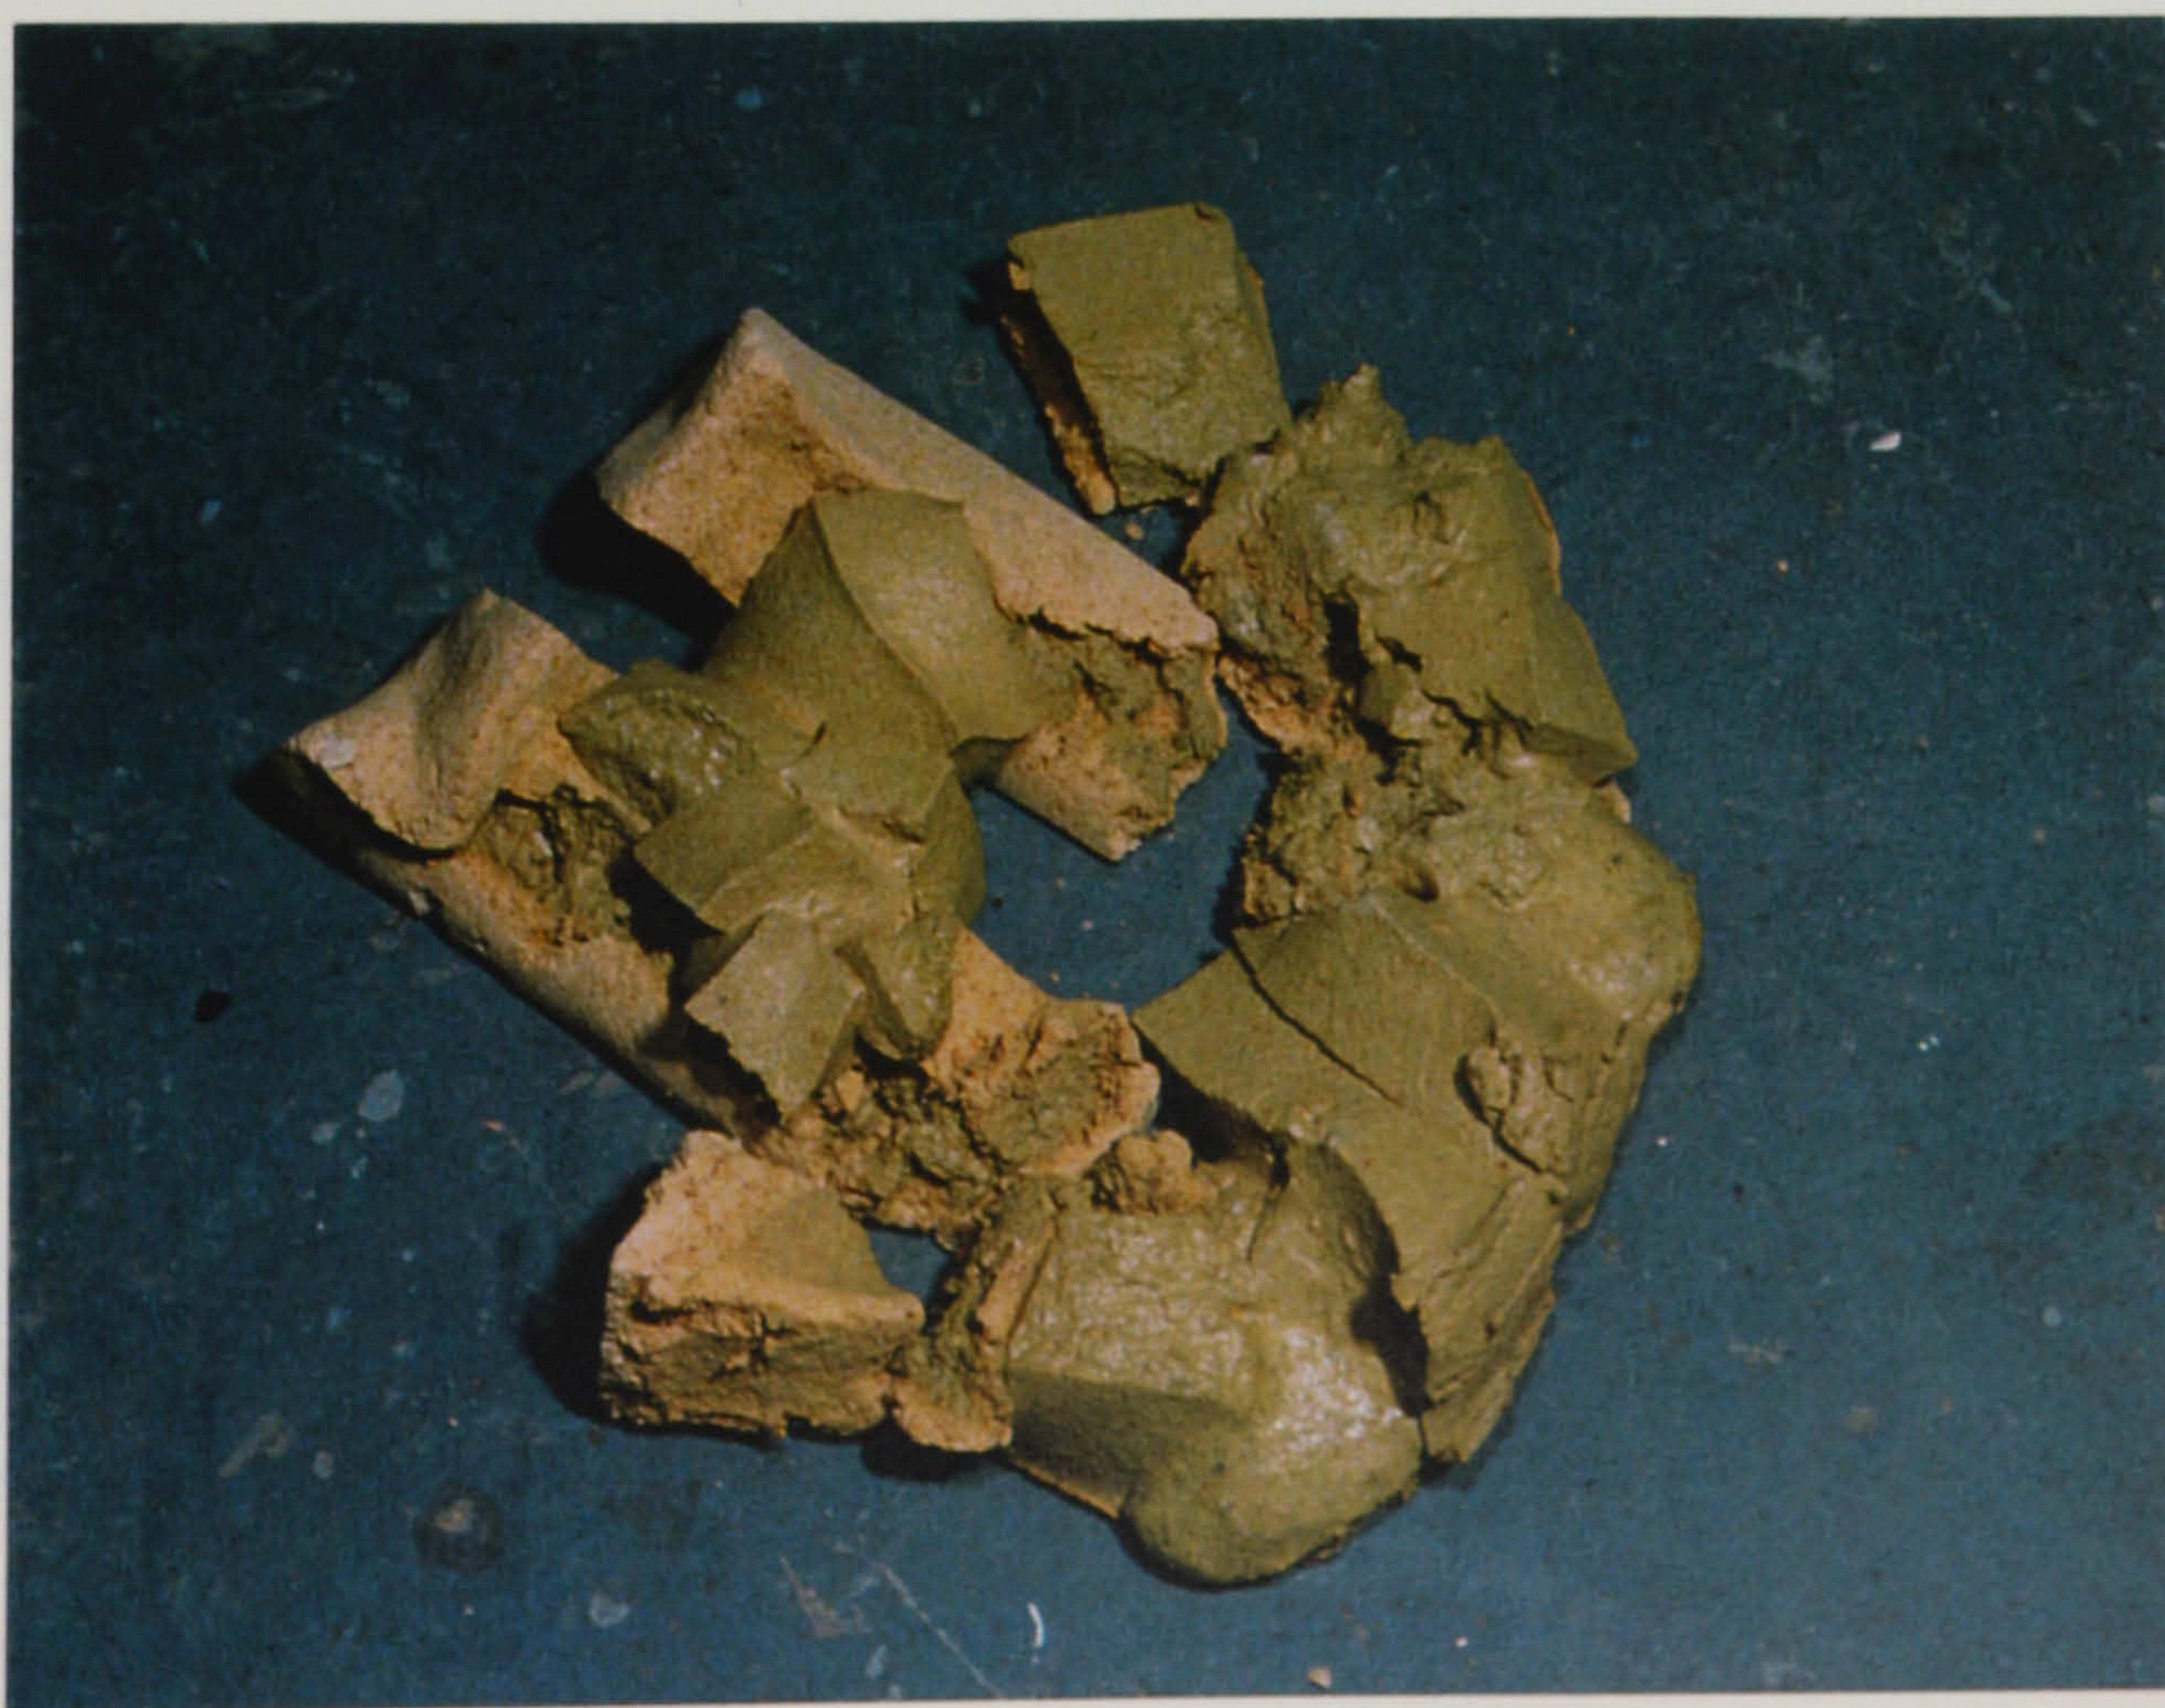
Following cooling of the samples inspection showed the typical length to be approximately 206mm, however there were some cracks in the bricks, in particular in one brick which had been arranged as a beam between two others. This length indicated similar shrinkage as would be expected for the Secar-51 samples fired to 1150°C. No development work was carried out on the Secar-71 bricks as a substantial amount of work would be required to find the necessary mix proportions and curing-drying-firing cycle to prevent cracking of the bricks. However, this brief investigation does show that similar compositions to those investigated fully could satisfy much more demanding temperature resistance requirements.

Figure A.4.10 - Condition of #11-R samples after heating to 1300°C

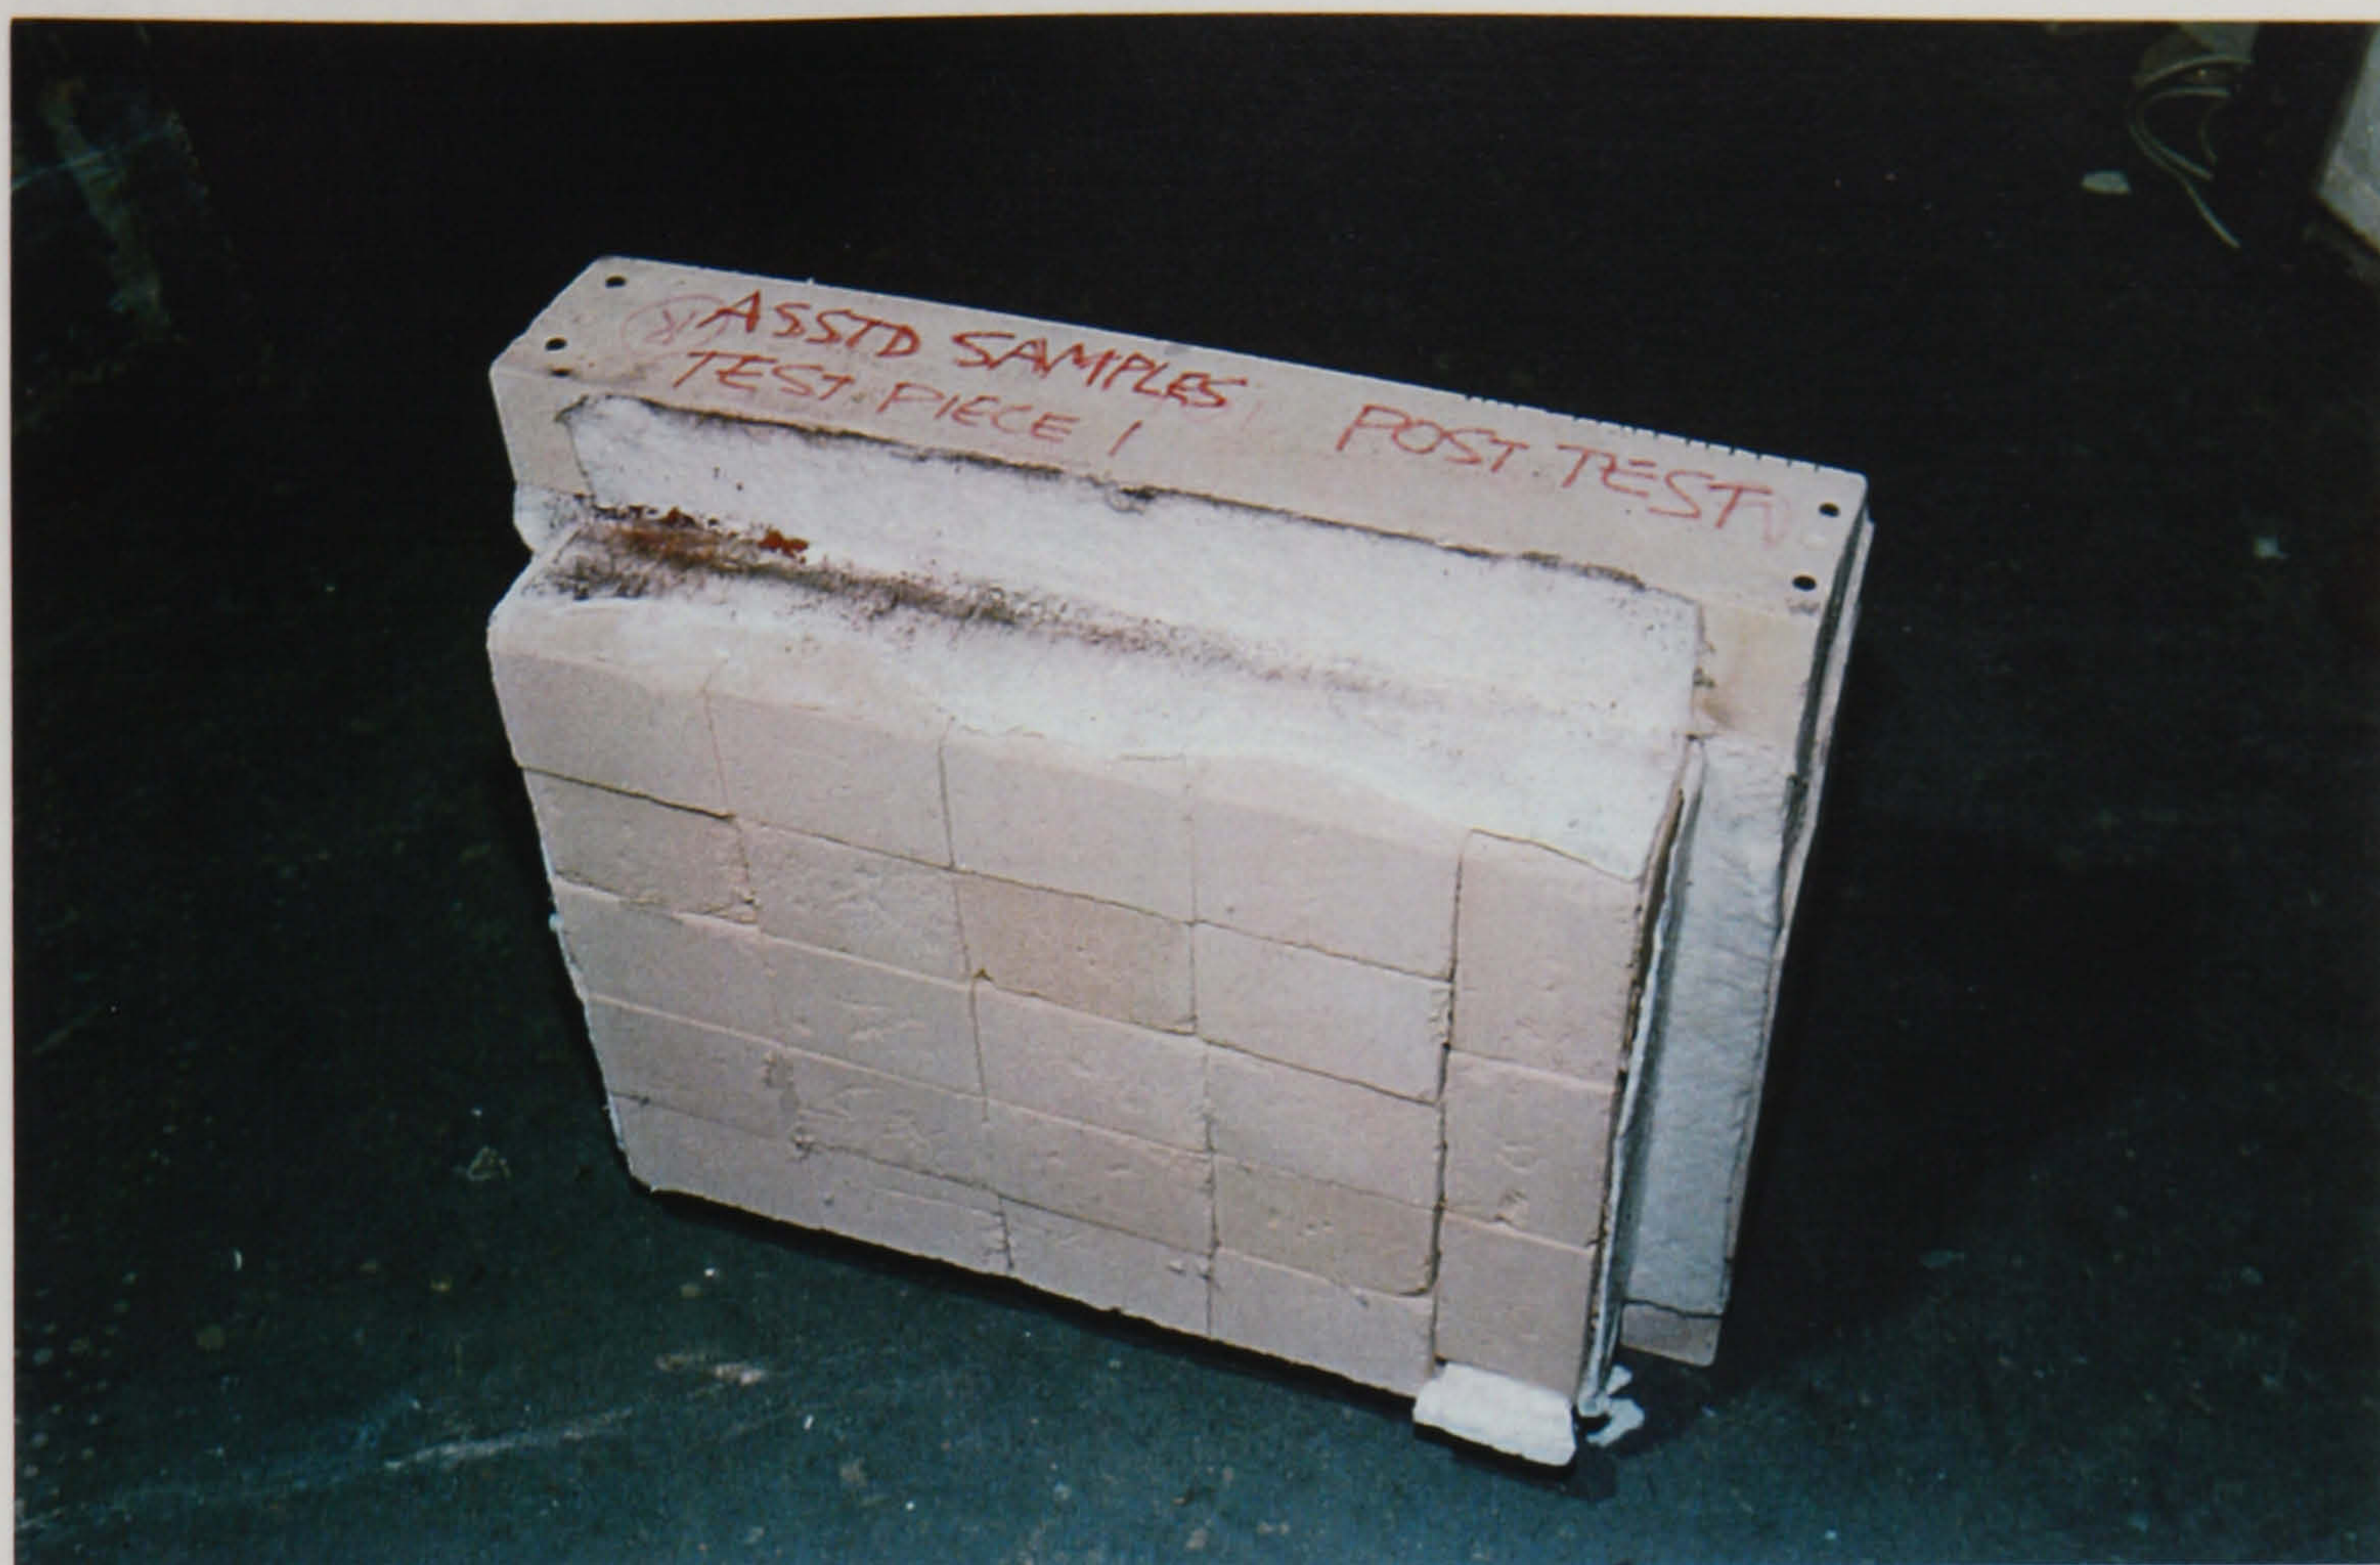
**Figures A.5.9 and A.5.10** show the post test condition of the full thickness test pieces for the assorted samples and for the #11-R bricks respectively.

Figure A.5.9 Post test condition of assorted Insuline samples

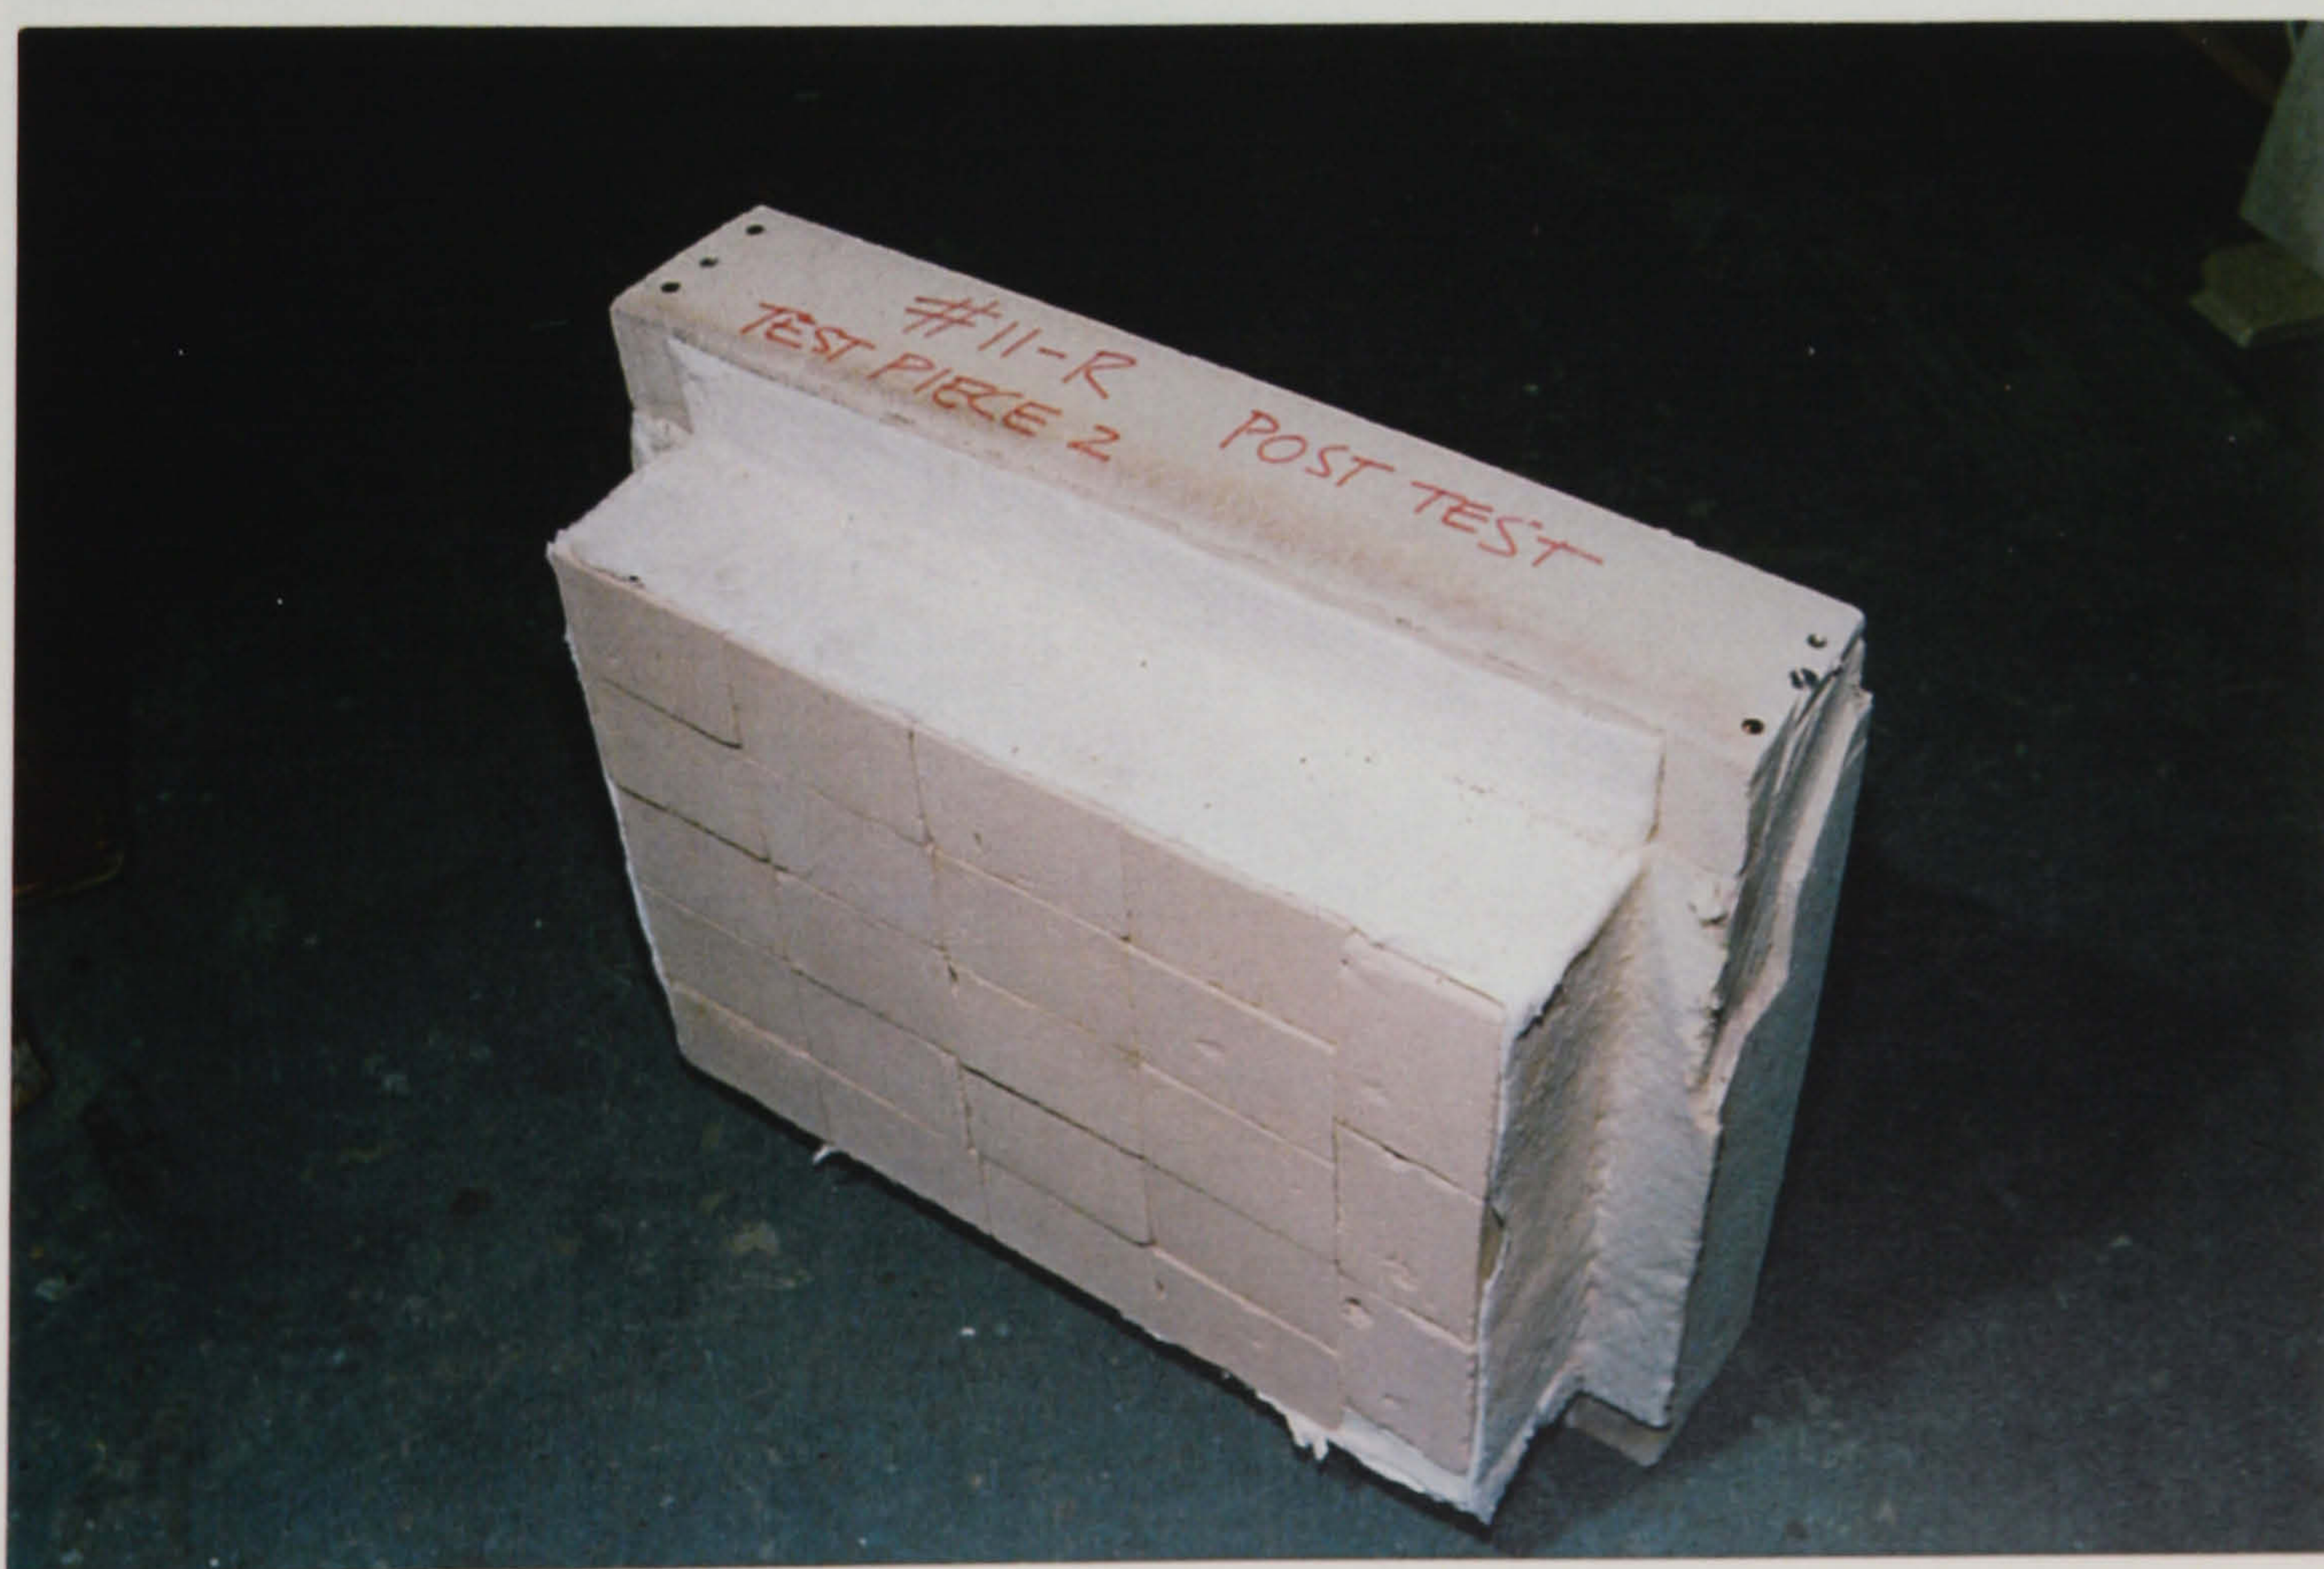
Figure A.5.10 Post test condition of Insuline #11-R samples
