## Thermographic Detection of Hidden Archaeological Features in a Cheshire Thatched Cottage, and Related Aspects of Thermal Performance: Case Study at Roadside Cottage

Anthony Simpson & Michael Nevell

University of Salford and Ironbridge Gorge Museum Trust, United Kingdom

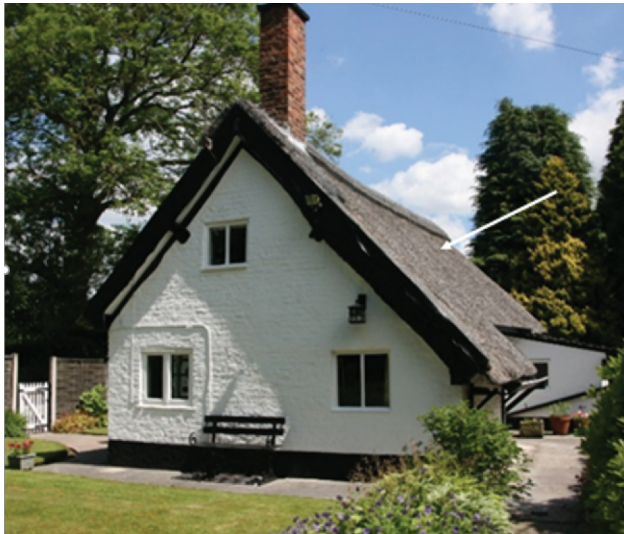
**Figure 3.** View of Roadside Cottage showing west gable end with ground floor L shape extension to the south (arrow showing area of investigation). Image copyright South Trafford Archaeological Group.

The current building retains much of the 15<sup>th</sup> to 17<sup>th</sup> century timber-framed structure. This includes not only the remains of two cruck trusses but also early roof fabric. Much of this roof structure, the ridge tree, purlins and many of the rafters, appears to be 17<sup>th</sup> and 18<sup>th</sup> century in date and presumably coincides with the widening of the hall bay and the raising of the roof line. The current western and eastern gable ends are shown in [Figures 3 and 4](#), respectively.

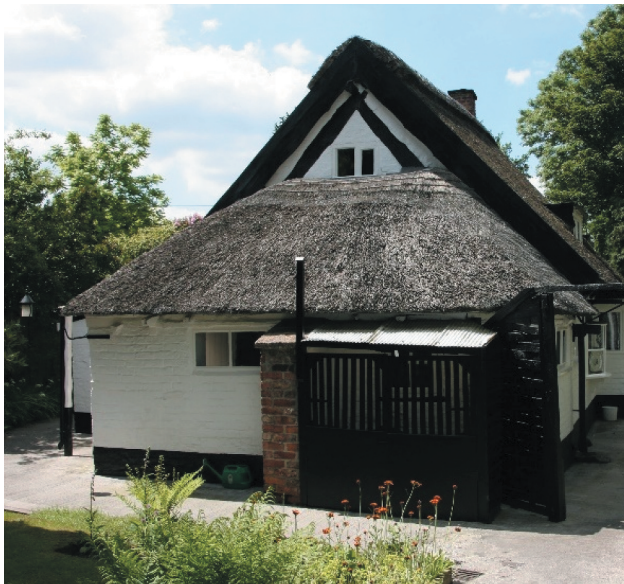
**Figure 4.** View of Roadside Cottage showing east gable end with ground floor thatched extension. Image copyright South Trafford Archaeological Group.

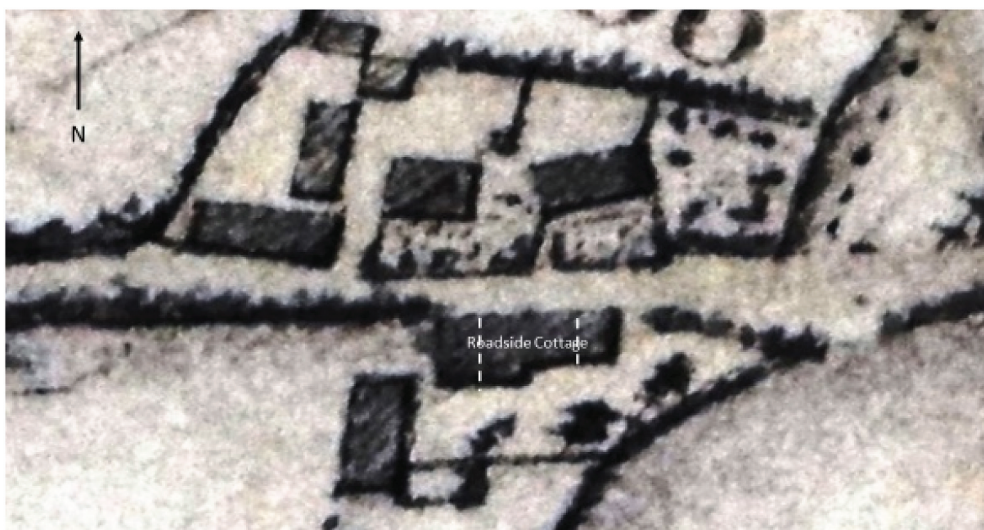
**Figure 5.** Stanley Estate Map 1787 Roadside Cottage & settlement – bisected by the old road. (Courtesy of Cheshire Archives and local Studies, Cheshire Record Office, Duke St Chester, CH1 1RL).

A 1787 Estate map<sup>13</sup> in [Figure 5](#) shows a 1-m extension to the south-facing lower floor and roof, the outshut, giving the building an 'L shape'. Today, the current building is somewhat truncated from the west by about 4 to 5 m compared to the outline shown on the Estate map. The approximate position of the current gable ends is indicated by dashed lines in [Figure 5](#).

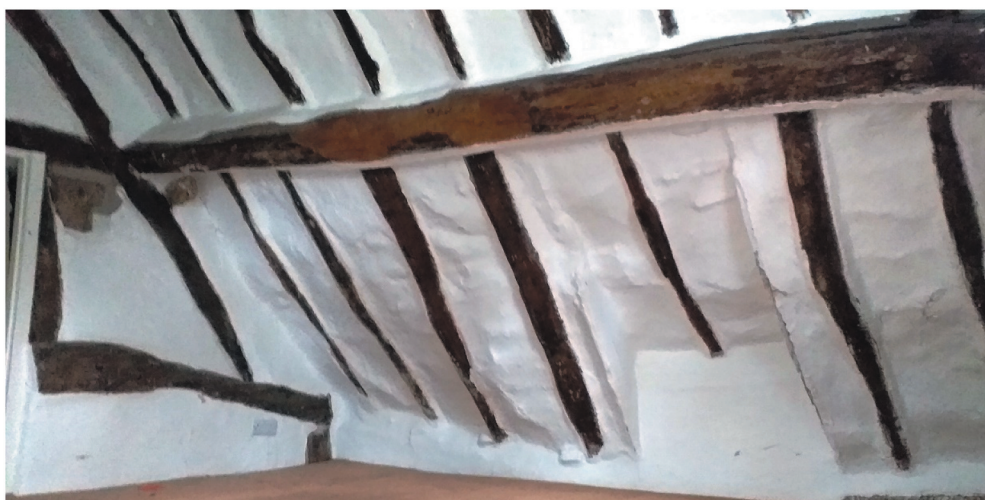
**Figure 6.** Internal view of south facing roof timbers and daub surface. Image copyright South Trafford Archaeological Group.

As shown in [Figure 6](#) the internal surface beneath the thatch was characterised by irregular natural tree branch shapes, roughly hewn roof purlins (approximately 200 mm x 200 mm cross-section) and common rafters (approximately 100 mm x 100 mm cross-section), with painted lime plaster (average thickness 50 mm) in between. Some of the walls retained older daub layers, consisting of a heavy clay, interspersed with chalk and combined with straw. An exposed area of daub can be seen near the top right of the doorway. The rectangular panel at floor level consisted of a 50 mm thick layer of plaster, and was of particular interest as it appeared to conceal an entrance to a potentially large space over the extension.

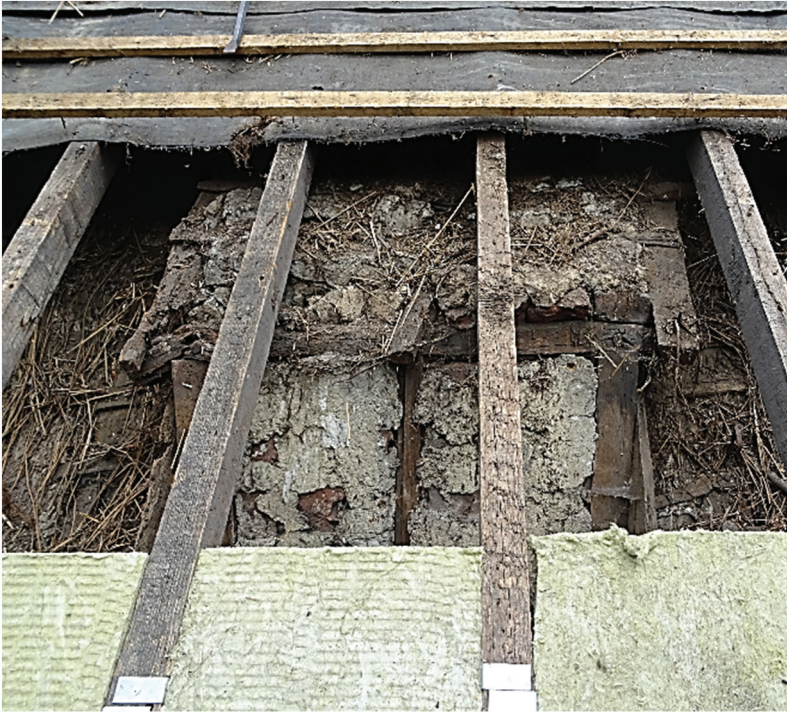
**Figure 10.** Infilled dormer-type window frame uncovered during re-thatching in July 2019. Image copyright Anthony Simpson.

At the time of the investigations the thatch on the cottage was more than 40 years old. This was removed in July 2019 and the cottage re-thatched, following an upgrade of insulation levels by inserting an additional 50 mm of mineral fibre insulation between the roof timbers, as well as renewing the roofing felt. For a limited time period the area under thermographic investigation was opened for inspection (Figure 10) revealing a very old unglazed dormer window frame, with an infill of clay mortar/brick fragments. The shape, size and position of the dormer matched that of the infrared image observed on the rectangular panel in the inside bedroom in Figure 7. It is thought that the infill took place in the 18th century or earlier when the cottage was extended south forming an L shape, and covered with a new shallower-pitch thatch roof. To avoid window tax many windows in this period were sealed, ready to be reglazed at a later date.<sup>20</sup>

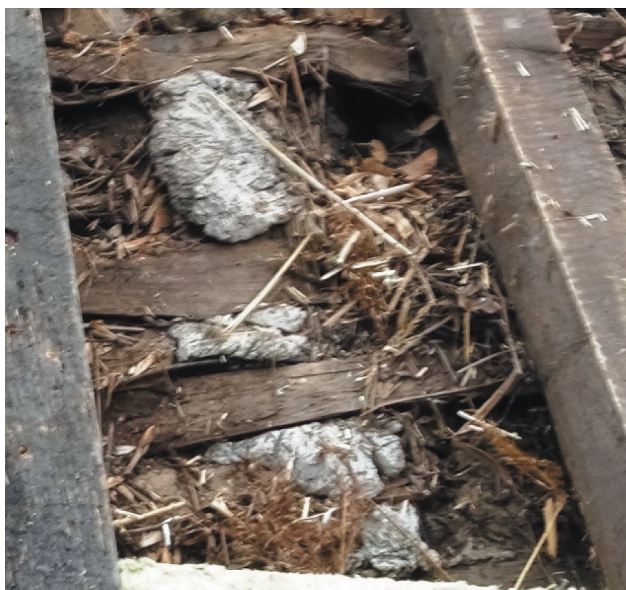
**Figure 11.** Laths bonded to plaster uncovered during re-thatching in July 2019. Image copyright Anthony Simpson.

The presence of laths (approximately 70 mm x 10 mm in cross section) was confirmed. The 'horizontal' laths were irregularly arranged and bonded to plaster, as shown in Figure 11. Timber-framing with wattle and daub panels was the dominant form of building construction in many parts of England and Wales from the mid-12th century. Lath eventually became common when plaster superseded daub from the 18th century.<sup>21</sup>

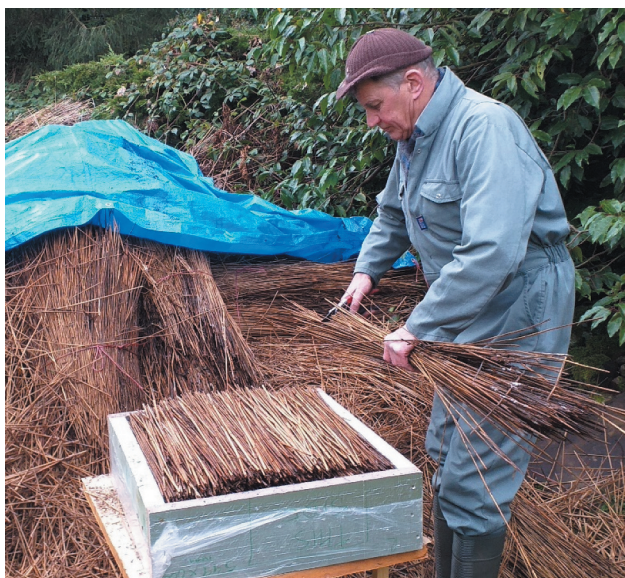
**Figure 15.** Preparing sample of original thatch removed from the roof for thermal conductivity testing. Image copyright Anthony Simpson.

A sample of the reed thatch removed from Roadside Cottage was cut to a length of 500 mm and assembled in an insulated test frame (internal dimensions 500 mm x 500 mm square x 180 mm deep), as shown in Figure 15. The thermal conductivity was measured at a sample thickness of 181 mm, under a constant pressure of 7 KPa, using a single specimen 600 x 600 mm square heat flow metre apparatus which complies with test standards ISO 8301 and BS EN 12667.
