## **Archaeological Evaluation Report**

Christ Church,  
(Plot K),  
King Street,  
Salford

SA/2019/40

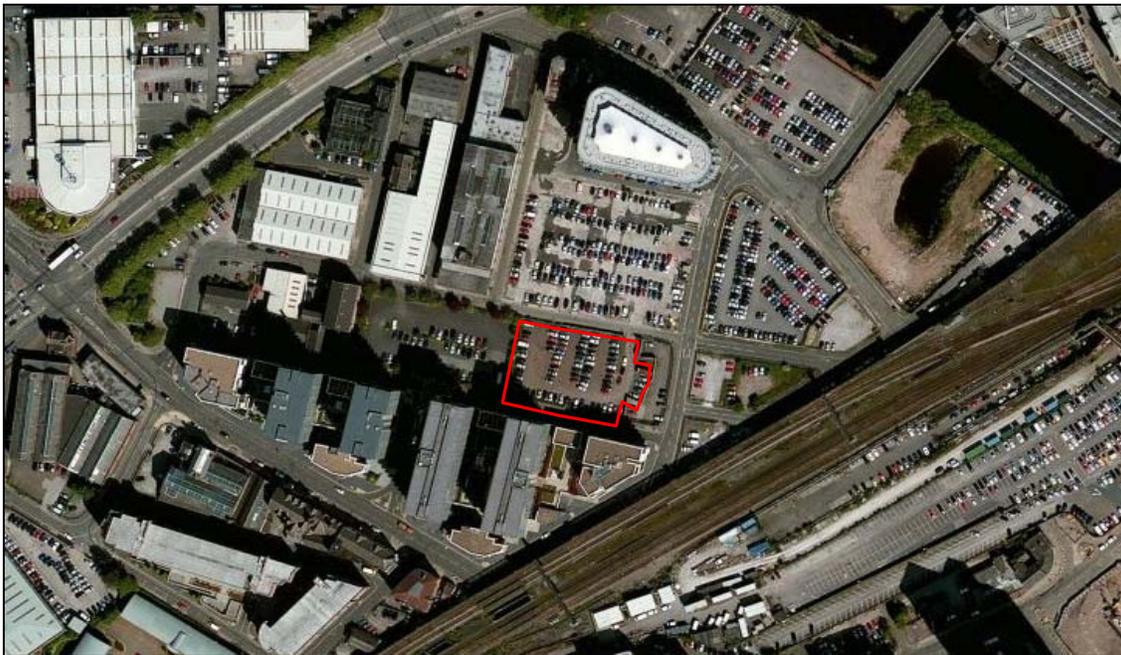
*Plate 1: Recent aerial photograph showing the location of Plot K*

The study area is situated in Salford city centre (Fig 1). Plot K comprises a plot of land bounded by King Street to the south and Queen street to the north, with car parks to the east and west (centred on SJ 83510 98890). The site was used in its entirety until recently for car-parking purposes, with further car parks and residential developments in the immediate vicinity (Plate 1). At the time of the archaeological fieldwork, the car park was accessible from Queen Street via an access road. To the west of the road was a low brick wall that formerly divided the site in two; only a small portion of the wall survives. Stone steps still present in the southern part of the site originally provided pedestrian access from King Street.

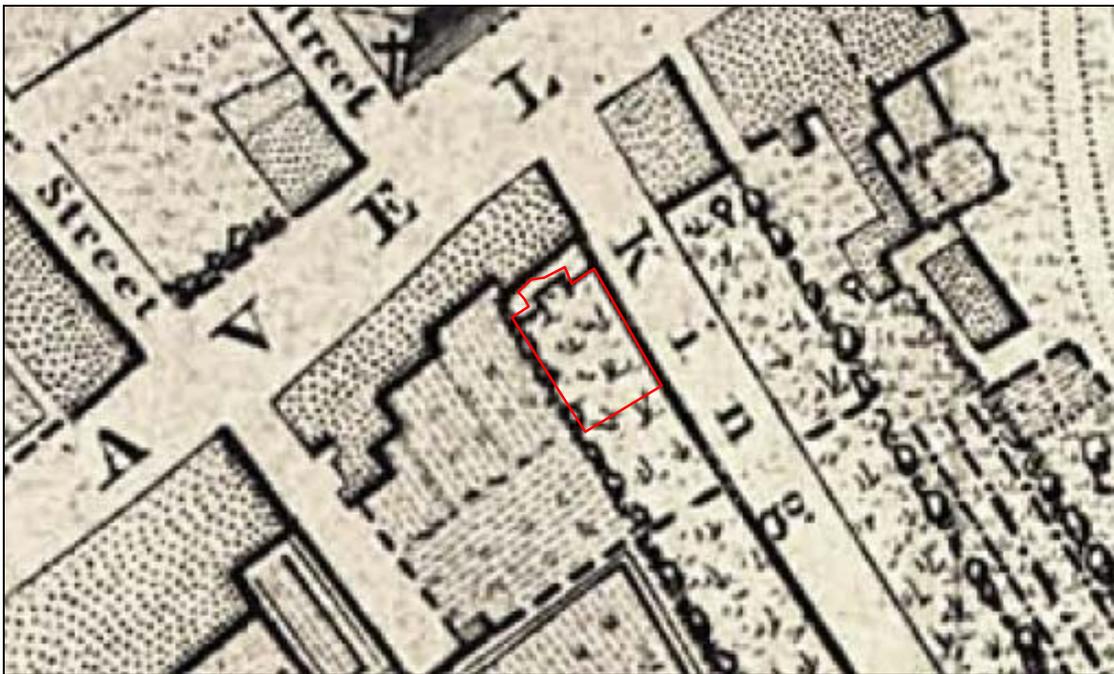
Plate 2: Plot K boundary superimposed to Laurent's map 1793

The earliest detailed maps that show the study area are Green's map of 1787-94 (Fig 3) and Laurent's map of 1793 (Plate 2). Both sources shed light on the site and its environs before the construction of the church. King Street had been laid out, but it was yet to see any building beyond the existing street frontage on Gravel Lane. Depicted in the manner of gardens, fields or orchards, much of the land to the west of Gravel Lane was not developed until the first decade of the 19<sup>th</sup> century. This early mapping reveals that the future size and extent of the church and graveyard would be dictated by existing field boundaries and property divisions. Such factors also account for the irregularity of the site's eastern boundary with the properties and yards on Gravel Lane.

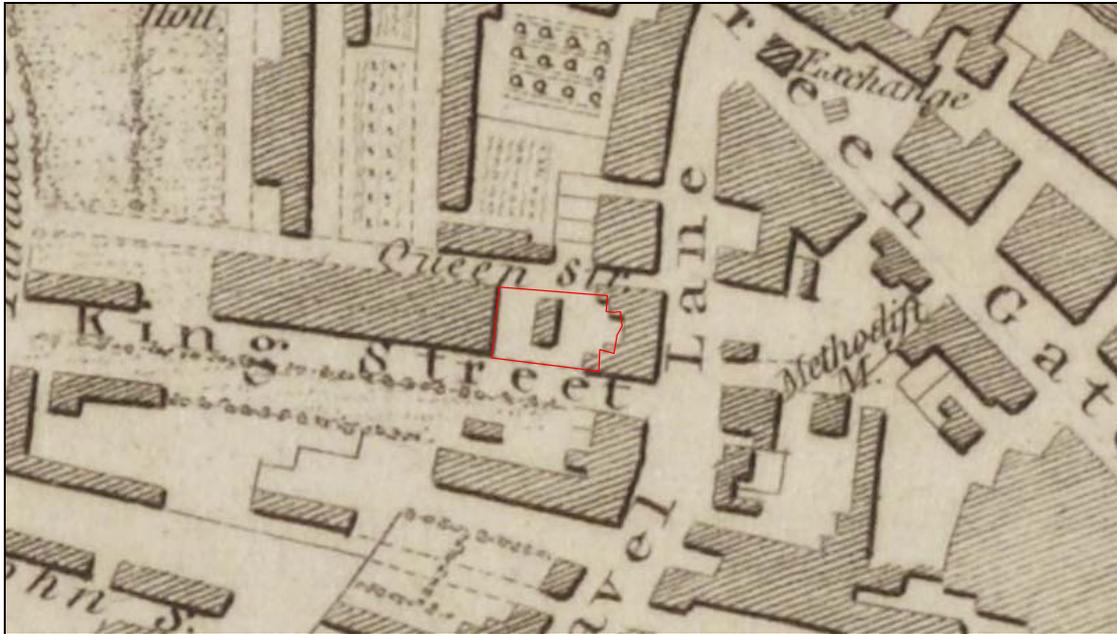
*Plate 3: Extract from Roper's map of 1807 showing Christ Church*

Plans published in 1804 and 1807 provide the first representations of the church and graveyard (Plate 3). These early plans help characterise the changing urban landscape around the site. By 1804, workers' housing had been constructed to the west of the church, which later maps clearly show comprised a row of houses built in pairs and small courts of back-to-backs. By the time of Banks & Co's map of 1831 the surrounding building plots were fully developed; new dwellings and industrial premises had been constructed to the north side of Queen Street, filling in the vacant plots occupied formerly by gardens (Fig 4).

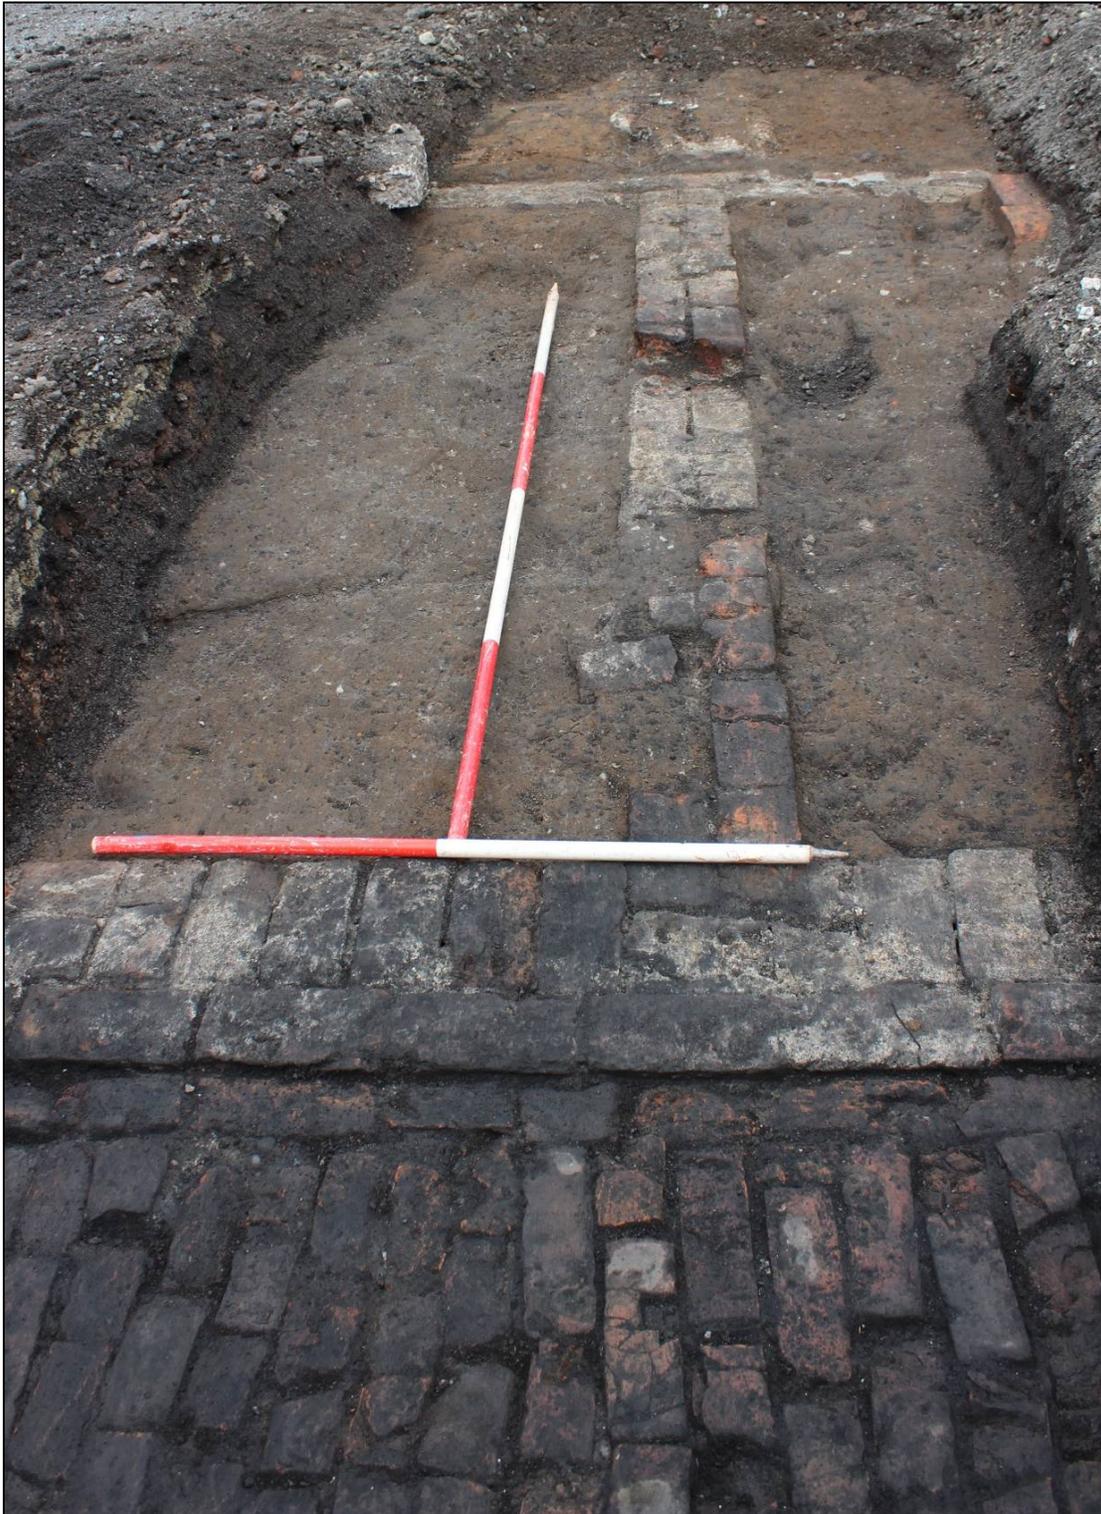
*Plate 10: General view across Trench 1 looking south*

The surviving foundations of the church walls were exposed in plan: 104, 105, 106. The walls were constructed of hand-made brick bonded with hard, light greyish-white lime mortar. Wall 104 was the northernmost wall of the church and being an external, load-bearing structure was wider than the internal partitions 105 and 106; it had a maximum width of 350mm and length of 1.50m, extending east and west beyond the limits of excavation. Wall 106 ran parallel with wall 104 and formed an east/west internal partition within the building; it had a maximum width of 230mm and length of 1.64m. Running between walls 104 and 106 was a north/south wall 105 (1.64m in length and 230mm in width); this was keyed into walls 104 and 106. The wall foundations were housed in narrow construction cuts, dug into the relict soil 107.

A brick surface (103) exposed in the northern part of the trench consisted of rows of hand-made bricks laid on bed. The southern and northern extent of the surface was framed by bricks 'on-edge'. Surface 103 extended over an area of 1.63 x 1.50m (Plate 12). The northern edge of the surface was partially truncated, possibly as a result of the rebuilding of the northern churchyard wall. The void between the wall and surface had been backfilled with loosely compact industrial material (102), namely clinker.

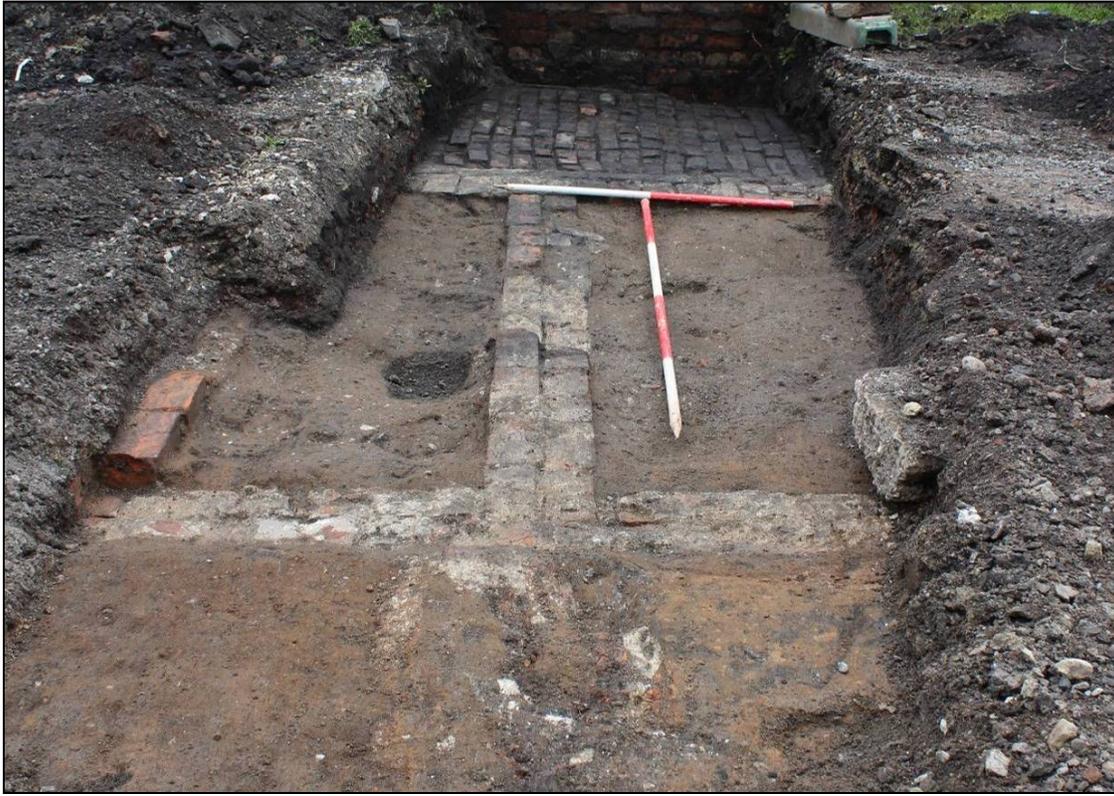
*Plate 11: General view across Trench 1 looking north*

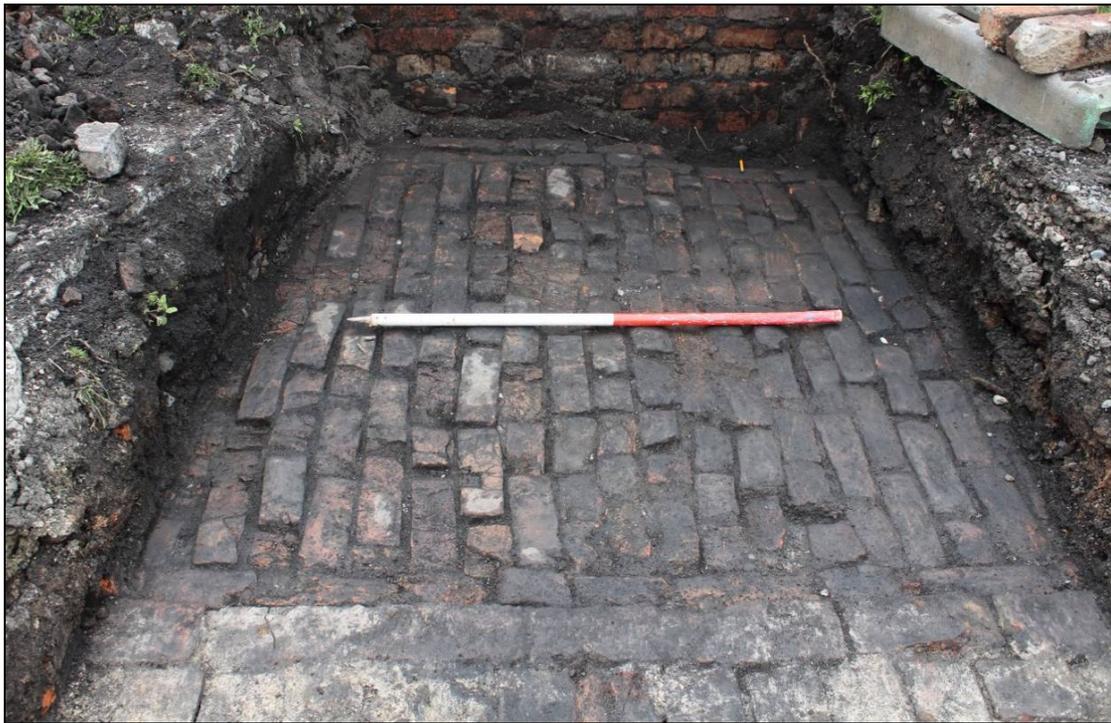
*Plate 12: Brick surface 103 exposed in the northern part of Trench 1*

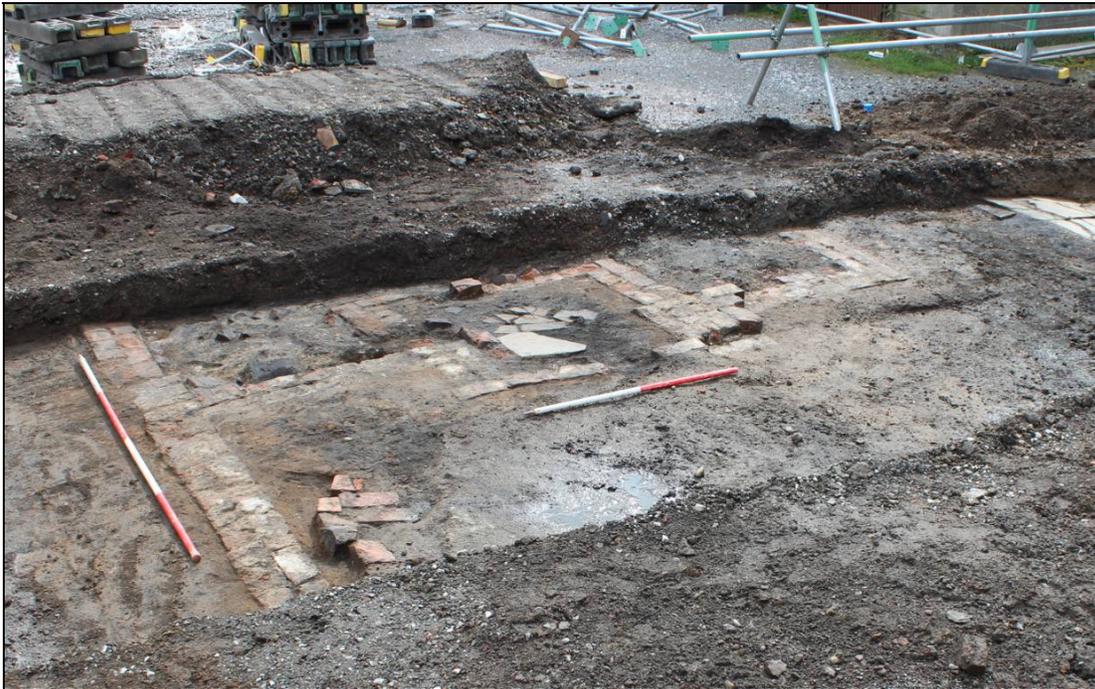
Trench 4 was placed across the south-west corner of the church. Measuring 15.8m in length and 2.85m width, it was excavated to a maximum depth of 0.53m (Plate 13). The foundations of the church were exposed immediately beneath the modern overburden, car park surface and levelling deposits (401). The majority of the trench was reduced to the top of relict soil deposits; vestiges of an external flagged walkway were exposed to the south of the church. Ledger stones were exposed to the south of the built remains.

*Plate 13: Built remains exposed in Trench 4 (1 and 2m scales)*

The foundations of the church were exposed at a shallow depth of 225mm beneath the modern ground surface, and formed the south-western corner of the church frontage. The foundations incorporated hand-made brick bonded with hard, greyish-white lime-based mortar. The northernmost brick walls (403 and 421) were aligned east/west and demarcated the southern extent of the church hall. Wall 403 was exposed to a total length of 2.09m, being stop-ended at its eastern extent; it had a width of 239mm. Wall 403 was an exterior, load-bearing wall. Wall 421 was tacked on to the eastern end of 403 and formed an internal continuation of the structure. Wall 421 was 228mm wide and extended for 0.72m in length eastwards beyond the limit of excavation.

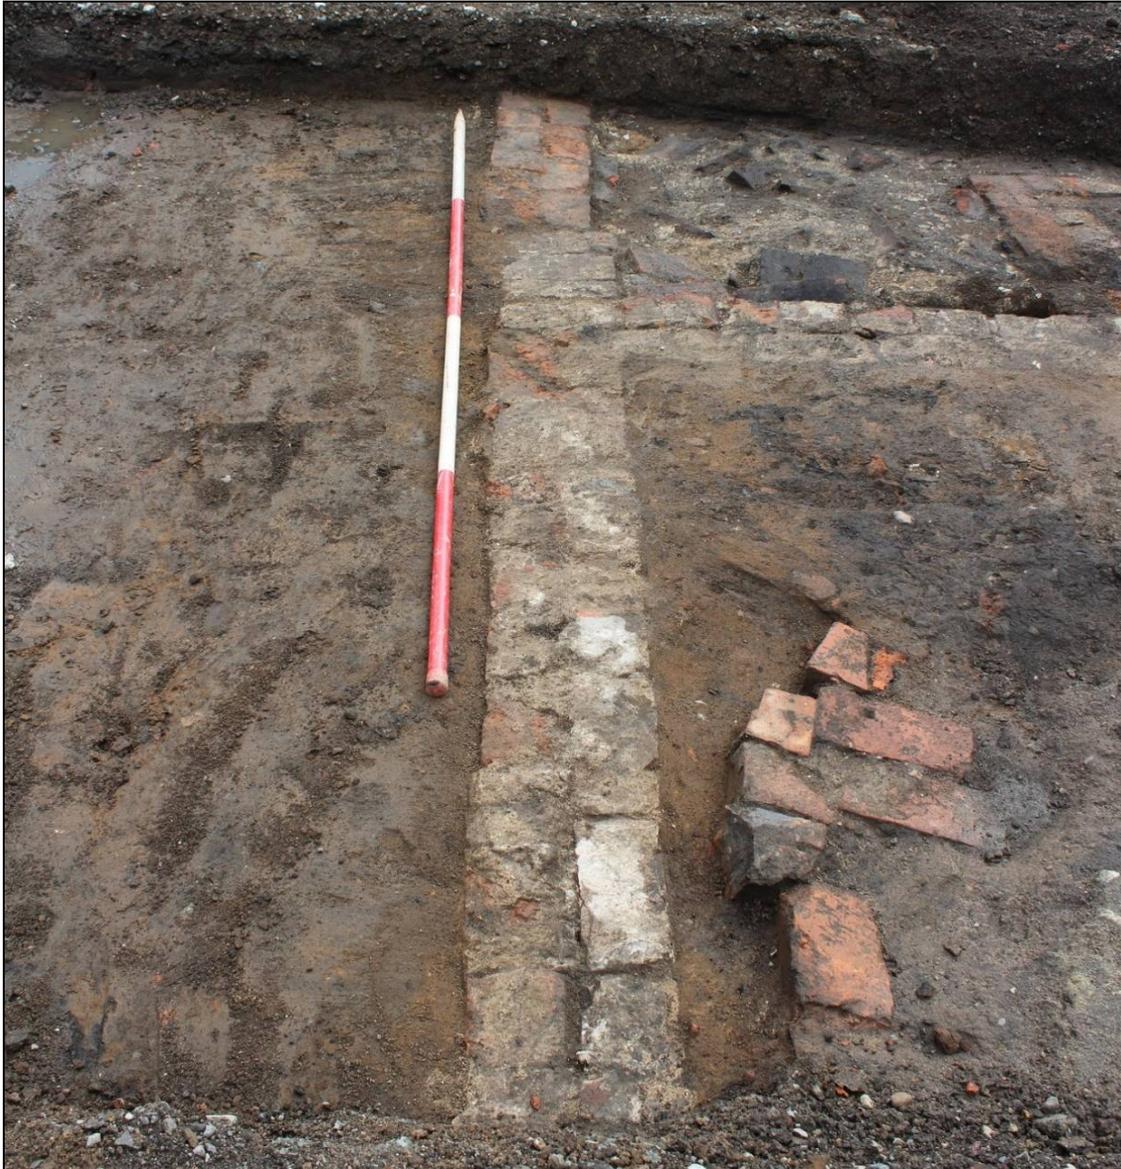
A series of walls (404, 405, 412, 413, 417 and 422) exposed to the south of wall 403 defined the southern portion of the church. The walls ranged between 138mm and 460mm in width, and most were two brick-widths thick.

*Plate 14: Walls 403 and 421 adjoining wall 404 (2m scale)*

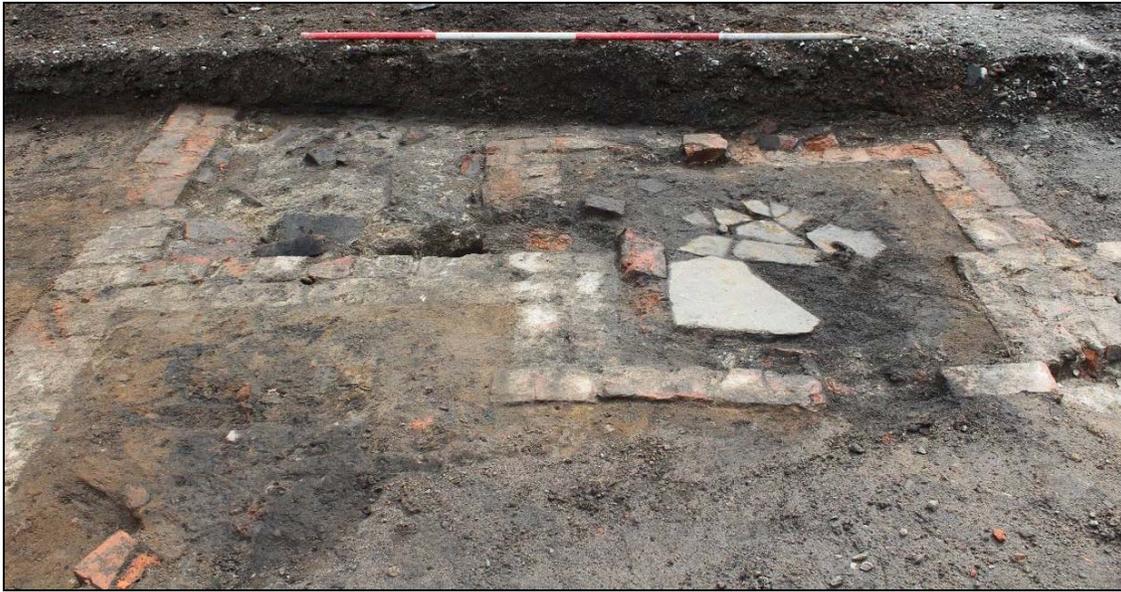
Walls 414 and 416 were 0.63m long and 201-284mm wide. Fragments of flat lying flagstones found within this structure may have formed the floor of a hearth / fireplace. The position of this particular structural element corresponds closely with symmetrical chimneys depicted on the 1850 Ordnance Survey Town Plan and subsequent line drawings of the church.

To the south of the chimney were walls 412 and 413, which formed the south-west corner of the building. Running north/south, wall 412 had a total length of 1.31m and maximum width of 0.24m. The easterly return of wall 412, wall 413, extended for a further 0.68m, continuing beyond the limit of excavation. Wall 413 was 271mm wide.

*Plate 15: Walls 403, 421, 422, 404, 416, 415, 417, 414, 405 and 412 (2m scale)*

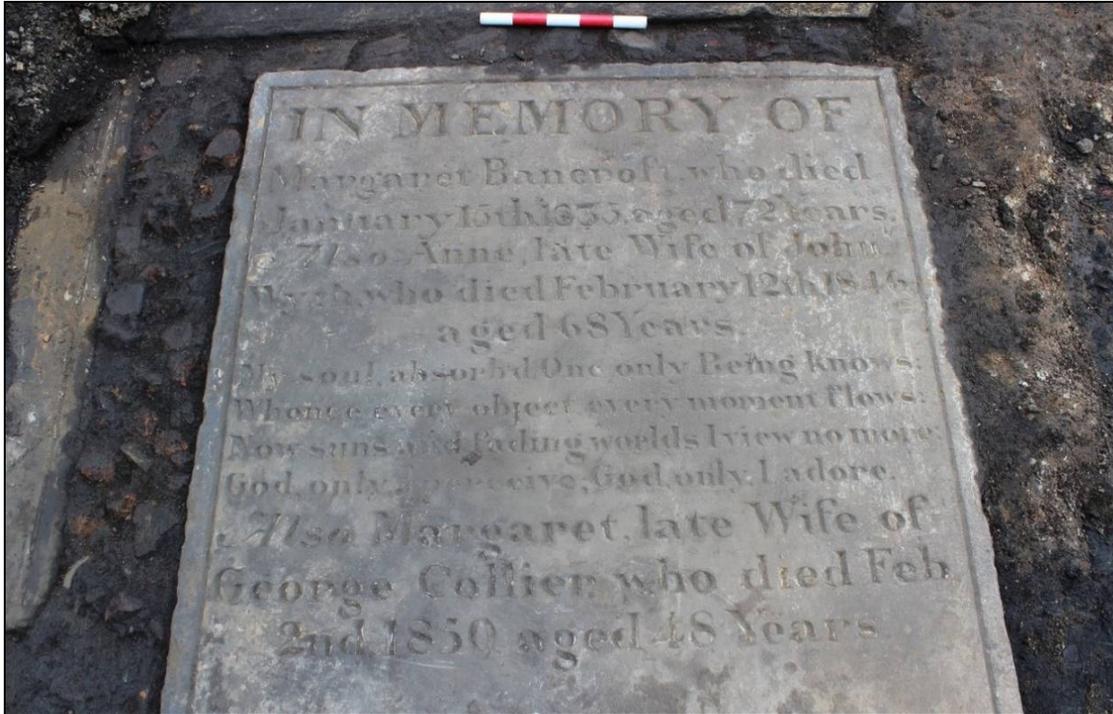
Immediately south of surface 409 were three ledger stones (Monument Nos: 31, 32, 32) and a large recumbent sandstone block (Plates 16 and 17). Remnants of further fragmented stone slabs were found at the extreme southern limit of the trench, abutting the southern churchyard wall. Indurated deposits of rubble, clinker and reworked soil had accumulated above and around the memorials and path in the southern part of the site, and evidently related to levelling events post-dating the decommissioning of the church and subsequent re-use. Similar rubble deposits 406 and 418 were encountered in the entrance to the church.

Plate 16: Detailed view of inscription on a ledger stone (Monument No. 31) in Trench 4

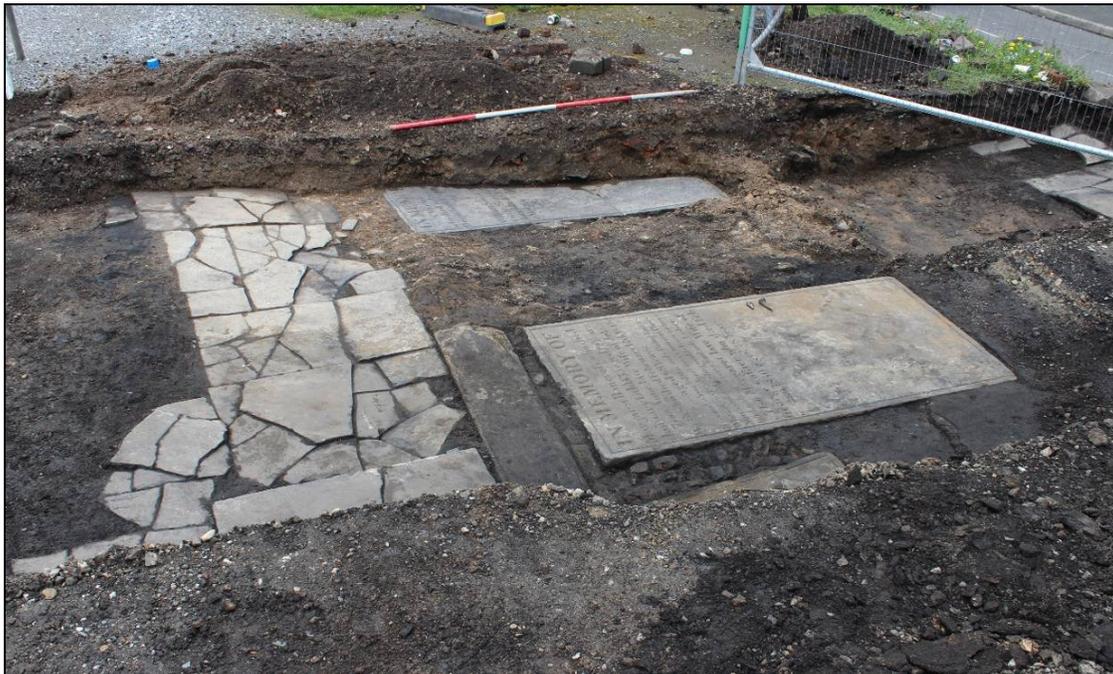
Plate 17: Southern half of Trench 4 looking south-east showing monuments 31 and 33 and stone surface 409 (2m scale)

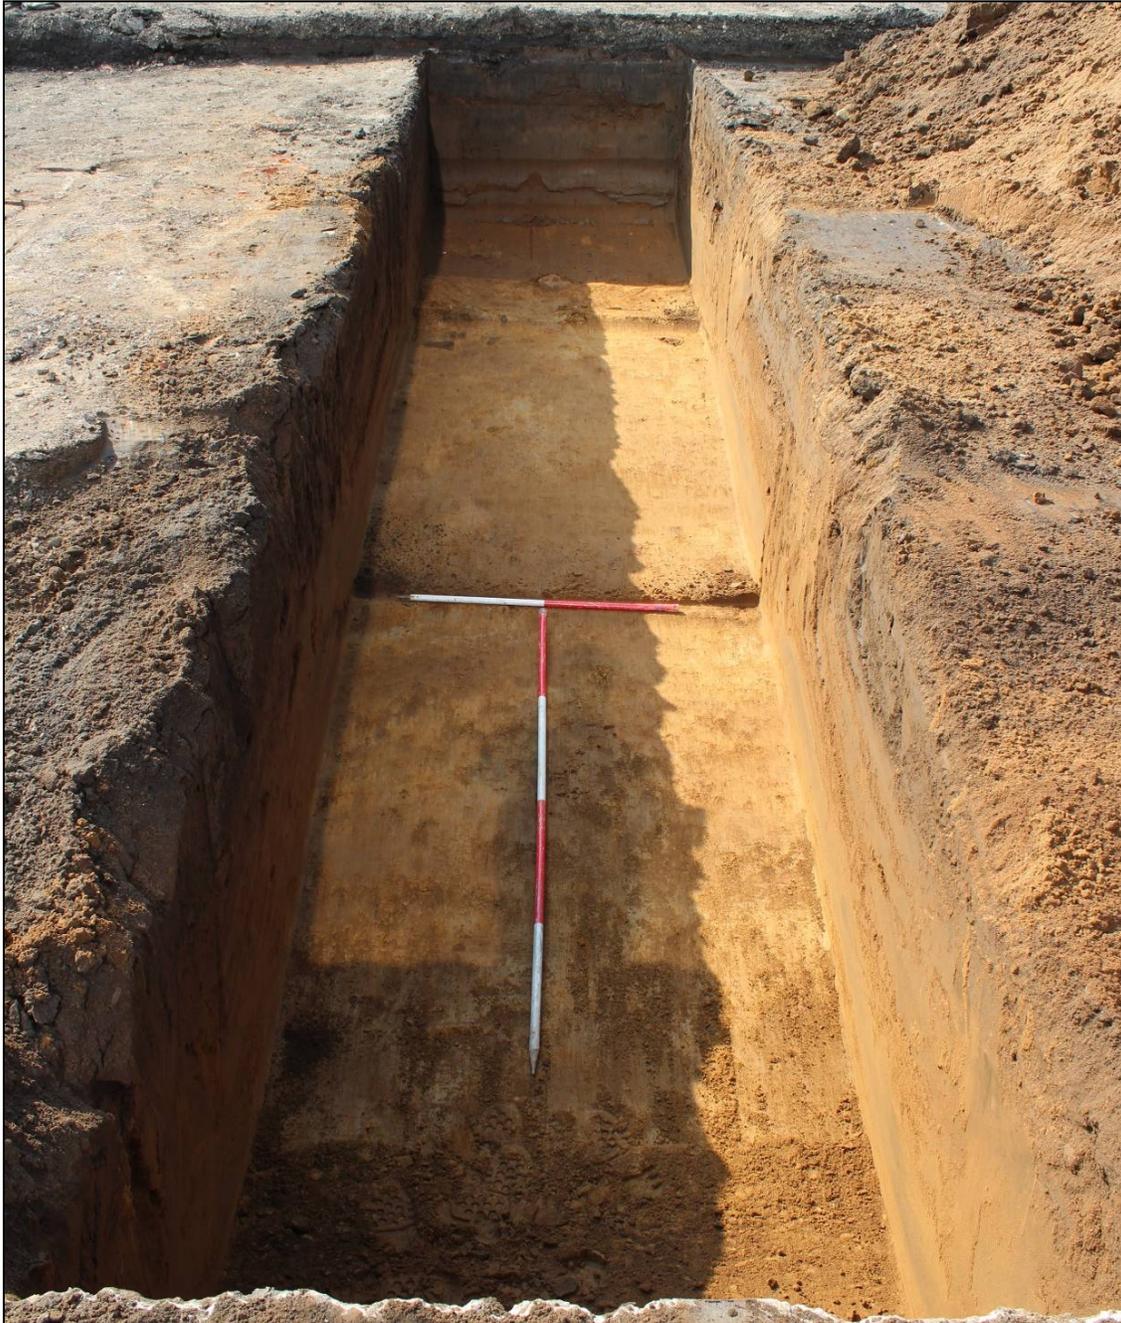
*Plate 18: Sondage 3 showing natural sand and overlying soils*

Area A was opened-up across the northern part of the church to further investigate its layout and assess the survival of internal elements of the building. A series of brick foundations and sub-floor brick conduits belonging to the church were revealed. Additional machine-excavated sondages were placed across the area as part of the investigation to assess the depth of the foundations and character of the underlying archaeology (Plate 18).

Natural deposits of sand were exposed at the base of the sondages, overlain by deposits of subsoil and relict soil. Post-medieval pottery was present in the upper levels of relict soil deposits (1017) with a single sherd of medieval pottery recovered from the subsoil (1025), close to the interface with the natural geology.

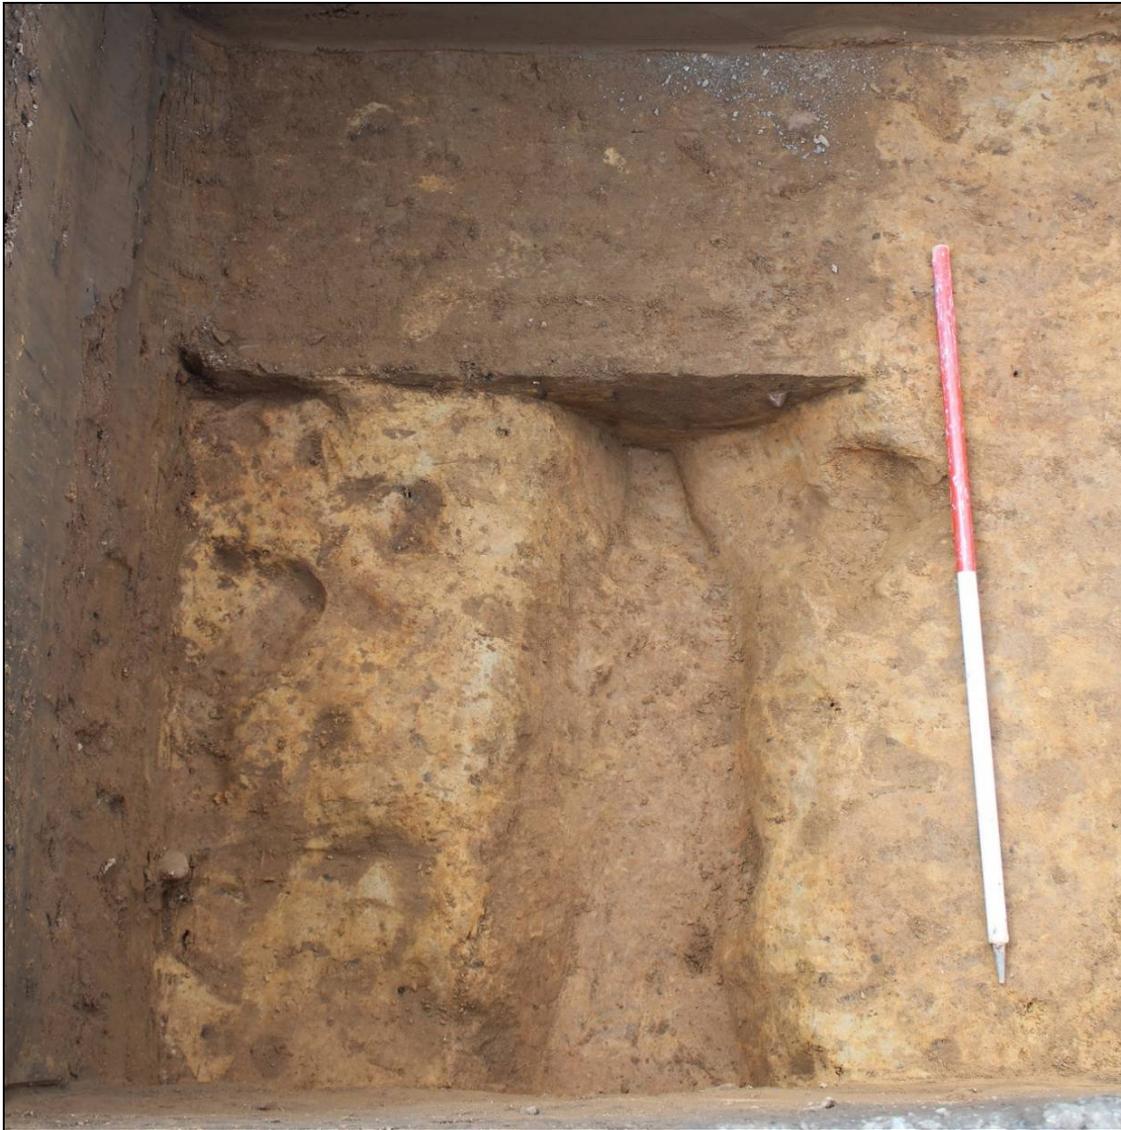
Cut into the natural geology at the southern end of sondages 1 and 3 was a shallow linear feature or gully, represented by cuts 1020 and 1022 (Plates 19 and 20). The gully was aligned broadly east/west; whilst having a regular appearance in plan it had a sinuous form and variable profile. It had a depth of 80-195mm and ranged from 280-550mm wide. The relatively shallow depth of the feature could be attributed to horizontal truncation through ploughing. The depth of the overlying subsoil and soils is suggestive of continuous farming or horticultural activity. The feature was filled with a light greyish brown to yellowish-brown silty sand (1021/1023) with occasional small, sub-rounded stones. No finds were recovered.

*Plate 19: Plan view of gully 1020*

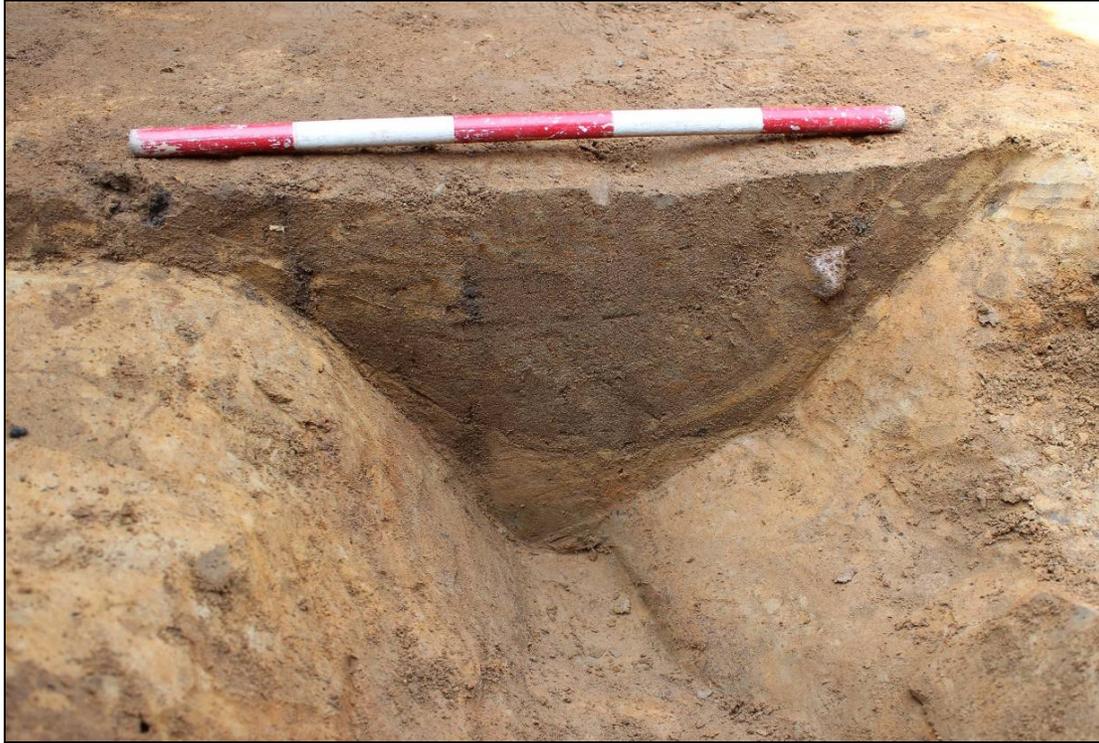
*Plate 20: East-facing section through gully 1020*

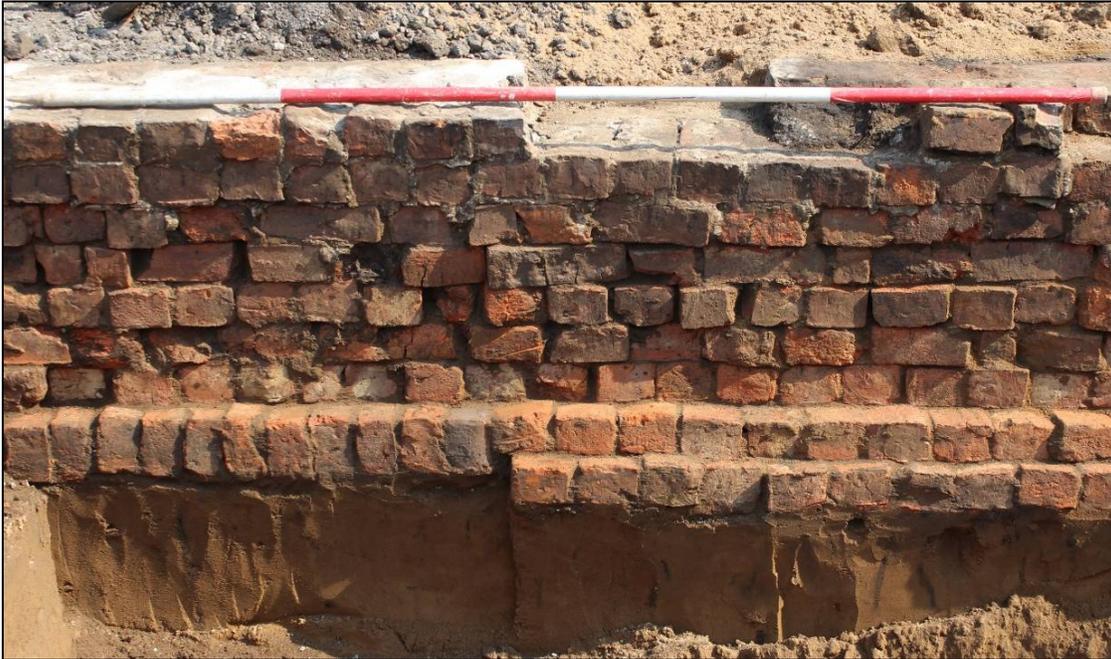
*Plate 21: Foundation of western external wall 1015 showing subsoil below (2m scale)*

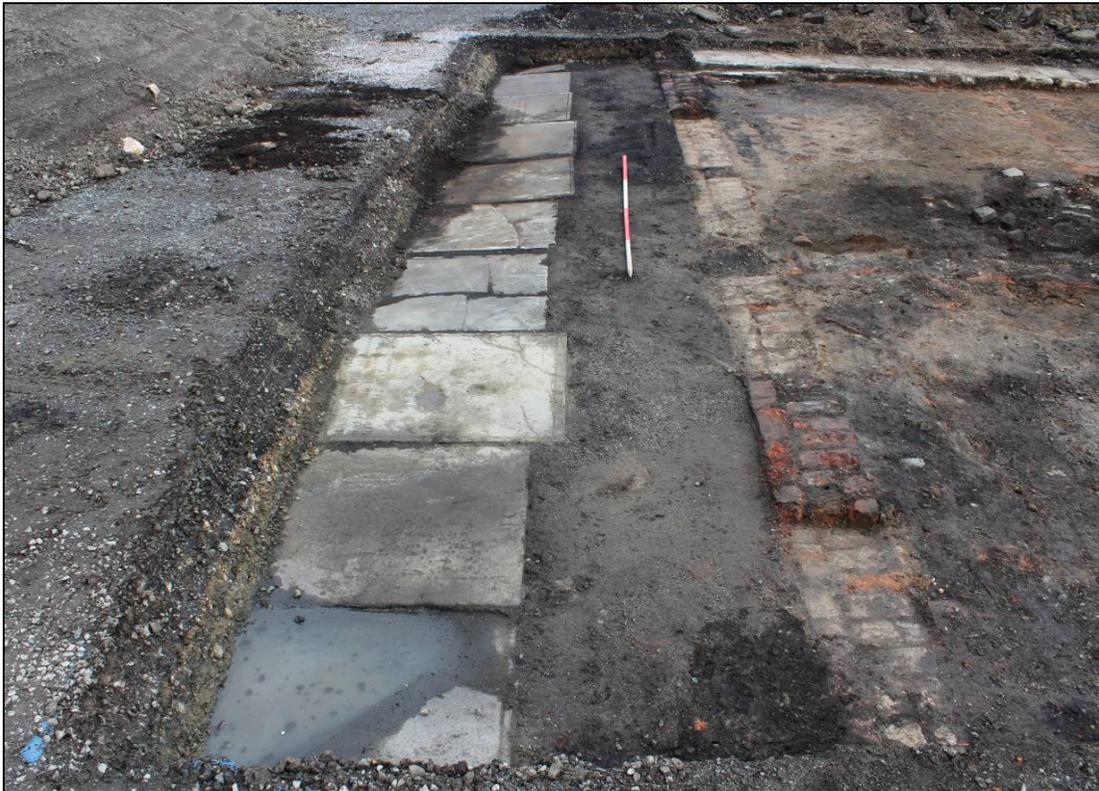
*Plate 22: Eastern wall of the church 1004 (2m scale)*

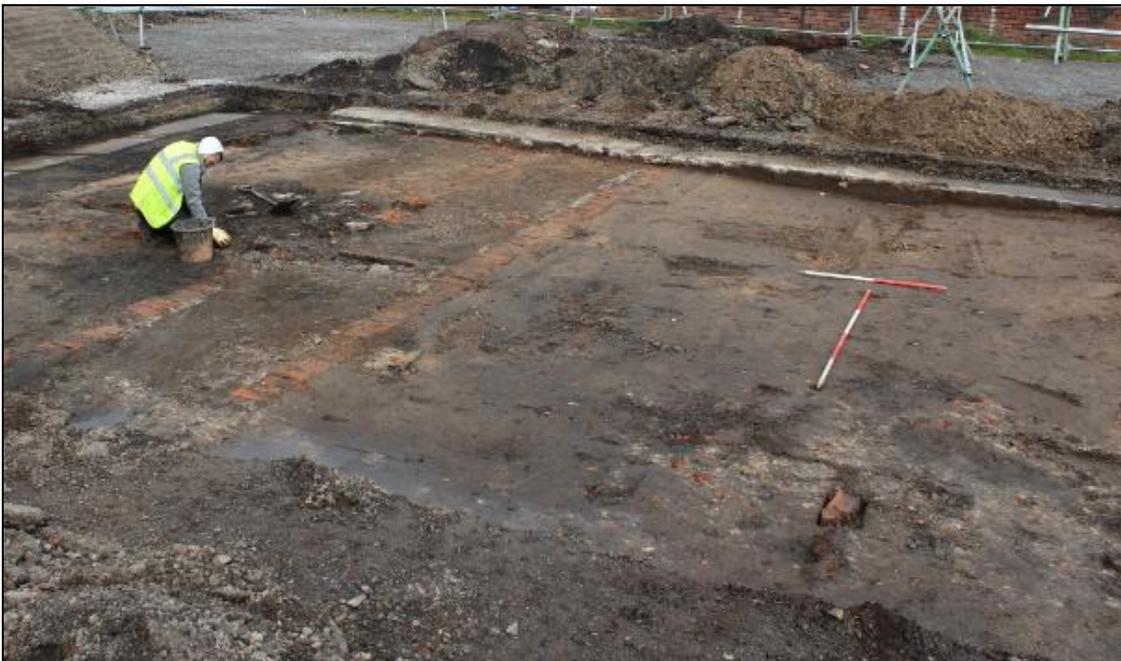
*Plate 23: Working shot during exposure of walls 1007, 1008, 1010*

The internal configuration of the church was defined by a series of east/west- and north/south-aligned brick walls: 1007, 1008, 1009, 1010, 1011, 1013, 1016 and 1014 (Plates 23 and 24). The position of the walls, together with their size and lack of substantial foundations, imply these were not load-bearing and in fact relate to internal divisions within the building. All the structural remains utilised hand-made brick and were bonded with lime mortar. It was possible to define construction cuts for the walls.

Walls 1007, 1008, 1010, 1011, 1013 and 1016 were north/south aligned and seem to delineate the eastern and western aisles of the church, as depicted on mid-19<sup>th</sup>-century historical mapping. The western aisle was represented by walls 1007, 1008 and 1010. Wall 1007 measured 4.05m long and had a maximum width of 270mm. Wall 1008 had a length of 2.26m and width of 240mm. Wall 1010 had a maximum length of 6.83m and was 300mm wide. An additional brick wall extended westwards from the southern end of wall 1009 to wall 1004. Wall 1009 was 300mm wide and 2.25m long. The western wall of the aisle was intersected by brick conduit 1006, measuring 520mm wide and 3.83m long. The internal width of the conduit measured 0.31m wide.

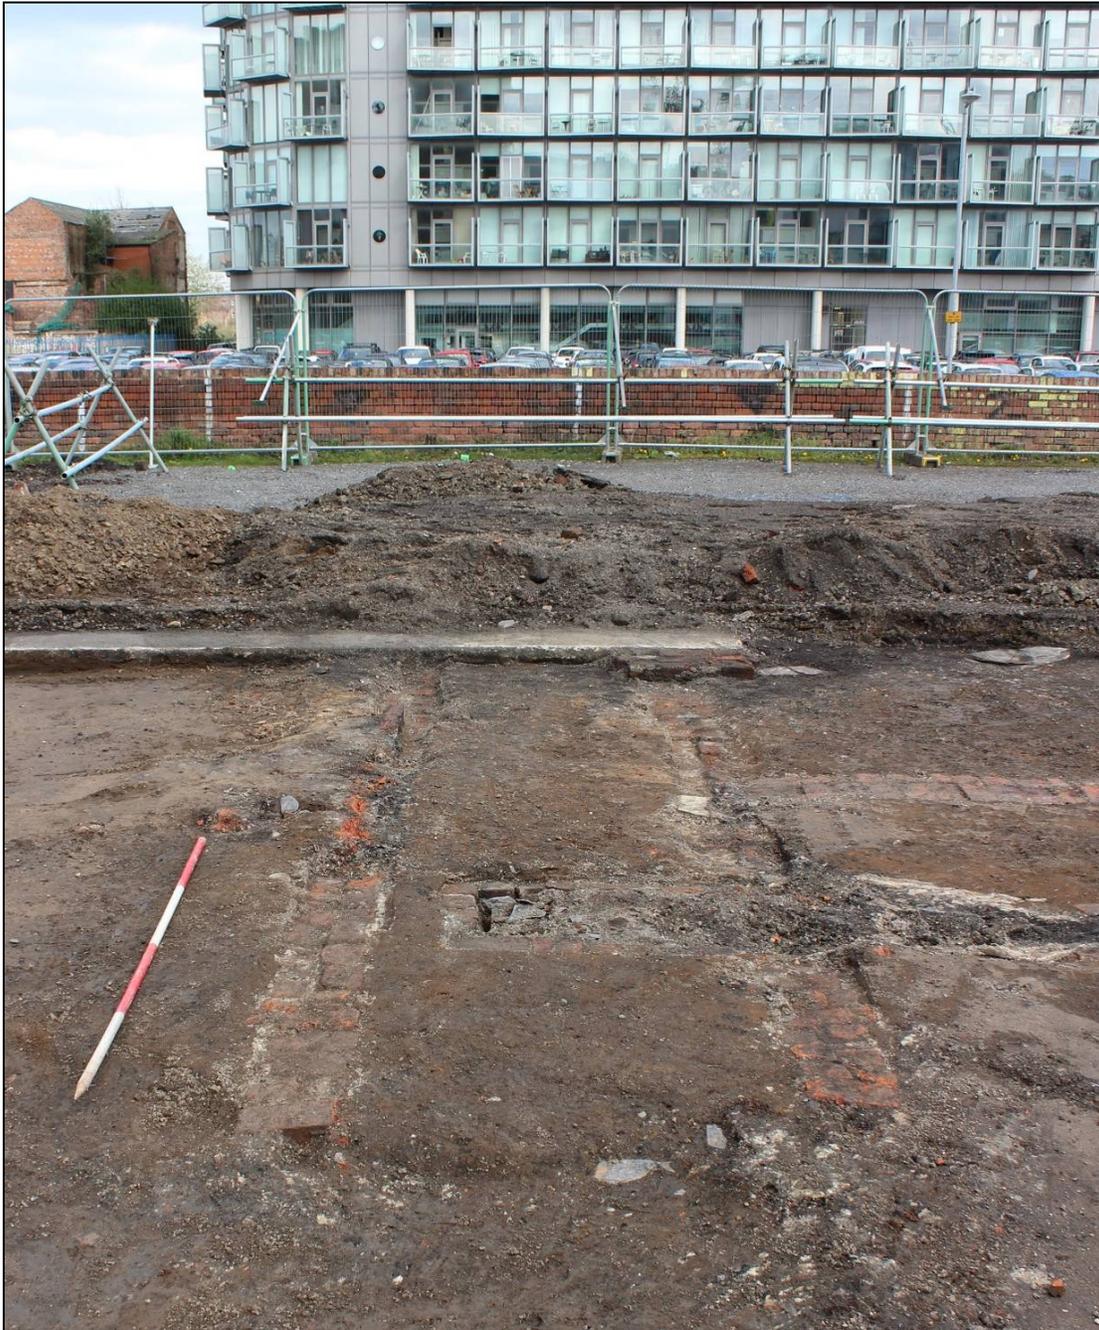
*Plate 24: Walls 1011, 1013, 1016, looking north towards the Abito Building (2m Scale)*

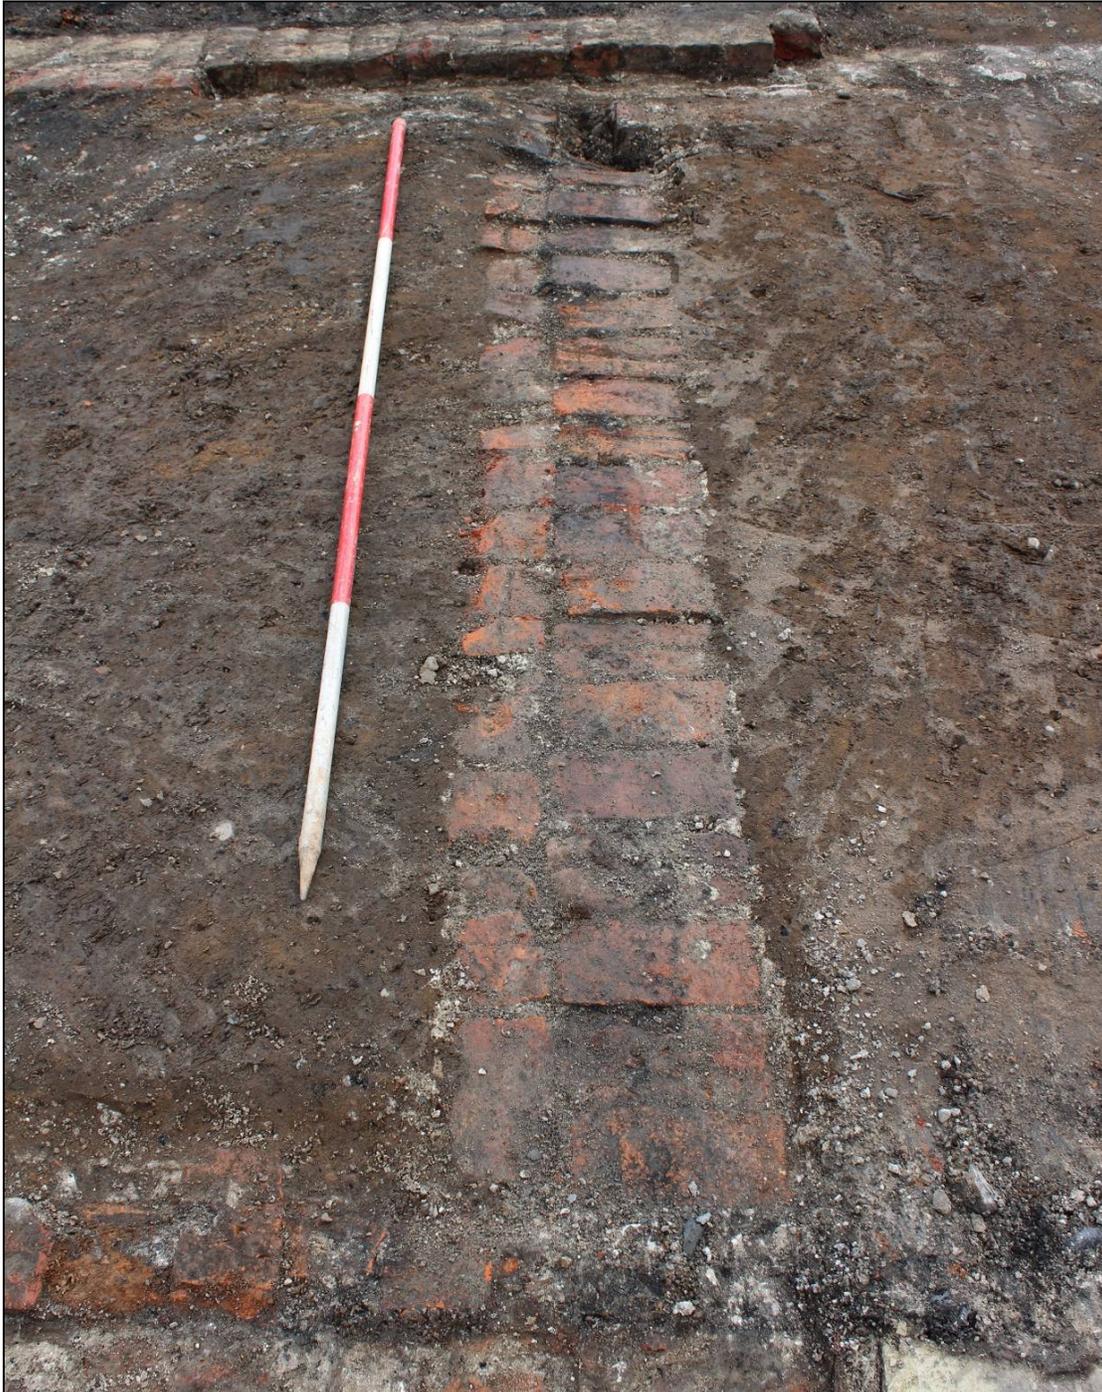
Walls 1013 and 1011 continued beyond the northern limit of the excavation and presumably extended as far as the main east/west wall of the church. An additional brick wall (1014), oriented east/west, was constructed between wall 1013 and wall 1014 (Plate 25). Measuring 2.60m in length and 0.34m in width, the wall probably reflects one of the internal divisions shown on the 1850 Ordnance Survey Town Plan.

*Plate 25: Wall 1014, looking east*
