## **Archaeological Evaluation Report**

Christ Church,  
(Plot K),  
King Street,  
Salford

SA/2019/40

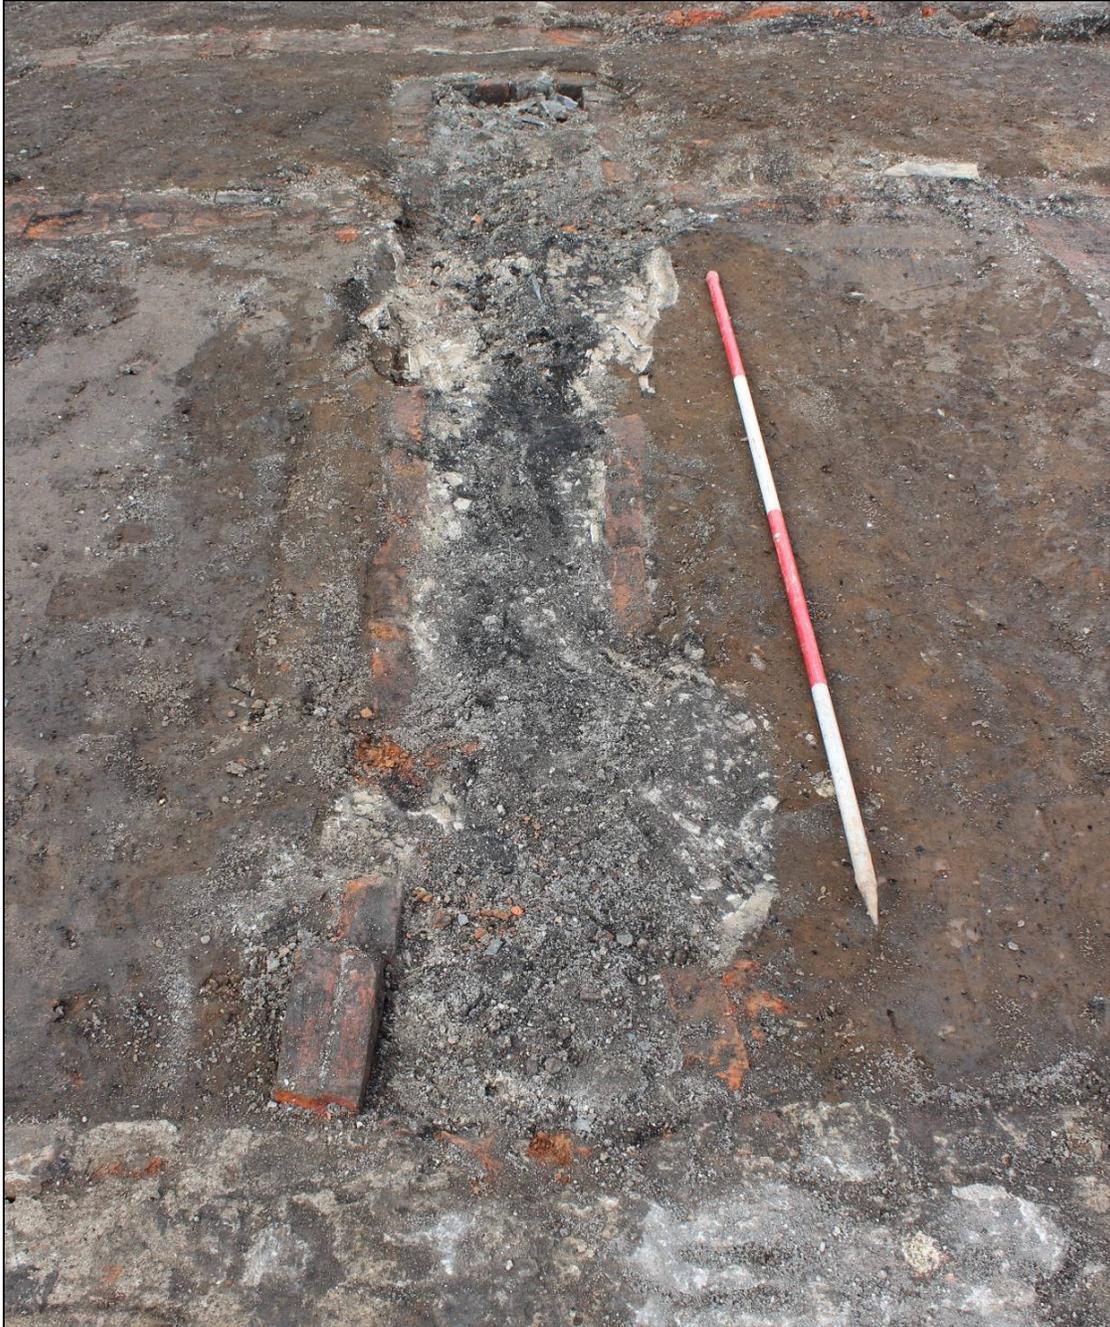
Two brick-built conduits (1006 and 1012) were exposed in the eastern and western sides of the building (Plates 26 and 27). These were aligned east/west and consisted of two parallel, single-skin brick walls atop a flagstone base. Their construction was better understood through the excavation of Sondage 2, which revealed the brickwork forming the northern face and base of 1012. Three courses of brickwork were visible.

*Plate 26: Brick conduit 1012, looking west (2m scale)*

Sub-floor conduits 1006 and 1012 within the church were interpreted as either heating or service ducts, and could have feasibly contained pipework for either hot water, steam or gas. The latter would have provided a means to either heat or light the building. The base of a chimney was also exposed in Trench 4. This was one of four chimneys depicted on 19<sup>th</sup>-century illustrations of the church (Plate 44), which is unusual in ecclesiastical architecture. As the church was used for several different purposes, from services, conferences and meetings, an array of rooms not usually found in the church included offices and a room housing a printing press (Antrobus 1997, 58-59). The chimney and flue arrangement visible on the mapping and archaeologically would have heated the day-to-day rooms of the church, namely its offices as well as William Cowherd's study.

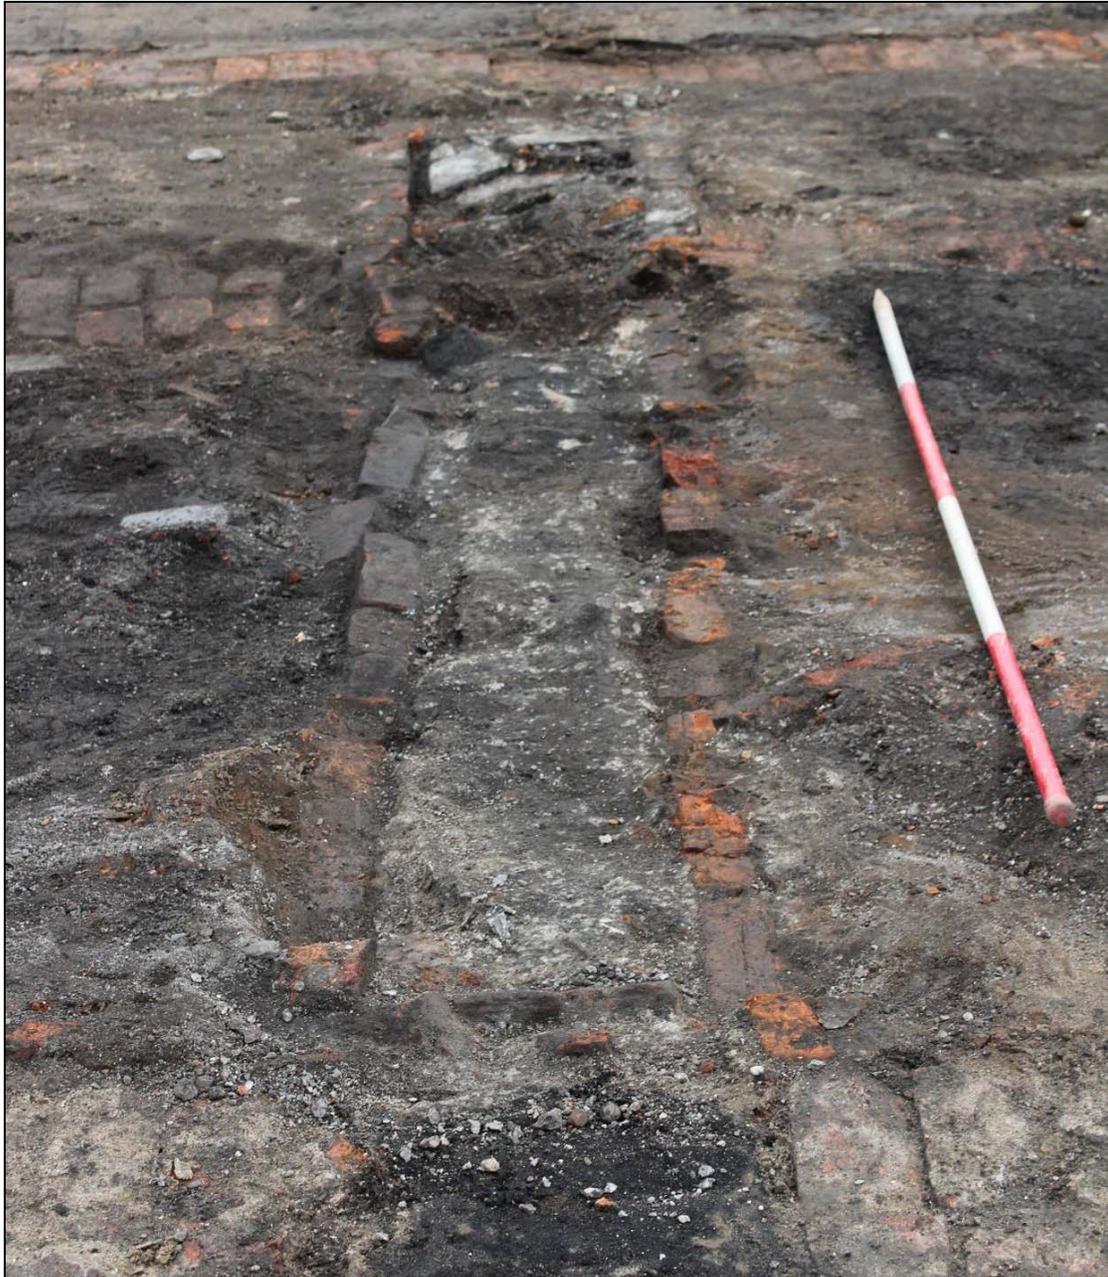
*Plate 27: Brick conduit 1006, looking east (2m scale)*

Conduit 1006, situated on the western side of the building, had a total length of 3.83m and maximum width of 0.52m (Plate 27). The interior of the structure measured 3.71 x 0.31m and was filled with a compacted deposit of degraded plaster and ash with frequent rubble inclusions. Conduit 1012 had near identical dimensions, extending to 3.80m in length and 0.70m in width with an approximate depth of 0.32m. The fill of the structure was broadly similar to 1006. The function of these sub-floor features was unconfirmed, although it is likely that they formed part of an under-floor heating system within the church.

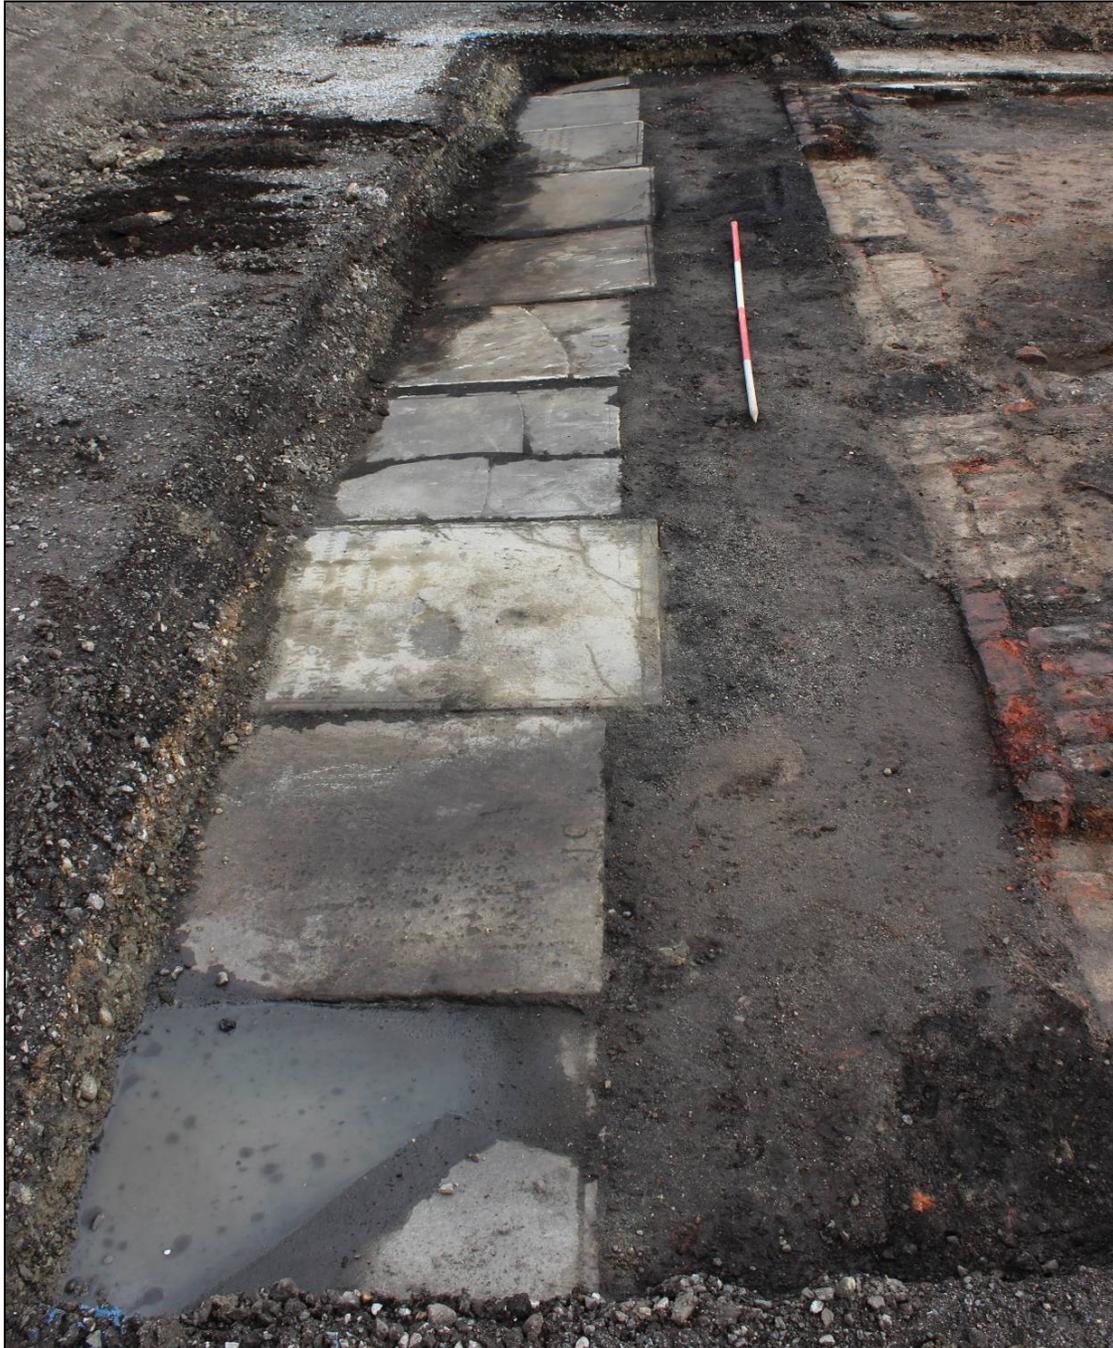
The majority of the structural remains encountered in the central part of Area A and trenches 1 and 4 had been reduced to the external ground level with no remnant floor surfaces visible. Much of the subsequent activity was associated with the more recent use of the site as a car park. An exception was a large concrete slab laid in the northern part of area that was laid over the reduced wall foundations (1007, 1010, 1011 and 1013) and therefore relates to the use of the site in the 20<sup>th</sup> century, following the demolition of the church.

*Plate 28: Ledger stones visible along the western edge of Area A*

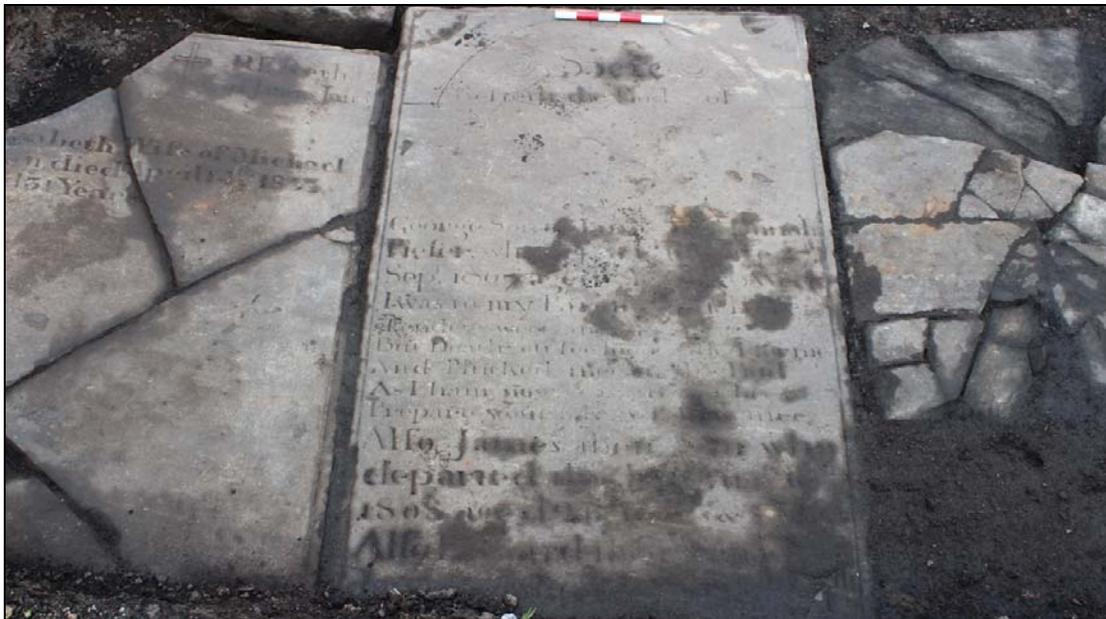
Trench 2 was placed in the northern part of the site, to the north-east of the church (Fig 2). The trench measured 7.60 x 2.15m, and was excavated to a maximum depth of 83mm, through modern overburden 201. In total, 12 ledger stones were revealed beneath the modern overburden (Monument Nos. 13–22).

Plate 29: Ledger stones in Trench 2, looking east (Monument Nos. 13–15)

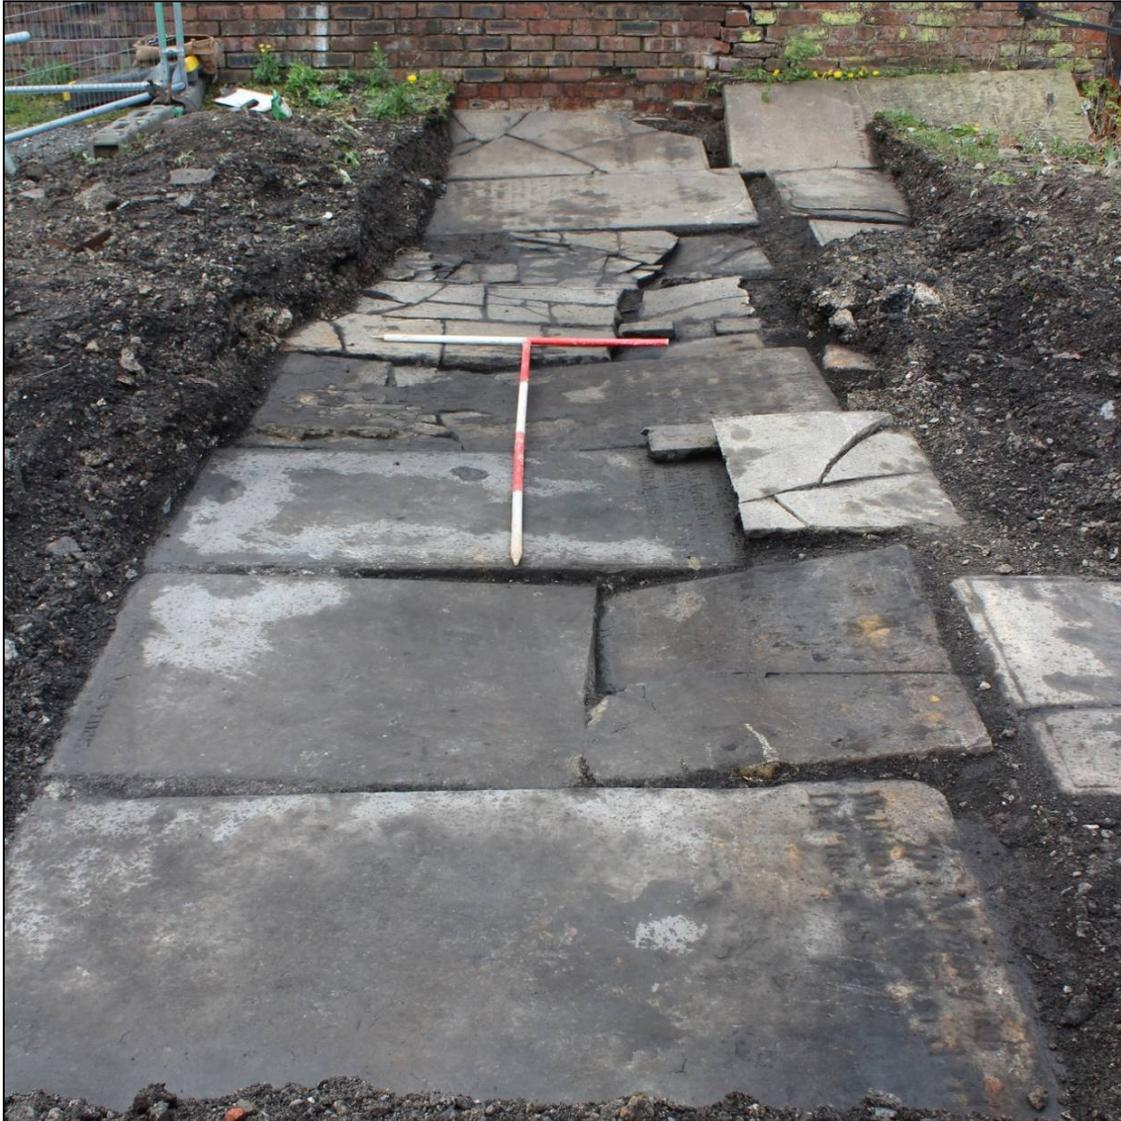
The ledger stones exposed in Trench 2 were laid in two north/south rows (Plate 30). Most of the stones were inscribed but varied in condition from being fully intact to fragmented. Whilst the majority of the stones were flat-lying, the northernmost ledger stones (Monument Nos. 13 and 24) rested against the northern boundary wall, and may have been moved from their original position.

*Plate 30: Trench 2, looking north, showing the two rows of ledger stones lying at a very shallow depth beneath the modern ground surface*

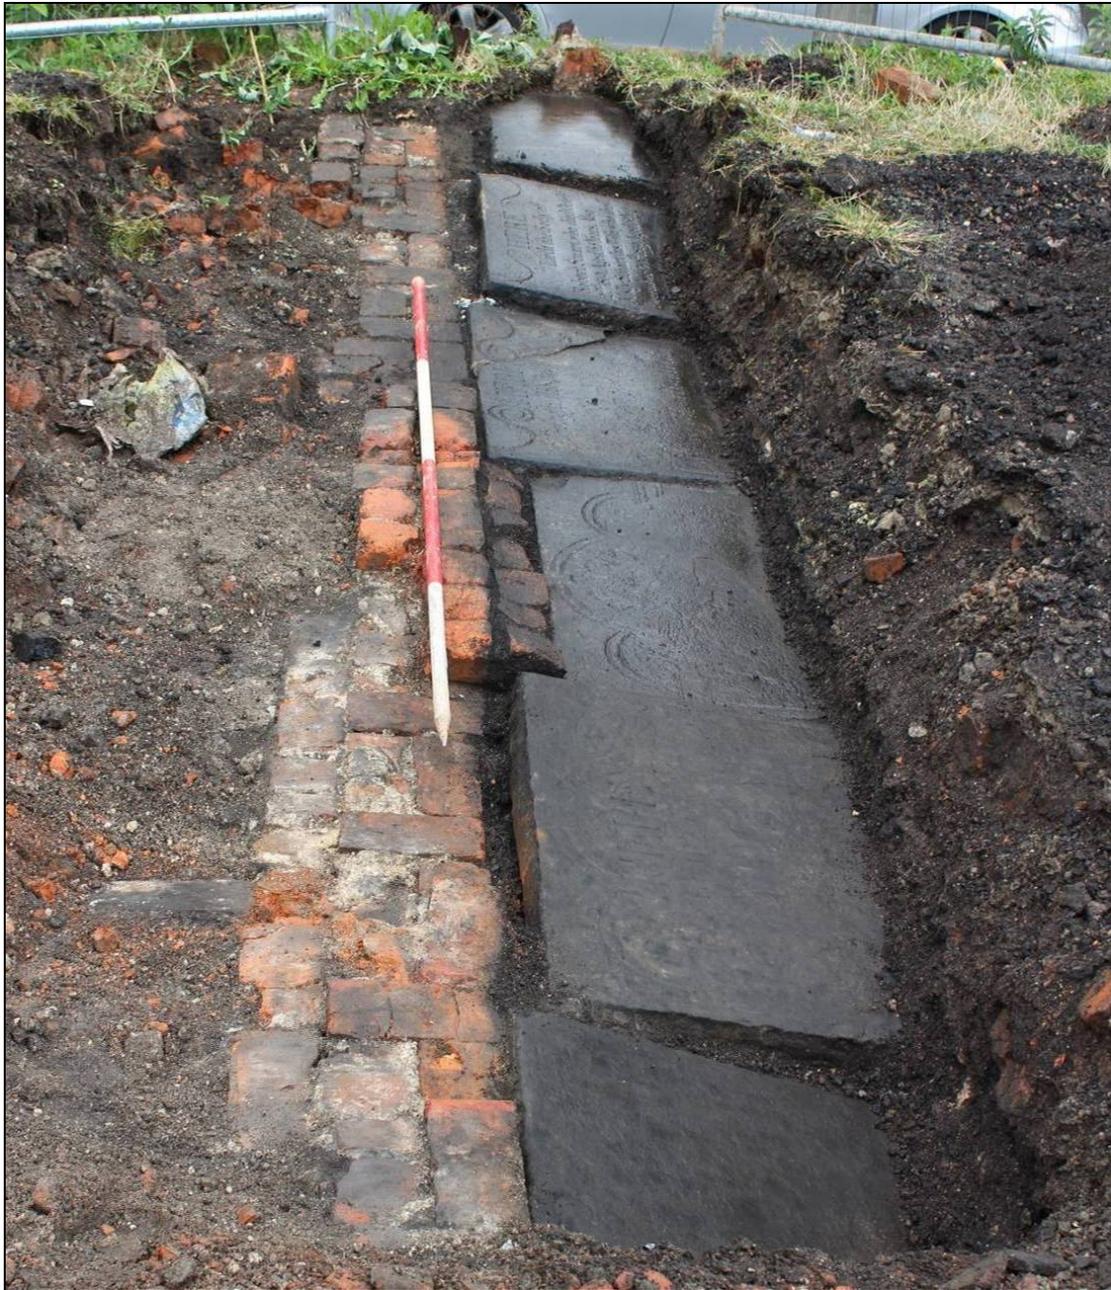
*Plate 31: Trench 3, looking south (2m scale)*

Trench 3 was placed in the southern part of the site, south-east of the church. The ledger stones and structural remains encountered were revealed at a relatively shallow depth of 234mm. The modern overburden was slightly deeper at the northern end of the trench, increasing to 500mm. The structural remains included the western wall of the Sunday School. Six ledger stones were partially revealed (Monument Nos. 30–35); these abutted the brick wall of the school building, and were aligned north/south, but all had slumped slightly to the west (Plate 31). Five of the ledger stones had visible inscriptions (Plate 32).

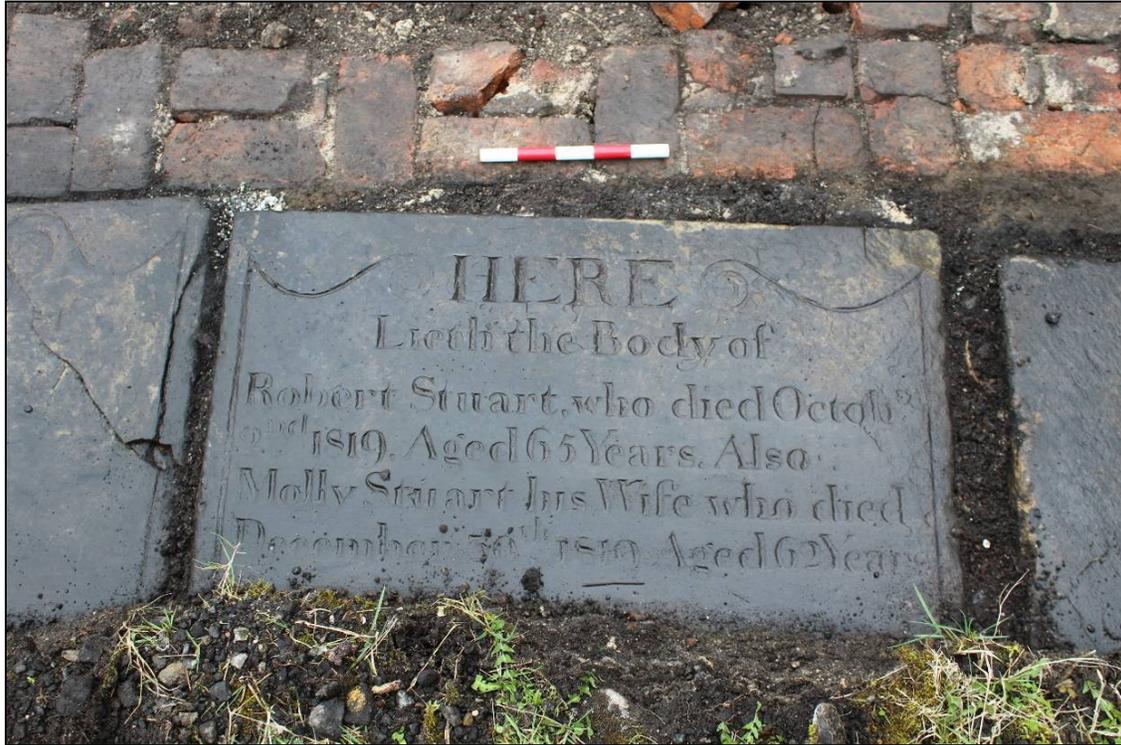
*Plate 32: Example of ledger stone exposed in Trench 3 (Monument No. 26)*

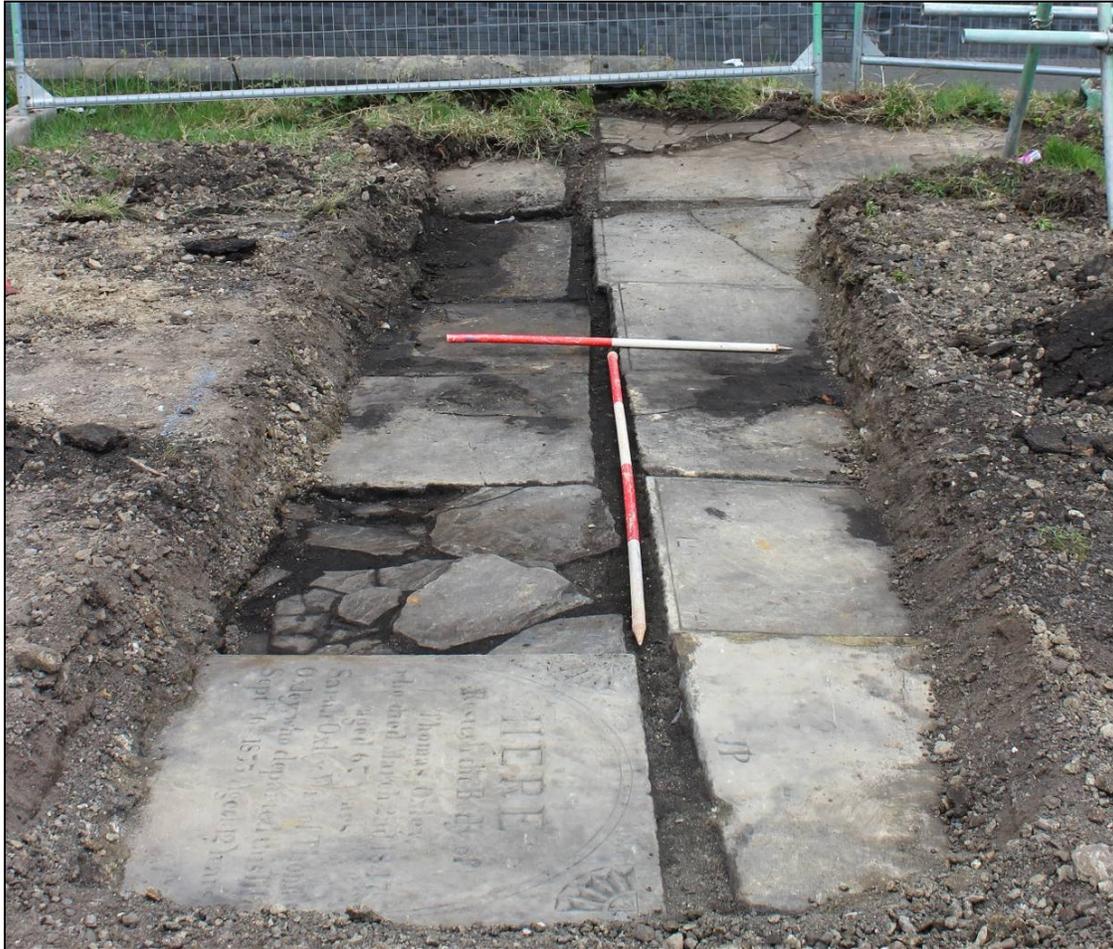
*Plate 33: General view of Trench 5 looking south*

Trench 5 was situated in the western half of the site, adjacent to the southern boundary wall. It measured 5.70 x 1.60m and was excavated to a maximum depth of 0.20m. The entirety of the trench was covered by tarmac and aggregate to a depth of 0.17m. Residues of bituminous substance were adhered to the underlying ledger stones in patches. The remains of 12 ledger stones were partially exposed (Monument Nos. 1–12) beneath the modern car park surface (Plate 33). The condition of the ledger stones varied from highly fragmented to intact.

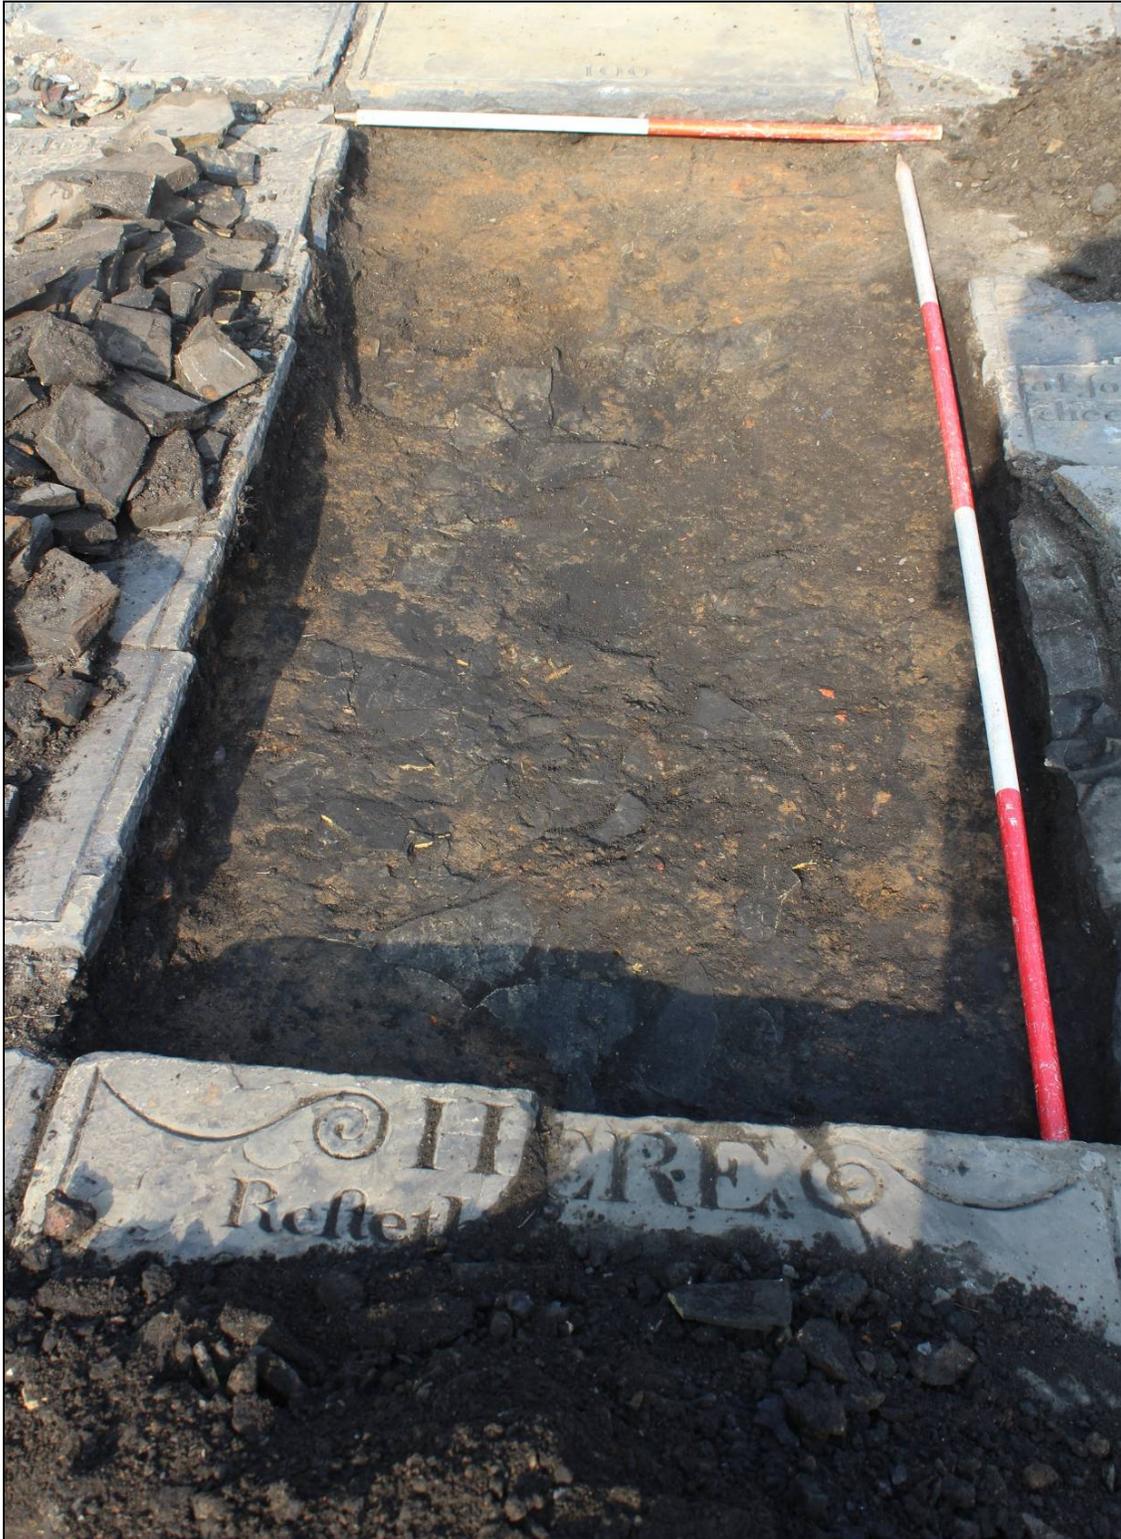
A test pit placed in the central part of the site was excavated upon completion of the recording of monuments in Area B. This exposed a burial plot that was cleaned manually to assess whether any grave cuts were visible. The test pit measuring 0.97 x 0.41m was placed at the eastern end of the plot; it was excavated to a maximum depth of 0.56m (Plate 34). The lowest stratigraphic unit encountered within the test pit was a layer of light greyish-brown silty sand (1205) with frequent small stone inclusions and charcoal flecking. Layer 1205 was a reworked soil deposit and had been used as backfill; it sealed the remains of a putative wooden coffin and lid.

Place 34: Excavation of a burial plot after removal of fragmented ledger stone fragments, Area B

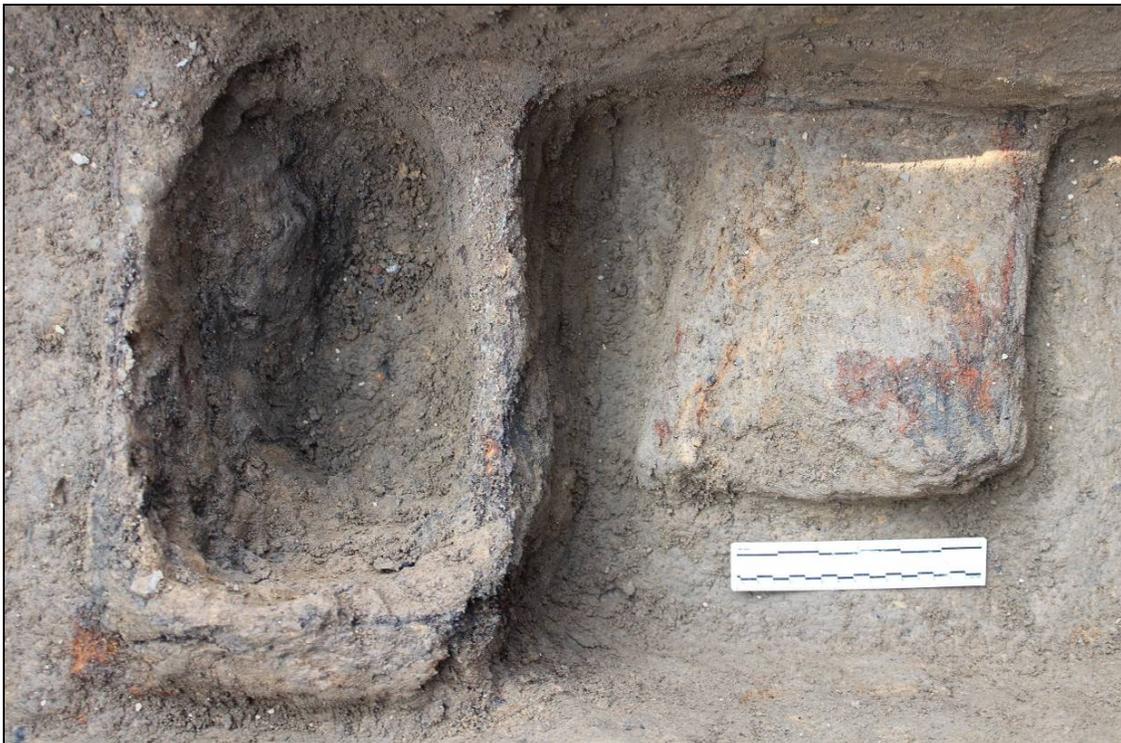
The putative coffin had a maximum width of 220mm and length of 370mm; the internal dimensions were 150 x 170mm, and the lid measured 230 x 245mm (Plate 35). The coffin interior was filled with 1204, a light greyish-brown silty sand similar to the backfill of the burial plot. The coffin was partially excavated and found to contain degraded bone. Stratigraphically above backfill 1205 was a layer of fragmented ledger stones and humic dark brown silty sand (1203), 152-160mm thick. This was in turn sealed by 110–260mm of modern overburden (1201). Although no articulated remains were encountered, the test pit was useful in establishing the depth and character of the graves.

*Plate 35: Partially exposed wooden coffin and lid*

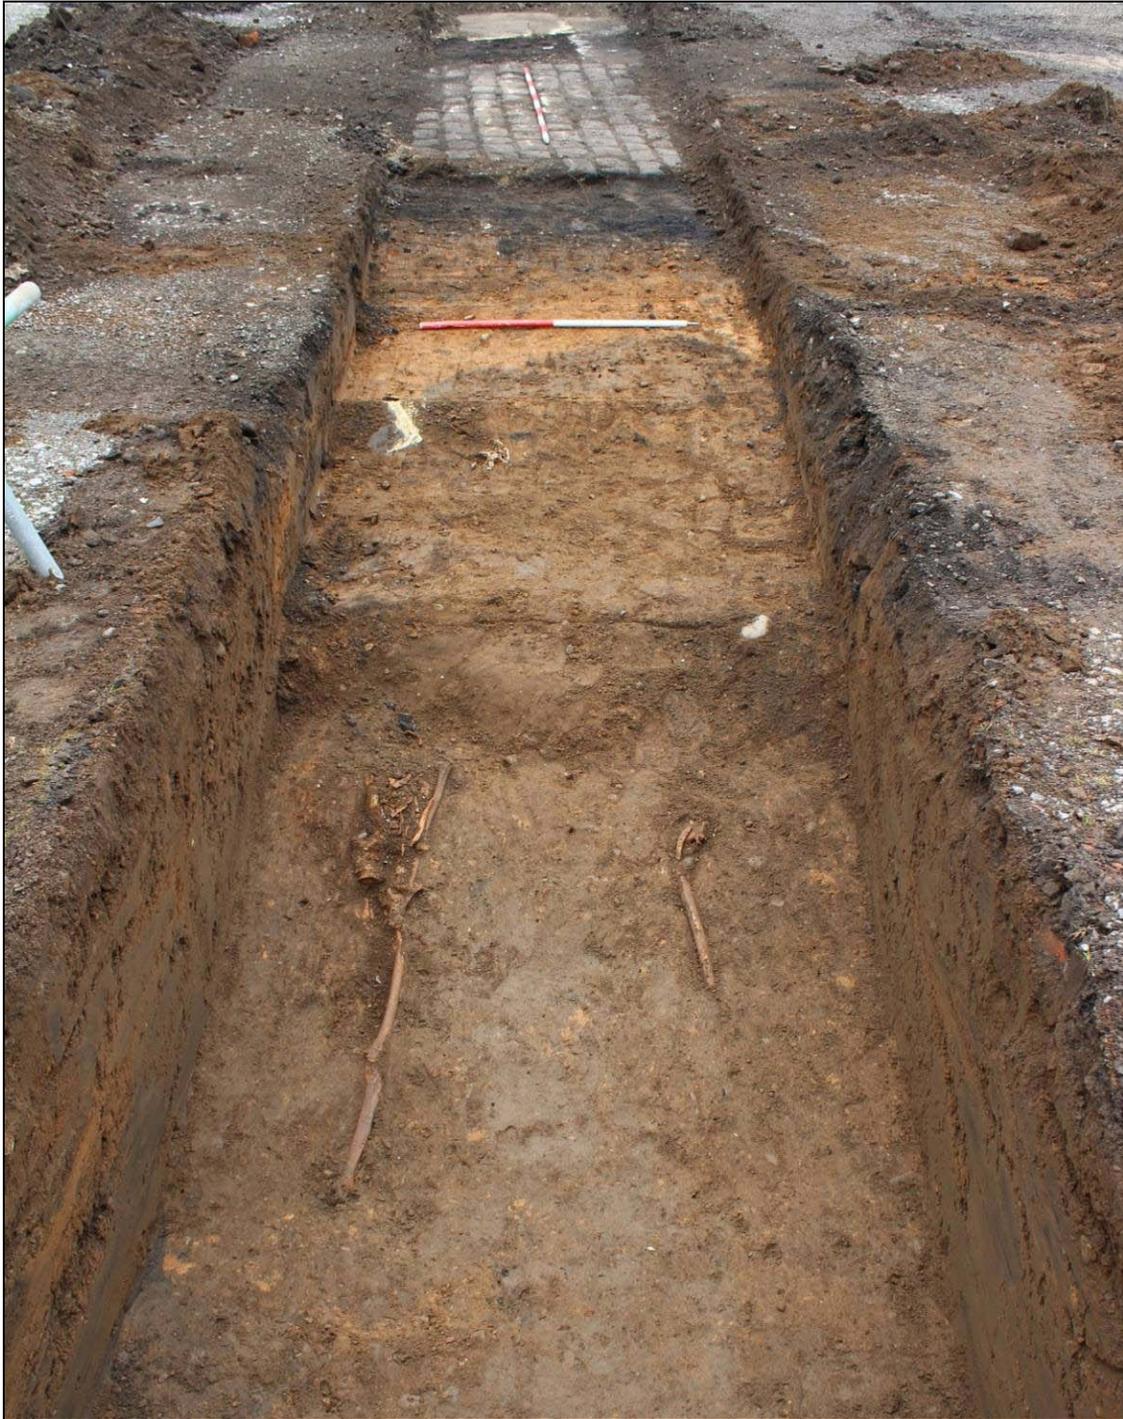
Trench 6 was placed close to the eastern boundary of the site (Fig 2). The purpose of the trench was to examine whether any burials existed beyond the supposed boundary of the church (as indicated by a dotted line on the Ordnance Survey mapping). The trench was approximately 10m long and excavated to a maximum depth of 9.80m and width of 1.70m wide. Deposits of a light brown silty sand soil, with moderate inclusions of sandstone were revealed below the modern ground surface 601 (tarmacadam and aggregate <5cm depth) at the eastern end of the trench. Two east/west-aligned burials (SK001 and SK002) were encountered below the soil deposits 602 at a depth of 660mm below the modern ground surface. Both burials were supine. The skeletal remains were extended, slumping down to east; this inclination suggests subsidence or settling perhaps caused by underlying burials.

*Plate 36: Trench 6, looking west showing burials SK001 and SK002*

Traces of thin wooden coffins and coffin nails were exposed around the edges of the skeletal remains; small copper alloy pins were also found, perhaps indicating a use of a shroud. The absence of ledger stones and shallow depth of the burials suggests these were paupers' burials.

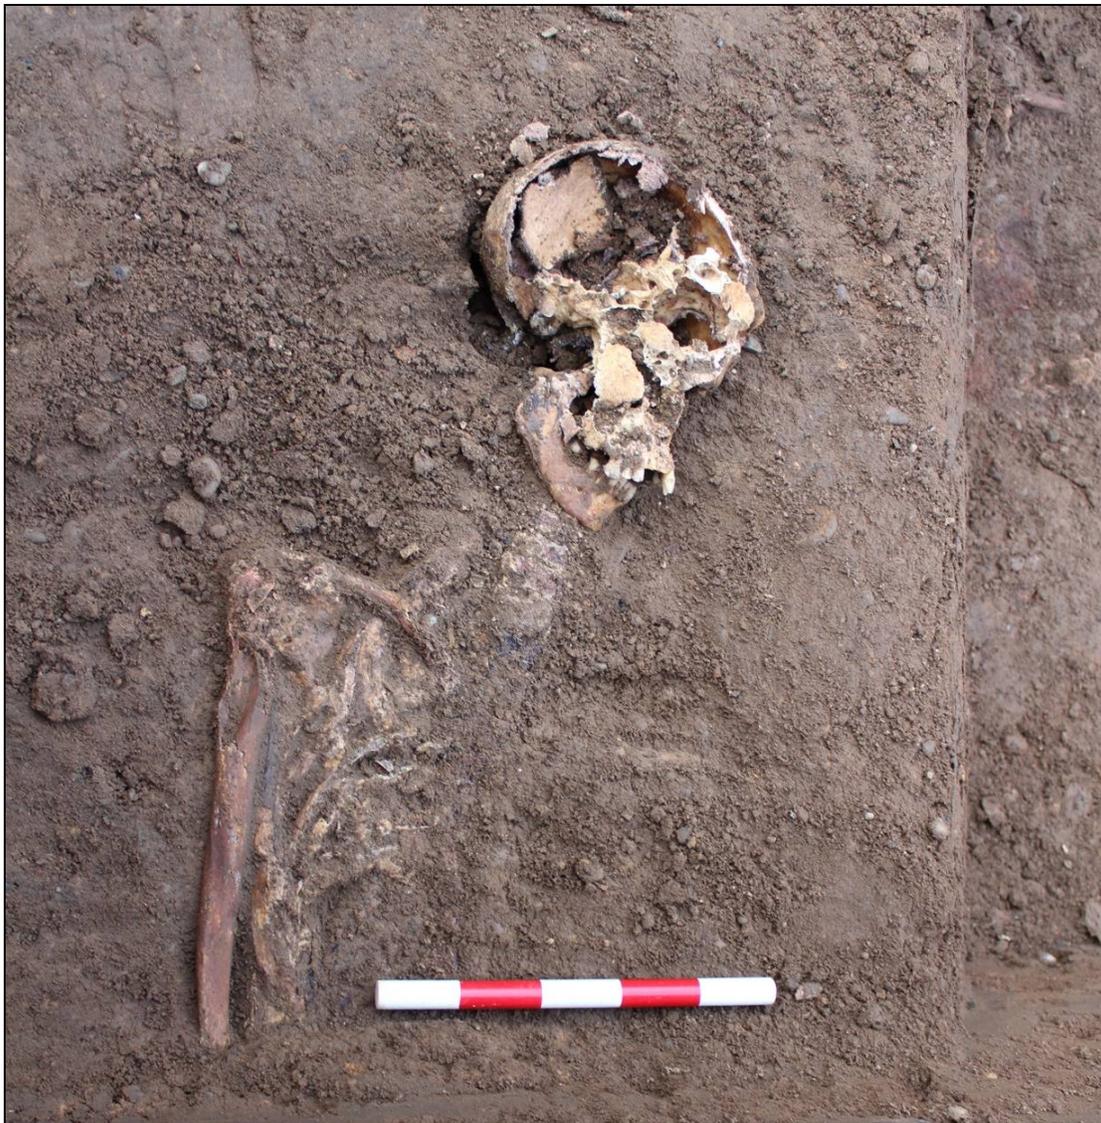
A north/south-aligned burial (SK003) in cut 611 was partially exposed at a depth of 950mm below modern ground surface, with further potentially articulated remains found to the west. SK003 was extended, leaning on its left side, with only its upper right-hand side of the skeleton and skull (collapsed during machining) visible (Plate 37). The condition of the bone in found in Trench 6 was generally poor, with the bone being soft and flaky.

Plate 37: Burial SK003 burial cut 611 in Trench 6

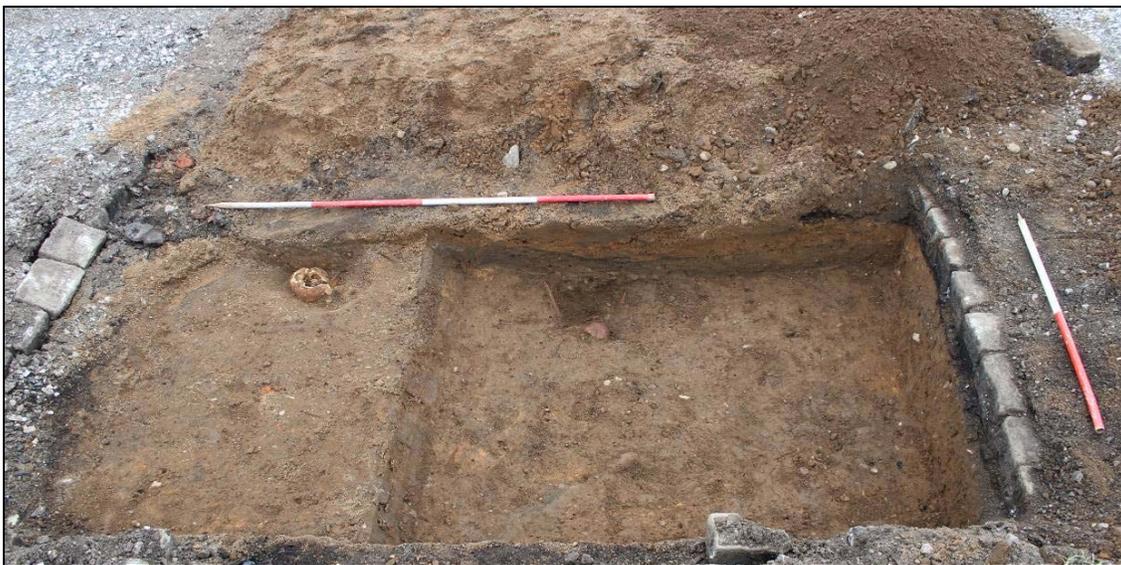
Plate 38: Trench 7, looking east

The trench was overlain by a shallow deposit of aggregate and tarmacadam (701), which covered setts 702. Beneath this, the western edge of the cutting of road 703 and underlying drain was visible due to the backfilled sand 704. Once reduced below the level of the drain cut, two potential burials were exposed (Plate 38). The southernmost burial was defined by cut 705. It was exposed more fully and revealed a skull, cervical vertebrae and arm bones SK004 (Plate 39). This lay 400mm below the current ground level in relatively good condition. The skull was partially collapsed and lay flattened on the southern side of the skull. The size of the skull and arm bones suggests this was a child's burial. An additional skull was exposed at a higher elevation to the north, approximately 260mm below the modern ground surface. Although found in association with other bones, not enough was exposed to confirm whether this represents a burial or if it had been disturbed historically; there is a possibility the bones had been displaced. The layer into which the burials were cut was a friable, light greyish-brown, silty sand 707 with frequent gravel inclusions.

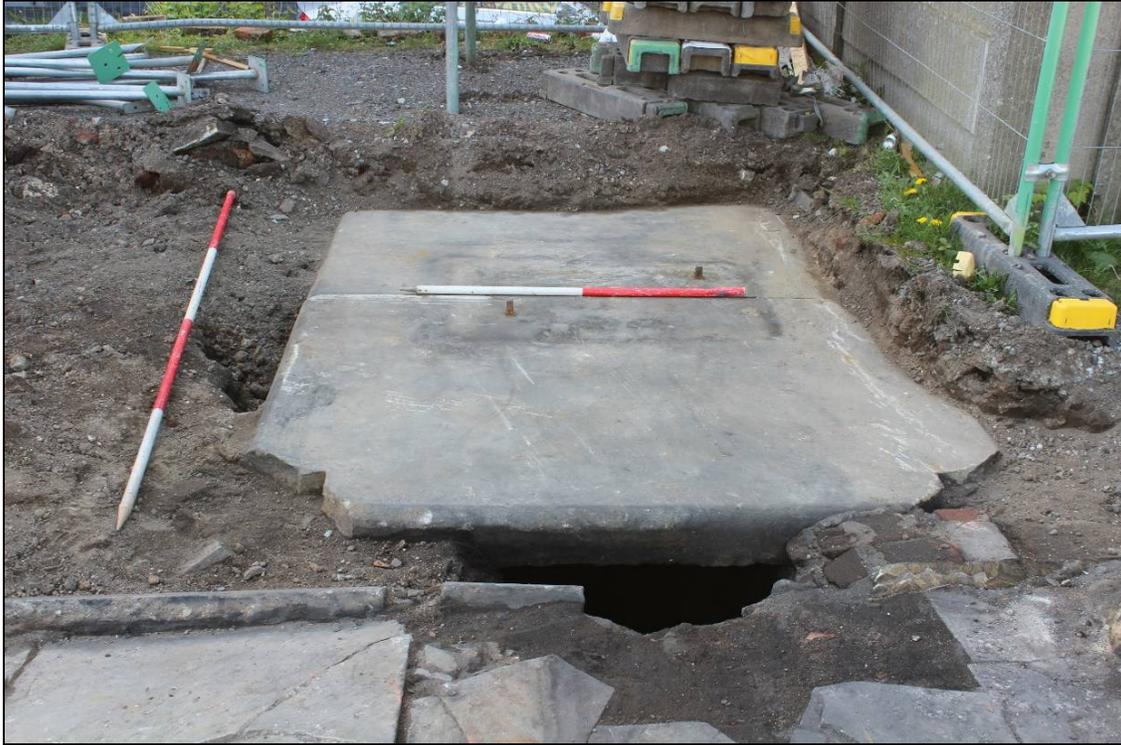
*Plate 40: Stone slabs sealing William Cowherd's vault*

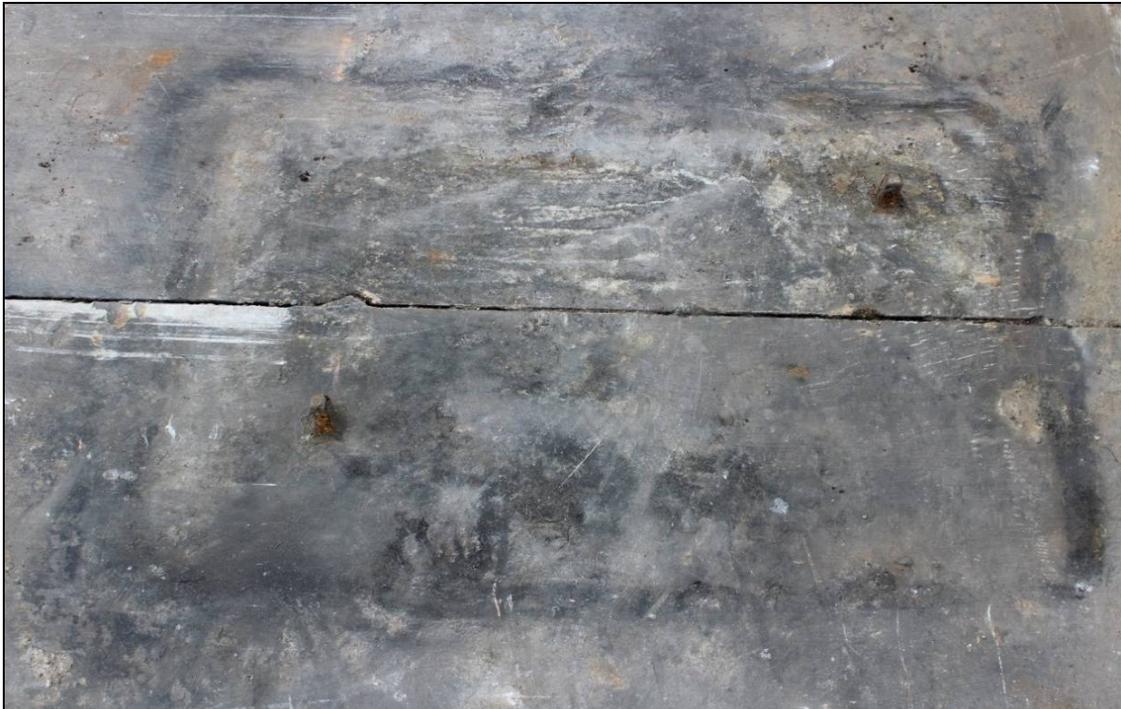
Two upright iron pins found in the middle of the slabs would have supported a grave marker, which had been removed (Plate 41). Angular perforations present in north-east and north-west corners of the stone footing may have supported upright ironwork railings known to have been erected around the tomb. The northern wall of the brick vault was partially collapsed, allowing the interior of the tomb to be inspected (Plate 42).

*Plate 41: Outline of grave marker*

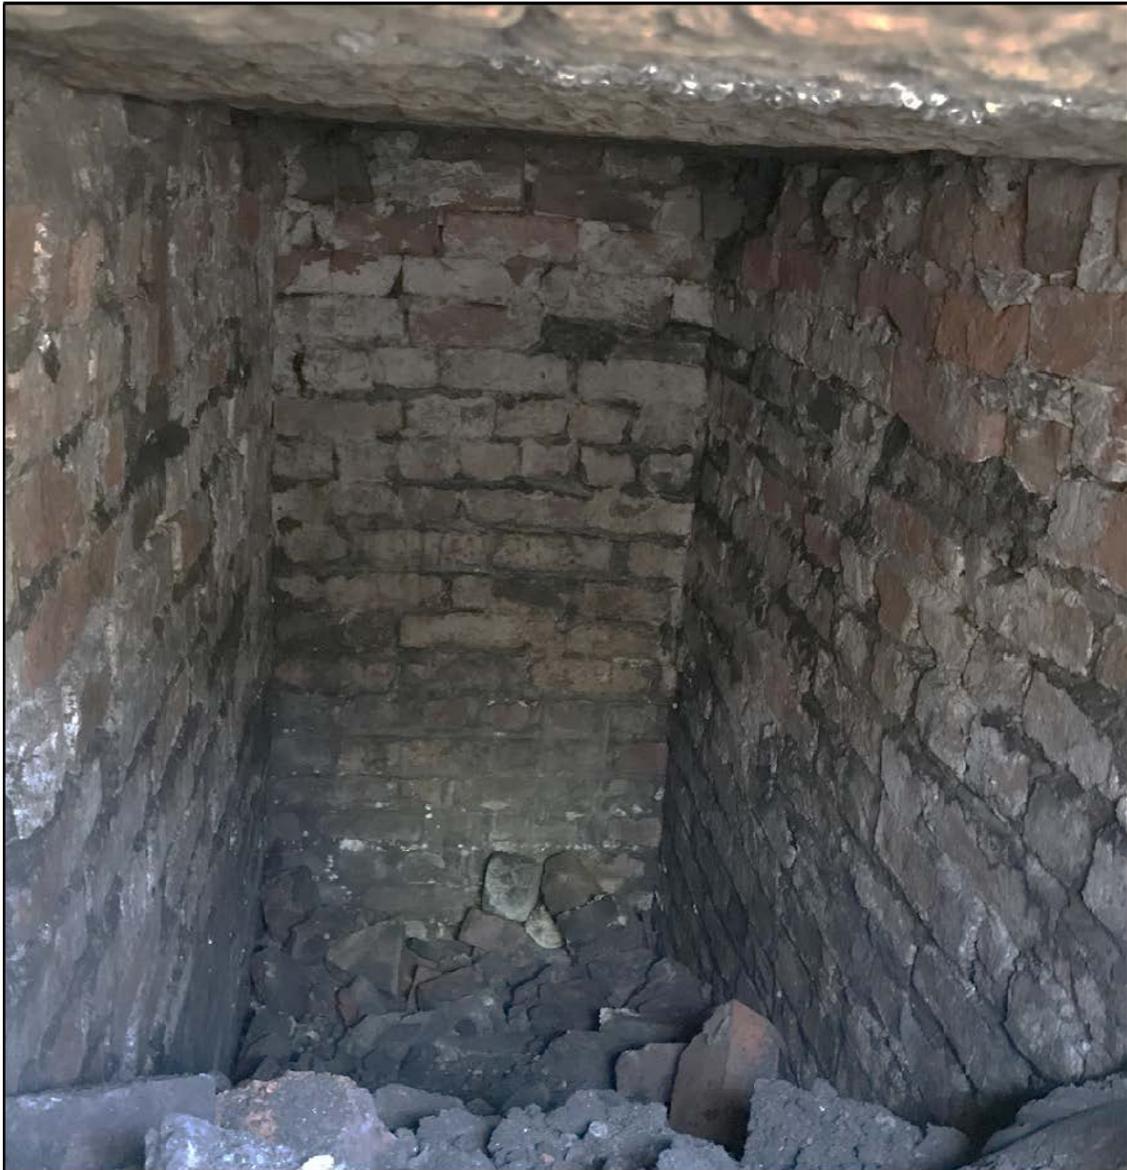
*Plate 42: Interior of William Cowherd's tomb*
