## **Archaeological Evaluation Report**

Christ Church,  
(Plot K),  
King Street,  
Salford

SA/2019/40

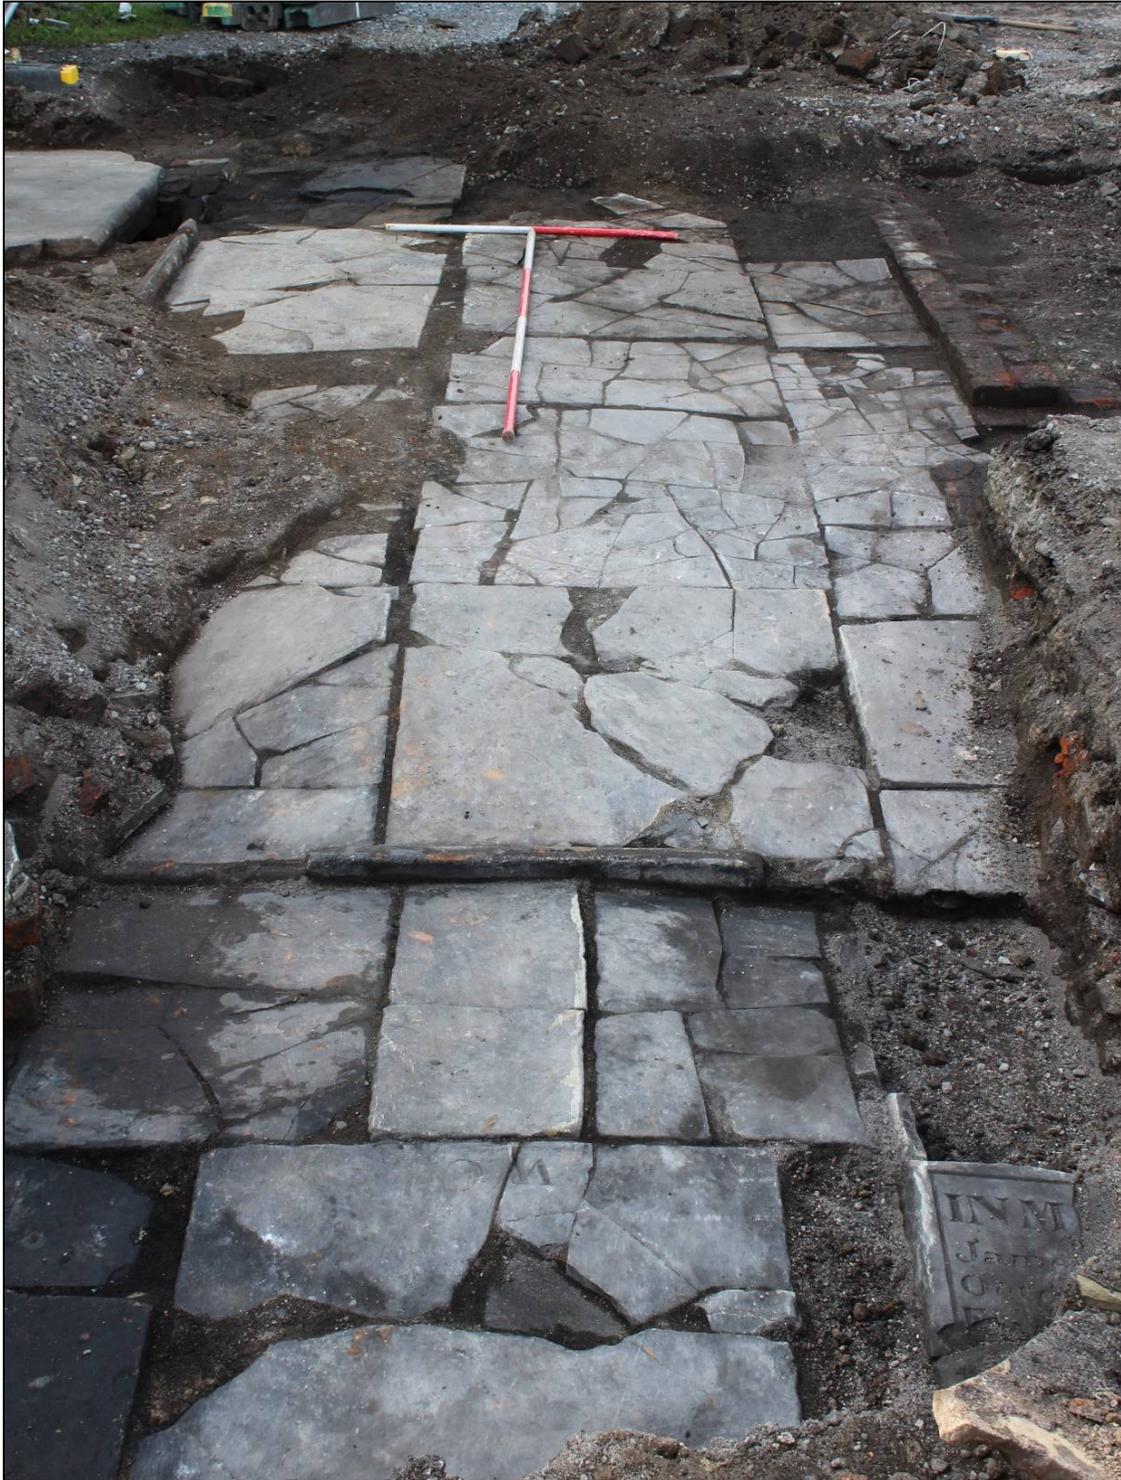
An additional 2m wide strip was excavated to the north of Cowherd's tomb to further contextualise the monument (Plate 43). To the north of the tomb was a flagstone surface (806) extending over an area of 3.80 x 2.00m. The foundations of a brick wall (804) were revealed along the northern edge of the trench and formed, the southern wall of the church, a continuation of front wall of the church found in Trench 4. An additional fragment of brick walling was revealed to the north of the tomb.

Plate 43: General view of Trench 8 (Monuments 48, 49 and 50 in the foreground)

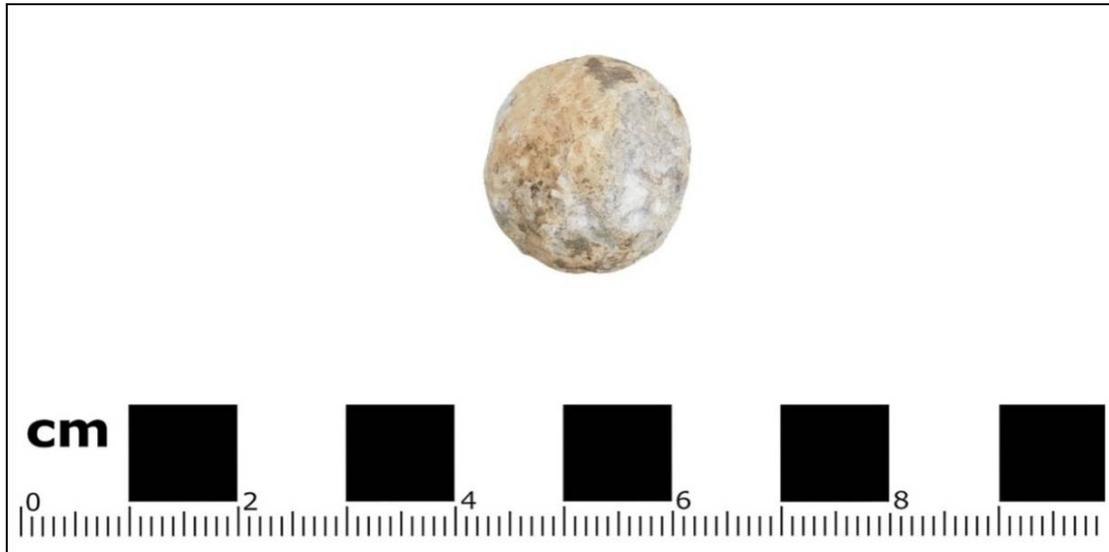
Plate 48: 17<sup>th</sup>-century musket ball recovered from relic soil 1017

Two lead objects were retrieved during the excavations. This consists of a lead gilded/painted handle from overburden 1001 in Area A. It is likely that this handle dates from the period of use at the site as a metal scrap yard rather than from its use as a cemetery. A single lead musket bullet, typical of 17<sup>th</sup>-century Civil War design and size, was also retrieved from relic soil 1017 (Plate 48).

The earliest material from the archaeological investigation was a single sherd of medieval pottery, recovered from layer 1025, at the interface of relic soil 1017 and the natural geology. The provenance of this sherd cannot be determined with complete confidence, although it is likely to have been produced locally in the 13<sup>th</sup> or early 14<sup>th</sup> century. Perhaps the most interesting artefacts, however, were found within the overlying relic soil (1017) and included a 17<sup>th</sup>-century musket ball, Cistercian pottery and a 17<sup>th</sup>-century stamped clay tobacco pipe bowl. The musket ball had not been used, and probably represent casual loss. Whilst it cannot be dated with any precision, it is reasonable to suggest that it was produced in the 17<sup>th</sup> century, given the other the other datable artefacts that were recovered in association, raising the possibility that the musket ball derived from the Civil War.

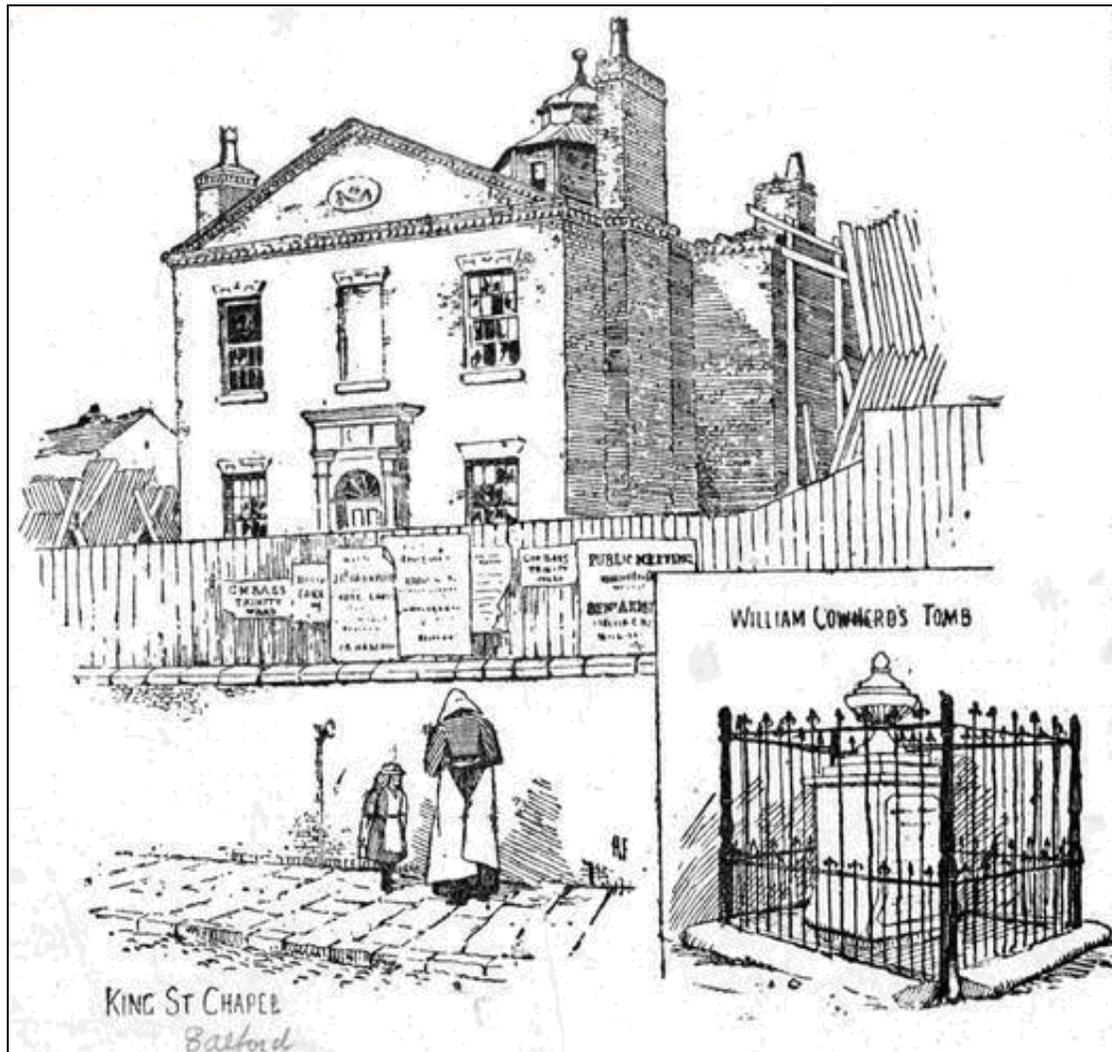
Plate 44: Christ Church, King Street, in the 1860s

The church was entered on its southern side from steps that led up from King Street. An additional step is depicted on the historical maps at the entrance to the building, perhaps indicating a raised internal floor level. This would account for the absence of internal floor surfaces within the footprint of the building. Vestiges of a stone hearth or chimney structure represent the only intact flooring encountered in the evaluation. To the south of the building were remains of an external flagstone surface, encountered in Trenches 4 and 8. To the rear of the church, the ground was surfaced with bricks, whilst to the east and west of the church were rows of ledger stones that presumably covered burials.

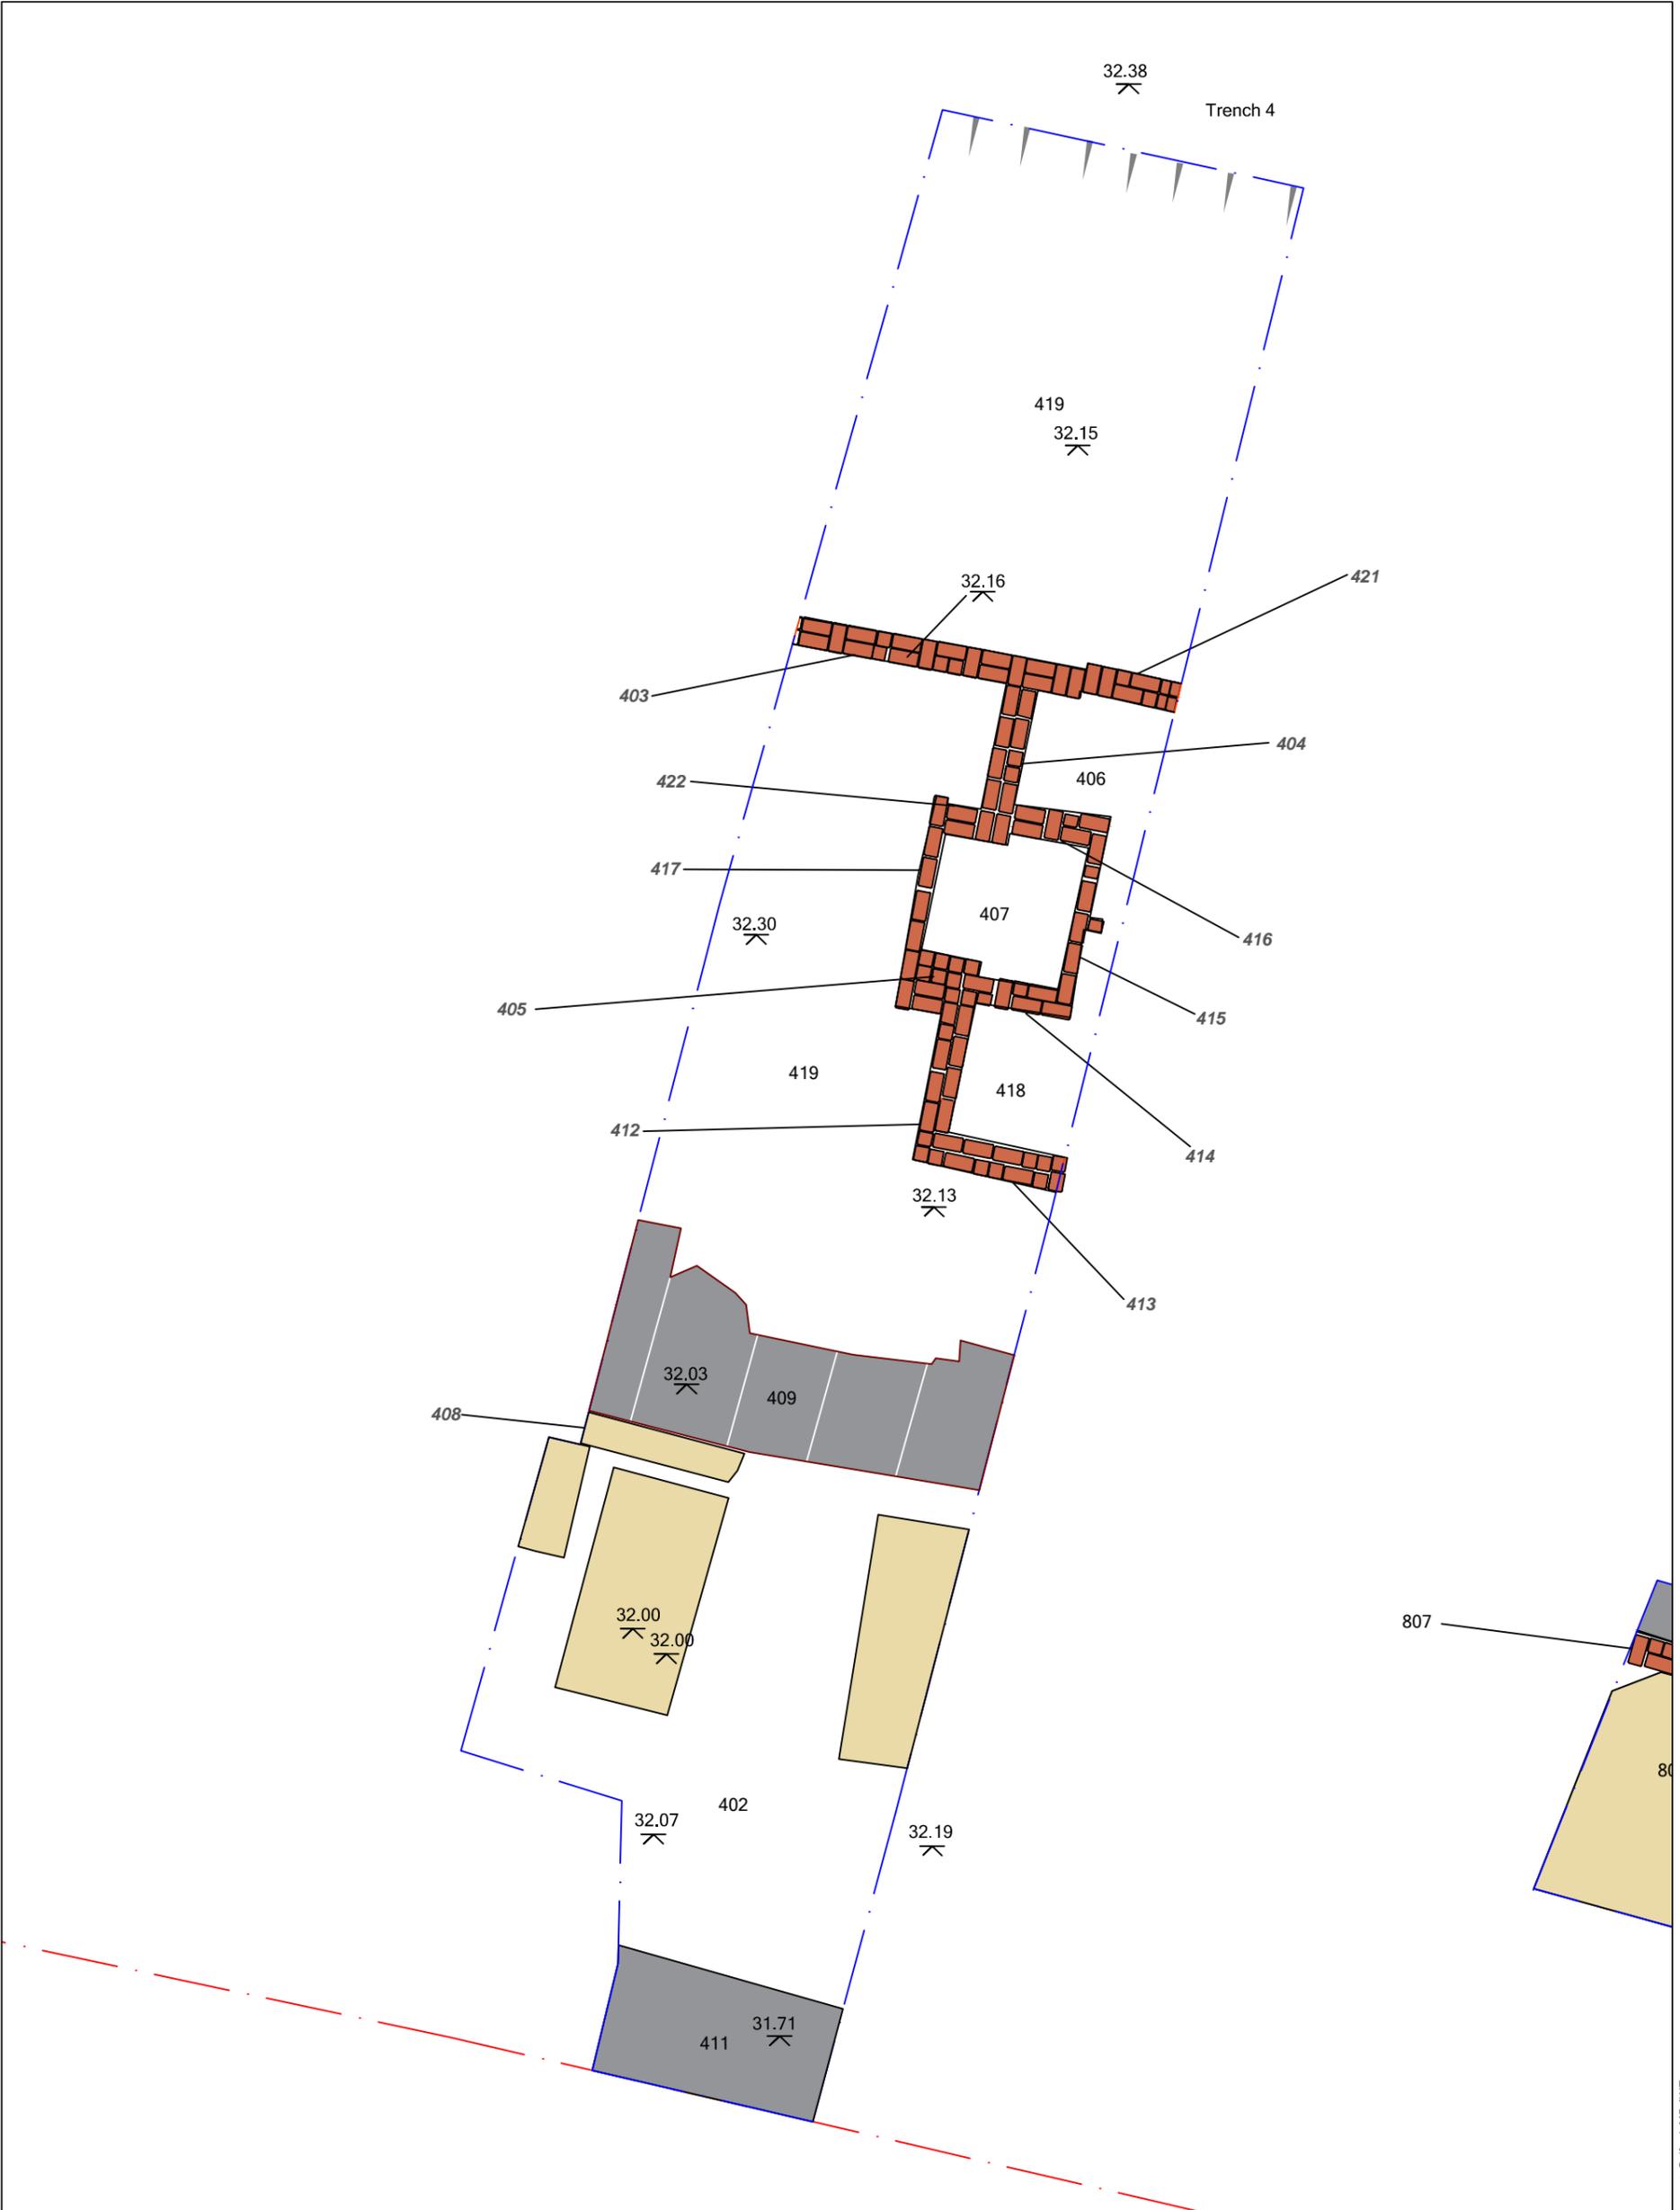
Christ Church, King Street, Salford  
 Plan of the excavated remains exposed in Trench 4

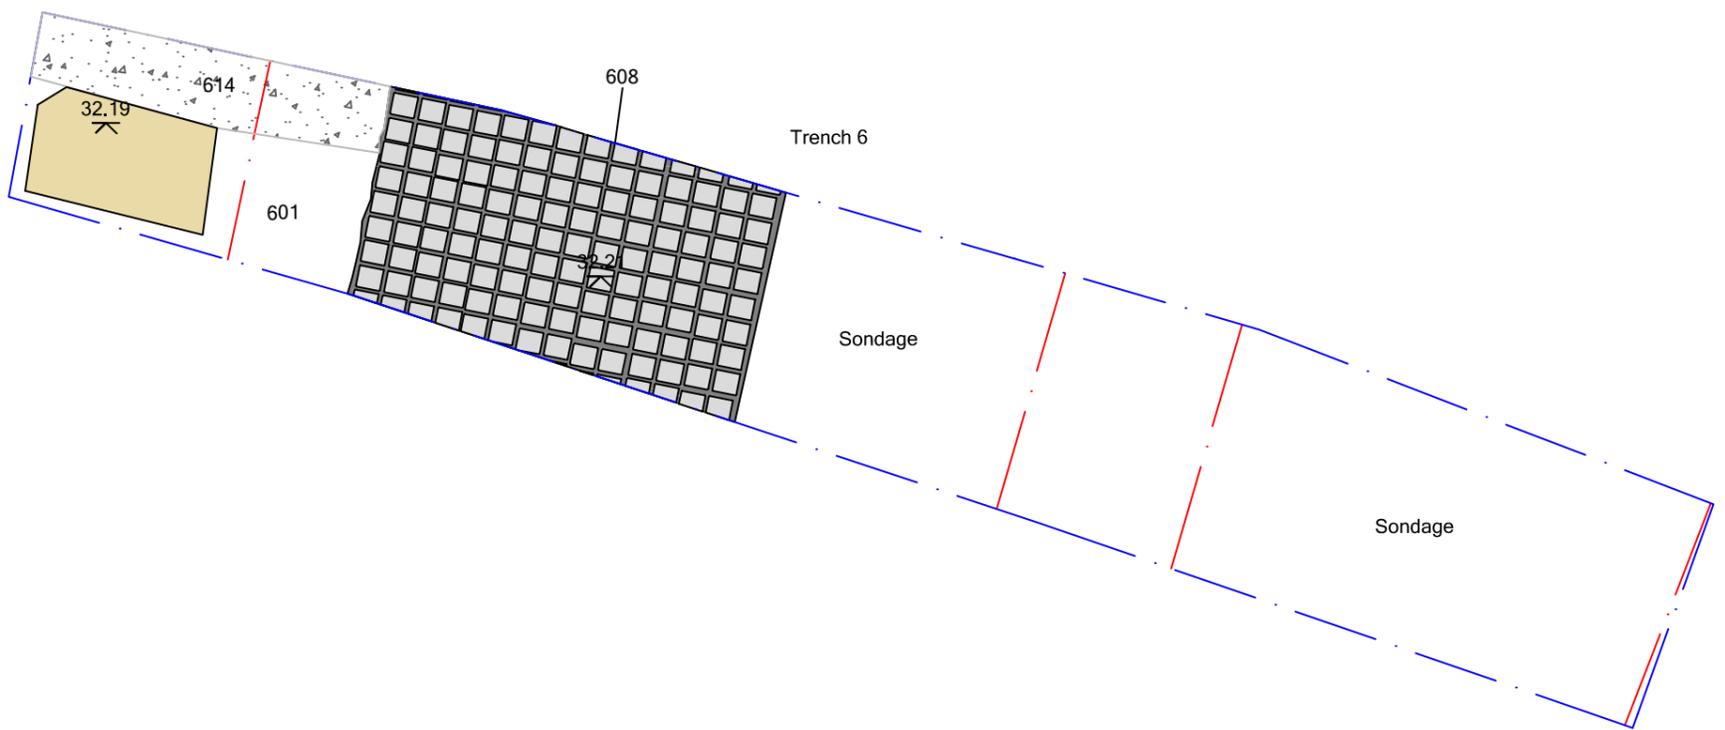
Christ Church, King Street, Salford  
Plan of the excavated remains exposed in Trenches 6 & 7

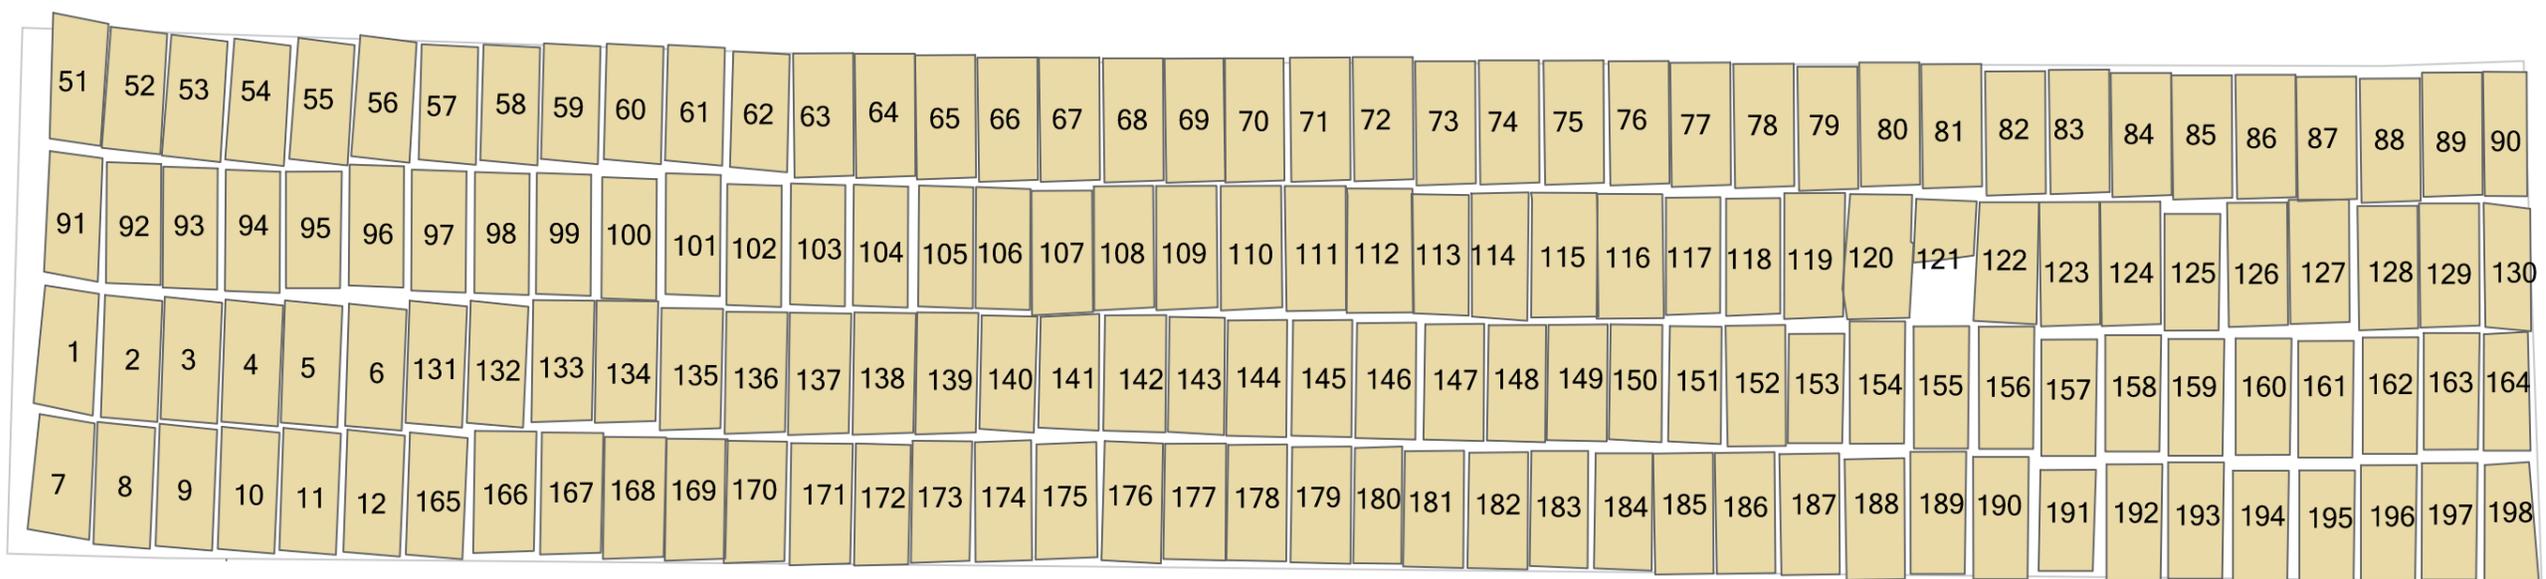
Figure 24: Ledger stones exposed in Area B with monument numbers annotated

In total, 198 ledger stones were recorded during the evaluation. A full photographic and written survey was completed of the monuments, which is summarised in *Appendix 3* (see corresponding Plans Figs. 24 and 25). A key objective of the evaluation was to establish to understand the depth and condition of the ledger stones. A great deal of data has been generated through the recording of the monuments and allows for some basic observations to be made.
