Structures

Experimental investigation of the residual behaviour of damaged masonry arch structures

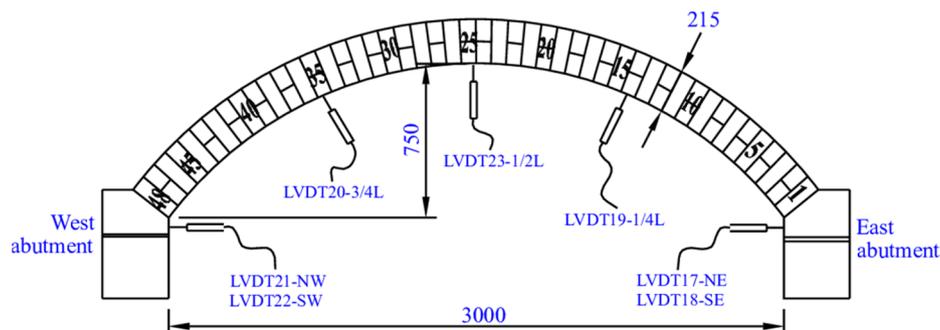
Fig. 1. General arrangement of the arch barrel and abutments, with the location of the displacement transducers (after [2]).

As mentioned earlier, all tests started with the de-centering process. It should be noted that the test arches were monitored during the de-centering process prior to any application of load, using the displacement transducers (Fig. 1). No significant movements were observed during this process. Therefore, it is assumed that the shape of the arch barrel at the start of each test was essentially identical.

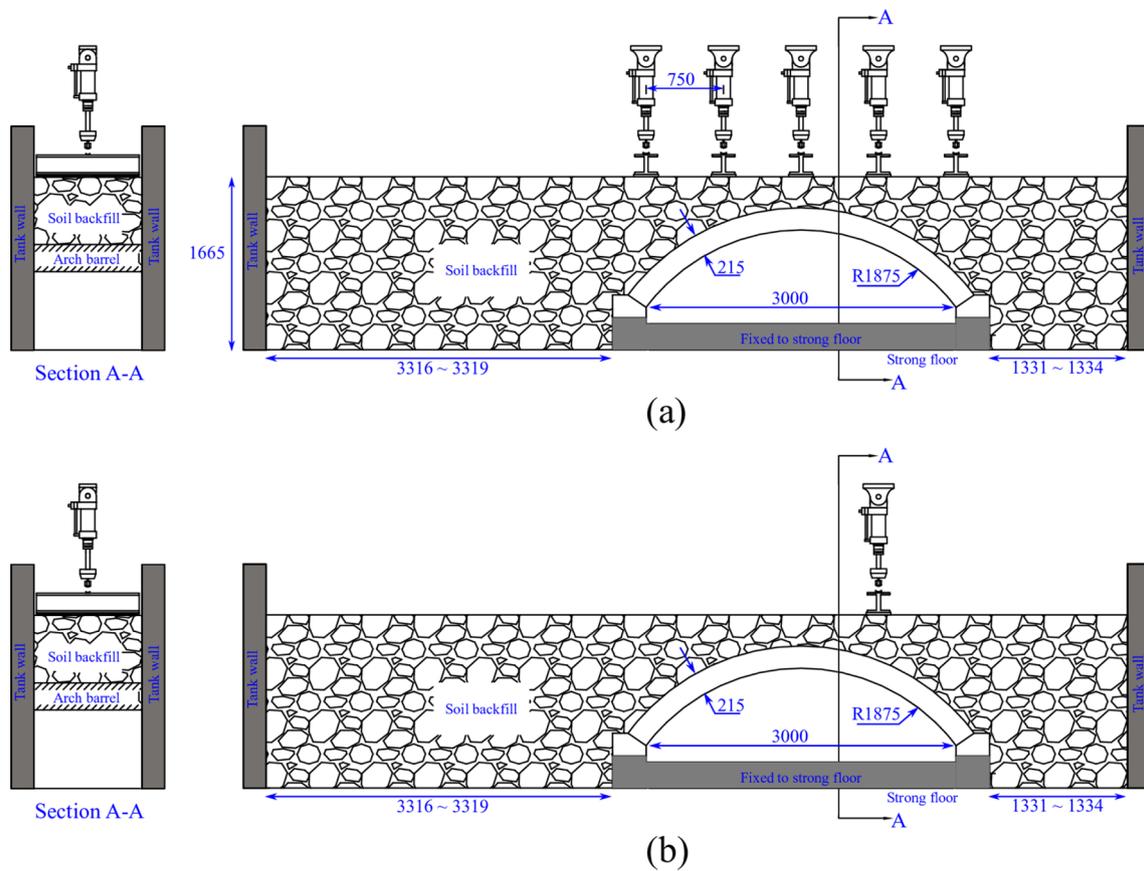
Fig. 2. Location of arch barrel related to test chamber and loading arrangements of (a) cyclic loading and (b) quasi-static failure load test.

The loading arrangement, as shown in Fig. 2, was designed to simulate highway loading conditions and sufficiently adaptable to allow application of both cyclic loading, representing working loading conditions in an in-service bridge, and quasi-static loading, allowing determination of bridge load carrying capacity.

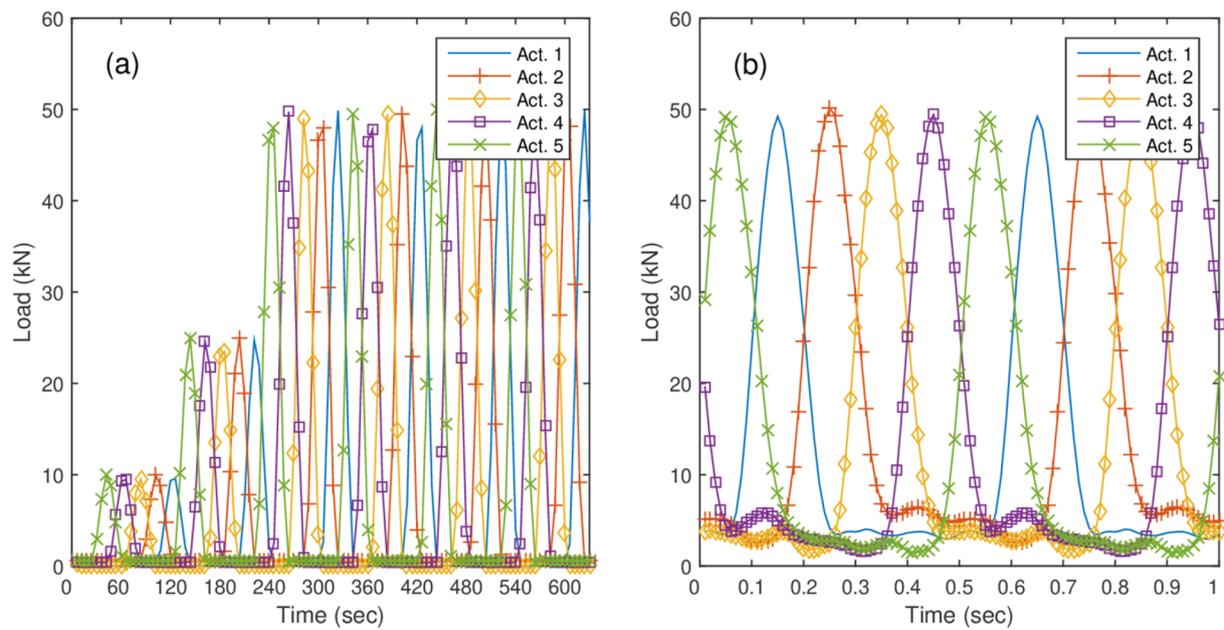
Fig. 3. (a) Entire slower cyclic loading regime (the same for all the tests) (b) faster cyclic loading regime (peak load was varied for part of EP4 and EP5) (after [2]).

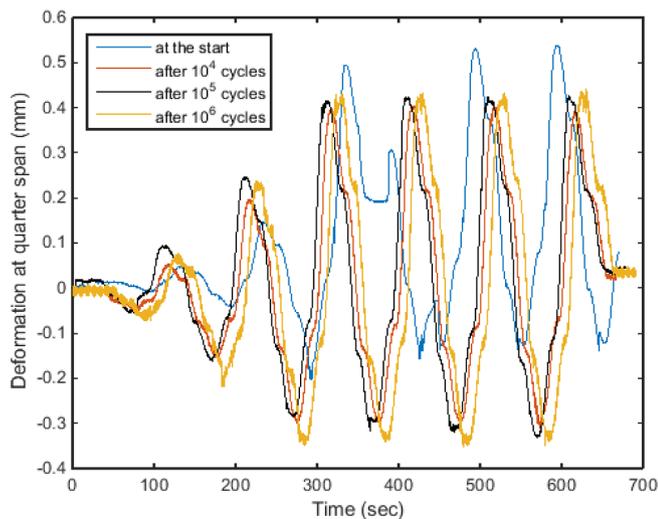
Fig. 4. Displacement against the time for the slower cyclic loading tests of EP1 prior to first quasi-static failure load test.

Arch barrel behaviour was observed throughout the cyclic loading tests of EP1. Arch barrel deformations during all the six cycle loading regimes (0.01 Hz and 50 kN peak load) prior to first quasi-static failure load test are illustrated in Fig. 4. The first slower cyclic loading test showed a slightly different behaviour to the rest of the slower rate cyclic loading tests, but the response in all cases indicated apparently elastic behaviour, i.e. recoverable, and at a very low level (< 0.7 mm peak displacement). In addition, during the first 10⁴ cycles of faster cyclic loading test, surface settlements directly beneath the loading beams were observed. The observations showed that there was no change in the profile of backfill for the remaining one million cycles.

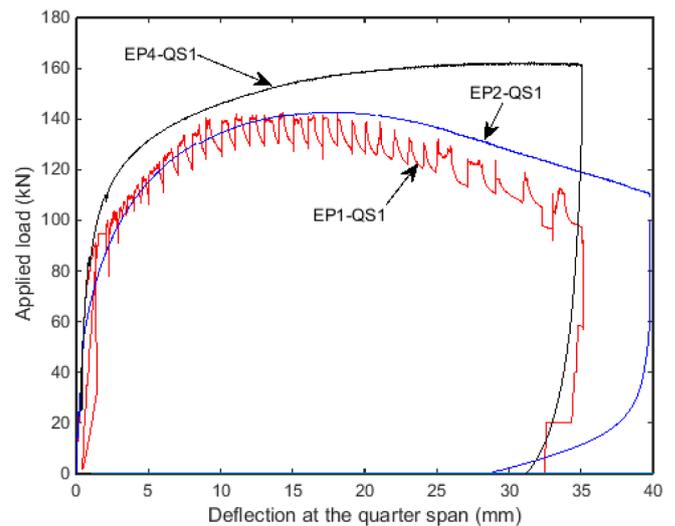
Fig. 5. First quasi-static failure load tests of EP1, EP2 and EP4.

Fig. 5 presents the load vs. deflection curves for the first quasi-static failure load test (QS1) for EP1, EP2 and EP4. EP1 and EP2 were subjected to a quasi-static load to induce failure and it is evident from this figure that the carrying capacity of the two arches is similar indicating that this period and level of cyclic loading had little impact on the arch carrying capacity, supporting the hypothesis that the level of cyclic

The main difference in results between EP1 and EP2 (Fig. 5) appear to relate to the initial stiffness of the arch-backfill system, as illustrated by the gradient of the corresponding load–deflection curves. This is likely attributable to densification of the soil backfill during cyclic loading during EP1, as described in Section 3.1.1.

During the EP1 quasi-static load test, an unload-reload loop occurred when the actuator load reached a level of around 90 kN (Fig. 5). Although not intentional, this provided some insight in to the behaviour

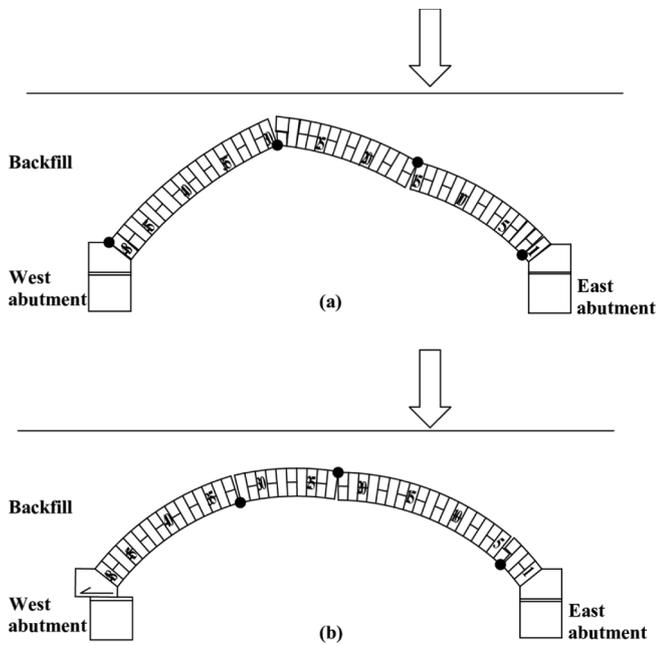
Fig. 6. Failure mechanism at first quasi-static load test of (a) EP1 and EP2 (b) EP4.

loading (as described in Section 3.1.1) was both below the serviceability limit, but also suggesting that it may also be lower than the permissible limit state. Fig. 6(a) illustrates the failure mechanism for the two arches; in both cases, a four-hinge mechanism is evident. Fig. 7 shows corresponding GeoPIV plots generated from digital analysis conducted on images of the backfill and arch deformation during testing. This figure illustrates the kinematic response of the backfill to the load application and to the deforming arch barrel, and the data is consistent with observations made by Melbourne and Alnuaimi [16] and Page et al. [23], for instance. The applied load is dispersed through the fill, but this dispersal is within a relatively narrow zone, with the arch barrel moving away from the backfill (active). In contrast, the passive zone in which the arch barrel moves towards the backfill encompasses a much larger volume of fill material. Much of the movement is confined to the arch barrel in both cases, although the vectors do indicate some displacement adjacent to the abutments. Abutment movements were monitored during testing and were seen to be of the order of 5 mm and < 1 mm for the west and east abutments of EP1 and EP2, as shown in Fig. 8.

EP4 showing similar stiffness profiles up to an applied load of around 60 kN, and EP1 and EP4 showing a similar stiffness profile up to around 80 kN. Figs. 6 and 7 also compare the difference in failure mechanisms and soil deformation, respectively. The western abutment slides outwards during the first quasi-static loading test of EP4 (Fig. 8), indicating that the overall failure was due to three hinges and sliding at the abutment, which was different from EP1 and EP2. Results indicated that the behaviour of the arch barrel and observed failure mechanisms were significantly influenced by the backfill materials.

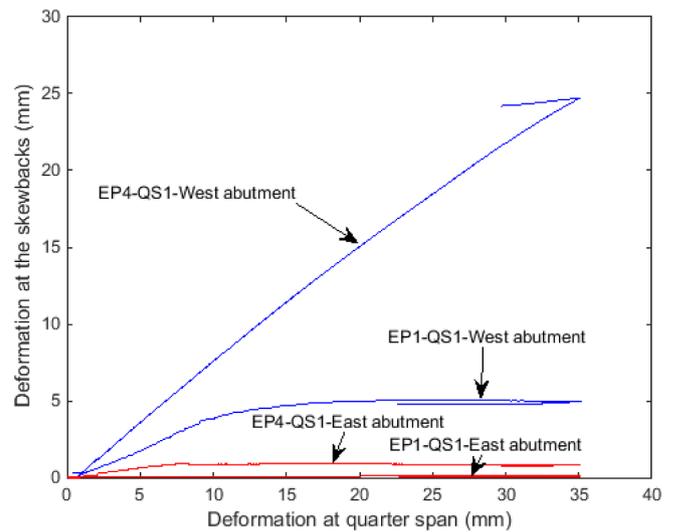
Fig. 8. Horizontal deformations of east and west abutments during first quasi-static failure load tests of EP1 and EP4.

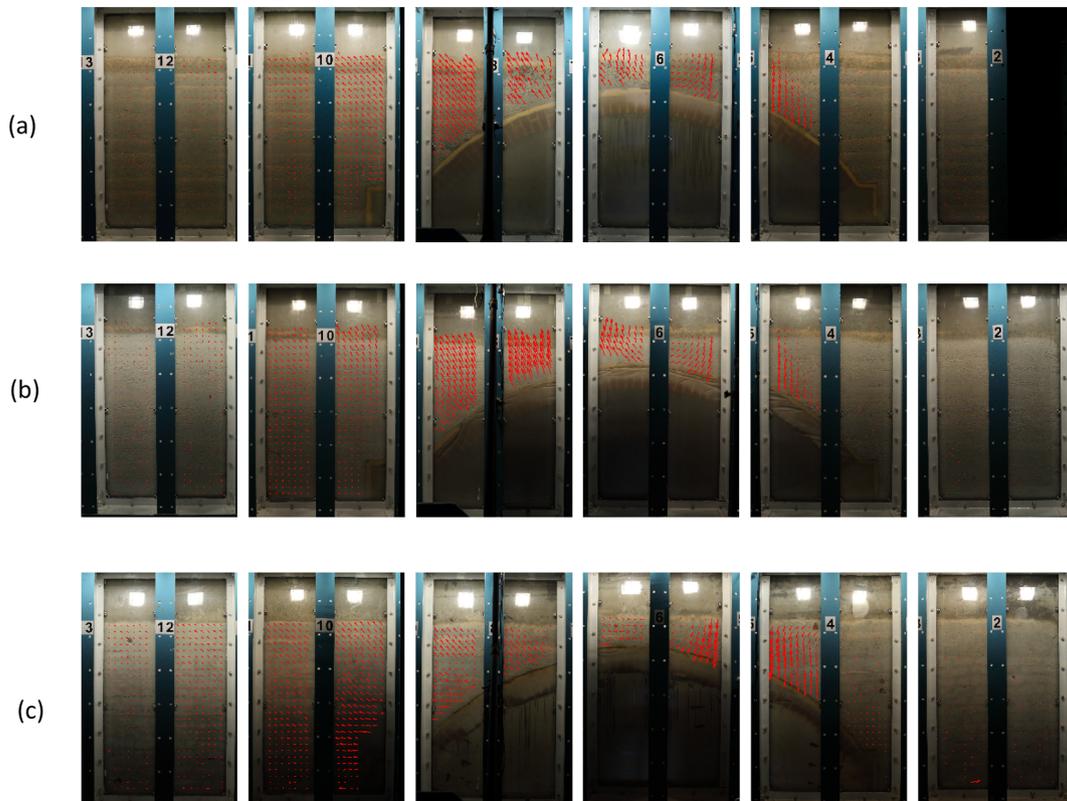
Fig. 7. Particle Image Velocimetry output from the start of the test until the maximum load (a) EP1_QS1 (b) EP2_QS1 (c) EP4_QS1.

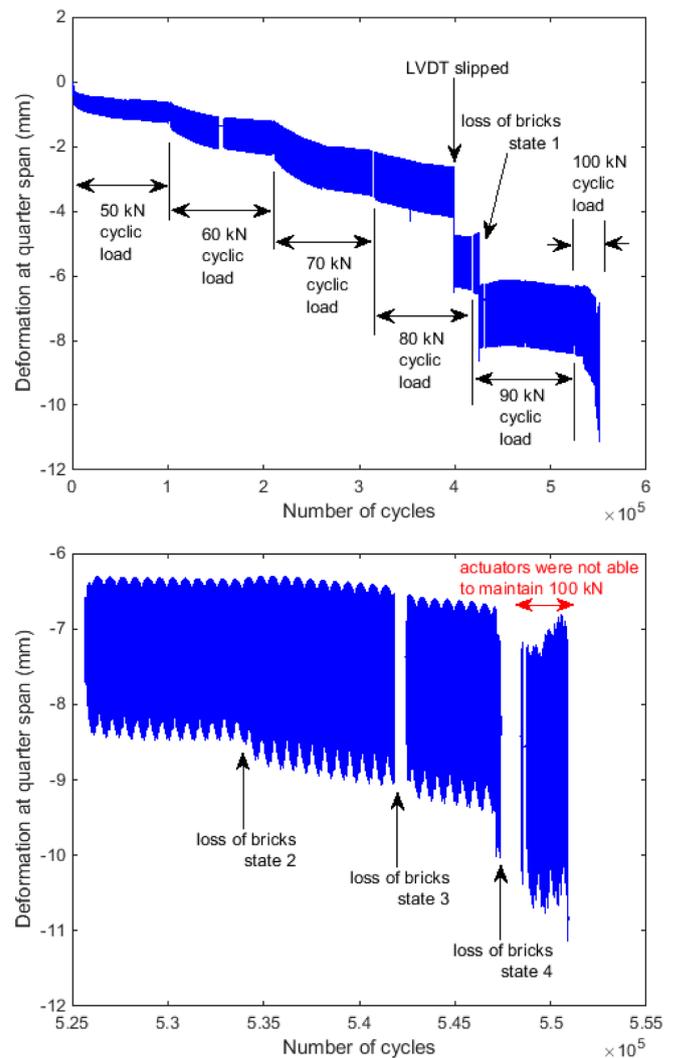
Fig. 9. EP5 – deformation at quarter span during faster cyclic loadings (a) from 50 kN to 100 kN (b) 100 kN.

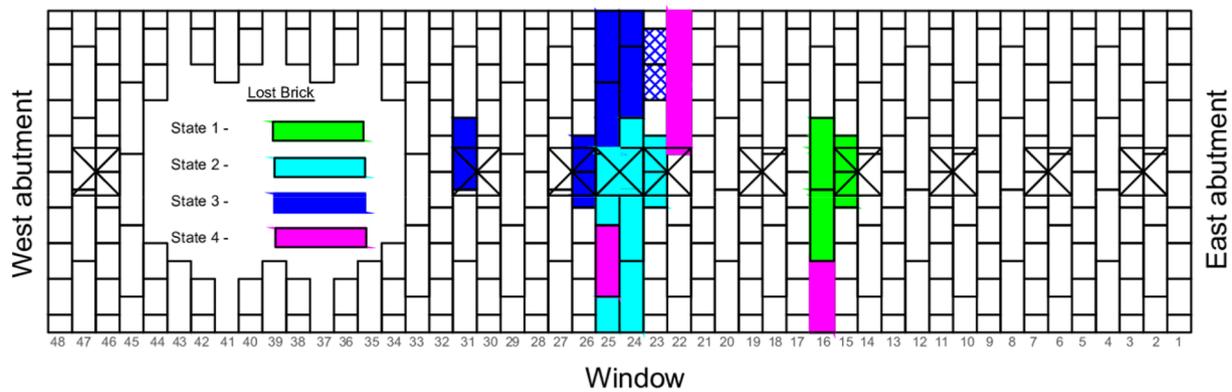
Fig. 10. Formation of fallen bricks during the cyclic loadings of EP5.

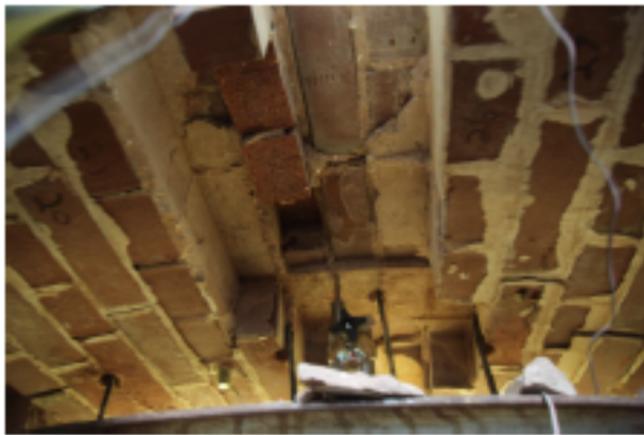
Fig. 11. Fallen intrados bricks near the crown of EP5 at the end of cyclic loadings.

The capacity of EP5 was around 115 kN, similar to EP1. It should be noted that the EP5 arch was subjected to various cyclic loading stages and a number of intrados bricks were dislocated completely prior to this quasi-static load test. In contrast to the second load test of EP1 and EP2, the EP5 test arch distorted significantly during the early stages of quasi-static loading.

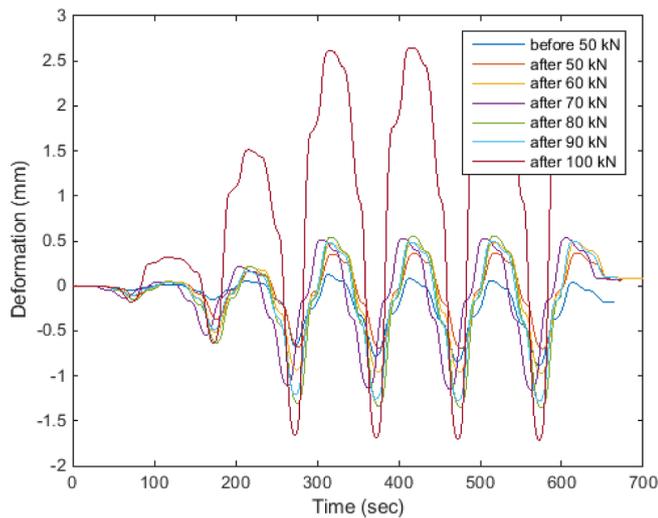
Fig. 12. Deformation amplitude during slower cyclic loading of EP5.

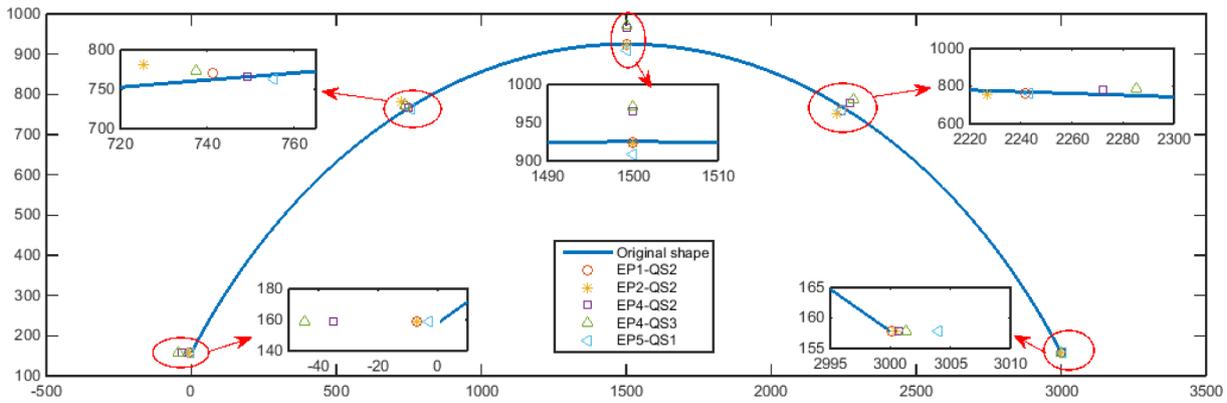
Fig. 13. Distorted shape of the arch barrel before each quasi-static failure load tests reported in this paper.

Due to the different load tests applied to the different arches reported on, the level and form of distortion experienced by any given arch differs. The aim of this section is to consider the magnitude and form of deformation due to the quasi-static loading of a virgin arch. Table 3 presents the tabulated distorted shapes of EP1, EP2, EP4 and EP5 before all quasi-static load tests, allowing direct comparisons to be made. The distorted profiles are schematically illustrated in Fig. 13. It can be observed that the distorted shape before the second quasi-static load tests were influenced by the state when the first quasi-static load was released; in other words, the current state of the arch will influence the future behaviour of the arch. In the case of EP5, there were a series of cyclic loads applied to the arch at different stages, with only a single quasi-static load test to failure employed; hence the distorted shape of EP5 was only due to those cyclic loadings.

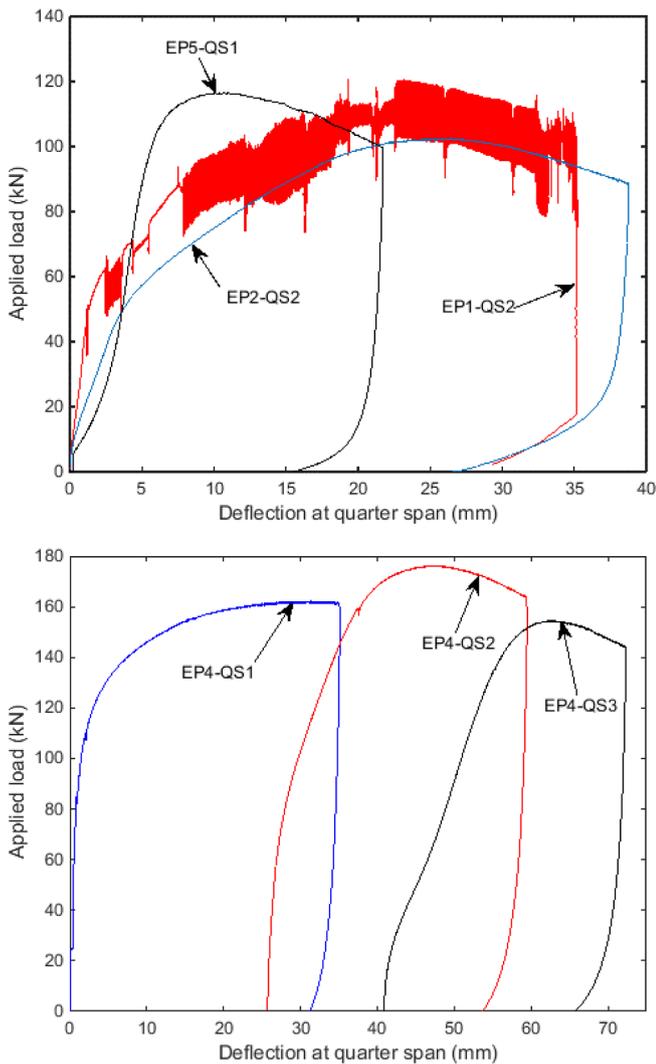
Fig. 14. (a) Second quasi-static load tests of EP1 and EP2, and first quasi-static load test of EP5 (b) All quasi-static load tests of EP4.

Fig. 14(a) presents applied load vs. deflection curves for the second quasi-static load test to failure of EP1 and EP2, where data is available. This data can be compared directly with that presented in Fig. 5, for the first quasi-static load test for EP1 and EP2, allowing observations to be made on the capacity of damaged arch structures. The data also allows an evaluation of the influence of the backfill material on both the initial capacity and also the damaged arch capacity as results are also presented for EP4.

The capacity as indicated in Fig. 14(a) can be seen to be reduced to

around 115 kN and 100 kN for EP1 and EP2, respectively. It is evident that the loss in capacity is more significant for EP2 than for EP1. Again, the difference between the two tests is the programme of cyclic loading (working loads) in EP1 that was absent in EP2, and the distorted shape at which the quasi-static (failure) load test was started (Table 3 and Fig. 13). In this case, the structural integrity of both arches had been compromised due to the first quasi-static load test.

In the case of EP4, there were three quasi-static failure load tests undertaken. The first of these was reported earlier. However, for the purpose of comparison, all the failure load tests are compared in Fig. 14. At the point of release of applied load of the first quasi-static load test, the arch barrel exhibited three-hinges plus a sliding mechanism (Fig. 6(b)) as the clay backfill deformed as the abutment displaced. However, the second quasi-static failure test exhibited a four-hinge mechanism after initial sliding of the West abutment (Fig. 15(c)). For the third quasi-static load test, the arch barrel exhibited a four-hinge mechanism, where sliding at the west abutment was negligible, suggesting increased mobilisation of the clay backfill strength. As shown in Fig. 14, the second quasi-static load path meets the point where the first load was released and continues to carry slightly higher

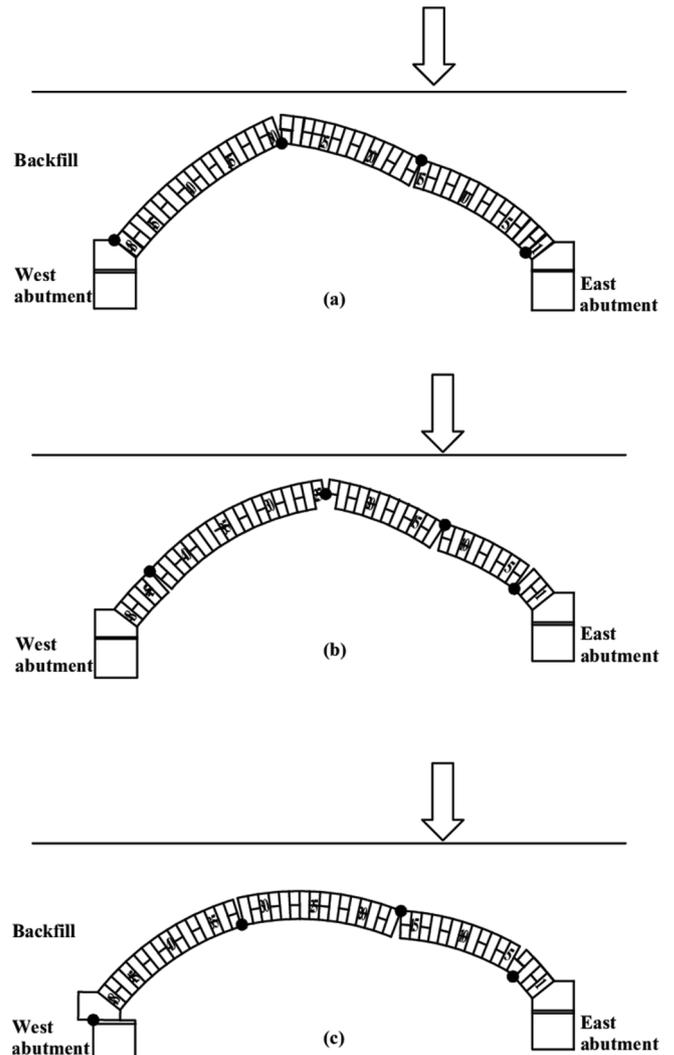
Fig. 15. Failure mechanism: (a) second quasi-static failure load test of EP1 and EP2; (b) first quasi-static failure load test of EP5; (c) second and third quasi-static failure load test of EP4.

Failure mechanisms of the EP1 and EP2 test arches during the second quasi-static failure load tests were the same as observed during the first quasi-static load tests (Fig. 15(a)). This confirms that the locations of the hinges do not change unless the type of loading changes. The EP5 test arch was a four-hinge failure mechanism, however, the hinges were formed at different locations, as shown in Fig. 15(b). It should be noted that EP5 was subjected to various dynamic loading stages prior to quasi-static loading to failure and a hinge near the midspan was formed coincident with a loss of bricks, likely due to the dynamic loading. GeoPIV analysis of the second quasi-static load tests of EP1 and EP2 are not available. Image correlation analysis of EP5 confirms that the hinges were formed in the middle part of the arch (Fig. 16).

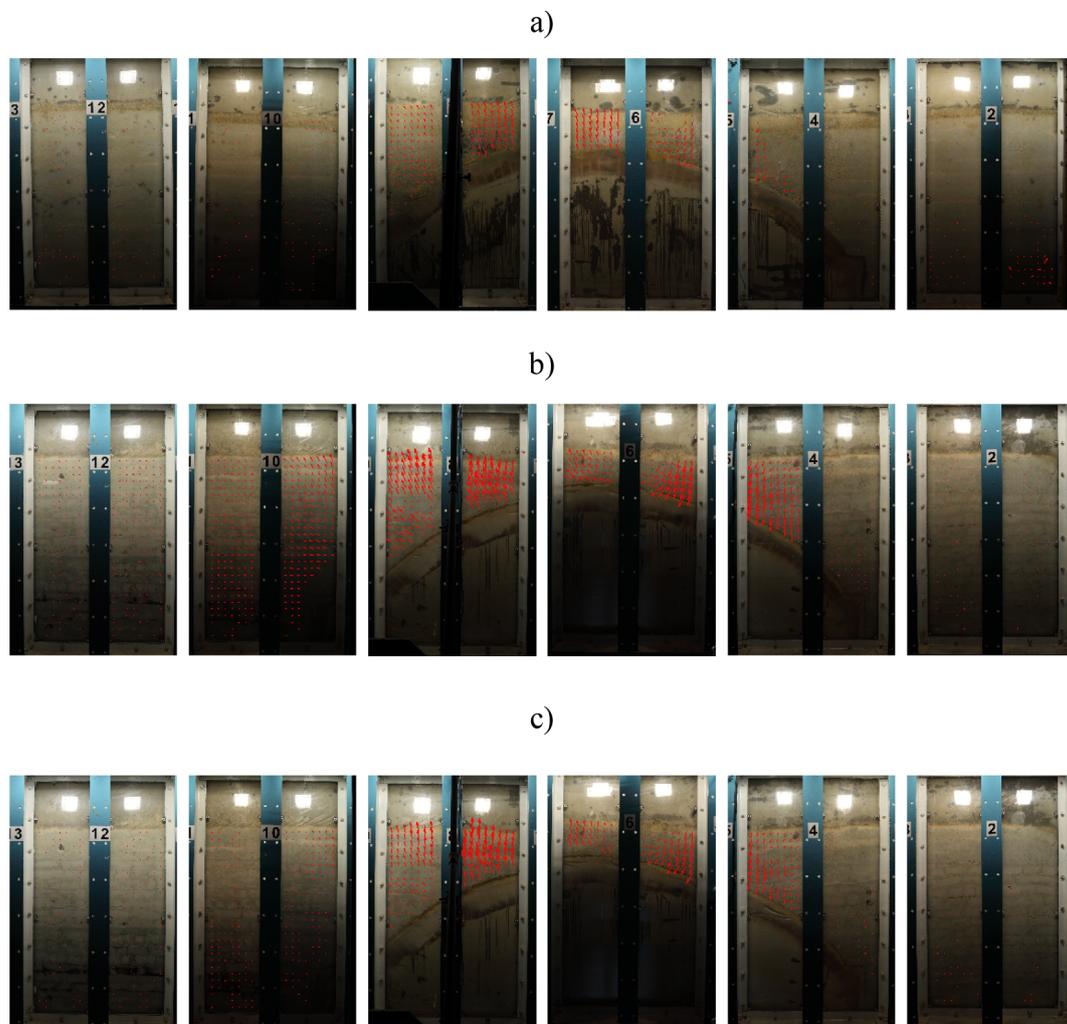
Fig. 16. Particle Image Velocimetry output from the start of the quasi-static test until maximum load carrying capacity of (a) EP5_QS1 (b) EP4_QS2 (c) EP4_QS3.

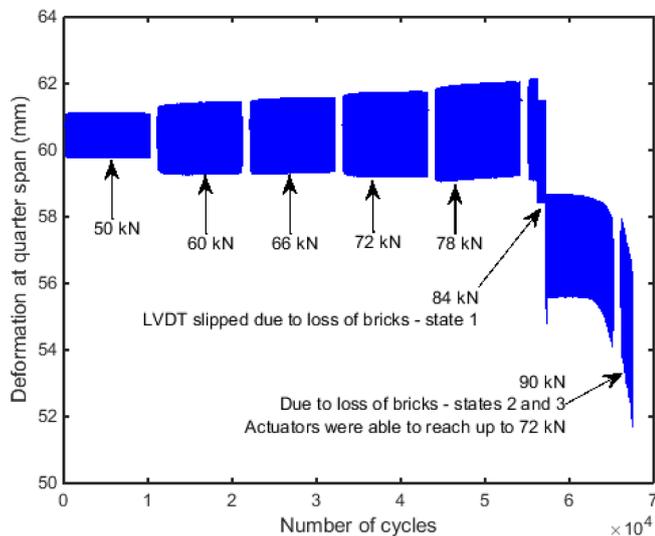
Fig. 17. Deformation amplitude during cyclic loadings of deformed bridges (after third quasi-static load test).

EP4 was subjected to faster cyclic loading regimes with various peak loads after all three quasi-static load tests. The test results are shown in Fig. 17. As expected, deformation amplitude increased with increasing peak cyclic loadings. The arch barrel was intact for loads up to 78 kN, but, at 84 kN peak cyclic load, brick loss was observed, subsequently damaging the LVDT support frame (Figs. 17 and 18). Deformation

amplitude increased due to this incident. However, more significant disruption was observed when the peak cyclic load level reached 90 kN, and began soon after the start of this cyclic loading regime. A row of bricks near to the three-quarter span and a number of bricks near to the crown were lost (Figs. 17–19) and the load subsequently dropped to 72 kN. Due to the oil capacity of the hydraulic pump it was not possible to exceed a 90 kN peak cyclic load level.

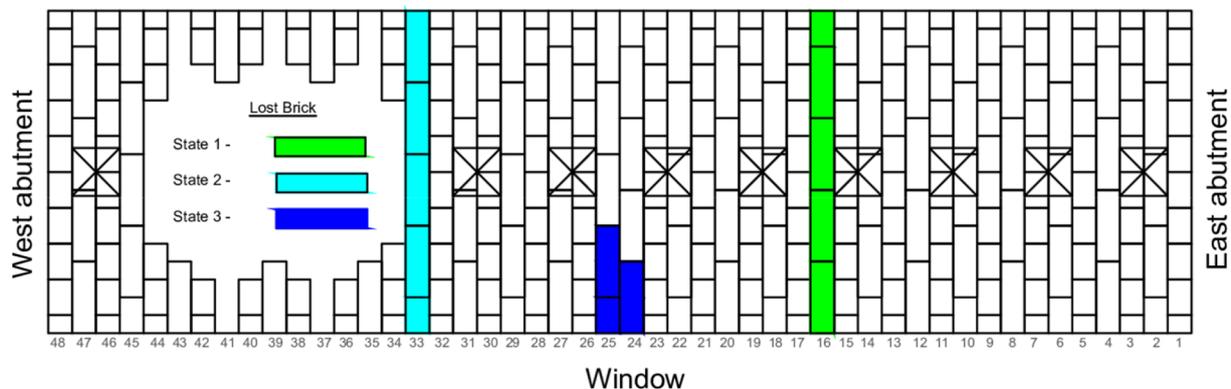
Fig. 18. Formation of fallen intrados bricks during the cyclic loadings of EP4.

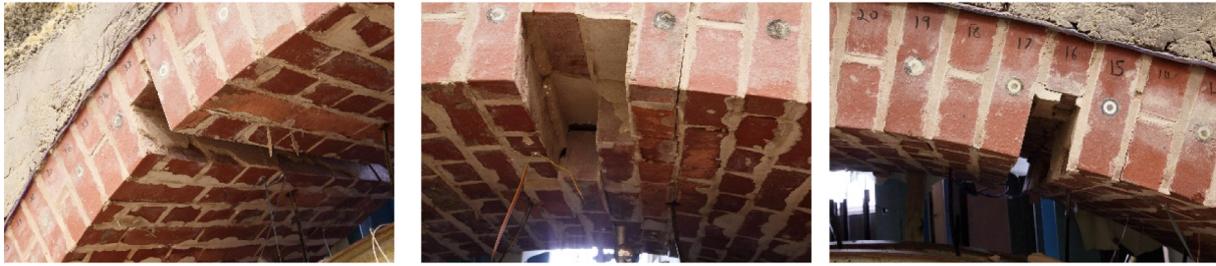
Fig. 19. Pictures of fallen bricks after cyclic loading of deformed bridge of EP4.
