Archaeological Evaluation

Victoria Mill,
Droylsden,
Tameside

Report No:
SA/2017/53

Document Type: Archaeological Evaluation Report

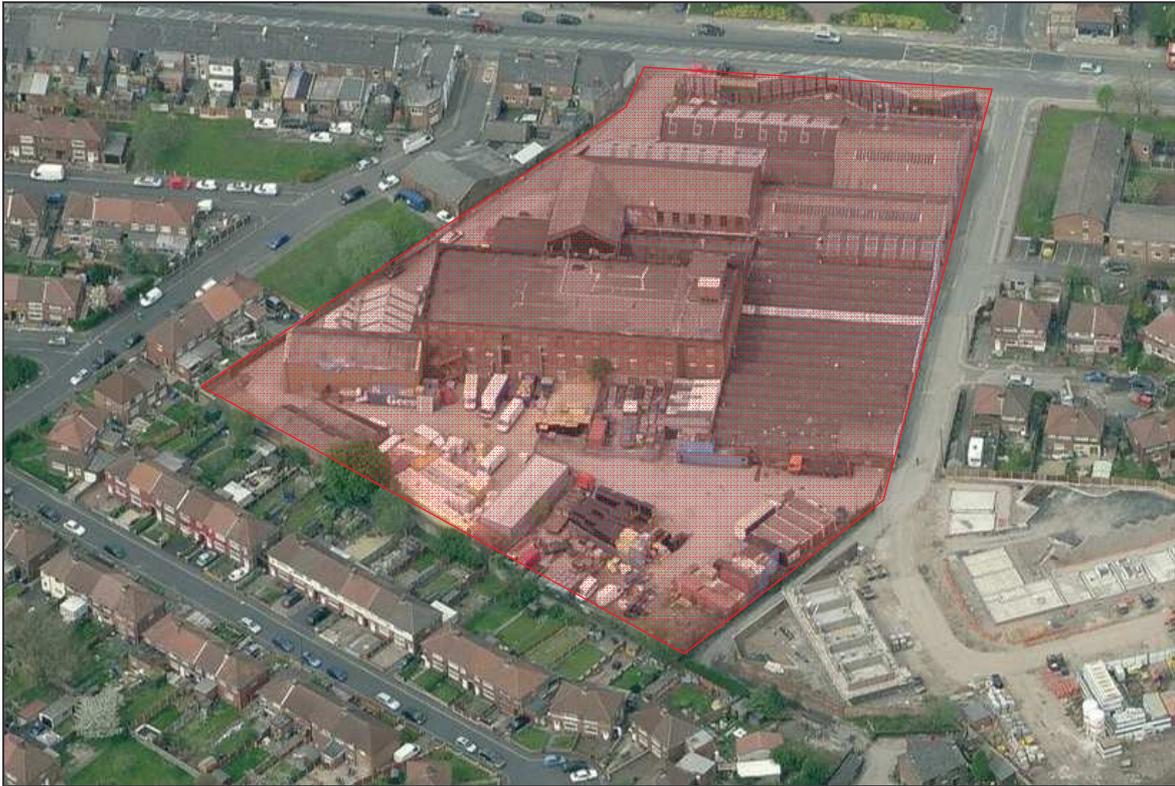
Plate 1: Recent aerial view of Victoria Mill prior to demolition

The site comprises a partially occupied 19th-century mill building with vacant land to the north, south and west, with access from Manchester Road (Plate 1). The mill was previously sub-divided into separate industrial and retail units, although the only one to continue in use is the motor garage in the far south-western corner of the building, adjacent to the proposed location for Trench 1.

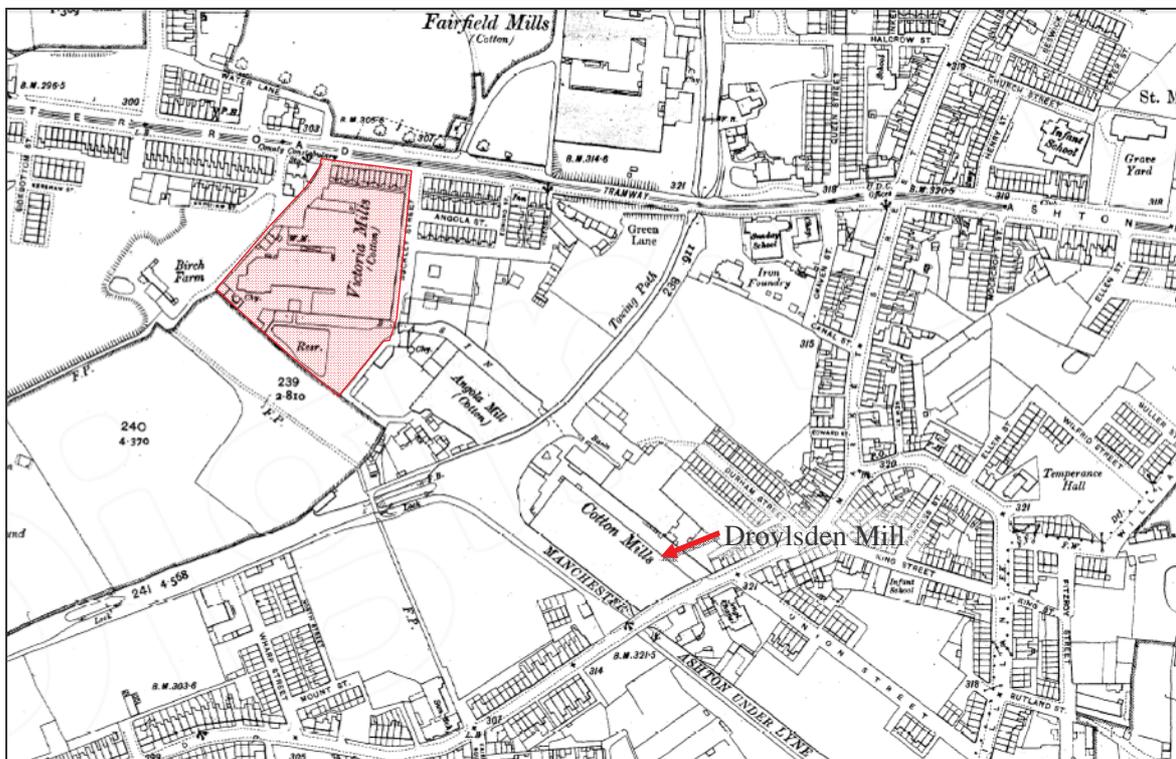
Plate 2: Development area superimposed on the Ordnance Survey map of 1909

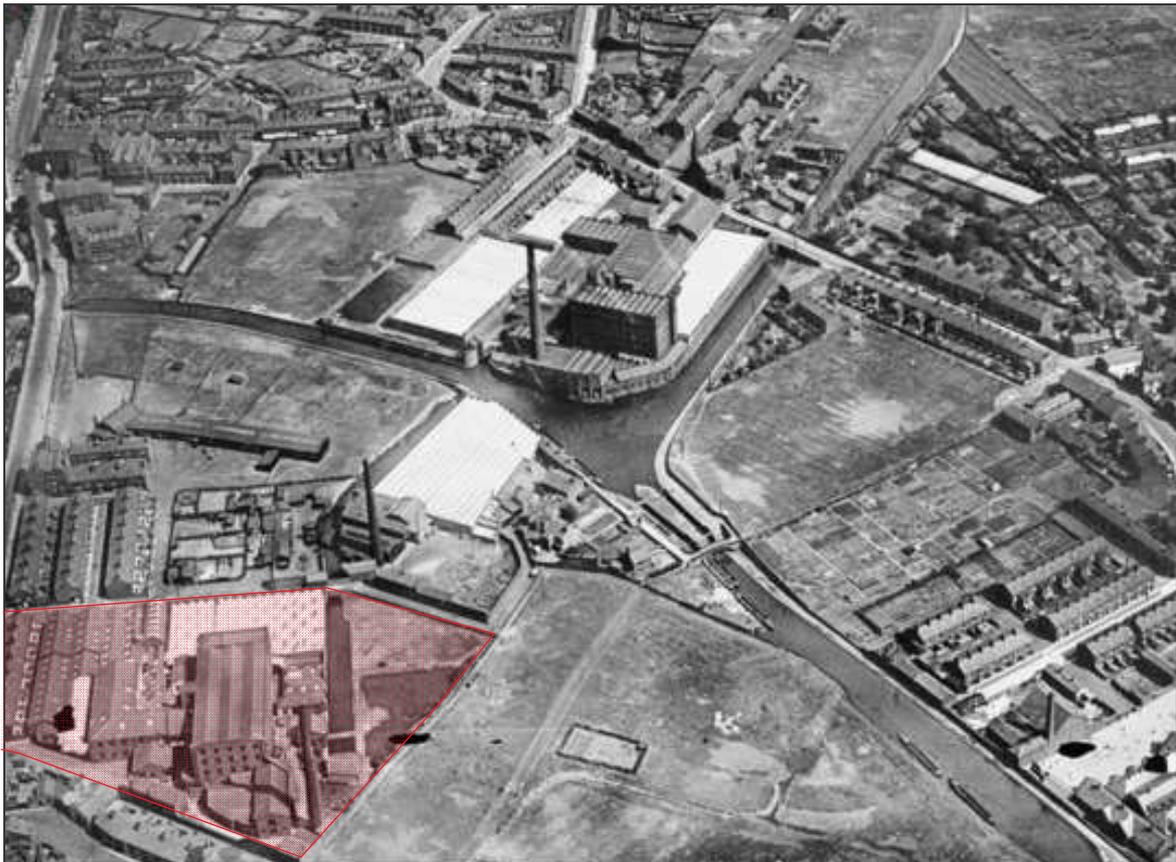
Plate 3: Aerial view across the study area in 1925

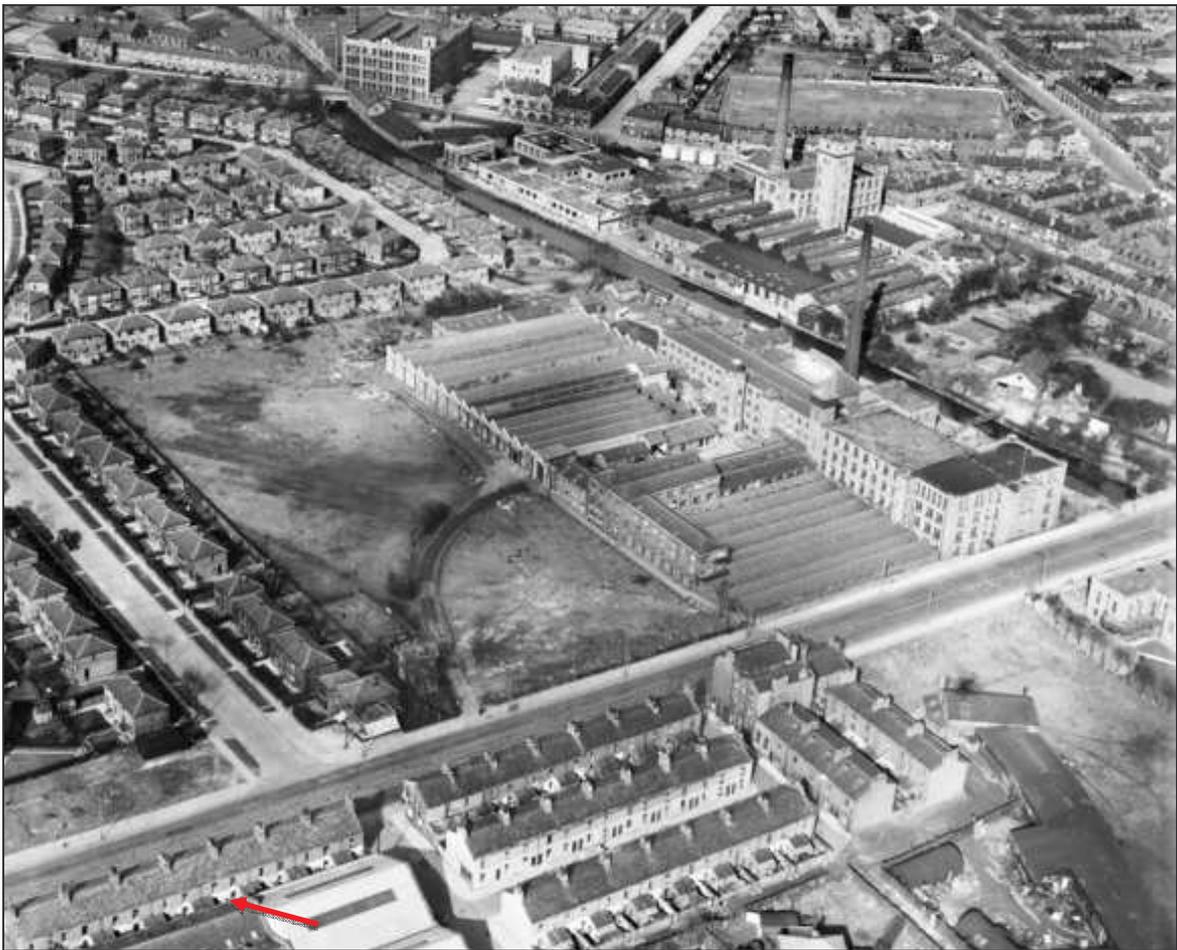
Plate 4: Aerial view across Fairfield Mills in 1949, with arrow marking the rear of the 71-97 Manchester Road

The former houses along the northern edge of the development site, 71-97 Manchester Road, are first shown on the Ordnance Survey map of 1894, which depicts a terrace of 14 double-depth dwellings, all with small outshuts and yards to the rear. The footprint of the houses remains unchanged on subsequent editions of Ordnance Survey mapping, and they were demolished between 1973-82.

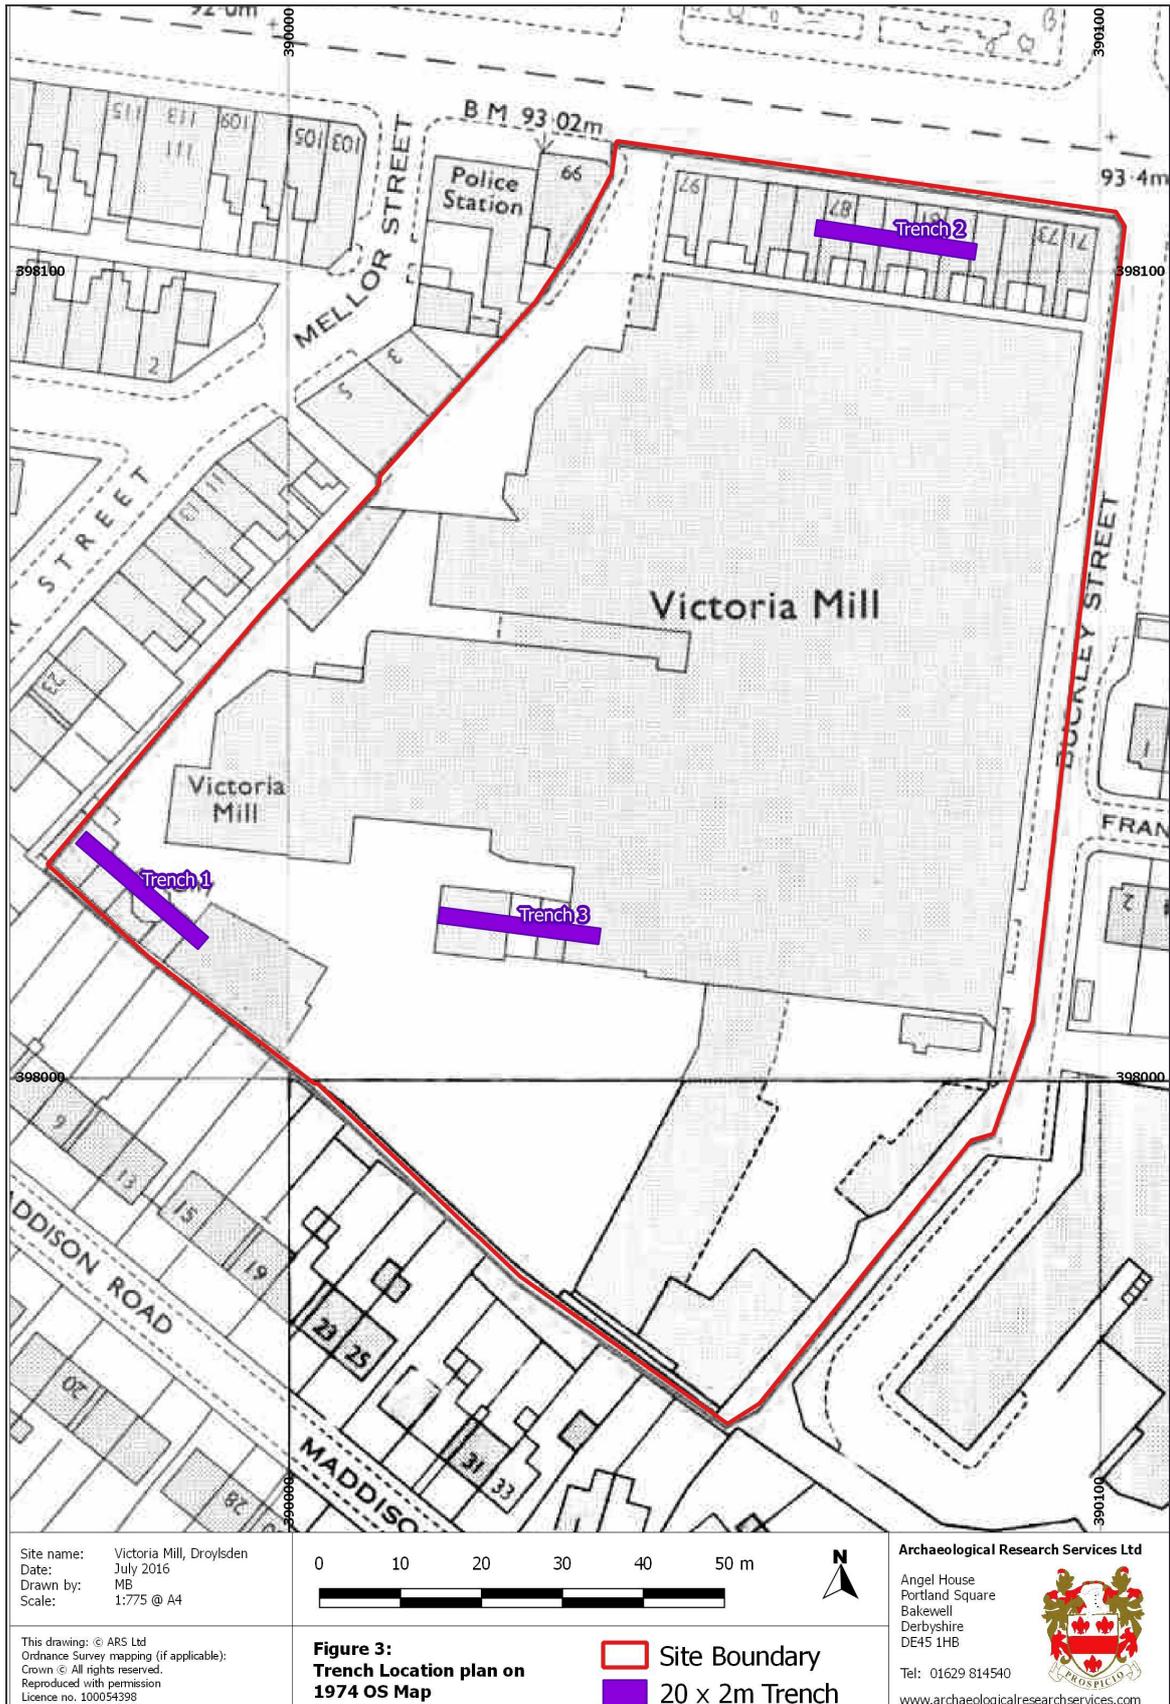
Figure 2: Proposed trench location plan (Holgate and Mora-Ottomano 2016)

The evaluation trenches were placed across the study area in order to determine the presence, extent, depth and state of preservation of the remains identified in the light of the results obtained from the historic building investigation (Grange 2017). Some leeway was allowed for movement of the trenches from the original marked positions due to services and terrain features.

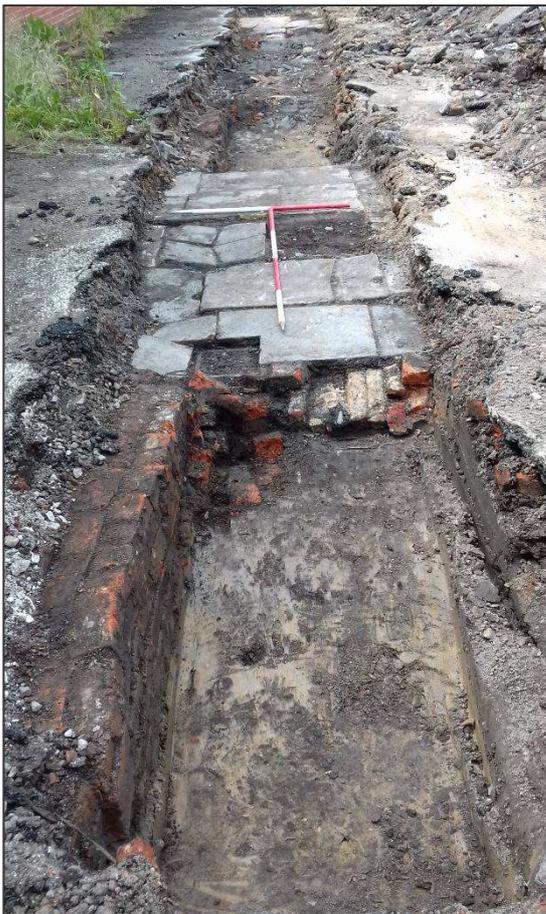
Plate 5: Trench 2 general shot, looking east

Trench 2 was located along the northern edge of the site, across the footprint of Nos 79-91 Manchester Road. It was aligned east/west and measured 20.50 x 1.8m, and was excavated to a maximum depth of 0.50m (Plates 5 and 6).

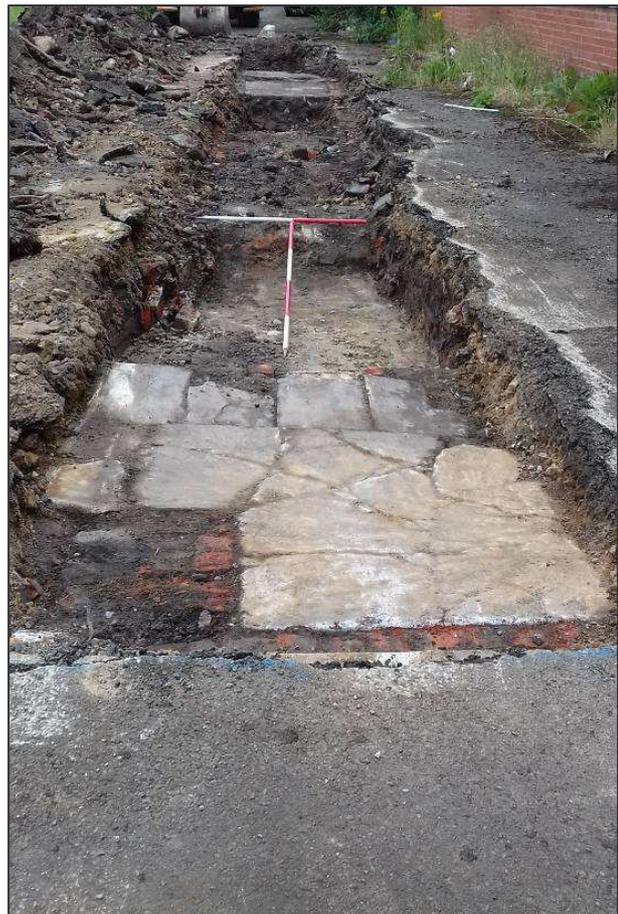
Plate 6: Trench 2 general shot, looking west

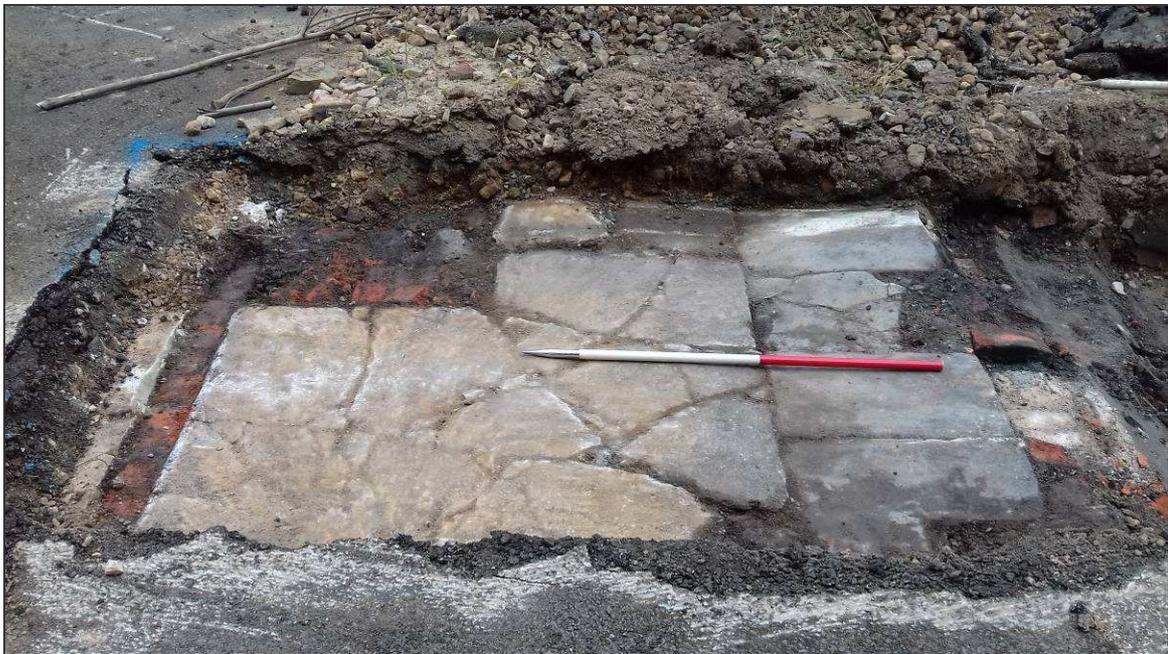
At the far western end of the trench a small section of flagstone floor (003) was revealed extending beyond the trench edges to the north, south and west (Plate 7). This abutted to the east a single-course wall (004), composed of hand-made bricks laid in stretchers and bonded with lime-based mortar. The wall was 0.11m wide, and aligned north/south. This was abutted to the east by a level area of concrete (006), extending 1.50m eastwards which had been laid around a rectangular brick feature (005) that was too badly degraded to identify its purpose. This feature measured 0.75 x 0.70m, and was composed of a black gritty clinker-rich deposit surrounded by the remains of a single course of crushed and fragmented bricks. To the east of concrete 006 lay a second flagstone surface (007), which measured 0.60m wide and comprised four stones, the southernmost of which had a square cut that continued south beyond the edge of the excavated trench. A second hand-made brick wall (008) was identified lying against 007, which was constructed from a single course of partially degraded bricks laid as stretchers with white mortar, aligned north/south (Plate 8). The wall had been constructed directly on top of a deposit of light grey sandy clay with moderate inclusions of brick, stone and mortar fragments 009, which extended 2.50m eastwards.

Plate 7: Walls 004 and 008 to the west and east, enclosing surfaces 005 and 006, looking north

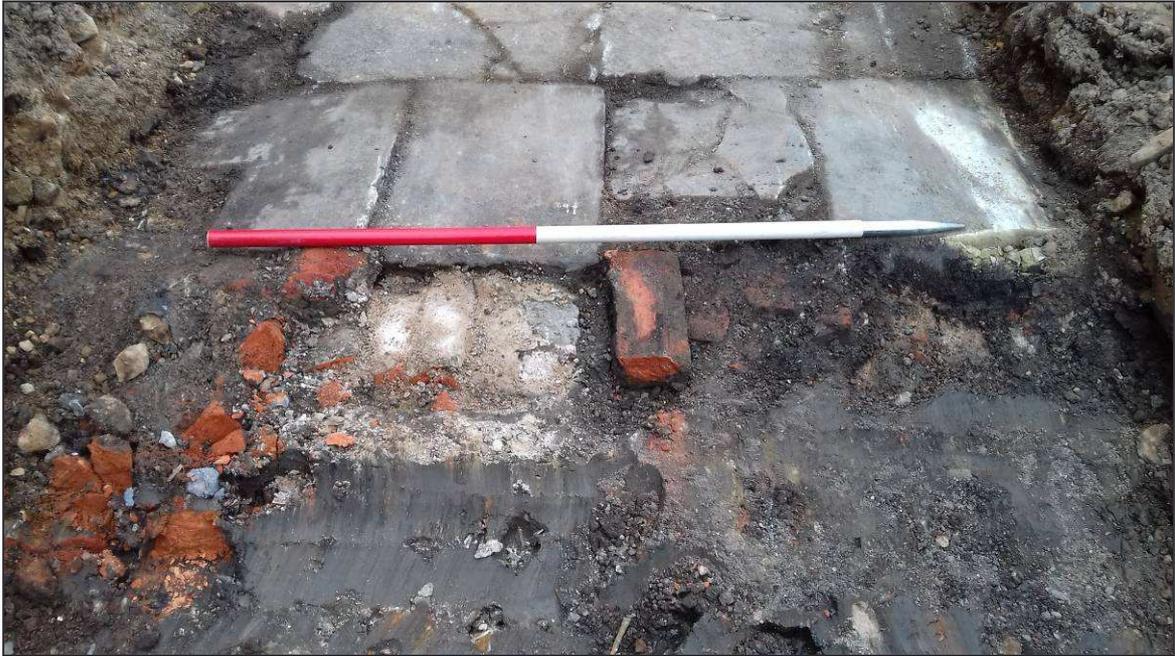
Plate 8: Detailed view of wall 008, looking west

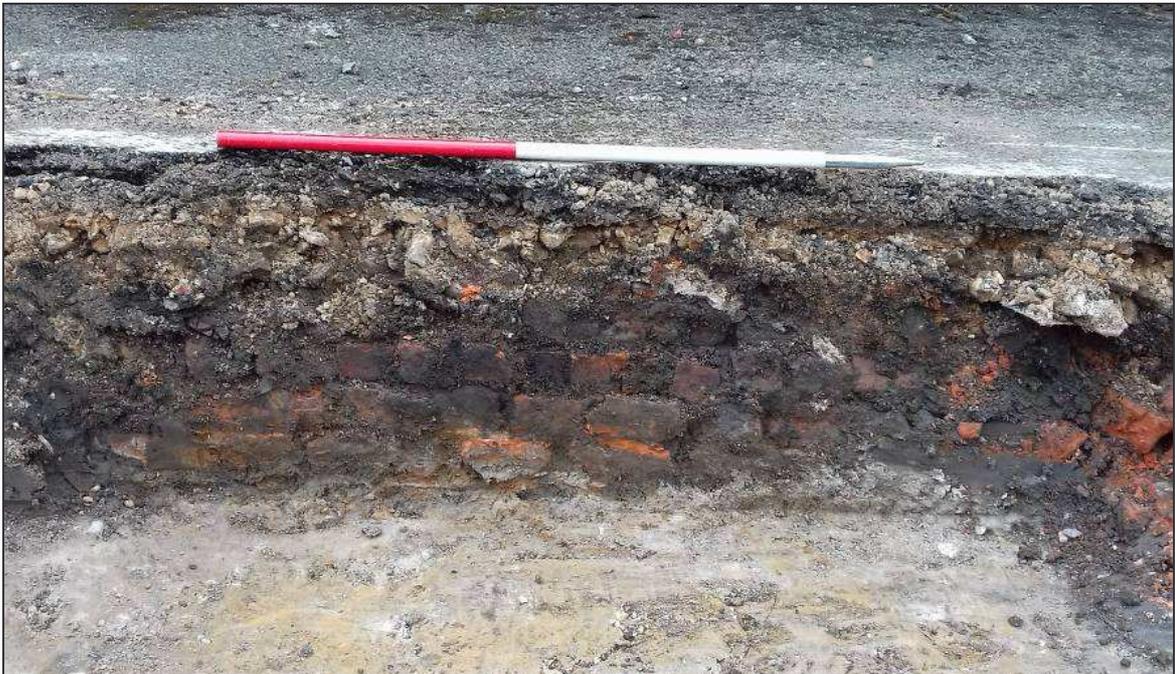
Wall **010** was revealed in the north-facing section of the trench, and was constructed from hand-made bricks laid with lime-based mortar. The wall survived to a height of three courses, equating to a height of 0.34m (Plate 9), although no foundation cut was observed.

Plate 9: Wall 010, looking south

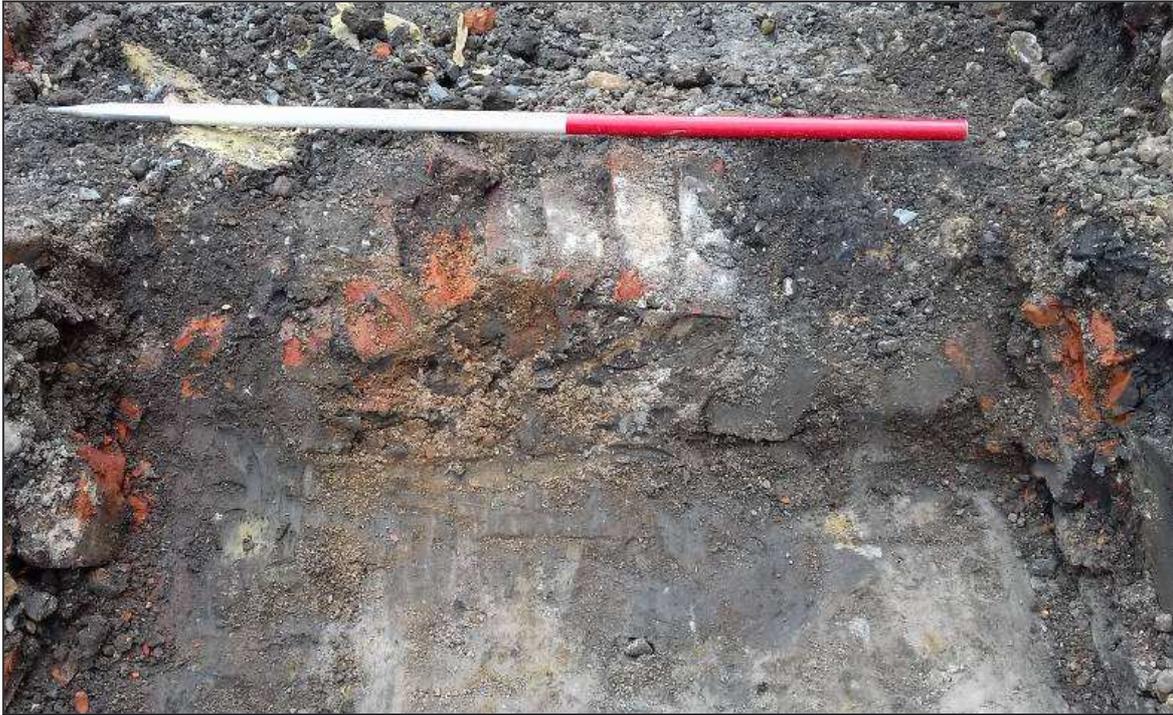
On the eastern side of deposit **009** lay a third north/south-aligned wall that was composed of hand-made bricks (**011**), which was almost identical to wall **008** but in a marginally less degraded state (Plate 10).

Plate 10: The fragmentary remains of wall 011, looking east

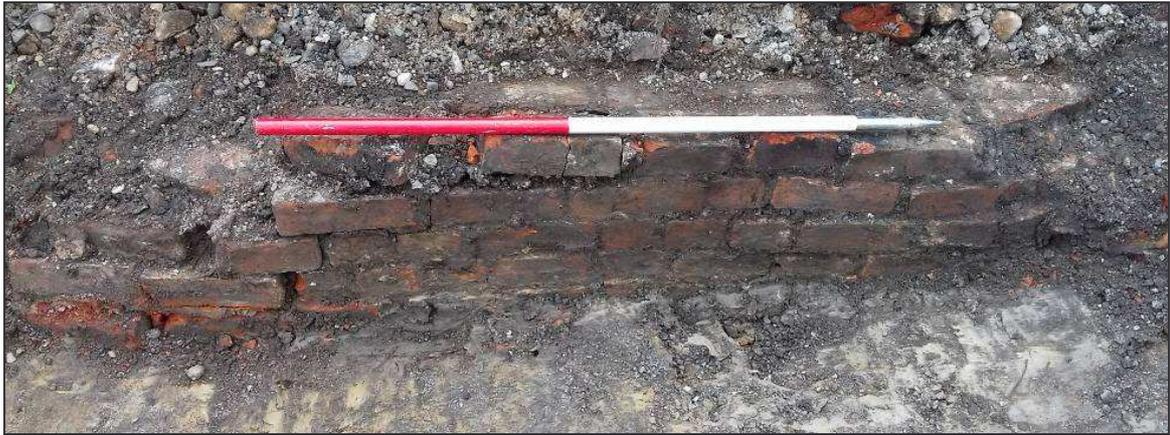
Levelling material **002** was identified across a large area to the east of wall **011**, which continued for 4.50m eastwards before a second east/west-aligned wall was encountered. This wall, **013**, was constructed from hand-made bricks, and was two courses wide (0.24m) and four courses high (0.38m). The wall was contained within a foundation trench (**026**) that was filled with a dark grey sandy clay (**027**) and cut into the natural clay geology (**012**; Plate 11).

Plate 11: Wall 013, looking south

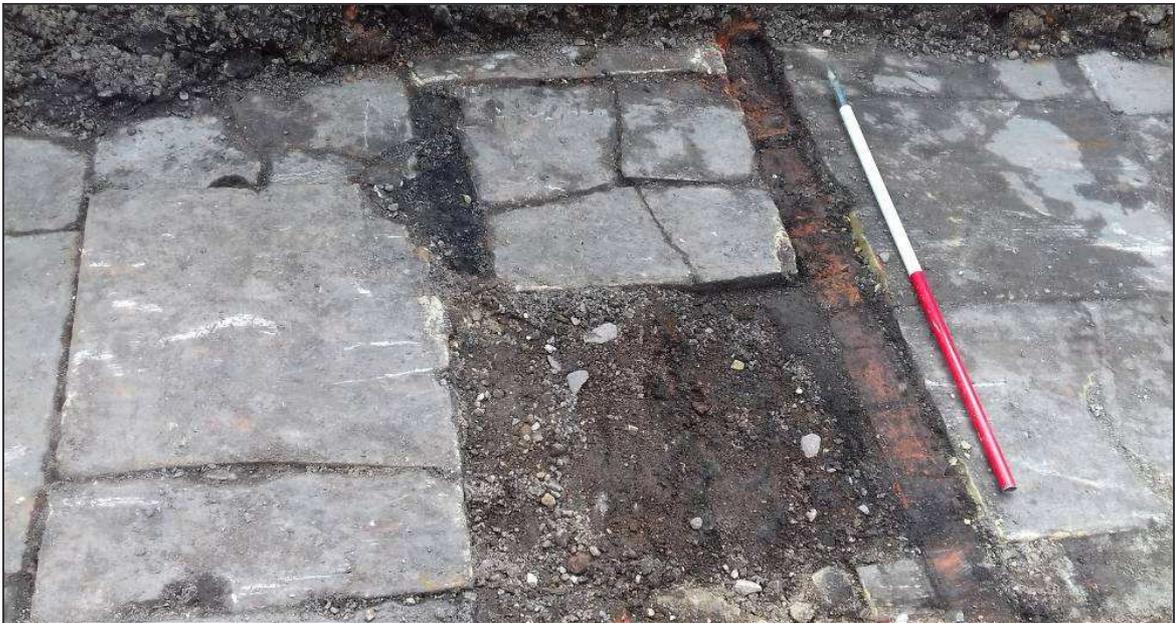
Approximately 1.10m to the east of wall **013** lay another flagstone surface (**014**), which measured 1.50m wide and continued beyond the trench edges to the north and south. This was abutted to the east by a single-course wall (**015**), which was composed of hand-made bricks and laid as stretchers; again, the bricks in this wall were moderately degraded (Plate 12). Wall **015** was, in turn, abutted to the south by a fourth flagstone surface (**016**), which was similar in form to the area represented by surfaces **006** and **007** with rectangular voids to the north and south. Lying against **015** and within **016** lay a 0.70 x 0.80m area of a gritty blackish-brown deposit (**028**), similar to **005** but without any evidence of a brick structure enclosing it.

Plate 12: Wall 015 showing flagstone surfaces 014 and 016 to the west and east respectively, looking south

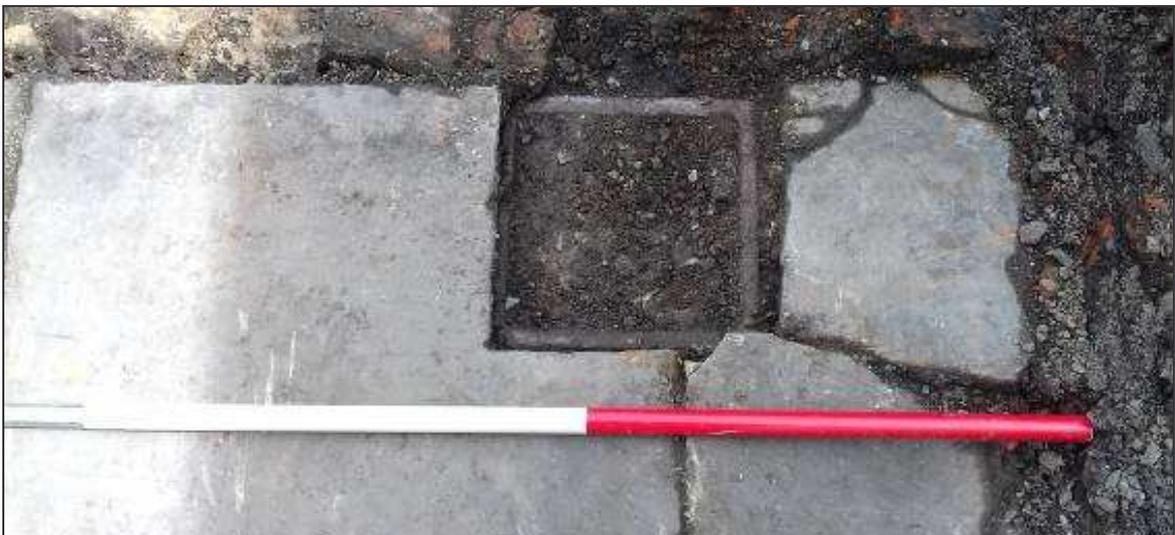
As with **006**, the flagstones forming surface **016** were laid around this area rather than it having been cut through the surface. A second feature within **016** was a square ceramic drain measuring 0.30 x 0.30m, lying on the far eastern side of the surface and abutting wall **017** (Plate 13). This wall formed the eastern boundary of surface **016** and was constructed from two courses of hand-made bricks laid in headers with a width of 0.24m. Again, the bricks were partially degraded and the wall had slipped slightly to the east, into the natural clay geology (**012**) that the wall was constructed on (Plate 14).

Plate 13: Ceramic drain within 016, looking east

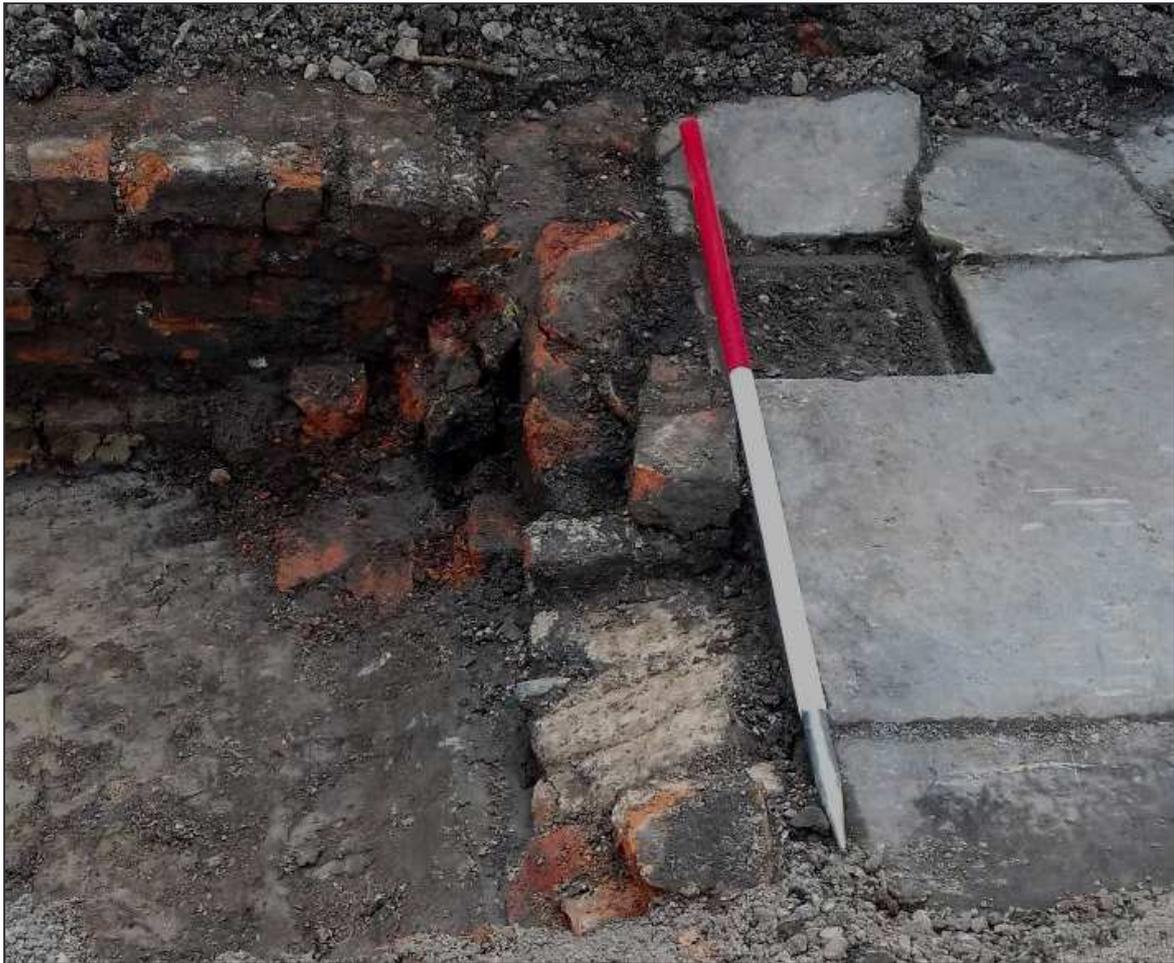
Plate 14: Wall 017, looking south

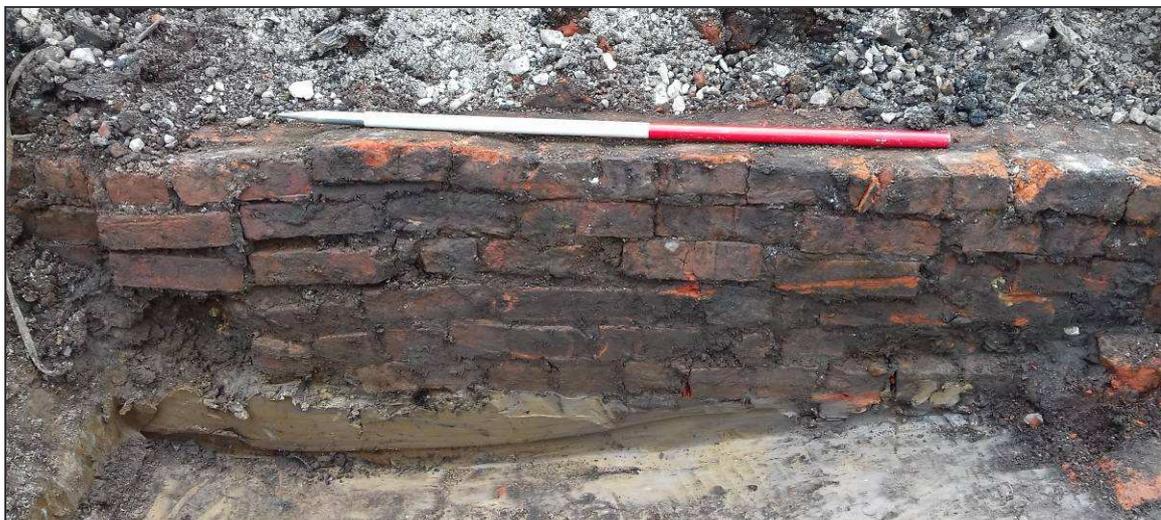
The final feature to be identified in this trench was a second east/west-aligned wall (**018**), which abutted wall **017** to the west, and continued beyond the edge of the trench to the east (Plate 15). The wall measured 0.24 x 2.10m, and survived to a height of 0.71m. It was constructed from hand-made bricks, and had been laid directly onto natural clay **012**.

Plate 15: Wall 018, looking south

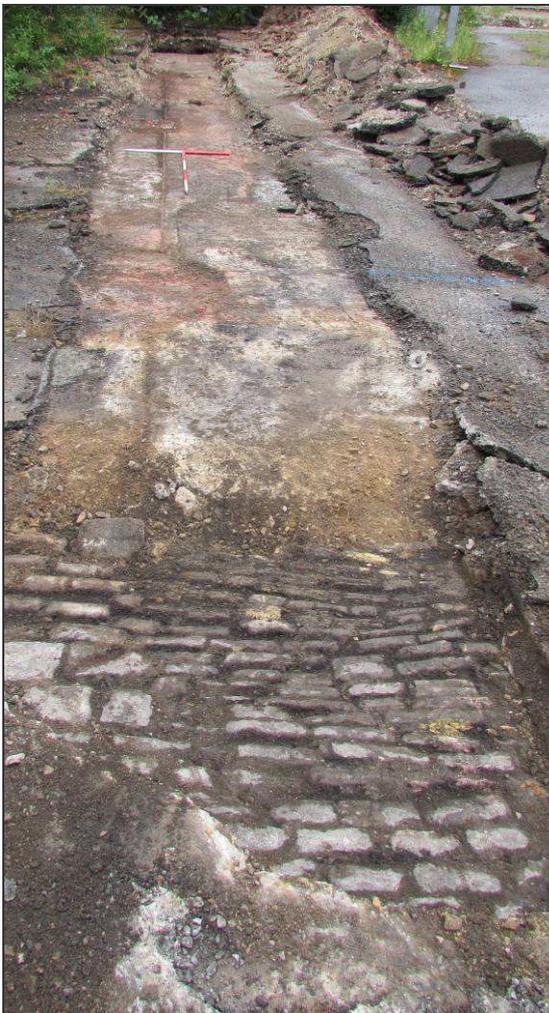
This trench was located on the southern side of the mill, and across the footprint of the southern extension that had been demolished in the 1980s. It was aligned east/west, measured 24 x 1.50m and was excavated to a maximum depth of 2m (Plate 16). The trench was overlain by a 0.30m thick layer of compact tarmac and stone chippings (**019**), which lay above up to 0.25m of demolition rubble levelling material **020**.

Plate 16: Trench 3, looking east

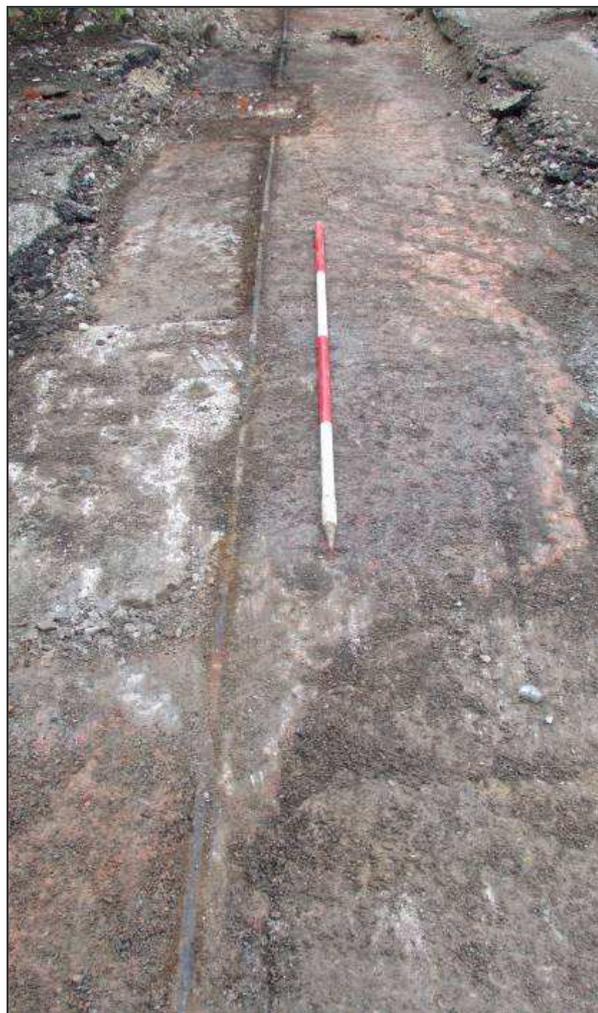
The majority of the central part of the trench was dominated by a layer of reinforced concrete (**023**), which extended 19.50m east/west and was 0.25m thick (Plate 17). Set within this were several iron rails, *c* 0.05m in diameter, which ran both north/south and east/west across the deposit and were hourglass shaped in cross-section. The concrete was broken in two places where the rails appeared to be grouped to reveal a compact deposit of crushed brick, concrete and mortar fragments **024** which lay below concrete **023** (Plate 18).

Plate 17: Concrete surface **023**, looking east

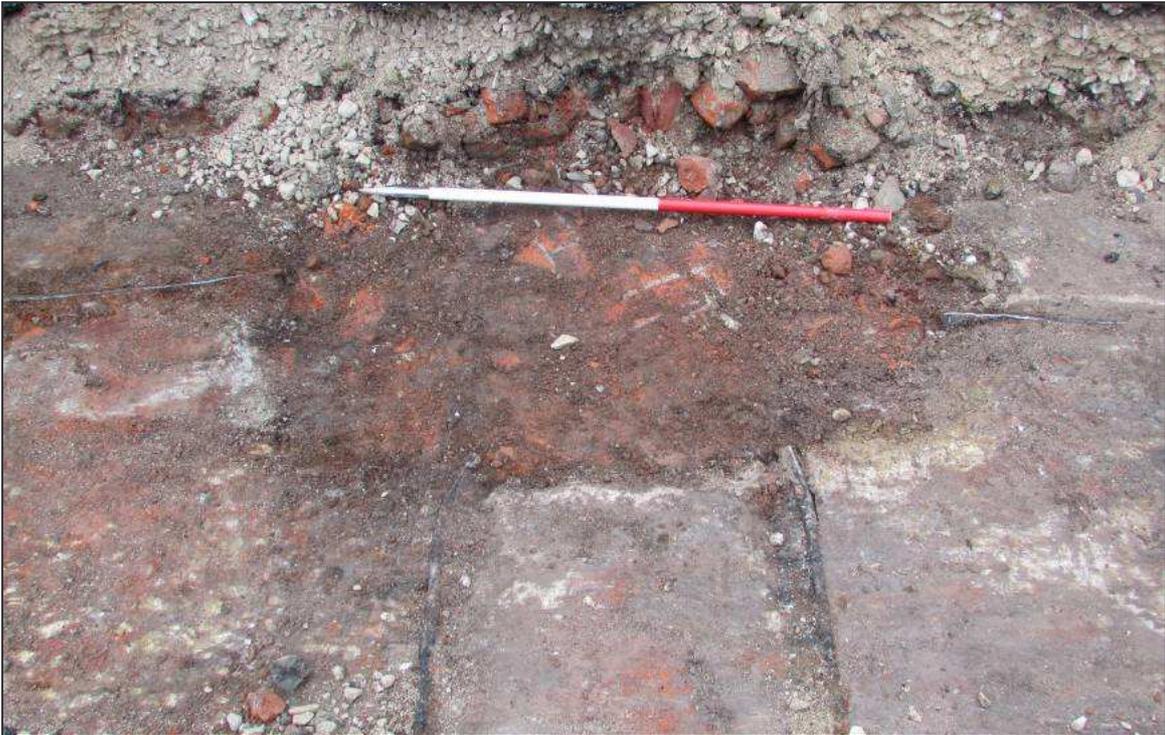
Plate 18: Break in 023 revealing deposit 024, looking north

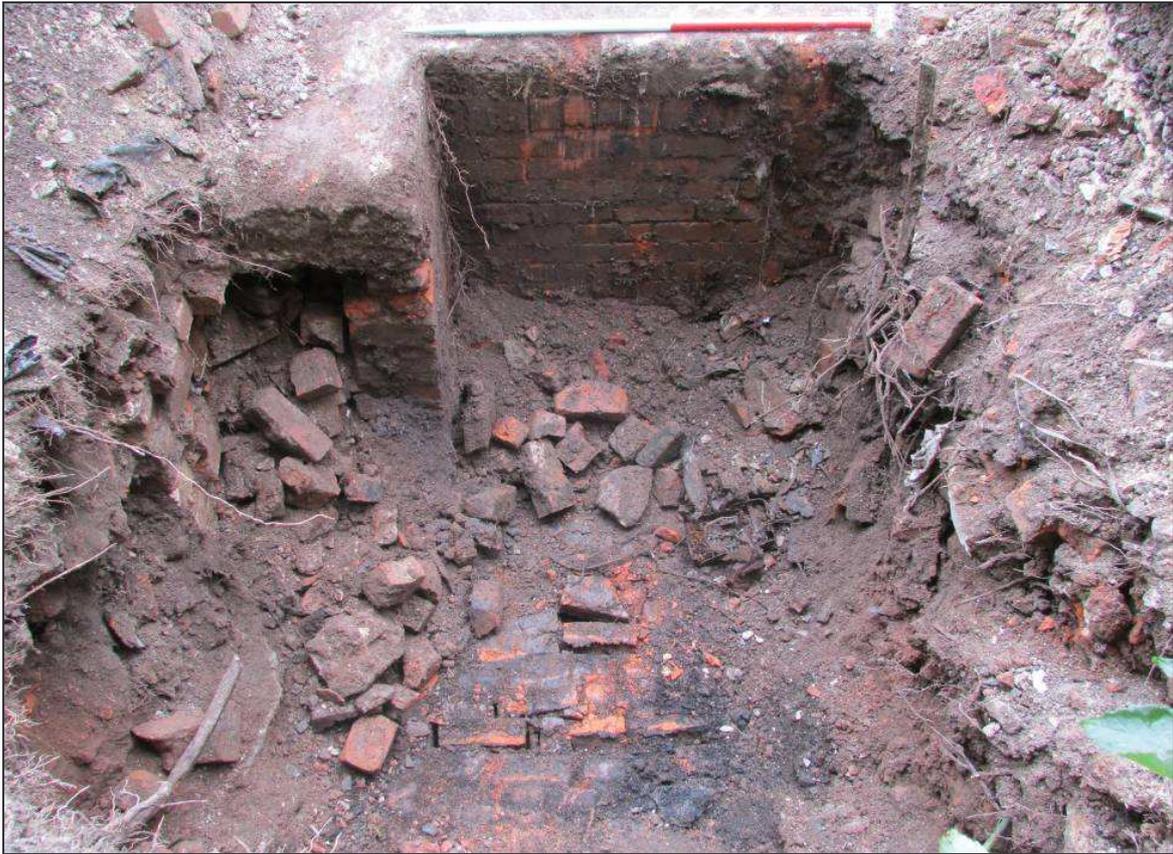
Towards the eastern end of **023**, the concrete was laid over an L-shaped hand-made brick wall (**022**) that measured 1.40m north/south and 0.45m east/west. The wall stood to a height of 1.00m, and was laid in English Garden Wall bond with a top course of headers laid on edge (Plate 19). To the south of this wall the concrete overlying it continued southwards beyond the trench edge to span a void filled by demolition rubble (**020**). To the east of wall **022** a small surface composed of hand-made bricks (**021**), which was identified at a depth of 1.30m below the existing ground surface, although this feature could not be investigated further due to health and safety concerns with the surrounding demolition deposit.

Plate 19: Wall 022 with surface 021 in the foreground, looking west

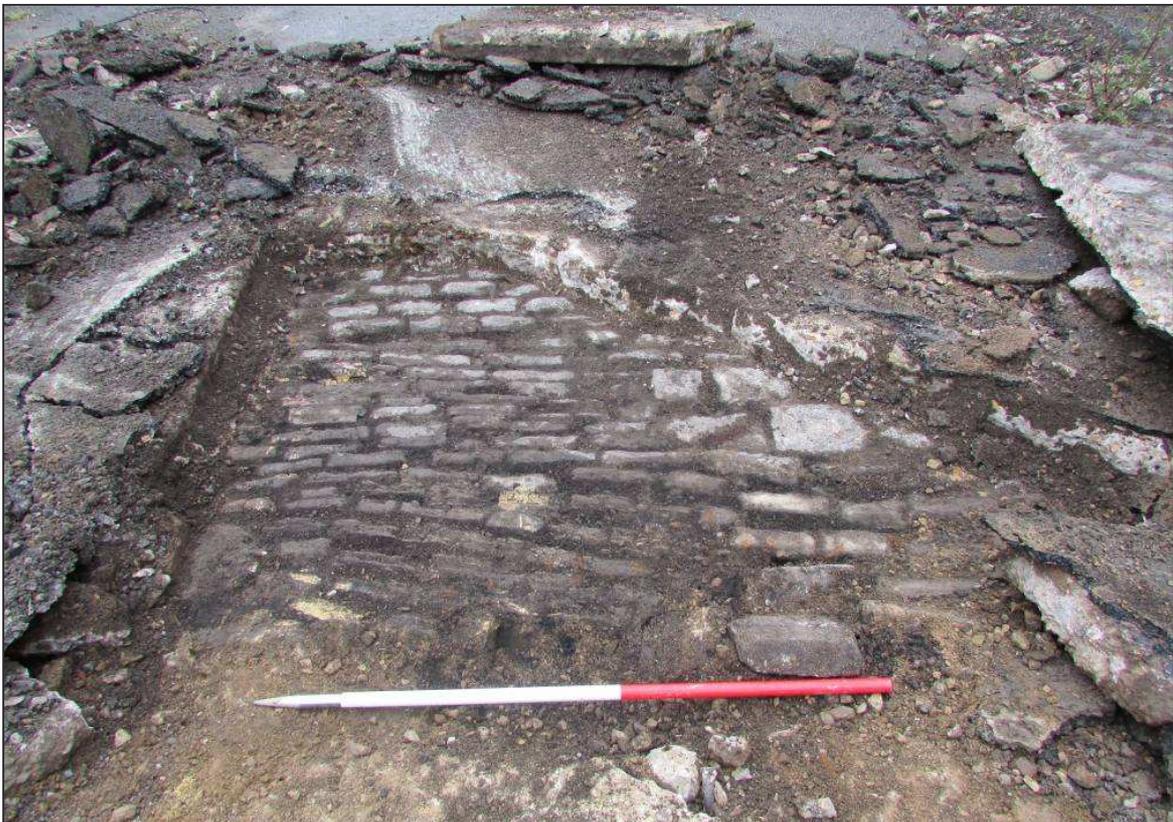
Abutting the degraded western extent of the concrete surface **023** lay an uneven cobbled surface (**025**), which extended beyond the trench edges to the north, south and west. The surface was composed of stone setts in varying sizes between 0.10m-0.25m with the larger stones to the north (Plate 20).

Plate 20: Cobbled surface 025, looking west

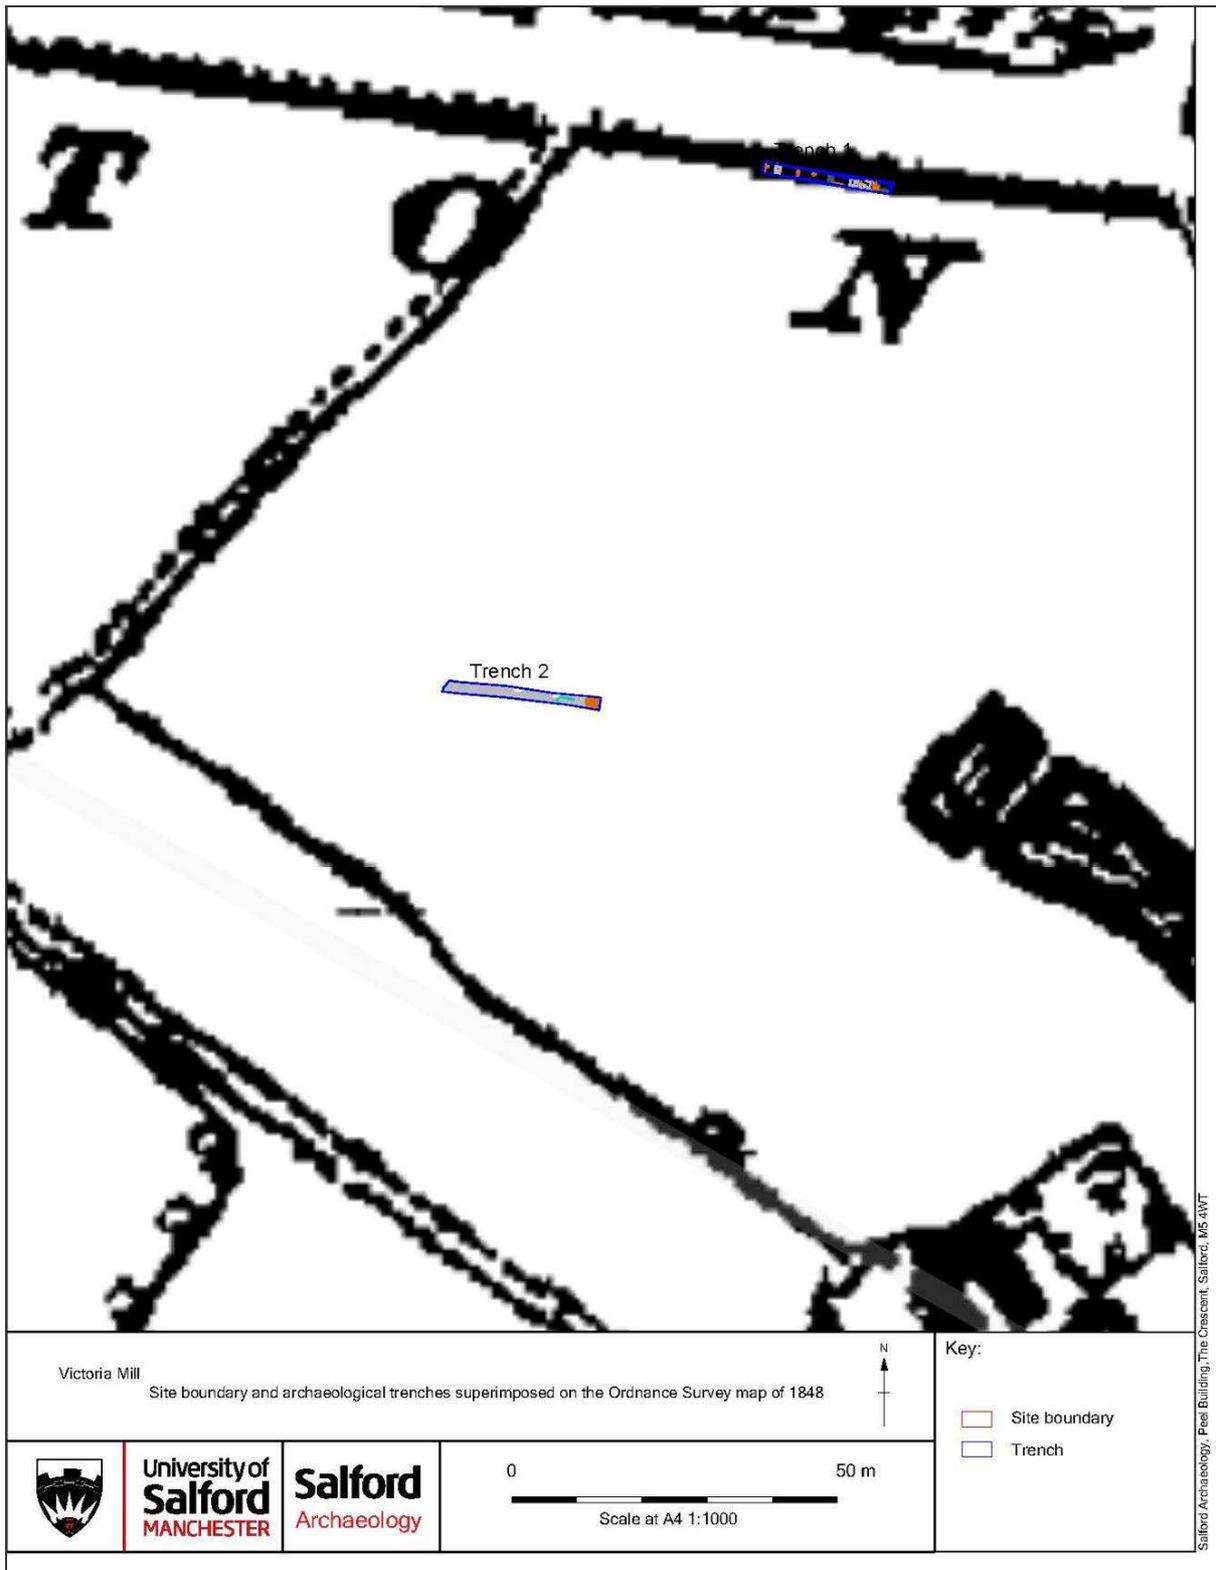
Figure 3: Trench locations superimposed on the Ordnance Survey map of 1848
