Archaeological Evaluation

Victoria Mill,
Droylsden,
Tameside

Report No:
SA/2017/53

Document Type: Archaeological Evaluation Report

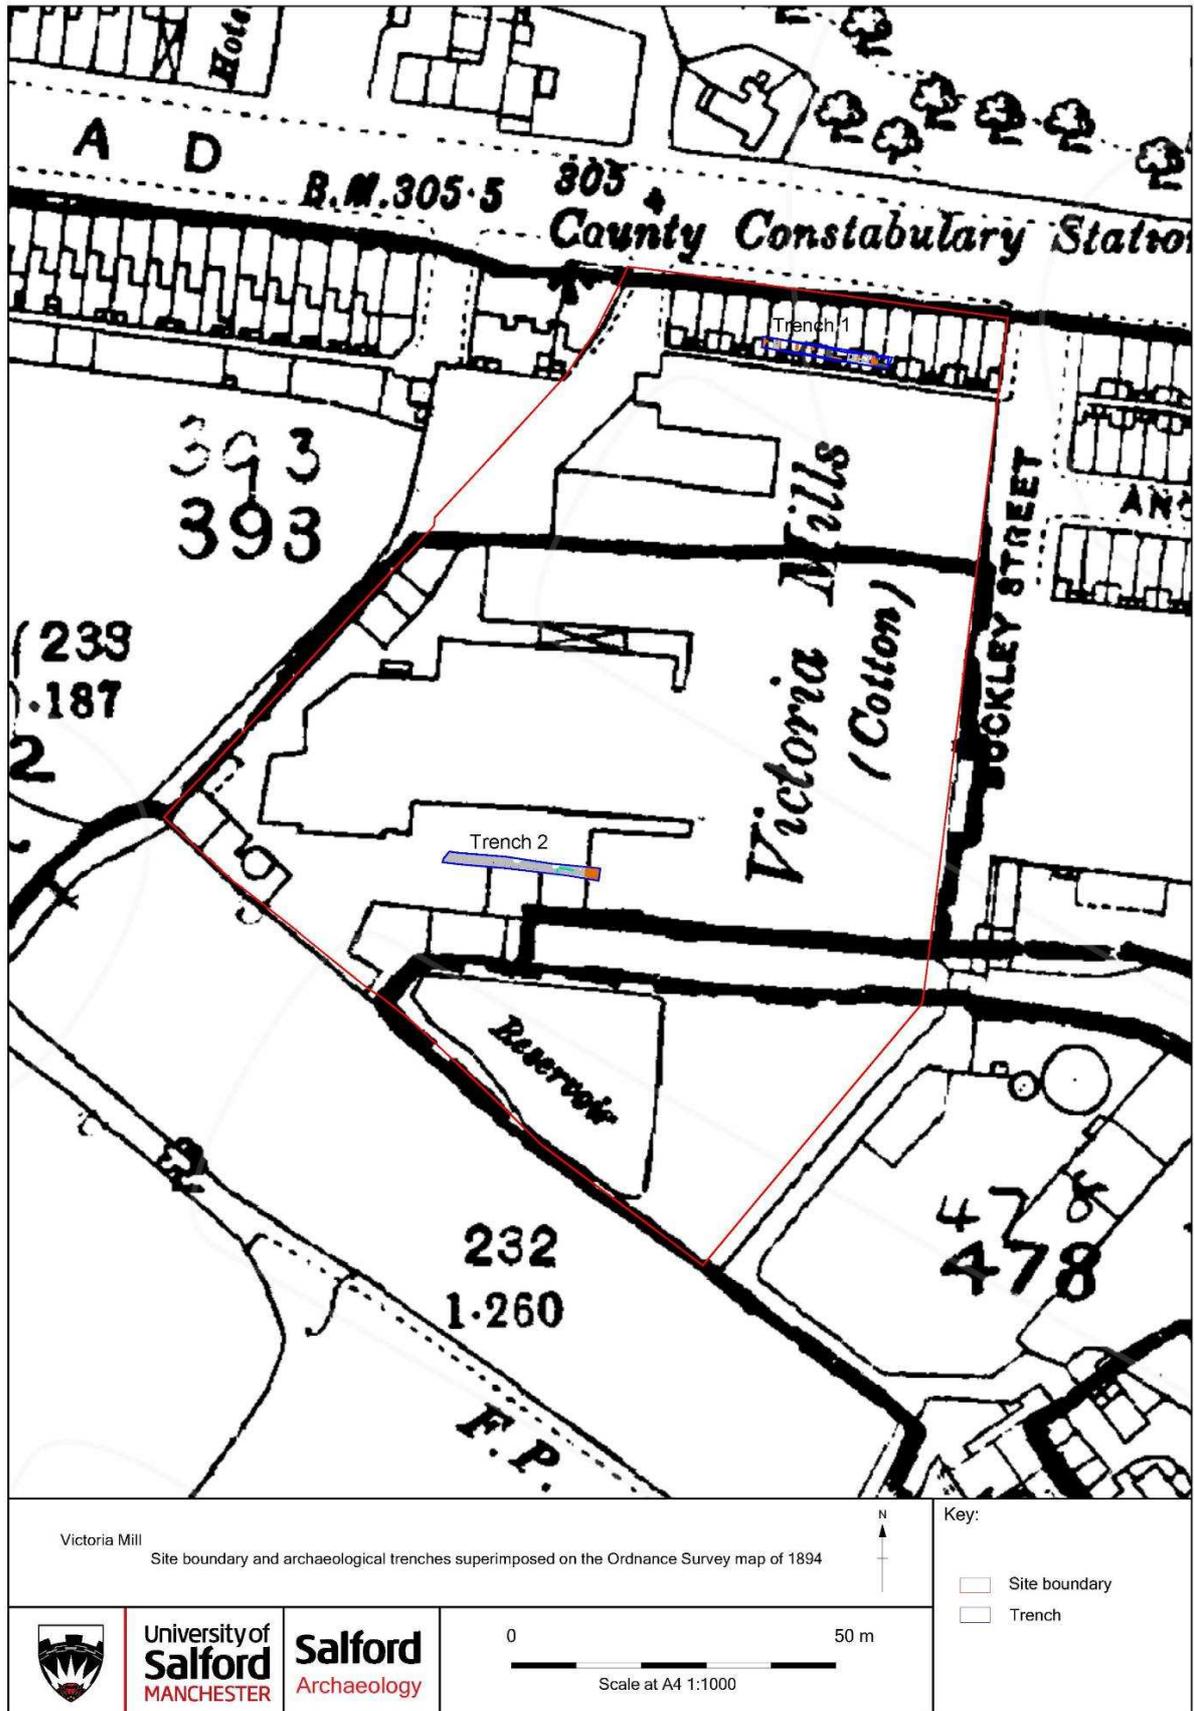
Figure 4: Trench locations superimposed on the Ordnance Survey map of 1894

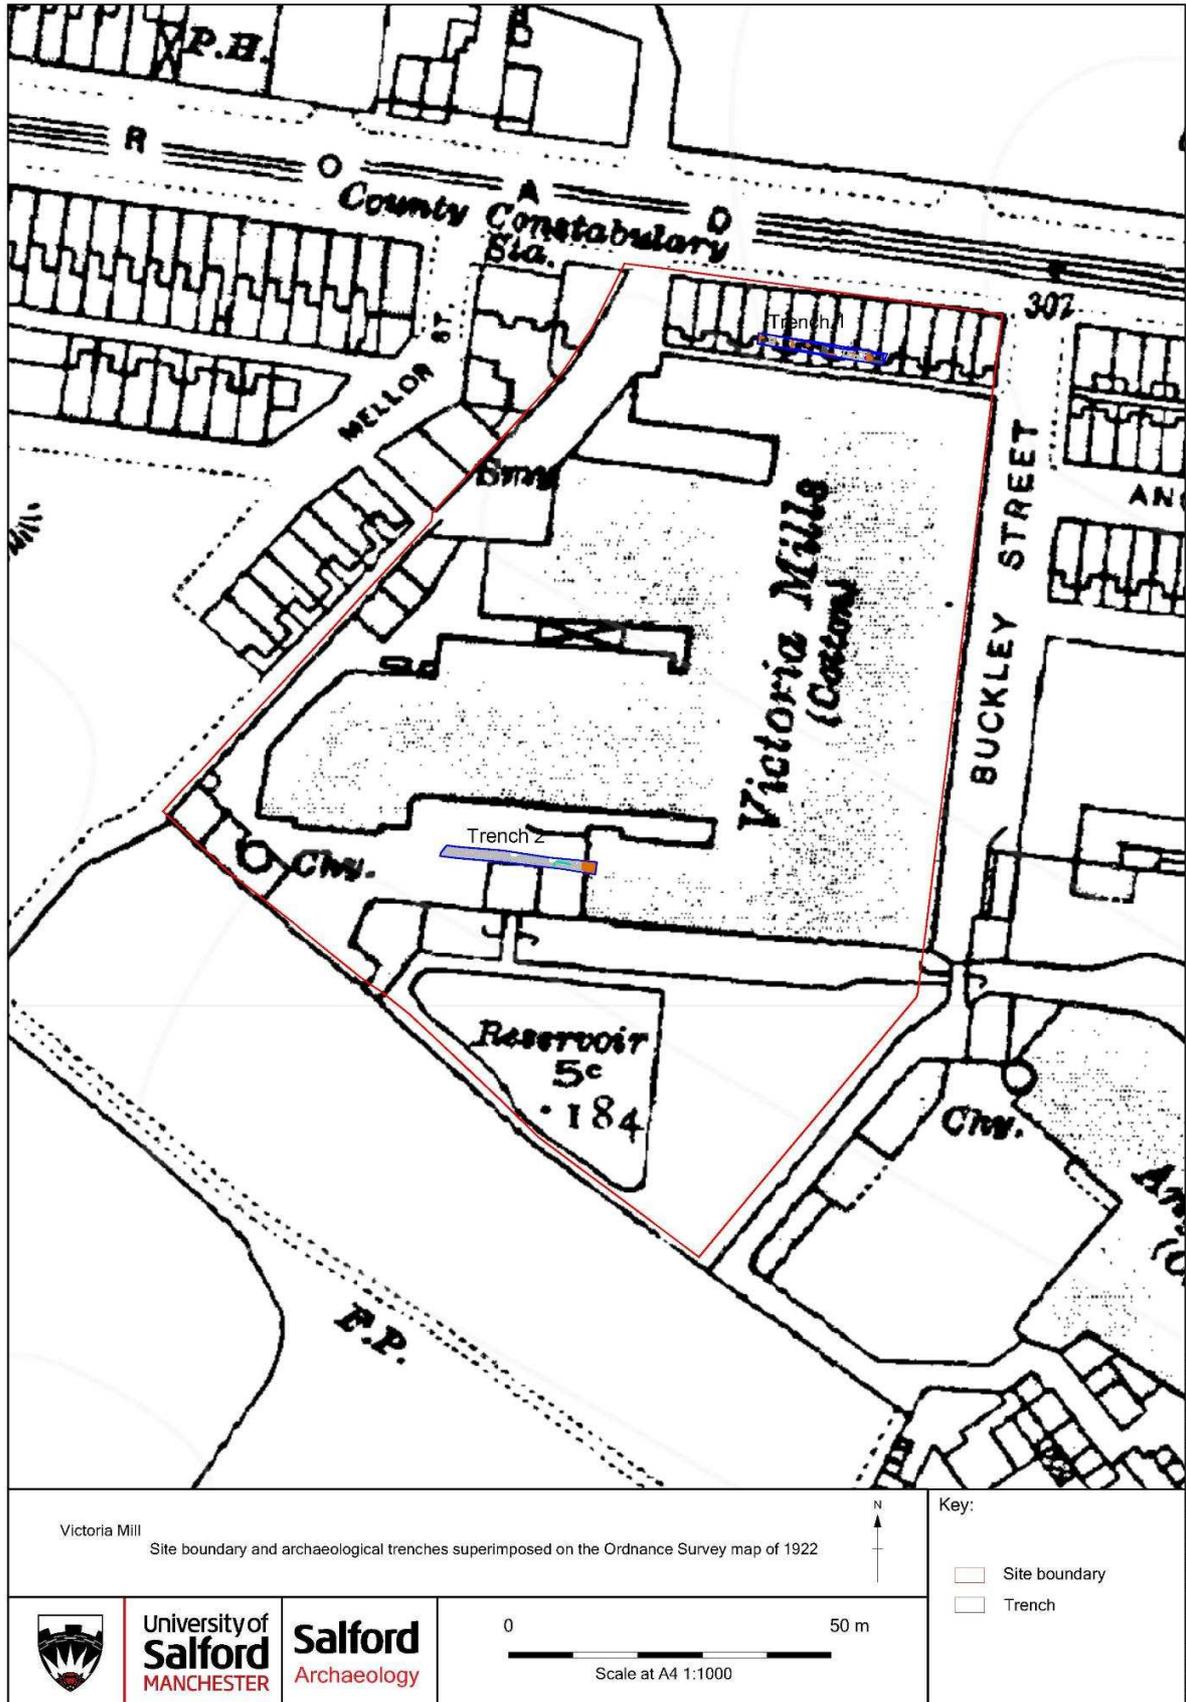
Figure 5: Trench locations superimposed on the Ordnance Survey map of 1922

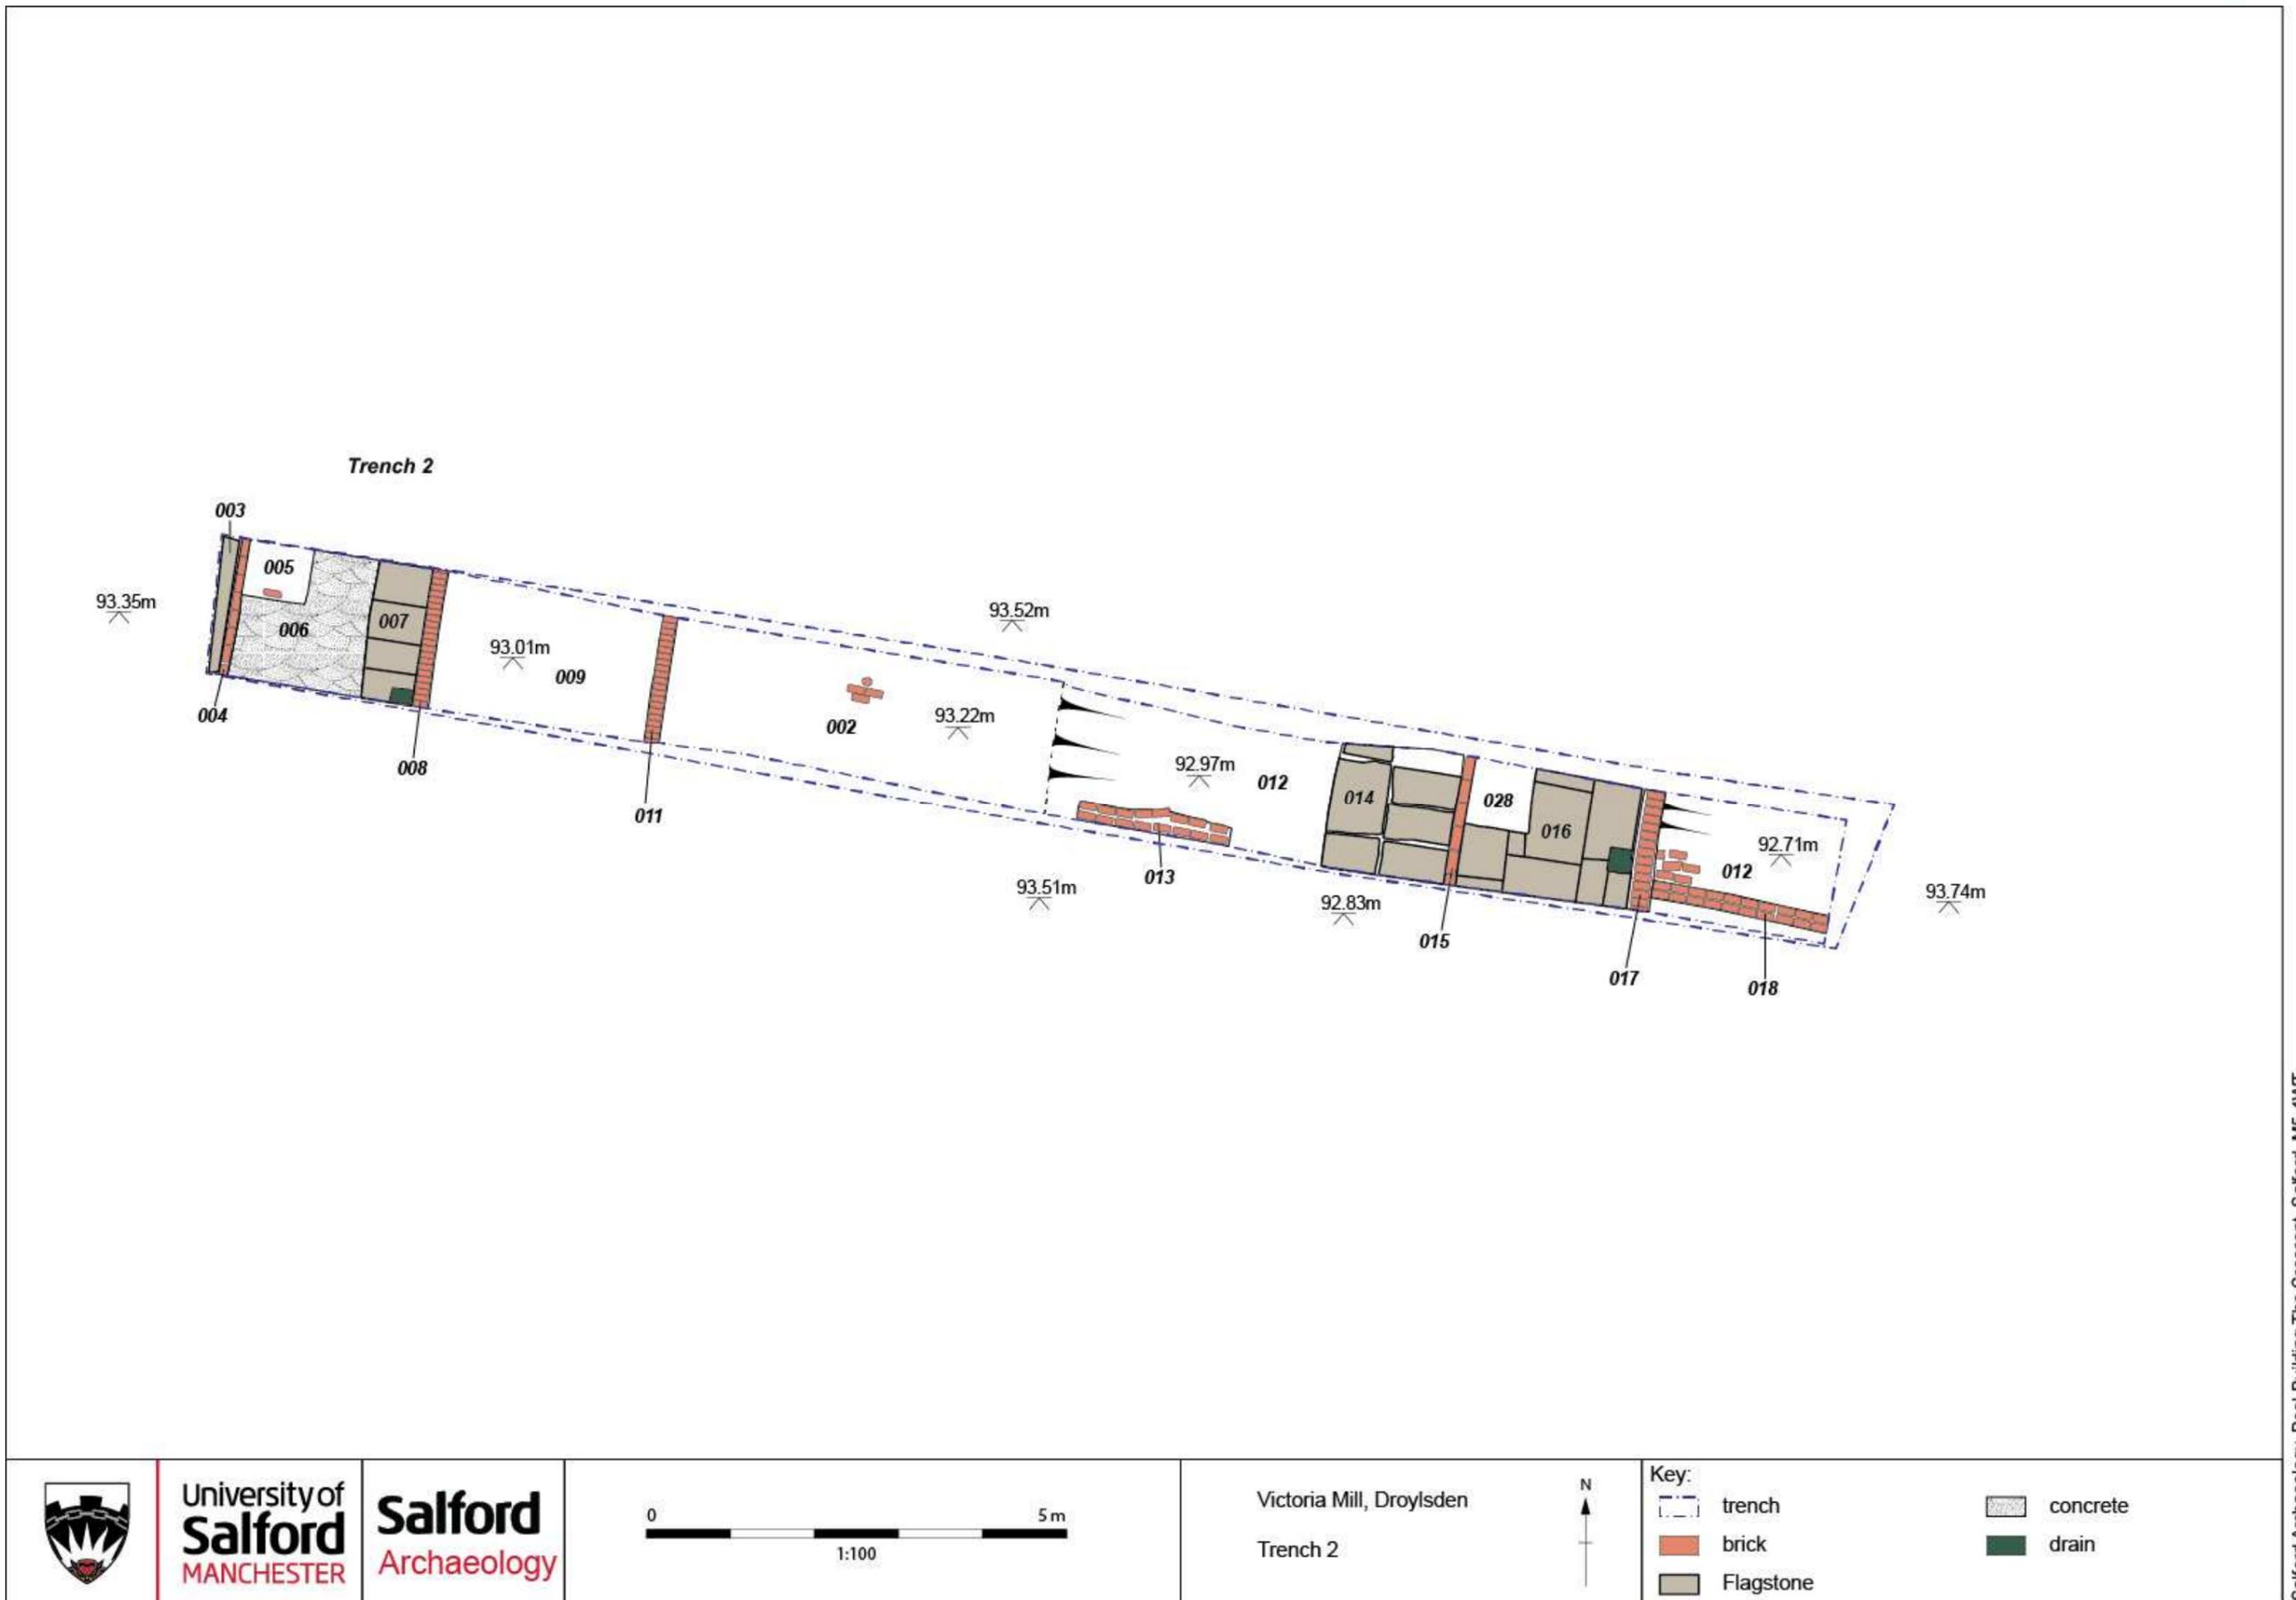
Figure 6: Plan of the excavated remains exposed in Trench 2

Remains relating to the mid- to late 19th-century workers' housing, as depicted on the Ordnance Survey mapping of 1894-1973, were uncovered in Trench 2. The remains clearly represent the foundations of double-depth houses fronting onto Manchester Road, with the repeating pattern of single-course brick walls and flagstone and concrete surfaces likely to represent the yards to the rear of these properties. The two larger east/west-aligned walls also correspond in both size and position, and are likely to be the rear walls of the houses. Neither the historic mapping nor the evidence uncovered during the evaluation suggests that these buildings were cellared. Following their construction, the buildings underwent very little alteration during their occupation with only superficial changes made, such as the relaying of a yard in concrete.

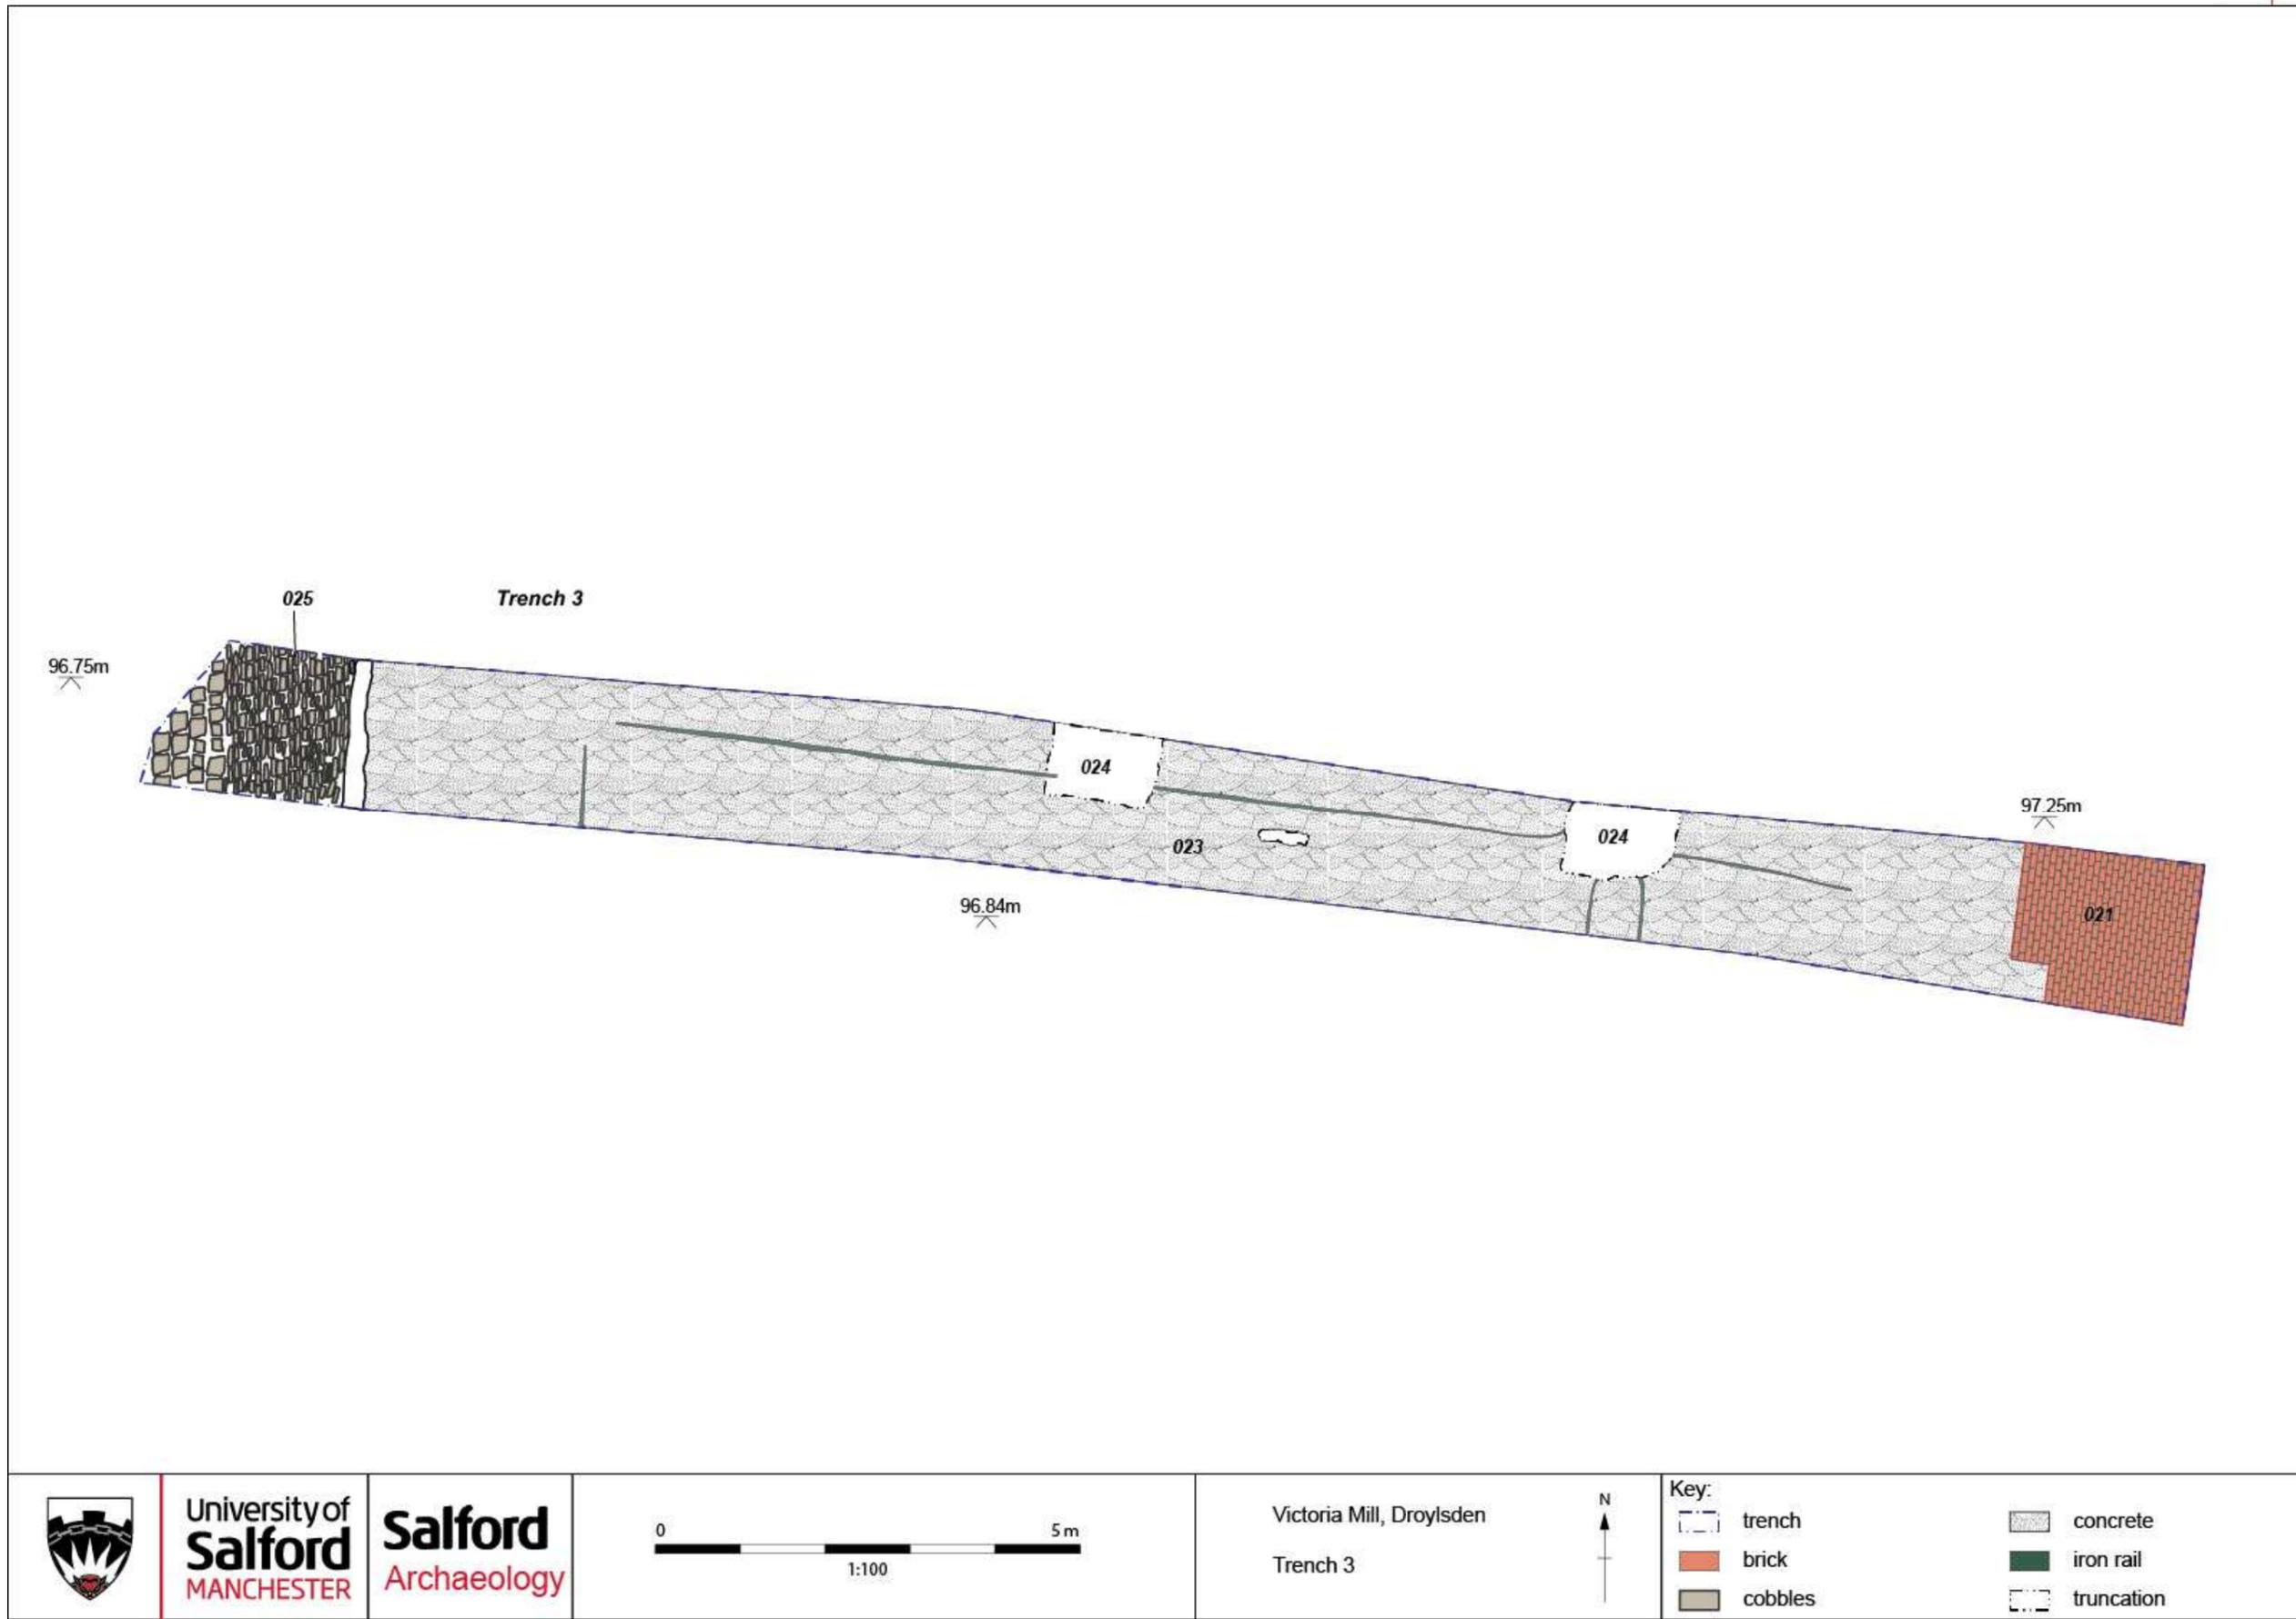
Figure 7: Plan of the excavated remains exposed in Trench 3

The remains uncovered in Trench 3 appeared to relate to the southern extension of the main mill building and the small free-standing structure to the west. The main extension was originally 15 x 15m in size, separated by a 2m-wide corridor between this and the main mill, with the small structure lying 8m to the west. By the 1960s, the main extension had been reconfigured to abut both the mill to the north and the smaller building to the west, although this westerly extension was narrower than the earlier extension. The concrete surface revealed is likely to be associated with this later layout and the wall seen below this surface to the east corresponds well with the western wall of the pre-1960s extension. It is therefore likely that the structures in this trench relate to the 19th- and early 20th-century occupation of the mill, and that the concrete was laid to create a level surface for machinery associated with the iron rails in use during the later 20th-century occupation.
