Salford Archaeology was commissioned by Muse Developments to undertake an archaeological evaluation of land on Oldfield Rd (centred on NGR: SJ82573 98439), currently being developed as part of Salford's regeneration scheme. This report consists of the results of three evaluation trenches excavated in December 2016.

1. Introduction

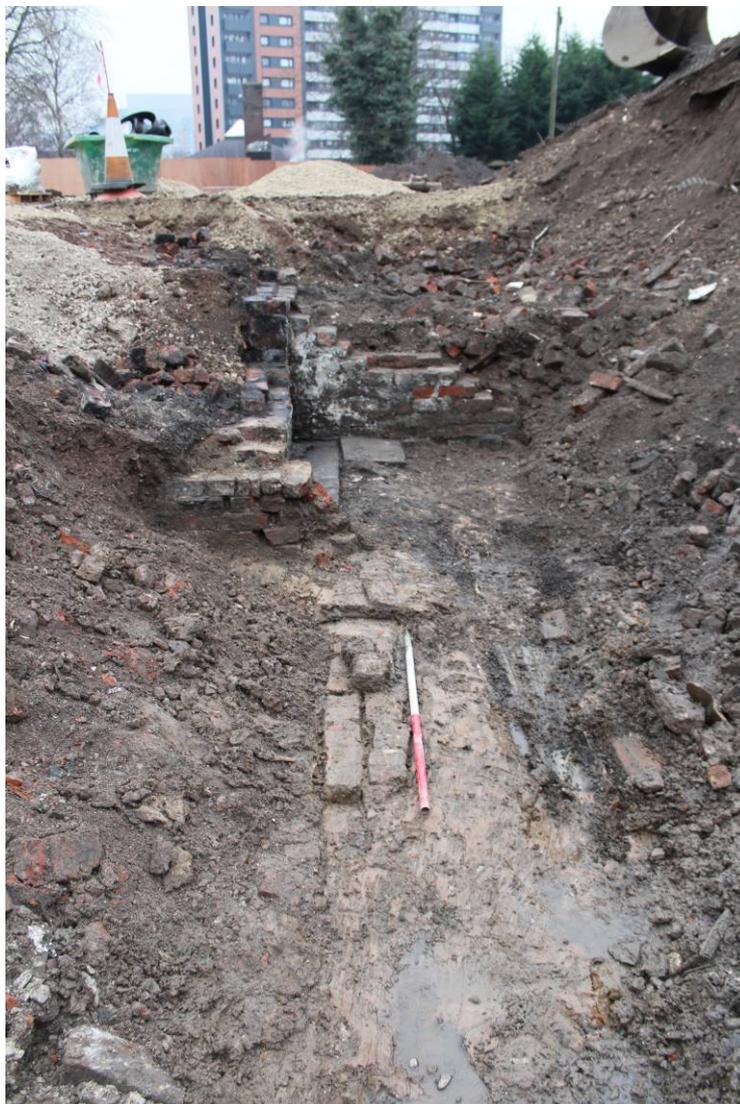
Plate 2: Trench A looking south-east

Evaluation Trench A measured 10.5m x 4m wide and was excavated to a maximum depth of 1.85m. It was aligned east-west across the footprint of the site of a public house, which stood as part of a block of buildings running north-south on Oldfield Road. The trench was located 5.7m to the south of a standing building (*Fig 6, Plate 2*).

It was set back from the edge of the former pavement due to a strong electrical signal detected during preliminary scanning. Given the loose compaction of the made ground, the trench edges were battered, leaving a strip of approximately 2m exposed

at the base of the trench, aligned east-west. At the base of the trench a modern service cut and ceramic pipe forming a land drain **06** (redundant) were observed and recorded. This ran east-west across the southern edge of the battered edge at the base of the trench.

The upper layer was made up of demolition rubble **01**, which relates to material from the demolished pub and newly introduced layer and piling mat. This lay to a depth of 1.85m. This deposit covered a series of walls and a partially surviving floor surface.

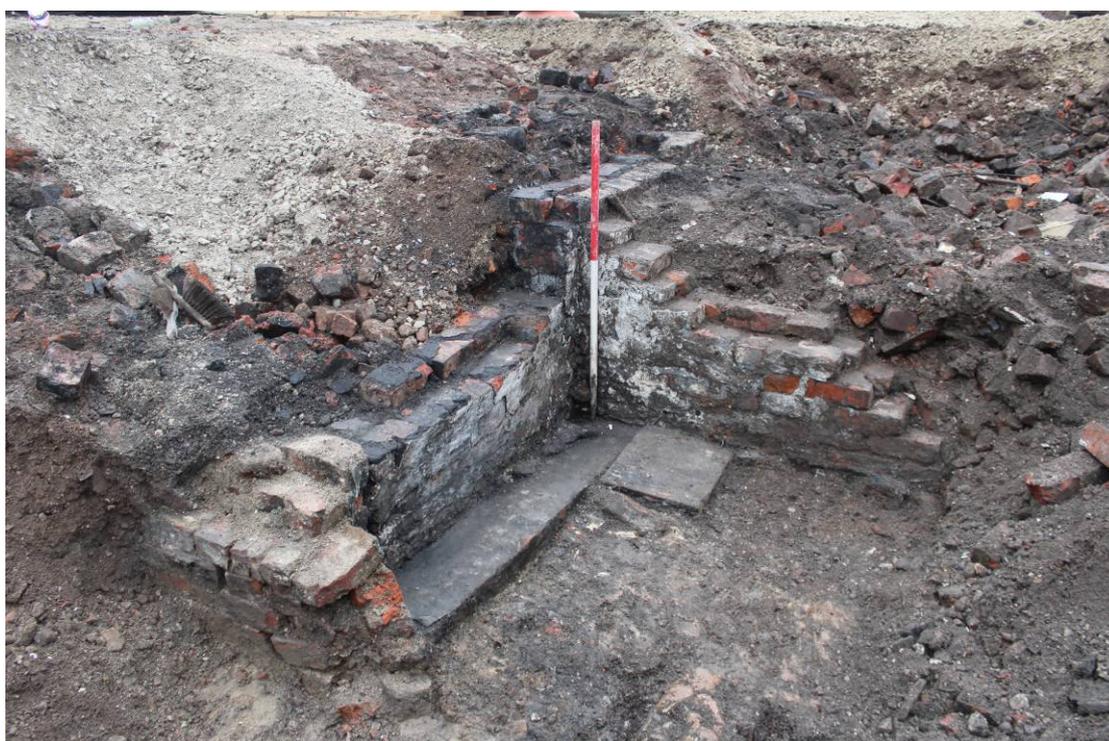
Plate 3: Walls 02 & 03 with floor 05, looking north

A substantial wall **02** was located in the eastern part of the trench, oriented east- west. The wall was 3.05m in length and 0.26m wide and survived to a maximum height of 0.86m. The wall was constructed of red brick (0.11m x 0.23m x 0.08m) and hard black bonding material. Adjoining wall **02** was another wall **03** (1.4m x 0.22m) oriented north - south. This wall **03** was constructed of white lime mortar and red brick (0.11m x 0.23m x 0.07m). It survived to a height of approximately 0.75m (*Plate 3*).

To the south of wall **02** and west of wall **03** survived a stone flag floor surface **05**. Although much of the surface had been removed during the building's demolition, two in-situ slabs were recorded.

Only fragmentary remains were uncovered of the former public house that originally occupied the area of trench A. Part of a few walls and a flag floor were uncovered at a depth of c. 1.9m suggesting a basement. Only one of these walls was built using lime based mortar, the others constructed with hard dark grey cement, suggesting that the remains were mostly later modifications to the original early 19th century building.

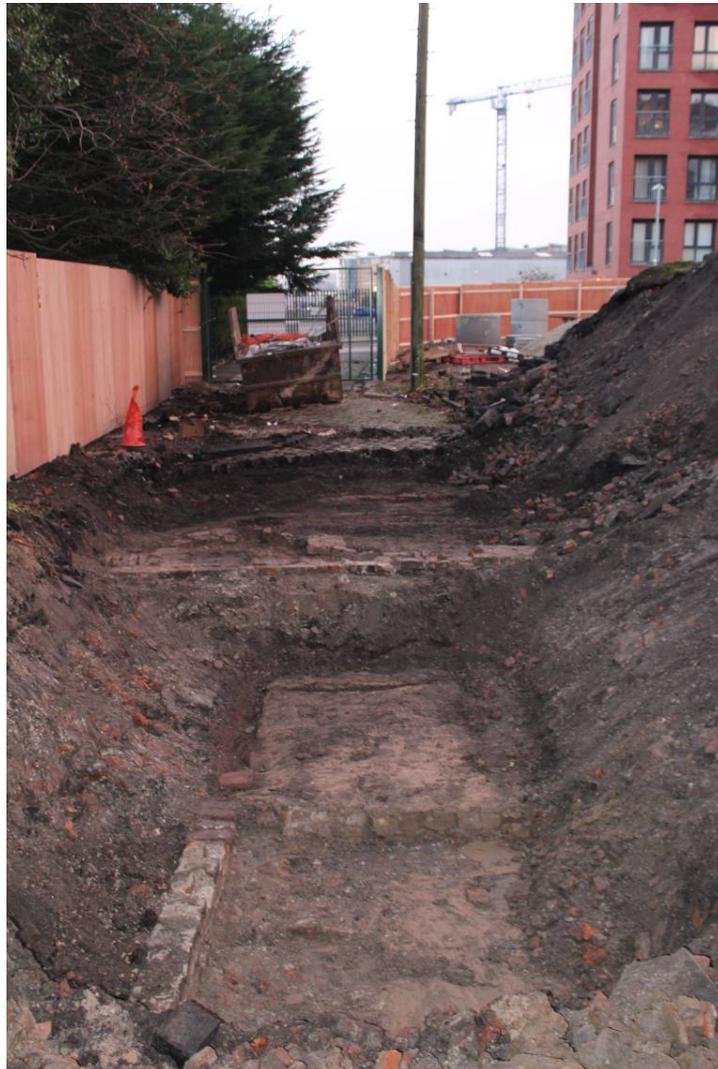
Plate 4: Trench B looking south-west

Trench B measured 4m x 11m and was located on the eastern boundary of the site area. The intended trench location straddled the boundary of the site area; as the target location was not feasible, the trench was instead positioned c.1m from the hoarding, aligned north–south (*Fig 7, Plate 4*).

This part of the site was originally traversed by an east–west road, Factory Lane. At the junction of Factory Lane and William Street (running north–south), the road

doglegged and widened. The junction between the roads was in recent decades lined with bollards, across William Street. The trench was located to the south of the bollards along the former road surface of William Street.

A cobbled surface, in places overlain by layers of tarmac was observed **07**. The road surface overlay a layer of made ground **08**, evidently introduced to create a well-drained level foundation for the road. It was composed of crushed clinker and rubble. The road surface and associated made ground lay up to 0.5m in depth. This overlaid a series of walls, relating to the former Islington Factory.

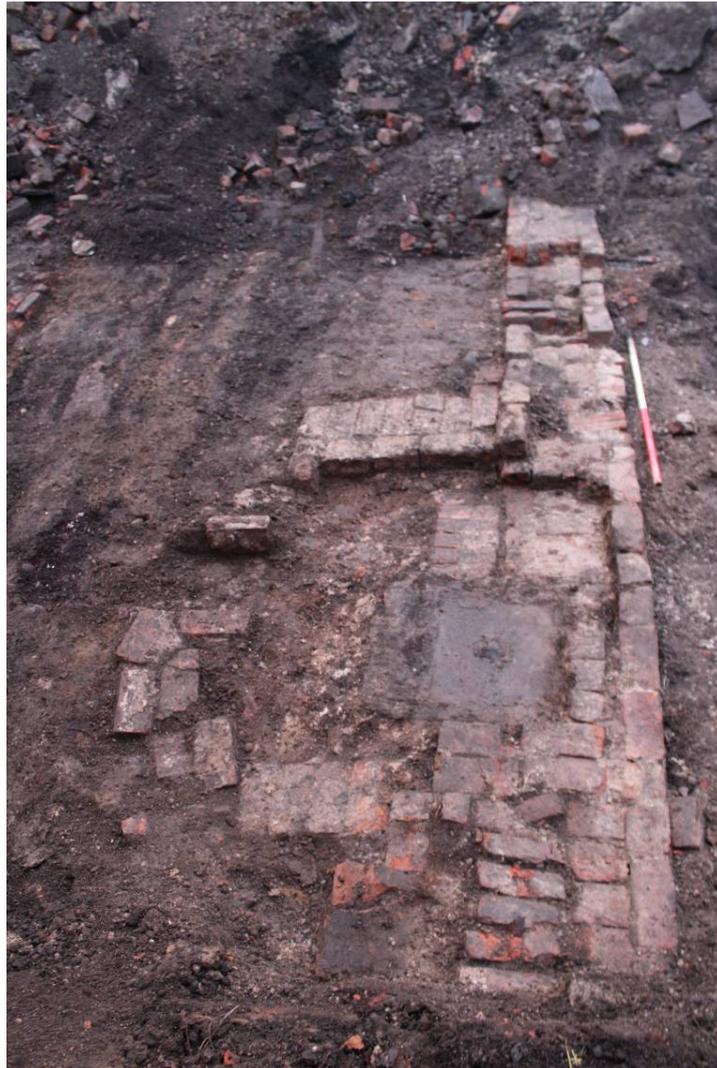
Plate 5: Wall 18 with walls 19 & 20 and column base 21, looking north-west

The most substantial of these walls was wall **18**, constructed of handmade red brick and crumbly light greyish white lime mortar the wall extended the full width of the excavation area. This has been interpreted as a load bearing wall of the mill building which occupied this part of the study area. The top of the wall lay some 0.3m below the current level of the road, stratigraphically below the made ground **08**. The wall was initially 0.48m wide and survived to a maximum height of 0.7m. The exposed brickwork was regularly laid, particularly the upper three courses on the north face of the wall in stretcher bond. The foundation of the wall (lower four courses) was less regular and in places, broken or half bricks interrupted the pattern of but otherwise consisted of regular courses. The base of the wall was somewhat undermined, close to the eastern limit of excavation. The north face of the wall showed evidence of being plastered with traces of a plaster or lime wash adhered to the brickwork; this reinforces the interpretation that the area to the north of the wall was an internal space (*Plate 5*).

Two stubs of brick wall (**19 & 20**) form the two sides of a 1.3m by 0.8m structure extending south from wall **18**. This originally appeared to have a brick wall running east-west at its southern side which had been truncated by later cast iron pipe **17**, running east-west to its immediate south.

Between walls **19** and **20**, mill wall **18** had been partially truncated by the addition of a concrete column base **21**. This was a late type of concrete and had the remains of a steel column embedded into it.

Trench B contained some remains of the south-western end of the former Islington mill. From the map evidence it is likely that wall 18 represents the south exterior wall of the mill, with walls 10, 11 and 13 representing internal walling not visible on the mapping. The excavated remains also suggest that this part of the mill was cellared.

Walls 19 and 20 may be the remains of an entrance way or an outbuilding constructed against the exterior wall of the mill. The south-west edge of this outbuilding had been destroyed by a later cast iron pipe and a brick drain.

Along with the drain and pipe the later modifications to the mill area also evidenced by the concrete and steel column base which had been punched through the former exterior wall.

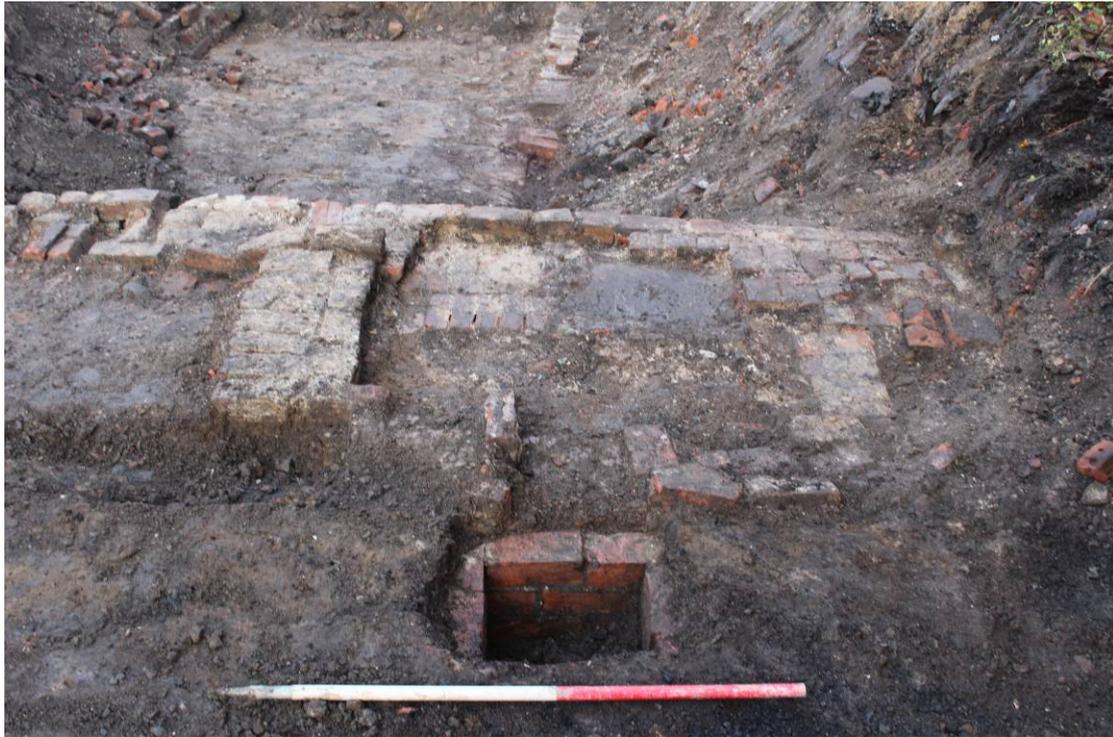
Plate 6: Drain 27 with walls 18, 19 & 20 and column base 21, looking north-east

To the south of wall **18** was a square brick drain **27** (0.63m x 0.58m) (*Plate 6*).

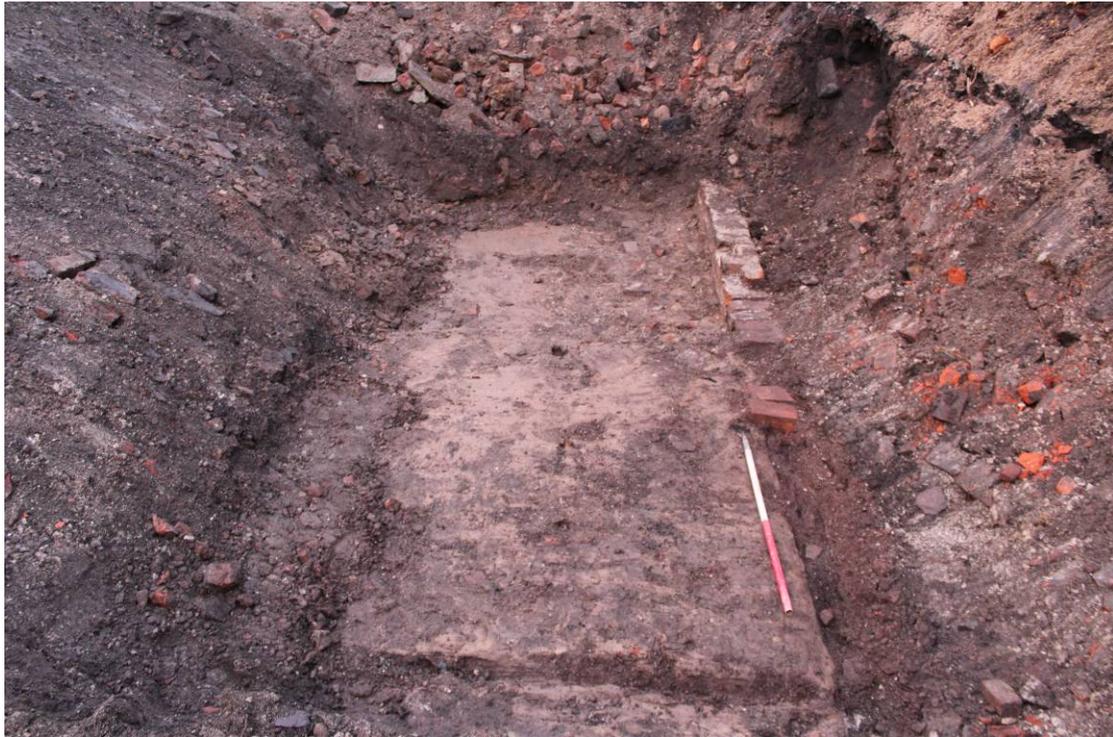
Plate 7: Wall 10, looking north-east

Two walls aligned perpendicular to wall **18** and a narrow construction cut may have functioned as dividing walls within this level of the mill. Wall **10** was located along the eastern limit of excavation and extended beyond the northern limit of excavation. This wall was constructed of handmade bricks and light greyish white lime mortar (*Plate 7*).

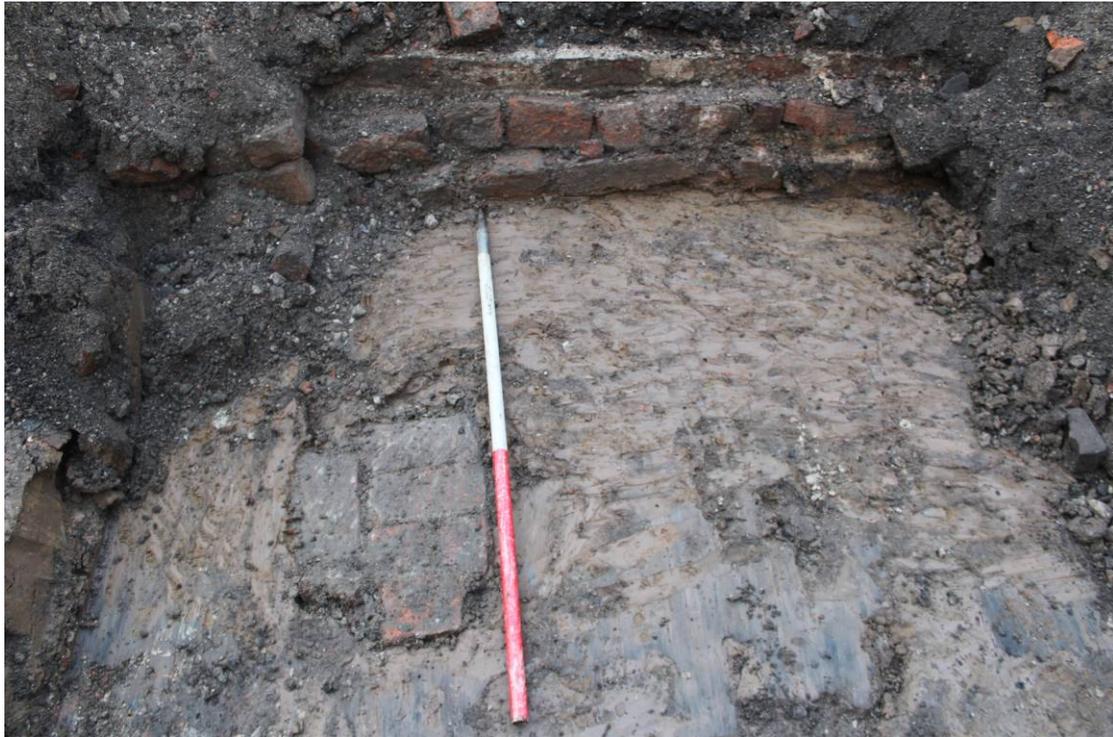
Plate 8: Brick pad 12, looking south-west

A further linear feature **11** ran south from this wall. This was filled with rotted wood and may have been a former doorway. Wall **13** was aligned parallel to wall **10**, located 2.88m to the west. The wall was of the same construction but laid in stretcher bond. In-between these two walls was a small sub-rectangular brick pad **12** (0.4 x 0.35) consisting of whole and broken bricks. This may have functioned to support a wooden beam or metal column. It was located 1.88m west of wall **10** and 0.6m east of wall **13** (*Plate 8*).

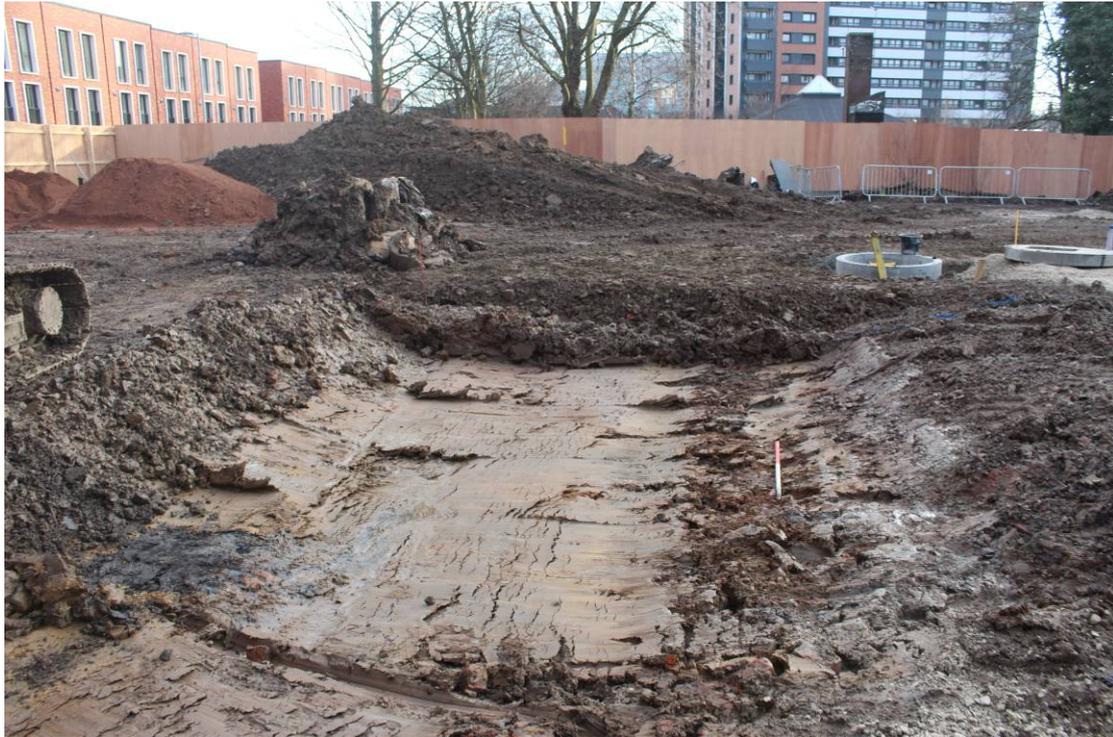
Plate 9: Trench C looking south-east

Trench C measured 10m x 4m and was located to the east of the southernmost terrace property on Oldfield Road. This area of the site had been subject to considerable disturbance during the recent groundwork. The trench was located in a low depression created by recent disturbance, filled with rainwater. The machining showed the base of the depression to be the natural boulder clay, a stiff light brown clay with greyish blue veining (*Fig 8, Plate 9*).

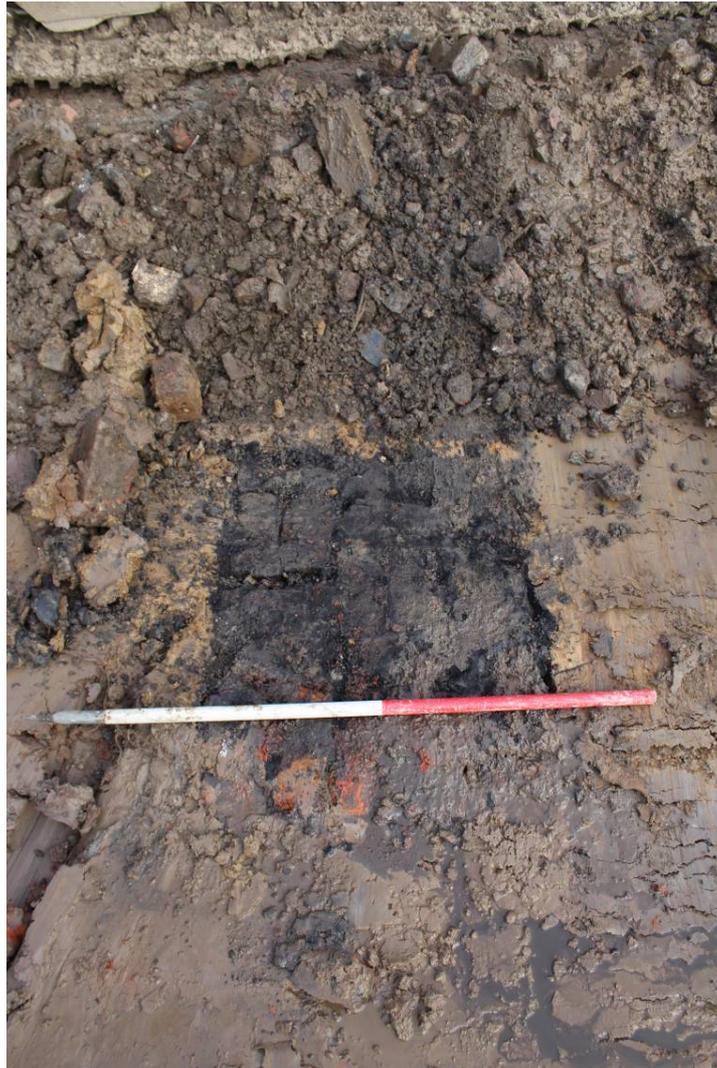
Plate 10: Brick pad 29, looking north-east

Two features were noted. The only structural evidence was a brick pad, **29**, rectangular in plan. The pad measured 0.65m x 0.85m and consisted of a single course of whole handmade bricks (*Plate 10*).

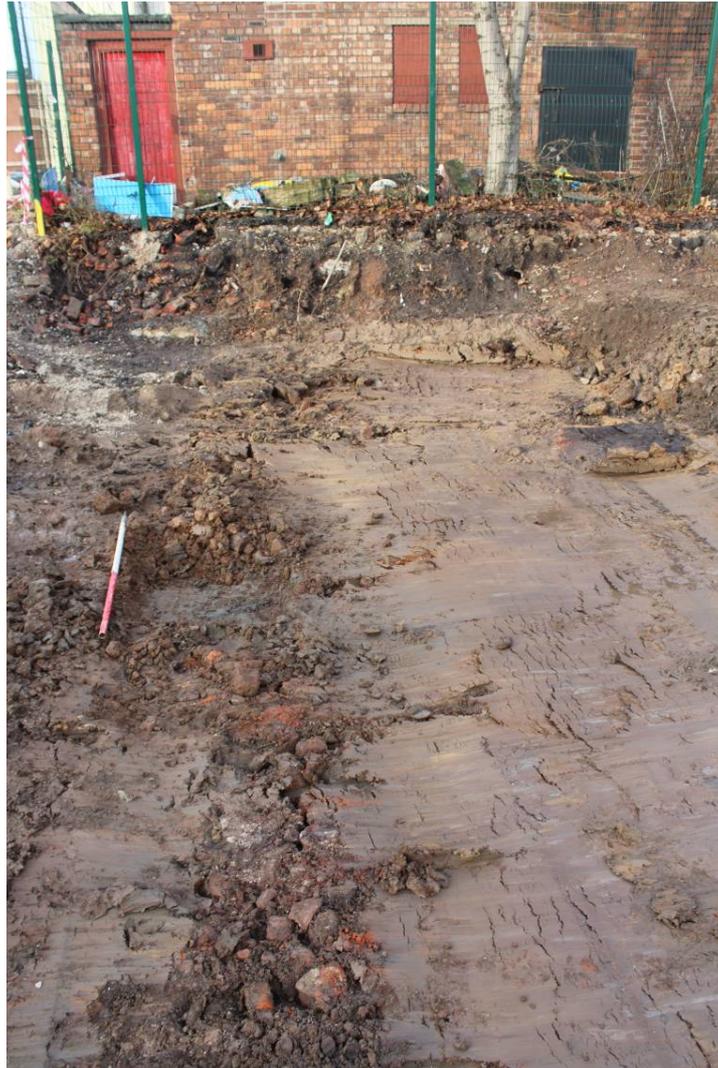
Plate 11: Hand dug slot across feature 30, looking north-west

A linear channel **30** ran east–west, severely truncated by recent activity. The channel ran along the southern edge of the trench, curving northwards at its western end. At the western extent, the channel survived to a width of 0.78m but at its southern end was denuded and survived to only 0.45m in width. It survived to a maximum depth of 0.35m. It had a primary fill of firm mid to light bluish grey clay with organic inclusions. The upper layer of fill was composed entirely of rubble, predominantly handmade brick. It may have been an infilled stream or drainage gully, backfilled with rubble, later masked during the development of the study area. A portion of the feature was excavated by hand to ascertain the depth of the fills (*Plate 11*). A machine sondage was also excavated across the feature down to natural clay.

The channel feature uncovered in trench C was inconclusive and ephemeral in nature. It may have been the channel for a former water course, the grey clay in its base suggesting that it was a water borne deposit. Its upper level had been purposely infilled during the 19th century suggesting that it was not particularly ancient. It appeared to be running from the rear of a former 19th century public house and may therefore have been a drain or water course associated with this.
