Archaeological Excavation and Historic Building Investigation

Local Crescent,
The Crescent,
Salford

Report No:
2019/25

Document Type: Archaeological Excavation and Historic Building Investigation Report

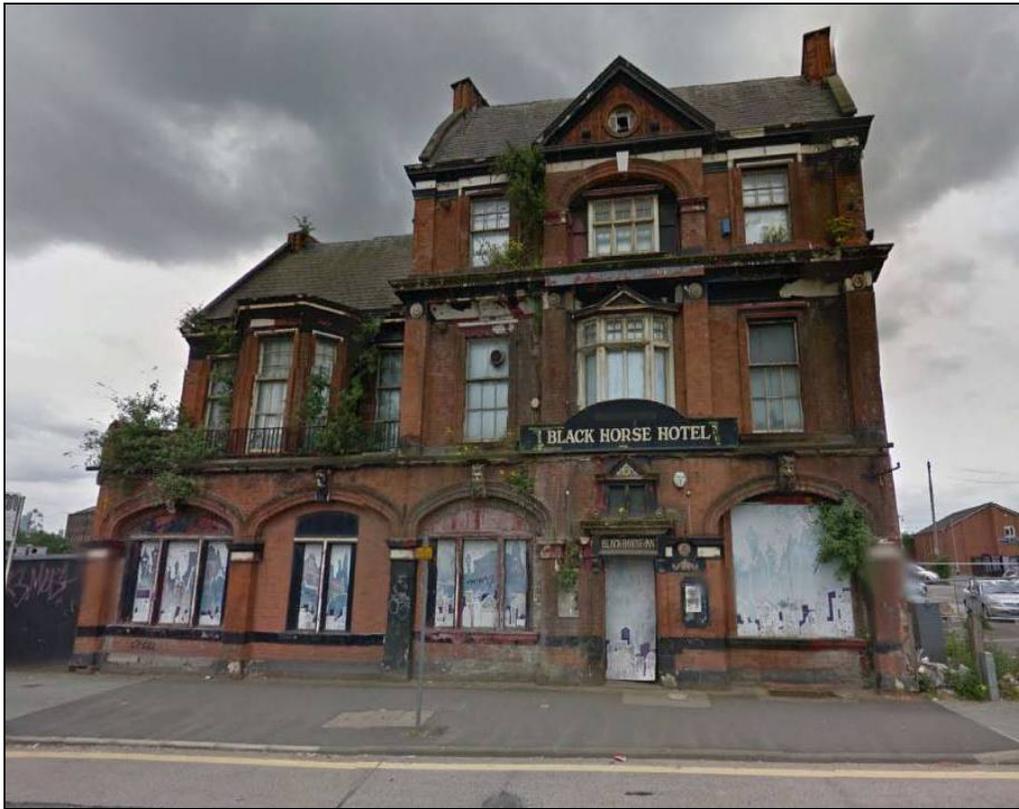
Plate 3: General view of the northern elevation

North elevation: the northern façade comprised five bays long which fronted The Crescent and afforded the main principle access into the building (Plate 3; Fig 2). The ground floor had four archways and the main doorway to the western end of the façade. Each archway had been formed from a three-pointed arched head that had been built from terracotta tiles forming a wave moulding. The keystone to each was a carved sandstone block that depicted Dionysus, a Satyr, a horse's head and a set of blacksmiths tools (Plates 4-7). The piers to the arches were built from brick with projecting pilasters, which had brick and sandstone capitals on each. Each arch contained a recessed window aperture that had brick square return end reveals, chamfered stone sills and three-pointed arched lintels. These housed three-light timber framed windows, which had been boarded up.

The second bay in from the eastern side had originally been an open arch, possible for cart access. This had been partially blocked up in the late 20th century with common brick. A window aperture had also been inserted at this time. It had brick square return end reveals, with a concrete lintel and a sandstone sill. A two-light, timber-framed window with a central timber mullion, was housed within this aperture. The main entrance into the building was located to the western side of this façade. The doorway had terracotta stepped reveals with a dressed sandstone tiered Jacobean-style pediment, which had the words 'BLACK·HORSE·INN' carved into the form. The timber-framed door was a later 20th-century addition (Plate 8).

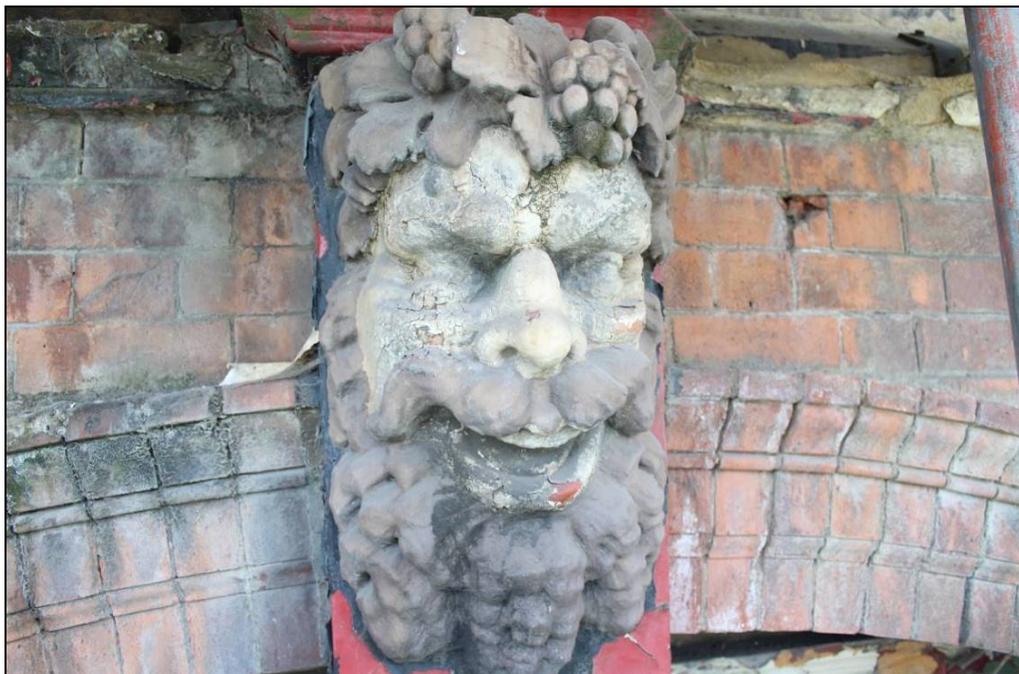
Plate 4: The carved keystone of the western archway depicting Dionysus

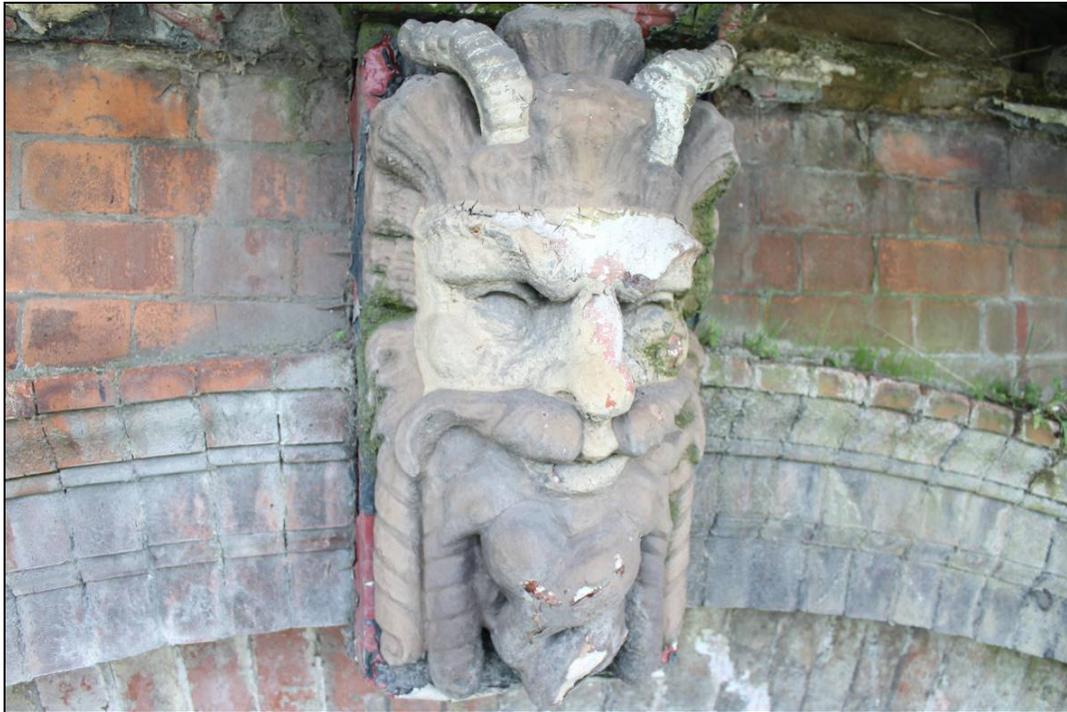
Plate 5: Detail of the Satyr carved keystone of the inner arch at the western end

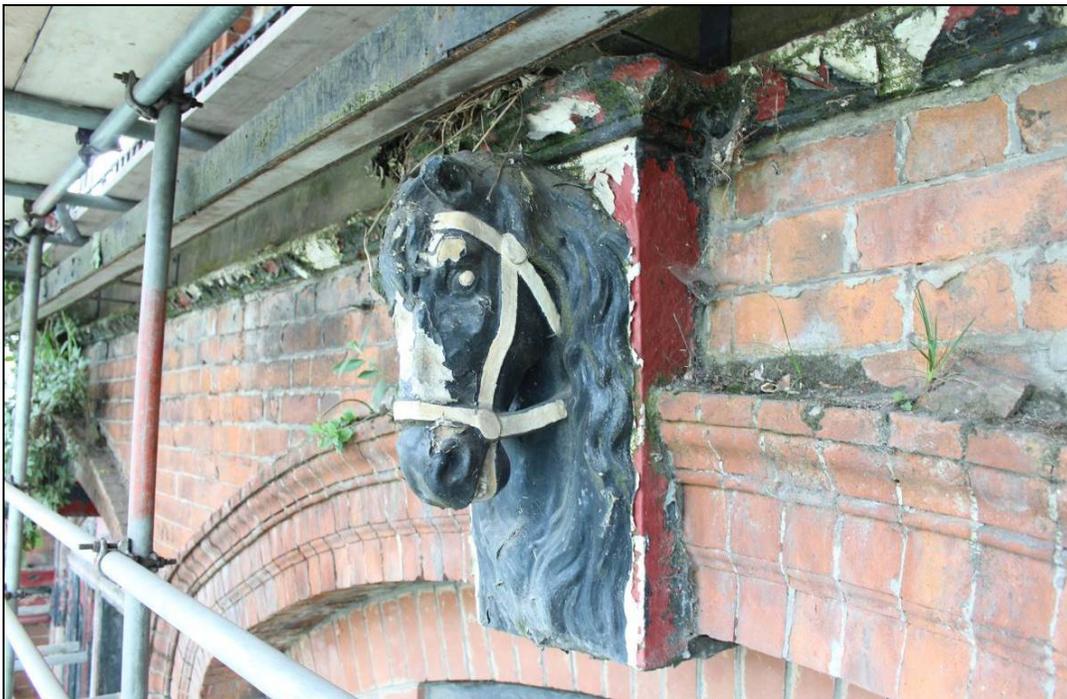
Plate 6: The horse's head carved keystone at the eastern end

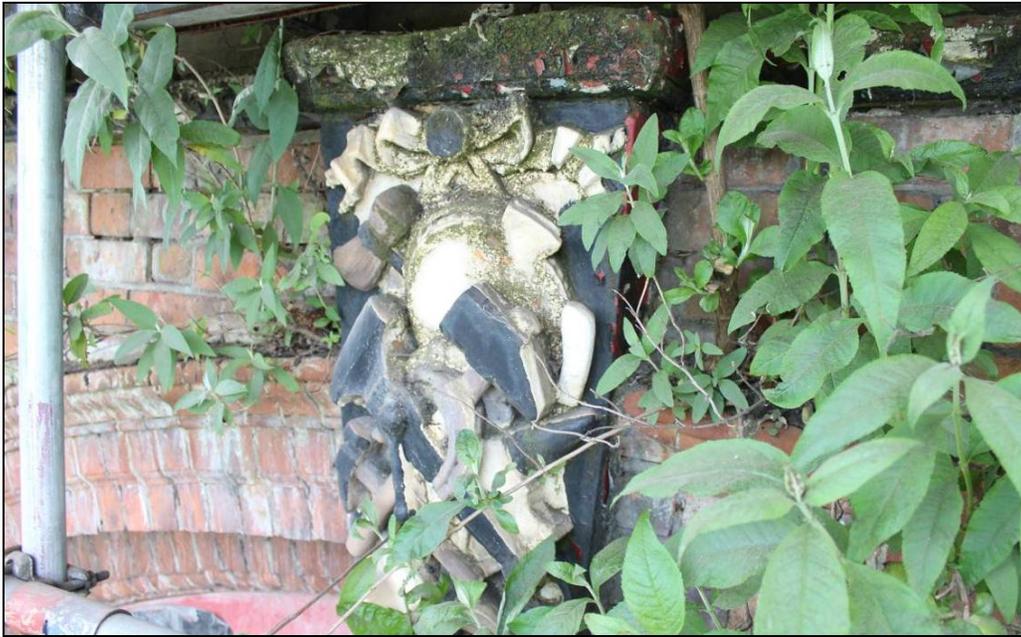
Plate 7: Detail of the blacksmiths tools carving on the eastern keystone

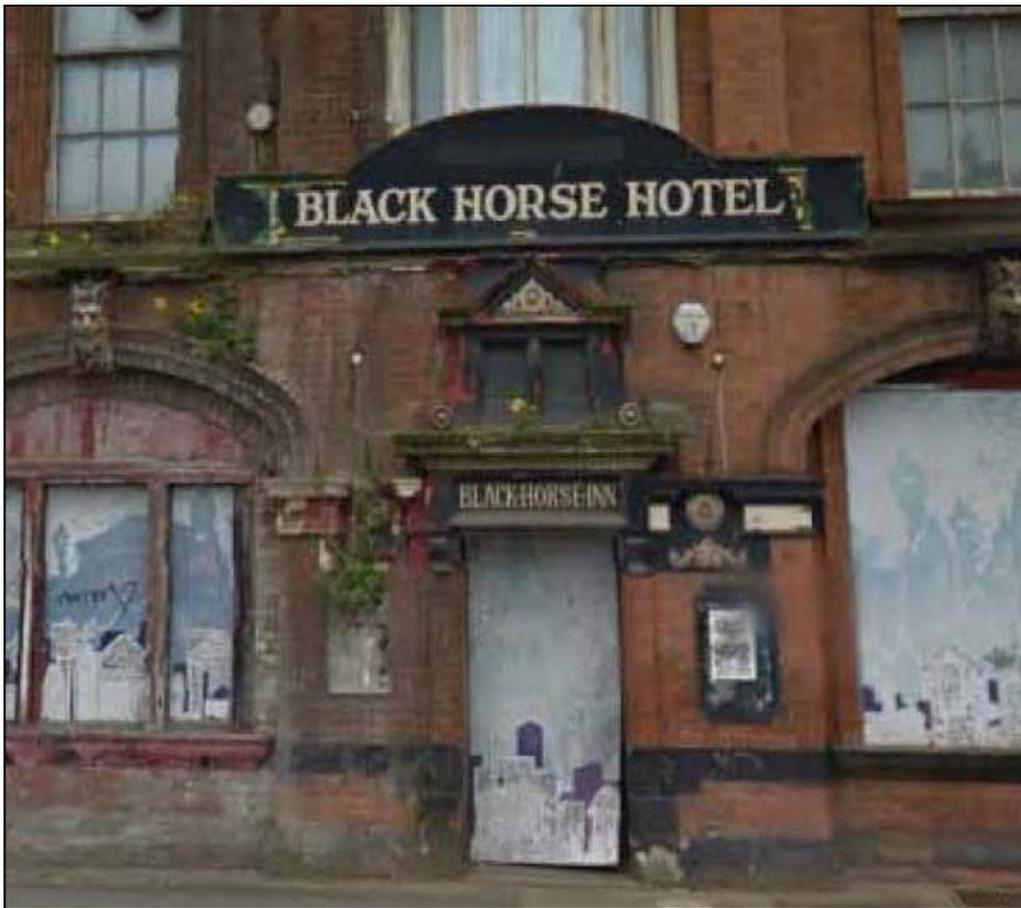
Plate 8: The main entrance into the hotel, fronting The Crescent

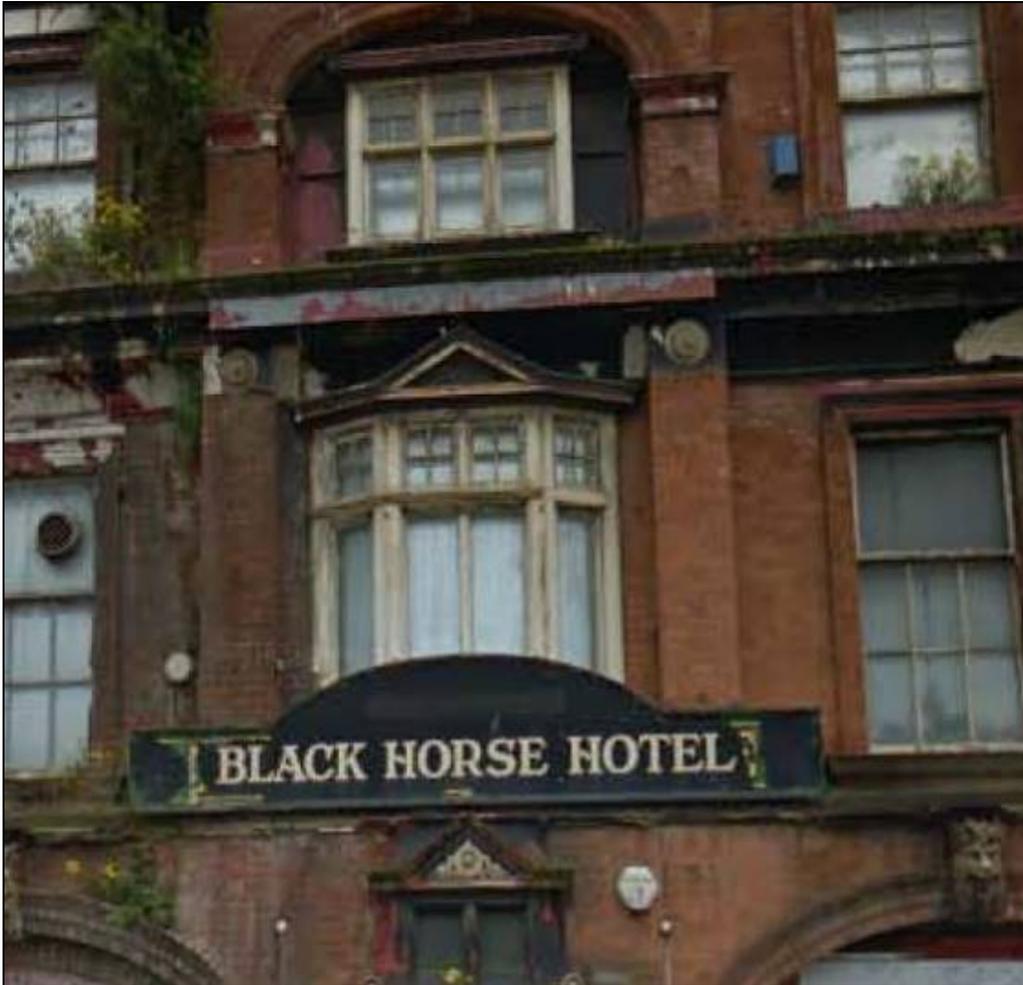
At first-floor level, a canted oriel window of stepped sandstone reveals with sandstone mullions was situated in the second bay from the western end (Plate 9). This was located between two half projecting pilasters which had flush sandstone capitals that had a terracotta flower at their centre. This window was flanked by two window apertures that had wave-moulded terracotta reveals and lintels with projecting chamfered sandstone sills. Each housed a timber-framed sash window that was one over six-lights with a bottom opening sash (Plate 9).

Plate 9: The canted oriel window on the first floor

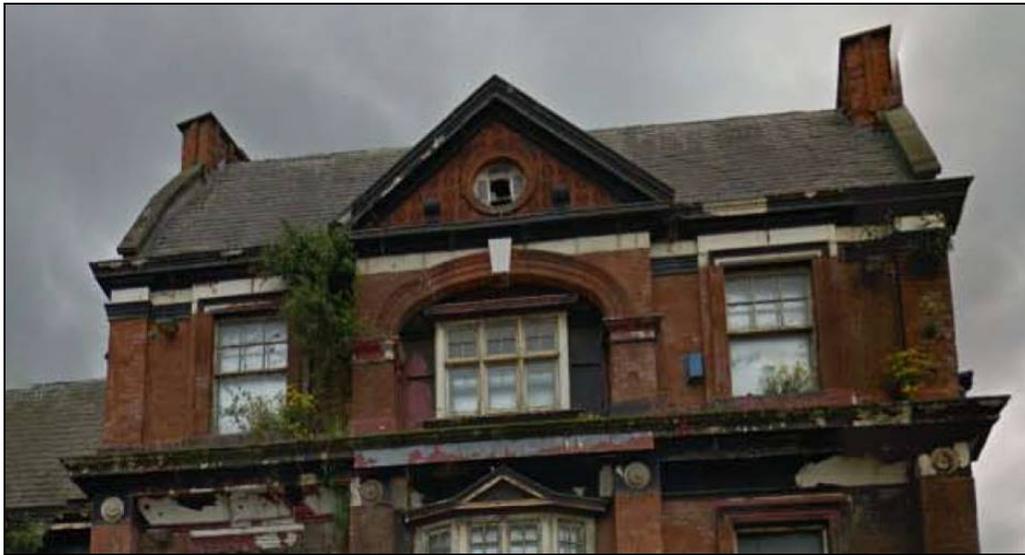
The second-floor central aperture on the western side was recessed in a three-point arch with terracotta wave moulding, with a white painted sandstone keystone. This was supported by two projecting pilasters that had plain capitals (Plate 11). The aperture had brick square return end reveals, a protruding brick lintel and a chamfered sandstone sill. This housed a three over three timber-framed mullion and transom window, which was also flanked by two recessed apertures. These had brick wave-moulded reveals with chamfered sandstone lintels and sills. Both contained a six over one light timber-framed sash window with a bottom sash opening (Plate 11).

A gabled dormer was located at the centre of the western roof that had a circular window above the eaves. The gable end had decorative terracotta tiles that were recessed between a protruding sandstone stringcourse and the timber verge. The window aperture had a wave-moulded terracotta reveal, which housed a five-light, circular, timber-framed window (Plate 11).

Plate 11: General View of the second floor at the western end of the northern façade

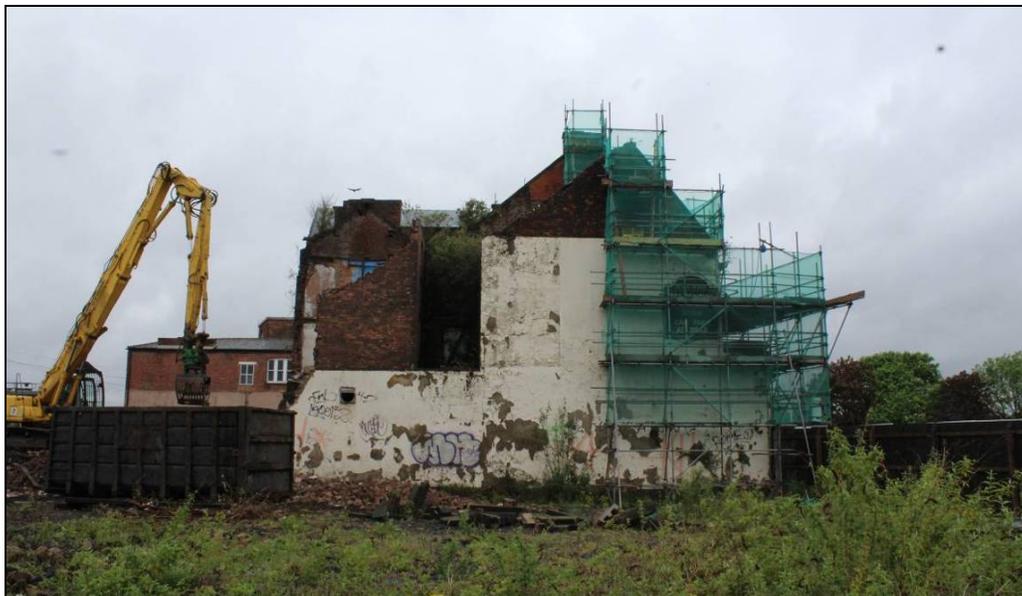
Plate 12: General view of the eastern elevation

The ground floor of the gable end had also been painted white, while the upper floors had been left bare. The roof had a sandstone verge that was stepped at the northern end.

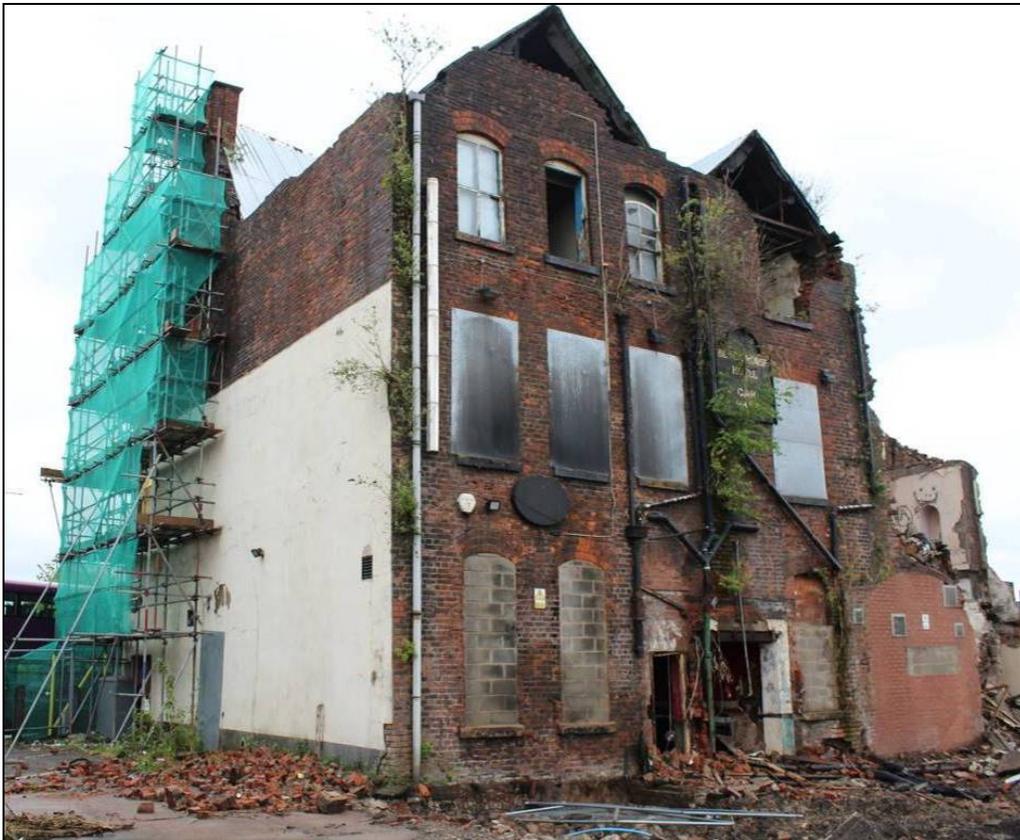
Plate 13: General view of the southern façade

Southern elevation: two gable ends were located at the western side of this elevation, while the eastern end had the side wall of the southern gable end on the eastern elevation (Plate 13; Fig 4). Each element of this façade comprised hand-made bricks laid in Flemish bond, with a replaced modern roof along with steel trusses. The ground floor of the two gables at the western end of the property comprised three window apertures and two doorways. The window apertures had a three-course Rowlock lintel, with brick square return end reveals and sand stone sills. Each had been recently blocked-up using modern concrete blocks.

At the centre of the two gables were two doorways that had been inserted into two earlier apertures. The western doorway had brick square return end reveals with a timber lintel (Plate 14). The earlier window aperture had a three-course Rowlock arched lintel and square return end reveals. This had later been blocked-up using machine-made bricks that were bonded with cement mortar (Plate 14). The second doorway, to the eastern side, had a rolled steel lintel which spanned the 2m opening. This also had square return end reveals with a concrete threshold (Plate 15). This would have provided access to a small single-storey lean-to that had been demolished prior to the commencement of the archaeological survey.

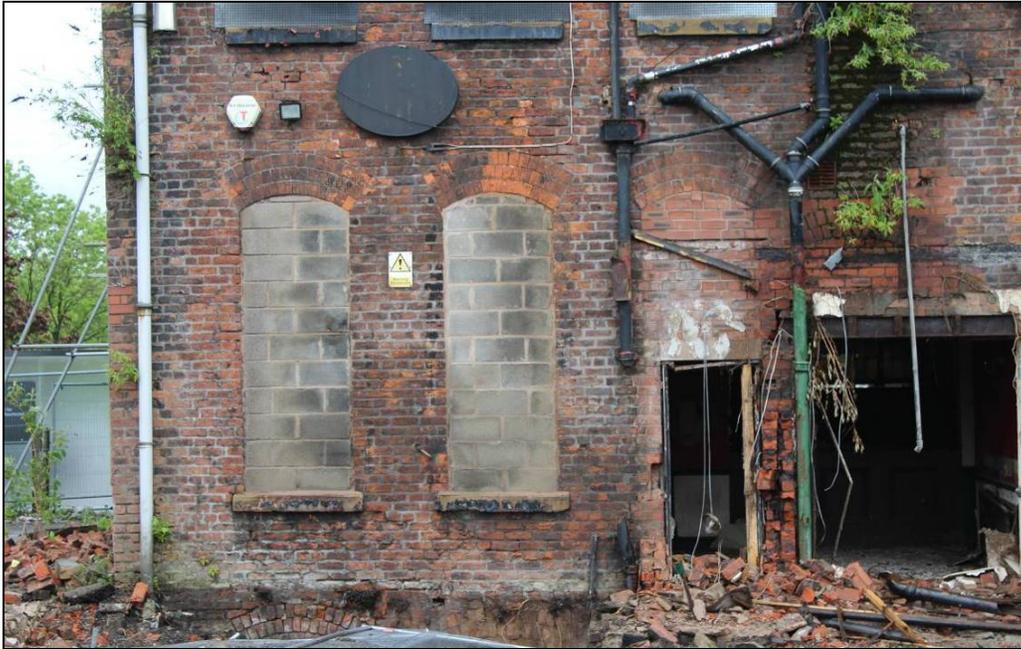
Plate 14: Detail of the ground floor of the southern façade

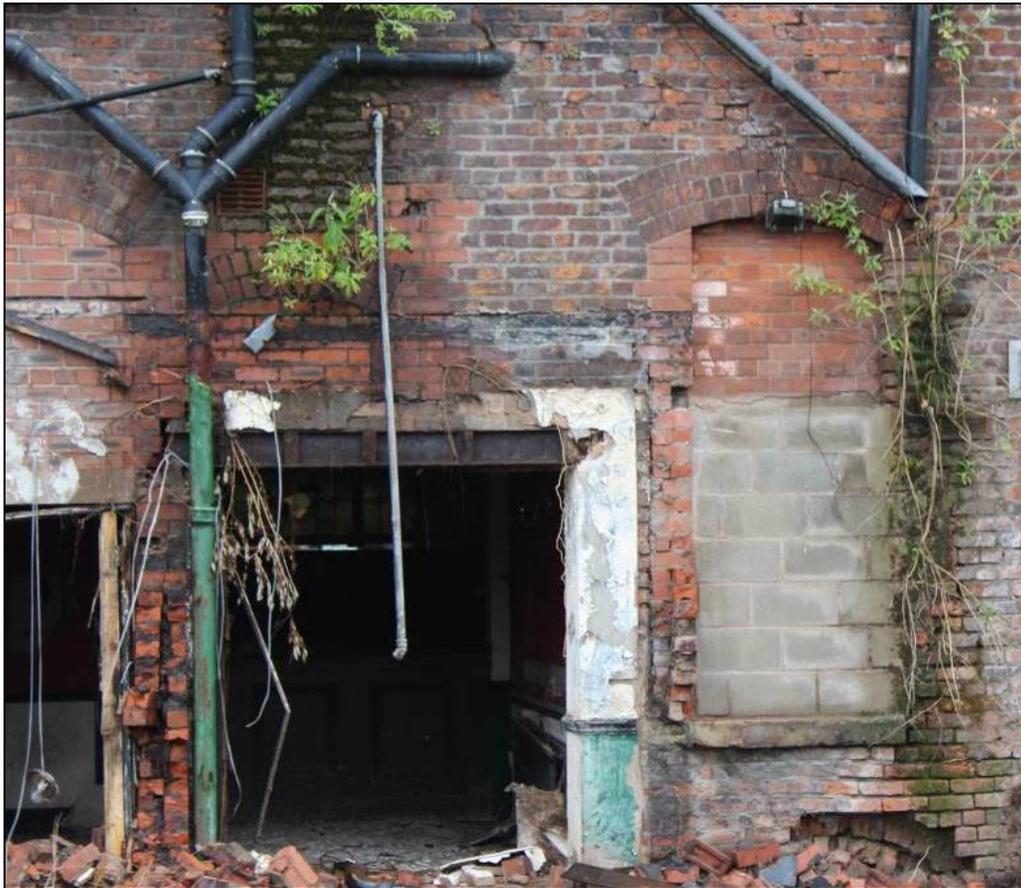
Plate 15: Detail of the later doorway at the centre of the southern facade

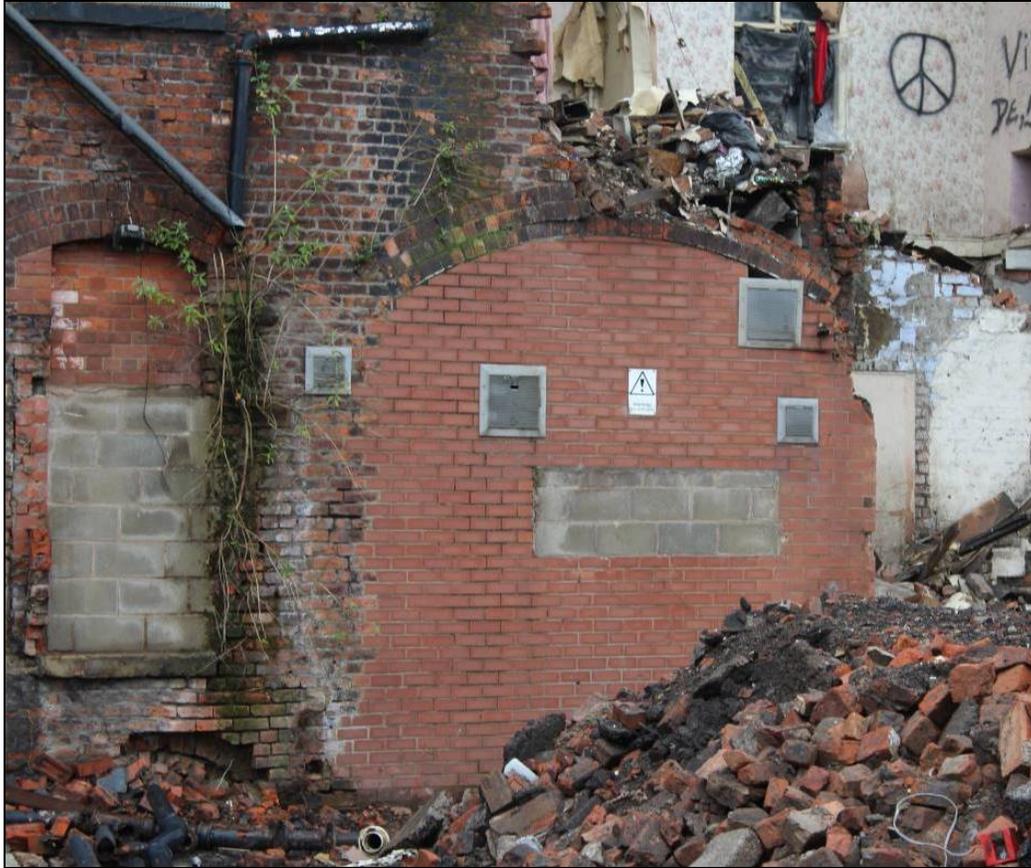
Plate 16: The blocked-up archway at the eastern end of the southern façade

The southern wall of the eastern gable contained a large, three-course, Rowlock archway with brick square return end reveals. This had later been blocked-up with modern common brick that had been bonded using cement mortar (Plate 16).

The demolition of the large three-course Rowlock arch on the southern elevation should that it had been constructed from machine-made frogged brick (Plate 19). The archway had been heavily modernised internally. A modern timber-framed and plaster board ceiling had been built at ground-floor level. This acted as the ceiling for a set of modern partitioned toilet cubicles (Plate 20). Above this ceiling was a galvanised steel ducting that was used for the air-conditioning for the pub (Plate 20).

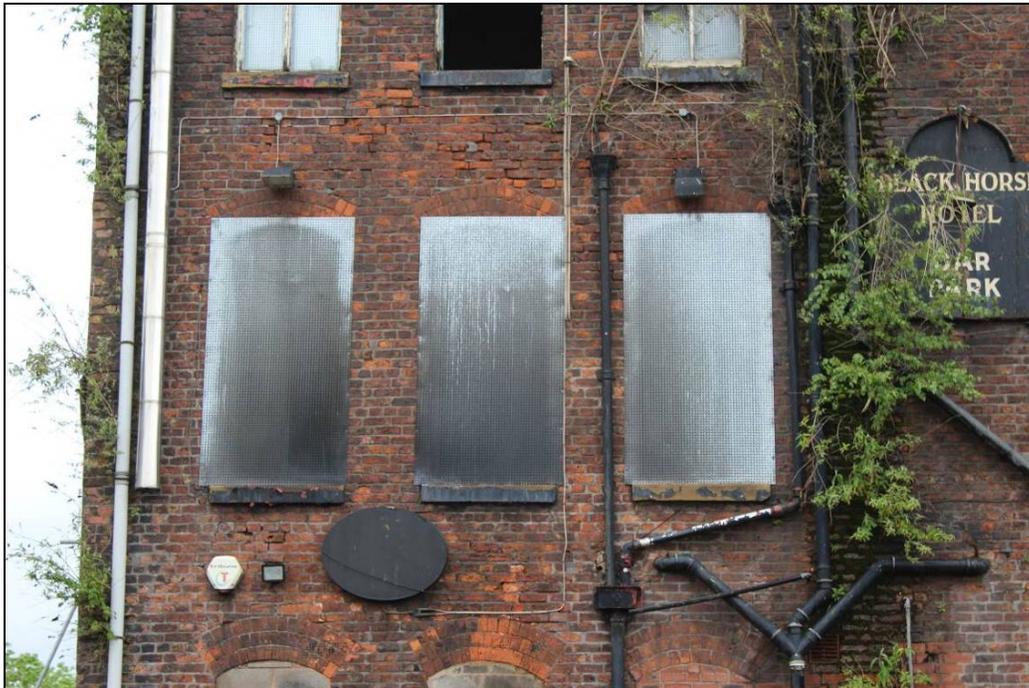
The upper floors of the southern façade had four window apertures to each floor within the two-gables, while the eastern side had a single window to each floor. Each aperture had a three-course Rowlock arched lintel, brick square return end reveals with chamfered stone sills. The first-floor windows had been boarded-up using steel mesh, but those on the second floor were observed. These were timber-framed two over two-light double-sash windows (Plates 17 and 18).

Plate 17: The blocked-up window apertures on the first floor

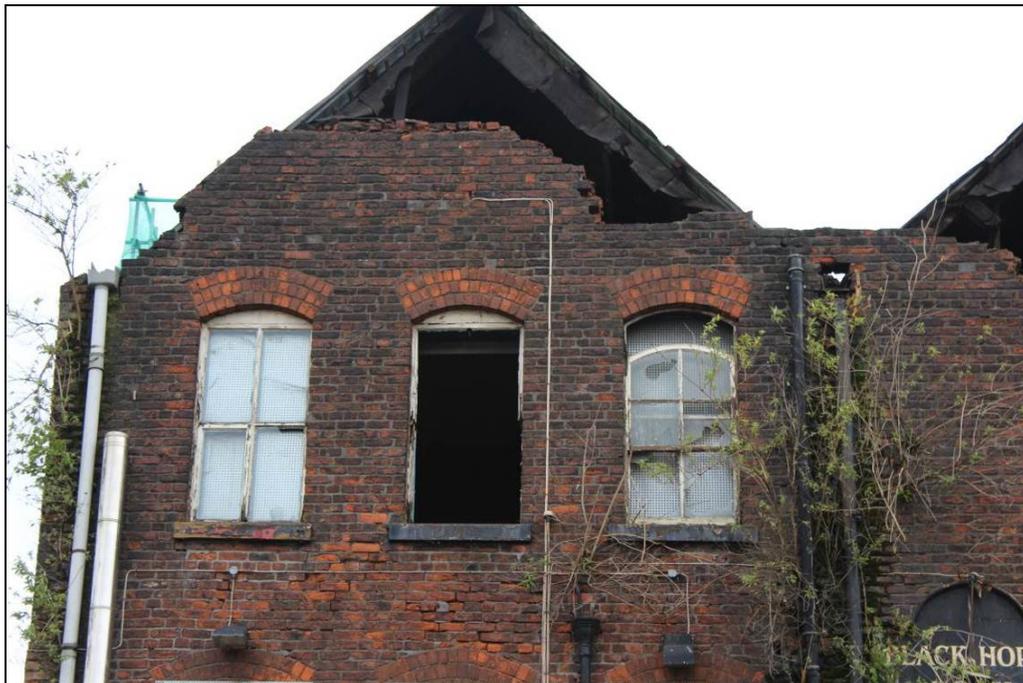
Plate 18: Detail of the second-floor window apertures

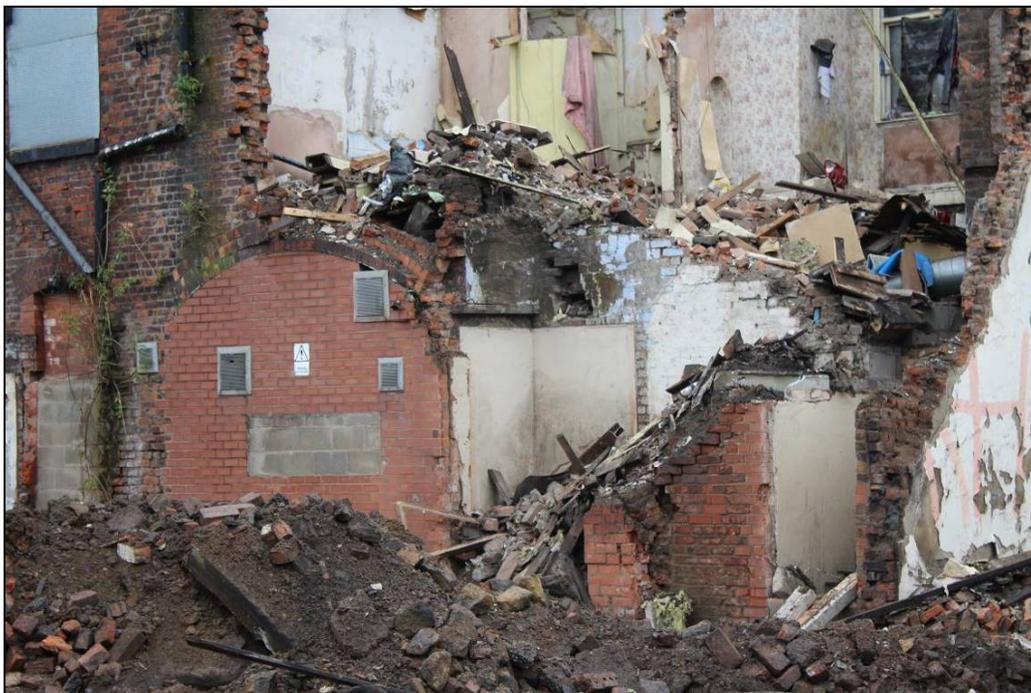
Plate B17: Detail of the blocked-up archway in the southern façade

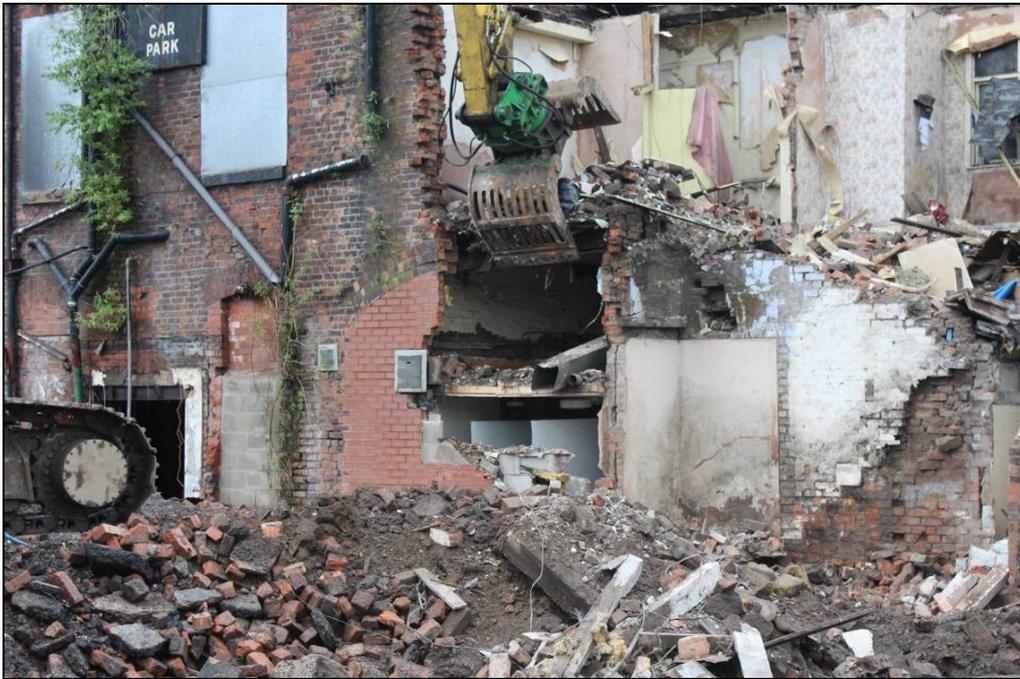
Plate 20: Detail of the demolition of the blocked-up archway in the southern façade

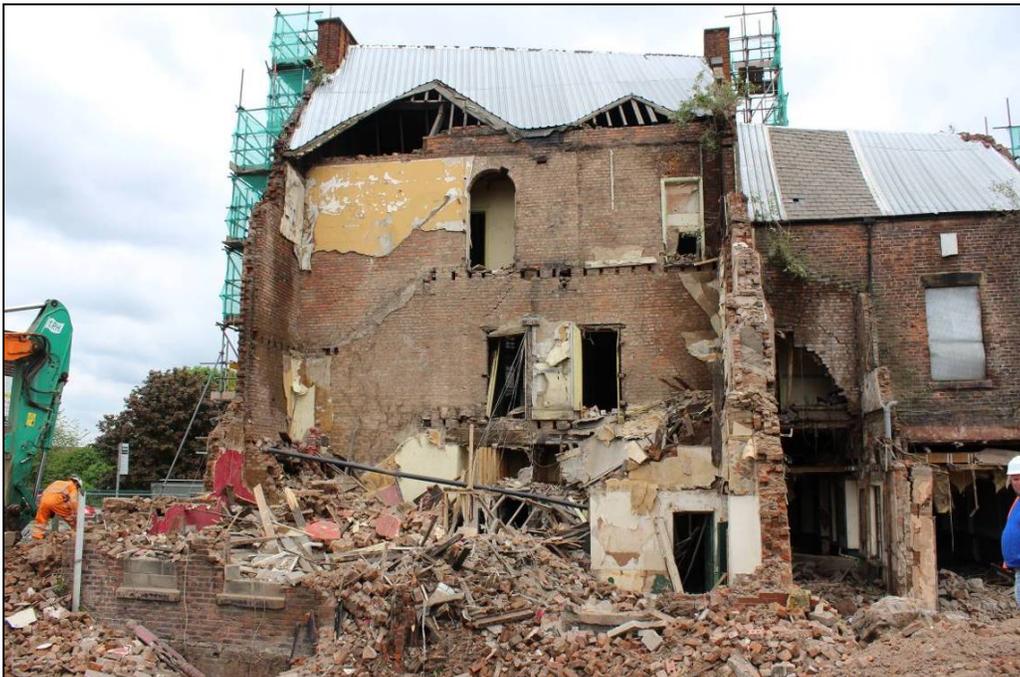
The upper floors of the property had also been modernised with the walls being covered in wallpaper, whilst the ceilings had been covered in plaster board. The internal doorways had segmental arched lintels with square brick return end reveals. Each aperture had moulded side and head casements, while the doors had been removed previously (Plate 21).

Plate 21: Detail of the interior of the western side of the building during demolition

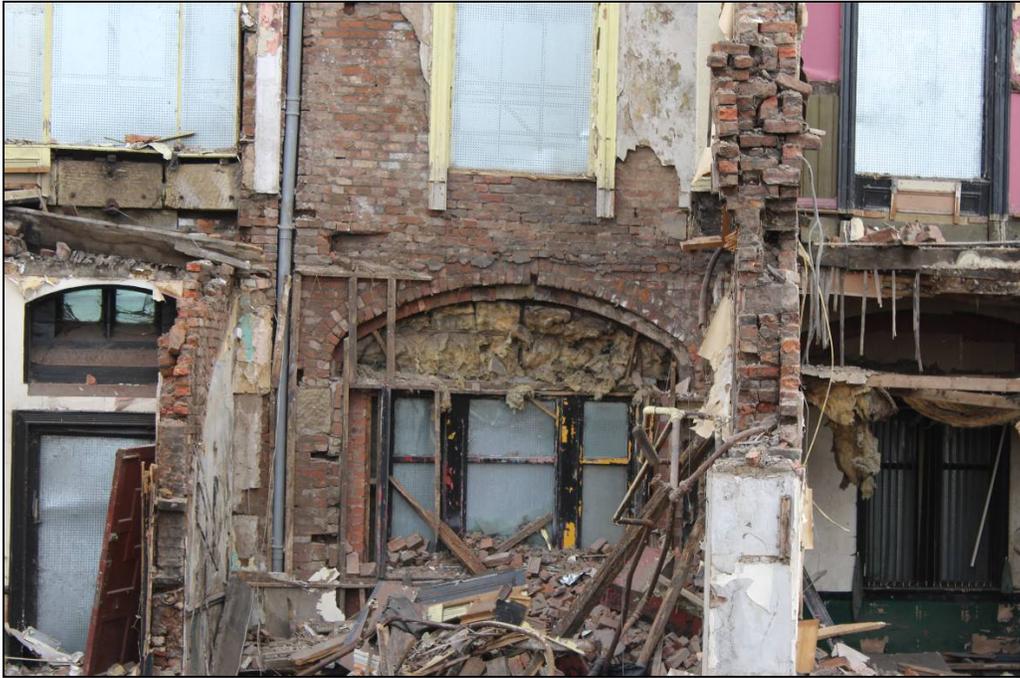
The large archway would have originally continued through the building, where a second external archway was located within the northern elevation. This archway had a three-course Rowlock arched lintel that was supported on flush sandstone corbels. The square return end reveals were built using hand-made brick that had been bonded using lime mortar. As with the southern arch, it had been partially blocked-up using modern common brick with a six-light timber-framed window in the centre. Within the arch, Rockwool insulation had been used from the springing point to the crown of the arch (Plate B20).

Plate 22: The internal view of the blocked-up archway in the northern elevation

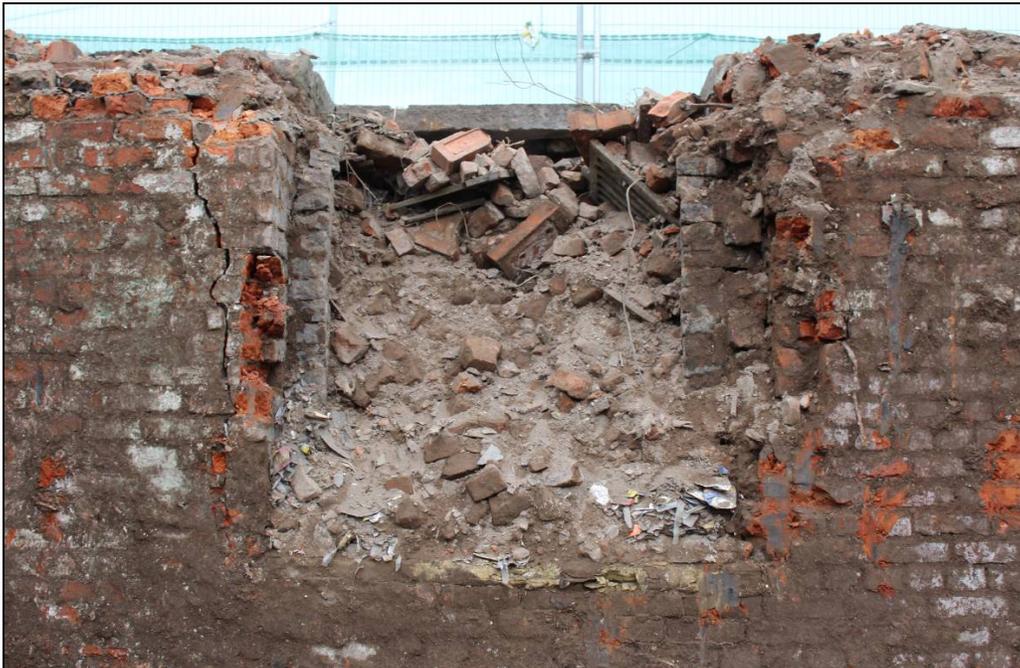
The hotel had a basement that was also observed during the watching brief. Two cellar lights flanked a doorway within the northern wall. Each aperture had brick square return end reveals with sandstone sills. Both had been infilled with brick rubble that had in turn supported the modern pavement above (Plate 23).

Plate 23: Blocked cellar light within the northern elevation

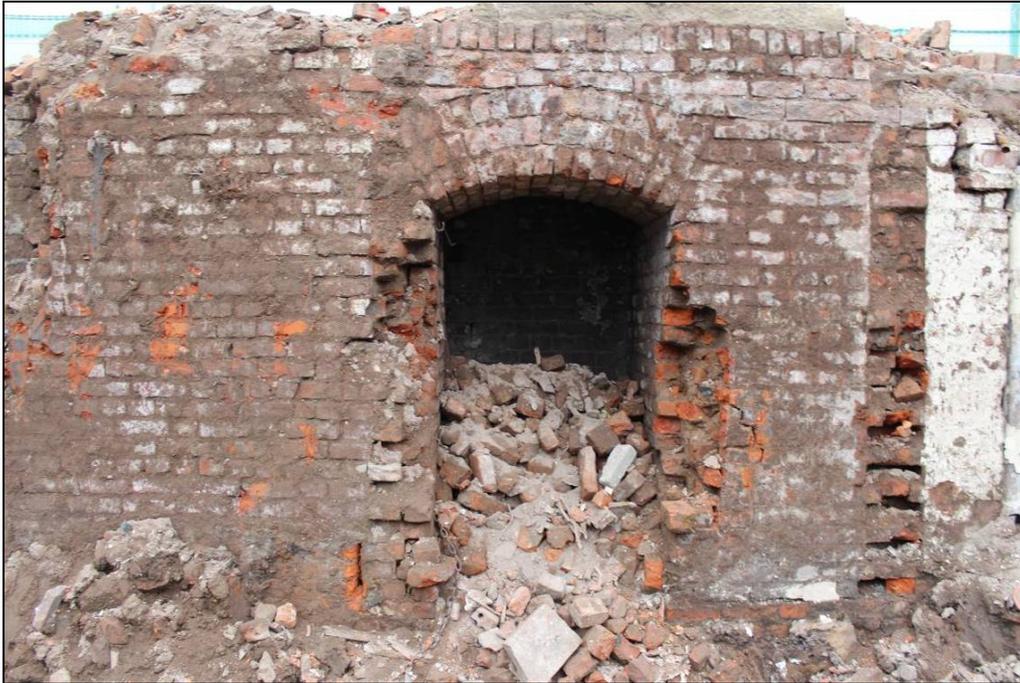
The small doorway, which would have led down from street level, had a brick three-course Rowlock arched ceiling with square return end reveals. This had also been infilled with rubble so was not possible to see if any of the stone stairs had been retained (Plates 24 and 25).

Plate 24: The blocked-up doorway within the cellar's northern wall

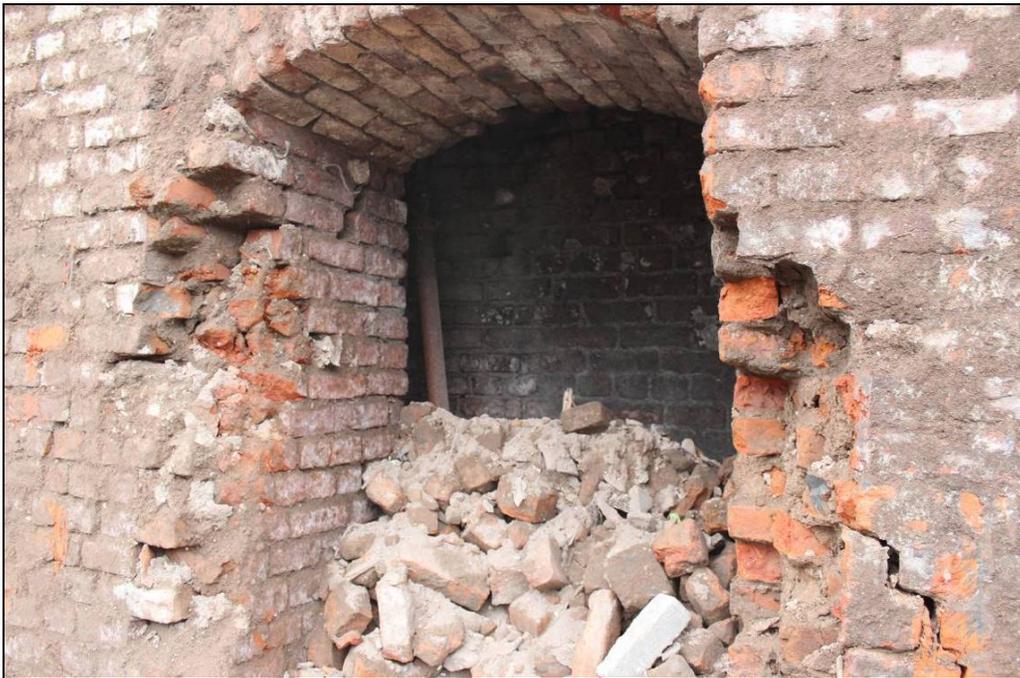
Plate 25: Detail of the blocked door and passageway leading up to street level within the northern wall

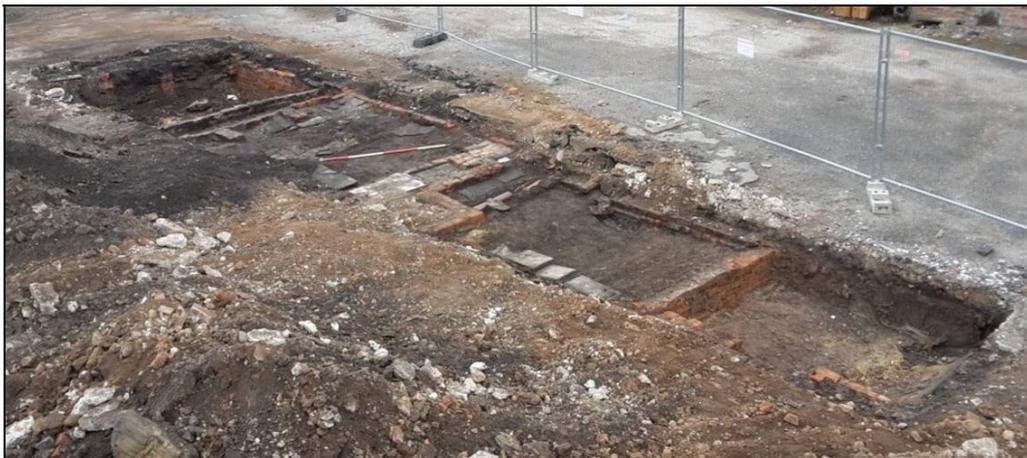
Trench 2 measured 15 x 2m, and was located in the west part of the site, along a north/south alignment, targeting a single-depth dwelling, to the south of Turner's Yard, and two properties along Beevor's Buildings, depicted on Bancks & Co's map of 1831 (Fig 8). Archaeological remains were encountered almost immediately, surviving at a depth of 0.15m to 0.45m below the modern ground surface. The partial remains of at least three buildings were uncovered along with brick and flagstone floors, and the base of at least one fireplace (Plate 26). The abundance of well-preserved structural remains resulted in this part of the site being subject to more detailed excavation subsequently (Area 1). The remains exposed in Trench 2 are described in detail in *Section 7.2*, below.

Plate 26: General view across Trench 2

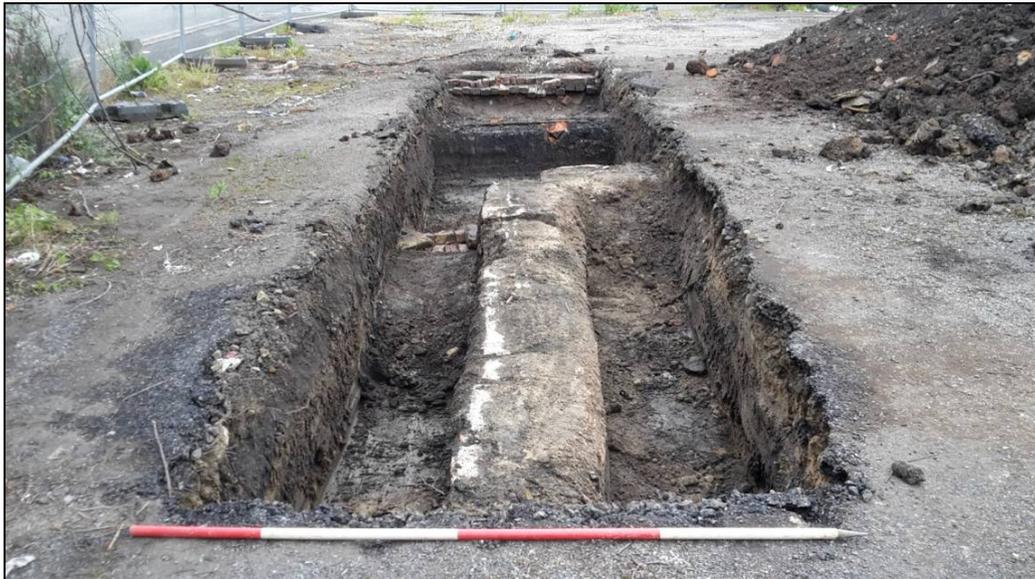
Trench 3, measuring 10 x 2m, was excavated along the south-west boundary of the site, along an east to west alignment, to a maximum depth of 0.75m. The trench targeted the remains of a property along Hulme Street and a small garden plot, depicted on Bancks & Co's map of 1831 (Fig 8). The trench contained a culvert (1001), composed of hand-made bricks and a stone capping, which had been truncated by a large L-shaped concrete block, measuring 5m long by 0.80m wide (Plate 27). To the west, a modern service pipe, no longer in use, spanned the width of the trench, beyond which lay a brick wall (1002), surviving to a height of two courses. The wall was formed by a double skin of hand-made bricks bonded with lime mortar and an additional double skin of machine-made bricks bonded with black mortar (Plate 28).

Plate 27: View of Trench 3 showing a modern concrete block and stone-capped culvert 1001

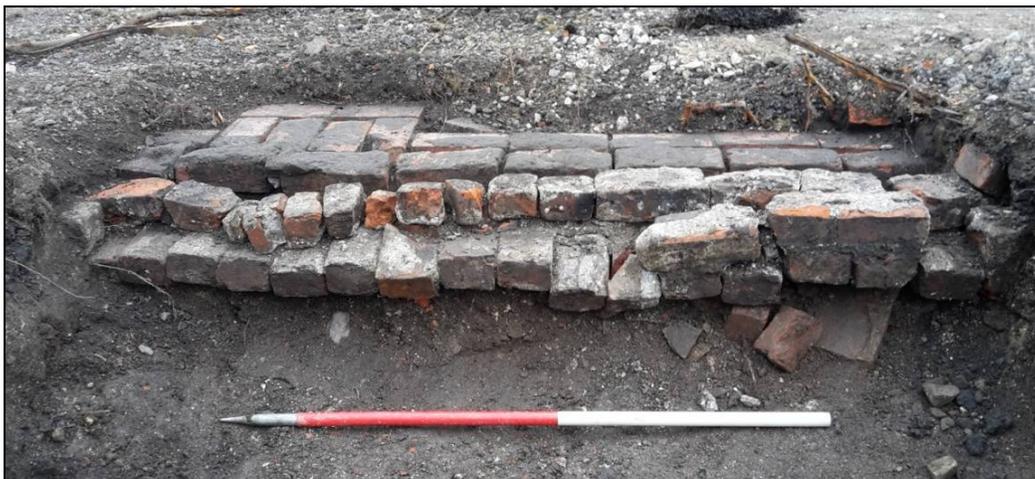
Plate 28: Brick wall 1002 formed of both hand-made and machine-made bricks

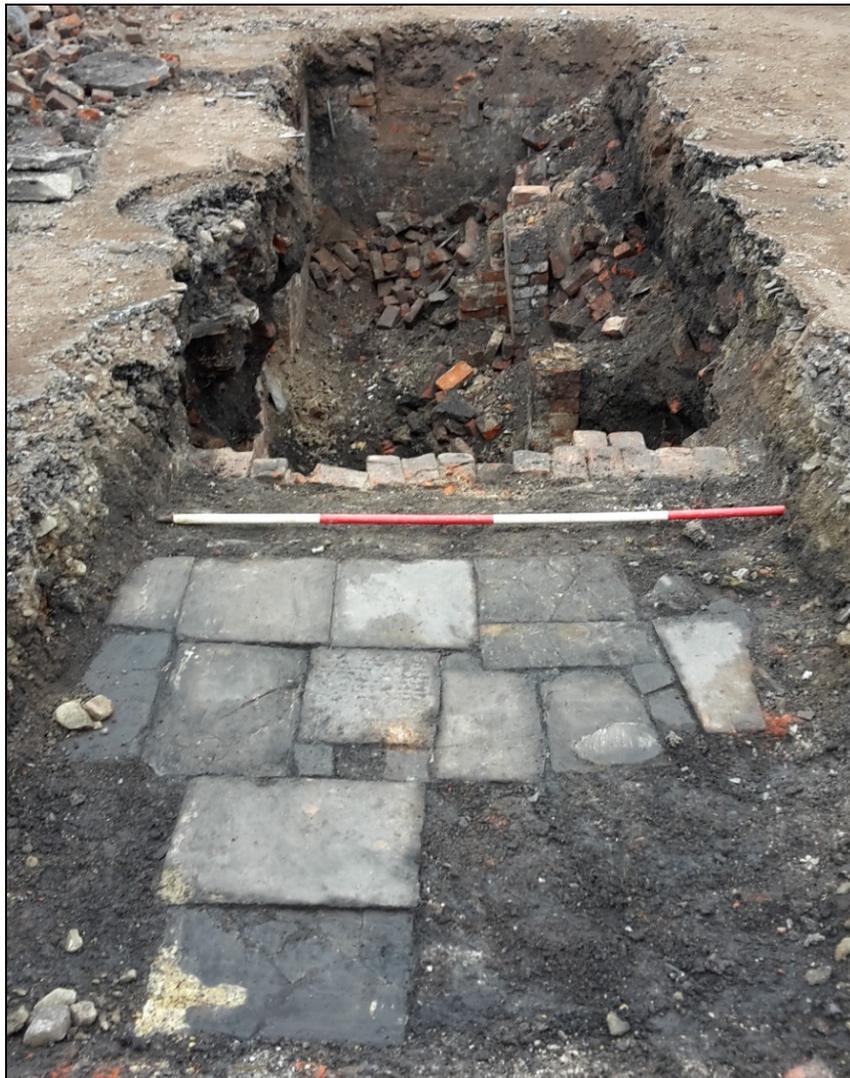
Trench 4 was situated to the north of Trench 3, measured 10 x 2m and was excavated to a maximum depth of 1.85m. The trench overlay the plan of a large-sized property and front garden that lined Hulme Street, depicted on Bancks & Co's map of 1831 (Fig 8). Excavation revealed a flagstone surface (1003) in the southern part of the trench, likely to have formed a front yard, which was positioned directly outside the building (Plate 29). A wall (1004) of hand-made bricks that survived to a height of 1.8m and spanned the width of the trench, demarcated the front, southern, wall of the house. The deep foundations of the wall suggest that the house was cellared. Within the cellar were two brick columns (1005), each measuring 0.24 x 0.24 x 1.60m. Along the western edge of the trench were the remains of hand-made brick wall 1006, measuring approximately 5m long and surviving to a maximum height of 1.60m. An opening evident in the fabric of the wall suggested that there had been a doorway leading to another room within the cellar (Plate 30). A recent brick buttress (1007) was also located in the western edge of the trench, comprising machine-made bricks bonded with sandy cement, measuring 0.48m wide and surviving to a height of 1.7m.

Plate 29: Trench 4 showing yard surface 1003 and brick-built buttresses 1005

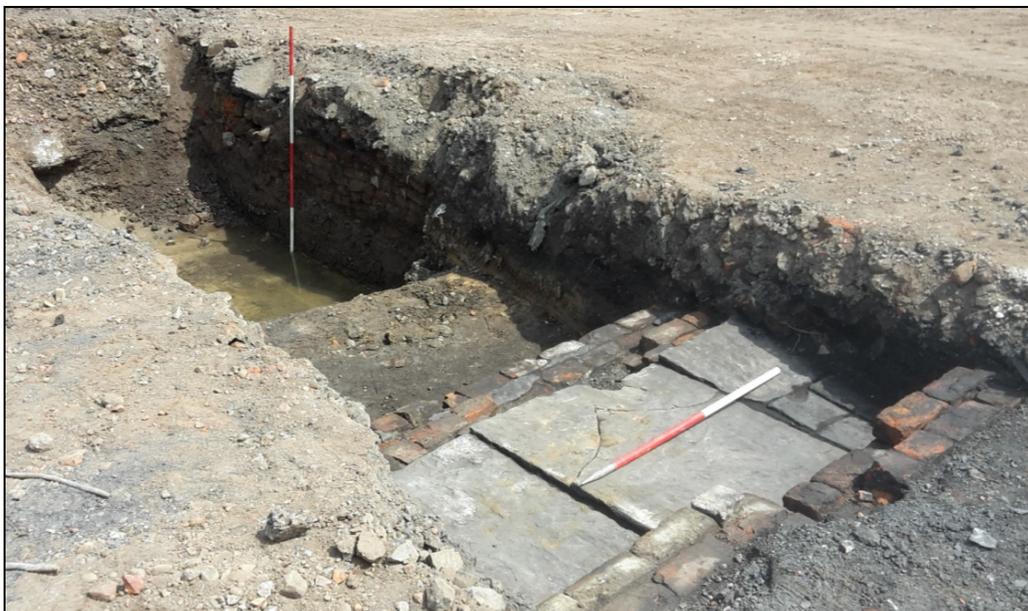
Plate 31: Trench 5 showing a passage formed by walls 1008 and 1009, and surface 1010

In the northern part of Trench 5, subsoil 1012, comprising dark brown silty clay, was exposed. Beneath 1012 were natural deposits of orange clay 1013 located approximately 1.55m below the modern ground surface. In the eastern edge of the trench were the remains of a poorly built wall (1011), measuring 3.5m in length and surviving to a height of 0.48m (Plate 31).
