Archaeological Excavation and Historic Building Investigation

Local Crescent,
The Crescent,
Salford

Report No:
2019/25

Document Type: Archaeological Excavation and Historic Building Investigation Report

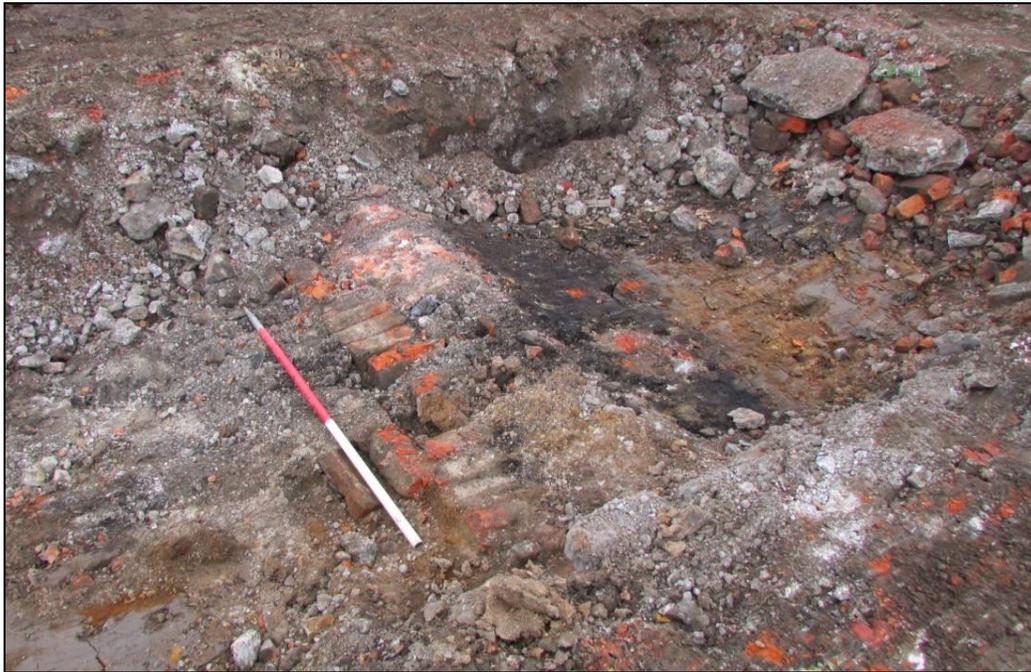
Plate 32: Wall 1014 exposed in Trench 6

The full extent of **Trench 6** was not exposed due to the presence of a huge pile of demolition rubble situated in the north-west corner of the site. Therefore, Trench 6 was excavated to a reduced length of 7.5 x 2m, and to a depth of 0.45m. Trench 6 had originally been placed over back-to-back dwellings situated on Crescent Court. The remains of a single wall 1014 were exposed in the western part of the trench, surviving at foundation level and measuring 0.23m wide (Plate 32).

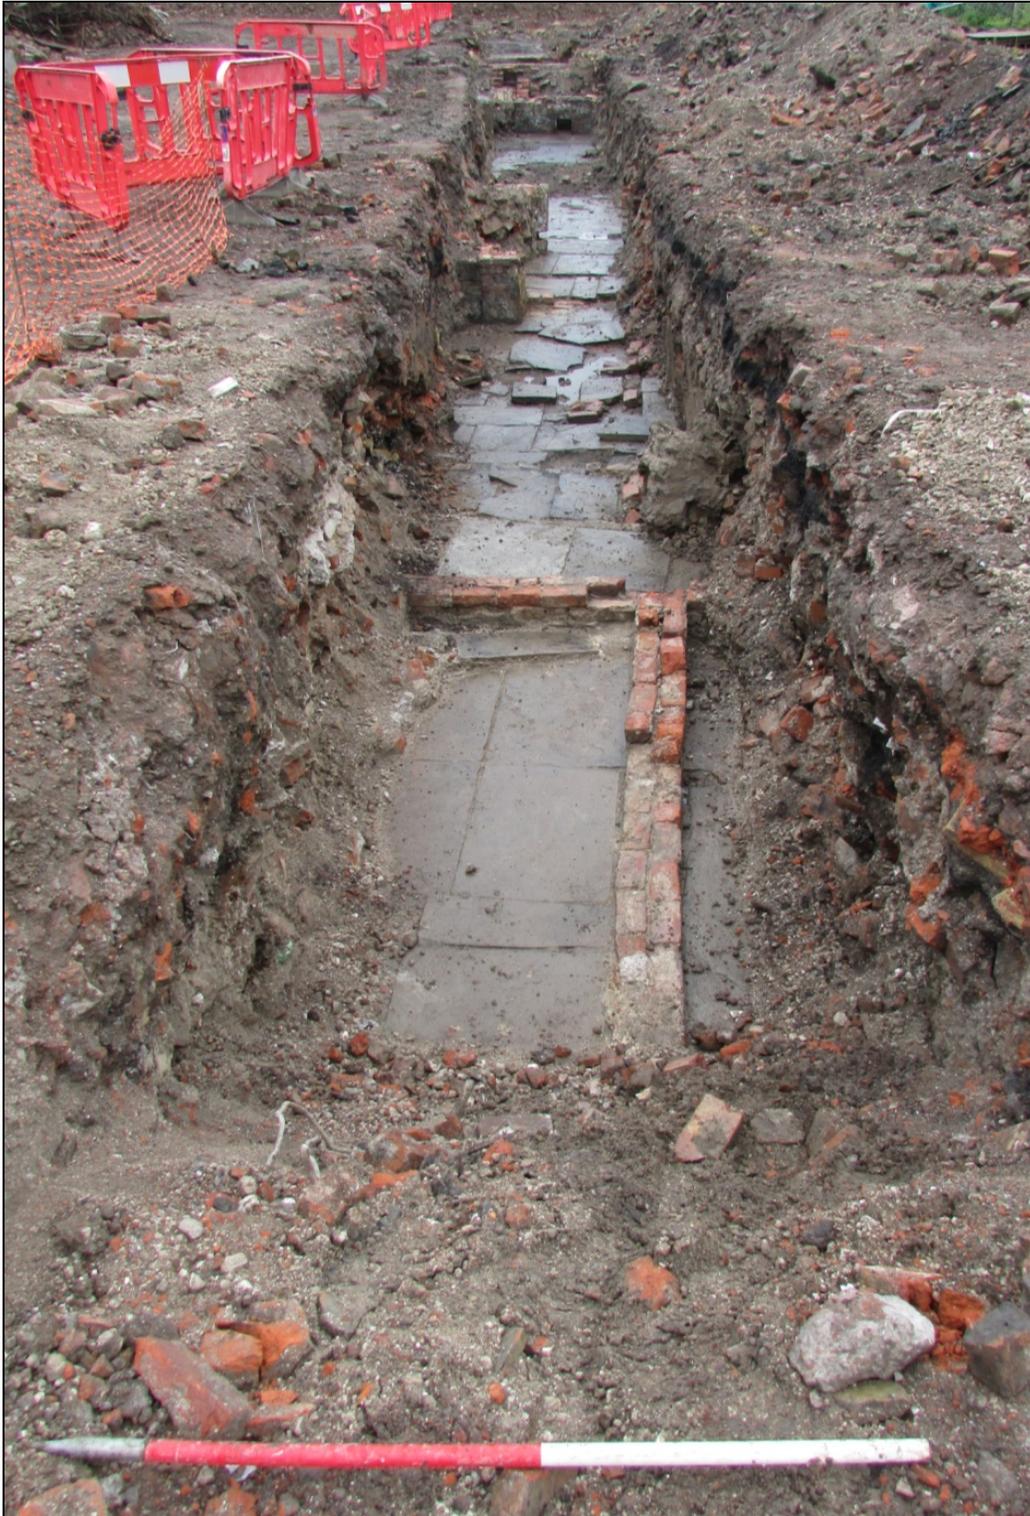
Trench 7 was situated in the northern part of the site, along an east/west alignment, and targeted the remains of large villa properties that lined The Crescent, first depicted on Green's map of 1787-94 (Fig 7). Trench 7 measured 60 x 2m, and was excavated to a depth of 1.2m. Significant structural remains were exposed throughout the length of the trench, comprising numerous brick walls, flagstone surfaces and fireplaces (Plate 33). The abundance of well-preserved structural remains resulted in this part of the site being subject to more detailed excavation subsequently (Area 2). The excavated remains are described in detail in *Section 7.3*, below.

Plate 33: Trench 7 showing extensive archaeological remains, facing west

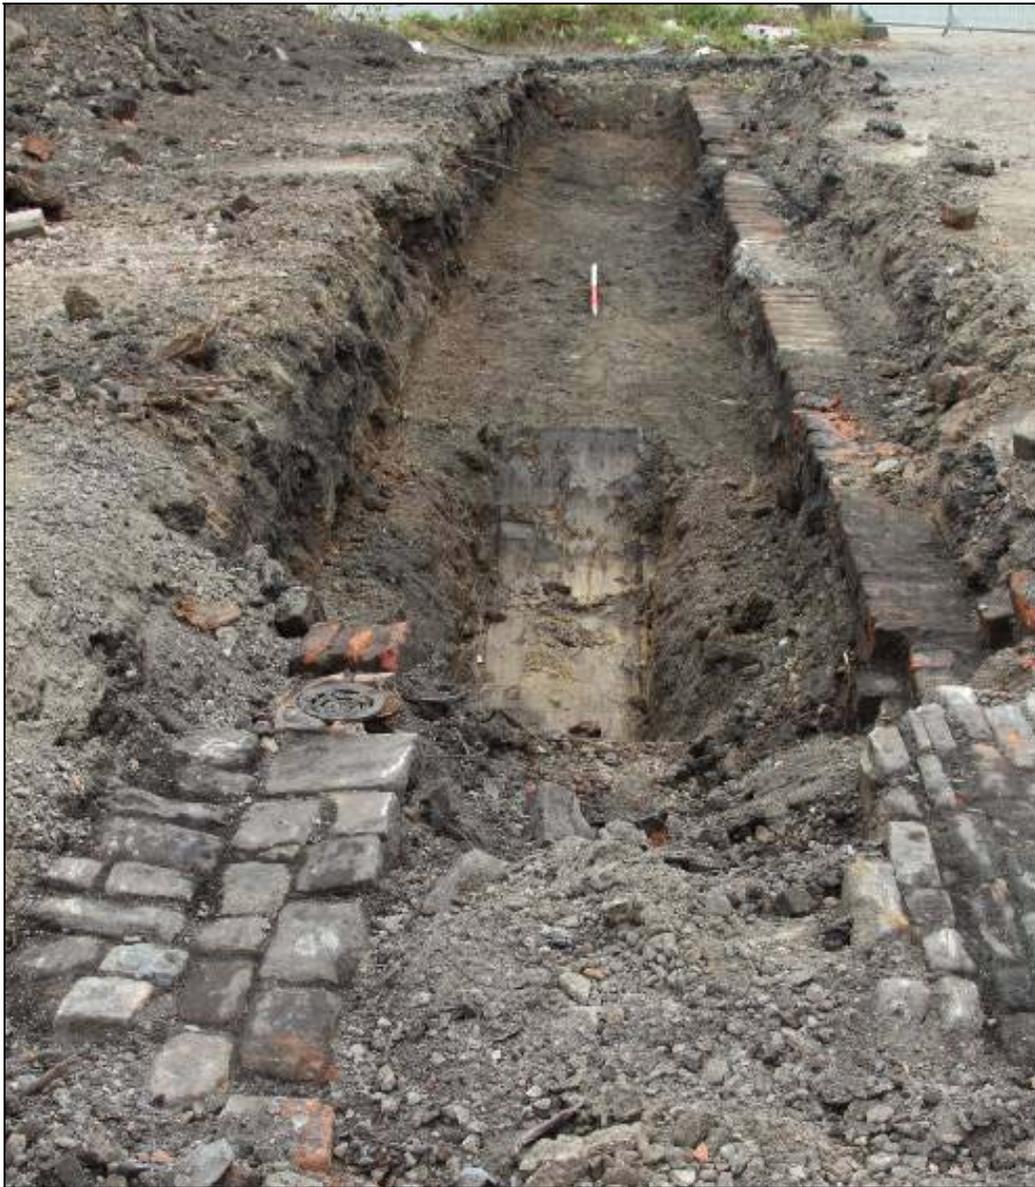
Trench 8 was located to the east of Trenches 4 and 5, orientated north/south and measuring 30 x 2m. The trench targeted areas shown on historical mapping as garden plots that had been subject to less development than other parts of the site (Figs 7-10). Excavation of the trench resulted in exposing a truncated cobbled surface 1031, measuring 2.10 x 1.20m. The foundation course of wall 1032 bonded with lime mortar was also uncovered, running parallel to the western edge of Trench 8 and continuing beyond the limit of excavation. A small sondage was excavated in the northern part of the trench to investigate the stratigraphy of the site, although negative features and/or plough soils had not survived (Plate 34).

Plate 34: Trench 8, looking south

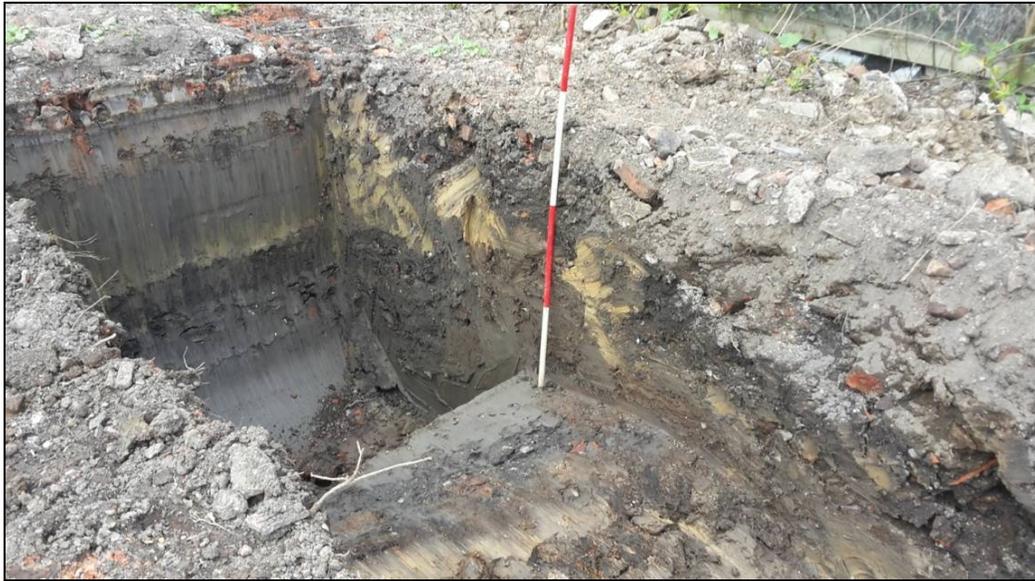
Plate 35: Trench 9 showing sondage excavated at the western end of the trench

Trench 9 was situated to the north of Trench 7, measuring 20 x 2m and was excavated to a depth of 1.2m. Trench 9 overlay garden plots to the front of Georgian villas that lined The Crescent (Figs 7 and 8). A sondage was excavated at the western end of Trench 9 to investigate the stratigraphy of the site, whether medieval plough soils had survived and the presence of any dating material (Plate 35). No negative archaeological features were identified in Trench 9, although a sherd of orange fabric pottery with a purplish-brown glaze, dating to the 18th century was recovered.

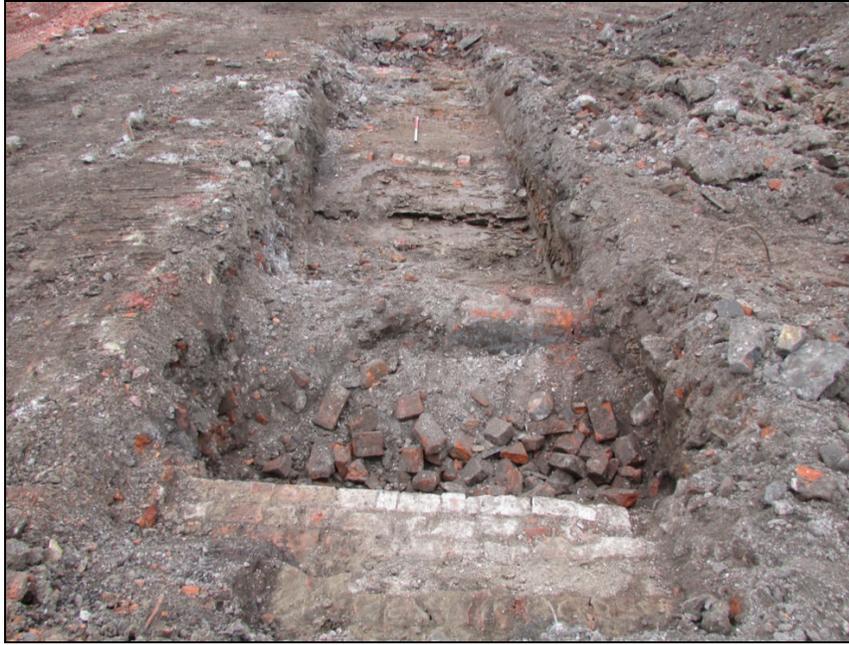
Plate 36: Trench 10 showing the foundation course of wall 1015, which demarcated the western wall of a dwelling along Crescent Court

Trench 10 was situated in the centre of the site, and targeted garden plots and potential medieval soils to the rear of Georgian villas that lined The Crescent. Later maps, dating to 1891, depict a row of single-depth dwellings situated in the western part of the trench (Fig 10). The excavation of Trench 10 exposed walls 1015 (measuring 2 x 0.33m), wall 1016 (measuring 4m) and wall 1016 (measuring 2 x 0.23m), which demarcated the foundation course of a property located on Crescent Court (Plate 36). Within the walls of the property was a rectangular brick feature (1019), which possibly formed the base of a stairwell. The badly preserved remains of wall 1020 survived towards the eastern end of the trench along with brick feature 1021, which both appear to have formed a small outbuilding depicted within a garden plot on the OS Town Plan of 1891.

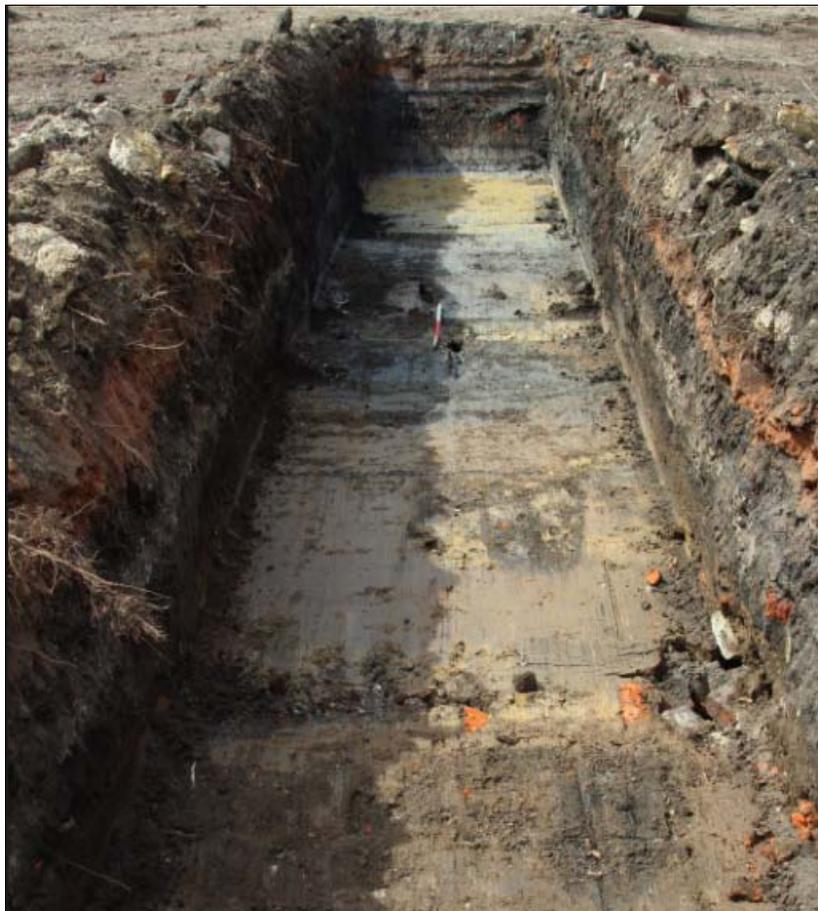
Plate 37: Trench 11

Trench 11 was situated to the north of Trench 12, along an east/west alignment, measuring 15 x 2m. The trench overlay an area that comprised three garden plots, which had the possibility of containing earlier medieval soils. Trench 11 was excavated to a maximum depth of 1.15m exposing natural pockets of clay 1013 (Plate 37).

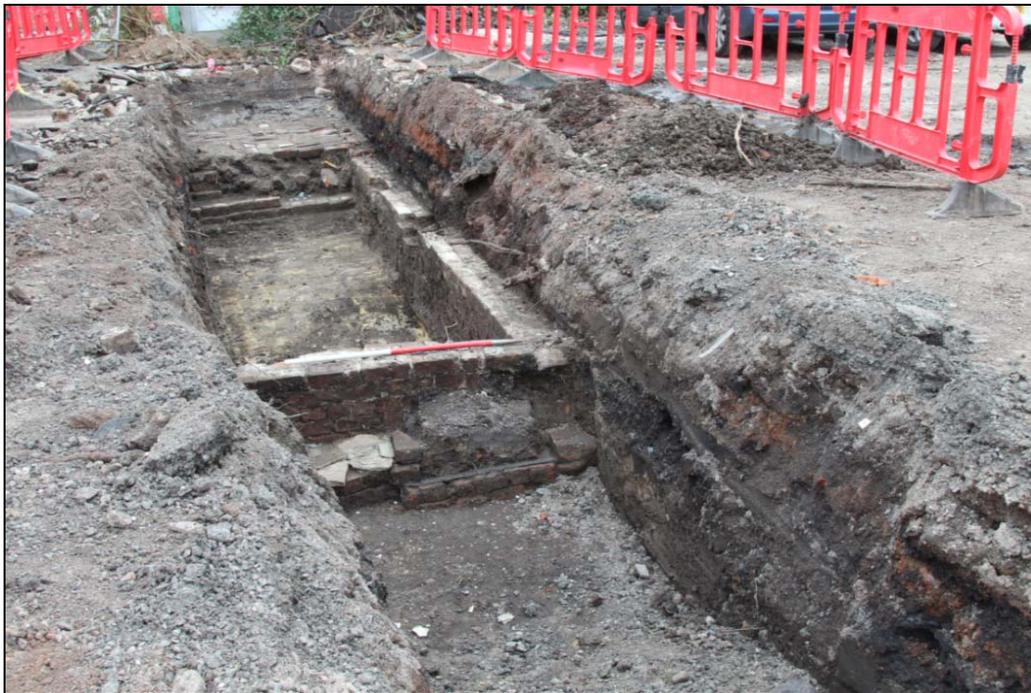
The excavation of **Trench 12** exposed the remains of brick surface 1033 (2 x 3.2m), which was bound by wall 1034 (6.9 x 0.24 x 0.75m), orientated north/south. Wall 1034 returned along an east/west alignment, forming a boundary around brick surface 1033. In the northern part of the trench wall 1034 returned along an east/west alignment, measuring 2 x 0.24 x 0.24m, continuing beyond the limit of excavation.

Constructed against the northern part of wall 1034, orientated east/west, was brick feature 1036, which appeared to form a small fireplace or hearth. A hard black material was discovered within brick feature 1036, along with numerous clumps of unworked glass in a variety of colours. All of the features exposed were constructed from hand-made bricks and lime mortar. Trench 12 was excavated to a maximum depth of 1.59m revealing pockets of brownish-yellow clay and natural sand and gravel 1013 (Plate 38).

Plate 38, Trench 12 showing wall 1034 and brick surface 1033

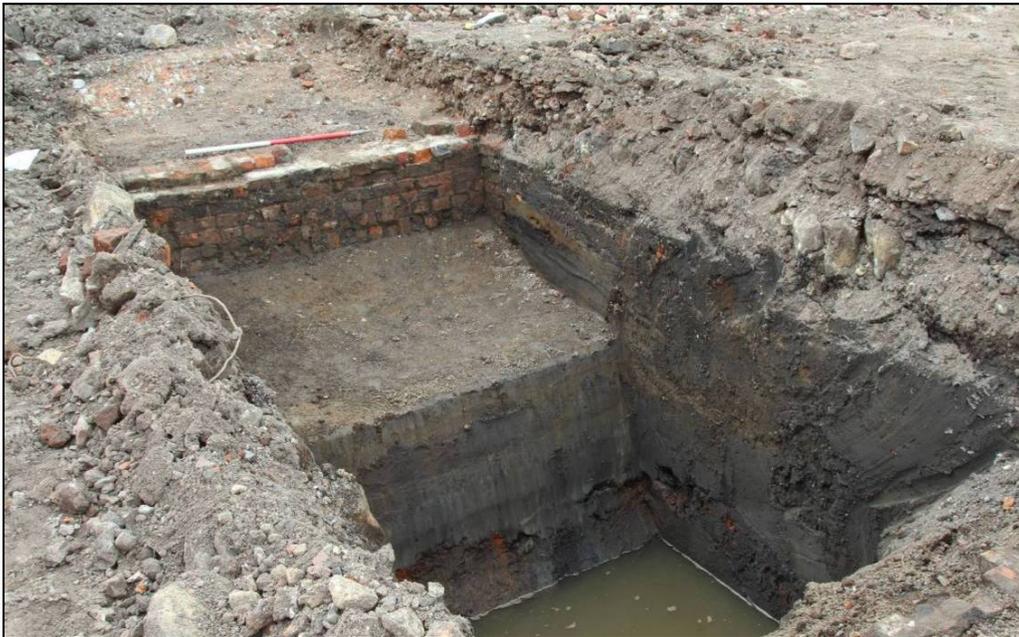
Plate 39: Trench 13

Trench 13 was only partly excavated due to the presence of a monitoring well that had to be retained. As a result, Trench 13 was reduced by 10m and was repositioned along a north/south orientation. Originally, it had been proposed that the trench was aligned east/west, targeting two small properties along Hulme Street, however, relocating Trench 13 meant that only one property was targeted. Wall 1035 was exposed in Trench 13, measuring 2.20 x 0.24 x 0.49m (Plate 39). Comparisons between the geo-rectified survey and historic mapping show that wall 1035 overlay a building depicted on the OS map of 1851 (Fig 9).

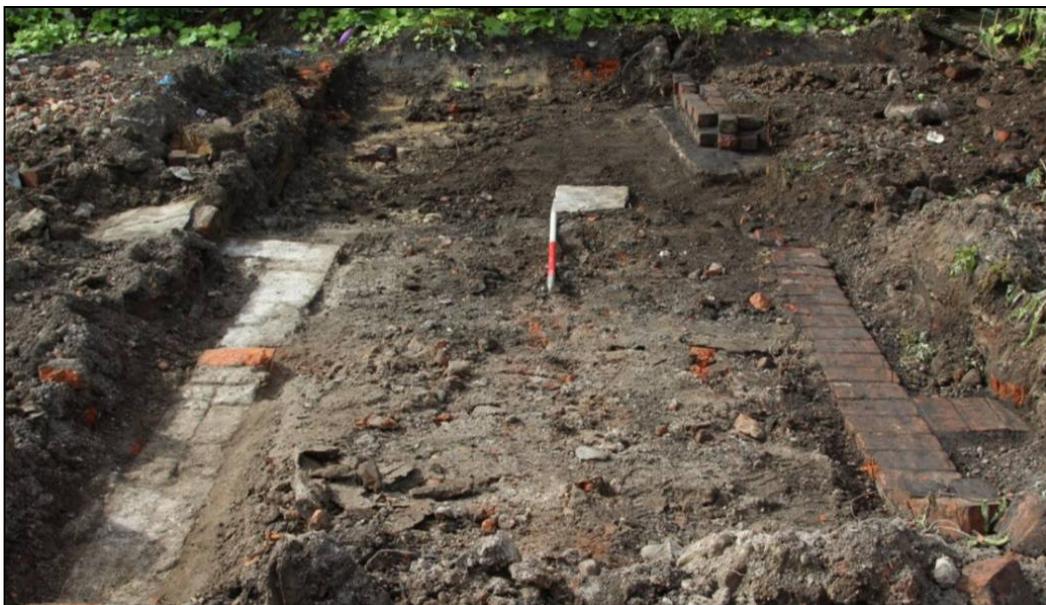
An additional trench was excavated to the east of Trench 13, to compensate for the reduced length and relocation of Trench 13. The trench measured 10m x 2m and was excavated to a depth of 0.30m. Three walls were exposed, comprising wall 1028 (measuring 2.2 x 0.23m), wall 1029 (measuring 2 x 0.23m) and wall 1030 (measuring 1.3 x 0.24m), which was built on top of flagstones (Plate 40). When the geo-rectified survey is compared to historic mapping, the three walls overly small buildings situated off Hulme Street, depicted on the OS map of 1891 (Fig 10).

Plate 40: Wall 1028 to the right, wall 1029 to the left and wall 1030 in the background, located in Trench 14

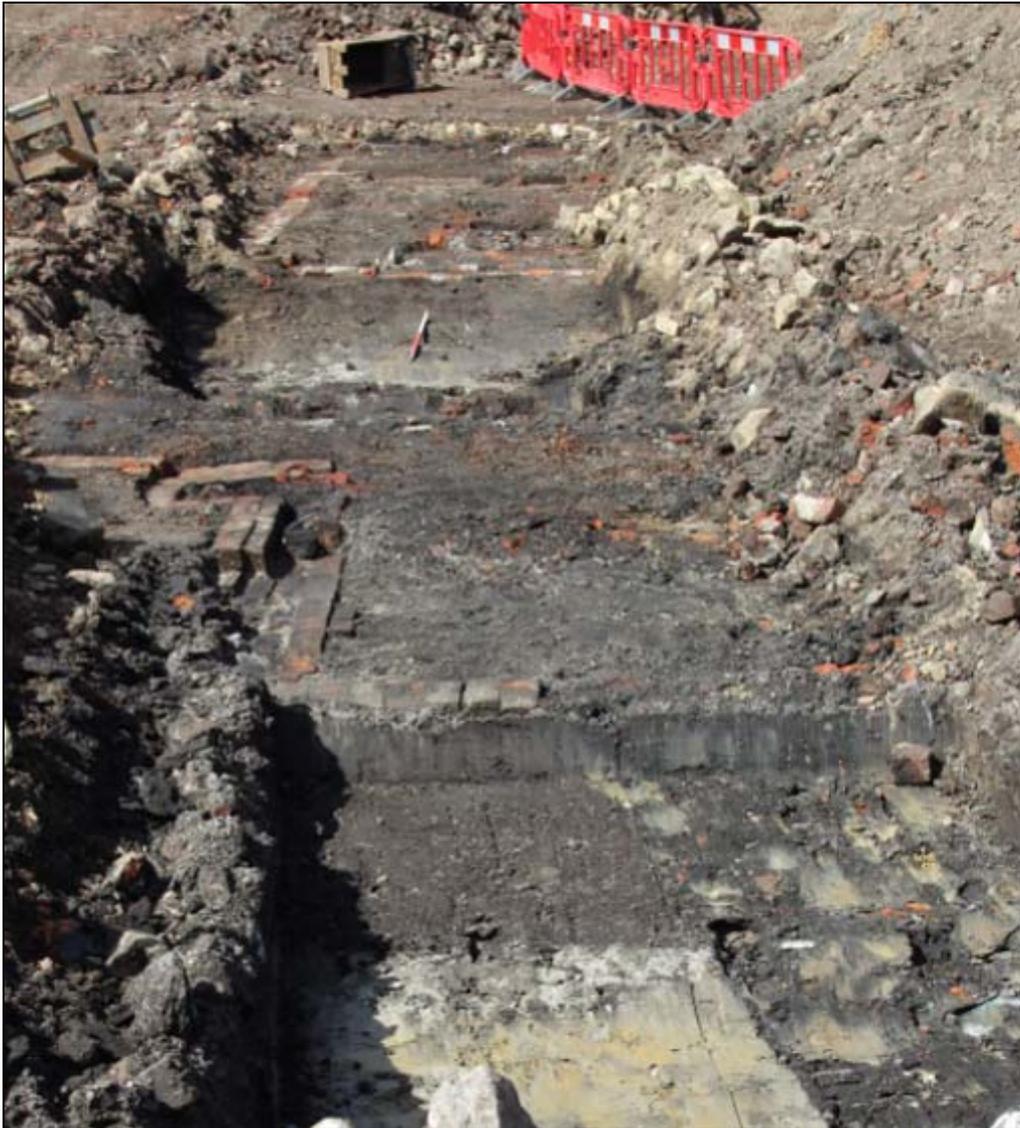
Trench 14 was located in the south-east corner of the site, targeting buildings depicted on Green's map of 1787-94 and single-depth dwellings that were later constructed on Rosson's Court, first shown on Bancks & Co's map of 1831 (Fig 8). Trench 14 measured 14 x 2m, orientated east/west and excavated to a maximum depth of 0.51m. Several walls exposed in this area that were likely to have been associated with buildings situated on Rosson's Court (Plate 41).

Plate 41: Trench 14, looking west

The discovery of well-preserved structural remains resulted in this part of the site being subject to more detailed excavation subsequently (Area 3). The remains exposed in Trench 14 are described in detail in *Section 7.4*, below.

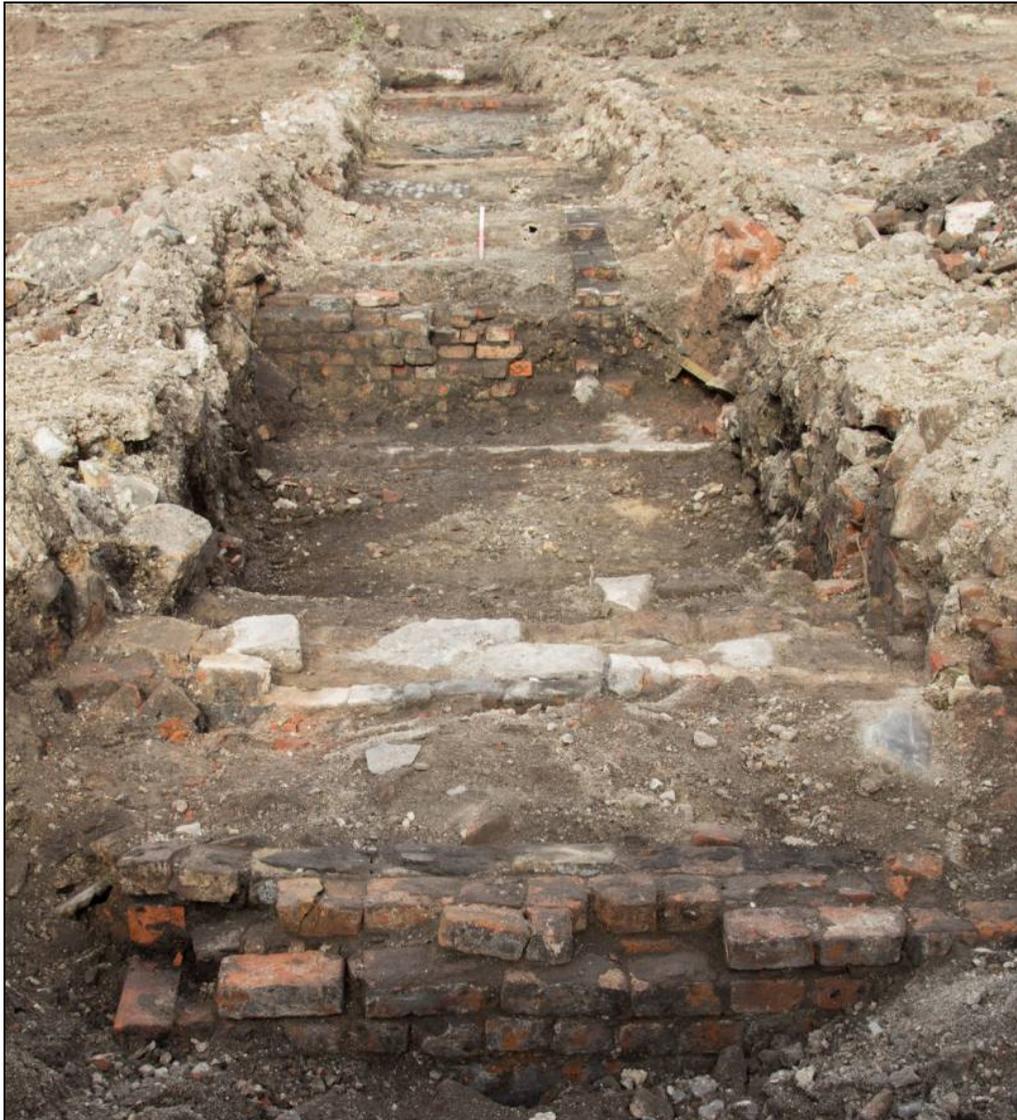
The results obtained from the excavation of Trench 15, Trench 16 and Trench 17 led to the excavation of Area 3. Trench 15 measured 30 x 2m, targeting two single-depth dwellings on Rosson's Court, depicted on Bancks & Co's map of 1831 (Fig 8). Several walls, a cobbled surface and a flagstone surface were exposed in Trench 15 and Trench 16 (Plates 42 and 43); these remains are discussed in *Section 7.4*.

Plate 42: Walls exposed in Trench 15, forming part of Area 3

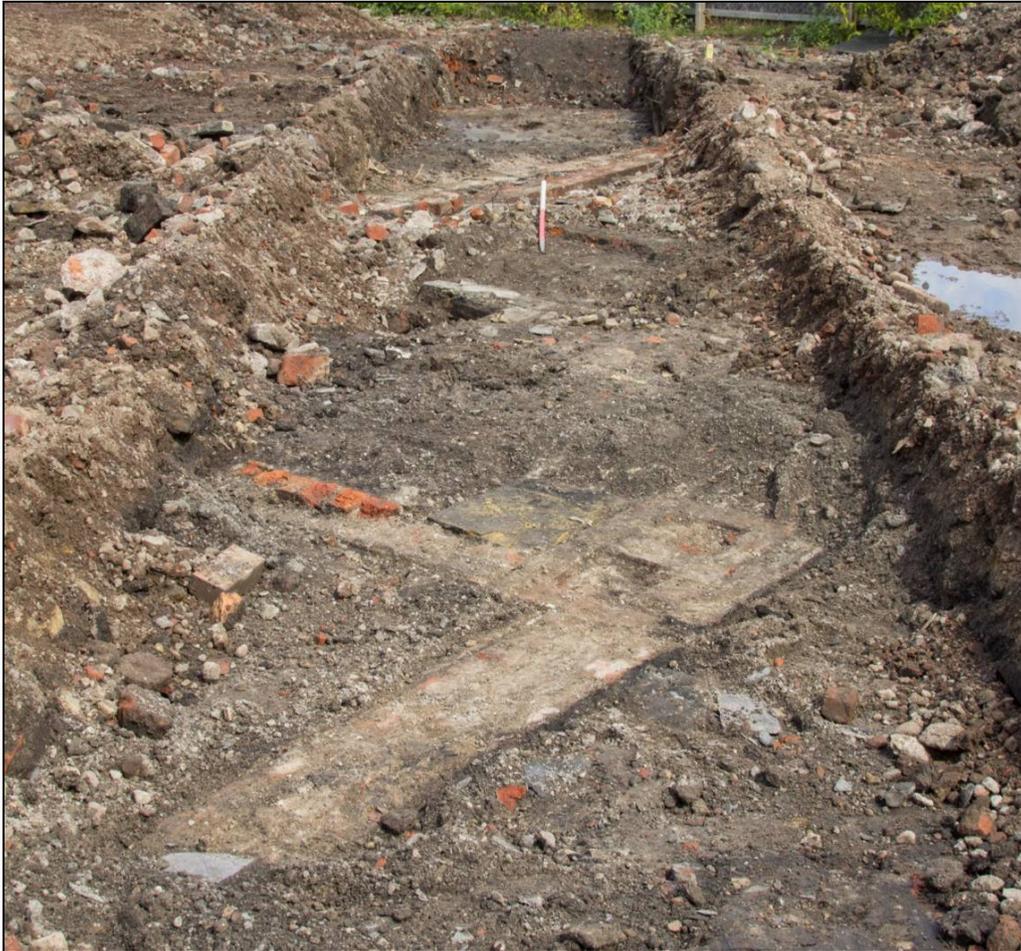
Plate 43: Exposed walls in Trench 16

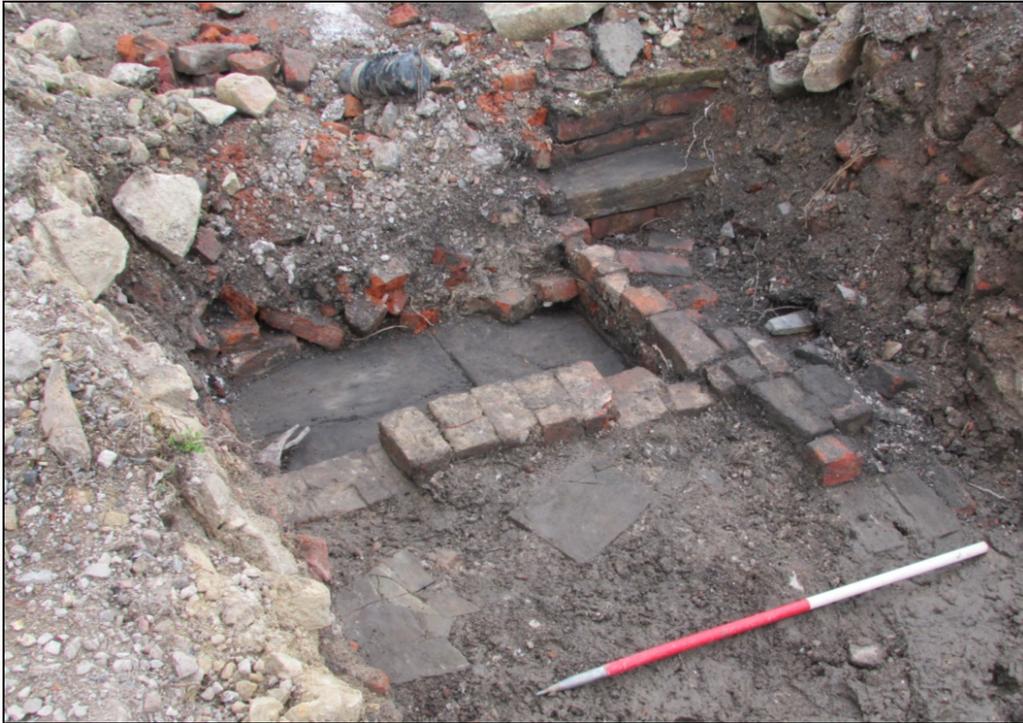
Trench 17 was located in the eastern part of the site, placed over the footprint of a single-depth dwelling situated along Gaythorn Street, and garden plots or allotments situated off Gaythorn Court. Trench 17 measured 30 x 2m and was excavated to a maximum depth of 1.10m. The remains of staircase 1022 were exposed in the eastern part of the trench (Plate 43). The staircase was formed by two steps, comprising flagstones laid above two courses of hand-made bricks. Flagstone surface 1027 was situated to the north of the staircase.

Plate 44: Staircase 1022 and stone flag surface 1027 exposed in Trench 11

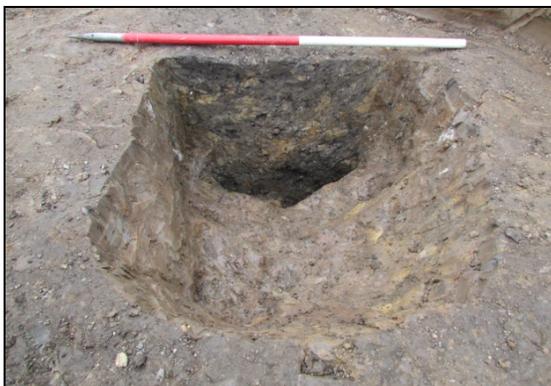
Towards the centre and western part of the trench were two linear features [1023]/(1024) and [1025]/(1026) (Plates 44-47). The excavated section of cut 1023 measured 1m long, 0.75m wide and 0.60m deep. A mid-brown, firm, silty clay (1024) was excavated from the cut, containing frequent inclusions of various types of ceramic wares, dating from the mid-18th to mid-19th century.

Plate 45: Cut [1023] and fill (1024)

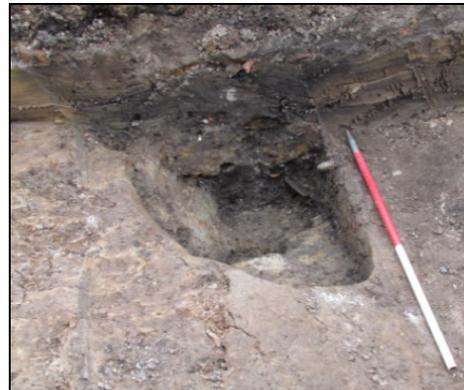
A section, measuring 0.5m long, 0.6m wide and 0.38m deep was excavated through cut 1025. Fill 1026 had the same composition as fill 1024, and similarly contained frequent sherds of various ceramic wares from the same date range. The evidence yielded from the features implies that refuse pits were dug in this part of the site. It is likely that the pits were used from the late 18th to mid-19th century.

Plate 46: Cut [1025] and fill (1026)

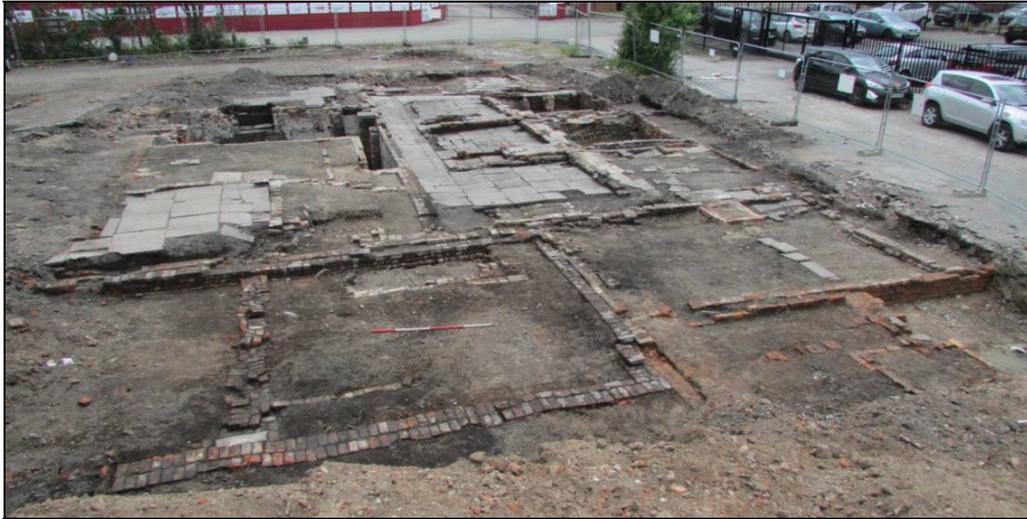
Plate 47: General view of Area 1, facing south

The excavation exposed the foundations of several dwellings, privies, yards, passageways and a cellar (Plate 47). A number of internal and external surfaces survived, comprising flagstones and bricks, although some surfaces had been removed during demolition or were formed of organic materials such as wood, which tend to decompose unless preserved in specific conditions.

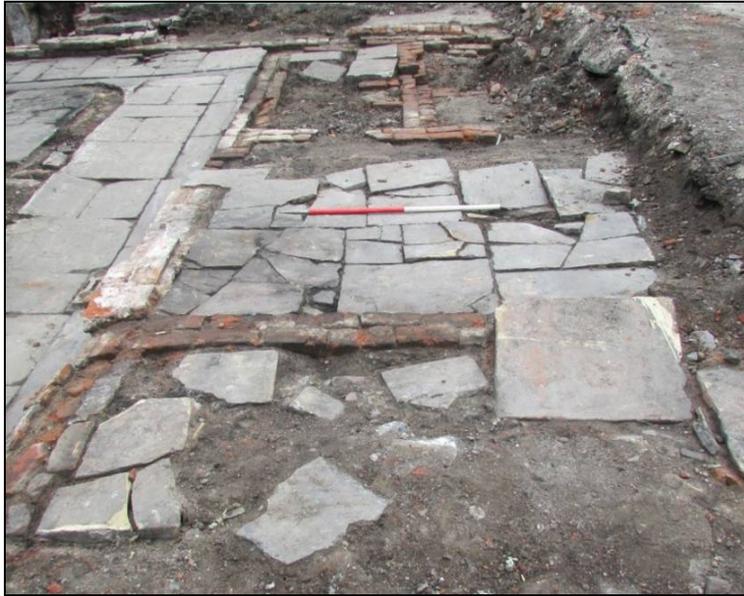
The remains of seven buildings were exposed during the excavation of Area 1, three of which were situated along Beevor's Buildings, all of an identical form. The excavation also exposed the remains of walls that formed outbuildings belonging to properties that fronted Hulme Street, situated in the south-west corner of Area 1, in front of a passageway formed by walls 2002, 2003, 2006 and 2007 (all surviving up to one-course high; Plate 48). Wall 2002, measuring 3 x 0.24m and wall 2003, measuring 3 x 0.24m, formed the southern boundary of a passageway that led to the privies and yards of houses along Beevor's Buildings. Wall 2006, measuring 18 x 0.24m, adjoined wall 2003, and formed the eastern boundary of the same passageway. The passageway, formed by the walls listed above, was orientated east to west.

Wall 2004, measuring 1.2 x 0.24m, extended southwards from the centre of wall 2002, forming a partition between the yards of two properties that were situated on Hulme Street. Wall 2005, measuring 3 x 0.24m, was situated directly opposite wall 2003, demarcating a privy in the yard of the easternmost property situated on Hulme Street. Flagstones 2008, of varying sizes, formed the surface of the yard and passageways (Plate 49).

Plate 48: Walls 2002, 2003 to the left; wall 2004 in the foreground and wall 2005 to the rear

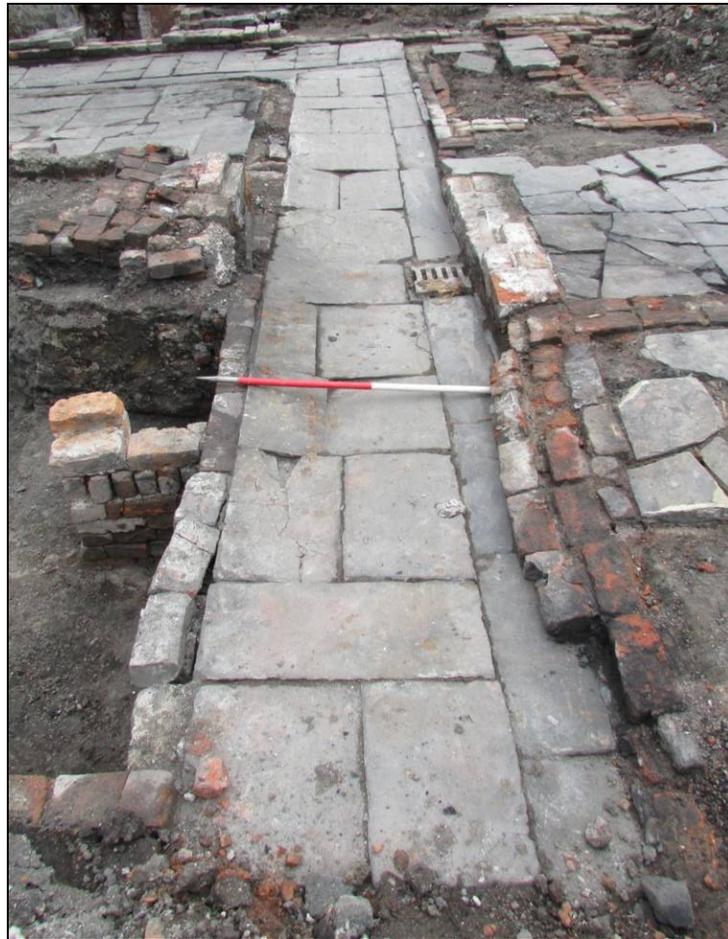
Plate 49: Passageway formed by walls 2002, 2003 and 2007

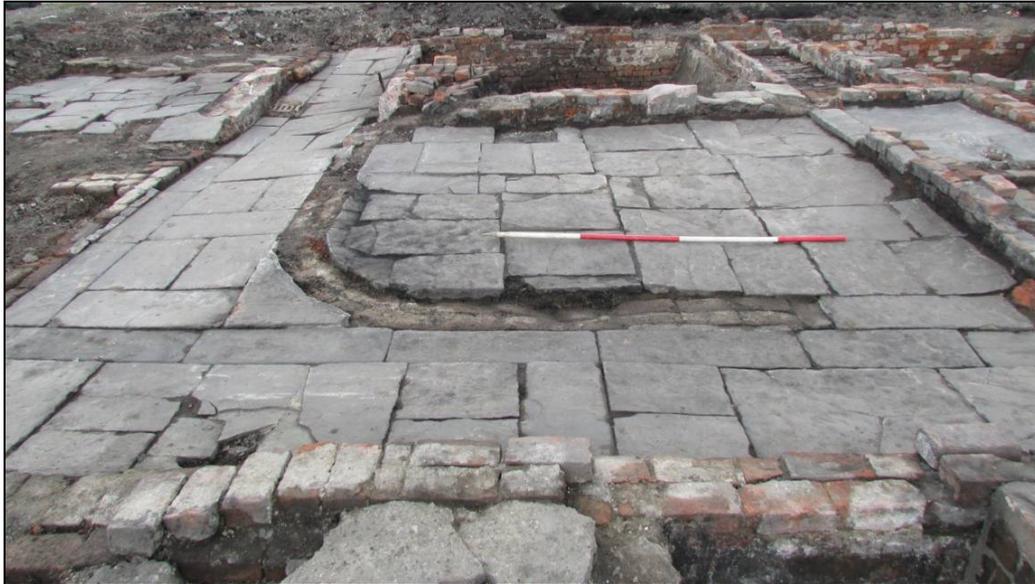
Single-skin wall 2007, measuring 2 x 0.48m, demarcated the northern wall of the passageway (orientated east/west), and also formed the southern wall of House 1. Wall 2009, measuring a total length of 4.5 x 0.24m, curved to change the course of the passageway to a north/south alignment. The terminus of wall 2009 formed a doorway, which provided access to the yard, privy and probably the entrance to House 1. The yard was bounded by walls 2009, 2010 (3 x 0.24 x 0.24m) and wall 2011 (1.35 x 0.24 x 0.18m), and was paved entirely with flagstones 2013 (Plate 50).

Plate 50: The yard of House 1

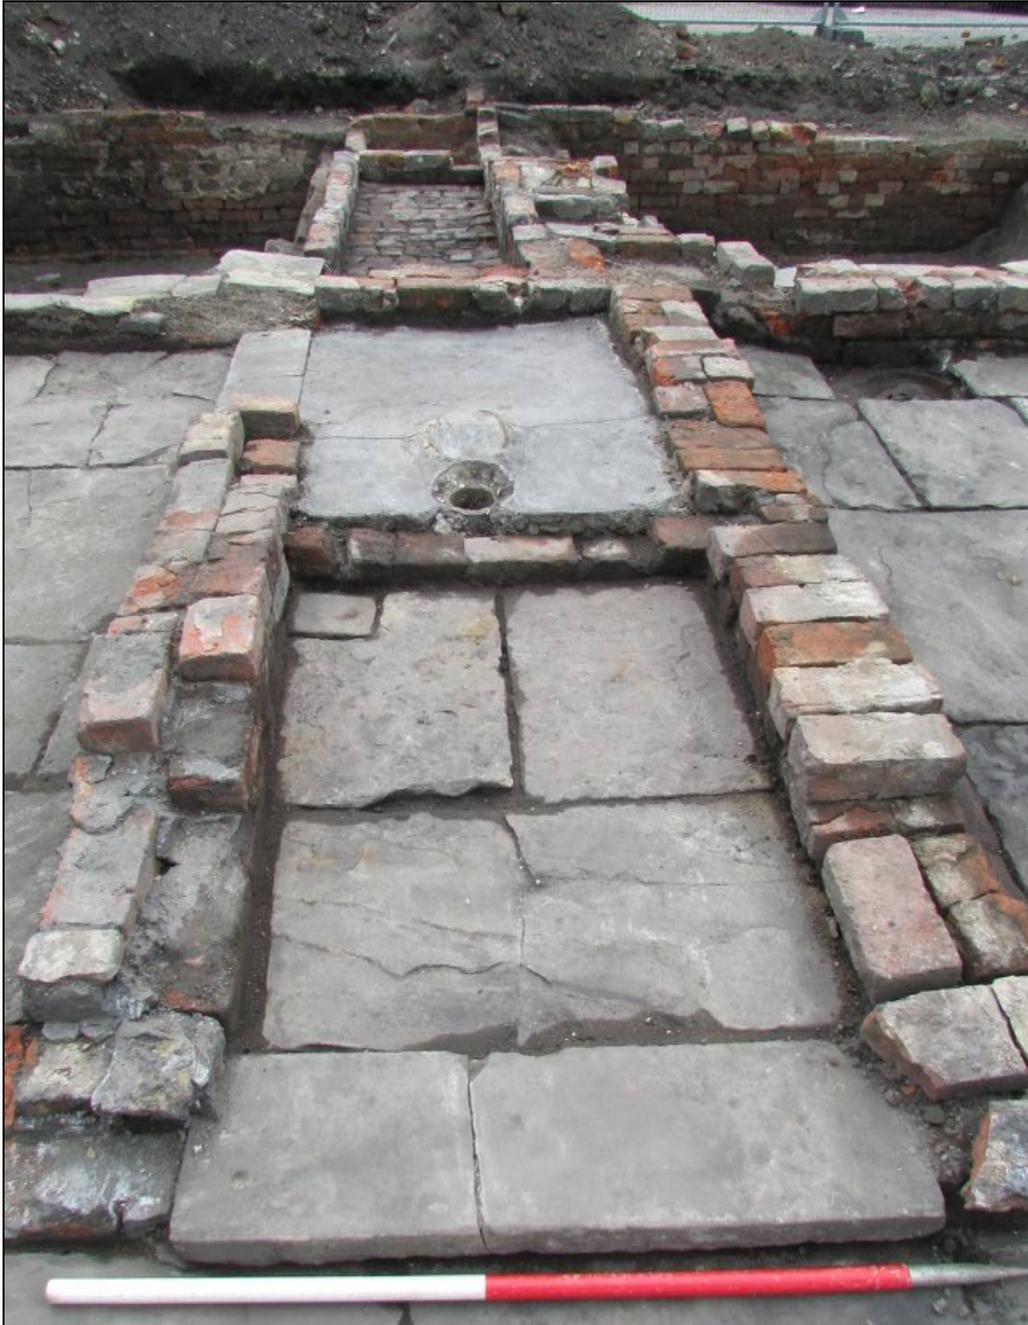
The privy was formed by walls 2011, 2012 (2.1 x 0.24 x 0.16m), and single-skin wall 2014 (0.7m long), entered through a threshold in the north-west corner of the yard. Flagstones 2013 continued through into the privy. A ceramic drainpipe that facilitated the removal of wastewater and sewage was also evident (Plate 51).

Plate 51: Privy situated in the yard of House 1

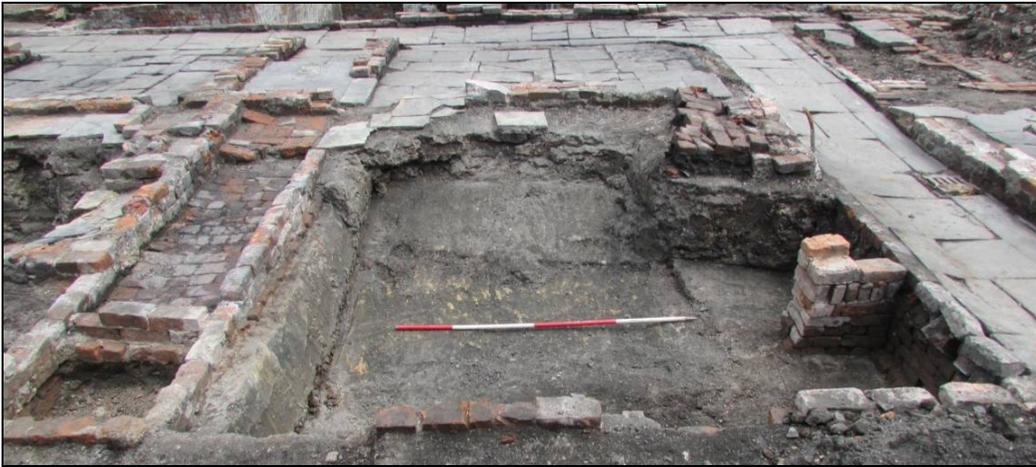
House 1 was bounded by walls 2010, 2007 and 2019 (4.5 x 0.11 x 0.6m) and wall 2015 (5.2 x 0.11 x 0.07m), all of which were only a single-skin wide (Plate 52). Walls 2007 and 2019 had deep foundations, measuring a depth of 0.6m, while walls 2015 and 2010 were only three-courses deep. A stone door jamb was incorporated into wall 2010, implying that the house was entered via the passageway rather than at the front of the street. Brick buttress 2020 extended north from wall 2007, measuring (0.48 x 0.24 x 0.49m), which was likely to have formed a fireplace. The fragmented remains of a brick surface, 2018, measuring 0.60 x 0.84m, survived in the south-east corner of the room, adjacent to wall 2007. Walls 2015 and 2016 (2.8 x 0.11m) formed the base of a stairwell, with brick surface 2017 situated between the two walls.

Plate 52: House 1, Beevor's Buildings

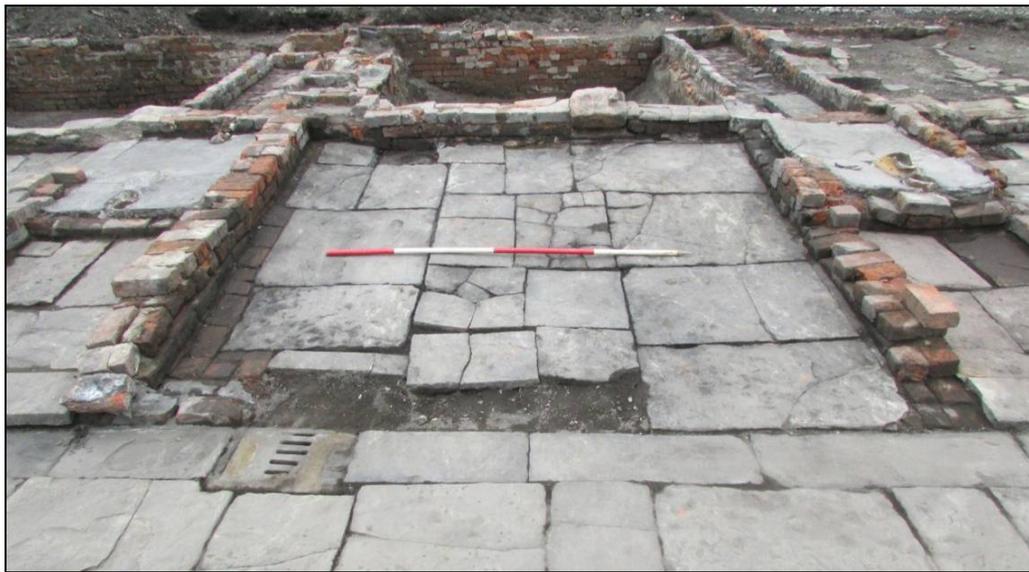
House 2 was situated adjacent to House 1, and was accessed via the same passageway. House 2 replicated the layout of House 1. A yard bound by walls 2012, 2021 (4.5 x 0.24 x 0.21m), 2022 (4 x 0.24 x 0.14m), was situated to the east of House 2 (Plate 53). Flagstones 2025 paved the entire floor surface, leading through into the privy situated to the north of the yard. The privy was formed by walls 2022, 2023 (0.70 x 0.11 x 0.14m) and 2024 (4 x 0.24 x 0.14m). Within the privy closet were the remains of a ceramic drainpipe situated in the same position as the previous privy. In addition, what appeared to be the base of ceramic toilet was also present.

Plate 53: The yard of House 2

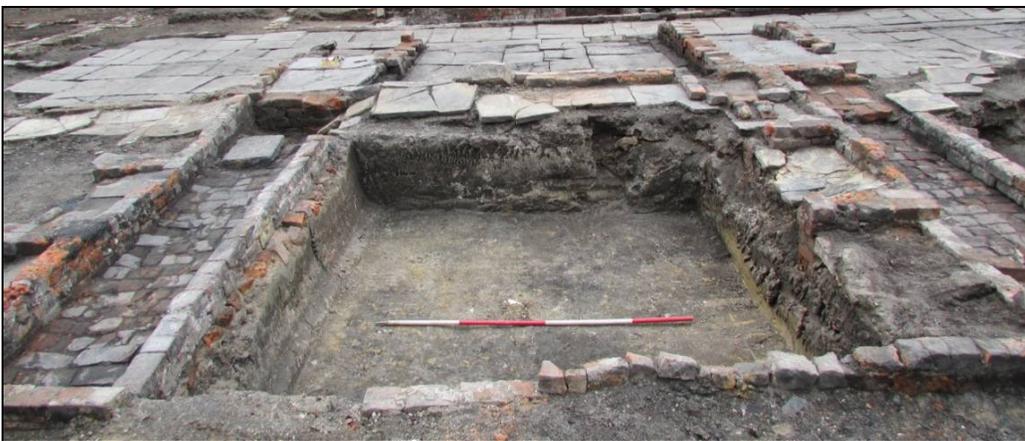
Similarly, a stone doorjamb was incorporated into wall 2021, implying that the house was also entered via the passageway rather than the street. Walls 2021, 2015, 2026 (4.5 x 0.11 x 0.14m) and 2027 (4 x 0.11 x 0.21m) bounded House 2 (Plate 54).

The base of a fireplace was situated along wall 2015, comprising two brick buttresses each measuring 0.48 x 0.24 x 0.35m. Flagstones 2028 were situated between the two buttresses and alongside wall 2021, which is likely to have formed the floor surface. A stairwell formed by walls 2027 and 2030 (4 x 0.11 x 0.14m) was situated along the north wall of House 2. Brick surface 2031 paved the surface between the two walls.

Plate 54: House 2

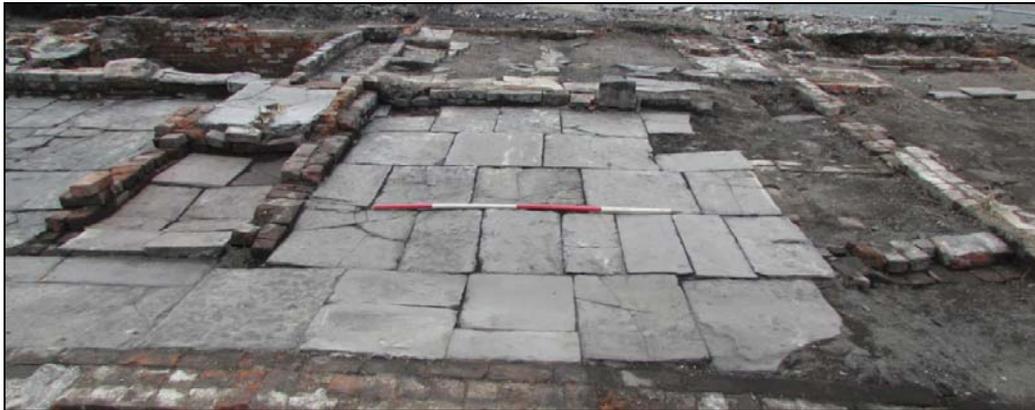
The remains of House 3 were situated to the north of House 2, at the northern limit of the passageway. A yard demarcated by walls 2024, 2032 (3 x 0.11 x 0.14m) and 2037 (10.5 x 0.24 x 0.14) was situated to the west of House 3 (Plate 55). The surface of the yard comprised flagstones 2036, however, these had been removed where the privy would have been located. Walls 2033 (0.75 x 0.24 x 0.14m), 2035 (0.6 x 0.24m) and 2034 (0.75 x 0.24m), formed the surviving walls associated with the privy, which was damaged considerably in comparison to the previous two properties.

Plate 55: The remains of the yard and privy associated with House 3

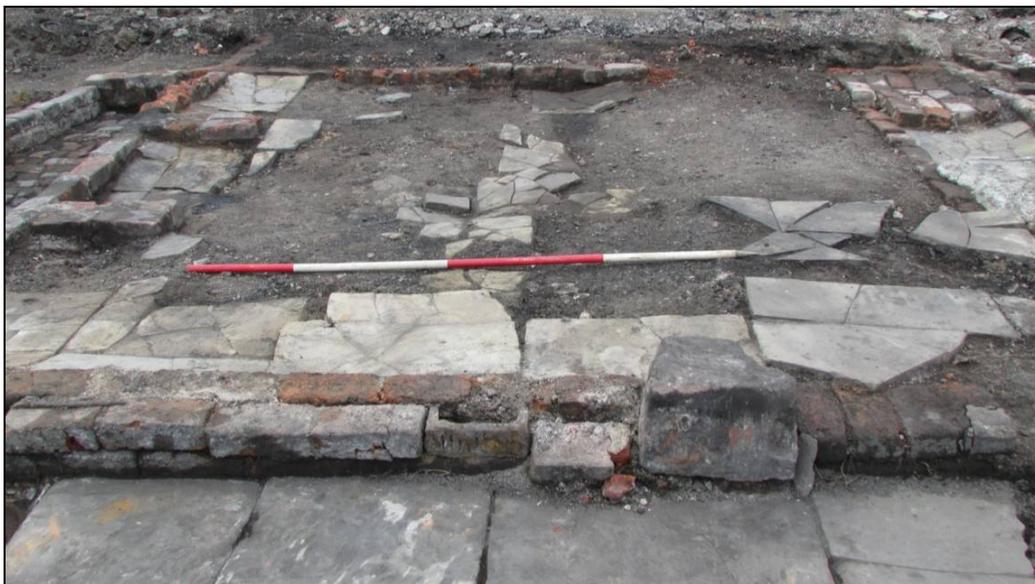
Plate 56: House 3

Walls 2032, 2027, 2037 and 2038 (2.5 x 0.11 x 0.14m), bound House 3 (Plate 56). A fireplace (2039), comprising two brick bases, each measuring 0.48 x 0.24m, extended northwards from wall 2027, replicating the layout of House 2. Damaged flagstones 2040 were situated between the two brick bases, surviving in fragments throughout House 3. A stairwell formed by walls 2037 and wall 2041 (2 x 0.11 x 0.7m) was located in the north part of the dwelling. The remains of brick surface 2042 measuring 0.60 x 0.35m were situated between the two walls. Brick surface 2042 was set above flagstones 2043, between walls 2037 and 2041.
