Archaeological Excavation and Historic Building Investigation

Local Crescent,
The Crescent,
Salford

Report No:
2019/25

Document Type: Archaeological Excavation and Historic Building Investigation Report

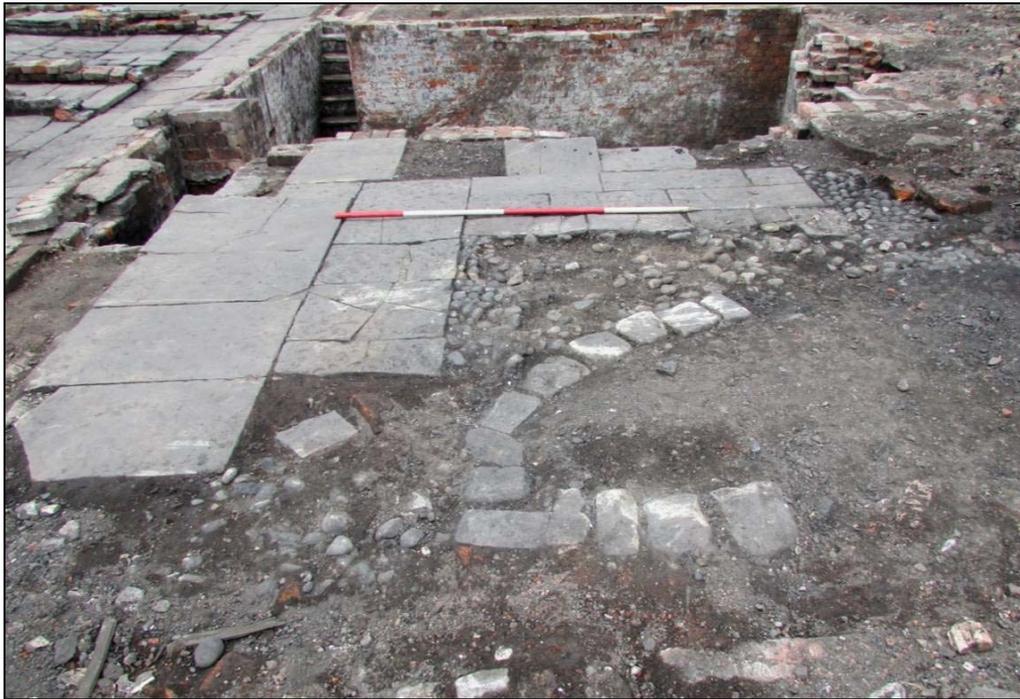
The yard comprised a flagstone surface (2044), a cobbled (pebble) pavement (2045) that probably led to the front door, and a curved feature that was formed by rectangular cut stones 2046 (Plate 57). Historic mapping demonstrates that the garden plot continued beyond the limit of excavation, towards the front of Hulme Street, setting the house a considerable distance away from the road.

Plate 57: The remains of an elaborate garden plot situated along Hulme Street

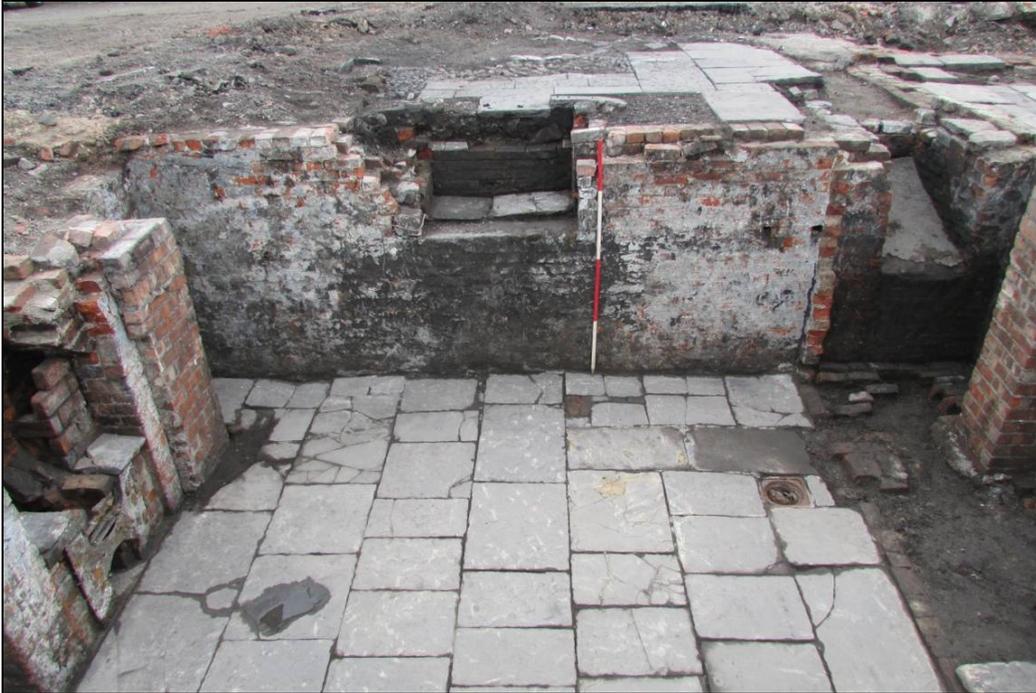
To the north of the yard were the well-preserved remains of a cellar bounded by walls 2006, wall 2047 (5 x 0.31 x 2.05m), 2048 (10 x 0.31 x 2m) and 2049 (6 x 0.24 x 2m). The entire floor surface was paved with flagstones 2056, covering an area of 5 x 6m. Within wall 2047 were the remains of a large window light, 2050, measuring 1.15 x 0.5 x 0.6m, the base of which was lined with flagstones. A coal chute was also incorporated into wall 2047, measuring 0.5 x 0.70m (Plate 58).

Plate 58: View of wall 2047, window light 2050 and coal chute 2051

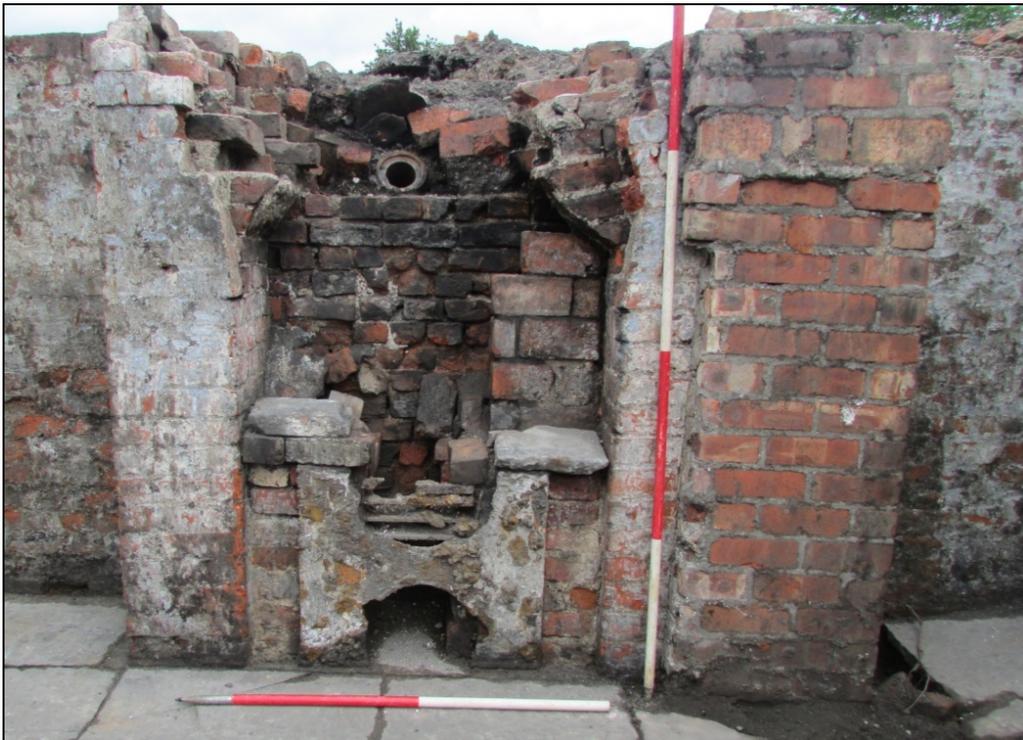
The remains of a large chimney breast, 2052, with a fireplace situated at its base were built against wall 2048. Chimney breast 2052 measured 1.3 x 0.5 x 1.8m, however, an additional brick column had been tagged onto the southernmost part of chimney breast 2052, measuring 0.5 x 0.6 x 1.75m, possibly to provide structural support (Plate 59). A metal grate, metal mantel face and smoke shelf were evident. Flagstones were positioned above the mantel face, implying that they may have formed a low mantel piece.

Plate 59: Fireplace 2052 incorporated into wall 2048

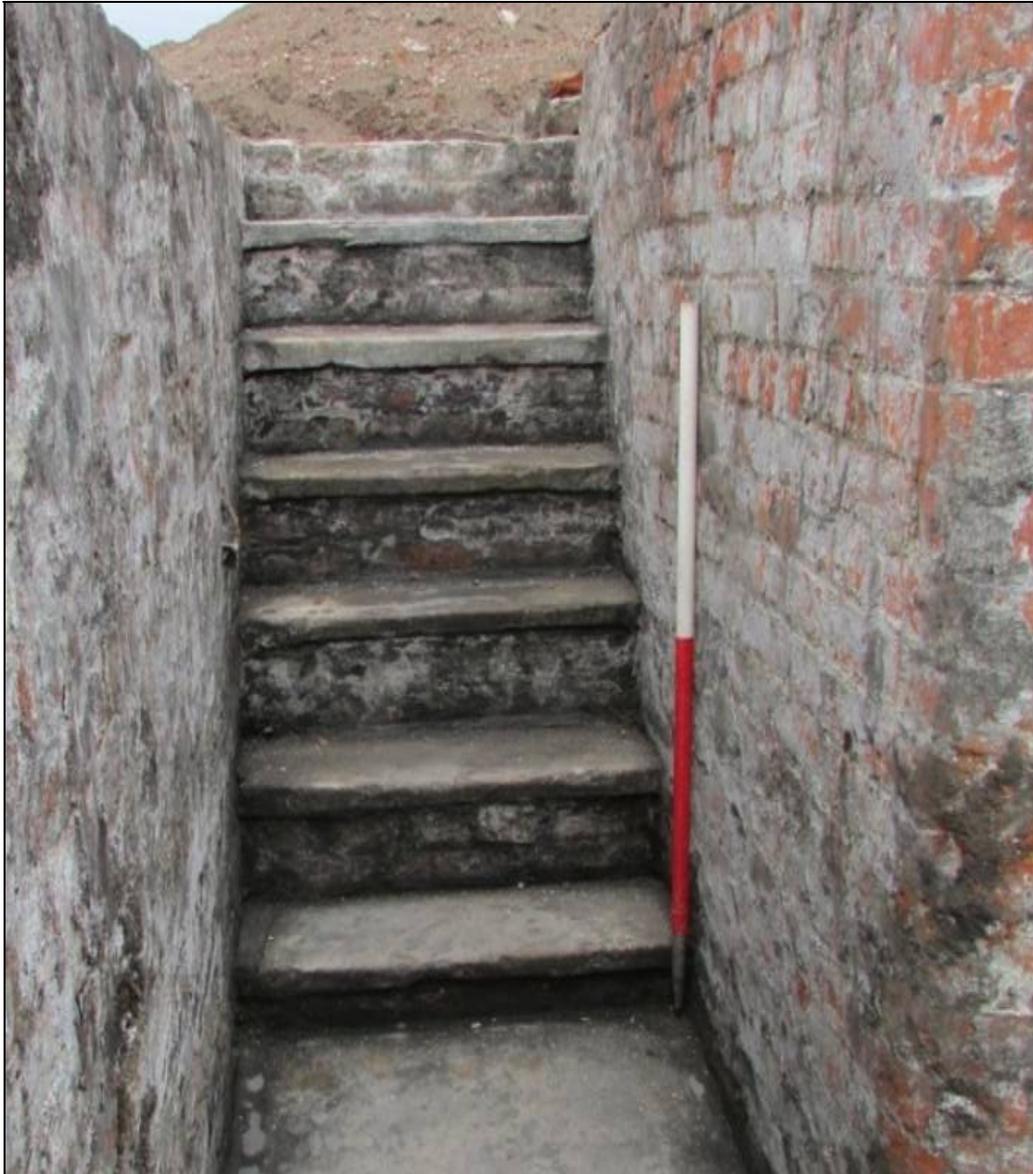
Plate 60: Staircase 2053

The well-preserved remains of staircase 2053 was built within wall 2049, comprising six flagstone steps set above two courses of bricks. Staircase 4053 was accessed internally, via a room located to the north of the cellar (Plate 60).

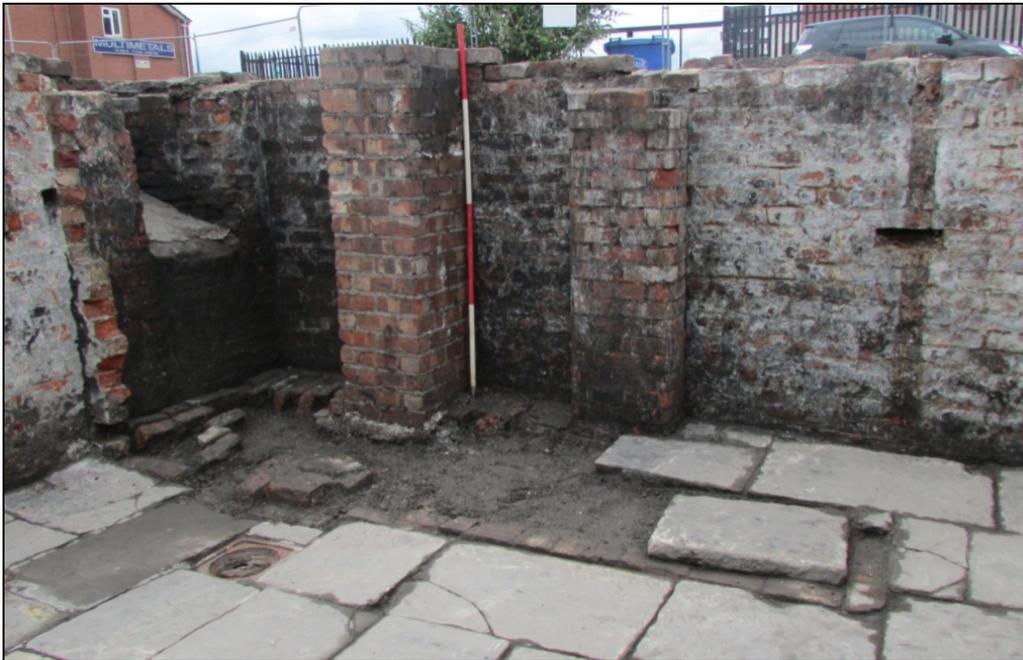
Plate 61: The base of single-skin wall 2057 and buttresses 2054 and 2055

Other features within the cellar included two brick buttress, 2054 (0.48 x 0.48 x 1.8m) and 2055 (0.24 x 0.24 x 1.7m) built against wall 2006, a drain situated within flagstones 2056, and the foundations of single-skin wall, 2057, aligned with coal chute 2051. Single-skin wall 2057 would have formed a brick-built cupboard for coal storage. The remains of wall 2057 can also be seen as keyed in bricks in wall 2047. In addition, a dark stain along wall 2006 was evident, presumably marking the position of a wooden doorframe where the storage cupboard was entered (Plate 51).

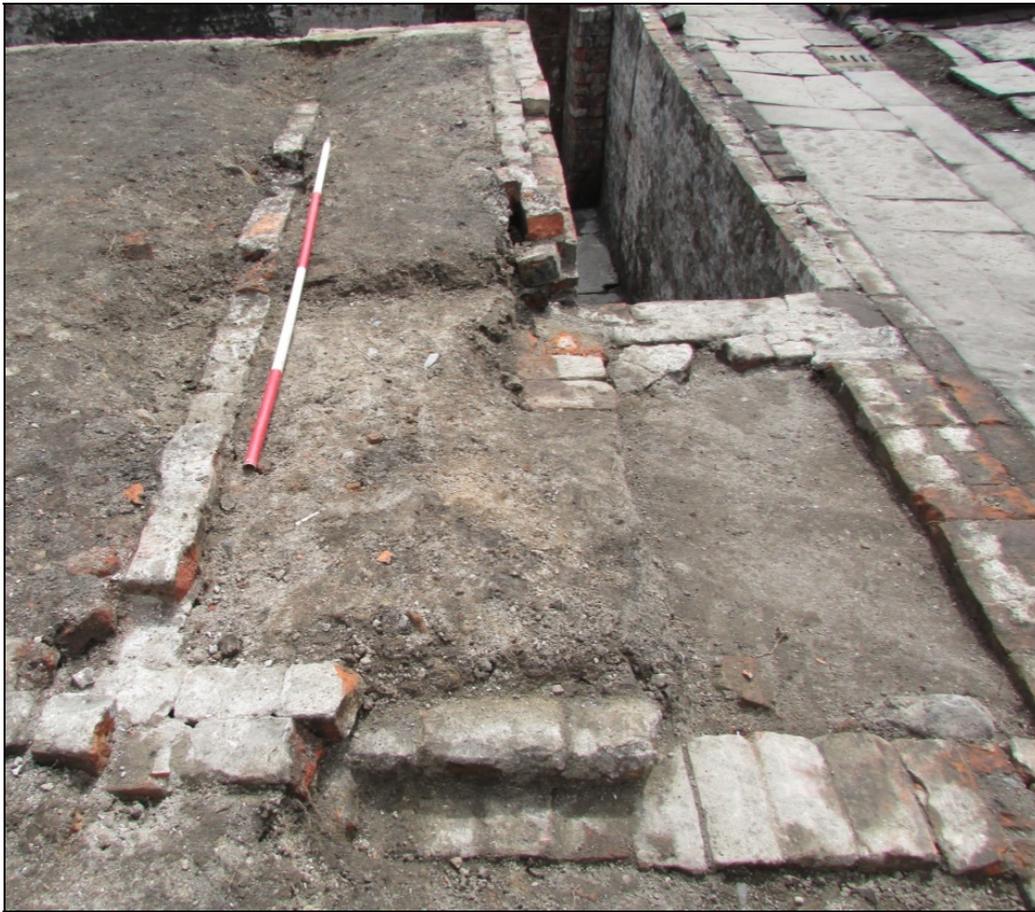
An additional skin of bricks adjoined wall 2006 for 1.2m at the top of staircase 2053 (Plate 62). Wall 2059, measuring 6 x 0.24m, adjoined walls 2006 and 2048 to form Room 2 in House 3. Within Room 2, single-skin wall 2058 (1.7 x 0.11m) extended south from wall 2059, to form a corridor leading to staircase 2053. Two brick bases 2060, each measuring 0.48 x 0.33m, extended west from wall 2048, which were likely to have formed a fireplace.

Plate 62: Single-skin wall 2058 extending south of wall 2059

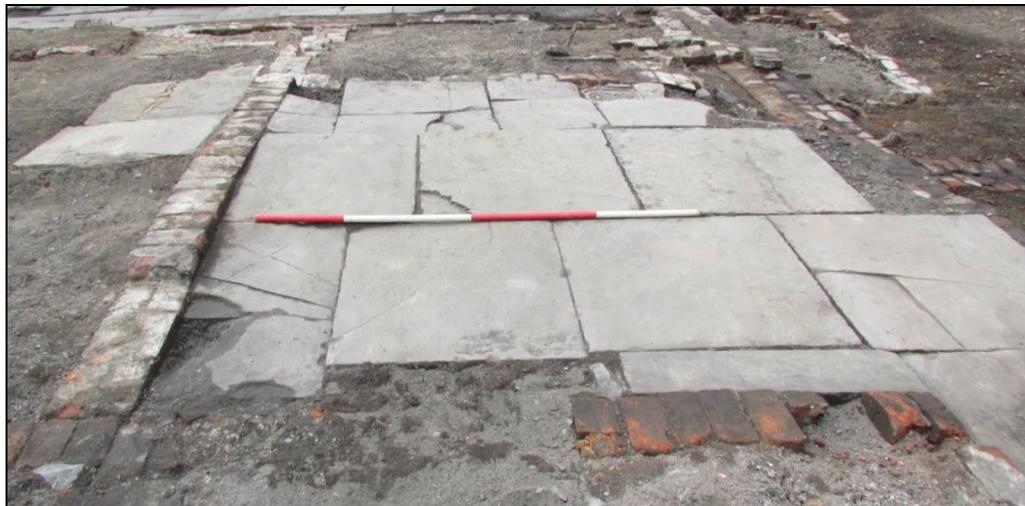
The remains of Room 3 were situated to the north of Room 2, demarcated by walls 2063 (measuring 2.5 x 0.24m), 2059, 2048 and 2061 (measuring 7 x 0.31m; Plate 634). A flagstone surface 2062 paved the floor and incorporated a single drain situated in the north-west corner of the room. To the west of Room 3 were the remains of Room 4, a small room with few surviving archaeological features. Wall 2006, 2061, 2063 and 2059 bounded Room 4. An additional L-shaped wall extended south from wall 2061, measuring 0.5 x 0.24m along a north/south alignment, returning along an east/west alignment, measuring 0.24 x 0.24m.

Plate 63: Room 3 walls 2059 and 2048, and flagstone surface 2062

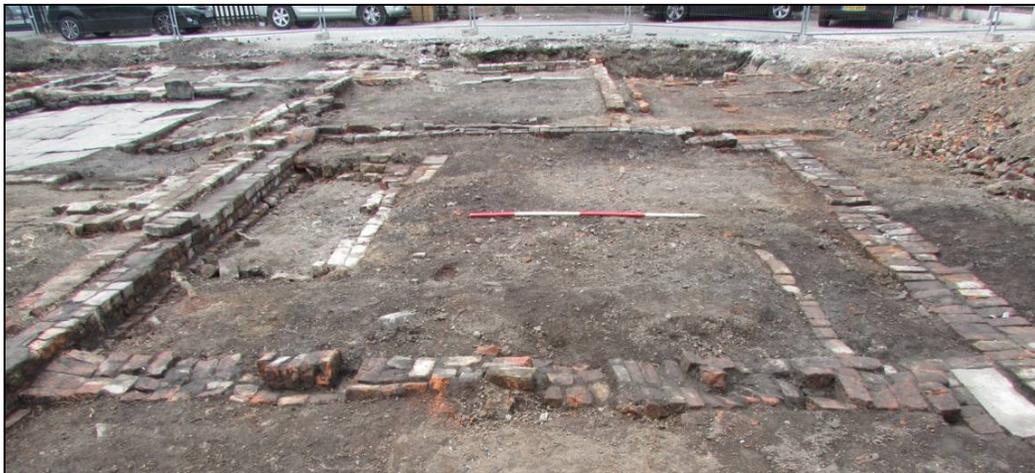
To the north of wall 2061 were the remains of one square room, Room 5, formed by walls 2065 (5 x 0.35m), 2066 (6.4 x 0.48m), 2067 (5 x 0.24m) and 2068 (5 x 0.24m x 0.21m), all of which were bonded with black mortar (Plate 64). Wall 2068 ran alongside an earlier wall 2061, bonded with lime mortar. Similarly, wall 2067 ran alongside wall 2069 (6 x 0.24m), bonded with lime mortar. Comparison with the georectified survey and the OS Town Plan of 1891 demonstrates that the remains of Room 5 may have been associated with Phase 4, particularly walls 2067, 2068 and 2065 (Fig 15). Within Room 5 were the remains of earlier walls 2070 (2 x 0.11m) wall 2071 (2 x 0.24m), wall 2072 (0.75 x 0.11m) and wall 2073 (0.75 x 0.11m), all bonded with lime mortar. Wall 2070 may have formed the external wall of an L-shaped building to the rear of the Black Horse, depicted on the OS map of 1851, Phase 3 (Fig 14). Walls 2071, 2072 and 2073 formed a rectangular shape, likely to have formed the base of a privy dating to Phase 2.

Plate 64: Wall 2068 to the left, wall 2065 in the foreground and wall 2066 to the right. Rectangular structure formed by walls 2071, 2072 and 2073 in the left of the picture and wall 2070 extending from wall 2065

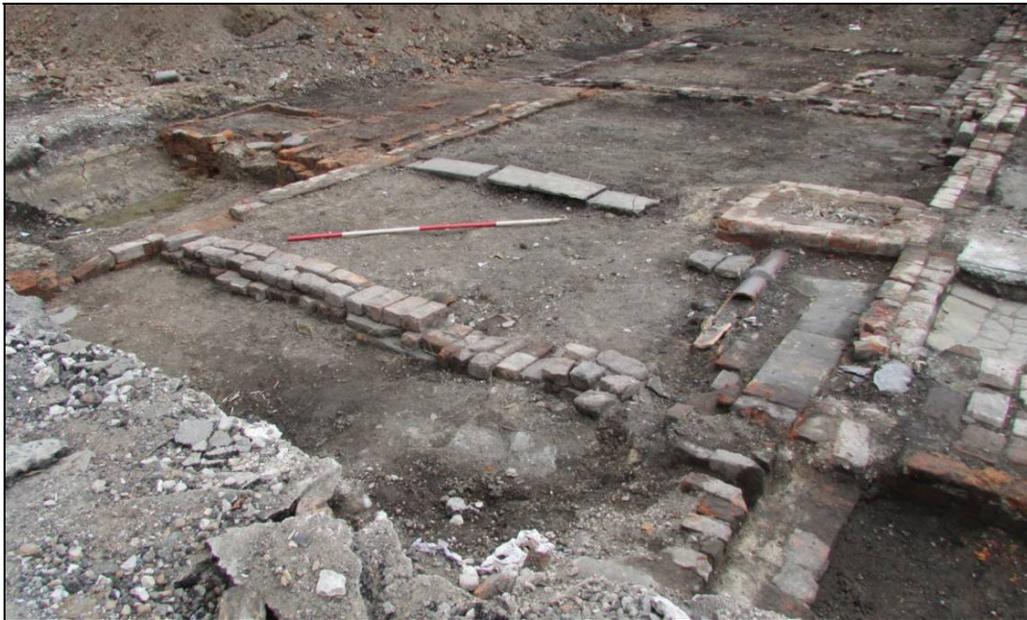
To the west of Room 5 were the remains Room 6, demarcated by walls 2069, 2037, 2076 (3.5 x 0.24 x 0.24m), and wall 2074 (7.5 x 0.24m; Plate 65). A line of four flagstones (2075) extended south from wall 2074, which would have presumably formed the floor surface. A square structure formed by wall 2077 was incorporated into wall 2078, measuring 0.94 x 0.11 x 0.07 by 0.90 x 0.11 x 0.07m. A ceramic drainpipe extended west from square structure 2077, implying that it may have functioned as an early manhole. When the historic maps are compared to the georectified survey it is clear that Room 6 overlies a building erected during Phase 2.

Plate 65: The remains of Room 6, wall 2076 is in the foreground, and square structure 2007 and wall 2037 are to the right

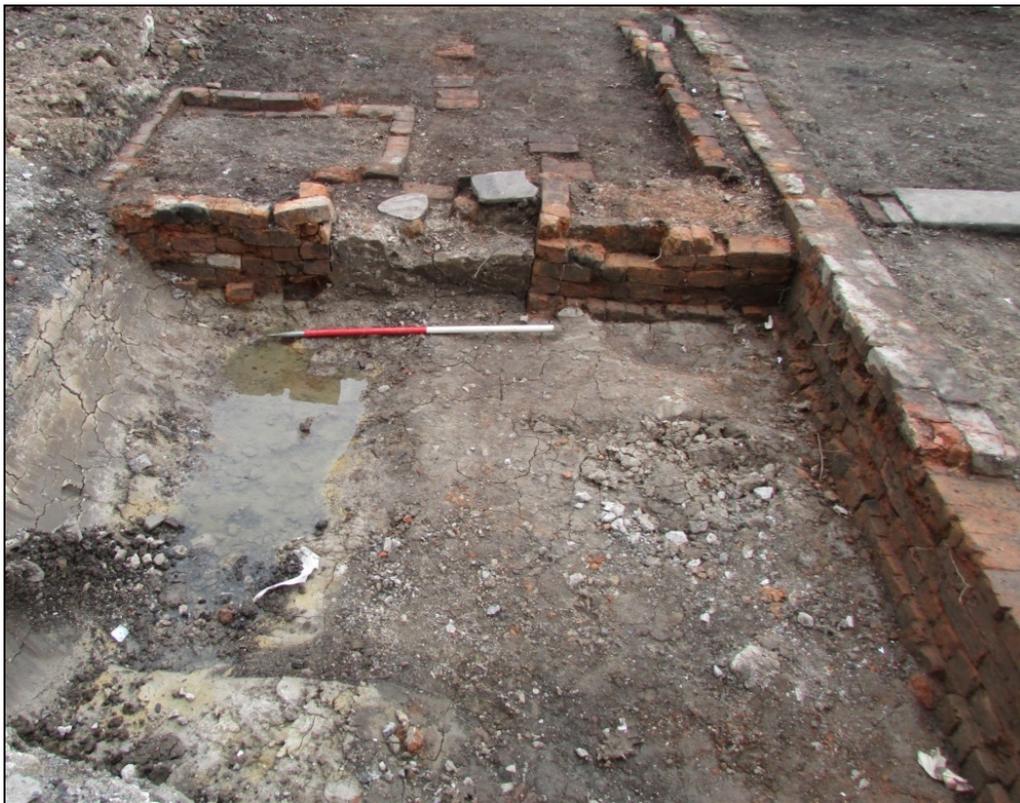
To the north of wall 2074 were the remains of several walls associated with additional buildings on Turner's Fold, dating to Phase 3. Wall 2080 (1 x 0.11 x 0.35m) and wall 2081 (0.7 x 0.11 x 0.35m) were separated by an opening measuring 0.8m, which was likely to have marked a doorway. A square structure formed by walls 2082 (0.94 x 0.11m), wall 2083 (0.94 x 0.11m) and wall 2084 (1.08 x 0.11m), extended east from wall 2081 (Plate 66). To the south was single-skin wall 2079, measuring 3 x 0.11 x 0.07m.

Plate 66: From left, wall 2081 and a square structure formed by walls 2082-4, wall 2080 and wall 2074. Wall 2079 in the background, to the right

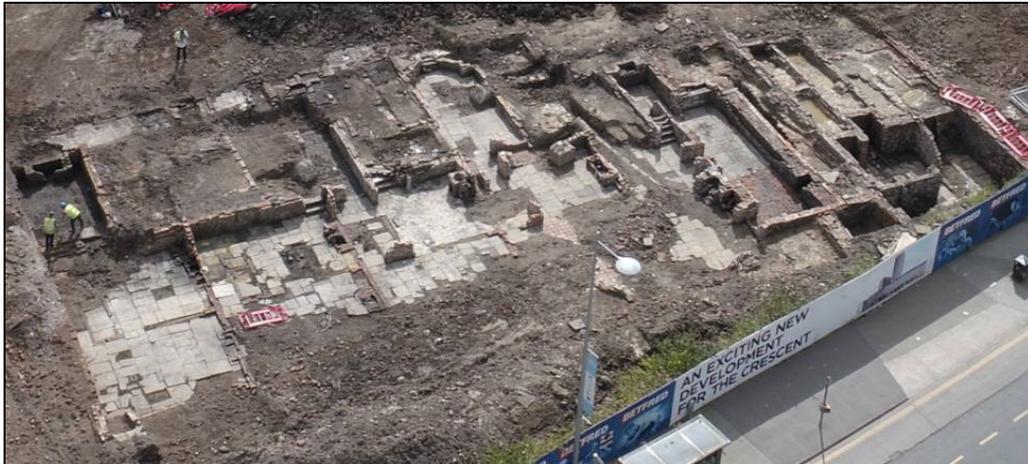
The well-preserved remains exposed in evaluation trenches 7 and 18 resulted in the excavation of Area 2, located in the northern part of the development site (Fig 16). The trench measured 45m east/west and 22m north/south, targeting Georgian villas that lined The Crescent (Plate 67). Natural deposits of sand and gravel (3000) were encountered between 0.35m and 1.2m below the modern ground surface. The deposit was covered by a modern demolition layer (3001), which was located beneath the modern ground surface, comprising wasteland and pockets of overgrown vegetation.

Plate 67: Aerial view of Area 2 from the eastern limit of excavation, looking west

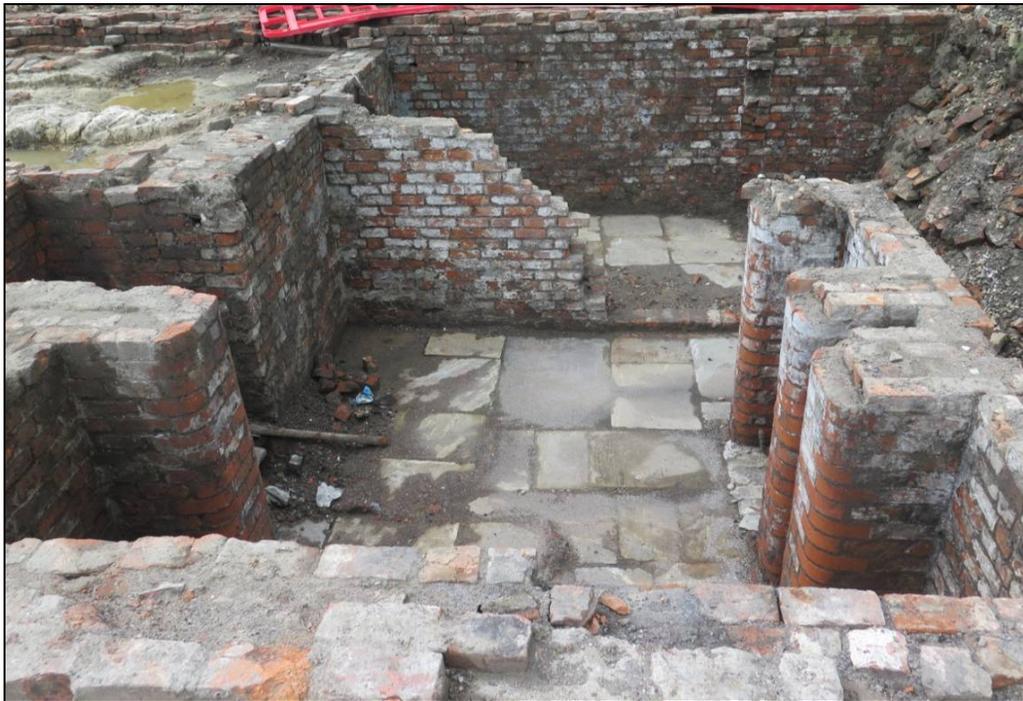
Plate 68: Building 1, Room 1 and Room 2, looking west

Within Building 1 were the remains of several rooms, Room 1, measuring 5 x 3.8m was formed by walls 3002, 3005, 3006 (measuring 5 x 0.24 x 1.90m) and wall 3007 (10 x 0.44 x 1.90m). Single-skin wall 3009 survived at foundation level, measuring 0.75m long. Wall 3009 was situated within Room 1, which had formed part of a stone and brick staircase that gave access to the cellar, however this was removed during excavation. The floor surface was partially paved with flagstones 3008 (Plate 68).

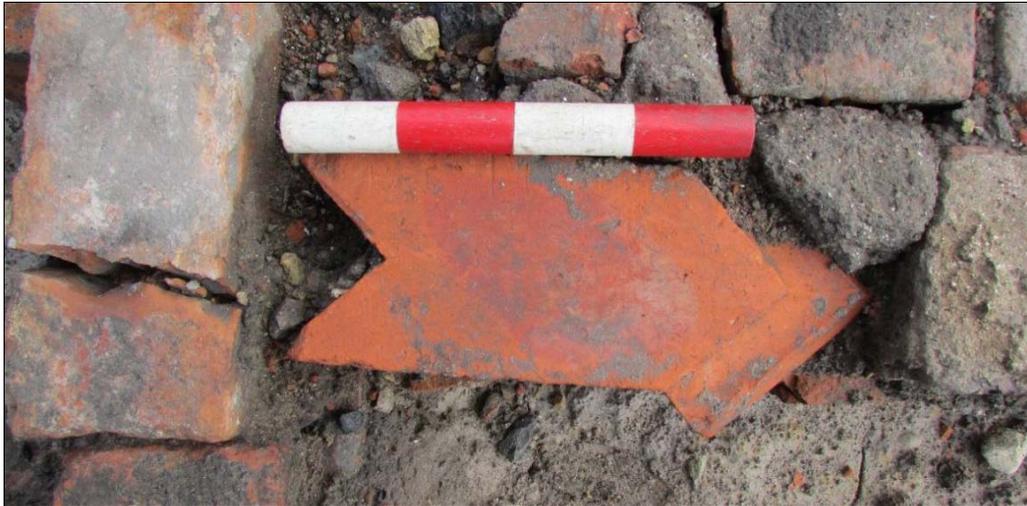
Room 2 was situated to the east of Room 1, and was bound by walls 3006, 3007, 3010 (1.18 x 0.24m), 3011 (9 x 0.24m), 3012 (1.6 x 0.48m x 2m) 3003 and 3004 (4.7 x 0.24 x 1.65m). The floor surface was paved with flagstones 3008, which covered the entire floor space, measuring 6.5 x 5m. A recess was built into wall 3007, measuring an area of 1.18 x 1.14m, formed by walls 3010 and 3011. The northern part of wall 3011 extended into Room 2 to form a buttress constructed from bullnose bricks. At the top of wall 3011 was an arrow-shaped brick (Plate 69). At the base of wall 3011 were the remains of a door jamb, measuring 0.18m long implying that the recess formed a storage cupboard. Wall 3012 adjoined wall 3011, a flagstone was used in the construction of wall 3012, situated 1.10m from the top of wall. It is possible that the flagstone formed a shelf.

Plate 69: An arrow-shaped brick located near wall 3011

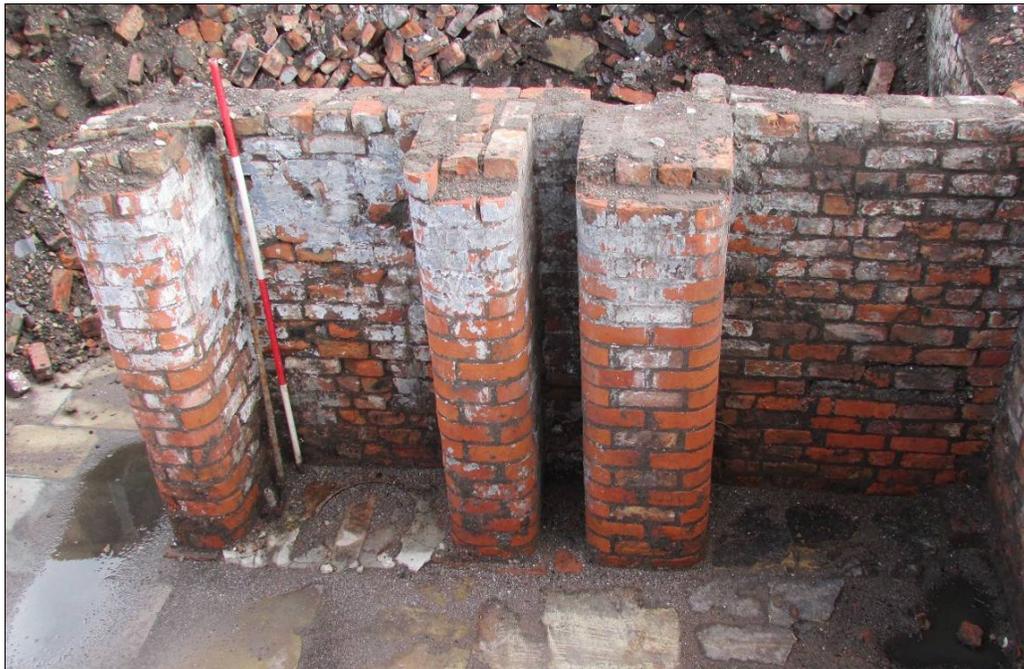
Plate 70: Remains of gas pipe in the 'smithy', looking north

Four buttresses extended from wall 3004, three extended south into Room 2, while one extended north into Room 3. The buttresses extended 0.48m from wall 3004, survived to a height of 1.65m and measured between 0.35m and 0.48m wide (Plate 70). All of the buttresses were constructed using bullnose bricks. Between the two most western buttresses was a gas pipe, with the flagstone on the floor having a circular imprint, possibly from a boiler. The remains of Room 3 was located to the north of Rooms 1 and 2, but was not fully exposed during the excavation. The exposed floor surface was paved with flagstones 3008, which continued through from Rooms 1 and 2, covering an area of 10 x 4m.

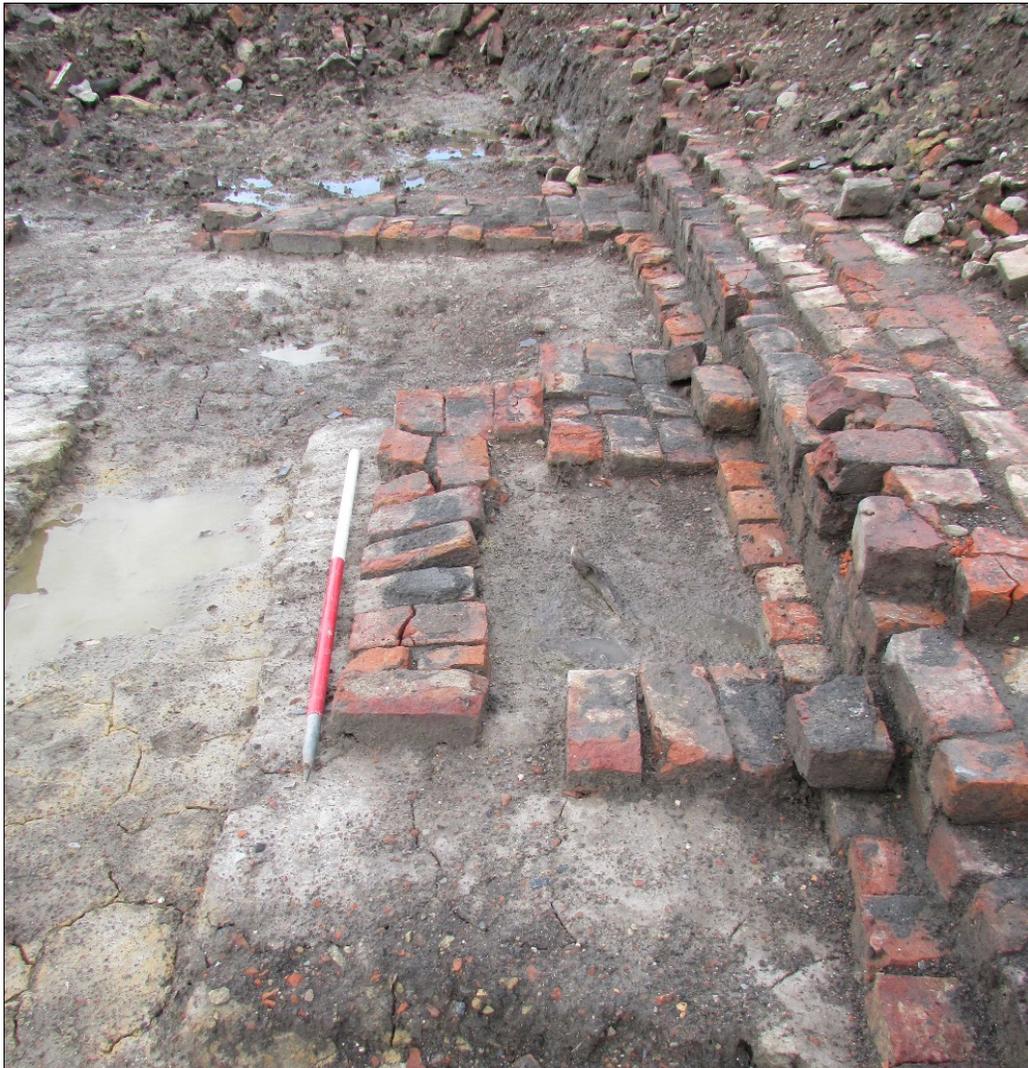
Plate 71: Brick feature 3013, looking south

To the south of Building 1 were a series of hand-made brick walls, most of which survived at foundation level, laid on natural sand 3000. Wall 3002 continued, surviving up to three-courses high, bonded with black mortar, extending beyond the southern limit of excavation. The remains of Room 4, formed by walls 3002, 3007, 3015 (4 x 0.35m), and 3016 (3.35 x 0.46m), was situated to the south of Room 1. Wall 3015 and 3016 were bonded with black mortar. A square brick feature, 3013, measuring 1.4 x 0.7m, extended to the east of wall 3003, surviving up to one course high (Plate 71). To the east of feature 3013 was single-skin wall 3014, measuring 0.72m, and surviving up to one course high.

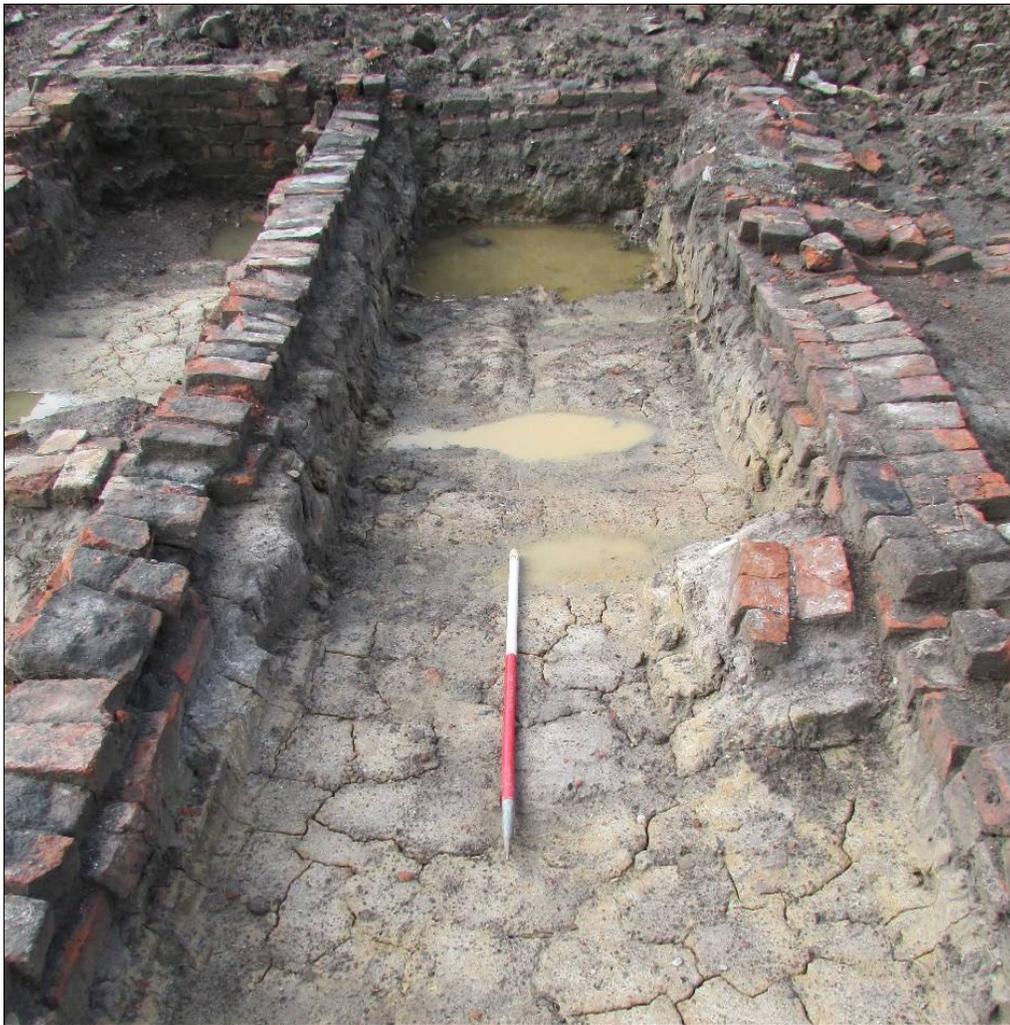
Plate 72: Walls 3011, 3017 and 3018 forming a rectangular feature

The remains of walls that formed a rectangular-shaped feature were exposed to the east of Room 4. The rectangular-shaped feature was demarcated by walls 3015, 3010, 3011, 3017 (1.7 x 0.24 x 0.14m) and 3018 (1 x 0.24 x 0.14m), which were bonded with black mortar (Plate 72).

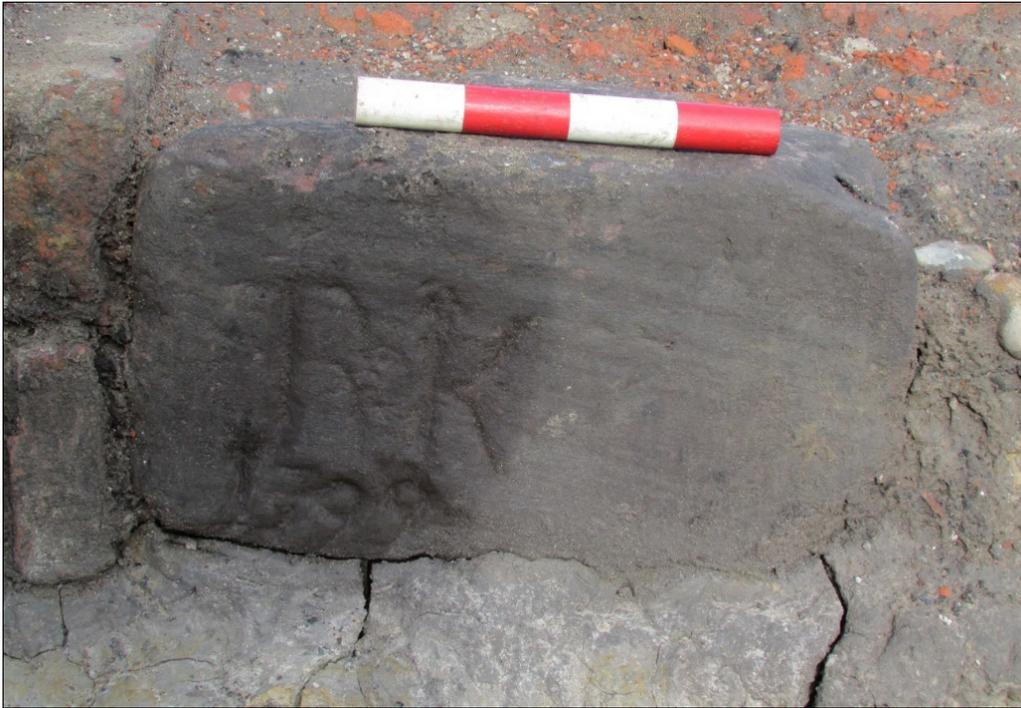
Plate 73: Stone included in brick wall 3003, showing masons mark

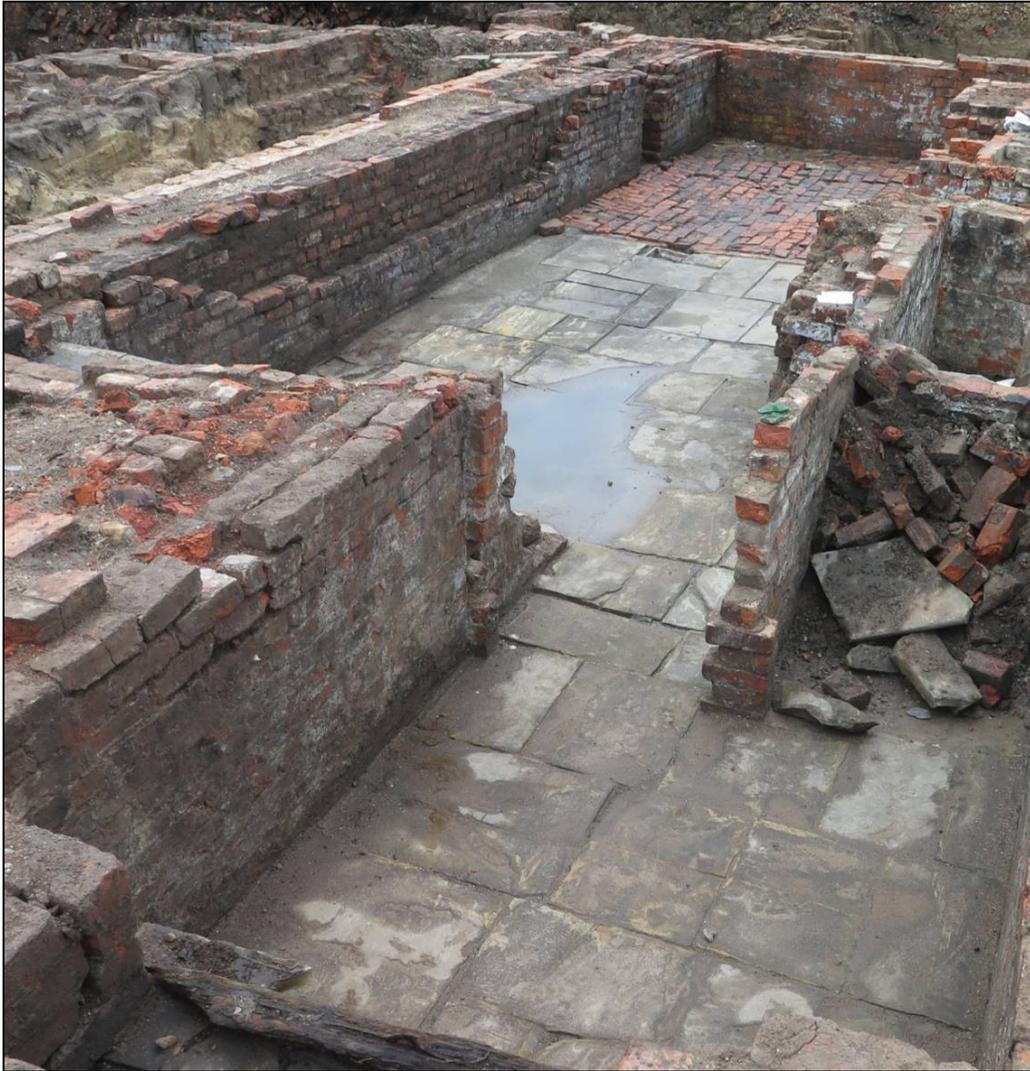
Plate 74: From the background to the foreground Room 1, 2 and 3 House 5, looking north-west

House 5 was demarcated by walls 3026 (7.83 x 0.24 x 1.10m), 3027 (1.10 x 0.24 x 1.10m), 3029 (0.40 x 0.60m), 3030 (5.21 x 0.35 x 0.38m), 3031 (0.60 x 0.24m), 3032 (5.7 x 0.24 x 1.09m), 3033 (3 x 0.24m), 3034 (3.1 x 0.23m) and 3047 (1.27 x 0.23 x 0.64m), all of which were bonded with sandy mortar. Wall 3026 and wall 3027 were the same walls, originally formed by a single-skin wall bonded with sandy mortar, both walls had a later skin of bricks added, bonded with cement mortar. A small alcove was built within wall 3026 and 3027, surviving to a maximum height of 0.75m. All the walls had remains of blue lime wash on them. Within House 5 were the remains of four rooms (Plate 74).

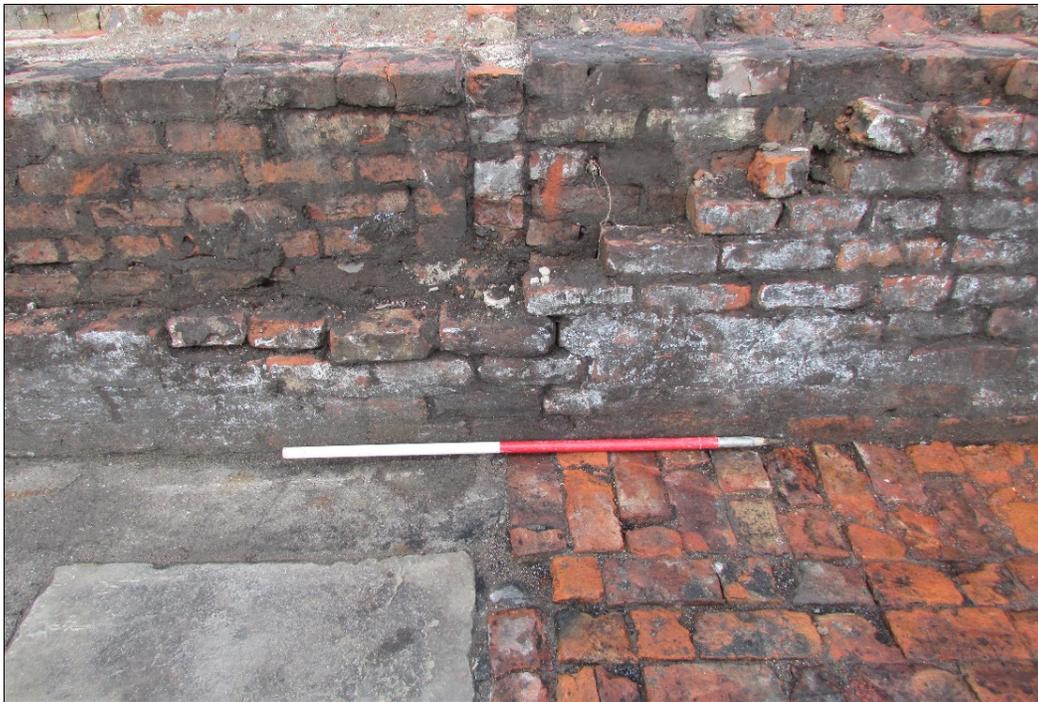
Plate 75: Wall 3026, looking west

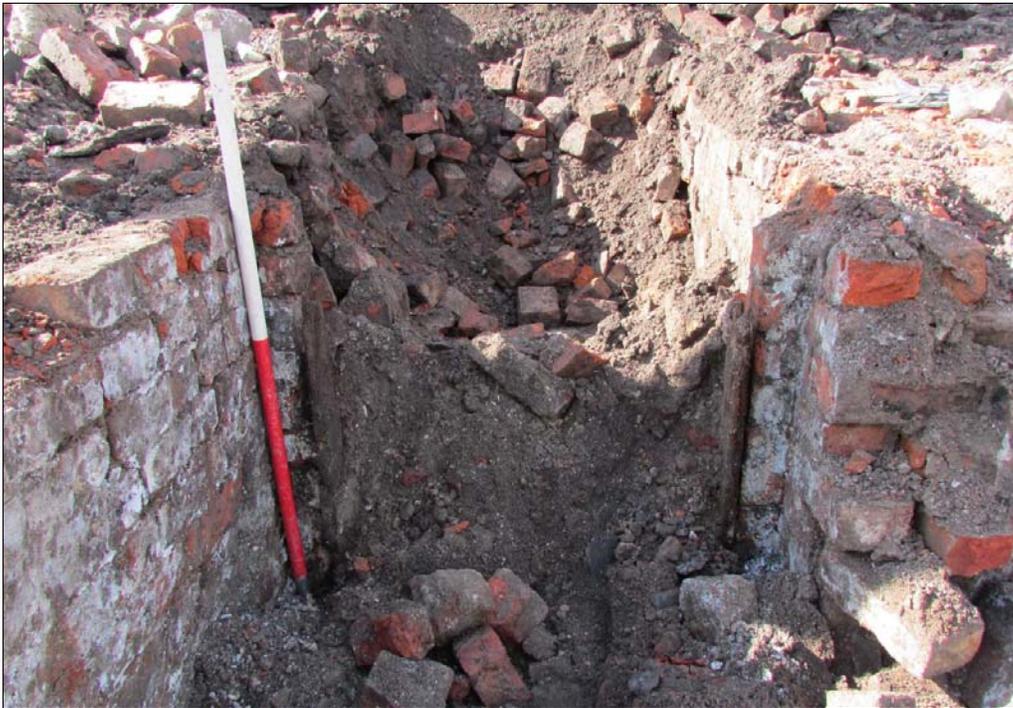
Plate 76: Doorway between Rooms 2 and 3, looking south

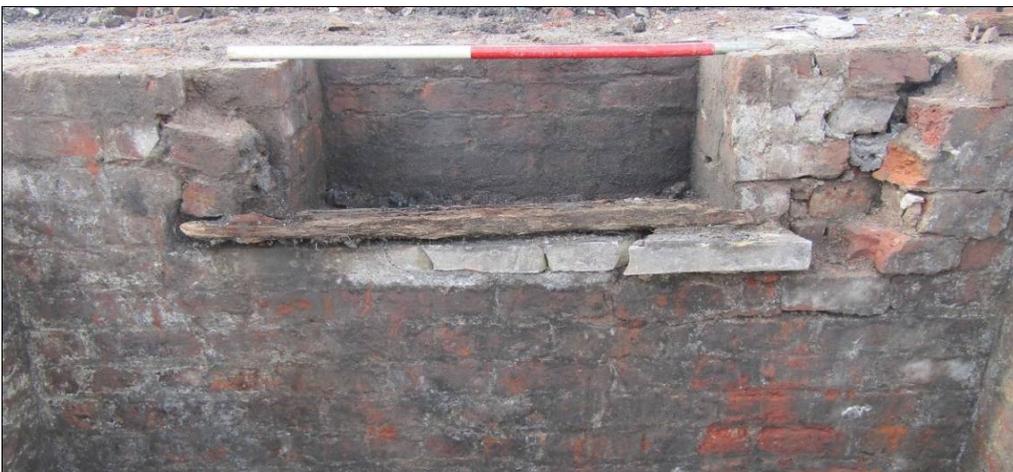
Plate 77: Cellar light 3046 in wall 3033, Room 3, House 5, looking south

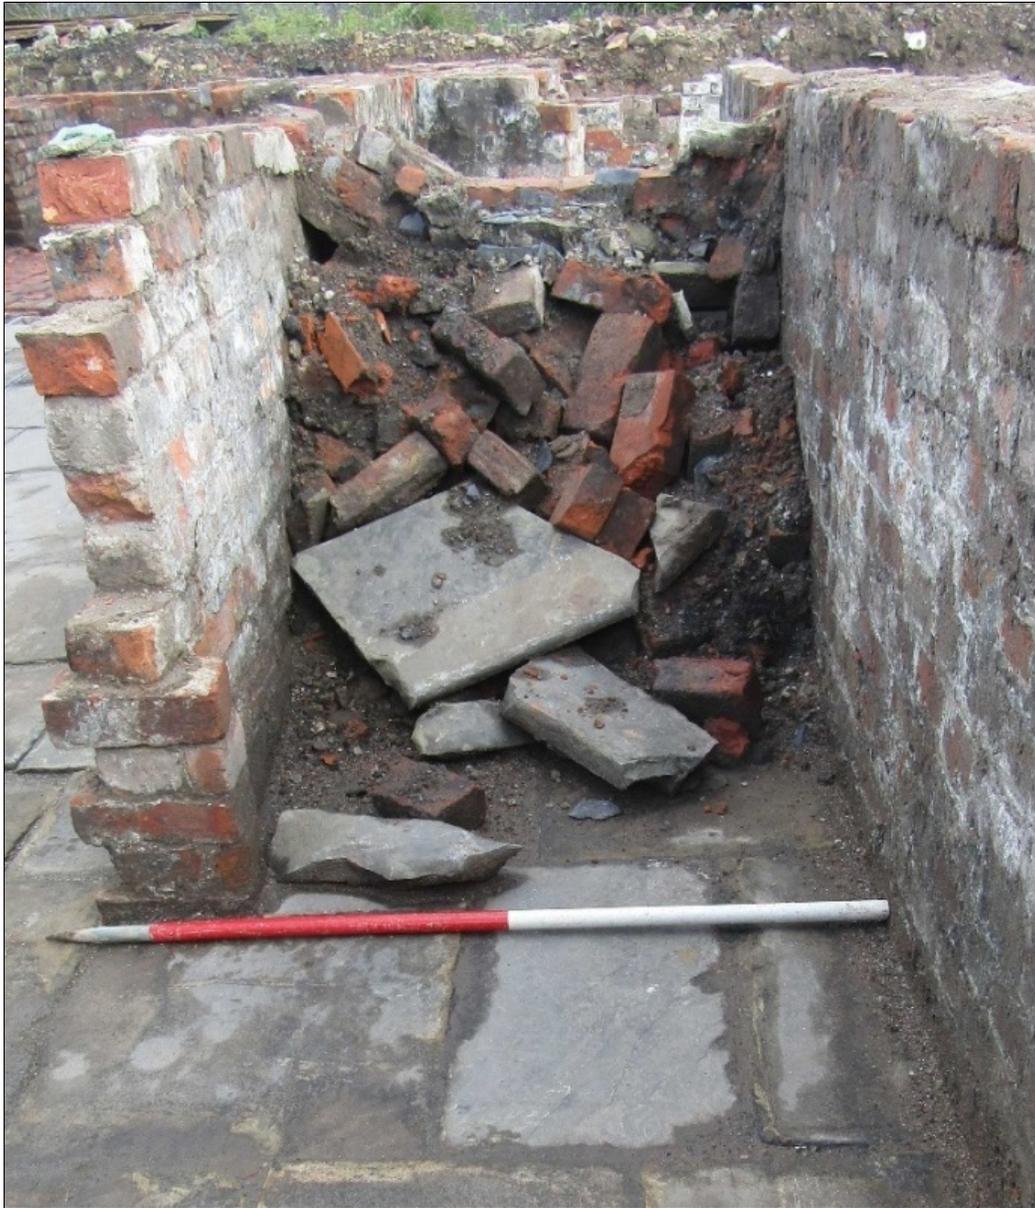
Plate 78: Possible cupboard underneath the stairs in Room 3, House 5, looking north

Room 3 was situated south-east of Room 2, and was bounded by walls 3044 (2 x 0.24 x 1.09m), 3033, 3032 and 3045 (0.75 x 0.11 x 0.92m). The entire floor was paved with flagstones 3043 measuring 2.31m north/south and 1.96m east/west. Wall 3033 was bonded with two different types of mortar from the east; 0.90m of wall 3033 was bonded with sandy mortar while the remaining 1.54m was bonded with cement mortar. wall 3033 also contained window light 3046, measuring 1.16 x 0.30m (Plate 77) A stone slab formed the base of the window light followed by a piece of wood, measuring 1.14 x 0.14m. In the north-east corner of Room 3 was a small opening measuring 0.75 x 0.80m, which may have formed a small cupboard (Plate 78).

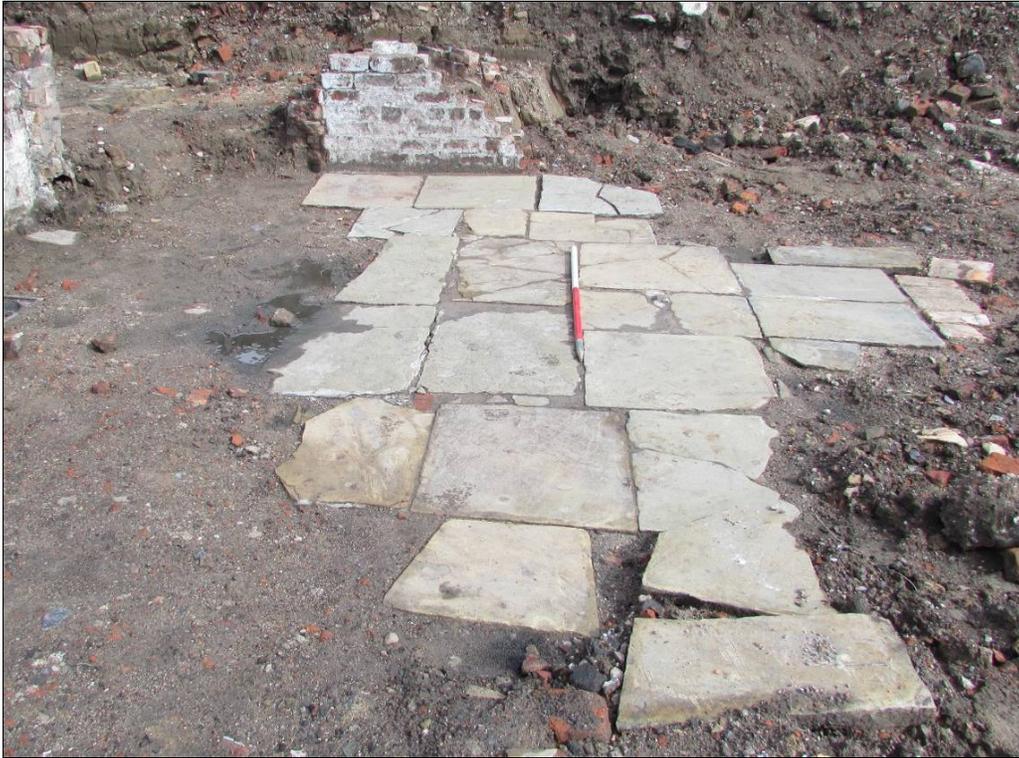
Plate 79: The northern half of Room 4, showing partially surviving bay window wall 3045, House 5, looking north

Walls 3045, 3039, 3030, 3031, 3028, 3036 and 3039 demarcated Room 4. Damaged flagstones 3047 formed the floor, surviving in the north and south-east part of the room (Plate 79). Wall 3031 survived at foundation level, but had been cut by a ceramic drain to the east. Wall 3045 was situated at the northern extent of the house and would have formed part of a bay window. A ceramic drain was visible next to blocked-up doorway 3028.

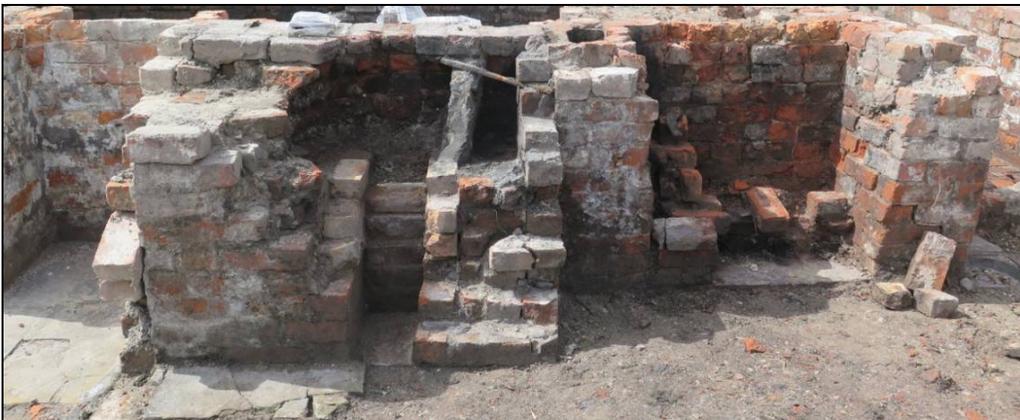
Plate 80: Boiler 3050 and fireplace 3049, looking west

Other features within Room 4 included brick fire range 3049 that was incorporated into wall 3036, measuring 0.93m wide. Two walls, measuring 0.50 x 0.36 x 0.68m and a large flagstone situated at the base, formed fire range 3049. Directly to the south of 3049 was structure 3050 that was likely to have formed a boiler, measuring 1.35m wide. Structure 3050 comprised fire bricks, curved bricks where a copper boiler would have sat and a smaller structure to the north, which would have formed a chimney. Structure 3050 was a later addition, the brick dimensions were slightly larger 230 x 105x 75mm and bonded by black mortar (Plate 80).
