Archaeological Excavation and Historic Building Investigation

Local Crescent,
The Crescent,
Salford

Report No:
2019/25

Document Type: Archaeological Excavation and Historic Building Investigation Report

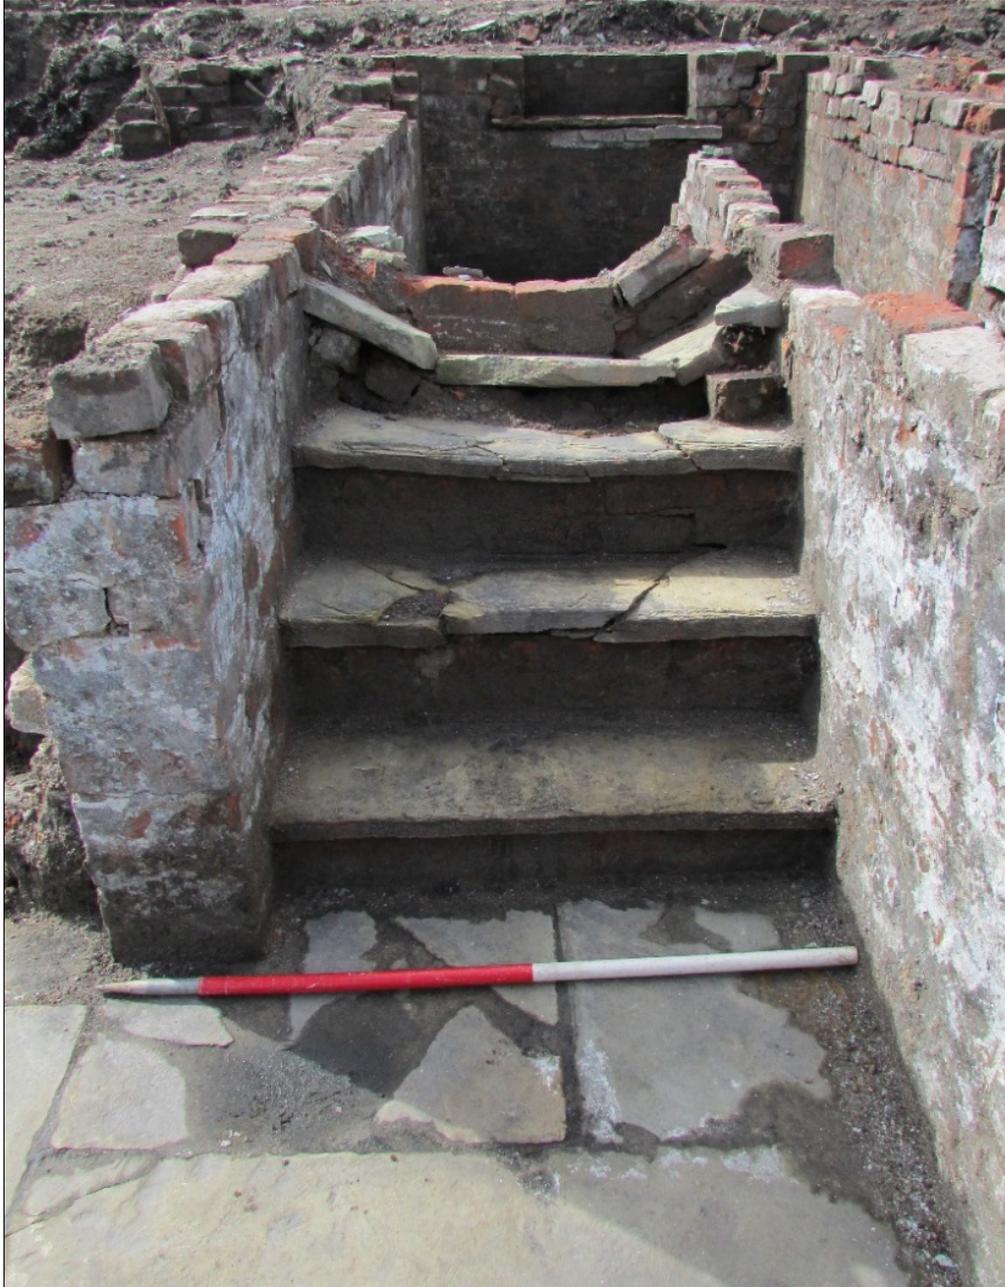
Plate 81: Stone steps in Room 4, House 5, looking south

Staircase 3051 was situated in the south-west corner of Room 4, built into walls 3039 and 3045. Staircase 3051 comprised four steps each formed by two courses of hand-made bricks forming the risers and flagstones used for stair treads (Plate 81).

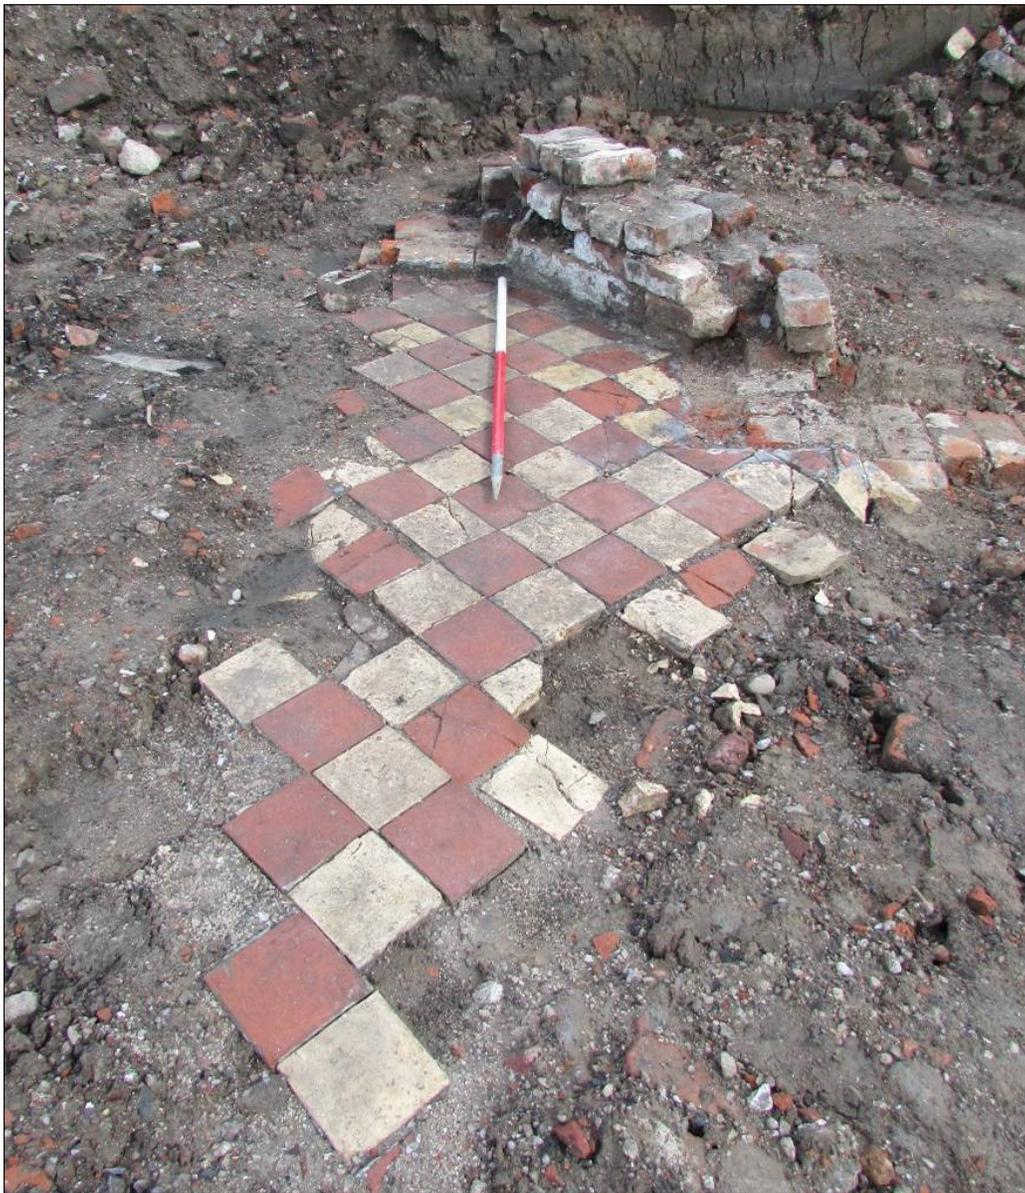
Plate 82: Floor 3059 and wall 3052 in Room 1, House 6, looking north

Room 1 was situated in the north section of the house, fronting Crescent Parade. Walls 3052, 3029 and 3060 (0.24 x 0.23m) demarcated Room 1. Wall 3060 was likely to have formed the dividing wall between Room 1 and 2, however, wall 3060 had been truncated by modern trial pits. Red and cream-coloured quarry tiles formed the floor, 3059, partially survived on the western side of the room, measuring a maximum length of 2.47m and a maximum width of 1.39m (Plate 82).

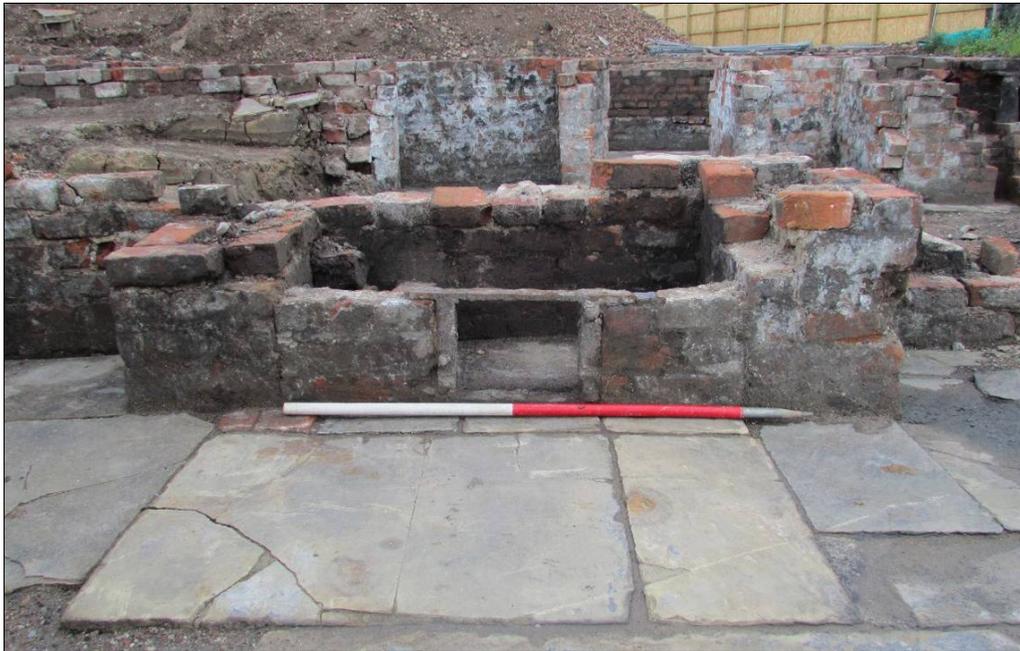
Plate 83: Fireplace 3064 in Room 2, House 6, looking west

Room 2 was situated to the south of Room 1, and was bounded by walls 3030, 3060, 3057, 3061 (2 x 0.23 x 0.93m) and 3062 (0.75 x 0.23 x 0.54m). Wall 3061 formed an L-shaped wall situated in the south-east corner of the room. Flagstones 3062 formed the floor in Room 2, covering an area of 5 x 4.7m. In the southern part of Room 2, flagstones 3062 had been truncated by modern trial pits. Fireplace 3064 was built into wall 3030, measuring 1.76 x 0.35 x 0.38m and was bonded with a lime mortar (Plate 83). The mantel face and metal frame was likely to have been a later addition, as the bricks used to construct this part of fireplace 3064 were not keyed into the rest of the brick structure.

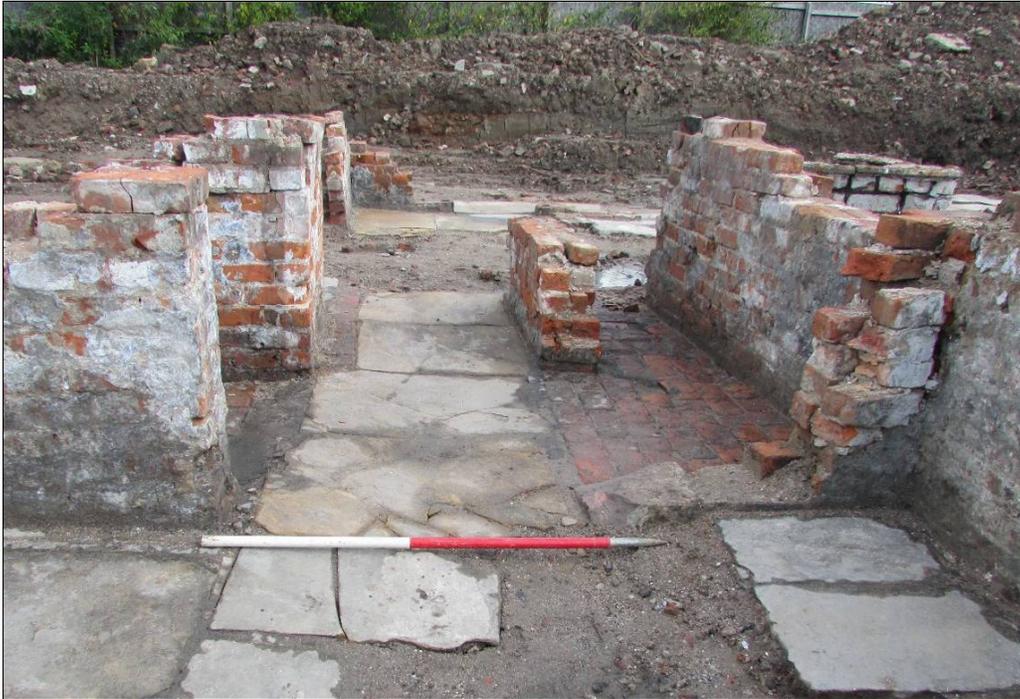
Plate 84: Room 3, House 6, looking north

Room 3 was located to the east of Room 2, and was formed by walls 3062, 3054 and 3061 (Plate 84). Room 3 measured a total area of 4.93m by 1.83m, and was divided by wall 3065, measuring 0.60 x 0.24 x 0.57m. On the west side of the wall, the floor comprised flagstones 3066 (4.93 x 1.7m), while on the east side of the wall the floor surface was formed by bricks 3067 (2 x 0.80m).

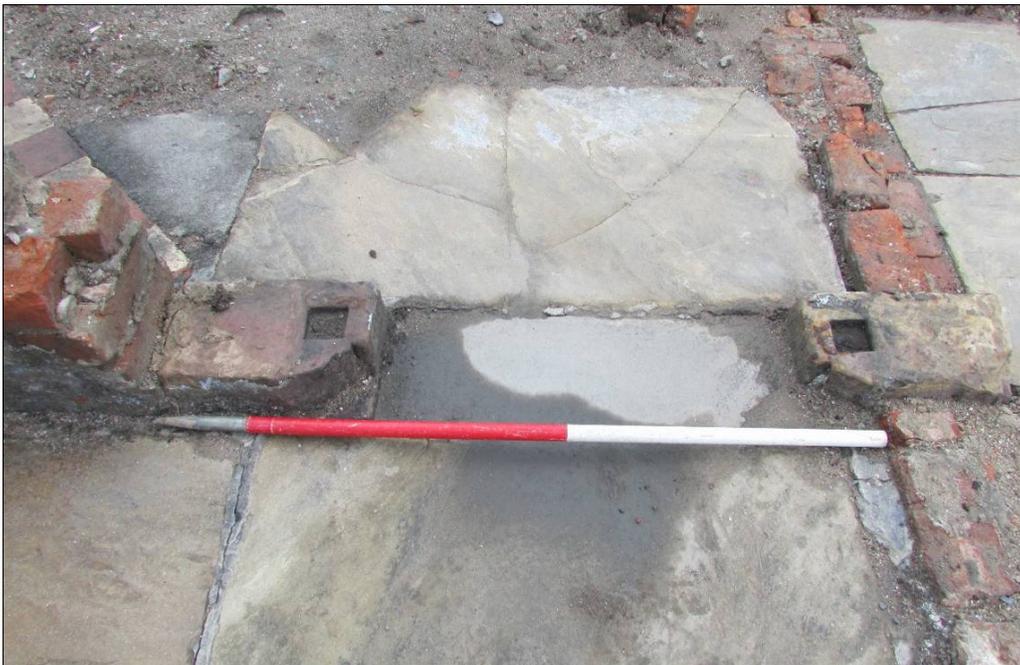
Plate 85: Door jambs between Rooms 3 and 5, House 6, looking north

A doorway measuring 0.75m wide led through into the area that was paved with brick surface 3067, which presumably formed a storage cupboard. Three other doorways were visible in Room 3, one situated in the north-east corner of the room and two in the south-west corner, leading into Room 4 and Room 5. The doorways measured between 0.72m and 1.3m wide, and comprised two stone door jambs (Plate 85). Room 3 is likely to have functioned as corridor providing access to Rooms 1, 2, 4 and 5.

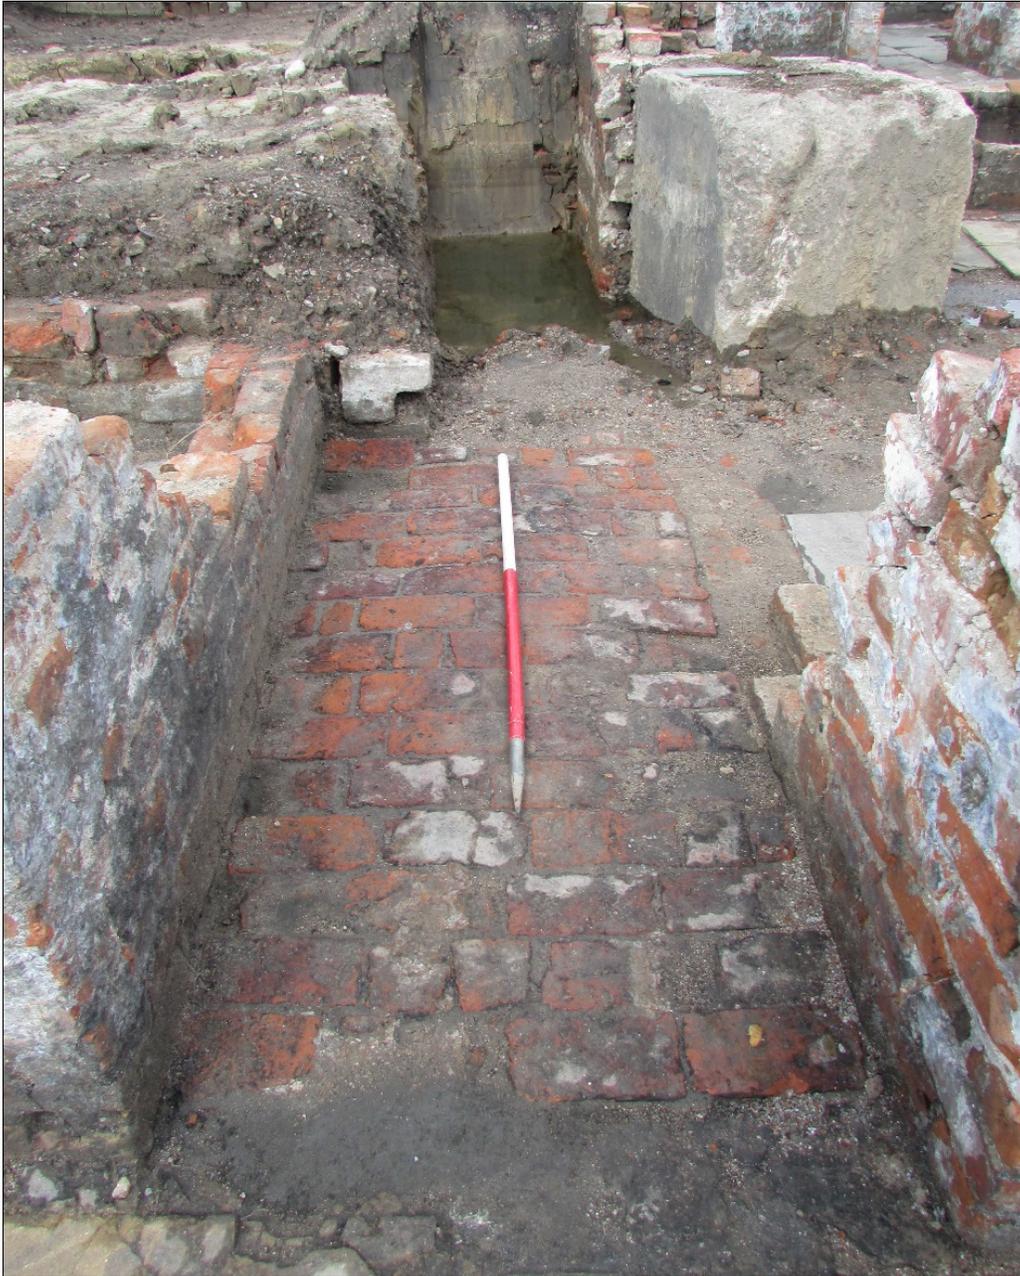
Plate 86: Room 2, House 6, looking west

Walls 3057, 3061 and 3068 (3.91 x 0.23 x 0.93m) demarcated Room 4. Hand-made bricks 3069 formed the floor, which covered an area of 4.69m by 1.30m. Access to the room was gained via Room 3, through a doorway, measuring 1.3m. Room 4 may have formed the base of a stairwell or large storage cupboard (Plate 86).

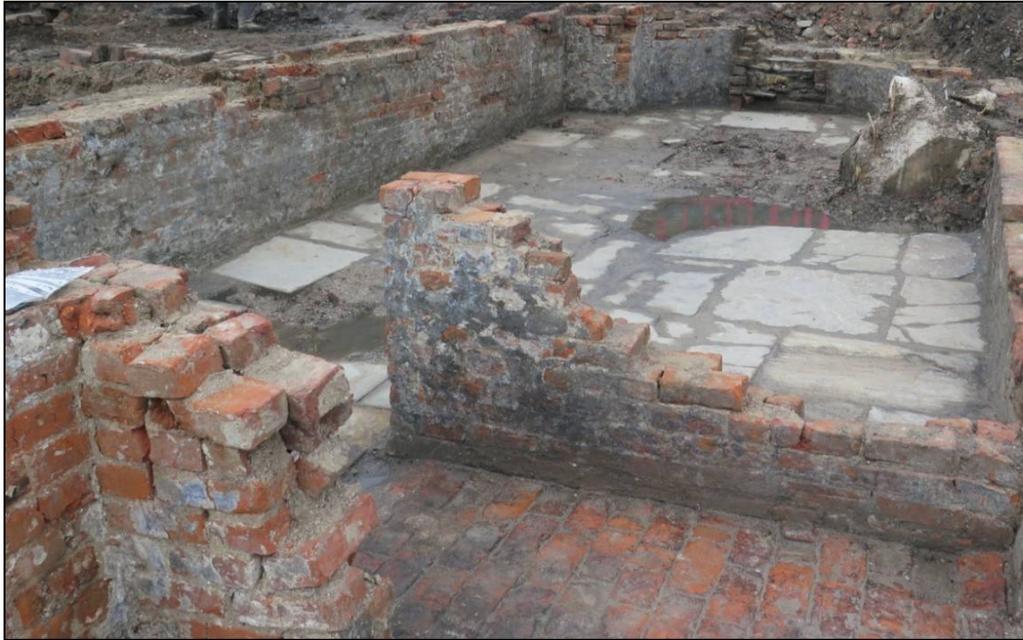
Plate 87: Room 5, looking south

Room 5 was the southernmost room in House 6, formed by walls 3068, 3056, 3055 and 3054 (Plate 87). Wall 3054 was truncated by a concrete block, and later repair work was visible at the base of the wall. A stopped end was visible 1.20m from wall 3055, which showed possible remains of a single course-partitioning wall. All the walls had remains of blue lime wash on them. Flagstones 3070 paved the floor in Room 5, covering an area of 6.32 x 4.5m. A bay window was built into curving wall 3055, constructed using bricks and stone slabs (Plate 88). To the south of the bay window, presumably outside House 6, were the remains of a small patch of maroon and yellow tiled floor which measured 1.25m north/south and 0.58m east/west.

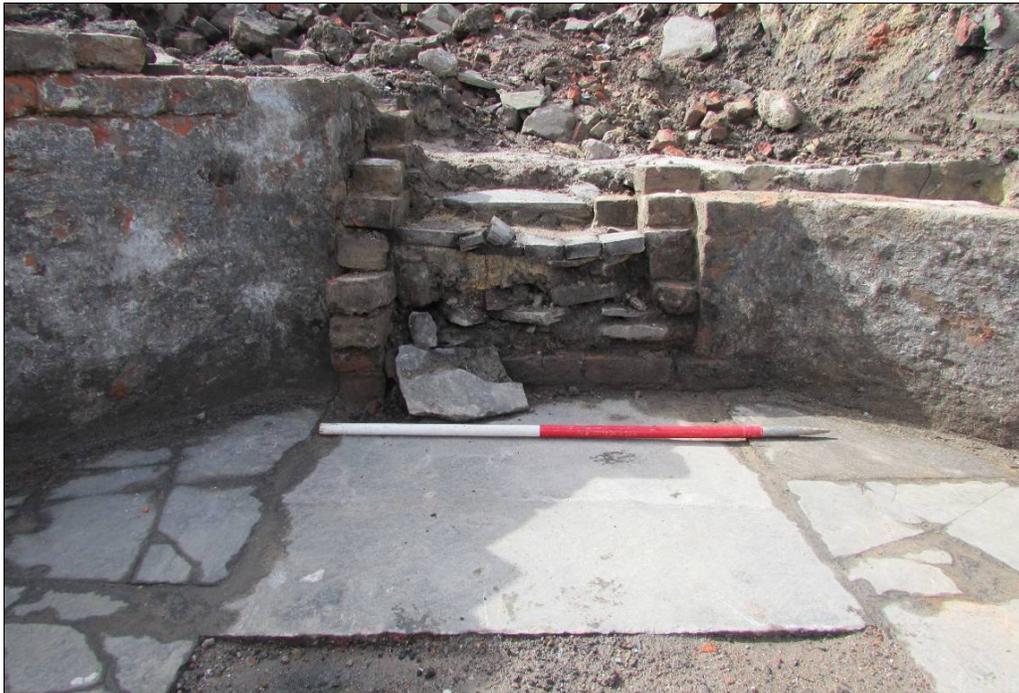
Plate 88: Bay window 3055, looking south

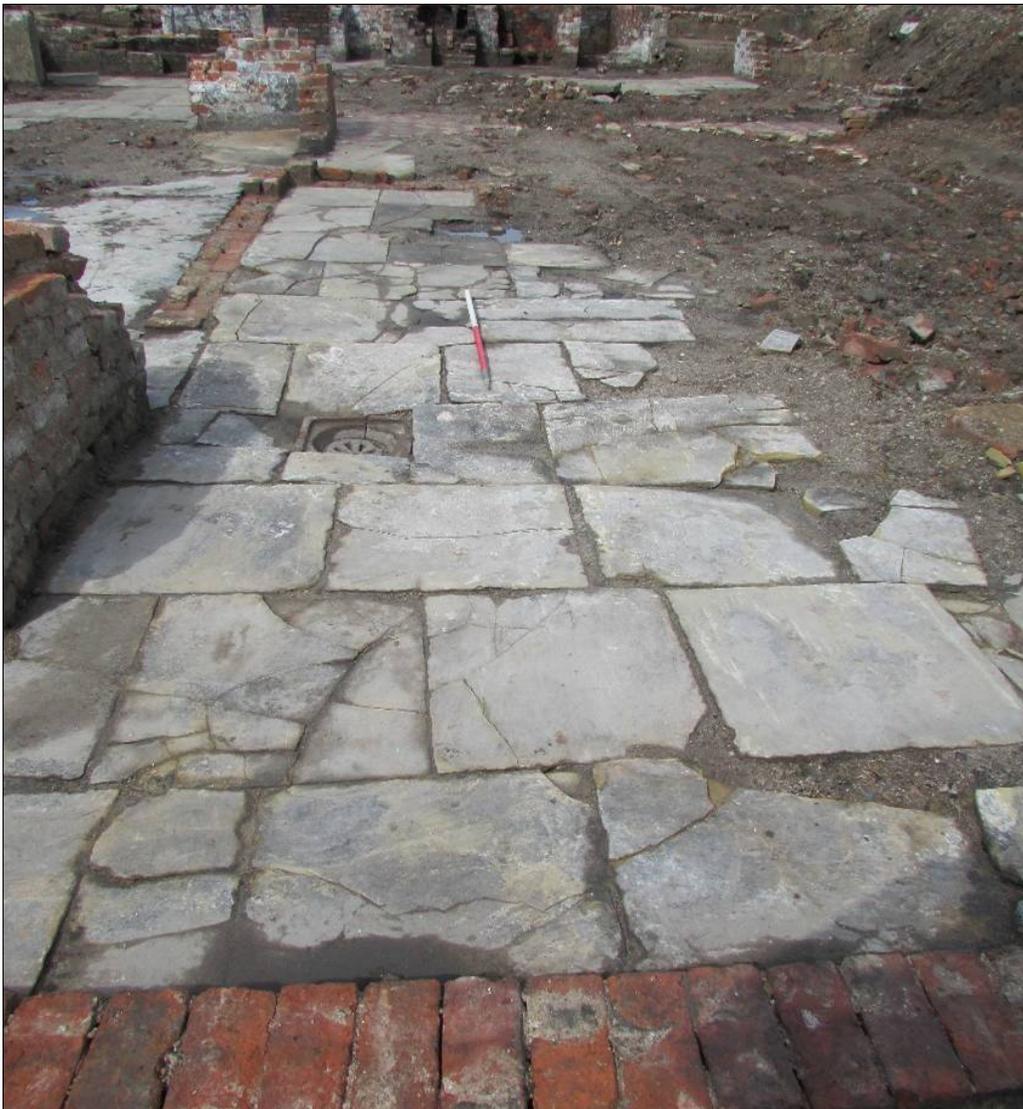
Plate 89, Room 1, House 7, looking west

Room 1 was the northernmost room in House 6, demarcated by walls 3053 (to the east), 3071 (to the west), party wall 3074 (3.08 x 0.23 x 0.23m) and party wall 3076 (1 x 0.23m). Doorways either side of wall 3076 were visible leading to Room 2 and Room 3 (Plate 74). The remains of Room 1 measured 6.16 x 2.47m, an area covered by flagstones 3075, however, the northern part of the room had been partially removed. A ceramic drain, measuring 0.40 x 0.40m had survived in flagstones 3075, located 0.43m from wall 3076.

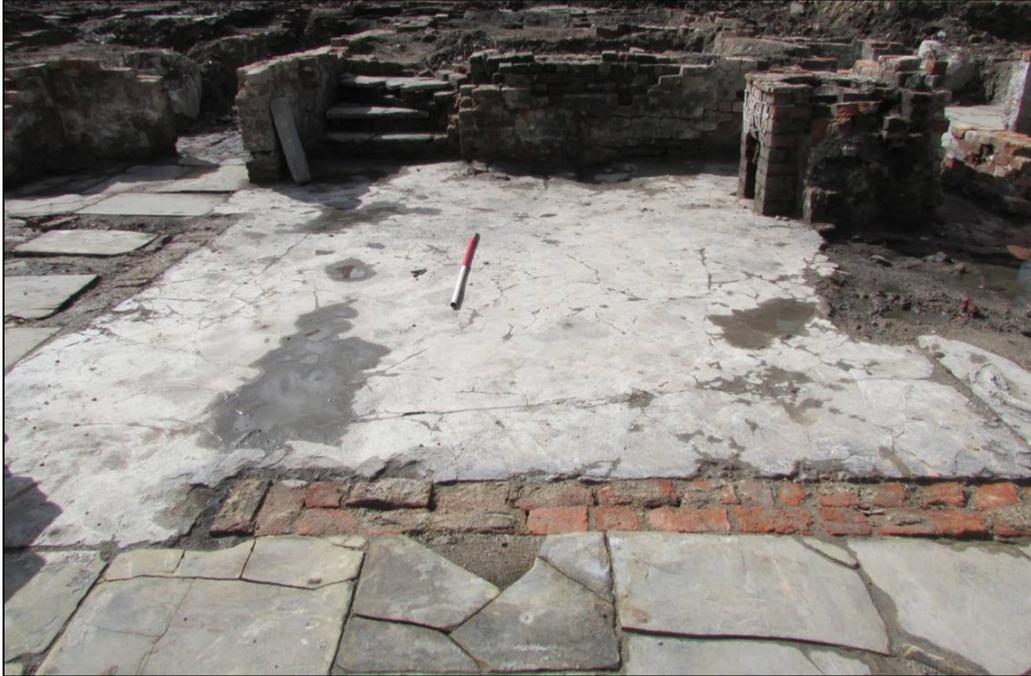
Plate 90: Room 2, House 7, looking south

Walls 3054, 3074, 3078 (6.59 x 0.23 x 0.89m) and 3079 (2.87 x 0.35 x 0.92m) formed Room 2, which was situated to the south of Room 1. Concrete 3077 covered the entire floor, measuring an area of 4.37 x 4.14m east/west. To the north of wall 3079 were the remains of a ceramic drain, which was covered by stone sink that was removed during excavation (Plate 90).

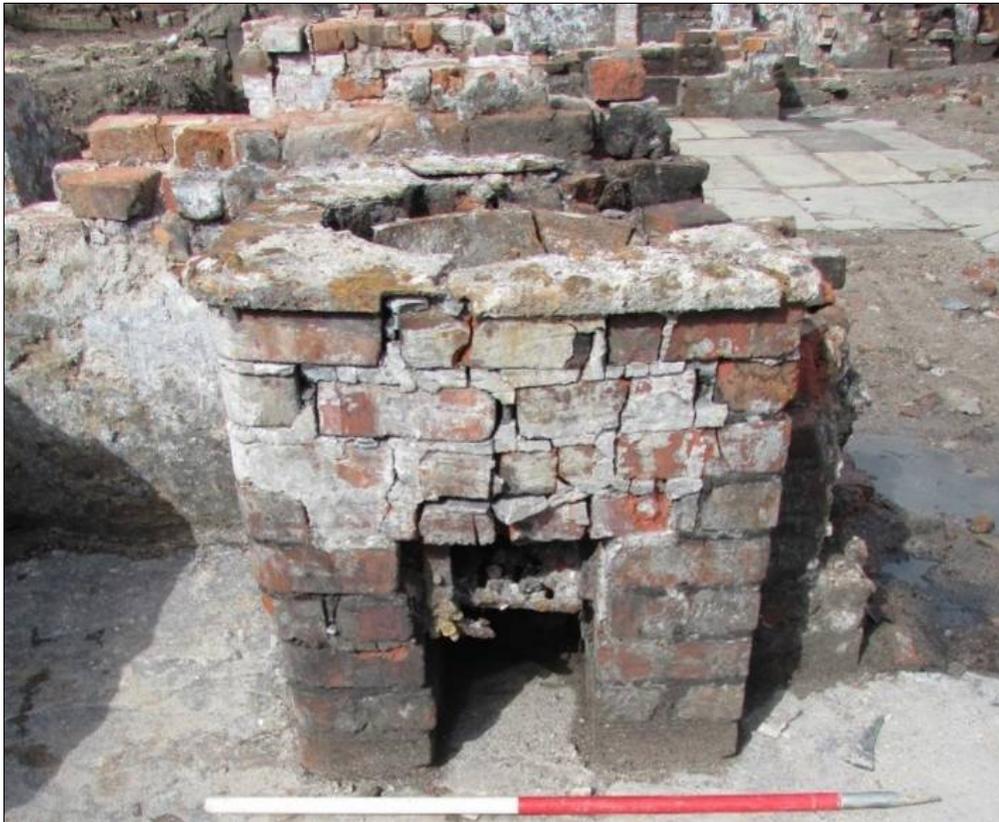
Plate 91: Copper/boiler3070 in Room 2, House 7, looking west

Copper boiler 3080, comprising a copper cylinder and brick-built structure with capped metal plate, measuring 0.74 x 0.74 x 0.83m, was built against wall 3054 (Plate 91). The bricks on the south side of the structure were bull nosed, while other bricks used to construct 3080 were wire cut and had been re-pointed with a white cement mortar. The north-west section of Room 2 had been truncated, which was presumably where a fireplace would have been situated.

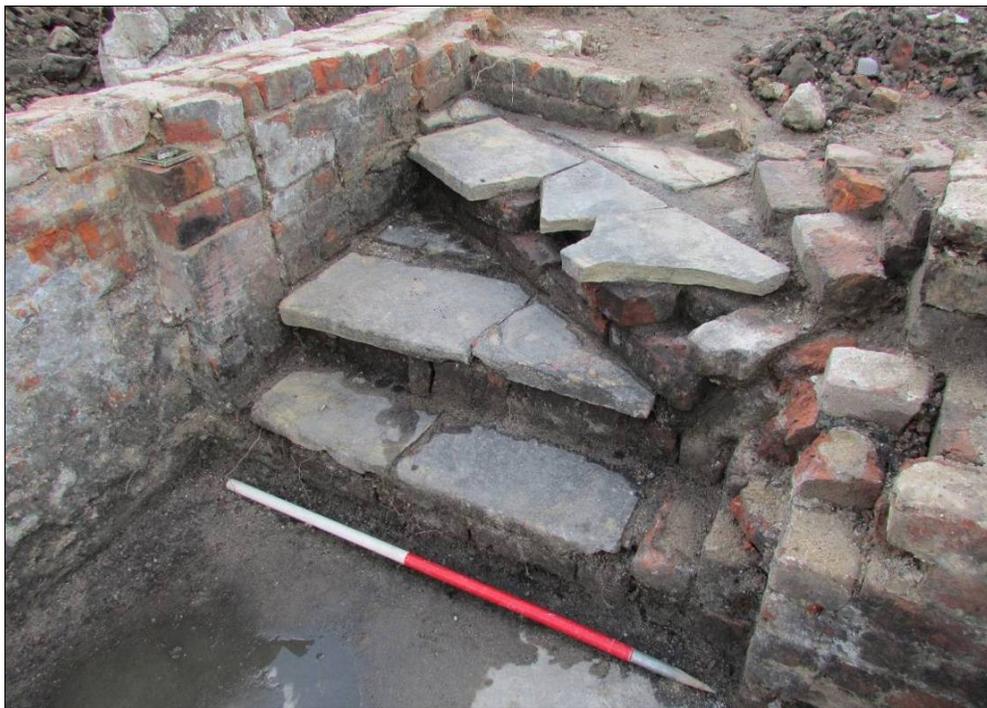
Plate 92: Stone spiral staircase 3081 in Room 2, House 7, looking south-east

Spiral staircase 3081 was built into the eastern part of wall 3079. Staircase 3081 ascended to the south, leading to a yard located at the rear of House 7. Staircase 3081 comprised three steps formed from a flagstone, measuring 0.80 x 0.21 x 0.09m, which was situated above two courses of bricks bonded (Plate 92).

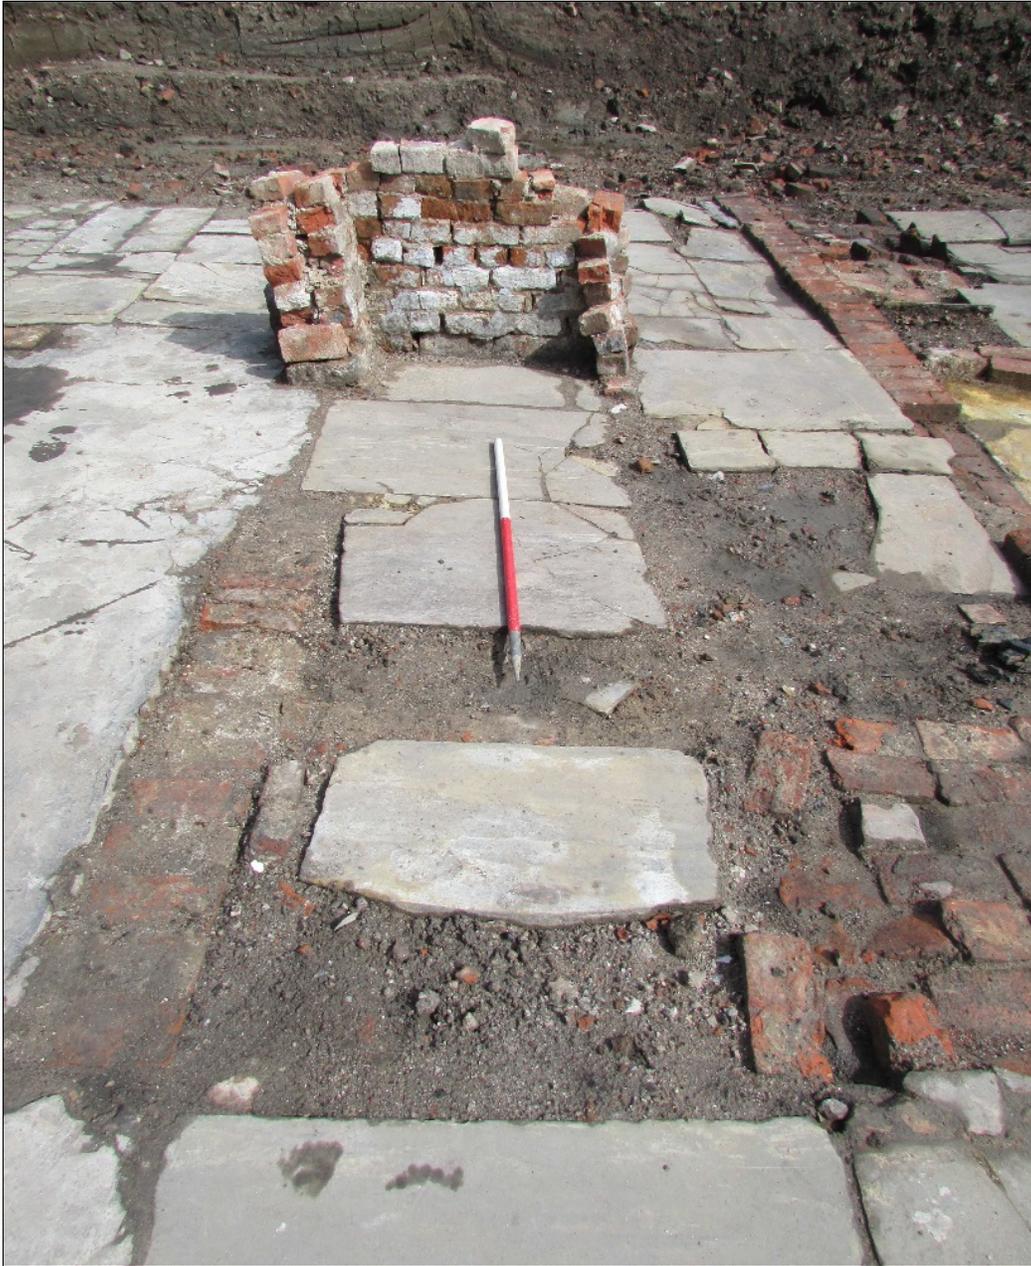
Plate 93: Room 3 and the remains of internal staircase formed by wall 3076, looking north

A rectangular-shaped room, Room 3, measuring 4.44 x 2m, was situated to the east of Room 2. Walls 3071, 3076, 3078 and 3082 (1 x 0.23 x 0.6m) demarcated Room 3 (Plate 93). Room 3 was likely to have comprised, a corridor, entered via Room 1, paved with flagstones 3083 (2.5 x 1m) and bricks 3084 (0.88 x 0.86m). The corridor may have led through to an internal staircase, built into wall 3076, which would have provided access to the first floor.

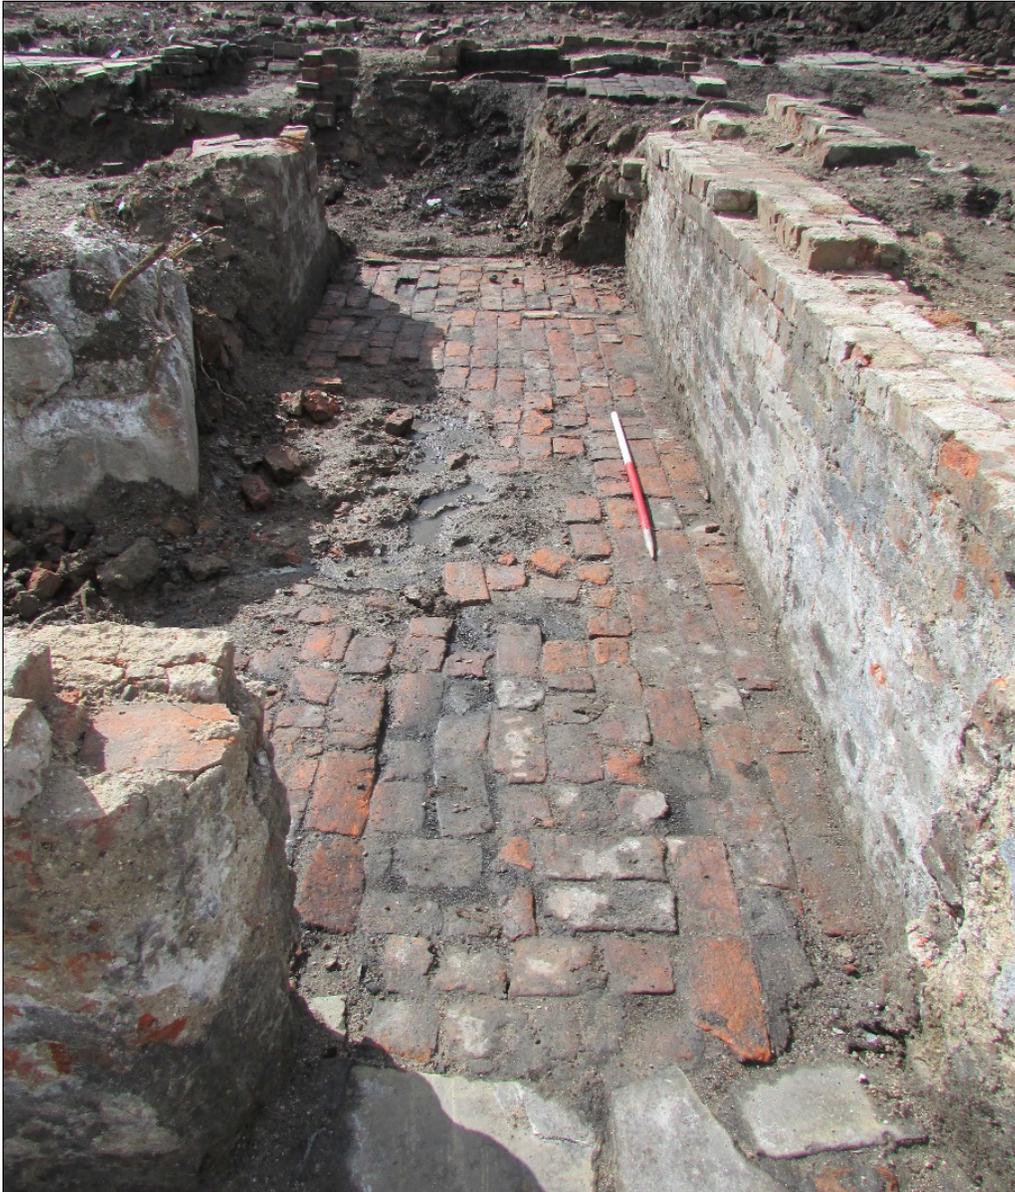
Plate 94: Room 4, House 7, looking south

Room 4 was located to the south of Room 3, with a small doorway measuring 1m wide, providing access. Walls 3078, 3082 and L-shaped wall 3072 demarcated Room 3. Wall 3072 was truncated by a modern concrete block (Plate 94). Hand-made bricks 3084 formed the entire floor, covering an area of 4.93m north/south and 1.66m east/west. When the geo-rectified survey is compared to historic mapping it is clear that the footprint of House 7 was established by 1831 and retained the same footprint throughout the 19th and early 20th century (Figs 18-20). The limited use of black or cement mortar within the structure suggest that few repairs or alterations took place, supporting evidence from cartographic sources.

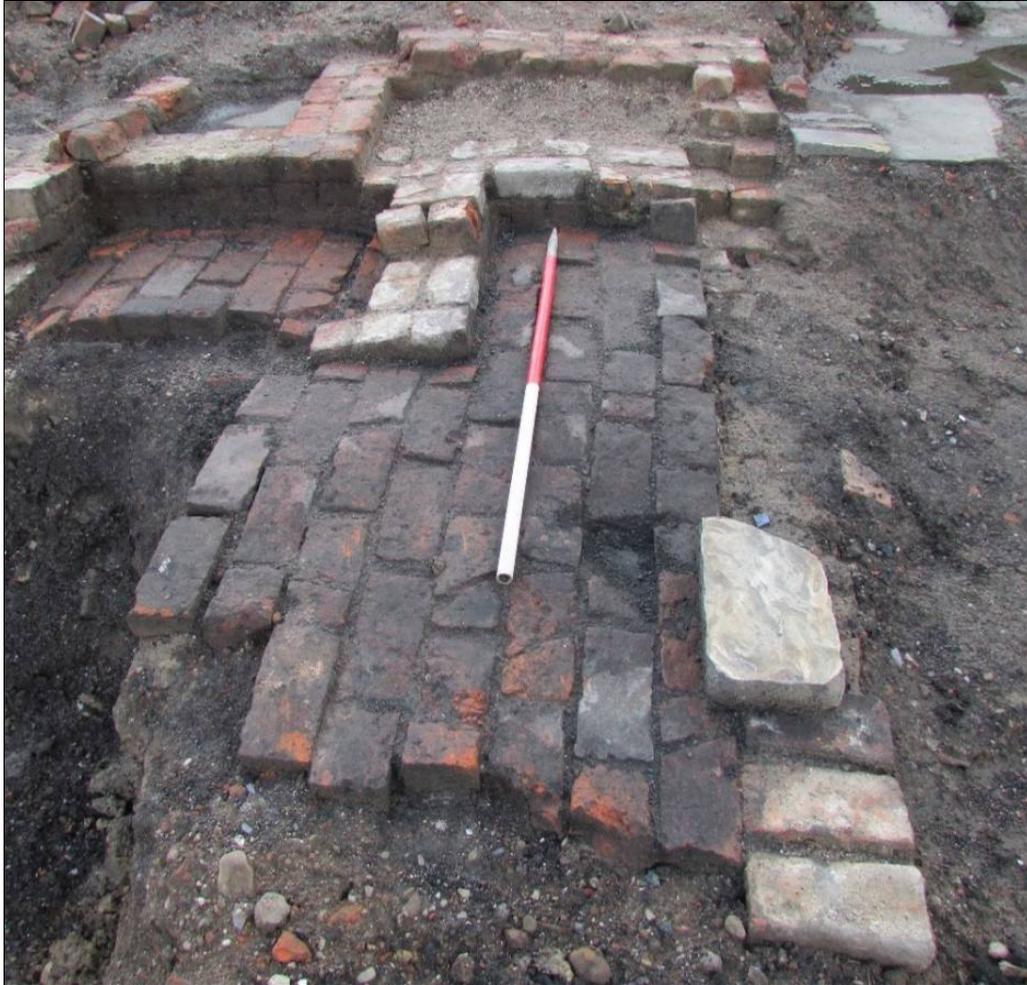
Plate 95: Brick floor 3090 and walls 3073, 3090, 3091 and 3092, looking south

To the east of flagstones 3093 was wall 3073, measuring a total length of 6m). Two buttresses, 3091 and 3092, both measuring 0.35 x 0.23m, extended from wall 3073. At the base of the wall were the fragmented remains of hand-made brick floor 3090, measuring 1.60 x 0.38m (Plate 95).

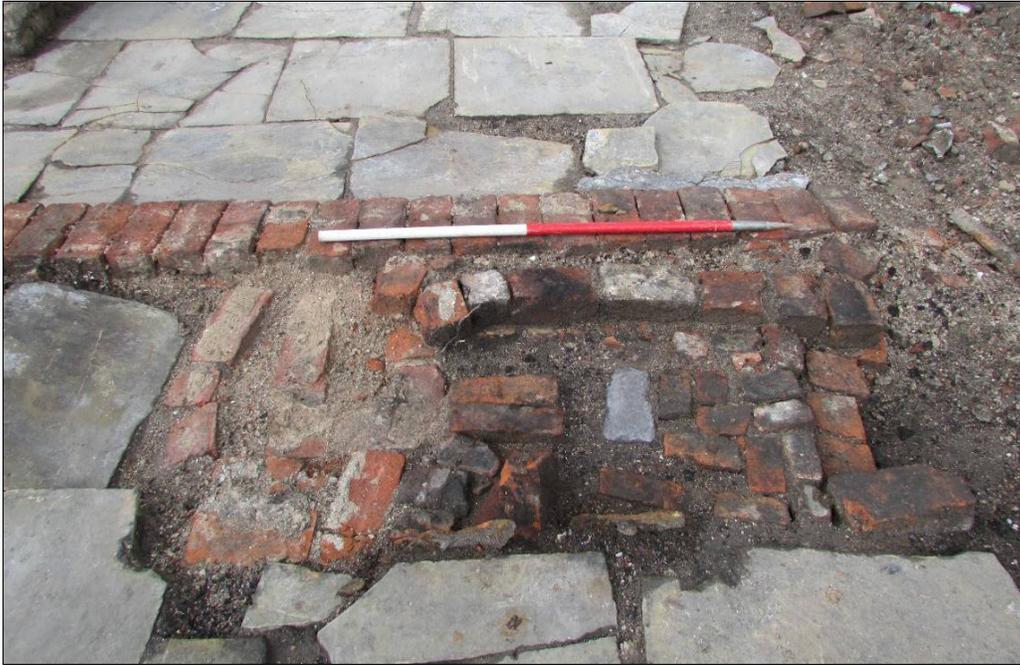
Plate 96: Damaged fireplace in Room 1, House 8, looking west

Room 1 was the northernmost room in House 8, measuring 6.39m east/west and 2.64m north/south, with the partial remains of flagstone surface 3100. Walls 3091, 3071, 3101 (5.44 x 0.35 x 0.92m) and the northern wall of structure 3102 (1.3 x 0.23m) formed Room 1. The poorly preserved remains of brick fireplace 3103, measuring 1.45 x 0.82m, were built against wall 3071 (Plate 96).

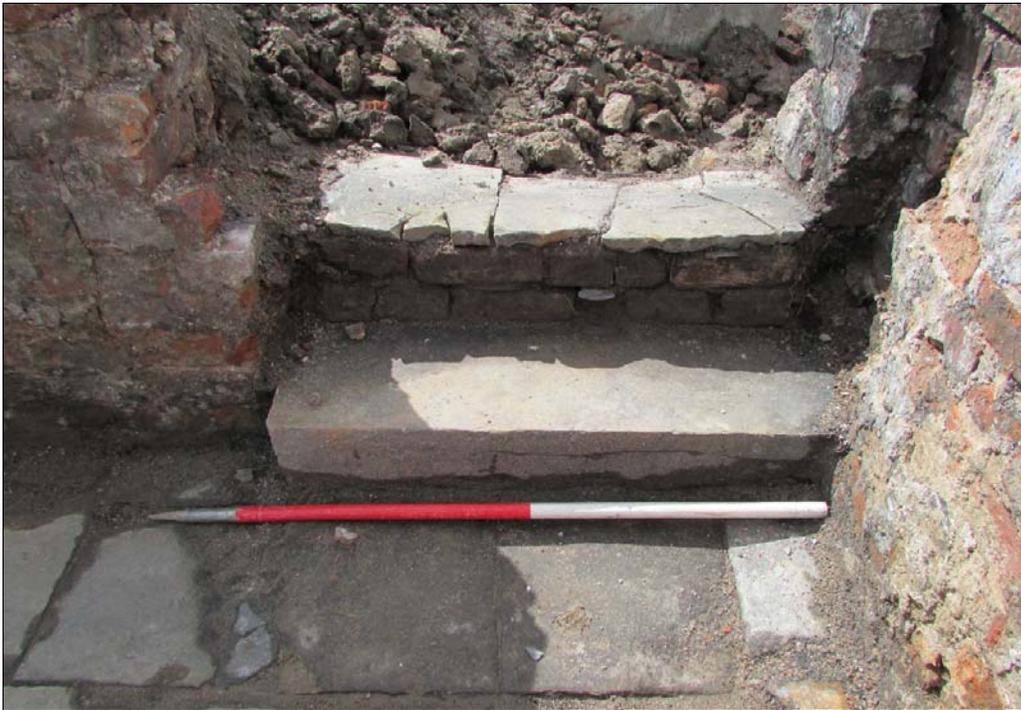
Plate 97: Stone staircase 3105, looking south

Room 2 was situated to the south of Room 1, with a doorway measuring 1.73m wide provided access. Walls 3094, 3071, 3101 and 3098 bounded Room 2, which measured an area of 6.43 x 4.20m, paved by flagstones 3104. A ceramic drain was situated 0.83m north of wall 3098, measuring 0.40 x 0.40m. Two sets of stairs survived in Room 2. Staircase 3105 survived in the south-west corner of the room, comprising two steps constructed from a flagstone set above two courses of bricks, each measuring 1.00 x 0.30m (Plate 97).

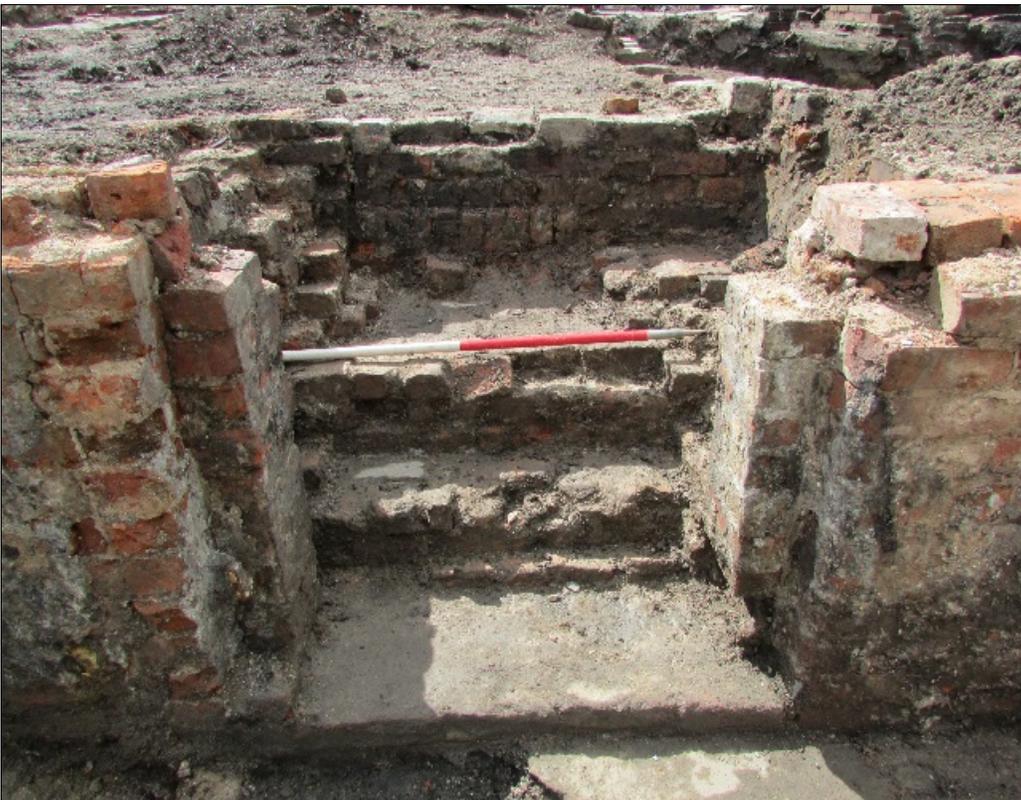
Plate 98: Staircase 3106, looking south

A wall, measuring 1 x 1m, constructed of hand-made bricks bonded with lime mortar had, blocked the second staircase 3106. The wall was removed, revealing staircase 3106, comprising two poorly constructed brick steps. Each step was formed by two courses of hand-made bricks, measuring 1.10 x 0.23m, but none were finished with a flagstone tread (Plate 98).

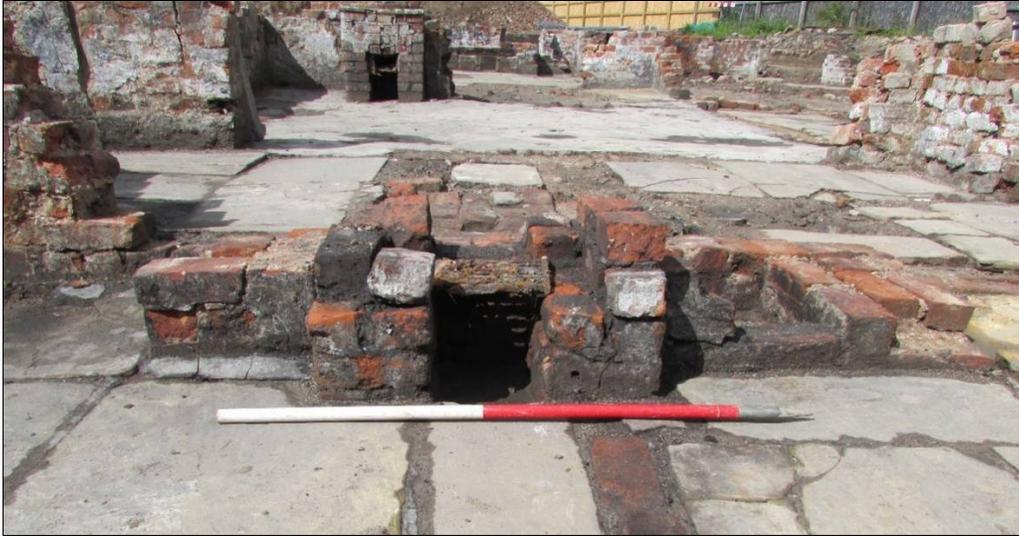
Plate 99: Fireplace 3107 in Room 2, House 8, looking west

Fireplace 3107 was incorporated into wall 3071, measuring 1.93 x 0.60m and comprised two brick-built buttresses that measured 0.53 x 0.40m (Plate 99). A square area, measuring 0.34 x 0.25m, was laid on top of the flagstones, forming the northern part of the fireplace and earliest phase. The central part of 3107, measured 0.67 x 0.48m, comprised the mantelpiece and a metal grate bonded with black mortar implying that later repair work was undertaken.

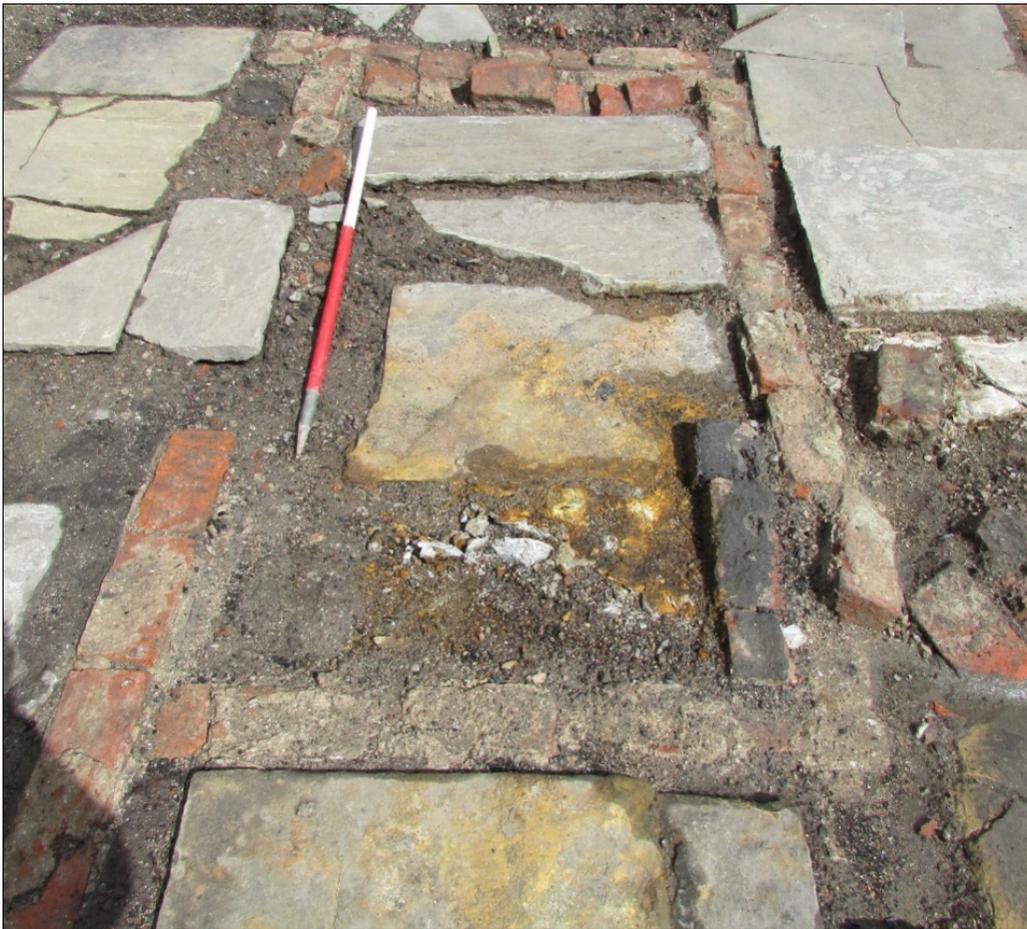
Plate 100: Feature 3102, Room 2, House 8, looking north

Rectangular feature 3102, measuring 3 x 1.3m was situated in the north-east corner of Room 2 (Plate 100). Feature 3102 may have formed the base of an internal staircase, which was presumably accessed via a doorway, measuring 0.85m, located in Room 1. This layout was similar to that recorded in House 7, Room 2. In the same area, a large amount of coal was discovered, which was likely to have been abandoned before the demolition of House 8 commenced.

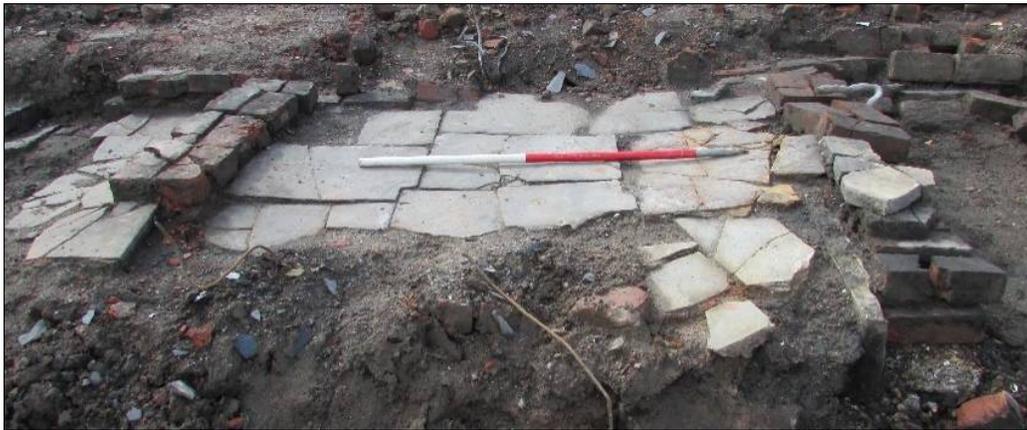
Plate 101: Wall 3108, wall 3073 and flagstones 3112

Three small brick structures were excavated at the rear of House 8, surviving in poor condition. The southern extent of the outbuildings had survived, although demolition or modern activity had removed the northern section of the yard. The small brick structures most likely formed outbuildings demarcated by walls 3073, 3099 (8 x 0.23 x 0.23m), 3108 (1.10 x 0.23 x 0.23m), 3110 (0.82 x 0.23 x 0.23) and 3111 (1.03 x 0.24 x 0.23m; Plates 101-102). Fragmented stone flag surface 3112 paved the surface of the outbuildings.

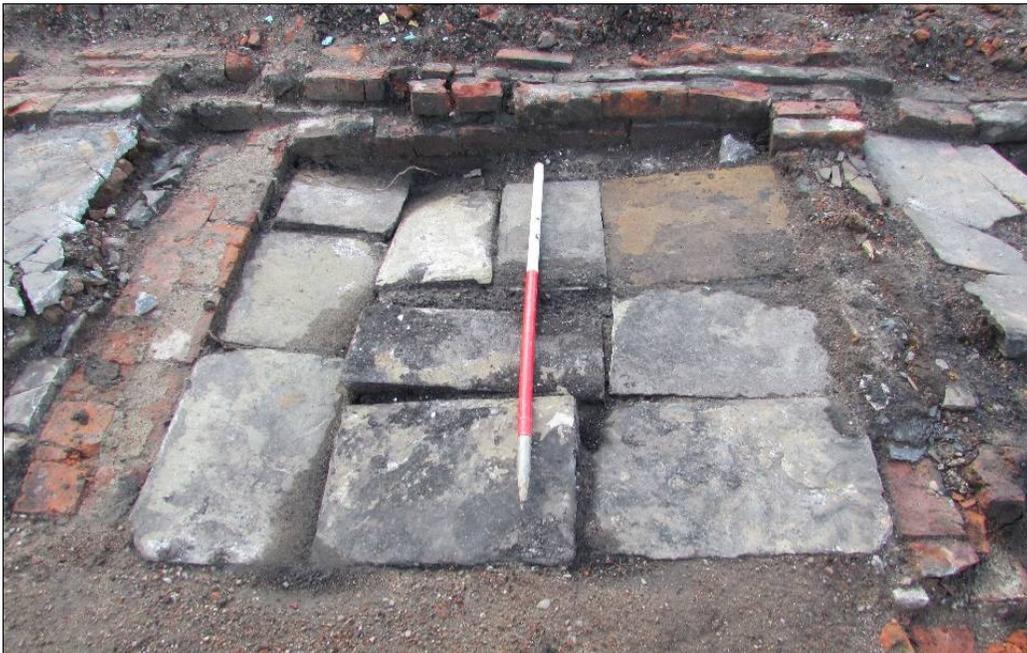
Plate 102: Wall 3111, and in the background wall 3099 and flagstones 3112

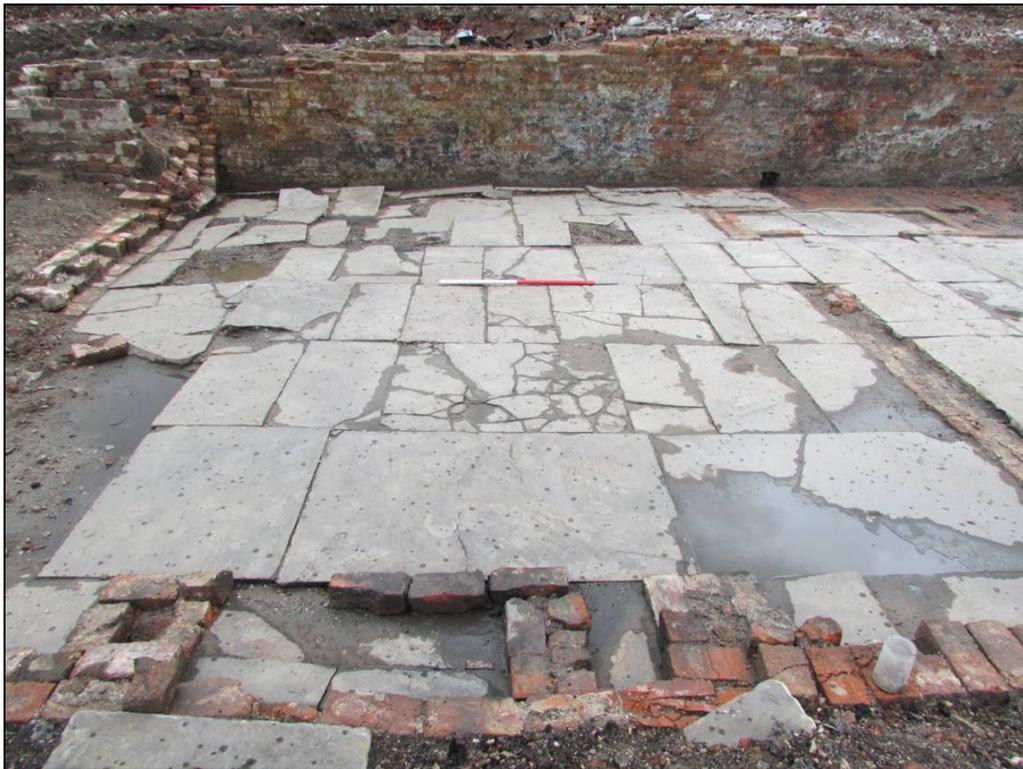
Plate 103: Room 1 House 9, looking north

The base of fireplace 3121 survived within Room 1, built alongside wall 3094, measuring 1.98 x 0.37m. Although the northern extent of Room 1 had not survived in Houses 7 and 8, it is likely that they would have formed the same plan as Room 1 in House 9, based on depictions of the buildings on historic mapping and their similar form. Square brick feature 3122 survived to the north of House 9, measuring 1.86 x 0.35m and 1.45 x 0.47m (Plate 103).

Comparisons between the geo-rectified survey and historic mapping clearly show that feature 3122 overlay a square feature, adjoined to House 9, depicted on Bancks & Co's map of 1831 through to at least 1891. Feature 3122 may have formed a large window light or short staircase, leading in to the cellar.
