Archaeological Excavation and Historic Building Investigation

Local Crescent,
The Crescent,
Salford

Report No:
2019/25

Document Type: Archaeological Excavation and Historic Building Investigation Report

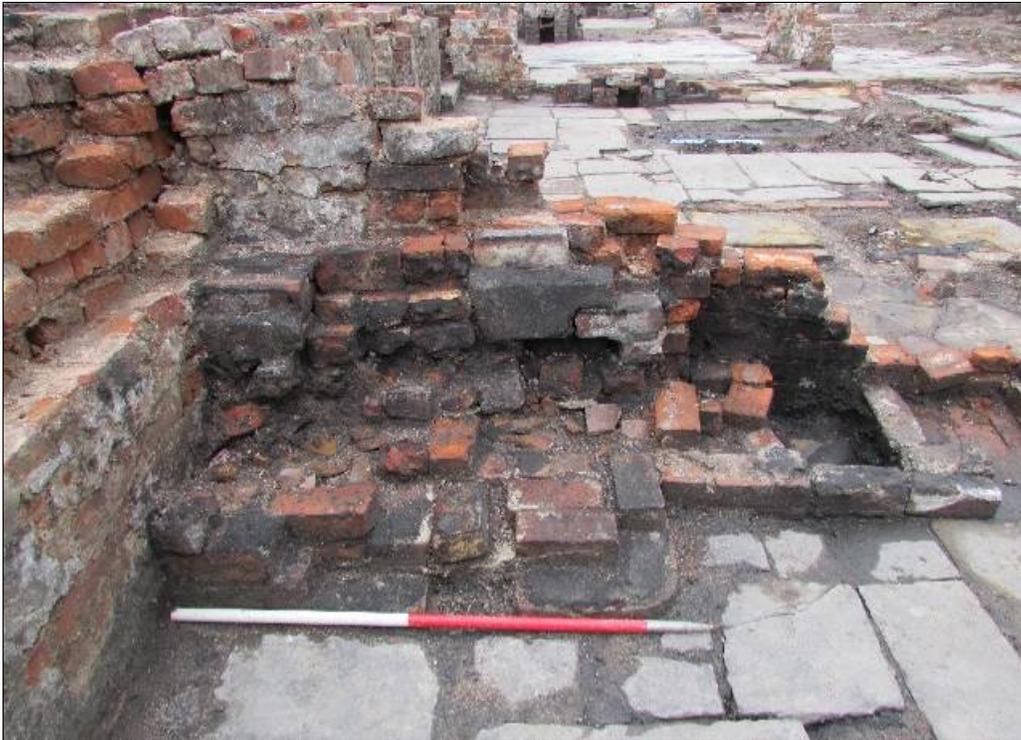
Plate 104: Boiler 3126 and fireplace 3127, in Room 2, House 9, looking west

In the south-west corner of the room were the remains of a possible boiler 3126 and fireplace 3127 against wall 3094 (Plate 104). Boiler 3126 measured 1.23m north/south and 0.76m east/west, and was constructed of firebricks and bullnose bricks in the north-east corner bonded with black mortar. The adjoining fireplace (3127) measured 1.90 x 0.38m, and was bonded with lime mortar, implying that it was of an earlier date than the boiler.

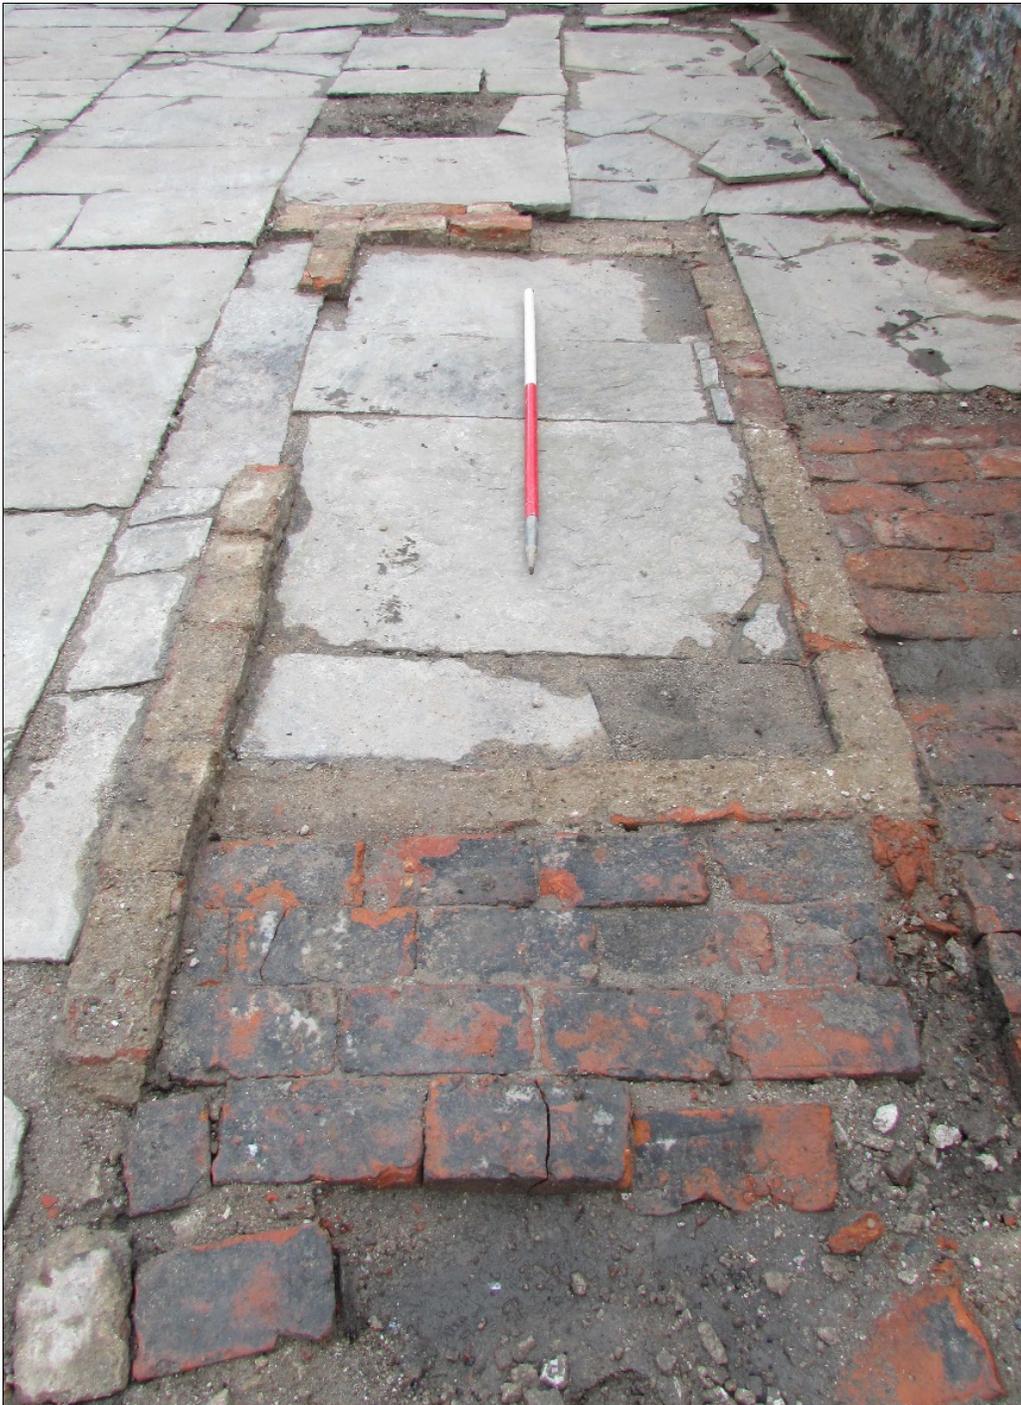
Plate 105: Rectangular feature 3120, looking north

A 0.85m-wide doorway was constructed in wall 3119, leading to the north into Room 1. On the eastern side of the doorway was rectangular brick feature 3120, measuring 2.30 x 1.13m (Plate 105). A single skin on the eastern, western and southern sides and a double skin to the north formed feature 3120. Its position mirrored feature 3102 in Room 2 of House 8, and feature 3076 in Room 2 of House 7, which were likely to have formed the base of an internal stairwell. To the east and south of feature 3120 was brick surface 3125, measuring 3.10 x 2.12m. To the east of feature 3120 was another 0.80m-wide doorway leading into Room 1. It is likely that the doorway lead to feature 3120 (probable base of a stairwell) and a small corridor.

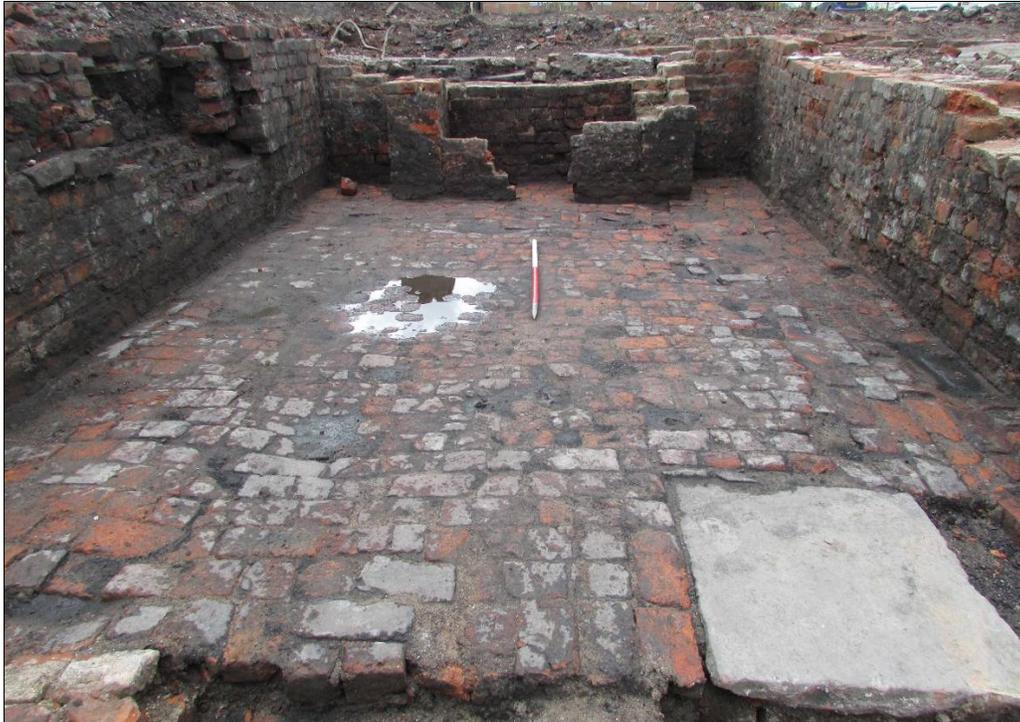
Plate 106: Room 3, House 9, looking south

Room 3 was situated to the south of Room 2, and measured 4.85m north/south by 3.20m east/west. Walls 3117, 3128 (1 x 0.24m), 3114 and 3115 bounded Room 3 (Plate 106). Walls 3117, 3128 and 3115 were bonded with sandy mortar, while wall 3114 was bonded with black mortar. Wall 3114 was bonded with sandy mortar to the north of Room 3, implying that the wall was repaired or reconstructed.

Fireplace 3130 was incorporated into wall 3115, measuring 1.30 x 0.55m (Plate 106). This comprised two buttresses, each measuring 1 x 0.36m and a single-skin wall, measuring 0.88m adjoined each buttresses, but was not keyed into them. Fireplace 3130 was also bonded with sandy mortar, suggesting that it was contemporary with wall 3115.

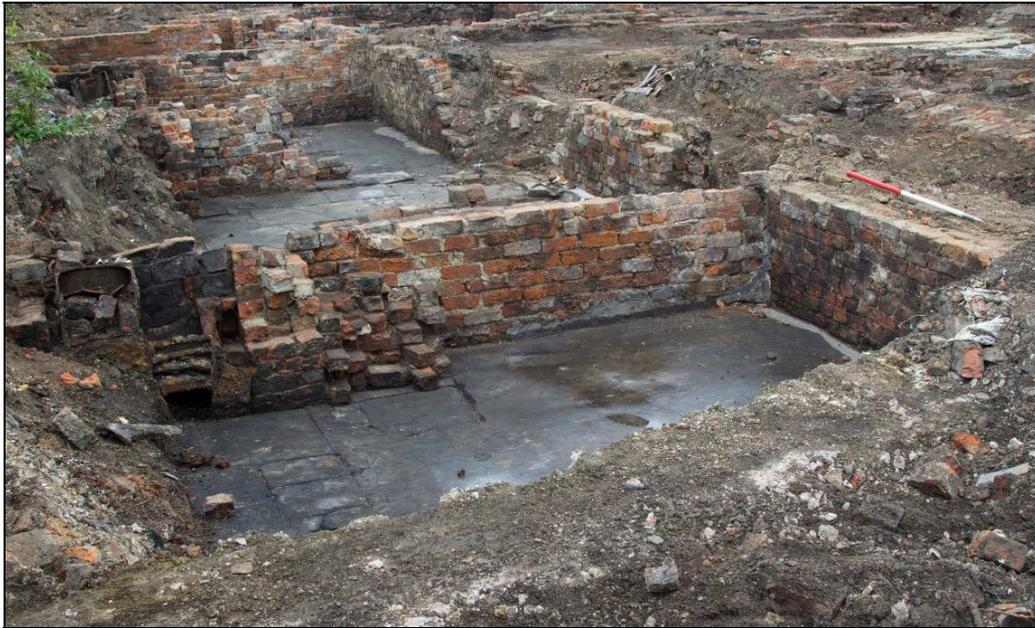
Plate 107: House 10 formed by wall 4003 and 4003 in the right, looking south

Beginning with the row of houses along the eastern side of the trench, which would have fronted Gaythorn Street, House 10 lay furthest north and was demarcated by walls 4002 and 4003 (Plates 107 and 108). The northern wall of the house, aligned east/west, lay beneath the northern baulk of the trench and remained unexcavated, due to the presence of live services. The front wall of the house to the east, also lay beyond the limit of excavation.

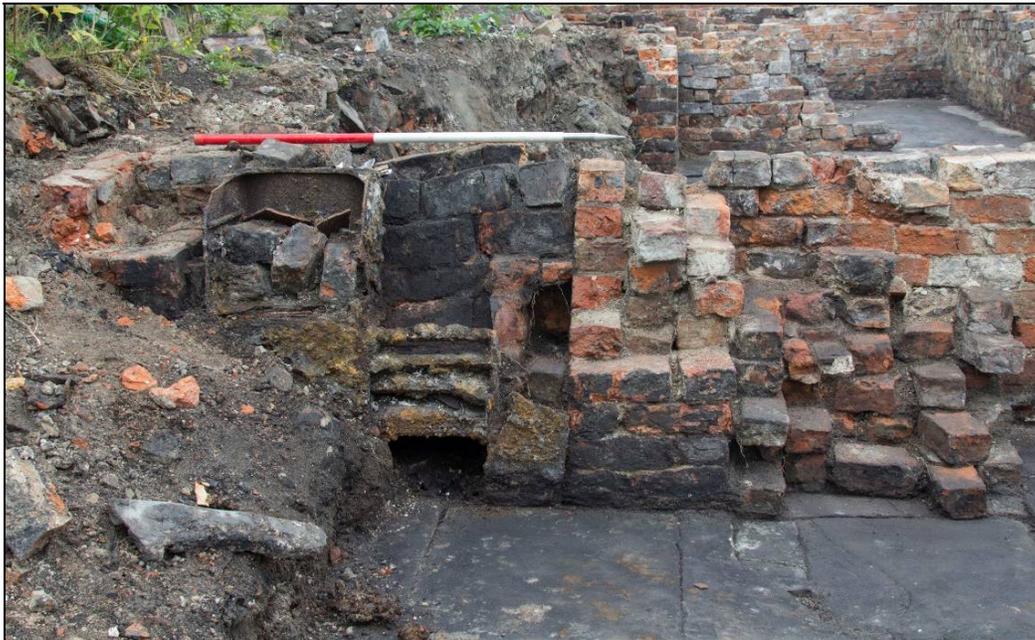
Plate 108: House 10 fireplace 4004, looking south

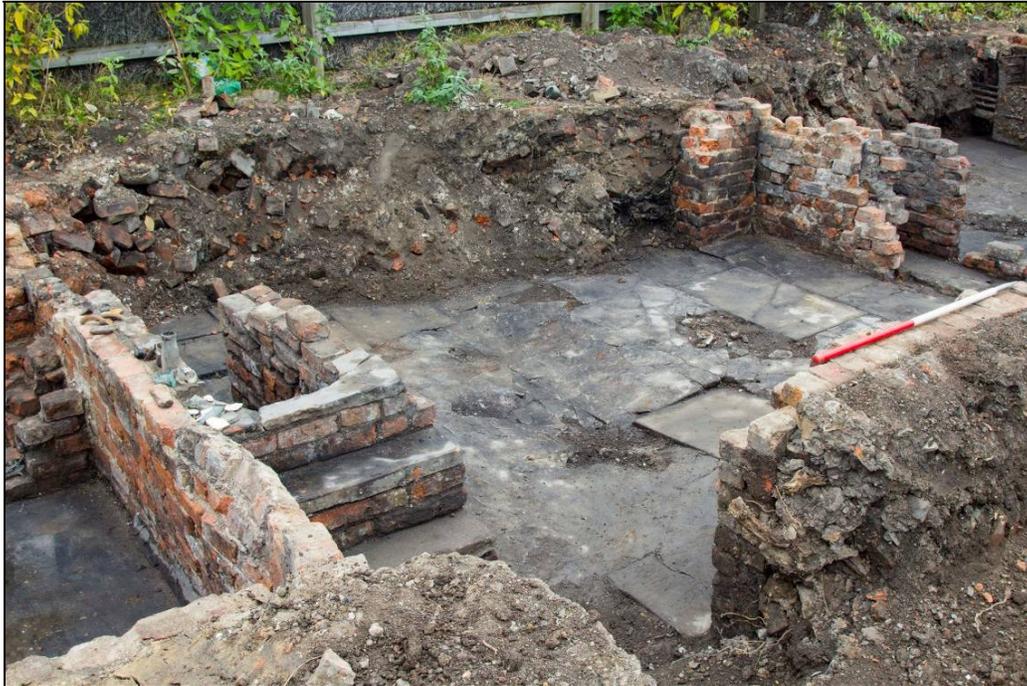
Plate 109: House 11, looking south-east

House 11 lay directly south of House 1, demarcated by walls 4007 (4.2 x 0.24 x 1m), 4008 (3.6 x 0.11 x 0.94m) and 4003 (Plate 109). The eastern, front wall of the house remained unexcavated under the trench edge. Staircase 4009 was constructed against wall 4003. The bottom three steps of staircase 4009 survived along with part of the hand-made, brick-built, supporting structure, bonded with sandy mortar. Each stone step measured 0.88m long, 0.23m wide, and 0.08m thick, and was supported by two courses of bricks. Under the stairs was a cast-iron pipe, which probably carried water and had been a later addition.

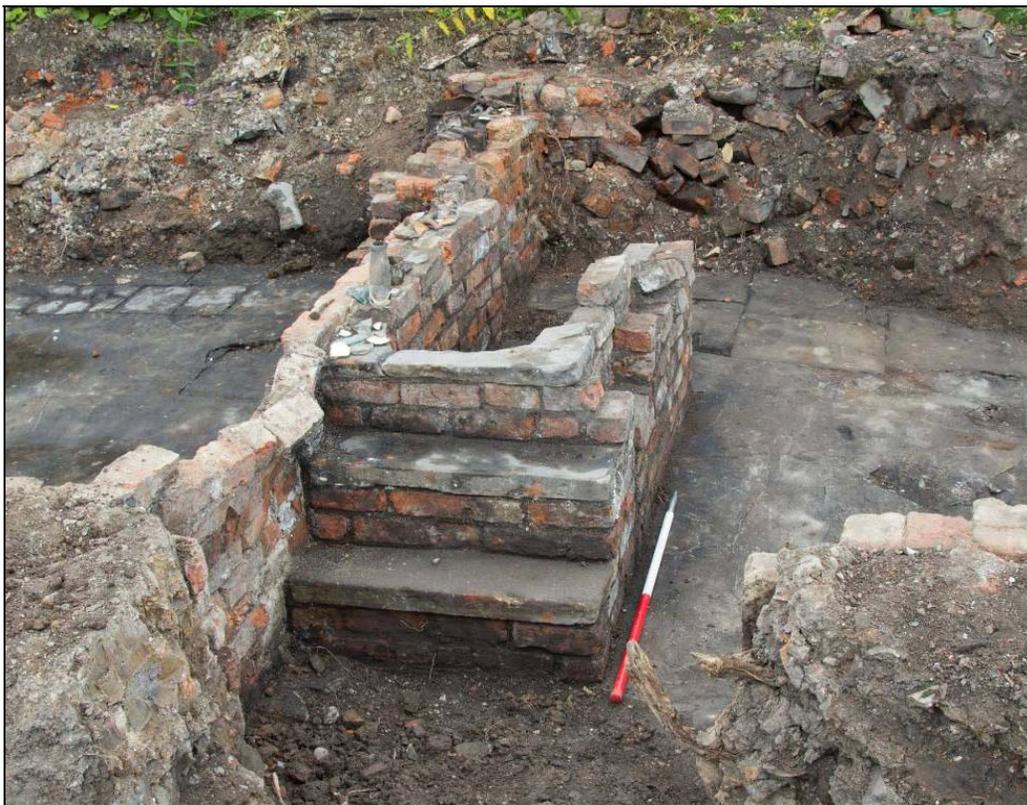
Plate 110: House 11 staircase 4009 built against wall 4008, looking east

A doorway, which would have led to an external staircase was situated opposite the bottom of internal staircase 4009. The first foundation step could be seen at floor level, measuring 0.35m wide (Plates 110-112).

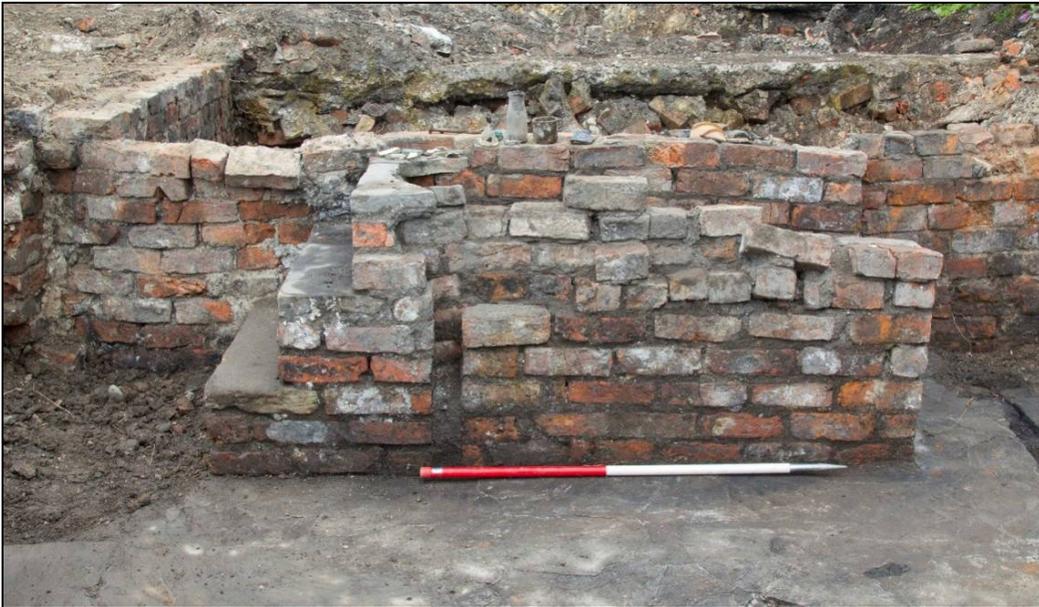
Plate 111: House 11 staircase 4009 showing a small gap in the supporting wall, looking north

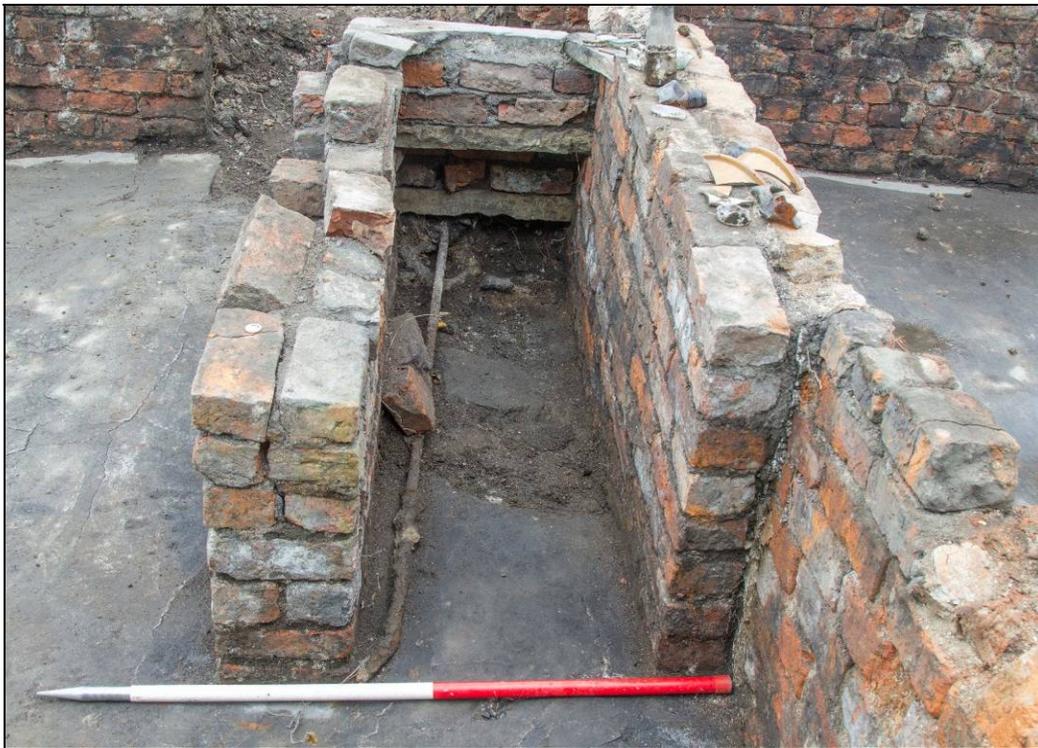
Plate 112: Metal water pipe under the staircase 4009 of House 11, looking west

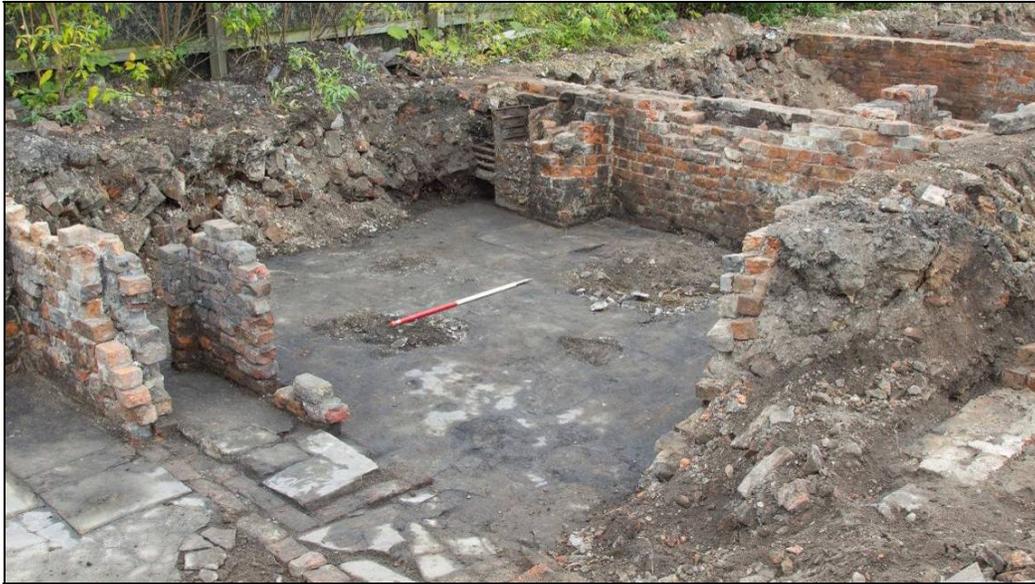
Plate 113: House 12, looking south-east

As with House 11, the northern, party wall 4008 contained internal staircase 4015, although little survived. Staircase 4015 comprised part of the supporting wall surviving to a height of 0.88m and the footprint of the staircase, which measured 1.90 x 0.72m. The floor underneath the staircase comprised flagstones 4016, the rest of the floor surface was covered by concrete (Plates 113-114).

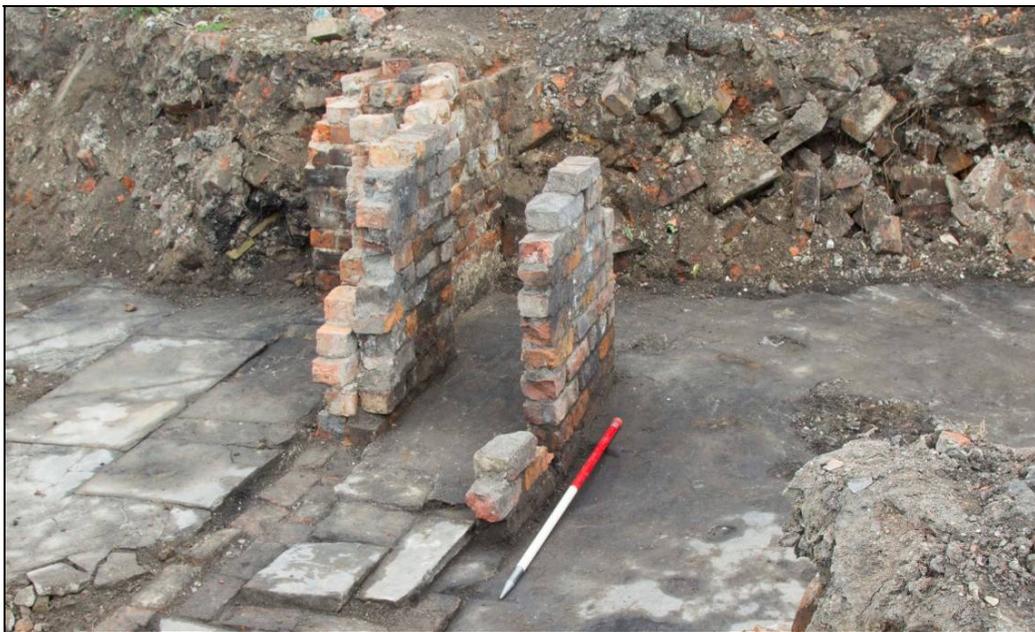
Plate 114: Partial remains of the internal staircase 4015 of House 12, looking east

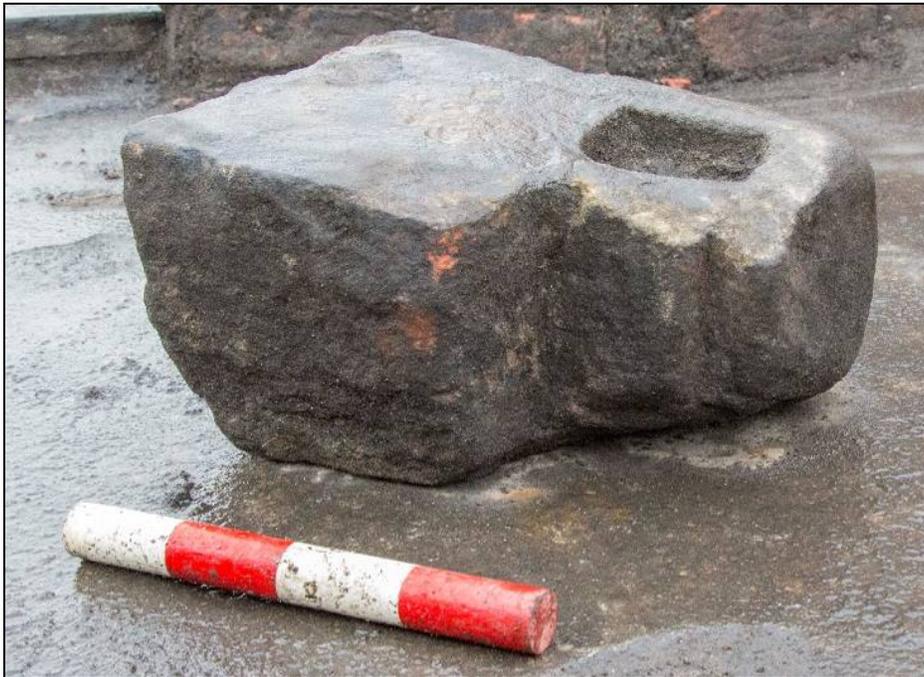
Plate 115: Detail of stone door jamb from House 3 after removal

At the northern end of wall 4012, a doorway to the external staircase lay opposite the bottom of internal stairs 4015, where the bottom stone door jamb survived *in-situ*. It appeared that this block of stone was very likely to have been re-used from the earlier stone building, comprising the same tool markings (Plate 115).

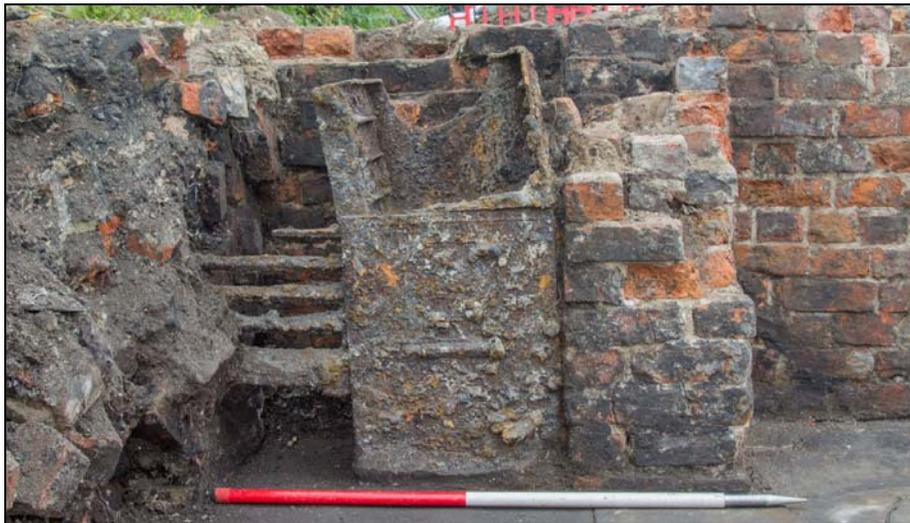
Plate 116: Detail of the fireplace 4018 House 12, looking south

Wall 4013, aligned east/west, appeared to have been constructed against the northern wall of House 13, suggesting Houses 10-12 were later than House 13. Wall 4013 comprised hand-made brick bonded with lime mortar, and survived to a height of 1.08m. Fireplace 4018 with cast-iron range survived *in-situ* (Plate 116) up to a height of 0.92m, along wall 4013.

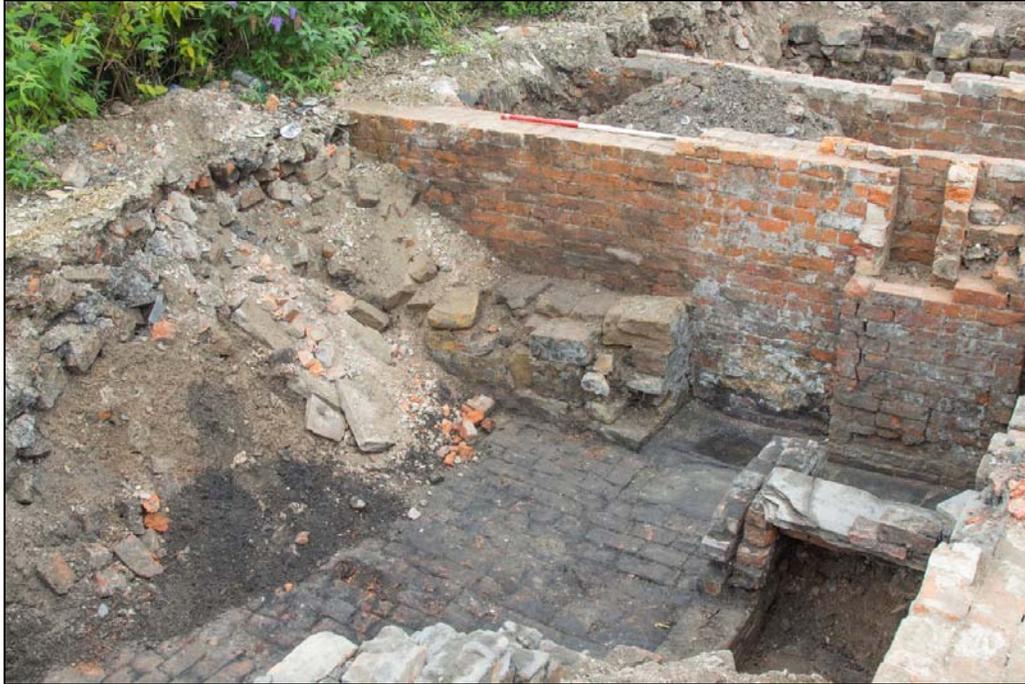
Plate 117: House 13, looking south-east

House 13 lay directly south of House 12 with a much deeper cellar floor than revealed elsewhere on the site (Plate 117). House 13 was demarcated by walls 4017, 4019, 4020 and 4021. Northern wall 4017, aligned east/west, comprised hand-made bricks, although the lower third of the wall had been constructed using natural stone, probably re-used from an earlier building (Plate 118). The eastern, front wall 4021, aligned north/south, and was abutted by brick-built wall 4020.

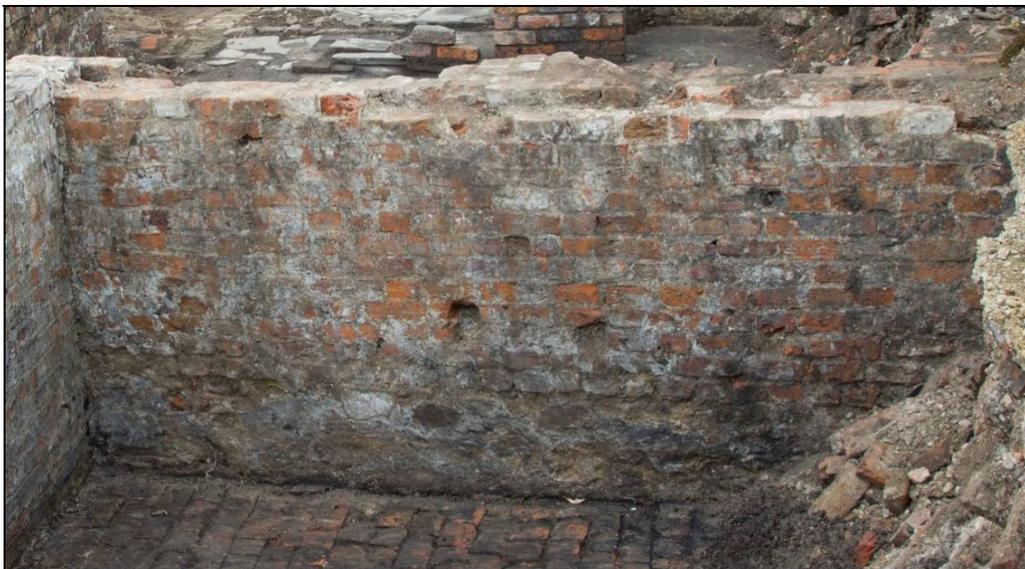
Plate 118: Detail of northern wall 4017 of House 13 showing stonework at the bottom

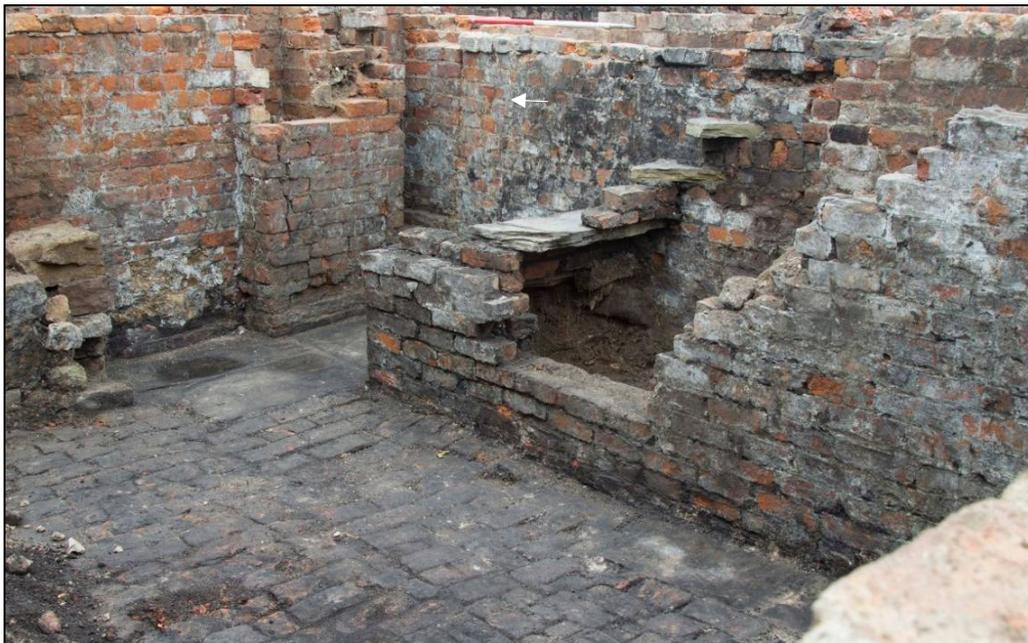
Plate 119: Detail of the staircase 4022 in House 13, also showing a phase break in the wall 4019, looking south-west

A possible construction phase break was visible in the inner face of wall 4019, at the bottom of staircase 4022, which could have represented the position of an earlier doorway or part of a perhaps rebuild of staircase 4022, suggested by the extra skin of bricks added into which staircase 4022 was built. Staircase 4022 was built against wall 4019, comprising a flagstone step supported on two courses of bricks, of which only the three bottom steps survived (Plates 119-22). The stone steps measured 0.36 x 0.93 x 0.09m, the height of each step measuring 0.32m. The supporting wall on the eastern side of the staircase consisted of two brick-courses in width using hand-made bricks bonded with black mortar (OPC), which again implies staircase 4022 had been rebuilt in the later 19th century or early 20th century.

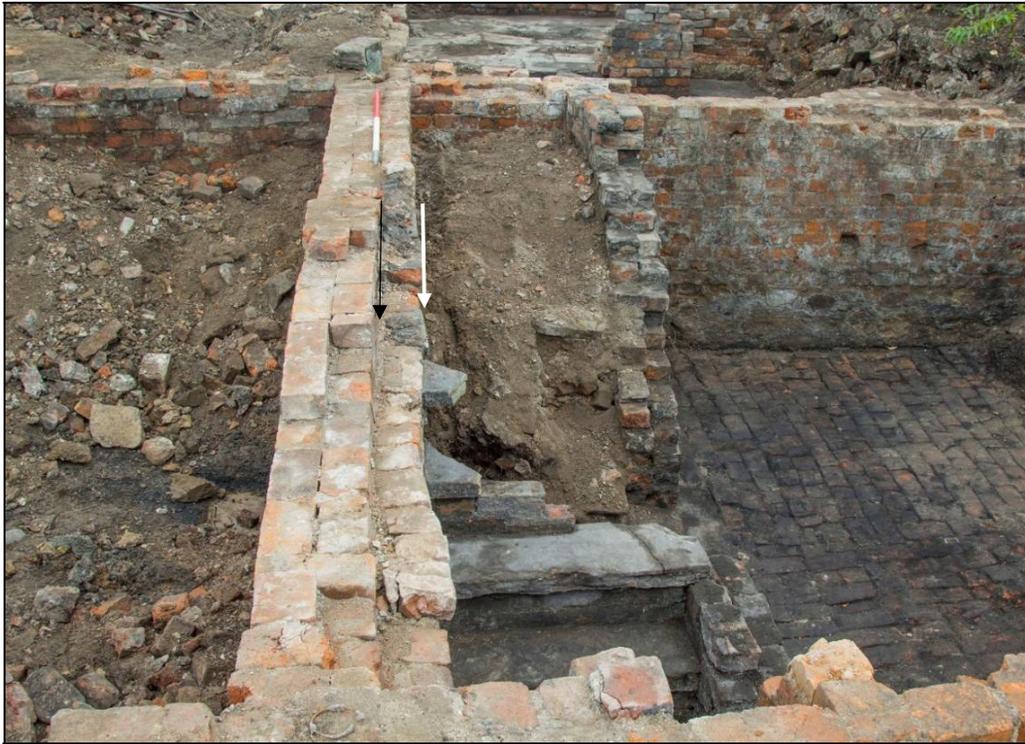
Plate 120: Western wall 4019 of House 13 (black arrow) and associated staircase 4022 with extra skin of bricks (white arrow), looking north

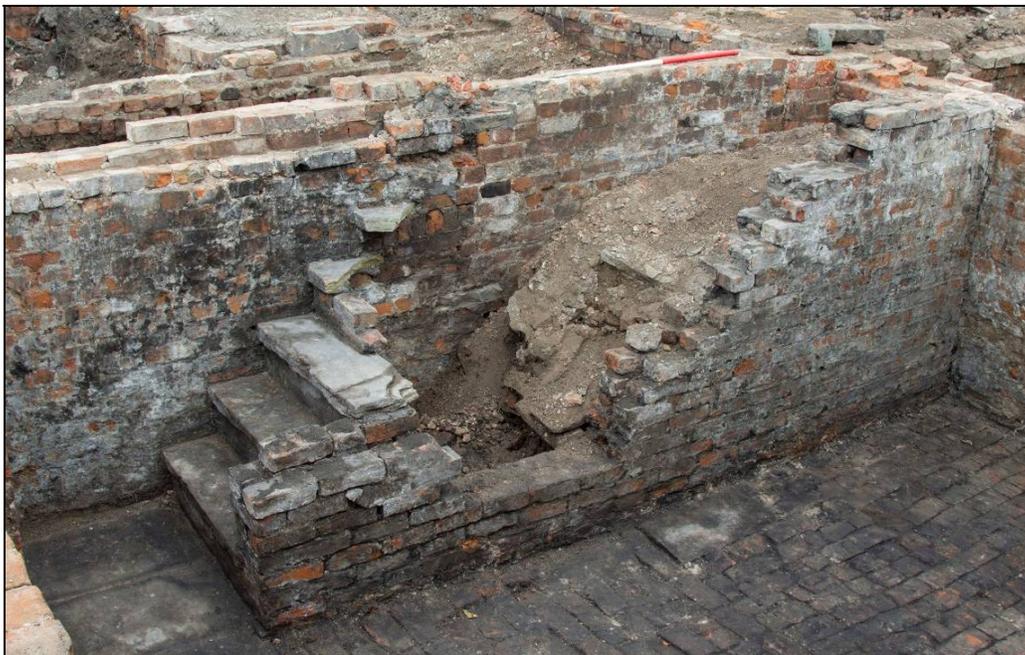
Plate 121: Staircase 4022 in House 13, looking north-west

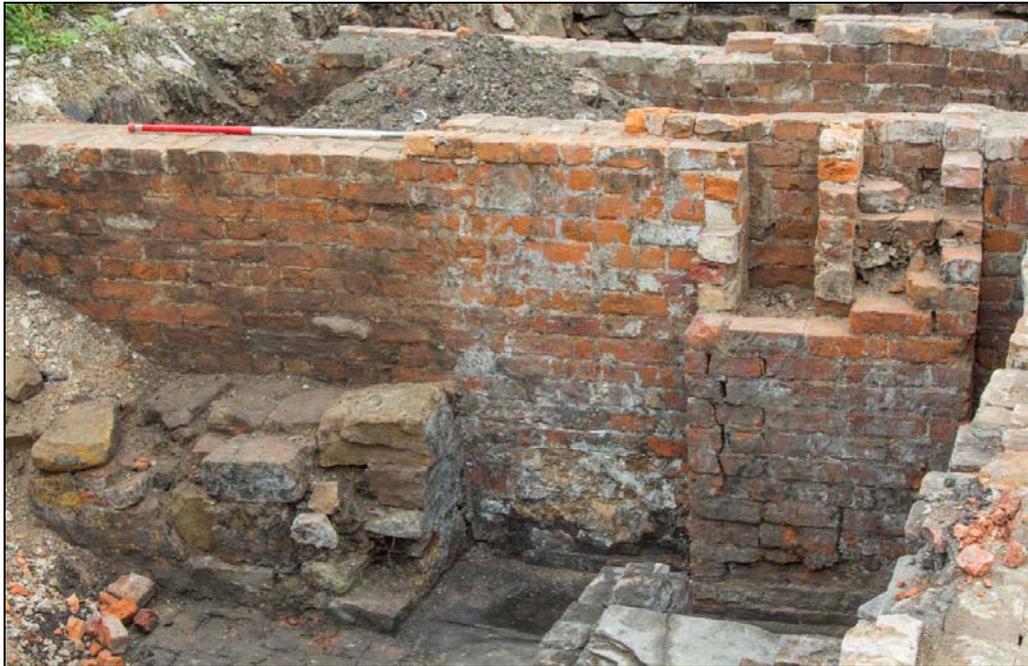
Plate 122: Unidentified features 4024 in the left and 4023 in the right, against wall 4020 of House 13, looking south

A stone plinth 4024, to the east of the brick feature 4023 also remains unidentified. The stone had probably been re-used from an earlier stone building. The presence of some hand-made bricks in the corner of the feature suggested that this was contemporary with the house and not an earlier stone building. The feature measured 0.63m in length and survived to a height of 0.76m (Plate 122).

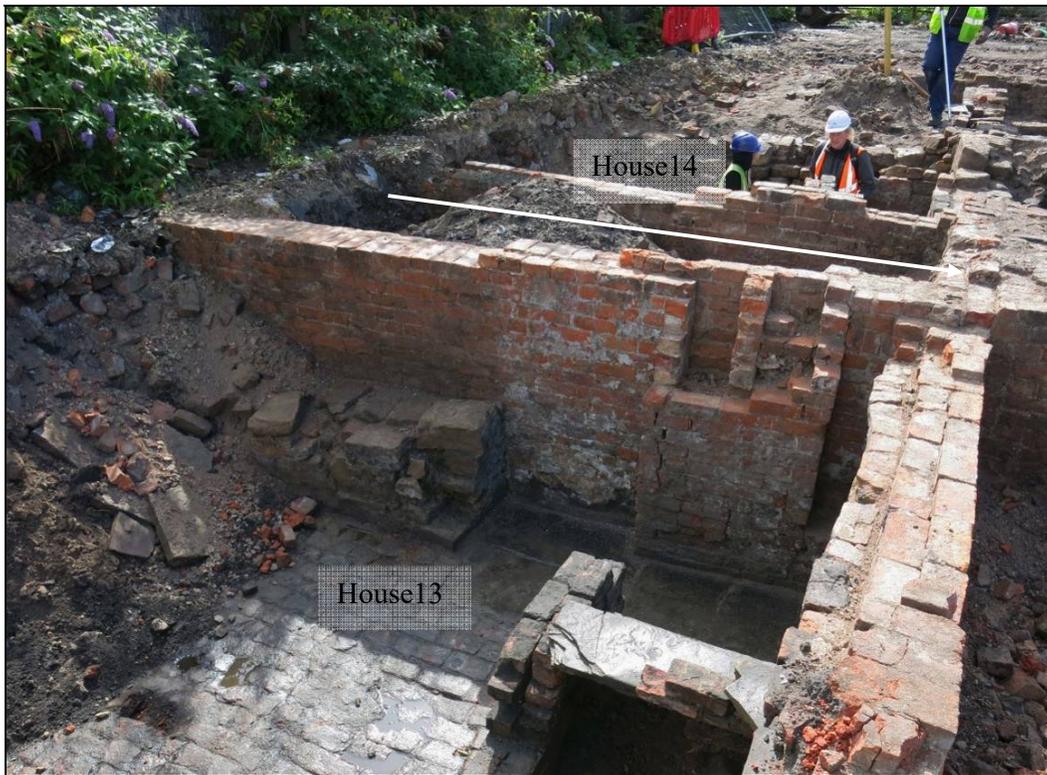
Plate 123: The white arrow shows the location of the alleyway between Houses 13 and 14 and the direction from Gaythorn Street to Rosson's Court, looking south

Walls 4020 and 4027 formed a covered alleyway, depicted on the OS Town Plans of 1851 and 1892 (Figs 24 and 25). The alleyway appears to have led from Gaythorn Street into Rosson's Court and lay between Houses 13 and 14 (Plates 123-125). No internal surfaces survived, and the natural geology was reached at a depth of approximately 1.5m.

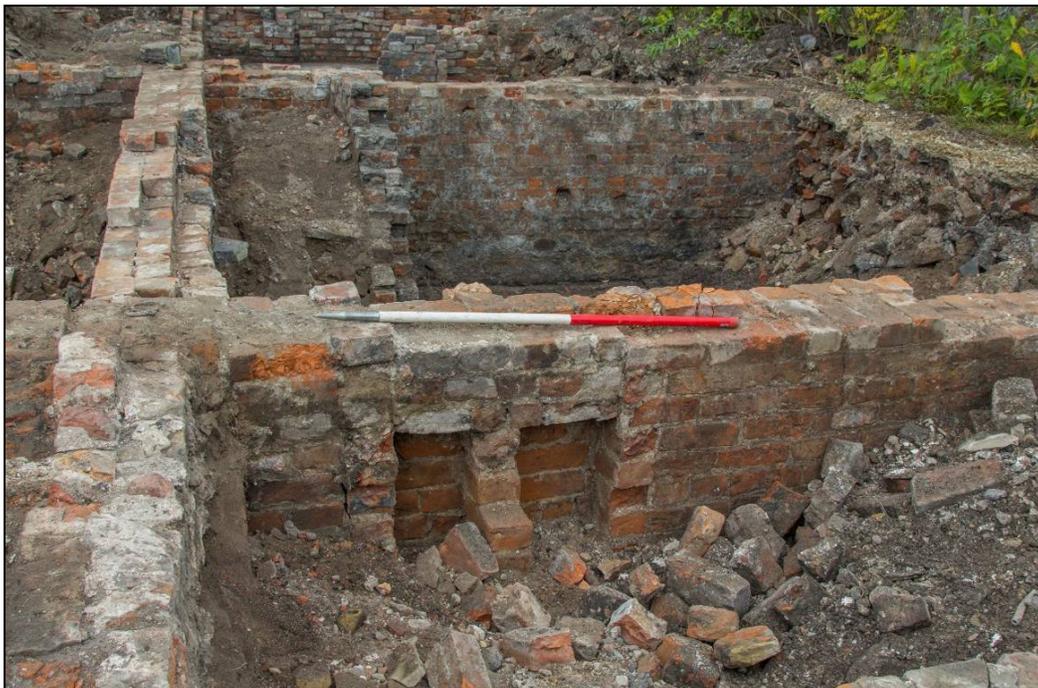
Plate 124: The southern side of brick feature 4023 found in House 13, looking north

Brick feature 4023, exposed in House 13, also appeared on the opposite side of wall 4020, within the alleyway. It remains probable that feature 4020 may have been the base of a brick built fireplace or chimney. It is unusual that the foundations lie below floor level in the alleyway.

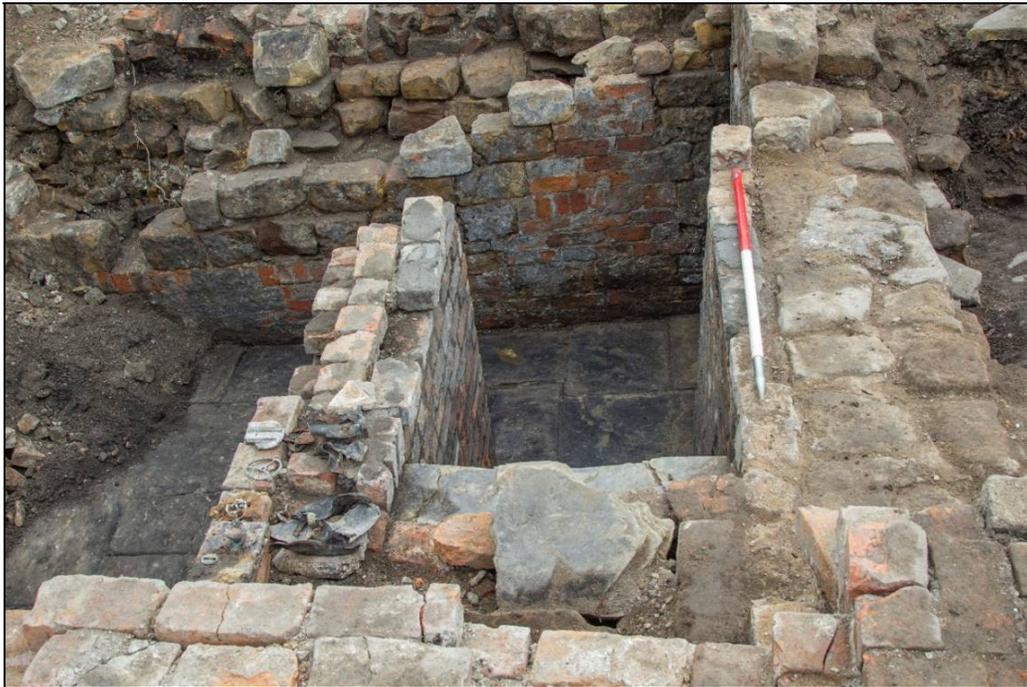
Plate 127: The 1m scale bar rests on top of a single-course brick wall built up against stone wall 4028 forming part of staircase 4030

Wall 4029 was aligned east/west, forming the southern wall of the house, and comprised mostly sandstone with some hand-made brickwork at the bottom. It appeared that most of wall 4029 had survived *in-situ*, but part of the north-facing elevation had been rebuilt on top of a brick-built base, leaving the rubble core of wall 4029 visible (Plates 127 and 128).

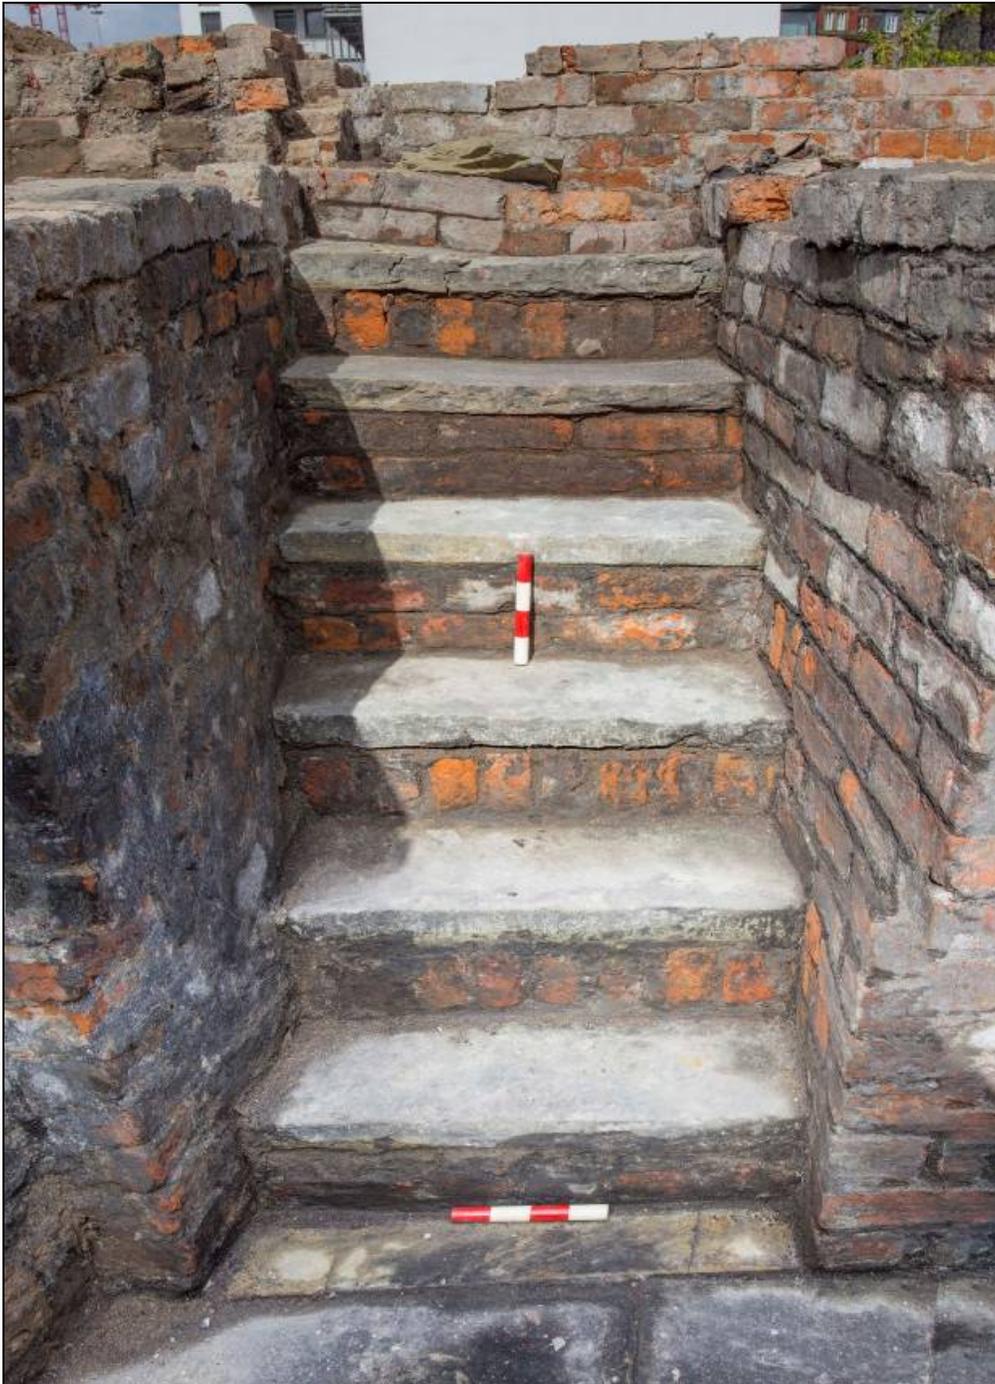
Plate 128: Staircase 4030 in House 14, looking north

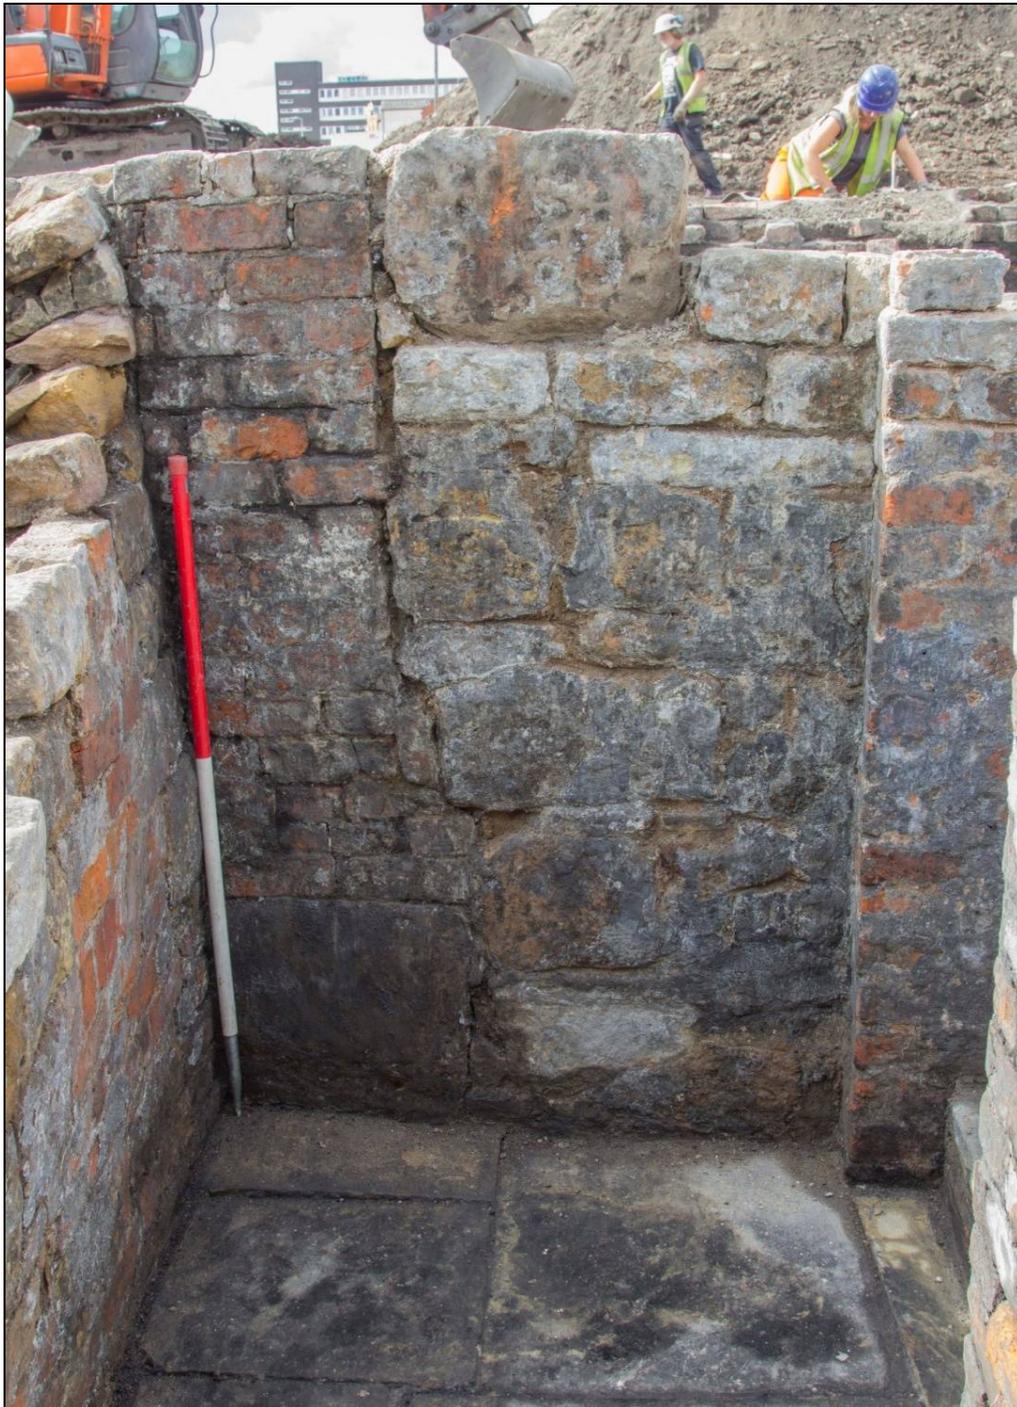
Plate 129: Wall 4028 of House 14 at the foot of the stairs showing an infill of bricks within stone wall 4028, looking west

At the foot of staircase 4030, in the south-west corner of the room, was an unusual infill of bricks within wall 4028, which appeared to have been bonded with lime mortar originally and showed signs of re-pointing near the top of the wall. This brick infill sat on top of a large stone block. The majority of the stonework probably survived *in-situ*, although the large stone block at the top of the wall with tool marks on the east-facing elevation may have been placed there to make up the required height of the wall.

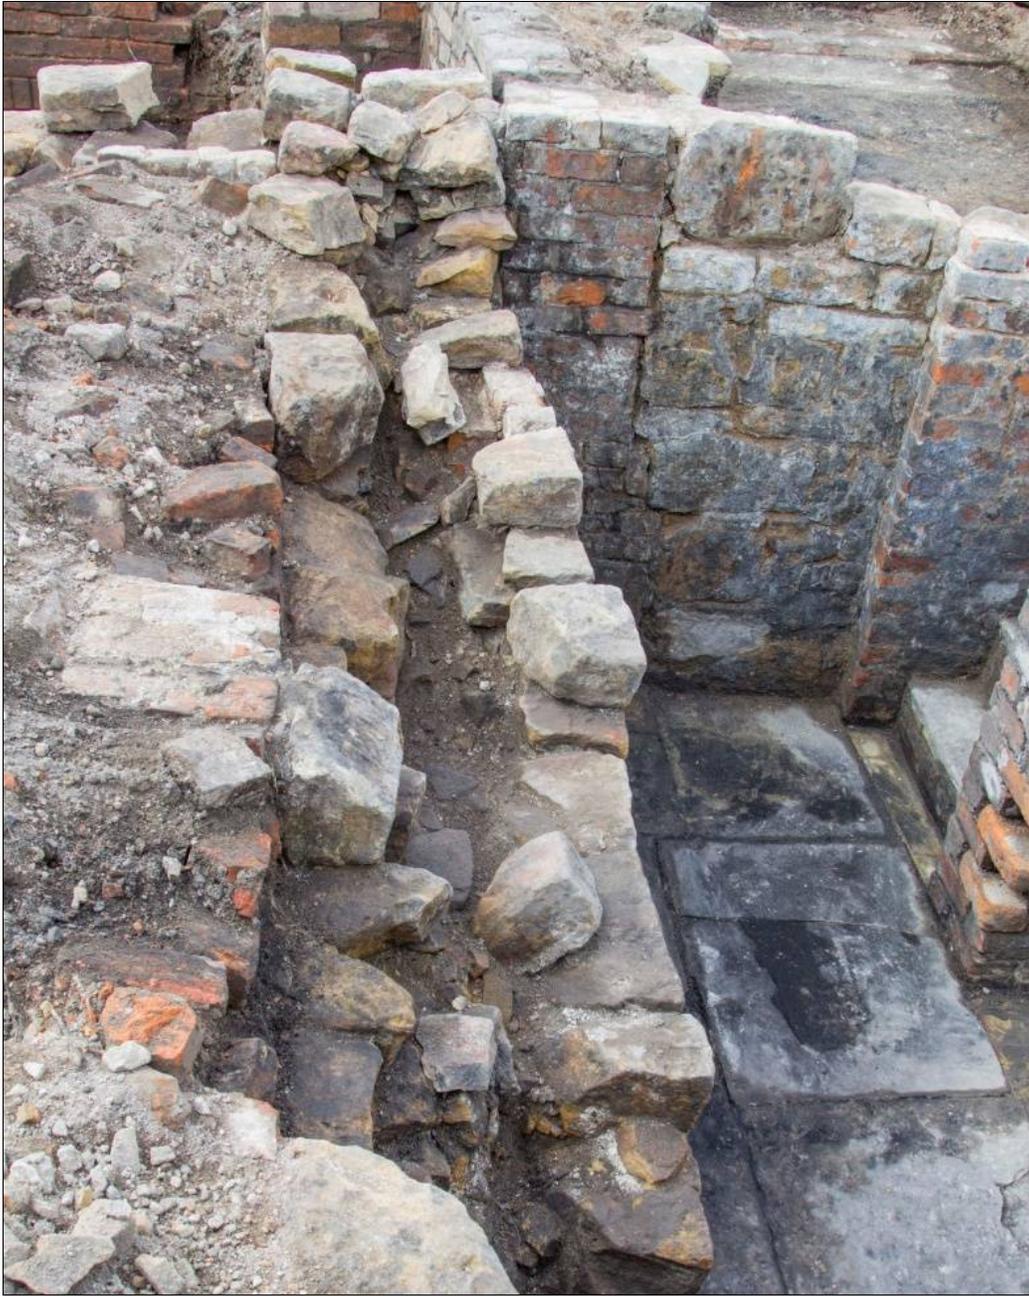
Plate 130: The southern wall of House 14 comprising mostly sandstone blocks, looking west
