Archaeological Excavation and Historic Building Investigation

Local Crescent,
The Crescent,
Salford

Report No:
2019/25

Document Type: Archaeological Excavation and Historic Building Investigation Report

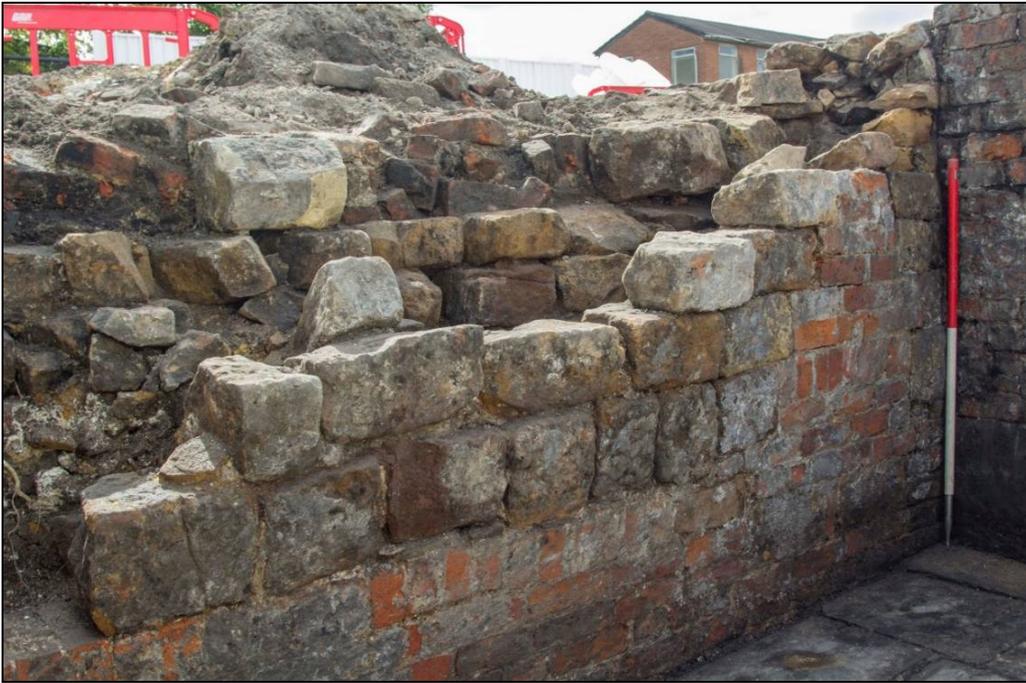
Plate 131: Wall 4029 of House 14 showing the part brick and part stone wall, looking south-west

Wall 4029 was aligned east/west, forming the southern wall of the house, and comprised mostly sandstone with some hand-made brickwork at the bottom. It appeared that most of wall 4029 had survived *in-situ*, but part of the north-facing elevation had been rebuilt on top of a brick-built base, leaving the rubble core of wall 4029 visible (Plates 127 and 128).

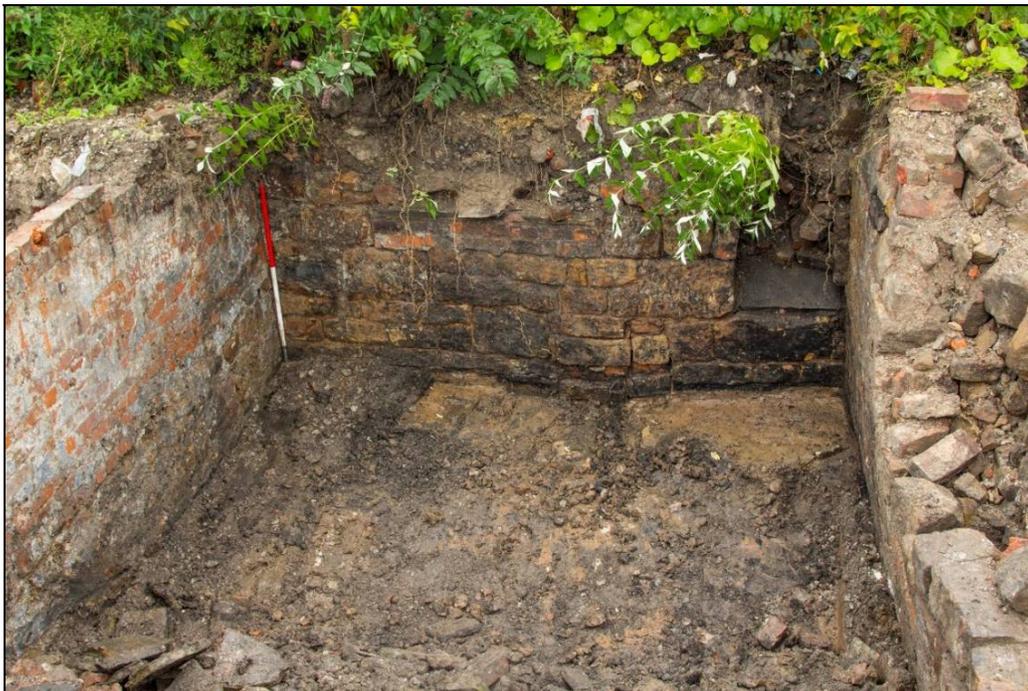
Plate 132: Stone wall 4021 forming the eastern, front wall of House 14 with added cellar light and coal chute, looking east

The final phase of excavation revealed the eastern, front wall 4021 of Houses 13, 14 and 15, aligned north/south, which comprised sandstone blocks with some hand-made brick modifications. Wall 4021 was almost certainly an *in-situ* survivor from an earlier stone building, which had been re-used and re-modelled to form the front wall. A cellar light had been added slightly off-centre to the room, and what was probably a coal chute in the south-east corner. Removal of flagstone floor 4031 revealing that the stone wall had been built on a thin levelling layer of black cinder on top of the natural clay (Plate 132).

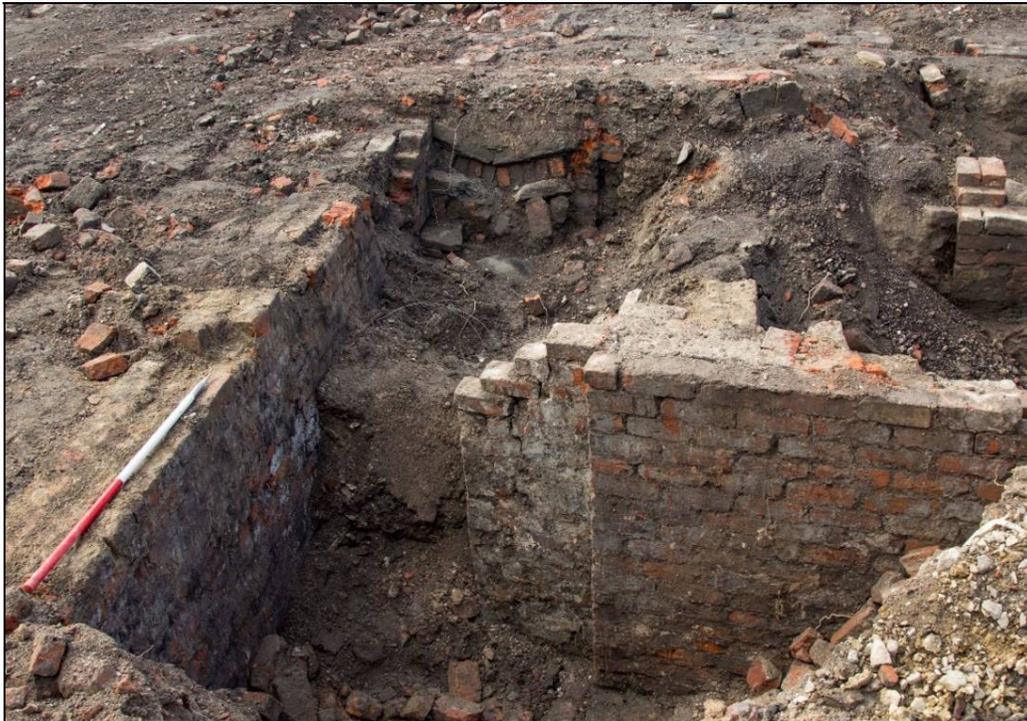
Plate 133: House 15 showing a doorway at the rear of the room leading to a collapsed and truncated staircase, looking west

House 15 lay adjacent to House 14, and was demarcated by walls 4028, 4029, 4021 and 4032 (6.5 x 0.35m). Although only partly excavated due to the presence of a monitoring well, stone wall 4021 was found to continue south into House 16. Wall 4032 was constructed using hand-made bricks and abutted wall 4021. A doorway, situated in the south-east corner of House 15, and adjacent to wall 4028, led to a collapsed staircase leading upwards, which probably led into a rear yard and/or outbuildings (Plate 133).

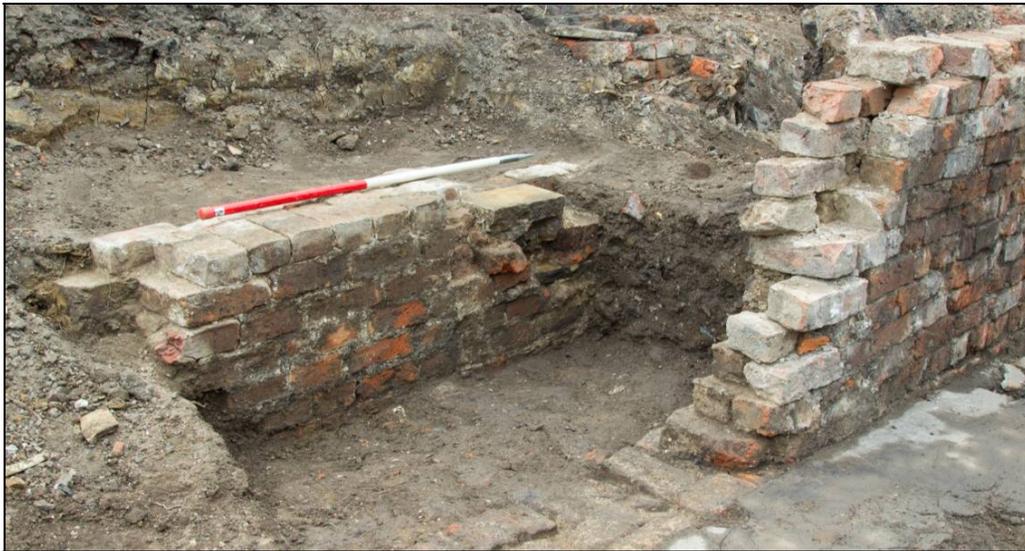
Plate 134: Wall 4063 forming external staircase into cellar dwellings

Houses 10-12 fronted Gaythorn Street, although the cellar dwellings exposed during the excavation were accessed via an alleyway to the rear of the properties, which was situated off Gaythorn Court. Although the staircases leading down into the cellars had been demolished prior to the excavation, the geo-rectified survey coupled with historic mapping demonstrates that the staircases would have been constructed within walls 4002 and 4012 to the east, and walls 4062, 4063 and 4064 to the west (Plate 134). The staircases were accessed via an alleyway bounded by walls 4062-4 to the east, and walls 4065 (1.3 x 0.36m) and 4066 (1.4 x 0.36m) to the west.

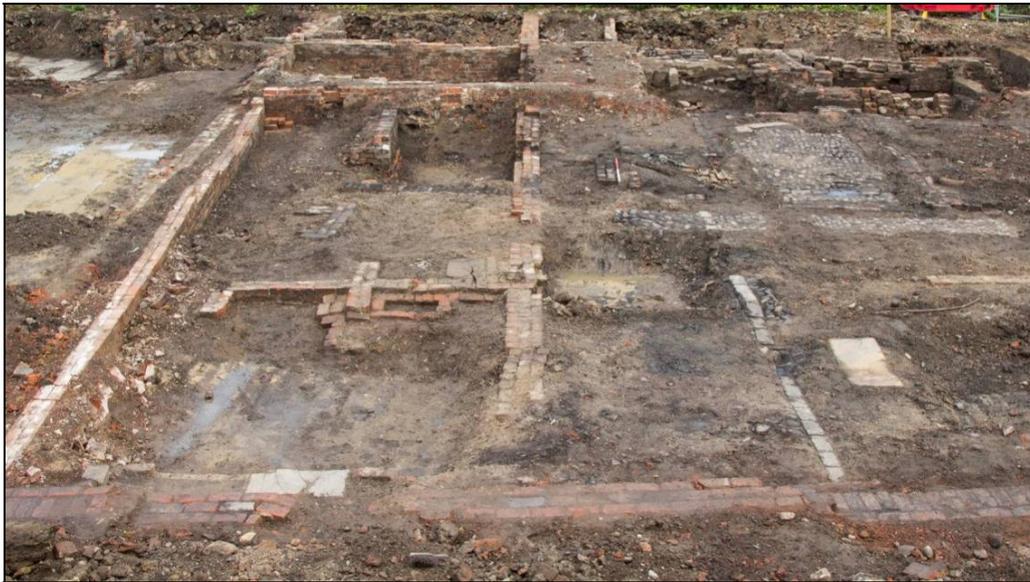
Plate 135: Walls and cobbled surfaces associated with Rosson's Court, looking east

Walls 4020, 4034 and 4033 demarcated the front and rear external walls of three properties in the northernmost area of Rosson's Court. One party survived, wall 4039 (3 x 0.24m), which extended north from wall 4034. Two buttresses extended west from wall 4039, which may have formed a fireplace. One buttress extended east from wall 4039, which too may have formed a fireplace. Square brick feature 4040 also adjoined wall 4039. Wall 4041 (1.25 x 0.44m) was situated immediately to the east of wall 4035, presumably forming another internal feature. Wall 4043 (0.80 x 0.24m) may have also formed an internal feature (Plate 135).

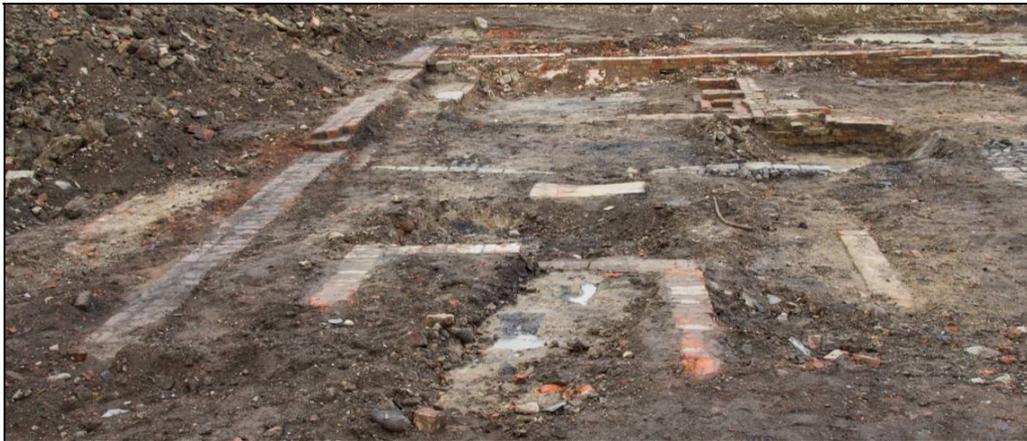
Plate 136: House 16

The truncated footprint of two more properties on Rosson's Court was also visible. House 16 was bound by walls 4047 (1.5 x 0.25m) to the west, 4048 (4.9 x 0.11m) to the north and 4049 (2.8 x 0.24m) to the east. House 16 was the northernmost dwelling in the western block of houses on Rosson's Court. A single flagstone was situated within the property, implying that the internal floor had been paved with flagstones. Wall 4050 was also situated within the building, measuring 1.5 x 0.24m along a north/south alignment before returning along an east/west alignment for 1.3m, finally heading southwards for 0.55m. Structure 4050 may have formed the base of a stairwell and storage cupboard. The space between wall 4048 and wall 4034 would have formed an open courtyard used by the occupants of Rosson's Court to access their houses. Cobbled surface 4060 survived in pockets across this part of the site (Plates 136 and 137).

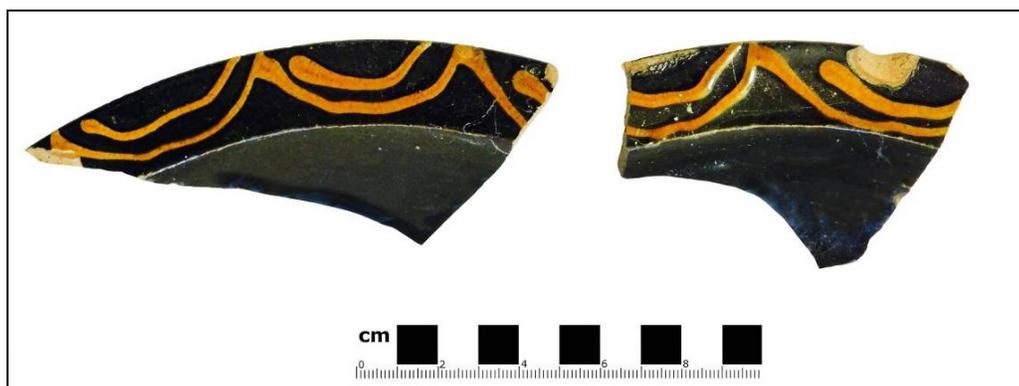
Plate 139: Sherds of dark-glazed slipware dish with decorated rim, fn 38 (Trench 9)

Ten sherds of slipware were recovered from the excavations. This includes a small sherd of Metropolitan slipware dating to the mid-17th century (Plate 138), a small sherd of a black-glazed slipware cup, and fragments of a dark-glazed dish with decorated rim, probably dating to the 18th century (Plate 139).

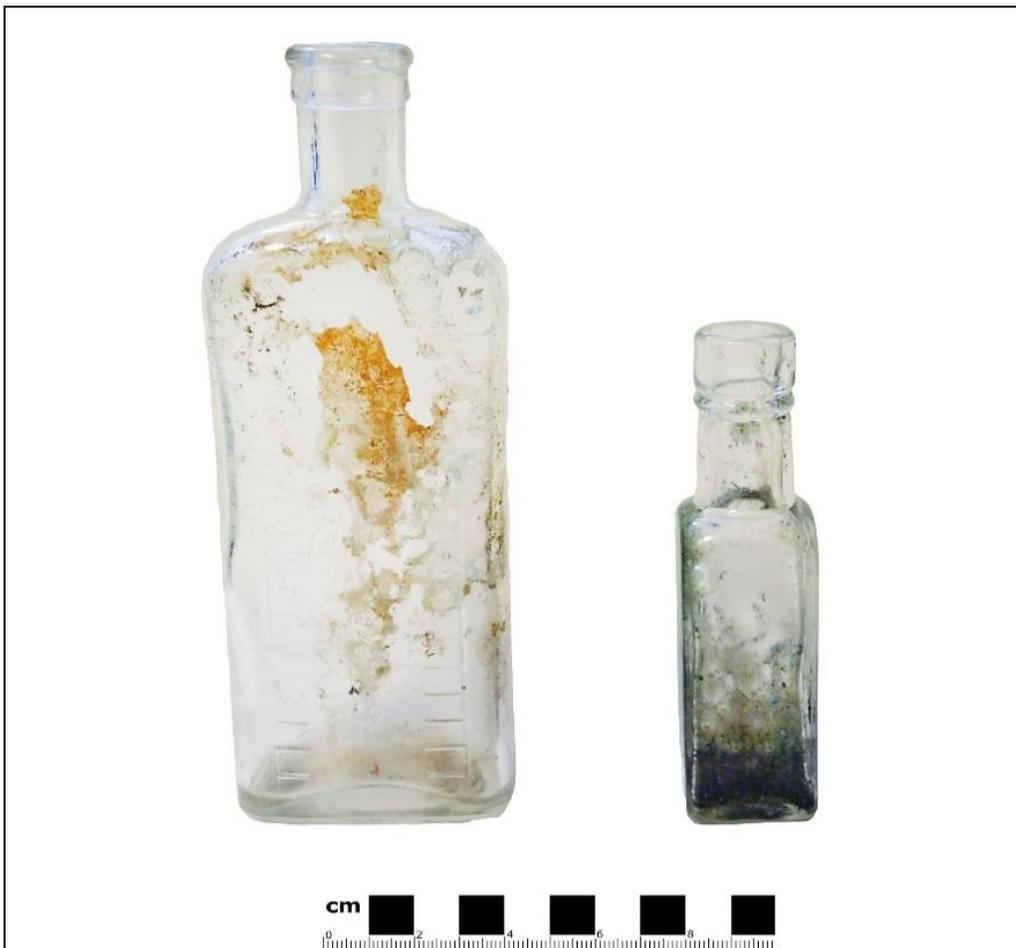
Plate 140: Clear complete glass bottles, 20th century, fn 14 (U/S)

Eight glass finds were retrieved from the site, all dating from the 19th to 20th centuries. The group consisted of glass bottle fragments, and two complete clear glass bottles: one with a rectangular base with measuring lines on the exterior; and a smaller square-based bottle (Plate 140).

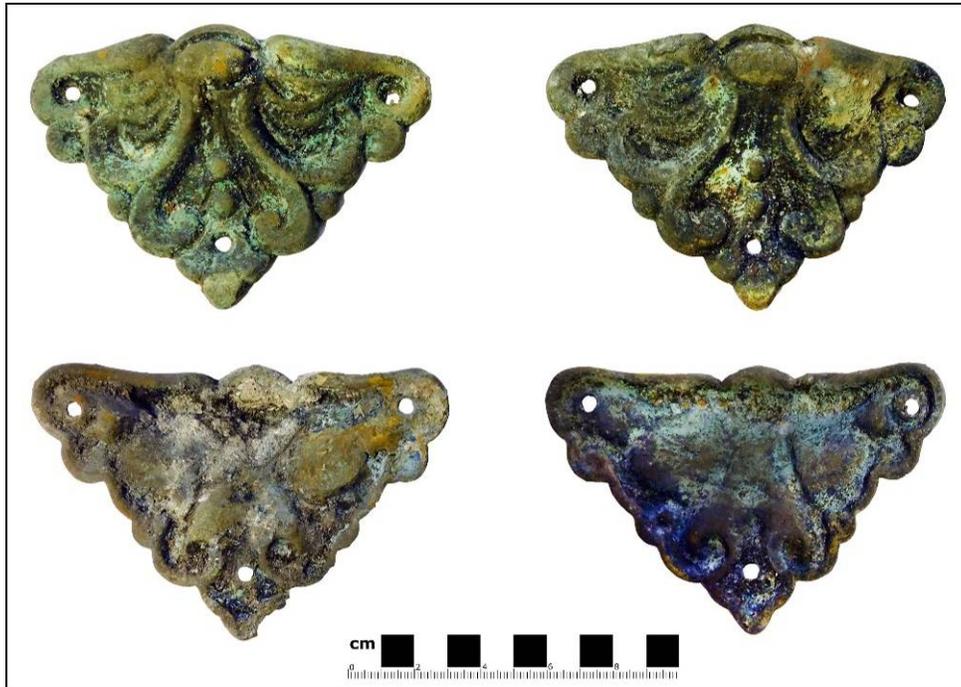
Plate 141: Two decorative copper mounts, fn 51 (Trench 2)

A small quantity of metal finds was retrieved from the site. These included two copper decorative mounts (Plate 141) and machine fittings including a gear wheel with impressed fabric, a rusted bolt, and a bracket (Plate 142).
