1 **SHEAR BEHAVIOUR OF LIGHTWEIGHT CONCRETE BEAMS**
2 **STRENGTHENED WITH CFRP COMPOSITE**

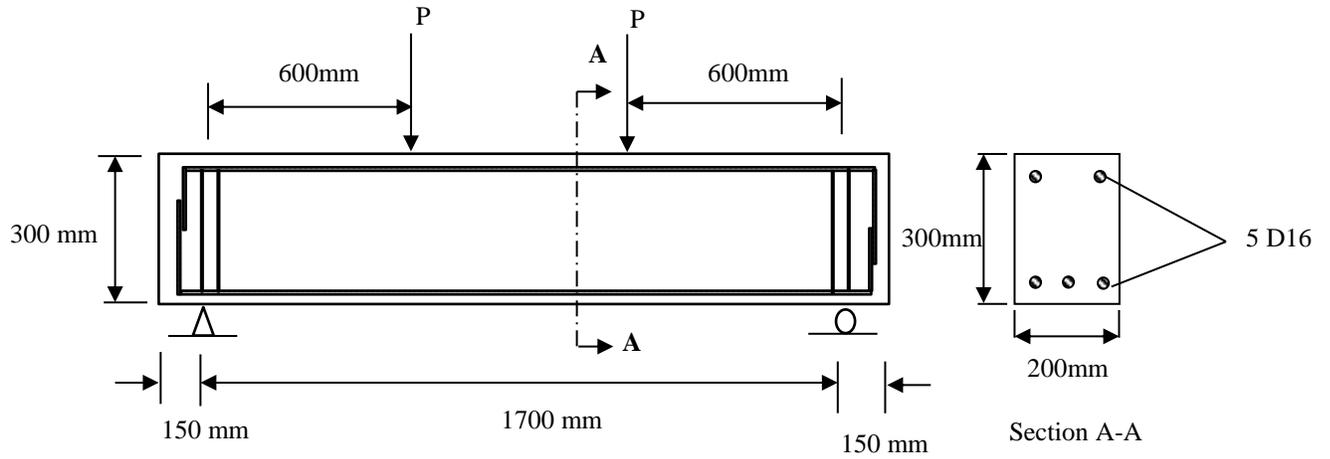
13 Figure 1: Beams reinforcement details

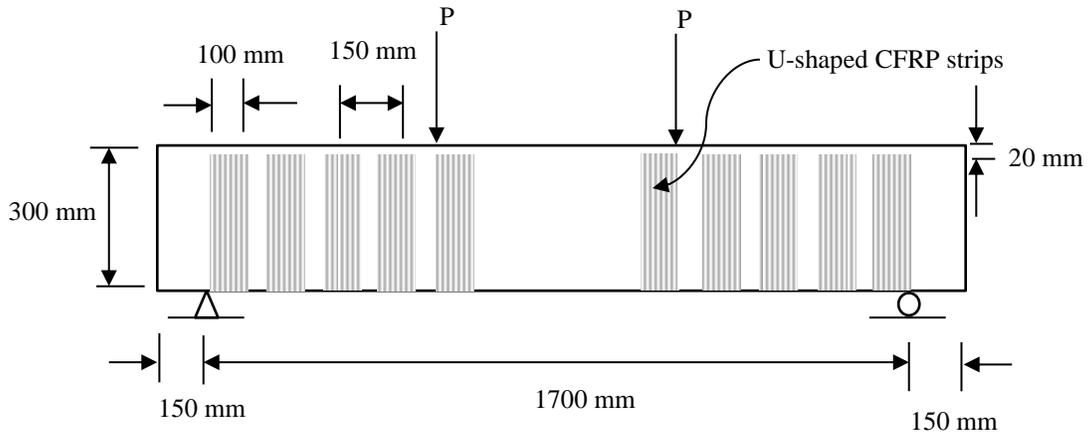
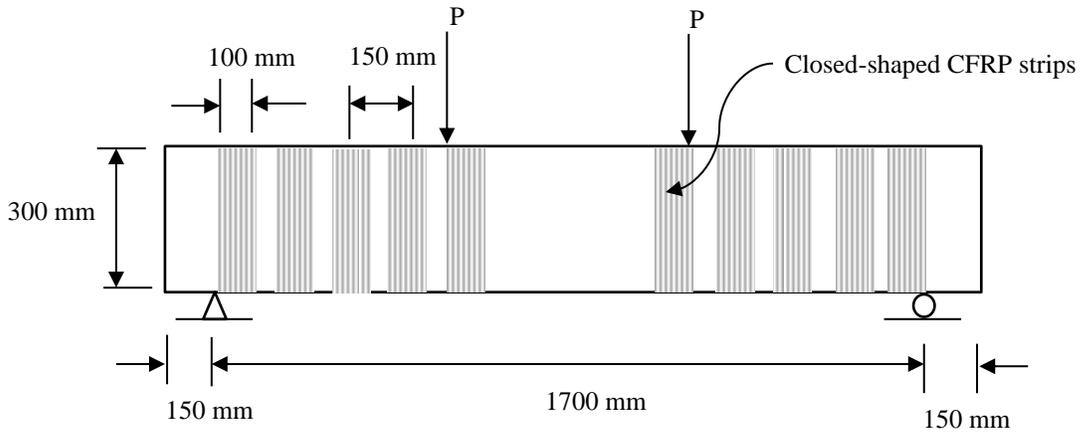
BL/N-UST samples

BL/N-CST samples

Figure 2: Strengthening detail

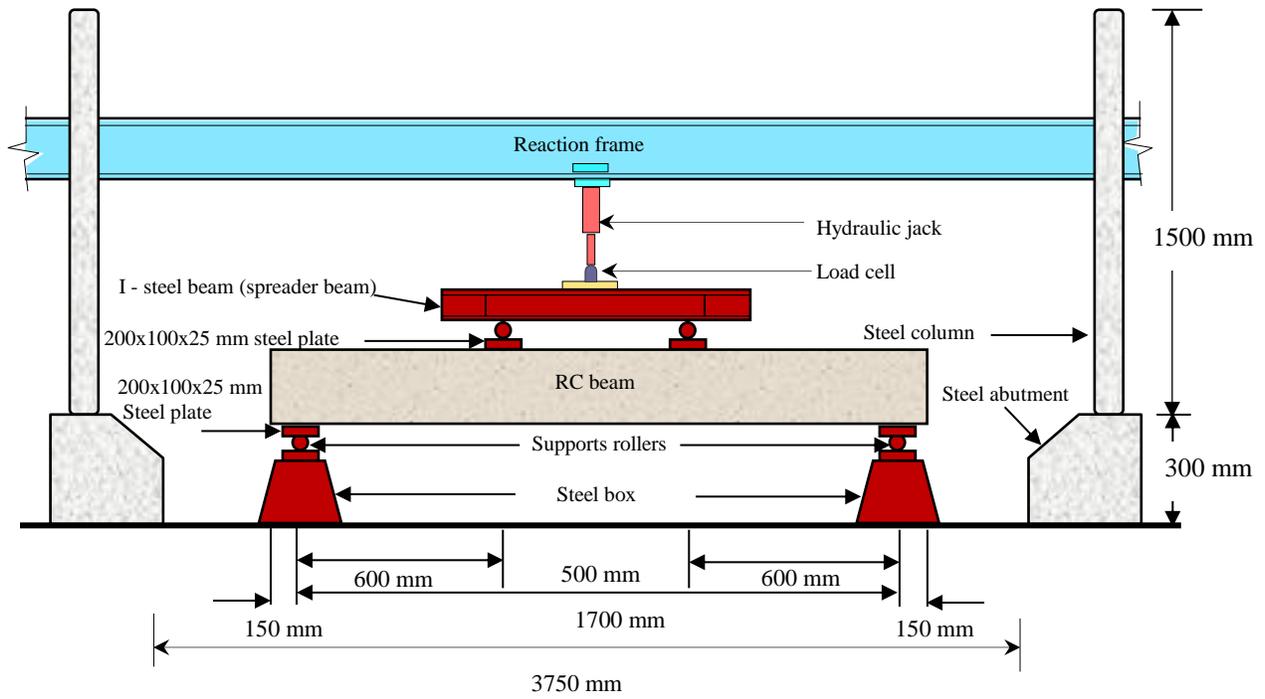
Figure 3: Details of test set-up

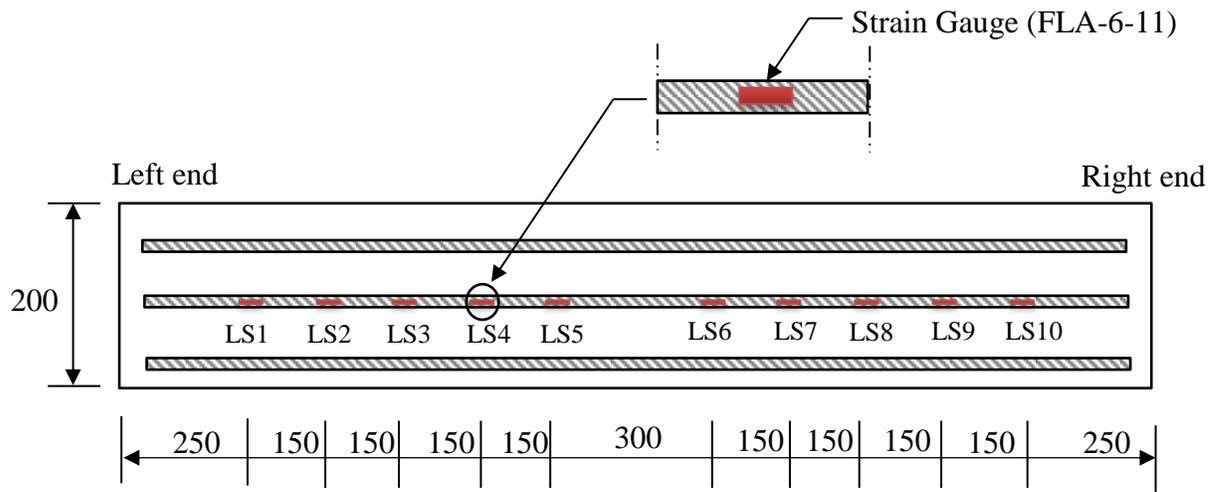
Figure 4: Position of strain gauges attached to the central bottom steel bar (plan view and all dimensions are in mm)

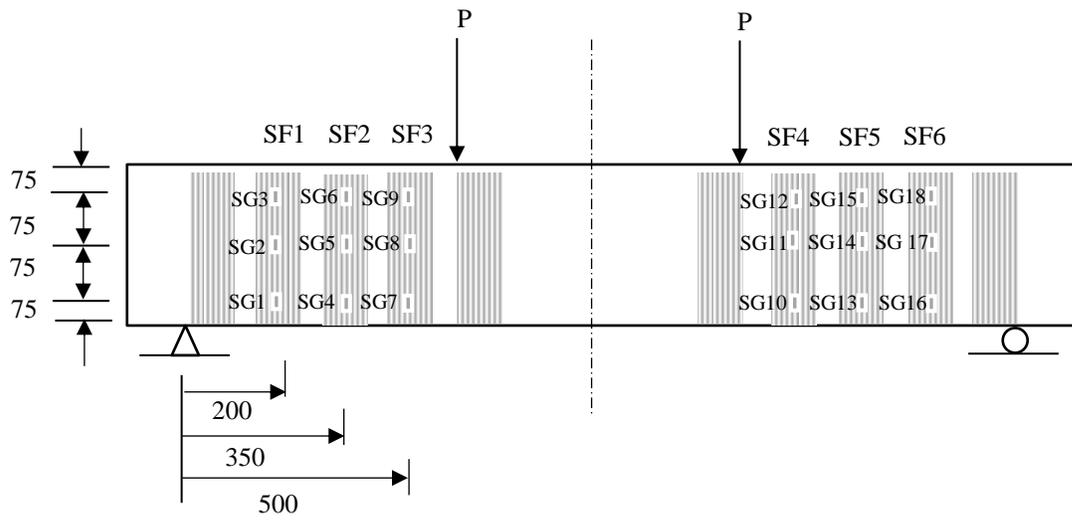
Figure 5: Position of CFRP strips and strain gauges (all dimensions are in mm)

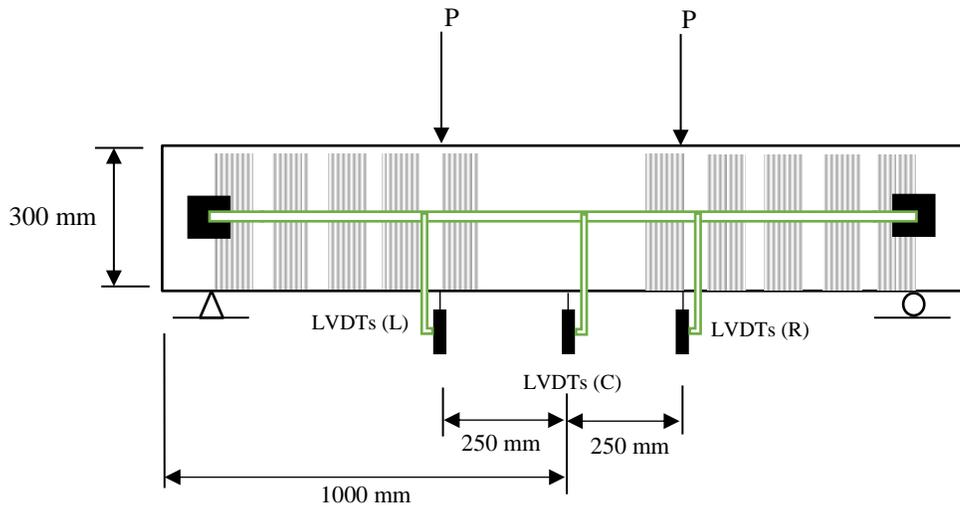
Figure 6: Location of the LVDTs underneath the test samples

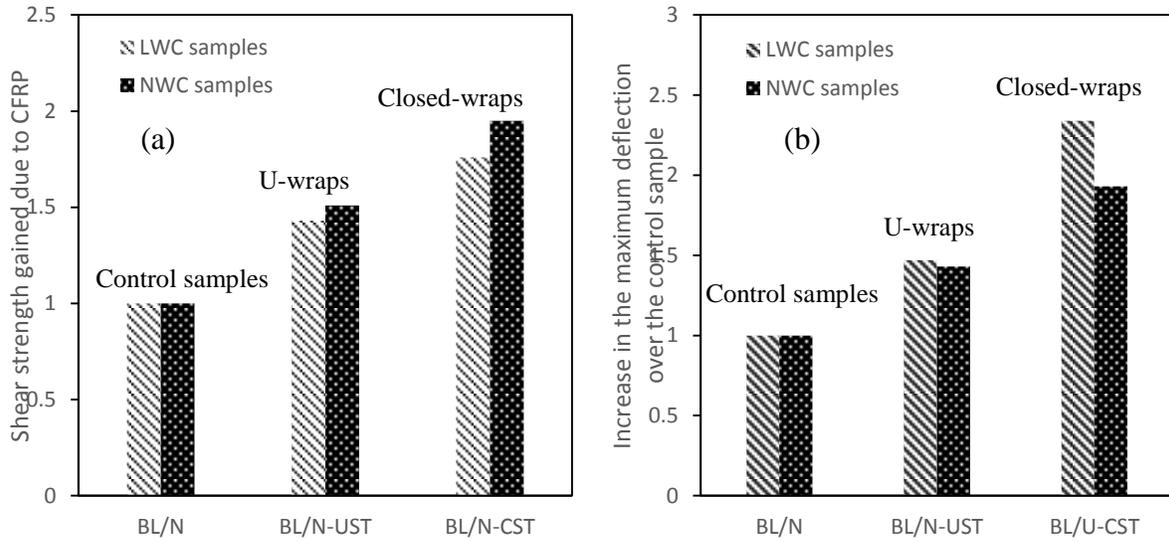
Figure 7: (a) Comparison of the shear strength gained due to CFRP reinforcement and (b) increase in the maximum deflection at failure compared with the control sample

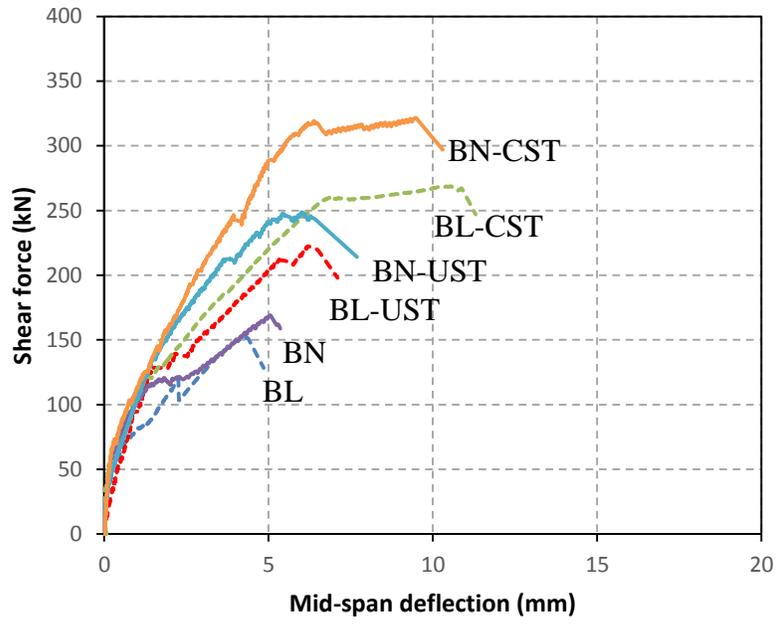
Figure 8: Comparison of load-deflection of LWC and NWC samples

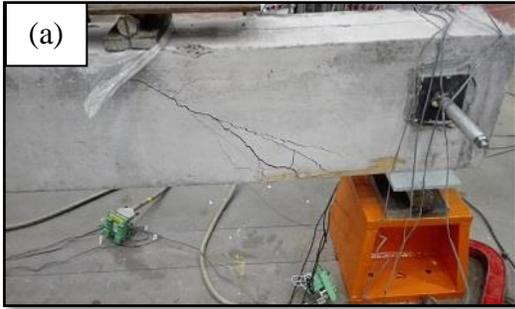
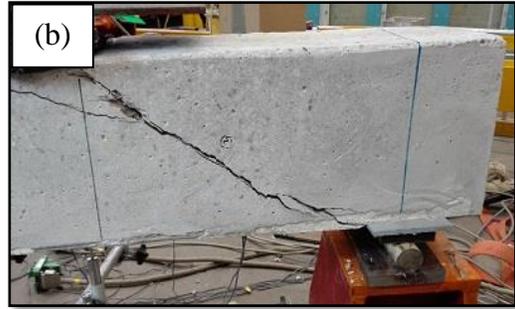
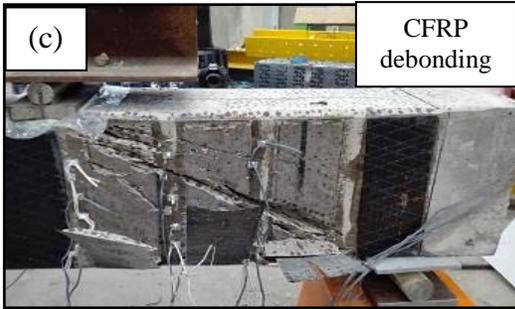
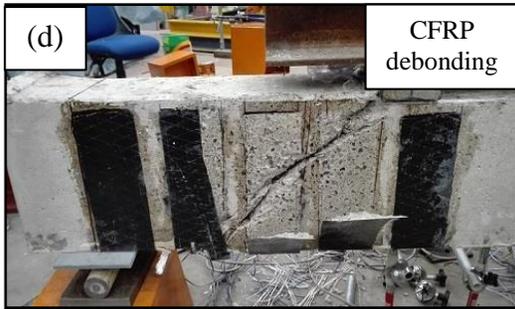
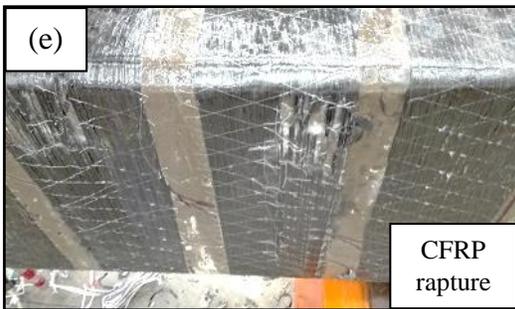
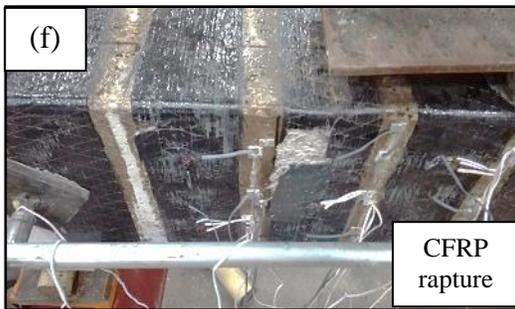
87 Figure 9: Failure mode of samples (a) BL, (b) BN, (c) BL-UST, (d) BN-UST, (e) BL-CST and
88 (f) BN-CST
89

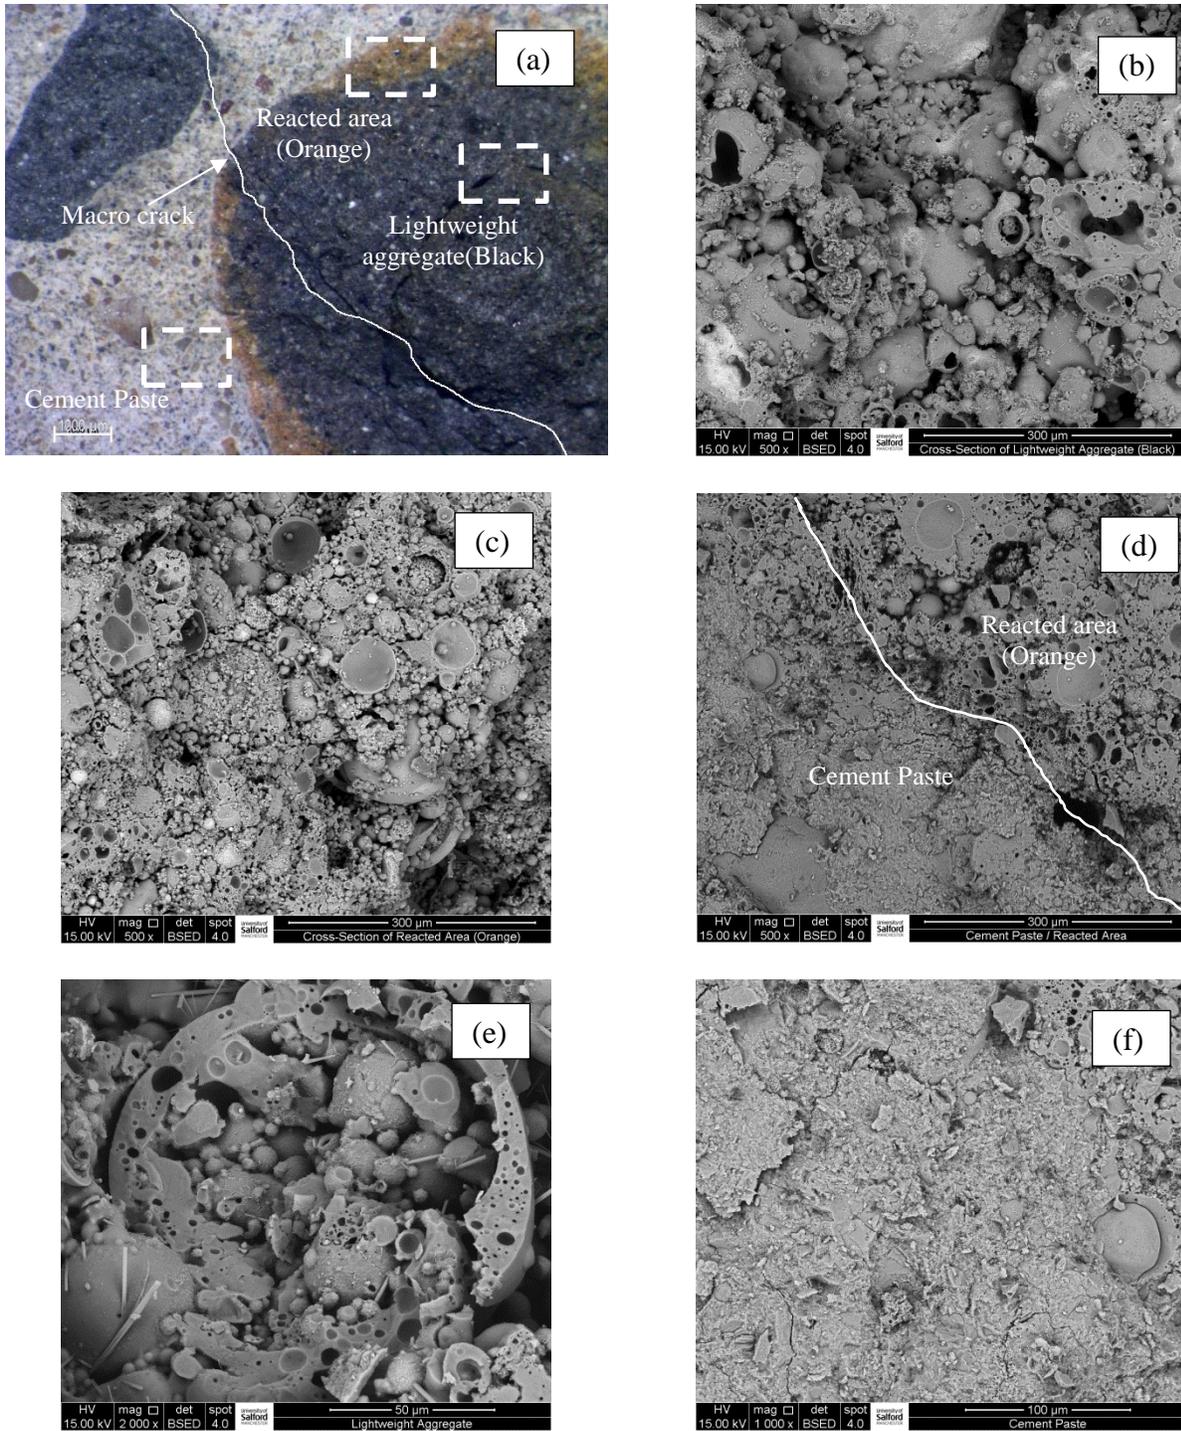
90 Figure 10: (a) Light micrograph of lightweight concrete sample, (b) SEM micrograph of
 91 lightweight aggregate, (c) SEM micrograph of reacted area of lightweight aggregate, (d) SEM
 92 micrograph of reacted area of lightweight aggregate and cement paste, (e) SEM micrograph of
 93 lightweight aggregate and (f) SEM micrograph of cement paste

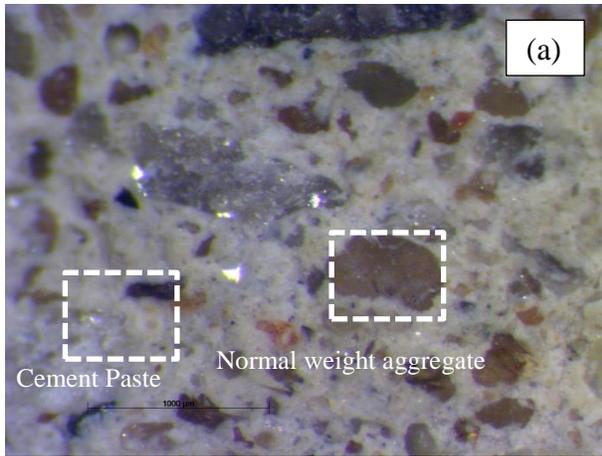
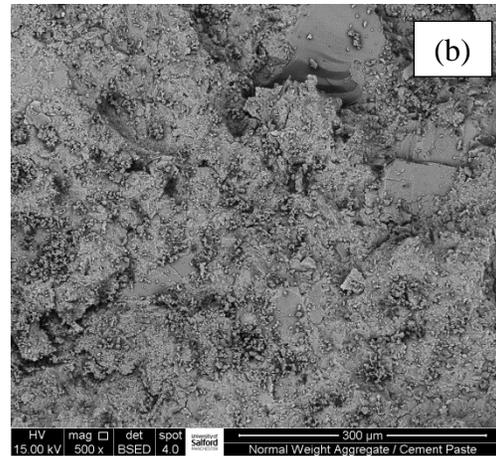
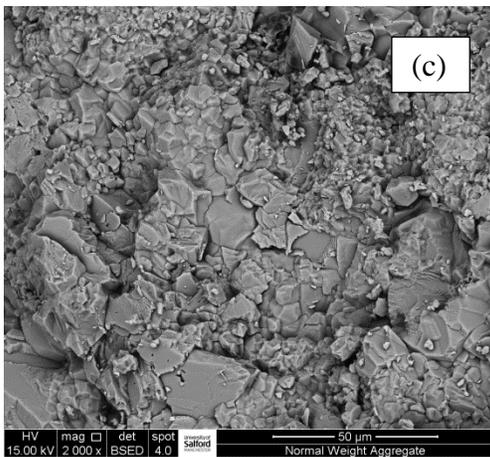
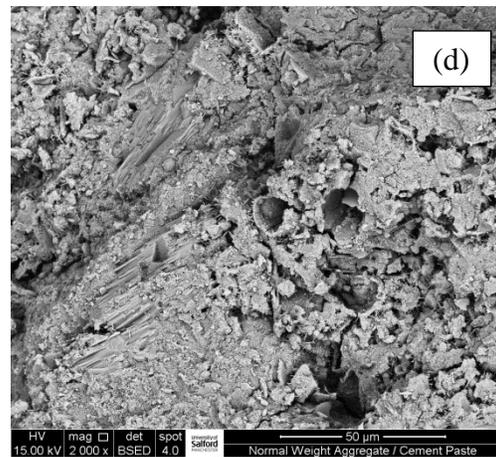
94 Figure 11: (a) Light micrograph of normal weight concrete sample, (b) SEM micrograph of
 95 normal weight aggregate and cement paste, (c) SEM micrograph of normal weight aggregate and
 96 (d) SEM micrograph of normal weight aggregate and cement paste
 97

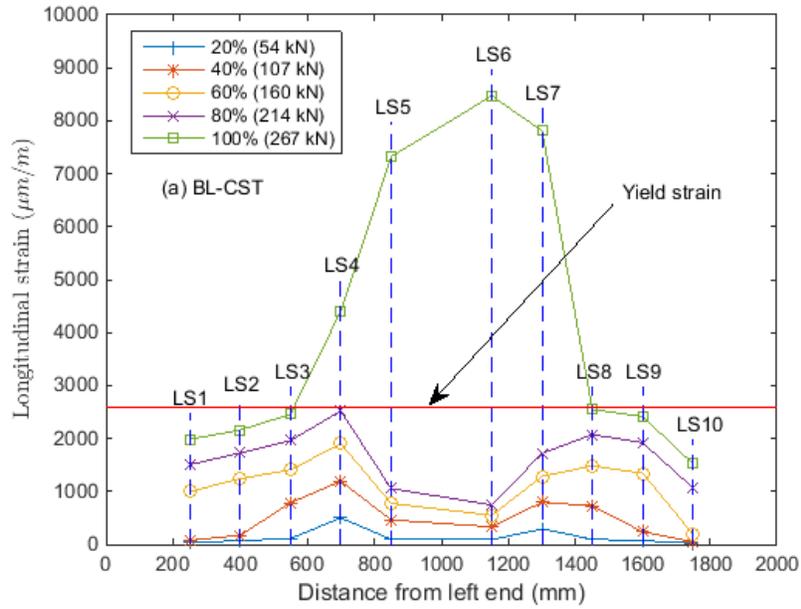
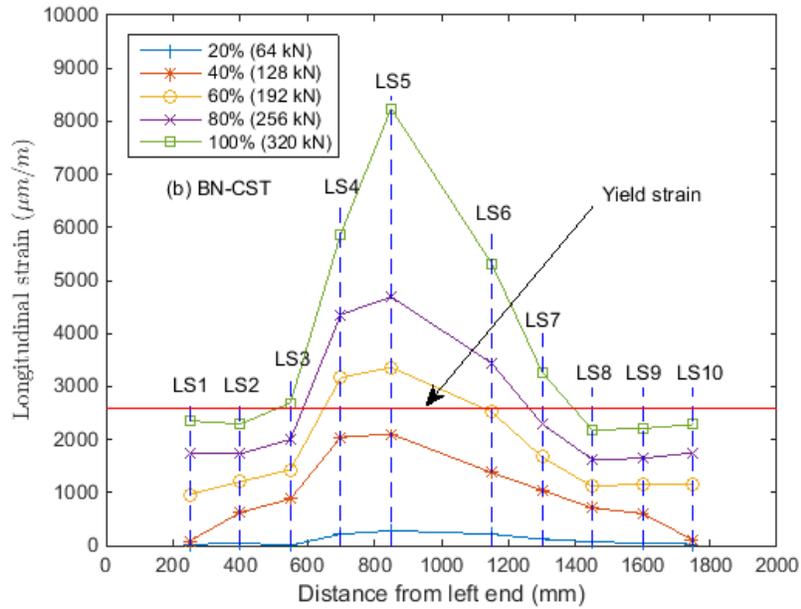
101 Figure 12: Strain profile along longitudinal steel reinforcement of specimen (a) BL-CST and (b)

BN-CST

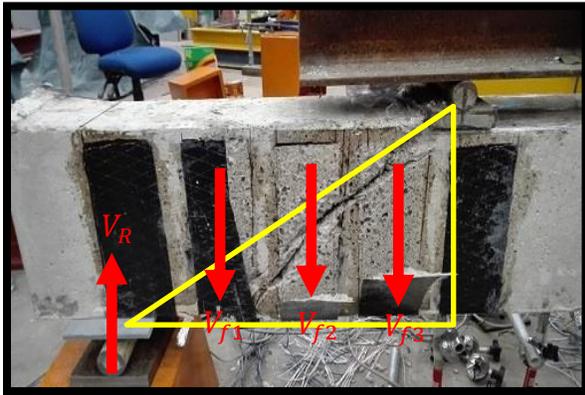
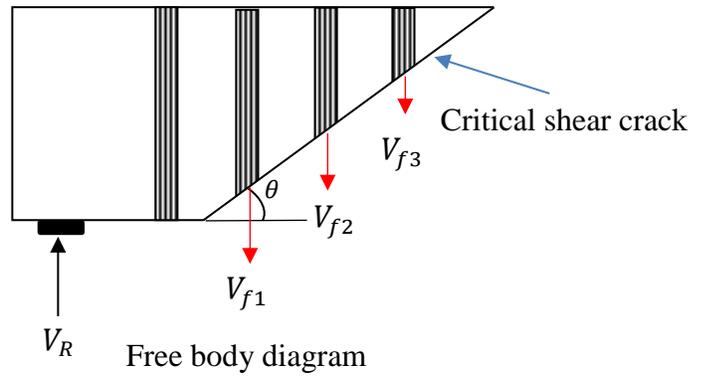
Figure 13: Internal forces in a failed concrete strengthened beam strengthened with CFRP

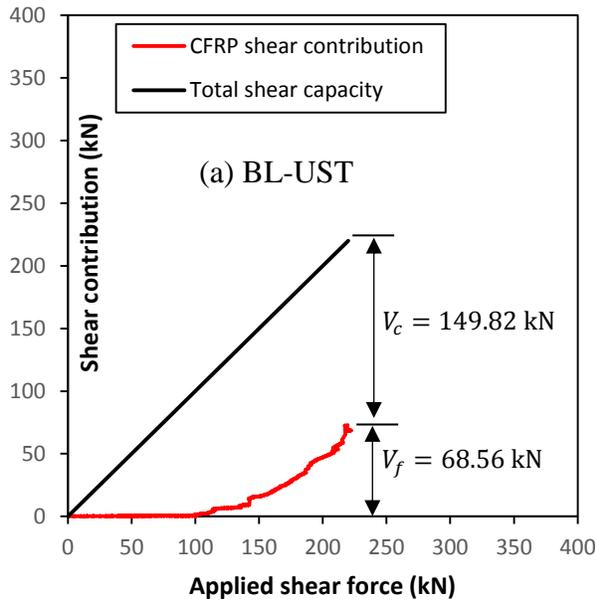
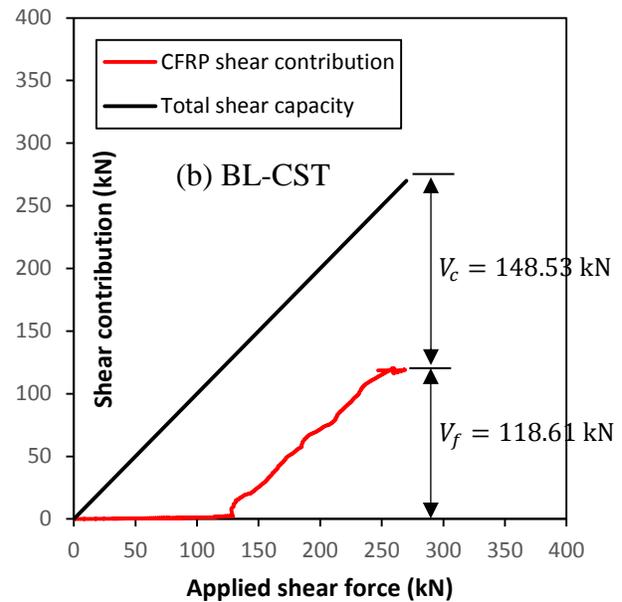
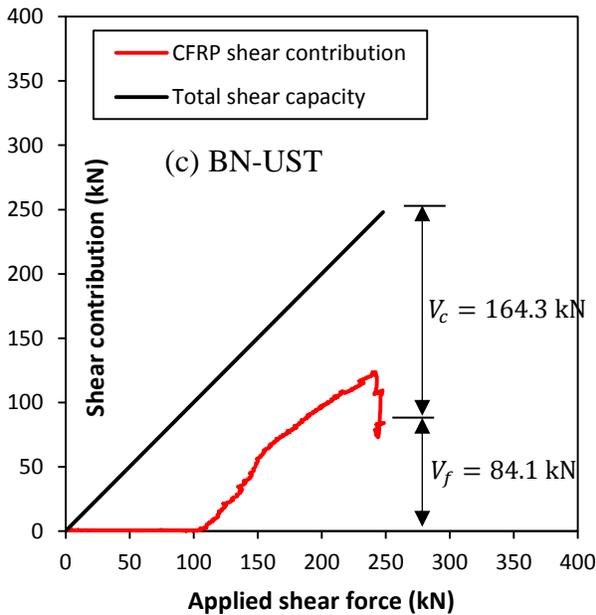
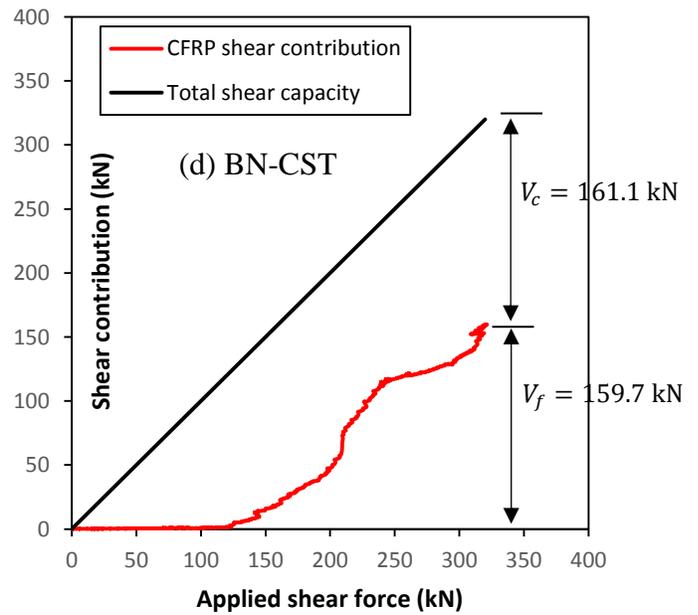
111 Figure 14: Estimated shear contribution of (a) BL-UST, (b) BL-CST, (c) BN-USL and (d) BN-

CST
