**Archaeological  
Evaluation Report**

Lytham Hall, Lytham,  
Lancashire

**Document Title:** Archaeological Evaluation: Lytham Hall, Lancashire

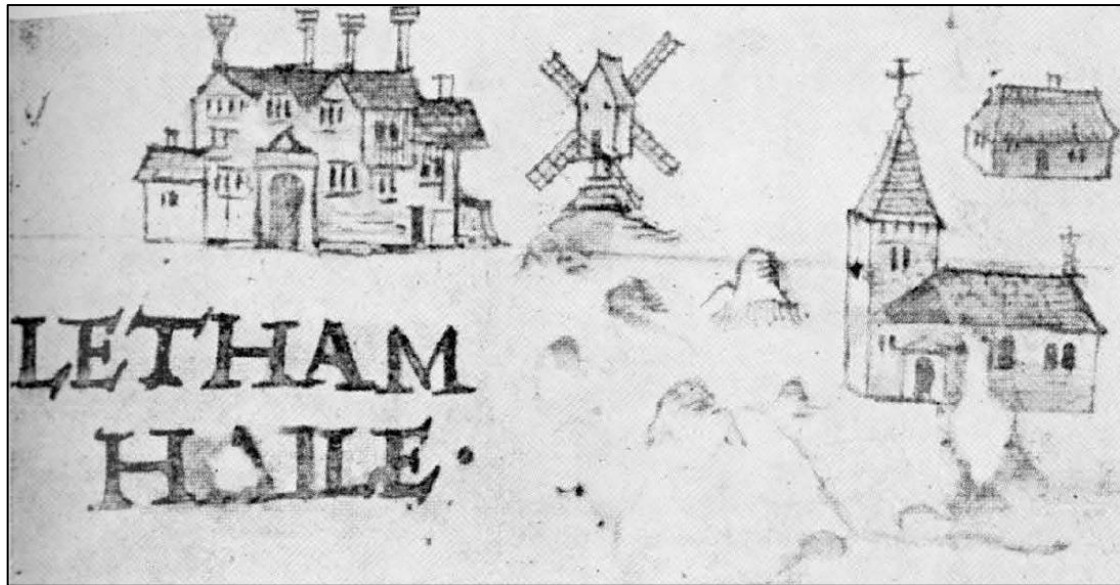
**Plate 1** A rare early depiction of Lytham Hall (top left) suggests that this was the building in existence prior to Clifton's alterations in 1625 (taken from Girouard 1960a, 131; Lancs. Archives ?DDCL/1056)

It is said that the Priory buildings were levelled so Clifton could construct his Jacobean Hall, however elements of fabric within these buildings suggest that some of the Priory was incorporated into the Hall. There is only one depiction of the hall which is dated to the early 17<sup>th</sup> century and it is depicted as a high gabled building with a timber upper storey and the rest of brick or stone (Girouard 1960a, 131-2; see Plate 1). It is also depicted with a triple span pitched roof with two smaller extensions either side. It is likely to predate alterations by Cuthbert made in 1625 because an inventory taken at his death in 1634 stated that there were around forty rooms within the hall (*ibid* 132) and therefore suggests a building larger than the one depicted.

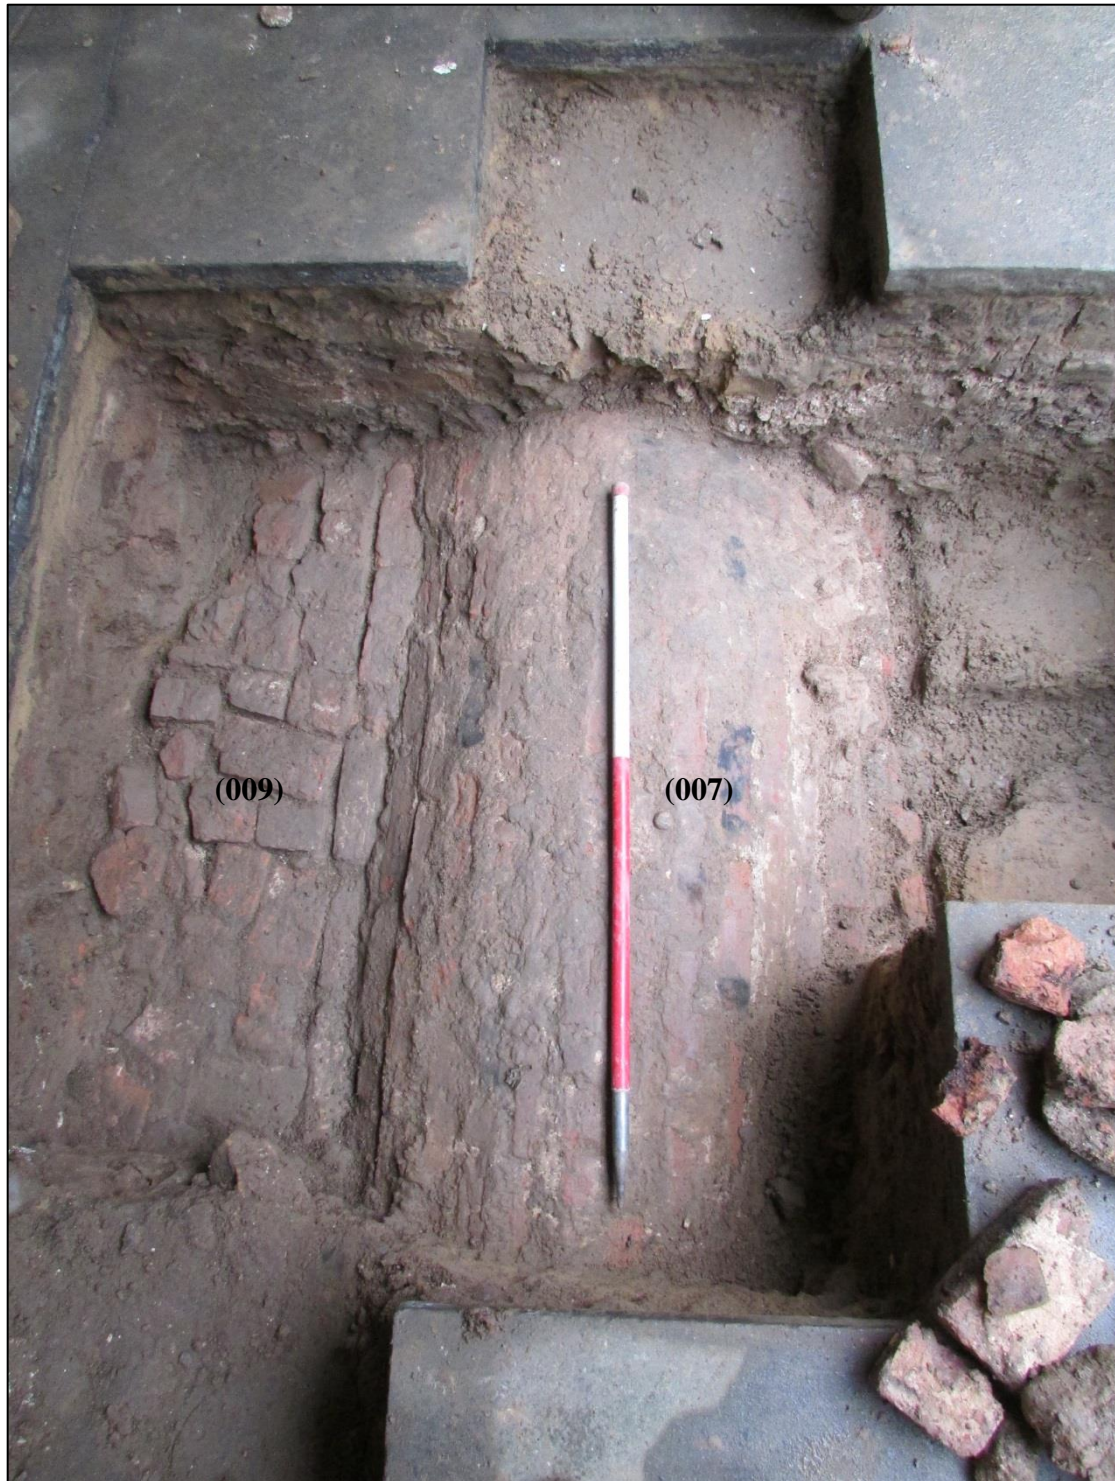
**Plate 2 General shot of Trench 1 (looking north)**

Trench 1 was located against the western side of the Jacobean courtyard and was an irregular shape due to where the flags were removed from. The uppermost deposit was **(001)**, concrete flags sat on a loose light yellow brown silty sand. This measured 0.15m in depth and sealed **(002)**, a fairly loose mid grey brown clayey silt with no observed inclusions. This measured < 0.10m in depth and sealed **(004)**, a fairly

compact mid brown grey silty clay with occasional small broken bricks, measuring < 0.15m in depth. This sealed (007), a large handmade brick culvert which was orientated N-S and consisted of stretcher bricks laid on side with a collar either side. This was visible over a length of 1.30m and measured 0.90m in width. This was abutted on the west side by (009), a handmade brick surface with regularly laid full and half bricks with excavated dimensions of 1.30 x 0.40m. This was the lowest observed deposit on the western side of the culvert (see **Error! Reference source not found.**). On the eastern side, sealed by (004) was (034), a fairly compact dark yellow grey silty clay with rare small sub-angular stones. This also appeared to seal (007).

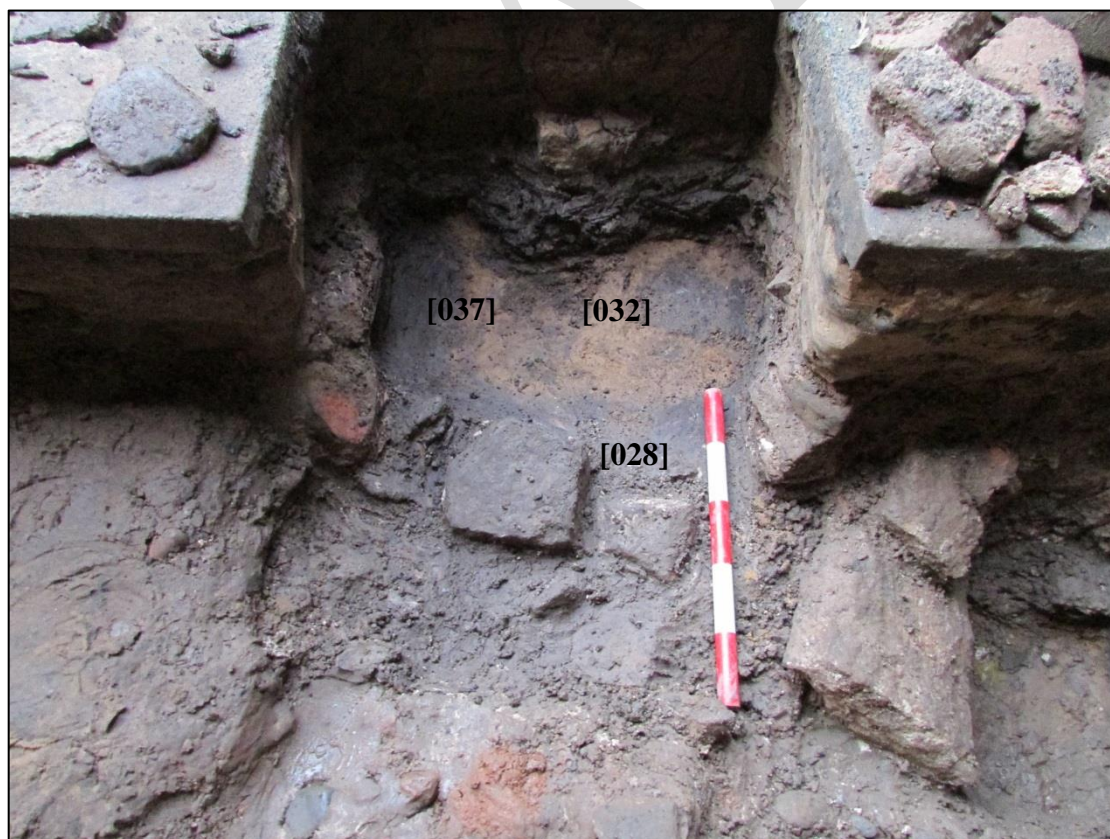
Plate 3 Cut features at S end of Trench 2

[031] appeared to truncate (003), which was a fairly compact mid brown grey silty clay with occasional large roof slates, medium sub-angular stones and rare brick fragments. This measured 0.15m in depth and was only visible at the southern end of the trench. (003) sealed (025), a compact dark brown grey silty clay containing rare large sandstone blocks, some with traces of mortar on. This deposit also contained the near complete late Cistercian ware cup (see Appendix 5). This in turn infilled [028], a linear cut running E-W. It was at least 1.30m in length, 0.60m wide and a minimum of 0.15m deep although it was not fully excavated. This in turn truncated (036), a dark brown grey clayey silt with no visible inclusions. This appeared to be the infill of [037], a linear cut running N-S and visible over a length of 0.30m and width of 0.10m. It possibly turns to run W-E also (see **Error! Reference source not found.**). [037] cuts (038), a malleable dark brown grey silty clay with no noted inclusions measuring 0.05m in depth.

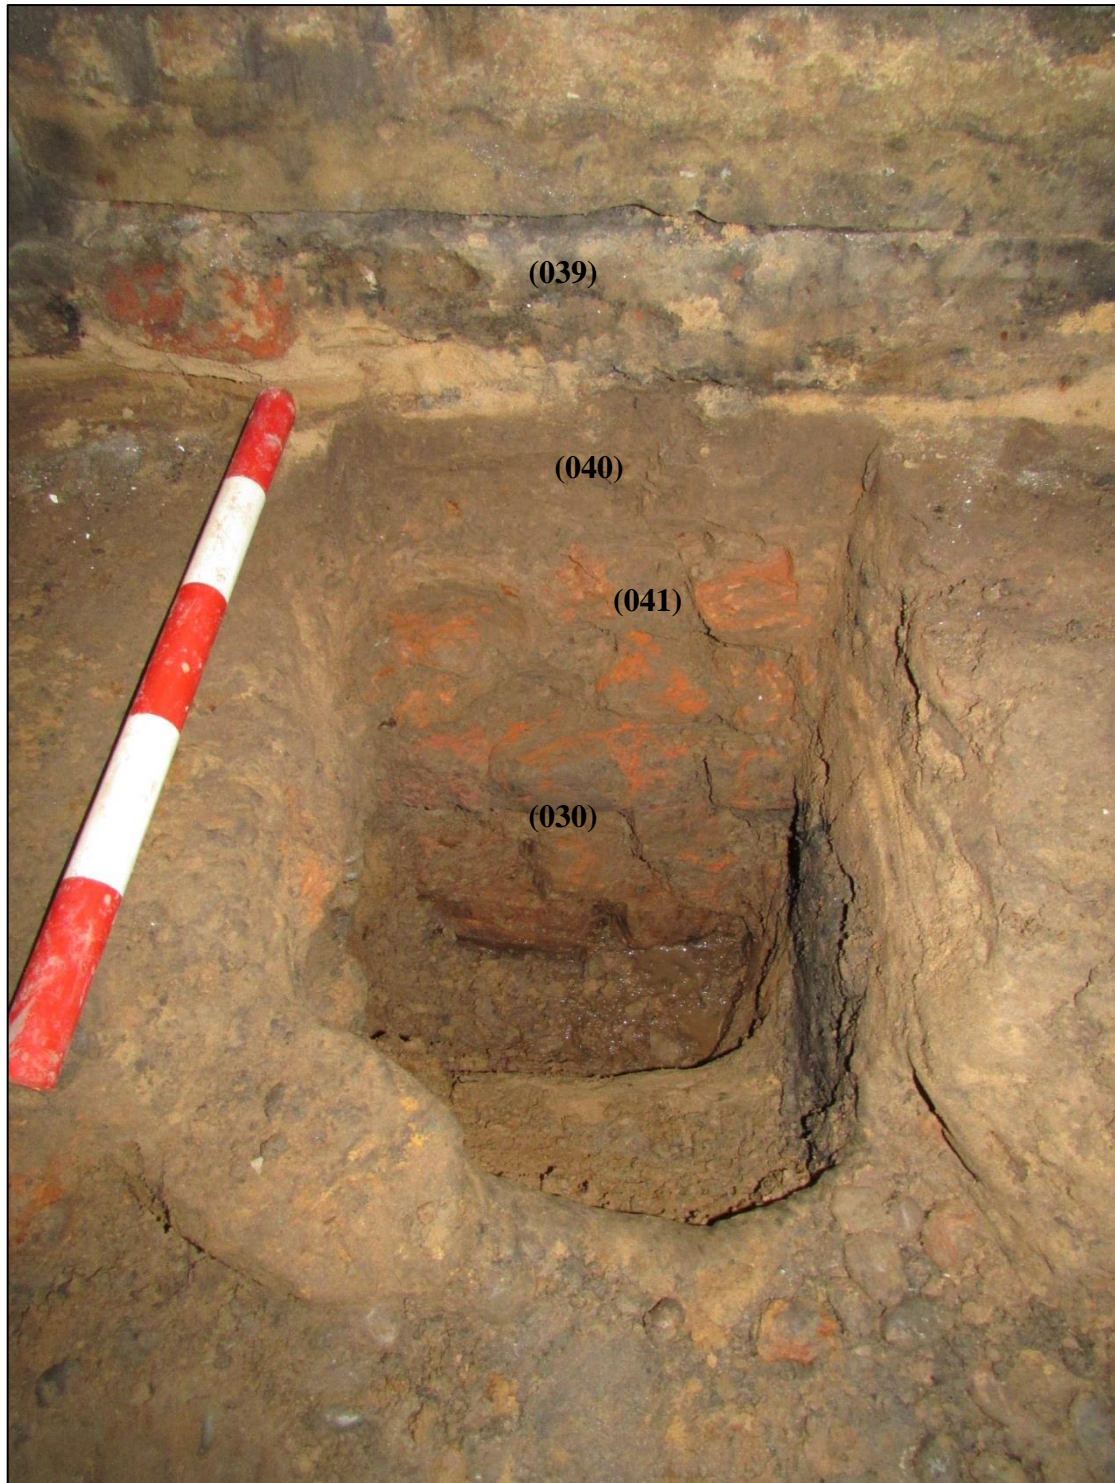
**Plate 4 Foundations of the Jacobean building within Trench 2**

(040) sealed (041), a loose dark grey brown silty sand with occasional inclusions of medium brick fragments. It measured 0.20m in depth and sealed (030), a handmade brick wall running E-W. Its full width could not be ascertained and it was only partially revealed in a slot by the foundations of the buildings however it was three courses high and measured 0.20m in depth (see **Error! Reference source not found.**).

This was infilling cut [029], a linear cut running E-W and measuring 0.15m in width. Deposit (041) was also within this cut and it measured 0.30m in depth overall.

Evidence for this building phase was found in Trench 2, where the demolition material appears to have been used to level up the ground surface. The cobbled surface was then truncated by the foundation cut for the southern building. This appears to have had a handmade brick foundation onto the natural sand. The brick wall along the southern elevation investigated in Trench 4 may be contemporary with this phase although the foundations on the two elevations are very different.

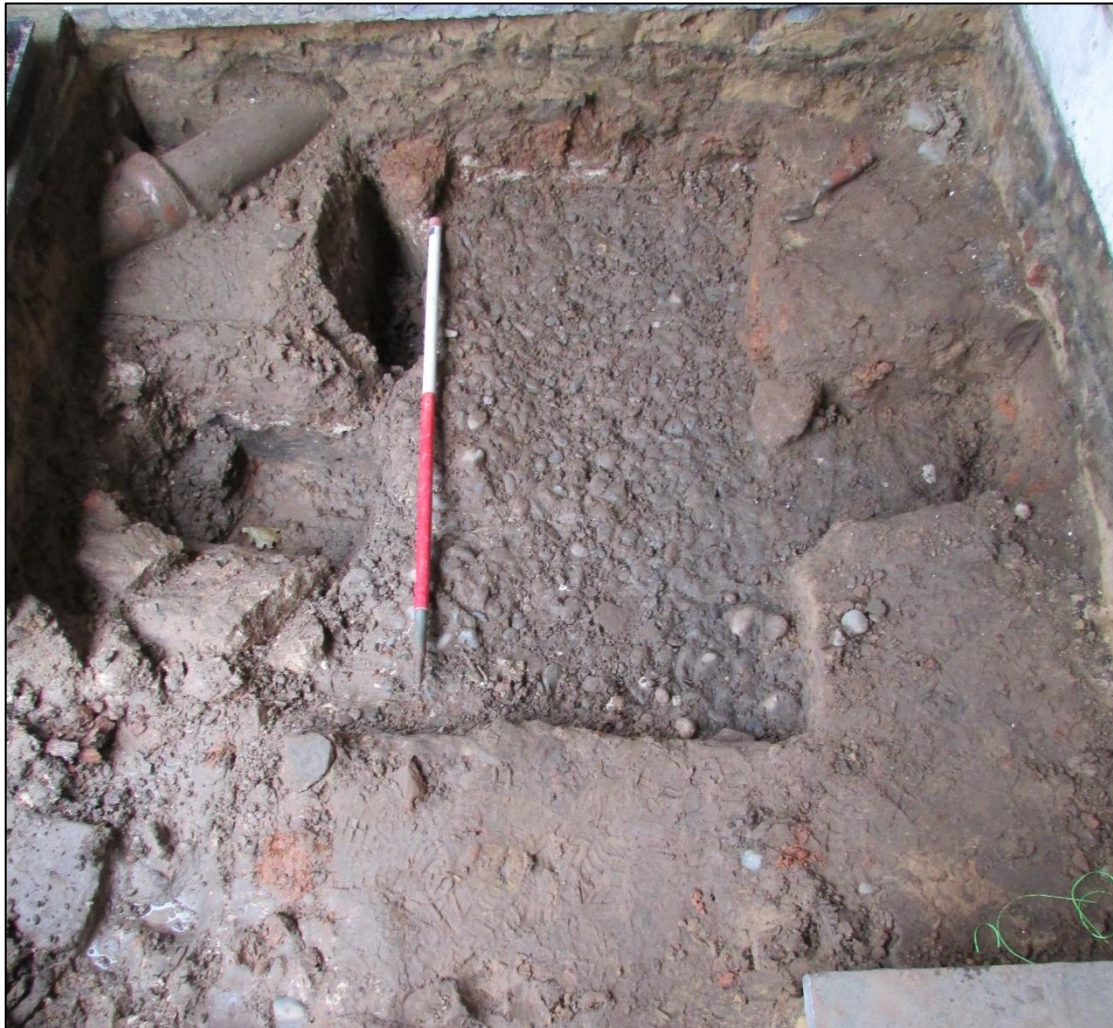
**Plate 5 Cobbled surface (011) in Trench 2**

[029] truncated (011), a cobbled surface with small stones tightly and randomly packed into a dark grey clay layer. Its excavated length was 1.40m and measured 1.20m in length and 0.05m in depth (see **Error! Reference source not found.**). Sealed below (011) was (026), a malleable dark brown grey silty clay with no inclusions observed. It measured up to 0.20m in depth however it was only partially revealed in section. This in turn sealed (027) and was the lowest observed deposit within this part of the trench.

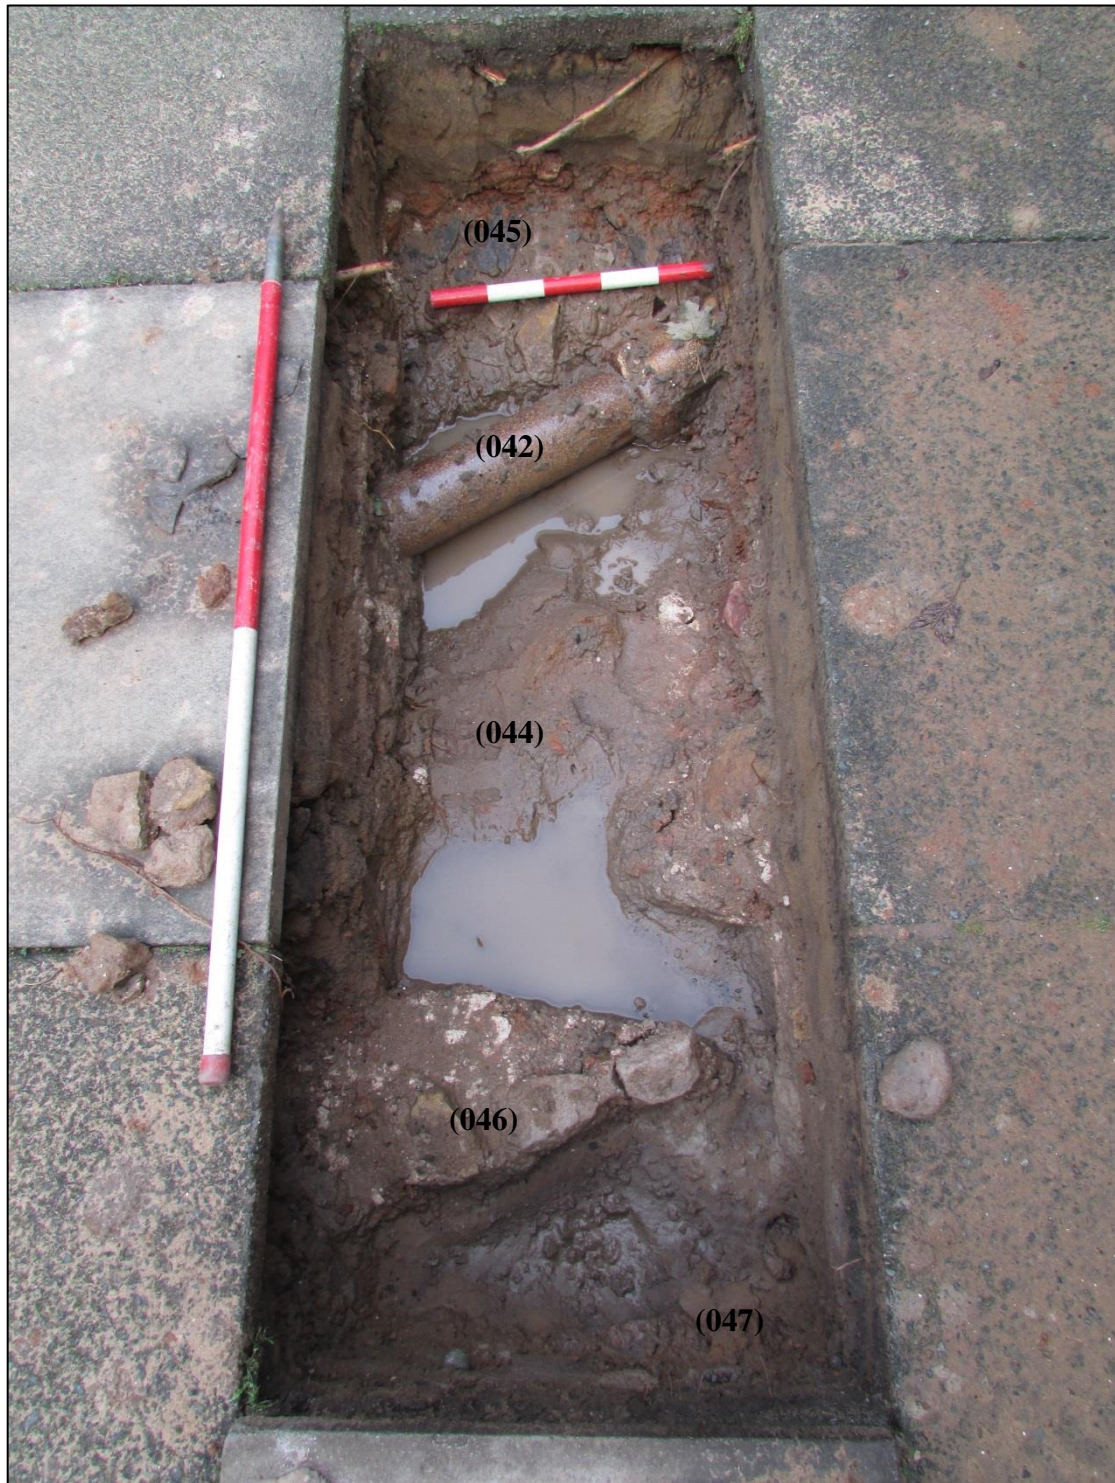
**Plate 6 General shot of Trench 3 (looking N)**

Trench 3 was located towards the centre of the courtyard however due to adverse weather conditions and being in the open, the trench flooded several times therefore it was only partly excavated. Overall it measured 1.85 x 0.65m and was orientated N-S and (001) sealed the trench. This sealed (042), a ceramic drain c.0.20m diameter,

orientated NE-SW and infilled with a dark brown grey silty clay with occasional small sub-circular pebbles. This infilled [043], a steep sided linear cut, orientated NE-SW and visible over a length of 0.70m and 0.40m wide. The depth was not fully excavated. This in turn truncated (044), a light reddish brown silty clay with inclusions of degraded brick, mortar fragments and small angular stones. This measured 0.10m in depth and sealed (045), a layer of slate or unknown stone type that easily fractures. This was located 0.30m below the ground surface and was not excavated to any further depth. It was excavated to maximum dimensions of 0.70 x 0.40m and was only located to the north of [043].

Partially sealed by (044) towards the S end of the trench was (046), a line of medium angular sandstones, measuring no more than 0.20m across and orientated NW-SE. These were only traced over a length of 0.40m and sealed (047), a fairly loose light brown grey sandy silt with frequent inclusions of mortar fragments. This was not fully excavated and was only visible in a small part of the trench to the north of (046). This was the lowest observed deposit stratigraphically and due to water ingress issues, this trench was not excavated any further.

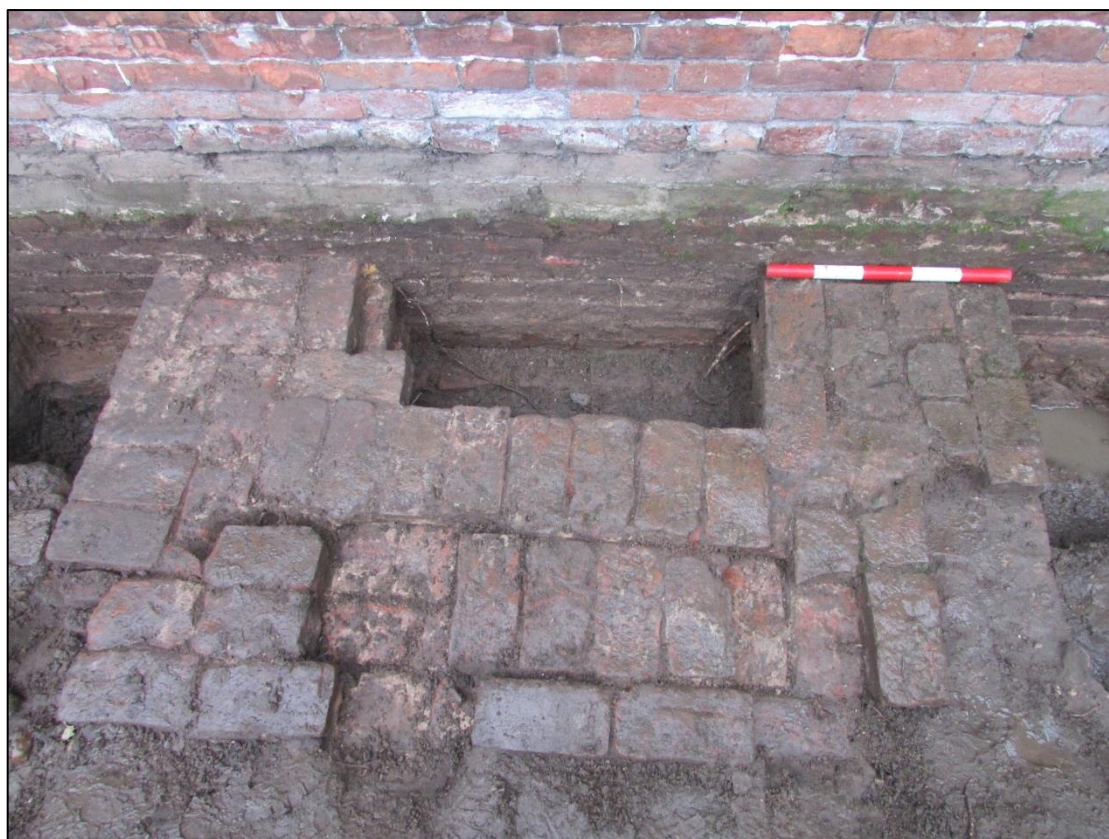
The trench was sealed by (008), a friable dark black brown loam topsoil material. This varied in depth and measured up to 0.30m in depth. This sealed (014), a handmade brick feature abutting the wall of the Jacobean building. Overall it measured 1.90 x 0.95 x 0.30m, had three sides and a rectangular aperture in the middle measuring 0.90 x 0.40m (see **Error! Reference source not found.**). To the west of this feature, a slot was excavated through the deposits on this side and (014) sealed (016), a fairly loose mid grey brown sandy silt and measured 0.20m wide and 0.10m in depth. It was excavated to a length of 0.50m and sealed the brickwork of the building. It was the infill of [017], a linear cut orientated E-W and excavated to the dimensions of (016). This in turn truncated (019), a compact mid red brown silty clay lens which measured 0.05m in depth and had no visible inclusions. This in turn sealed (018), a friable mid brown grey clayey silt which had no visible inclusions and measured < 0.20m in depth. This was the lowest observed deposit in this area and could not be excavated further due to water ingress.

**Plate 7 Feature (014)**

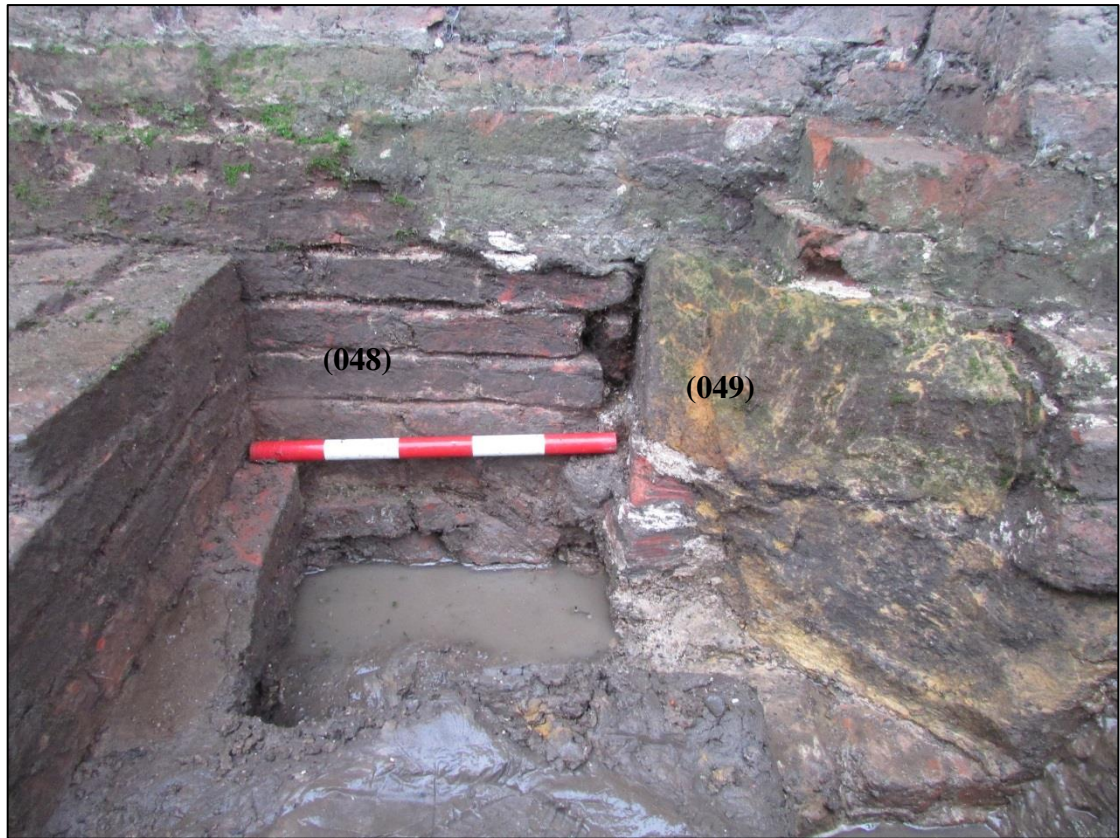
Within this cut was (048), the foundations of the later extension of the Jacobean courtyard buildings. This consisted of three courses of handmade brick which stepped out each time and partly cut into large stones which appeared to be two courses high measuring 0.50 x 0.50m. This stone in turn sat on another course of mortared handmade brick although due to water ingress, the area could not be excavated further. The stones appear to have been worn away and this part of the foundation cuts into (049), the handmade brick foundations of the Jacobean wall. Although it is not clear where the base of the foundations were, towards the base of the excavations, the foundations consisted of at least two courses of stepped out brick although the bricks appear not to have been arranged in a regularly pattern (see **Error! Reference source not found.**). [021] truncated (022), a compact dark brown grey silty clay with rare small rounded pebbles and frequent inclusions of small mortar fragments. This was the lowest identified deposit in this area and due to water ingress, the area could not be excavated any further.

**Plate 8 The foundations of the two differently phased buildings revealed in Trench 4**

When Carr built the main three storey house at the eastern end of the complex, he also constructed a link between the Jacobean wing and this new building. This evidence was found in Trench 4, where the stone and brick foundations for the link appeared to truncate the earlier wall.

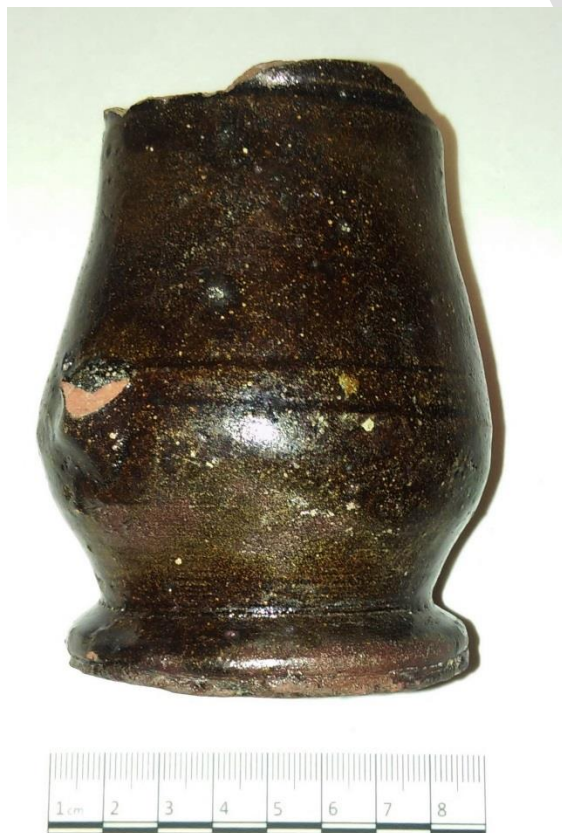
2101.2.1 – Cistercian ware mug recovered from Trench Two, lying beneath the roof slates, above the area of negative archaeological features. The item shows characteristic uniform fine ware mid reddish brown smooth fabric, with no inclusions in the temper and handmade construction. The glaze appears as a lead glaze which is mid to dark brownish purple in colour and the item had connections for two handles. The mug is 900mm tall and 706mm at its widest point. The item reflects the typical bulbous formed pottery associated with Cistercian wares and is similar to Brears type 7 (formally type 14) in its profile. This item offers a date approximation of late 16<sup>th</sup> century.

**Fig three:** showing a scale photo of the Cistercian two handled mug.
