**Archaeological
Evaluation:**

Gore Street Car
Park, Gore Street,
Salford, Greater
Manchester

Client: UK Land
and Property

Report No:
01/2016

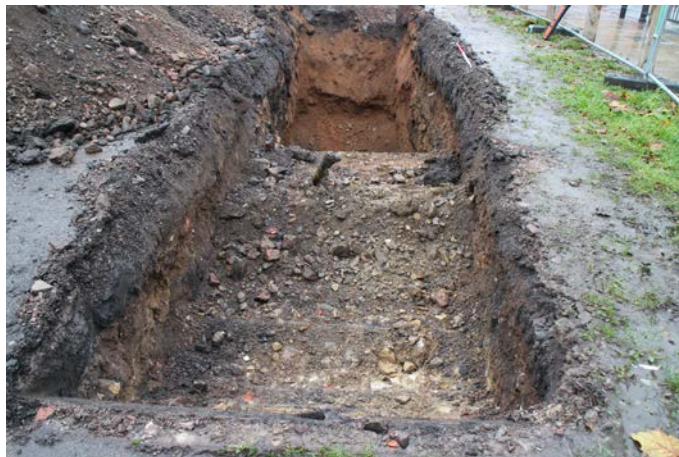
Plate 2: Trench 1 general shot, looking southwest

The trench was overlain by a 100mm thick layer of compact MoT **100** which lay above 300mm of compact mixed clay and demolition rubble levelling material **101**. Below this was dark brown compact mixed clay and brick rubble **102** into which had been laid a plastic gas pipe **103**, now capped. Beyond the gas pipe layer **102** was excavated further into by machine until natural sandy clay **105** was observed at a depth of 2.7m. Within the southeast trench the corner of a hand made brick cellar wall **104** with white lime mortar could be seen. The top of this wall at 0.7m below the current ground surface and continued down to the natural clay at 2.7m

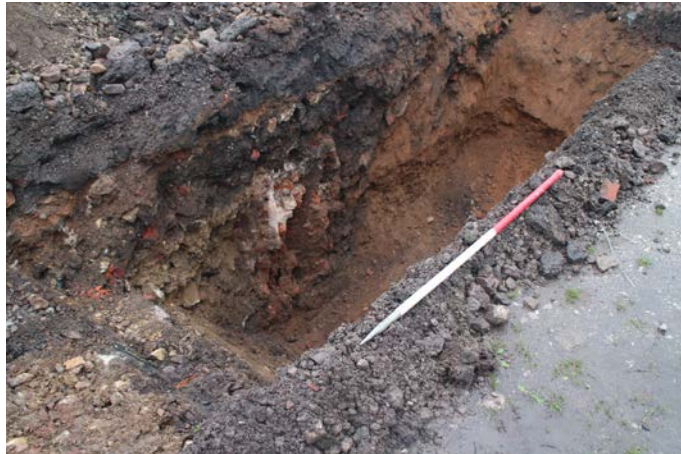
Plate 3: Wall 104, looking south

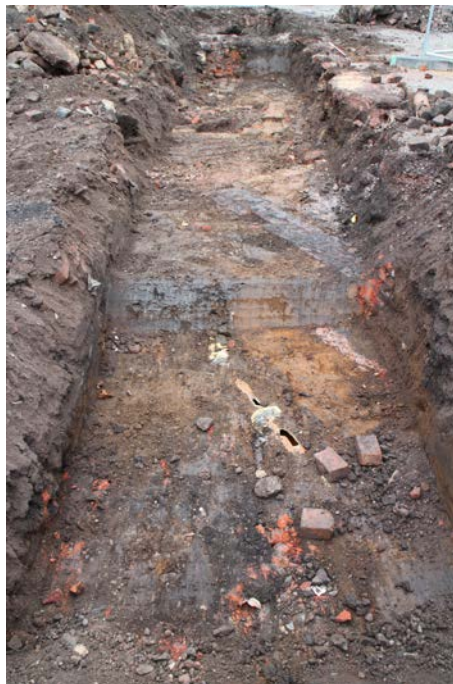
The trench was overlain by a 350mm thick layer of compact MoT **200** with 300mm of compact mixed clay and demolition rubble **201** below it. A ceramic drain **202** ran southwest across the western end of the trench and cut through a mid to light brown sandy silt plough soil **203**. This contained no dating material but strongly resembled plough soils encountered on a number of sites within the vicinity of Salford and Manchester.

Plate 4: Trench 2 general shot, plough soil 203 visible on right, looking east

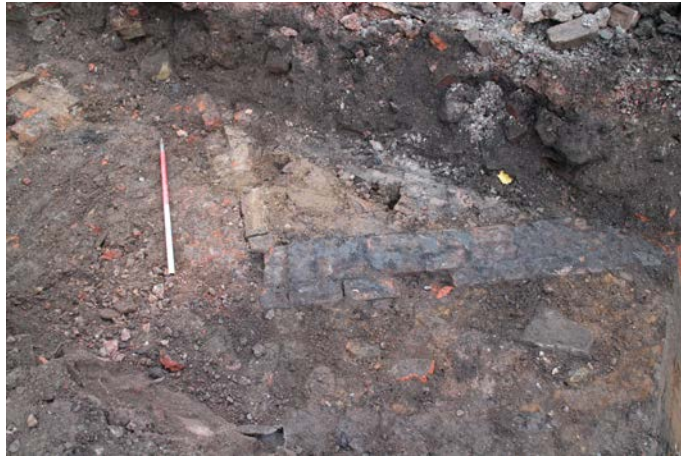
To the east the plough soil was cut by a wall **204** of late 19th century machine made brick with a hard dark cement. This ran northeast from the southern section for 2.7m before returning southwest. At its corner it had been partially truncated by a later concrete pad **205**.

Plate 5: Wall 204, looking southeast

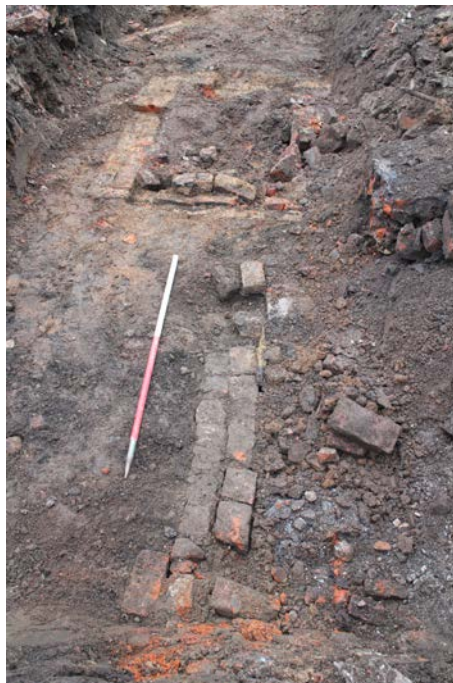
At 4.7m to the east of this wall was a 1.65m wide brick structure **207** comprising a wall running southwest from the north section for 0.9m, turning southeast at a right angle for 1.13m and then returning northeast to the section, forming the southwest end of a rectangular structure. The walls were constructed from two stretchers of hand made brick with white lime mortar and the interior was filled mixed clay and brick rubble. Between this structure and wall **204** to the west was a deposit of mixed clay and brick rubble levelling material **206**. This material, and structure **207**, cut a second patch of plough soil **210**. This was also cut at its east side by later disturbance containing cinder **211**, and at the north by a partially surviving stretch of handmade brick wall **208**. This was two stretchers wide and had white lime mortar. At the north side of the wall was a loose mixed demolition rubble infill demolition **209**, strongly resembling cellar fill and suggesting that wall **208** was the remains of a cellar cutting through the earlier plough soil.

Plate 6: walls 207 and 209 with ploughsoil 210, looking west

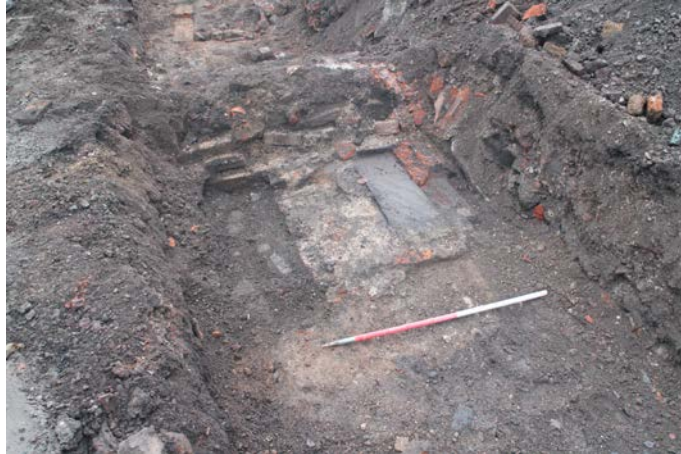
against this wall, to the east, was a brick structure **213** which comprised a 1.25m by 0.9m handmade brick base with a stone slab set into its upper surface, slightly offset to the north of centre. Associated with this was a rectangular deposit of cinders **216** at its south side, within the 'L'-shape formed by structure **213** and wall **212**. Surrounding this was a rectangular deposit light brown mixed sand and gravel **215** which lay within a levelling layer of compact clay and brick rubble.

Plate 7: Wall 212 and structure 213, looking west

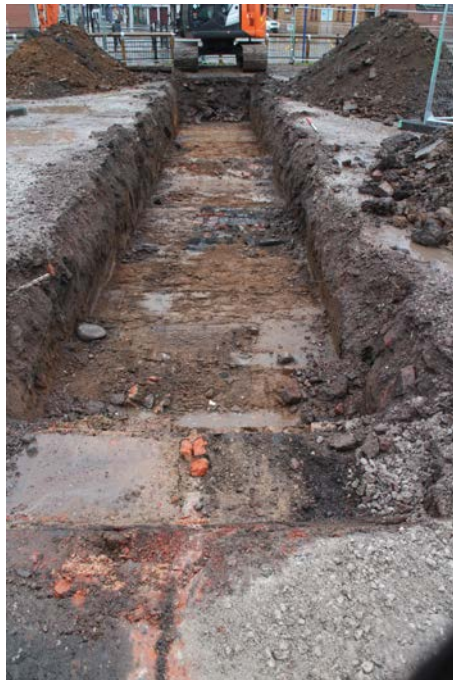
The trench was overlain by a 0.3m thick layer of compact MoT **300** with 0.2m to 0.6m of compact clay and brick rubble levelling material **301** below. Beneath this, within the northwest half of the trench, natural yellow sandy clay **302** was observed.

Plate 8: Trench3 general shot, looking southeast

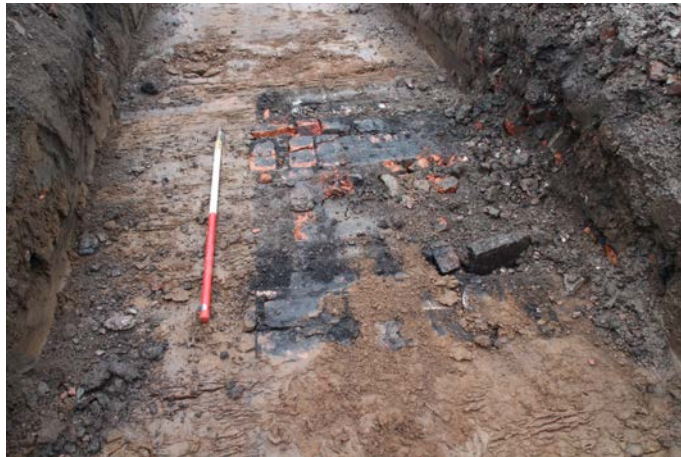
At the southeast edge of this pad the natural was at a depth of 0.9m below the current ground surface, as if terraced down, and contained a second brick pad **304**. This was also of hand made brick with lime mortar and was 1.6m wide, running out of the northeast section for 1.3m.

Plate 9: Brick pad 304, looking northwest

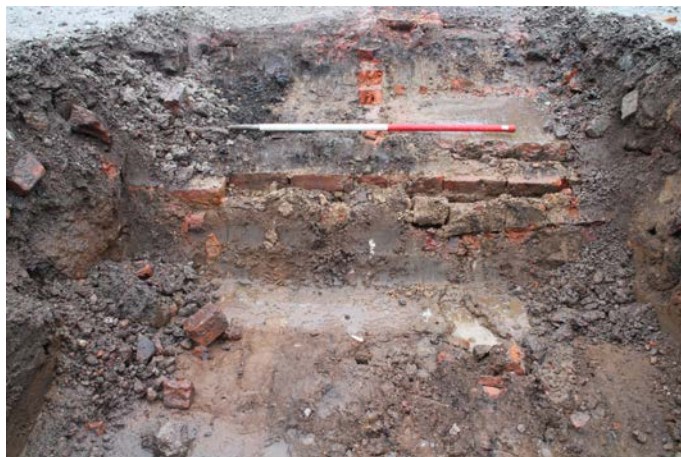
At 1.03m from the southeast end of the trench a brick wall **305** ran across at right angles. This comprised two stretcher courses of hand made brick with lime mortar and had a single course wide wall running at right angles from it to the southeast. These stood to a height of 0.3m and were c. 0.25m below the current ground surface.

Plate 10: Brick wall 305, looking southeast

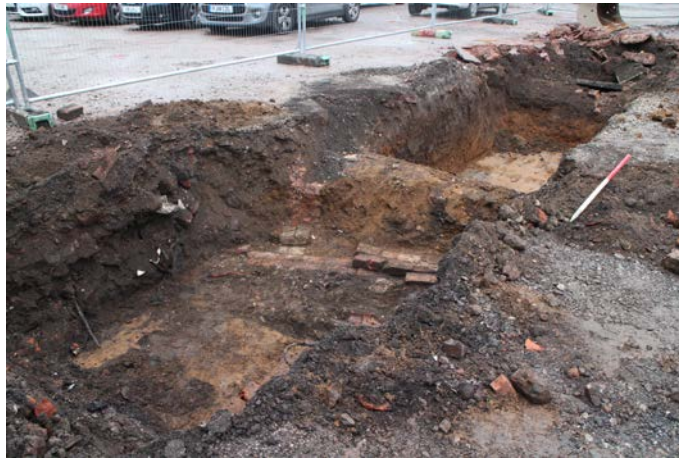
The trench was overlain by 0.26m of compact MoT **400** with 0.4m of compact clay and rubble **401** below it. At the northwest end of the trench was a modern brick manhole 1.38m square. This had been cut into the clay and rubble.

Plate 11: Trench 4 general shot, looking northwest

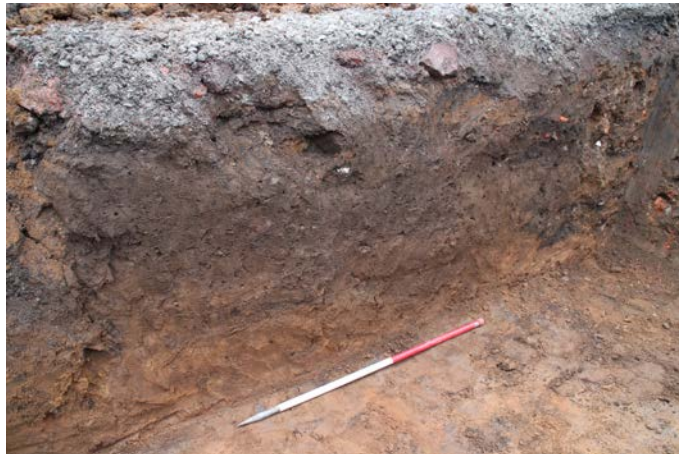
Between the manhole and wall **404** natural yellow sandy clay **407** was observed at a depth of 1.3m. Between the bottom of clay rubble levelling layer **401** and the natural clay was a 0.64m thick deposit of mid to light brown fine friable sandy silt plough soil **409** similar to that in trench 2. This was photographed in section. It contained no dating material.

Plate 12: Plough soil 409 in section, looking southeast

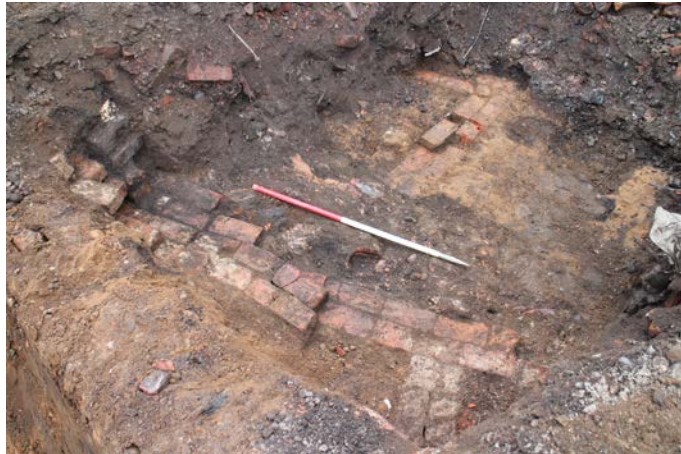
Immediately to the southeast of wall **404** was a drain cut **405** with a ceramic drain pipe. This truncated the north end of a hand made brick wall **406** which ran southwest from the northeast trench edge for 0.66m before turning northwest where it was truncated. This was cut into natural clay **407**. In the southeast corner of the trench the natural clay was cut into by a modern pit **408** containing mixed sand, gravel, ash and refuse including drinks cartons.

Plate 13: Walling, drains and disturbance at south end of trench, looking southeast

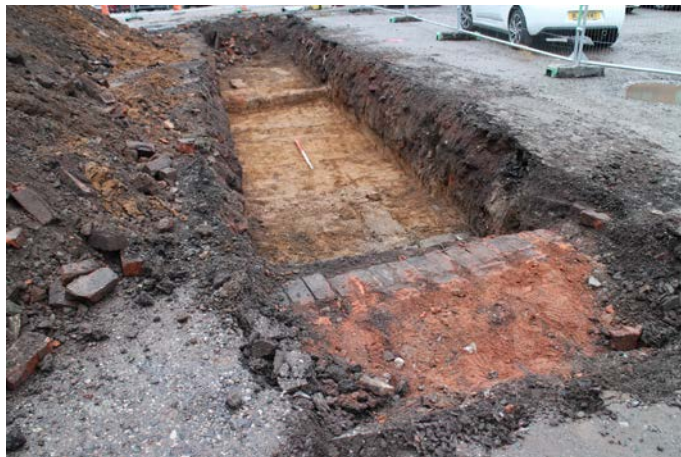
The trench was overlain by a 0.25m thick layer of compact MoT **500** with 0.65m of compact clay and brick rubble levelling material **501** below it. Beneath the levelling material, at 0.9m below the current ground surface, natural yellow sandy clay **502** was observed.

Plate 14: Trench 5 general shot, looking north

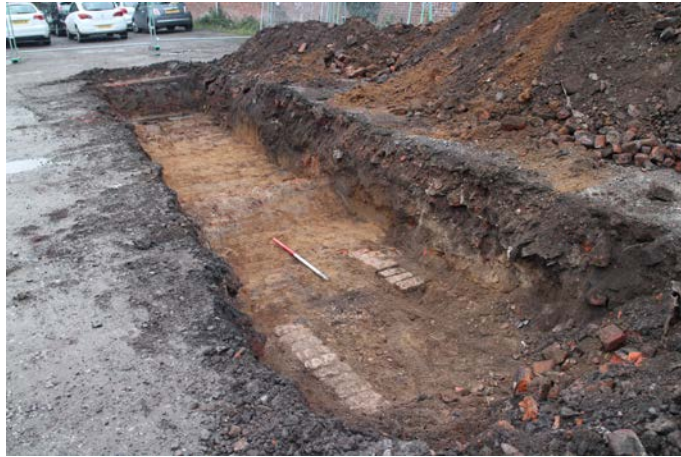
Two parallel stretches of walling were observed within the clay at the northwest end of the trench. Both ran southeast and were a single header course in width. They were of handmade brick with no discernable mortar. Wall **503** ran southeast for 3.66m whilst wall **504** ran southeast for 2.13m and at its southeast end widened out into two header courses.

Plate 15: Walls 503 and 504, looking southeast

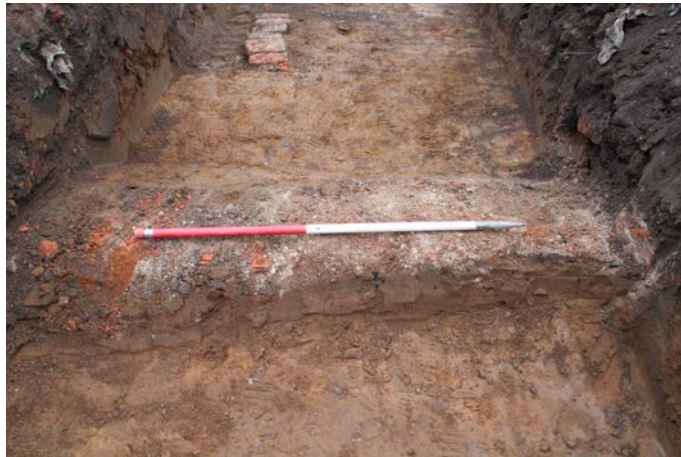
At 1.38m to the southeast of this a rough 0.53m wide structure of brick rubble and cement **505** ran northeast/southwest across the trench. This may have been part of the footing for a wall.

Plate 16: Wall footing 505, looking northwest

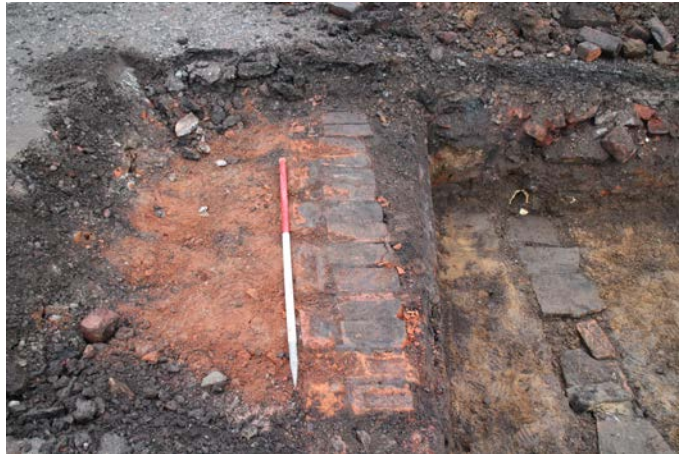
A three stretcher course wide wall **507** ran across the trench 1.02m from its southeast end. This was of hand made brick with lime mortar and survived to 0.7m in height. The top of this wall was 0.02m below the current ground level. A stone capped brick drain **506** ran parallel to the wall, 0.75m to its northwest. It was 0.45m wide and built from hand made bricks with no discernible mortar.

Plate 17: Wall 507 and drain 506, looking southwest

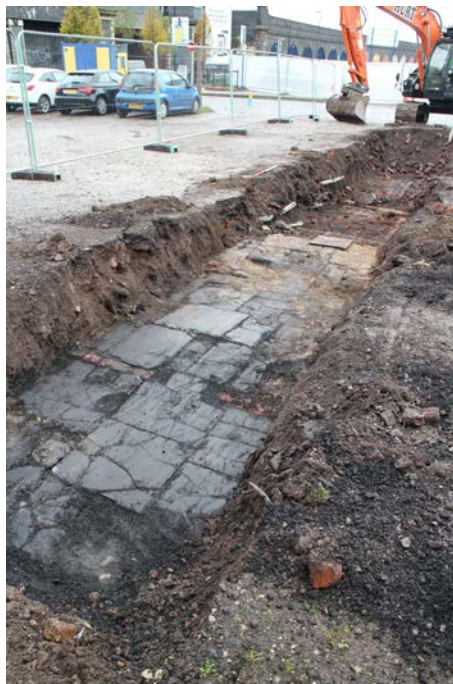
The trench was overlain by a 300mm thick layer of compact MoT **600** with a 400mm thick layer of moderately compact demolition material levelling **601** below. At the southwest end of the trench, below the demolition rubble levelling, was a deposit of very loose rubble and refuse **602** containing plastic bags, plastic drinks bottles and the remains of a number of broken uPVC window frames. Observed within this deposit was to top of a 2.29m long and 0.48m wide section of modern brick walling **603**. This comprised four stretcher courses wide of machine made frogged brick with hard light grey cement.

Plate 18: Trench 6 general shot, looking southwest

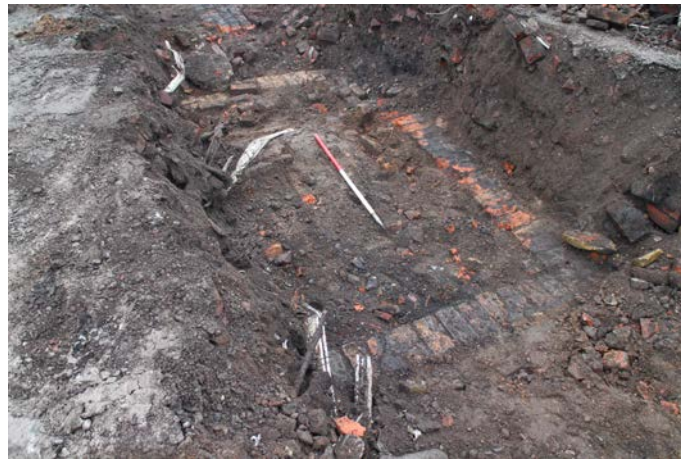
walls, each 1 header course wide, forming the northwest end of a rectangle. The southwest and northeast walls ran parallel to each other 3.13m apart. The southwest wall was of handmade brick with lime mortar, the northeast of 19th century machine made brick with dark cement. The northwestern wall was also of 19th century machine made brick with dark cement and was not keyed in to the other two walls, as if it was later blocking. This may represent one or more late 19th century modifications to an earlier structure. The structure was filled with mixed rubble and clay **605** and was also set into a compact clay and brick rubble deposit **606** to its northeast, presumably the original levelling material used during the construction of the 19th century buildings.

Plate 19: Brick structure 604, looking west

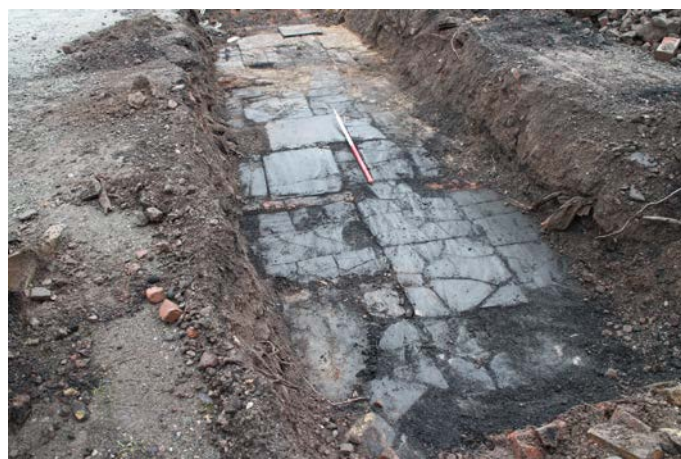
The northeastern 6.8m of the trench was occupied by a brick and stone flag building. This comprised an external brick wall at its southwest side which had been truncated at both ends, running northwest/southeast. Two walls, **609** and **610**, ran northwest/southeast to the northeast of this forming a 1.5m wide room or corridor. The gap between these two walls formed a 0.66m wide doorway leading into a larger room to the northeast. This room was 2.2m wide and had a northeast/southwest brick wall **211** at its northwest side forming a division between this room and one to the northwest, accessed by a 0.75m wide entrance at the northwest corner of the room. Another wall **212** ran northwest/southeast at the northeast side of the room with a 0.55m wide doorway leading into a further room to the northeast. All these walls were a single header course wide and built from handmade bricks with lime mortar. The rooms were laid with a stone flagged floor surface **608** and were 0.7m below the current ground level.

Plate 20: Building walls and floor surface, looking southwest

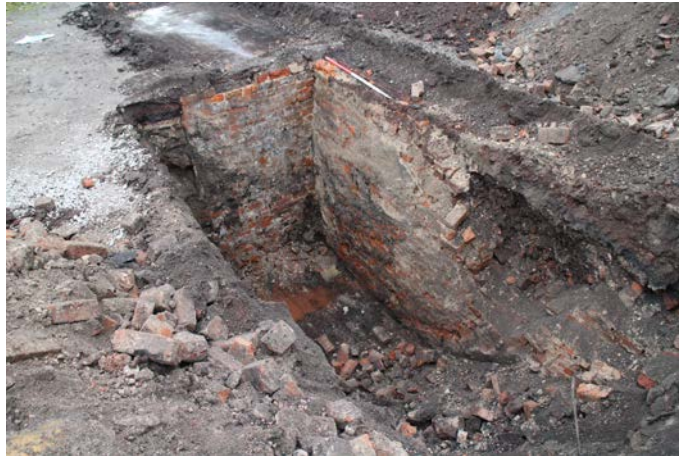
The trench was overlain by a 100mm thick layer of compact MoT **700** with 170mm of compact mixed rubble levelling material below it. Immediately below this the northeast 3.47m of the trench was covered with a concrete slab **702**. Immediately southwest of the concrete slab and 0.35m below the current ground level a brick wall **703** ran northwest/southeast across the trench and then turned southwest along the southeast trench edge. The wall was two courses in width and built from hand made brick with lime mortar. It survived all the way down to a stone flagged floor **704** surface at 2.8m below the current ground level. The walling and floor formed the cellar of a late 18th/early 19th century house and was filled with mixed demolition cellar fill **705**.

Plate 21: Cellar walls 703 and floor 704, looking east

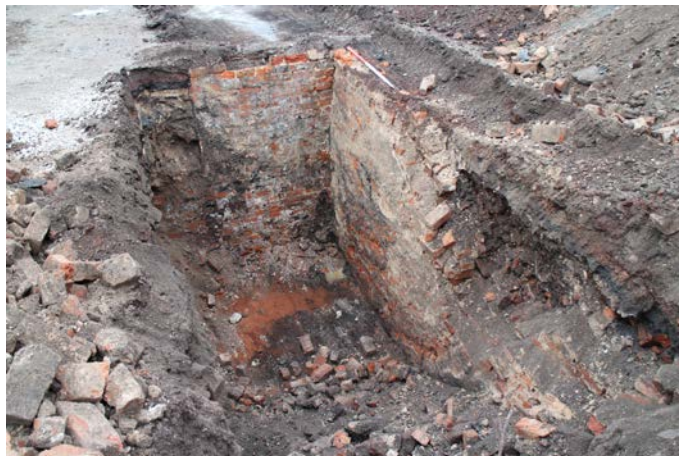
The trench was expanded in width to 2.5m within the cellar in order to expose an intact cellar light window with a stone sill visible within the northeast wall elevation. To the southeast of wall **703**, between the wall and the trench edge, was an infill layer of cinders **706**, possibly part of the road makeup outside the cellar.

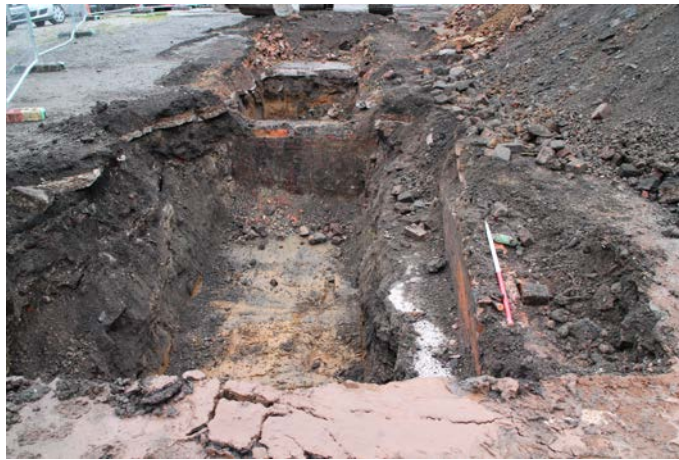
It was overlain by 150mm of compact MoT **800** with 400mm of compact rubble levelling material **801** below it. Beneath this the northwestern 2.6m of the trench were covered with a concrete slab **802**. Below the slab was a 1.1m thick layer of mixed sandy clay **807**, assumed to be redeposited natural, with natural yellow sandy clay **803** observed below that at 1.9m below the current ground level.

Plate 23: Trench 8 general shot, looking northwest

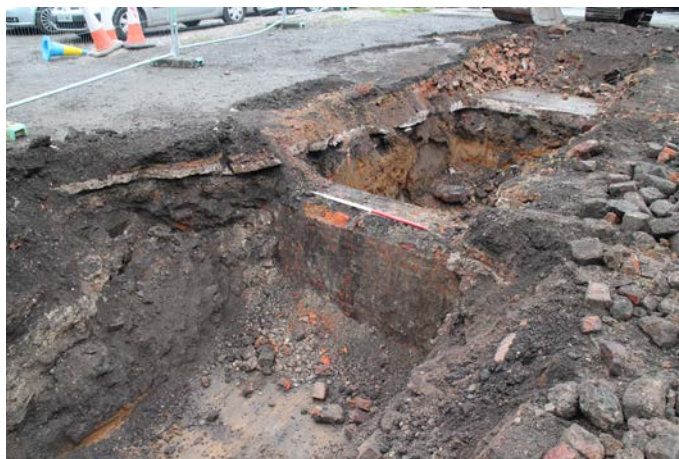
A hand made brick wall ran across the trench northeast/southwest 5.7m from the southeast end. This was two courses wide and survived to 1m in depth, the top of the wall being 0.35m below the current ground level. To the southeast of this wall the natural clay was observed at 1.52m in depth with redeposited natural above it. At this point the trench was widened to expose a wall **805** which ran northwest/southeast at the northeast side of the trench. This was built from modern bricks with three holes through them. It lay 70mm below the current ground level and stood 0.49m deep on a concrete beam **806**. The beam was 0.4m deep and truncated the upper part of wall **804** where it passed through it.

Plate 24: Wall 804, looking northwest

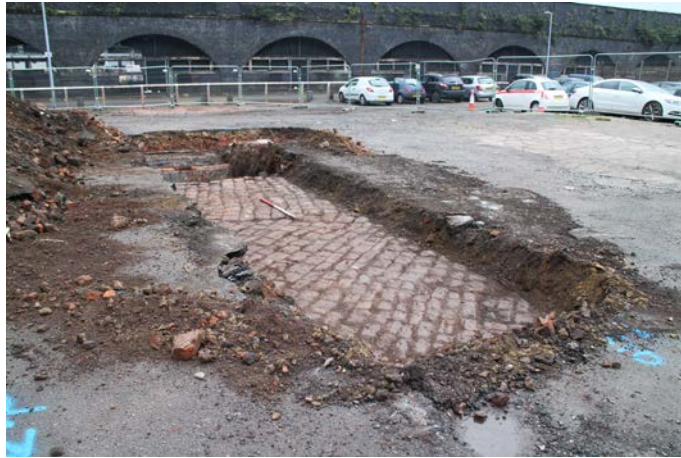
The trench was overlain by 0.24m of compact MoT **900** laid directly over a surface of sandstone sets **901**. The sets ran northwest/southeast at its southeast side but then angled northeast/southwest at the northwest side, as if two separate surfaces had come together at this point. It was felt that this may have been a yard surface. To the southeast of this natural yellow sandy clay **902** was observed at a depth of 0.94m below the current ground surface.

Plate 25: Trench 9 general shot showing set surface 901, looking south

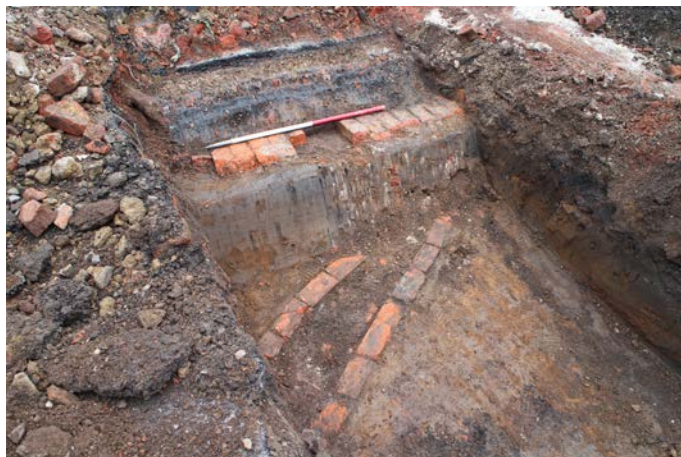
At the southeast end of the trench was a brick wall **903** running northeast/southwest 0.56m below the ground level. It comprised two stretcher courses wide of hand made brick with lime mortar and was 0.38 in depth. Running below this to the northwest was a brick drain **904**, cut into the natural clay. This was 0.57m wide and originally would have been capped with stone slabs.

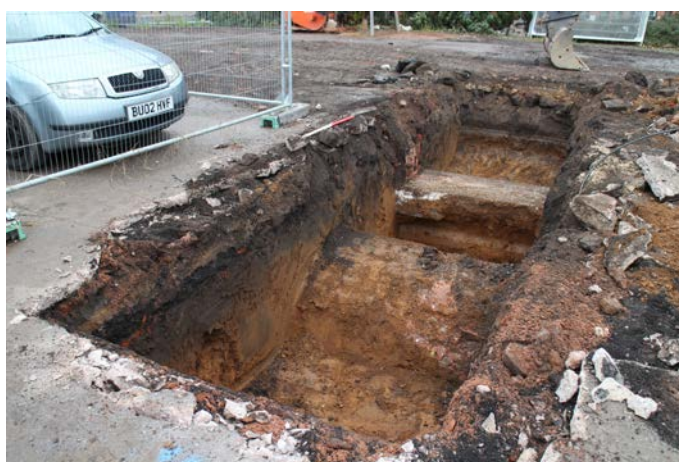
It was overlain 0.1m of compact MoT **1000** with 0.3m mixed rubble levelling material **1001** below. Beneath this was 0.6m of mixed loose rubble **1005** above 0.6m of redeposited natural clay **1006**. The natural yellow sandy clay **1004** was observed at a depth of 1.6m. A modern brick wall **1002** ran across the trench northwest to southeast at 2.55m from the northeast end of the trench. The top of the wall was 0.14m below ground level and descended to a 0.95m wide concrete footing at a depth of 0.79m. At 1.4m to the south of this, on the southeast side of the trench, was a 1.1m square concrete block **1003**, 0.68m deep, possibly a base for a stanchion.

Plate 27: Trench 10 general shot, looking northeast

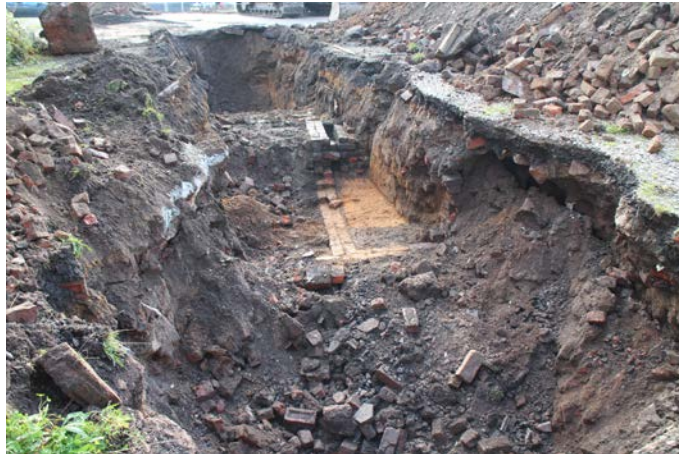
At the northwest end of trench 11a (*Fig 9*), below the levelling material, was a deposit of loose rubble and refuse **1112** within a modern cut. This was excavated to a depth of 2m at which point material was observed that resembled insulating board and excavation at this end of the trench was abandoned and backfilled.

Plate 28: Trench 11a general shot including wall 1102, looking south

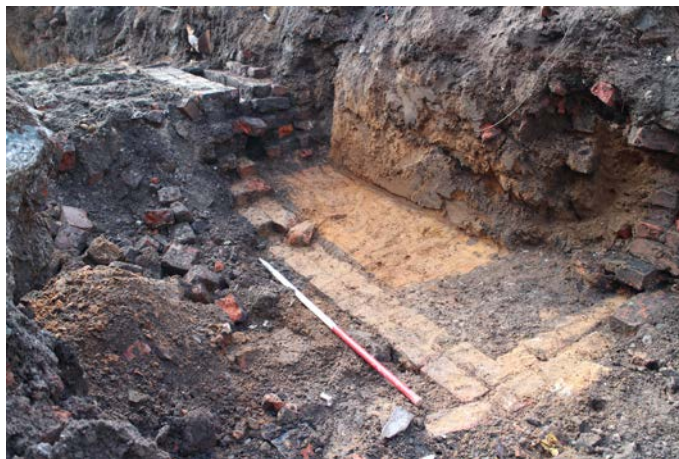
Excavation continued beyond this point and at 3.44m from the northwest end of the trench was a brick wall **1102**. This was two stretcher courses wide and built from hand made brick with lime mortar. It ran east for 1.22m and then turned south for 4.13m at which point it was truncated. Within this wall was a fine yellow sand **1105**, possibly natural, which had been cut alongside the point at which the wall turned. The cut contained a mixed grey gravel and cinder fill **1104**. This side of the wall was thought to be the exterior of the building and contained a brick drain **1103** which ended at a downpipe surrounded by concrete. To the eastern and northern sides of the wall, and truncated at the north by refuse deposit **1112**, was what appeared to be cellar fill **1106**, suggesting the interior of a cellared building. To the south of these structures natural sandy clay **1113** was observed at a depth of 0.65m.

Plate 29: Wall 1102 and drain 1103, looking southwest

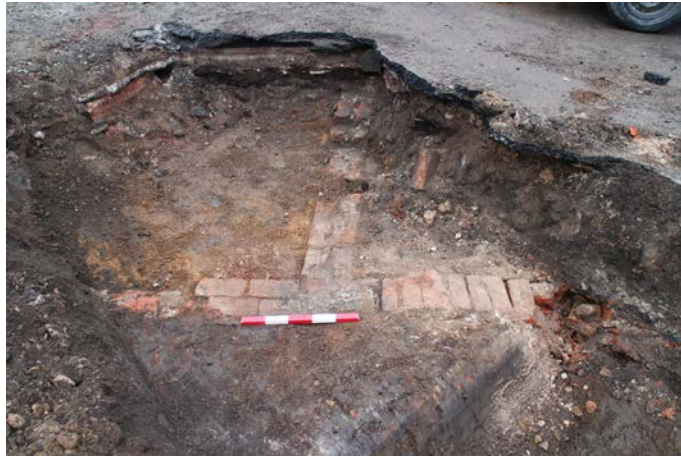
At the northwest end of trench 11b (*Fig 8*) was a brick wall **1108** running northwest/southeast across the trench and with another wall section running northeast from its centre into the corner of the trench. These walls were two stretcher courses wide and built from hand made brick with lime mortar. They were cut into a layer of mixed mid brown compact gravel **1109**. The walls lay at 0.63m below the current ground level.

Plate 30: Walling 1108, looking northeast

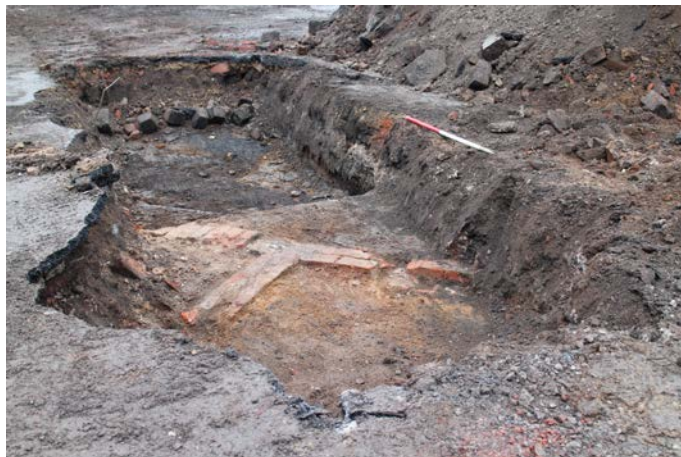
At the southeast end of trench was a surface of sandstone sets **1107**, a continuation of those within trench 9. They appeared to have been truncated beyond this point and may originally have extended to wall **1108**.

Plate 31: Trench 11b general shot, looking southwest

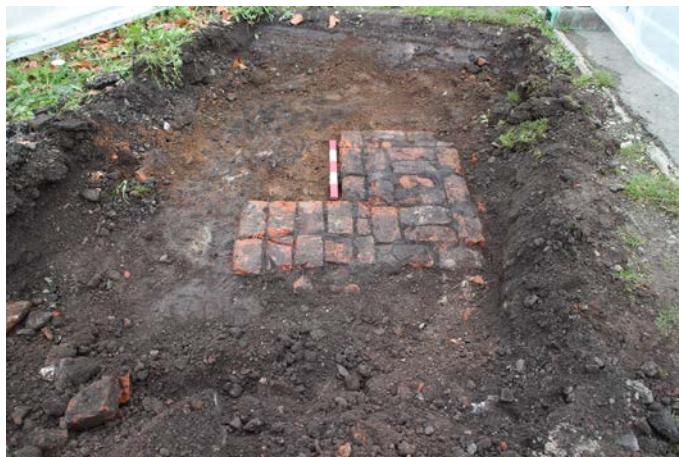
At the northwest end of the area an 'L'-shaped brick structure **008** was uncovered 0.5m below the current ground level. The main part of the structure was 1.05m long by 0.6m wide with a 0.47m by 0.44m return running southwest from it. It was built from hand made brick with lime mortar.

Plate 32: Brick structure 008, looking north

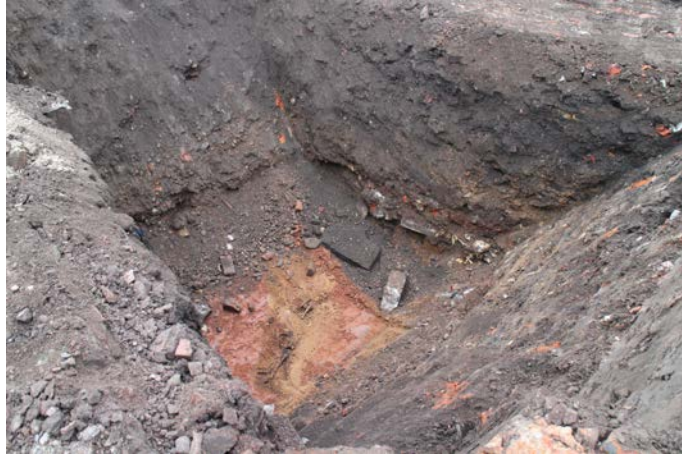
From the southern end of the disturbed gravels the levelling extended straight down to the pink sandstone rockhead **014**. This sloped slightly downwards from 2.9m below ground level at the north to 3.2m below ground level at the south. A series of burials were observed cut into the rockhead across the centre of the area. Three of these were single graves **004**, **005**, and **006**, and one appeared to be two or more intercutting graves **007**. Human bones could be seen within the fill of grave **004**.

Plate 33: Grave 004 with visible human remains, looking southwest

Five or six graves were observed during the evaluation, at a depth of c. 3m, three of them distinct grave cuts into the rock and another that appeared to be the base of two three graves cutting into each other. Inspection of the graves could only be made from the surface due to the depth of the evaluation trenches but the fill of the graves was distinctly different from the surrounding pink sandstone and one of the graves clearly contained human remains. As the presence of services, the installation of an inspection well and the proximity of the road meant that not all of the area could be evaluated it can be assumed that there may be up to possibly ten graves extant. It is not known whether these contain a single burial or multiple inhumations. The depth would suggest that only the very bottom burials survive.

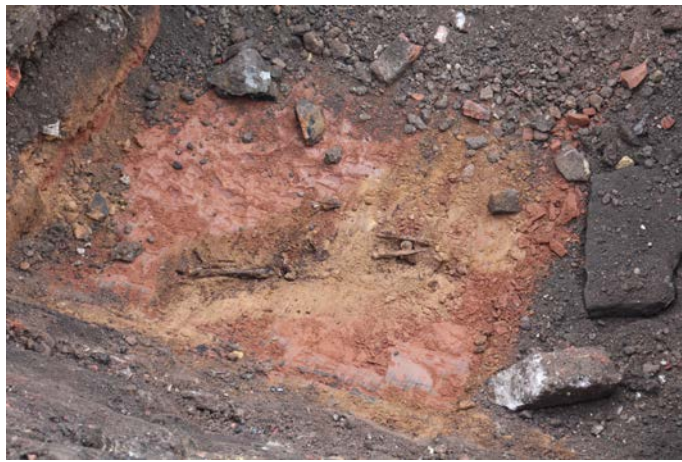
Plate 34: Close-up of human remains within grave 004, looking southeast

The observed burials are likely to be the very base of the grave cuts and were filled with a yellow sand and gravel which was distinctly different from the pink sandstone rockhead. The graves appeared to only occur within an area beginning 13.5m south of the northern end of the trench and extending for 11m to the south of this. As grave **007** appeared to be intercutting graves it can be said that only five or six burials were observed.

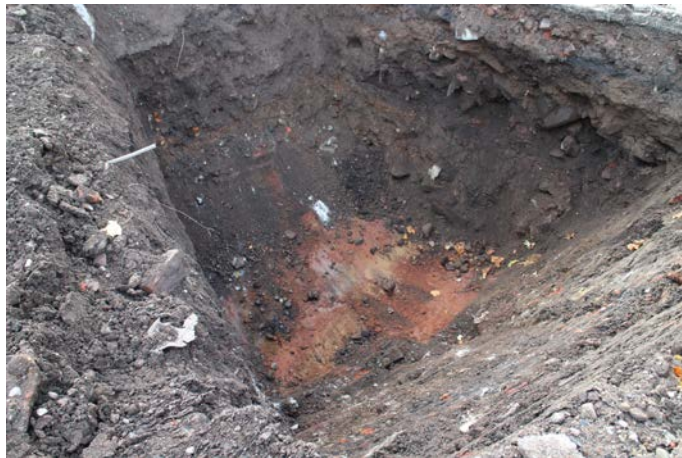
Plate 35: Intercutting graves 007, looking southwest

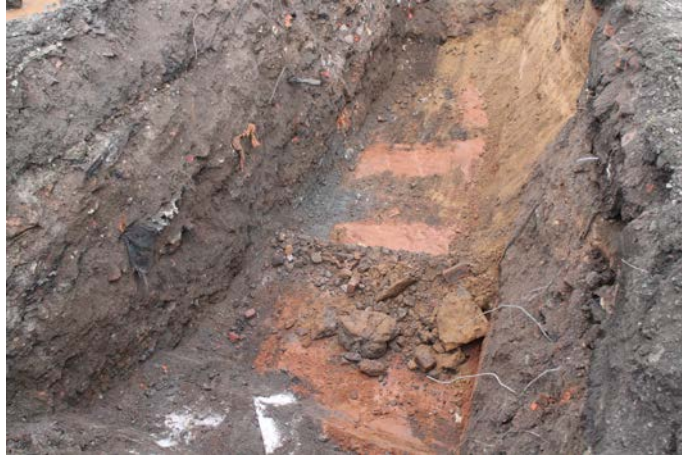
To south of this a series of linear features **010**, **011** and **012** had been cut into the rockhead. These are likely to be associated with drainage.

Plate 36: Linear drainage features in rockhead, looking north

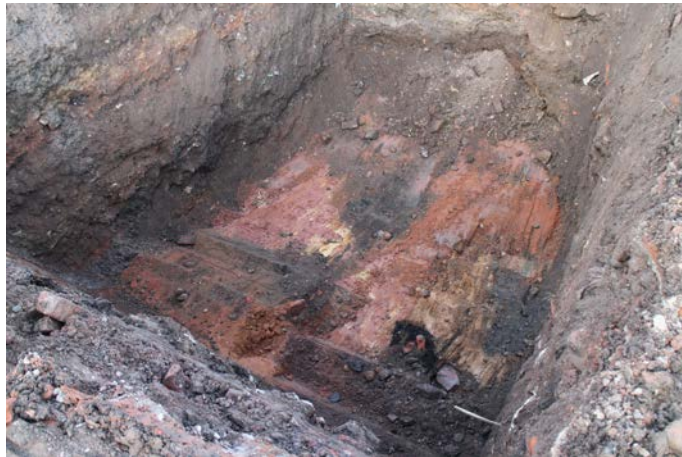
Another large 3.4m wide cut **013** was observed cut into the rock in the southeast corner of the trench. This was filled with red gravel and had a square deposit of cinders in its centre.

Plate 37: Modern disturbance, looking northwest
