Archaeological Excavation

Of the Leat at
Marland Mill Farm,
Rochdale

Technical Report:

Report No: 14/2014

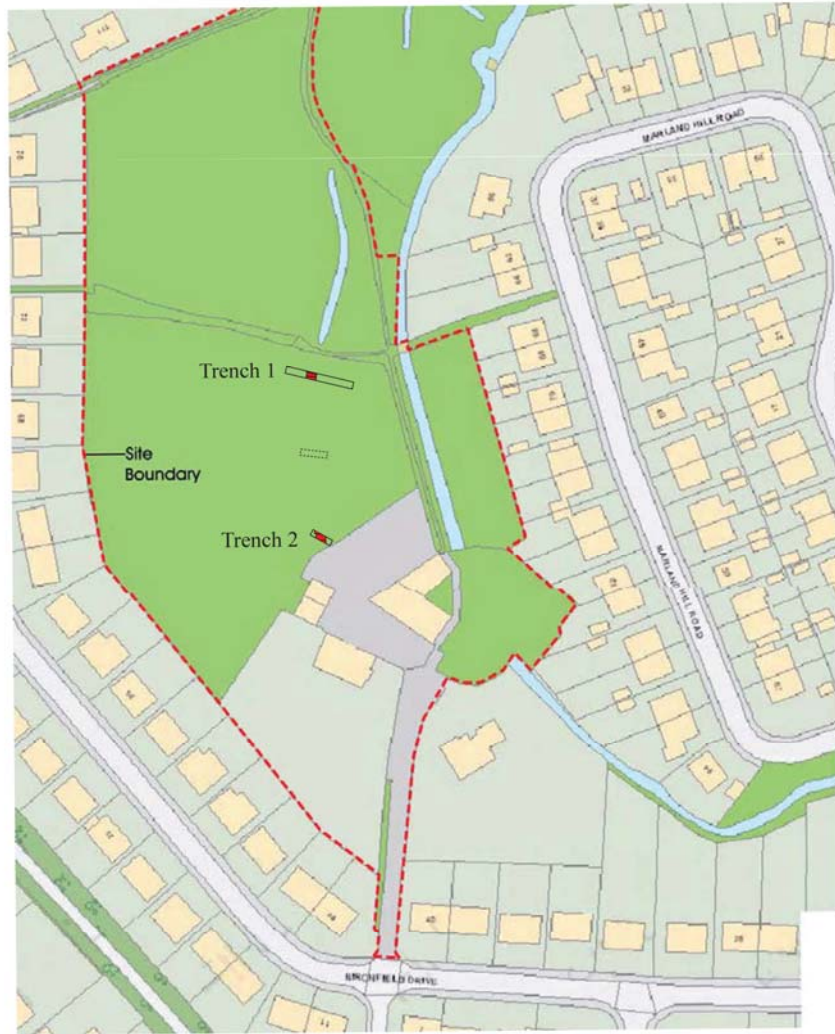
Figure 2. The location of evaluation trenches at Marland Mill Farm (labelled). Scale 1:1250. Reproduced from modern OS mapping by permission of Ordnance Survey on behalf of the Controller of Her Majesty's Stationary Office. Crown Copyright . All rights reserved. Licence number: 100050261.

Three evaluation trenches (Fig 2, 6-7) were located across the line of the leat as recorded by the desk-based assessment in 2013, where it would be impacted by the development. These were excavated using a mechanical digger with a 1.6m wide toothless ditching bucket. The machine excavations were supervised by a professional archaeologist at all times.

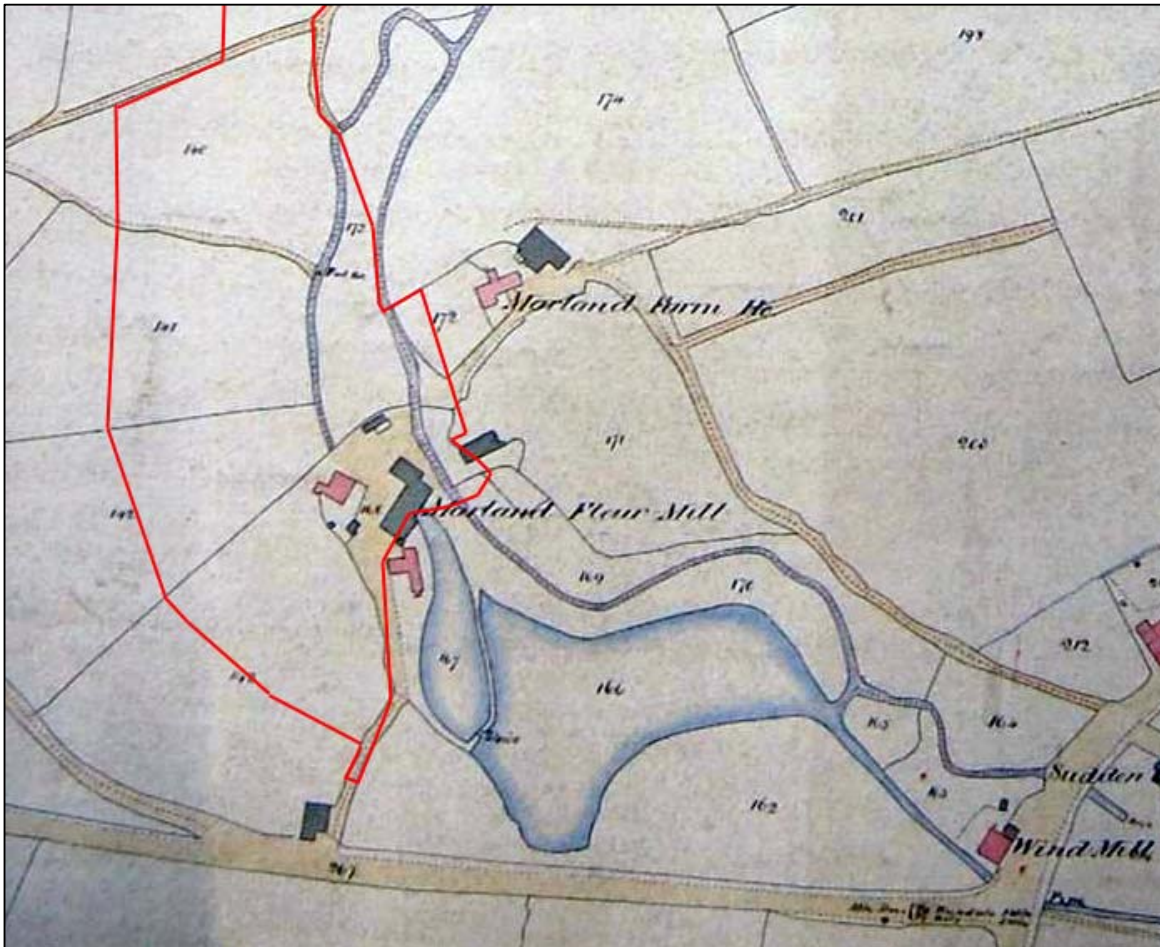
Figure 3: The Marland Mill Farm study area on the 1844 Castleton Township map (outlined in red approximately) showing the line of the leat.

Map evidence in relation to the Marland Mill site is strong for the period between the censuses of 1841 and 1851. The Castleton Township map of c1844 (RLSL LA/Z/3/C; **Fig 3**) and the OS first edition map surveyed 1844-7 (**Fig 4**) show similar detail. Two linked reservoirs are situated on the south-eastern side of the main mill building to the west of the Windmill Inn at Sudden Bridge. The township map labels the mill as 'Marland Flour Mill' and the OS map as 'Marland Mill (corn)'. The schedule for the township map identifies Joseph Holden as being both owner and occupier of the mill and surrounding buildings, the reservoirs and the fields to the west of the mill extending to the hamlet at Marland. The main mill building does not fully match that shown on the OS map of 1890-1 (**Fig 5**), indicating that the mill was significantly altered sometime and expanded between 1844 and 1891. The inscribed date-stone on the building which currently occupies the site (JH 1847) suggests that Joseph Holden was undertaking building work on the site around 1847. The 1844 Castleton Township map also shows the line of the tail race, a trackway to the north, a west to east footpath and boundary going over the tail race, a further field boundary to the south, and the farmhouse to west of the mill, shown as an L-shaped structure. In addition the 1844-7 Ordnance Survey map shows a footpath along the river and two bridges across the tail race.

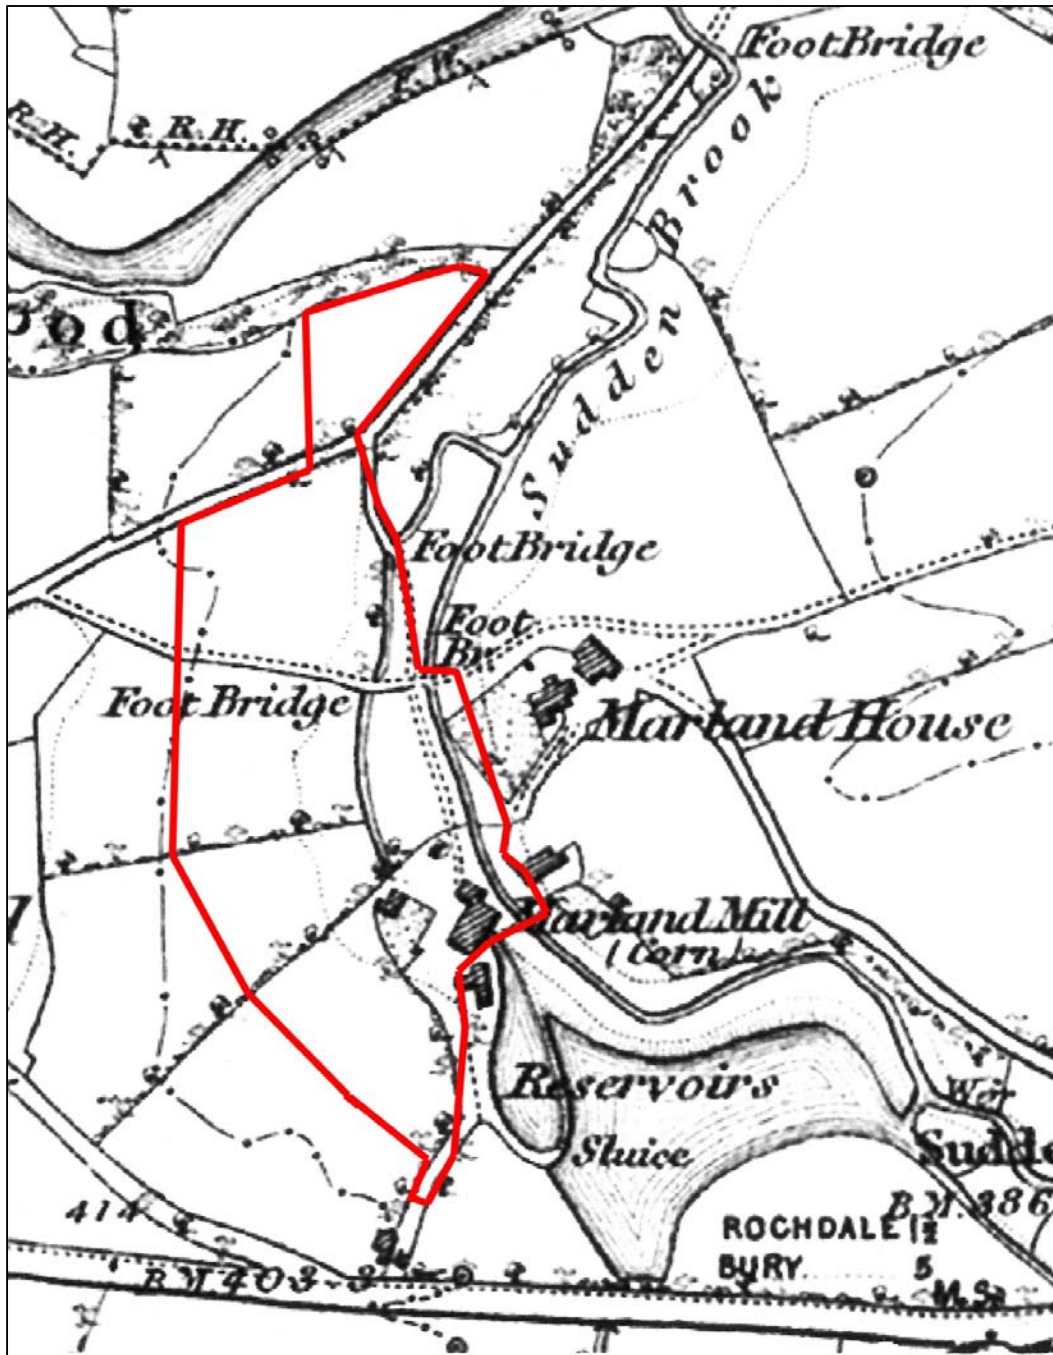
Figure 4: The Marland Mill Farm study area on the OS 1844-7 six inch map (outlined in red) showing the line of the leat.

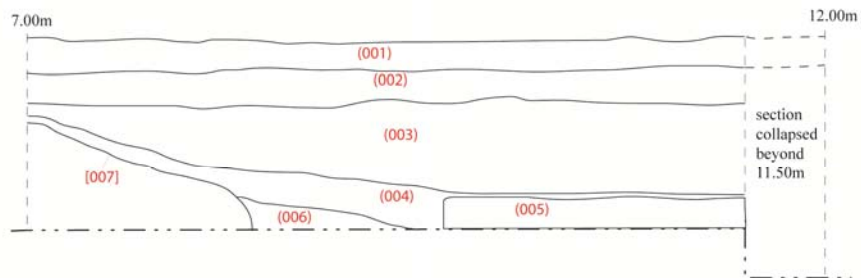
Trench 1: Partial, N facing section.

Figure 7: Excavated section of T1 showing the top of the stone-lined leat, and the earlier leat cut line..

A possible leat cut [007] was observed at around 7.00m from the eastern edge of the trench and roughly 0.60m below current ground level. Beyond this within the trench towards the east only natural sand and pebble shale deposits encountered, concurrent with riverine geology. Possibly due to a high water table, at 1.00m below surface, ground water was observed in base of trench. Drawings show contexts associated with [007]. Below the base of (005), flooding occurred. It was noted that sediment beneath (005) was displaced during machining and the water course, observed later in T3, began to flow into the western end of the trench. A possible return of cut [007] and fill (006) were observed in the trench section beyond (005) as flooding occurred. However the speed at which the trench flooded, eventually causing section collapse, meant this was not recorded.

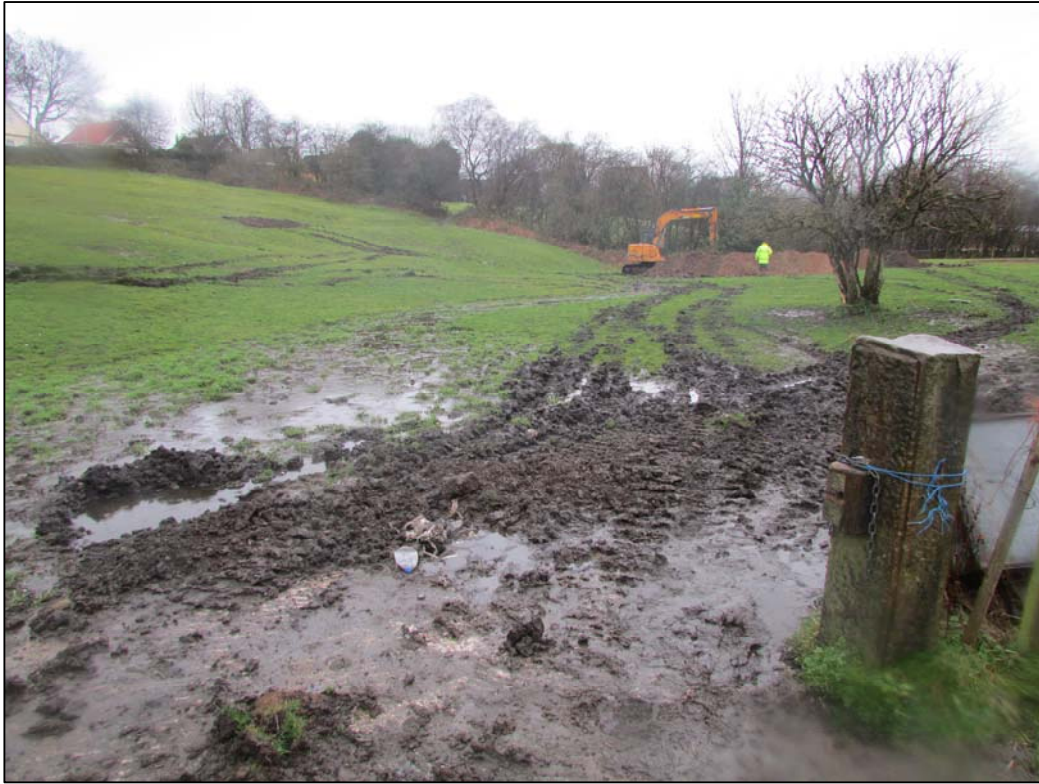
Figure 8: The location of T1 as viewed from Marland Mill.

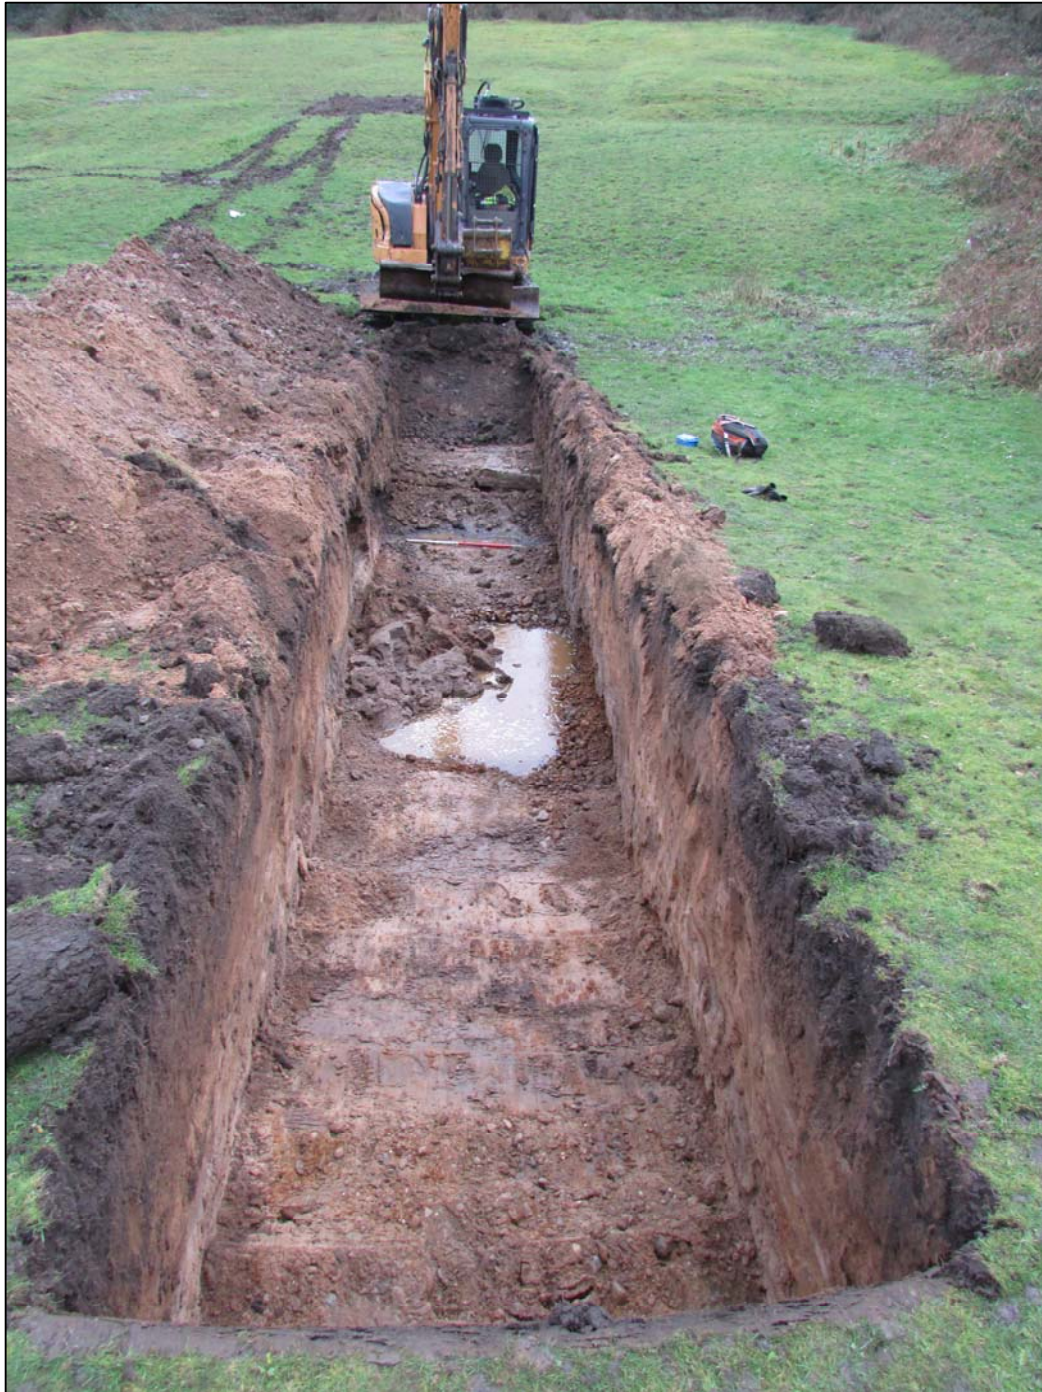
Figure 9: T1 looking west.

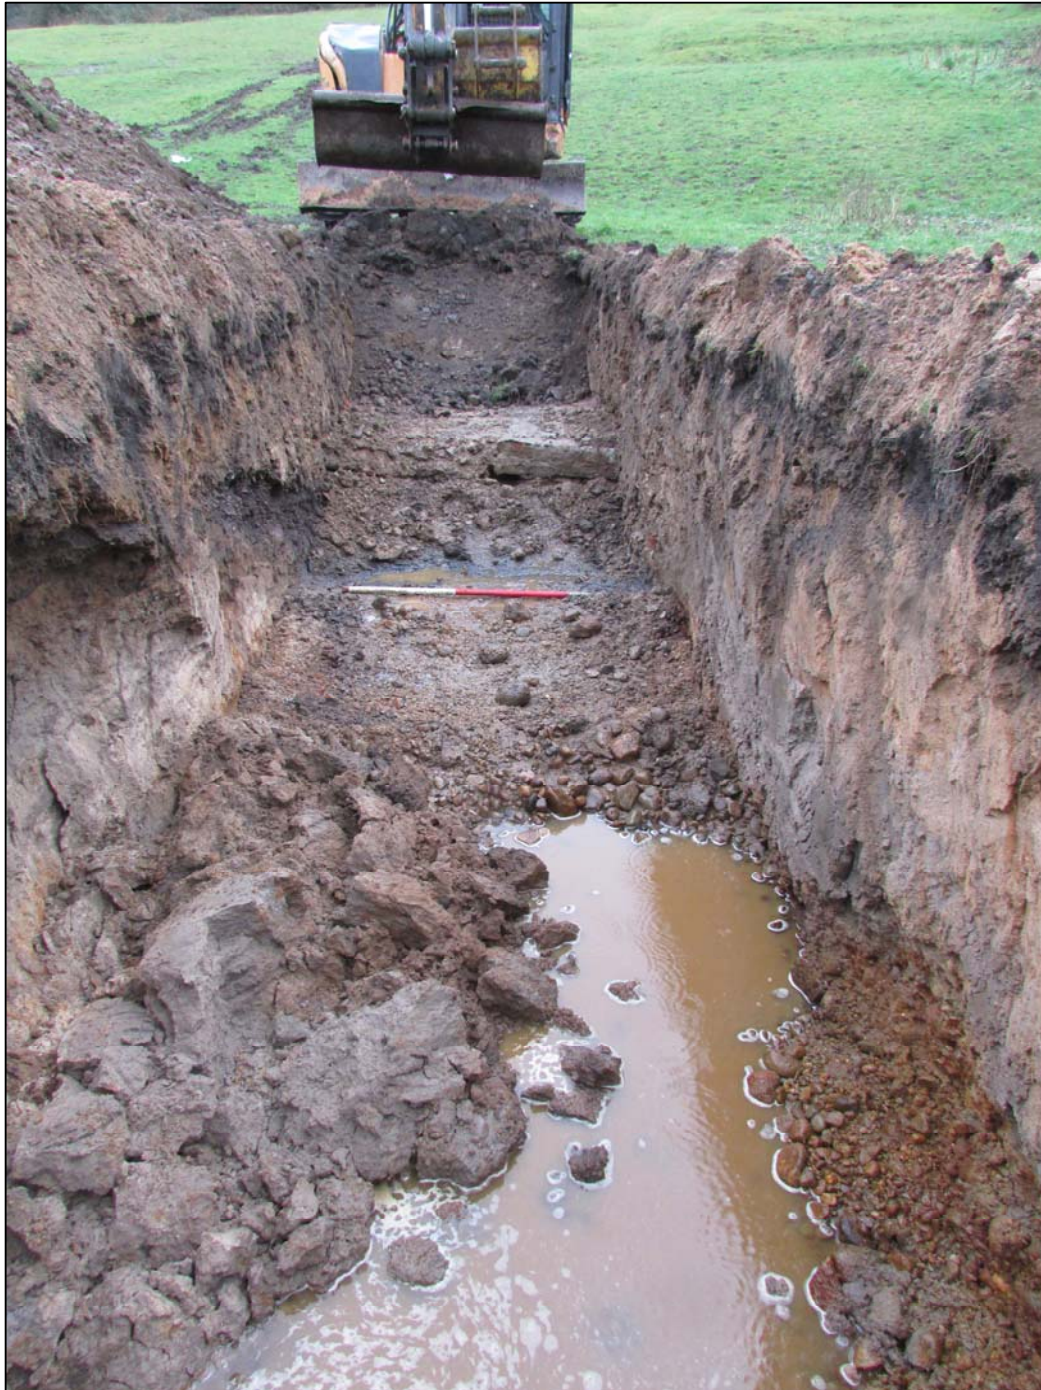
Figure 10: Detail of the western end of T1 looking at the cut and silt marking the line of the leat.

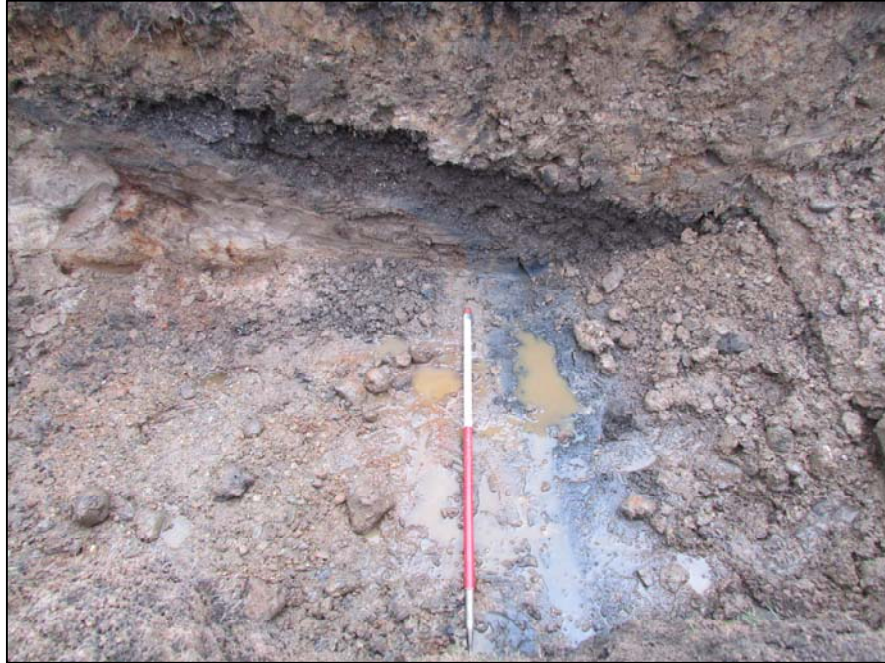
Figure 11: Detail of the leat cut [007] and silt (006).

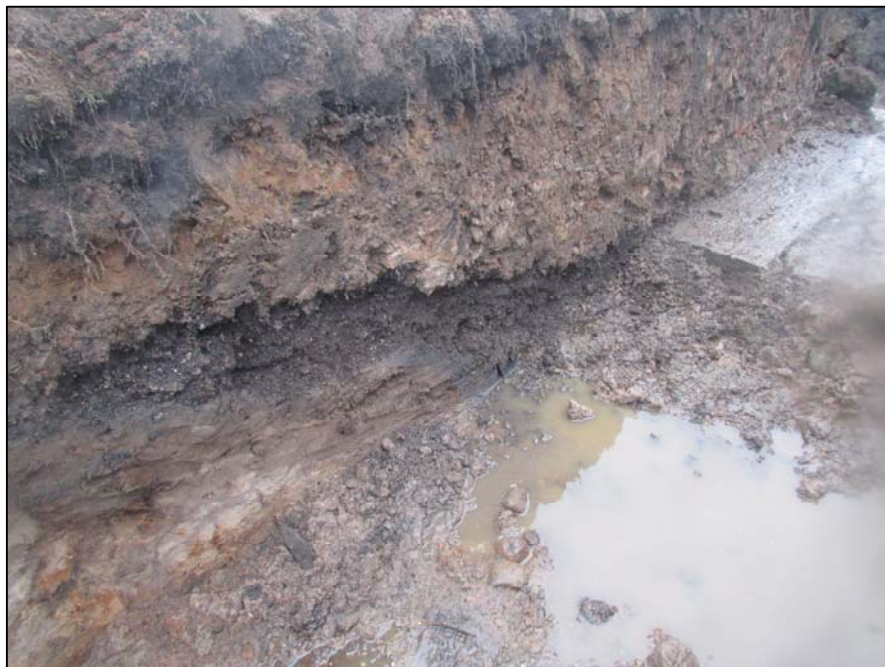
Figure 12: Detail of the leat cut [007] and silt (006) in relation to the stone capping (005).

It seems likely that the present form of the leat dates from the 19th century when the corn mill was converted to textile uses and the leat covered over. Until the mid-19th century this has been an open feature. Trench 1 was found to contain a cut which can be associated with this earlier phase of leat structure, although there was no evidence for its date.

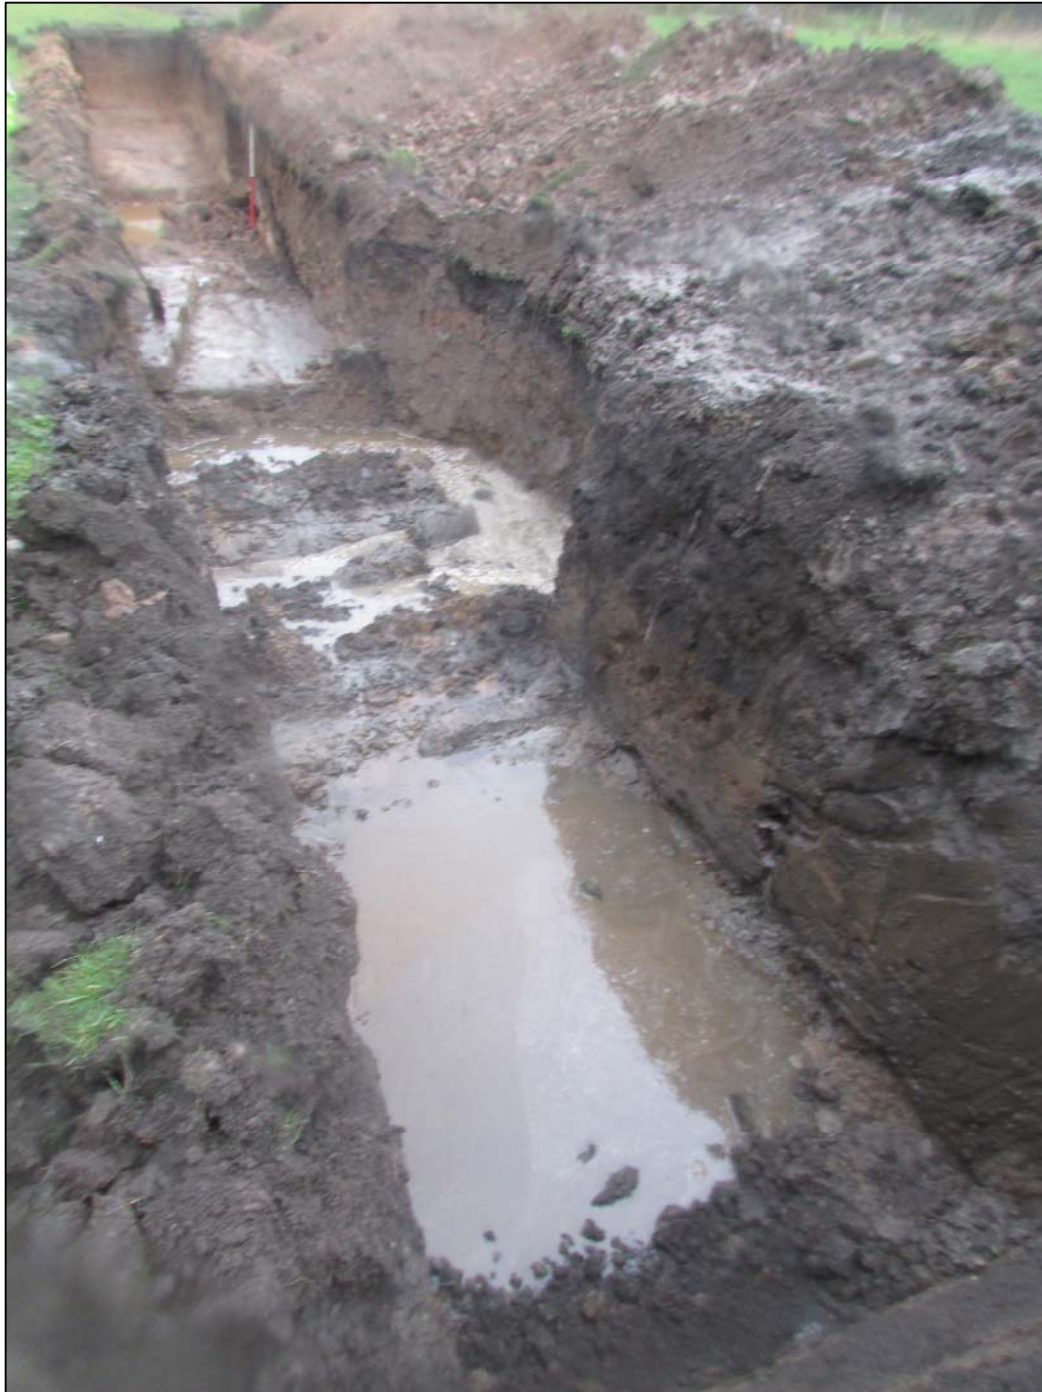
Figure 13: T1 looking east.

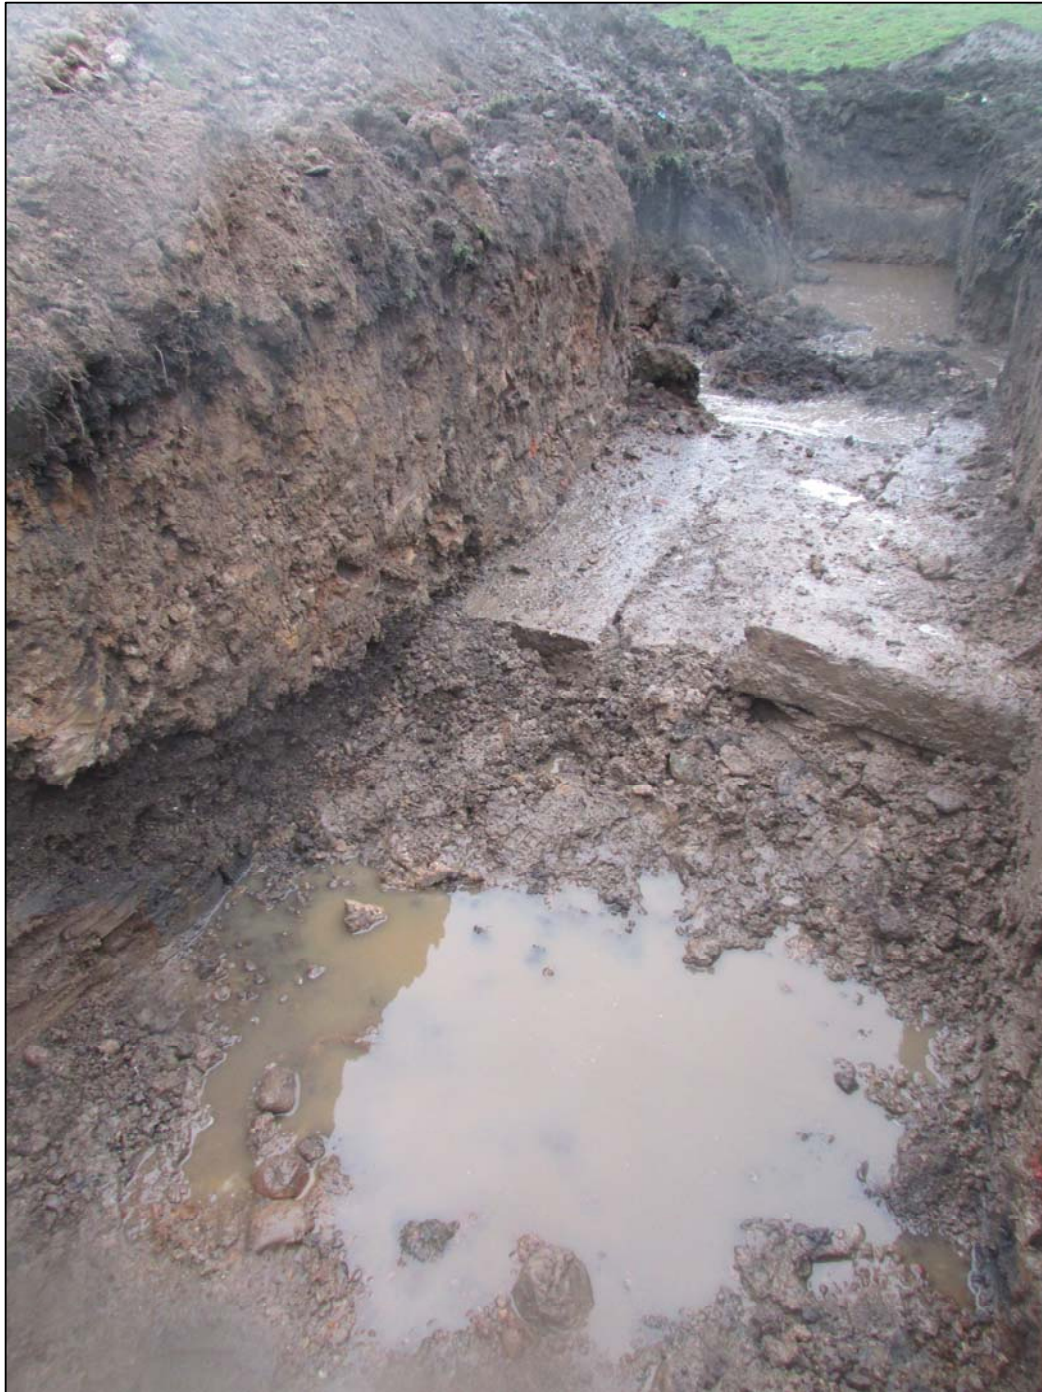
Figure 14: T1 looking west across the stone culvert (005).

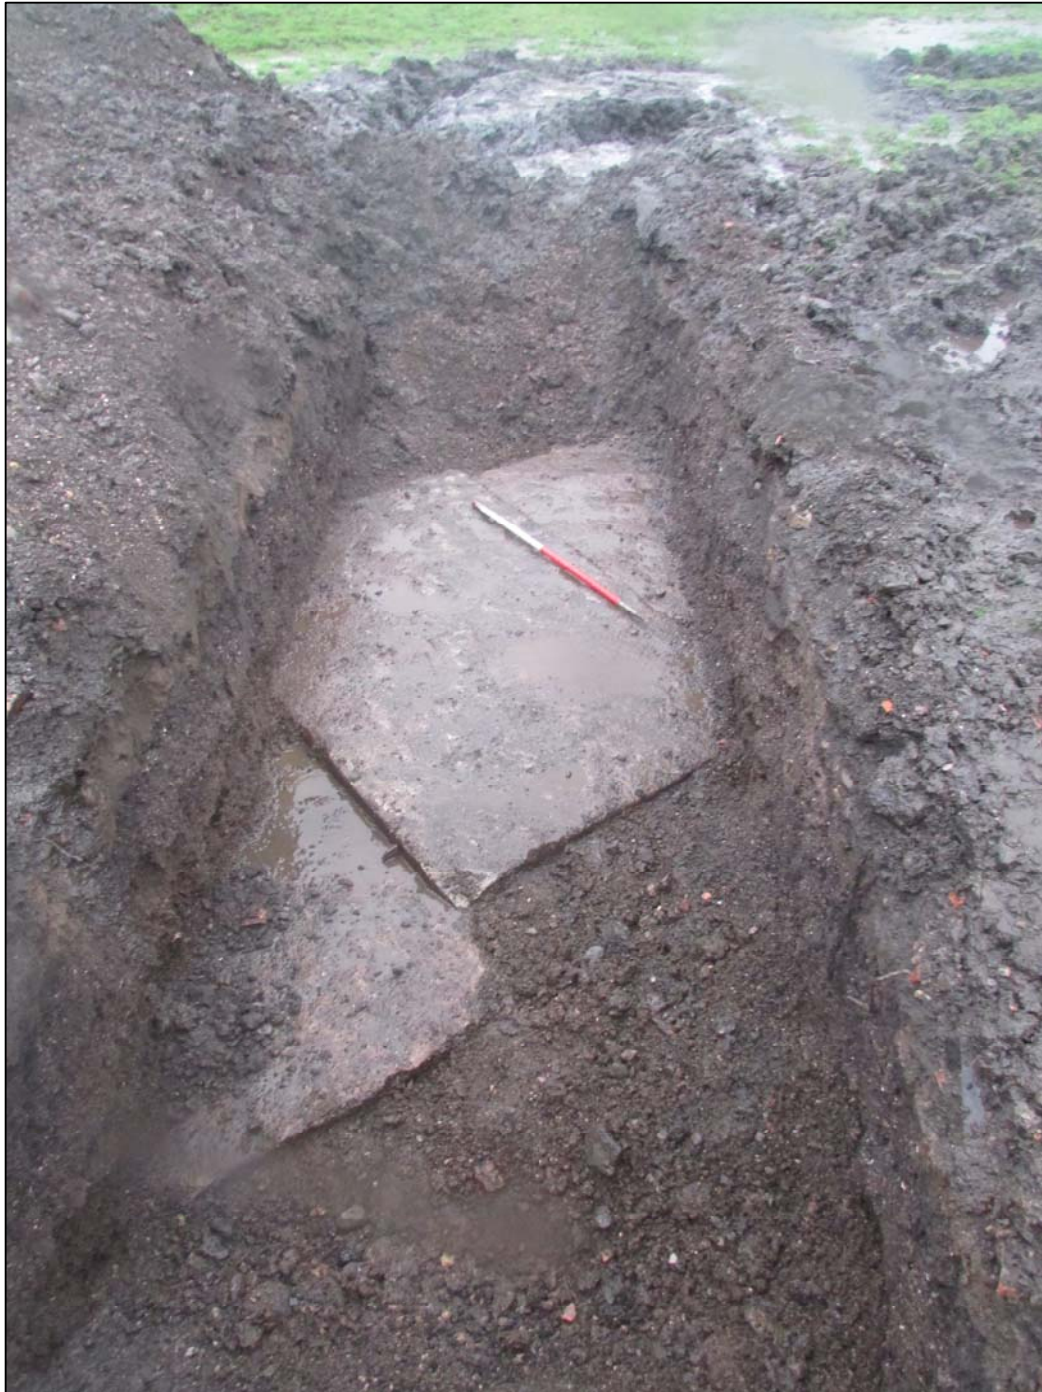
Figure 15: T2 looking east across the stone culvert.

It was excavated to 1.00m as excavation beyond that depth in T1 resulted in flooding of the trench. The top of the stone culvert (009) was recorded seen at this depth, with fills (008) noted as a similar deposit to (004).

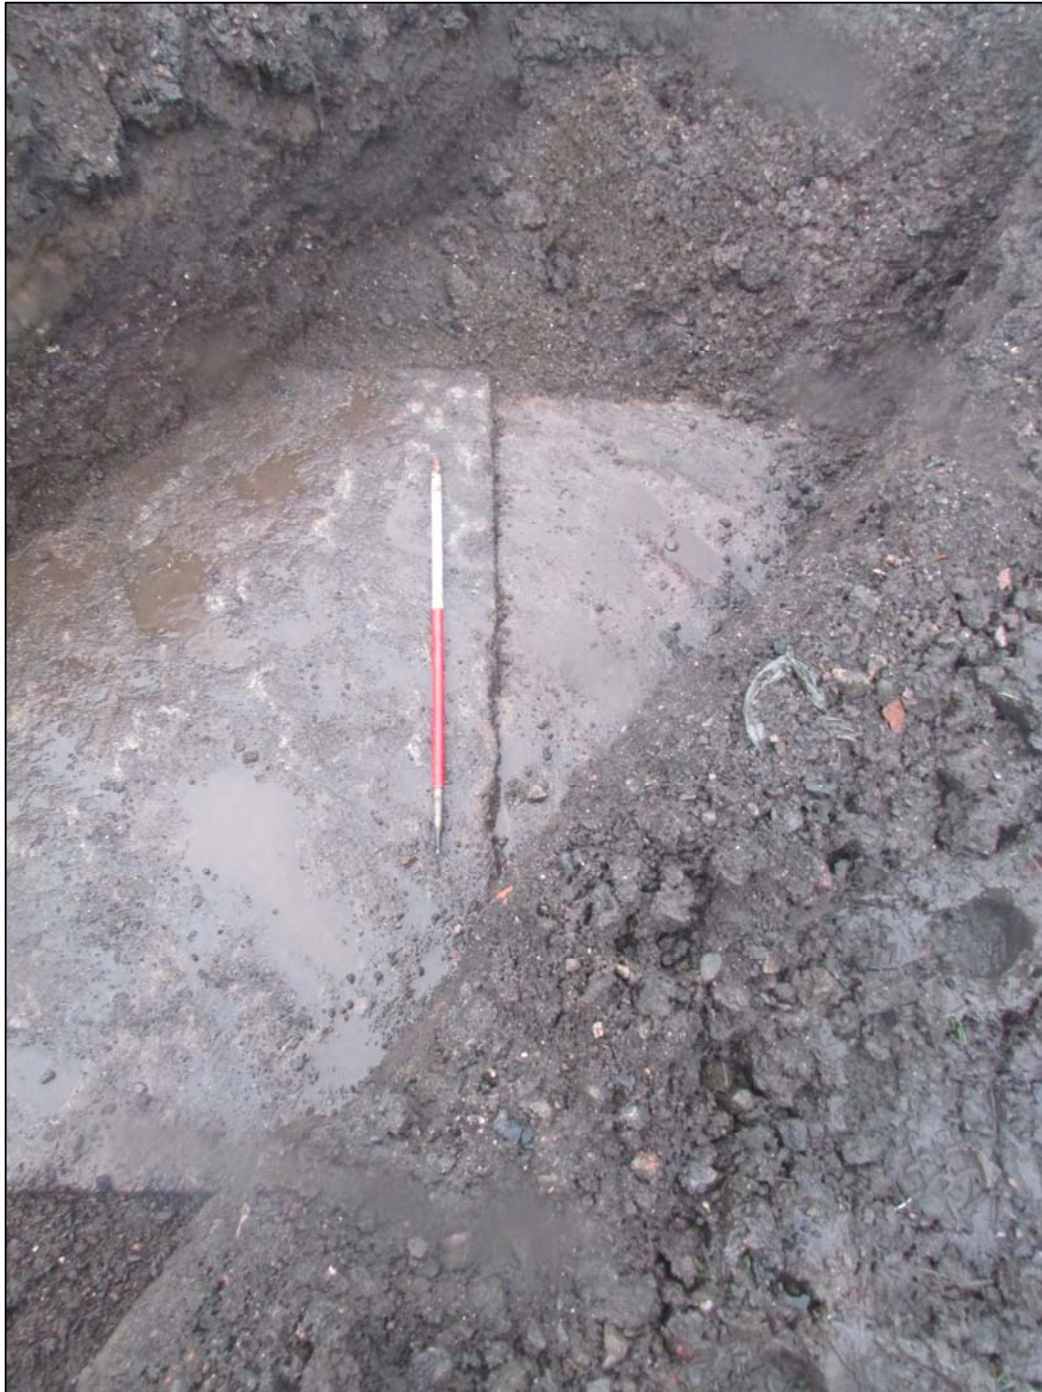
Figure 16: T2 showing the top of the culvert.

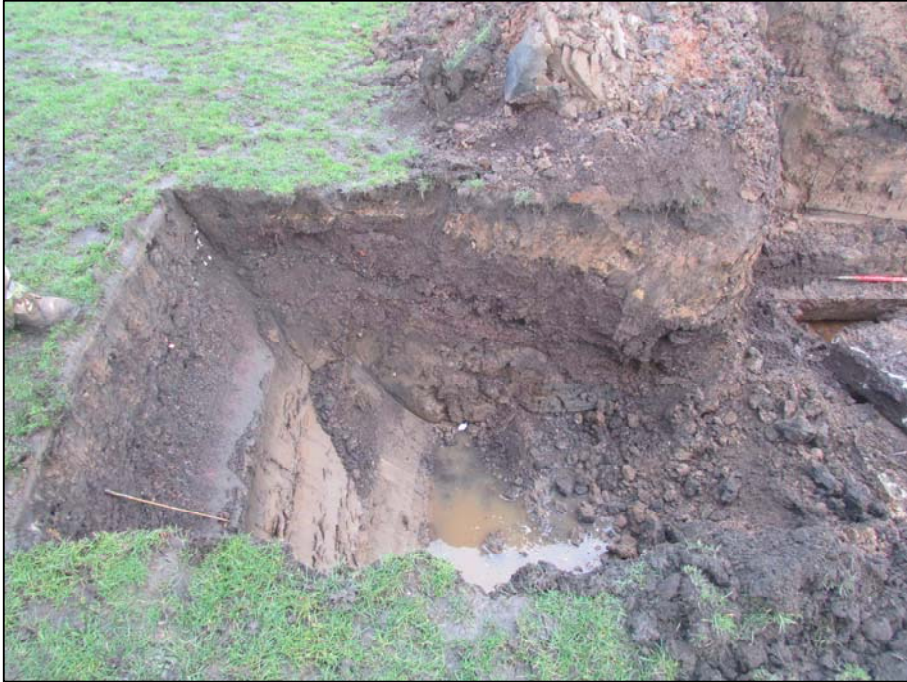
Figure 17: T3 looking north.

This was an additional trench to the WSI excavated at the request of the developer and agreed to by CfAA as a compromise to the limited excavation of T2. This was only recorded photographically due to time constraints but highlighted the possible leat structure as being preserved between T1 and T2. A stone slab/flag from the culvert (012) was dislodged during excavation allowing the still functioning water course to be observed beneath. The cut [010] was similar to [007] and similar fills (011) were also observed to (004) seen in the section of T1.

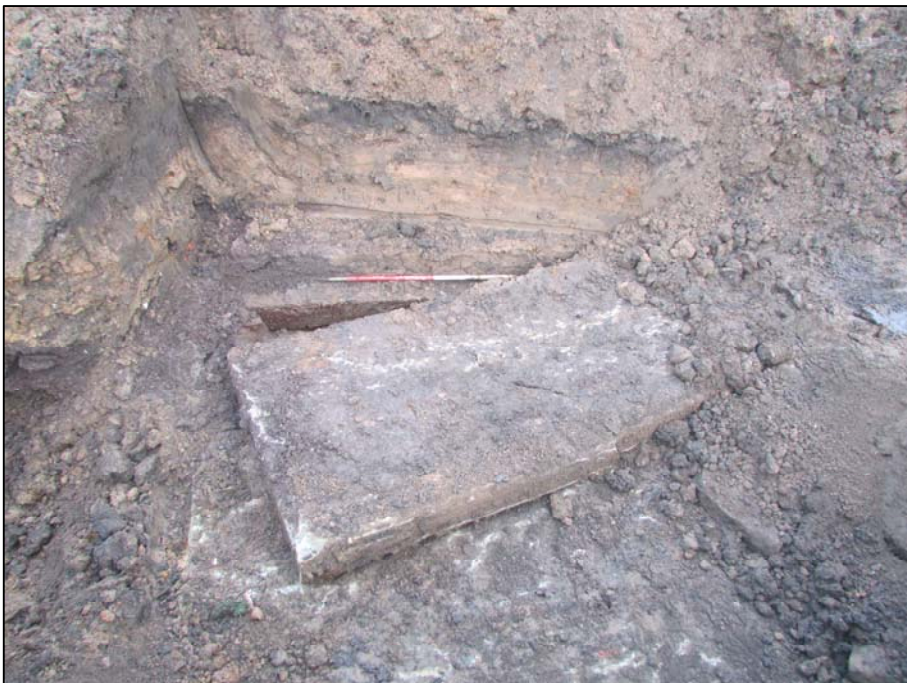
Figure 18: T3 looking at the top of the culvert (012).

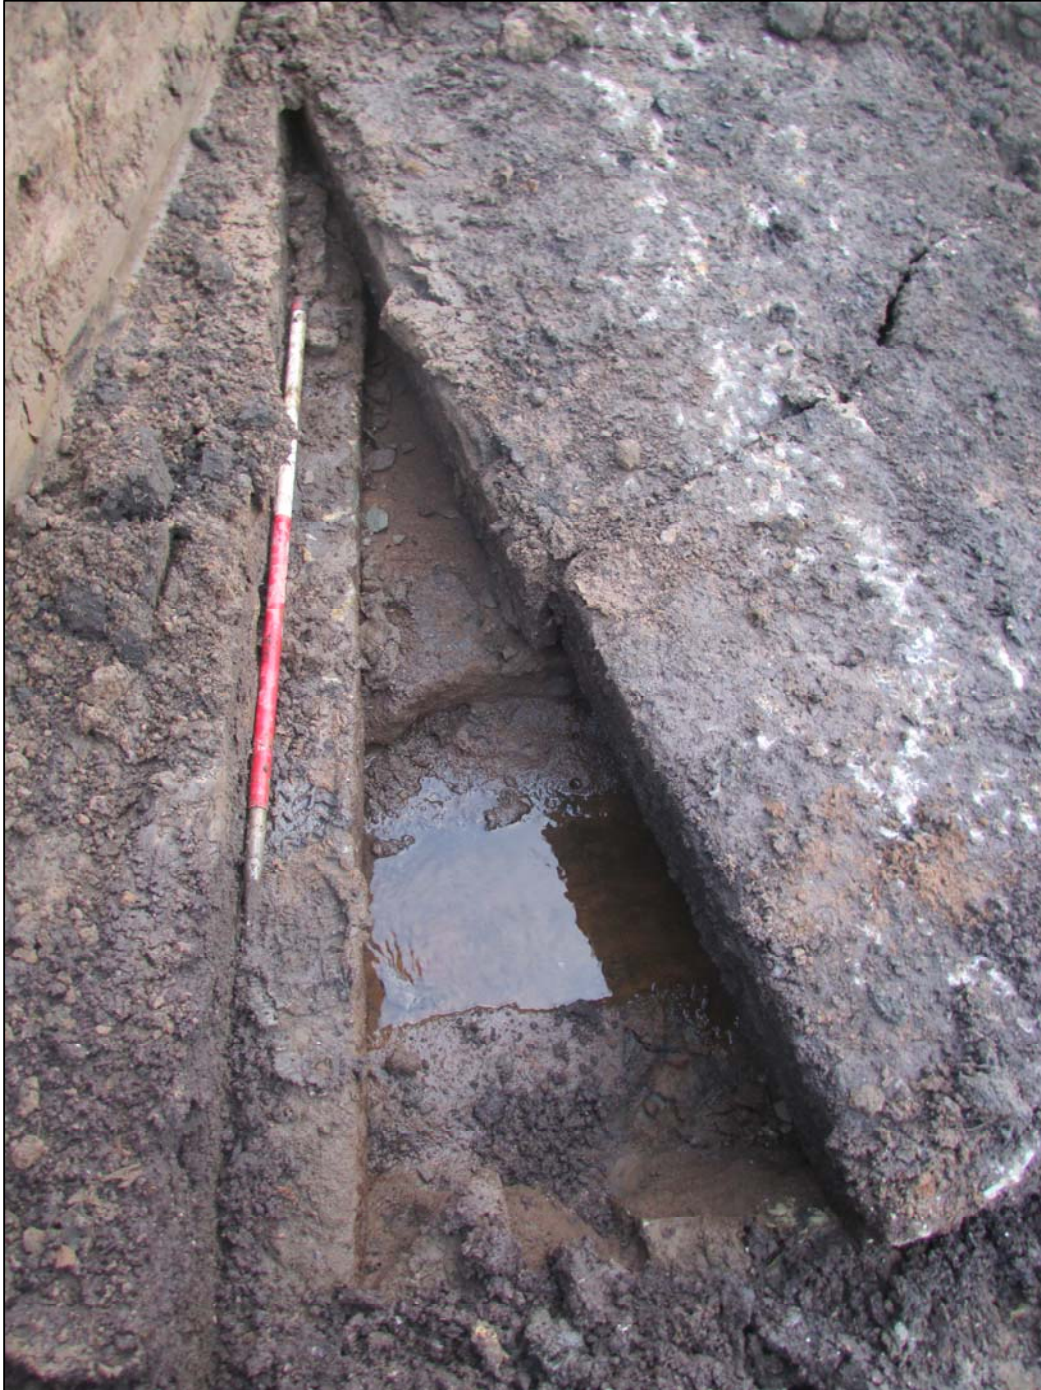
Figure 19: T3 looking at the silts and water within the culvert.

The evidence from the three evaluation trenches shows that the leat was a stone-lined and covered culverted, and is still preserved and functioning within the study area. The evidence from T1 showed a stone covered water source that, when damaged, flooded the entire western end of the trench. T2 and T3 also highlighted the continuation of this structure throughout the southern field.
