**Archaeological  
Excavation:**

Land off Stanley  
Street, Central  
Salford: Plot B1  
(New Bailey  
Prison)

**Technical  
Report:**  
Rachael Reader

**Document Type:** Archaeological Excavation Report

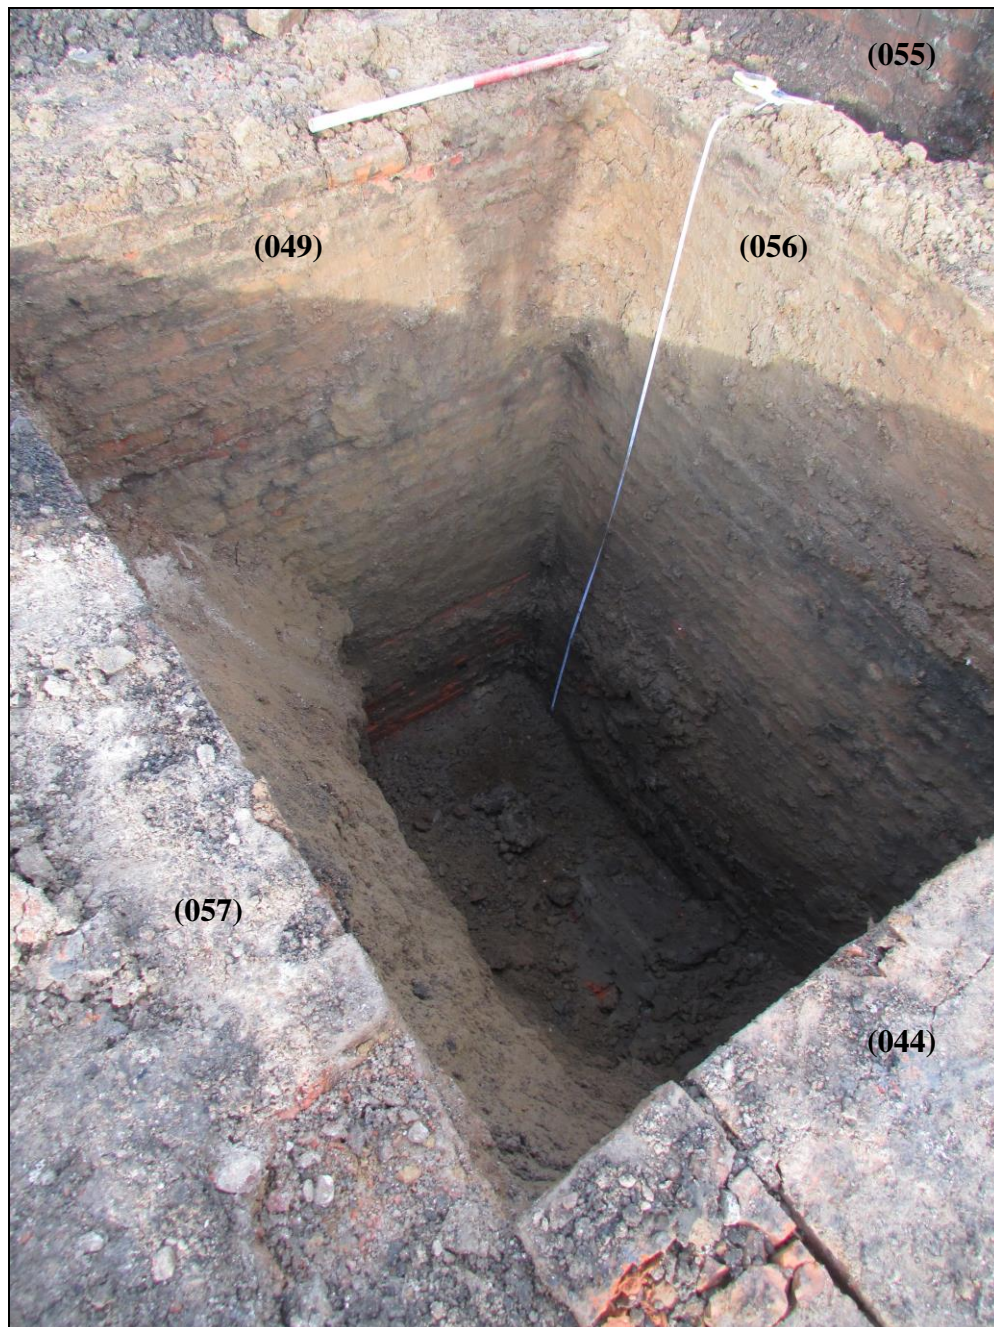
Fig. 3 Sondage within Male Felon Cells showing the depth of the walls reaching c.3.00m deep.

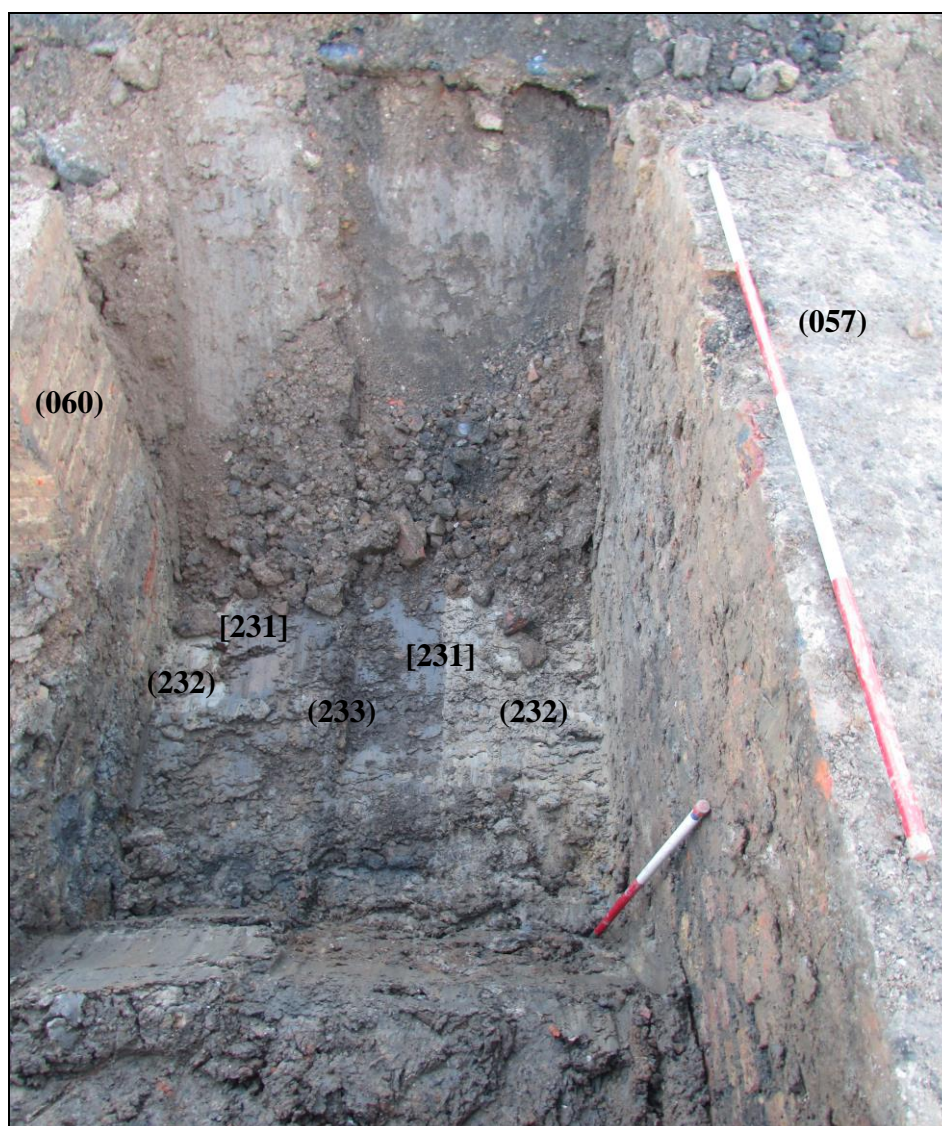
Fig. 4 Sondage between wall (057) and pillar (060) revealed a possible later cut or the foundation cuts for the respective wall and pillar.

pillar measuring 0.72 x 0.70 x 1.80m (excavated depth). A sondage was placed between (060) and (057) (see Fig. 4) and revealed that (228) sealed (284), which measured up to 1.00m in depth and physically sealed **(230)**, a fairly compact dark greyish brown silty clay with lenses of light greyish yellow clay and rare small (<0.05m) sub-angular stones. There were also rare small fragments of brick within this deposit also. This deposit measured up to 0.50m in depth and sealed **(233)**, a very compact dark brownish grey silty clay with no inclusions noted. (233) was the infill of **[231]**, which appeared to be a linear cut measuring 0.50m in width and orientated NW-SE. This truncated **(232)**, a fairly compact light yellowish grey silty clay with rare small (<0.05m) sub-rounded pebbles. This was the lowest observed deposit in this area and had to be backfilled due to health and safety concerns. It is also possible that [231] may be the foundation cuts of (057) and [060] into (233), with (232) infilling the cuts however the former was considered more likely due to the nature of construction observed elsewhere in the Male Felon Cells.

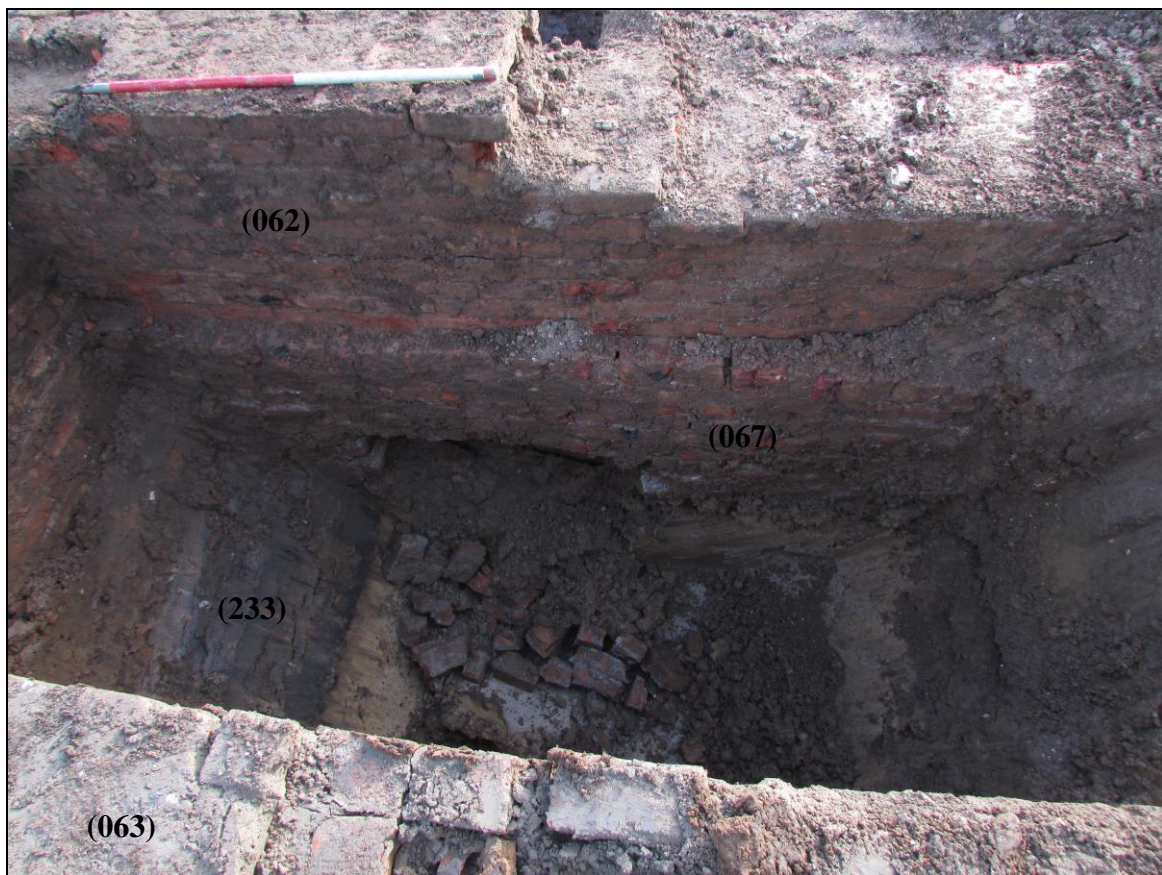
Fig. 5 Wall (067) partially collapsed, revealing that it was a separate wall to (062).

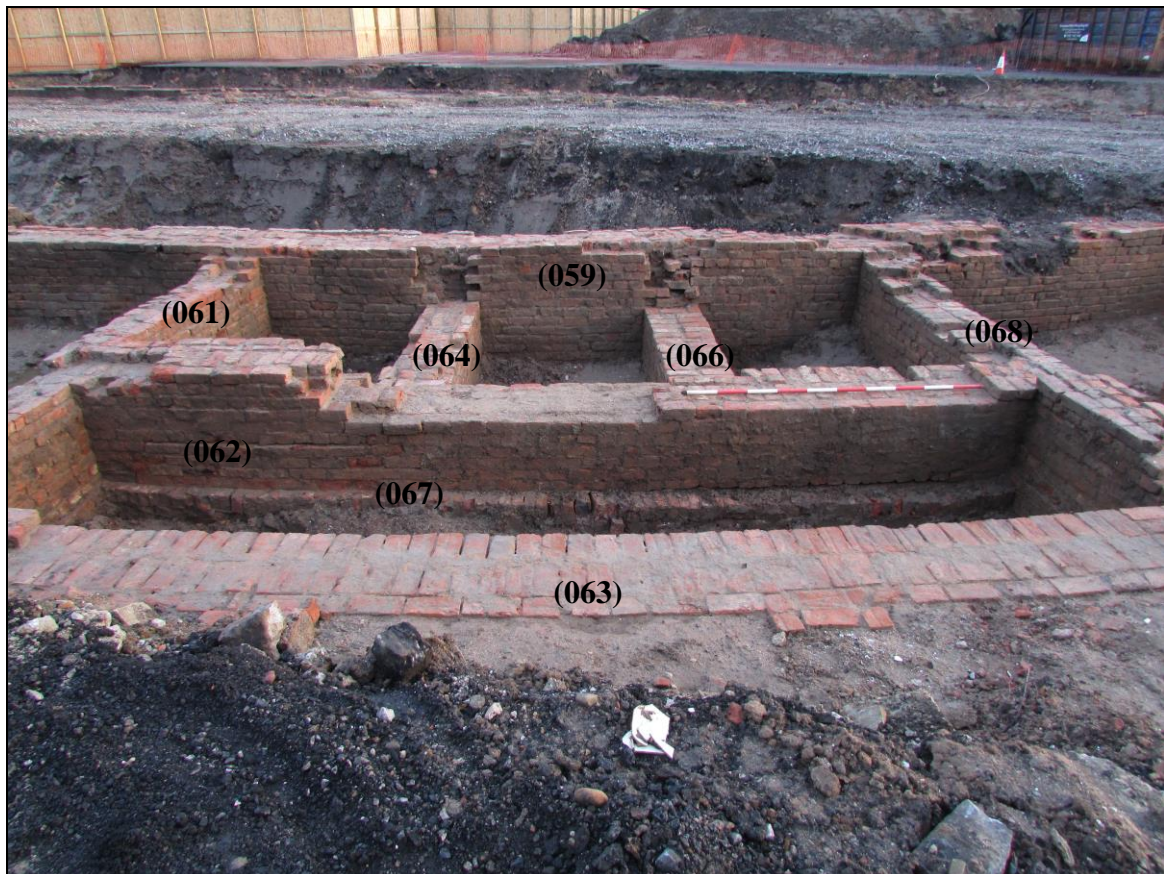
Fig. 6 Example of the cells, flanking a corridor. The lower levels of (064) and (066) suggest that they may have been lowered while the prison was still in use.

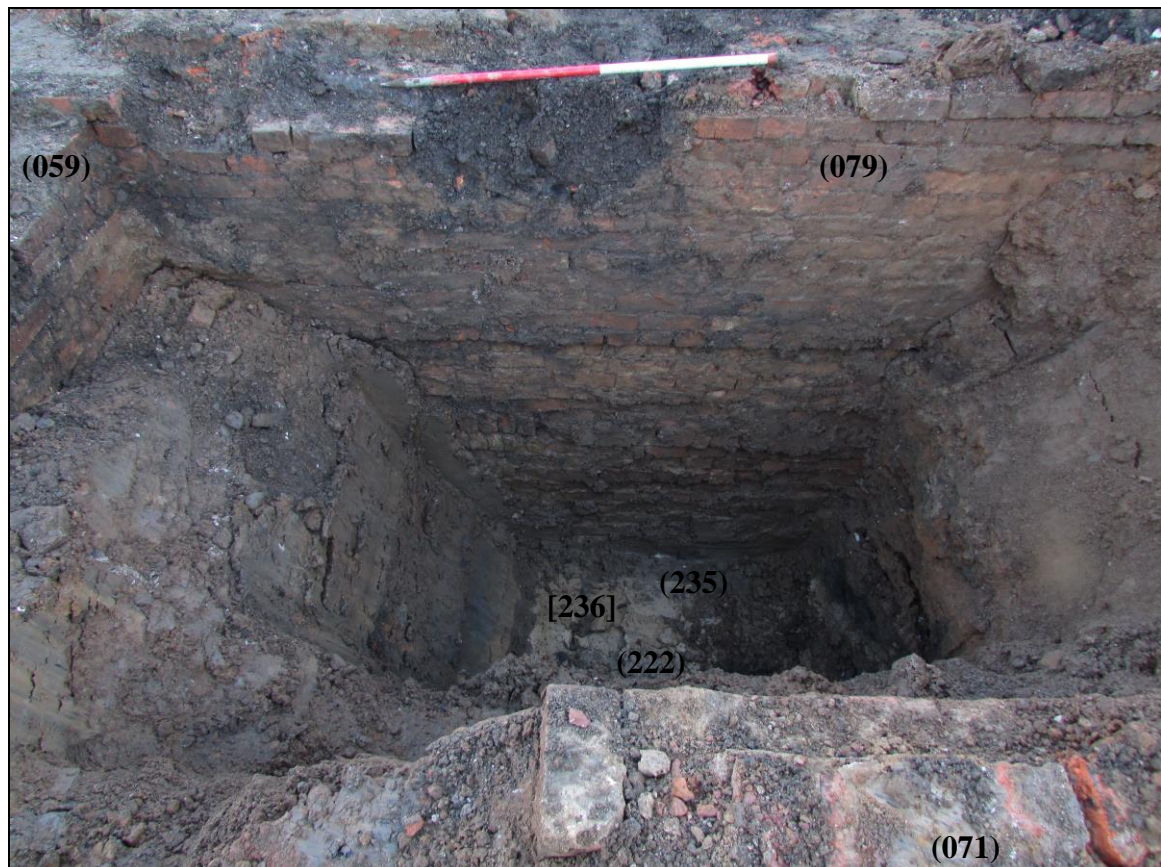
Fig. 7 Foundation cut [236] for wall (079) was revealed that the wall survived to a depth of  $2.20\text{m}$ .

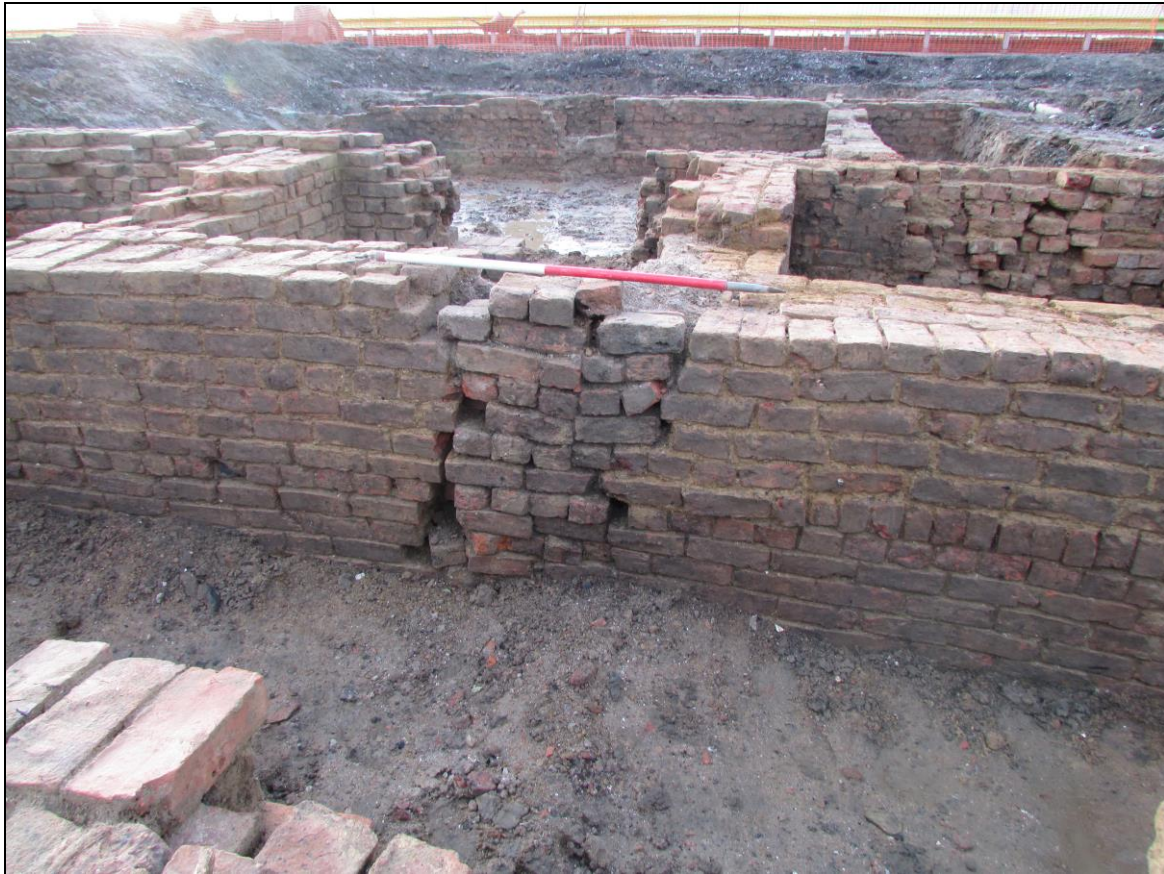
Fig. 9 Partial rebuild (170) of wall (169) after being truncated by [160].

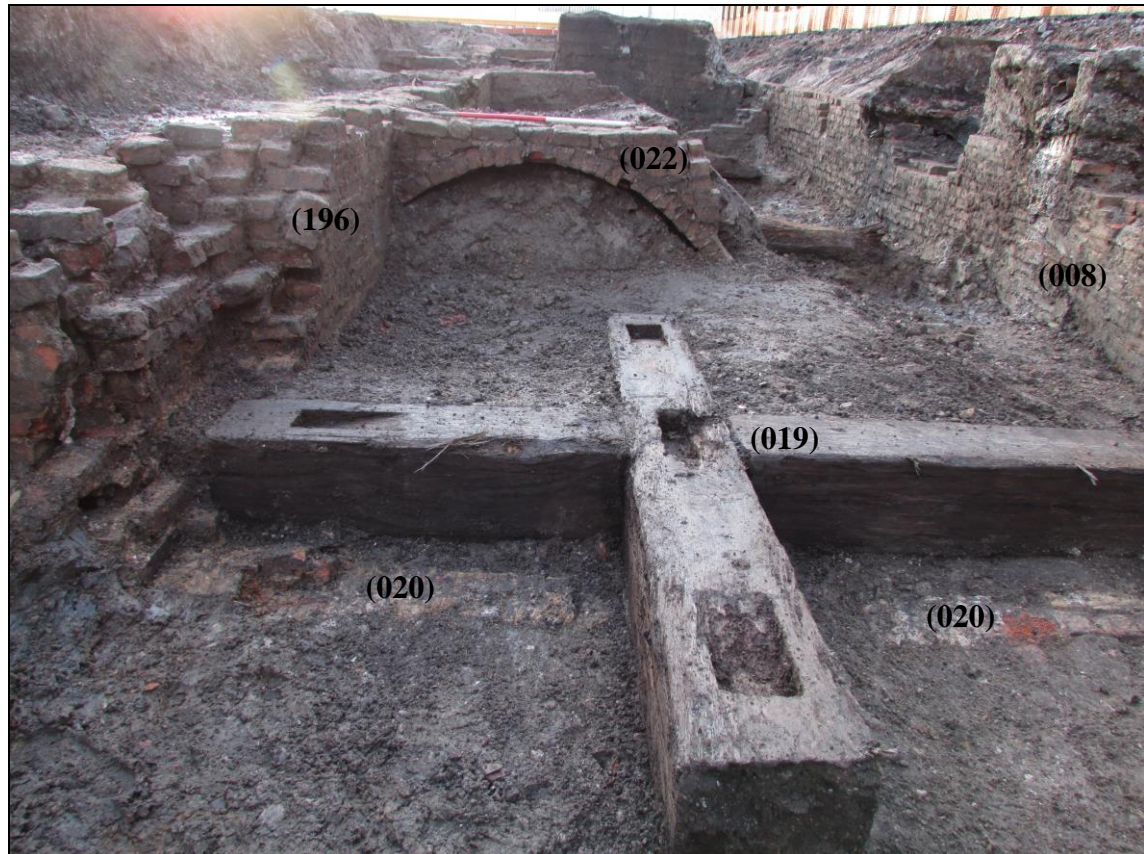
Fig. 10 (022) with the only surviving archway within this area.

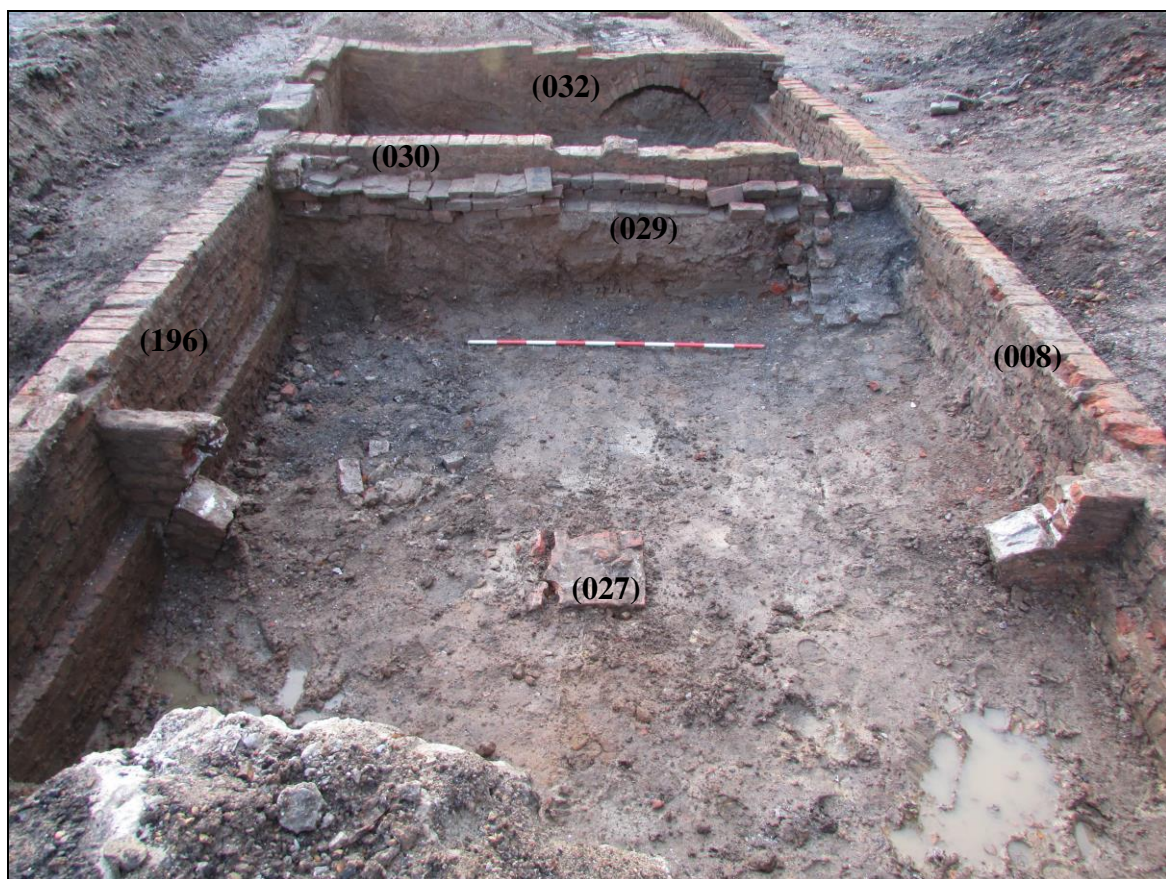
Fig. 12 General shot of the dividing walls in the workshops in Trench 1, which varied in preservation.

fragmented remains suggest that this wall originally had two archways, with a central supporting pillar and measured 3.50m in length (see Fig. 12). The arches appear to have consisted of stretcher laid bricks on side and the wall was keyed into both (008) and (196). Running parallel with (027) to the S was **(030)**, a handmade brick wall measuring two courses wide and orientated NW-SE. This wall had two archways built in, defined by two courses of alternating headers and stretchers laid on side and each arch measured 1.40m at their widest point. This wall measured 4.30 x 0.24 x 3.20m, which was revealed during a sondage which had to be backfilled due to the extreme depth. The archway was shown to rest on a pillar which appeared to be built into (008). This only extended out from the arch by one course, c0.11m. Below (031) was **(241)**, a fairly compact mid brownish grey silty clay with rare small (<0.05m) sub-angular stones, with occasional lenses of light yellowish brown clay. This measured up to c2.00m deep and lay physically above the natural clay (222). There was no foundation cut visible for this wall. Above (196) to the immediate SE of (030) was **(242)**, which was a large stone measuring 0.75 x 0.25 x 0.20m, which showed patterns of wear and was broken in two places. Flagstones appeared to define either side of this and were partially built into (196).

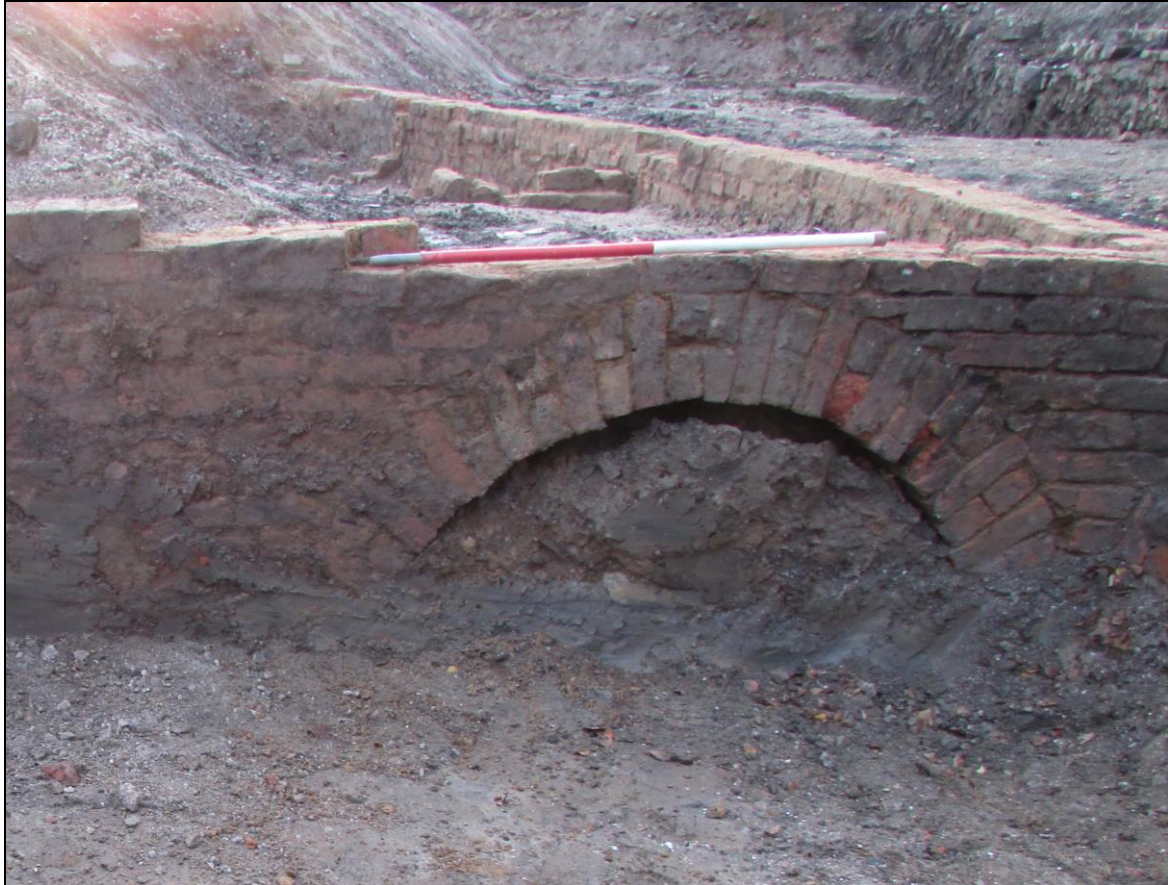
Fig. 13 Wall (032) showing the alternating header/stretcher construction of the archway.

handmade brick wall, orientated NW-SE and measuring two courses wide. The bonding was mostly stretcher with occasional header rows and measured 4.28 x 0.24 x 3.20m. Again, two archways were constructed within this wall and measured 1.40m at their widest points. The arches consisted of two courses, laid on side and like (030), consisted of alternating headers and stretchers (see Fig. 13).

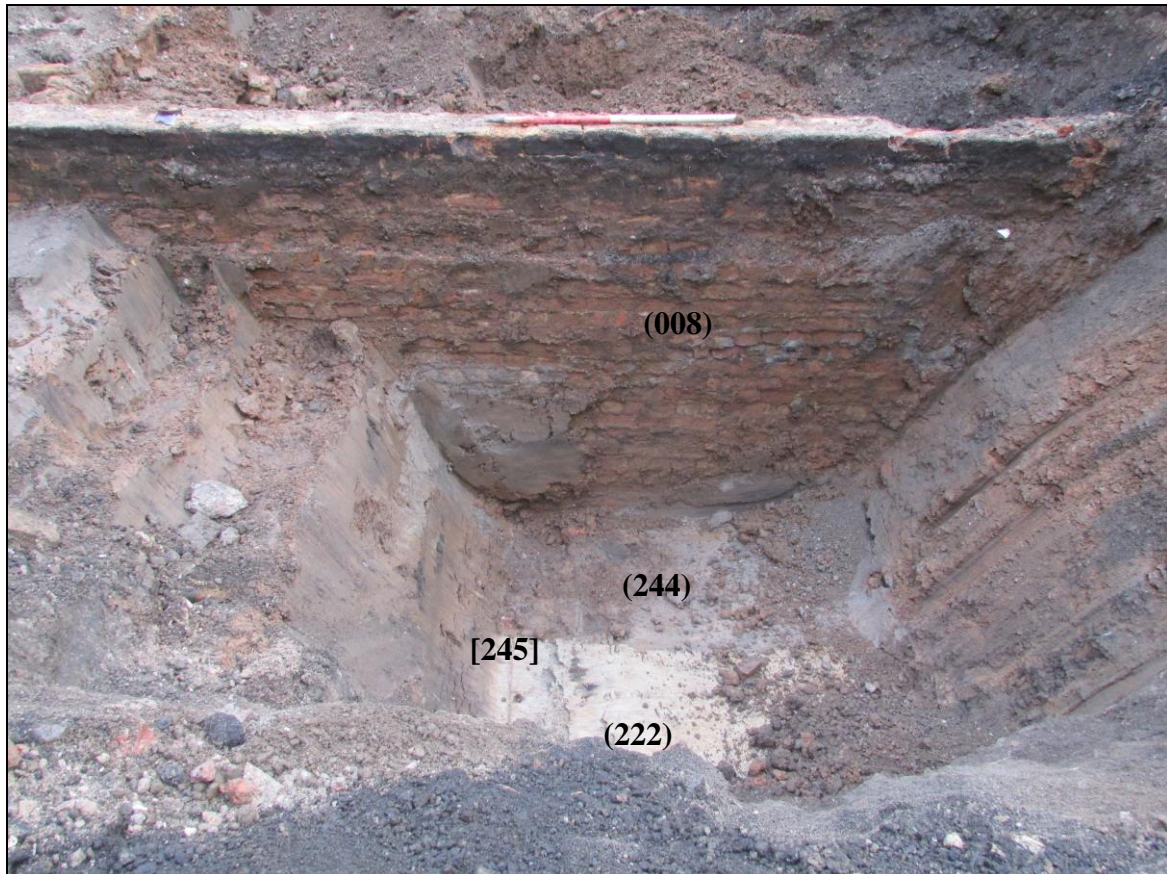
Fig. 14 Possible foundation cut [245] for wall (008).

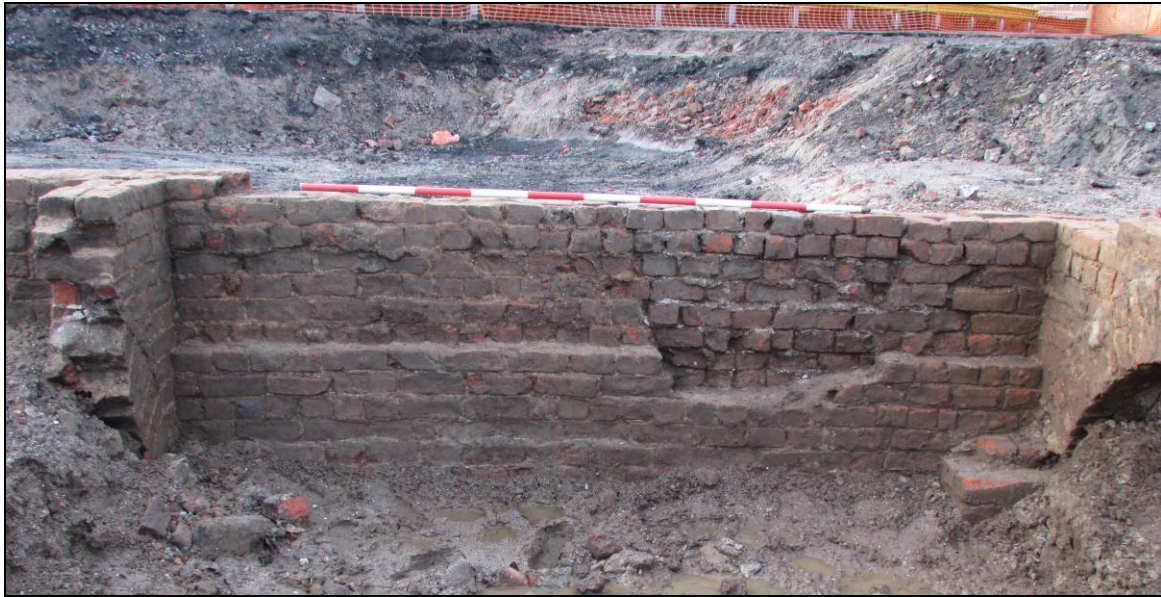
Fig. 16 Wall (085) with later repair, shown on the right.

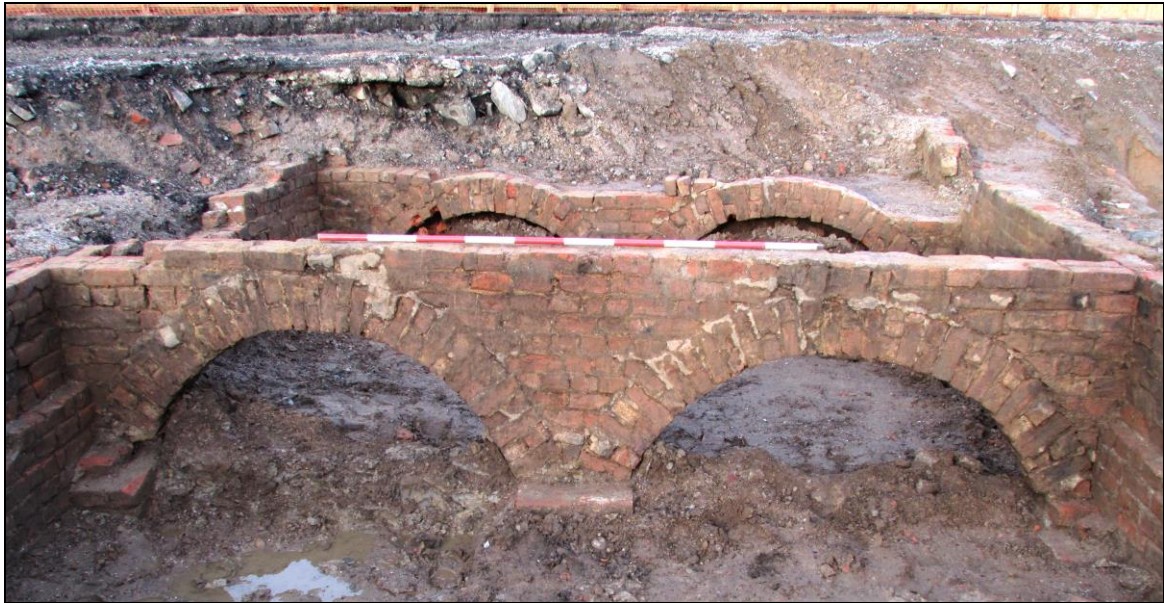
Fig. 17 Wall (090) showing the archway construction.

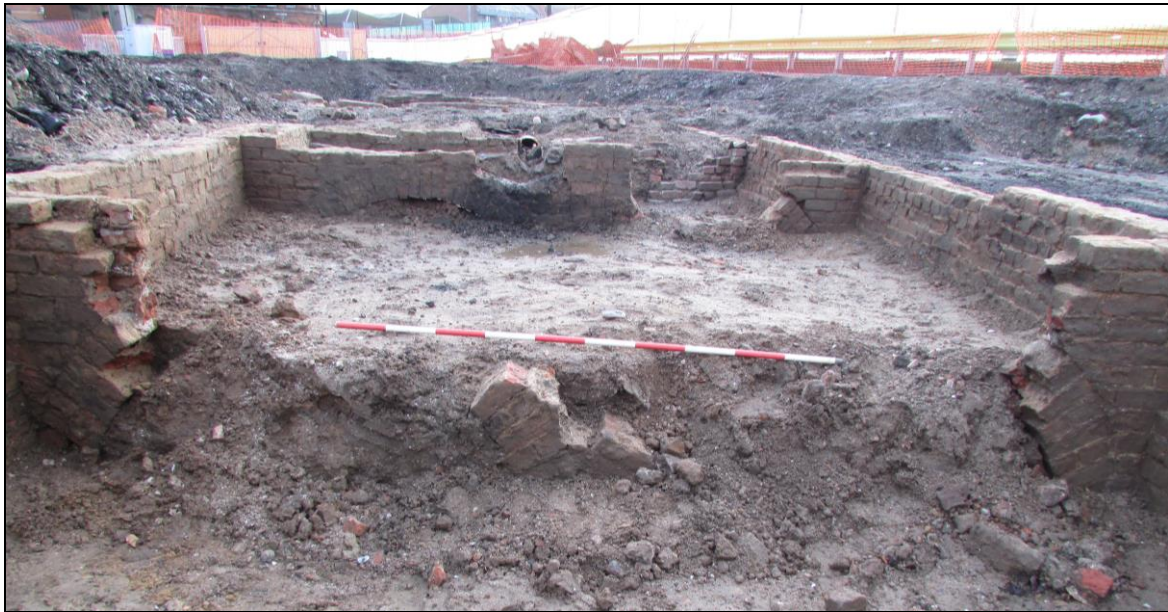
Fig. 18 The badly truncated remains of wall (094) with evidence for segmented archways.

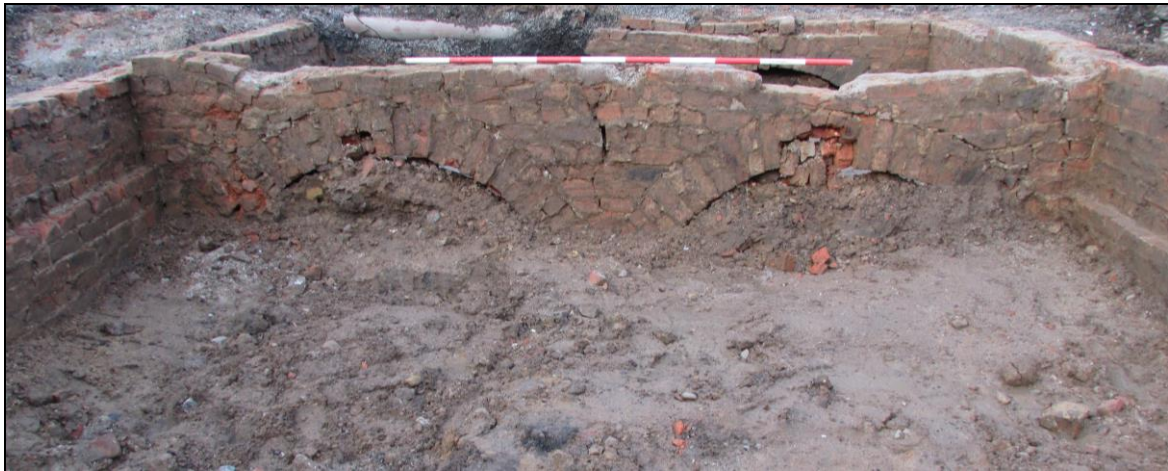
Fig. 19 Wall (181) was relatively intact but badly cracked in places, suggesting it may have been affected by subsidence.

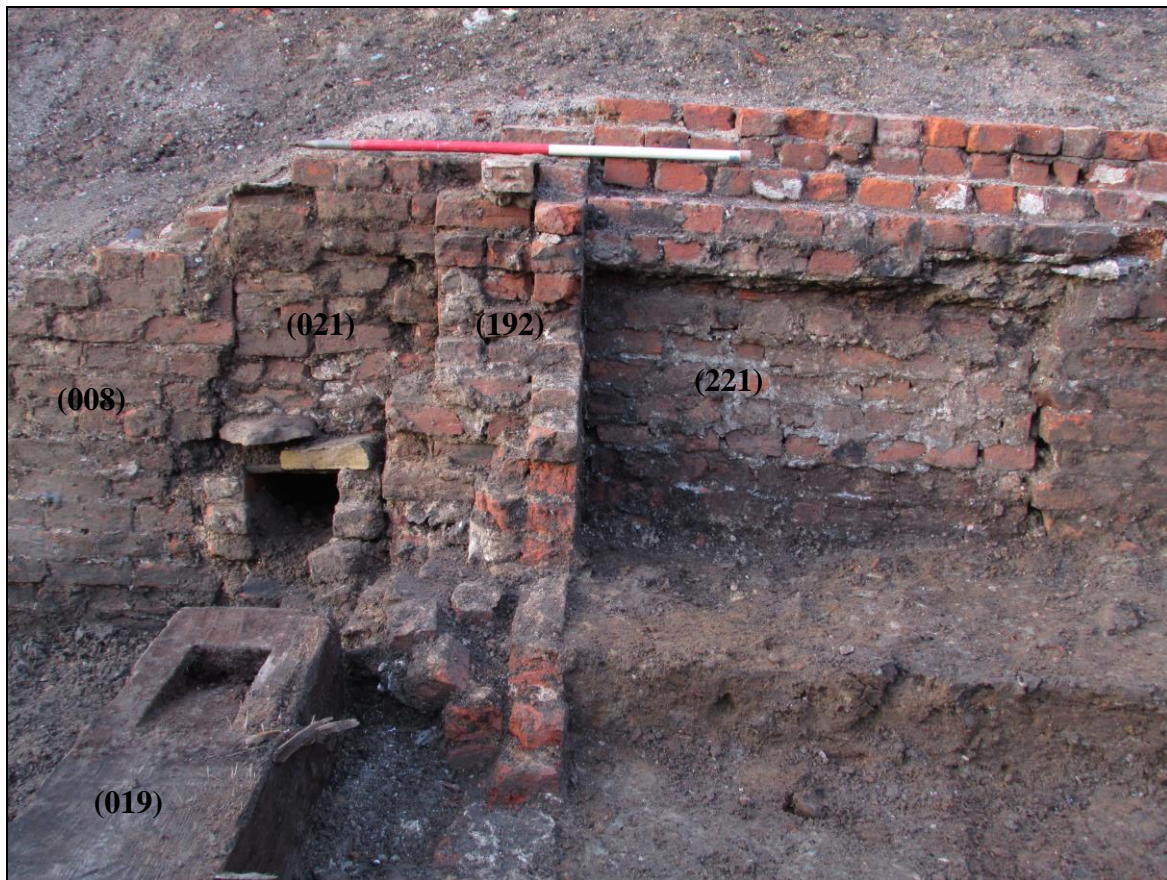
Fig. 20 The differing mortar between (008) and (221) shows where the Hospital Wing was added.

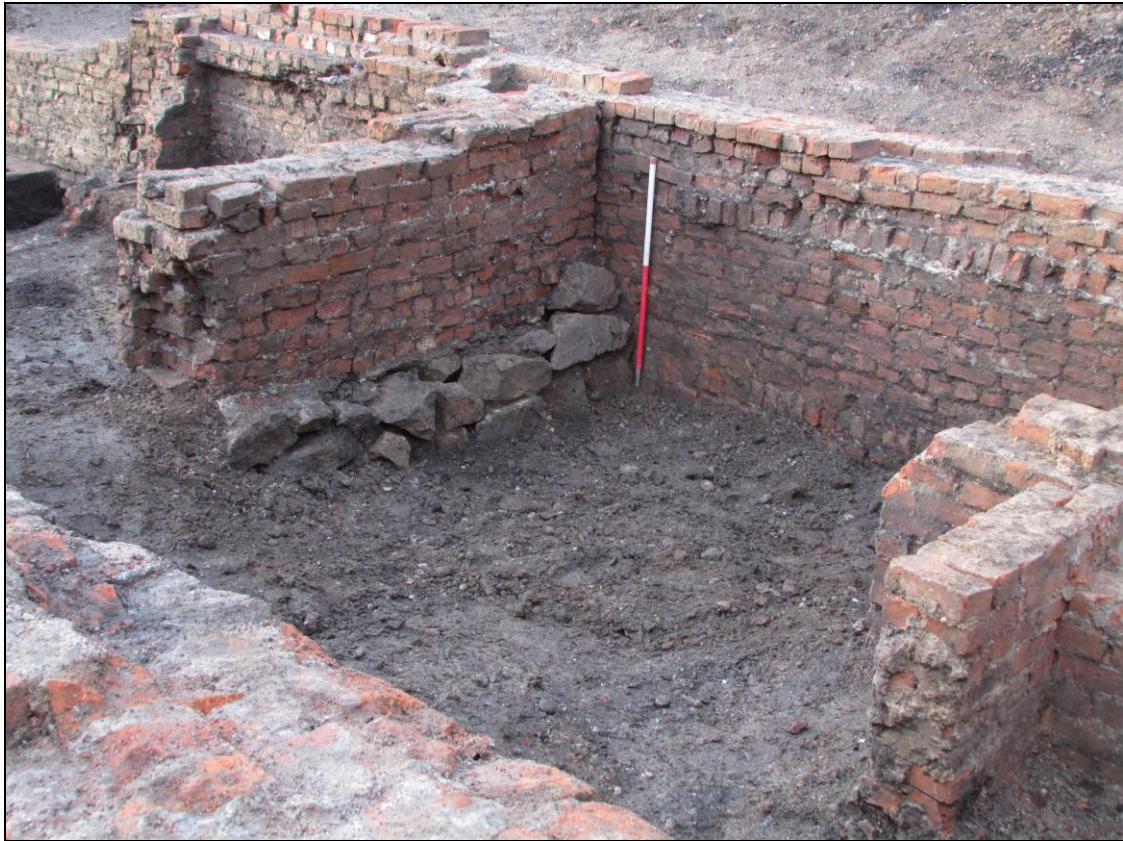
Fig. 22 Wall (016) with unmortared stone foundation (017).

(221) partially ran parallel with (189), a handmade brick wall measuring two courses wide and orientated NE-SW. There was no discernible bonding pattern, with headers laid on side in places. The wall measured 2.70 x 0.24 x 0.90m and the foundations consisted of a row of header bricks laid on side, constructed onto a series of irregular shaped flagstones. This abutted (192) and lay directly below (188), which were two flagstones averaging 0.40 x 0.31 x 0.04m. Another flagstone lay to the S of (188), which appears to relate to this and measured 0.60 x 0.40 x 0.04m. Abutting the corner of (189) and (192) was (252), a handmade brick drain measuring 0.68 x 0.40 x 0.70m, the centre of which was filled with a loose light whitish grey silty sand. Abutting (189) to the NE was (097), a handmade brick wall, measuring four courses wide and orientated NW-SE. The bonding consisted of mostly stretcher rows with occasional header rows but not conforming to a particular pattern. This wall was visible for 2.60m in length and excavated to 1.40m in depth. (097) abuts (189) and appears to be keyed into (096). (097) appears to be a continuation of (016), a handmade brick wall, measuring four courses wide and orientated NW-SE. The bonding was inconsistent, with areas of Flemish as well as pure stretcher and header rows. (016) measured 2.28 x 0.52 x 1.00m. (097) abuts (221) and also (018), a handmade brick drain, broadly square, measuring 0.60 x 0.50 x 0.75m. This also abutted (221). (016) was built onto (017), which appeared to be the footings for wall (016). This consisted of a series of large sub-angular light greyish brown sandstones, measuring up to 0.40m in size. These were irregularly laid and measured up to 1.00m in depth. (016) appeared to be partially mortared to (017), however the stones themselves were not mortared together

(see Fig. 22). (017) also abutted (221) and was partially visible below (097), suggesting that (016) and (097) were once a continuous wall. However a gap had been punched through, measuring 1.15m wide.

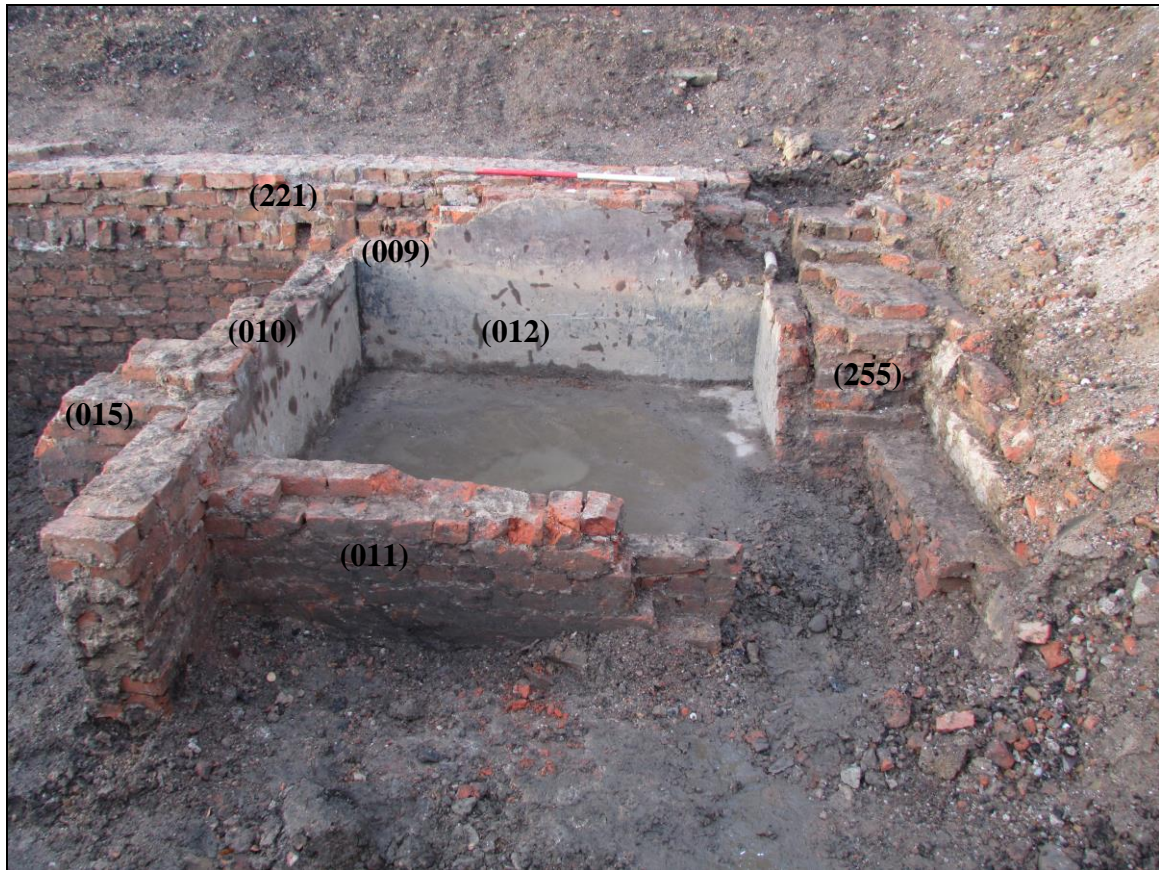
Fig. 24 Possible boiler room within the Male Hospital Wing.

Abutting the SE face of (221) for 2.00m in length was **(009)**, a handmade brick wall, measuring two courses wide and orientated NE-SW. No coursing was visible but it survived to 1.00m high and measured 2.00m long. It appears to abut **(010)**, a handmade brick wall, measuring two courses wide and orientated NW-SE. Bonding was fairly regular although no particular pattern was observed. This measured 2.66m in length and was excavated to a depth of 0.96m. Keyed into (010) and running NW-SE was **(015)**, a handmade brick wall measuring three courses wide. This wall appeared to consist of mostly stretcher bond, however this wall only measured 0.50m in length and was excavated to a depth of 0.70m. (015) has no physical relationships with other walls. Keyed into (010) towards the SE end was **(011)**, a handmade brick wall, measuring two courses wide and orientated NE-SW. Bonding was alternating header/stretcher rows and was visible for 1.70m and excavated to a depth of 0.50m. (009), (010) and (011) were lined with **(012)**, which was compact and dark brown, measuring 0.01m in thickness. This also lined **(013)**, which was partially visible at the SE end and was a handmade brick floor, laid on bed. The rest had been obscured by (012). Running SE from (221) and parallel to (010) was **(255)**, a handmade brick wall measuring up to five courses wide and running NW-SE. Again this was lined with (012) but reduced down to three courses wide to the SE and appeared to be partially built onto a stone block. These may be truncated steps. This marked the eastern extreme of the Male Hospital Wing (see Fig. 24).

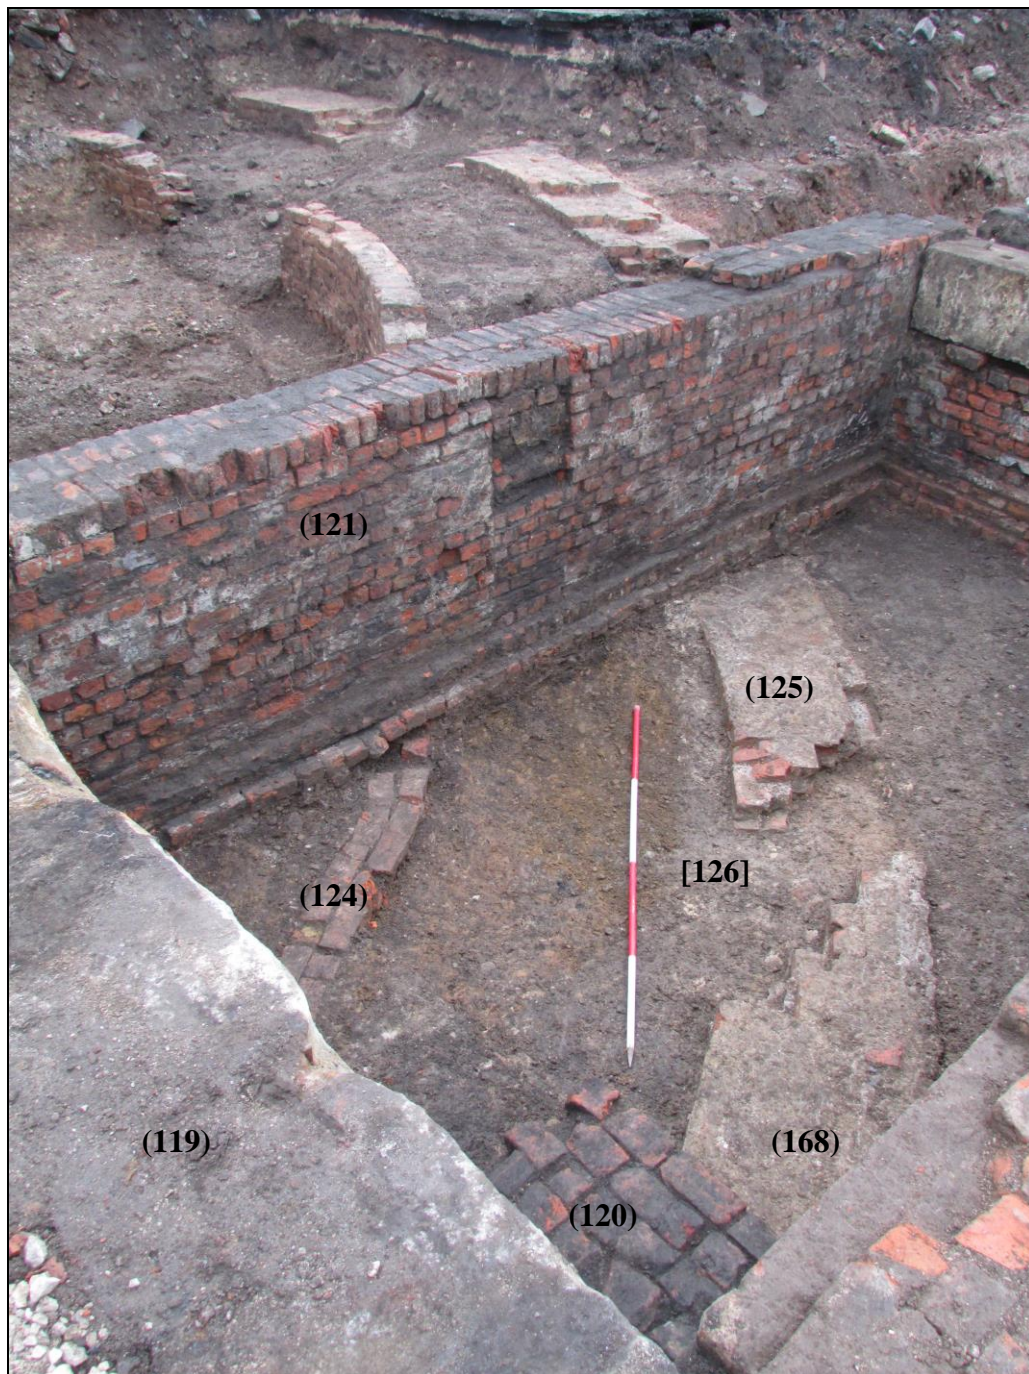
Fig. 28 Prison remains surviving to varying heights, thanks to truncation by later railway remains.

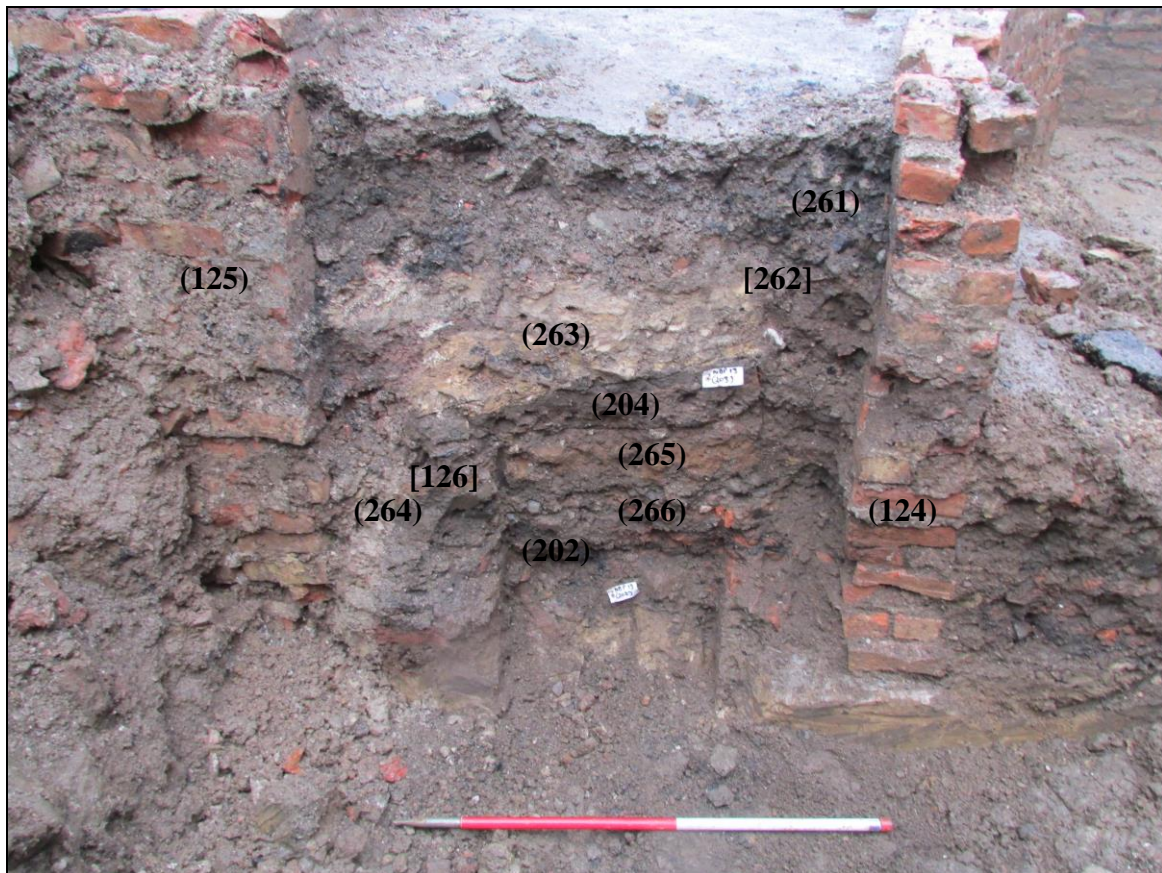
Fig. 29 Deposits between the chapel walls (125) and (124).

Between walls (124) and (125), a series of deposits were encountered (see Fig. 29), which had also been found during the earlier evaluation. Lying below (227) was **(261)**, a fairly loose mid greyish brown silty sand with occasional small (<0.05m) sub-rounded stones and rare brick fragments. This was sat within cut **[262]**, which was an almost vertical cut 0.25m SW of (124) and appeared to be the foundation cut for it. This was visible to a depth of 1.00m. This cut truncated **(263)**, a fairly compact light yellowish brown silty clay with occasional small-medium (<0.15m) sub-angular stones and measured 0.30m in depth. This in turn sealed **(264)**, a fairly loose light yellowish grey silty clay with frequent small (<0.05m) sub-angular stones. This was visible to a depth of 0.75m, within cut **[126]**, a

vertical sided cut for wall (125) and visible to a depth of 0.50m. This truncated **(204)**, a fairly loose dark brownish grey sandy silt with occasional small (<0.05m) brick fragments. This measured 0.20m deep and was the lowest observed deposit during the evaluation and was sampled for palaeoenvironmental information. **(203)** in turn sealed **(265)**, a fairly loose light reddish brown silty sand with rare small (<0.05m) sub-angular stones, which measured 0.20m in depth. This in turn sealed **(266)**, a fairly loose light greyish brown silty sand with occasional small (<0.05m) sub-rounded pebbles and brick fragments. This was visible to a depth of 0.30m and sealed **(202)** a fairly loose light greyish brown silty clay with occasional small (<0.05m) sub-rounded stones, measuring 0.20m deep. This in turn sealed the natural clay **(222)**. This was sampled during excavation as it appeared to predate the prison and may relate to the agricultural use of the area.

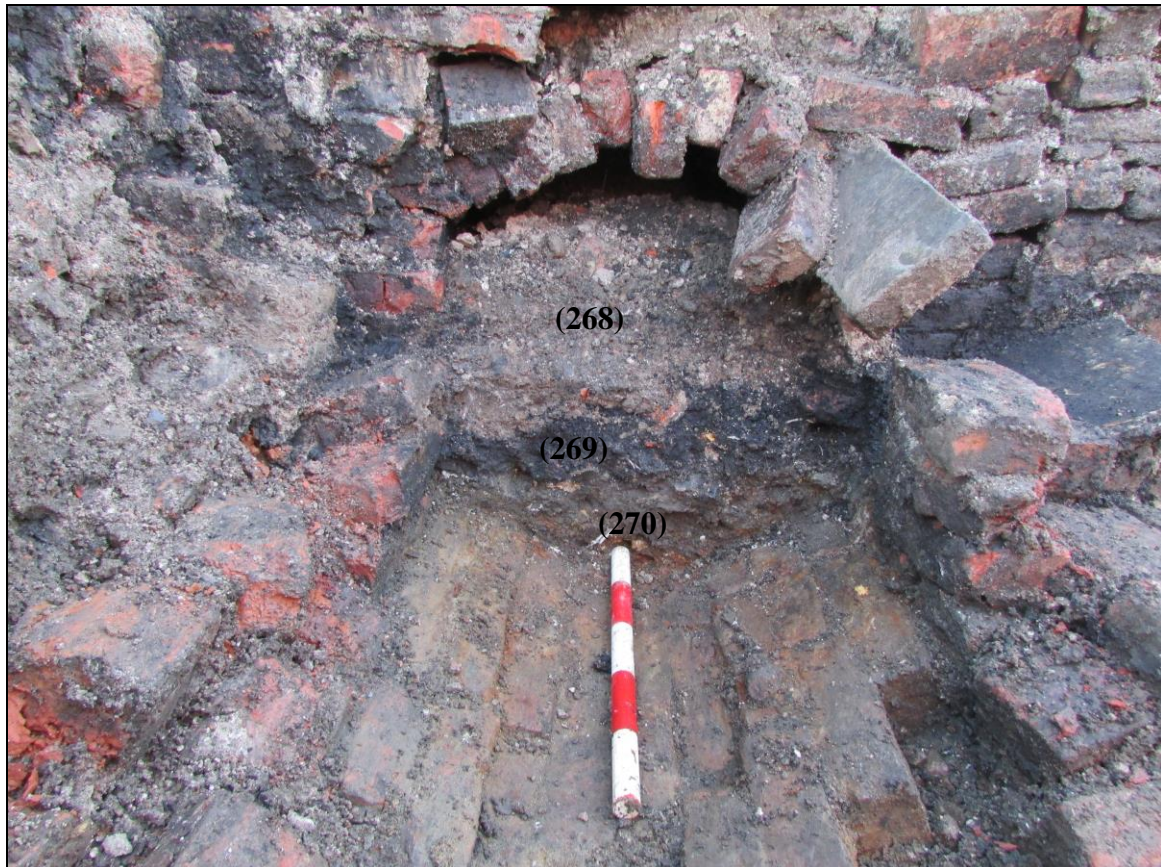
Fig. 34 Detail of deposits within the interior of the possible sewer (153).

Immediately SW of (151) was **(153)**, a handmade brick tunnel, measuring two courses wide with an inner chamber measuring 0.60m in diameter. It appeared to run broadly NW-SE and was excavated to a length of 2.10m. Its overall width was 1.00m. To try and gauge the construction style and relationship to other features, part of it was removed and revealed three distinctive fills (see Fig. 34), including **(268)**, a loose light brownish grey silty sand with frequent inclusions of small (<0.05m) sub-rounded stones, mortar and brick fragments. This measured 0.25m in depth and sealed **(269)**, a fairly loose mid blackish grey clayey silt with inclusions of occasional small (<0.05m) sub-rounded stones and brick fragments. This measured c0.10m in depth and in turn sealed **(270)**, a fairly compact light brownish grey silty clay with rare inclusions of small (<0.05m) sub-angular stones, also measuring 0.10m deep. Due to the proximity to the trench edge, (152)'s relationship with (157) could not be ascertained for definite, however it appears to have been built into it and also appears to have been keyed into (151) although again, later truncation, this time by (121), makes this difficult to ascertain.
