**Archaeological  
Excavation:**

Land off Stanley  
Street, Central  
Salford: Plot B1  
(New Bailey  
Prison)

**Technical  
Report:**  
Rachael Reader

**Document Type:** Archaeological Excavation Report

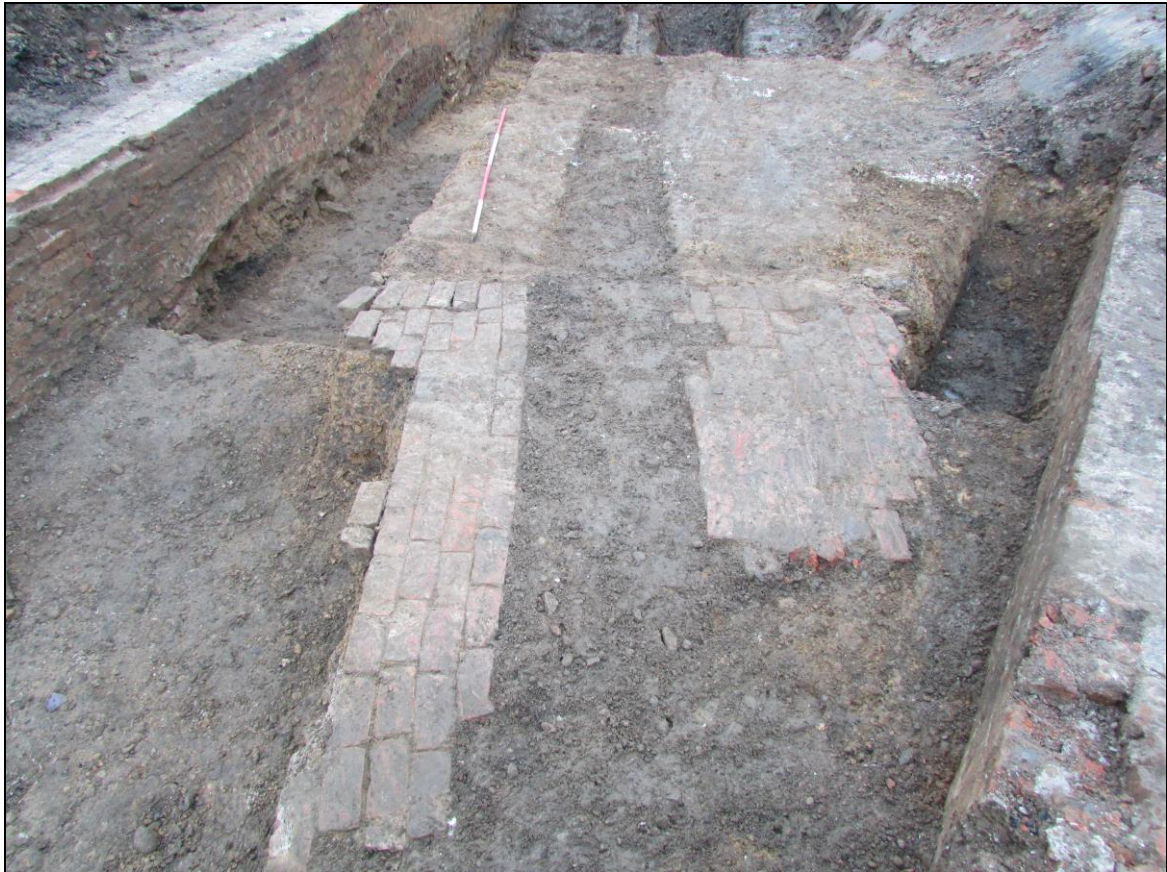
Fig. 37 Possible floor surface (158), truncated by pipe trench [160].

(158) lay on **(162)**, a fairly loose light reddish brown silty sand with abundant small (<0.05m) and occasional medium (<0.15m) sub-rounded pebbles. This broadly covered an area measuring 5.00 x 7.00m and reached a depth of 0.70m. To the immediate SW of (158), (162) was very compacted and gradually became shallower in depth. This in turn sealed **(272)**, a fairly loose light yellowish grey clayey silt with occasional small-medium (<0.15m) sub-angular stones. This measured up to 0.30m in depth. This in turn sealed **(273)**, a fairly compact mid greyish brown silty clay with rare small (<0.05m) sub-angular stones and measured c0.20m deep. This in turn sealed **(274)**, a fairly loose light reddish brown clayey silt with rare small (<0.05m) fragments of mortar, also measuring c0.20m deep. These two deposits just described were visible within a sondage placed along the N face of (157), both within the archway and S facing section.

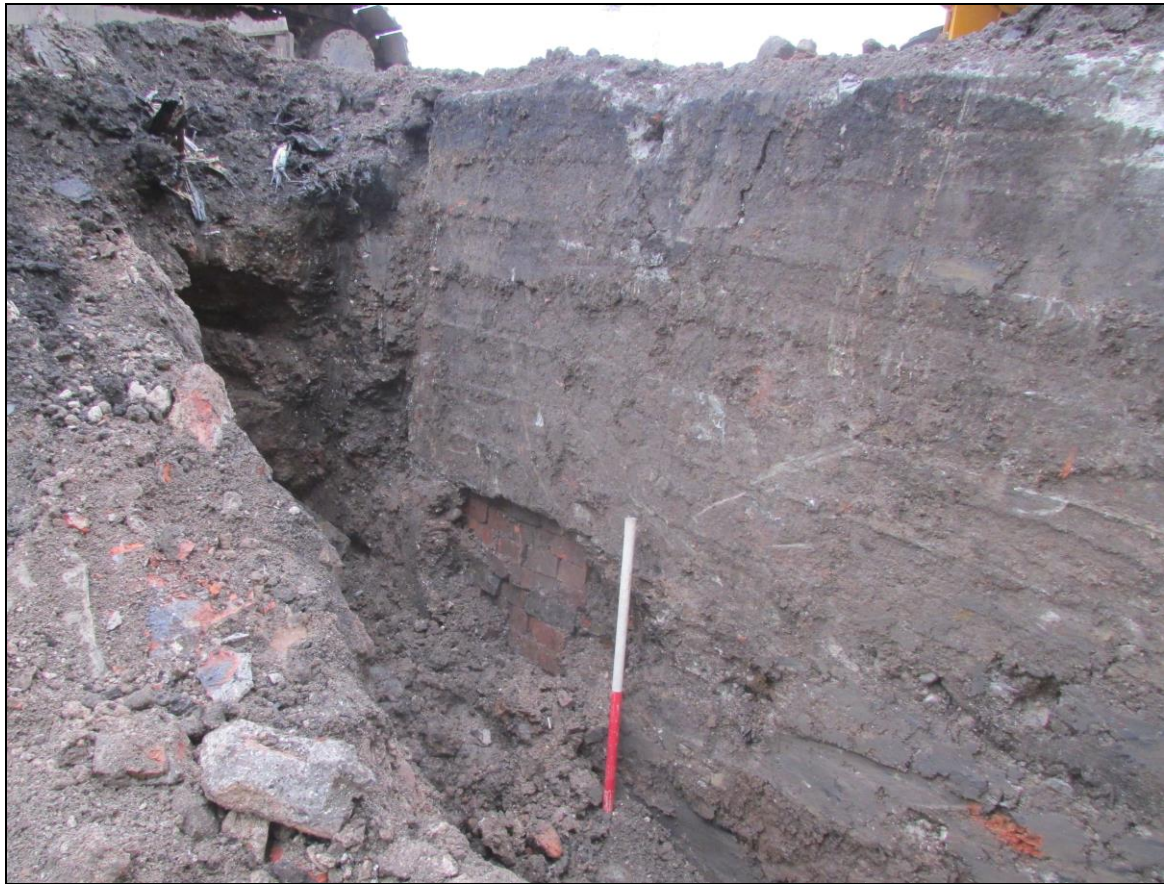
Fig. 43 Concrete stanchion (024) sat on machine made bricks.

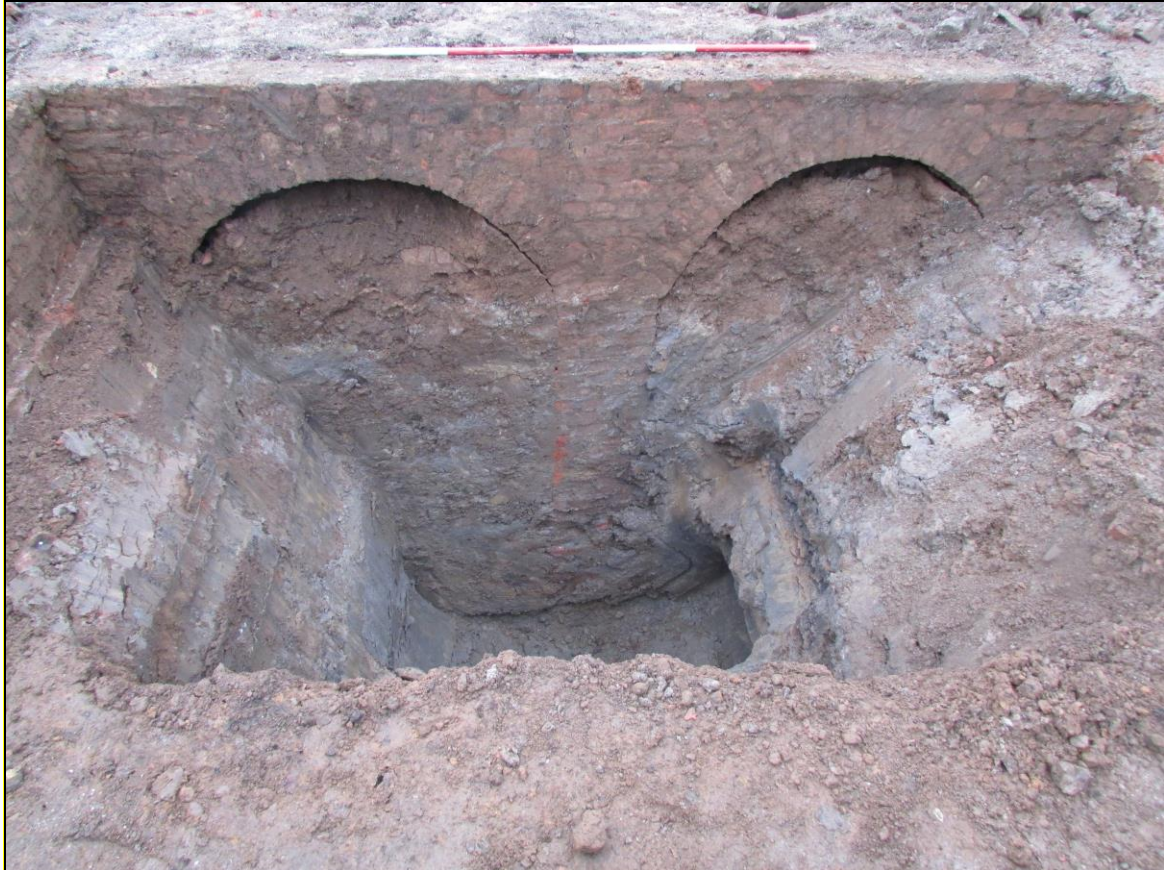
Fig. 47 Wall (090) showing possible phasing of blocking the archways, indicating they were never meant to be used as a basement level.

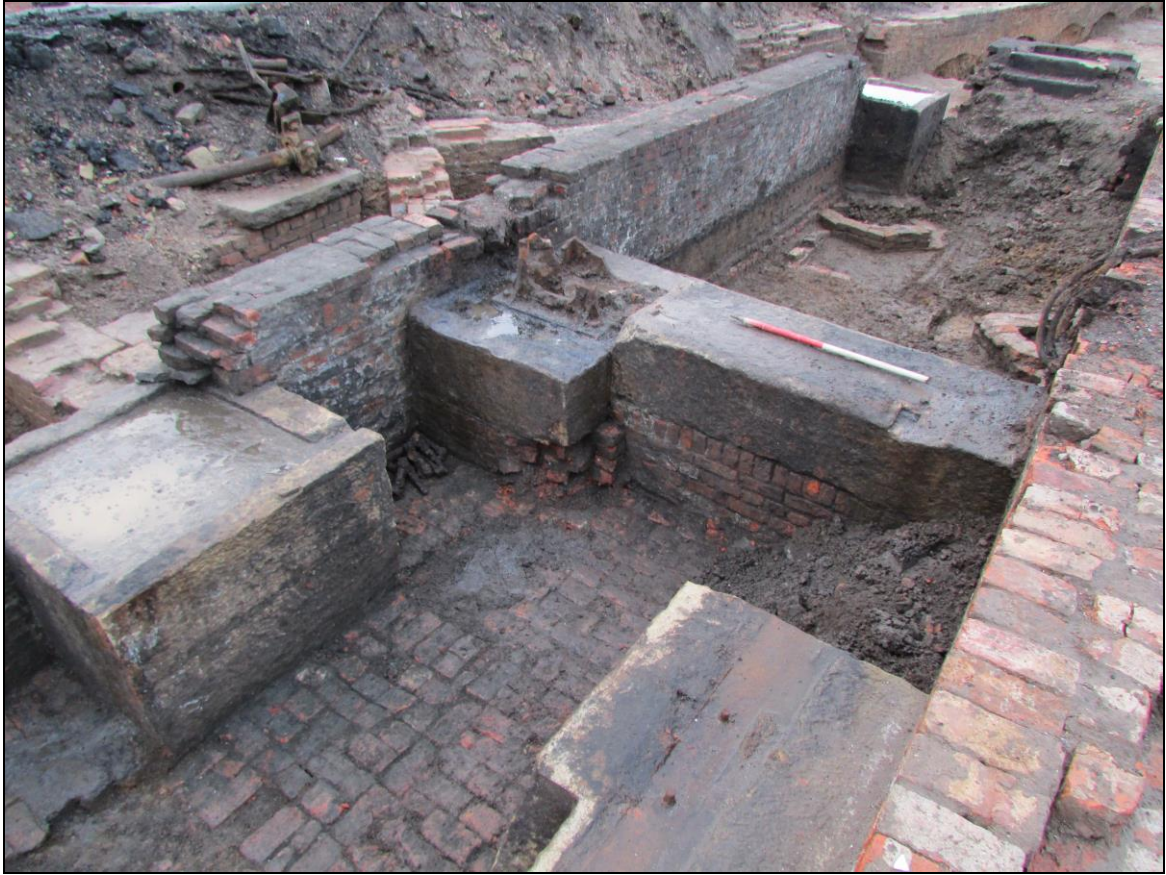
Fig. 48 The hydraulics for the capstans ran along this stone block (with the ranging rod). Note the driveshaft related to it located within the top left of the picture.

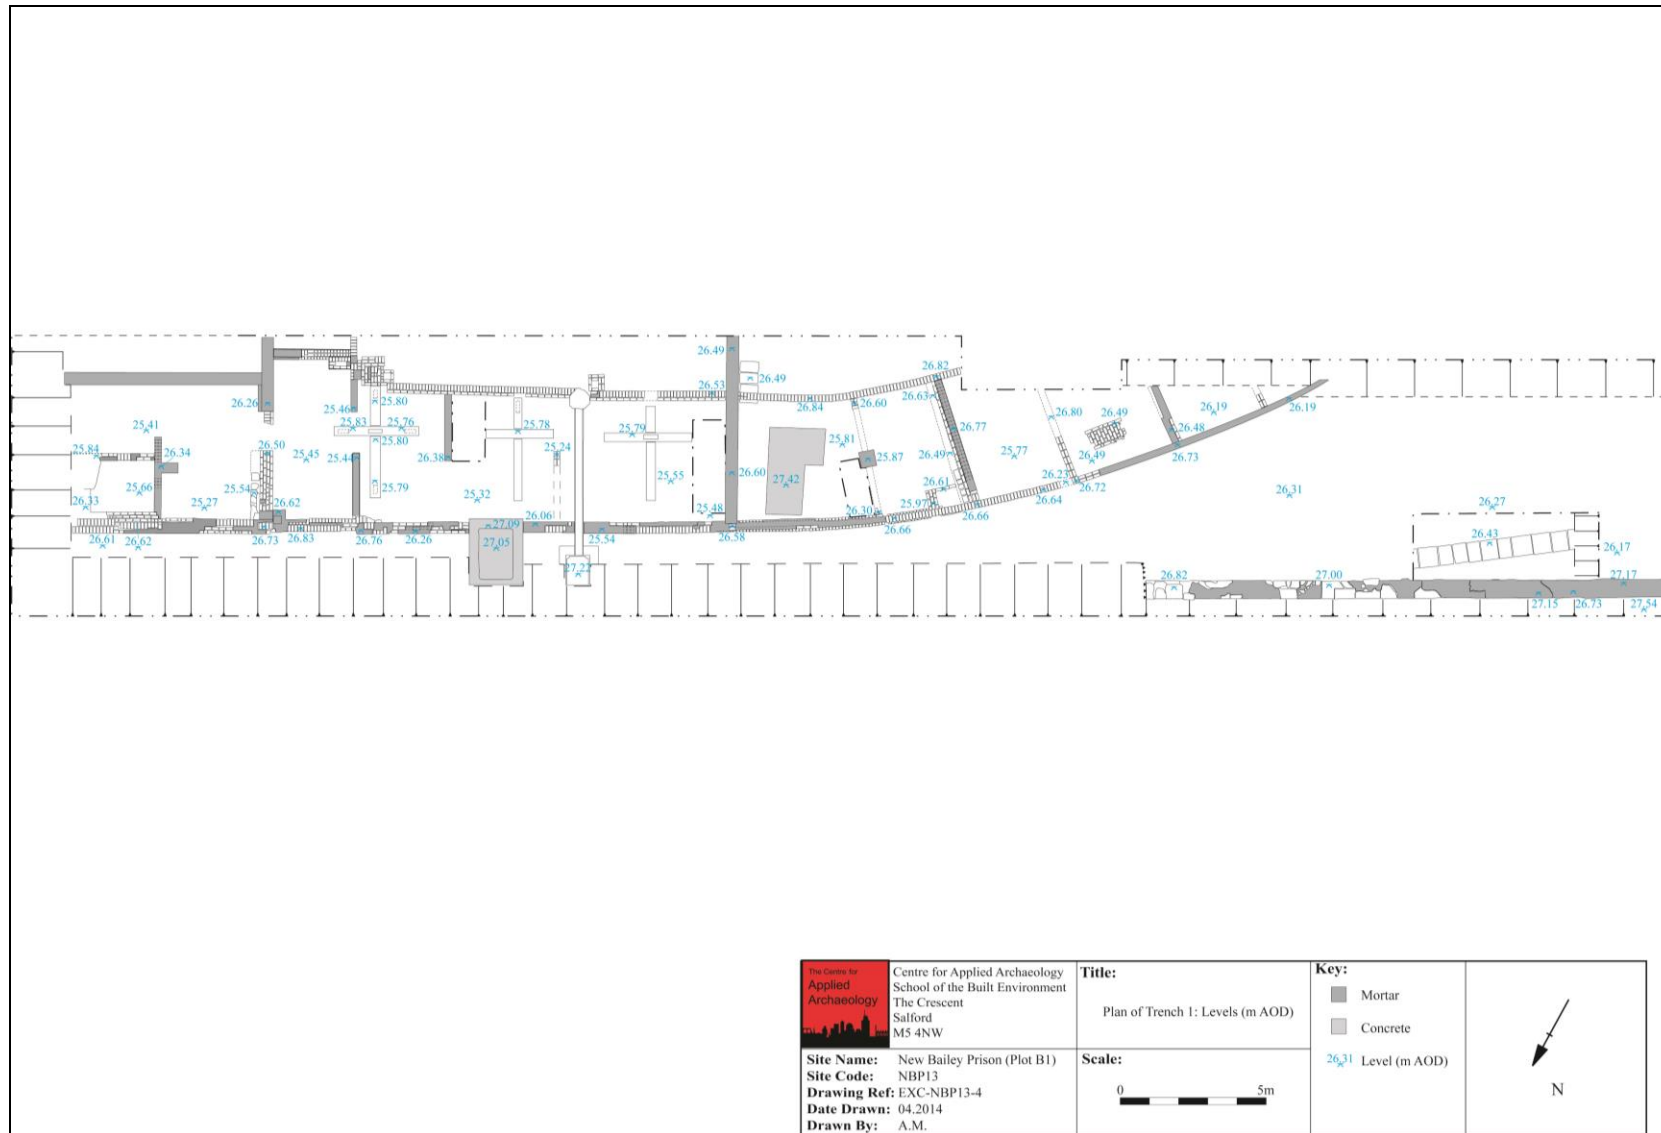
Fig. 63 Plan of Trench 1 showing the levels (m AOD)

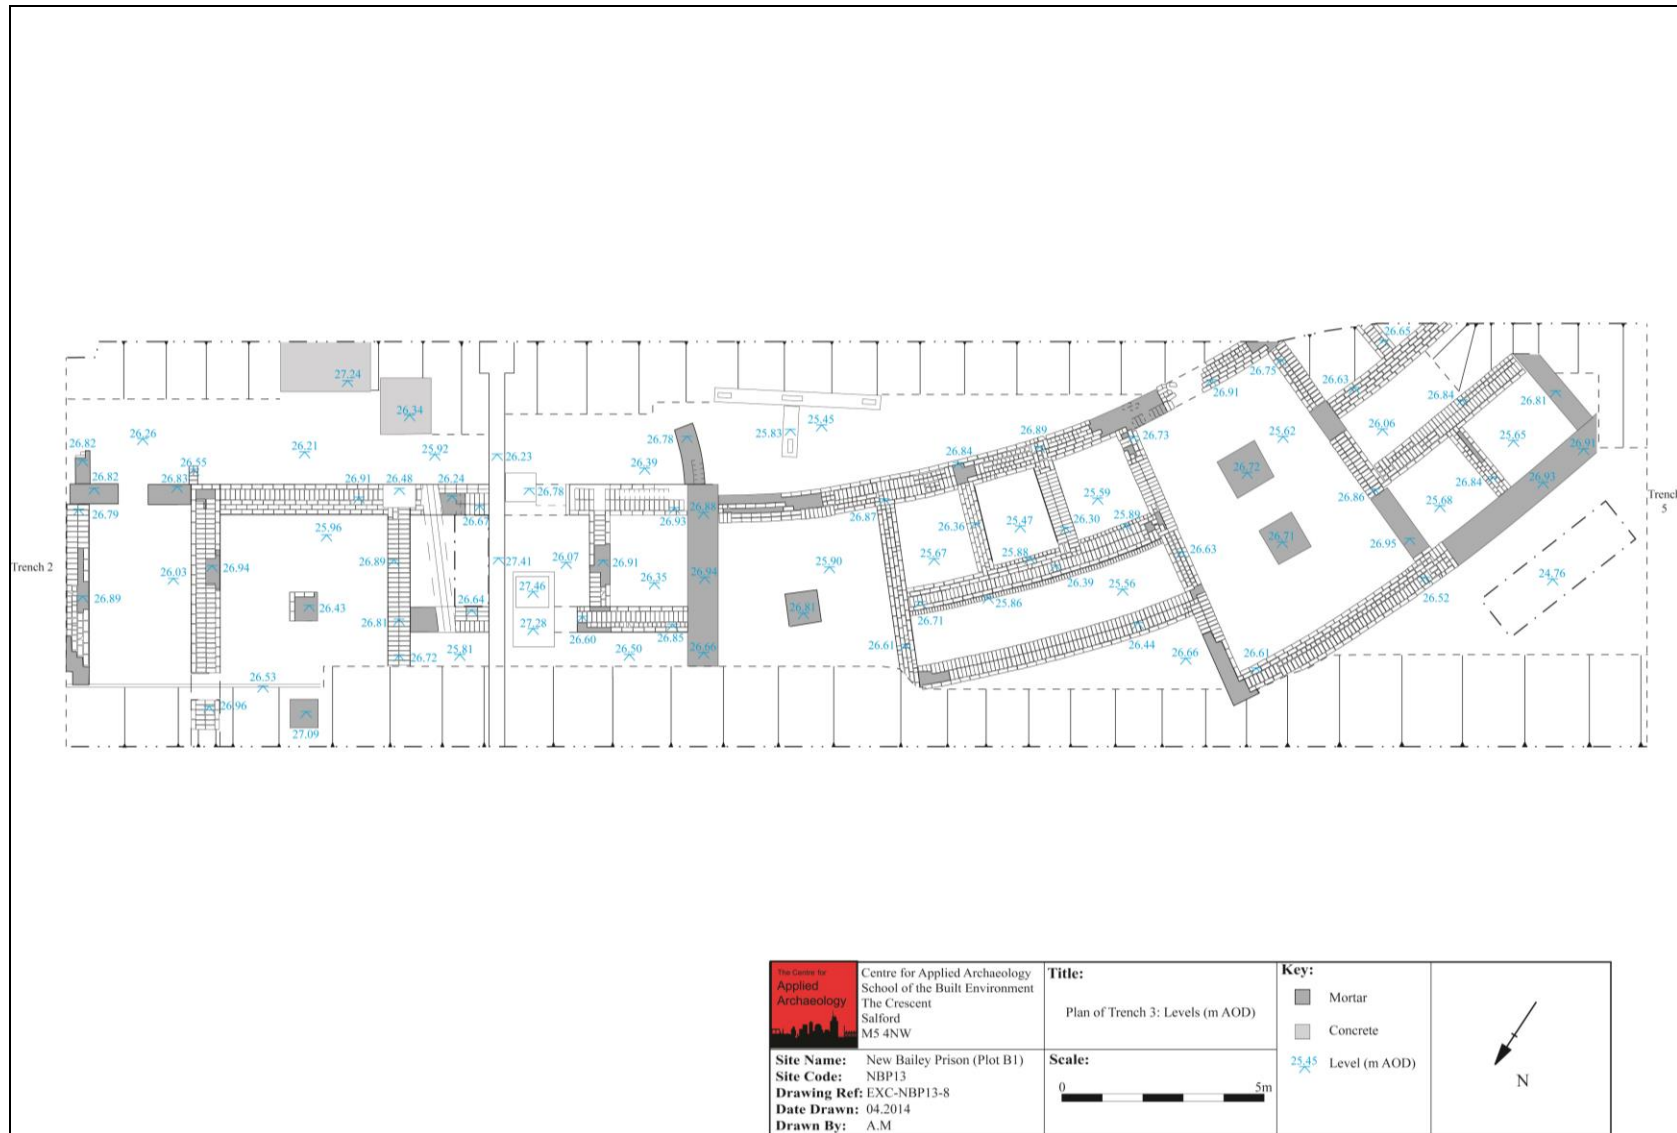
Fig. 67 Plan of Trench 3 levels (m AOD)

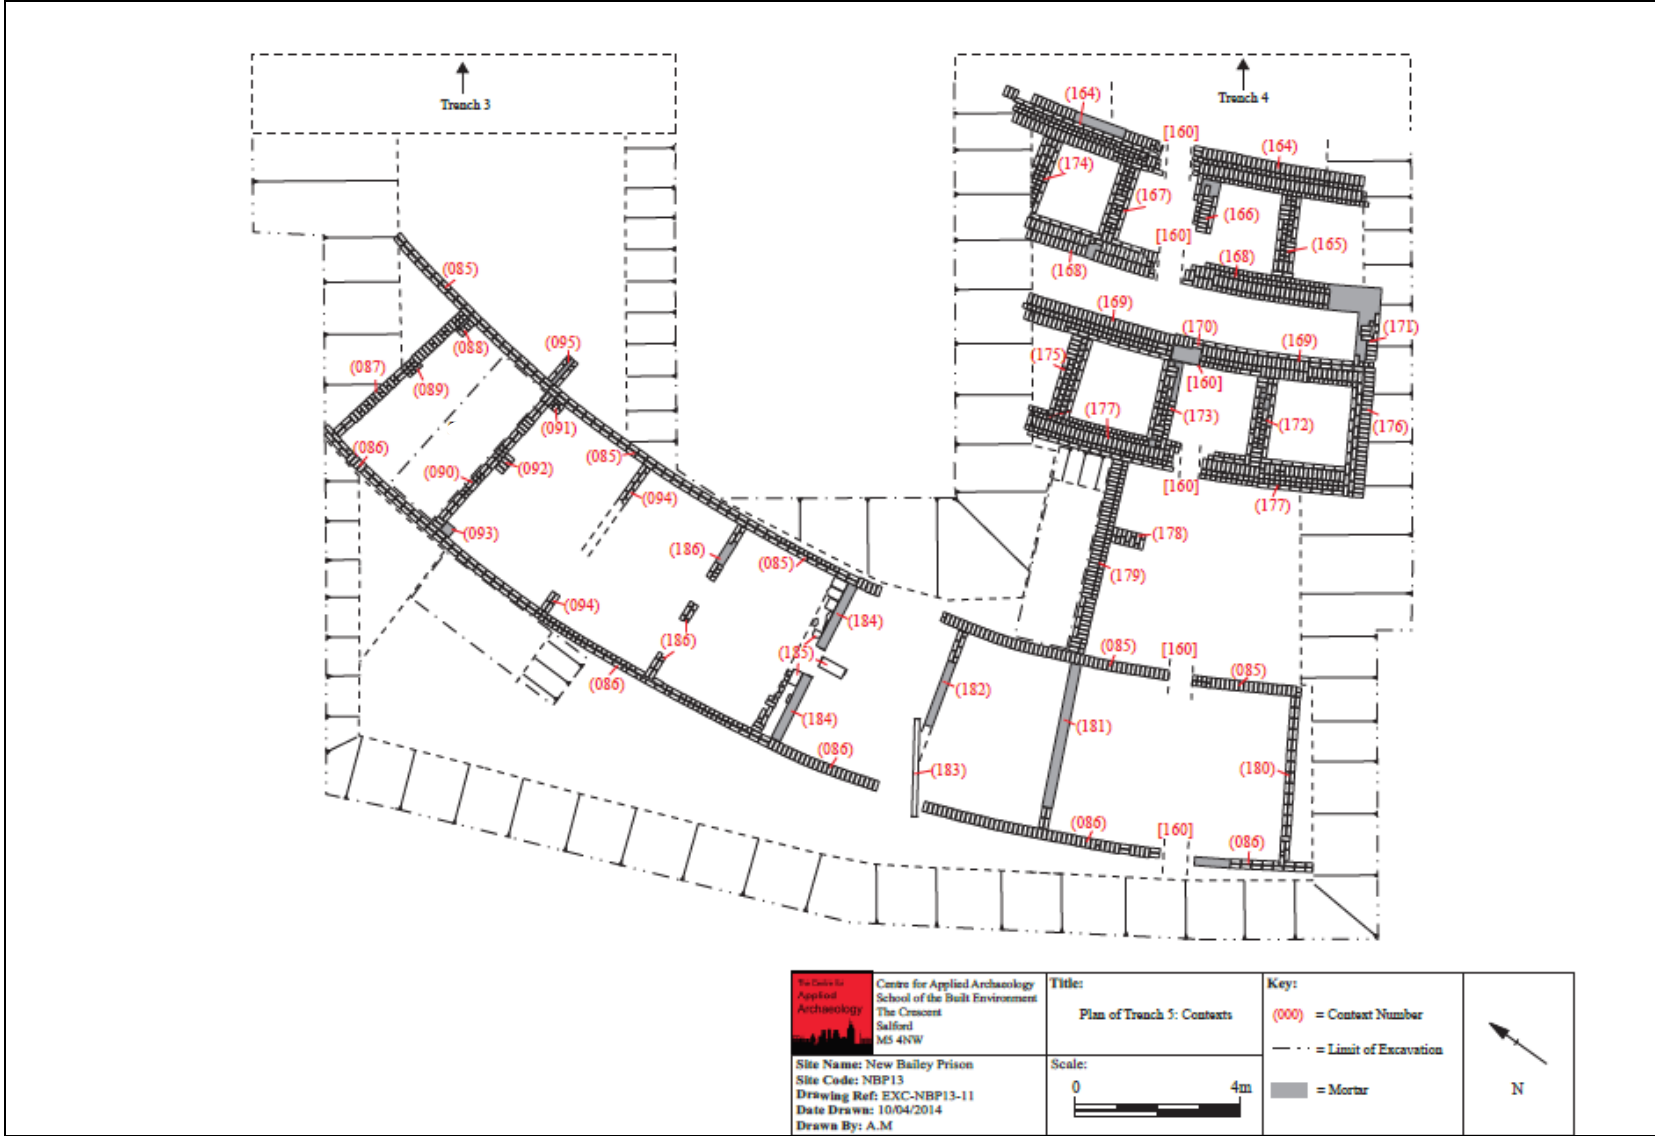
Fig. 70 Plan of Trench 5 showing features excavated

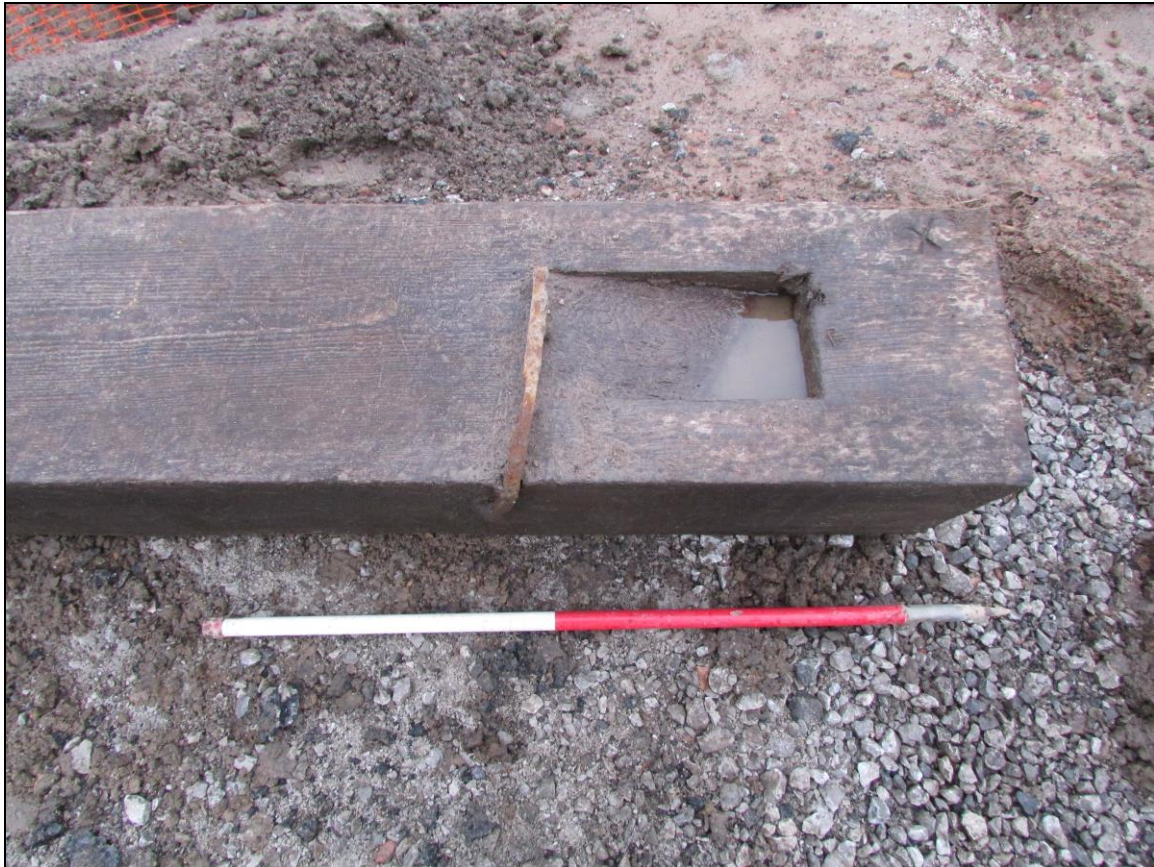
Fig. 75 The NE-SW timber showing the iron bracket, as well as markings carved into the timber

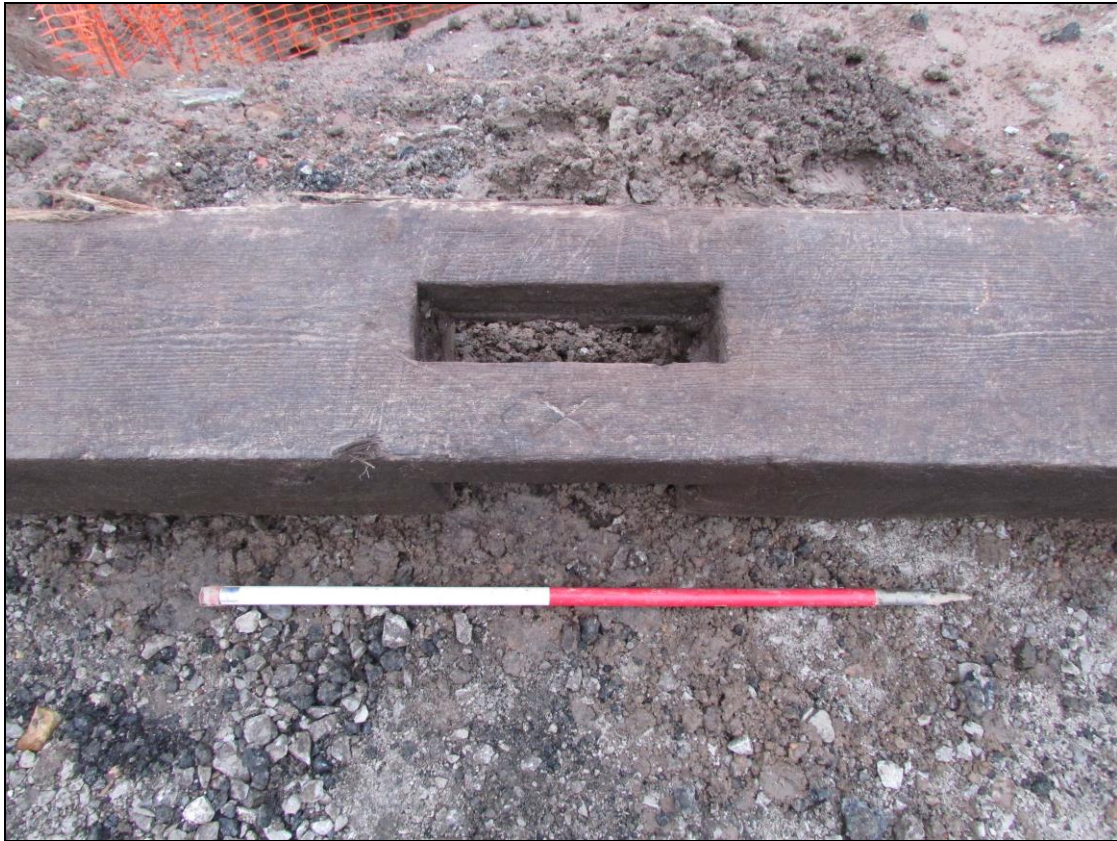
Fig. 76 NE-SW timber: central groove with cross marking below
