**Archaeological
Evaluation:**

Land off Stanley
Street, Central
Salford: Plot B4
(New Bailey
Prison)

Client: English
Cities Fund

Report No:
05/2014

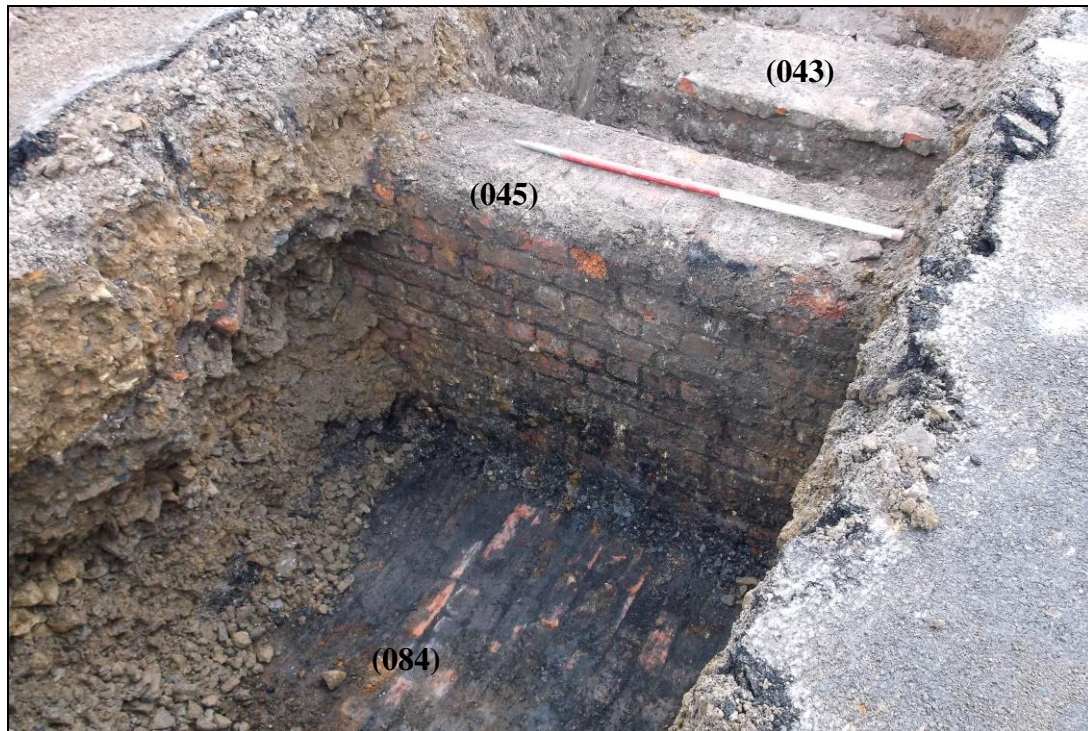
and (046) was **(086)**, which was a handmade brick floor which was stretcher laid and on bed. This was located *c*1.50m below the current ground surface however due to the instability of the section edge, had to be recorded by photograph only and backfilled (see fig. 2).

Fig. 2 Brick flooring (084) associated with wall (045). Note the earlier wall (043) to the rear

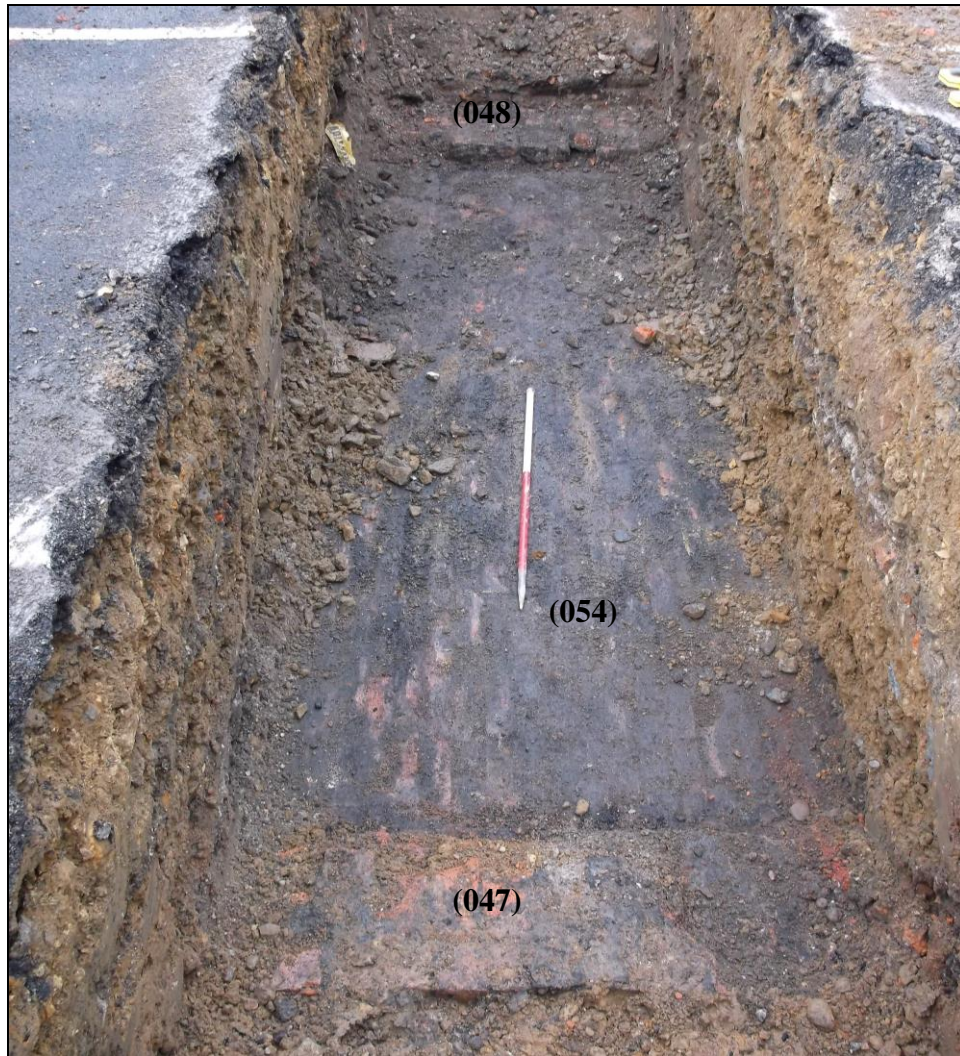
(047) was stratigraphically below (087) and was a handmade brick wall, four courses wide and running NW-SE. This wall only survived to maximum height of 0.35m but appeared to be the same alternating bond as (045) and (046). The foundations were revealed for this wall and it appeared to consist of two individual header courses, each stepped out. Again, due to the depth and section instability, this was only recorded by photograph and backfilled. **(048)** was located *c*4.30m to the NW and was also a handmade brick wall, four courses wide, and orientated NE-SW. This also had a compact dark blackish grey mortar however (048) was in poor condition and only survived to two courses high. Again, due to the depth and section instability, it was recorded by photograph only. (048) was also located at the NW extreme edge of the trench, therefore no infill was visible associated with this wall. Running between (047) and (048) was **(054)**, which was a handmade brick floor, stretcher laid and on bed. Again due to instability issues, this was recorded by photograph only (see fig. 3)

Fig. 3 Walls (047) and (048), with associated flooring (054)

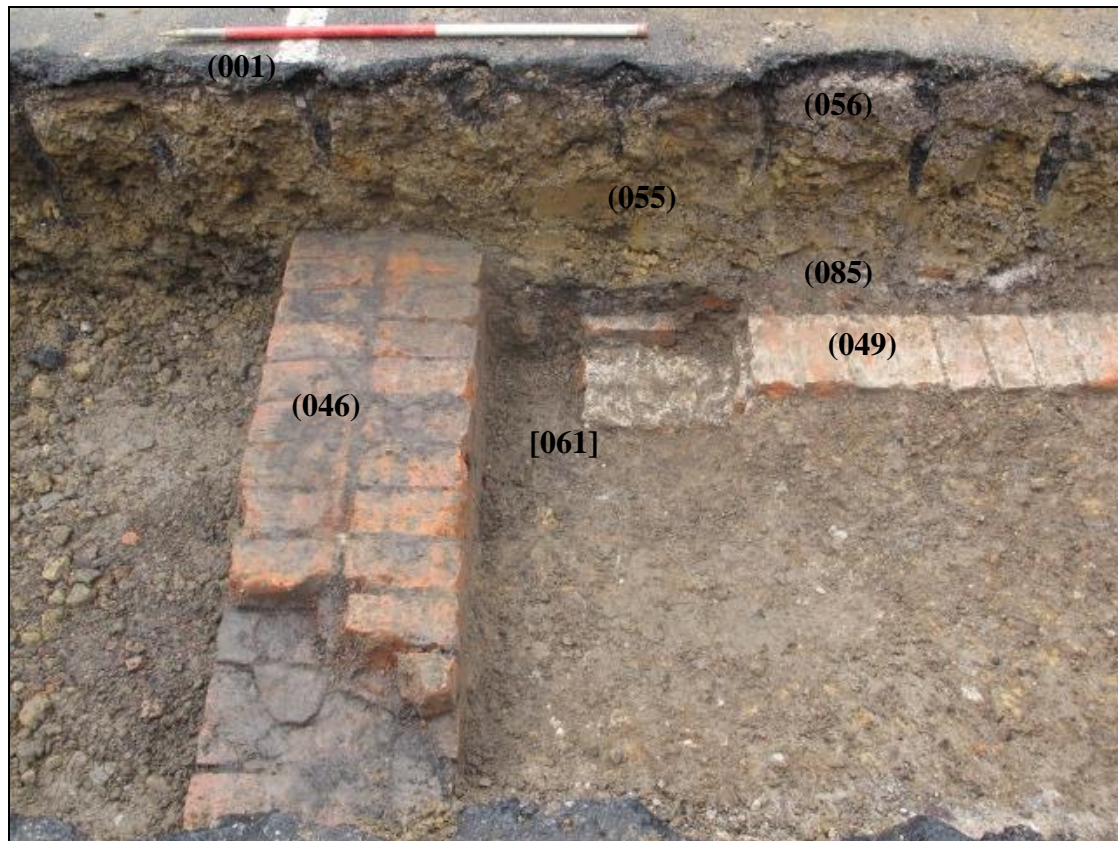
Fig. 4 Wall (046), within [061], which had truncated wall (049)

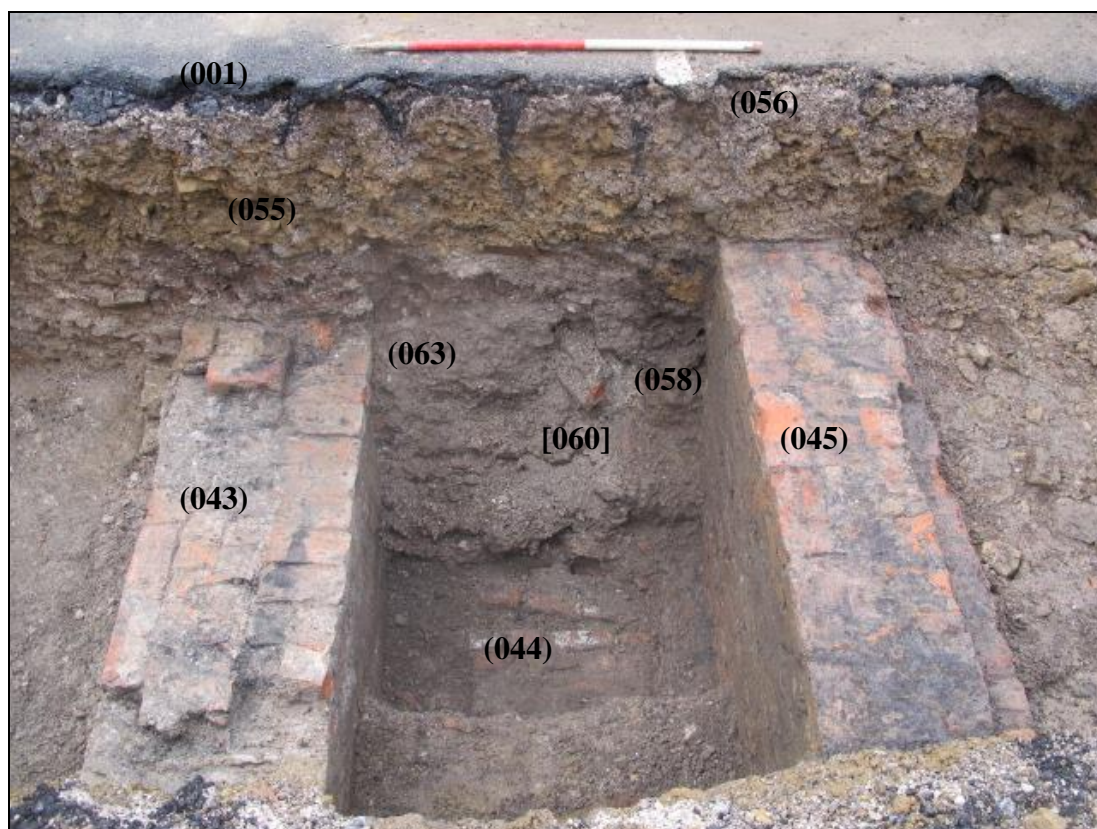
At the SE end of the trench and broadly contemporary with (049), (051) and (052) was **(043)**. This was a handmade brick wall, five courses wide, running NE-SW and visible for 1.70m in length and excavated to c1m deep. The bonding appeared to be fairly regular however it was obscured by what appeared to be remnants of plaster on the NW face. This wall was sealed by **(063)**, which was a loose light whitish grey silty sand with rare small (>0.05m) angular stones. There were abundant mortar fragments, as well as varying sizes of rare brick fragments and large fragments of stone flags were visible lower down within this deposit. A timber sleeper was also present. (063) also sealed **(044)**, which was a handmade brick surface, stretcher laid and on edge. This appeared to have been truncated by (043), although it is possible that they are broadly contemporary (see fig. 5). At the SE extreme of the trench and only surviving in the NE facing section was **(042)**, which was a handmade brick wall, two courses wide and appeared to run NE-SW although this was badly truncated. The mortar again was compact and light whitish grey in colour. (042) was stratigraphically above **(079)**, a very loose light yellowish brown silty sand with no inclusions noted. This was the lowest observed deposit within this area.

Fig. 5 Wall (043) appears to truncate (044) but they may be contemporary. Wall (045) is a later construction

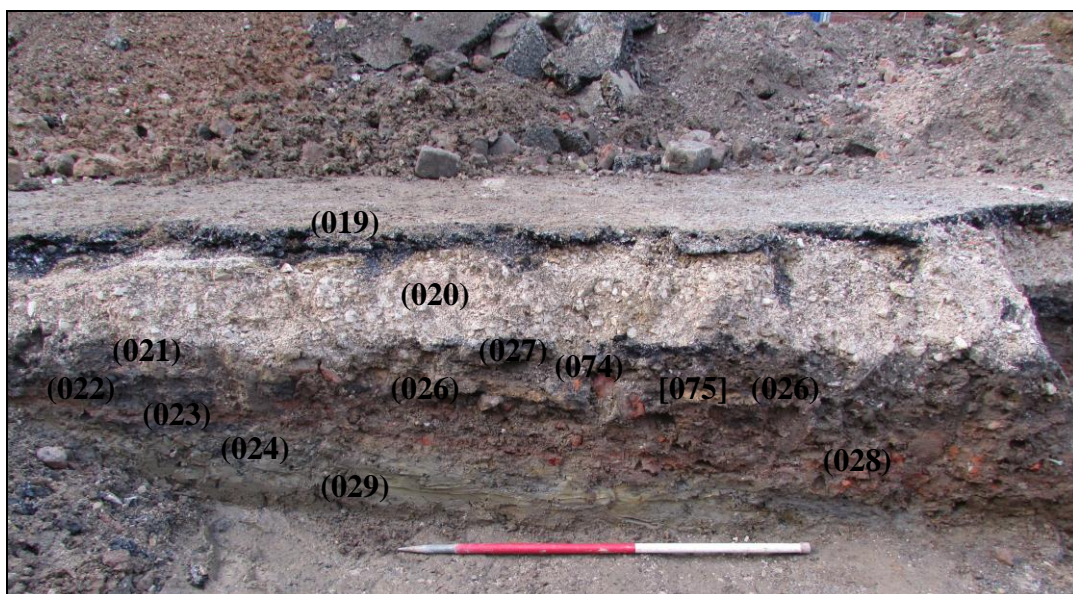
Fig. 6 NE facing section within the SE part of the northern trench

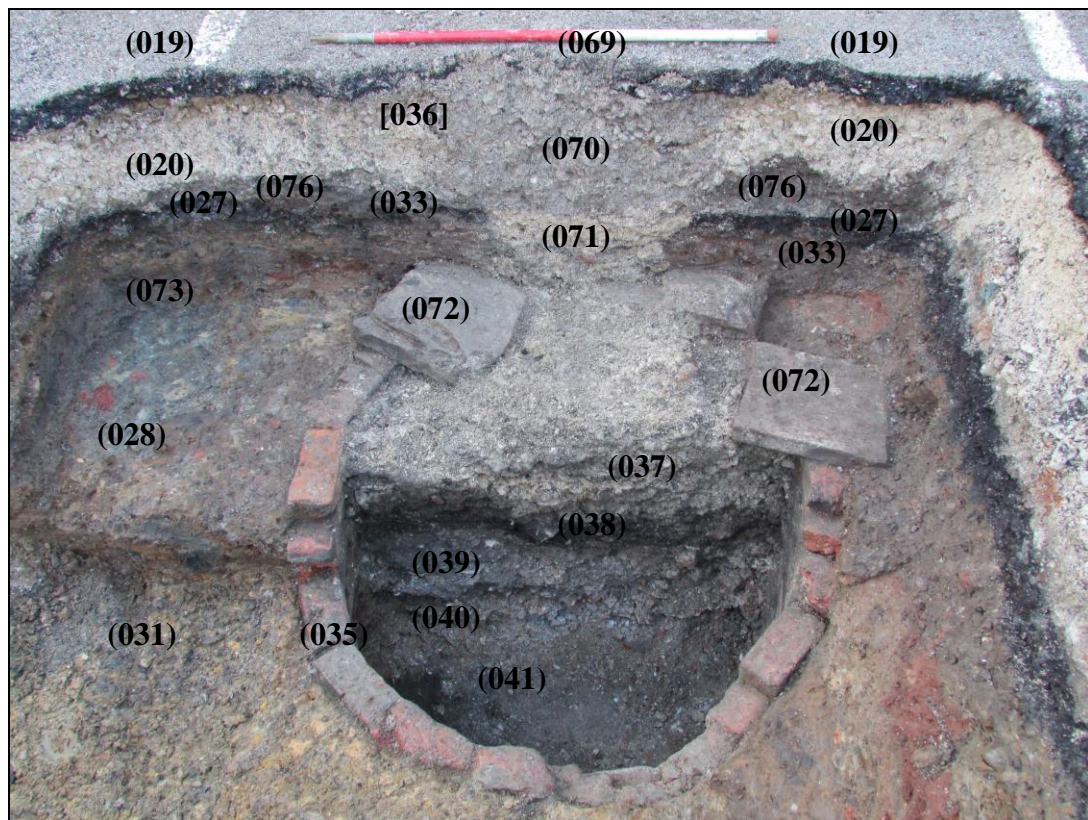
The deposits below (072) described above were the infill of **(035)**, which was a handmade brick circular feature (bricks measuring 0.23 x 0.11 x 0.07m), one course wide and laid in stretcher bond. This was excavated to a depth of 1.05m however due to depth and space issues, the full depth was not excavated (see fig. 6). (035) lay stratigraphically above **[034]**, which was also infilled by (032) and (033). This was an almost vertical sided cut only visible to the south of (035) and visible for a depth of 0.23m. This appeared to be the cut for (035). This in turn lay stratigraphically above **(028)**, which was a fairly compact dark reddish brown silty clay with rare small (>0.05m) angular stones and measuring up to 0.25m in depth. This deposit also contained frequent small brick fragments and whole bricks also. (028) lay stratigraphically above **(031)**, which was a fairly loose mid orangish brown sandy silt with frequent small (>0.05m) sub-rounded stones and measuring up to 0.14m in thickness. This was stratigraphically above **[025]** which was a broadly U-shaped cut with a relatively steep c25° slope before rounding off to a gently sloping and fairly uneven base. (026) was the uppermost deposit within this cut and the depth was up to 0.60m.

Fig. 7 Structure (035) and NE facing section of the northern part of Trench F

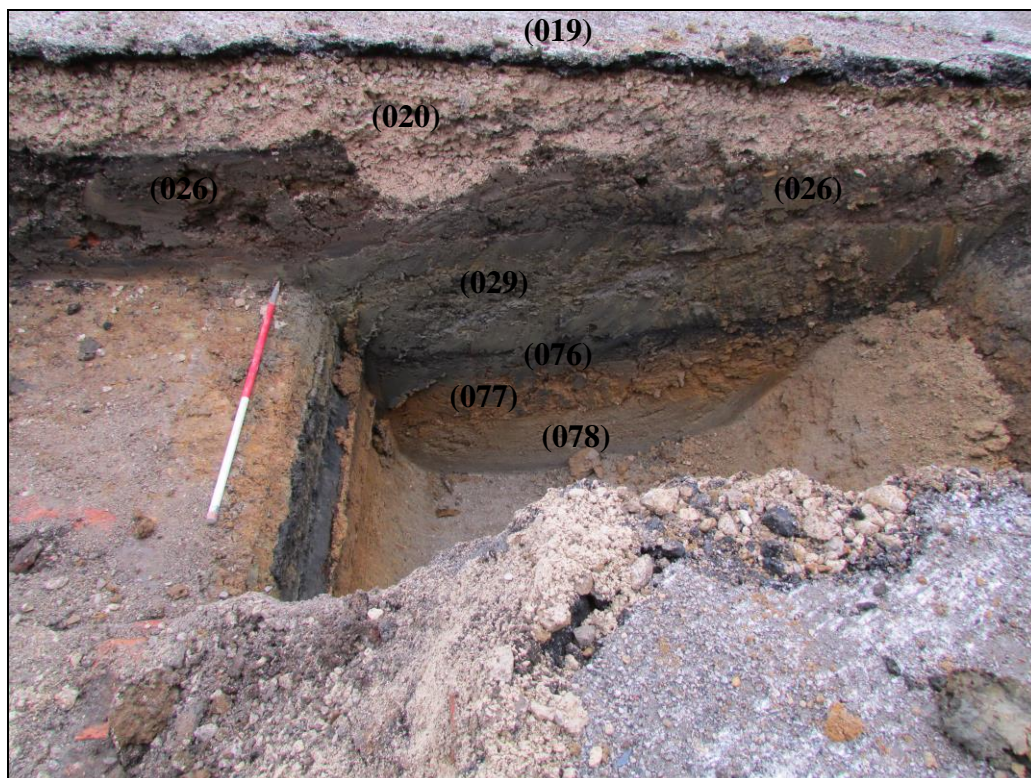
The following layers were revealed during a sondage and backfilled due to the depth. Stratigraphically below **(029)** was **(076)**, which was a compact dark bluish grey silty clay with rare small (>0.05m) sub-rounded pebbles and measuring up to 0.30m thick. **(076)** lay stratigraphically above **(077)**, which was a mid orangish brown clayey sand with frequent small (>0.05m) sub rounded pebbles and measured up to 0.25m in thickness. **(077)** in turn lay above **(078)** which was a fairly loose light bluish grey silty sand with abundant inclusions of small (>0.05m) rounded pebbles. This was interpreted as natural river gravels and at 1.90m below the current ground surface, was the lowest observed deposit within this trench.

Fig. 8 Sondage through lower deposits of trench to reveal natural geology c2m below the current ground surface

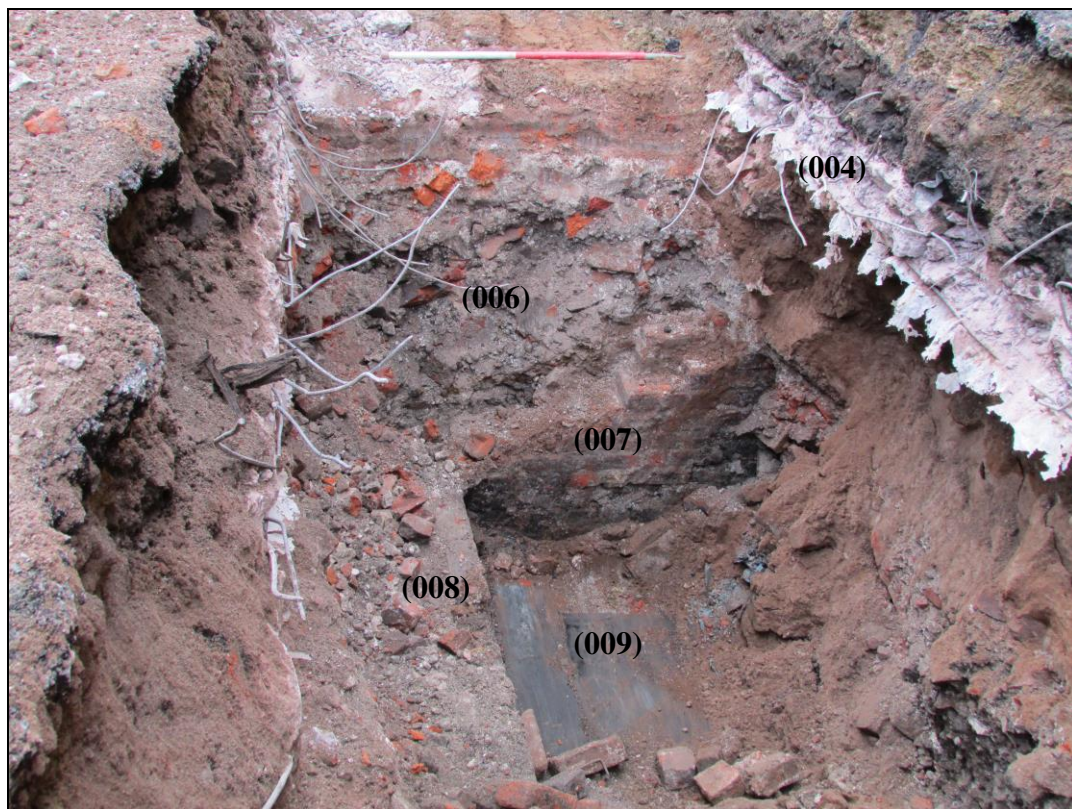
7.50m in length, at the southern end of the trench. Approximately 3.50m from the southern end of the trench was **(005)**, which appeared to be a handmade brick surface with bricks laid on bed, measuring 0.23 x 0.11 x 0.07m. It was only visible within an area measuring 1.00 x 0.40m and was laid directly onto **(006)**, which was a very loose dark brownish grey silty sand with frequent inclusions of deliberately deposited large architectural fragments of stone, including a possible keystone for an arch. There was abundant handmade brick within this deposit as well. This sealed **(007)**, which was a handmade brick wall, two courses wide and running NE-SW. Due to the depth and instability of the section edges, the bonding could not be ascertained, however it survived to a maximum of seven courses high and measured 1.50m in length. **(007)** also appeared to have traces of plaster on the wall (see fig. 2). Running adjacent to **(007)** was **(008)**, which was also a handmade brick wall, 2 courses wide and running NW-SE. Again due to the depth, the bonding could not be ascertained. The wall however survived to a maximum of three courses high and was visible for 0.80m. Both **(007)** and **(008)** appeared to be bonded with a loose white coloured mortar but depth issues meant this could not be confirmed for definite. **(007)** and **(008)** defined **(009)**, which appeared to be a stone flag floor with flags measuring up to 0.50m in length and width. **(007)**, **(008)** and **(009)** survived at a depth of c.2m but due to the depth and instability of the upper deposits, this area was recorded by photograph only and backfilled (see fig.9).

Fig. 9 Walls **(007)**, **(008)** and floor **(009)** c2m below current ground surface

Walls belonging to the radial building, part of the misdemeanant wards were identified, including (015) which may have had circular windows, as well as (016) and (018). (015) appeared to be constructed directly onto the natural geology, with very little evidence for any cuts. The foundations appeared to have been strengthened with redeposited clay (014). A subterranean level to the prison was also positively identified, with walls (007) and (008) and floor (009) in a fair state of preservation.

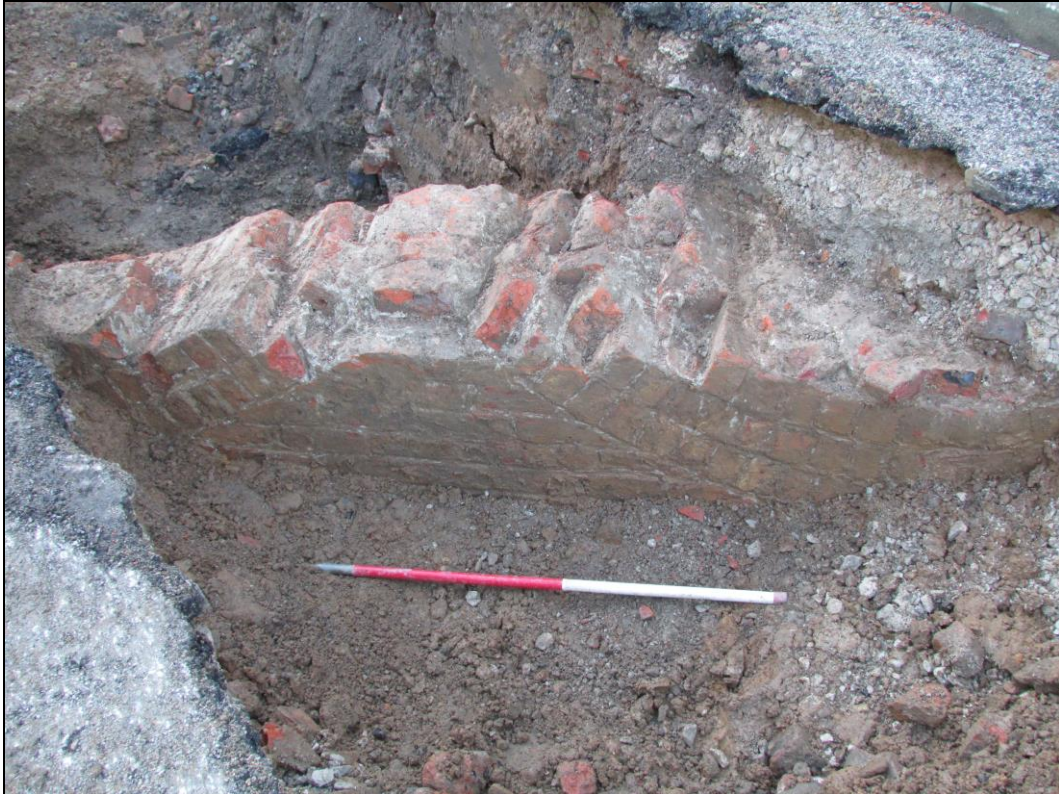
(014) lay stratigraphically above (015), which was a handmade brick wall, 5 courses wide, running E-W. The bond was mostly a regular stretcher bond, with one row of headers visible. The foundation consisted of a three courses which stepped out on each course with the upper two courses stretcher. The lower course consisted of headers laid on bed and on side. Partially visible also were two possible curved window bases which were three courses thick and were defined with header laid bricks. (014) also appears to seal (016), although this was not physically related to (015). (016) was a handmade brick wall, which was a minimum of two courses wide and appeared to be a two stretcher/one header bond although only six courses high was excavated. This ran N-S and was only visible in the NE facing section at the NW end of this trench. Its excavated limits were 0.23 x 0.65 x 0.45m. To the SE of (015) was (018), which was a handmade brick wall, two courses wide and running E-W. This was only visible in the NE facing section and was badly truncated but was also sealed by (014). These walls were bonded with a fairly loose light whitish grey mortar. (015) and (018) appeared to be built directly onto (017), which was a very compact light yellowish orangish sandy clay with no inclusions noted. This appears to be the natural geology and the lowest observed deposit within this trench, at 1.50m below the current ground surface.

Fig. 10 Wall (015) with possible window bases in the brickwork

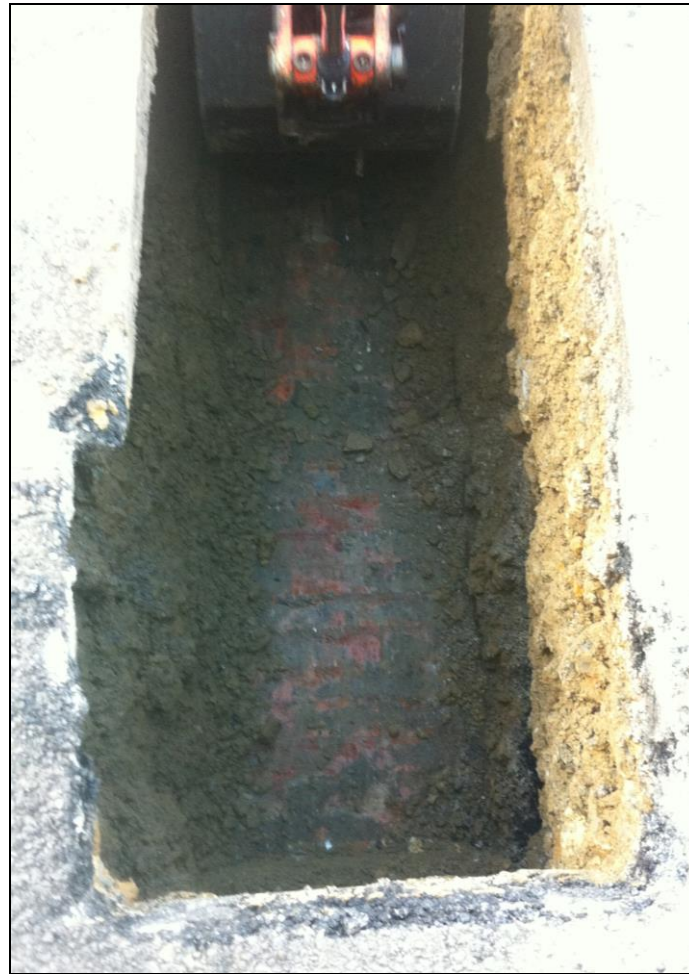
Fig. 11 Brick floor (094)

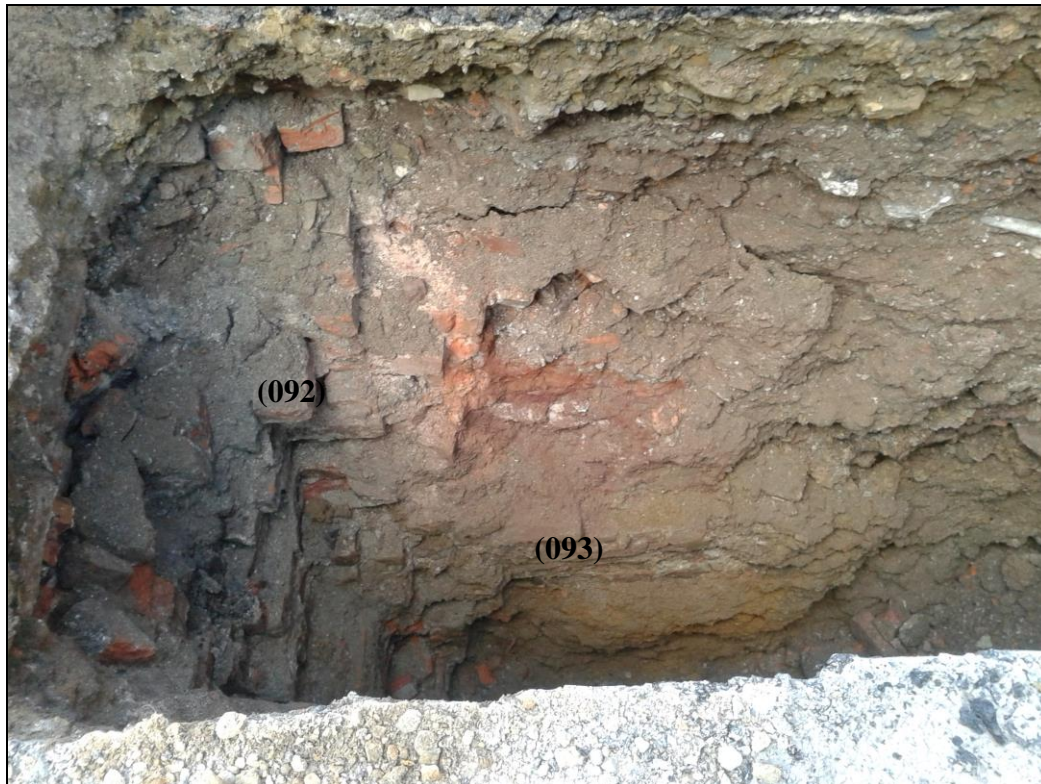
Fig. 12 Truncated walls (092) and (093) revealed in Watching Brief Trench 1

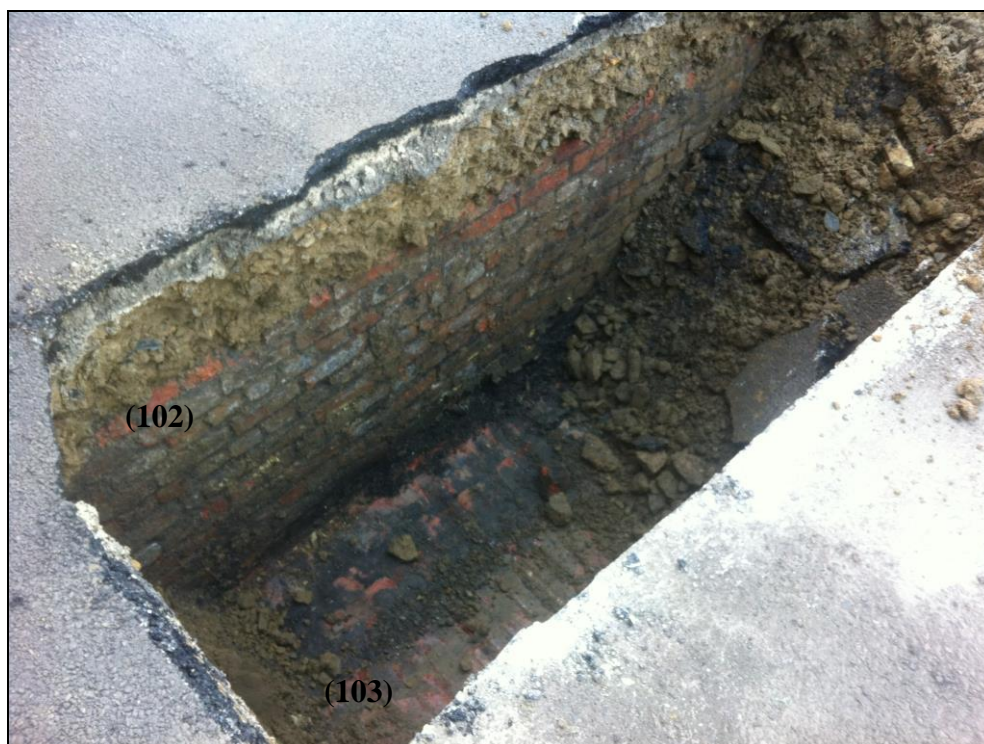
Fig. 13 Handmade brick floor and wall in Trench 2

Trench 2 was located c.14m to the east of Trench 1 measuring 3.30m x 1.20m and orientated northwest-southeast. Wall (102) was identified directly below the hardcore layer (002) lying against demolition layer (095) and was composed of handmade bricks laid in English bond with black mortar. The wall, which formed the western extent of the trench, stood 11 courses high and extended beyond the northwest and southeast limits of excavation. At a depth of 1.50m this wall abutted a handmade brick floor (103) also laid with black mortar and continuing beyond the limit of the trench in all directions. It is believed that these features are a continuation of those identified in the evaluation Trench B. Excavation proceeded through the floor surface to a depth of 2.70m revealing an orange-grey silty sand layer (096) with frequent large (>0.10m) rounded pebble inclusions lying immediately below. This layer contained no inclusions or features.

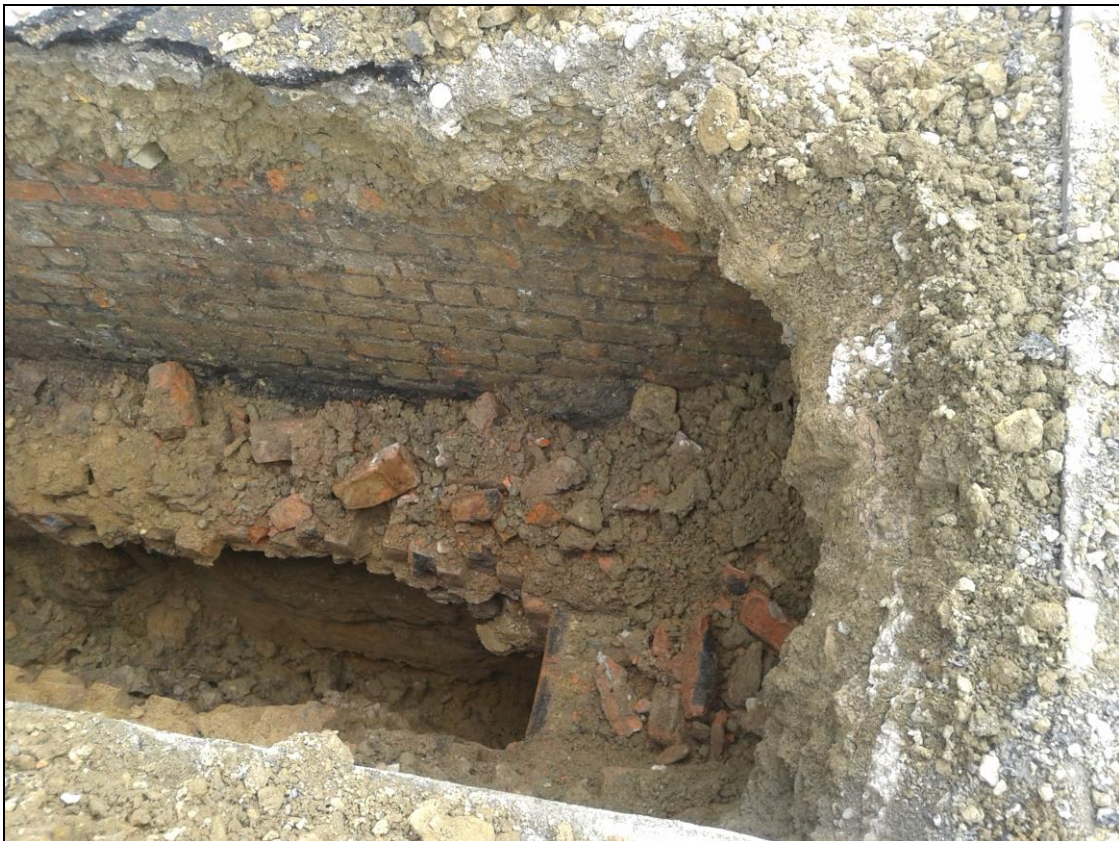
Fig. 14 Deposit (096) below floor (103)

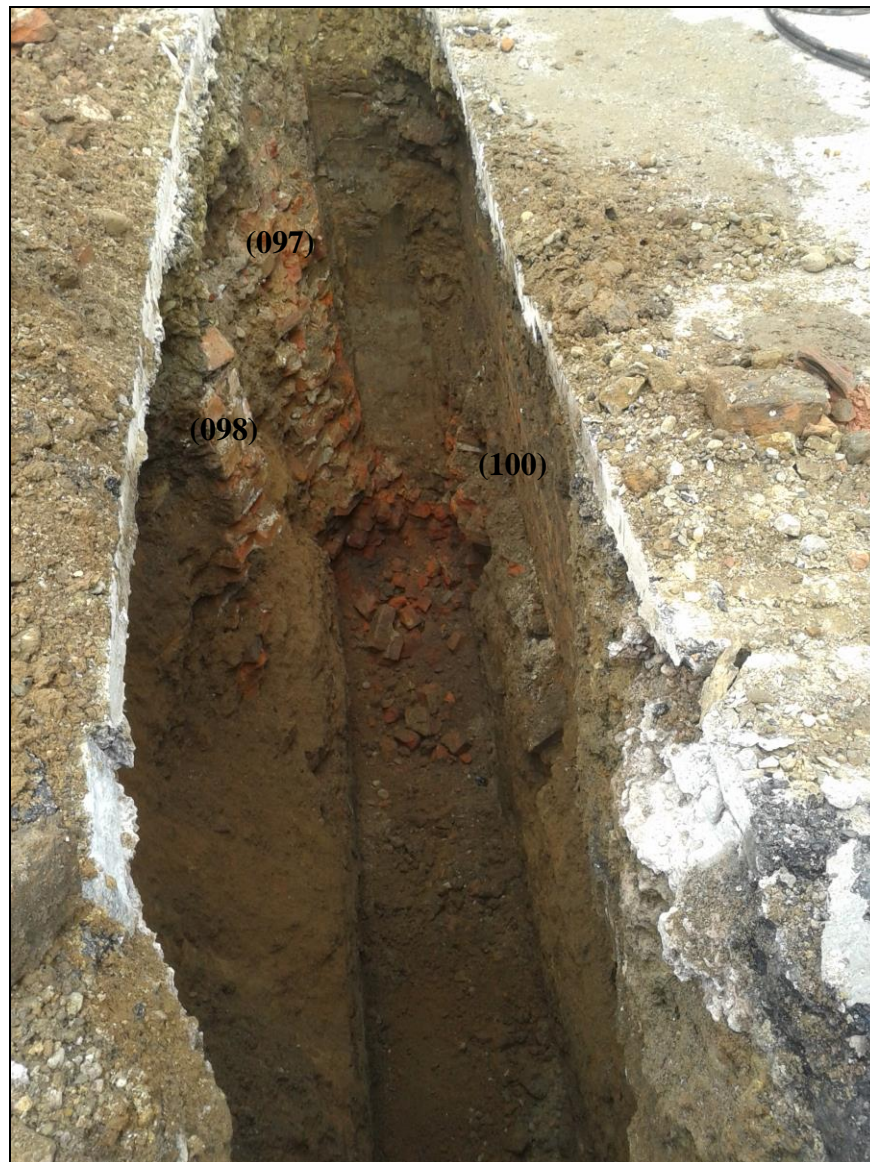
Fig. 15 Wall (100) truncating (097) and (098)

Trench 3 was located *c.*21m to the northeast of Trench 2 measuring 4.90m x 0.76m orientated northwest-southeast. The western extent of the trench was formed by a handmade brick wall **(099)** identical to (102) which was identified directly below (002). This wall lay against a loose sandy demolition layer **(104)** which filled the straight foundation cut **[101]**. This was found to truncate two handmade brick walls, **(097)** to the southeast and **(098)** to the northwest which lay 1.20m apart. Wall (098) was revealed at a depth of 0.36m, was two courses thick bonded with white mortar and stood to a height of 1.64m. Wall (097) was also bonded with white mortar but was found to be 4/5 courses thick (approx.0.80m) and extended the full depth of the trench, 3.20m. At a depth of 2.50m an orange-grey sandy silt was identified which contained no features or inclusions. A fourth brick wall **(100)** was also identified however this was set back *c.*0.50m from the eastern side of the trench and obscured by demolition layer (095).

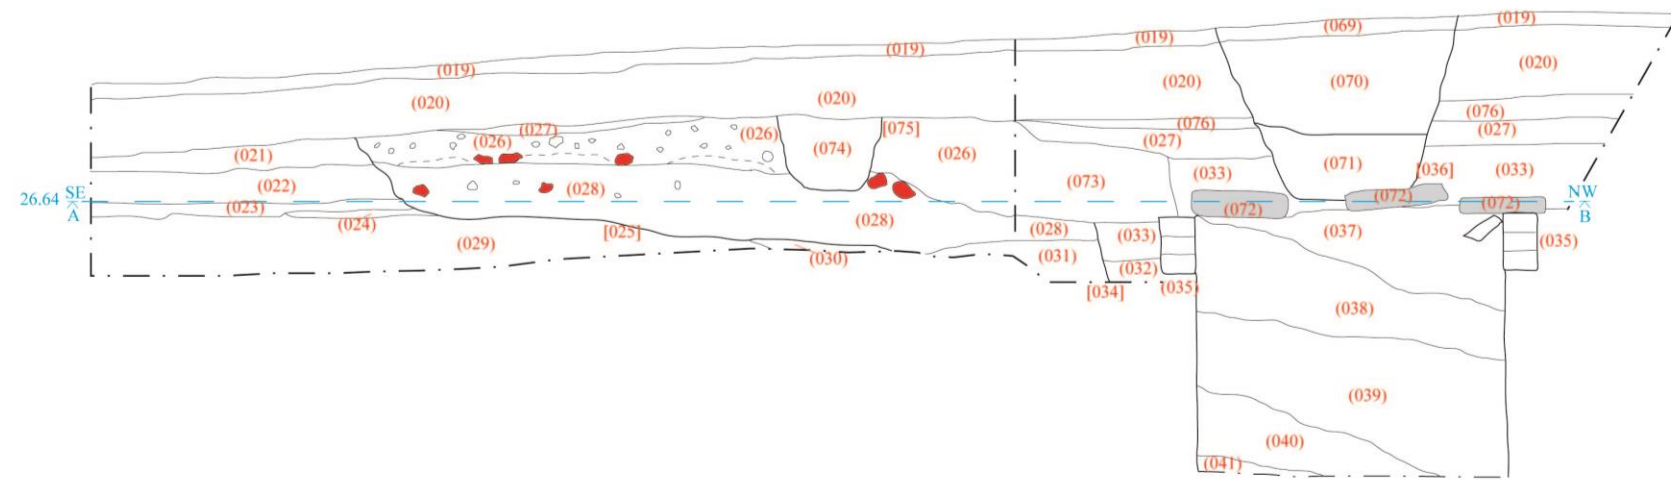
Fig. 21

Trench F: NE Facing Section

Plan of Trench F: Northern Part

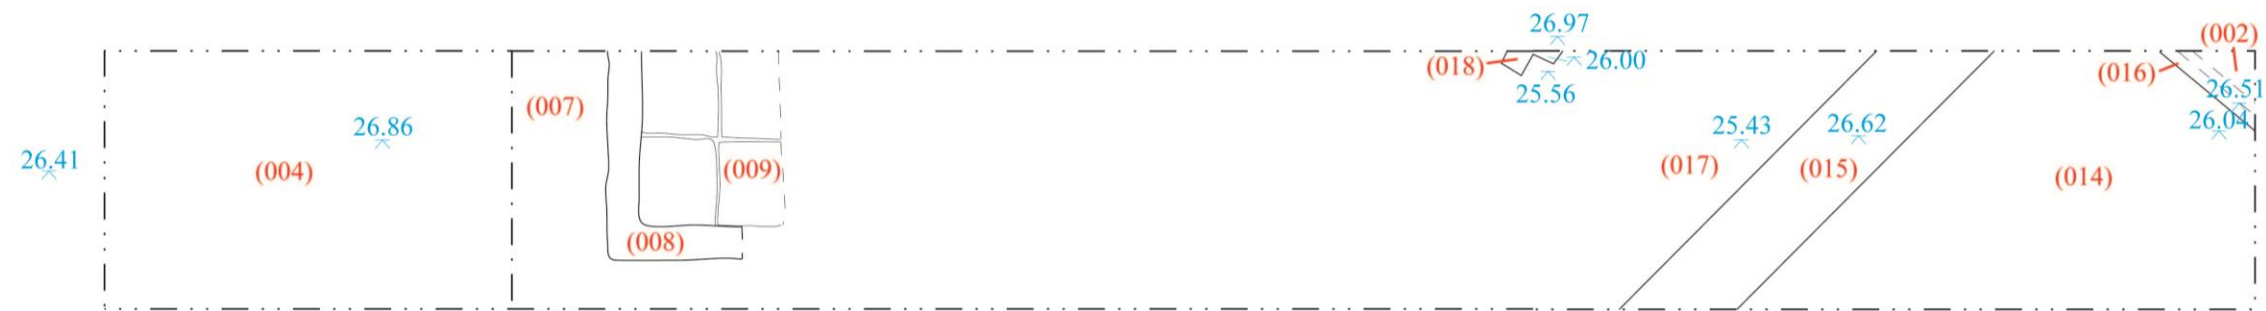
<p>The Centre for Applied Archaeology</p>	<p>Centre for Applied Archaeology School of the Built Environment The Crescent Salford M5 4NW</p>	<p>Title: Southern part of Trench F</p>	<p>Key: (000) = context numbers 00.00 = Height AOD ┌ ┐ = Edge of excavation</p>
