**Archaeological
Evaluation &
Excavation
Report.**

Ellesmere Street,
Hulme, Manchester

Client: De Trafford
Estates Group

Report No: 2014/04

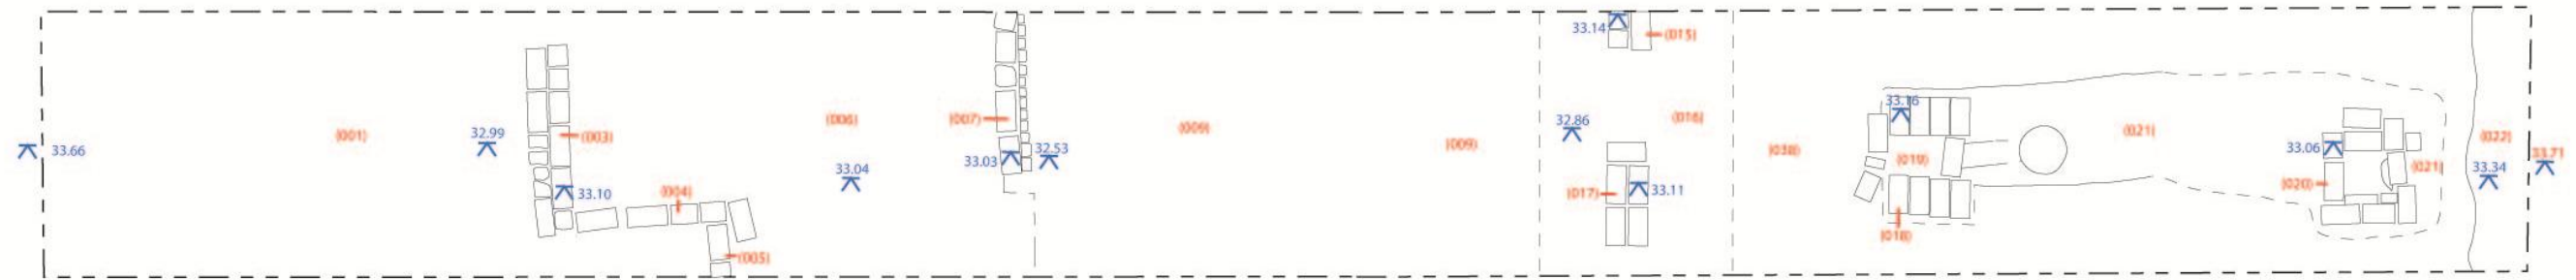
Trench 1

Trench 3

The uppermost deposit within trench 1 was **(001)** a layer of friable dark blackish grey silty clay, with occasional very small >0.01m rounded pebbles and frequent very small >0.01m sub-angular stones. This deposit sealed the whole trench and measured up to 0.60m deep in places. This lay stratigraphically above **(002)**, which was a friable mid brownish grey silty clay with frequent medium – large 0.10 – 0.23m fragmented bricks. This was visible for 11.50m in length and was not observed within the SE extreme of the trench and measured 0.15m in depth.

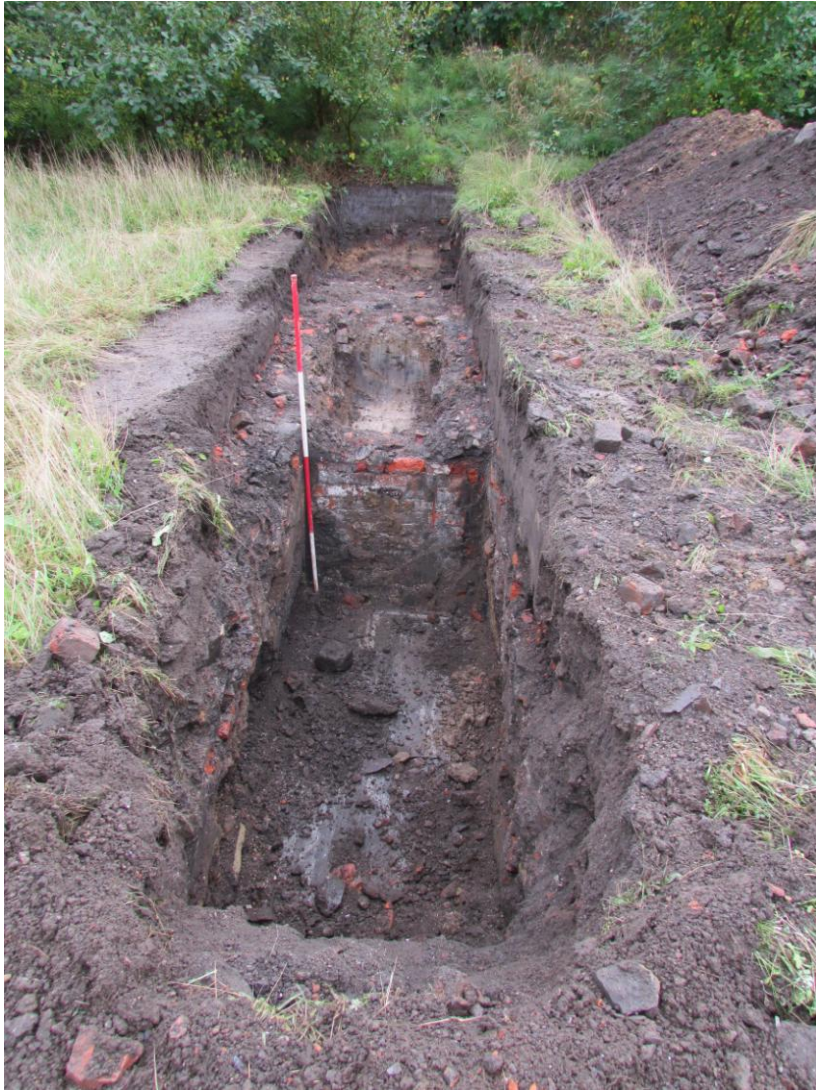
Figure 10. Trench 2 showing the concrete floor of cellar, with an internal view of the outer wall of the housing. Looking South.

Wall (042) appears to form the southern external wall of the terraced housing; its orientation of east-west would suggest that this was the back wall of a house which fronted onto Cawdor Street. Walls (043), (044) and (053) extended south beyond (042) suggesting that they relate to the small 'cells' at the back of the housing which can be seen on the historic mapping. No pipes were found that would suggest there was a toilet in the vicinity, these wall may therefore be dividing walls between the 'cells' or yards. The cut for the wall (043) was visible [045] and was infilled with (046). Contemporary with these walls was (055) the concrete floor of the cellar which appeared to be intact and relatively good condition.

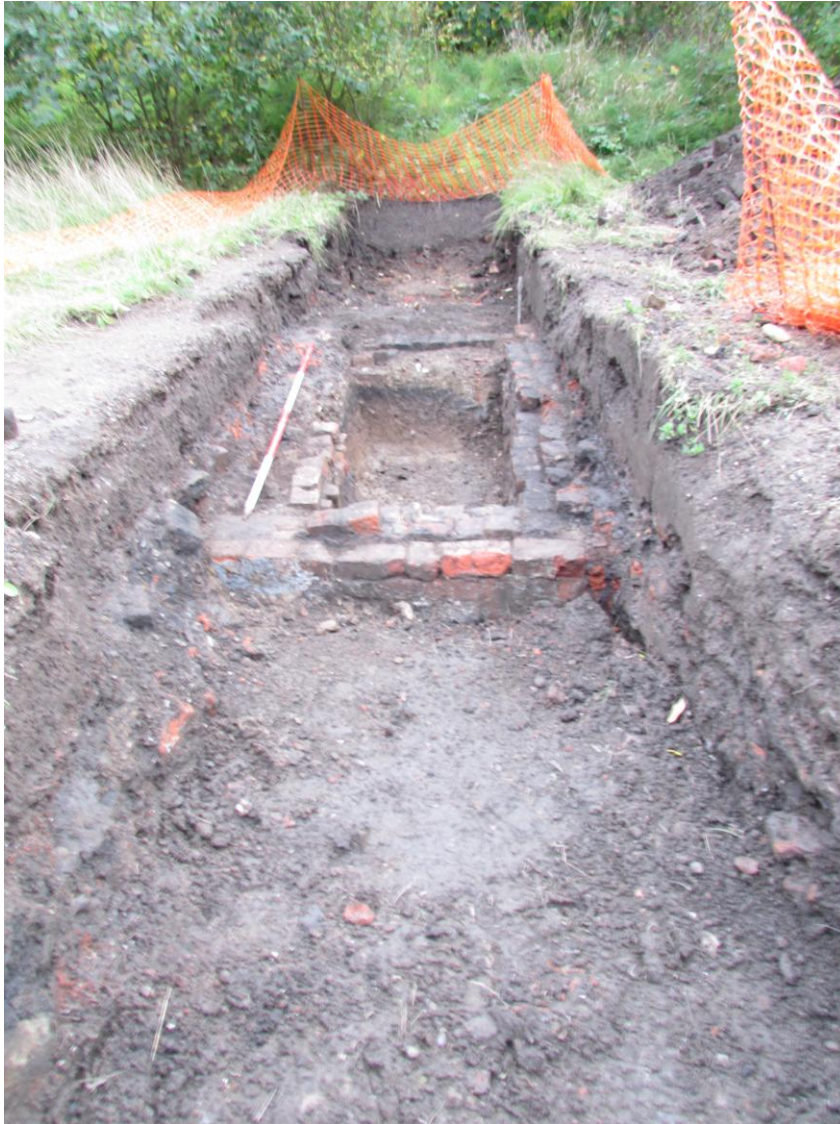
Figure 11. Trench 2, the cellar has been filled in, in the foreground, showing the relationship of the walls (042), (043) and (044).

[045] was the foundation cut for wall (042) and (043) located to the south of (041) in the middle of the trench. (042) was orientated east-west across the width of the trench and butted up against (041), was a 3 course handmade brick wall, on the north face of the wall was an area of blue paint, held together with black mortar the top courses were very damaged. This was associated at its western end with (043) again a 3 course handmade brick wall which was orientated north-south (**Figure 11**).

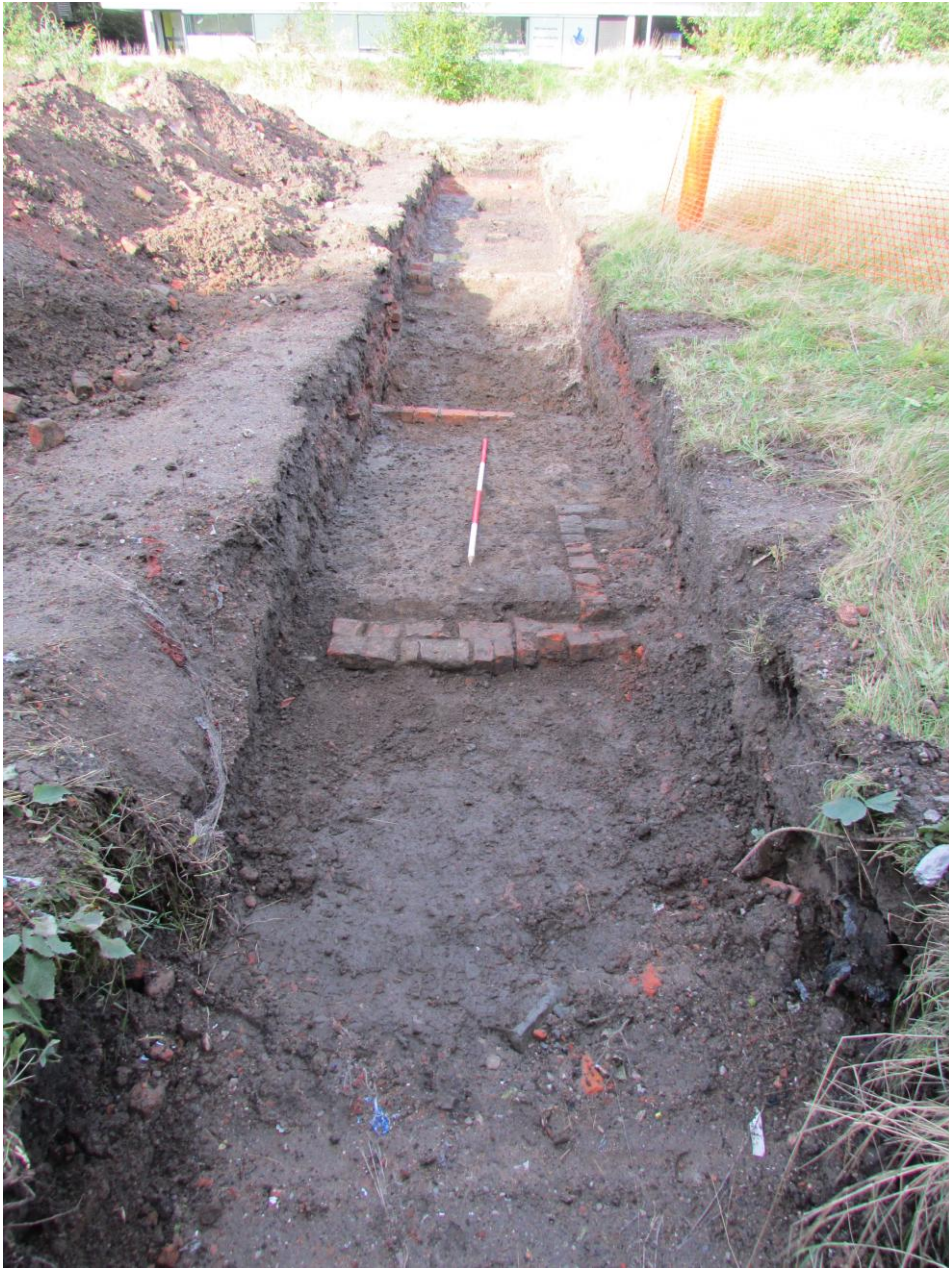
Figure 12. Trench 1, showing walls (003), (004) and (005), looking northwest.

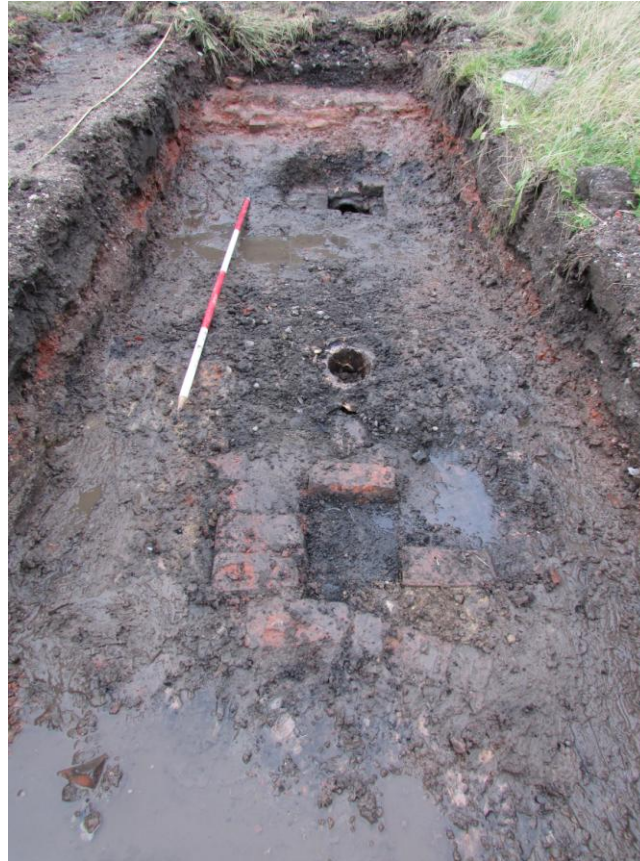
Figure 13. Trench 1, showing (018) and (019) looking towards (020). Looking NW

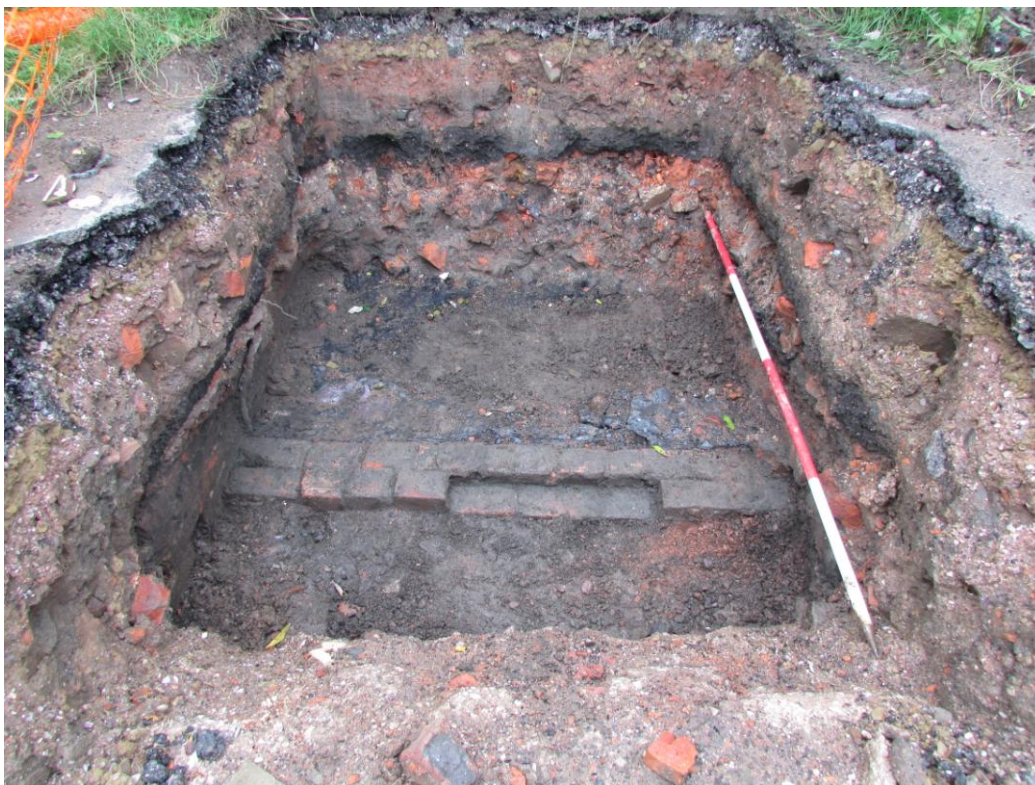
Figure 14. Trench 3 showing (028) the wall and (029) possible bitumen floor. Looking N

At the northern extent of the trench beyond (028) lay **(029)** a bitumen like substance which is a possible floor for (027) and (028), the bitumen was overlaying **(030)**. (030) a dark brownish grey silty clay which was located in the far NW corner of the trench was also the lowest deposit within this area; a section of this measuring c.0.45m in width was also found on the southern side of (028) butted up against it **(Figure 14)**.

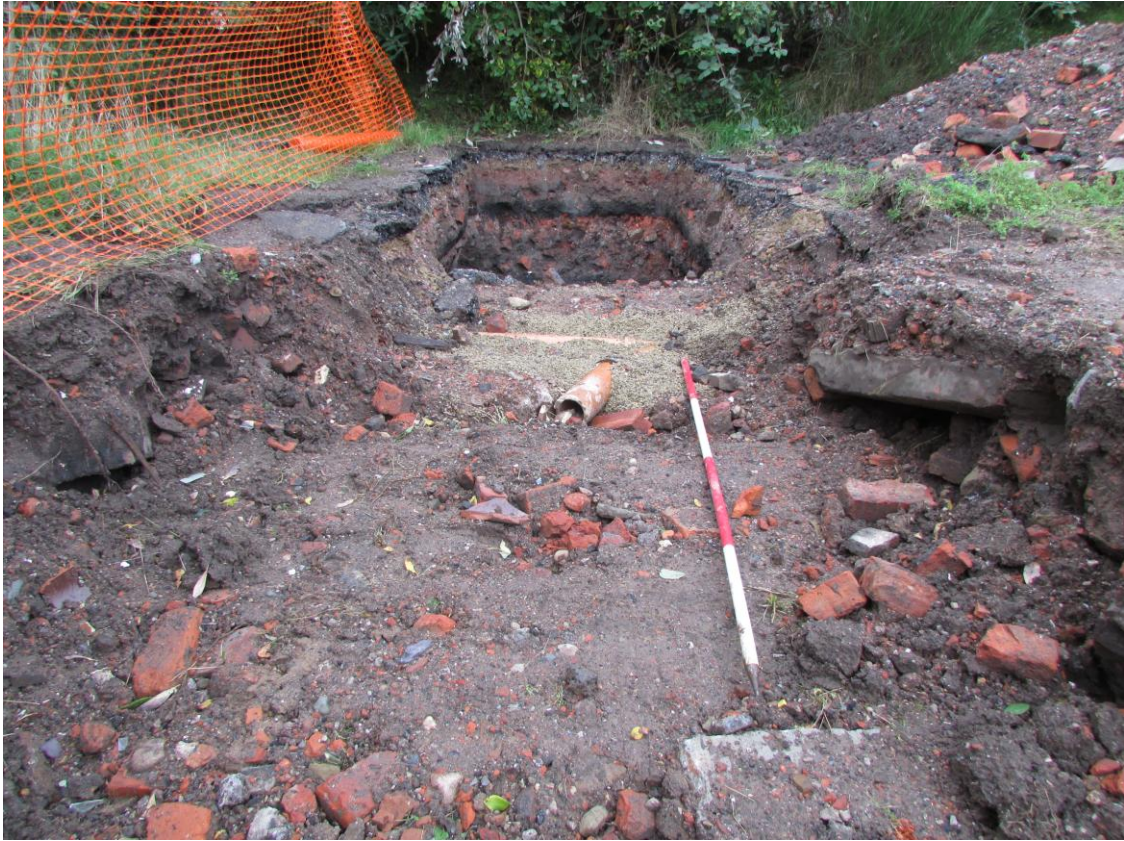
Figure 15. Trench 3, showing modern disturbance, Looking North

To the south of (028) & (030) there is disturbance for c.2.50m of modern services which had been infilled with stone chippings and was found to be sitting on a concrete block. Between this and **(032)** could be found **(040)** a mid brownish grey silty clay with an abundant number of bricks, again this was most likely modern disturbance relating to the services **(Figure 15)**.

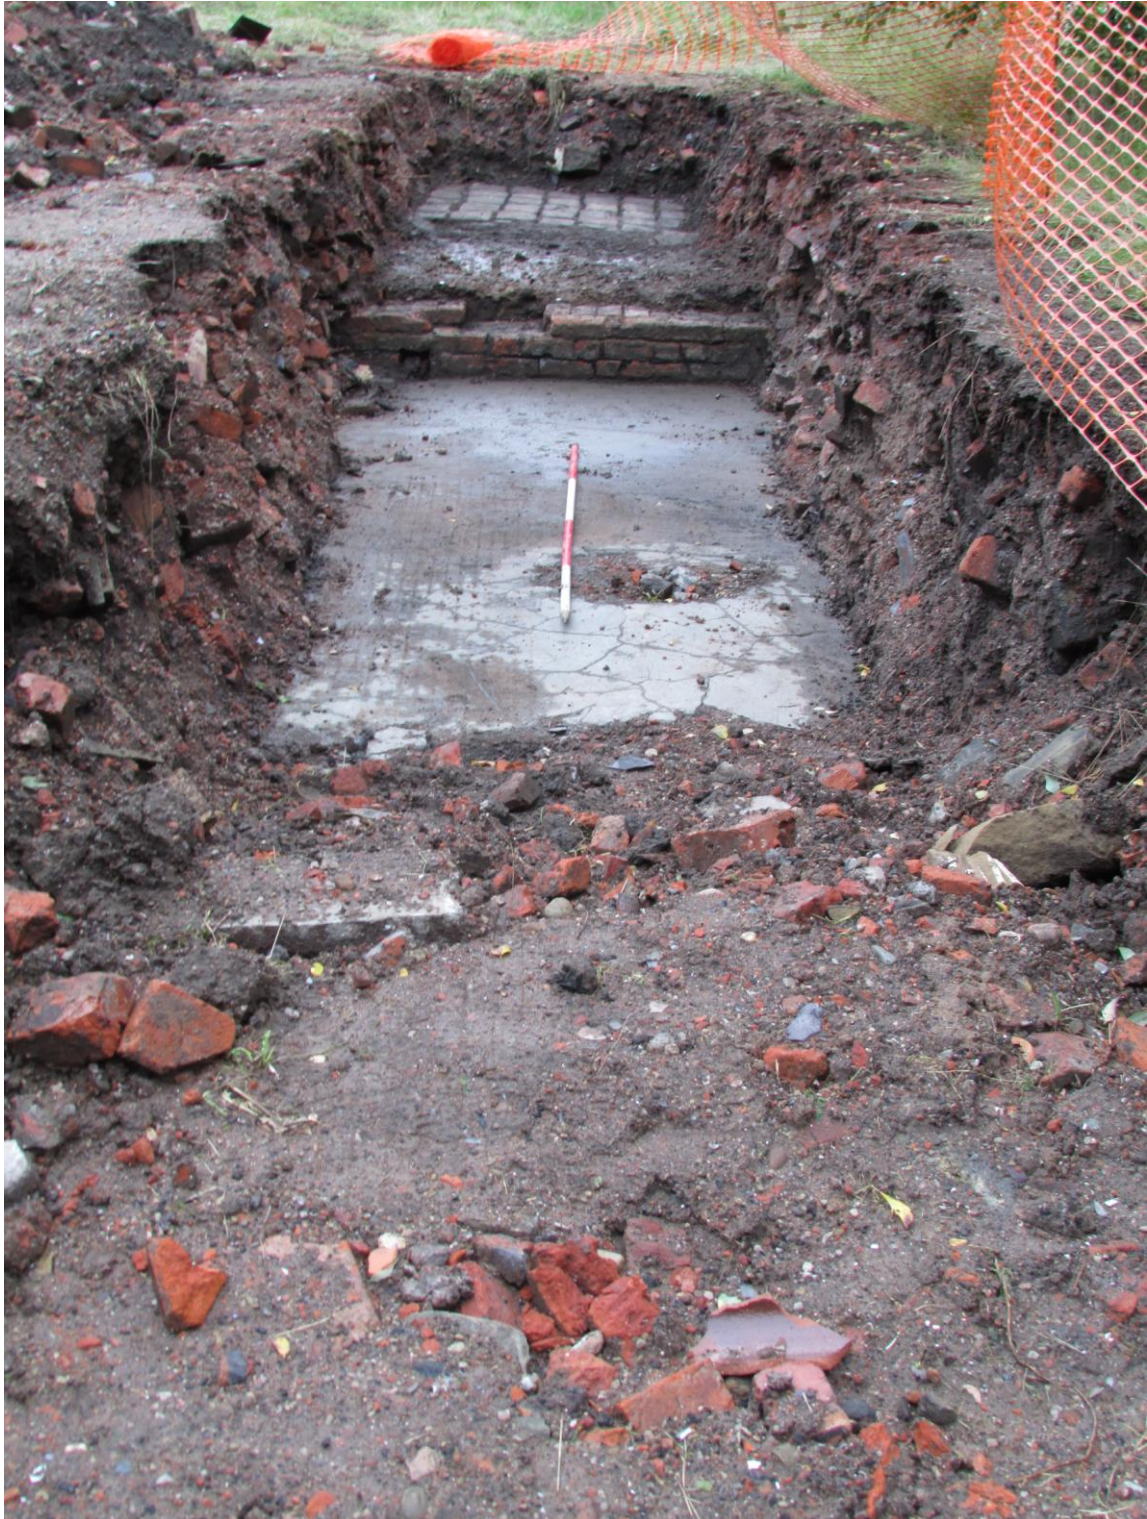
Figure 16. Trench 3, showing the concrete floor of the Brass Foundry and outer wall, with the cobbles of Cawdor Street in the back. Looking South

(031) a light whitish grey sandy silt with an abundant number of bricks and mortar and other building material, sat above (032) and below (031), (032) was the floor surface of the brass foundry uncovered in this area, it ran into both sides of the trench and was c.4m in length where it met **(033)** which sat on top of it. (033) a machine made brick wall 3 courses wide laid in a mixed header and stretcher bond, orientated in a SW-NE direction and sealed by (031) **(Figure 16)**. To the south lay **(037)** mid brownish grey silty clay, possible foundation layer for the pavement. This was boarded to the south by **(036)** the sandstone edging of **(034)** this being the large cobble sets, relating to Cawdor Street, this ran into the trench at the southern end. Finally this was overlaid by **(035)** a dark blackish grey silty clay that sealed (034).

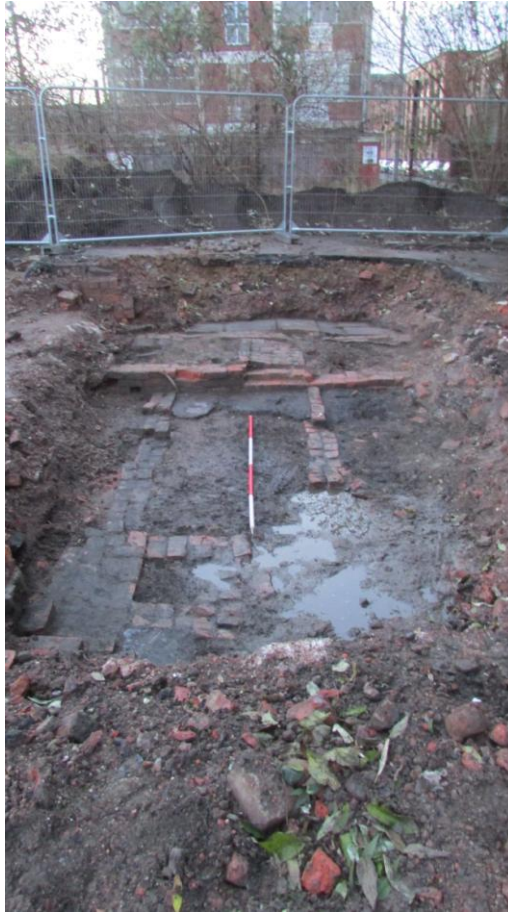
Figure 20. Showing the North-West section. Looking West.

Overlying (**003**) between (**005**) and (**007**) a light grey layer of concrete (**004**) with frequent inclusions of pebbles was identified. (**004**) could also be found to the south of (**006**). Overlying (**004**) was a compacted layer of black-brown silty loam (**008**) with very frequent inclusions of brick, stone, slate and pebbles. (**008**) was identified between (**005**) and (**007**) and to the north of (**006**), (**Figure 20**).

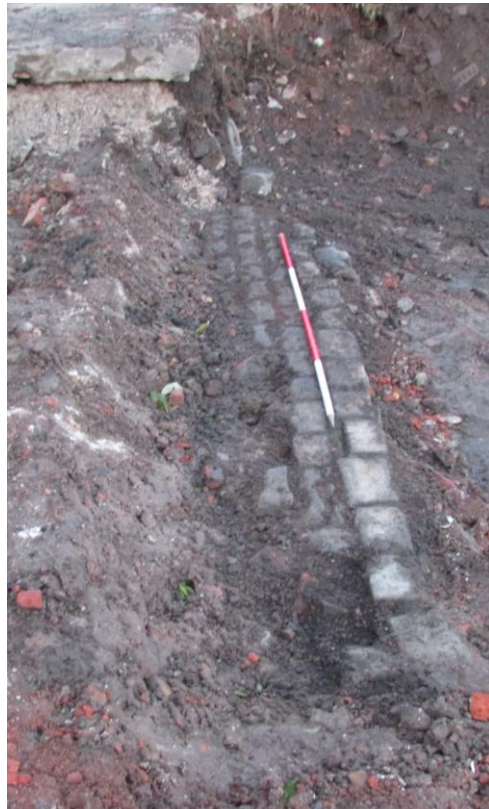
Figure 21, Showing the cobble sets (016) in Area B, looking East.

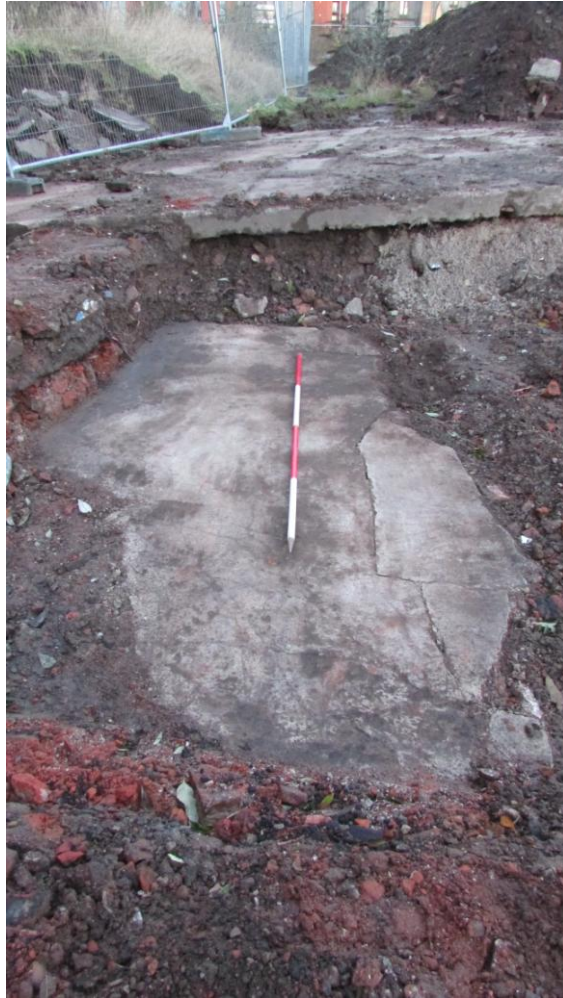
Figure 22, Showing (015) A Concrete floor truncated by modern disturbance located in the North-East corner of Area B.

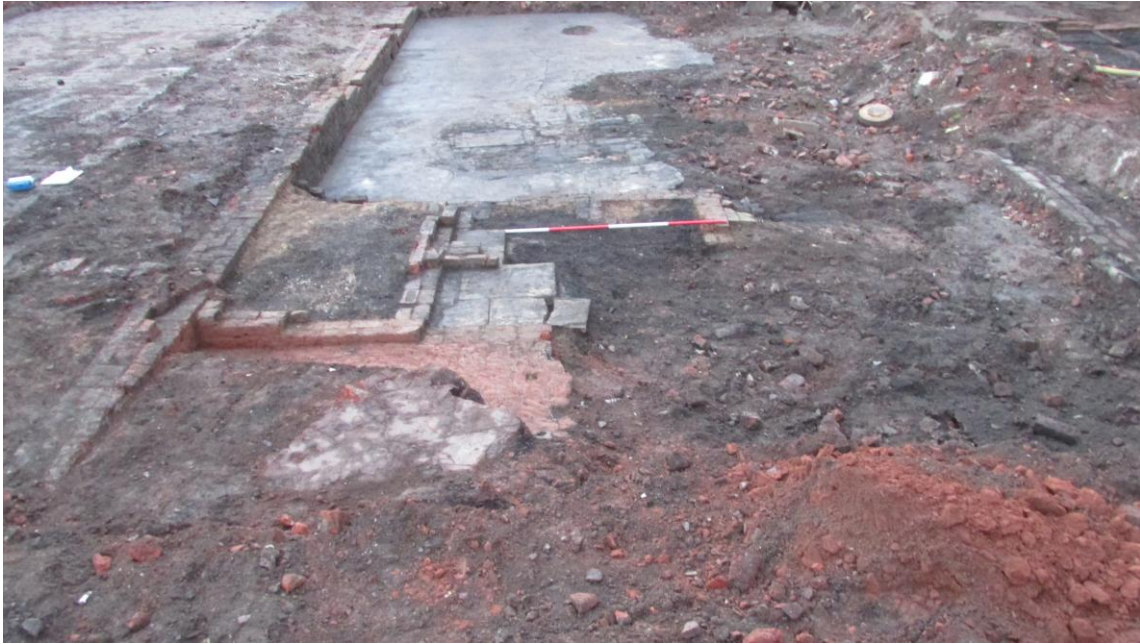
Figure 23, Showing the South-East section of Area B, looking West.

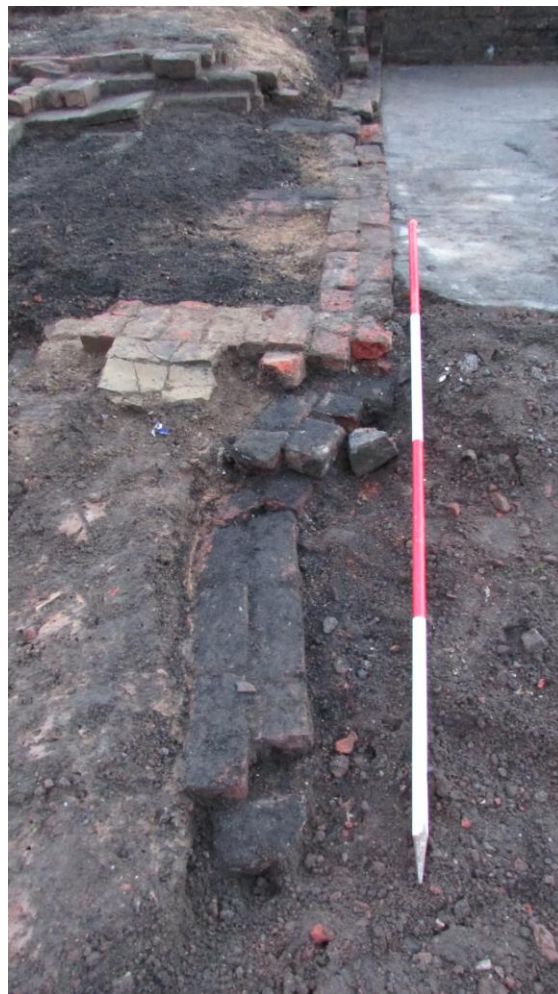
Figure 24, Showing (070). Looking South.

From the continuation of wall (019) two further walls extend north, first (070) which has 3 brick projections that may indicate a fireplace or alcove and sits on top of the concrete floor (018). The other wall attached to (019) was (071) which also ran to the north; this has a wall projecting off it (072), this is associated with (073) a number of flagstones which suggest there was a floor surface at this level, this has again been damaged by the modern disturbance. Adjacent to this was (074) which consisted of small brick sets which could represent a floor or platform.

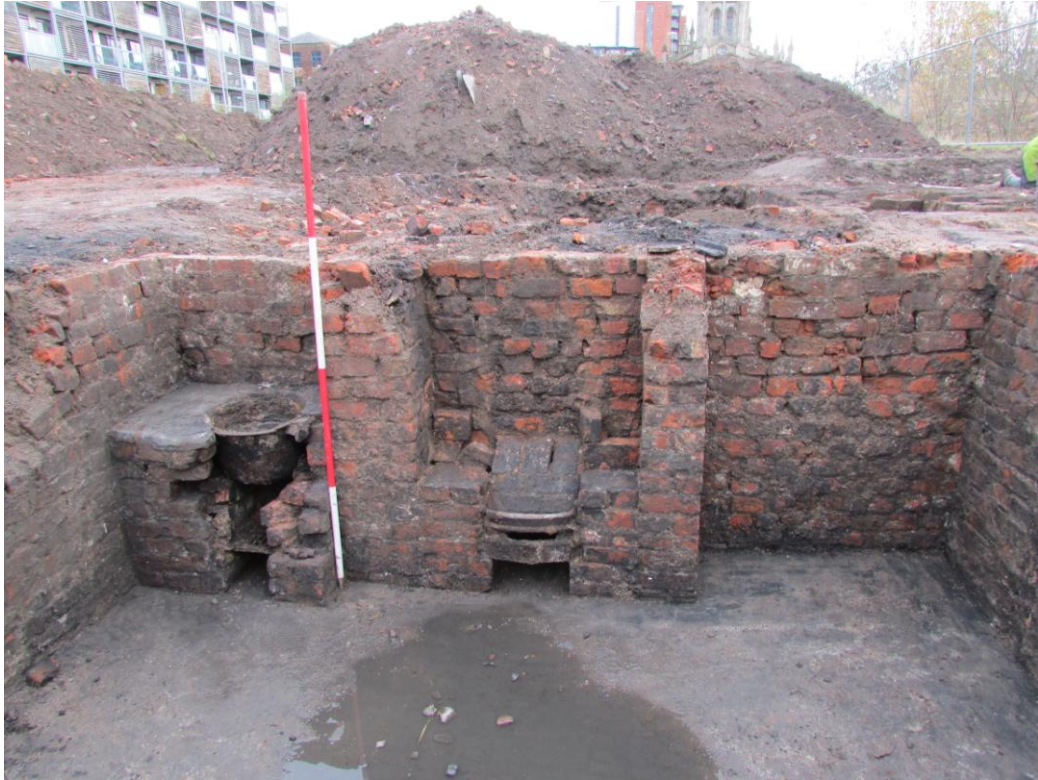
Figure 25, Showing the fireplace and wash boiler in Cellar 2, looking East.

(043) a 1 course wide wall which separated Cellar 2 and 3; this was made of hand-made bricks laid in stretcher bond, with brick projections for the fireplace. The fireplace in Cellar 2 **(044)** was excavated and found to still have its metal grill, Figure 25 & 27. In the Northeast corner was **(042)** an area similar to (034) this was more complete however, with the metal bowl still present sat on top of the bricks (Figure 25 & 26).

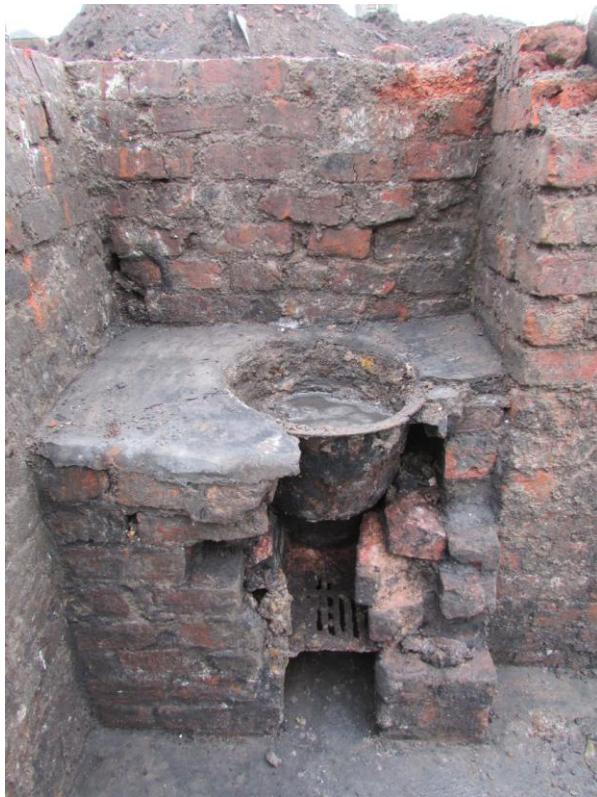
Figure 26, Showing detail of wash boiler in Cellar 2, looking East.

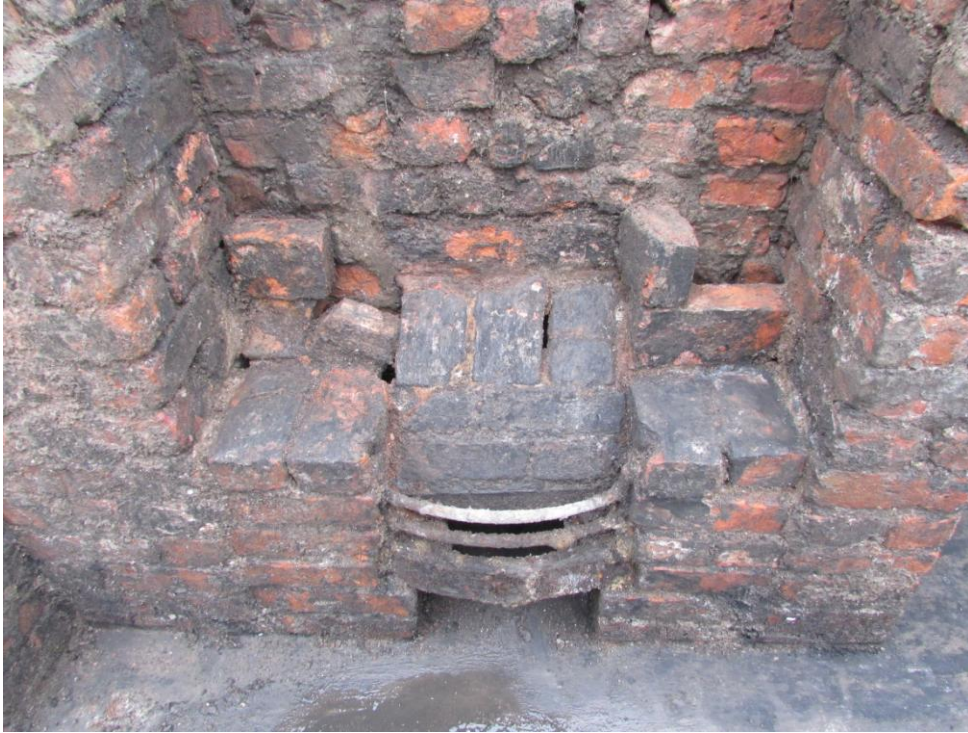
Figure 27, showing a close up detail of the fireplace in Cellar 2.

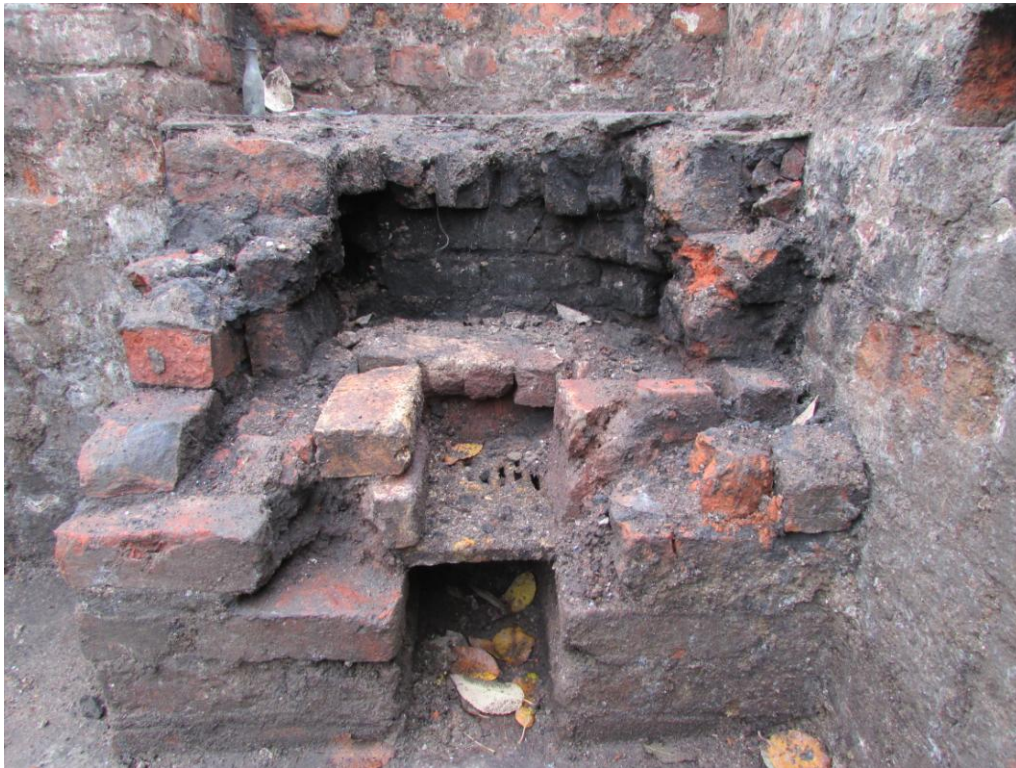
Figure 28, Showing the remains of the wash boiler (034) in Cellar 1, looking West

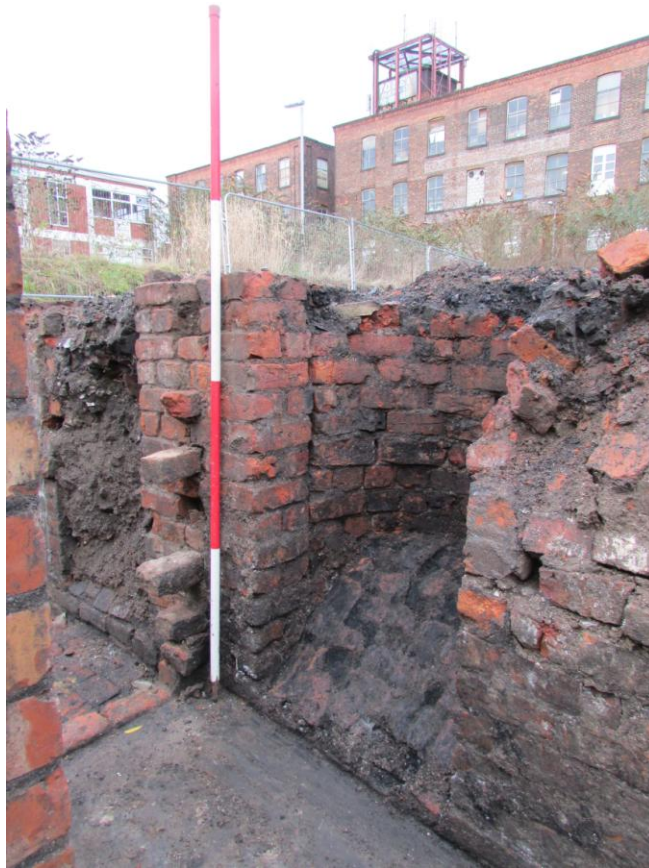
Figure 29, showing (041) a possible coal chute.

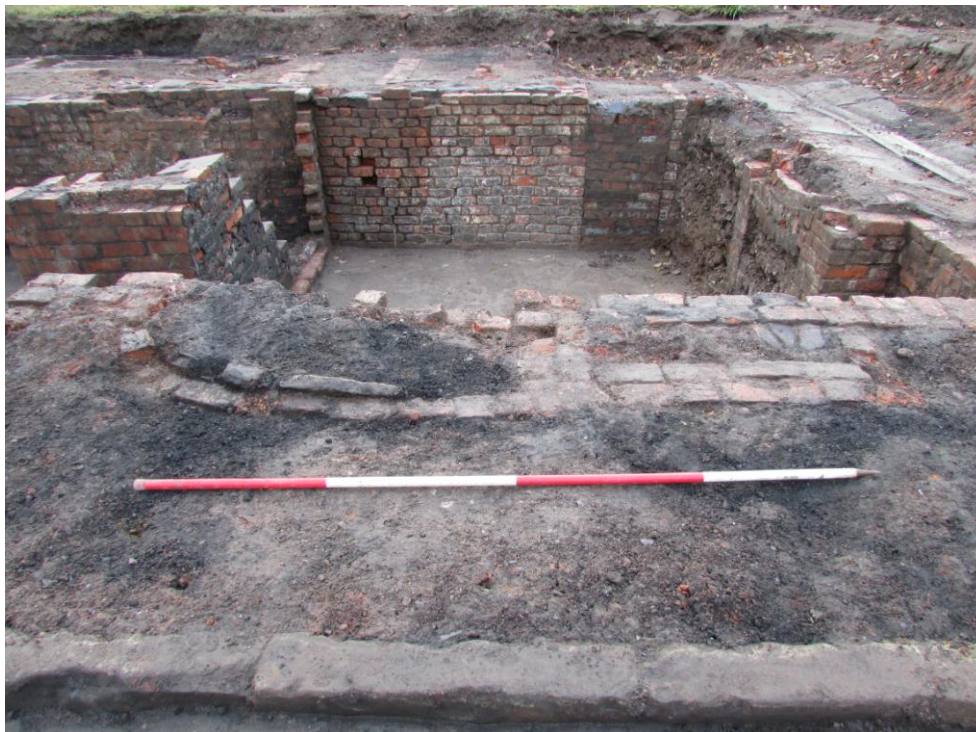
Figure 30, Showing (031), on the right is the possible blocked light looking into Cellar 1, facing South.

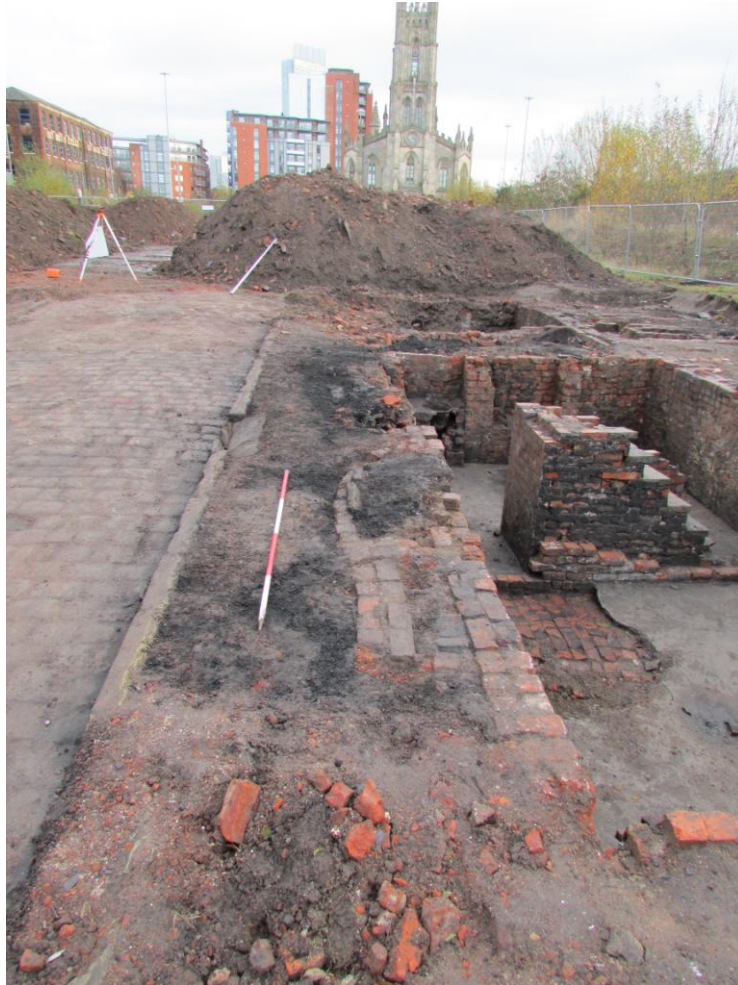
Figure 31, showing the pavement area between Cawdor Street and the remains of the housing on the south side of Cawdor Street.

To the south of (023) was **(024)** a layer of dark black clinker lying between (023) and **(026)**. (024) was compacted yet loose when trowelled, (**Figure 31**). Contained within (024) was **(031)**, a curved brick wall which was 1-2 courses wide.

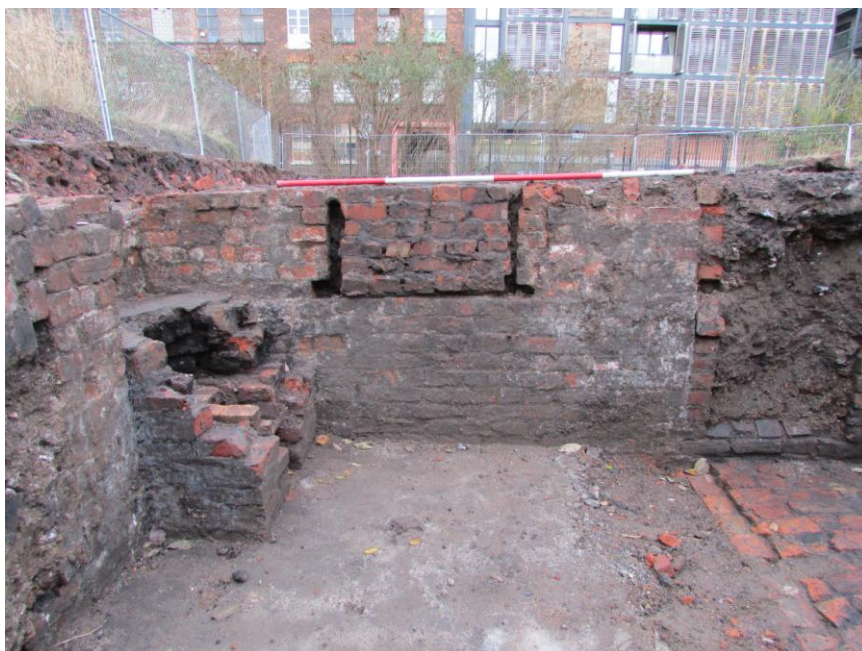
Figure 32, showing the internal detail of (031) the possible blocked light in Cellar 1, with (034) to the left of the picture.

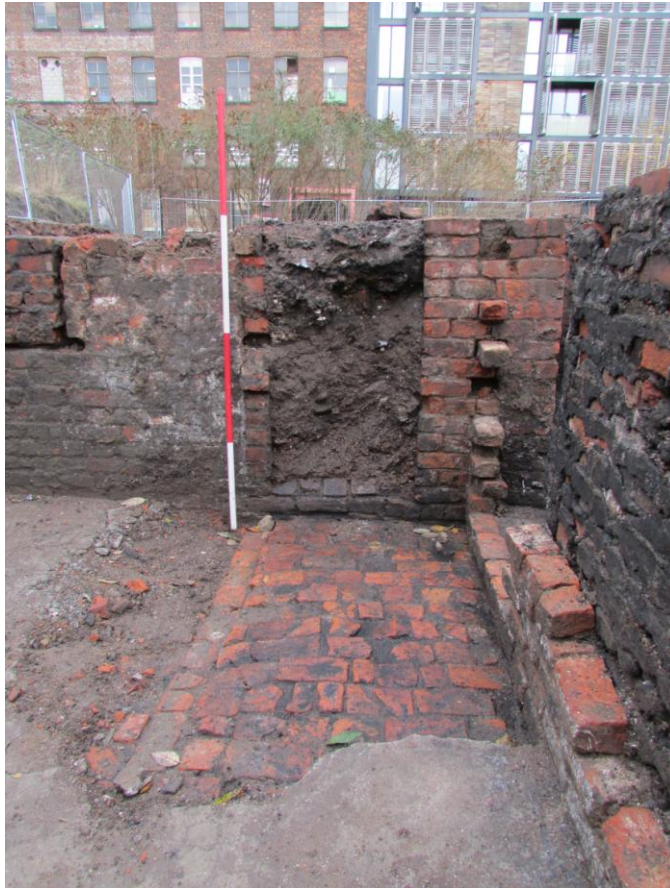
Figure 33, showing the brick floor of Cellar 1 (033) below (032) the later concrete floor, to the right can be seen (027) the remains of the skin wall separating Cellars 1 & 2. Looking North.

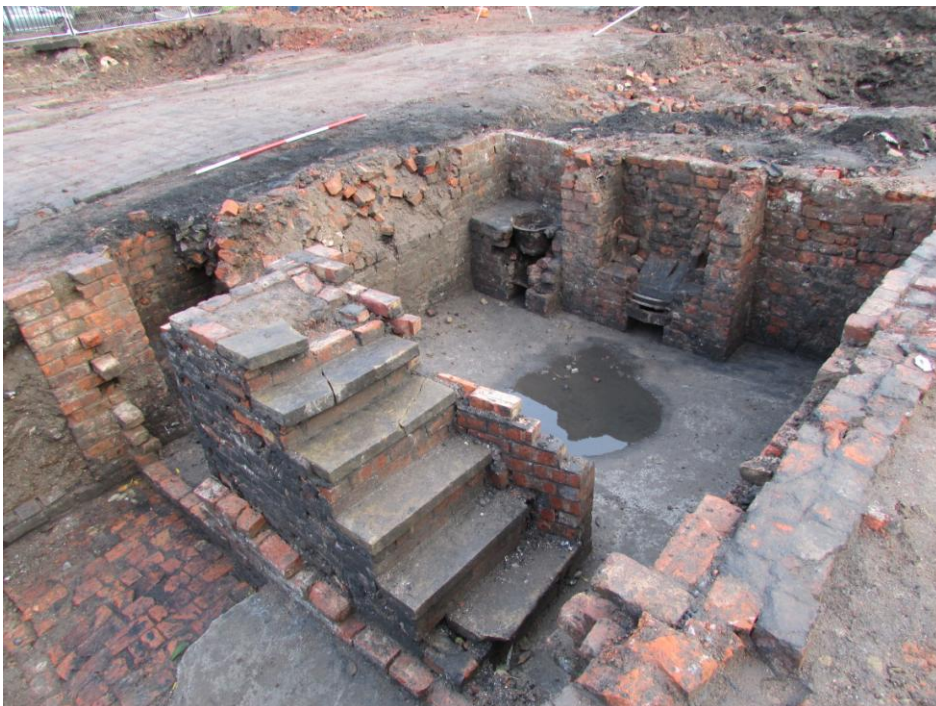
Figure 34, an overview of Cellar 2 looking north east.

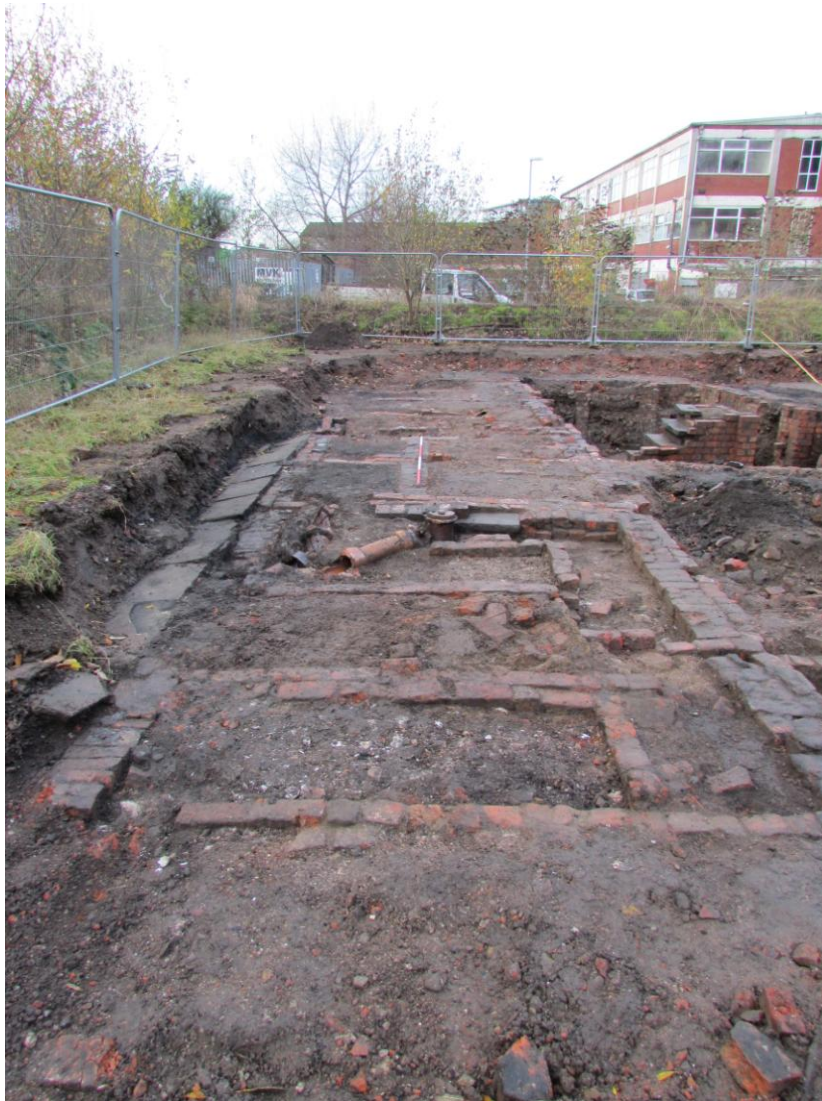
Figure 35, an overview of the southern area of the excavation, showing the small yard areas of the houses, with possible outhouses.

(053) were four bricks laid in stretcher bond that were 0.90m in length, (055) between (051) and (047) and abutted against the western side of (053), (056) could be found on the eastern side of (053) between (047) and (057), Figure 35.

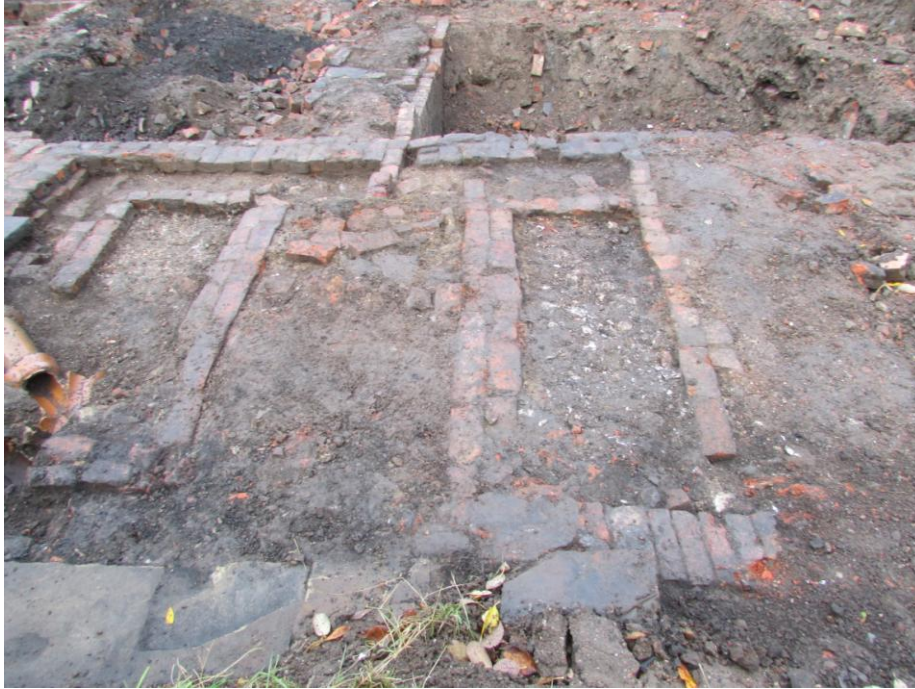
Figure 36, a detail photograph showing the small yard areas, with Cellar 3 (on the left) and Cellar 4 (on the right) in the background.

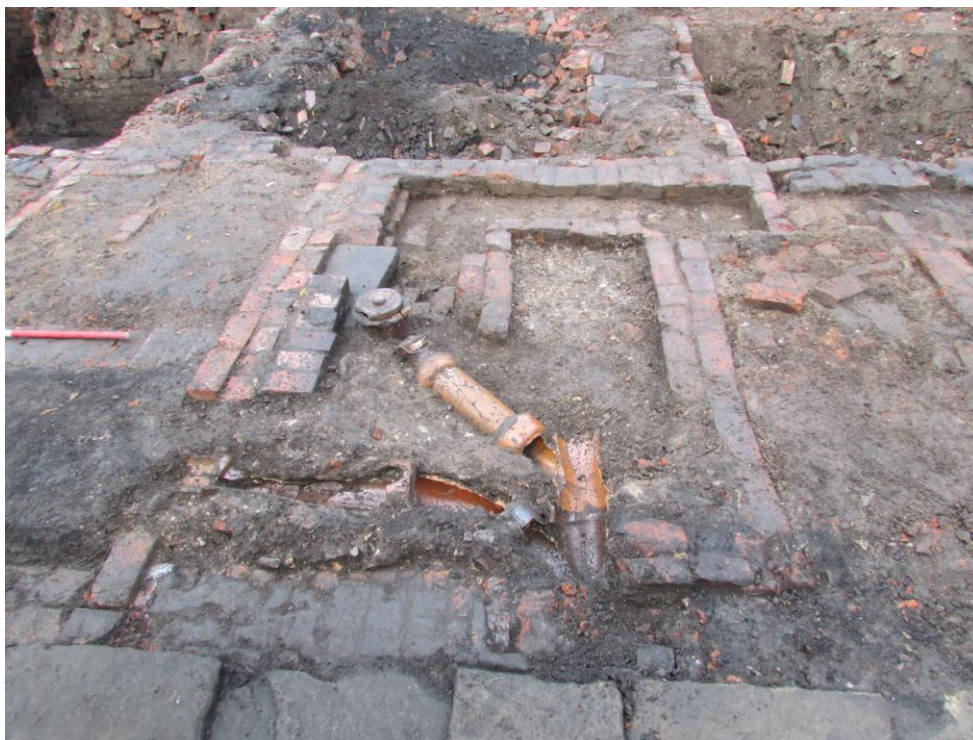
Figure 37, detail photograph showing the possible outhouse area associated here with the house of Cellar 3 & 4, in the foreground it is possible to see the small passageway (054) that lay at the back of these houses.

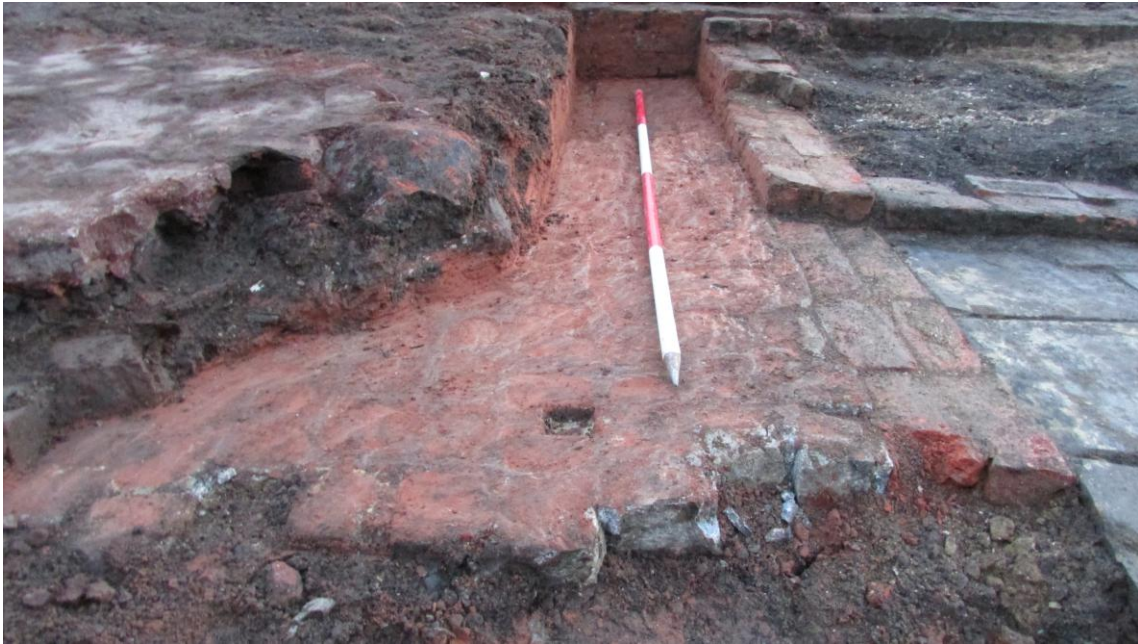
Figure 38, showing features (074), (075) and (079). Looking South.

Abutting the eastern side of (071) was **(074)**, a truncated brick floor surface set with black mortar, (**Figure 38**). Directly above (074) a clean red sand layer **(079)** was identified, which appeared compacted but was loose when trowelled. (079) appeared to extend eastwards underneath **(075)** and **(080)**.
