**Archaeological
Evaluation &
Excavation
Report.**

Ellesmere Street,
Hulme, Manchester

Client: De Trafford
Estates Group

Report No: 2014/04

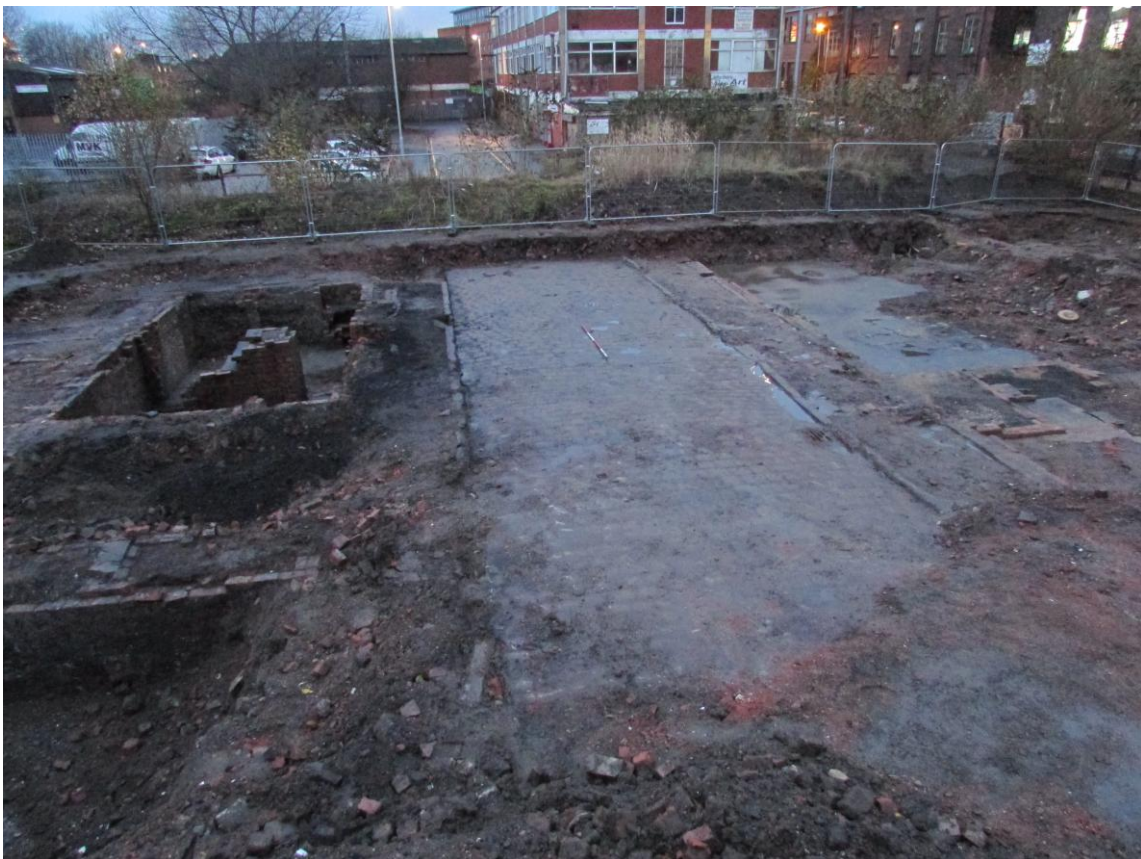
Figure 39, An overview of Area C looking west.

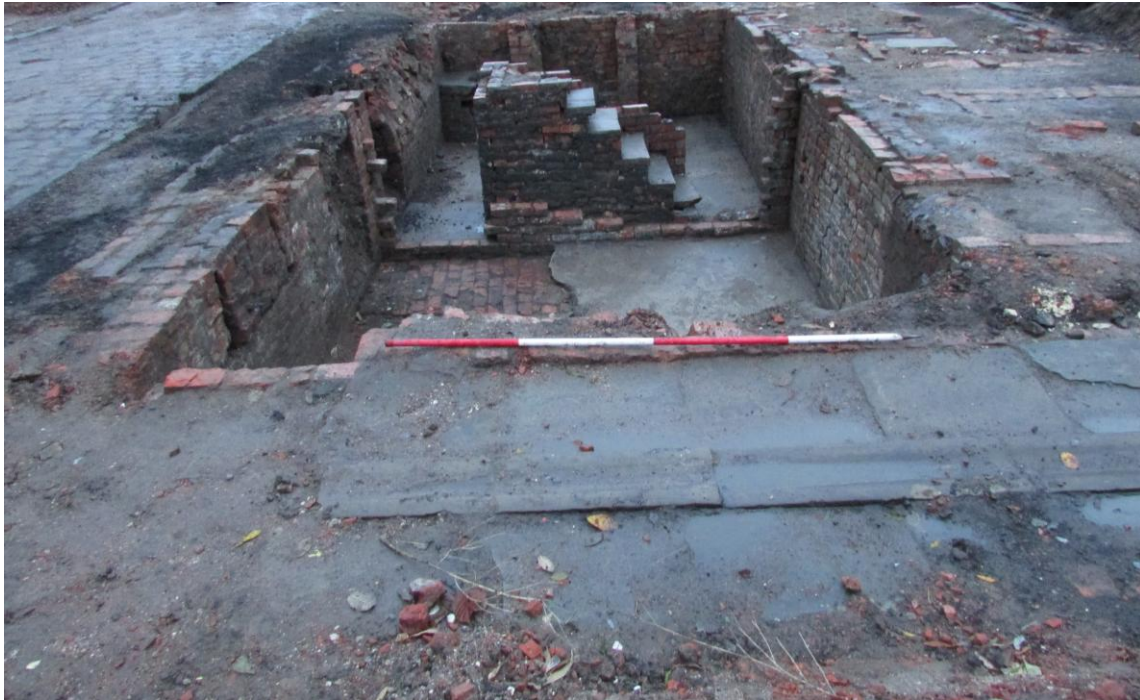
Figure 40, Ginnel at Western edge of excavation, looking East.

This proved to be the area with the most archaeological remains that were in parts well preserved. At the western trench edge could be found (029) a stone flagged floor that had a central drainage channel and was determined to be a ginnel or passageway between the back of the houses that fronted

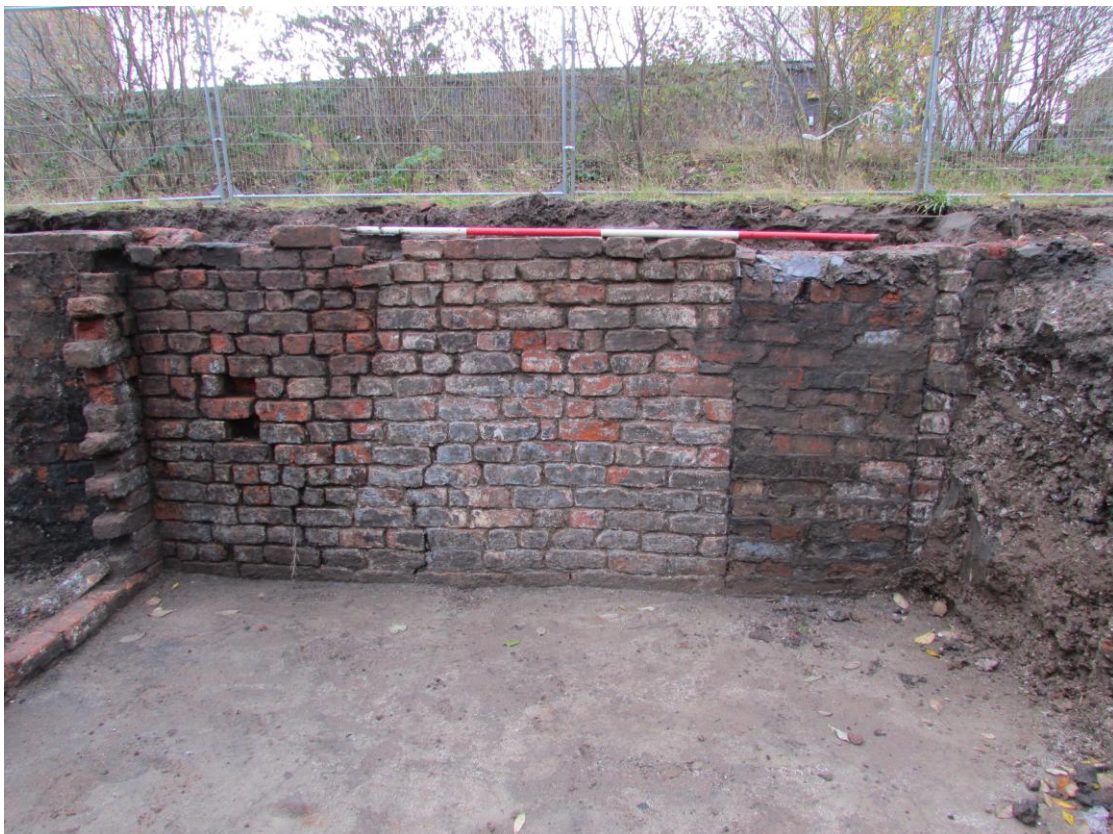
Figure 41, South wall of Cellar 1, to the right of the photograph it is possible to see the blocked doorway.

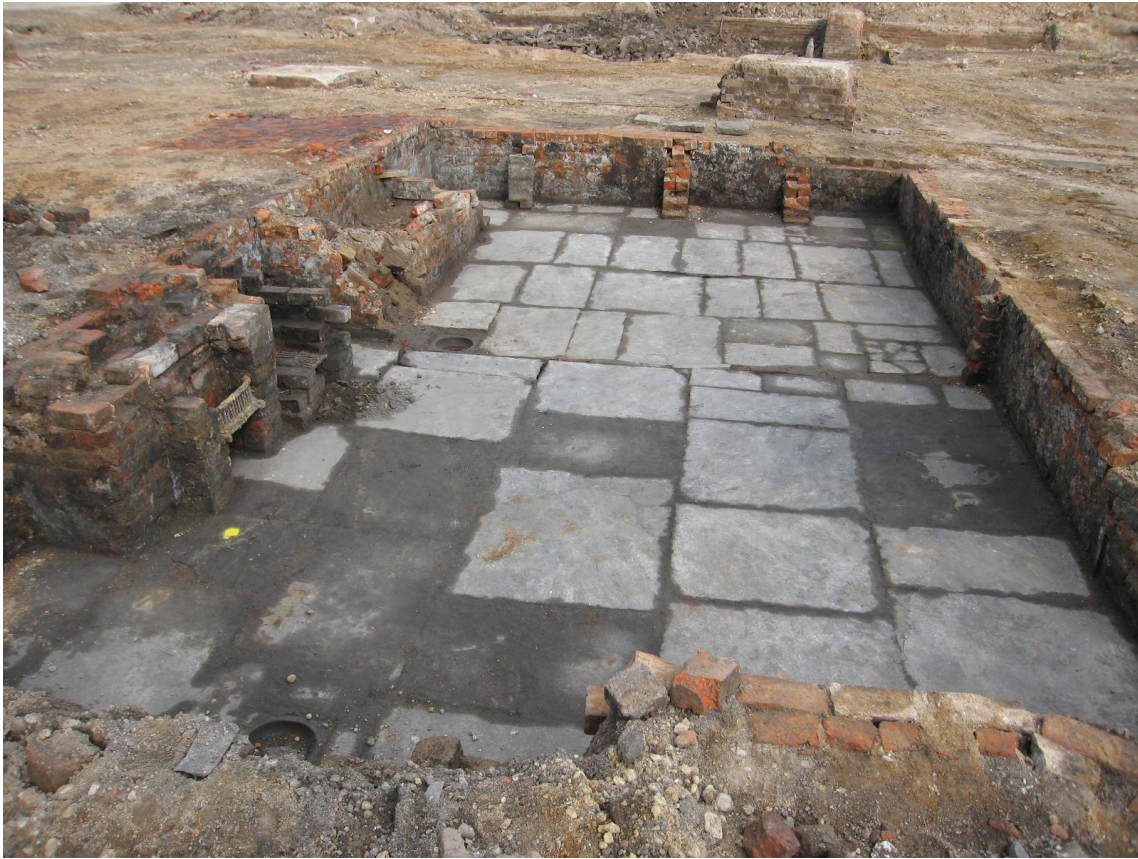
Figure 43, Showing a site off Chester Road called Arthur Street; it is possible to see in this picture similarity to the housing on Ellesmere Street. In this picture there are two dwellings the foreground representing the better preserved of the two, on the left is still visible a fireplace with accompanying 'set pot', as can be seen in Ellesmere Street, (courtesy of Norman Redhead GMAAS).

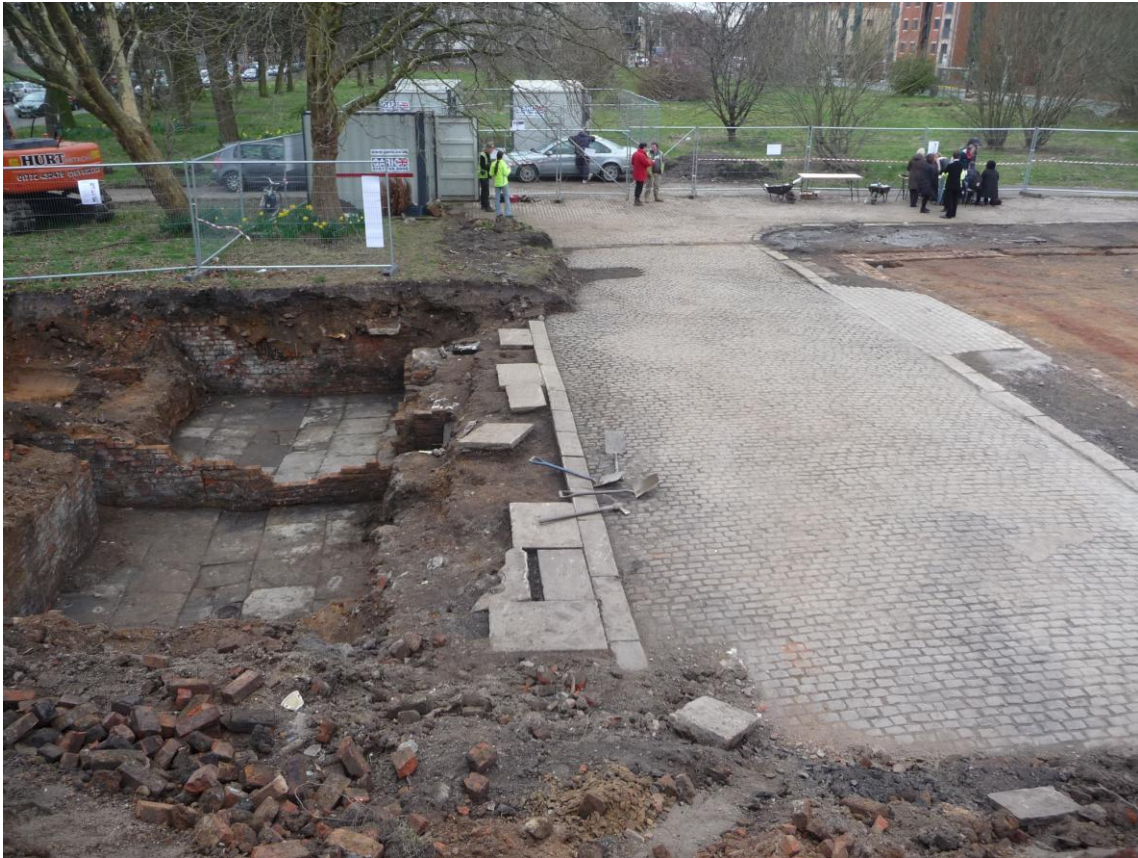
Figure 44. An overview of the site at Birley Fields, Hulme. These houses (the remains on the left) were located in close proximity to Holy Trinity Church, seen on the right of the cobbled Dale Street, (courtesy of Norman Redhead GMAAS).

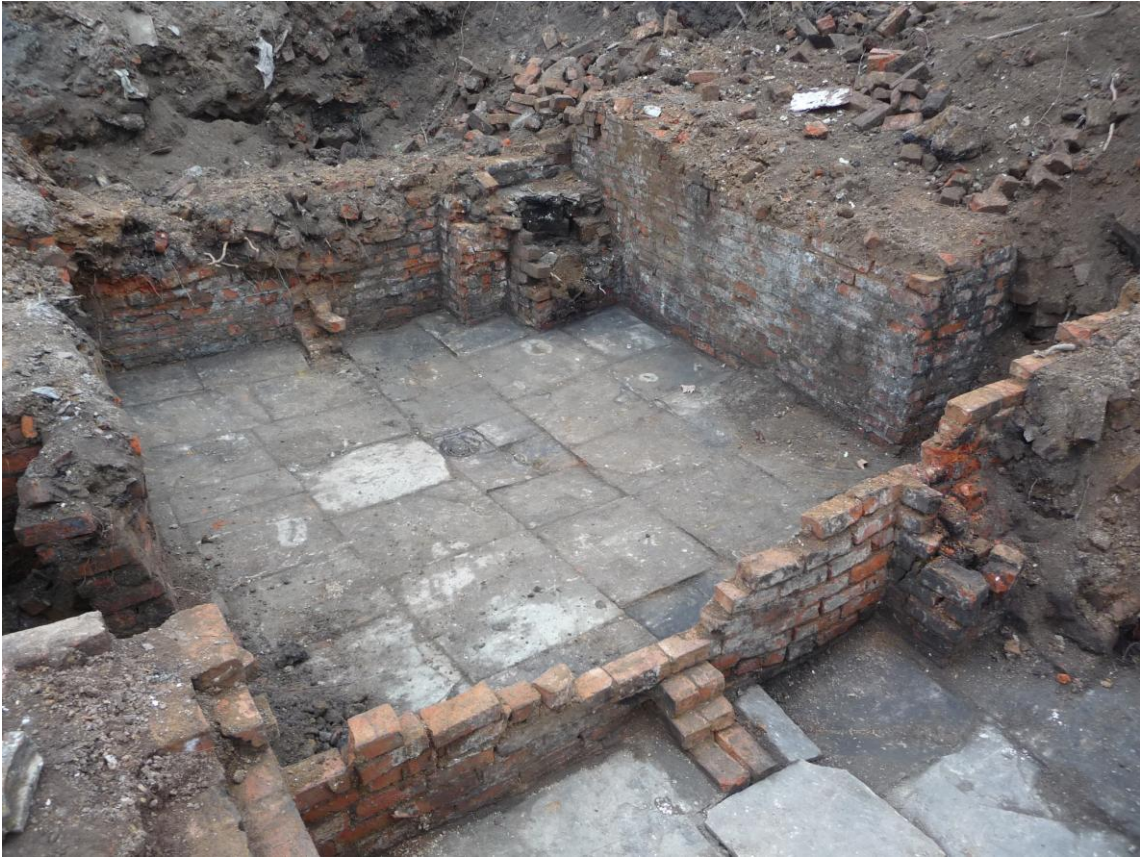
Figure 45. A detail shot of the houses of Birley Fields. It is possible to see the similarities to those of Ellesmere Street. There is a single skin wall separating the dwellings and in the far right corner are the remains of a 'set pot', (courtesy of Norman Redhead GMAAS).
