**Archaeological
Watching Brief**

Former Site of
Washington House,
Central Salford: Plot
B7 (New Bailey
Prison)

Technical Report:
Rachael Reader

Report No:
2015/14

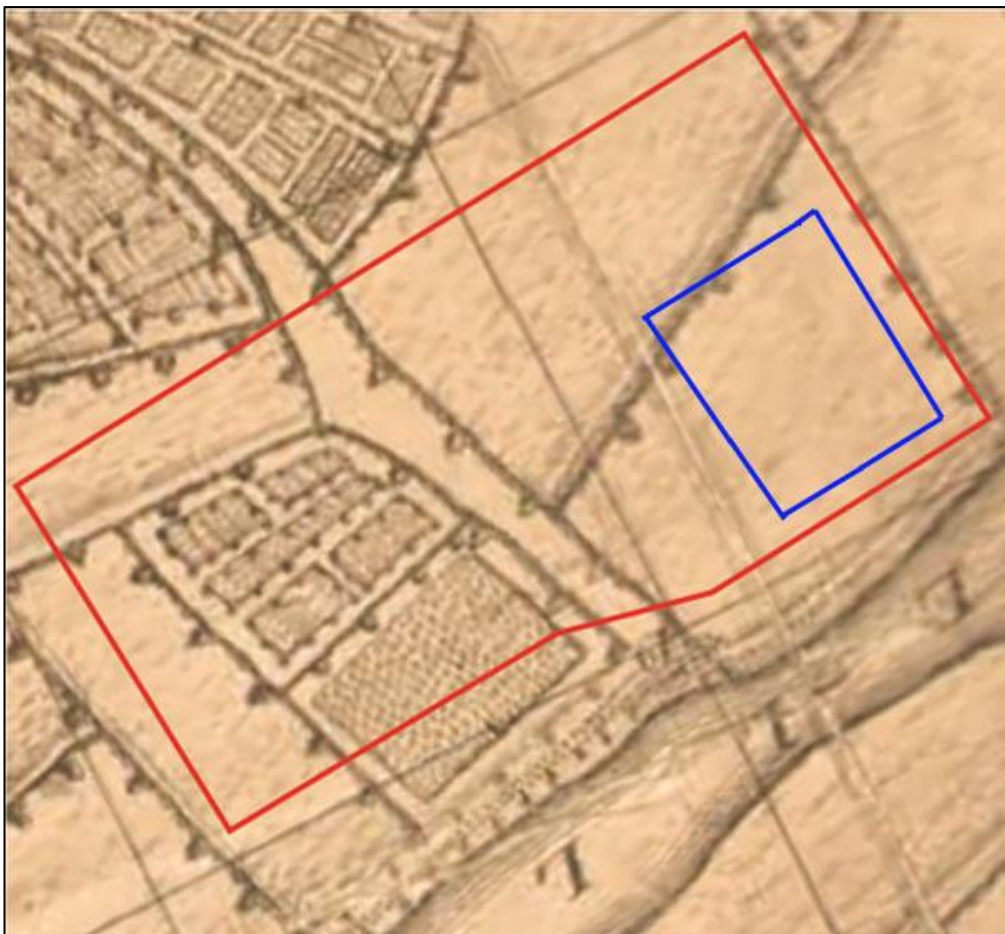
Fig. 2 Zone B (in red) as mapped by Casson and Berry in the early 18th century. Plot B7 is shown in blue (maps taken from Nash 2013)

Historical research has revealed that prior to the 18th century, the site and much of its surroundings were undeveloped farmland. Casson and Berry's map of Manchester and Salford, dated 1741, shows that during the first half of the 18th century, the environs were occupied by several enclosed fields and a central route-way aligned north/south, which ran between Chapel Street and the river Irwell. Within the western half of the study area, there were a series of rectangular garden plots (**Site 1**), possibly allotments utilised and managed by local tenants (see Fig. 2).

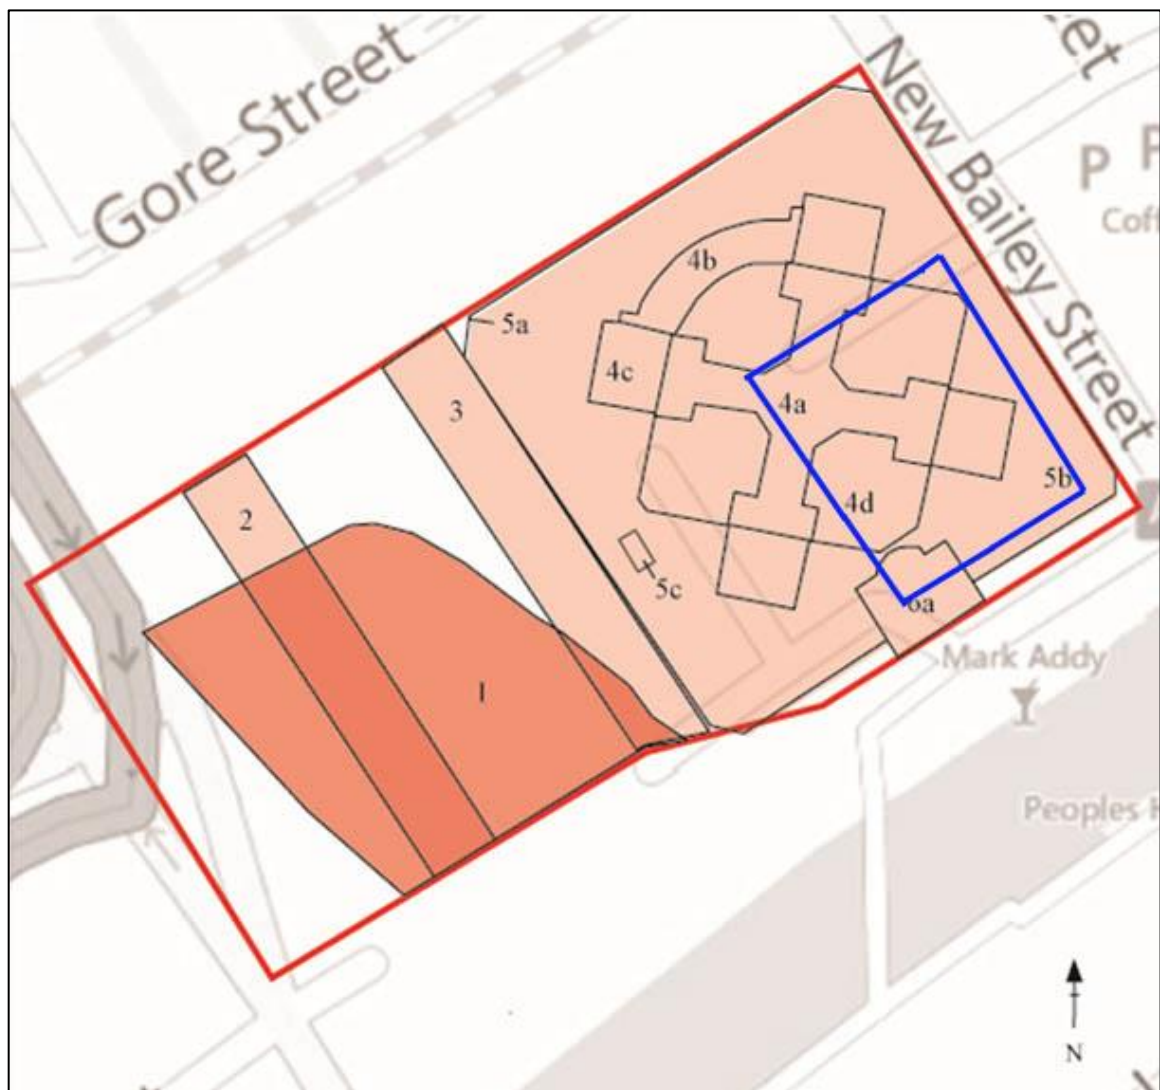
Fig. 3 Gazetteer map of features depicted on Green's 1794 map within Zone B

By Green's map of 1794 the study area had been substantially redeveloped. The garden plots had been cleared and the western half of the study area was occupied by two roads aligned north/south named Bolton Street (**Site 2**) and Falkner Street (**Site 3**). The eastern half of the study area had been occupied by New Bailey Prison (see Fig. 3), which was constructed between 1787 and 1790 and was one of the first prisons in England to be

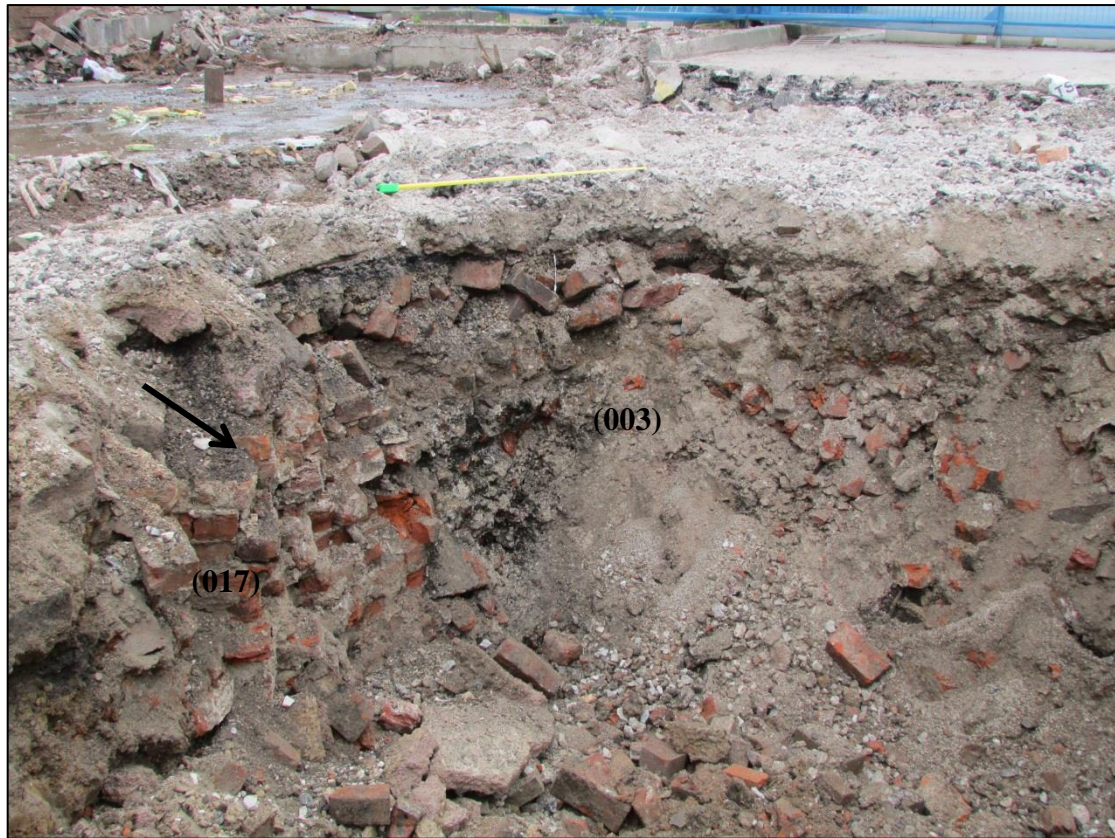
Fig. 6 Archaeological remains relating to the Matron's Parlour (wall highlighted) bears a striking resemblance to the Clothing Room remains recorded on plot B4 and appear to survive beyond a depth of 1.50m

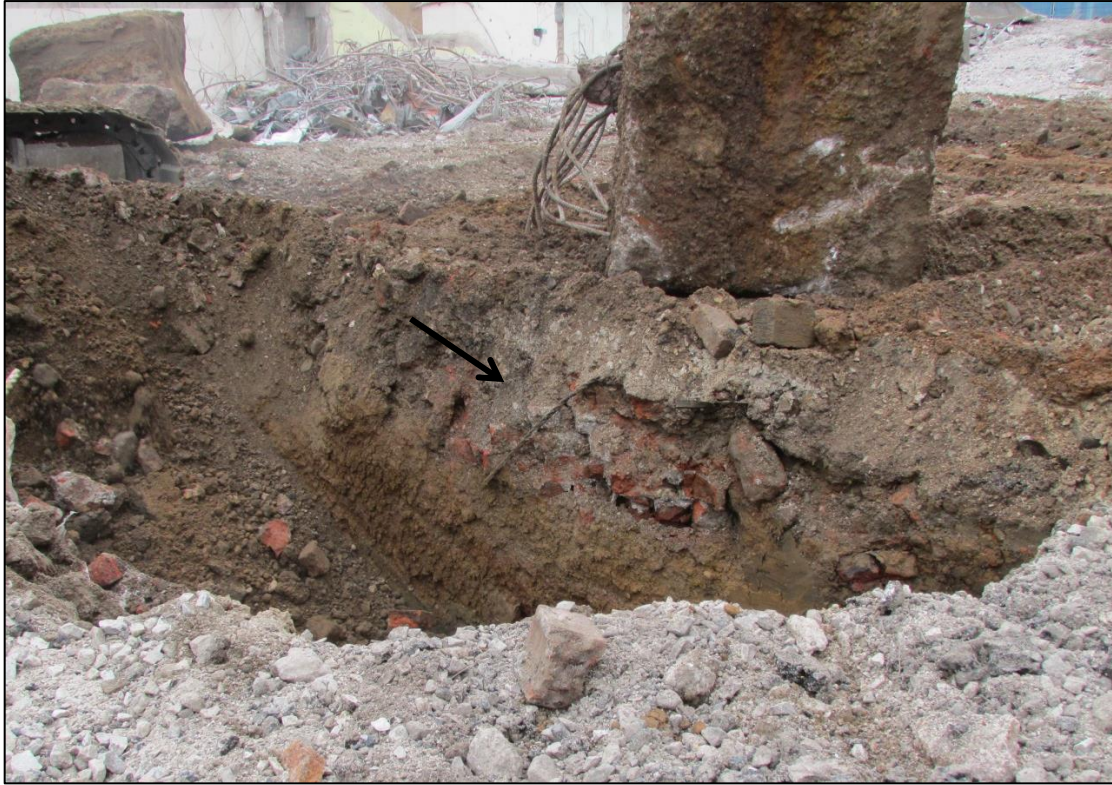
At least three walls, **(018)** and **(019)** were observed, at their shallowest, 0.20m below the ground surface and consisted of handmade brick, bonded with a creamy white mortar. These walls corresponded with the eastern wing of the Female Misdemeanant Wards although they only reached a maximum of 0.50m deep. At the north-west corner of the site, wall **(017)** were observed reaching a depth of at least 1.50m and appeared to be part of the area marked on the map as the Matron's parlour within the central part of the radial building. **(017)** was sealed by **(003)**, a loose light brown grey silty sand with abundant inclusions of crushed mortar and frequent fragments of handmade brick. This was observed to be at least 1.30m in depth.

Fig. 7 Walls relating to the Female Misdemeanant Wing still survive (as shown above), however they were frequently shallow and the natural geology is visible here at 0.50m below the surface

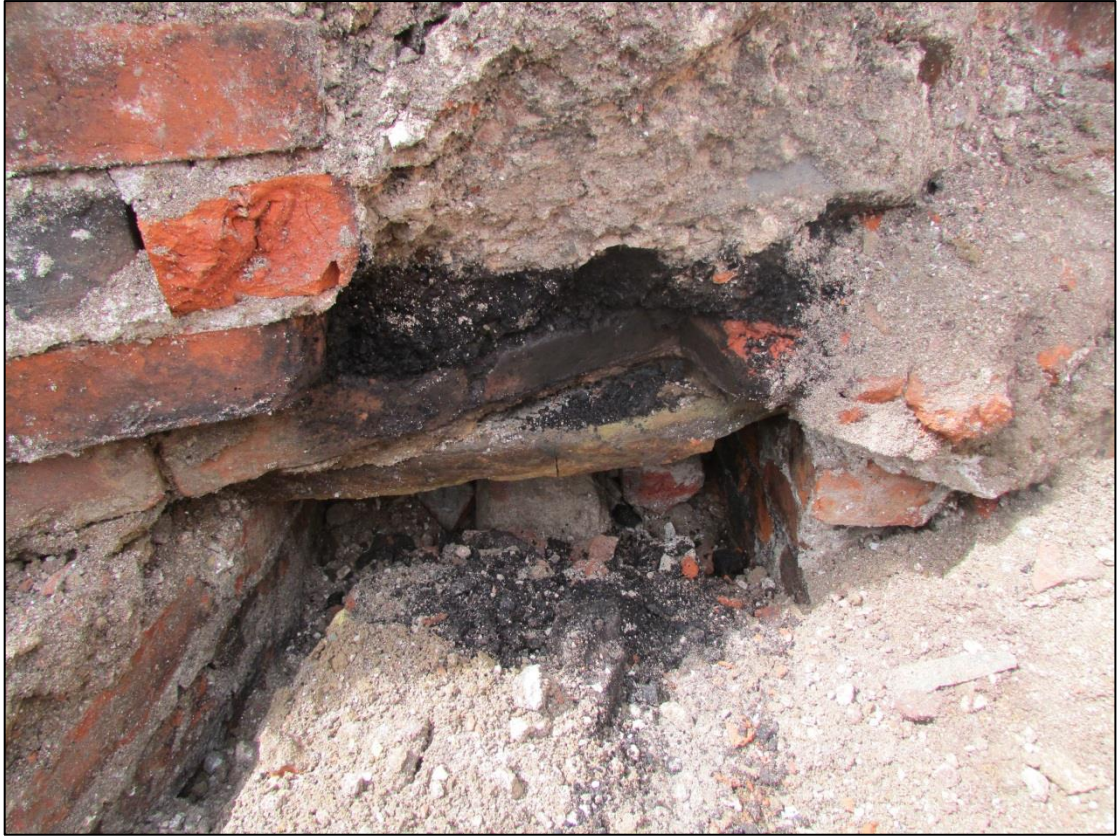
Fig. 8 Close up of possible flue, with *in situ* heat affected bricks and black ashy deposit above. This was located approximately 1.50m below the ground surface

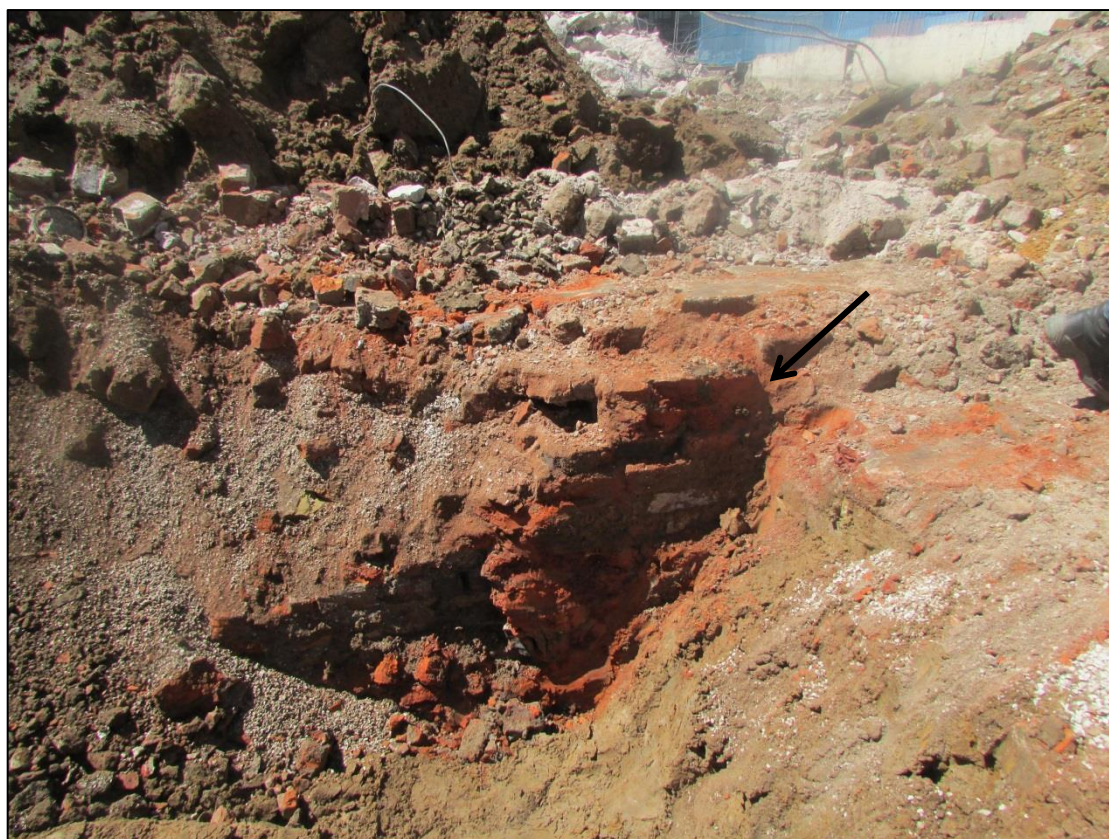
Contexts **(008)**, **(009)**, and **(010)** were three handmade brick walls observed within one of the geological trial pit 8). **(008)** was a minimum of six courses wide and they were all observed reaching a depth of 1.50m. These walls appear to be part of a Female Felon Cell. The area between these walls were infilled by **(011)**, a mid grey brown silty clay with no observed inclusions and measuring up to 2.00m in depth.

Fig. 9 Substantial walls forming one of the Female Felon Cells were found to survive to 2.00m deep

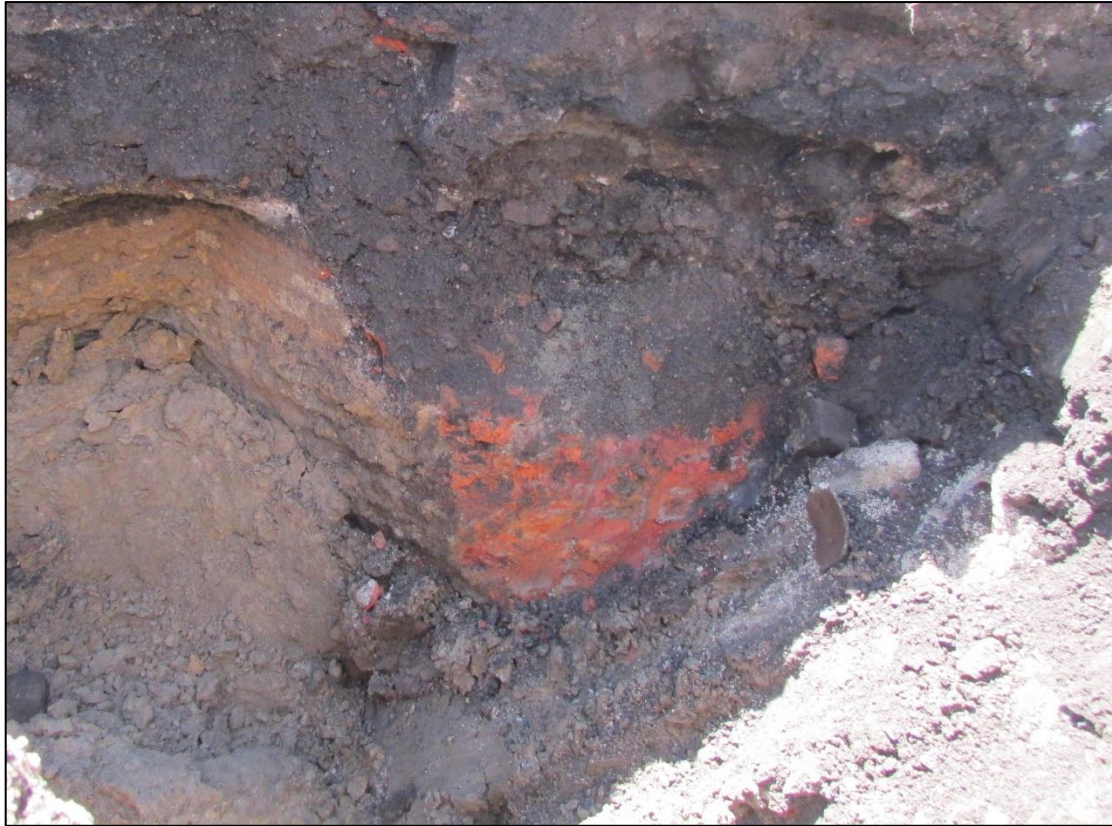
The upper level was sealed with a mix of paving slabs and a concrete slab, as well as associated stanchions. Within the SW corner of the site, geological test pit 1 revealed a significant amount of overburden and mixed backfill (016). This was a very loose dark brown grey silty sand with frequent brick fragment inclusions. This reached a depth of 2.80m and sealed a layer of concrete which lay on the natural geology (004). Below the paving slabs at the NE corner of the upper level was (011), a loose light brown yellow sand measuring up to 0.50m in depth and appeared to be levelling material for the paving slabs. This was observed sealing (012) in geological trial pit 6, a layer of concrete with inclusions of crushed brick, likely related to the railway yard and measured < 0.10m in depth. This sealed (002) which in turn sealed (013), a compact mid grey brown silty clay with frequent inclusions of crushed brick and mortar. This measured up to 1.50m deep and sealed (014), a handmade brick wall, orientated N-S and a minimum of six courses wide. The top of this wall was visible at

1.50m below the ground surface and measured at least 1.30m deep. This was part of the external wall for the curved Female Felon Cell building.

Fig. 10 External wall of Female Felon Cells revealed in section

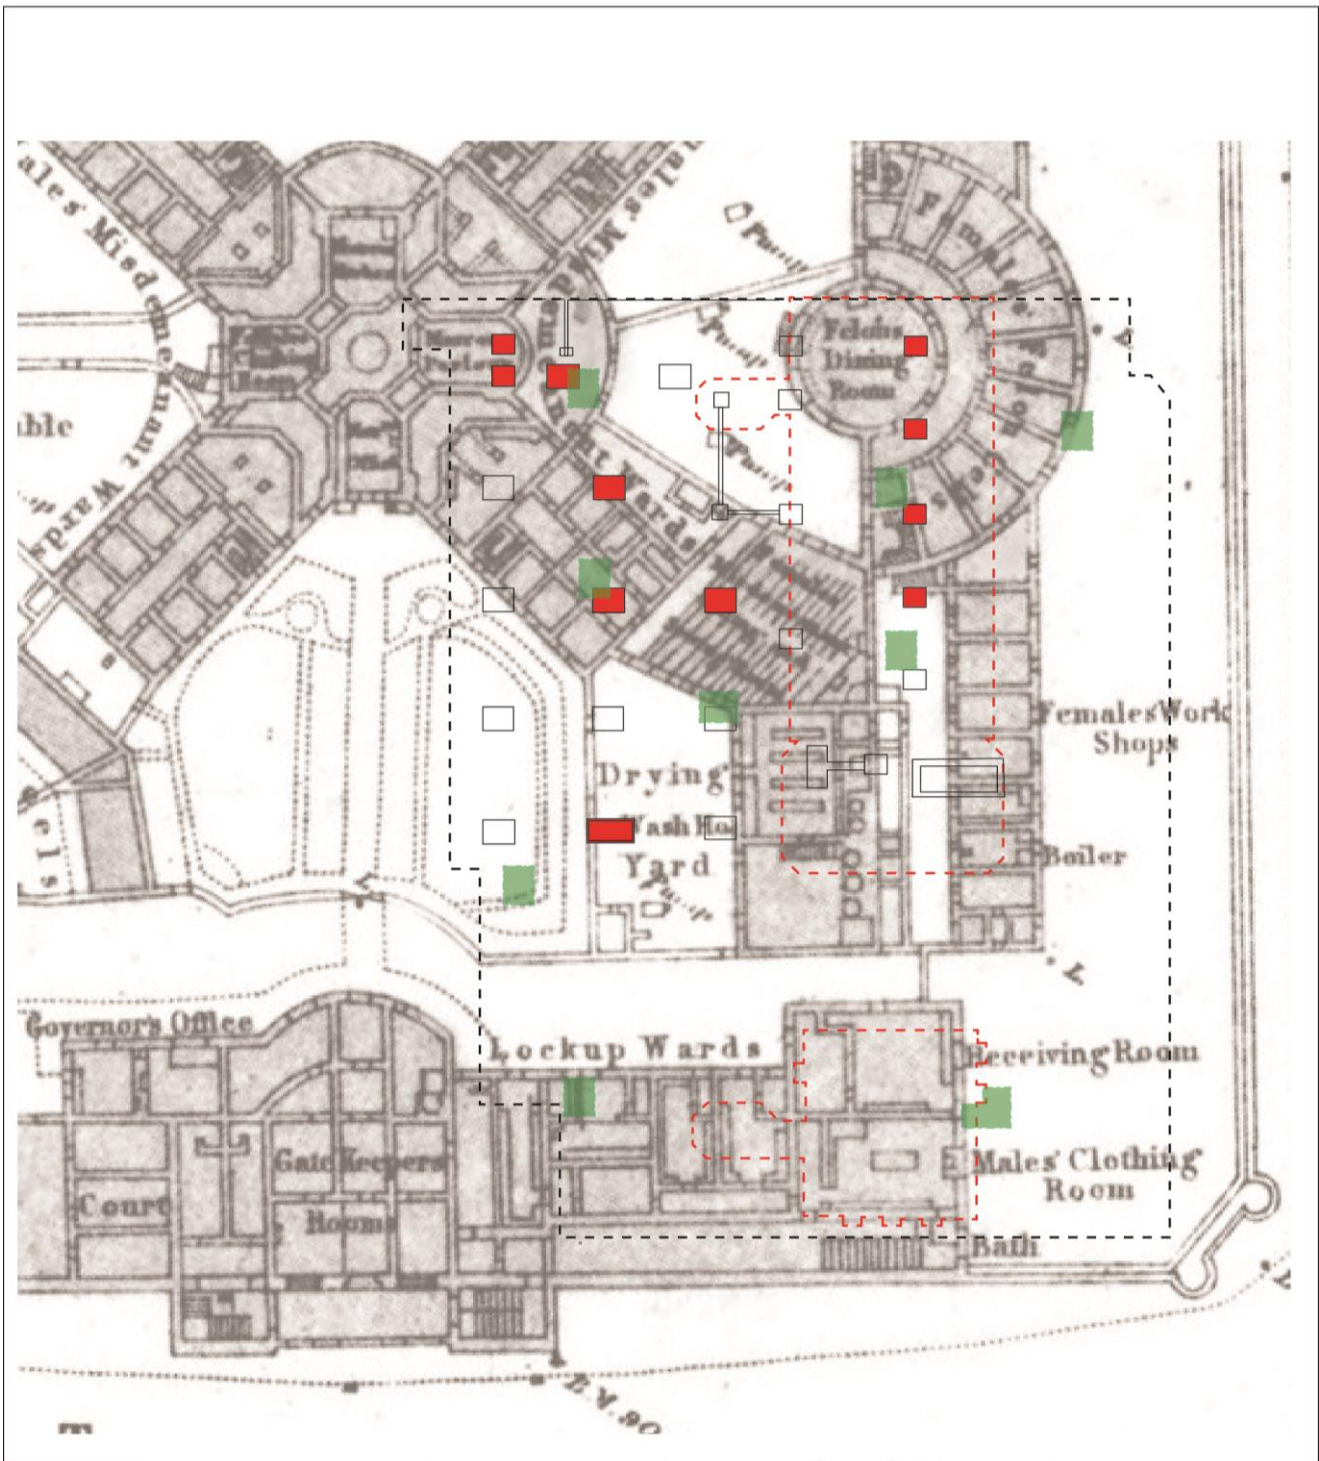
The remains of New Bailey Prison were found to be in varying states of preservation, with walls relating to the Female Misdemeanant Ward, Female Felon Cells and Wash House positively identified, surviving at depths greater than 1.50m below the basement level of Washington House. The depths of walls observed varied between 0.50m and 2.00m, with the shallowest identified relating to the individual cells within the radial building. Potential basement levels were identified within the Felon's Dining Room, Wash House and Matron's Parlour. Different mortars were also encountered, indicating that different phases of buildings were present. The walls were constructed directly onto natural clay and this was observed at a range of depths, between 0.50m and > 2.50m (see Fig. 14 for the location of archaeology observed).

<p>Centre for Applied Archaeology College of Science and Technology The Crescent Salford M5 4WU</p>	<p>Title: Plot B7: Observed Archaeology</p>	<p>Key:</p> <ul style="list-style-type: none"> Former Washington House Building Plot B7 Extent Stanchion Stanchion and archaeology identified Geological Trial Pit
