**Archaeological
Evaluation:**

Dig Greater Manchester:
Hulme Barracks,
Barracks Park, Hulme,
Manchester

Technical Report:

Report No: 2015/01

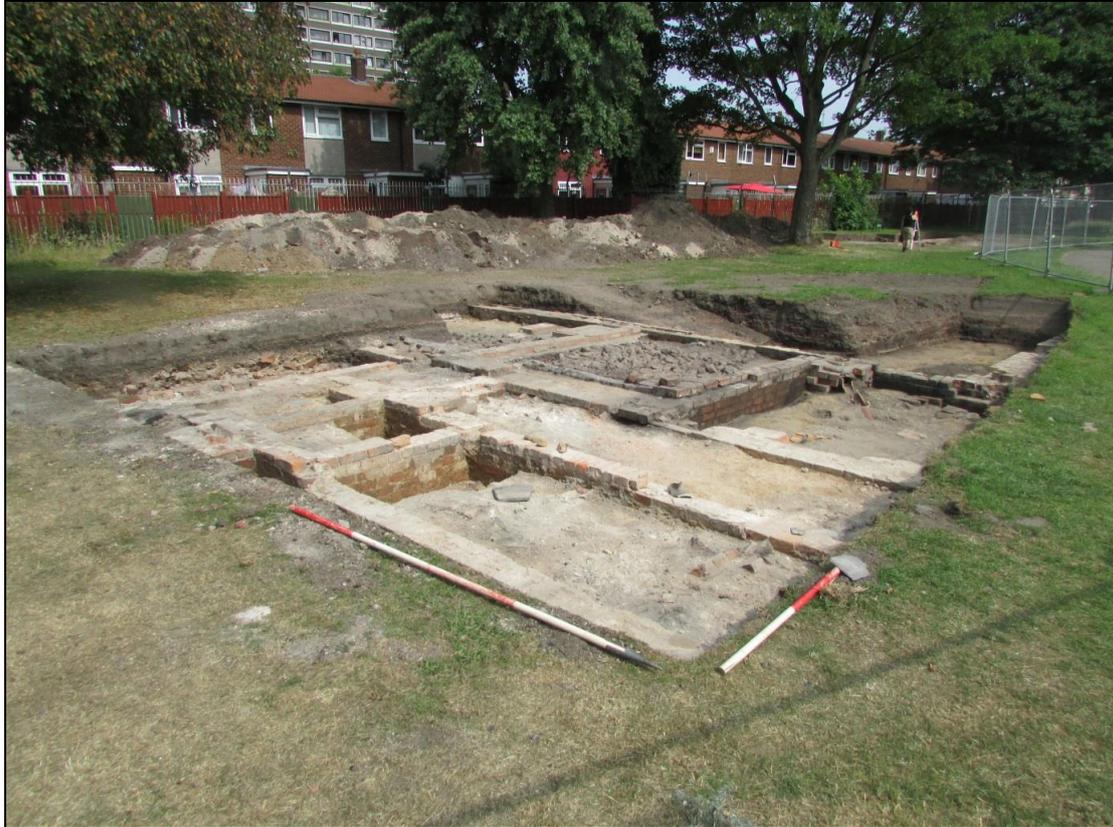
Fig. 1 General shot of Trench 1

Trench 1 was located over the remains of the canteen and was broadly rectangular with a small SE extension. This measured at its maximum, **xxx** and was sealed by **(001)**, a fairly loose dark blackish brown loam, which varied in depth although did not measure any deeper than 0.30m. Infrequent small fragments of 20th century ceramics were encountered in this deposit. **(001)** sealed **(009)**, a very compact red shale levelling layer with no inclusions noted, measuring < 0.05m in depth. This in turn sealed **(010)**, a fairly loose dark greyish brown deposit with abundant inclusions of grit and infrequent inclusions of stone, slag and ash, measuring c.0.10m in depth. **(010)** sealed **(011)**, a layer of crushed brick measuring c.0.10m in depth and sealing **(012)**, a fairly loose dark greyish black coal tip deposit, measuring 0.05m in depth. **(013)** lay below **(012)** and was a friable dark blackish brown silty clay with inclusions of 19th century ceramics, glass and metal. **(013)** sealed **(018)**, a fairly loose mid yellowish brown silty sand with inclusions of small sub angular stones and broken brick. This deposit was not fully excavated and was only found towards the NW end of the trench.

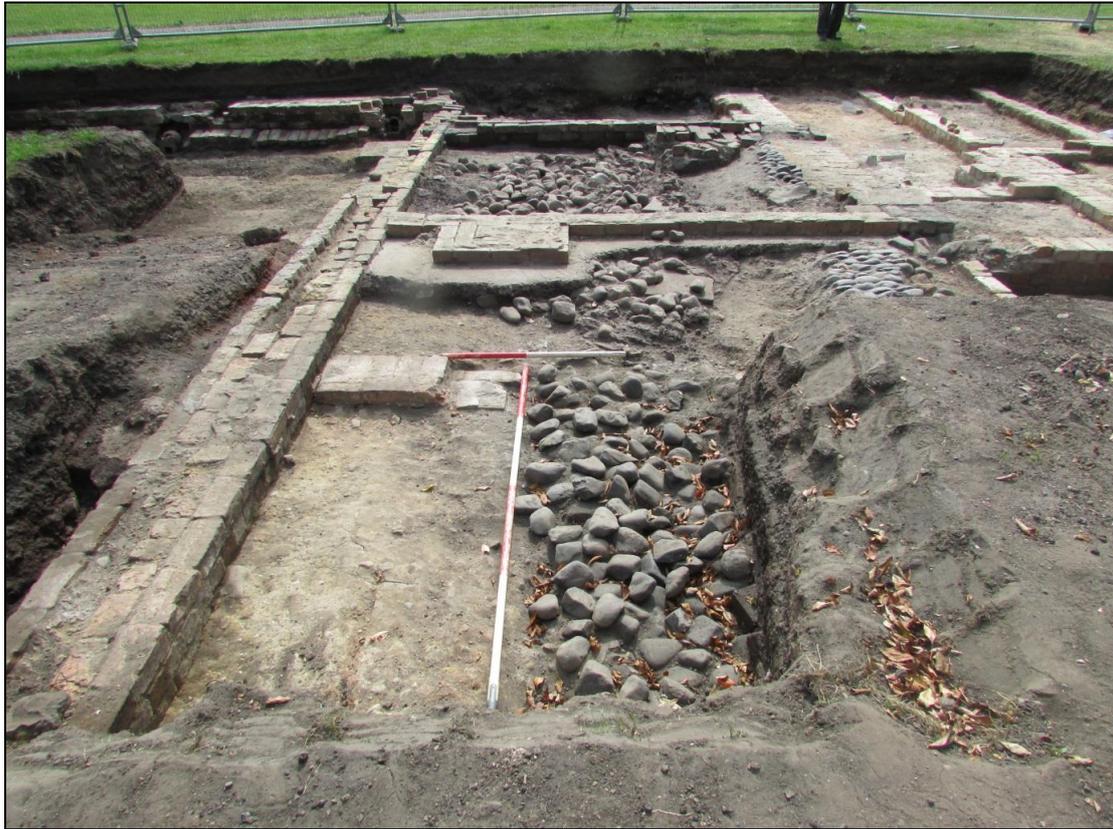
Abutting (088) to the NW was (023), a truncated area of small cobbles (< 0.20m) measuring at its maximum dimensions 4.40 x 3.10m. These appear to have been redeposited and do not survive *in situ*. This was also sealed by (022), a dark brown clayey silt which formed the infill between the cobbles of (023) containing 19th-20th ceramics and glass. (092) abutted (023) to the NW and was a handmade brick wall, three courses wide, orientated NE-SW and measuring 4.70m in length. The wall was bonded with a compact white mortar and was truncated in several places (see below). Not physically related to (092) but on the same alignment was (110), a handmade brick wall, surviving to three courses wide, orientated NE-SW and measuring 1.20m in length. This was bonded with compact white mortar and was badly truncated but appeared to be the continuation of (092). Abutting (110) to the SE was (111), an area of closely packed, regularly laid cobbles (< 0.20m) measuring a maximum of 1.20 x 0.40m and was badly truncated at the SE end. This appears to be the *in situ* remains of the surface (023).

Fig. 2 Remains of cobbled surface (023)

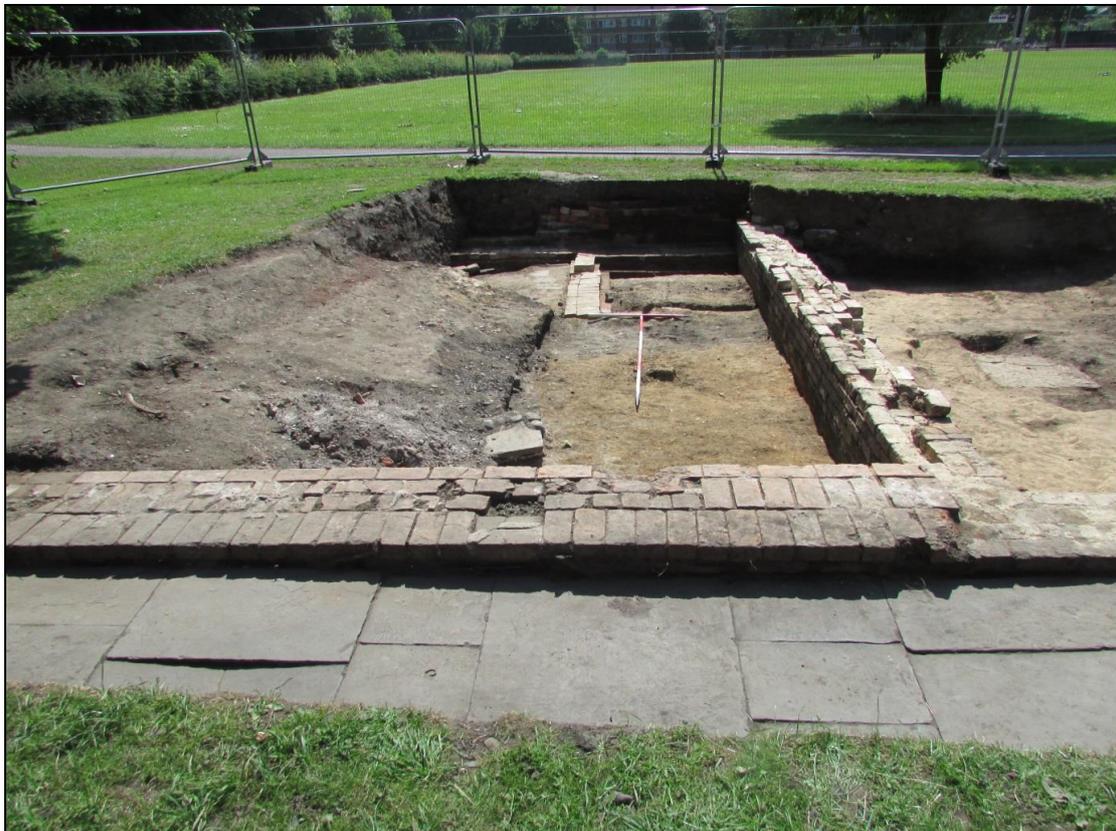
Also abutting deposit (062) and wall (063) was (072), a machine made brick wall, 3 courses wide, orientated NW-SE and measuring 4.20m in length, continuing beyond the NW and SE trench baulks. This survived to two courses in depth and sat on a brick plinth, one course deep with header bricks laid on side. The wall was bonded with a soft white mortar and was abutted by (071) to the SW. This was a handmade brick wall, a minimum of two courses wide, orientated NW-SE and measuring 4.20m in length. The wall was a minimum 7 courses deep and bonded with a soft white mortar. This wall also abuts (063) and continues to run beyond the NW and SE baulks. The bricks measured 0.23 x 0.12 x 0.07m. Also abutting the NE face of (072) was (073), a machine made brick wall, 3 courses wide, orientated NE-SW and measuring 2.00m, before turning to run SW for 0.80m. The wall sat on a machine made brick plinth, one course deep with header bricks laid on side and projecting NW 0.13m. (072) truncates (074), a handmade brick drain, orientated E-W, which survived to one course deep on a stone base. It measured 2.00m in length and continued beyond the SE trench baulk.

Fig. 4 Shot of SE end of Trench 2

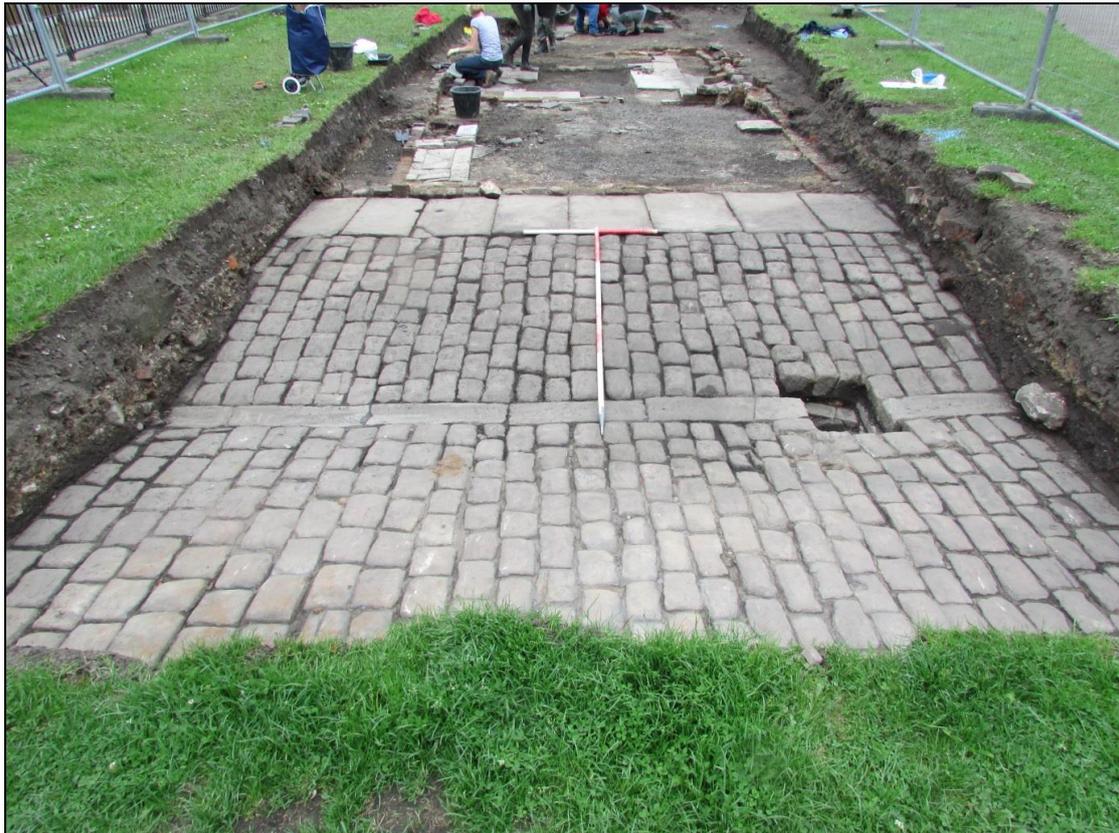
Trench 3 uncovered the remains of several houses and the trench measured broadly 20.00 x 4.40m. It was orientated NE-SW and was sealed with **(001)**, a fairly loose dark blackish brown loam, which varied in depth although did not measure any deeper than 0.30m. Infrequent small fragments of 20th century ceramics were encountered in this deposit. **(002)** was sealed below (001) and was a fairly compact mid brown silty clay with frequent inclusions of small pebbles and brick rubble, measuring < 0.10m deep. (002) in turn sealed **(003)**, which was a very compact dark coal tip layer with inclusions of slag and measuring < 0.10m in depth.

Fig. 5 General shot of Trench 3

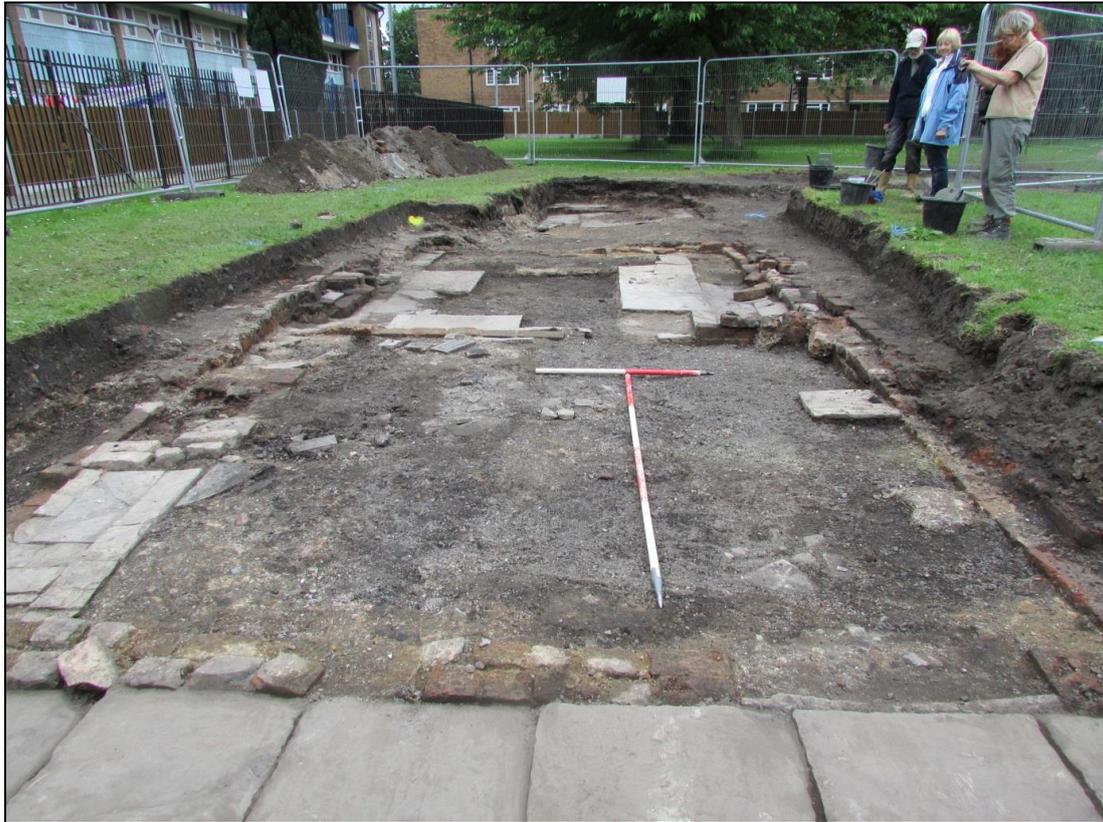
Across the area of Room 1 was **(082)**, a badly preserved stone surface sitting below (003). Fragments of the surface were visible over an area measuring 3.60 x 3.04m. Abutting the corner of (025) and (030) was **(032)**, which was an area of flagstones measuring 0.95 x 0.50m. The flagstones were small but varied in size and consisted of yellow sandstone. Abutting (032) to the south was **(031)**, two handmade brick projections abutting the inner (W) face of (030), 2 courses wide. These projected 0.52m W and defined an area measuring 0.69m, with **(033)** lying between. This was a broken hearth stone, measuring 0.80 x 0.50m and also abutting (030). Abutting the S side of (031) was **(097)**, an area of flagstones similar to (032) but badly truncated and covering an area measuring 0.77 x 0.48m. Abutting (097) to the S was **(098)**, a handmade brick wall, one course wide, orientated E-W and measuring 3.50m in length. It abuts (027) and (030) and has a possible threshold towards the W end, measuring 0.85m wide. The threshold contained **(047)** at its west end, which was a stone jamb with a metal door hinge preserved in it and measuring 0.24 x 0.16m. Abutting (027) at the W end of the trench was **(034)**, a single broken flagstone measuring 0.39 x 0.39m. The contexts described above sealed **(020)**, a compact yellow clay with frequent inclusions of sub-angular stones and visible over an area measuring 3.00 x 3.04m.

Fig. 6 General shot of House 1

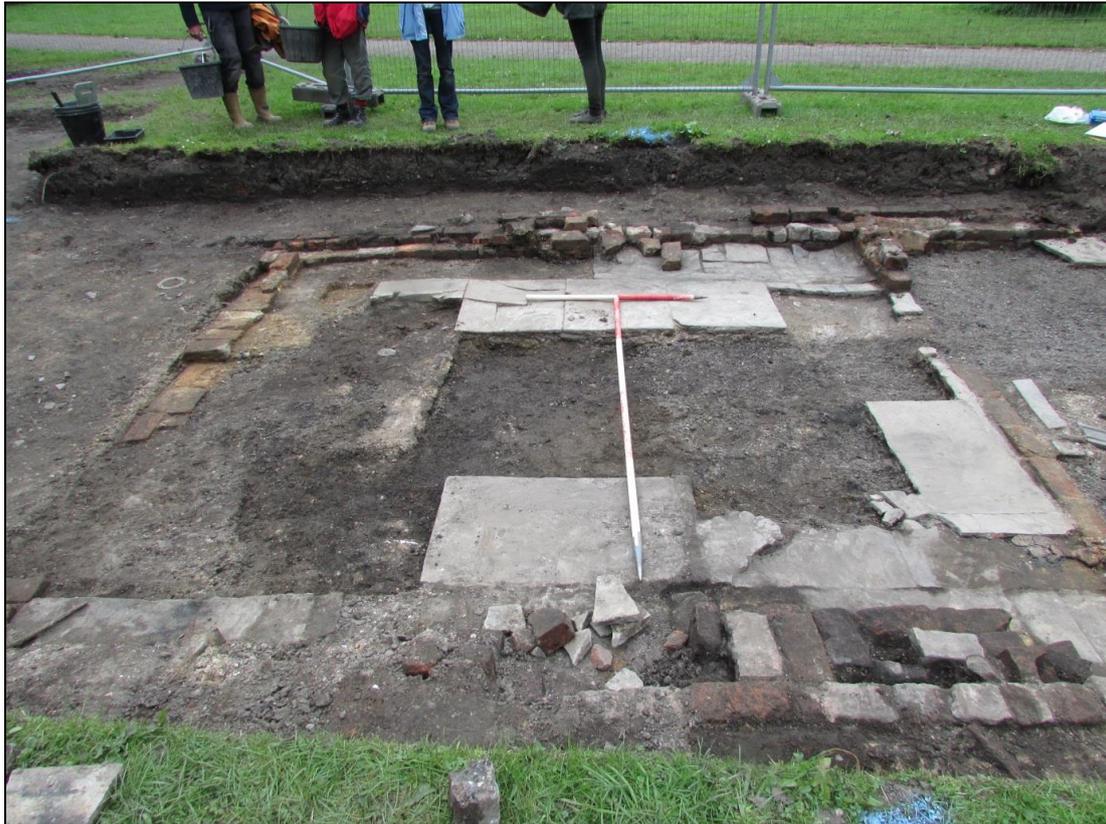
Abutting the S side of (098) was **(036)** which were a series of Yorkshire stone flags, varying in size between 0.87 x 0.58m – 0.18 x 0.25m. The area appears to have been more extensive but has been truncated in the centre of this area. They were best preserved within the E and N parts and also abuts (029). Abutting (036) to the N was **(035)**, which consisted of two handmade brick projections, 2 courses wide, orientated E-W and measuring 0.50m in length and set 0.90m apart. The N end abuts (098) and contains **(099)**, which was an area of Yorkshire stone flags, measuring 0.50 x 0.20m with bricks laid on top at the S end. The overall area measured 0.80 x 0.50m.

Fig. 7 Shot of House 1, Room 2

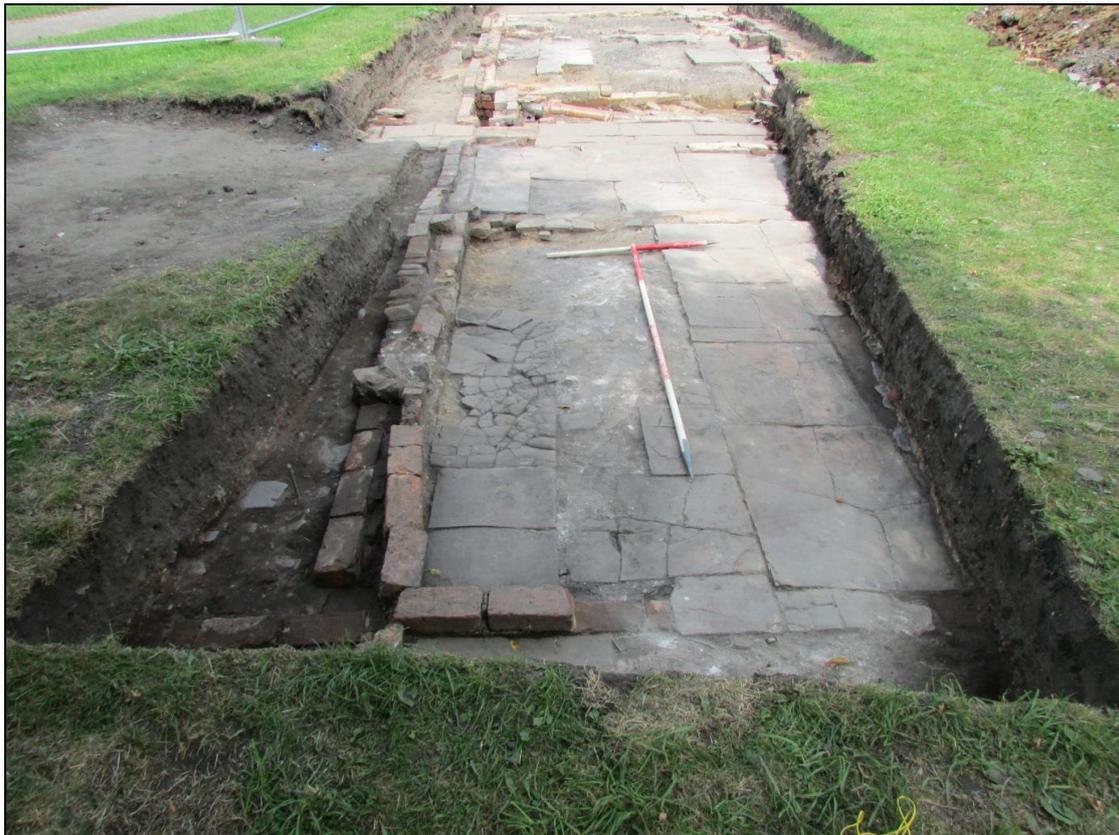
Flagged surface (039) also abuts **(040)** to the N, a handmade brick wall, two courses wide, running 2.60m E-W then returns N-S for 1.56m. This part of the wall has a possible threshold within the centre, measuring 0.77m wide. (040) is abutted by **(041)**, a Yorkshire stone flag floor surface covering an area measuring 2.43 x 1.51m, with stones varying in size between 0.78 x 0.60m and 0.95 x 0.74m. This was partially overlaid by **(042)**, which is a layer of white concrete covering an amorphous area measuring 2.40 x 1.40m at its widest. (041) was abutted to the S by **(043)**, a handmade brick wall, 2 courses wide, aligned E-W and measuring 2.13m in length

Fig. 8 Remains of House 2

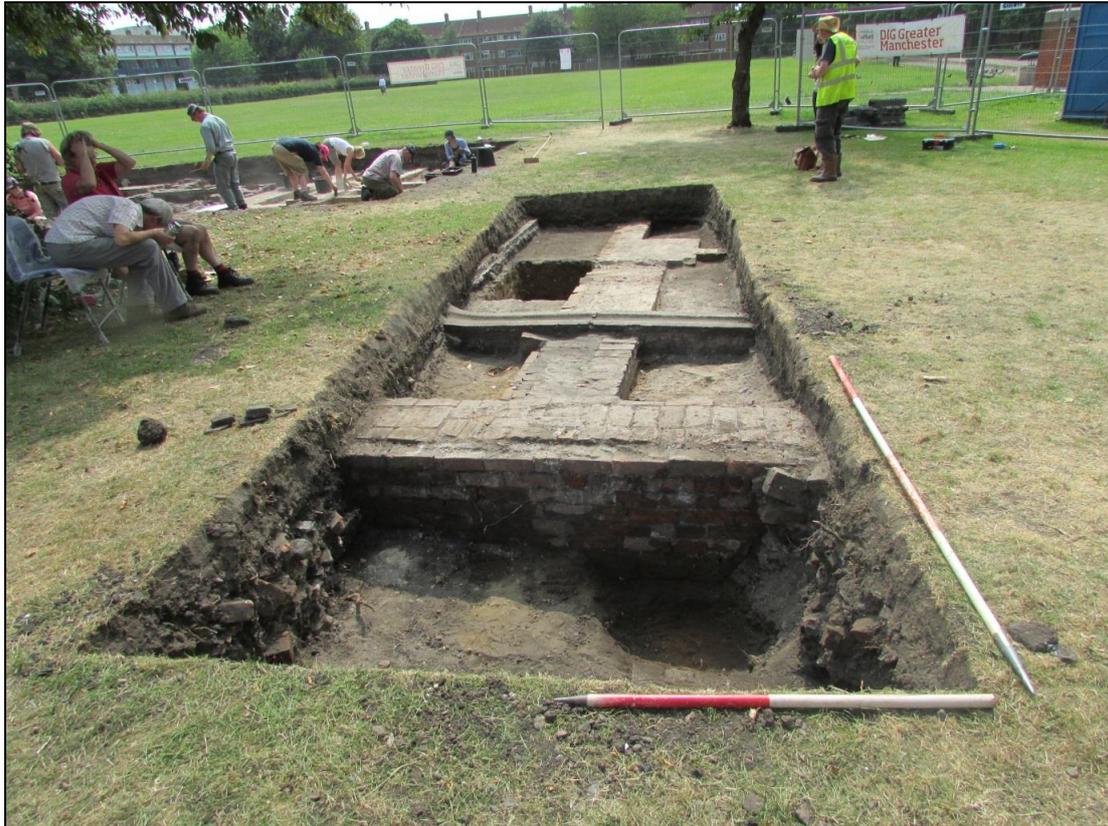
Fig. 9 General shot of Trench 5

Trench 5 uncovered partial remains of the barracks and the canteen and the trench measured broadly 8.00 x 2.20m. It was orientated NE-SW and was sealed with **(001)**, a fairly loose dark blackish brown loam, which varied in depth although did not measure any deeper than 0.30m. Infrequent small fragments of 20th century ceramics were encountered in this deposit. **(001)** sealed **(009)**, a very compact red shale levelling layer with no inclusions noted, measuring < 0.05m in depth. This in turn sealed **(010)**, a fairly loose dark greyish brown deposit with abundant inclusions of grit and infrequent inclusions of stone, slag and ash, measuring c.0.10m in depth. **(010)** sealed **(011)**, a layer of crushed brick measuring c.0.10m in depth and sealing **(012)**, a fairly loose dark greyish black coal tip deposit, measuring 0.05m in depth. **(012)** sealed **(049)** which was a concrete curb running NW-SE across the trench before slightly curving at the E baulk. The curbing is traced further SW running NE-SW, measuring 0.31m wide with a gully measuring 0.16m wide. **(013)** lay below **(049)** and was a friable dark blackish brown silty clay with inclusions of 19th century ceramics, glass and metal. **(013)** sealed **(102)**, a fairly compact light yellowish brown silty clay with frequent inclusions of sub-angular stones and brick. This was excavated to a depth of 0.50m.

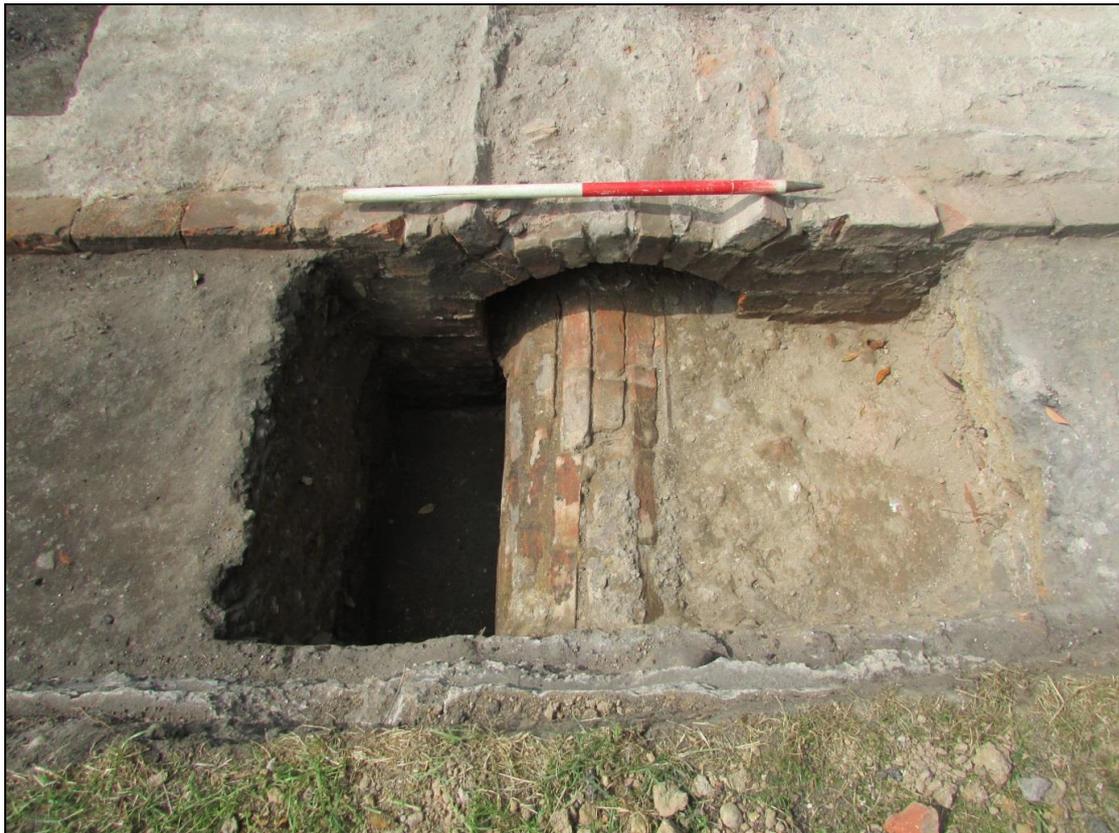
of headers laid on side and measuring 0.70m in width. It was again six courses wide like wall (050) and was constructed over **(075)**, a handmade brick arched culvert, measuring 0.30m wide, excavated to a length of 0.84m and with bricks laid on side measuring 0.23 x 0.11m. **(075)** was also sealed by (102). Abutting archway (051) to the SW was **(052)**, a rectangular brick feature measuring 0.97 x 0.61m covered with mortar obscuring the bonding. The bricks were handmade, measuring 0.23 x 0.12 and this feature was abutted by **(053)** to the SW, a handmade brick wall, three courses wide, orientated NE-SW with bricks measuring 0.23 x 0.11m and excavated to a length of 1.85m. This wall continues running beyond the S baulk. Abutting the NW face of (052) was **(054)**, a handmade brick wall, two courses wide, orientated NW-SE and measuring 0.27m in length, with bricks measuring 0.23 x 0.11m.

Fig. 10 Arched culvert (075) running below (051)
