Heliyon 2 (2016) e00154

Potential tree species for use in urban areas in temperate and oceanic climates

Miklas Scholz^{a,b,*}, Vincent C. Uzomah^b, Furat A.M. Al-Faraj^b

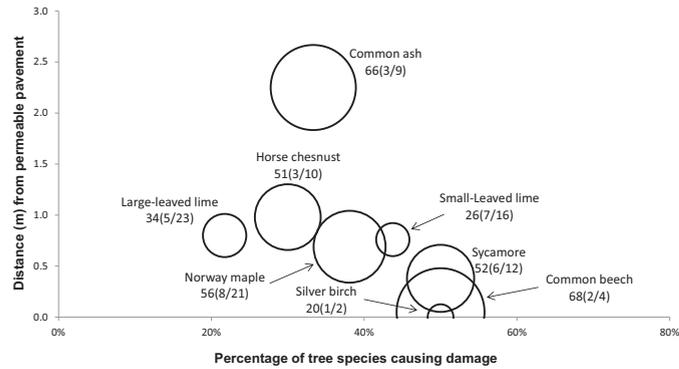
Fig. 2. Relationships of tree diameters at breast height (DBH (cm); represented by circles), average distances of trees away from permeable pavements, and the proportion of trees within 10 m to these structures subjected to moderate to severe damage. Note: $x(y/z)$, where x represents DBH and z indicates the number of the tree species out of which y trees caused damage.

Fig. 2, Fig. 3, Fig. 4, Fig. 5, Fig. 6, Fig. 7, Fig. 8 show the relationship of tree DBH, average distance of trees away from the structures, and the proportion of trees close to structures that caused moderate to severe damage. Note that only moderate and severe damage was considered, considering that the reason for light damage is often unclear. Apart from tree-related damage, other reasons for damage might be as important but only further destructive tests on site might reveal the main reason(s) for damage.

For $x(y/z)$, where x represents the DBH (cm), which is also signified by the relative size (diameter) of the circle. The diameters expressed by circles give a visual indication of the maturity of the average tree species, which makes visual comparisons between trees easier. The entry z indicates the number of the tree species within 10 m of the structure, out of which y trees caused moderate to severe damage.

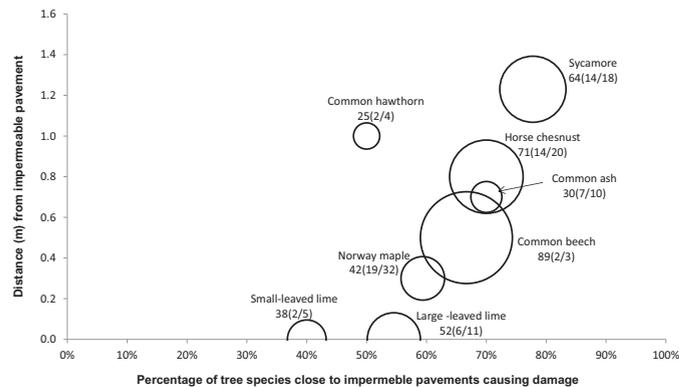
Fig. 3. Relationships of tree diameters at breast height (DBH (cm); represented by circles), average distances of trees away from impermeable pavements, and the proportion of trees within 10 m to this structure subjected to moderate to severe damage. Note: $x(y/z)$, where x represents DBH and z indicates the number of the tree species out of which y trees caused damage.

For permeable pavements, most significant ($p < 0.05$) damage to permeable pavements was caused by trees located within 0–1.0 m away from a structure, except for those from *F. excelsior*. About 33% of *F. excelsior* located close to permeable pavements caused damage to these pavements if their average diameter was 66 cm and if their average distance was 2.3 m away from the permeable pavements (Fig. 2). The trees with the highest percentage of moderate and severe damage to permeable pavements (up to 50%) were *F. sylvatica*, *A. pseudoplatanus* and *B. pendula*. However, the corresponding sample sizes were rather small. The average distance of *F. sylvatica* and *B. pendula* to permeable pavements was 0 m, indicating that most of these two species were planted too close to the pavement. The average DBH of these trees was 68 cm and 20 cm, respectively (Fig. 3).

For an impermeable pavement, the further away the tree (up to a distance of 1.4 m), the higher is the percentage of this tree causing damage irrespective of the tree DBH (Fig. 3). This is rather unexpected, considering that a large tree DBH is usually linked to large roots, which would cause damage at close range. However, the tree DBH variability is relatively small and the sample sizes are rather small as well. Regression analysis did not reveal any significant findings.

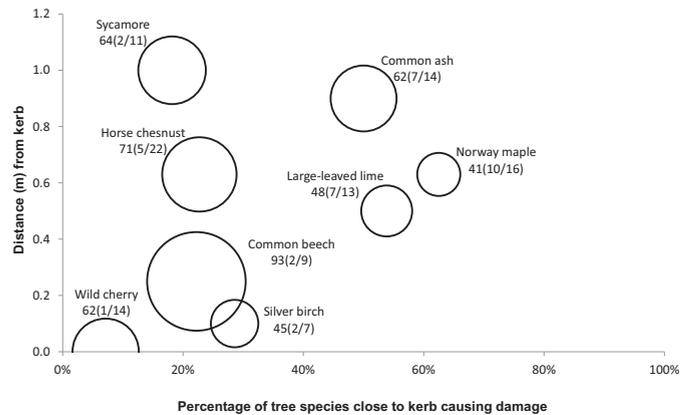
Fig. 4. Relationships of tree diameters at breast height (DBH (cm); represented by circles), average distances of trees away from kerbs, and the proportion of trees within 10 m to these structures subjected to moderate to severe damage. Note: $x(y/z)$, where x represents DBH and z indicates the number of the tree species out of which y trees caused damage.

Kerb damage comprised 19% of all recorded structural damage. *Acer platanoides* caused the most damage to kerbs (10 out of 16 trees were located close to kerbs) from an average distance of 0.6 m and with a mean DBH of 41 cm (Fig. 4). Similar to *A. platanoides* was the impact of *T. platyphyllos* (7 out of 13 nearby *T. platyphyllos*), *A. pseudoplatanus* (2 out of 11 surrounding trees) and *F. excelsior* (7 out of 14 surrounding trees) caused damage to kerbs from the furthest average distance of 1 m (Fig. 4).

Other trees that caused damage were less than 1 m from the kerb as shown in Fig. 4. *Prunus avium* was the best tree suitable for kerbs: only 1 in 14 trees caused moderate to severe damage (Fig. 4). However, most *P. avium* were very closely located (0 m) to kerbs, and their average DBH was 62 cm. This was closely followed by *F. sylvatica*. Although for *F. sylvatica* of an average DBH of 93 cm (indicating trees well-advanced in age) and an average distance of 0.23 m from kerbs, only 2 out of 9 trees caused moderate to severe damage to kerbs (Fig. 4). The worst tree to be located close to kerbs is *A. platanoides*. For trees of this species with an average DBH of 41 cm (indicating middle age) and located about 0.6 m from the kerbs, about 10 out of 16 *A. platanoides* caused moderate to severe damage to kerbs (Fig. 4).

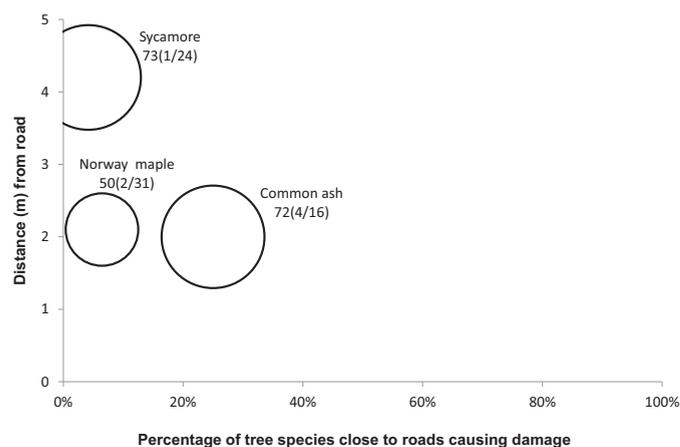
Fig. 5. Relationships of tree diameters at breast height (DBH (cm); represented by circles), average distances of trees away from roads, and the proportion of trees within 10 m to these structures subjected to moderate to severe damage. Note: $x(y/z)$, where x represents DBH and z indicates the number of the tree species out of which y trees caused damage.

The percentages of damage to roads and retaining walls were 3% each. Only three trees (*F. excelsior*, *A. platanoides* and *A. pseudoplatanus*) caused moderate to severe damage to roads (Fig. 5). Trees that caused damage to roads were located within an average distance of 2–5 m away from roads, indicating that the majority of them were planted close to the pavements.

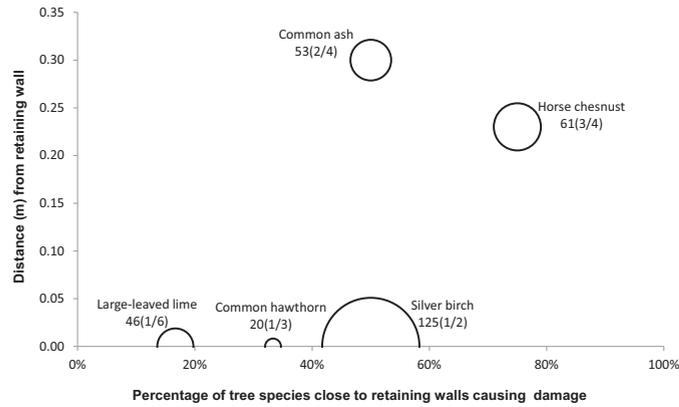
Fig. 6. Relationships of tree diameters at breast height (DBH (cm)); represented by circles), average distances of trees away from retaining walls, and the proportion of trees within 10 m to these structures subjected to moderate to severe damage. Note: x(y/z), where x represents DBH and z indicates the number of the tree species out of which y trees caused damage.

Not many trees were found close to retaining walls. For *B. pendula* with a DBH of 125 cm and planted at an average distance to structures of close to 0 m, only 1 out of 2 trees caused moderate to severe damage (Fig. 6). *Aesculus hippocastanum*

caused the most damage to retaining walls. Three out of four *A. hippocastanum* with an average DBH of 61 cm and located at a mean distance of 0.25 m away caused moderate to severe damage to retaining walls (Fig. 6).

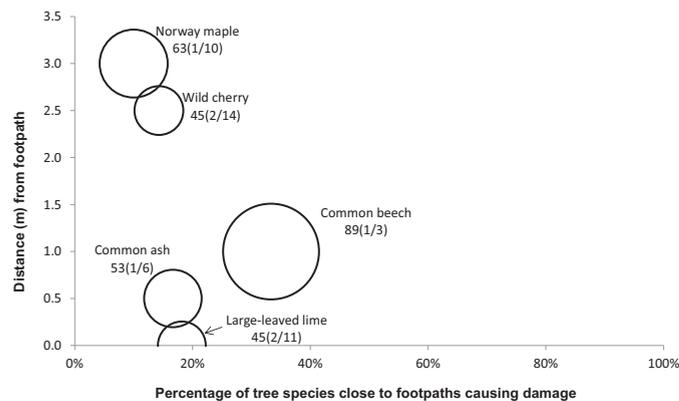
Fig. 7. Relationships of tree diameters at breast height (DBH (cm)); represented by circles), average distances of trees away from footpaths, and the proportion of trees within 10 m to these structures subjected to moderate to severe damage. Note: x(y/z), where x represents DBH and z indicates the number of the tree species out of which y trees caused damage.

Concerning *T. platyphyllos*, most trees that caused damage to urban structures (for example, impermeable pavements, retaining walls and footpaths) were very closely located to these structures compared to other trees (Fig. 4, Fig. 6, Fig. 7). Based on the survey, there was no record of severe to moderate damage by *T. platyphyllos* to some structures such as roads and walls. About 20% of the *T. platyphyllos* planted close to permeable pavements caused severe and moderate damage to permeable pavements from an average distance of 0.7 m. The average DBH of *T. platyphyllos* that caused damage were 34 cm. *Tilia platyphyllos* of this diameter were considered as still being in their growing stage (Table 1). The older these trees become, the more severe the damage would be.

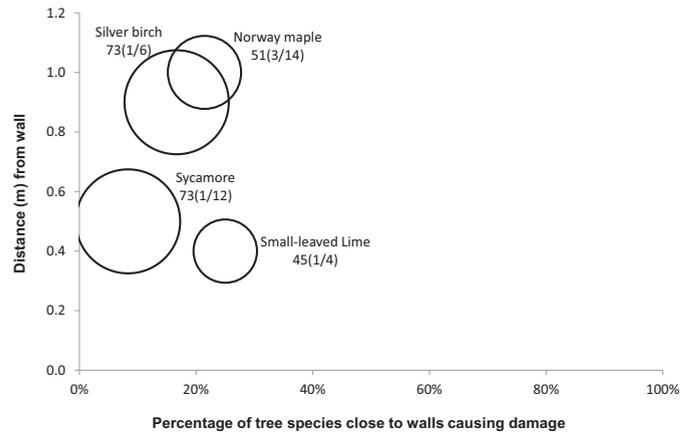
Fig. 8. Relationships of tree diameters at breast height (DBH (cm)); represented by circles), average distances of trees away from walls, and the proportion of trees within 10 m to these structures subjected to moderate to severe damage. Note: $x(y/z)$, where x represents DBH and z indicates the number of the tree species out of which y trees caused damage.
