BEHAVIOUR OF BACKFILLED MASONRY ARCH BRIDGES SUBJECTED TO CYCLIC LOADING

L. Augusthus-Nelson¹, G. Swift², C. Smith³, M. Gilbert³, C. Melbourne¹

SUMMARY

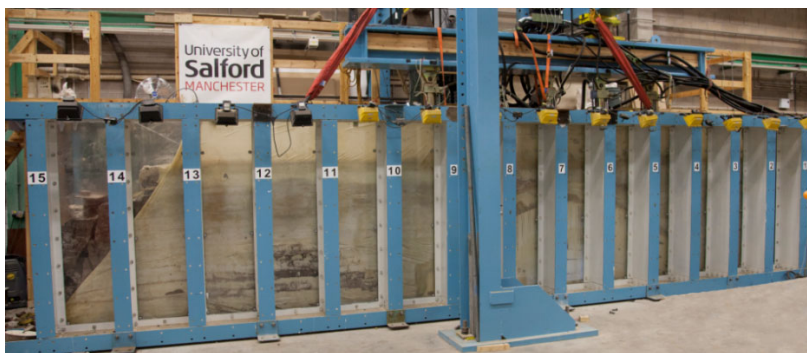
Fig. 2. Masonry arch bridge test chamber located at the University of Salford.

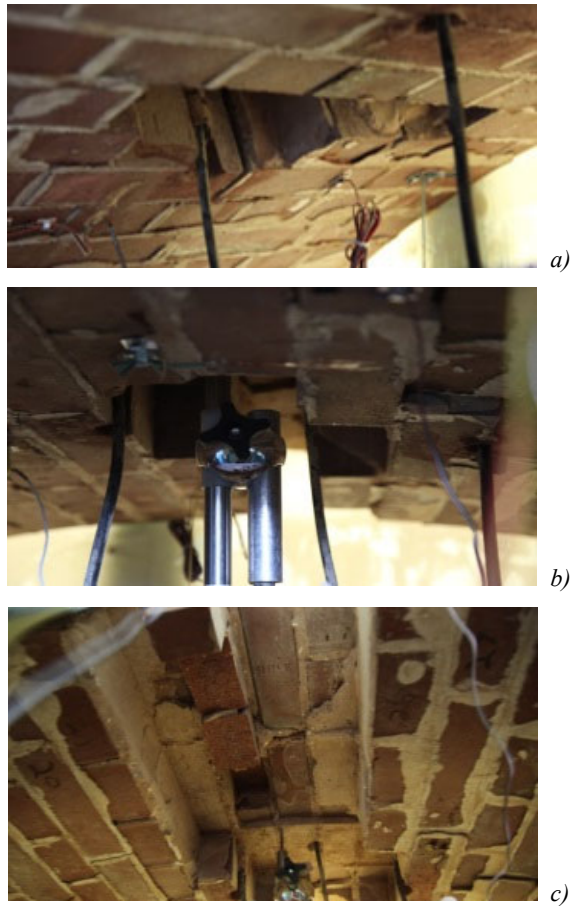
Fig. 7. Lost bricks at: a) state 1, b) state 2, and c) state 3 and 4.

The arch barrel deformed significantly at the start of 100 kN cyclic loading stage. At around 10^4 cycles, bricks fell out at the crown (denoted state 2 in Figures 5, 6 and 7). Immediately afterwards the amplitude of the arch deformation increased by approximately 0.5 mm at the quarter span. Further bricks were lost at the crown at around 1.7×10^4 cycles (state 3) and at 2.3×10^4 cycles (state 4). Immediately after state 4, the loading actuators were not able to reach the peak load of 100 kN due to significant reduction in the stiffness of the bridge. (This was because the hydraulic pump was unable to supply oil at a sufficient rate to maintain the desired cyclic loading regime.)
