# A review of the existing Wayfinding strategy for Salford Royal NHS Foundation Trust

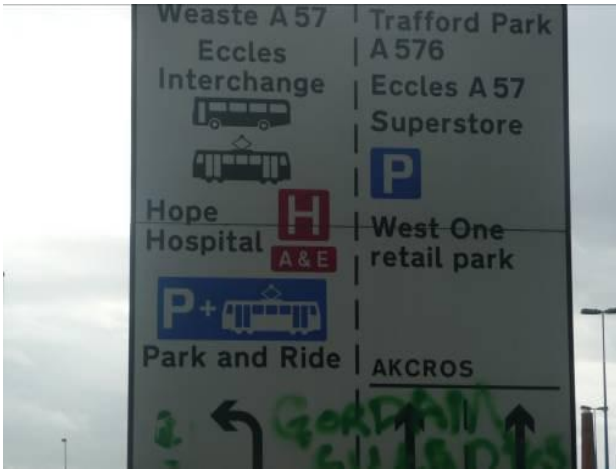
**1:** This picture is of the first sign one sees after coming off the off the M60. It is situated few yards beyond the first traffic circle. The directions for the hospital are easy to spot

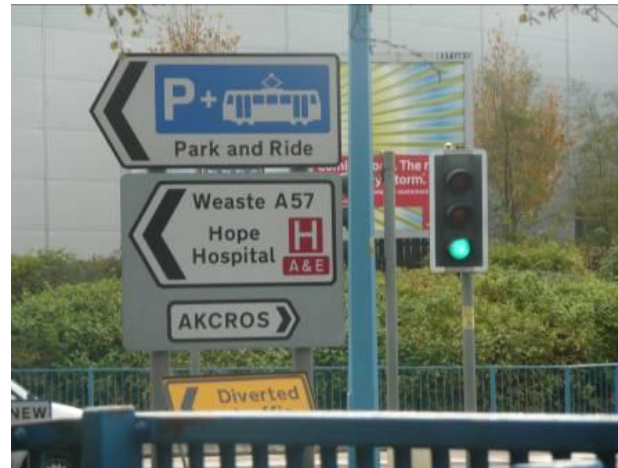
**2:** At the second traffic circle which is not far from the previous sign is another well situated sign giving clear directions.

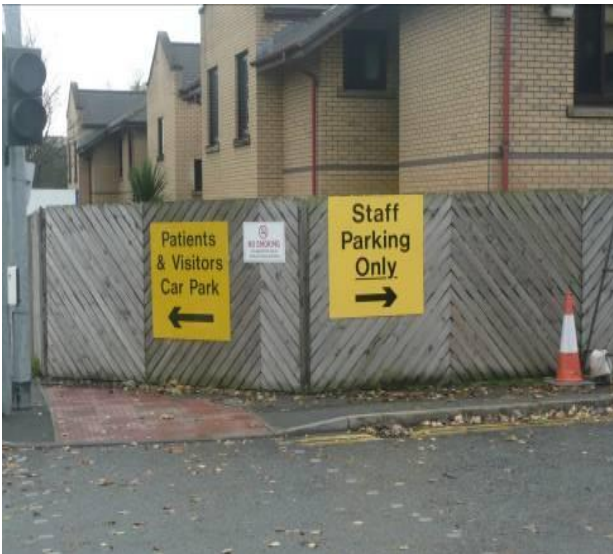
**3:** These signs can be spotted from a good distance once one turns into the lane that leads to the hospital. They are situated at a pedestrian crossing controlled by traffic lights. The use of a yellow background here attracts attention from a distance. Good contrast

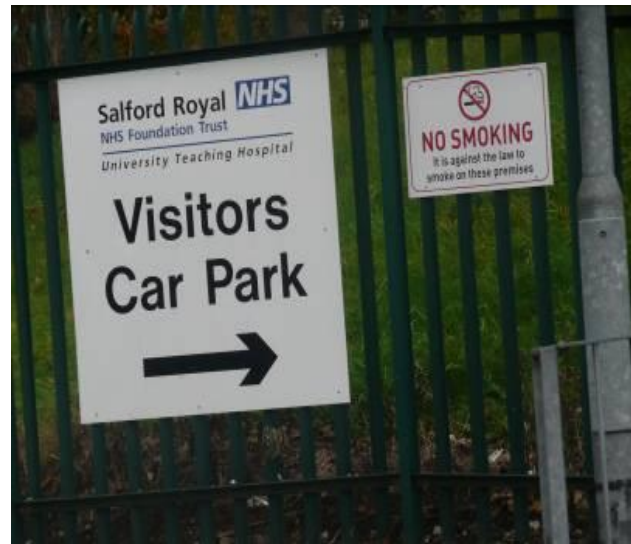
**4:** Yet another useful sign which can be easily understood and identified. It is situated at the entrance of the car park and is only a few yards from the previous set of signs

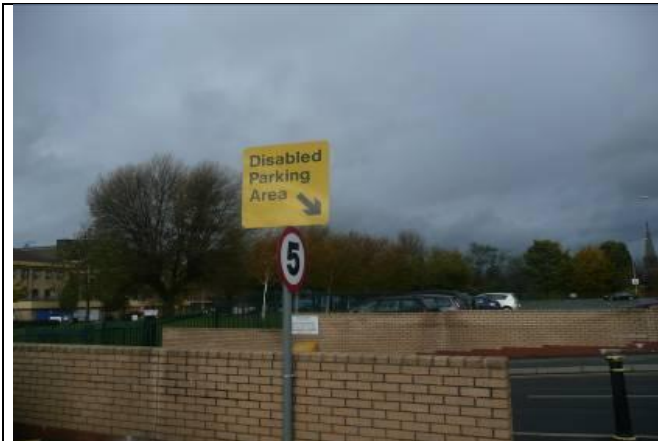
**5:** Inside the car park the signs guiding the disabled visitors are clear and situated at key positions where they can be easily identified. Again the use of a yellow background is effective.

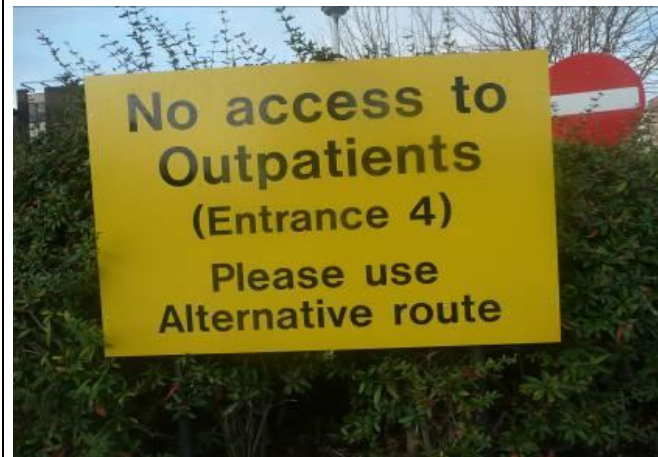
**7:** The instruction on this signs cannot be missed. In the next picture are directions for the alternative route

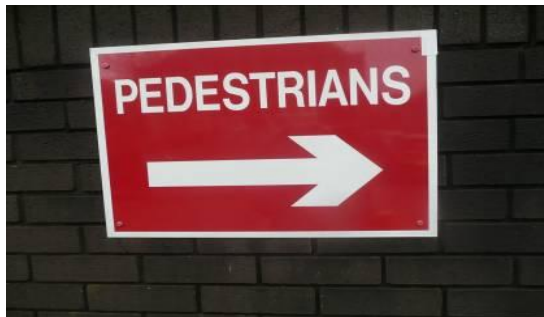
**9:** This sign gives to the A&E department. NB: The red background and white lettering are consistent with the bottom instructions in pic 6. Once again, another clear sign which communicates with the user from a good distance.

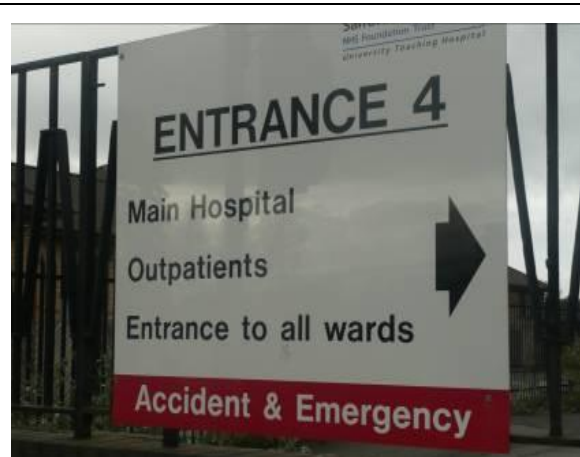
**6:** This sign faces the car park and is on the other side of the road dividing the hospital and the car park. Its strategic positioning means that it can be easily identified by both pedestrians and motorists. Here the use of the red background to denote A&E is consistent with that used in pic 1, 2, 9 and 24 but not with the messages in pic 7(prohibition) , 17 and 18 (directions for the red area)

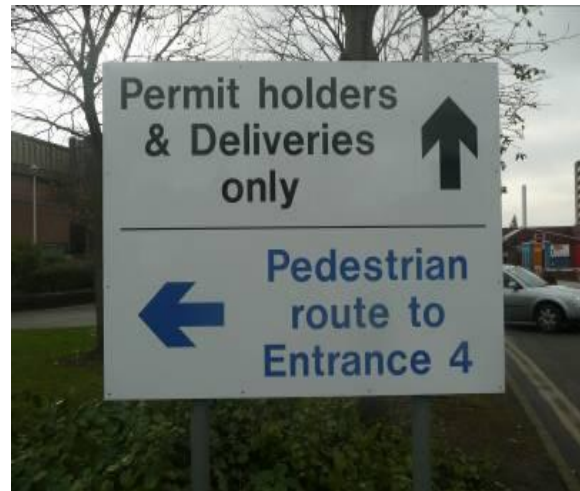
**8:** Not too far away from the last sign is this sign clearly communicating which way the pedestrians should go.

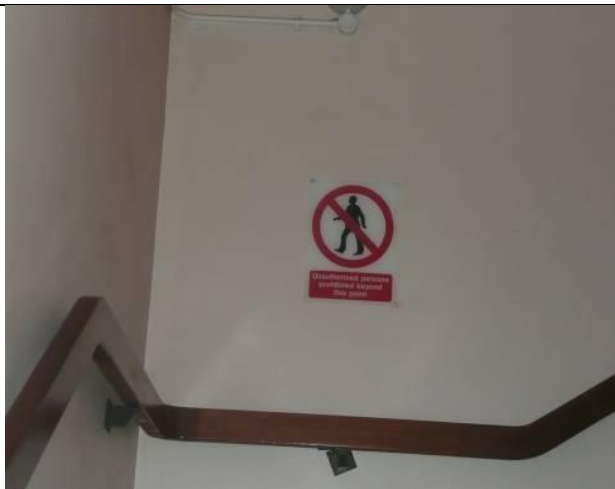
**10:** A pictogram forbidding unauthorised persons to go beyond the point where the sign is positioned. This sign is positioned at the top of the stairs that can be seen in pic. 33

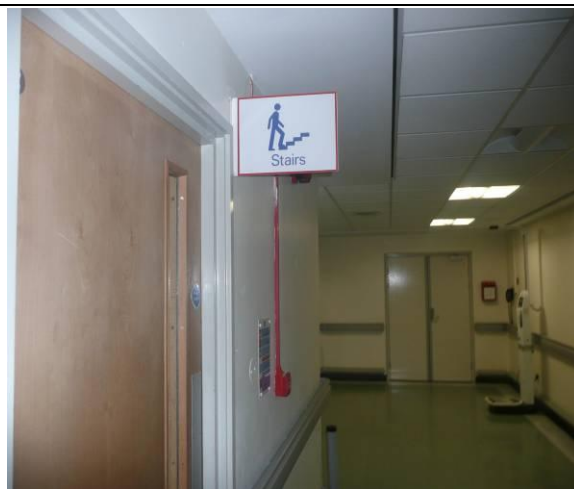
**11:** This sign informs the user of the presence of stairs. It would be interesting to find out if the pictogram would be interpreted differently if the word *stairs* was missing. Apart from the announcement of the stairs, the pictogram appears to inform the user which way the stairs are leading (UP). This concept is paid attention later (see pic 40)

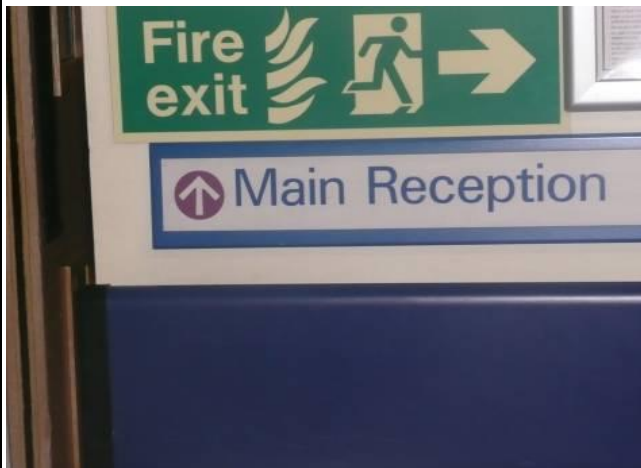
**12:** Here the symbol of a fire and a person running away from it could not be understood in other terms. Aided by an arrow, the two pictograms could be understood even by those who may have difficulty with reading

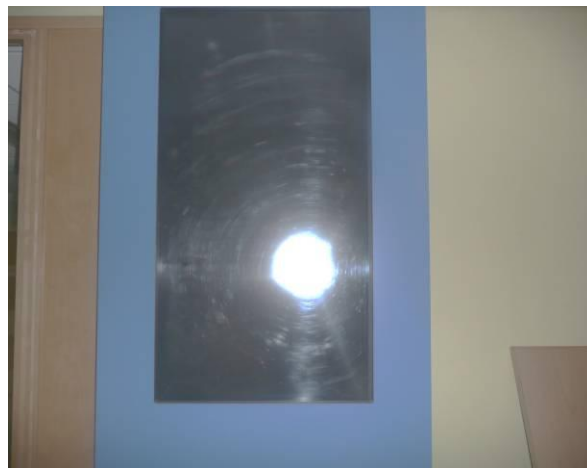
This is a picture of a VDU found at the outpatient reception. Patients attending clinics are guided by information displayed on this unit as to which way to go. As will become apparent later, its value is appreciated by staff doing clinics at the weekend

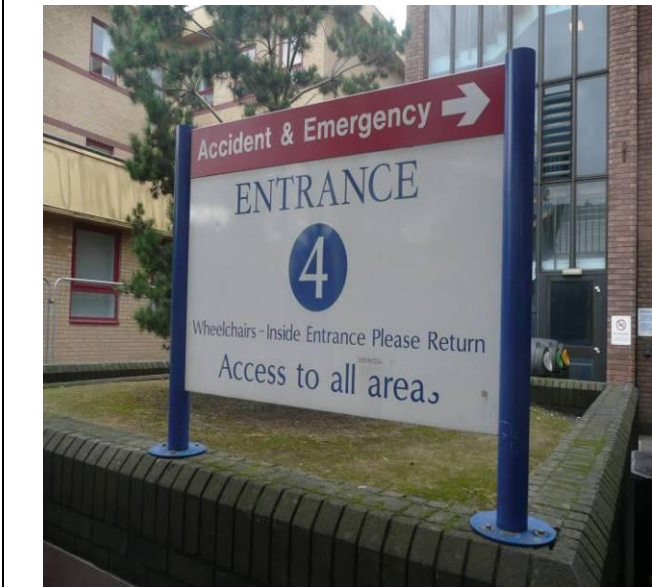
**13:** This sign is positioned a few yards to the right of the actual entrance. It is difficult to miss which way to go from this point. This is partly due to the fact that the entrance itself is designed in such a way that one is able to identify it as one without the need for words to announce it (big glass doors, rotating doors with compartments etc).

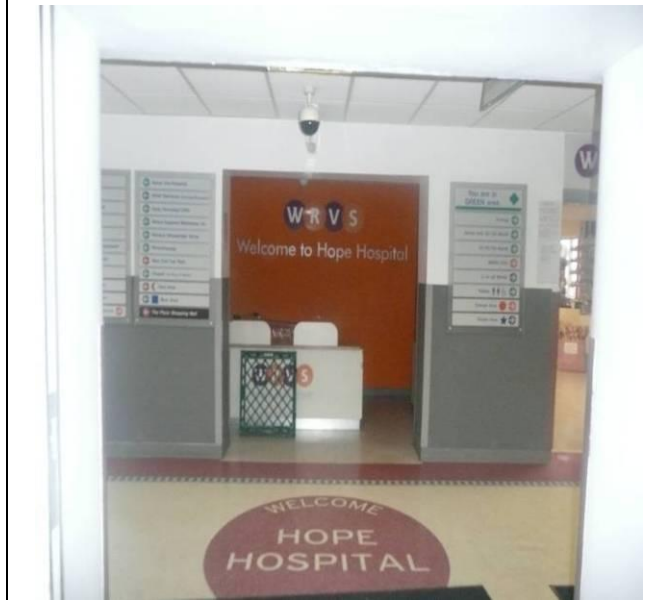
**14:** Yet another clear entrance announcing arrival with warmth (WELCOME). The visitor is presented with not only useful and clear information but the smell of coffee coming from the WVRS shop not too far to the right. The atmosphere here is very comfortable.

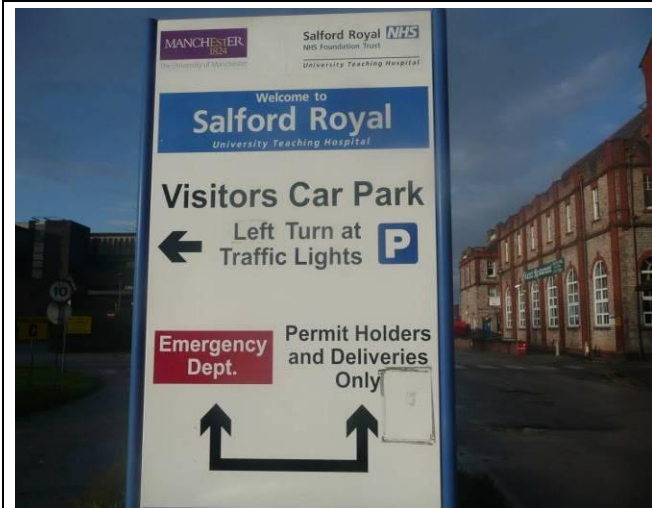
**15** This sign faces the lane that runs through hospital. The information and directions on it are clear and easy to follow.

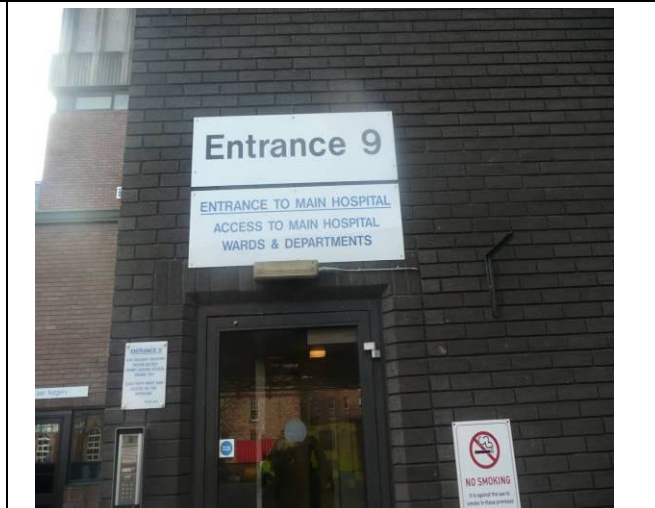
**16:** Unlike the other entrances around the hospital, this entrance could be easily mistaken for an ordinary door had it not been for the big and bold announcement on top of the door

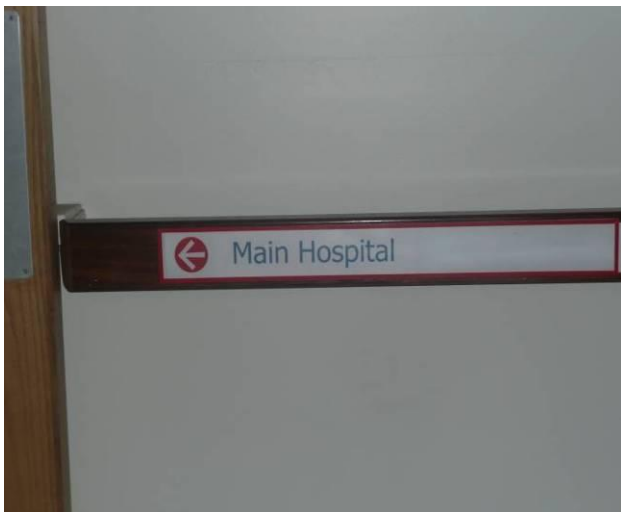
**17:** This sign clearly communicates which way to go for the main hospital (through the red area). Not difficult to spot.

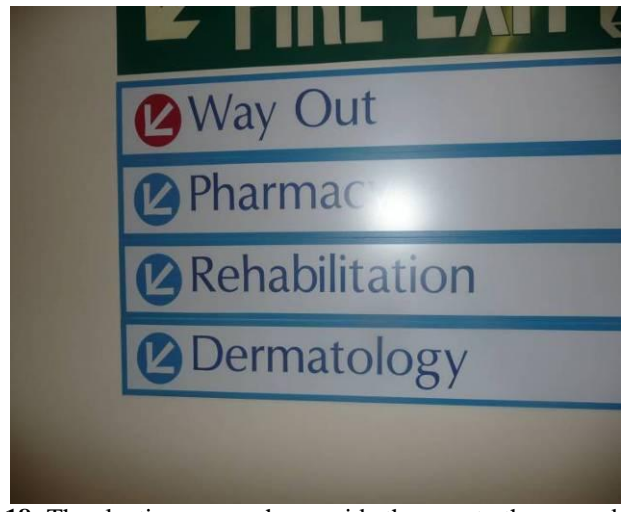
**18:** The slanting arrows here guide the user to the ground floor. The signs are on the stairs between the ground floor and the first floor of the blue area. The red arrow says the way out is through the red area

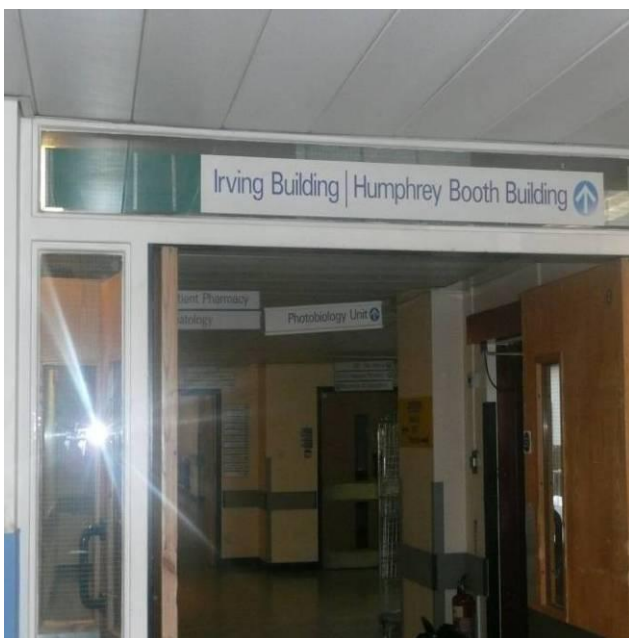
**19:** Here is another bold announcement of the two buildings housed in the blue area.

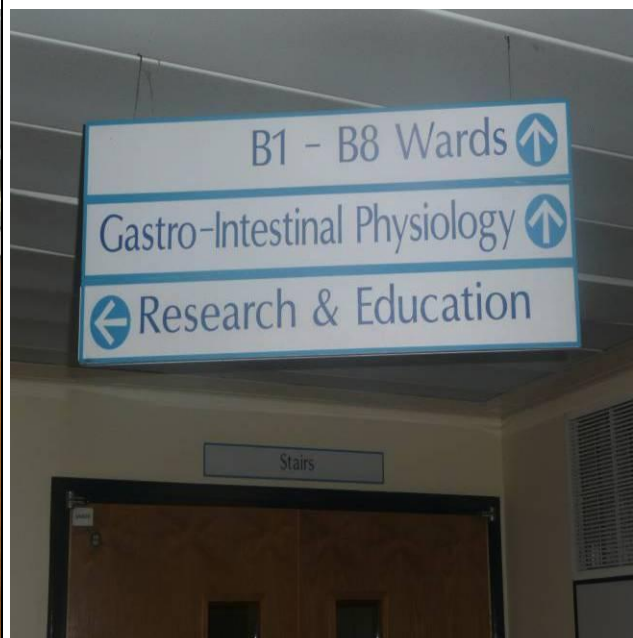
**20:** These directions are strategically placed to communicate that going through the stairs would take the user to the next floor where the wards and the Gastro-Intestinal Physiology can be found.

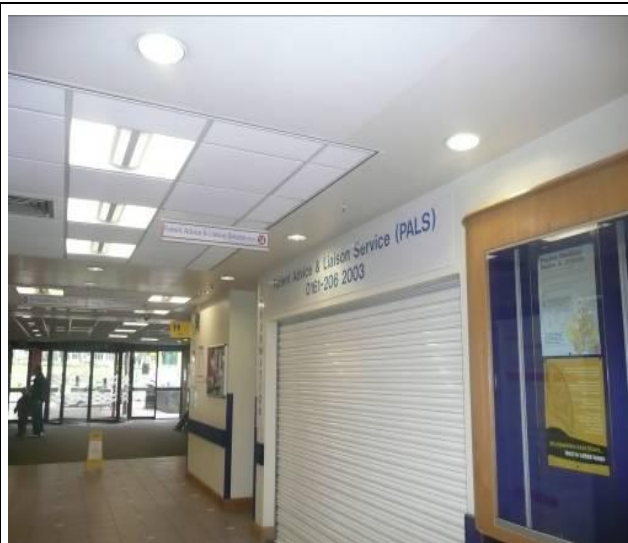
**21:** PALS personnel appear to be the first point of call as they are situated at the beginning of the internal journey via entrance 4. However, other hospital staff in general (nurses, porters, etc) will always stop and give directions either voluntarily or when asked

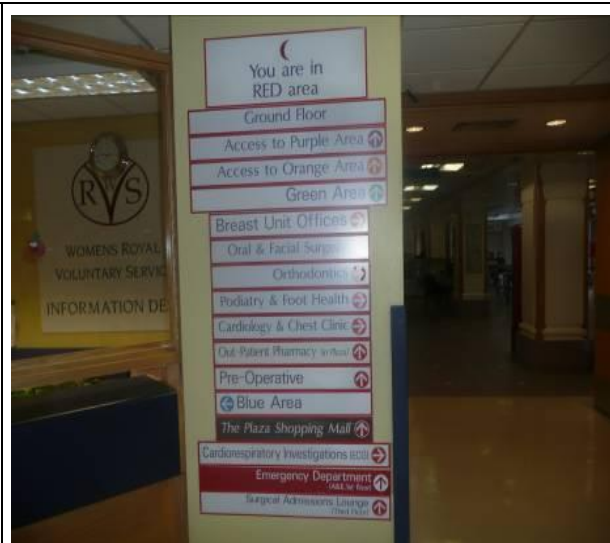
**22:** The WRVS volunteers are quick at spotting someone who is lost. They offer spontaneous help even to those who decide to make sense of the directions seen on the wall without asking for help. Interestingly most people appear to prefer to use this service more than they do the directions on the wall which can be seen in this picture.

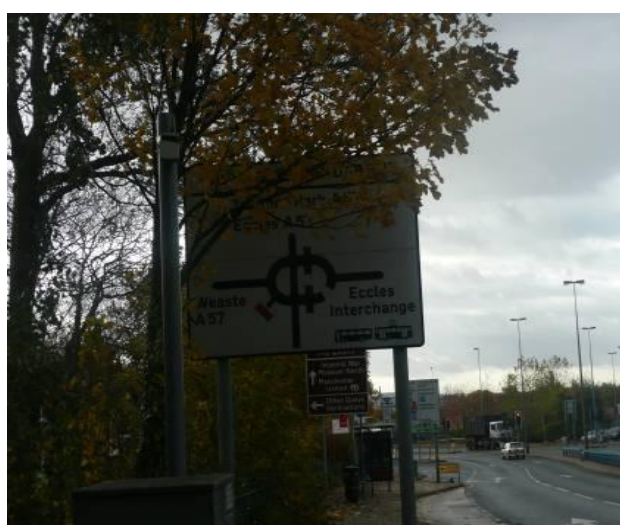
**23:** This sign is a few yards before the sign shown in pic 1. The vital information that should communicate road position for the hospital is obscured by overgrown trees. As both signs are very close to each other, it is easy to miss the correct turn to the hospital

trimming back the foliage which obscures the direction giving signs (pic 23 & 24), putting up a sign for the hospital at the first traffic circle off the motorway, putting up one or two bold signs in the distance between the second traffic circle (pic 2) and the last sign (24) and making the last sign bigger and bolder. Lessons can be learned from Balfour and Beatty who are keen to guide their customers all the way from the first traffic circle to where they are on the hospital site. In the medium to long term there is need to clear the confusion caused by ambiguous and misleading signs. A reduction in the number of signs used internally is likely to create a less confusing environment. There is plenty of scope for improving the environment by paying more attention to the current confusion caused by what appears to be a haphazard use of colour. The hospital environment also has a lot of room for embedding other forms of knowledge that should help the user find their way with much ease apart from signs and written word. The use of meaningful artistic landmarks on the bear walls and long corridors (see pic 30 & 51) that characterise the hospital could be one way of doing it. Literature on wayfinding also suggests several principles for improving wayfinding strategies in complex environments by paying attention to the design and architectural layout of buildings. For example, instead of labelling various entrances to the hospital by written word or sign some kind of landmark which can be spotted from a good distance on top of the roof could be used to denote entrances.

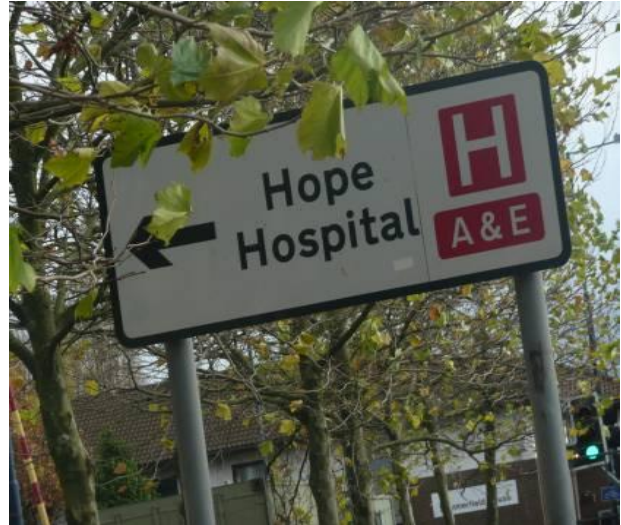
**24:** This sign is the first sign one's sees after the one shown in pic 2. Between the two signs is a distance of at least a mile and a half. The branches of the overgrown tree make it easy for one to miss this crucial sign. As it happens the turn is only a few yards away at the traffic lights seen beyond the sign. It is possible that most drivers find themselves braking suddenly to turn right or miss it completely. The sign is not very bold.

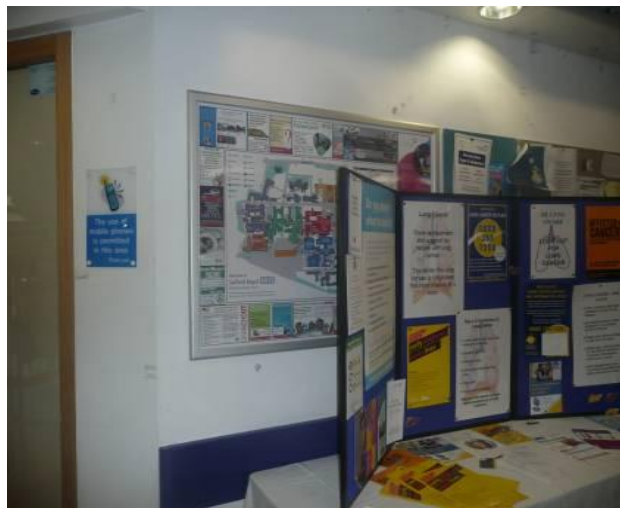
**25:** Behind the display seen in this picture is a map which should be at every entrance and at key decision points. Needless to point out that the vital wayfinding information cannot be easily accessed in this instance

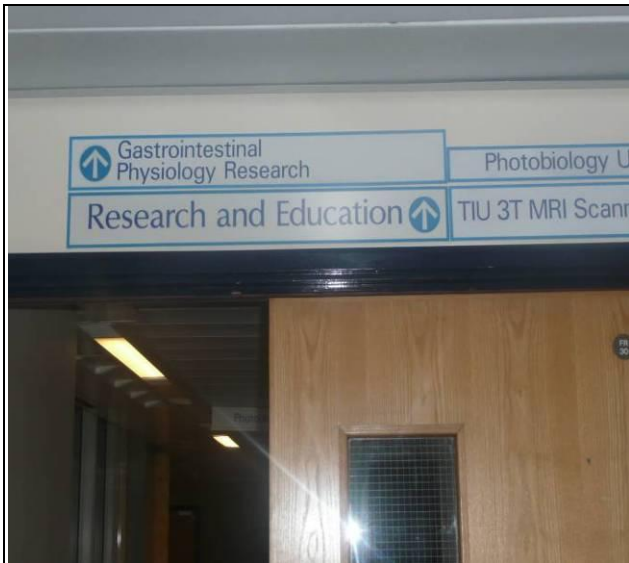
**26:** The directions for the desired destination could be interpreted as next floor up or straight ahead. This is on the ground floor of the blue area. When one follows the straight ahead prompt, they eventually end up at the red door seen in the next picture

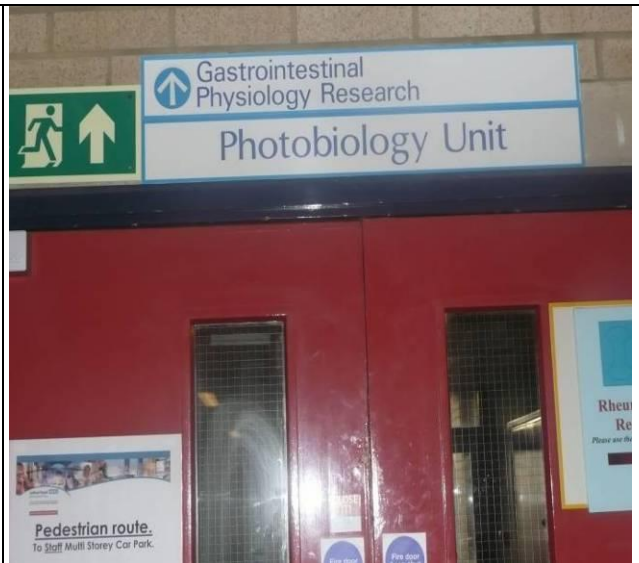
**27:** This picture is of a door on the ground floor. The directions for the destination could still be interpreted in the same way as in the previous picture. However, some new information (sign for the fire exit) may lead one to the conclusion that the destination is straight ahead.

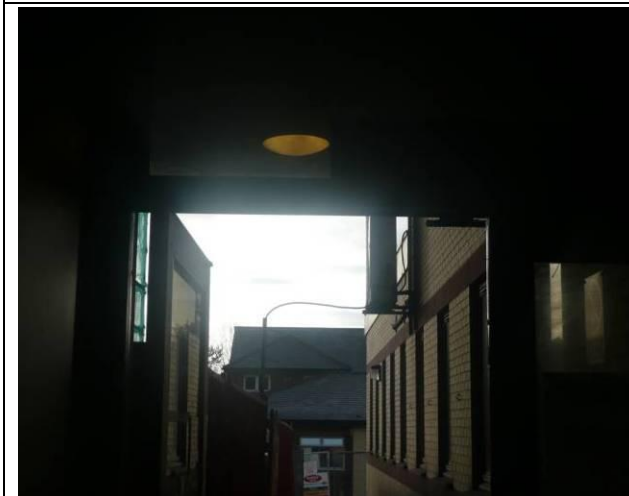
**28:** This is what one finds on opening the red door, the fire exit. It becomes clear at this point that the arrow indicates that the destination is on the next floor.

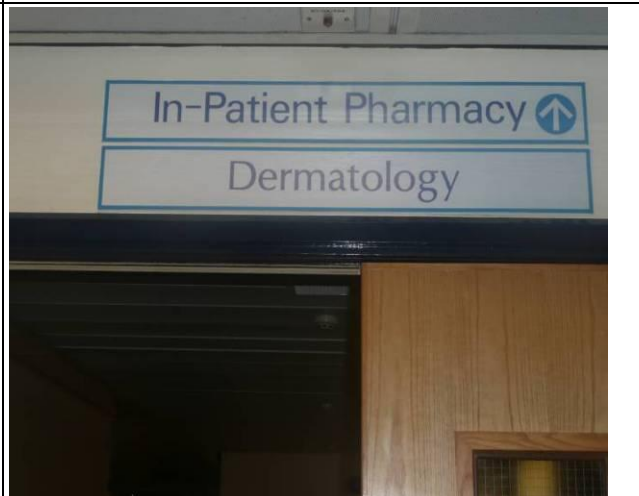
**29:** These signs are positioned at the beginning of the section of the blue area which houses the departments shown. The missing arrow on the bottom sign creates the impression that Dermatology comes before In-patient pharmacy.

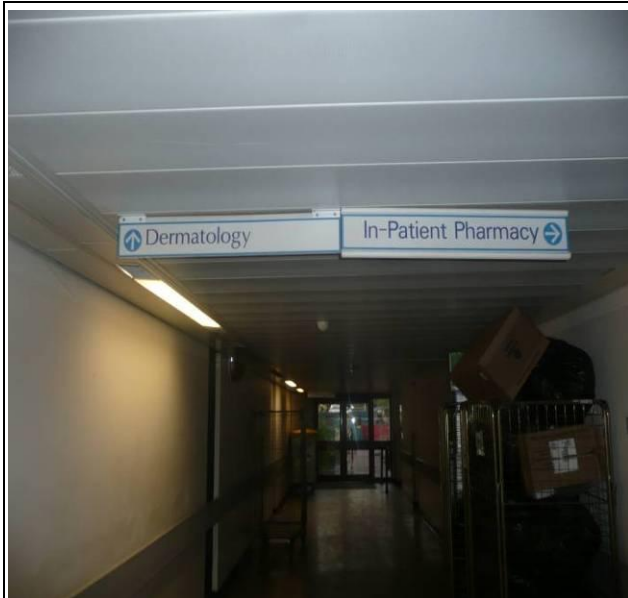
**30:** However, the next set of signs gives a different message. Dermatology is further ahead and the door to the pharmacy can be seen on the left hand side

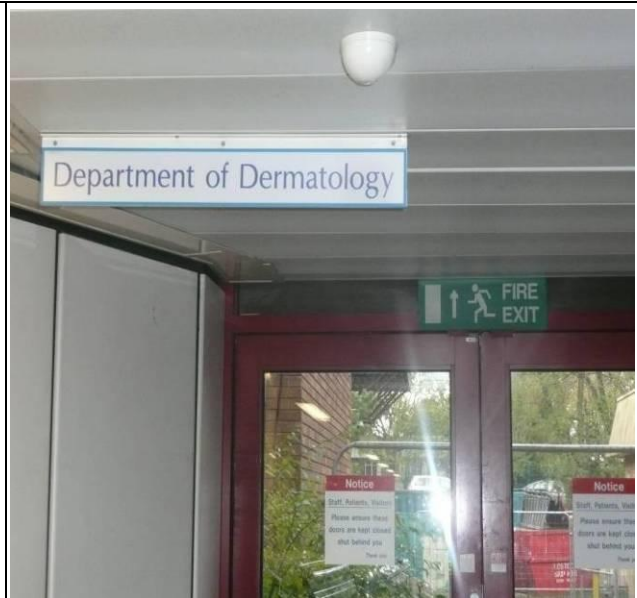
**31:** Here there is a complete lack of guidance. Again, the missing of an arrow appears to announce arrival and indeed the door to the department is situated opposite the sign on the left hand side. The confusion created in this part of the hospital is observable in the way users go past the sign through the fire door and back again.

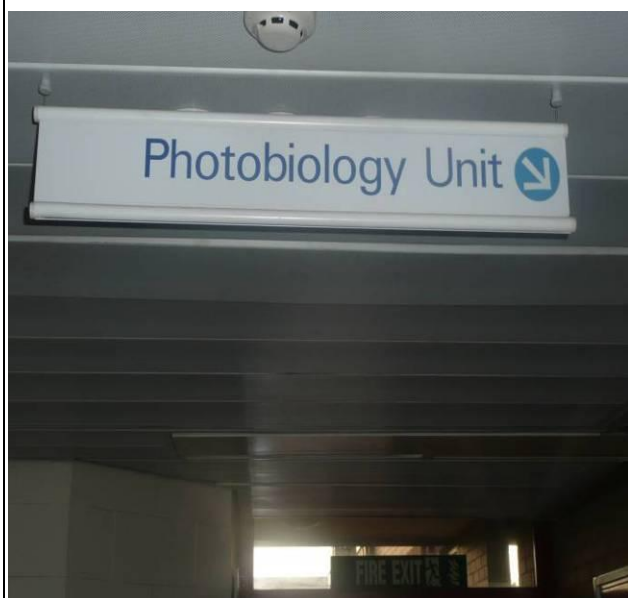
**32:** Is it right here or down downstairs. Going by the message portrayed by the arrows in pic 18, Photobiology is downstairs. However, the unit is opposite the sign to the left and it is on the ground floor (see pic 27) Perhaps a straight arrow (see pic 30) would be less confusing.

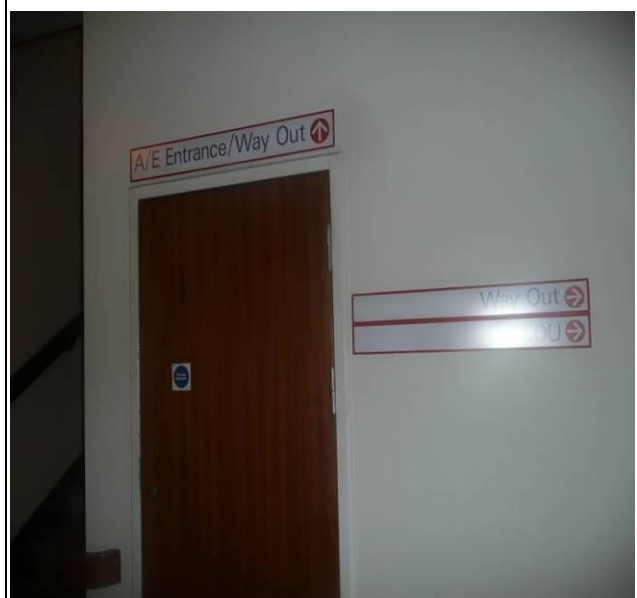
**33:** Is it though the door, up the stairs or to the right? As it happens, the door seen here is a cupboard and just at the top of the stairs is the symbol for no unauthorised entry (see pic 10). Could it be the case that this symbol was put to clear this confusion?

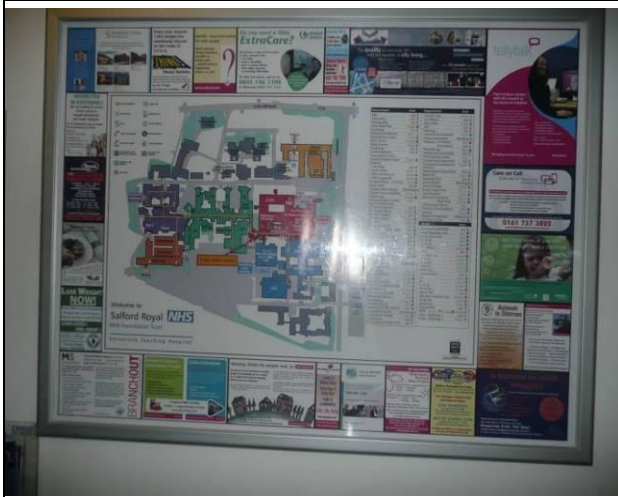
**34:** Map found at every entrance and key decision points (too much clutter and colour and commercial activity). A very small number of users can be observed trying to make sense of the maps with great deal of frustration. In entrance 4 where the help from PALS and WVRS is readily available, these maps appear to serve the purpose for which they were designed.

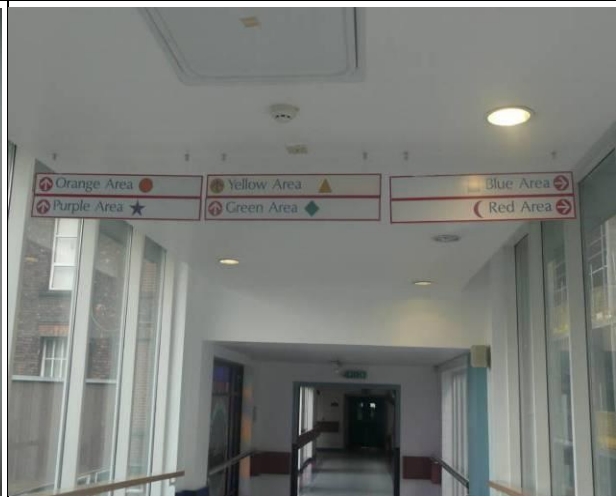
**35:** Signs in the connecting corridor between the red area and the purple, orange, green and yellow areas. Some admit to not paying attention to signs (see section colour). Besides what about those who cannot read? The symbols representing each colour coded area do not appear to be used by visitor's patients or staff who guide for wayfinding purposes.

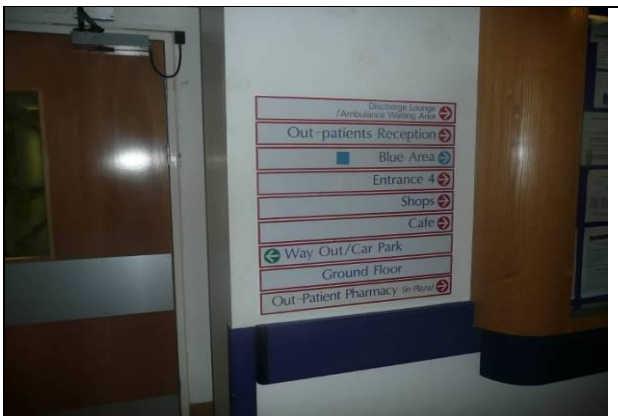
**36** The **way out/car park** instruction here is confusing because entrance 1 to which the arrow points has been closed. From this point, nothing else gives the user an alternative way of getting out. This also happens to be the instruction quickly spotted by those arriving on the ground floor via the lift. Here, it is not difficult to tell by way of behaviour that someone is struggling to make sense of this part of the environment. The instructions contained in pic 37 happen to be on the wall opposite this artefact.

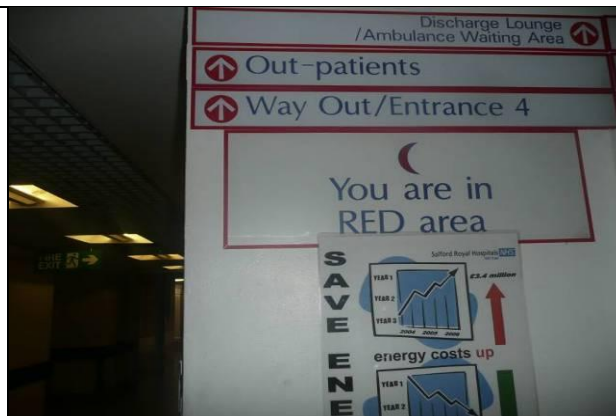
**37:** The instructions on this picture appear to have been put for the benefit of those coming from the car park (see pic 36). The arrows are well positioned for those looking for a way out through the Plaza. However, this set of instructions is easily missed by those walking out of the lift area which is to right of this wall. Unfortunately, the instructions for the way out end here. Beyond this sign, the user is presented with yet more challenges of working their way out through the Plaza (see pics 38 & 39). Pic 43 shows in full the corridor to the left of this wall.

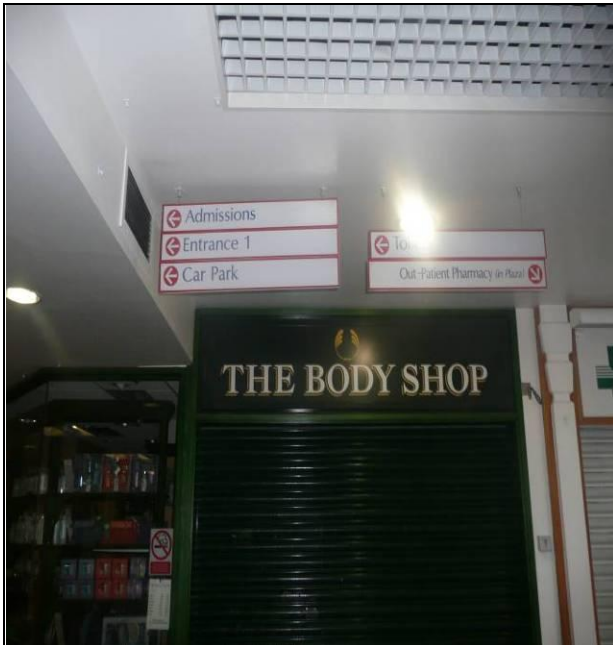
**38:** This shop is situated at the end of the corridor shown in pic 42 and is opposite the doors which can be seen in pic 39. The area in between is a busy dining area which is laced with several other shops and a canteen. Direction giving signs are drowned by large bold ones advertising the commercial activity in this area. The latter distract one from finding their way out.

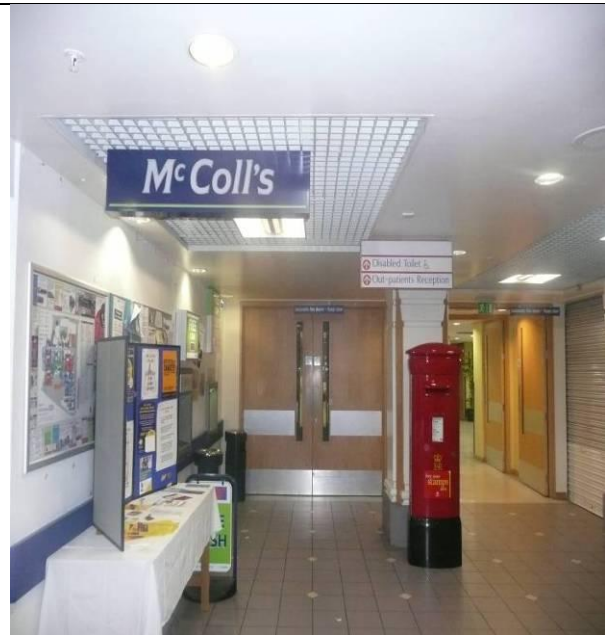
**39:** The automatic fire doors seen on either side of the pillar box mark the end of the Plaza. Hanging above the pillar box are signs guiding the user to the disabled toilet and outpatient reception but not the way out. It is only after one has walked through the open doors to the left that one is presented with the directions guiding one out of the hospital.

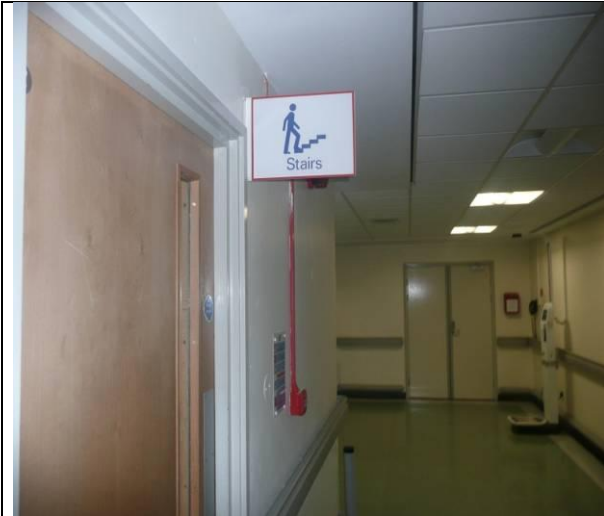
**40:** This sign is found on the first floor. The pictogram appears to say the stairs are for going to the next floor up. However, once you go through the door, it is clear that the stairs are for both up and down.

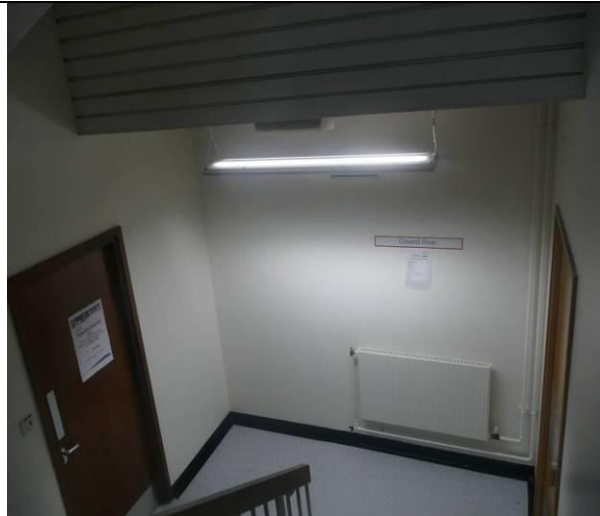
**41:** The ground floor sign on the wall clearly announces that you have arrived but confusion follows because the user is not guided as to which door gets them out. The artefact on the door to the left is an advertisement. The door to the left is the exit.

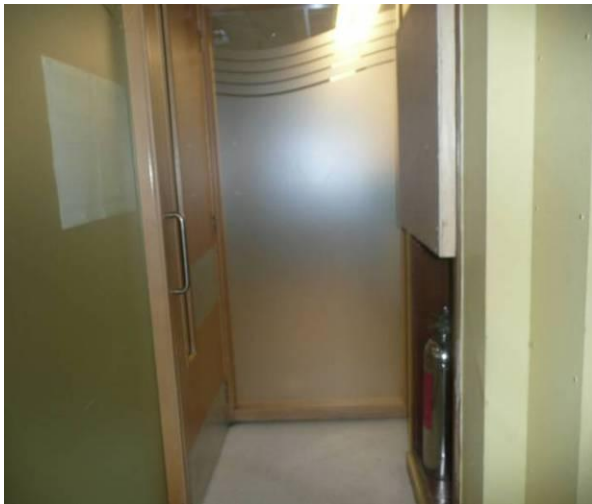
**42:** The confusion continues here where one is presented with a small corridor with complete absence of guidance. However, the open door clearly invites one to walk through in search of further clues. Food for thought: Is this door a fire door? If it is, should it not be kept shut all the time

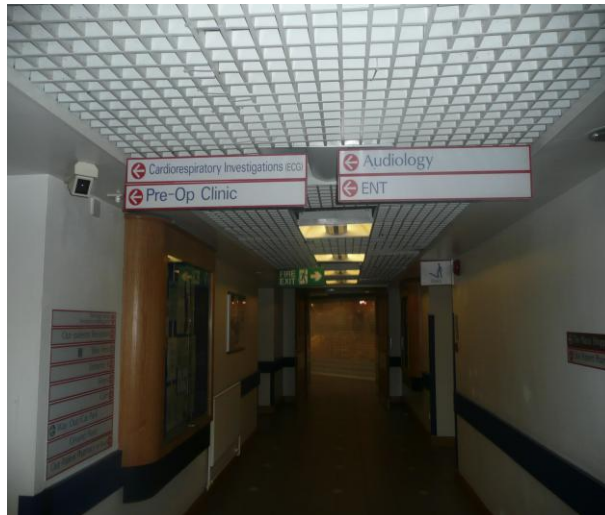
**43:** This picture shows the breakdown that occurs when one tries to find their way out via the Plaza area. On the right can be seen the pictogram announcing the stairs on the ground floor. When one gets out, straight ahead is a painting; to the left are hanging signs with instructions for clinical destinations and to the right which happens to be the way out to entrance 4 nothing at all to guide the user. The instruction on the wall to the left have instruction for the way out to the car park (see pic 36)

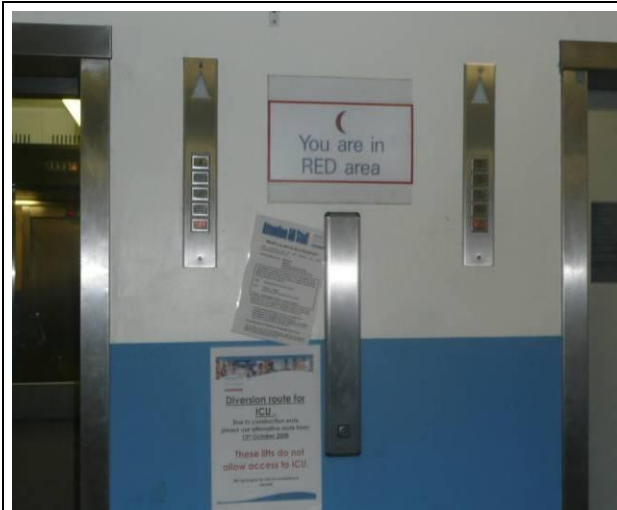
**44:** The journey by lift starts on the ground floor not far from the entrance to the blue area. Where to find lifts is clearly labelled. Besides, other people are always ready to assist.

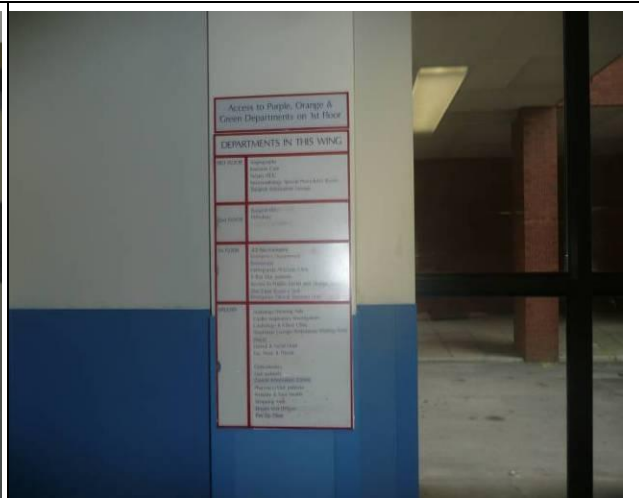
**45:** This is on the ground floor. The information giving sign is on to the left when stepping out and to the right when going into the lift. Opposite is another set of lifts seen in the next picture.

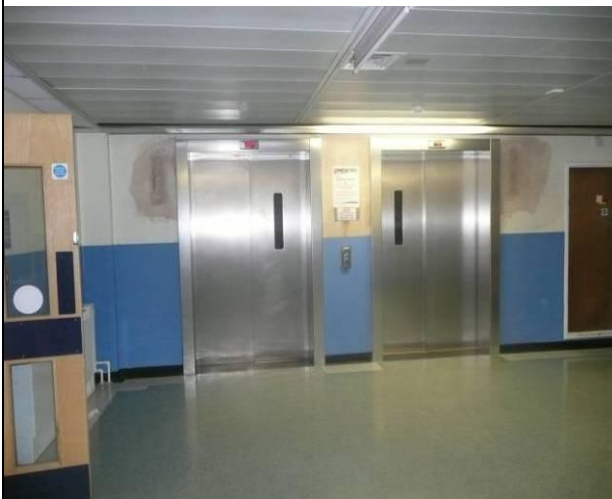
**46:** This is a picture of what one is presented with on stepping out of the lifts on the first floor. Straight ahead another set of lifts can be seen. Here people can be observed looking straight ahead for clues. Some information giving artefact can be seen between the lifts.

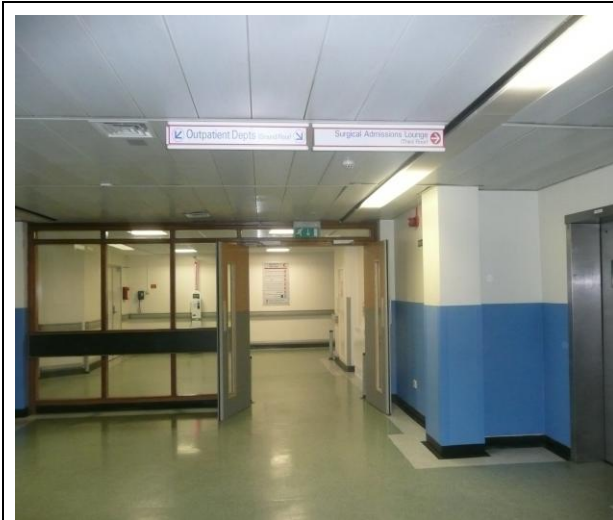
**48:** The hanging signs do not give immediate information to the user coming out of the lift as they are not facing the lifts. They are meant to guide people into the lifts. Within the lift area, a clear breakdown can be observed. Once again as has been pointed out earlier, the open door (see Pic 41) clearly invites one to walk through in search of further clues. Also the sign on the wall beyond the door is an invitation to explore.

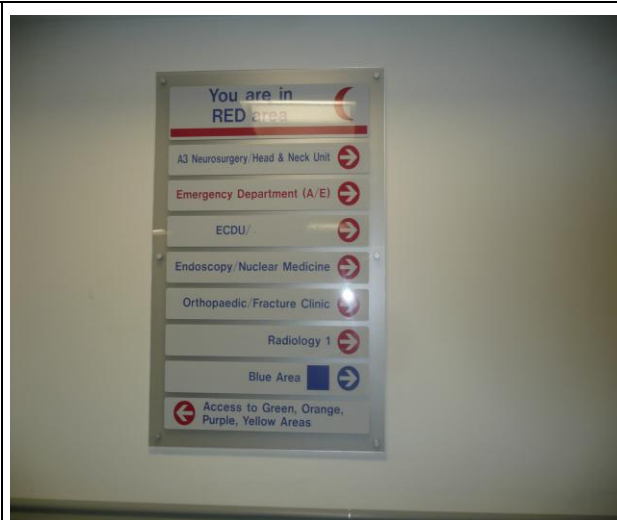
**49:** This sign is a close-up of the one which can be seen on the wall beyond the door (pic 48). Its clarity and sense of purpose cannot be faulted. However, the next set of pictures demonstrates the breakdown in the last set of instructions connecting the red area to the purple, green, orange and yellow areas.

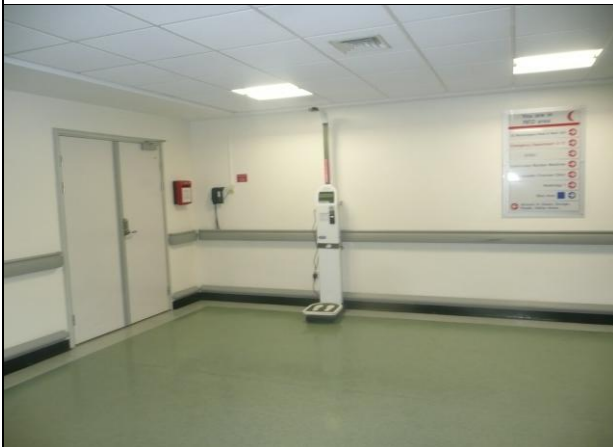
**50:** To get to the other areas via entrance 4 one must use the lift or stairs up to the 1<sup>st</sup> floor. When using the stairs, the journey finishes on the corridor shown in pic 40 and in good sight of the instructions that can be seen on the wall in this picture. When using the lift the sign is the same one seen in pics 48 & 49 above. The impression created by the instruction at the bottom is that to get to the areas highlighted one has to walk through the doors that can be seen here. People can be observed walking up to this door and trying the handle. If this was not a locked door, several people would find themselves heading in the wrong direction.

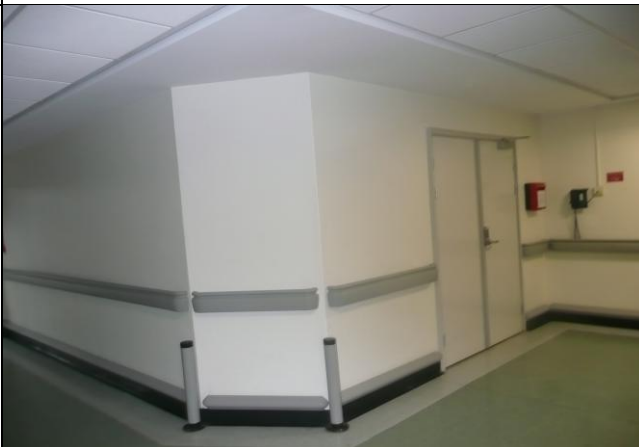
**51:** Intuitively people appear to follow the curve which can be seen hear in the hope that this is the right way to go as there is nothing else to guide them.

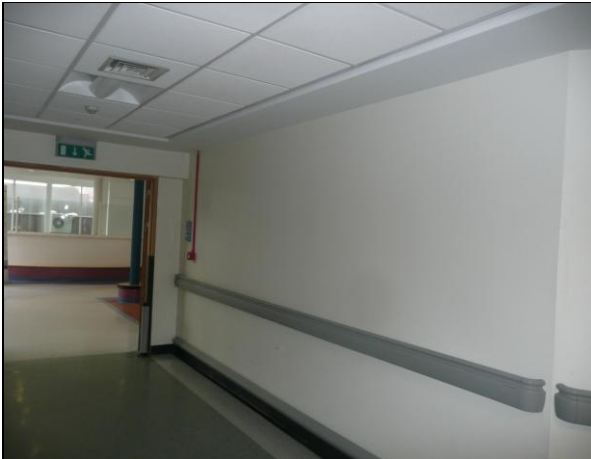
**52:** This picture shows the continuation of the curve in the previous picture. Through the open doors can be seen the beginning of the corridor which connects the red area to the other four areas. Unfortunately, there is no bold announcement of this anywhere else apart from the instruction identified earlier. Those unable to read for one reason or another must find this particular part of the hospital most challenging.

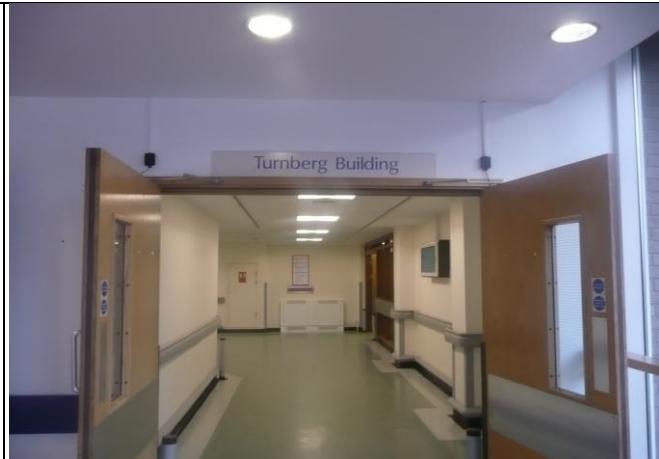
**53:** This picture is of the other side of the door seen in the previous picture. Here the announcement of the destination helps the user orient accordingly. Confusion remains as to why such an announcement was thought unnecessary on the other side of the same door.

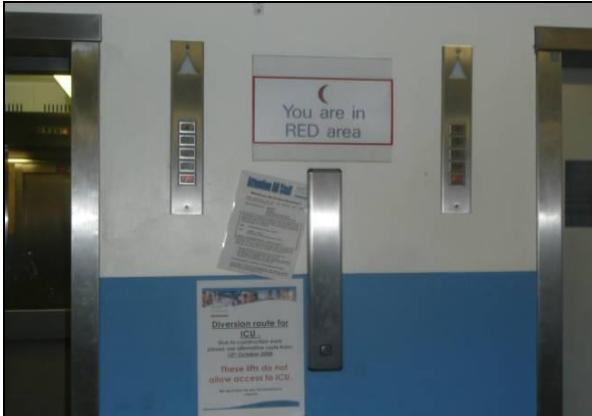
**54:** Blue in the red zone. Unfortunately this lift area is at the beginning of the blue area. From a distance the blue colour is more prominent than the sign announcing the red area.

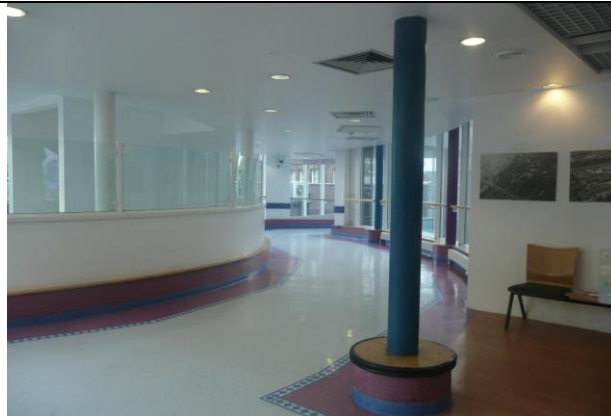
**55:** This is the section that one is exposed to on leaving the red zone (see pic 52). Some think the purple is significant as this is the beginning of the connecting corridor leading to the purple, green, yellow and orange areas. But what about the blue trimmings?

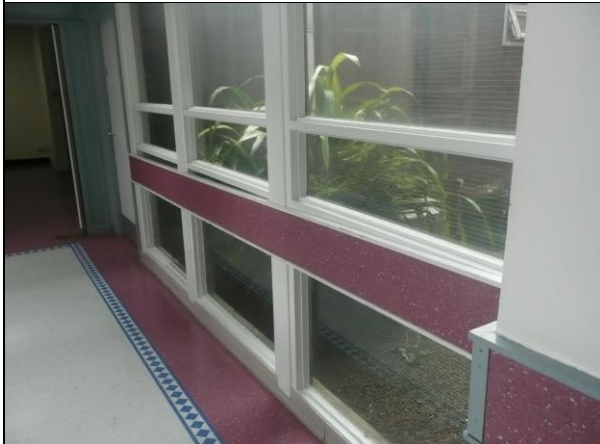
**56:** The emphasis on the purple colour continues down the corridor this time including the skirting board as can be seen.

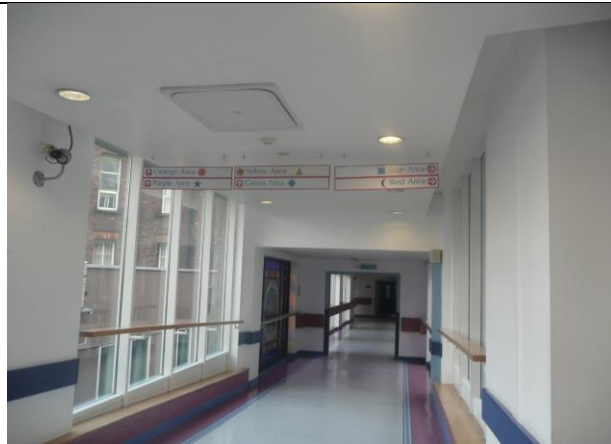
**57:** However, the sudden appearance of blue on the skirting boards here communicates a different message. One starts to wonder at this stage whether the purple colour is intended to lead the user to the purple zone or purely for decorative purposes.
