# A review of the existing Wayfinding strategy for Salford Royal NHS Foundation Trust

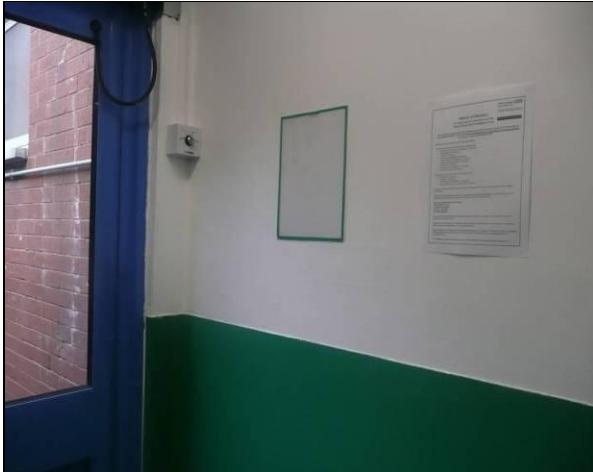
**58:** Green in the green zone. This place can be found along the corridor of the green zone. Is this significant? What was the thinking behind this? Someone must have thought it a good idea perhaps.

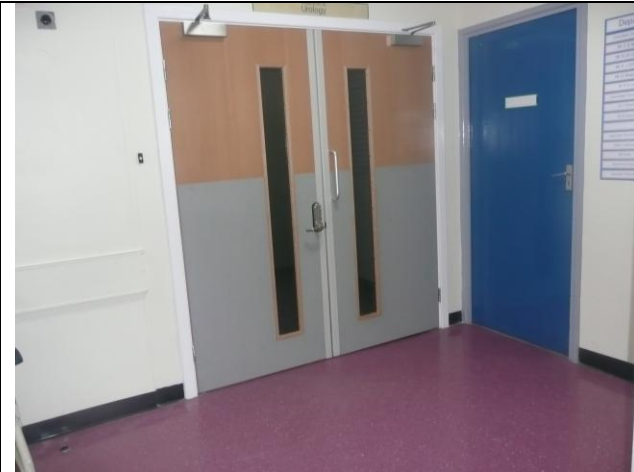
**59:** This picture shows a section in the green zone not too far away from the places shown in pics 58 & 60. See the purple floor, the white skirting board and the grey and blue on the doors. More confusion!

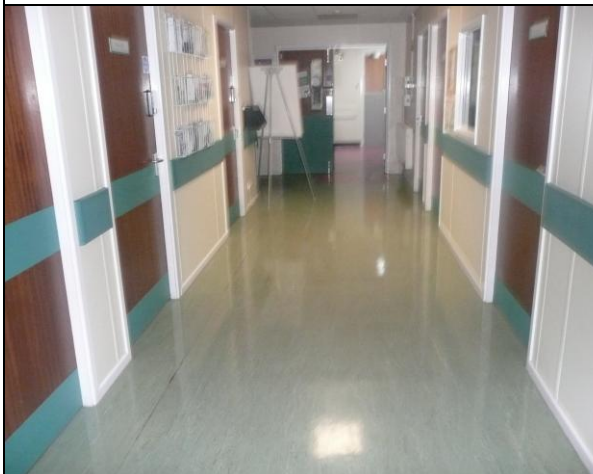
**60:** Still in the green zone, see the turquoise trimming. Was this an effort to maintain the green colour coding? In most of the green zone, however, the colour coding appears to be consistent (green in green), suggesting that someone must have valued the appropriate use of colour in communicating with the users of the setting thus aiding wayfinding.

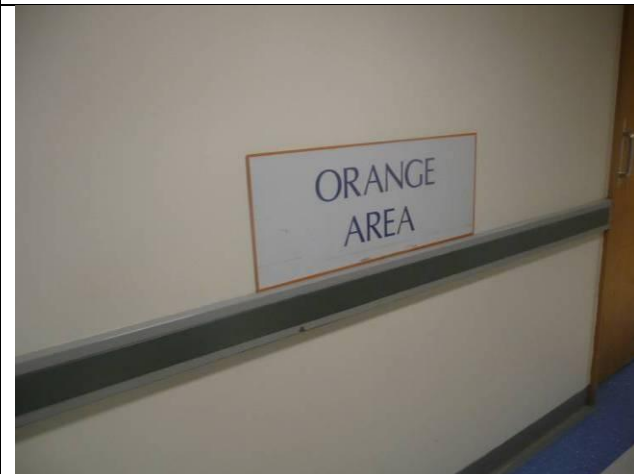
**61:** Here a strip of dark green with grey edges can be seen on the wall. What about the strip of blue along the floor. Blue appears to pop up in several places in the hospital. It would be interesting to find out why blue seems to be so popular.
