**The Cheadle Green Bicentenary
Community Excavation:
An Archaeological Investigation
at Cheadle Hall, Stockport.**

CfAA Report 2010/07

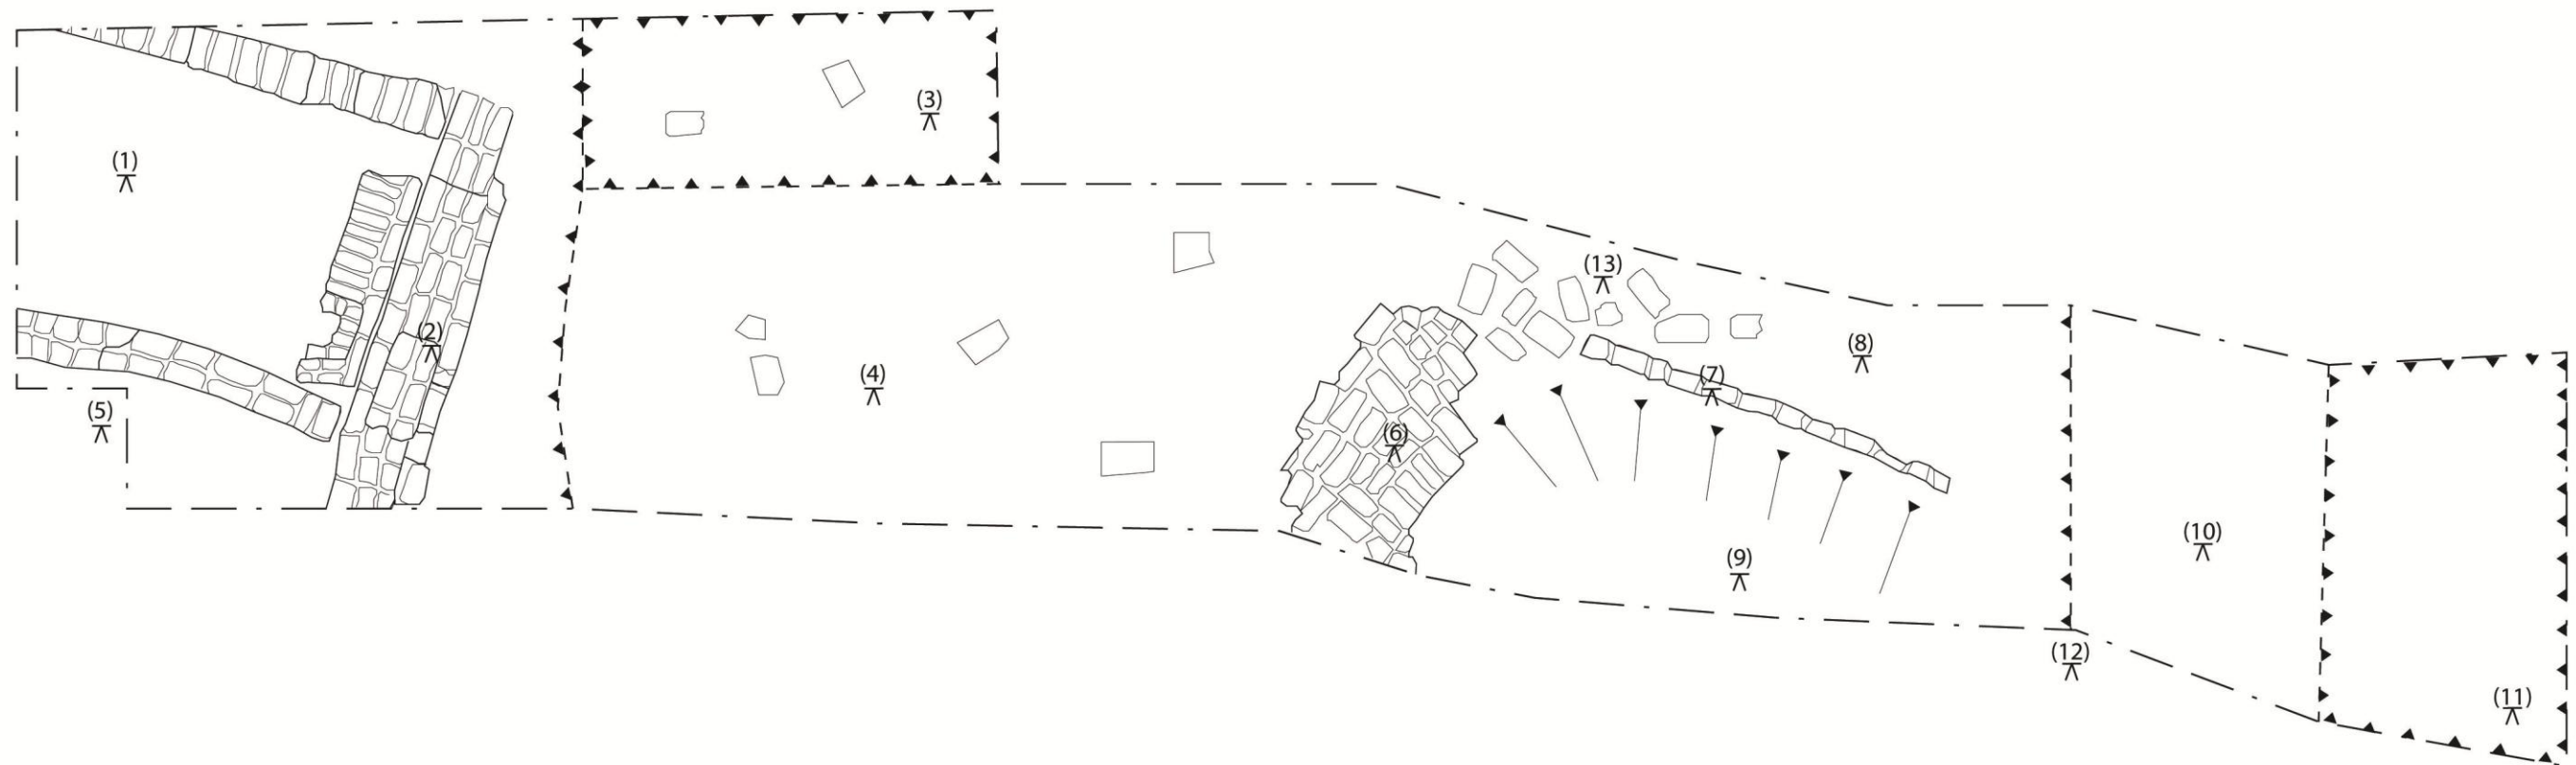
<p>The Centre for Applied Archaeology</p>	<p>Centre for Applied Archaeology CUBE 113-115 Portland Street Manchester M1 6DW</p>	<p>Title: Trench 1 Levels</p>	<p>Key:</p> <p>(1)

Levels taken from TBM (see Appendix 4)</p>	<p>N ↓</p>
<p>Site Name: Cheadle Green, Stockport. Site Code: CG10 Drawing Ref: EX-CG-10-7 Date Drawn: 27-09-2010 Drawn By: SC</p>	<p>Scale: 1:20</p> <p>0 1.00m</p>

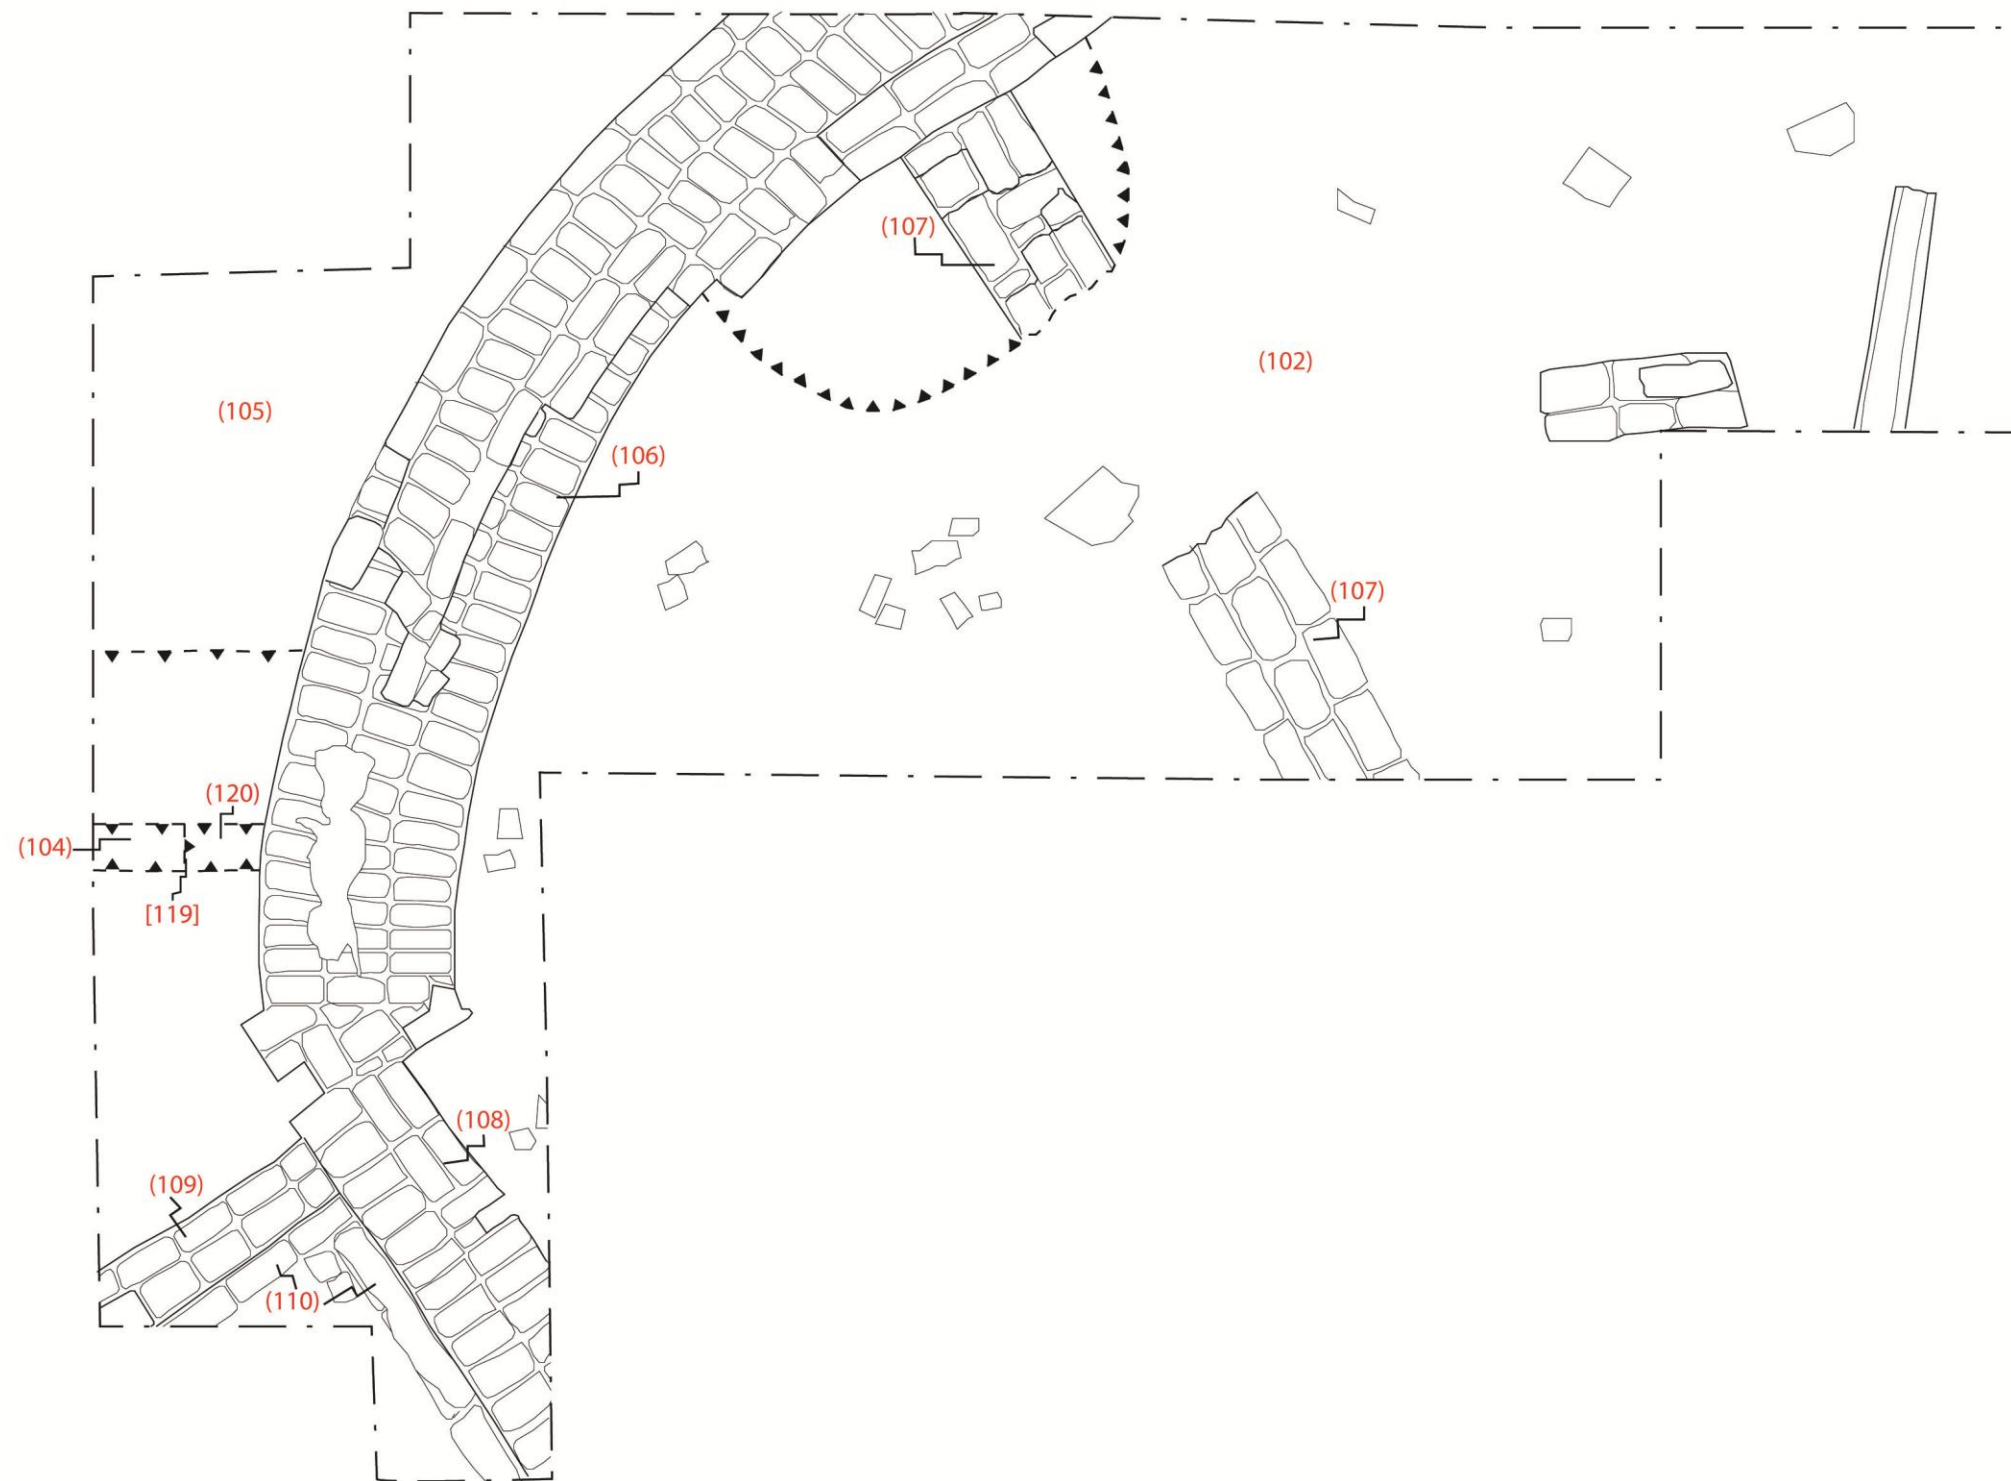
<p>The Centre for Applied Archaeology</p>	<p>Centre for Applied Archaeology CUBE 113-115 Portland Street Manchester M1 6DW</p>	<p>Title: Trench 2 Plan</p>	<p>Key:</p> <p>(102) Context - Layer/Wall</p>	<p>N</p>

<p>Site Name: Cheadle Green, Stockport. Site Code: CG10 Drawing Ref: EX-CG-10-9 Date Drawn: 27-09-2010 Drawn By: SC</p>	<p>Scale: 1:20</p>

Trench 2 was located c.14m to the south-west of the concrete pond (**CG-10 Fig. 5 & 7**). The trench was extended twice to follow the curving southern gable wall resulting in an L shape in plan running in a northwest-southeast/northeast-southwest direction (**CG-10 Plate 7**). The western part measured 3.30m x 6.80m, the eastern part 5.00m x 2.00m. This trench contained a large section of the southern gable of the Hall (106), including evidence of a divided cellar, and the interface between this gable and the main (108) and extension walls (109).

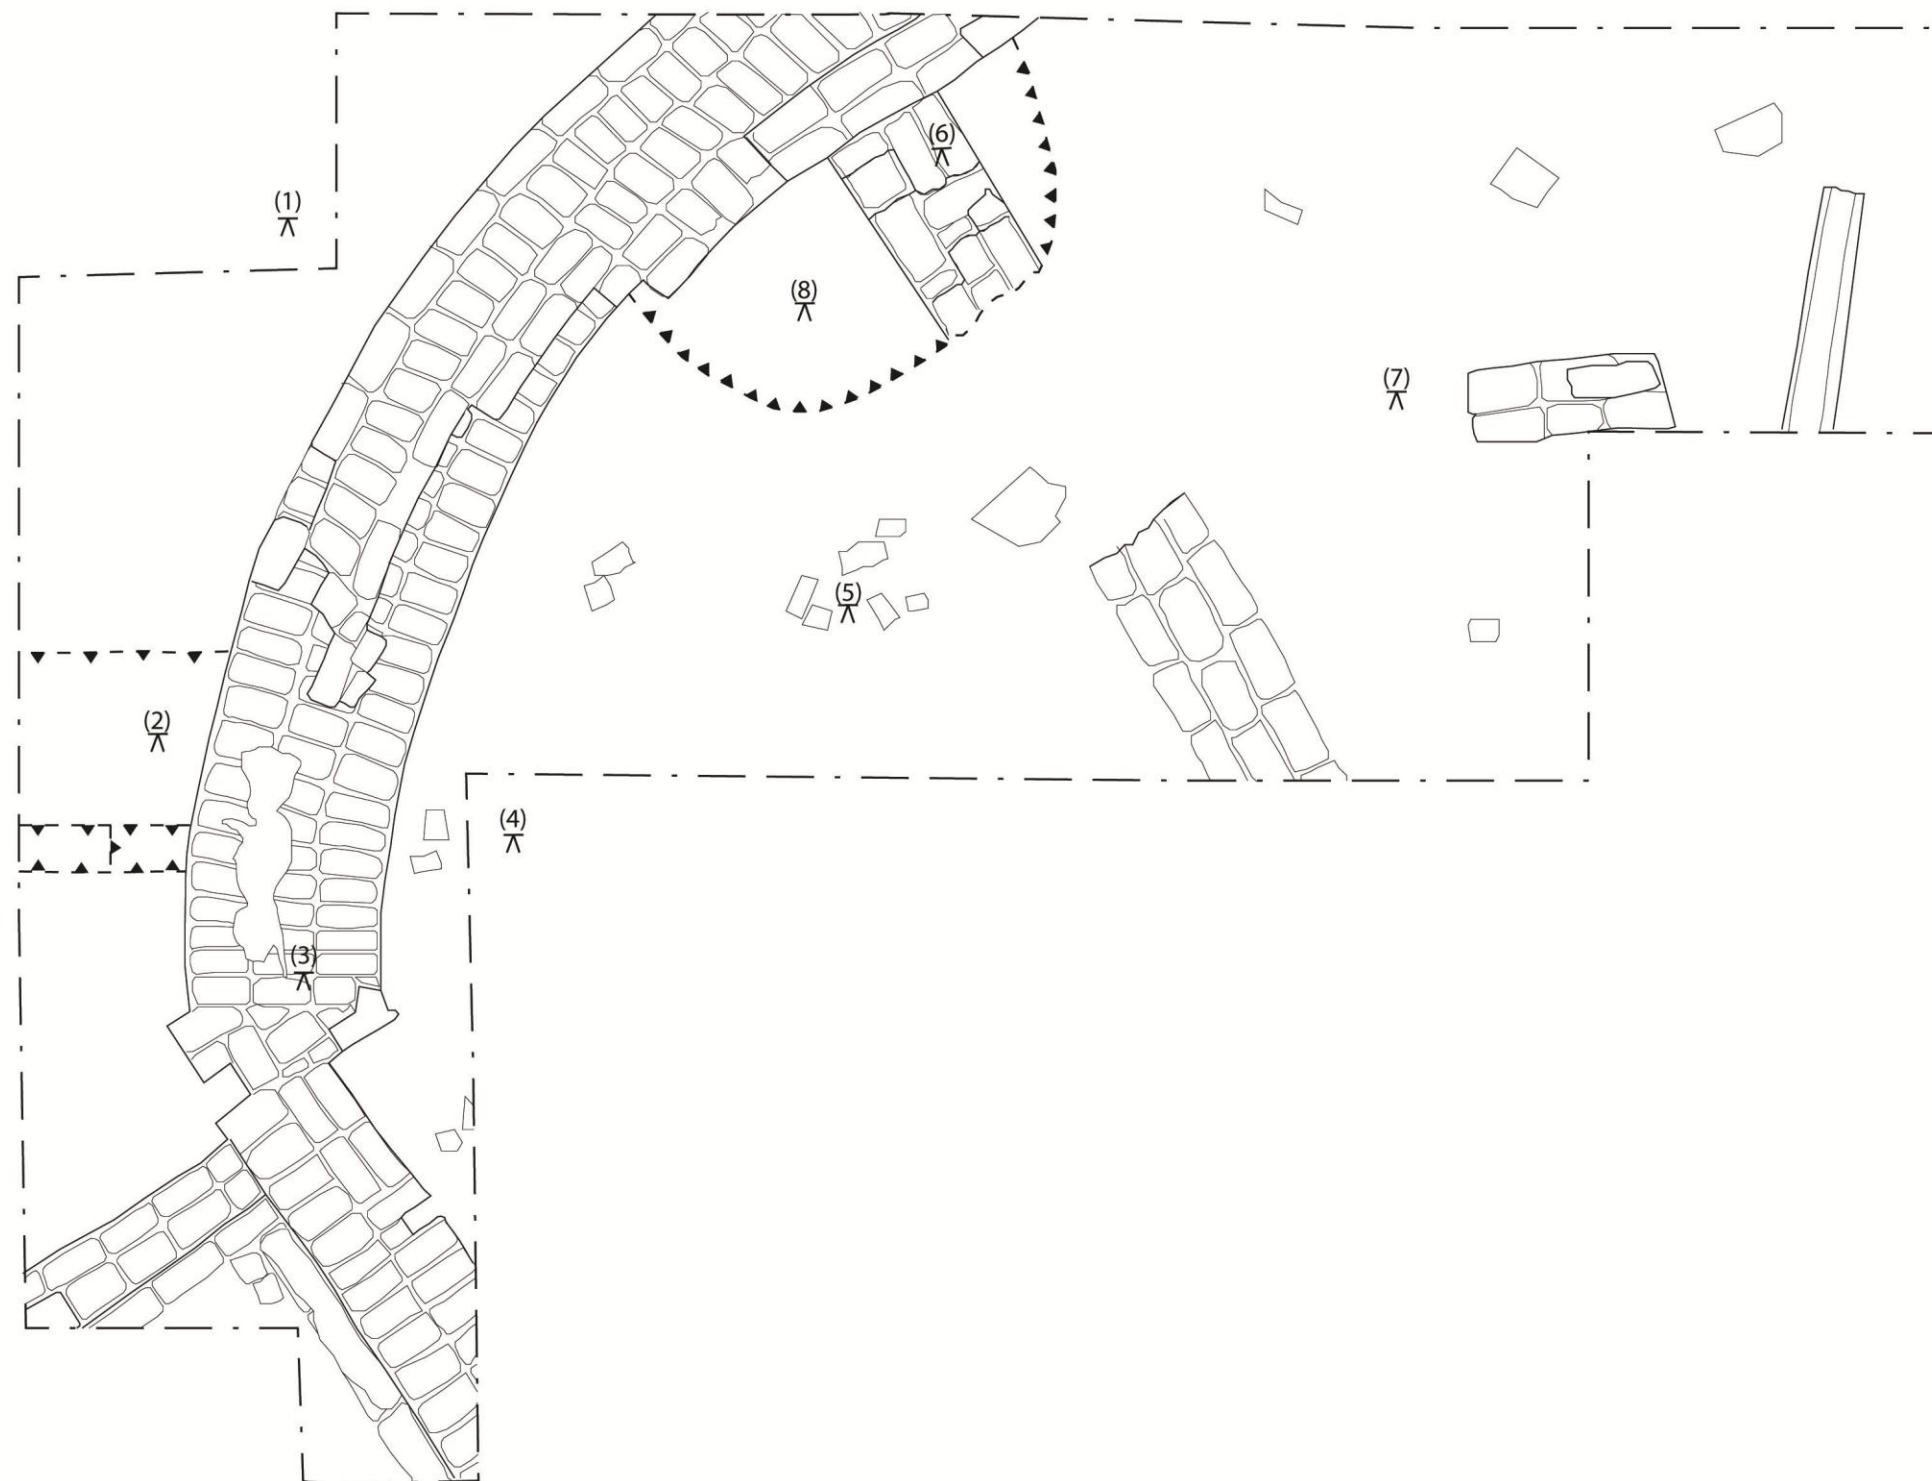
The Centre for Applied Archaeology	Centre for Applied Archaeology CUBE 113-115 Portland Street Manchester M1 6DW	Title: Trench 2 Levels	Key: (1) Levels taken from TBM (see Appendix 4).

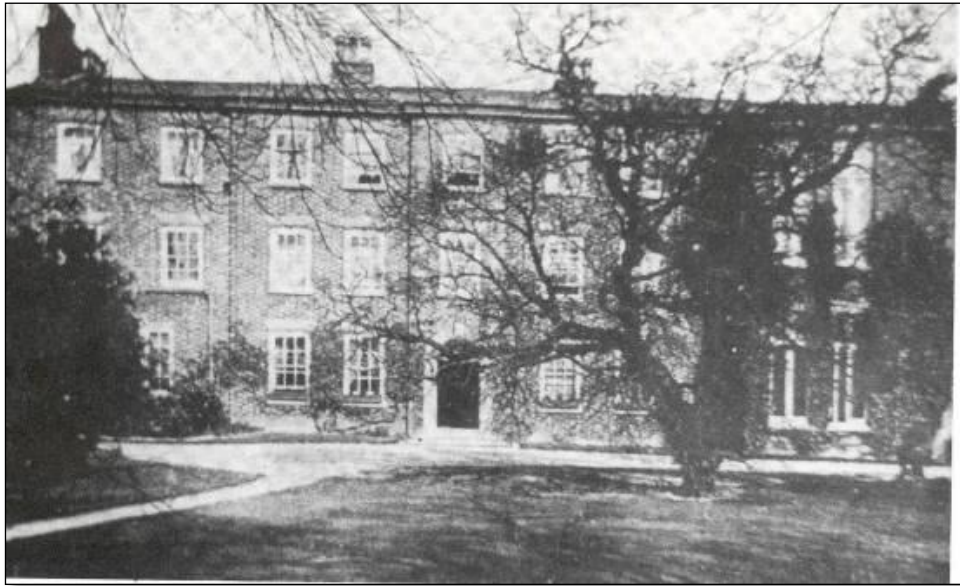
CG-10/Plate 1: Cheadle Hall front elevation. Cheadle Conservation Area Character Appraisal, 2006.

The hall appears in photographs from the late 19th and early 20th century (**CG-10/Plates 1-3**) as being 3 storeys high and 10 bays long with a rounded gable at the southern end and an extension to the rear. The first cartographic evidence for the Hall is the 1846 tithe map which shows a regular rectangular footprint with a

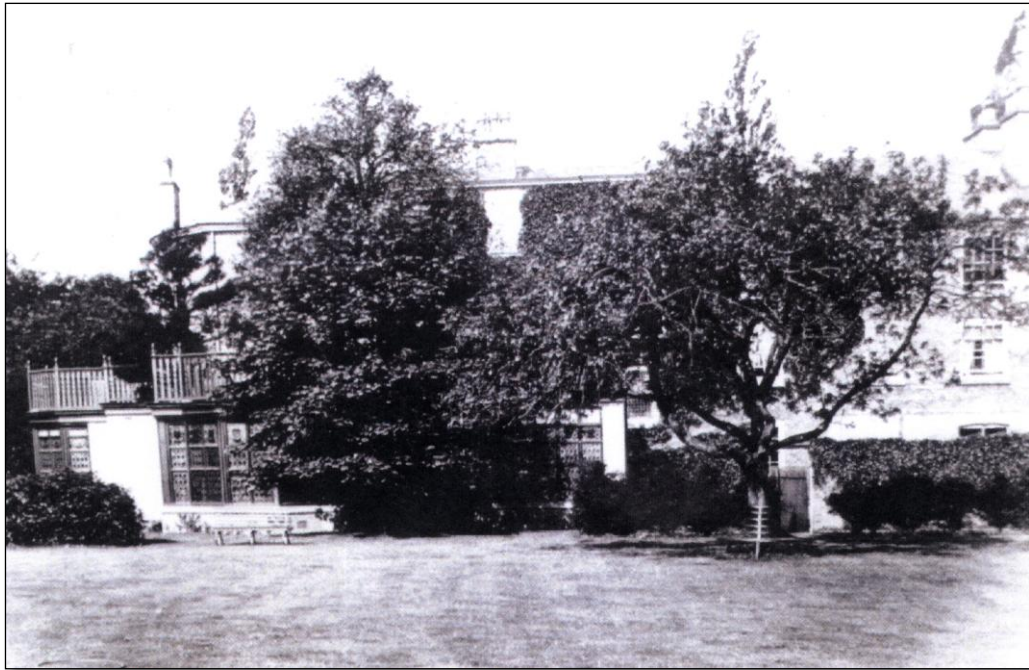
C
G-10/Plate 3: Cheadle Hall rear elevation. Courtesy of Mrs P. Seddon, Cheadle Civic Society.

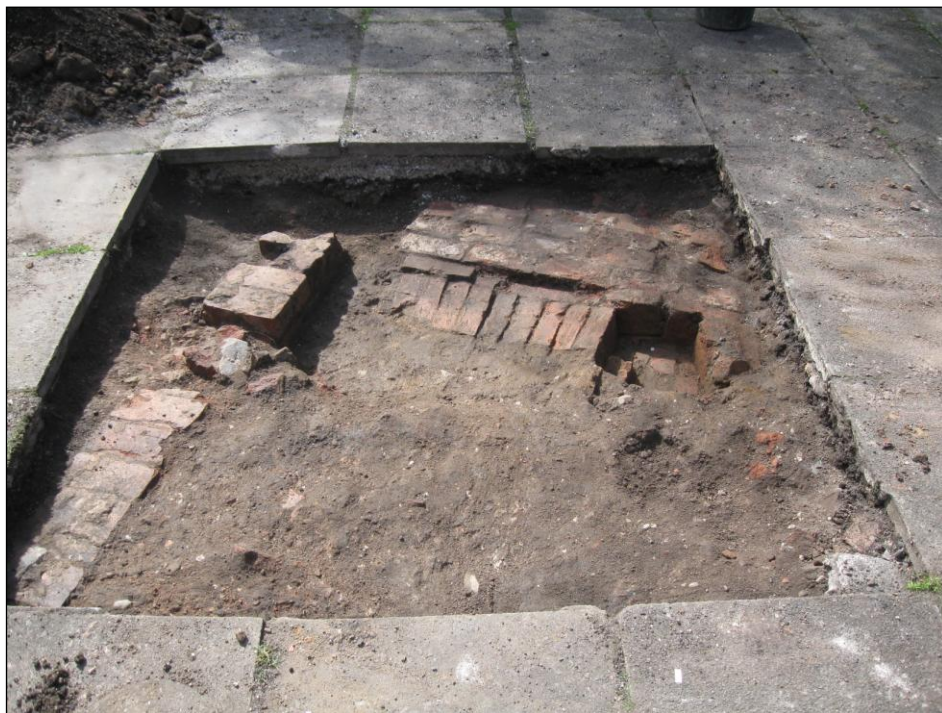
CG-10 Plate 4: Walls (111) and (113) as seen during the April 2010 evaluation. Looking west.

revealed a curved wall that has been interpreted as the curving southern gable of the Hall that was the extent of the mid to late 19th century development (**CG-10 Plates 4 & 5**). The middle section of the western exterior wall was also found with an internal wall dividing cellars.

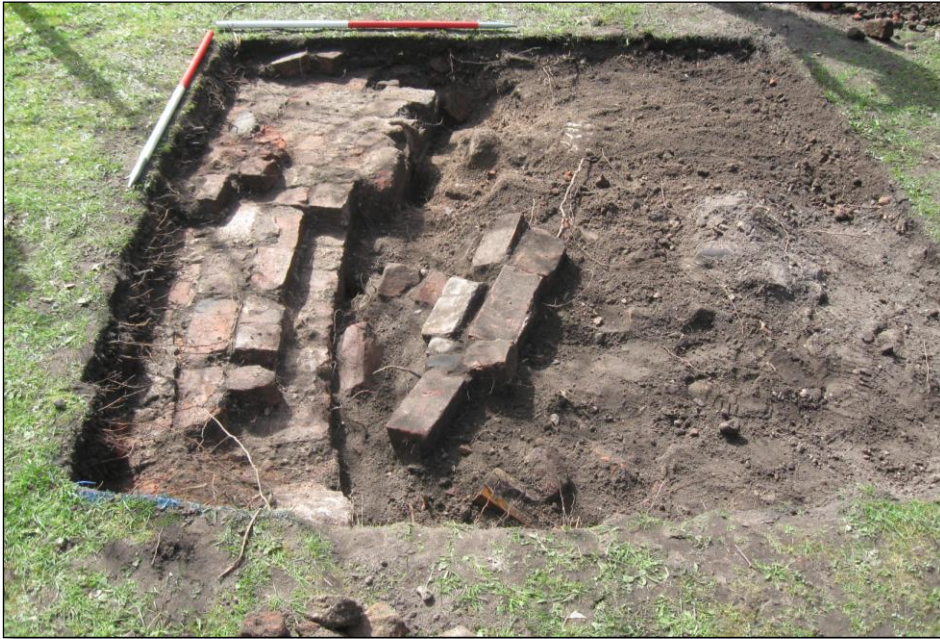
CG-10 Plate 5: Wall (106) as seen during the April 2010 evaluation. Looking south.

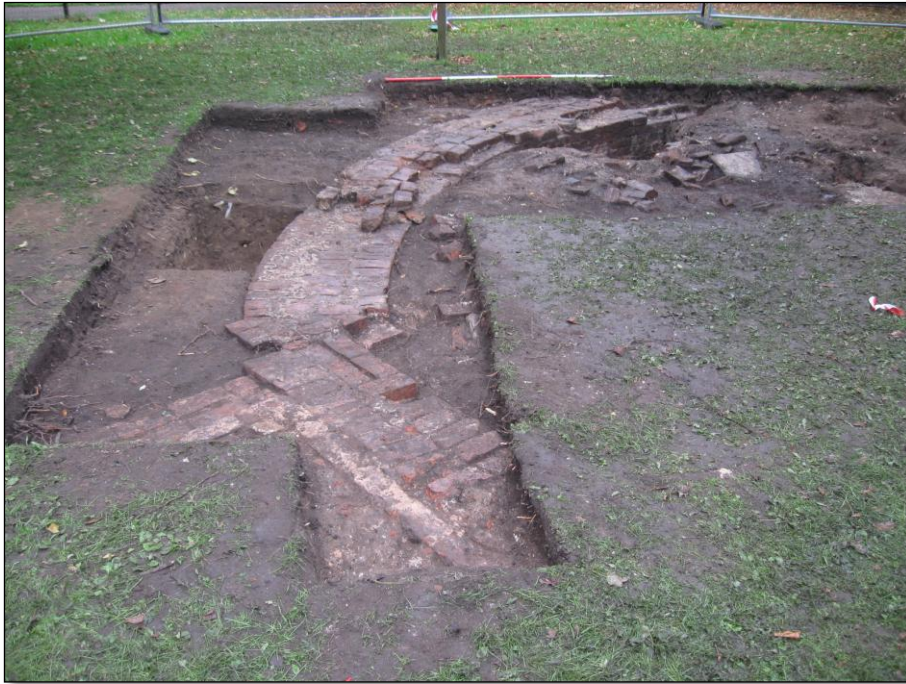
CG-10 Plate 7: General view of Trench 2. Looking south.

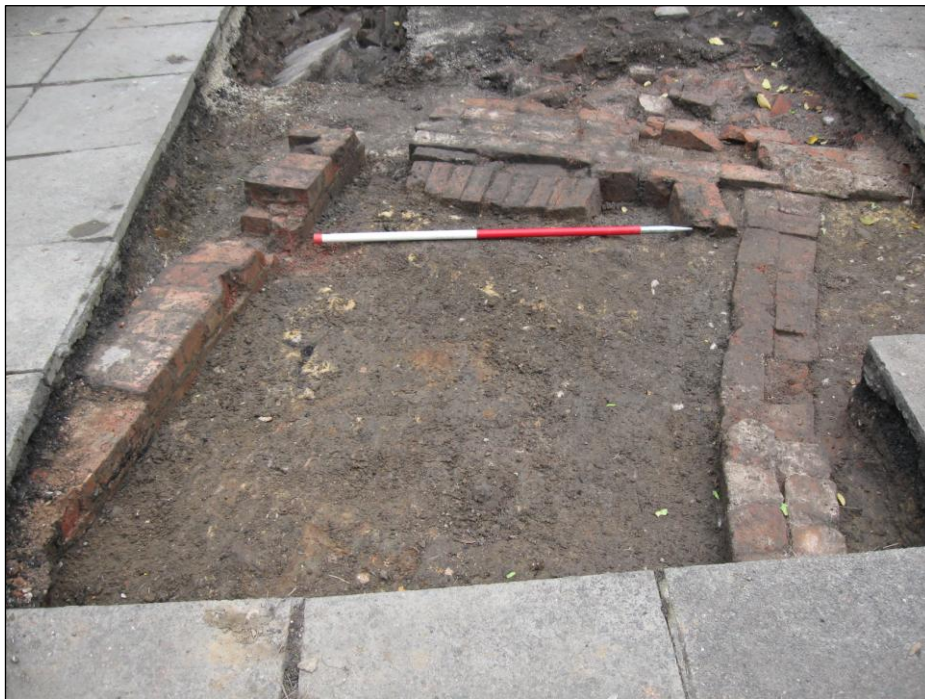
CG-10 Plate 8: Walls (111), (112) and (113) at eastern end of Trench 1, showing clay layer (103) between. Looking west.

Trench 1 identified a number of features of archaeological interest. The north-south orientated brick wall (111) and associating east-west abutting walls (112) and (113) relate to a brick built structure extending east from the main eastern wall. The north-south wall (111) dating from the mid 19th century is wider than (112) and (113) and may have an entrance in the centre represented by the extra courses of brick on its eastern side (**CG-10 Fig. 6**). The east-west walls also date to the same period and are narrower, approximately 0.20m, suggesting this structure may have been a single storey. These walls correspond with the small structure extending eastwards from the eastern wall as seen from the map evidence first appearing on the 1872 OS map of Cheadle (**CG-10 Fig. 3**). This may be an entrance way or porch. The lack of demolition debris in the clay layer (103) surrounded by these walls would suggest that this may be an internal levelling layer for the structure.

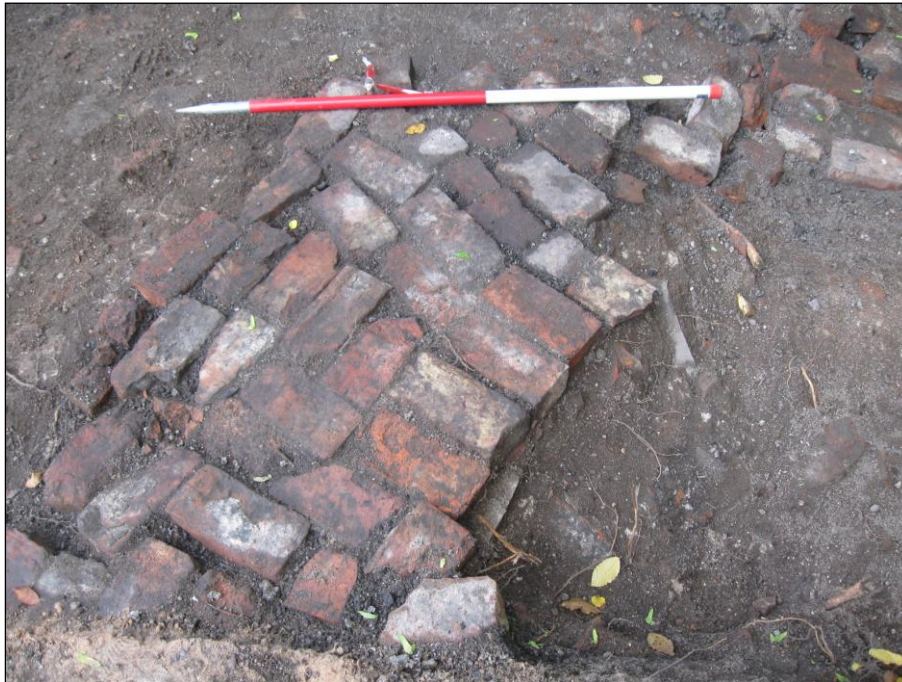
CG-10 Plate 9: Possible brick floor surface (114) showing wall (115) extending west from the southwest corner. Looking south.

In the centre of the trench, running north-south and extending beyond the northern edge of the trench lay a handmade brick surface (**114**) (**CG-10 Plate 9**). This was a level area of bricks laid with headers and stretchers but in no regular pattern. Wall (**115**) lay approximately 0.50m to the west of the brick surface and comprised a single course of handmade bricks laid in a stretcher bond orientated in an east-west direction (**CG-10 Plate 10**). This wall had little surviving mortar and was therefore loose in its setting.

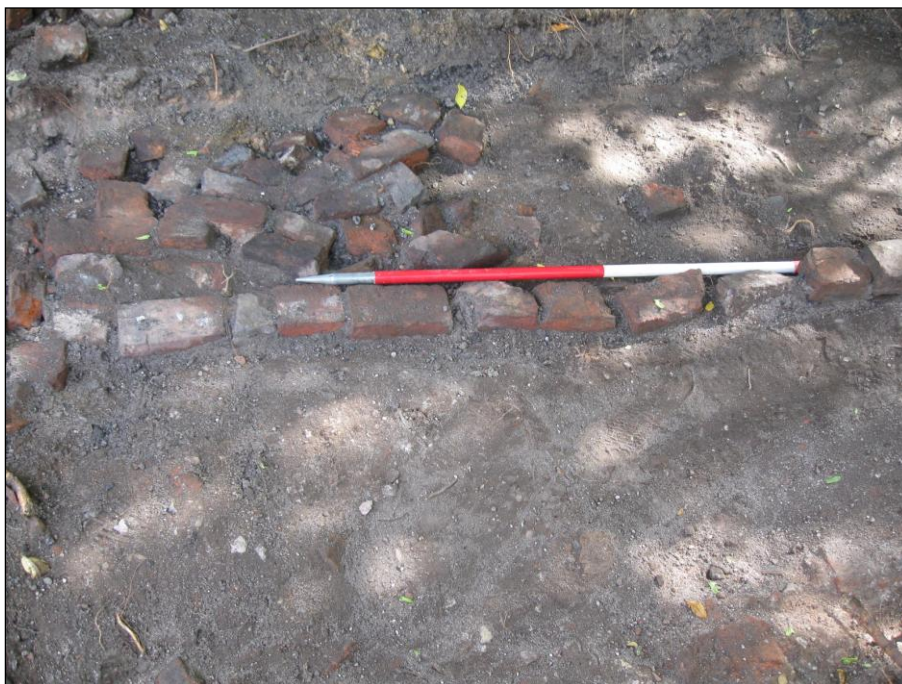
CG-10 Plate 10: Single course wall (115) to the west of brick floor (114) showing layer (102) on both sides. Looking south.

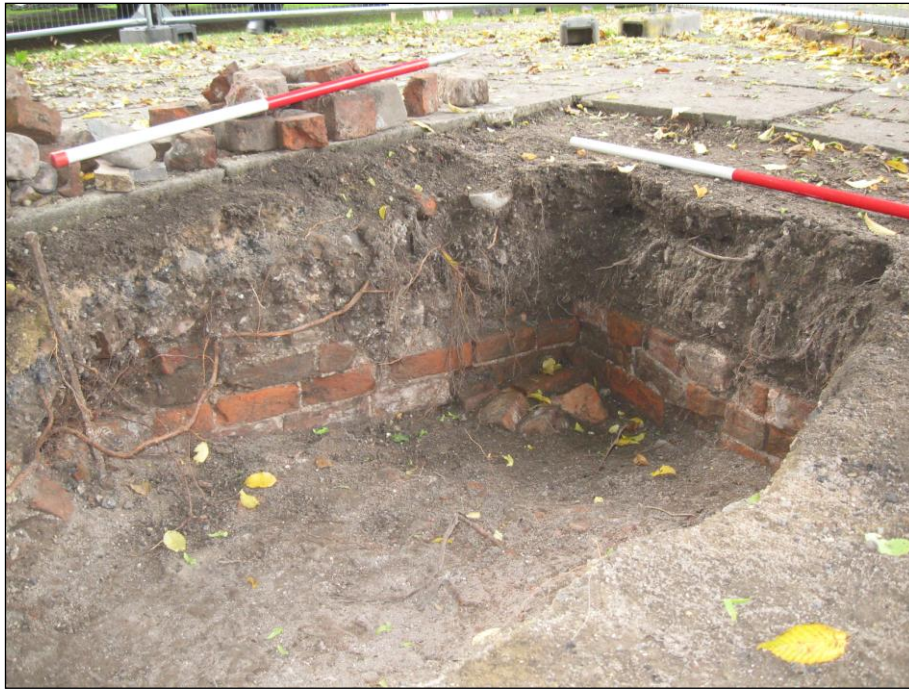
CG-10 Plate 11: Sondage at western end of Trench1 showing walls (116) and (117) with fill (118) between. Looking northwest.

At the western end of Trench 1 a sondage was excavated to locate the remains of walls that were found during the evaluation. At a depth of c. 0.30m walls (116) and (117) were identified in the south and east facing sections respectively. Wall (116) was excavated to reveal three courses of handmade bricks, the lower two laid as stretchers and the top course as headers. Wall (117) was also exposed to a depth of three courses, all laid in a stretcher bond. The height and depth of both walls was unknown due to their position in section (**CG-10 Plate 11**). The fill of this sondage lying against (116) and (117) was directly below demolition layer (102) and comprised a dark grey/brown loam (118) containing fragments of brick, wall tile and an iron bar. This layer is likely to be an infill of the cellar/basement of the Hall.

At the western end of Trench 1 walls (116) and (117) were identified but not fully excavated. Constructed during the 19th century, wall (116) ran east-west and is likely to have been an internal cellar dividing wall similar to (107) in Trench 2. Wall (117) appears to have been of similar date and construction. Its north-south alignment and position on the western side of the site would suggest that it could possibly be the main western wall of the Hall. Lying against (116) and (117) fill (118) seems to have been laid to infill the hall's cellars, the low proportion of rubble would suggest this was done prior to demolition.

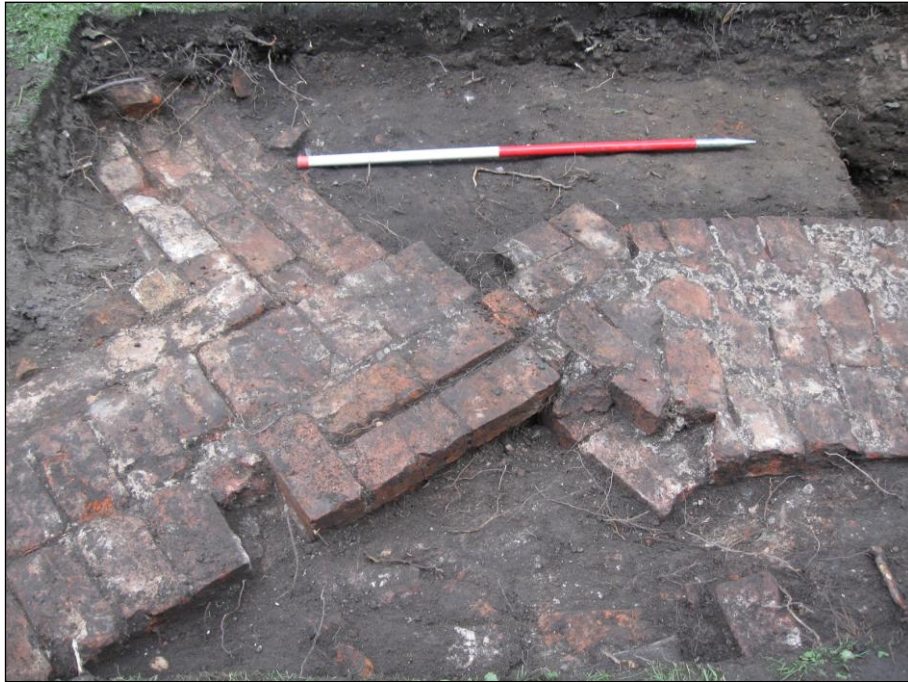
CG-10 Plate 13: Interface of southern gable wall (106) and main eastern (108) and extension (109) walls with internal single facing course (110). Looking east.

Wall (108) was constructed using two courses laid in header bond of handmade bricks and measuring 0.55 x 1.00m. This wall extended north beyond the northern edge of the trench. Wall (109) measuring 0.30m x 1.10m was butted to (108) and comprised two courses of hand made bricks laid in stretcher bond. Both (108) and (109) were faced on the northern side by a single course laid in stretcher bond with large amounts of mortar in situ (**CG-10 Plate 13**).

Butting (106) to the north, wall (108) represents the southernmost extent of the main eastern wall. This appears to be a later (mid-late 19th century) rebuilding as the remains of an earlier brick line is visible keyed in to the northern end of [106]. Aligned northeast-southwest, wall (109) butts (108) and is part of the late 19th century extension. The thickness of the wall would suggest the probable height of the extension to be less than the main older structure and photographic evidence shows it to be a single storey with a first floor terrace (**CG-10/Plate 3**). Both walls (108) and (109) have been internally faced by a single course of bricks in the late 19th-early 20th century, possibly as part of a later refurbishment or alteration.

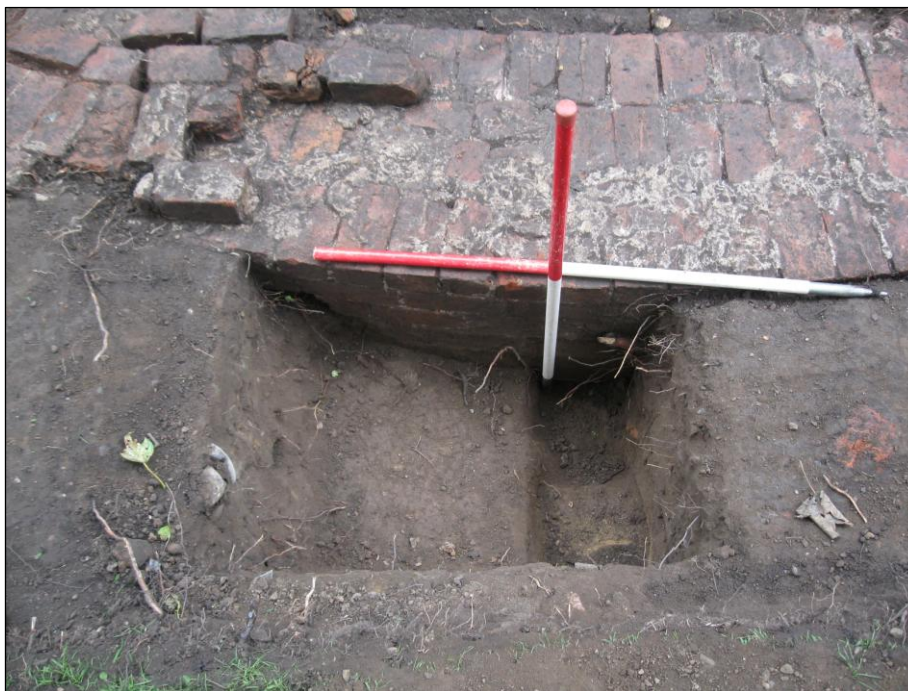
CG-10 Plate 14: Sondage cutting (105) to the east of wall (106) in Trench 2 showing an area of natural silty clay in the northeast corner. Looking west.

Located immediately to the east of wall (106) a sondage measuring 0.90m x 0.80m was cut through layer (105) to establish the nature and survival of the outer face of wall (106) and to identify if an earlier external ground surface was present. No external surface survived although the natural clay (**104**) was exposed at a depth of 0.40m (**CG-10 Plate 14**). This sondage also revealed the cut of the foundation trench [**119**] for wall (106) and its dark brown loamy fill (**120**).

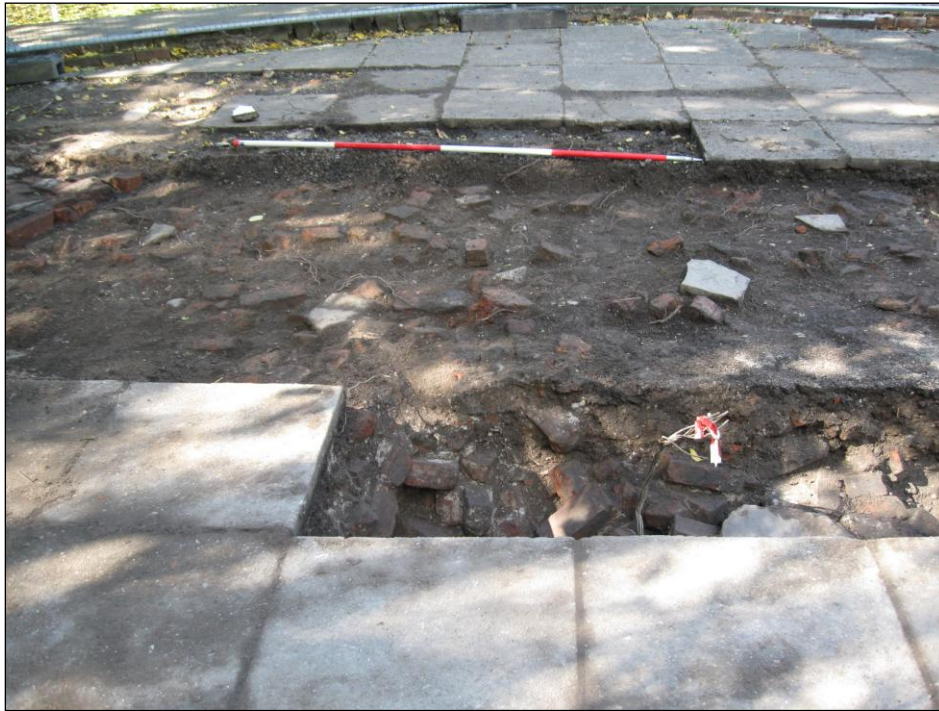
CG-10 Plate 15: Mid section of Trench 1 showing demolition layer (102). Looking north.

To the west of walls (111), (112) and (113) was demolition layer (102), the depth of which, c.0.44m excavated, indicates that no internal surfaces survive on the eastern side of the hall structure. This layer did, however produce architectural materials such as brick, floor tiles and flagstones and fragments of glazed wall tiles dating to the 19th and 20th centuries. Within this layer, aligned north-south, lay the remains of a possible brick floor (114) and internal wall (115) both with lime mortar intact dating to the mid 19th-early 20th century. Surface (114) represents the only possible floor surface to be found on the site.

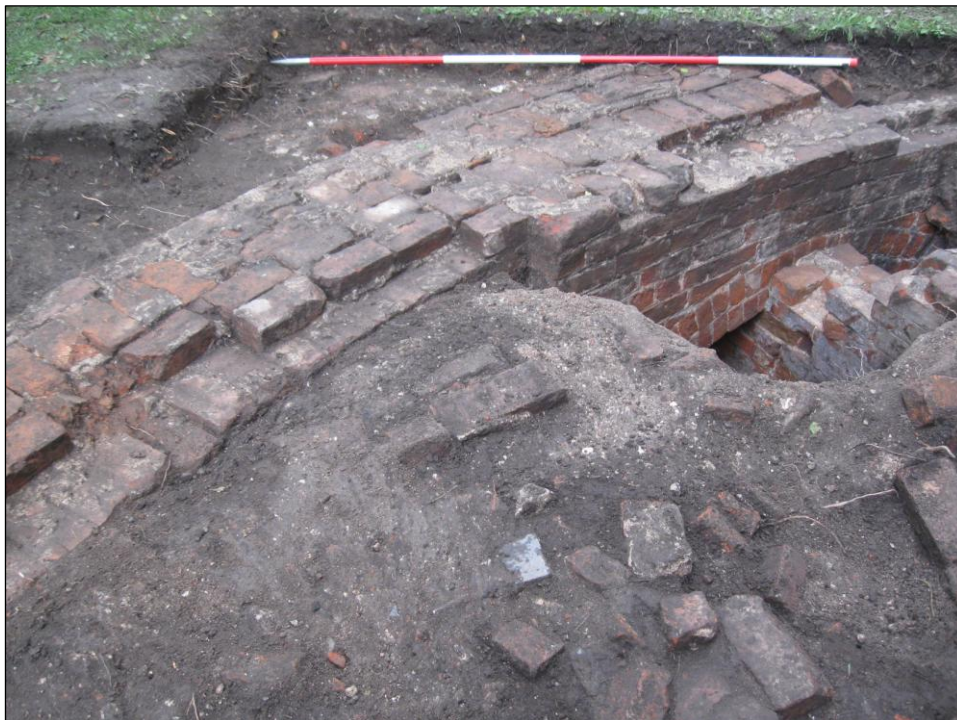
CG-10 Plate 16: General view of southern gable wall (106) and internal cellar dividing wall (107). Looking south.

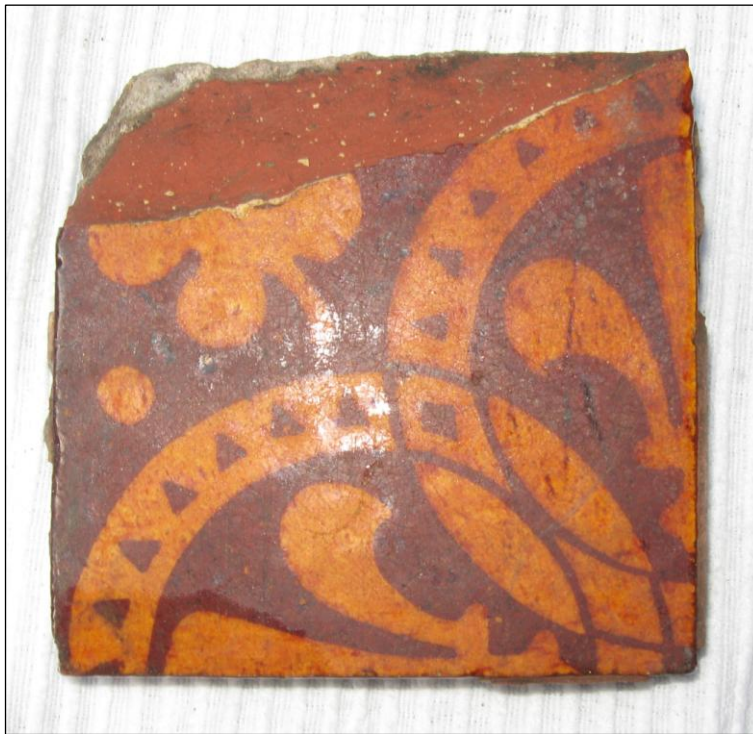
CG-10 Plate 17: Arts and Crafts Victorian tile, one of many recovered from Trench 2.

Photo Number	Plate Number	Description	Orientation (looking)
1 – 11		Working shots showing Open Day visitors	Various directions
12	CG-10 Plate 18	Finds on the Open Day	-
13	CG-10 Plate 17	Arts and crafts hearth tile	-
14 – 26		Open Day displays	-
27 – 28		Working shot	S
29		Working shot	SW
30		Sondage cutting layer (105) to the east of wall [106] showing natural layer (104).	S
31		Sondage cutting layer (105) to the east of wall [106], showing natural layer (104).	W
32 – 33		Sondage at western end of trench 1 showing walls [116] & [117]	N
34		Sondage at western end of trench 1 showing walls [116] & [117]	NW
35 – 36		General view of Trench 1, eastern end.	N
37 – 38	CG-10 Plate 15	General view of Trench 1, eastern mid section	N
39 – 40		General view of Trench 1, western mid section	S
41 – 42		General view of Trench 1, western end	S
43 – 45	CG-10 Plate 11	Sondage at western end of trench 1 showing walls [116] & [117]	NW

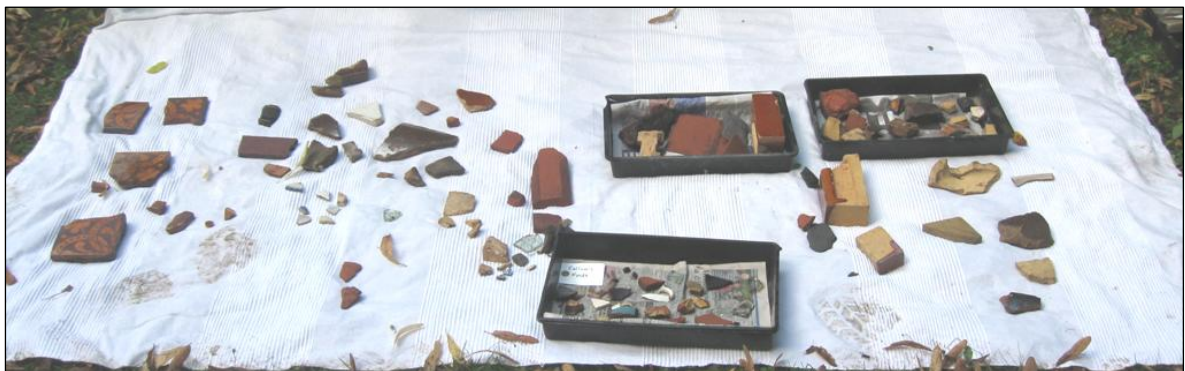
CG-10 Plate 18: Collection of tiles glazed hearth bricks and pottery recovered and processed during the open days

During the excavation many artefacts in the form of late 19th and early 20th century pottery were recovered (**CG-10 Plate 18**). Also there was a deal of material associated with the fixtures and fitting of the Victorian period hall most notably a number of Arts and Crafts style floor tiles (**CG-10 Plate 18**), glazed hearth bricks and a gas light fixture. On general inspection the bulk of this material was associated with the late 19th century phase of Cheadle Hall at the time it was owned by James Watt.
