85 Broughton Lane, Salford An Archaeological Historic Building Survey of a Newspaper Depot

A Report by Dr Michael Nevell & Ivan Hradil

CfAA Report No: 13/2010

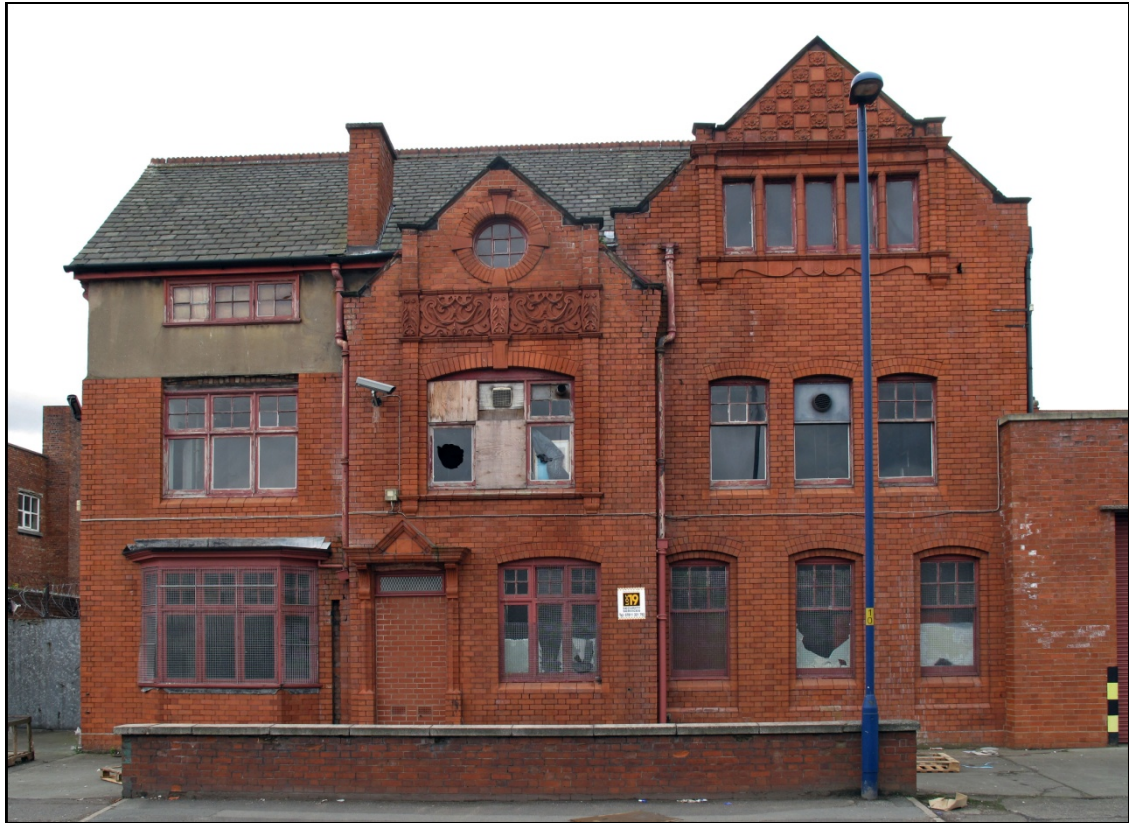
Fig 24: Broughton Lane facade of GF1.

The main façade of this building (**Fig 24**) formed part of the northern elevation of the complex fronting Broughton Lane. It was three storeys and built from 'Accringtons' type brick in Flemish bond throughout the elevation.

The fenestration within the façade consisted of five separate types. The ground floor level starting from the western end had three tall single recessed windows with a triple header segmental arch. The windows were originally sash, but had been replaced with a single light with six square lights at the upper section to the turning piece. The larger central façade window was single recessed with a double header segmental arch.

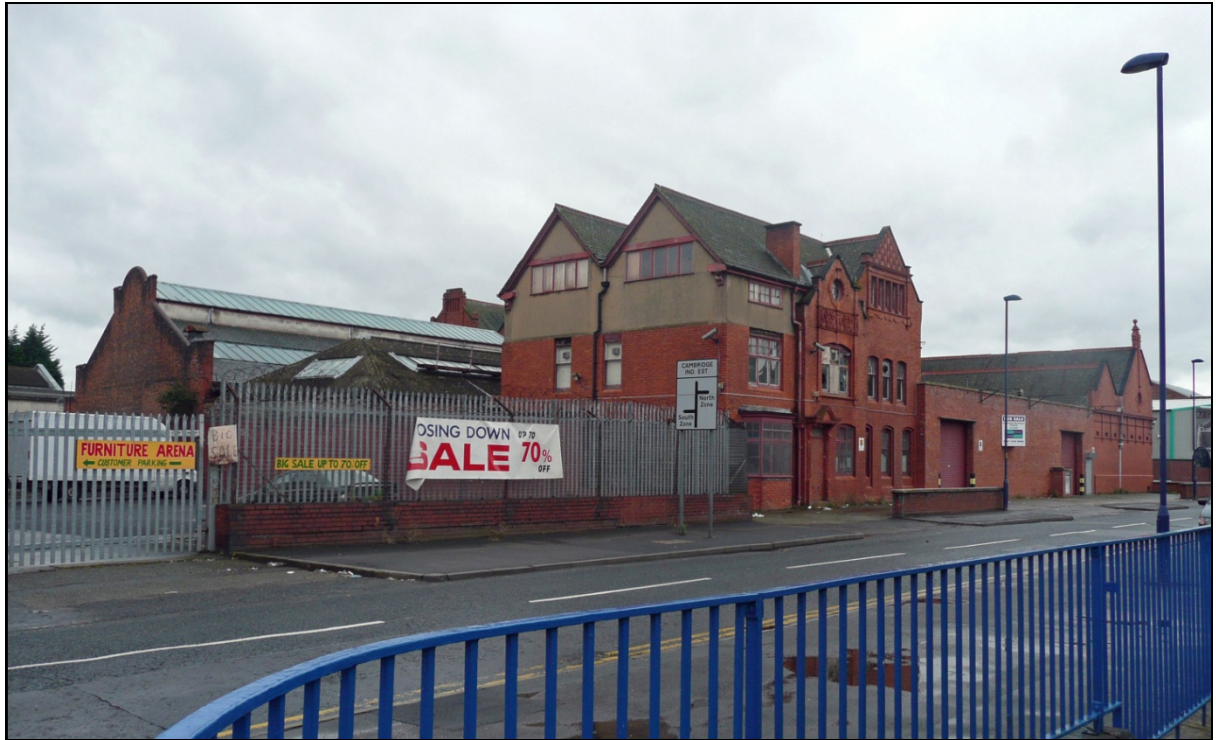
Fig 26: General view of the site from Broughton Lane looking west.

The eastern elevation (**Fig 26**) faced to a small yard (designated as Y3) and was double gabled. The fenestration was present only at the first and second floor levels. The first floor windows were recessed tall narrow double light sash located approximately central to the elevation with a simple false timber lintel. The two second floor windows were long five light windows also with false timber lintels. Within this elevation were two doorways, the doorway at the northern end led into the ground floor level while the southern end doorway led down into the basement area (**Fig 27**). The southern elevation for the most part was obscured with the works area buildings designated as GF2.

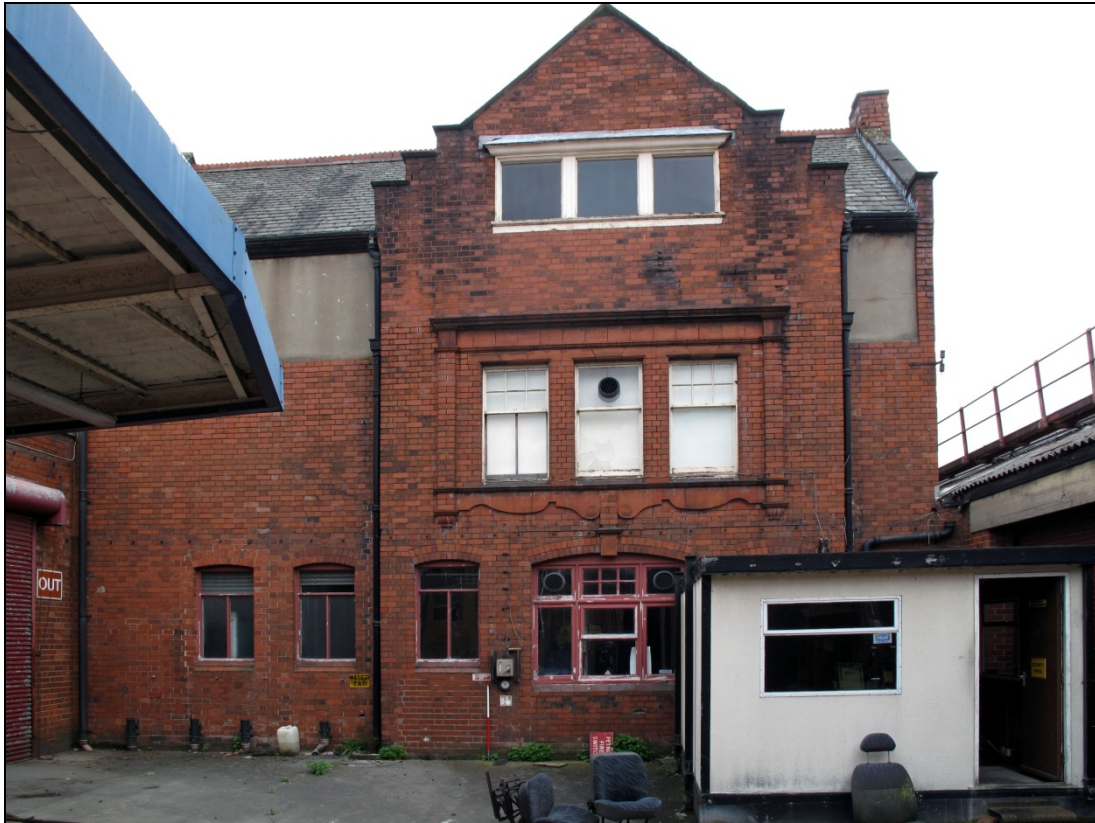
Fig 28: View of GF1 western elev., in Y1

The western elevation (**Fig 28**) faced to the main yard (designated as Y1) and had a false gable wing at the southern end. The gable had three crow steps to each pitch and copping stones. The majority of the fenestration was within the false gable. There were two three light windows with turning pieces in the double header segmental arches with the sills as sloping step up to the northern end at ground floor level. The false gable wall at ground floor level had single identical windows as described above at the northern and southern ends. The central area of the wall was occupied by a large double timber mullion and transom window with a turning piece in the brick

double header segmental arch. The main lower lights were large single light vents with a central double light of which the upper light was a vent. The three upper vents comprised of single lights to either side of a six light central vent. At first floor level was a large centrally located fenestration which comprised of three sash windows placed close together. The window had an architectural decorated surround similar in pattern as at the western end of the northern facade, though the apron was of a more elaborate design with a short pilaster which butted to the head of the keystone of the lower floor window. The second floor window may be a later insertion. It was a long three light window with two timber mullions, the lintel was also of moulded timber (ogee cyma recta).

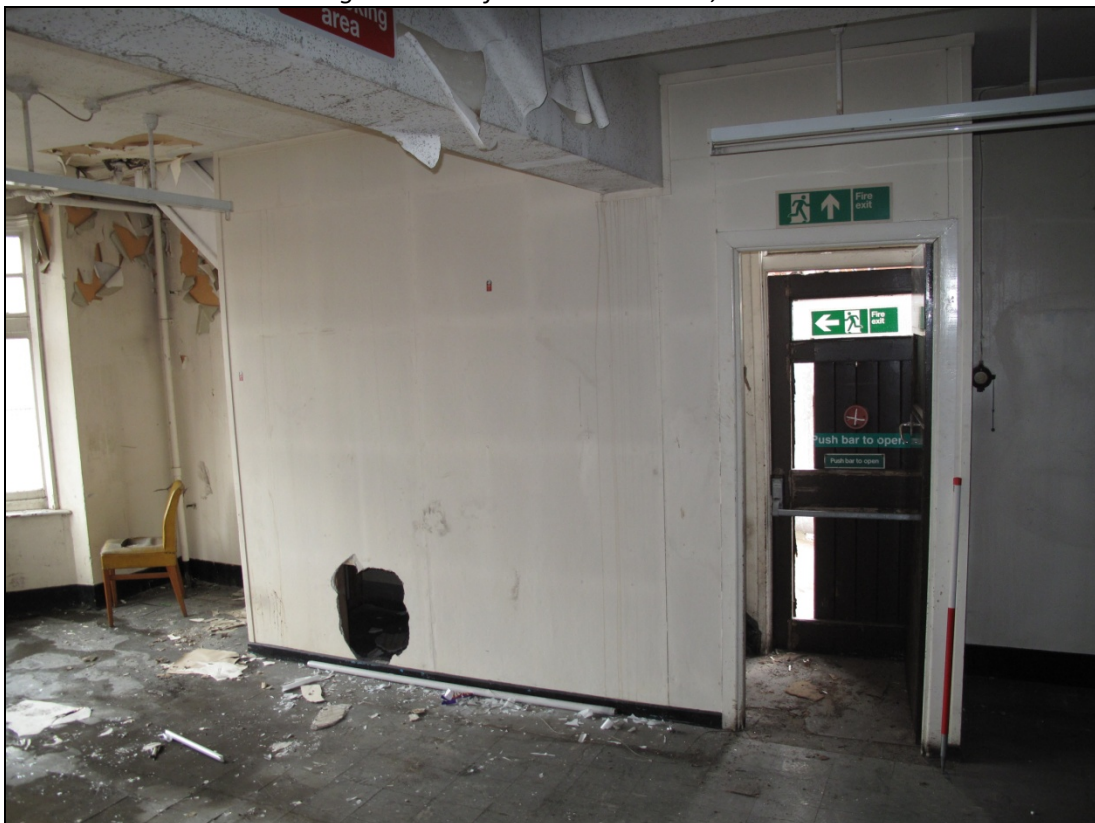
Fig 29: GF1 area 'a' looking to the E elev., wall from the S end.

A later inserted stairway with stud plaster board cladding had been built to the eastern elevation wall at the northern end (**Fig 29**). The northern elevation wall contained the splayed window bay (**Fig 30**) with the later inserted stud wall to the front door at the western end. In the western end of the southern elevation wall was a blocked bay window with a second blocked window at the eastern end (**Fig 31**). The western dividing wall had a doorway at the northern end into area ‘GF1b’ with a centrally located blocked door into the central stairwell with a further doorway at the southern end into area ‘GF1c’.

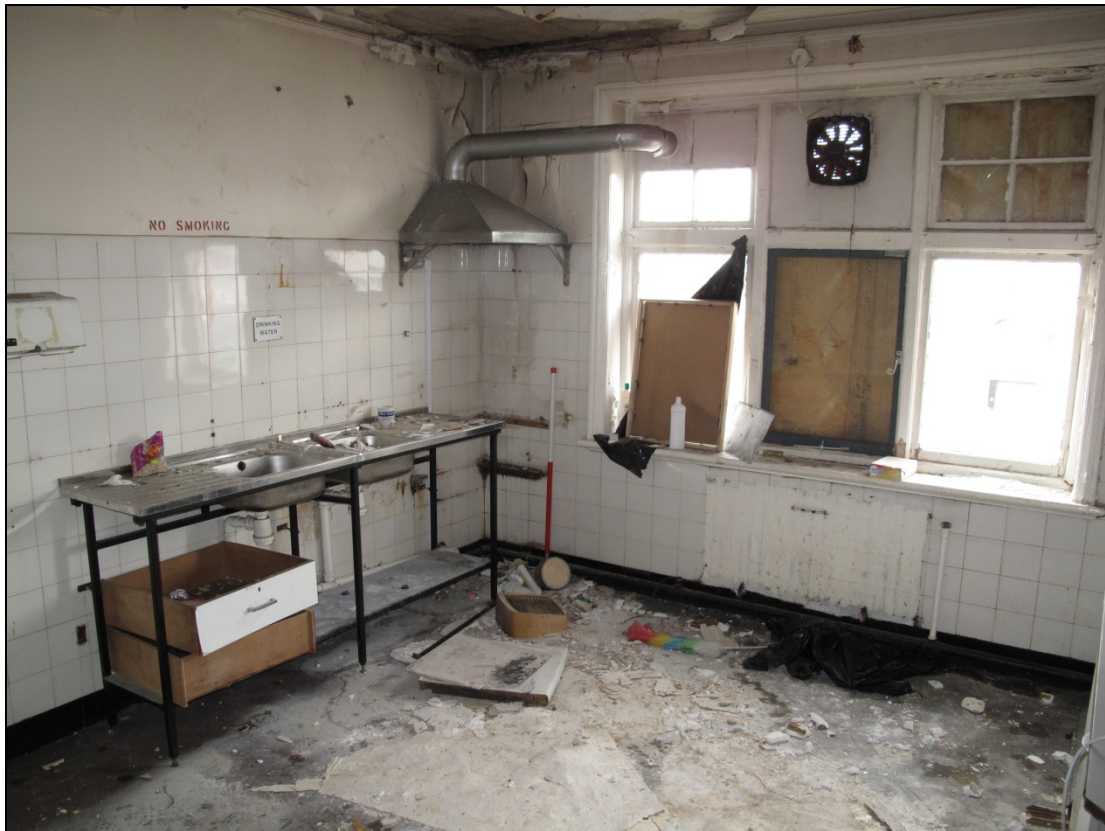
Fig 32: 1F1 looking to the W end of the N elev., wall in area 'c'.

The room was situated centrally to the northern facade wall with a rectangular foot print. A single large window was in the northern elevation wall (**Fig 32**) with cross doorways at the southern ends of the western and eastern dividing walls. At the time of the survey this area had functioned as a kitchen area.

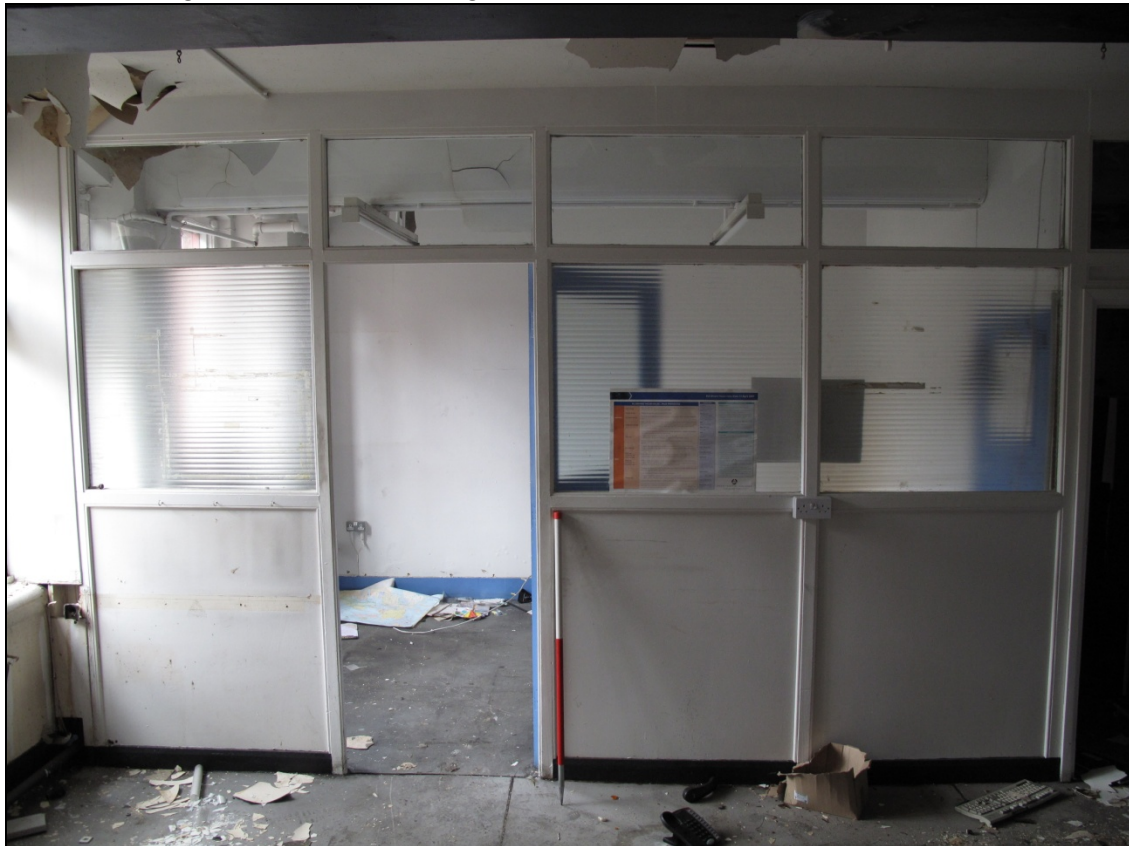
Fig 37: GF1 area 'e' showing glazed office partitions to the N end.

This area was the second largest room and was located to the southern end of the western elevation wall and the western end of the southern elevation wall. At the southern end of the western elevation wall was a doorway leading into the main yard area ‘Y1’ (**Fig 36**) with two windows. At the northern end of the area it was further subdivided into two areas with glazed and stud panel walls (**Fig 37**).

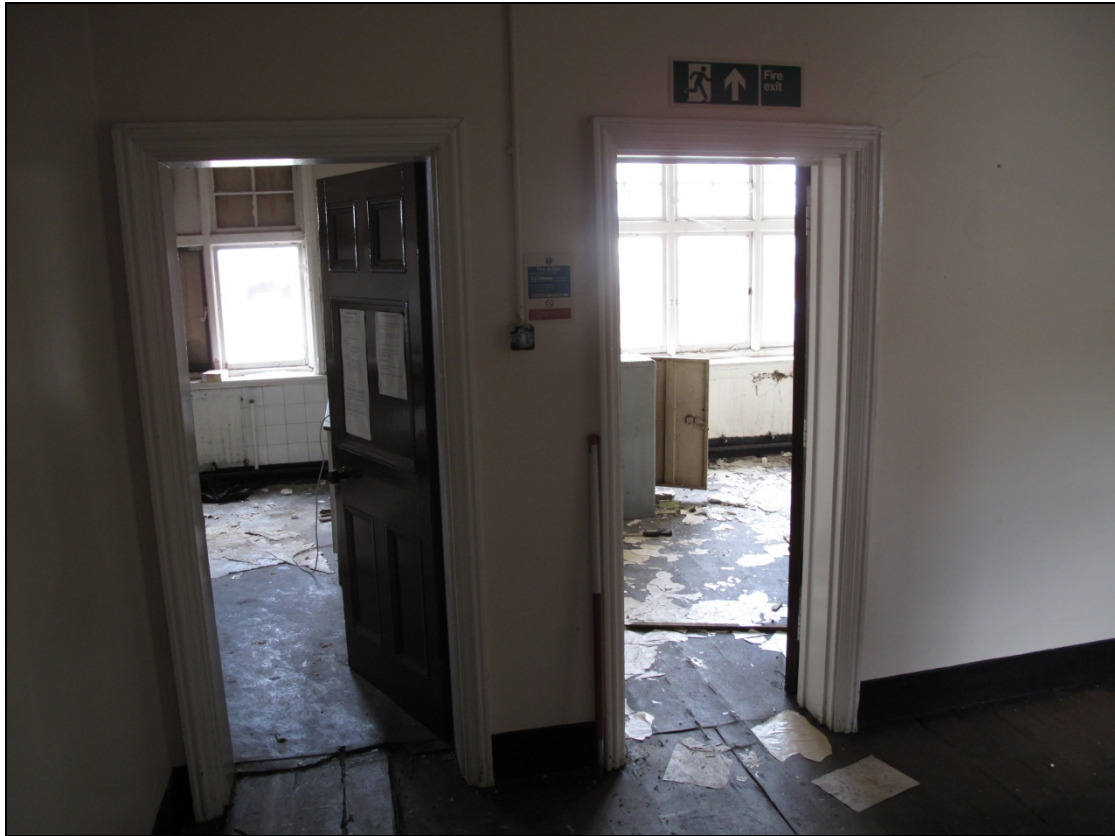
Fig 38: 1F1 area 'b' showing the N dividing wall with doors to 'a' & 'c'.

Located to the southern end of the eastern elevation and the eastern end of the southern elevation walls and formed a large square floor area. The northern dividing wall had two side-by-side doors into areas ‘GF2a & GF2c’ (**Fig 38**)

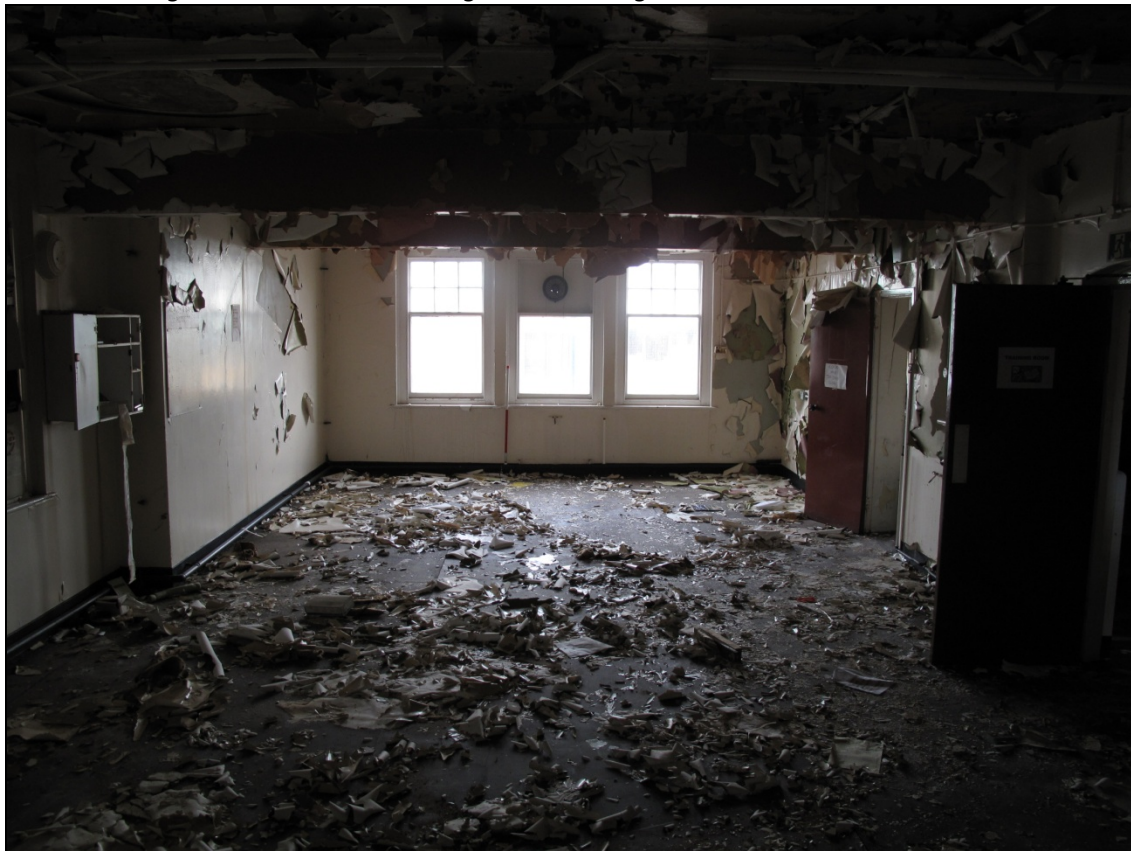
Fig 39: 1F1 general view of area 'd' looking to the N elevation window.

This area was the largest room which compromised of the entire length along the western elevation wall. The triple side-by-side windows were located in the northern wall (**Fig 39**) with a further triple window set in a shallow bay at the southern end of the western elevation wall. Centrally located within the eastern dividing wall were two doorways leading into areas ‘GF2c’ and the central stair well.

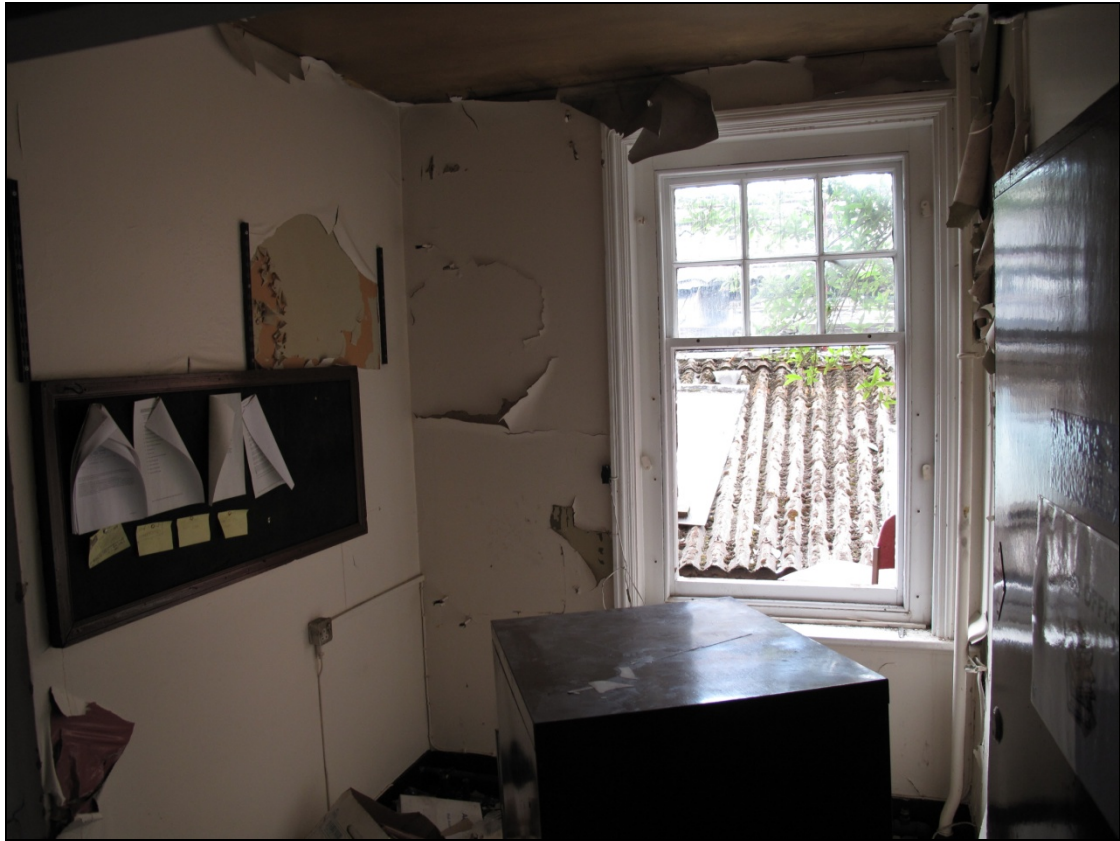
Fig 40: 1F1 showing the S elev., wall window in area 'e'.

This area was the smallest room located centrally to the southern elevation wall with a single window within that elevation (**Fig 40**). A single door in the northern dividing wall led into the central stair well area and an open through way led into area 'GF2b.
