35 Barnsfold Road, Hawk Green, Marple Stockport
An Archaeological Building Survey of a
17th to 20th Century Farmhouse

A report by Dr Michael Nevell

CfAA 2010 (4)

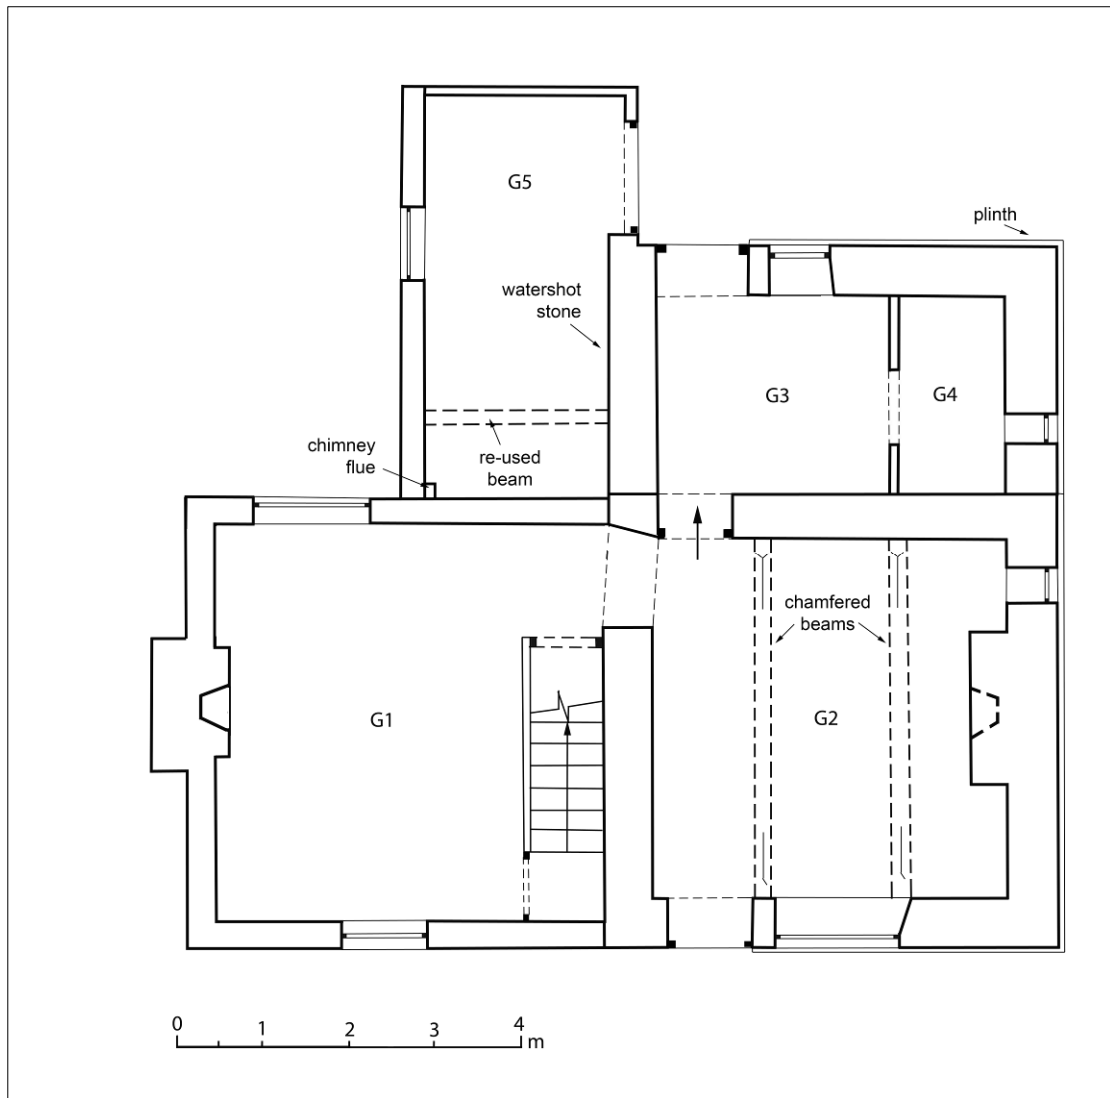
Fig 6: Ground floor plan of 35 Barnsfold Road.

35 Barnsfold Road was a two storey, stone and brick, cottage with an L-shaped plan form. The long axis of the L-shape was aligned west to east whilst the short axis was aligned north to south and lay on the south-western side of the complex, forming a single-storey outshut. Internally, the ground floor contained five rooms (G1-G5; **Fig 6**), whilst there were three rooms on the first floor (FF1-FF3; **Fig 7**).

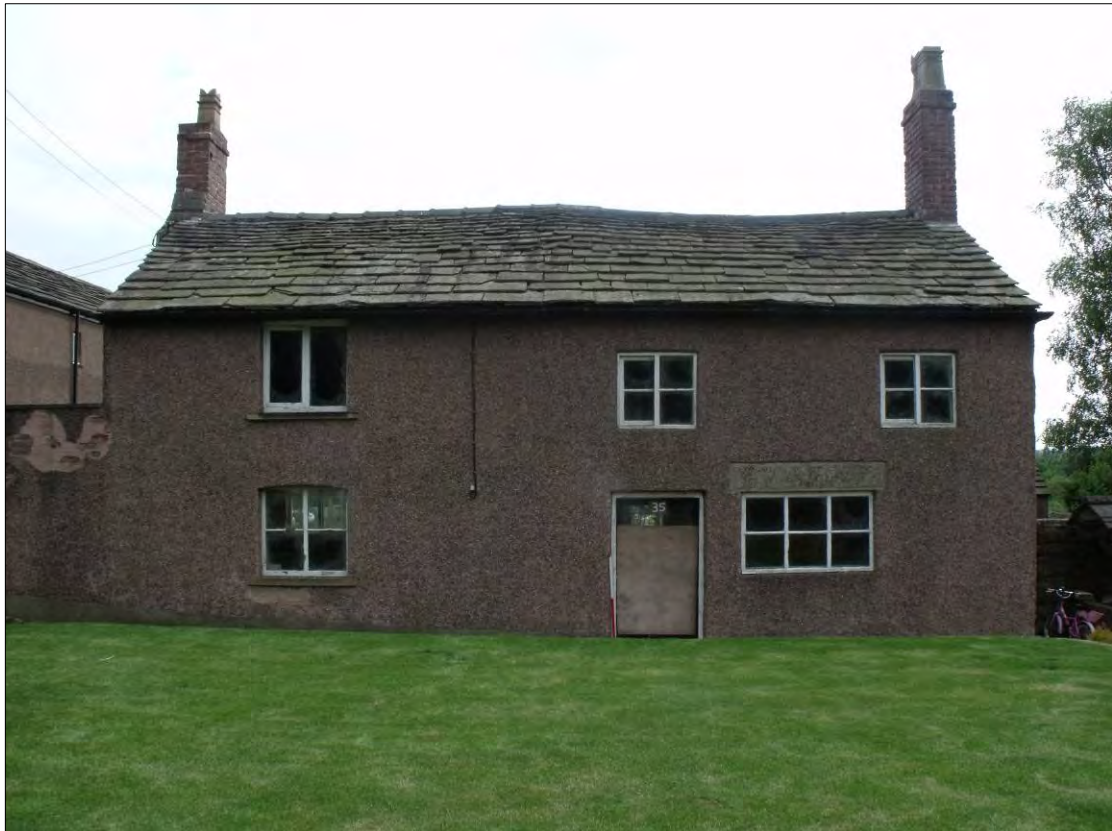
Fig 9: The northern elevation of 35 Barnsfold Road.

The northern, main, elevation of the property had been rendered, obscuring much of the finer architectural and archaeological detailing. This elevation sat on a shallow plinth at the western end and was two storeys high, with gable end chimney stacks, built in hand-made brick. The roof was covered in graduated stone slates, those above the western bay being thick and capped with stone ridges. The thinner slates above the eastern bay were capped with ceramic ridges. On the ground floor there were two window openings flanking a doorway off-set to the west. The eastern ground floor window was square with a four-light casement window with two-lights that opened vertically. The western ground floor window sat beneath a very heavy, and long, stone lintel suggesting that this may originally have been a doorway and window arrangement. The current window was a six-light casement with the two central lights opening vertically. The first floor of the elevation contained three window openings. The eastern window was a two-light casement with a stone lintel and sill, and vertical light openings. The middle and western window openings were the same; each being a four-light casement window with two-lights that slid open horizontally.

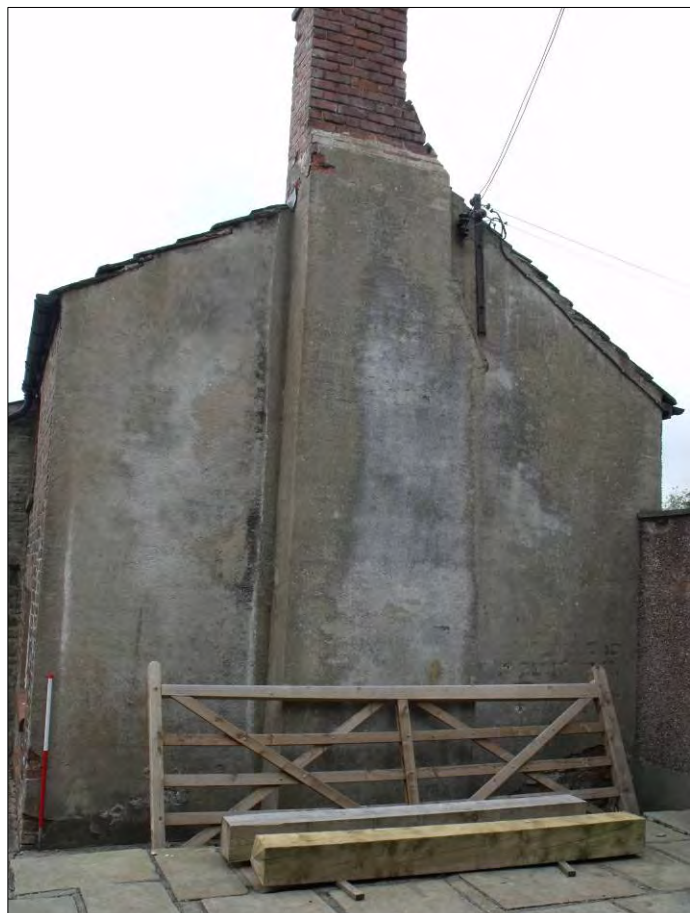
Fig 10: The eastern gable of 35 Barnsfold Road.

The eastern gable was also rendered obscuring much of the detail. The brick chimney could be seen to sit on an extruded stack and beneath the rendering was hand-made brick.

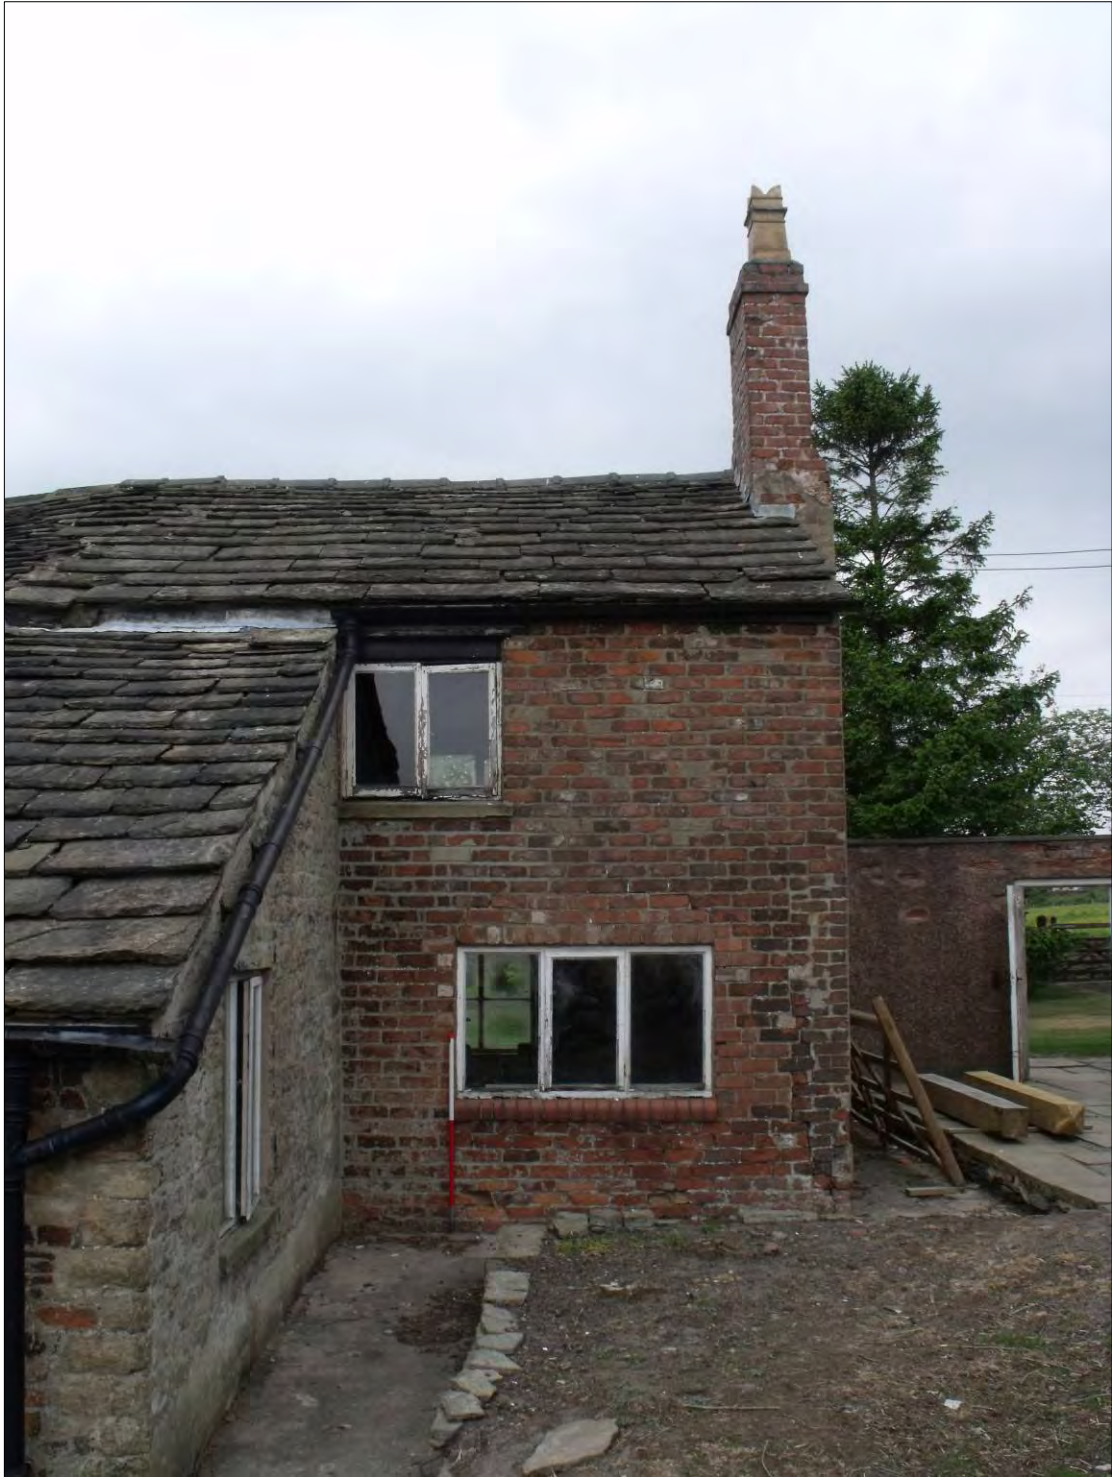
Fig11: The south-eastern elevation of 35 Barnsfold Road.

The southern elevation of the eastern bay was built in a mixture of hand-made and machine-made brick in a very irregular English Garden wall bond. There were two window openings. The ground floor window was a three-light casement with a central opening light with a machine-made bull-nosed brick sill and a brick headed lintel. The brick around this window was rebuilt in machine-brick. Above was a mixture of hand-made and machine-made brick. The first floor window was a two light casement with vertical opening lights immediately beneath the eaves. The sill was a later replacement in concrete whilst the lintel was also a later replacement, and was a rolled steel joist (RSJ).

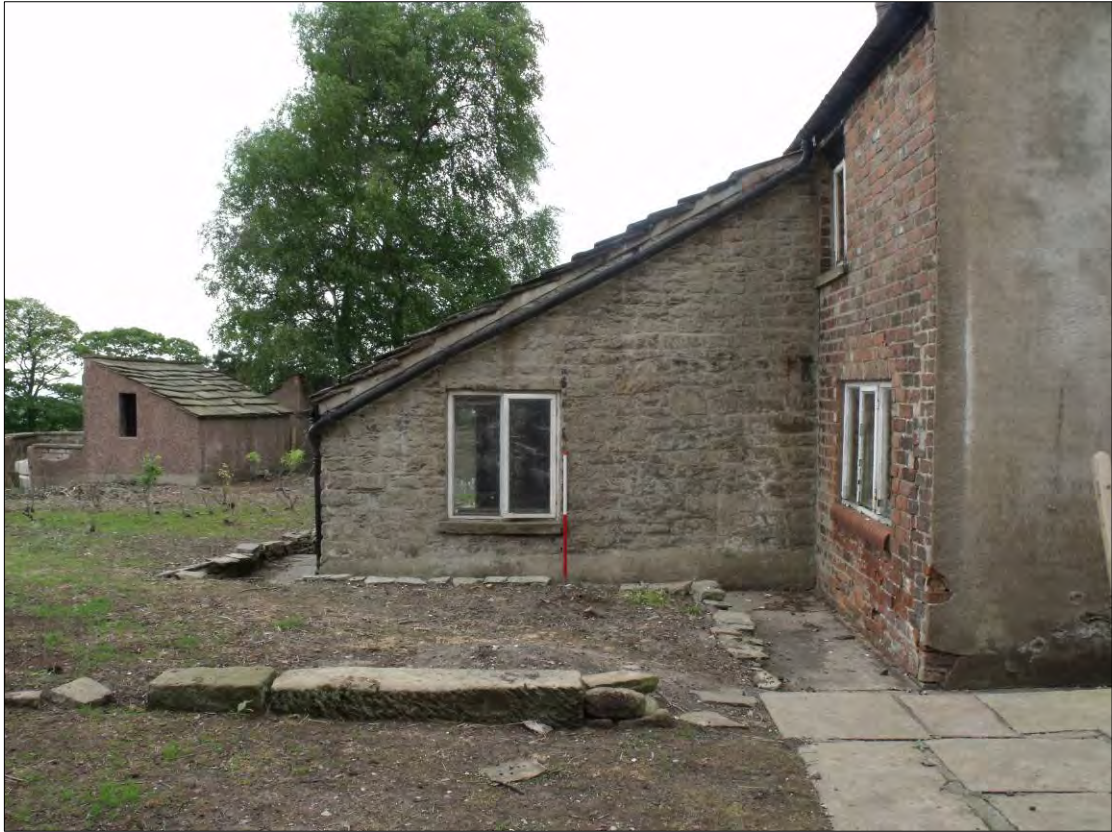
Fig 12: The south-eastern gable of the outshut at 35 Barnsfold Road.

The eastern elevation of the outshut was built in roughly finished coursed stone sitting on a shallow plinth. There was a single opening, a two-light casement with concrete sill and stone lintel and a vertically opening light.

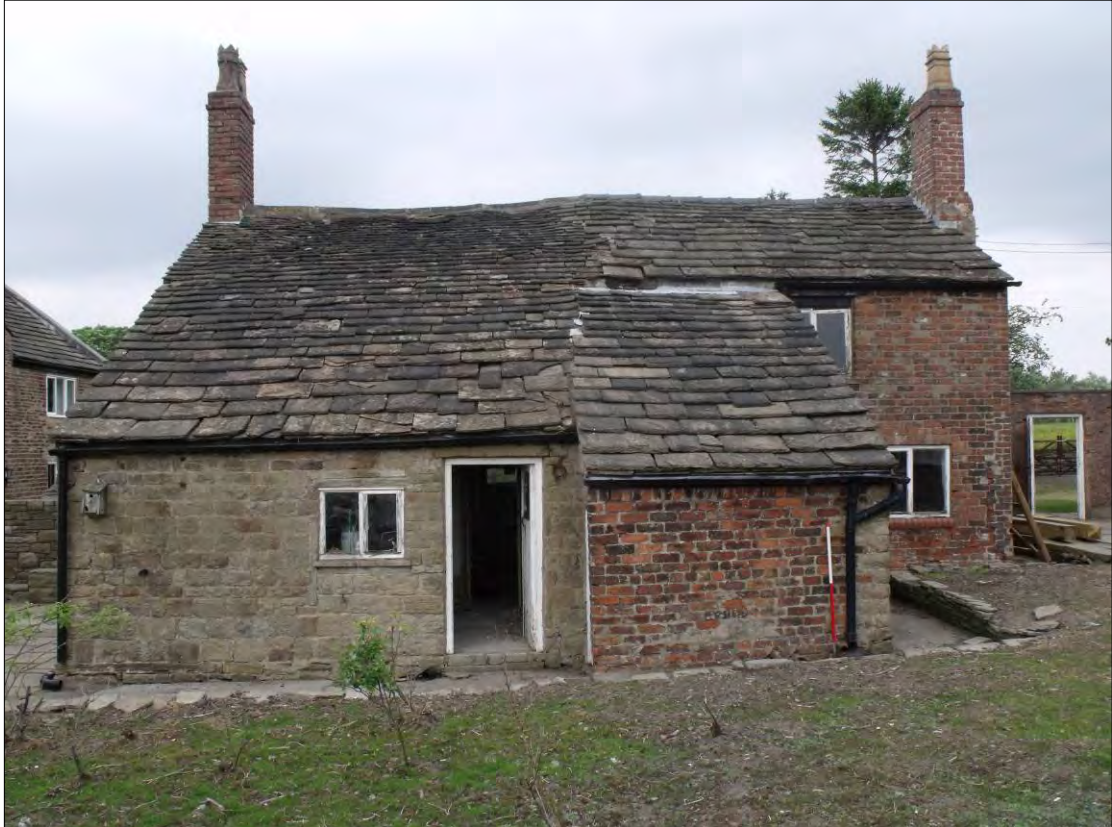
Fig 13: The southern elevation of 35 Barnsfold Road.

The southern elevation of the outshut range (rooms G3, G4 and G5) was built in hand-made brick and ashlar stone. The gable end to room G5 projected slightly beyond that of the southern elevation to rooms G3 and G4 and was built in hand-made brick to the west and stone to the east with a straight building break between. The stone elevation to rooms G3 and G4 sat on a shallow two course stone sill and contained two openings. These were a doorway to the east with a stone lintel and a two light casement window to the west with a vertical opening light with a stone lintel and sill. This window appears to have been originally a doorway, as shown by a change to the stonework and a vertical building break below the western edge of the window.

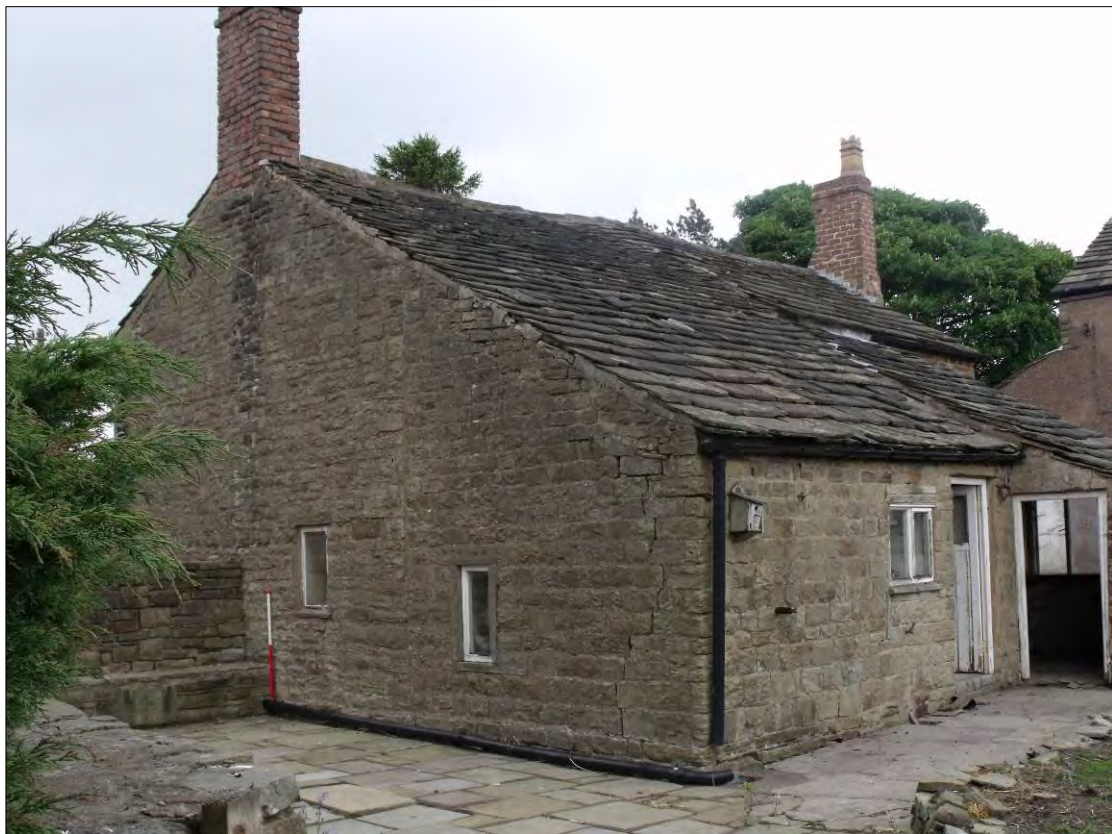
Fig15: The western gable of 35 Barnsfold Road.

This was built on a plinth, three-courses deep, and there was a straight vertical building break between the two ground floor windows. The northern window was a single light with a stone lintel and sill, whilst the southern window was also a single light but with a stone surround. The northern corner of the elevation had large quoins, whilst the northern side of the building break had a few smaller quoins. The southern corner of the elevation had no quoins but there was a large crack where the southern gable of the outshut, G3, had begun to slip down the hill. North of the building break the masonry was roughly finished, whilst south of the break the masonry was dressed stone in regular courses. The chimney stack rose above the top of the gable and was built in hand-made brick.

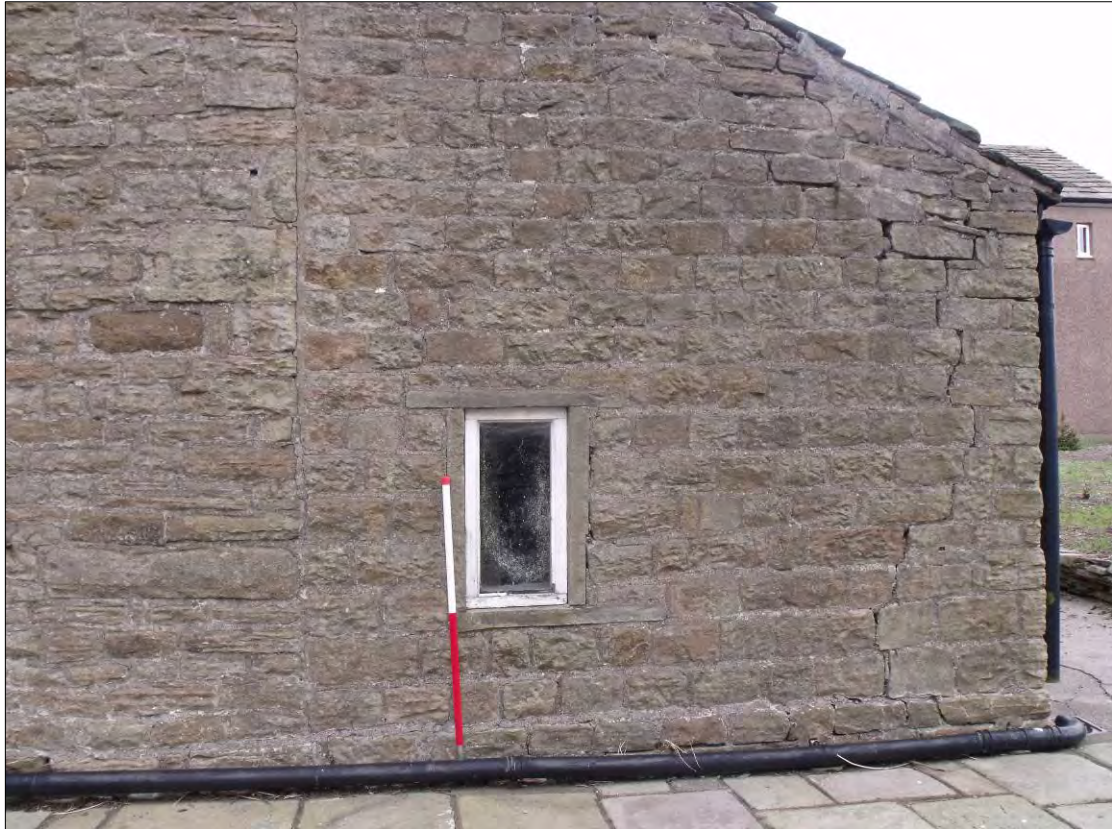
Fig 16: detail of the western gable of 35 Barnsfold Road showing the break at the south-west corner

This saw the addition two single-storey, stone-built, rooms to the southern gable of G2, and represented by rooms G3 and G4. This is shown by the vertical break-line in the western gable of the cottage. This may have acted as a pantry/scullery area. It had a graduated thick stone slate roof contemporary with the roof covering over FF2 and suggesting that it had been replaced at this period. There were also stone ridge pieces above FF2. However, there is evidence to show that this roof covering had been re-laid in the 20th century (see below Phase V). The style of the stone-work and roofing suggests a broadly 18th century date for this addition.

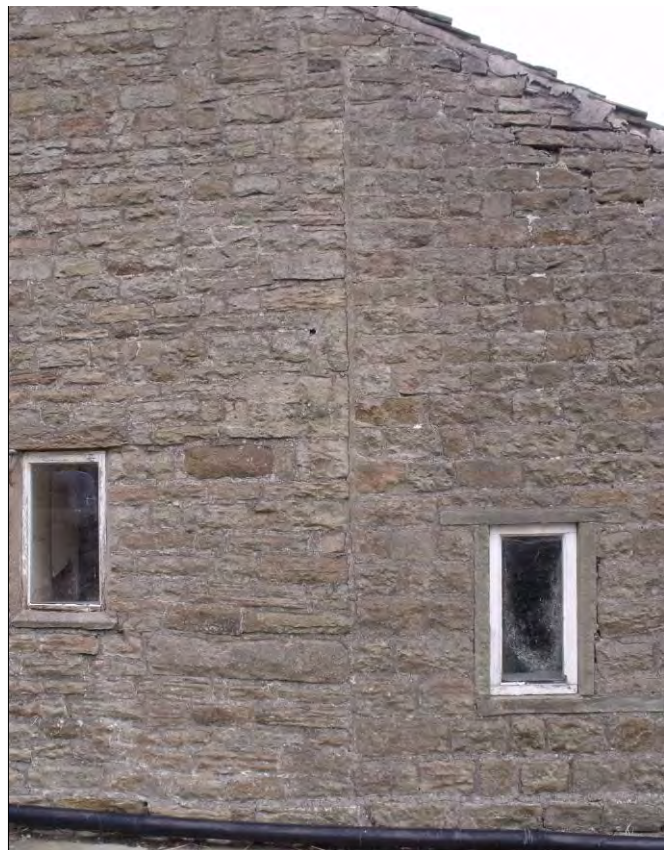
Fig 17: Detail of the western gable of 35 Barnsfold Road, showing the building break between the two windows.

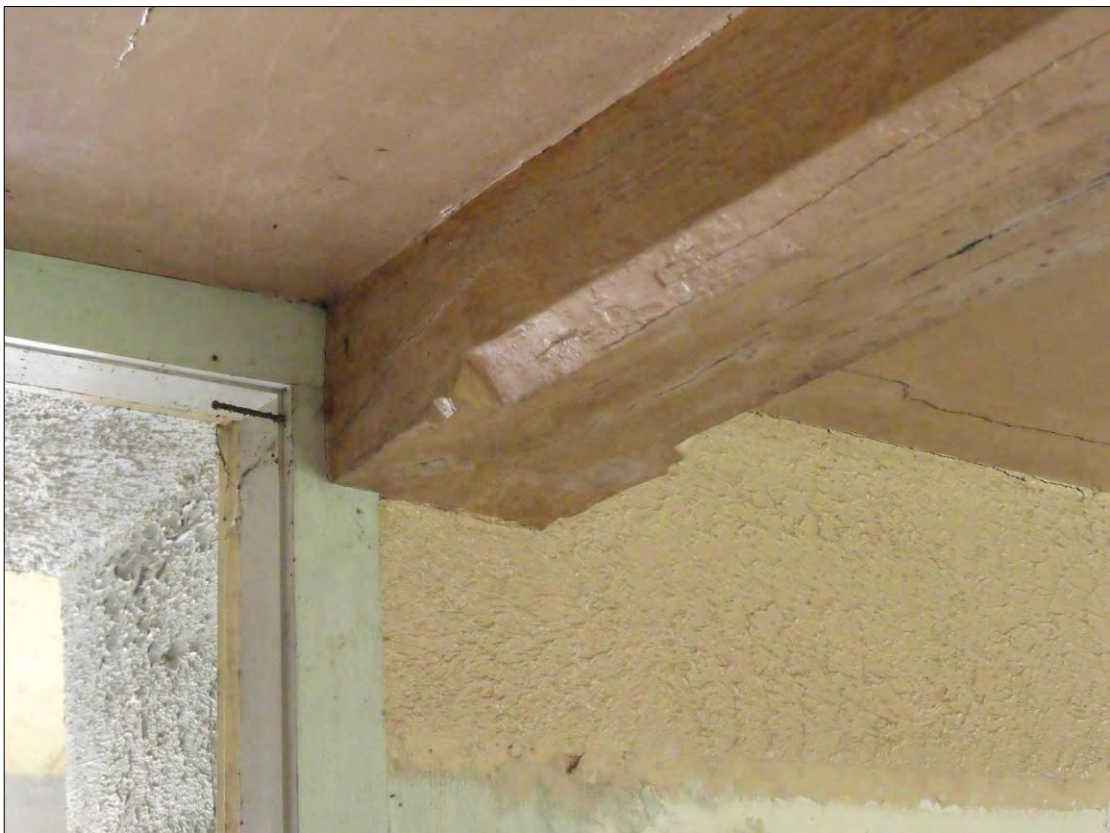
Room G2 (**Fig 26-30**) lay at the eastern end of the complex and was entered via an external doorway in the northern elevation, via a doorway into room G1 on the eastern side and via a doorway with a step down into G3 on the southern side. The southern side of the doorway into room G1 had a full-height chamfer. The floor of the room was covered in 20th century bitumen. There were two window openings in the

Fig 28: Room G2 looking at the southern end of the eastern ceiling beam. Note the deep chamfering and run out stops.

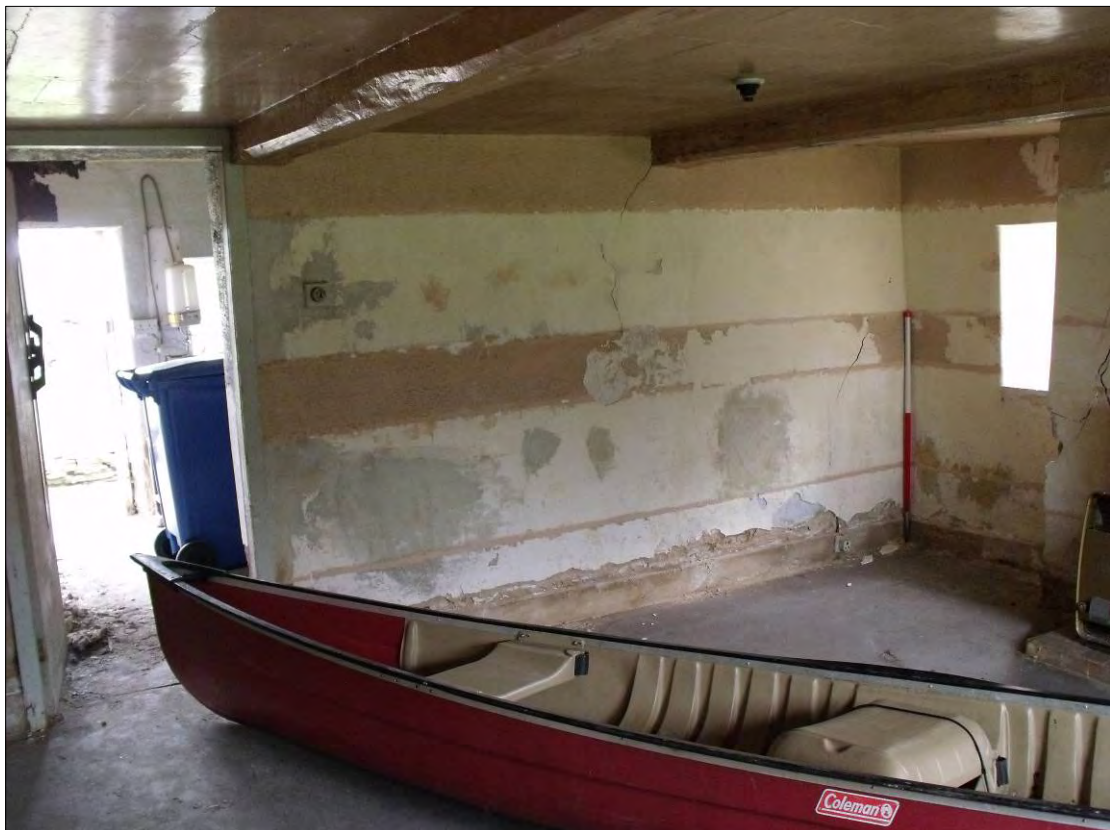
Fig 30: Room G2 looking southwards towards the kitchen area, room G3. Note the chamfered ceiling beams.

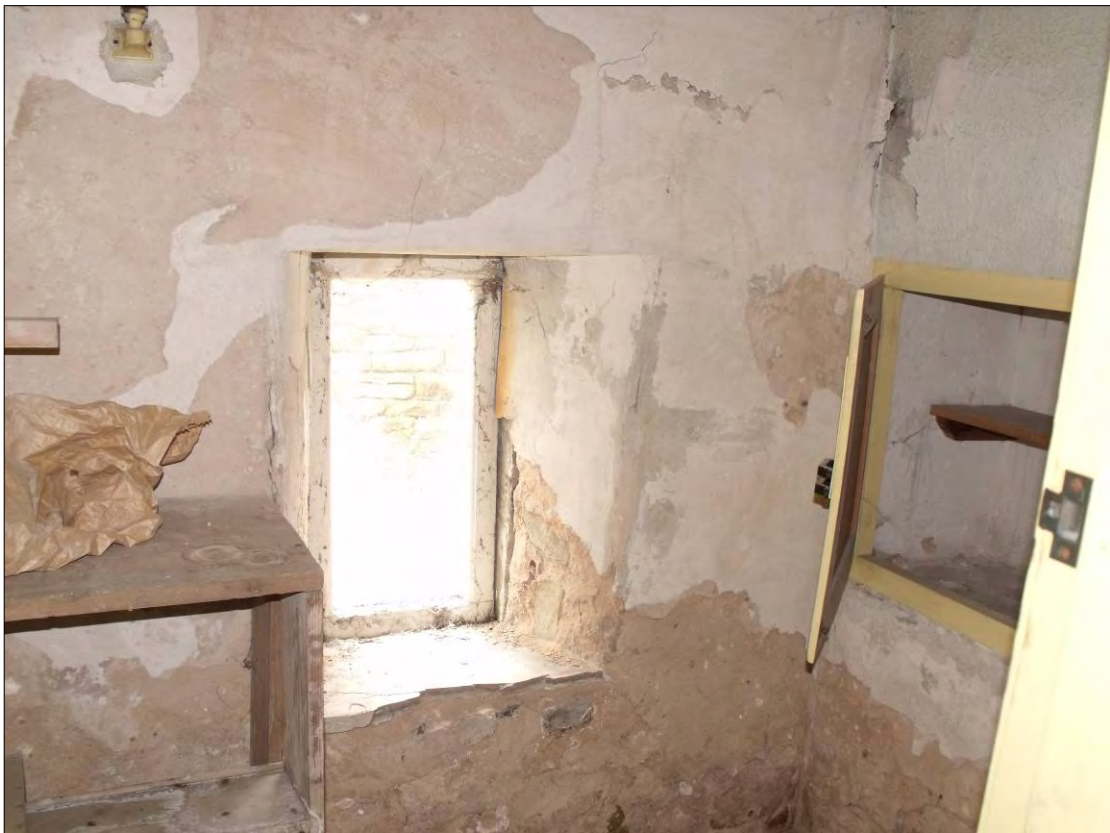
Room G4 (**Fig 34**) lay on the western side of the outshut and was only accessed from G3 via a narrow, central, doorway in the middle of a stud partition. It had a bitumen skimmed floor and the walls were plastered. There was a single narrow window opening in the western elevation. The ceiling was covered in hardboard.

Fig 34: Room G4 showing the chamfered window in the western gable.

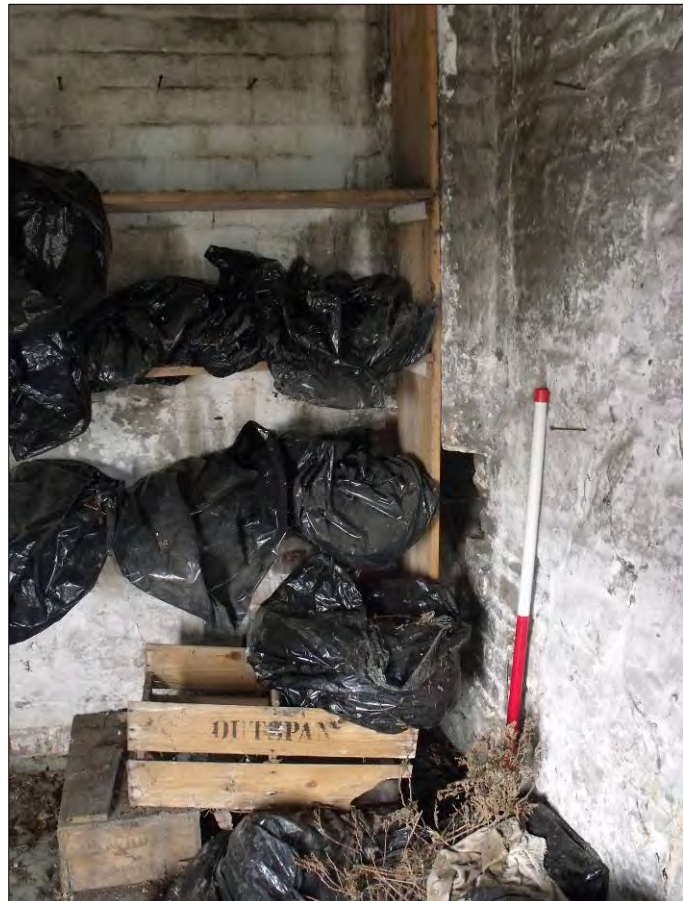
Room G5 (**Fig 35-8**) lay on the eastern side of the outshut and was only accessed from an external doorway in the south-western corner of the room. It had a stone flagged floor and the walls were lime-washed. The western wall was built in watershot stone indicating that originally it was an external elevation for room G3 from the 18th or very early 19th century. The southern wall had been rebuilt in hand-made brick. There was a single opening in the eastern wall. The roof structure was exposed in the ceiling and had five rafters, four in machine-cut pine, whilst the one at the northern end was a re-used oak purlin. In the north-eastern corner was a small hand-made brick flue, square in section that rose the full height of the room. This may have been a feature connected with brewing in this room, although no other related features were noted.

Fig 37: Room G5 looking northwards, showing the re-used ceiling beam supporting the rafters. Note the small brick chimney in the corner, Was this used as a brew house?

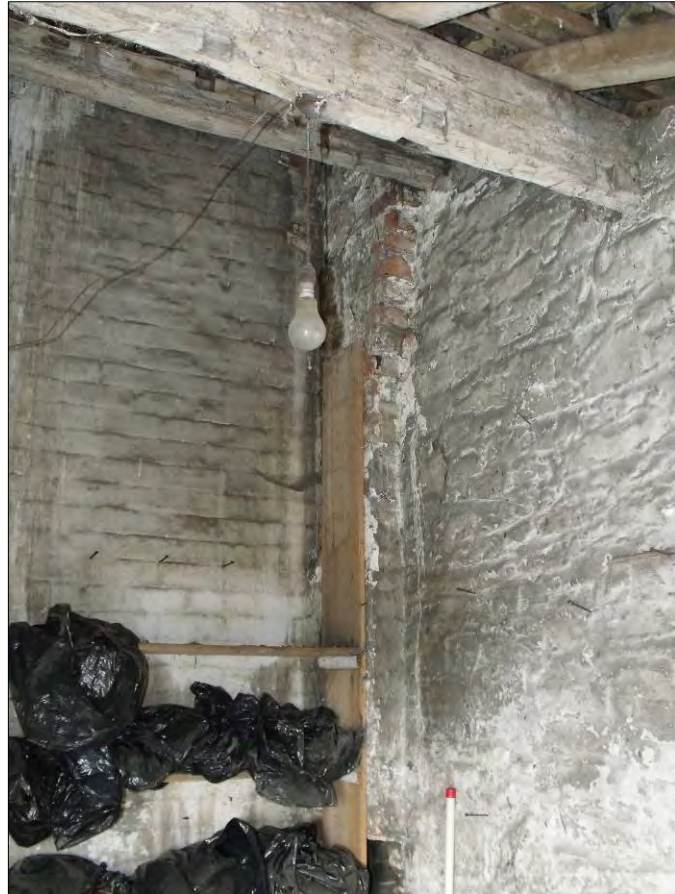
Fig 38: Room G5 looking north-westwards at the watershot stone partition with room G3, which was a former gable wall.

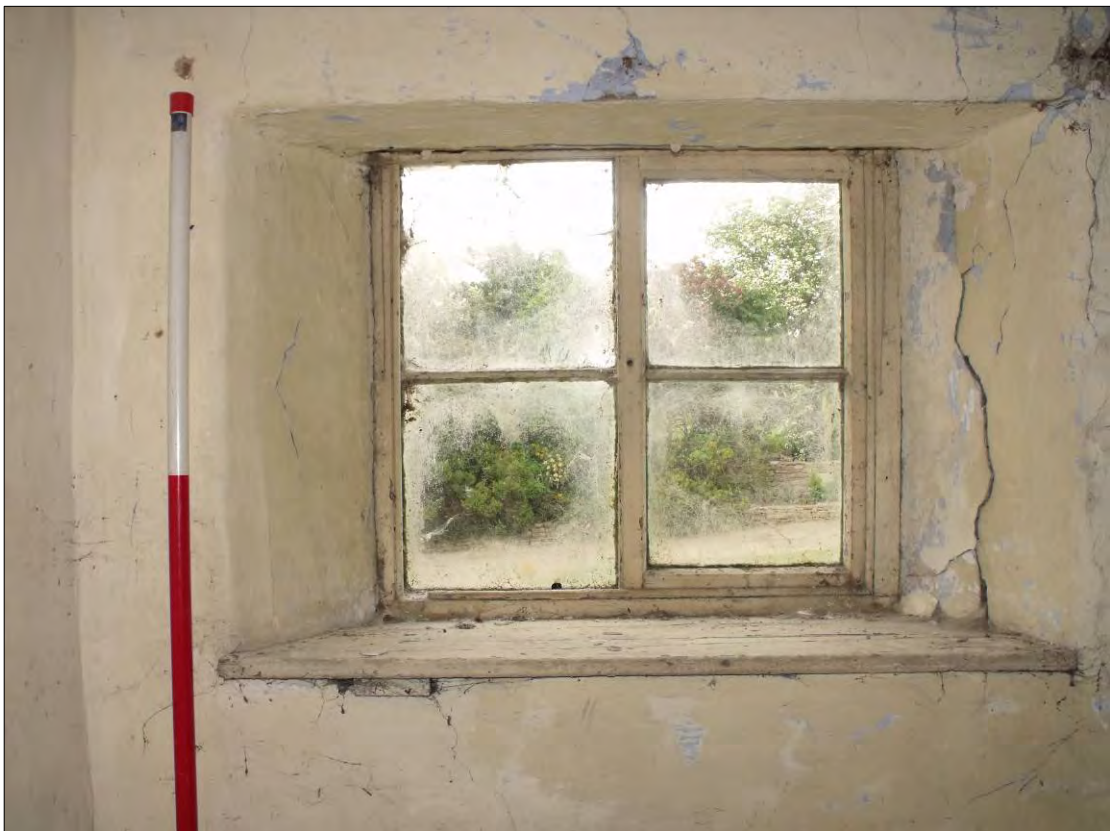
Room FF2 (**Fig 39-43**) lay at the western end of the building. The floor comprised a mixture of six inch pine floor boards and a few nine-inch wide floorboards running north to south. All the walls were plastered. There was a mid-20th century glazed tile fireplace in the middle of the western gable. There were two casement windows in the northern elevation, each of which had chamfering and each of which slide open horizontally. The ceiling was plaster-covered and the room rose partially into the roof space exposing the bottom of two purlins running west to east.

Fig 42: Room FF2 showing the north-western chamfered casement window.

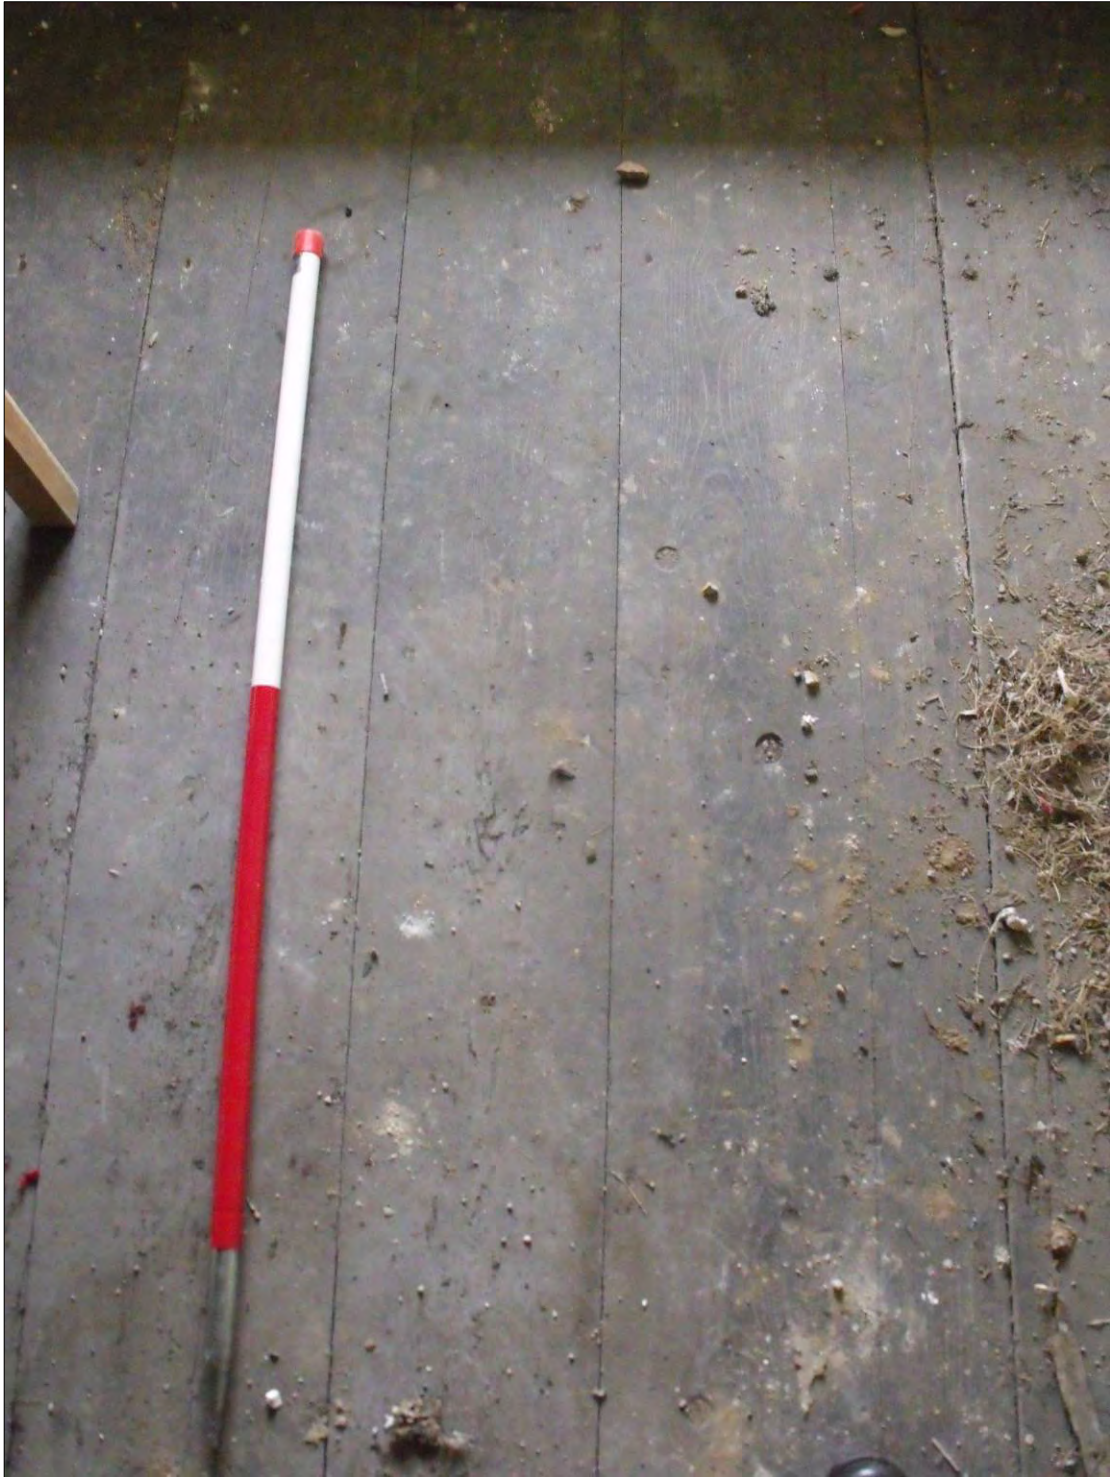
Fig 43: The floorboards in room FF2 showing the six inch pine (left) and nine inch oak (right) floor boards.

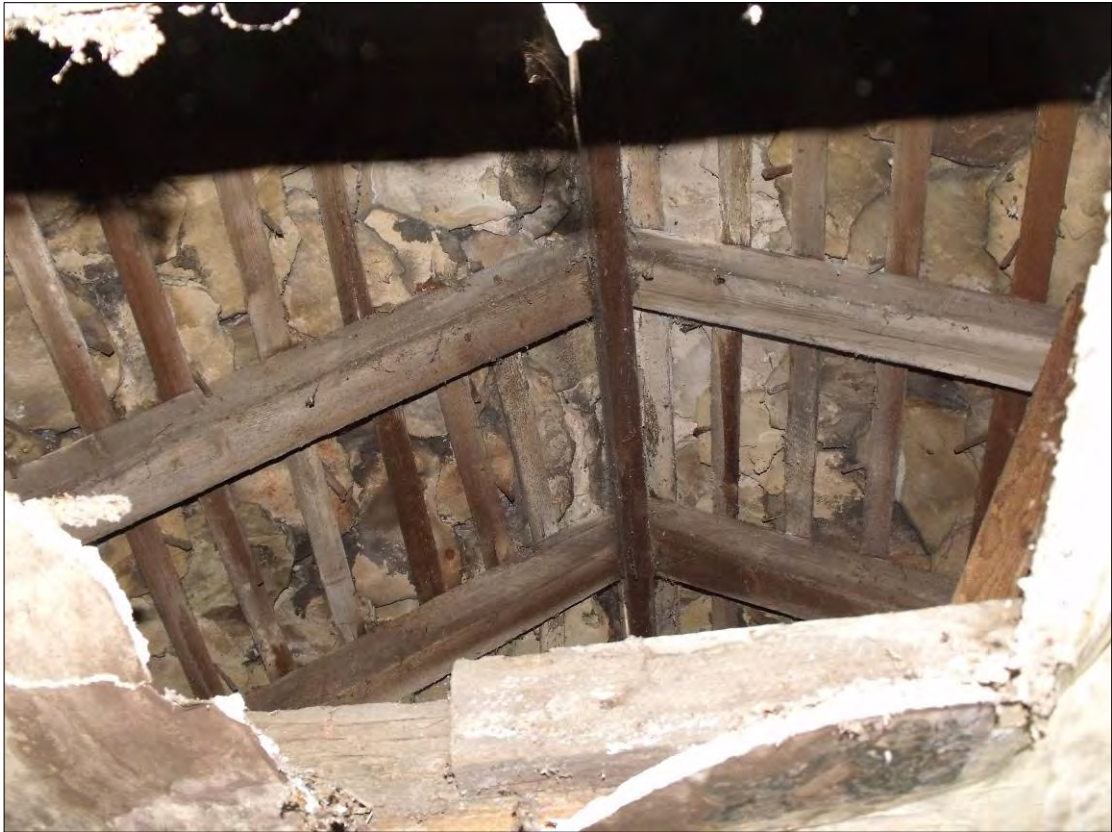
Most of the roof structure within 35 Barnsfold Road was not accessible at the time of the current survey. However, a hole in the ceiling in room FF2 revealed part of the roof structure above this room. This showed that in this part of the building the roof structure comprised machine-cut pine rafters and a thin machine-cut ridge tree which supported the earlier thick graduated slate roof.

Fig50: Detail of the roof structure (machine-cut pine rafters) above room FF2.

This period saw the rafters above FF2 replaced with softwood versions, showing that the roof slates above FF2 and G3 and G4 had been re-laid during this period. The northern, front, elevation and the eastern gable were rendered, presumably to mask the join between the stone and brick bays and to give the northern elevation some symmetry. The southern wall of the outshut G5 appears to have been rebuilt in brick during this period. The stud partition between rooms G3 and G4 was inserted during this phase and the floors of each room were covered in bitumen. The fireplaces in rooms G1 and G2 were rebuilt during the mid-20th century and the floor in G2 was skimmed with bitumen during this period. The casement windows in G1, the northern elevation of G2, and in FF3 were replaced during this period. The floors in rooms FF2 and FF3 were replaced during this period and a new fireplace inserted into FF2.
