Newton Hall, Tameside, Greater Manchester

A report on the Community Archaeological Evaluation of a
Medieval and Post-Medieval Landscape

A Report By: B Grimsditch, Dr M Nevell & R Garratt
Report No: 02/2010

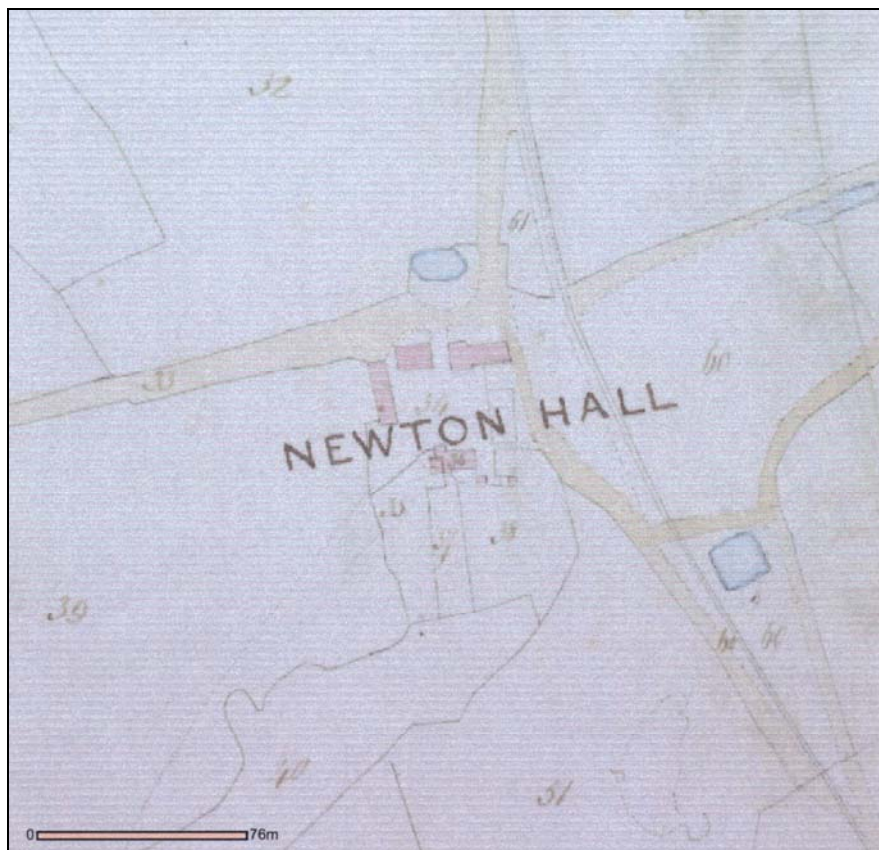
Figure 2 - 1847 tithe map

The earliest map viewed was the 1847 tithe map which showed a complex of buildings surrounding an open yard. The timber framed hall (building 1) was to the east with a rectangular building (building 2) off the north eastern corner of the hall (**Plate 2**) with a 'T' shaped building (building 3), running in an east west orientation, off the eastern end of building 2. At the southern end of the site was a further building (building 4) which was rectangular in form, running in an east west orientation, with extensions on the north western and south western corners. There were also two other small square outbuildings to the south east of building 4. This map indicated that the hall was longer in form than to the north than that seen on modern mapping and is shown with its northern gable abutting Dunkirk Lane whereas today the northern gable is several metres short of the roadway. The tithe map indicates that the hall site covered plots 34-38 inclusive and the land was owned by Francis Dukinfield Palmer Astley although the persons occupying were Henry Lees and Samuel Swire. Unfortunately the only description of the plots was '*Building*' thus little information could be ascertained about the use of the buildings.

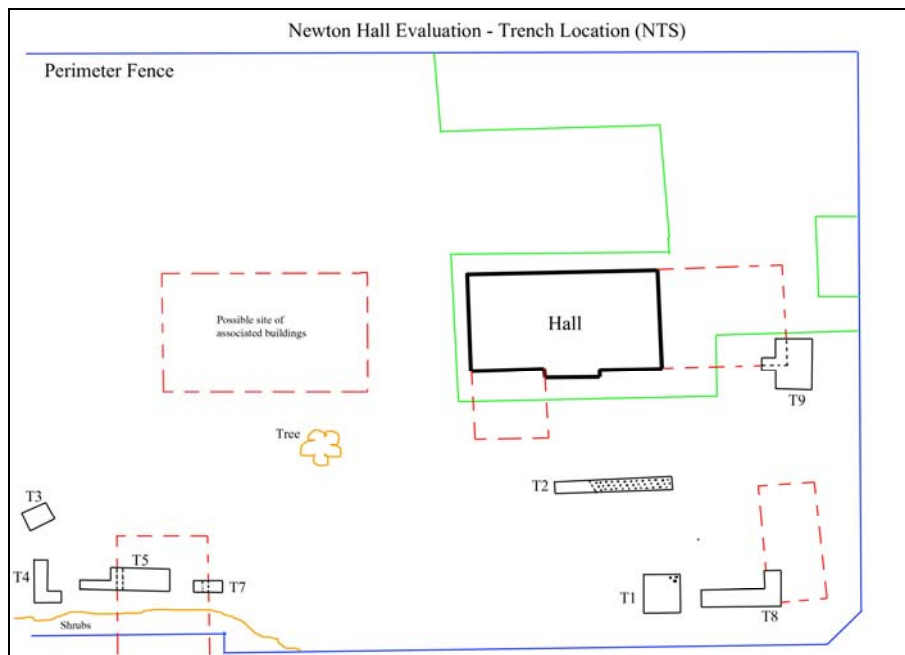
Figure 12 - Trench Location Plan (not to scale)

- 3.2** Nine evaluation trenches were excavated in this manner. Trench 1 was opened in the north eastern corner of the site was orientated in an east/west alignment and measured c. 4.00m x 2.00m. The purpose of this trench was to locate and evaluate any remains of a structure indicated on late 19th century mapping.

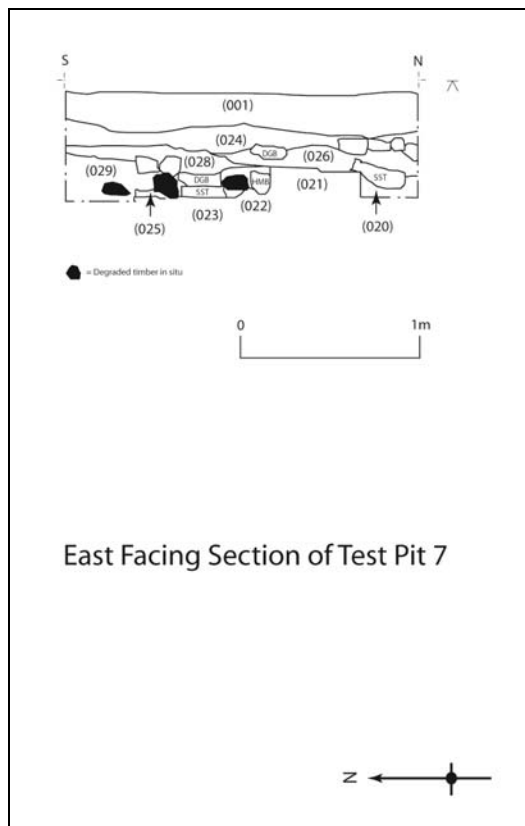
Trench 7 measured c. 2.900m by 0.60m and lay in a north south orientation. It was located c. 7.00m to the north of trench 5 and was positioned to locate any structural features associated with the wall (034) discovered in trench 5. On removing the top turf level a layer of mid brown soil containing gravel (024) was revealed below which at the northern end was a layer of dark brown soil with inclusions of brick and stone building material (028). At the southern end of the trench below (024) was a thin layer of mid grey clay material containing inclusions of broken brick. Below (026) towards the northern end of the trench was a laid coursed rubble red sandstone wall c. 0.50m wide and running the full width of the trench (021). To the north of this wall (021) was a layer of hand made brick rubble below which was a layer of black cinder material (020). Along the southern side of wall (021) was a layer of brick and lime mortar (022) c. 0.25m wide at the southern edge of which was a length of very degraded timber. Below this construction layer and to the south of it was a mid yellow clay layer (023) c. 0.60m wide that was contained another piece of very degraded timber (025). Finally south of this timber was a further layer of yellow clay (024) lighter in colour than (023).

It was determined that it was necessary to locate the northern of building 4 and as a result trench 7 was opened. Although only 0.6m wide this trench revealed a wall of red sandstone (021) bonded by lime mortar. This wall ran parallel to wall (034) in trench 5 and the sandstone blocks were similar to the erroneous red sandstone block in wall (034). Wall (021) however, was only 0.5m wide as opposed the wall (034) that was 0.7m wide. Along the southern edge of this wall was course of handmade brick bonded by lime mortar that could possibly be a later addition to the interior of the wall (021). It is suggested that although of different materials this wall represented the northern wall of building 4. The amount of brick, stone and other building debris found overlaying the wall remains and trench would suggest that the structure that was there had been demolished and the rubble used as a hard standing over which a cinder layer was laid prior to the land being developed.

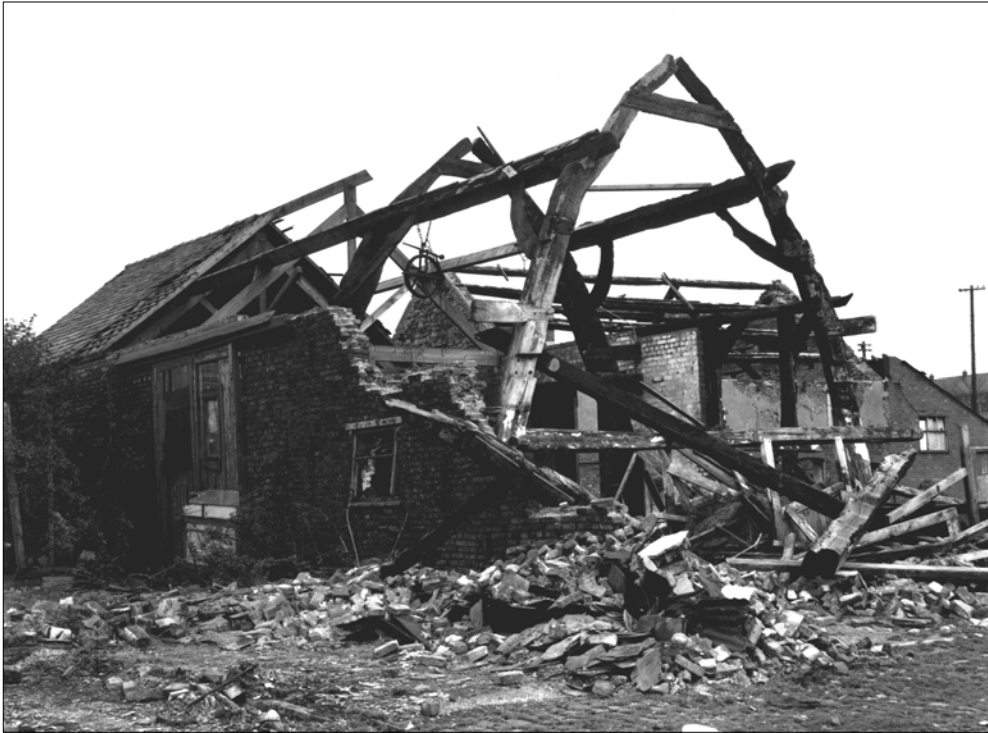
Plate 1 – Newton Hall in 1969 prior to restoration, showing the 18th century threshing barn during demolition

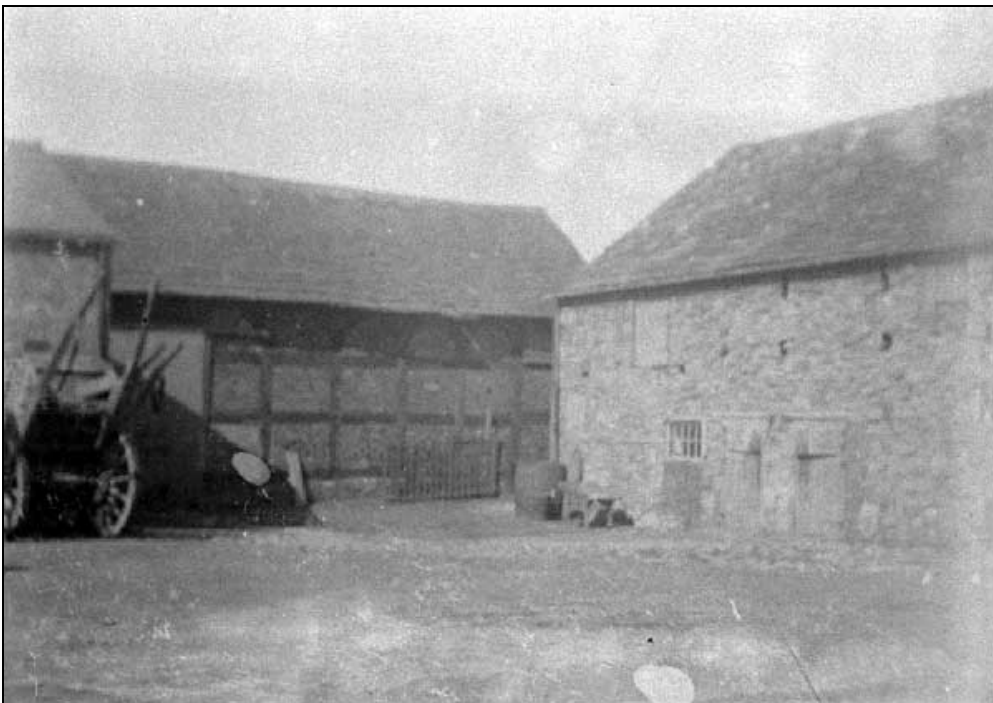
Plate 2 - Newton Hall in the late 19th/early 20th century (Hall, building 1 to left and building 2 to the right) (courtesy of Tameside Local Studies Library)

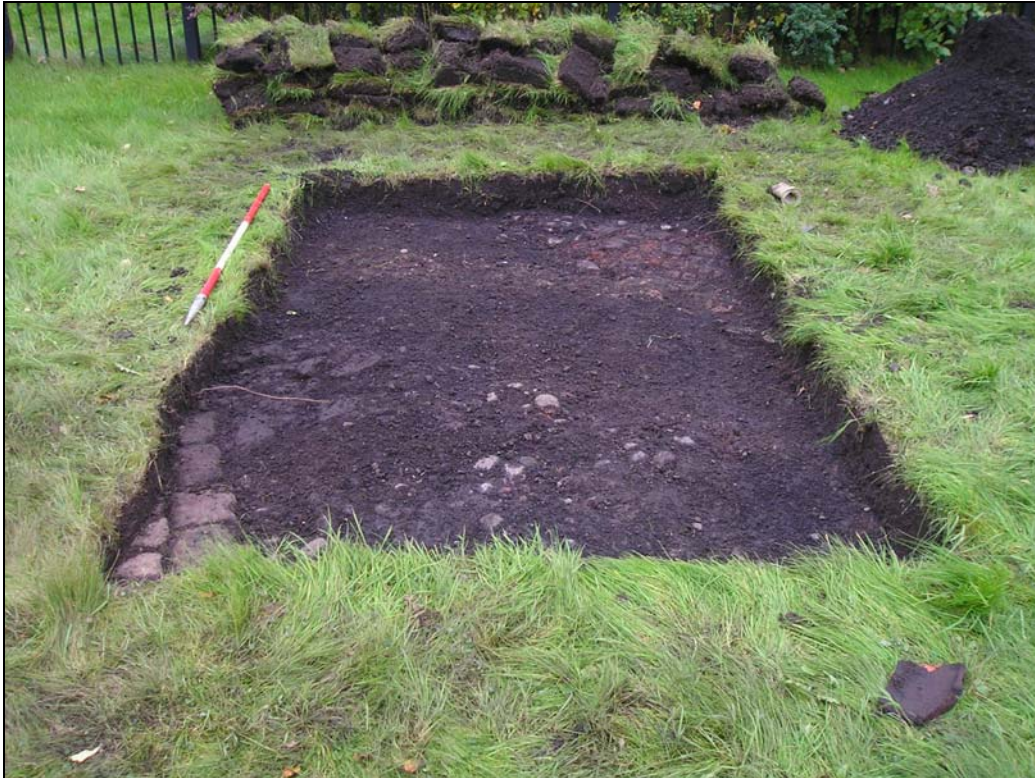
Trench 1 was located in the north eastern corner of the site in the area where 19th century mapping indicated a large rectangular building in line with the Hall (building 2). Further investigation indicated that the Hall may have been truncated to the north thus the location of this trench was erroneously placed too far to the south. However, the investigation of this trench was continued as it was possible that it would indicate the composition of any floor that may have made up the interior of the farmyard enclosed by the Hall and other buildings indicated by the 19th century mapping. A thin layer of turf was removed immediately below which was a black cinder layer (003). In the north western corner of trench 1 were two rows of stone setts laid within (003). These setts were running in a north east/south west orientation. In the south western corner of the trench was a layer of compacted brick and stone (006). Running from the north eastern corner in a south westerly direction was a linear cut feature denoted by the yellow clay fill (005). (*Plate 3*)

Plate 3 – Trench 1 looking east showing cobbled surface

This trench was located using the measurements from the extant hall (building 1). Unfortunately information obtained later on during the investigations indicated that the structure perceived to be in that area was in actual fact sited further to the north under an area of landscaping that had raised the ground level to over 1.50m. However, this trench did indicate the presence of structural deposits in the western section in the form of brick and stone rubble and a possible drainage cut. Also to the north western corner were at least two courses of stone setts also seen in trench 2. It is therefore probable that this trench was placed on the internal farmyard shown by the remains of a cobbled surface.

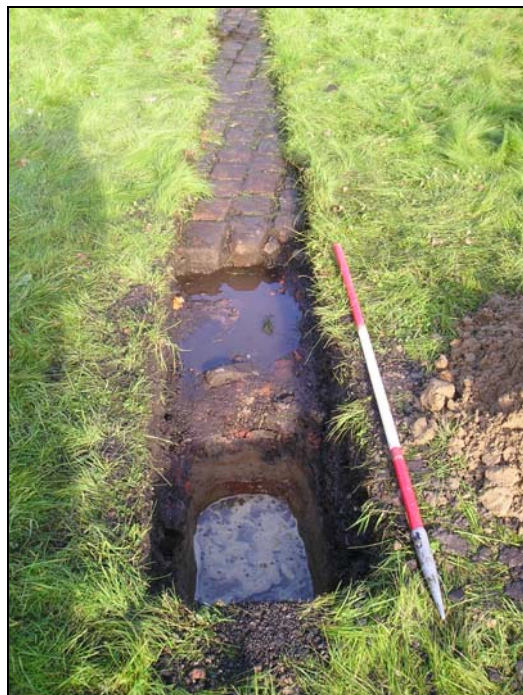
Trench 2 was opened to evaluate any remains of a cobbled farmyard surface as hinted at by the discovery of the stone setts in trench 1. The thin turf covering was removed and immediately below was a stone sett surface (017) running in a north east/south west orientation. The setts were laid on a thin layer of black cinder similar to (003) that in turn was laid on top of a stone and brick rubble layer (018). The setts appeared to have been truncated at the southern end of the trench. A small sondage was excavated at the southern end of the trench to determine the nature of the archaeology below (018) which revealed a layer of light yellowish brown sand. Although this layer was only excavated down to c. 1.00m below the ground surface it appeared to continue (*Plate 4*).

Plate 4 – Trench 2 looking north showing cobbled surface with rubble make-up layer and natural sand deposit

The cobble setts ran through most of the trench but at the southern end the setts appeared to have been removed affording an area that could be investigated below the level of the setts. This showed that the setts had been laid on top of a cinder layer similar to that found in trench 1. Significantly this cinder layer was on top of a layer of brick and stone demolition rubble suggesting that earlier buildings had been demolished within the vicinity and used as a levelling layer for the cobbled surface. Due to the placing of this cobbled surface on top of earlier demolition rubble it is suggested that this cobbled surface formed the inner farmyard of the complex created in the late 19th century. However, this could not be substantiated by artefactual evidence.

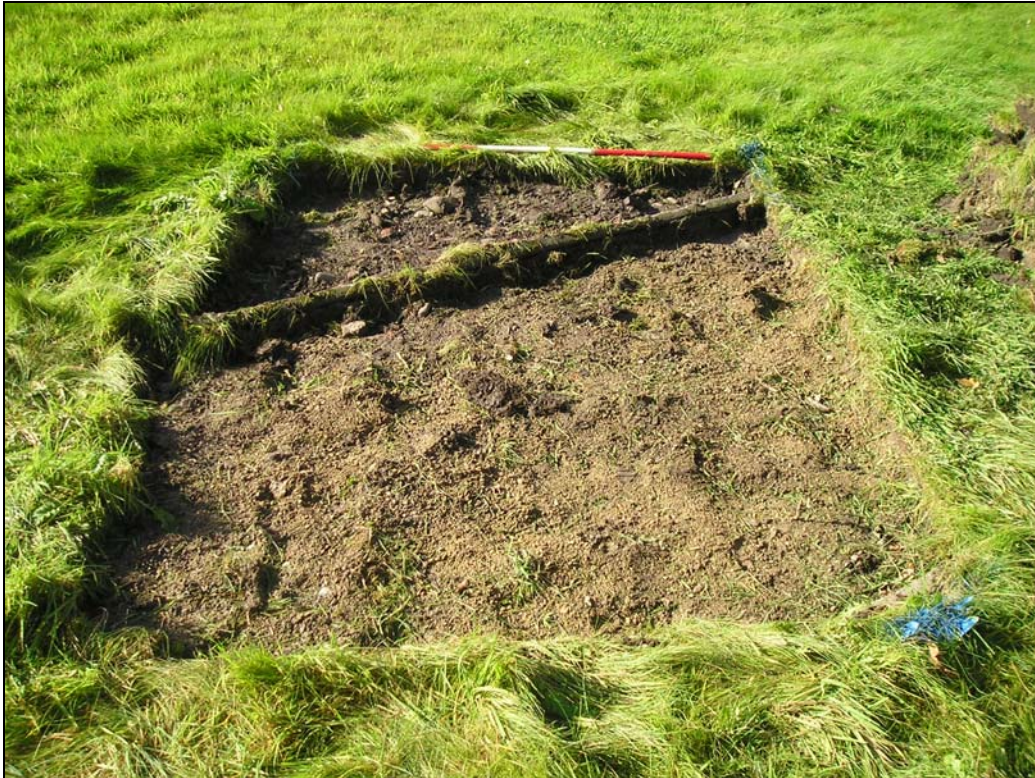
Using 19th century mapping this trench was opened over southern exterior of what was indicated as being a long rectangular structure. The trench measured c. 3.00m by 2.00m and lay in a north west to south east orientation and was situated c. 30m south east of the Hall. On removing the thin surface turf layer it was seen that the trench was divided into two distinct areas the division being created by concrete edging stones (009) running in a north/south direction across the full length of the trench. In the north eastern corner of the trench an identical line of concrete edging stones was also revealed. Between the two sets of edgings was a mid brown gravel layer (008) and on the outside of the edgings was a dark brown soil with inclusions of brick rubble and stones (**Plate 5**). An area of the context (008) was excavated to determine its depth which was revealed a c. 0.20m and below was a dark brown layer (015).

Plate 5 – Trench 3 looking west, showing gravel path and concrete edging

The trench was sited over what was thought to be the north western exterior of a structure a distance to the south east of the hall to investigate the existence of any approach from the hall to the structure. The concrete kerbing and the stone chip surface between suggest a late 19th/early 20th century connecting pathway from the hall and associated buildings to the structure south east of the hall.

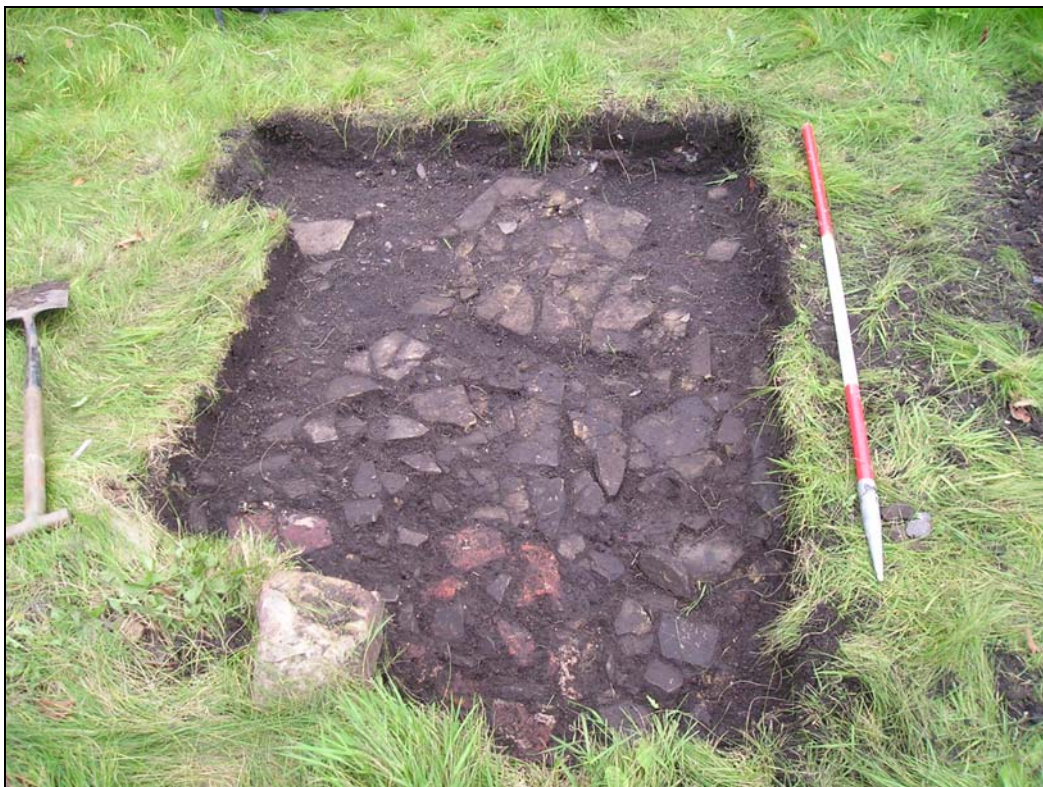
As with trench 3 this trench was opened at the rear of the indicated long rectangular structure c. 5.00m to the east of trench 3. The trench measured 1.70m by 1.70m and was later extended west by a further 1.5m. Removal of the top turf layer revealed a dark brown soil with gravel inclusions (016). Within this layer were several features. At the eastern end was a square yellow sandstone flag broken into several pieces and running in a westerly direction the full length of the trench were several more pieces of broken yellow sandstone (010). At the south western end of the trench were two distinct areas of brick rubble (011) & (012). Context (011) was made up of two machine made bricks with (012) being composed of large pieces of machine made brick rubble (**Plate 6**).

Plate 6 – Trench 4 looking east showing degraded path

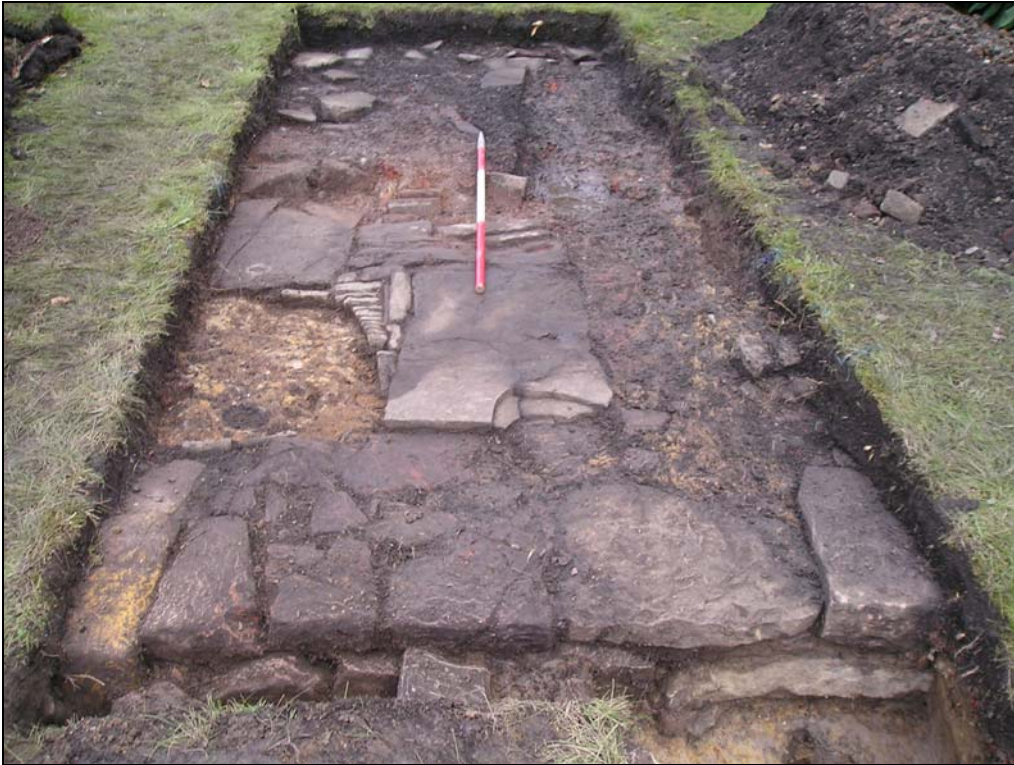
Trench 5 was opened c. 5.00m to the north of trench 4 to locate the southern external wall of the long rectangular building (building 4) to the south east of the Hall. It measured c. 4.50m by 2.00m and orientated north/south (**Plate 7**). To the south of this trench was a previously excavated trench that had not been back filled and had been excavated down to natural clay deposits (trench6). This unfilled trench was probably the result of geotechnical investigation. It was decided to take advantage of this exposed earlier trench to obtain a full section of the layered deposits in that area and as such trench 5 was joined to trench 6 making the full length of the overall trench c. 7.00m. On removal of the thin turf a thin layer of black cinder (045) which covered a layer of building rubble in the form of broken brick and stone in a matrix of dark brown humic soil and yellow clay (047). At the northern end of the trench, within the context (047), were several broken pieces of gritstone blocks. Central to the trench on its western edge was a stone slab (036) and immediately to the west of this was a series of laid thin setts covering an area c. 0.50m by 0.70m (042) that was bounded at their southern edge by another large stone slab (036). To the west and south of (036) was an area measuring c. 0.80m by 0.70m of light yellow clay (039) that at its north eastern corner had some of the thin setts (042) laid within it (**Plate 8**). At the southern end of this feature and central to it was a circular possible post hole denoted by its dark brown fill [040]. To the south of (036) & (039) and running the full width of the trench east to west was a laid stone coursed rubble wall (034) measuring c. 0.70m in

Plate 7 – Trenches 5 & 6 looking north showing southern elevation wall of building 4 and internal flooring

Located to establish the southern elevation of the rectangular structure (building 4) to the south east of the hall this trench revealed several features that could be associated with a possible later domestic structure. The wall (034) was mainly of large grey gritstone blocks; however, interspersed were one of yellow sandstone and one of red sandstone. This suggested that this wall had been repaired or had been built with re-used stone work. To the north of the wall (034) were several features suggestive of an interior. Central to the trench and running off wall (034) was a of large stone flag terminating in a set of four courses of laid cobbles at which point the flags turned right angle to the west. It is possible that this series of stone flags represents the floor

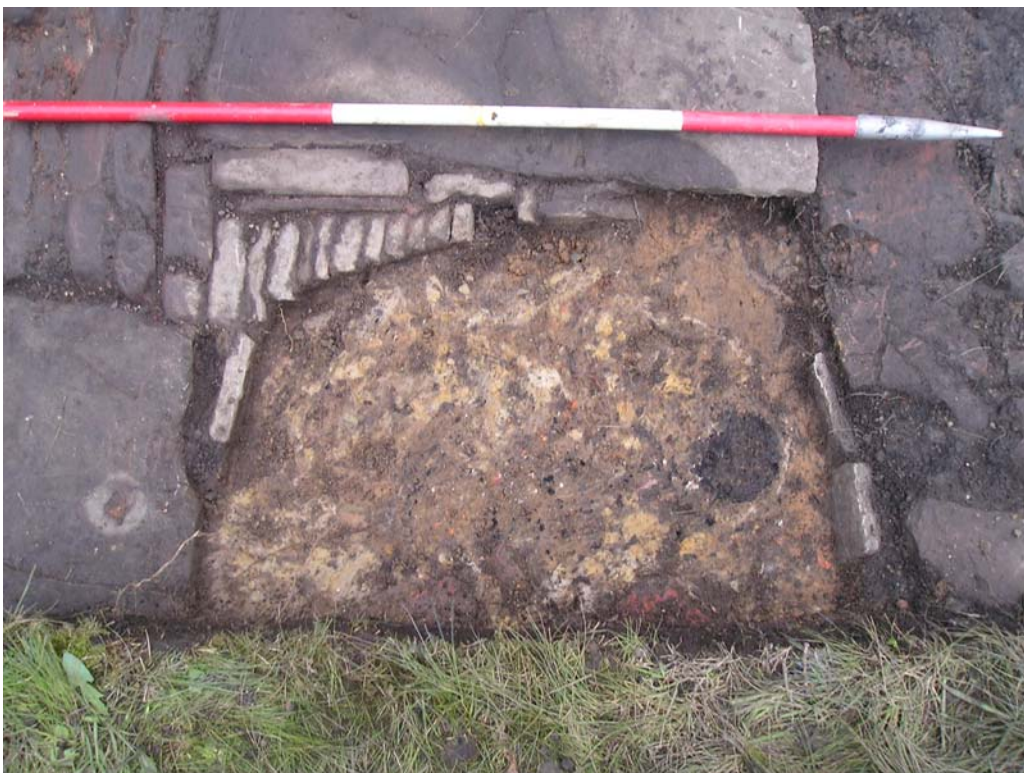
Plate 8 – Trench 5 showing internal feature containing circular post hole

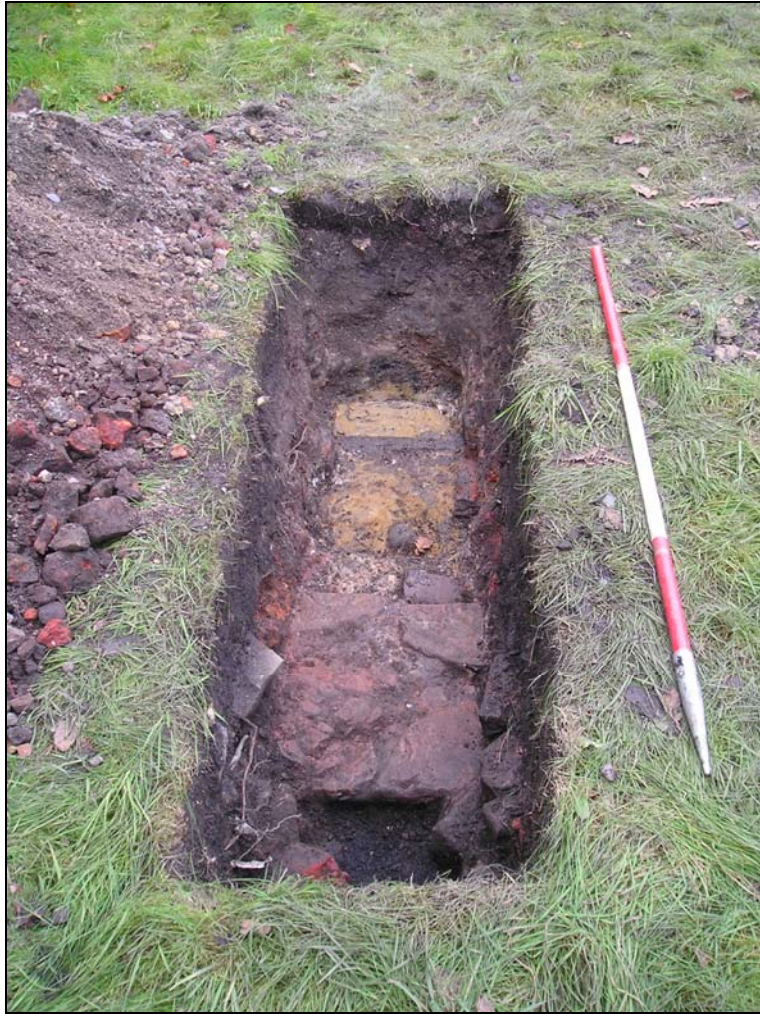
Plate 9 – Trench 7 looking south showing northern elevation wall of building 4

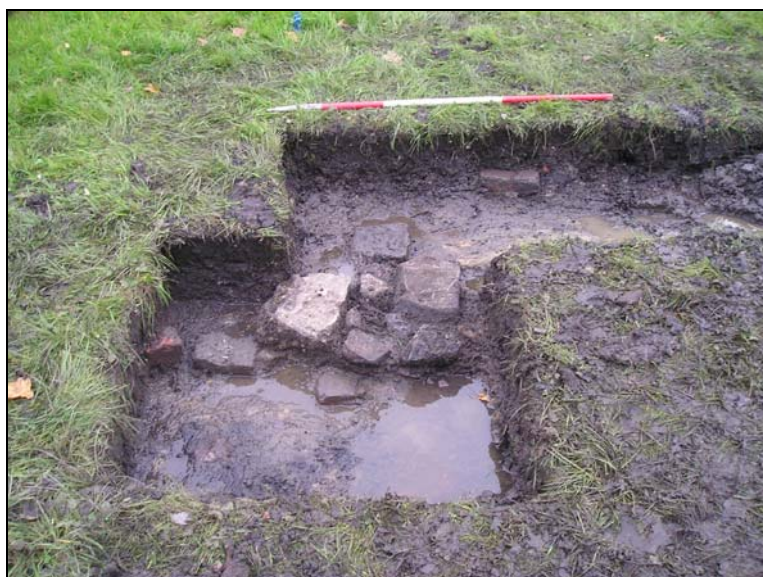
This trench was a further attempt to locate any remains of the large square building seen on the 19th century mapping located to the north east of the Hall and was positioned to the north of trench 1. Difficulties were encountered with this trench with the ingress of water consequently only the top turf was removed and any features seen recorded. On removing to top turf level a layer of brick and stone rubble was revealed (052) and at the northern end of the trench there was a possible linear cut feature [049] running in a north west/south east orientation denoted by a light yellow clay fill (053). Within this layer were several stone blocks (050) that although appearing to be running in line with [049] were too ephemeral to place an interpretation on.

Plate 10 – Trench 8 showing possible remains of building 2

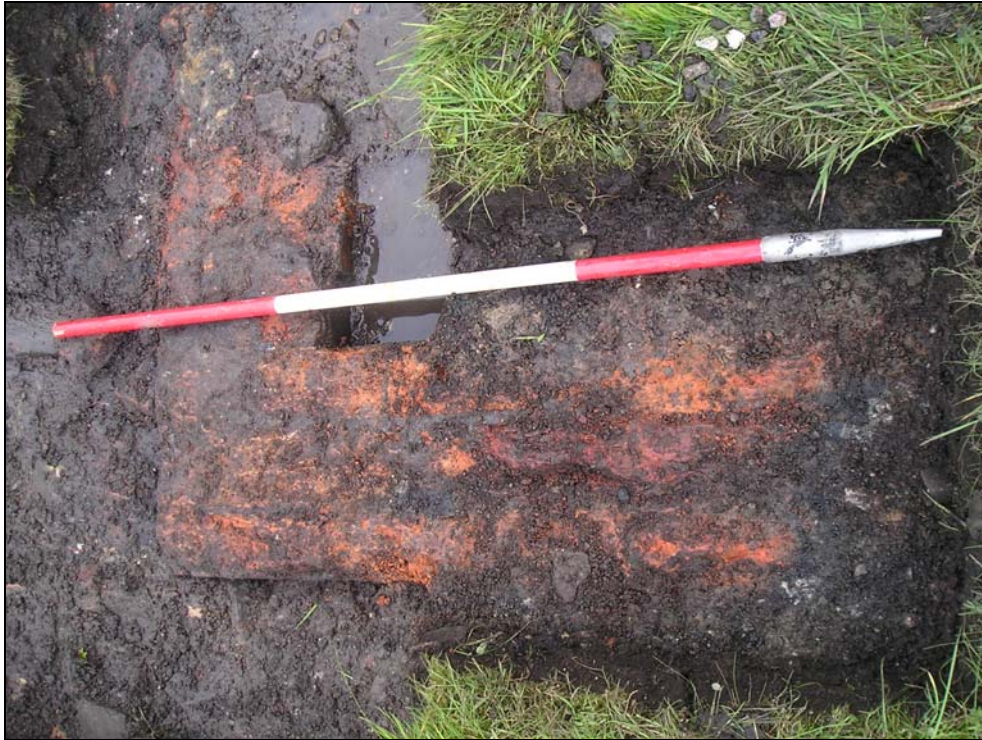
the Hall had been truncated at some time prior to the mid twentieth century and whether the original cruck structure had been extended during its development. The top turf level was removed revealing a hand made brick wall (054), three courses wide and at least two courses deep, forming a right angle that was directly in line and corresponding with the north eastern corner of the Hall (*Plate 12*). The wall was surrounded by a dark brown clay soil (055).

Plate 11 – Trench 9 looking east showing north eastern corner of extension to building 1

Map evidence suggested that during the mid 19th century the hall (building 1) was substantially longer at the northern end. Trench 9 was opened to investigate this possibility. Immediately below the topsoil a wall of handmade brick (054) was uncovered this wall turned at perpendicular to the west and was exactly on line with the eastern elevation of the hall. It is probable that the original cruck hall had been extended to the north possibly when the hall went out of use as a domestic structure and was extended to accommodate a larger and more agricultural purpose.

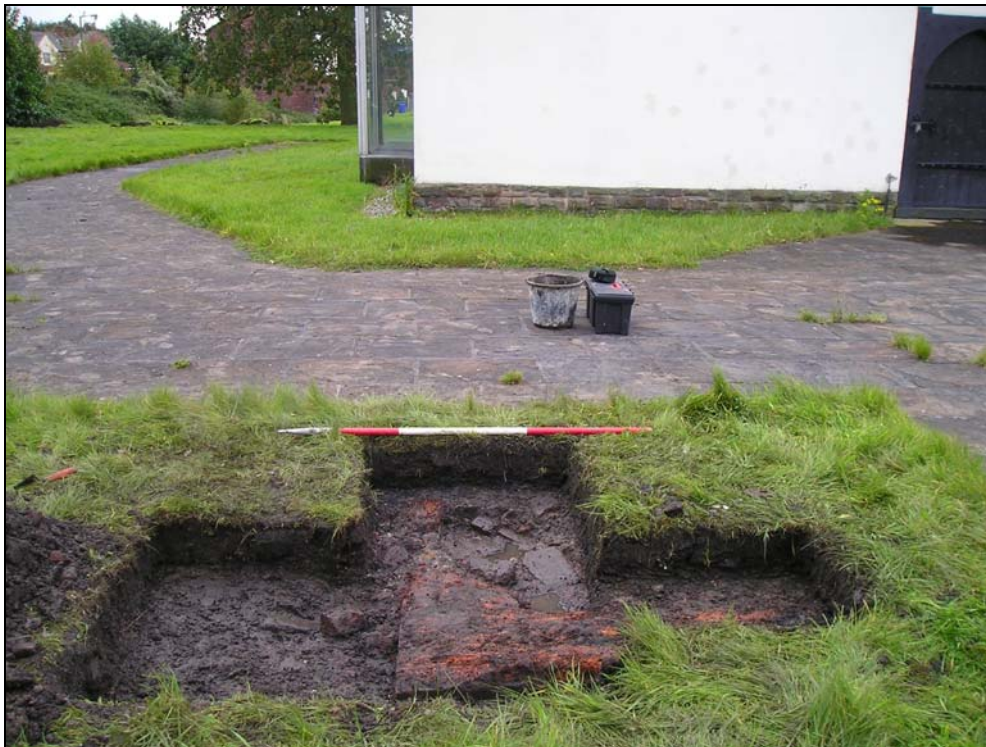
Plate 12 – Trench 9 looking south showing relationship of brick wall with the north eastern corner of building 1
