Gothic Farm Cottage, Romiley, Stockport, Greater Manchester.

A PPG15 Assessment of a Cruck Cottage

Report No: 04/2009

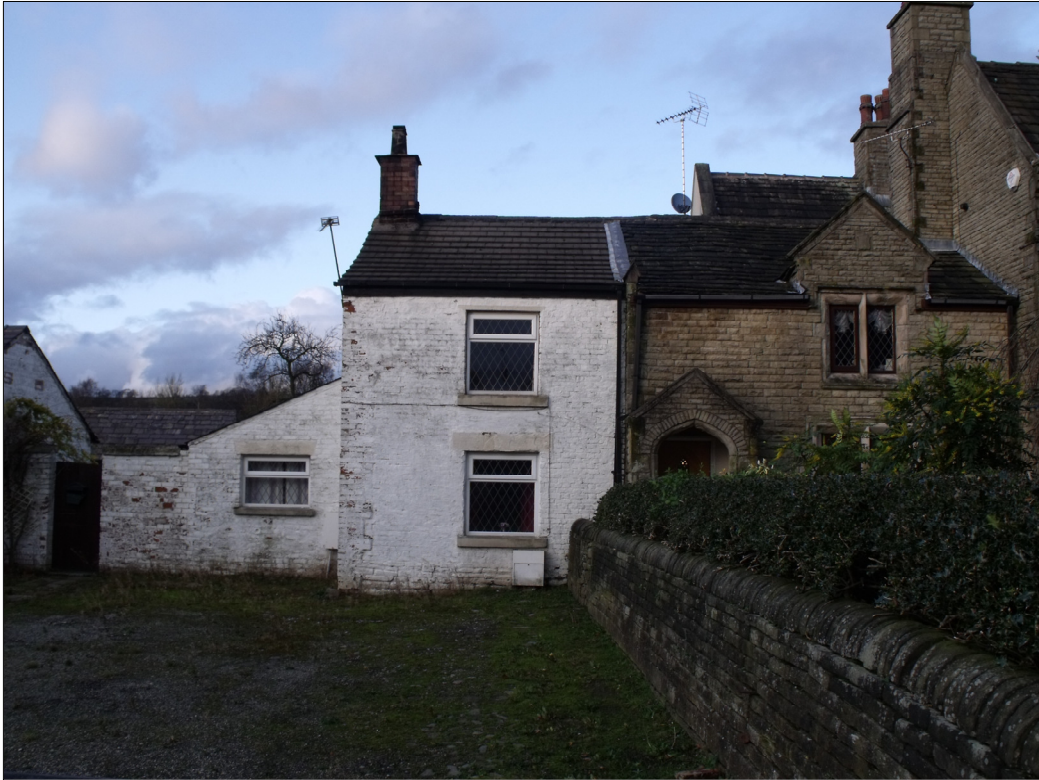
Fig 2: The southern elevation of Gothic Farm Cottage (the white brick building).

Most of the cottage was built from handmade bricks, although single storey rooms G1, G2 and G5 were made from machine bricks. Within the southern wall of rooms G3, FF4 and FF5 several different fabrics were visible. The handmade brick wall in English Garden Wall Bond sat on a stone plinth four courses high, whilst a jagged building break ran from top to bottom of the western end of the elevation indicating that the western gable of G3 had been rebuilt. Internally, it was unclear what material formed the ground floor covering, but the first floor was covered in narrow pine floorboards, as far as could be seen. A large oak beam in G3 was supported by a circular-section cast-iron column with side flanges at the top, whilst a blocked doorway was visible between G4 and the store at the northern end of the Gothic farm hallway. A second blocked doorway may have been located in the eastern wall of the landing, FF1, in the middle of the cruck truss. The most striking feature of the building was this single surviving oak cruck truss. The roof coverings were thin Welsh slates.

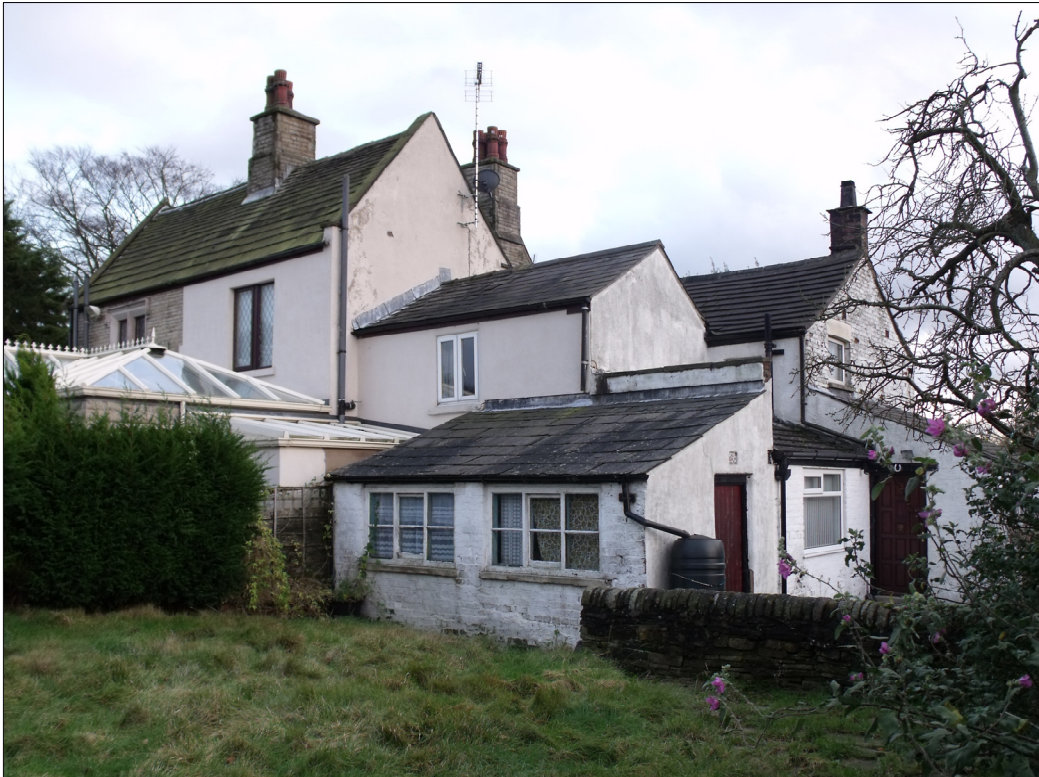
Fig 3: The eastern and northern elevations of Gothic Farm Cottage.

Gothic Farm Cottage occupies the western third of the Gothic Lodge complex. It was a one and two storey brick and stone structure two bays deep with pitched slate-covered roofs. The northern bays were rendered but the southern bays were built in English Garden wall bonded brick and lime mortar with the southern-most wall resting on a stone sill four courses deep. Externally there were window openings in the southern, northern and western elevations with stone lintels and sills, but the casements had been replaced by late 20th century UPVC window frames. There were two doorways in the western gable elevations, one leading into room G5, the northern single-storey lean-to which was a self-contained structure, and one giving access through room G1, a single storey kitchen area, into the main part of the property.

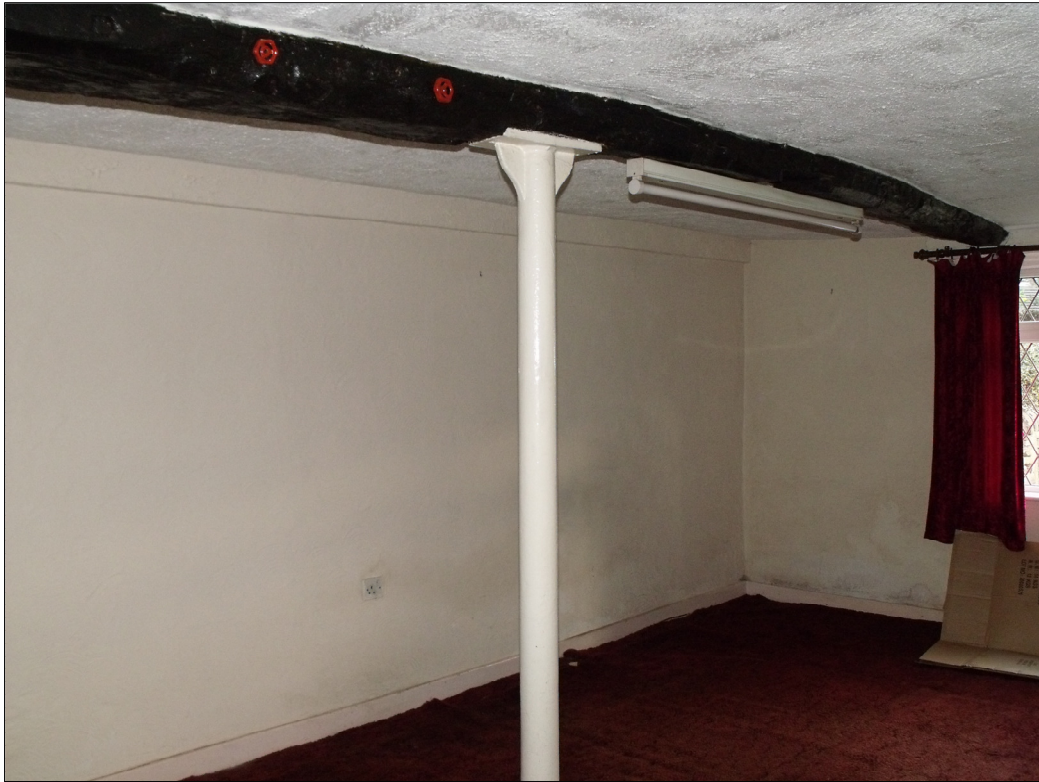
Fig 4: The transverse beam and cast-iron column in G3 looking south.

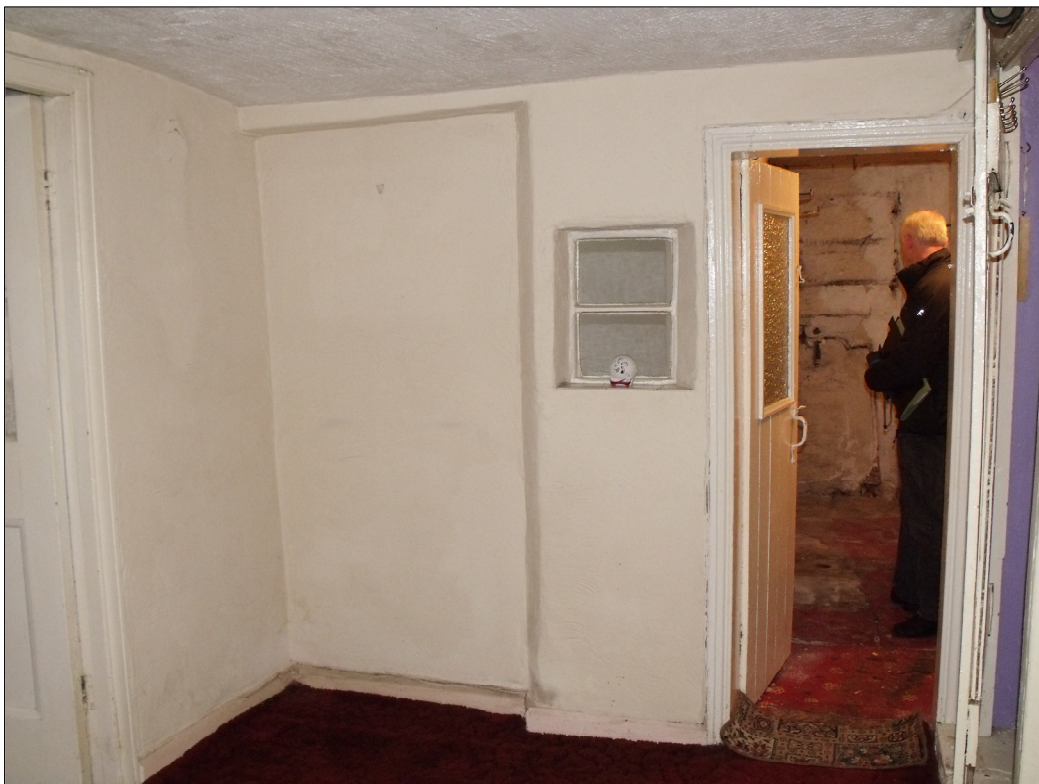
Fig 5: The blocked doorway and earlier window in G2, looking south.

In terms of fixtures and fittings the most notable features were the survival of an earlier window between rooms G2 and G3, and three earlier plank and baton doors, that were probably 18th century in origin. One formed a low cupboard to the south of the fireplace in G3 and had hand-forged butterfly hinges. The second was formed by a plank and baton door on 20th century hinges leading into FF3. This had a hand-forged latch and handle, although the door itself appeared to be more modern. The third was formed by another plank and baton door into FF4 which had hand-forged strap hinges with club-designed ends sitting on iron gudgeons. It also had a hand-forged latch and handle.

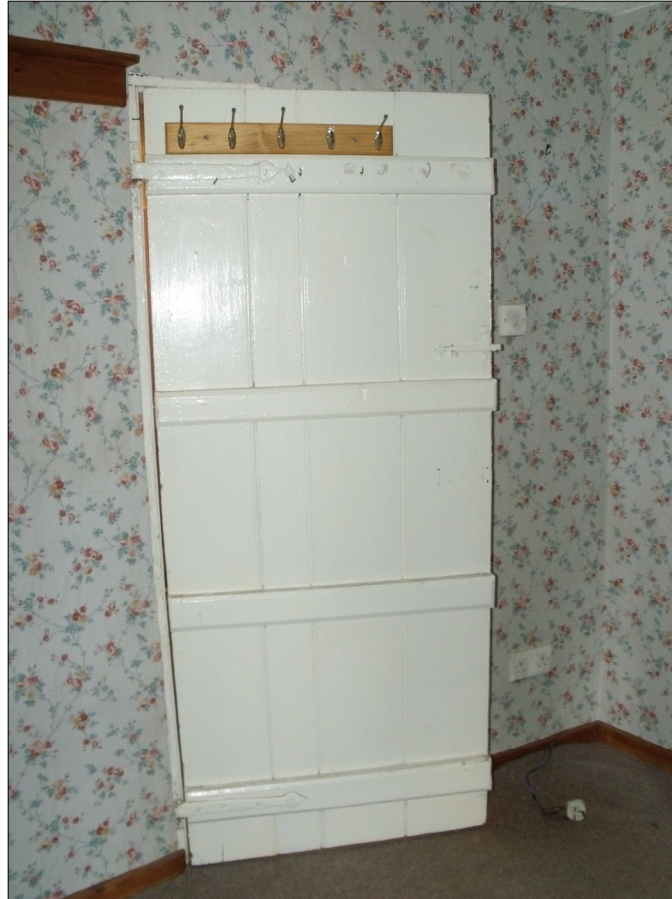
Fig 6: The plank and baton door on iron gudgeons and with iron strap hinges in FF4.

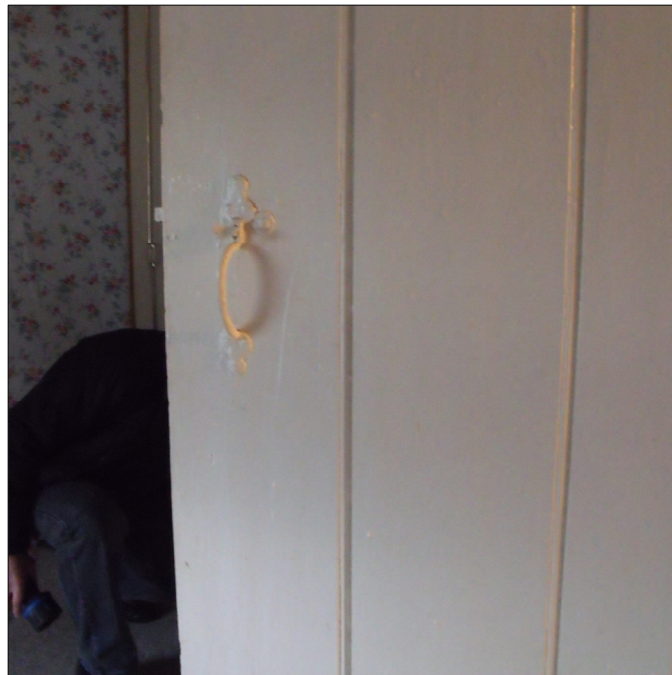
Fig 7: The hand-forged handle to the plank and baton door in FF4.

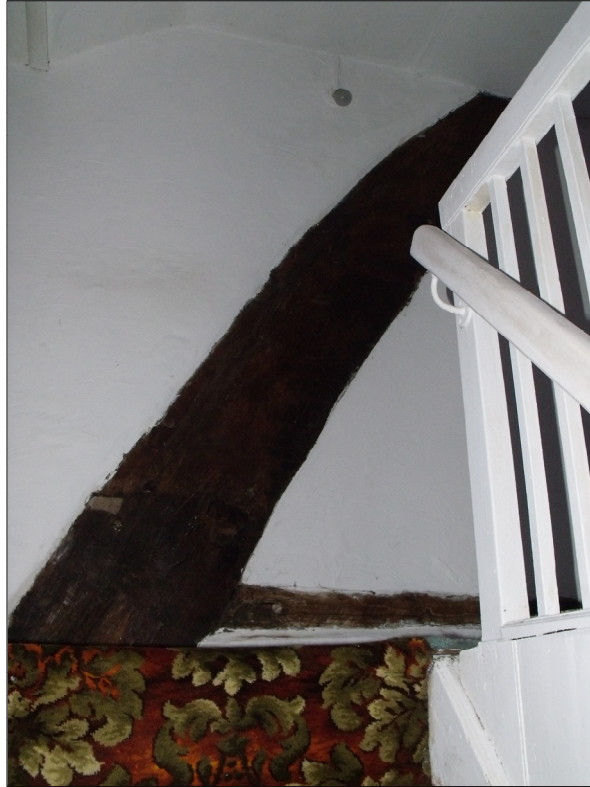
Fig 8: The western cruck blade in the landing area FF1 looking east.

An even earlier phase of activity was represented by a single pit-sawn oak cruck truss. The two blades of this truss were located in the eastern wall of the cottage. Surviving fabric was seen at ground floor level in the eastern wall of the Gothic Lodge western hallway, but because of the flying freehold the upper portion of the cruck truss could be seen in room FF1 and in the roof space above rooms FF1 and FF5. The cruck truss was cut from oak trees at least 150 years old and had Alcock Type C blades (single smooth curves) and an Alcock Type L1 apex (Alcock N W, 1981, *Cruck Construction*. The Council for British Archaeology Research Report No 42).

The earliest element of Gothic Farm Cottage is the single surviving cruck truss in the eastern wall of the cottage. This appears to have been a closed truss, and its location to the east of the ground floor hallway in Gothic Lodge suggests that it was always an internal structural feature. The original size of this cruck house is unclear, although the stone sill along the southern wall of G3 almost certainly marks the line of the external walls. These were timber, as shown by the stub of a spur wall on the western cruck blade, and the stone wall probably acted as a low plinth. The presence of the transverse beam in the ground floor room G3 may suggest that other earlier fabric associated with this primary phase may survive with the cottage.

4039 cruck buildings are known from Britain, of which 364 (roughly 9%) have been dated by tree-ring analysis, giving a date range of roughly AD 1262 to AD 1793 for this building type. However, 346 (95%) of the dated examples lay within the years 1262 to 1632, suggesting that the presence of a cruck building is a good indicator of an early settlement. Indeed, 237 (65%) of the dated cruck buildings were built before 1500 implying that two-thirds of all the known cruck buildings are probably late medieval in origin. The size of the oak trees used at Gothic Farm Cottage, and the presence of pit-sawn timbers strongly suggests that this feature is 15th or early 16th century in date.

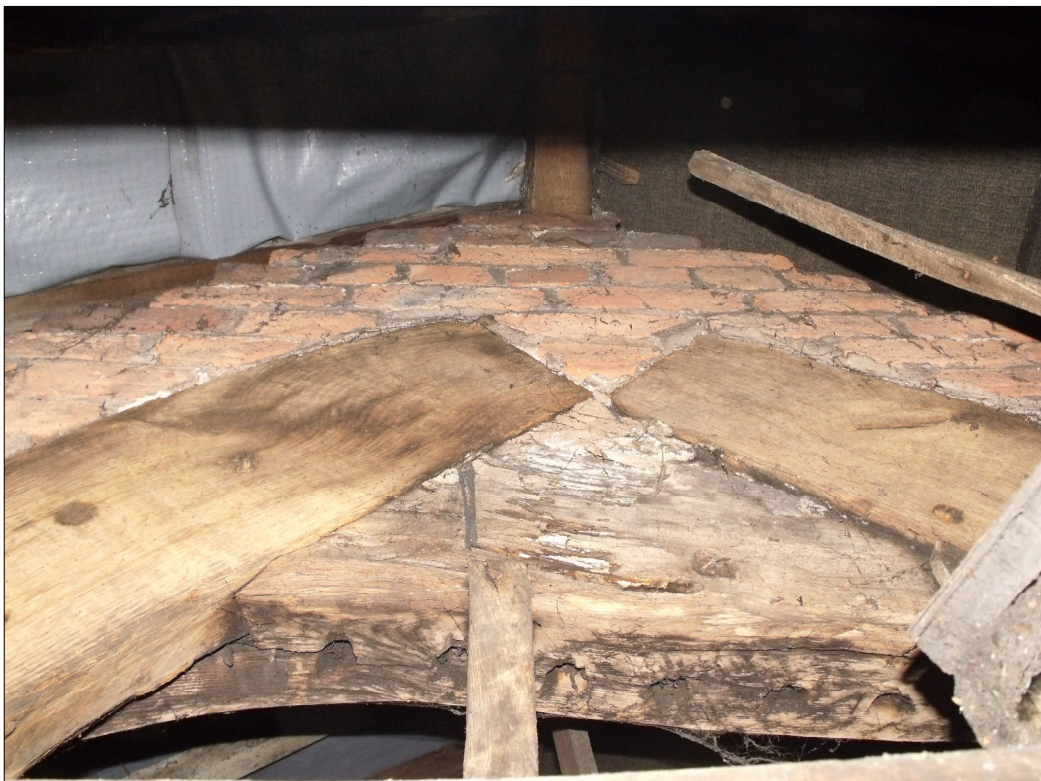
Fig 9: A detail of the apex form of the cruck truss in the roof space above FF1.
