Conservatory Fabric Performance Report

This report presents the findings of a study investigating the fabric performance of a typical conservatory, with a focus on how different ceiling configurations impact thermal efficiency. The study evaluated the performance of four distinct ceiling scenarios:

This technical report reports on the fabric performance of a typical conservatory built by CI Group and measured under controlled conditions at the Energy House 2.0 (EH 2.0) research facility at the University of Salford (UoS). The primary focus of the report is to evaluate the effectiveness of a ceiling insulation solution, the “C.H.R.I.S. System,” in enhancing the conservatory's overall performance.

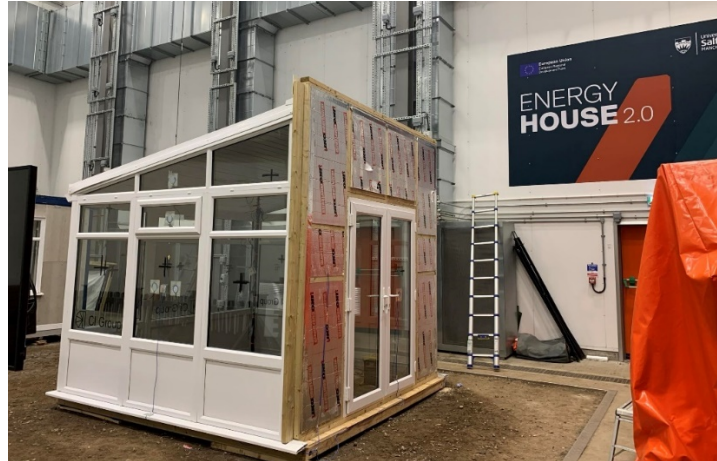
Figure 1. Overview of the case study conservatory

The structure under investigation is a typical conservatory with a floor area of 9 m² and a volume of 22.6 m³. The fabric performance of the conservatory was investigated by the EH 2.0 research team. Figure 1 shows the case study conservatory.

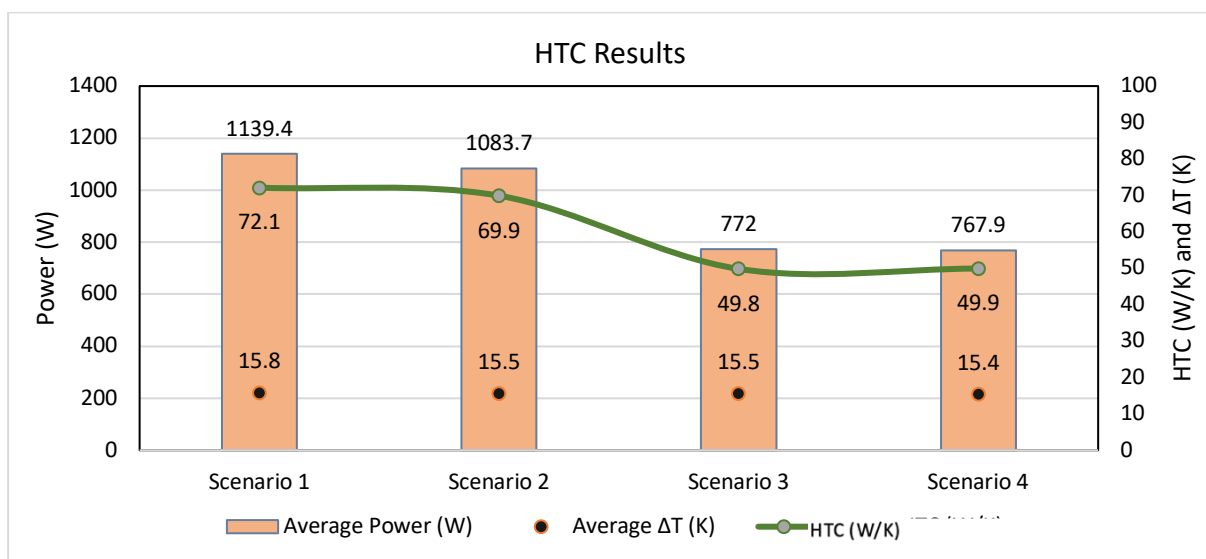
Figure 6. Heat Transfer Coefficient (HTC) Results.

Figure 6 below compares the HTC results during the 4 different scenarios.

From Figure 6, we observe that the addition of the C.H.R.I.S. System in Scenarios 3 and 4 significantly reduces the HTC by approximately 30%, compared to Scenarios 1 and 2. To maintain an indoor temperature of 20°C in a 5°C environment, the power input requirements are as follows:

- **Scenario 1** (Glass roof); the HTC is **72.1 (±0.7) W/K**.
- **Scenario 2** (Polycarbonate) the HTC was **69.9 (±0.6) W/K**.
- **Scenario 3** (Polycarbonate Roof + C.H.R.I.S. System) the HTC is **49.8 (±0.8) W/K**.
- **Scenario 4** (Glass Roof + C.H.R.I.S. System) the HTC is **49.9 (±0.8) W/K**.

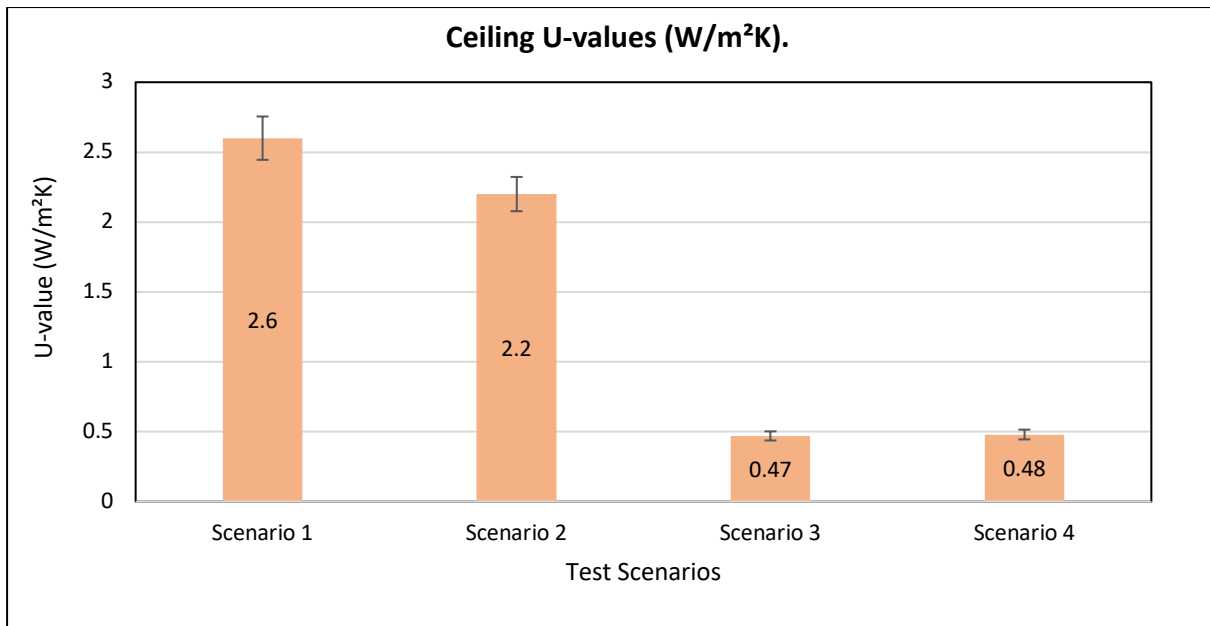
Figure 7 Ceiling U-value Across the Different Test Scenarios

Figure 7 compares the ceiling U-value during the four different scenarios.

- ***Scenario 1 (Glass Ceiling)***; the average calculated U-value is **2.60 (±0.16) W/m²K.**
- ***Scenario 2 (Polycarbonate Ceiling)***; the average calculated U-value is **2.20 (±0.13) W/m²K.**
- ***Scenario 3 (Polycarbonate Ceiling + C.H.R.I.S. System)***; the average calculated U-value is **0.47 (±0.02) W/m²K.**
- ***Scenario 4 (Glass Ceiling + C.H.R.I.S. System)***; the average calculated U-value is **0.48 (±0.02) W/m²K.**

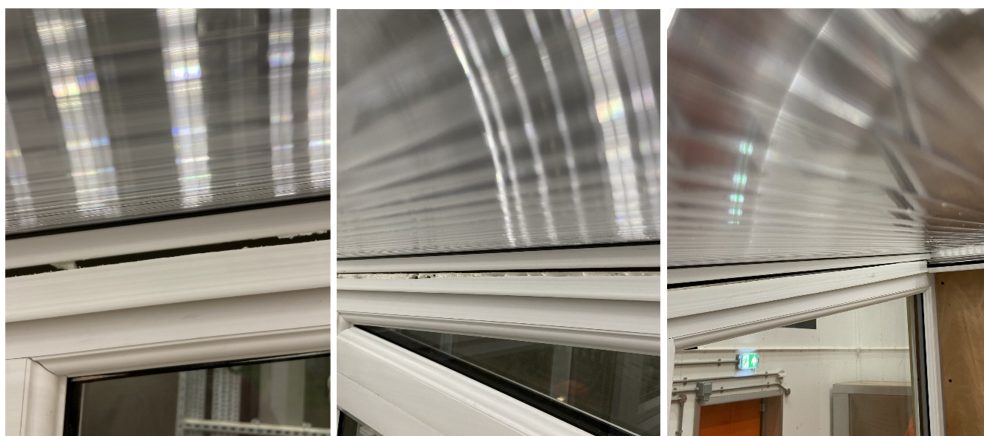
Figure 9 Show Sealant Disparity Across Different Areas of the Ceiling (More Visible During Scenario 2)

Note: As observed in the figures above and noted during the blower door test, the high pressure associated with the blower door created abnormal conditions within the conservatory. These conditions included noticeable movement of the floor and ceiling, which we believe led to inflated AP50 results and introduced additional air leakage patterns that are not typically present under normal conditions. Given these factors, we recommend using the Pulse Test results instead, as we believe they provide a more accurate representation of the building's air tightness in this case.

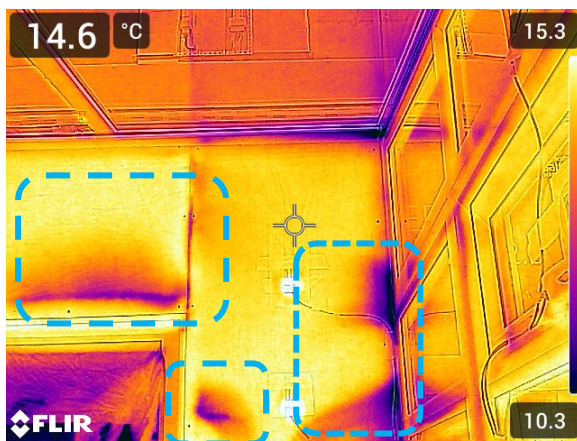
The figures 11 and 12 above show the insulation around the main door. Cold areas (blue colour) and patterns of air movement can be seen around the ceiling behind the wall (between the insulation and outer wood board) and the timber frame. This indicates a deficiency in the insulation, thermal bridges and potential air leaks from these areas.

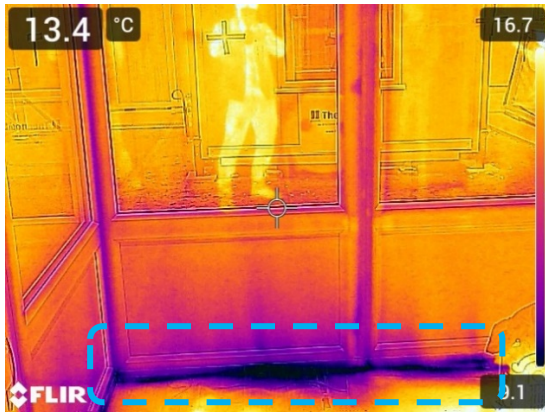
Figures 13 and 14 above show the interior space of the conservatory during the depressurisation test. Cold areas (blue colour) and patterns of air movement are visible around the floor and the ceiling, indicating potential air leakage through these elements.

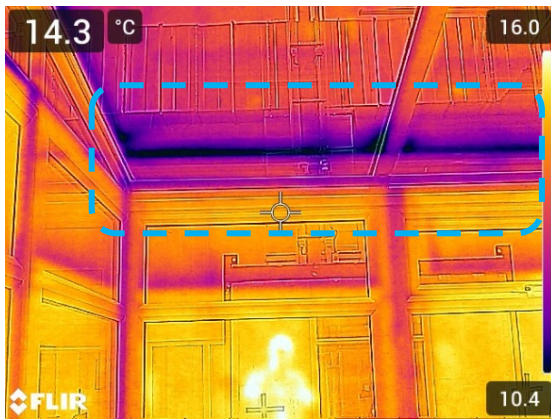
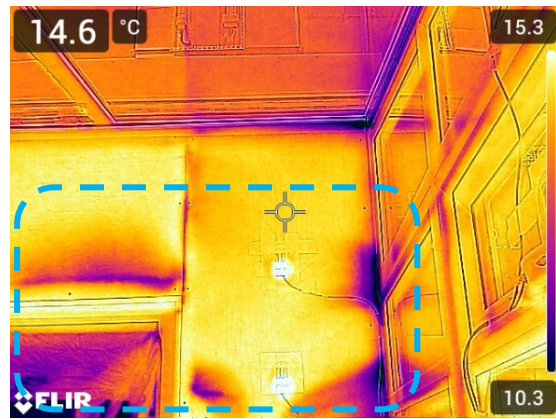
Figures 15 and 16 above show the internal different areas of the roof under the depressurisation phase of the blower door during Scenario 2. The cold area, highlighted in blue, shows potential areas of air leak and points of heat loss.

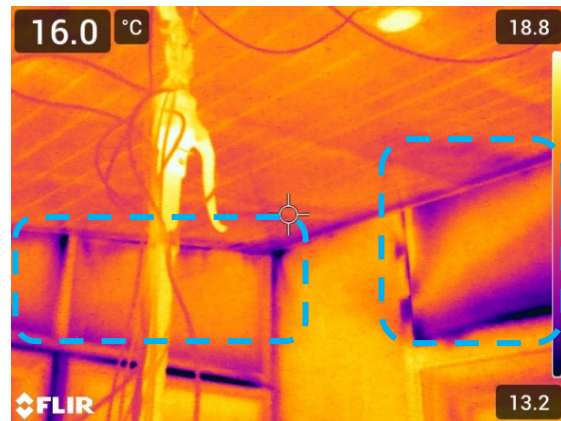
Figures 23 and 24 above show the internal different areas of the ceiling under the pressurisation phase of the blower door during Scenario 4. The figures show potential air leakage and heat loss points through the ceiling.

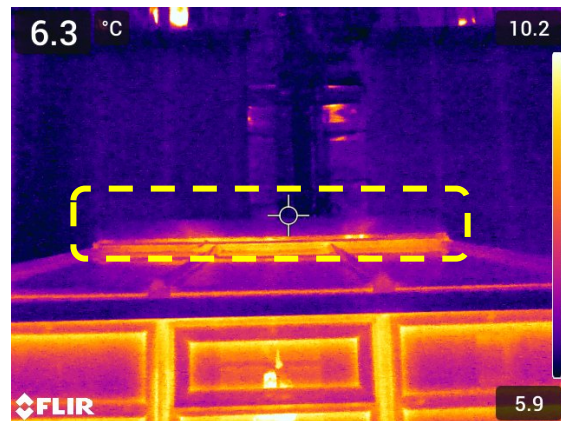
Figures 25 and 26 above show external different areas of the ceiling under the pressurisation phase of the blower door during Scenario 4. Visible areas of heat loss and air leakage can be seen across different points of the conservatory ceiling.

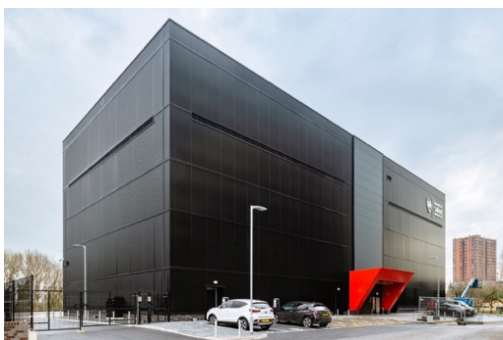
Figure 28 External View of EH 2.0

Temperature and relative humidity within the chambers can be maintained at a constant steady state or varied according to seasonal and daily patterns. Figures 28 below show an external view of the EH 2.0 facility. Figure 29 shows an inside view of chamber 2 with the conservatory in-situ.

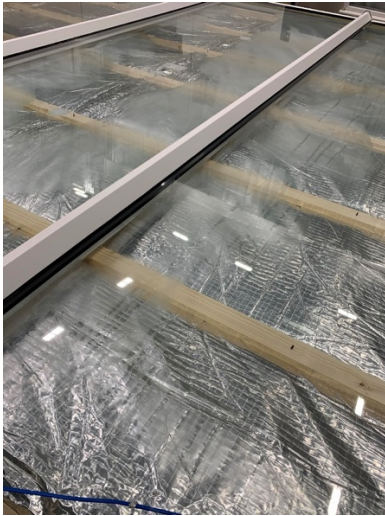
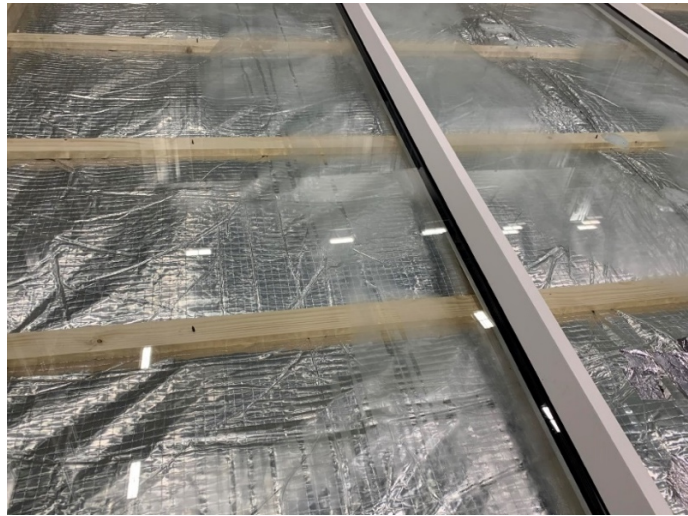
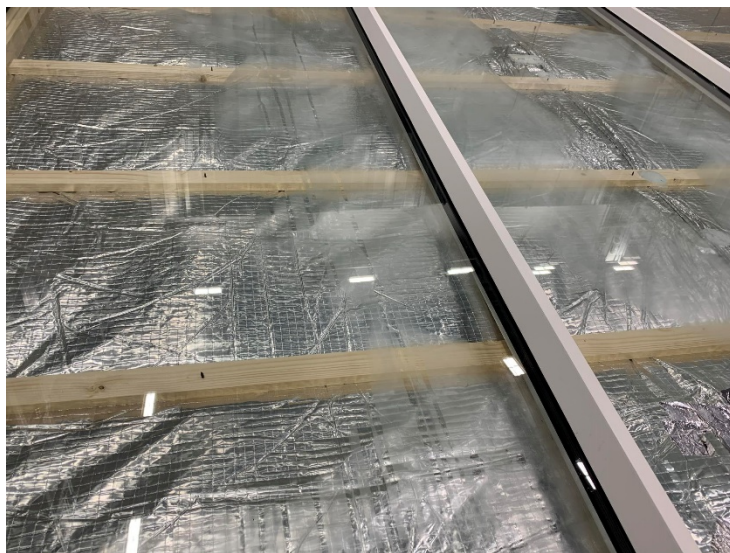
Appendix F- Ceiling Condensation

- **U-Value Performance:** Scenario 2 (polycarbonate Ceiling) outperformed Scenario 1 (Glass Ceiling) in terms of U-value. The addition of the C.H.R.I.S. System in Scenarios 3 and 4 significantly improved ceiling U-values, with similar results for both configurations. However, condensation was observed between the glass and insulation in Scenario 4, likely due to trapped air between the cold glass surface and the warmer insulation (see Appendix F for details).

- Improve the conservatory's airtightness, focusing on the areas identified as problematic during the pressure tests and thermographic surveys.
- Investigate and address the insulation around the main door.
- Examine the condensation issue observed in Scenario 4, particularly the interaction between the glass roof and the insulation.
