# DEEP Report 5.01

# Salford Energy House

## Fabric Performance Testing

**Prepared by Energy House Labs Research Group, University of Salford**

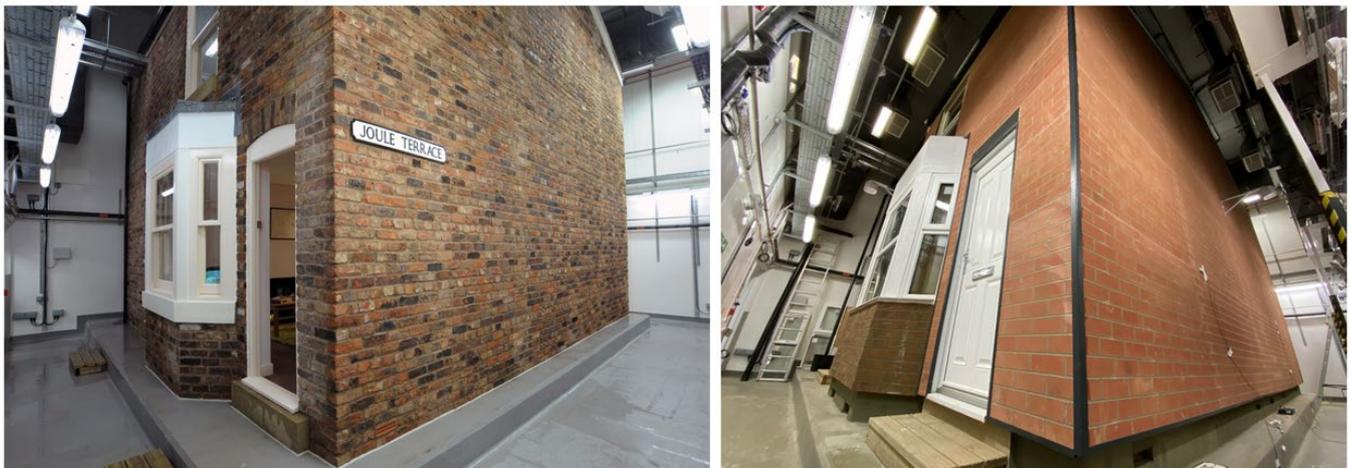
**Figure 1: The Salford Energy House test facility pre-retrofit (left) and post-retrofit (right)**

Testing was performed at the Salford Energy House test facility (Figure 1). It contains the Energy House, a replica Victorian solid wall end-terrace house constructed within an environmental chamber capable of replicating external air temperatures between -12 °C and +30 °C. It was built using reclaimed materials and traditional construction methods and can be retrofitted to most fabric thermal performance standards. The Energy House has a conventional hydronic central heating system with radiators in each room that can be served by a domestic gas condensing combination boiler or an air source heat pump. It has an infrared heating system and can also accommodate other forms of electric space heating. The Energy House shares a party wall with a similar building, referred to as the conditioning void. Environmental conditions in the chamber and conditioning void can be controlled and repeated across multiple test periods. This makes it possible to measure the impact of changes to the Energy House's building fabric and space heating provision with greater confidence and speed than houses in the field<sup>4</sup>. Please refer to Appendix A for more details of the Energy House construction and Appendix B for floor plans.

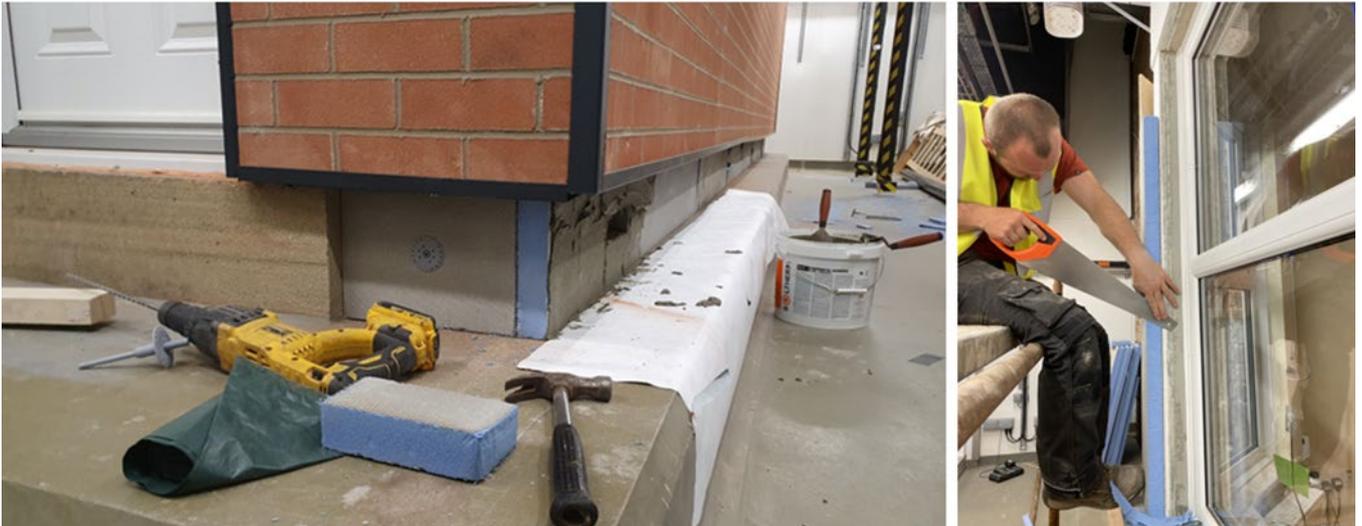
**Figure 3: Whole house approach retrofit works. Extruded polystyrene (XPS) being applied to walls below DPC level at Stage 6a (left) and to bay window mullions at Stage 6b (right)**

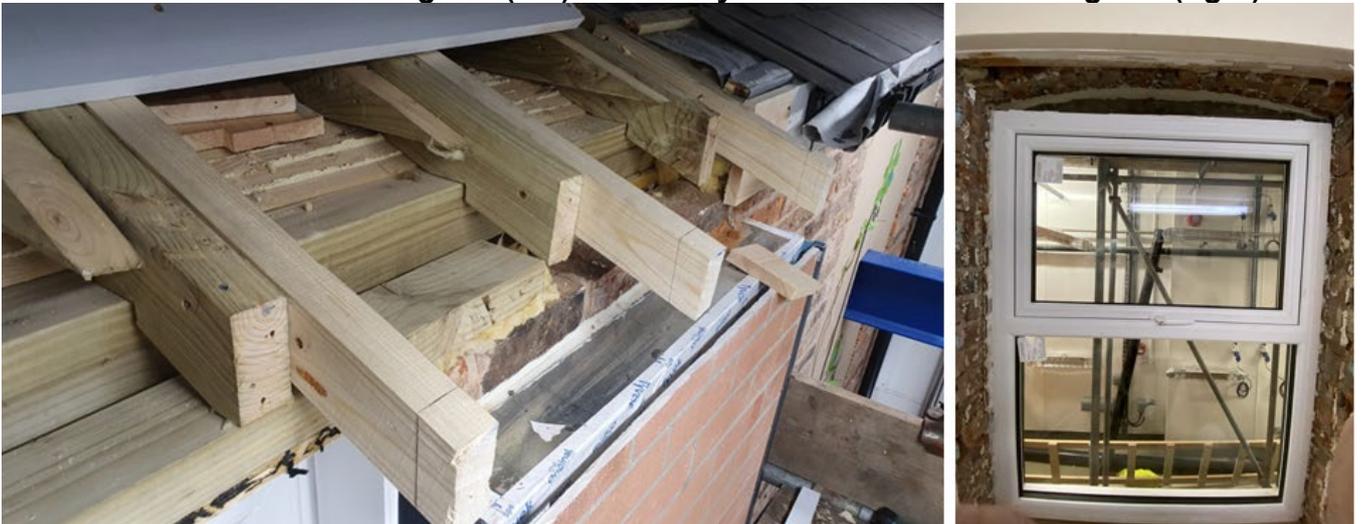
**Figure 4: Whole house approach retrofit works. Eaves being extended over EWI at Stage 6c (left) and window moved in line with EWI at Stage 6d (right)**

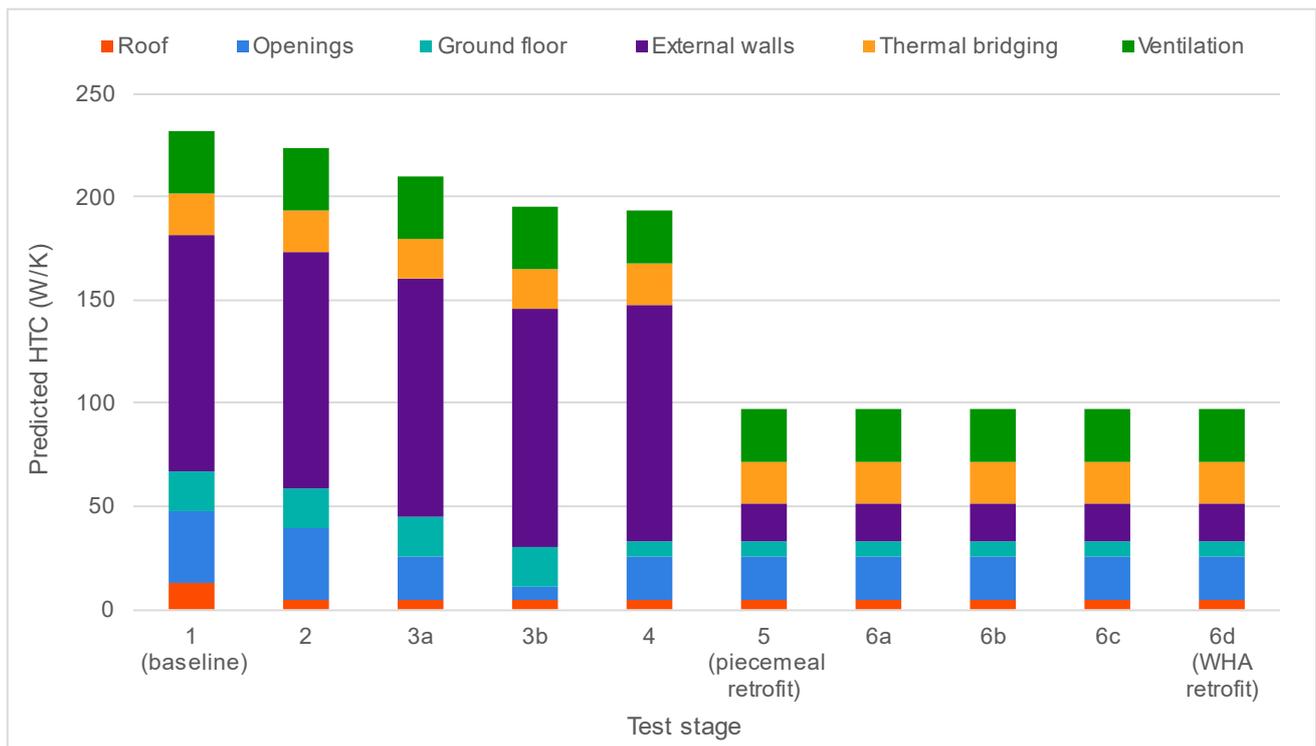
**Figure 5: Energy House predicted HTC at each Phase 1 and Phase 2 test stage**

The baseline (Stage 1) predicted HTC of the Energy House was 231.7 W/K. The predicted HTC for the full piecemeal (Stage 5) and whole house approach retrofits was 97.4 W/K, a 134.3 W/K (58%) reduction from baseline. The reason for the piecemeal and whole house approach predicted HTCs being the same is due to RdSAP assuming the same thermal bridging heat losses throughout the retrofit process. The only change in SAP assumed infiltration rate occurs at Stage 4 with floor sealing reducing the infiltration rate from 0.2 ACH to 0.1 ACH. The EWI applied at Stage 5 was predicted to result in the single greatest HTC reduction from any previous retrofit stage (50%). The 96 W/K EWI HTC reduction is 72% of the total predicted reduction in HTC resulting from the full retrofit. This is because the external walls are the greatest heat loss area (47% of total heat loss area) and the 84% (1.54 W/m<sup>2</sup>K) predicted reduction in U-value resulting from their retrofit.

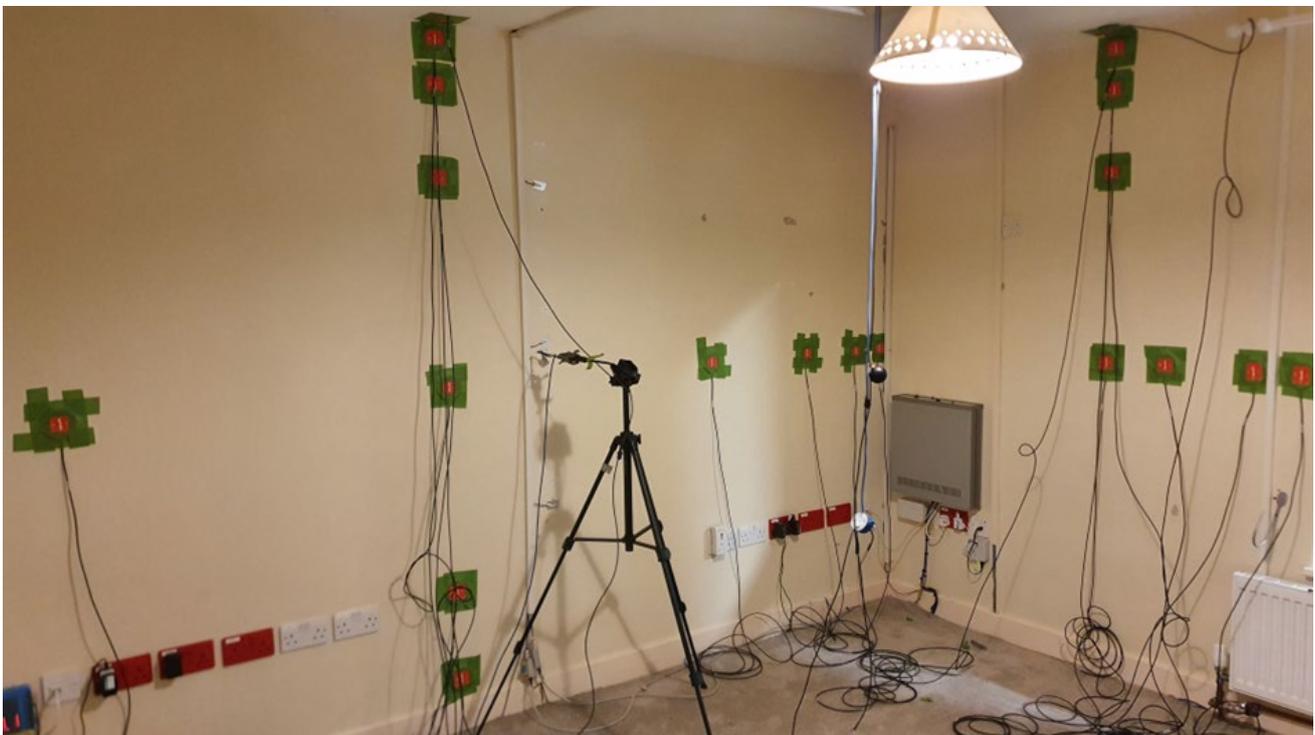
**Figure 6: HFPs on the external walls of bedroom 1 measuring heat flux density**

Measurements of heat flux density (heat flow rate), from which in-situ U-values were calculated, were taken at 74 locations on the thermal elements of the Energy House and conditioning void using heat flux plates (HFPs). Figure 6 shows HFPs on the external walls of bedroom 1.

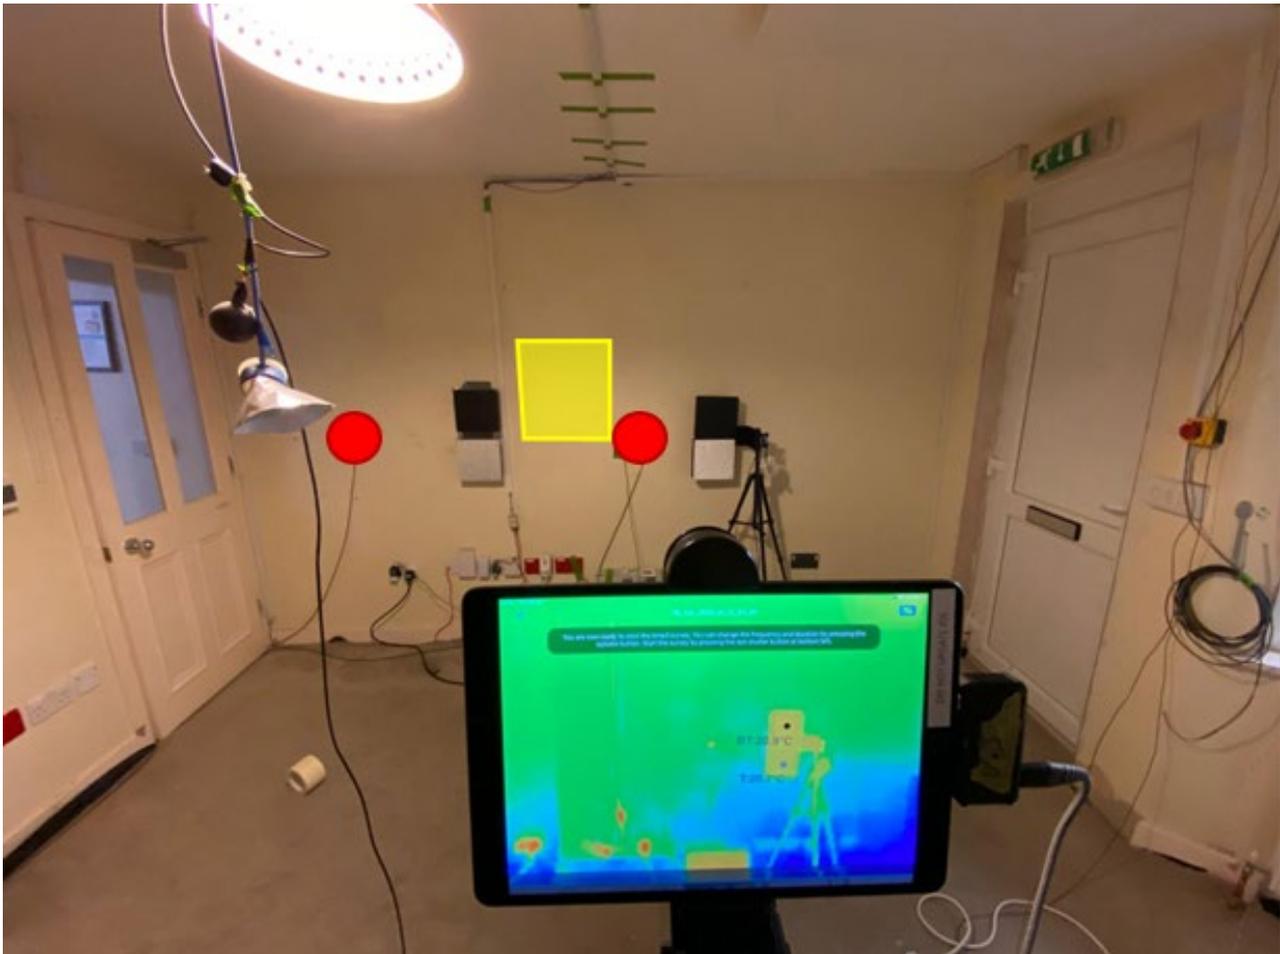
**Figure 7: Heat3D external wall U-value measurement. Yellow square denotes Heat3D measurement area and red circles the location of HFPs EW1 and EW2**

Heat3D requires a room to be pre-heated using a convective heater with PID controller at a constant temperature for a period of up to 12 hours prior to a one-hour period in which timelapse infrared thermography is used to estimate heat flux and U-value. Figure 7 shows the location of the Heat3D external wall U-value measurement and the DEEP external wall HFPs in the living room (EW1 and EW2).

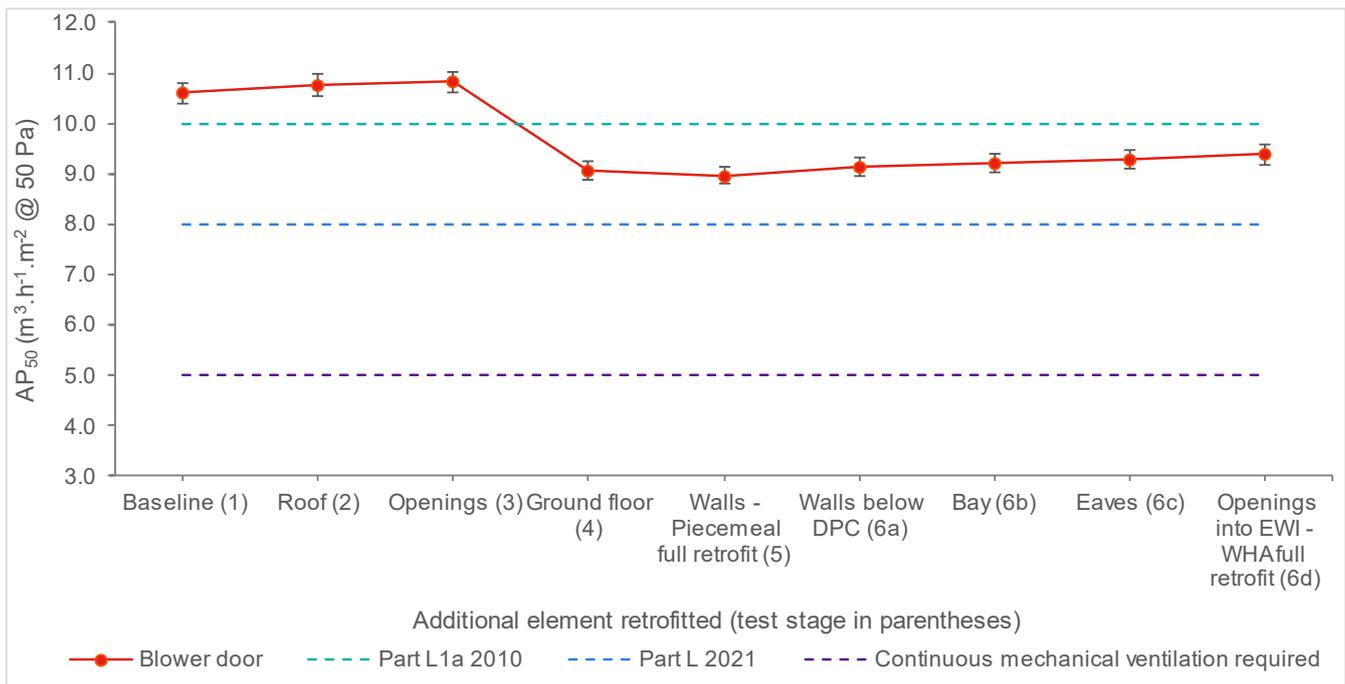
**Figure 8: AP<sub>50</sub> value at each Phase 1 and Phase 2 test stage**

From Stage 4 onwards, the AP<sub>50</sub> value was below the (upper) limiting value for permitted new-builds under Part L1a 2010 (10 m<sup>3</sup>.h<sup>-1</sup>.m<sup>2</sup> @ 50 Pa). The AP<sub>50</sub> value throughout the retrofit process was above that required to comply with Part L 2021 (8 m<sup>3</sup>.h<sup>-1</sup>.m<sup>2</sup> @ 50 Pa). Therefore, the retrofits failed to provide the airtightness required to meet modern design standards for low

Figure 8 illustrates the AP<sub>50</sub> value measured using a blower door test at each Phase 1 and Phase 2 test stage.

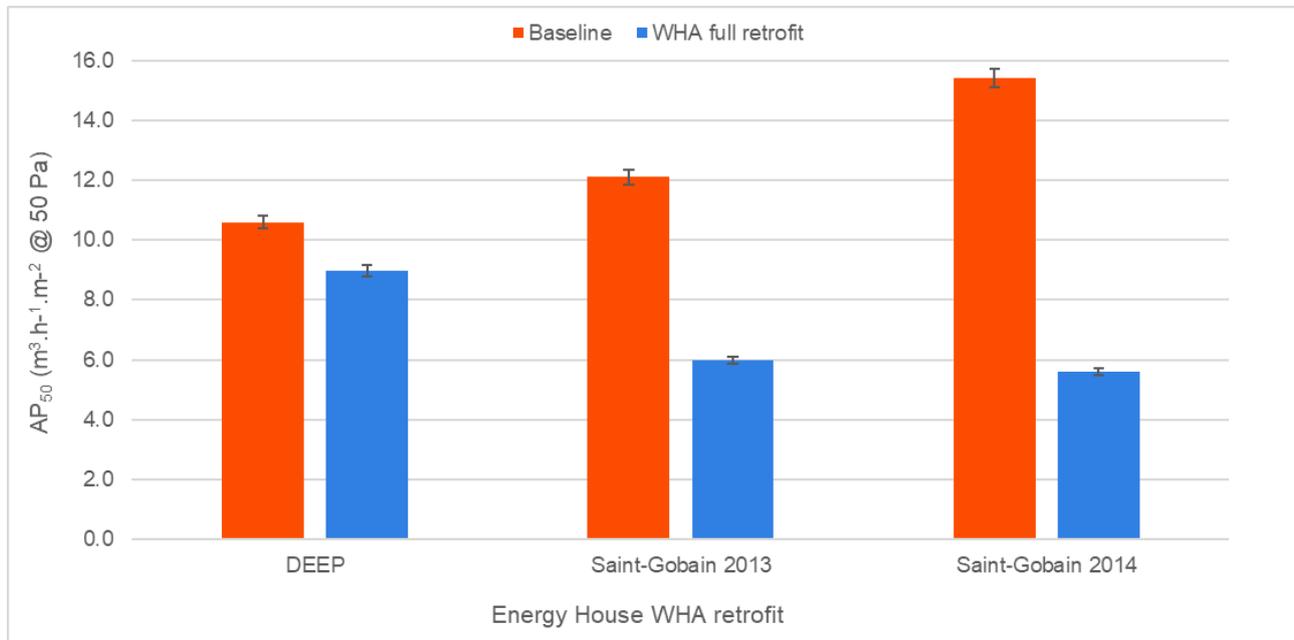
**Figure 9:  $AP_{50}$  values following whole house approach retrofits to the Energy House**

The 12% reduction in  $AP_{50}$  value resulting from the whole house approach retrofit in DEEP is significantly lower than the respective 50% and 64%  $AP_{50}$  value reductions from baseline achieved by the 2013 and 2014 Saint-Gobain whole house approach retrofits of the Energy House. However, it must be noted that both Saint-Gobain retrofits started from a higher baseline<sup>39</sup>. It is interesting to note that both Saint-Gobain post-whole house approach retrofit  $AP_{50}$  values were  $\sim 6 \text{ m}^3 \cdot \text{h}^{-1} \cdot \text{m}^{-2}$  @ 50 Pa. The Saint-Gobain retrofits were undertaken for commercial purposes and followed ‘best practice’ installation that included remedial works following blower door air infiltration investigations. The Saint-Gobain findings could indicate that the lowest  $AP_{50}$  achievable from a ‘best practice’ whole house approach retrofit of the Energy House is  $\sim 6 \text{ m}^3 \cdot \text{h}^{-1} \cdot \text{m}^{-2}$  @ 50 Pa. If that is the case, then the DEEP whole house approach  $AP_{50}$  value was  $\sim 60\%$  worse than could be expected from a ‘best practice’ retrofit. The baseline configuration of the Energy House for DEEP and the Saint-Gobain 2013 test was almost identical, however there was a 13% difference in baseline  $AP_{50}$  value. These findings highlight the difficulty with making predictions about the pre-and post-retrofit airtightness of dwellings and the requirement for blower door testing.

Figure 9 compares the  $AP_{50}$  values resulting from the DEEP Energy House whole house approach retrofit with the Saint-Gobain whole house approach retrofits of the Energy House.

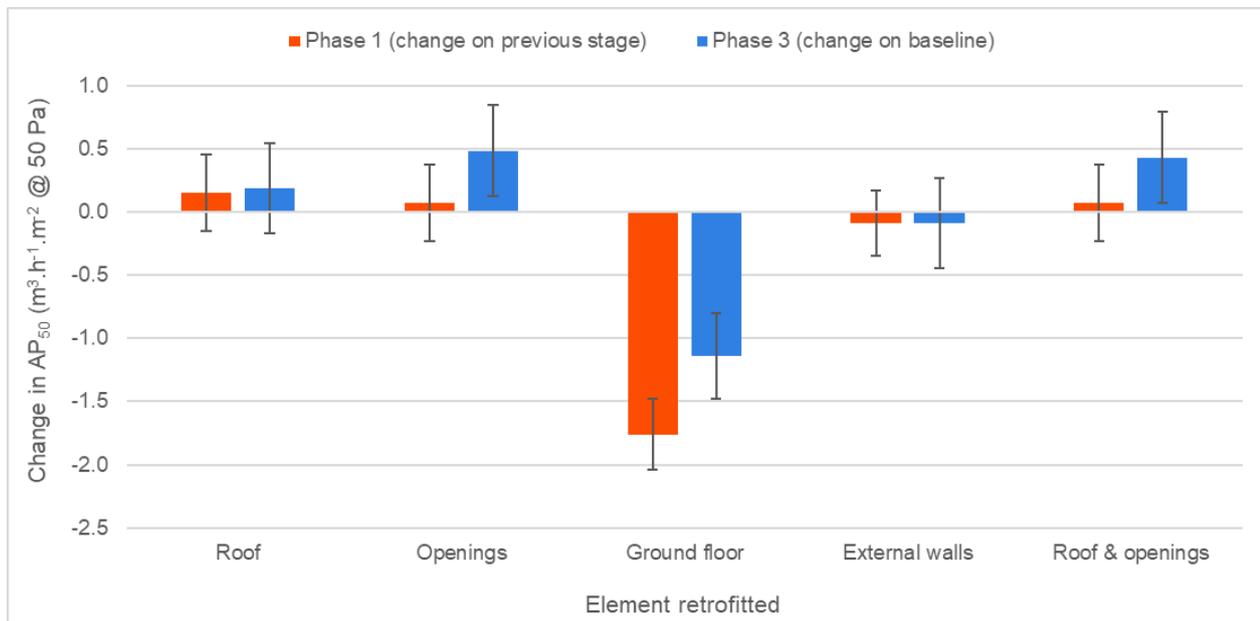
**Figure 10: Change in AP<sub>50</sub> value resulting from elemental retrofits in Phase 1 and Phase 3**

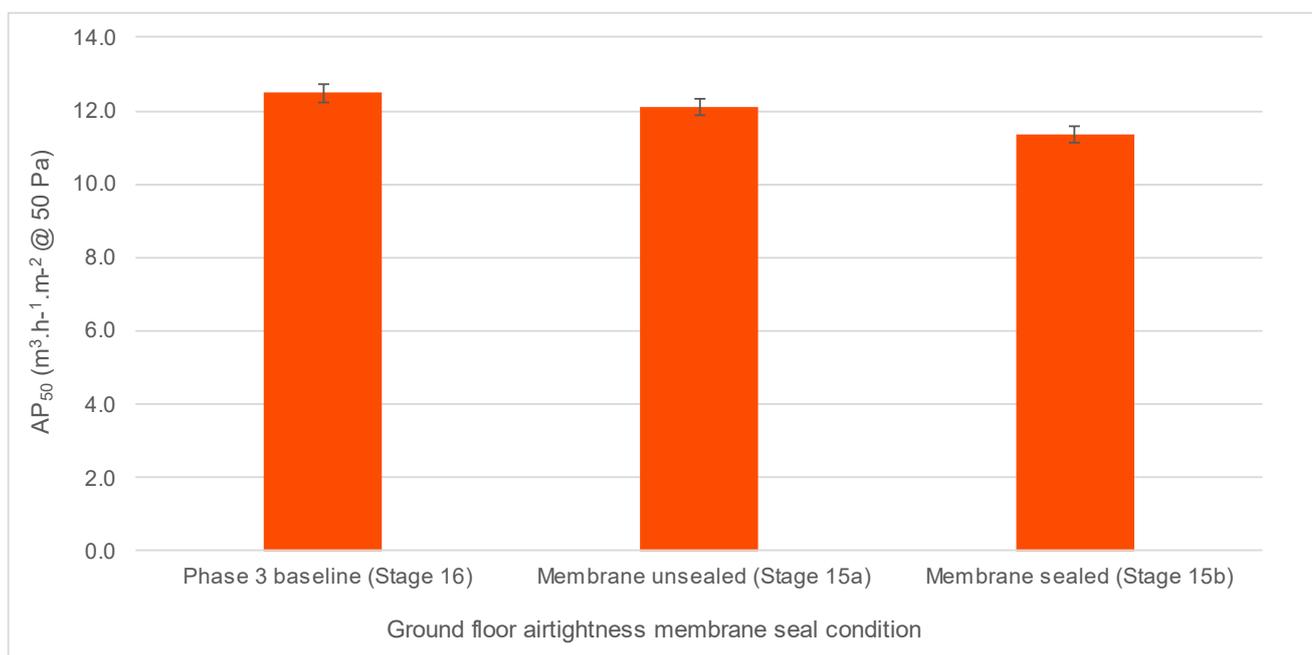
**Figure 11: Impact on  $AP_{50}$  value due to floor membrane during Phase 3**

The ground floor retrofit resulted in the greatest reduction in  $AP_{50}$  value in both Phase 1 and Phase 3 of the DEEP tests. Air infiltration identification showed that the installation of the ground floor membrane during the Phase 1 retrofit provided an effective ground floor seal at locations where it was correctly applied and sealed to the perimeter. The air source heat pump internal unit was not removed due to the cost and complexity, so an attempt to seal around the unit was made. This was only partially successful and highlights an issue with perimeter sealing where internal fixtures are not removed for a retrofit. In Phase 3 the ground floor was retrofitted, and the membrane initially left unsealed at junctions with the internal and external walls, thresholds, and door reveals (Stage 15a). Following Stage 15a, the membrane was taped along its perimeter to provide a seal (Stage 15b). Figure 11 shows the impact of the floor membrane during Phase 3.

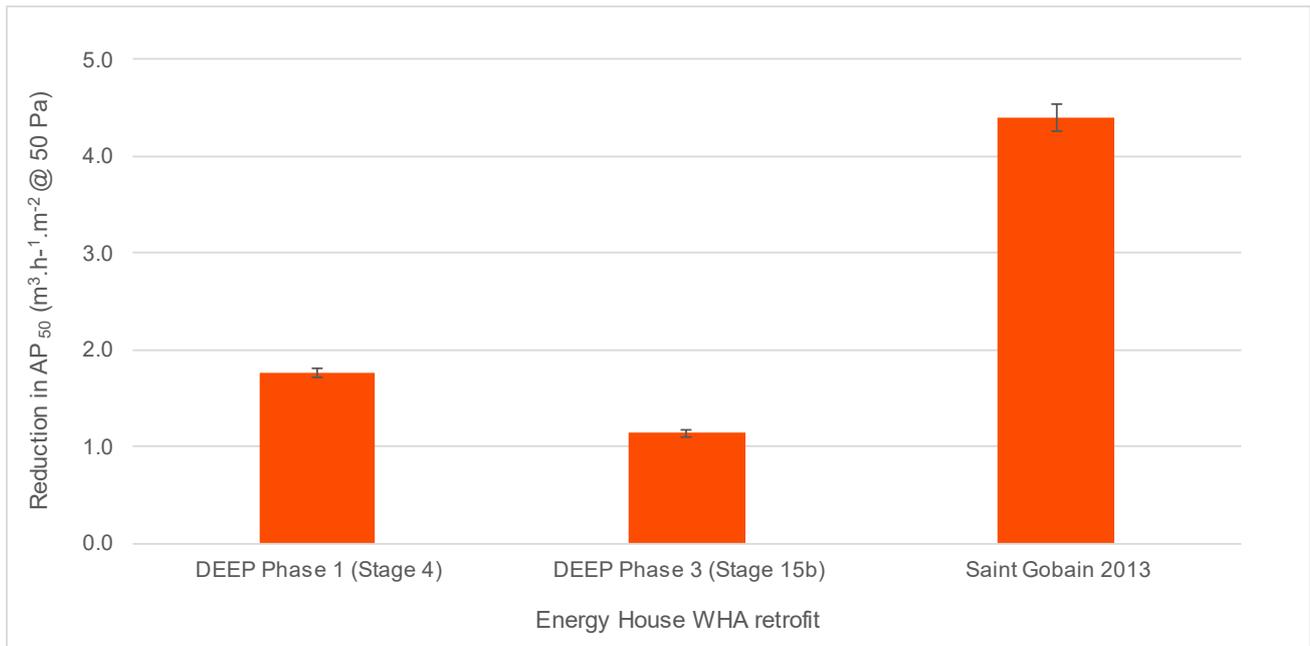
**Figure 12: AP<sub>50</sub> value reductions resulting ground floor retrofits of the Energy House**

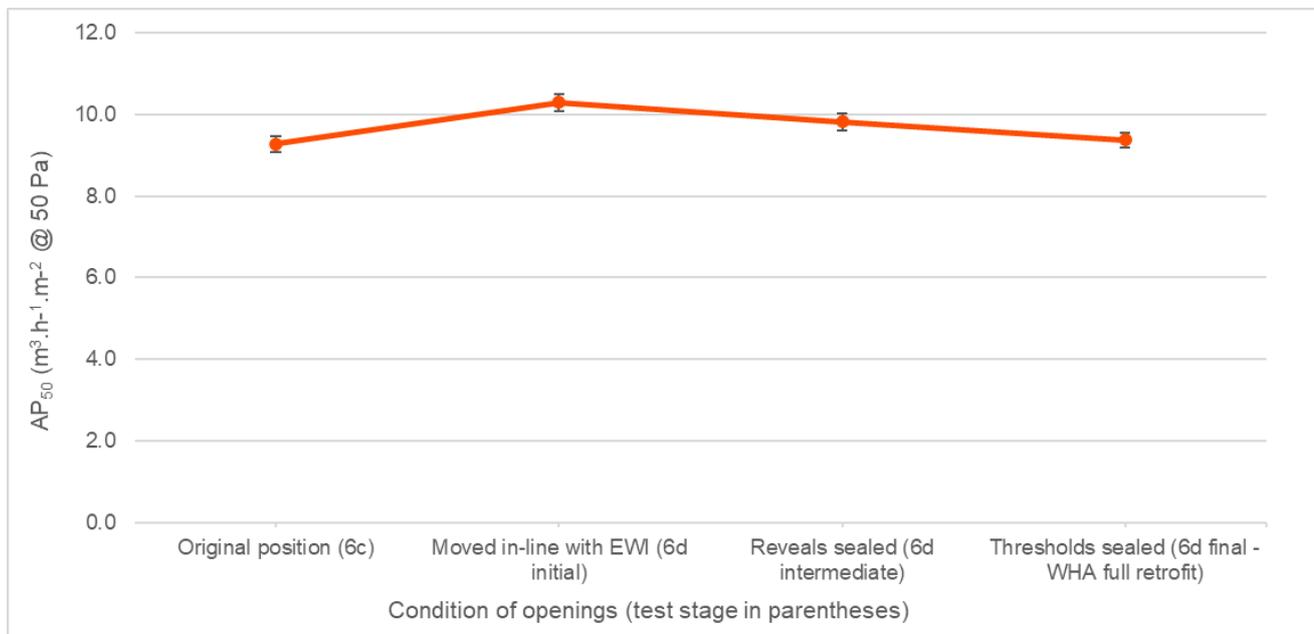
**Figure 13: AP<sub>50</sub> value measured during remedial works at the final whole house approach retrofit stage (6d)**

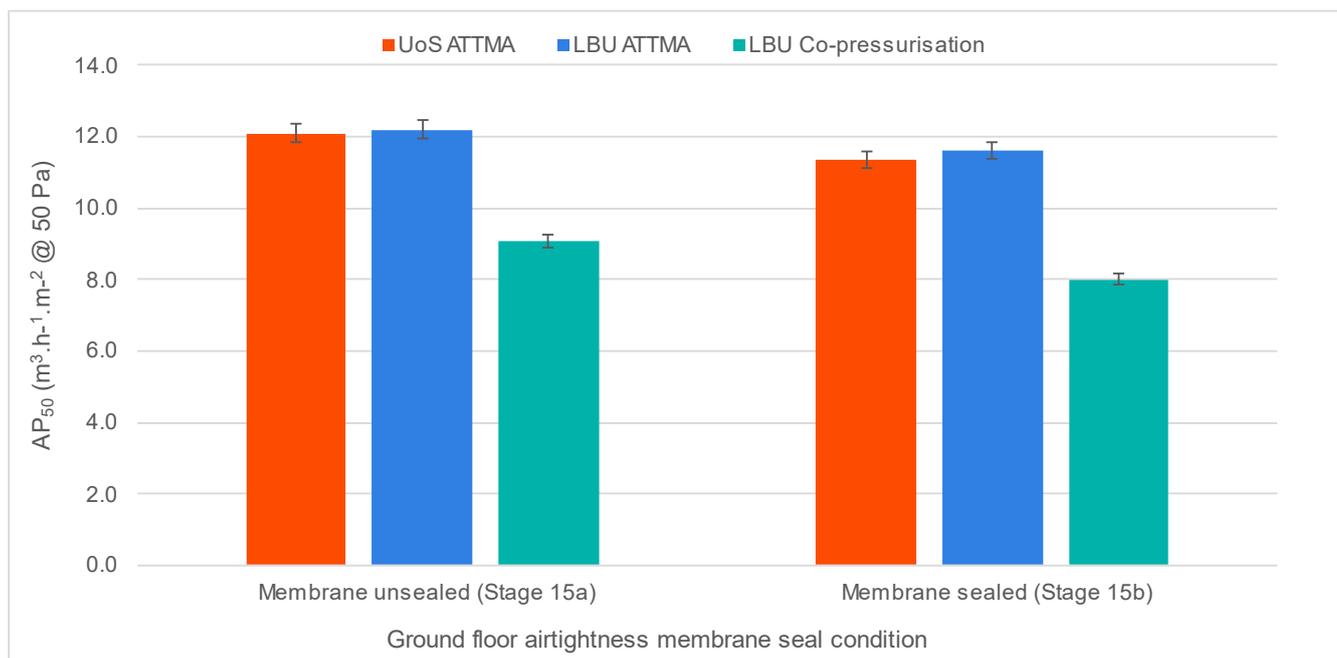
**Figure 14: Results of the Stage 15 co-pressurisation tests**

The co-pressurisation tests show that a significant proportion of the AP<sub>50</sub> value measured during the blower door tests can be attributed to inter-dwelling air exchange. Sealing of the ground floor membrane suggested that the proportion of inter-dwelling air exchange increased. This was not expected due to the ground floor perimeter being identified as the primary air infiltration path and the presence of gaps in the party wall brickwork at underfloor void level. CO<sub>2</sub> release in the Energy House during the steady state tests also suggested inter-dwelling air exchange under reduced pressure differentials as CO<sub>2</sub> concentration in the conditioning

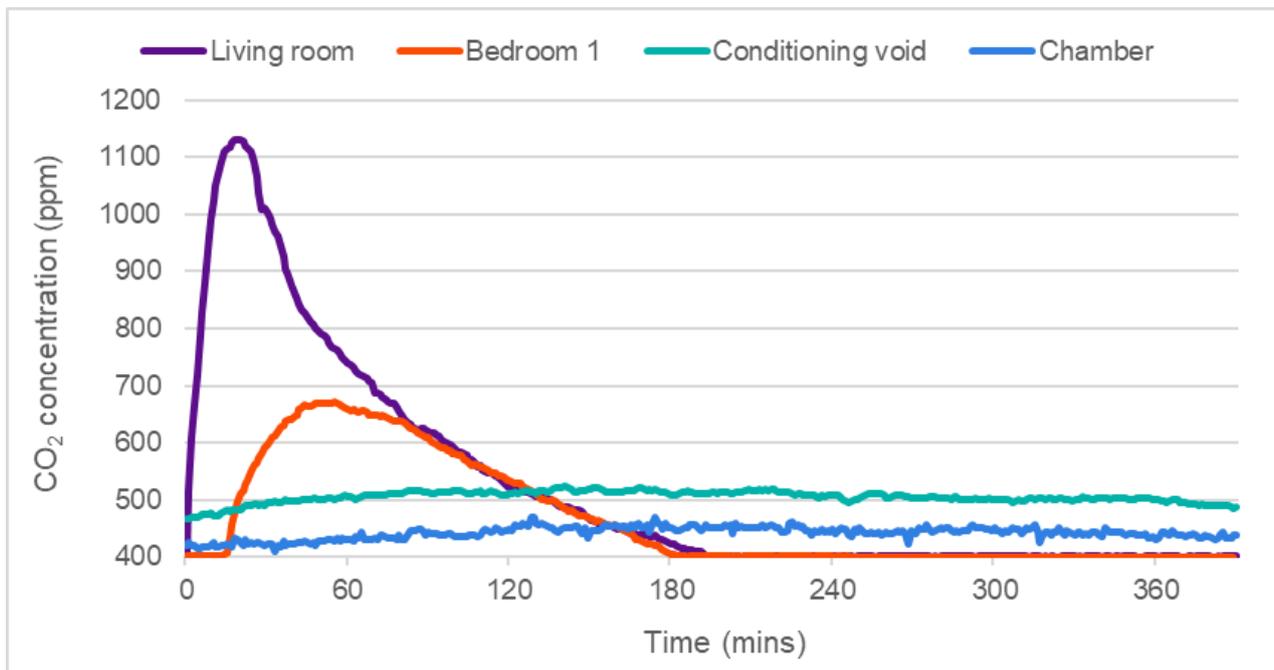
**Figure 15: CO<sub>2</sub> concentration in Energy House, conditioning void, and chamber following CO<sub>2</sub> release in Energy House**

void rose soon after release. Figure 15 shows CO<sub>2</sub> concentration in the Energy House, conditioning void, and chamber following CO<sub>2</sub> release in the Energy House.

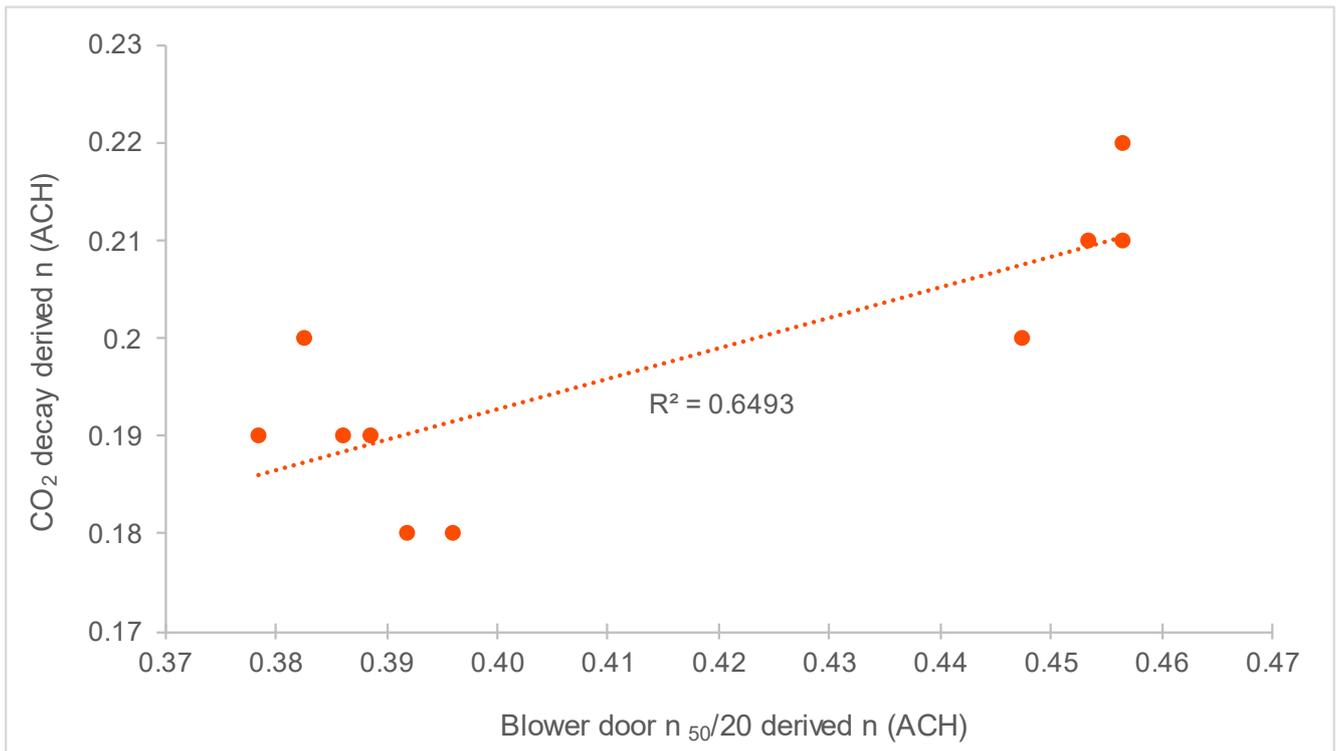
$n$  and  $H_v$  derived from the blower door test results were generally double those derived from CO<sub>2</sub> concentration decay measurements. The large discrepancy was expected as the Energy House chamber provides sheltered test conditions meaning the main driver for air exchange is buoyancy driven stack effect. The test environment means that CO<sub>2</sub> derived  $H_v$  was used to disaggregate the fabric and ventilation components of the HTC. Figure 16 shows the relationship between blower door test and CO<sub>2</sub> decay derived  $n$ .

**Figure 16: Relationship between blower door  $n_{50/20}$  and CO<sub>2</sub> derived n**

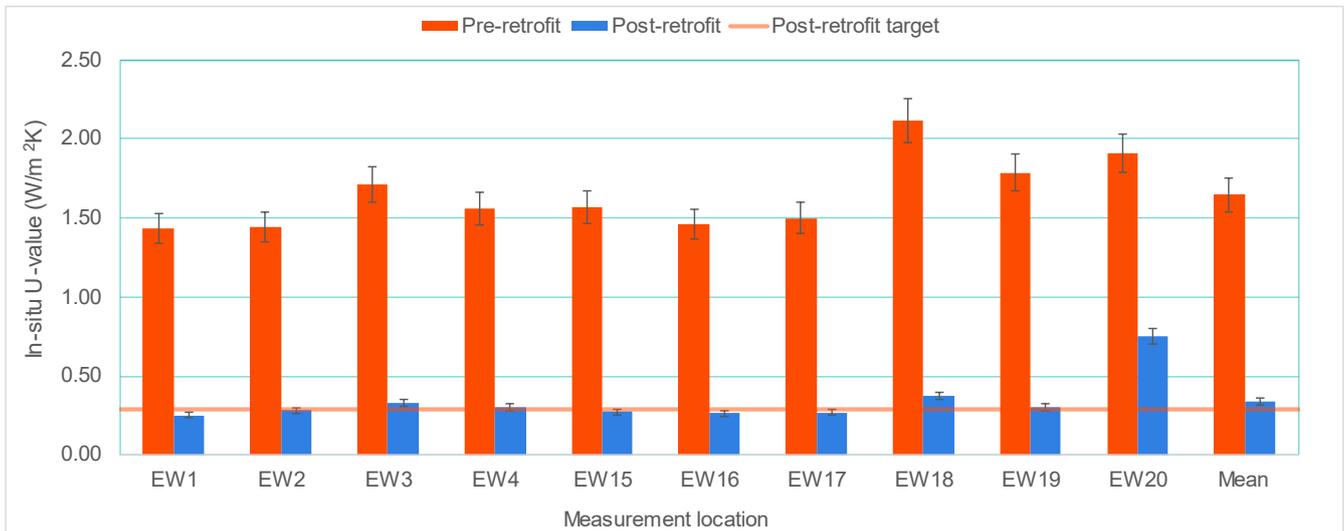
**Figure 17: Unbridged external wall in-situ U-value measurements pre- and post-retrofit**

Figure 17 shows the external wall pre- and post- retrofit U-values at locations used in the calculation of the external wall in-situ U-value.

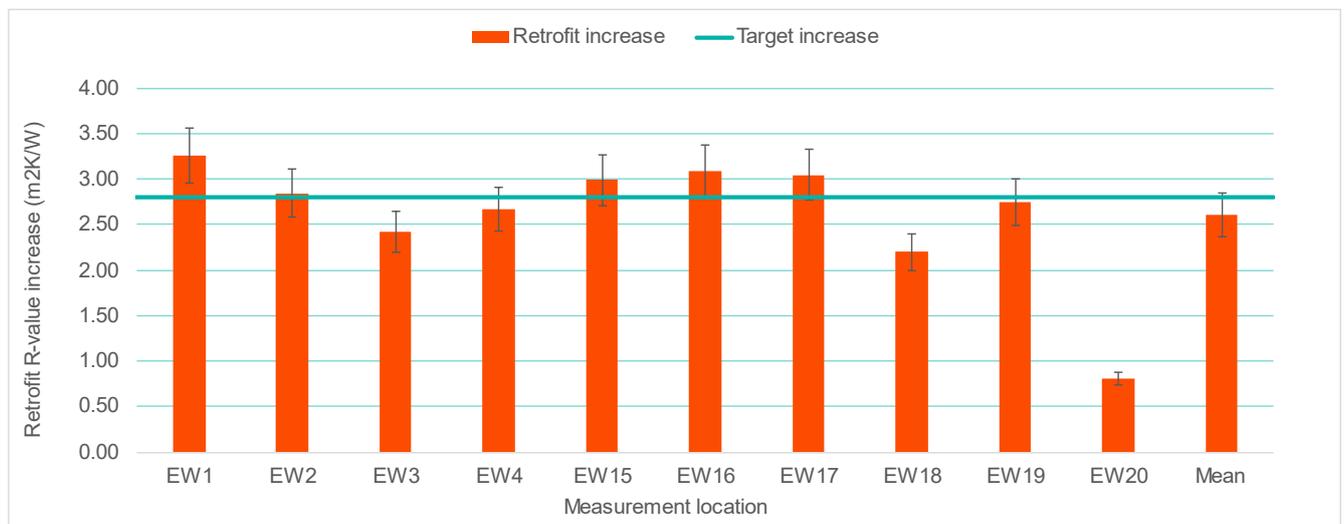
**Figure 18: External wall retrofit R-value increase at non-bridged locations**

Figure 18 shows that significant retrofit underperformance was measured at 3/10 of the external wall locations used to calculate the external wall in-situ U-value, most notably at EW20. Inspection of the EWI during its deconstruction in Phase 3 did not reveal any issues with its installation. Underperformance was measured in the 2013 Saint-Gobain tests in the regions around EW3 and EW20. Borescope investigation at the location of EW3 during the 2014 Saint-Gobain study revealed a cavity within the solid wall above an airbrick in the vicinity of EWI allowing chamber air to infiltrate the wall structure. A high-volume smoke air leakage investigation revealed the presence of interconnected air paths within the gable wall at first floor level towards the rear of the Energy House extending to verge level. It was suspected that warm air was bypassing the EWI layer in this region of wall. Prior to the EWI install in DEEP, four HFPs were fixed to the exterior of the external wall at corresponding locations to the location of internal HFPs to assess whether bypassing of the EWI was occurring. Figure 19 shows heat flux measured at locations on internal wall surface and corresponding locations at wall/EWI interface.

Figure 18 shows the external wall retrofit R-value increase at locations used in the calculation of the external wall in-situ U-value. Change in R-value at each location is not dependent on baseline performance.

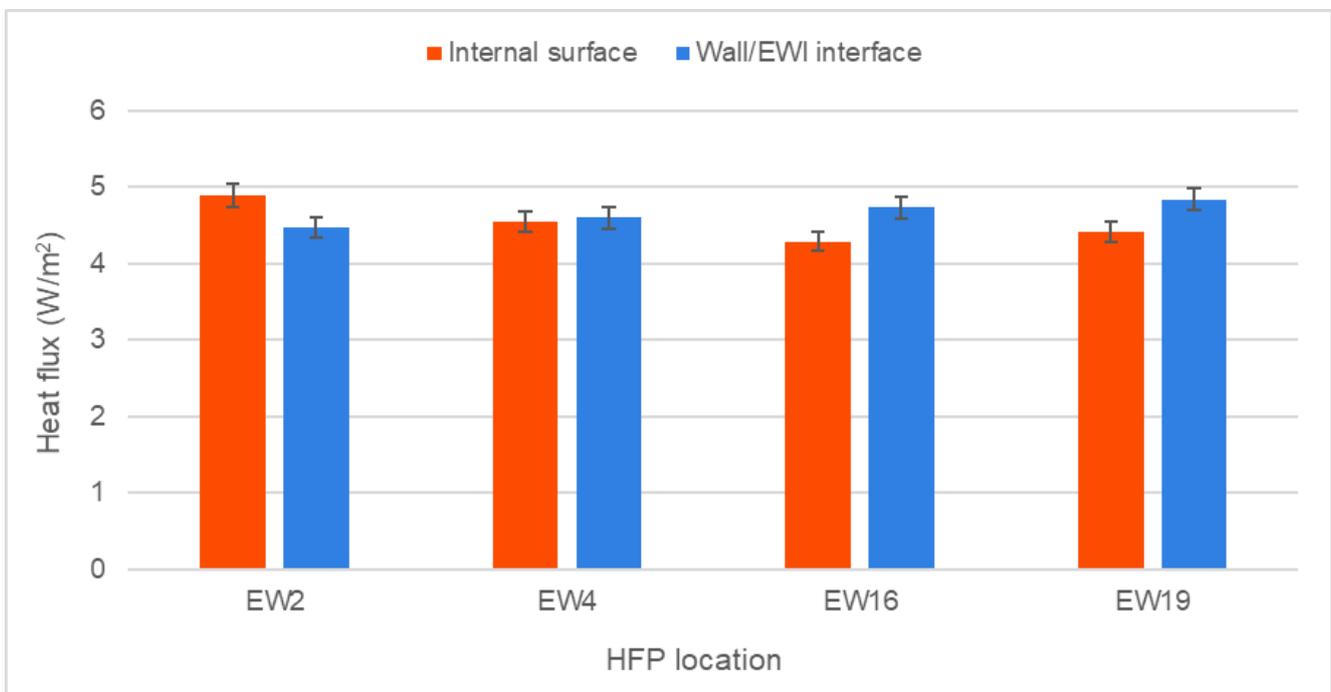
**Figure 19: Heat flux measured at locations on internal wall surface and corresponding locations at wall/EWI interface**

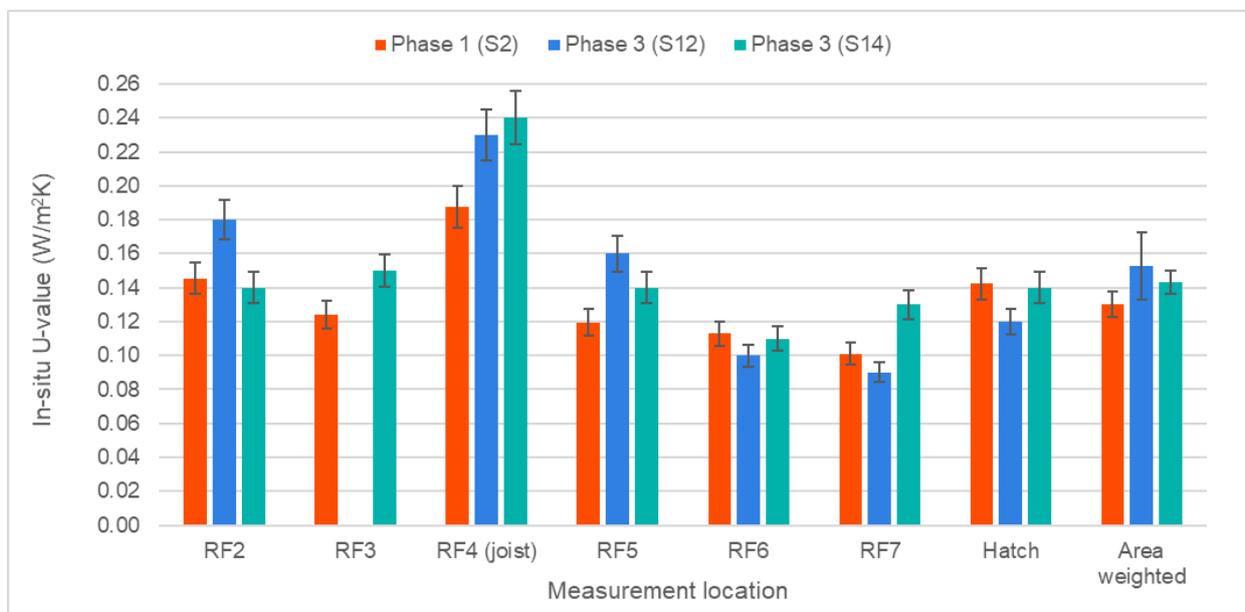
**Figure 20: Roof retrofit in-situ U-value at each location for each retrofit**

Figure 20 shows the in-situ U-value at each location used to calculate the roof retrofit in-situ U-value in each test (RF3 was not measured at Stage 12 due to a sensor error).

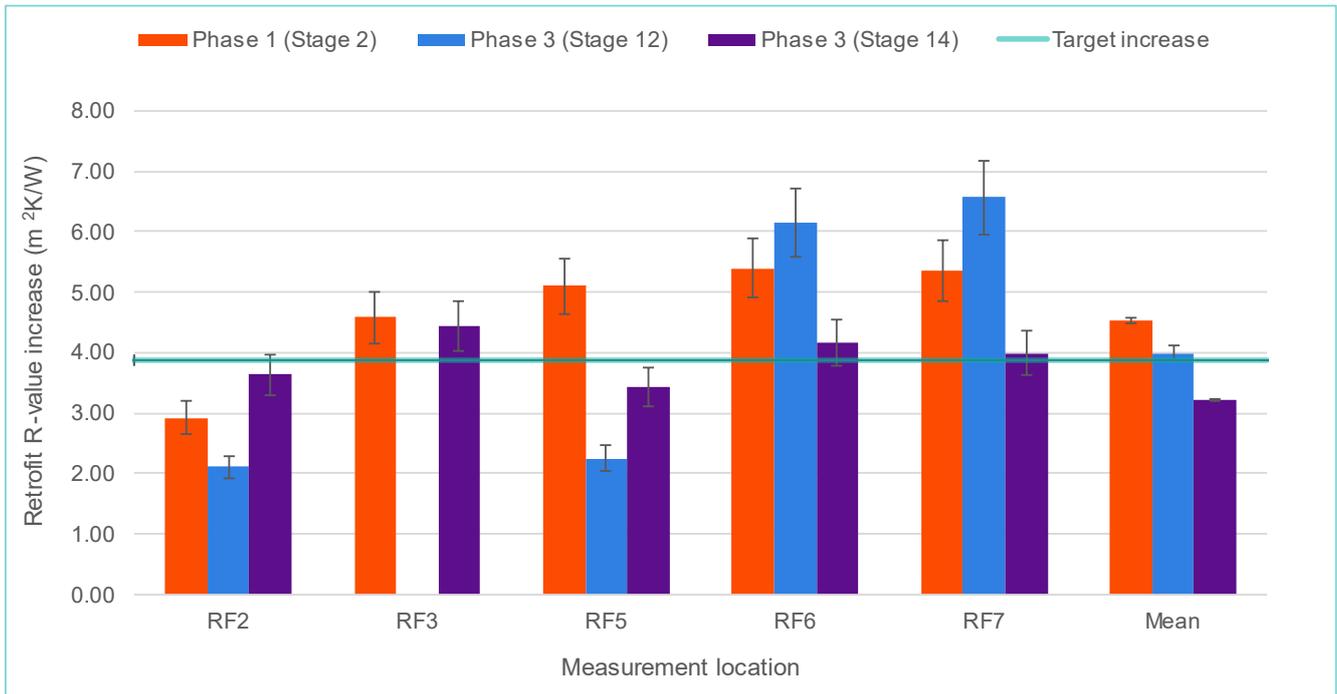
**Figure 21: Increase in R-value at each unbridged HFP location on the roof for each retrofit**

Figure 21 compares the R-value of the 170 mm mineral wool (3.86 m<sup>2</sup>K/W) applied to the loft during each retrofit with the measured increase in R-value at each unbridged location.

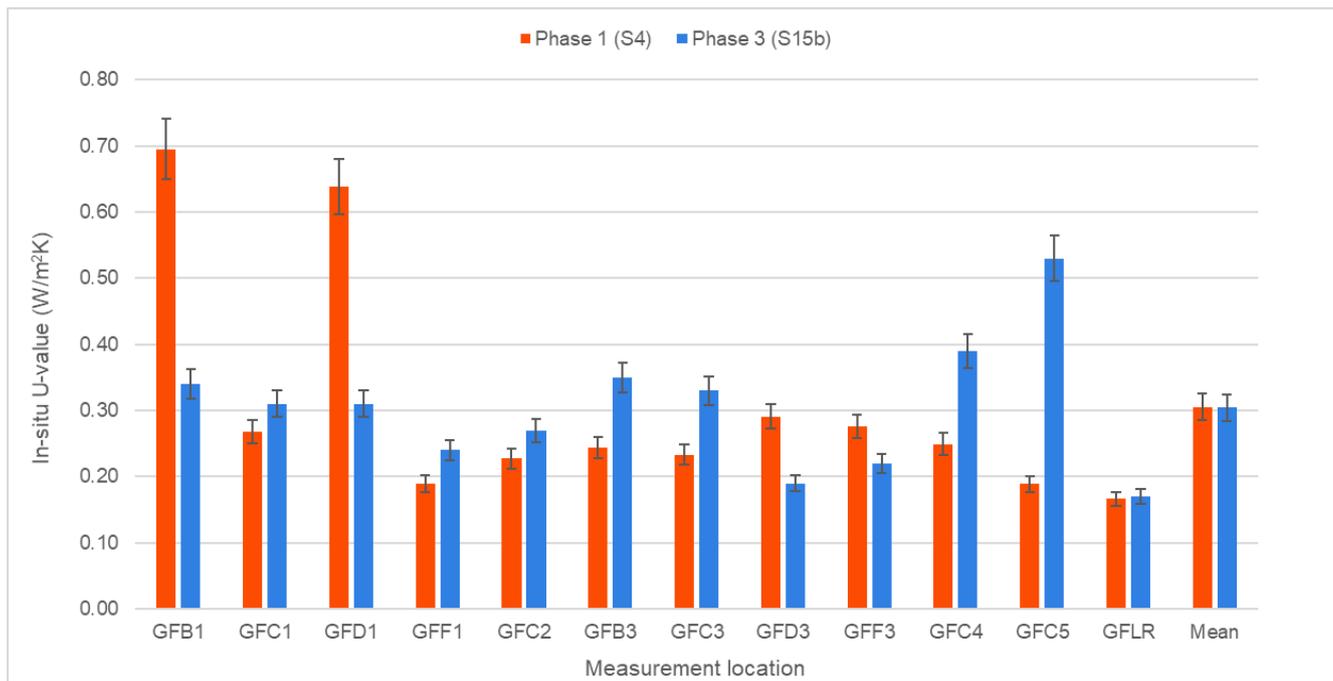
**Figure 22: Ground floor retrofit in-situ U-value at unbridged locations for each retrofit**

Figure 22 shows the in-situ U-value at each location used to calculate the ground floor retrofit in-situ U-value in Stages 4 and 15b.

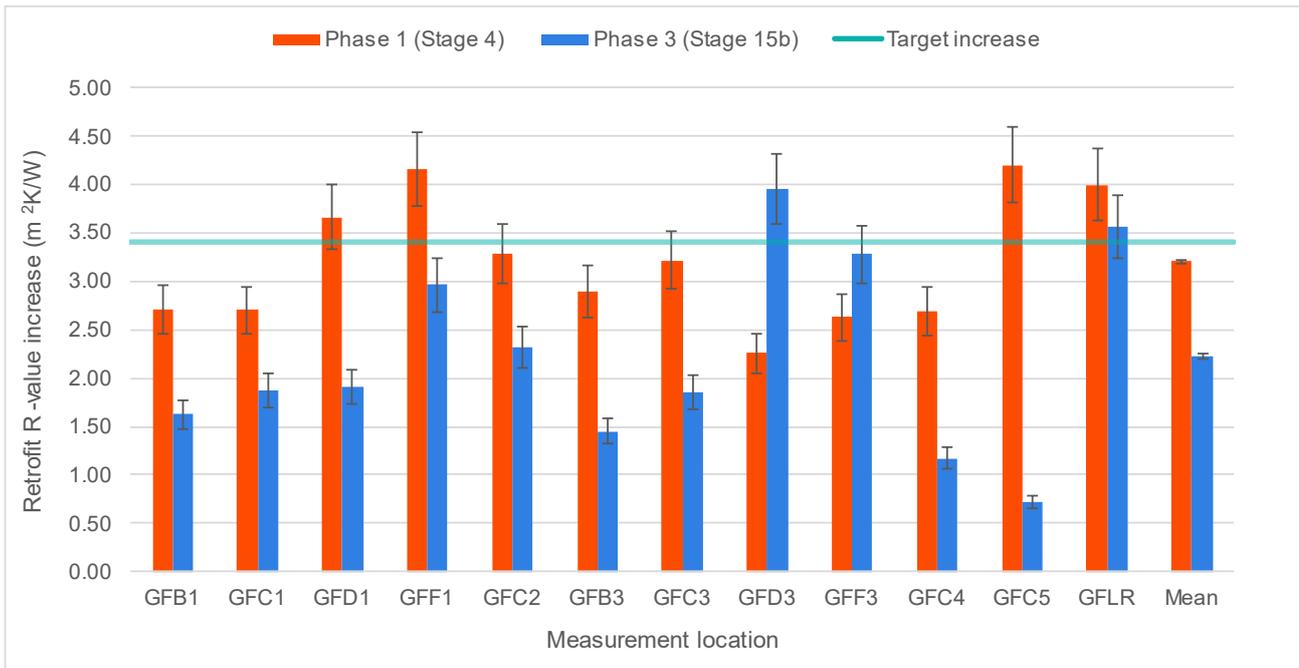
**Figure 23: Increase in R-value at unbridged locations on the ground floor for each retrofit**

Figure 23 compares R-value of the 150 mm mineral wool (3.41 m<sup>2</sup>K/W) applied to the ground floor during each retrofit with the measured increase in R-value at each unbridged location.
