# DEEP Report 5.01

# Salford Energy House

## Fabric Performance Testing

**Prepared by Energy House Labs Research Group, University of Salford**

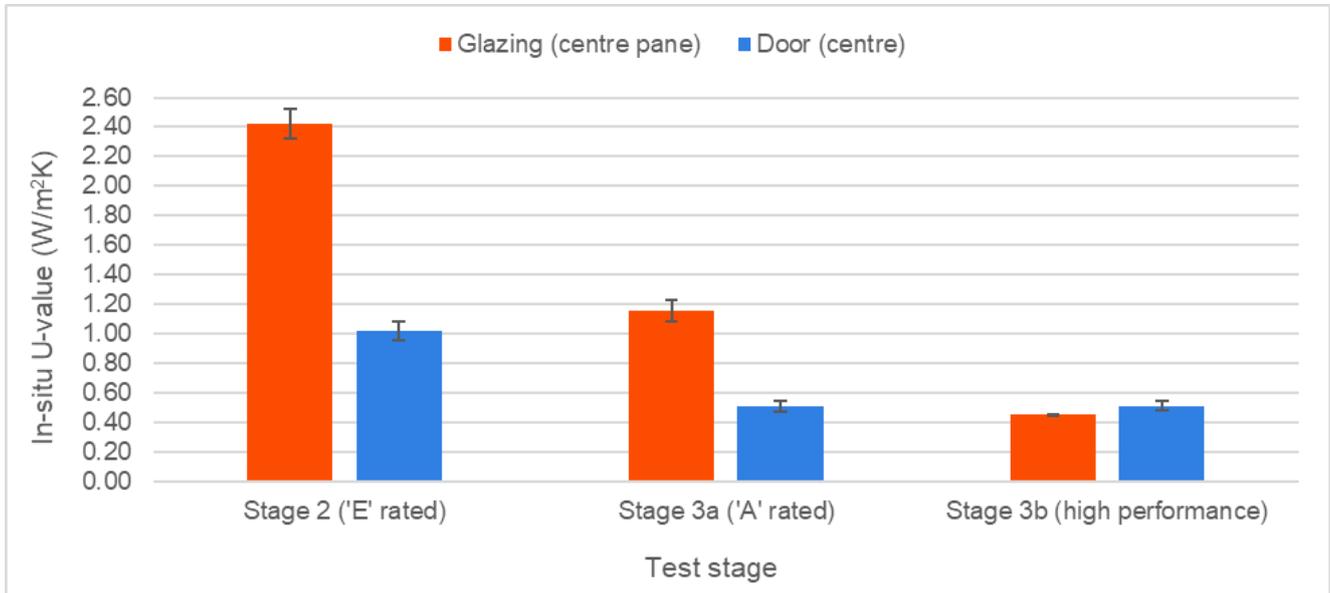
**Figure 24: In-situ U-value of openings pre- and post-retrofit**

Table 11 and Figure 24 provide the pre- and post-retrofit in-situ U-values for the openings during Phase 1. It must be noted that only the original window frames were retained throughout the entire test programme and only the DGUs were changed.

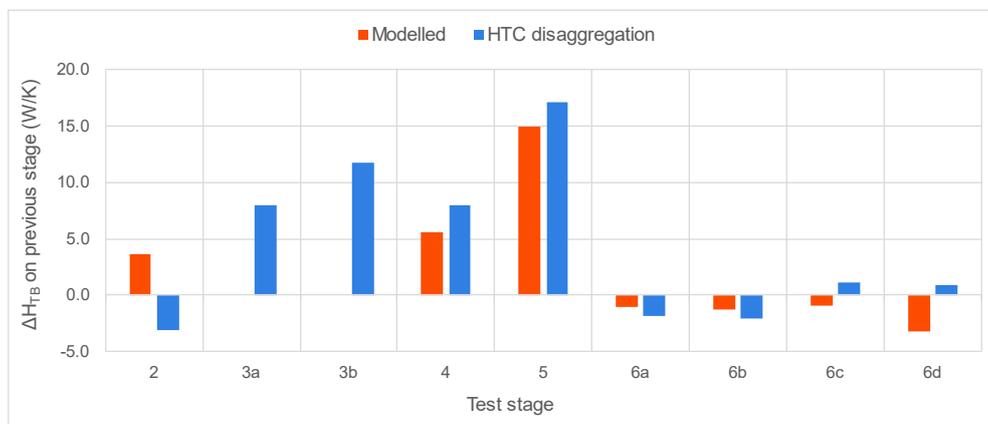
**Figure 25:  $H_{TB}$  change on previous test stage based on thermal modelling and HTC disaggregation (Stage 3b is change from Stage 2 and Stage 4 is change from Stage 3a)**

Figure 25 compares the change in  $H_{TB}$  at each stage of the retrofit process obtained through thermal modelling and HTC disaggregation.

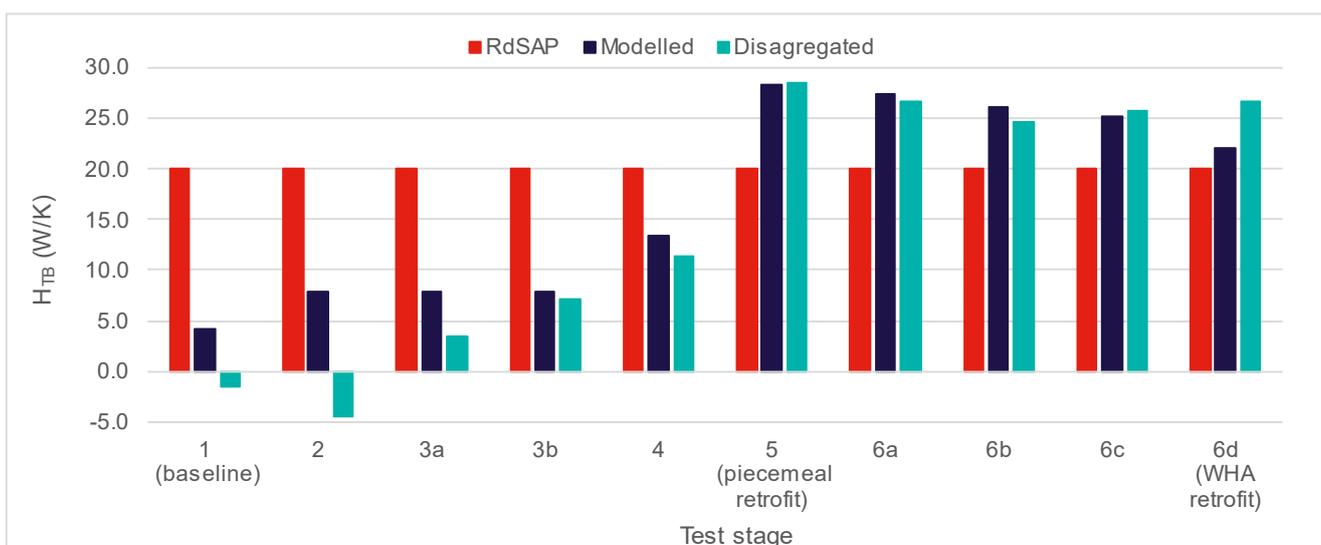
**Figure 26:  $H_{TB}$  derived from RdSAP, thermal modelling, and HTC disaggregation**

Figure 26 compares the  $H_{TB}$  derived from thermal modelling and HTC disaggregation with the  $H_{TB}$  calculated using the RdSAP assumed  $\gamma$ -value of  $0.15$  W/m<sup>2</sup>K.

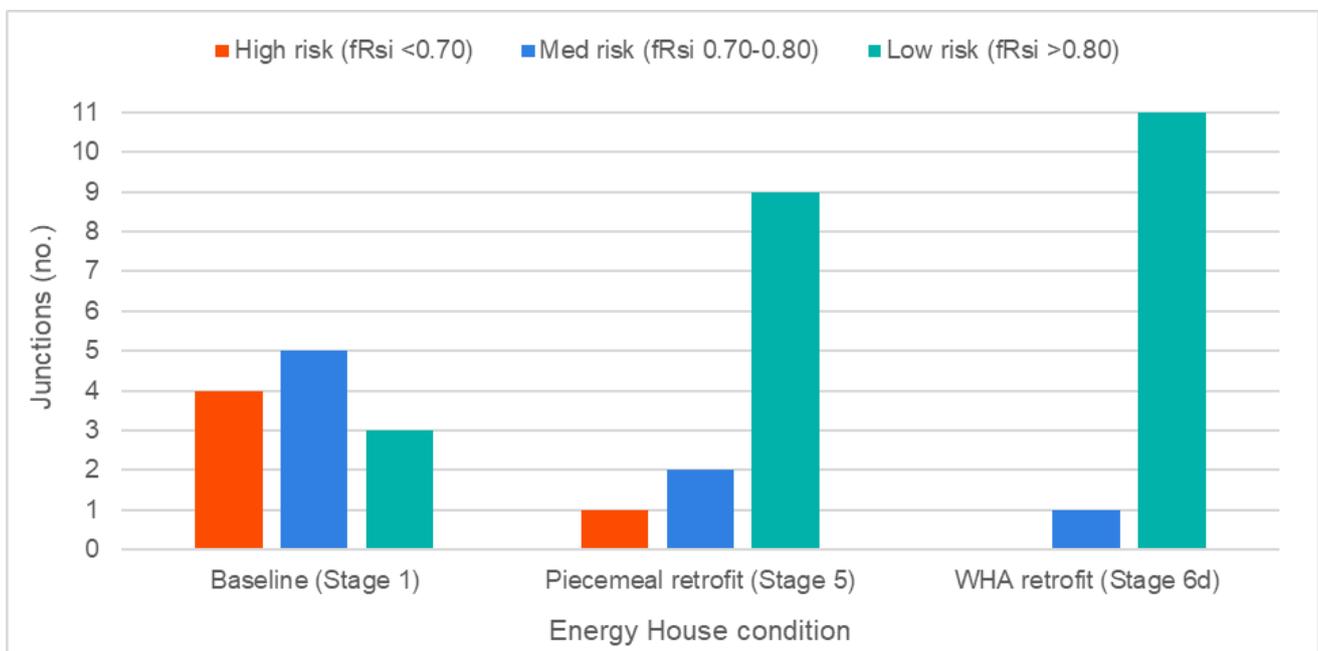
**Figure 27: Energy House junctions in each  $f_{\text{CRsi}}$  risk category**

Figure 27 shows the number of the Energy House's junctions in each surface condensation and mould growth risk category at the landmark test stages. Although the  $f_{\text{Rsi}}$  values may not be applicable to all solid wall dwellings due to construction details and materials, the change in behaviour resulting from retrofit is likely to be similar for dwellings with junctions in comparable configurations.

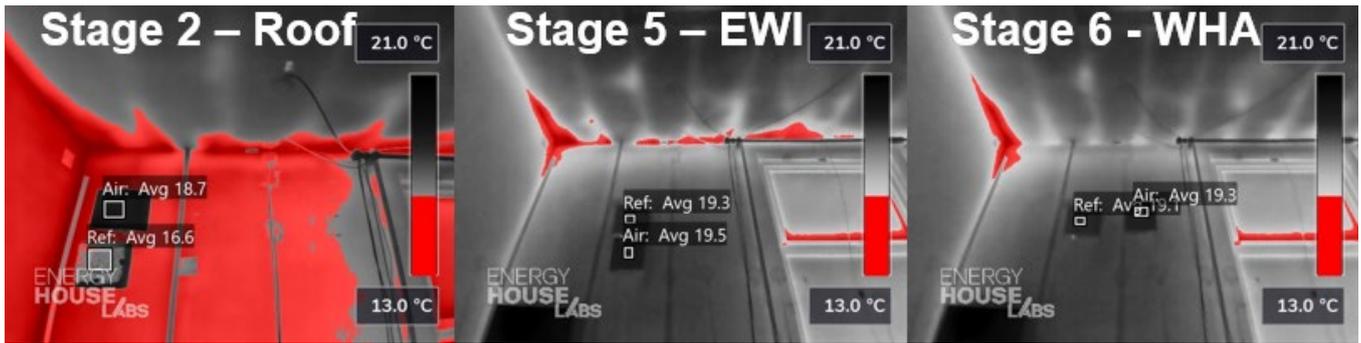
**Figure 29: Thermography of eaves and front and gable walls at test Stages 2, 5, and 6. Locations below the  $f_{CRsi}$  of 0.75 which are deemed to pose a risk of surface condensation and mould growth are highlighted in red (measurements on glazing panels are unreliable)**

In both Figure 29 and Figure 30 a residual risk of surface condensation and mould growth following the whole house approach retrofit was evident at the eaves/gable interface at the verge on both the front and rear elevations. These locations are highlighted in Figure 31.

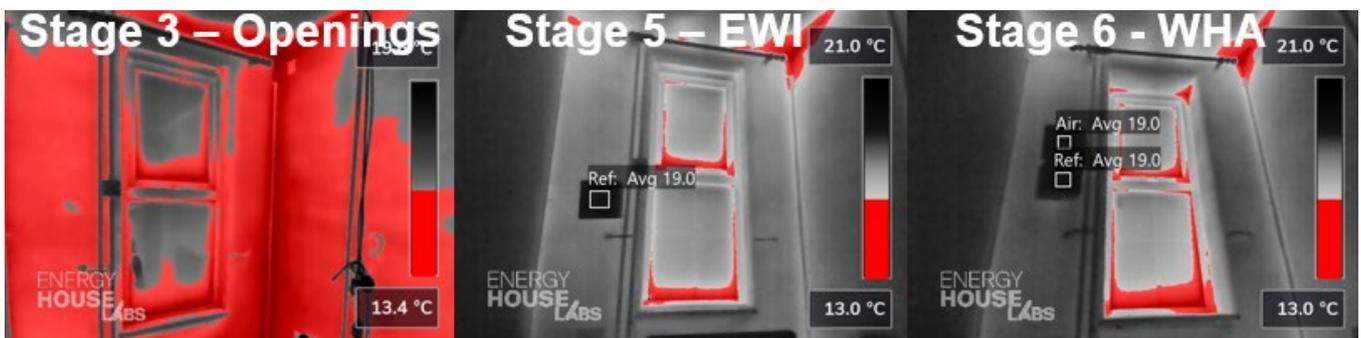
**Figure 30: Thermography of rear window and rear and gable walls at test Stages 3, 5, and 6. Locations below the  $f_{CRsi}$  of 0.75 which are deemed to pose a risk of surface condensation and mould growth are highlighted in red (measurements on glazing panels are unreliable)**

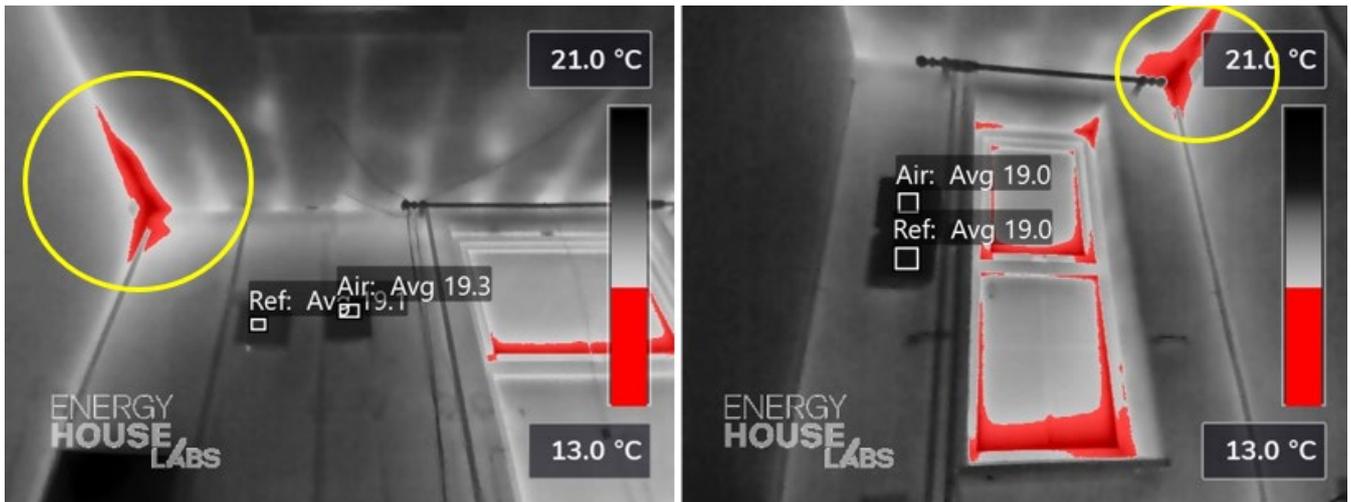
**Figure 31: Thermography of eaves/gable interface at verge (circled) on both the front (left) and rear (right) elevations after the whole house approach retrofit. Locations below the  $f_{CRsi}$  of 0.75 which are deemed to pose a risk of surface condensation and mould growth are highlighted in red (measurements on glazing panels are unreliable)**

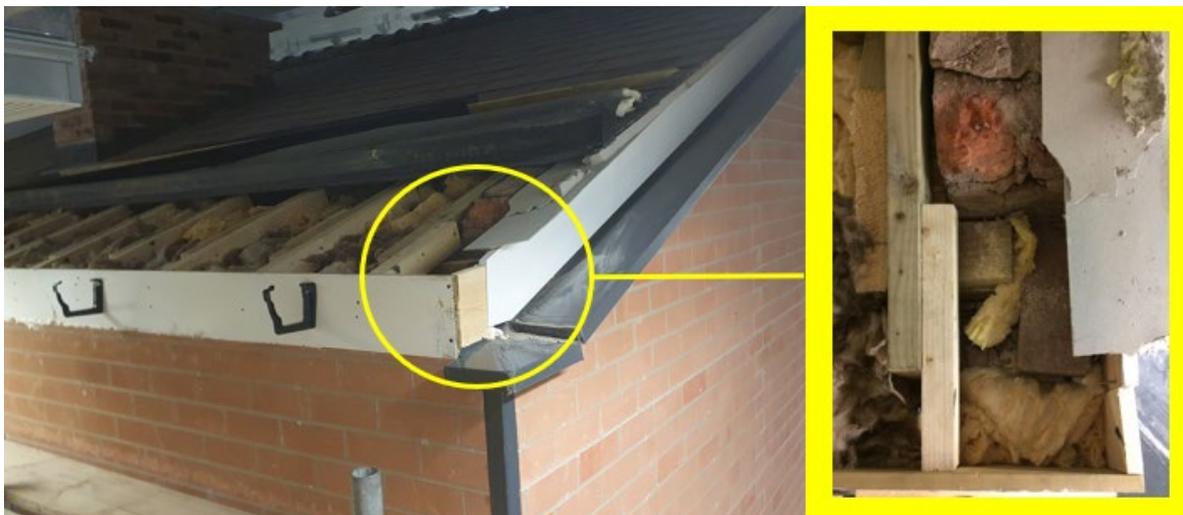
Figure 32 shows that although some effort was made to insulate the eaves/gable interface, the gap between the rafter and gable wall was too narrow to be insulated. In addition, thermal bridging through the gable brickwork is thought to have contributed to point thermal bridging at this detail.

**Figure 32: Hard-to-treat detail at eaves/gable interface at verge resulting in residual risk of surface condensation and mould growth following the whole house approach retrofit**

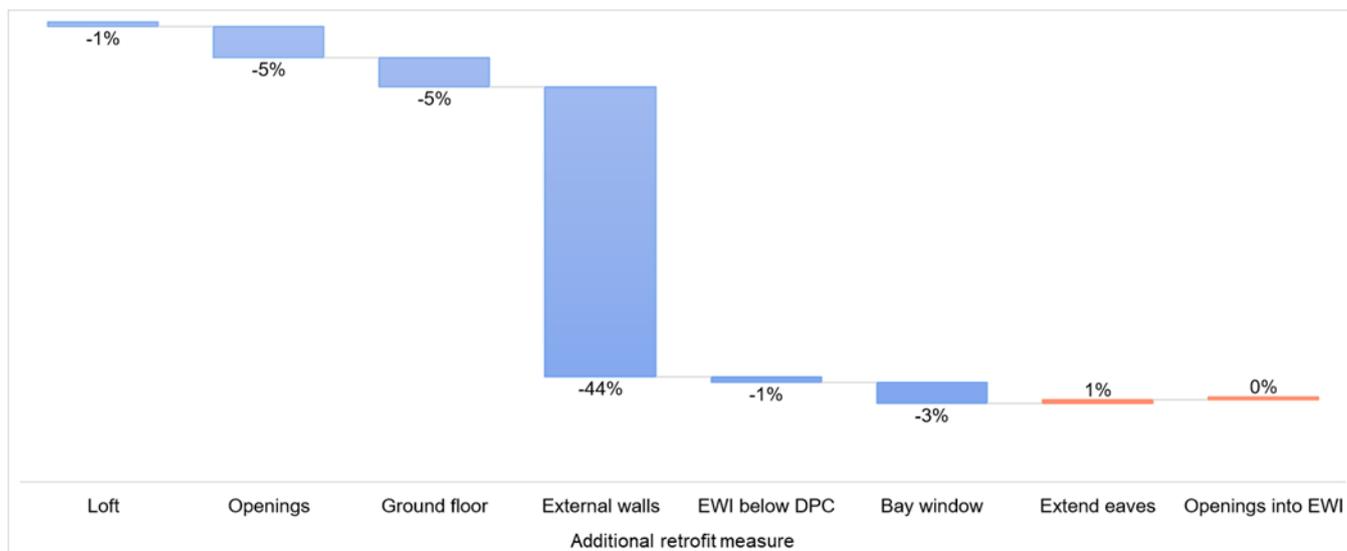
**Figure 33: Cumulative impact of retrofits at each stage in Phases 1 and 2**

Figure 33 shows the cumulative impact of each retrofit during Phases 1 and 2.

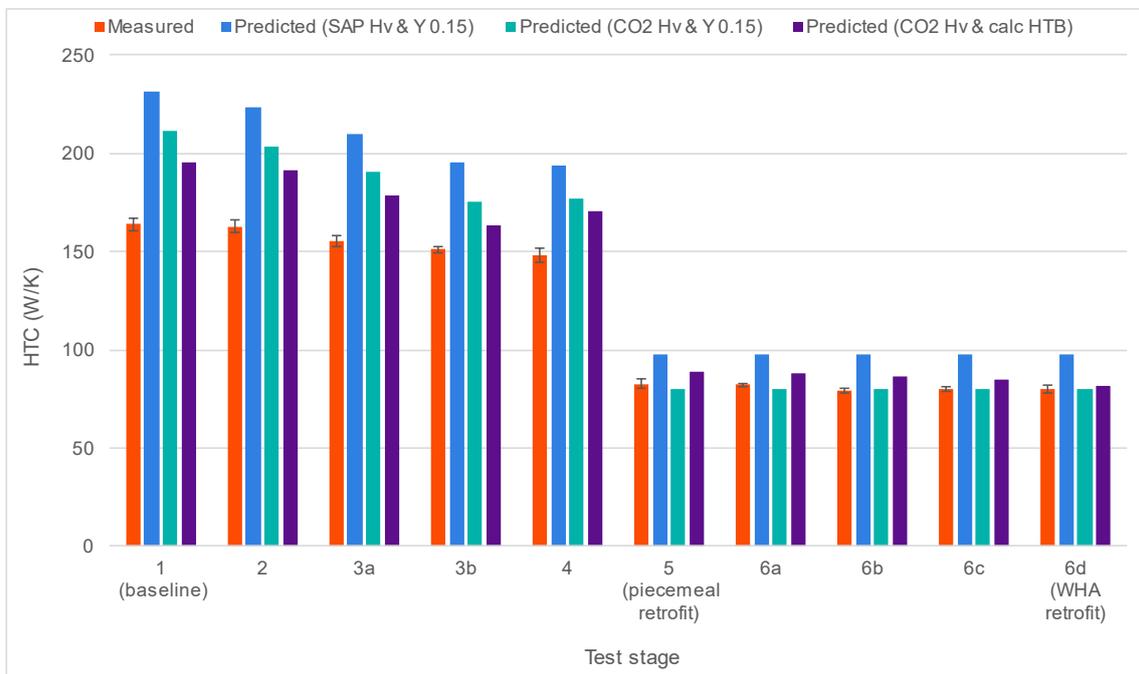
**Figure 34: Measured and predicted HTCs at each stage of the retrofit process**

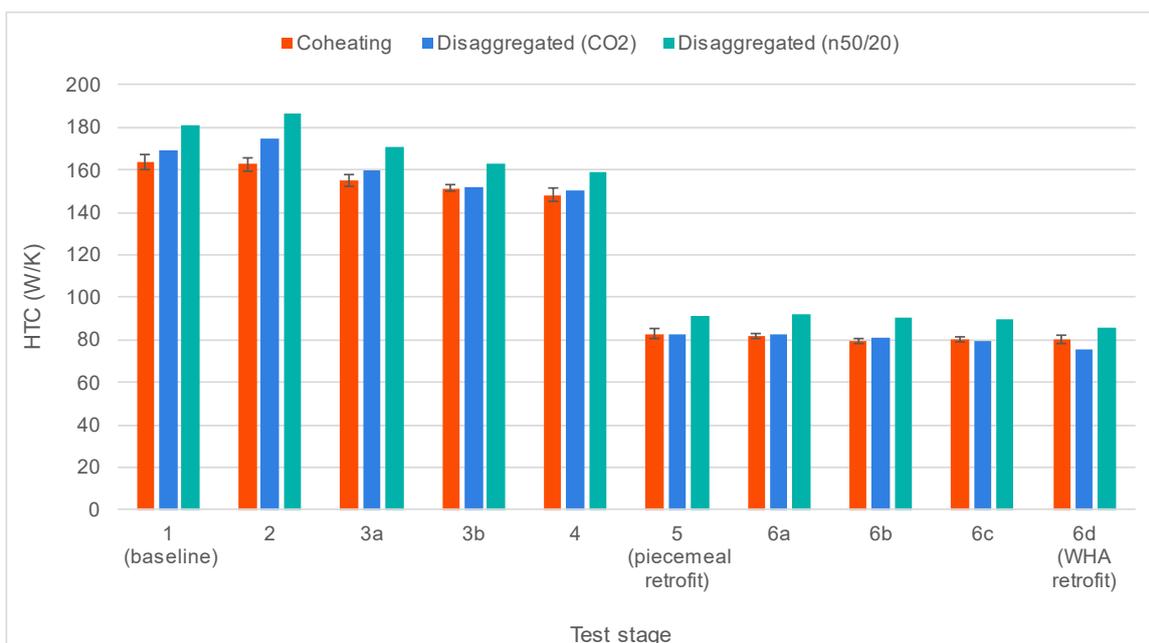
**Figure 35: Coheating test measured HTC and disaggregated HTCs using  $H_v$  derived from CO<sub>2</sub> decay and  $n_{50/20}$**

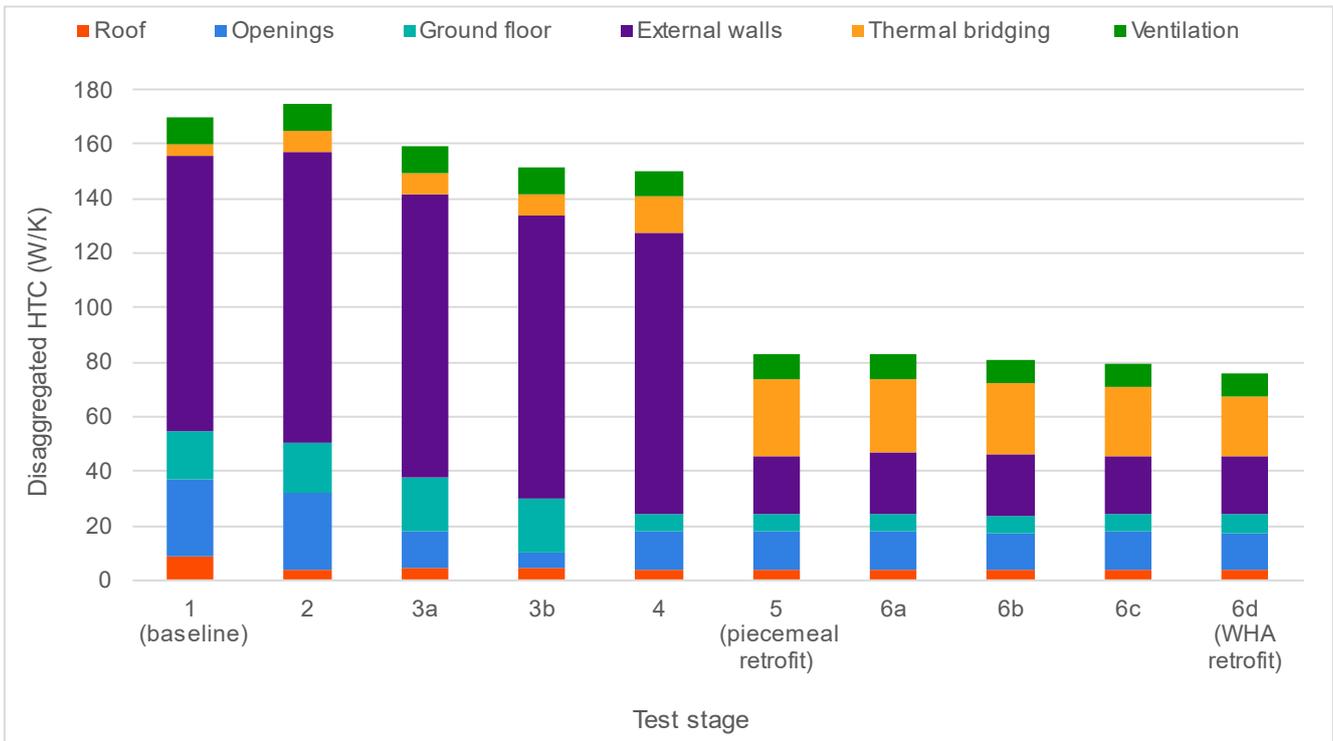
**Figure 36: Disaggregated HTC at each stage of the retrofit process**

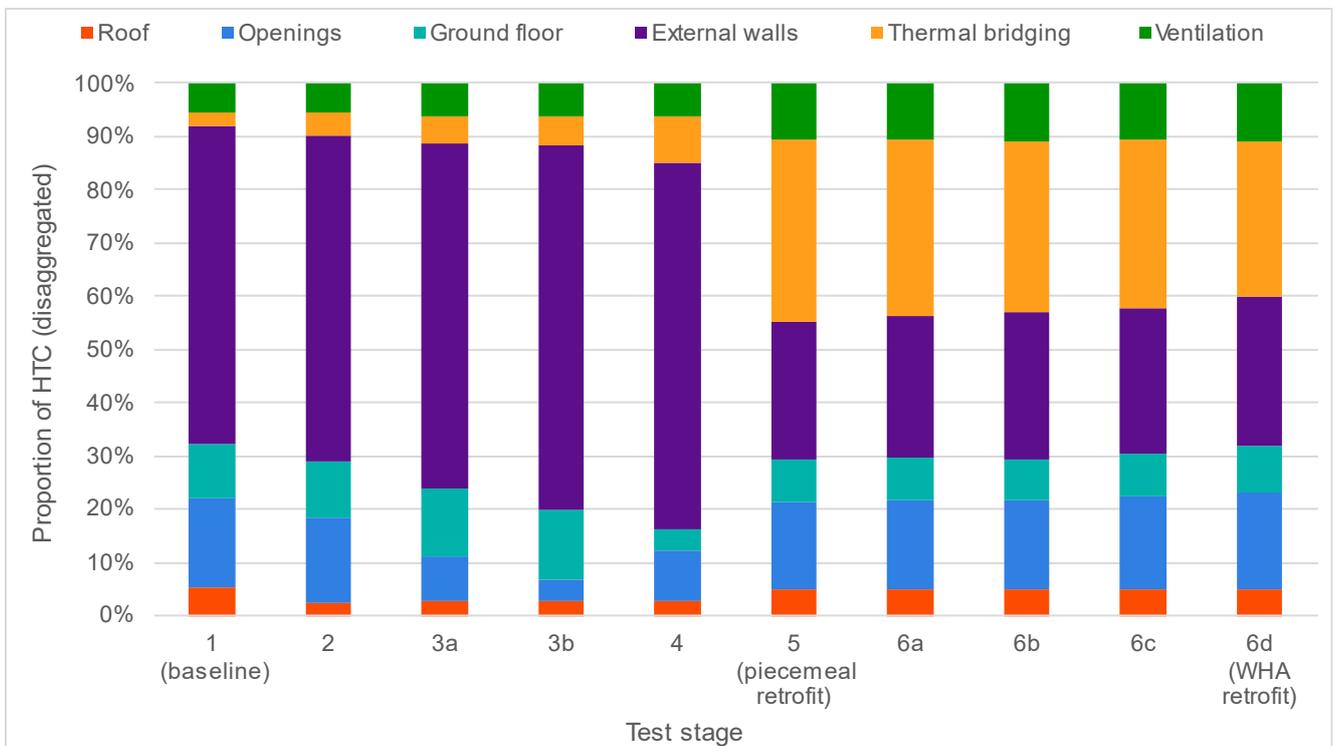
**Figure 37: Proportion of heat losses from each component of the HTC at each stage of the retrofit process**

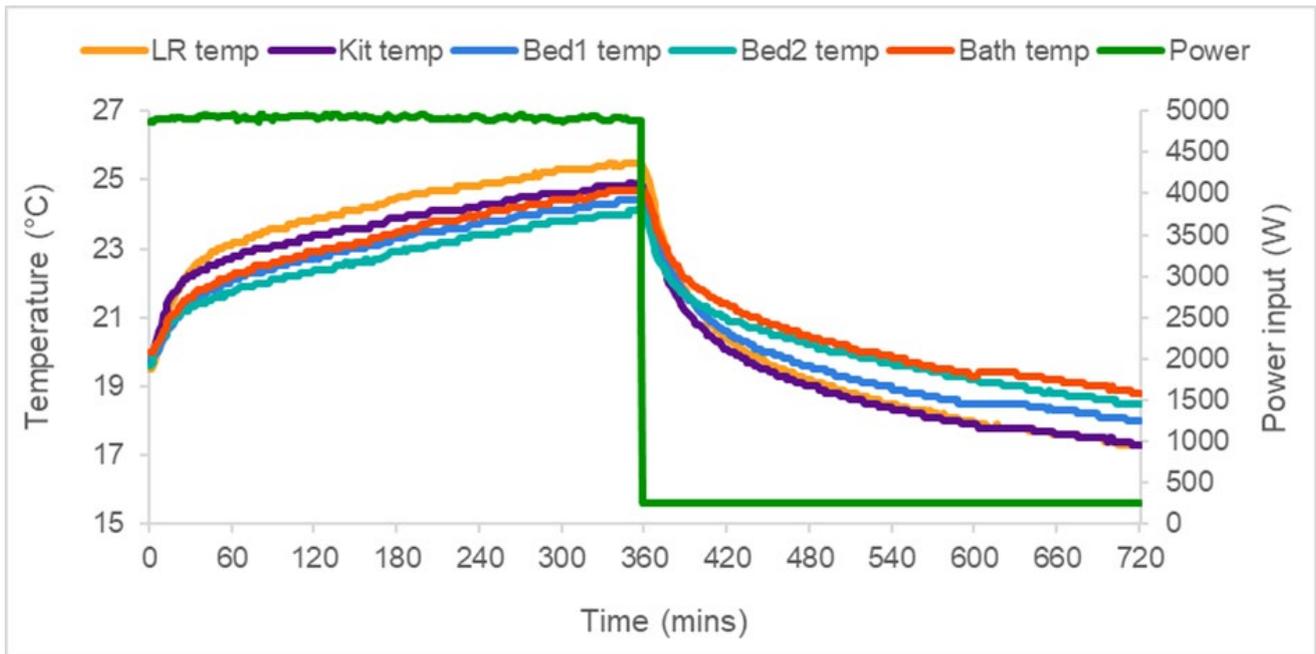
**Figure 38: Internal temperatures and power input measured during the Stage 1 QUB test**

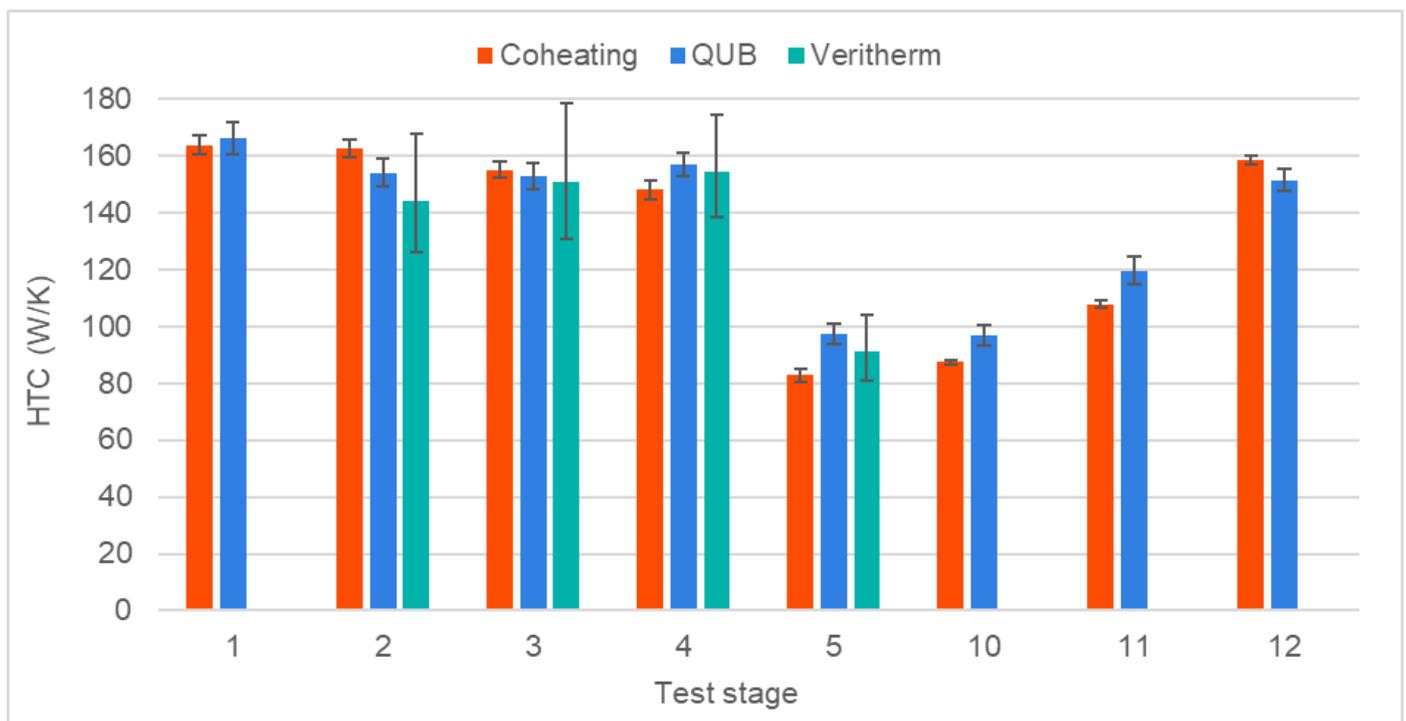
**Figure 39: HTC's measured using the coheating, QUB, and Veritherm test methods**

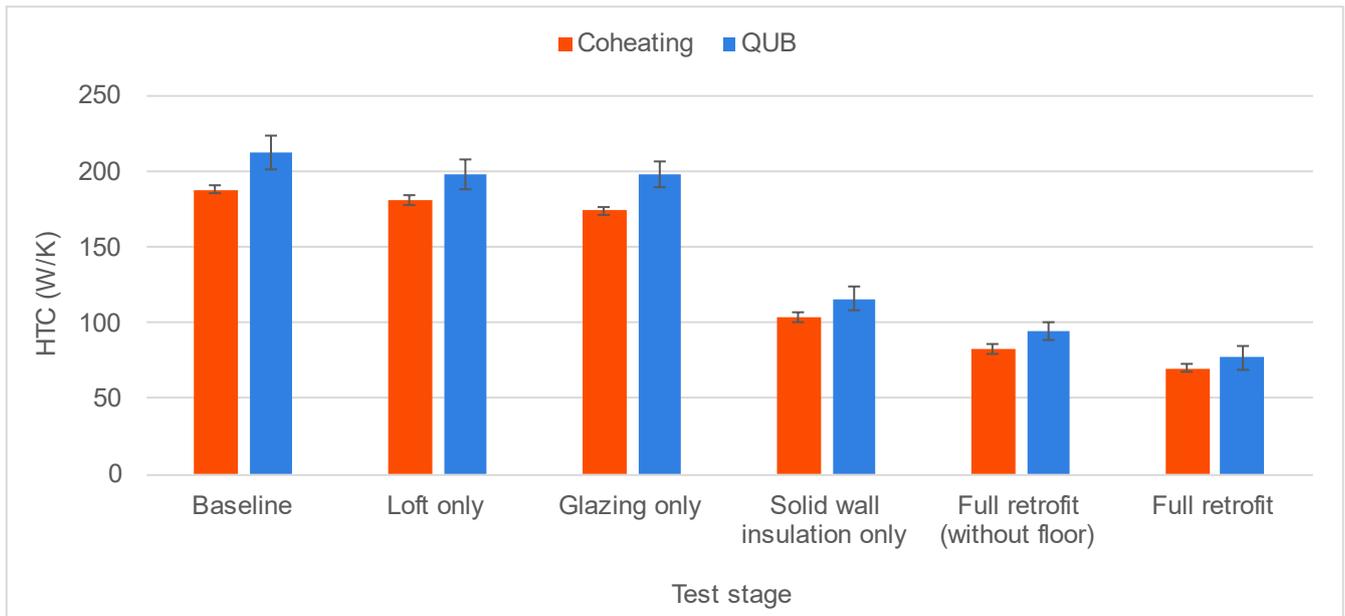
**Figure 40: Coheating and QUB HTCs at each stage of the 2013 Saint-Gobain retrofit**

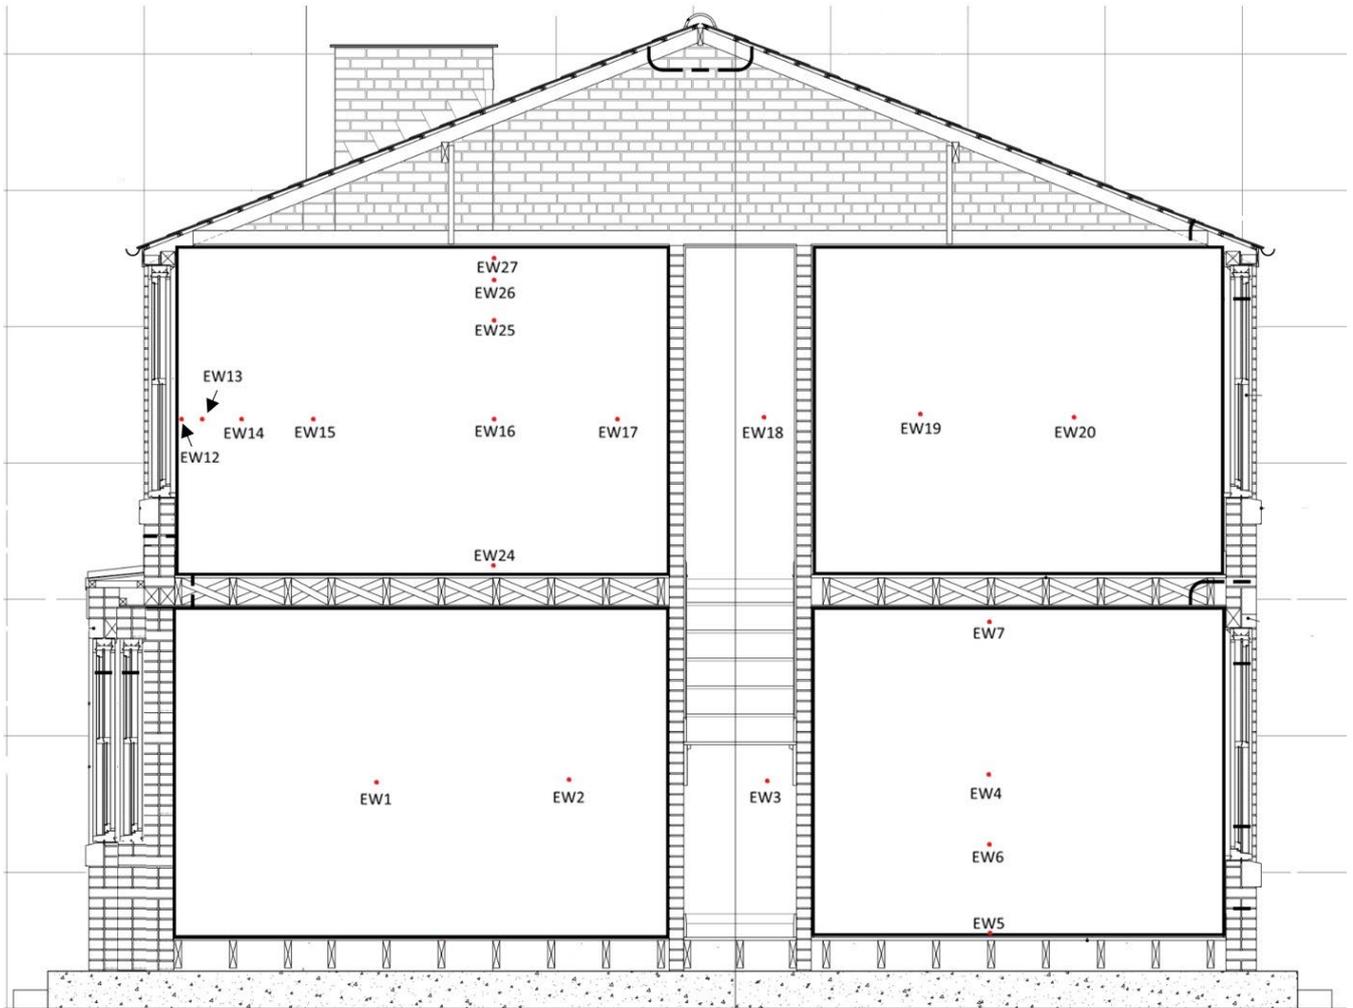
**Figure D1: External (gable) wall HFP locations and identifiers**

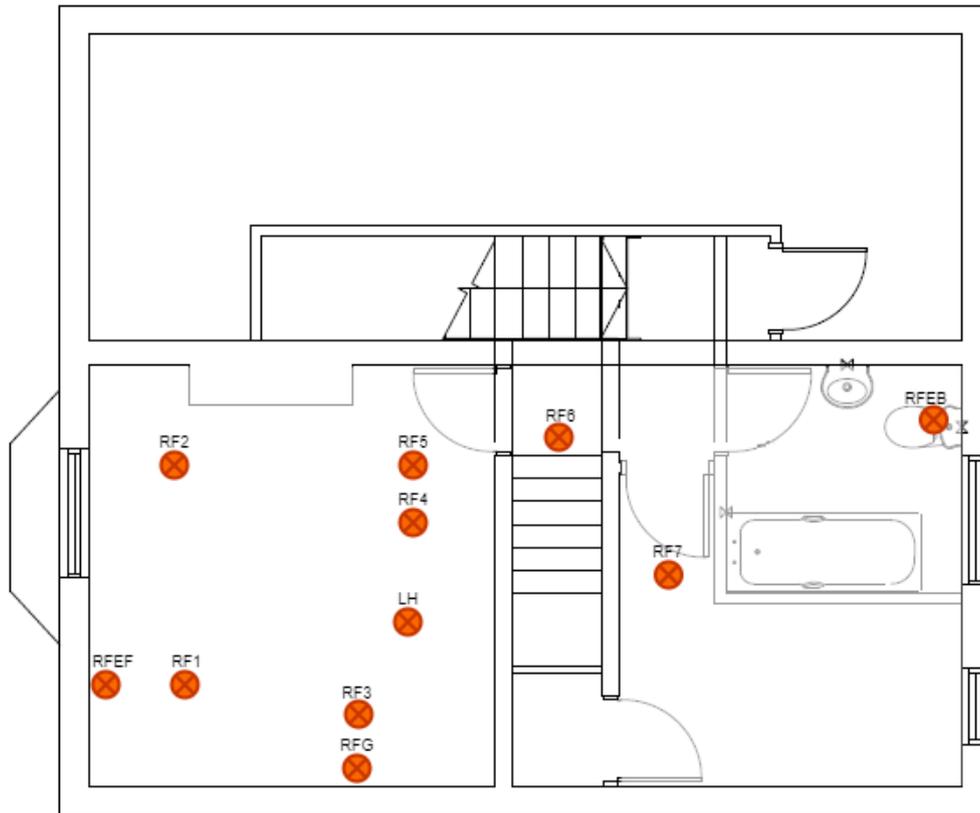
**Figure D2: Roof HFP locations and identifiers**

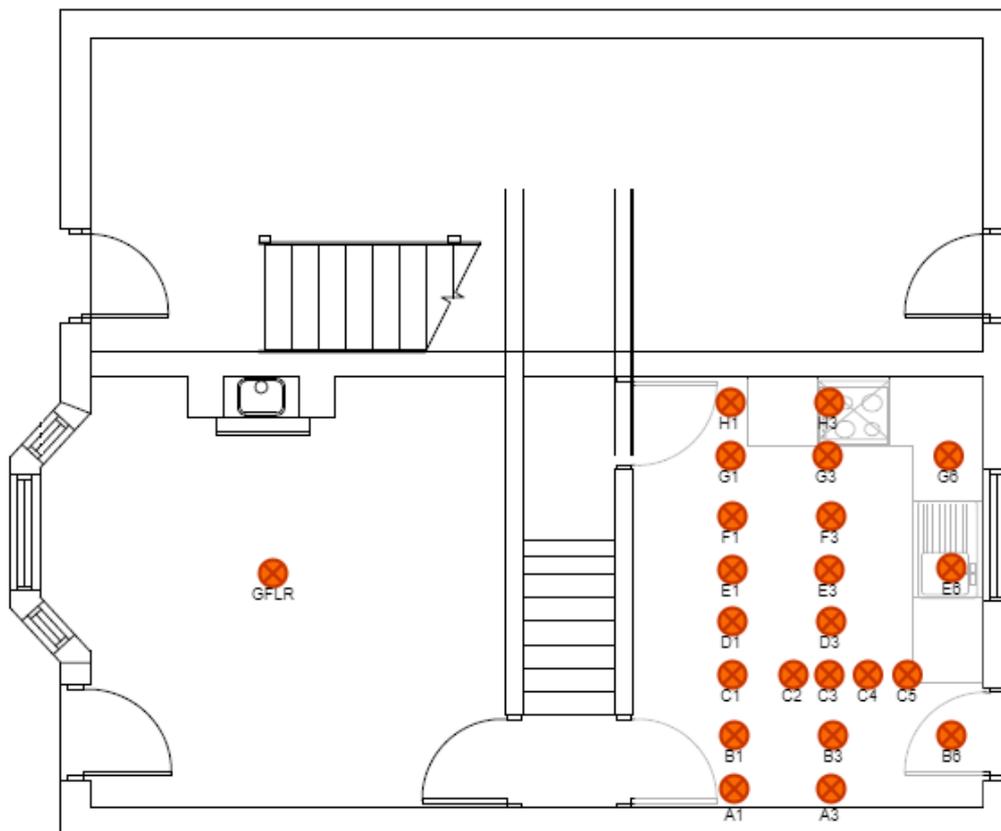
**Figure D3: Ground floor HFP locations and identifiers**

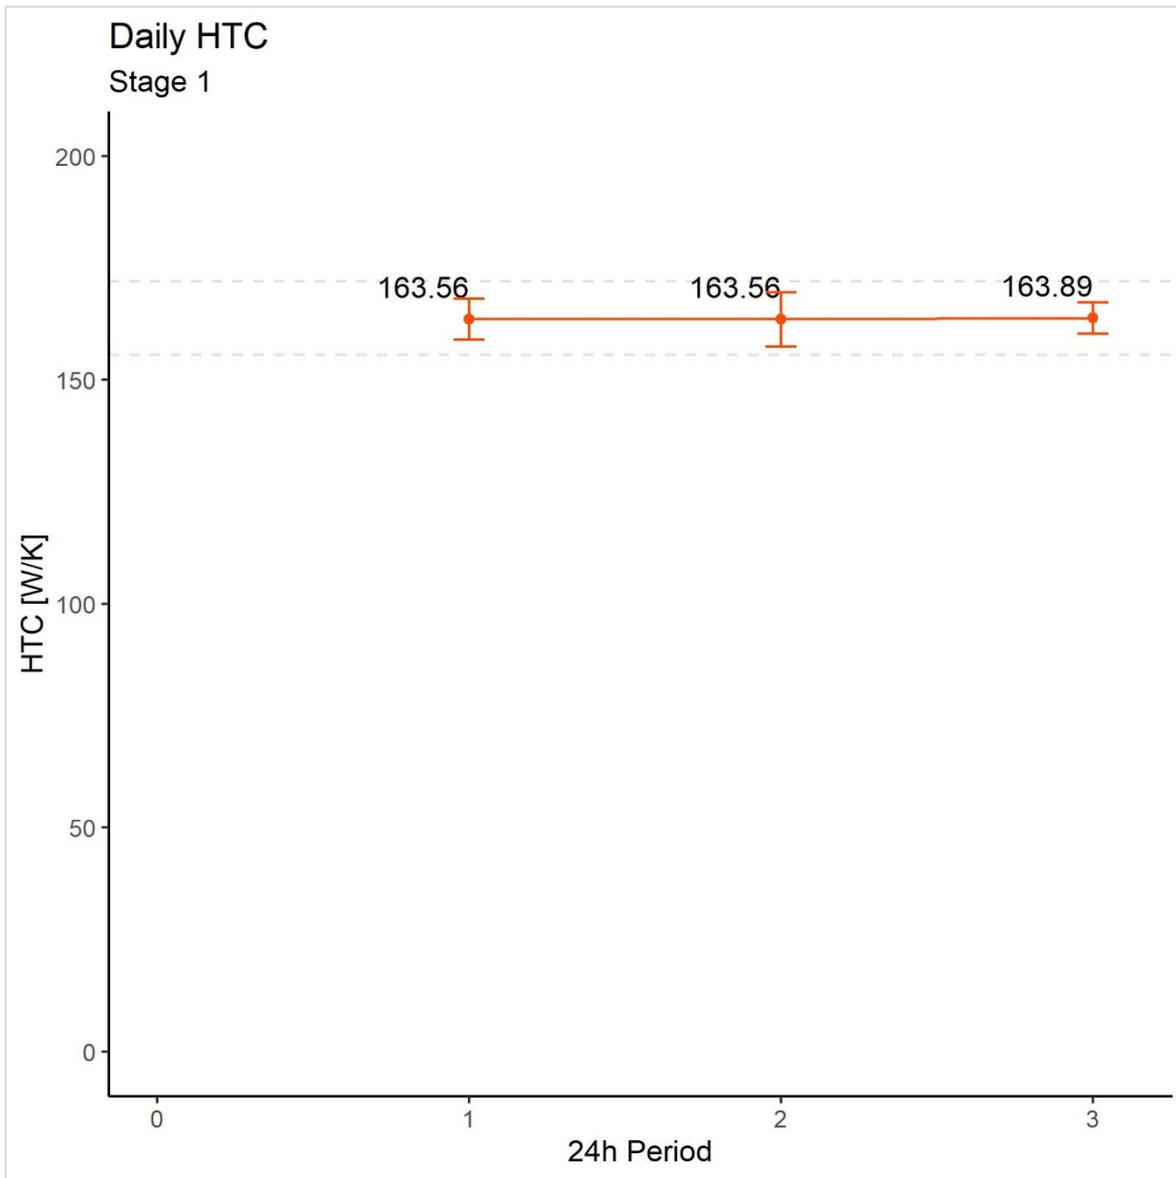
**Figure E1: 24-hour HTCs with uncertainty measured during Stage 1 baseline steady state measurement period test**

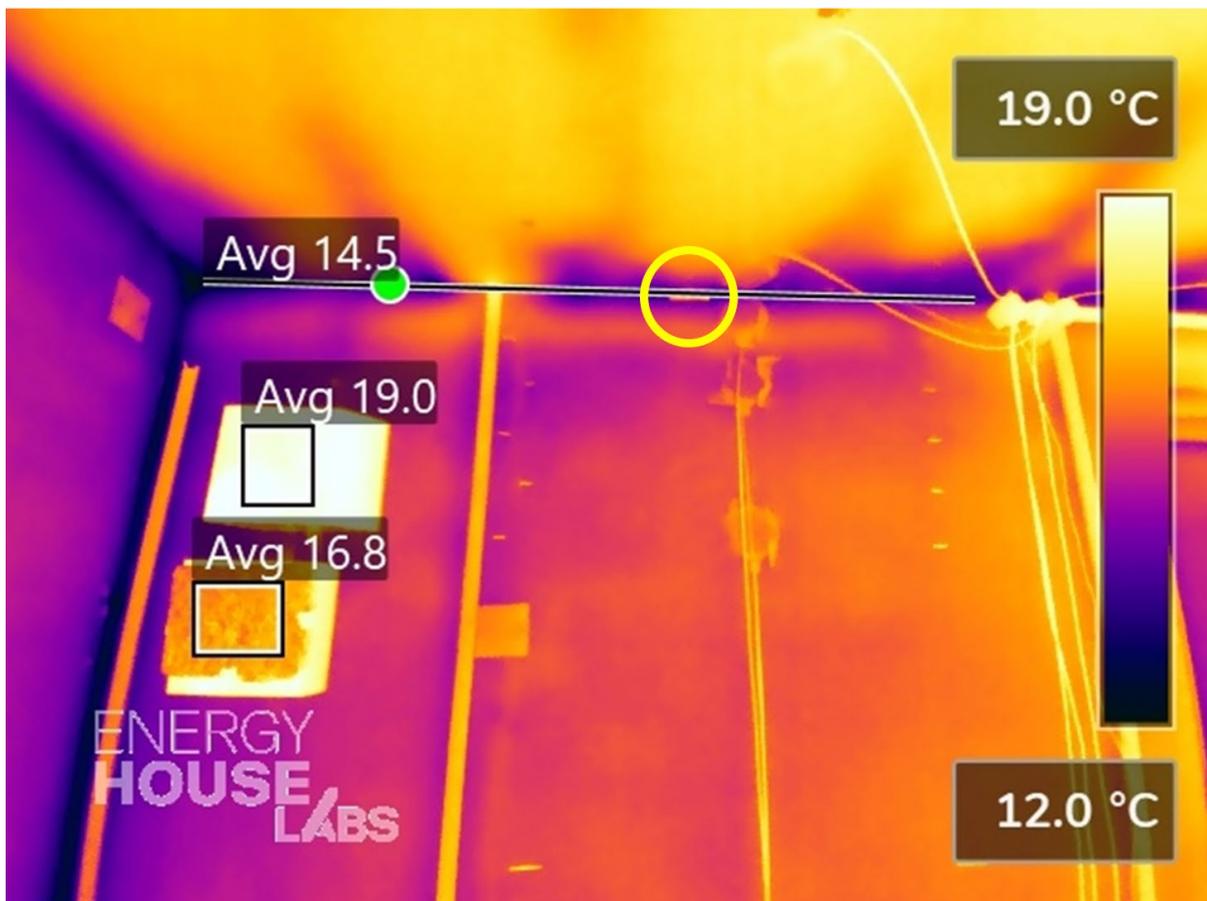
**Figure G1: Thermogram of the eaves junction in Bedroom 1 at Stage 2 of the DEEP retrofit. Location of surface temperature thermocouple circled**

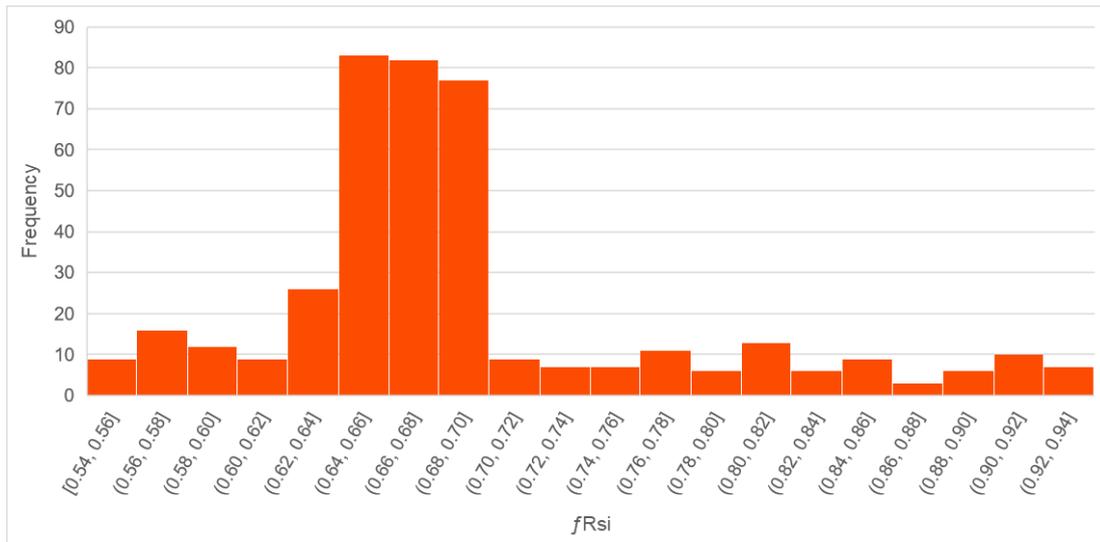
**Figure G2: Frequency distribution of eaves in-situ  $f_{Rsi}$  measurements obtained using thermography**

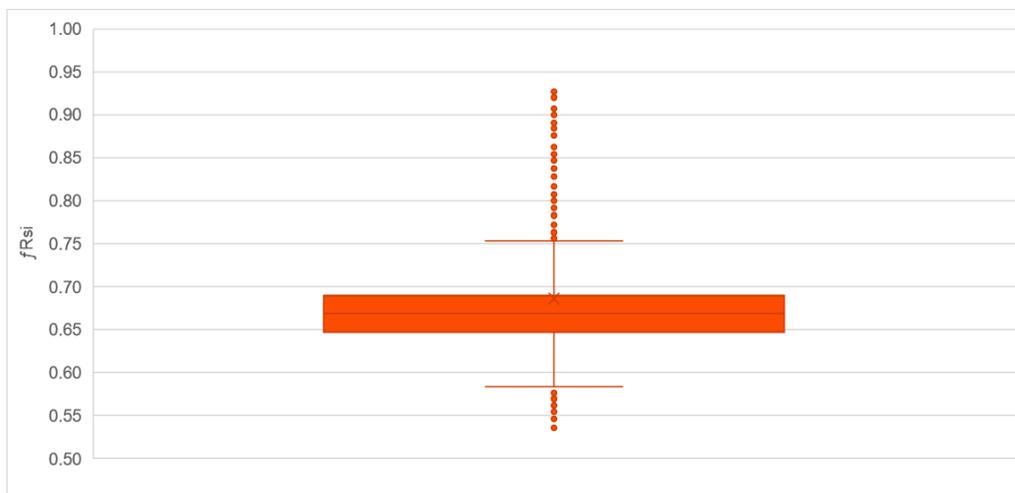
**Figure G3: Box plot of the in-situ  $f_{Rsi}$  measurements derived from thermography**
