# Vector Homes Baseline Fabric Performance Report of “Vector V1 Prototype Studio”

Report version: FINAL V4

This technical report examines the fabric performance of the Vector V1 studio, built by Vector Homes, and tested under controlled conditions at the Energy House 2.0 research facility at the University of Salford.

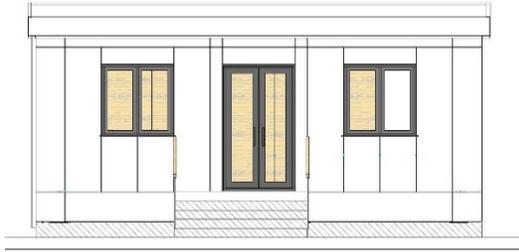
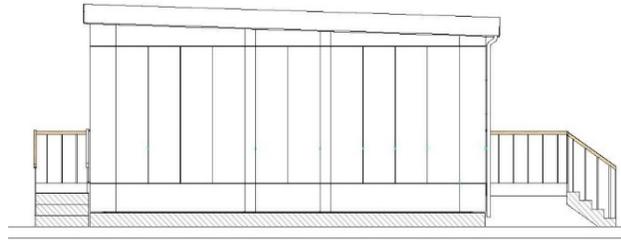
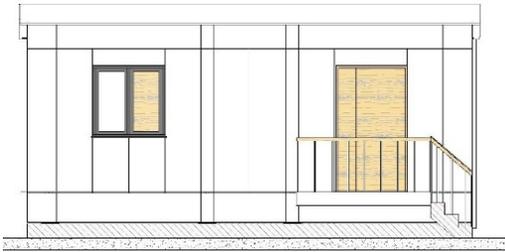
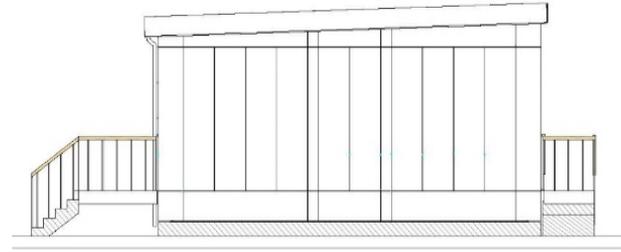
Figure 2. Rear façade of Vector V1

Figure 3. Left façade of Vector V1

Figure 4. Front façade of Vector V1

Figure 5. Right façade of Vector V1

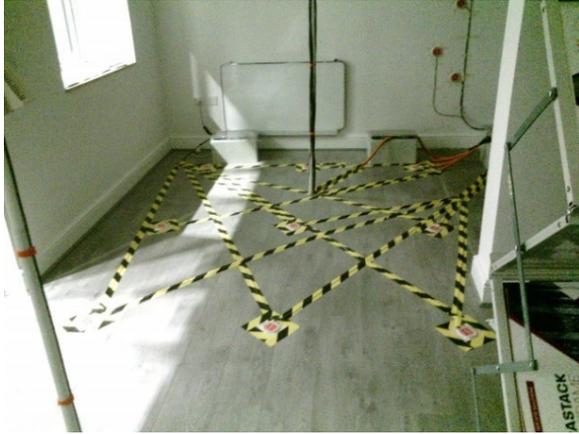
Figure 6. Heat flux measurements - floor

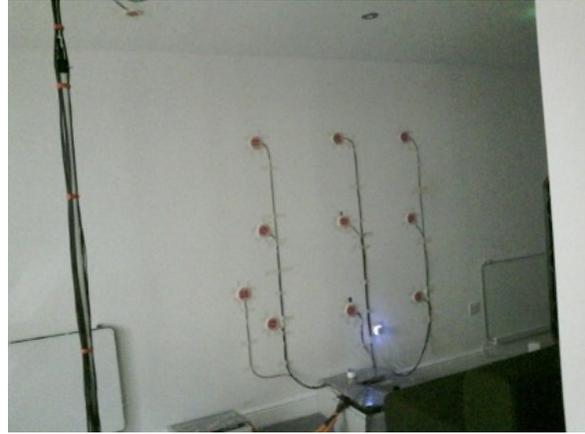
Figure 7. Heat flux measurements – wall

A stratification in the measured U-value of the external wall was observed (Table 13), with greater heat flux (and therefore U-value) measured using the three lower HFPs, reducing with the middle three HFPs, and reducing further at the top three HFPs. This could indicate thermal bypass within the wall, with cold air infiltrating the wall at the bottom, and being heated as it rises towards the top.

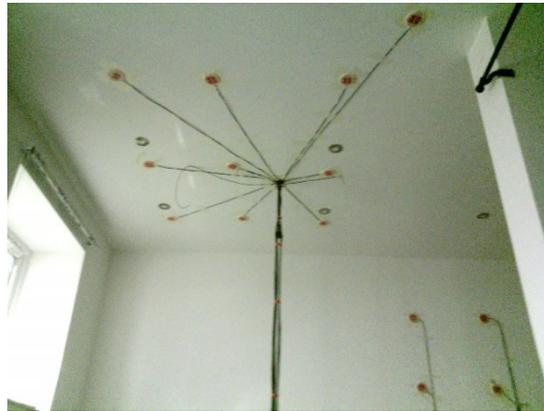
Figure 8. Heat flux measurements - ceiling

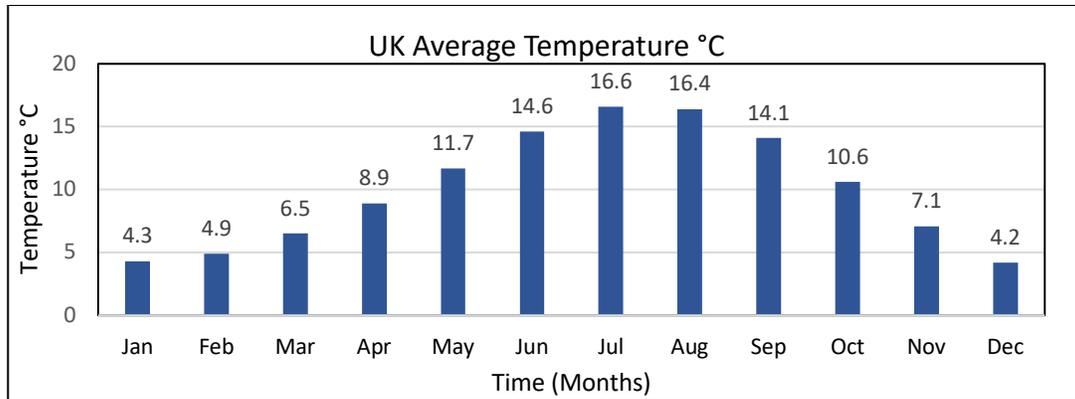
All the tests and measurements of the Vector V1 were carried out within the environment of the Energy House 2.0. The chamber's HVAC system was set to maintain 5 °C during the test days, while the indoor temperature was maintained at 21 °C. Figure 9 below illustrates the average temperatures in the UK according to the according to RdSAP10, 2024 [5]. These temperatures were used to provide a representative external temperature of the United Kingdom during the winter months (December to March).

Figure 9. Average monthly UK temperature [5].

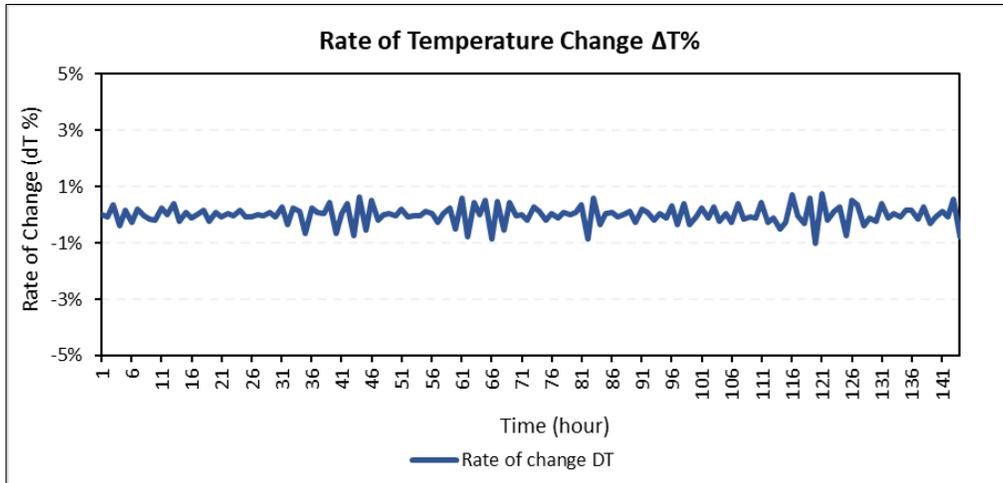
During the Co-heating test, the temperatures on both sides of the fabric remained at steady state for 5 days. Figure 10 shows the rate of change of the temperature difference ( $\Delta T$ ) during the Co-heating test, the  $\Delta T$  remained steady with variations between 1% and -1%.

Figure 10. Rate of change of the temperature difference ( $\Delta T$ ) during Co-heating test.

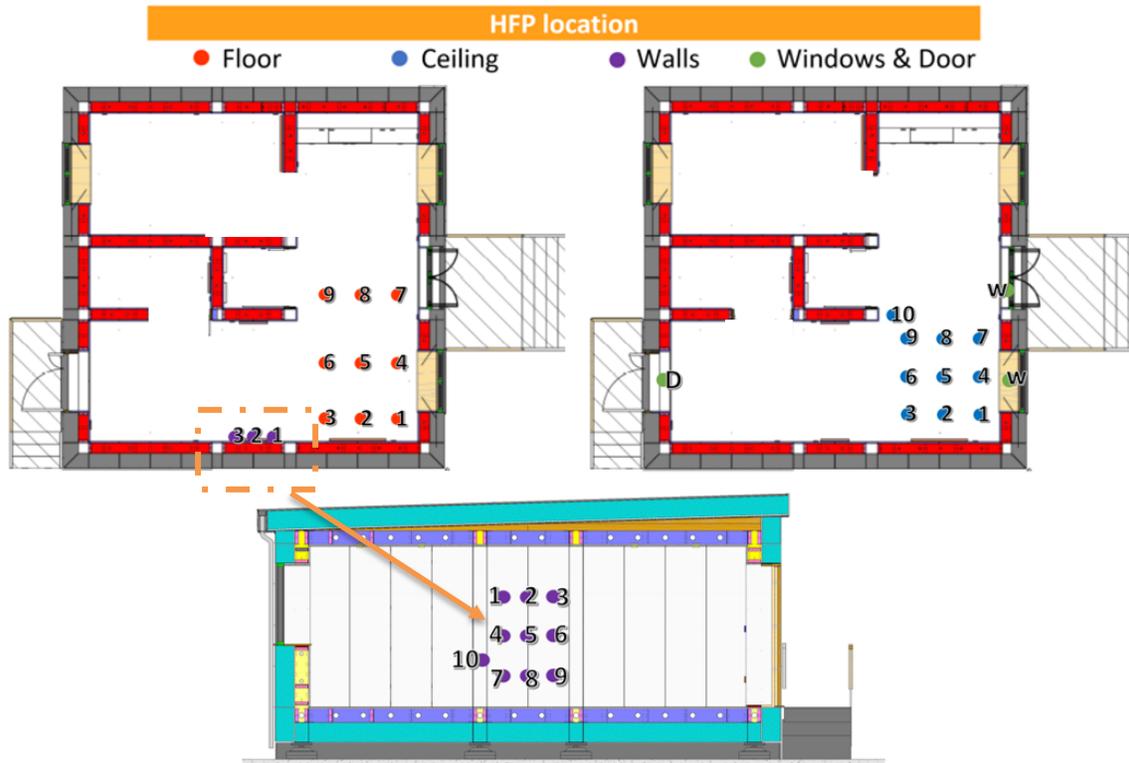
Measurements of heat flux density, from which in-situ U-values were calculated, were taken at 35 locations on the external elements of Vector V1 using heat flux plates (HFPs). The HFPs were fixed to surfaces using adhesive tape and thermal contact paste. The  $\Delta T$  for each in-situ U-value measurement was calculated using the internal and external air temperature differential measured in the vicinity of each HFP. Figure 11 shows the HFP's location within Vector V1.

Figure 11. HFP locations on the external elements of Vector V1 (wall measurements were conducted on the right façade).

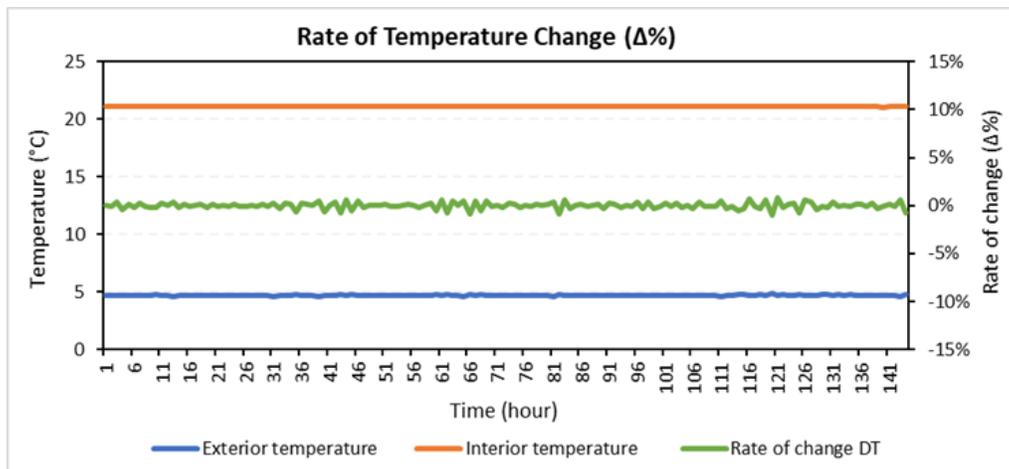
Figure 12 and Figure 13 show that steady state conditions were reached for more than 72h for both the temperature and the average heat flux with less than 1% and 4% change for both temperature and heat flux, respectively.

Figure 12. Rate of temperature change (%) during the U-Value measurements.

Figure 12 shows the average indoor temperature, the chamber temperature, and the rate of change of the  $\Delta T$  ( $T_i - T_e$ ) for the Living Room, Figure 17 below shows the average heat flux and the rate of change (%) during the same period. The HTC was calculated over the entire period of the stable measurement. The U-value calculations were done over 24 hours of these stable measurements.

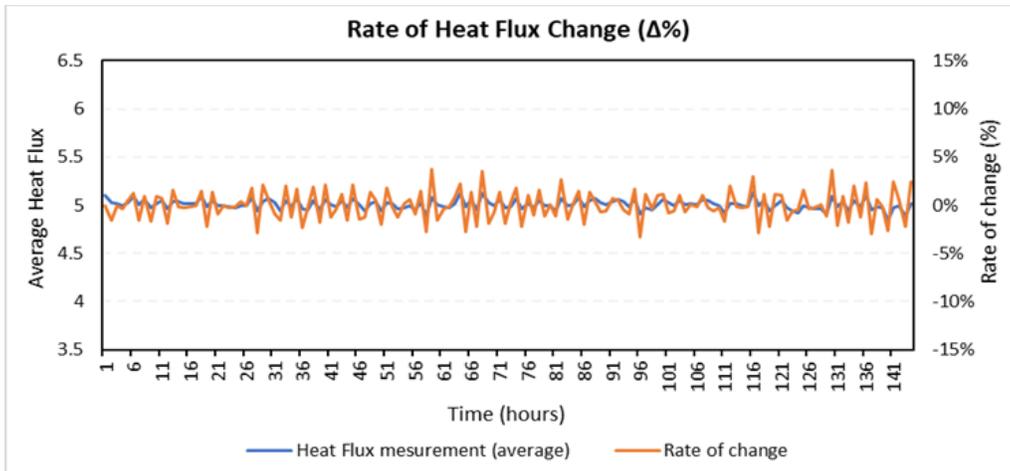
Figure 13. Rate of heat flux change (%) during the U-Value measurements

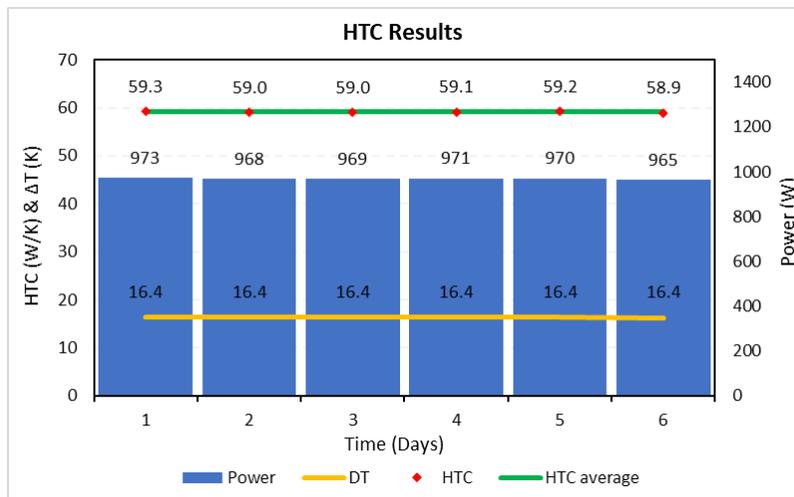
The Co-heating test results indicated that the HTC of the Vector V1 was **59.1 (±4.8) W/K**. Although this is lower than the design value of **67.2 W/K<sup>6</sup>**, it should be noted this value has used the default thermal bridging values from SAP. The thermographic survey suggests greater levels of bridging at junctions, which should have been accounted for in the design value. As such, a direct comparison should not be made. Figure 14 below are the measurements for the HTC.

Figure 14. Heat Transfer Coefficient (HTC) results.

Figure 14 shows that to maintain an indoor temperature of 21 °C at a chamber temperature of 5 °C, an average daily power input of ~970 W is needed, which reflects a stable HTC measurement. The HTC indicates that to maintain a 1 K temperature difference over the building envelope, 59.1 W of heating power is required.

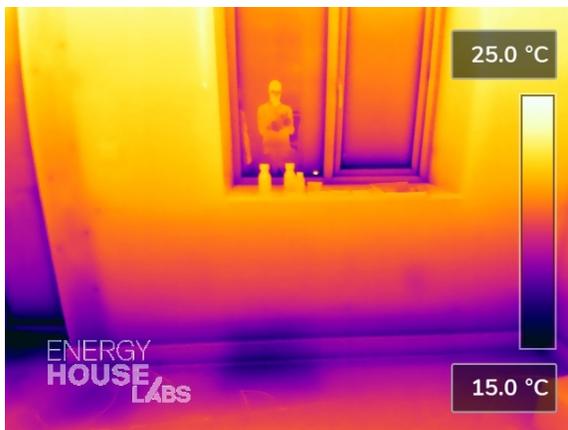
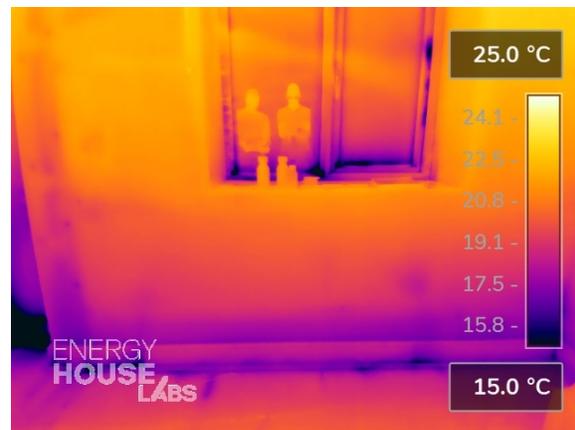
Figure 15. The Living Room floor under no artificially induced pressure differential

Figure 16. The Living Room floor under depressurisation test

The figures above compare the floor and window of the Living Room of Vector V1 without artificially induced pressure differential (Figure 15) and during the depressurization test of the blower door (Figure 16). In both figures cold areas can be seen around the floor and the edges of the window, indicating poor insulation distribution around these areas. During the depressurization test (Figure 16), areas of air movement are visible in both the window and floor

of the Living Room of Vector V1. This air movement can be seen across the entire floor area of Vector V1, indicating poor insulation or insulation deficiency in the floor area.

Figure 15 below shows the Living Room floor under no artificially induced pressure differential. Figure 16 below shows the Living Room floor under the depressurisation test.

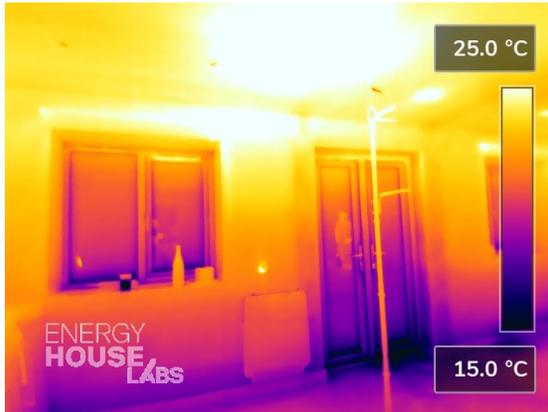
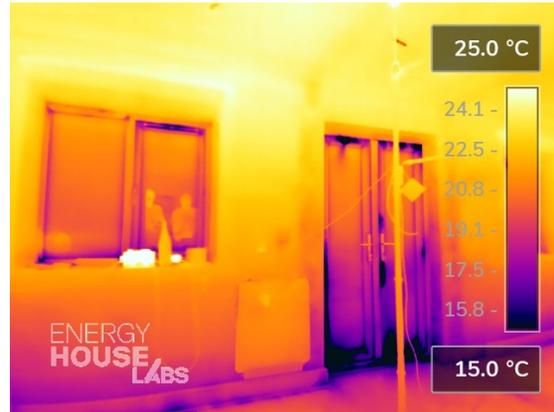
Figure 17. The french door under no artificially induced pressure differential

Figure 18. The french door under depressurisation test

Figure 17 and Figure 18 compare the french door of Vector V1 without artificially induced pressure differential and during the depressurization test of the blower door. Cold areas are visible around the floor and warmer areas are closer to the ceiling, with a temperature difference of 10 °C. When a pressure difference of -50 Pa was introduced, air movement patterns became visible around the floor, the french door frame, and the window of Vector V1, indicating areas of potential air leakage and insulation deficiencies.

Figure 17 and Figure 18 below show the french door before and during the pressurisation test of the blower door, respectively.

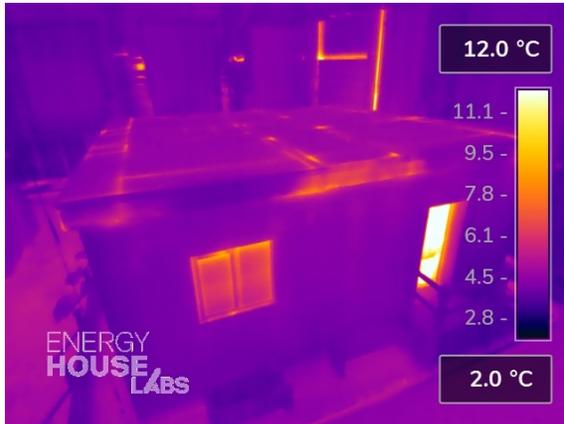
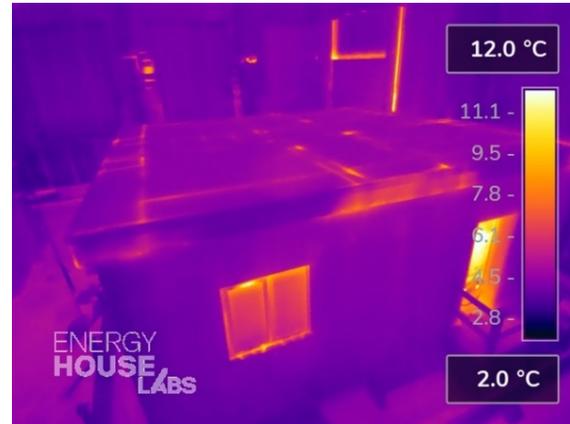
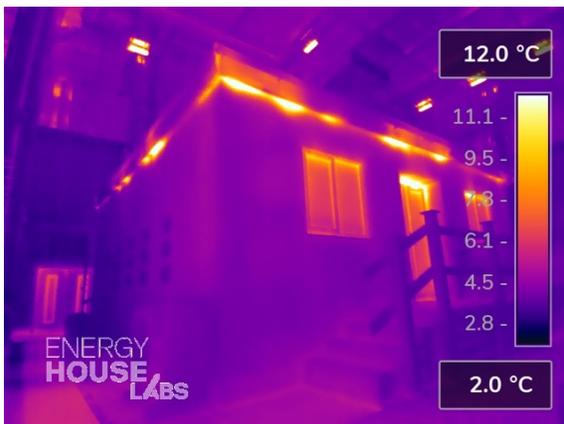
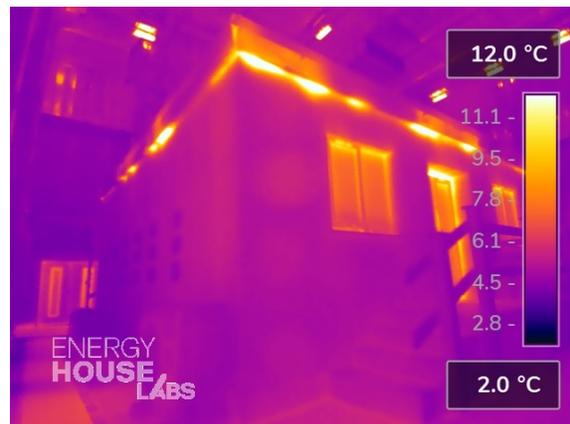
Figure 19. Exterior view of Vector V1 under no artificially induced pressure differential

Figure 20. Exterior view of Vector V1 during pressurisation test

Figure 21. Exterior view of Vector V1 roof under no artificially induced pressure differential

Figure 22. Exterior view of Vector V1 roof during pressurisation test

The figures above are thermal images showing an exterior view of the Vector V1 before and during the pressurisation test of the blower door. The temperature scale on the right indicates a range from 2.0 °C to 12.0 °C, with colour gradients representing different temperatures. Warmer areas (yellow to orange hues) around the windows, the studs, and the roof suggest potential points of heat loss, where warm air from inside the house is escaping. The significant temperature difference between these warmer areas and the cooler exterior surfaces highlights insulation weaknesses, thermal bridges, and air leakage points. This temperature variation indicates that the insulation quality and air sealing are inconsistent across the exterior of the house.

Figure 19 - Figure 22 show the exterior of Vector V1 before and during the pressurisation test, respectively.

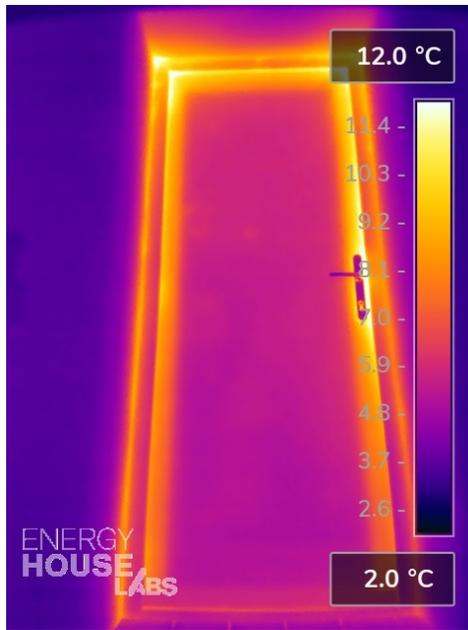
Figure 23. Exterior view of Vector V1 GRP composite door under no artificially induced pressure differential

The figures above show the main door of Vector V1 without artificially induced pressure differential. Greater levels of heat loss can be observed around the perimeter of the GRP composite door, this may be attributed to thermal bridging and air leakage. However, air leakage cannot be confirmed without the induced pressure differential.

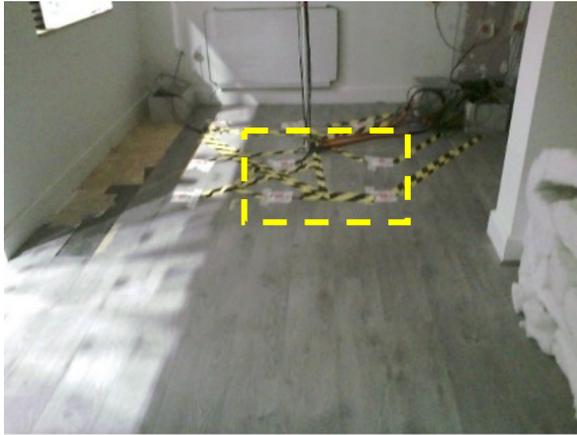
Figure 24. Phase 2 heat flux measurements - floor

This section shows the locations of the U-value measurements, highlighting the differences between the initial (Phase 1) and upgraded materials and designs (Phase 2).

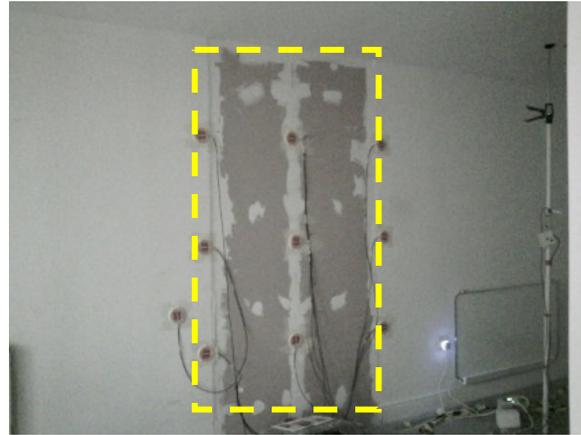
Figure 25. Phase 2 heat flux measurements – wall

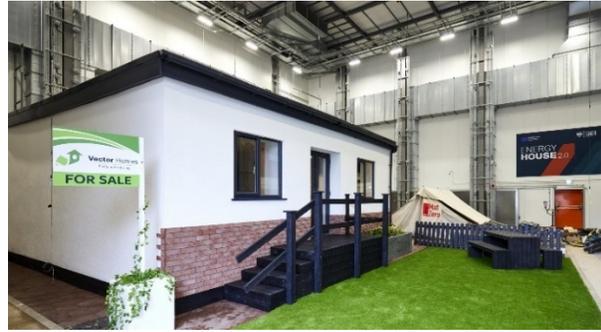
Figure 27. Inside view of Chamber 2 of EH 2.0

Temperature and relative humidity within the chambers can be maintained at a constant steady state or varied according to seasonal and daily patterns. Figure 26 below show an external view the EH 2.0 facility. Figure 27 shows an inside view of Chamber 2 with Vector V1.

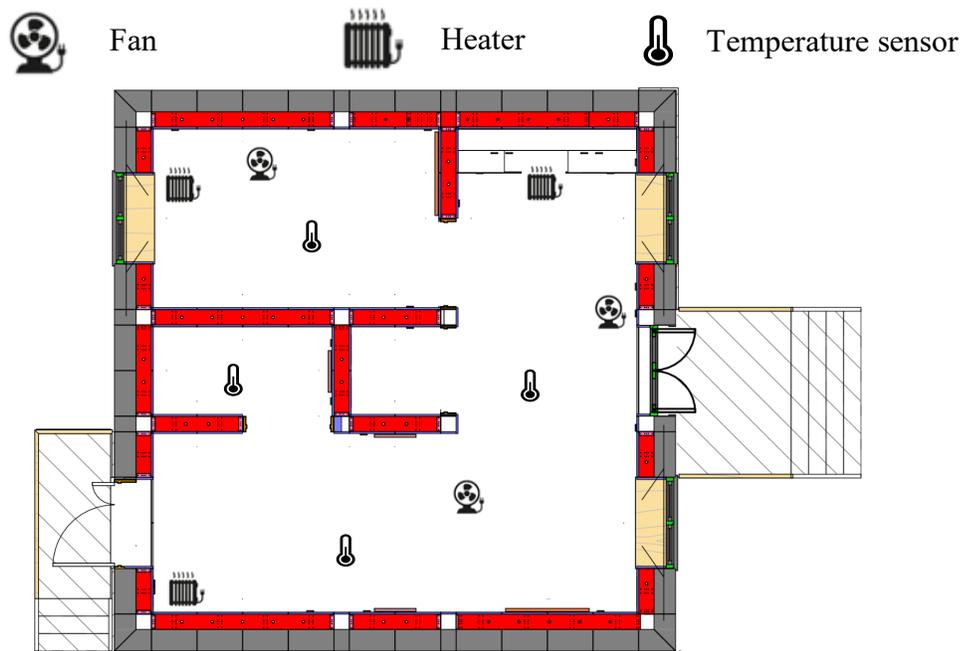
To obtain the HTC, a Co-heating test was carried out. During the test, to increase the homogeneity of the air temperature inside the house, air circulation fans were used, which remained in the same location and at the minimum speed setting during the test as in the Figure 28. This setting allows for the air to be mixed but without significantly altering any surface resistance to the external elements. The fans and heaters were positioned in such a way that they do not directly affect the temperature sensors.

Figure 28. Heater and fan locations during the Co-heating test
