**Archaeological
Evaluation
Interim Report:**

Daisy Mill,
Longsight,
Manchester

Client: Laing
O'Rourke

Report No:
22/2015

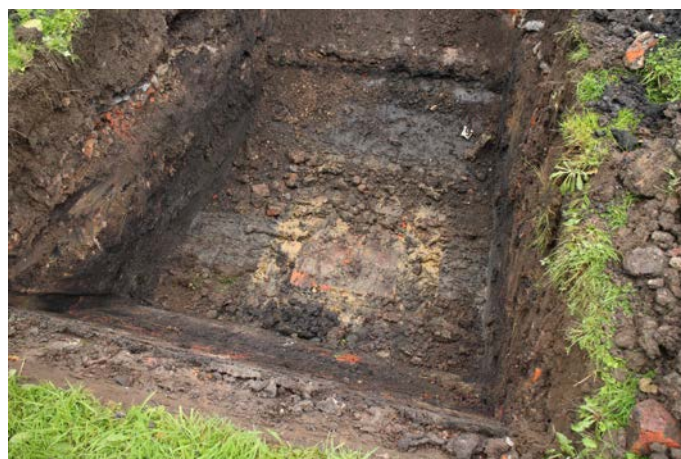
At the southeast end of trench 1 was a 0.6m square pad (**103**) of machine made brick with hard grey Portland cement. This lay within a roughly rectangular 1.6m by 1.2m feature cut into the 1960's demolition rubble. This feature was filled with a mixed yellow clay (**104**). Due to the depth excavation at this point and the unstable nature of the sides the trench was not continued any deeper.

Plate 2: Brick pad 103, looking northwest

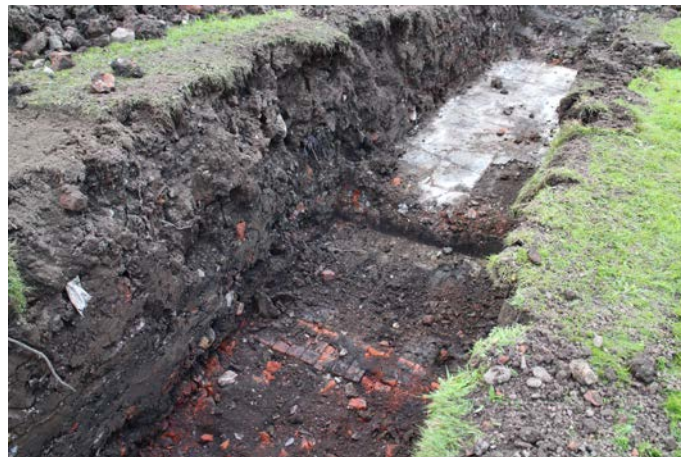
A late concrete (105) floor surface lay 1.8m to the northwest of the brick pad, at 48.73m AoD. This spanned the width of the trench and was 3m in length. Beyond this was loose demolition rubble (102) which was not excavated any further into due to the depth and unstable nature of the trench. A brick wall (106) was observed running through this material northeast/southwest across the trench 1.1m to the northwest of the concrete floor. The wall was two stretcher courses of machine made brick with hard grey Portland cement.

Plate 3: Brick wall 106 and concrete surface 105, looking east

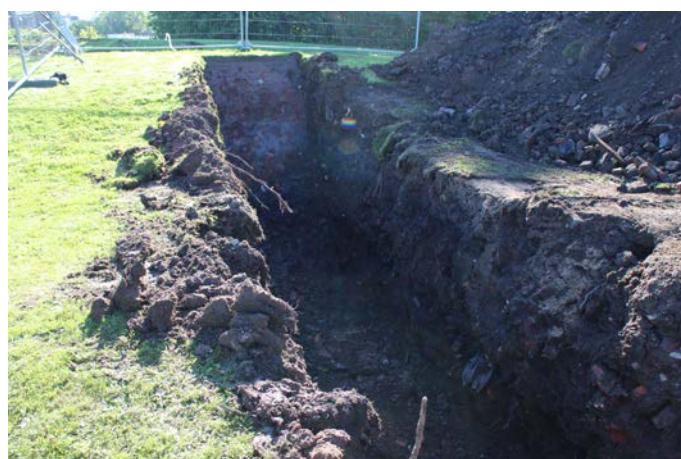
The trench was overlain by a 200mm to 300mm thick layer of turf and topsoil (200) which lay above a 2.5m to 1.6m deep layer of compact clay and rubble landscaping material (201). Below this was a 0.5m to 1m thick deposit of loose demolition rubble (202) containing brick, stone, cinders, clay, slate and plaster. Across southeast 13.9m of the trench it wasn't possible to excavate below the demolition layer due to the depth and unstable nature of the excavation.

Plate 4: Depth of excavation in trench 2, looking southeast

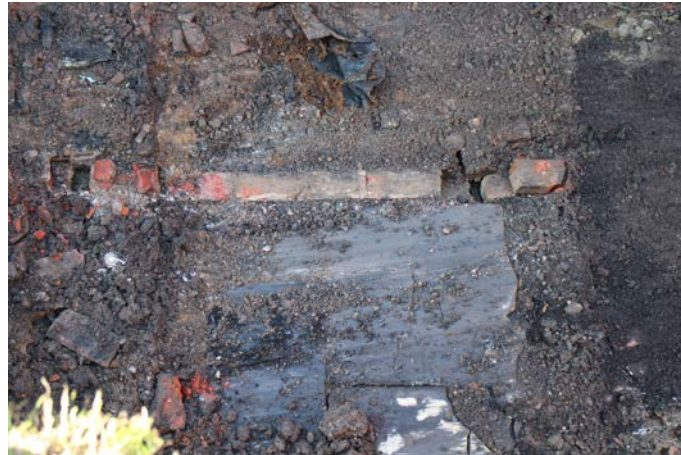
Within the northwest end of the trench a handmade brick wall (**203**) ran northwest for 4.3m and then turned southwest into the trench edge. This was built from handmade bricks in a header bond with white lime mortar. To the northeast and northwest of the wall was a stone flag floor surface (**204**) at 47.28m AoD. It is likely that the wall and flag surface extended beneath the demolition to the southeast but could not be reached due to the depth.

Plate 5: Wall 203 and flag floor 204, looking southwest

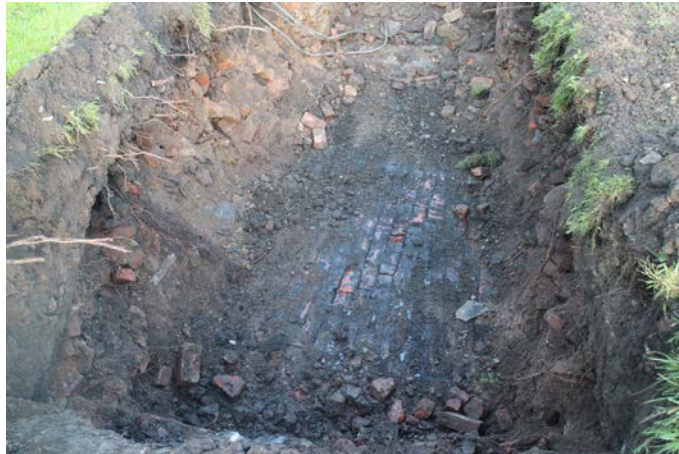
Below the turf at the southeast end of the trench was a stone filled linear cut with a blue plastic duct (**303**) running east/west across the trench. The presence of this meant that the southeast 3.4m could not be excavated further. Beyond this, at a depth of 1.9m, was a floor surface (**311**) of handmade brick overlain by loose demolition rubble (**302**).

Plate 6: Brick floor 311, looking northwest

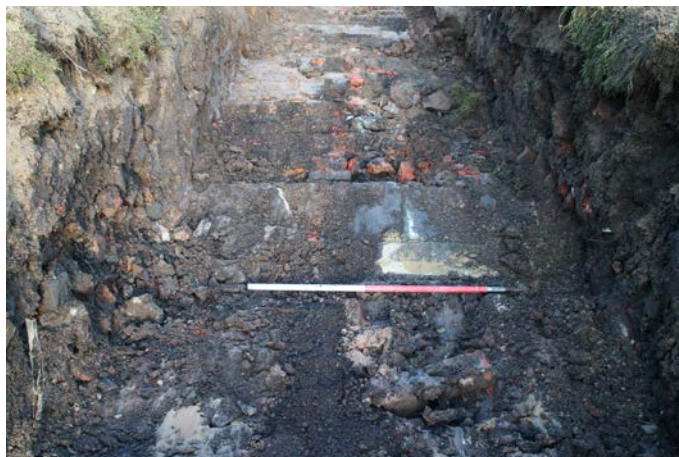
Running northwest from wall (**306**) was a second brick wall (**307**). This also comprised a single stretcher course of handmade brick with white lime mortar and ran for 5.5m where terminating. Running northeast into the trench edge from a point 3m along wall (**307**) was a 0.75m wide stretch of stone flagging (**308**).

Plate 7: Wall 307 and floor 308, looking northwest

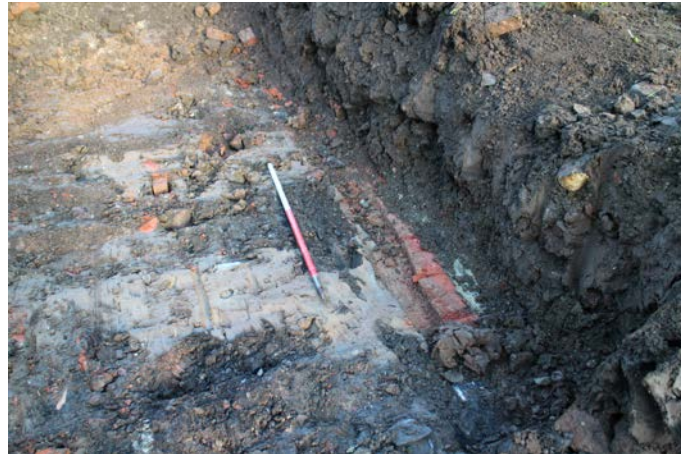
A 3.3m stretch of brick wall (**309**) lay 0.8m to the northwest of wall (**307**), at the northeast edge of the trench. This comprised two stretcher courses of handmade brick with white lime mortar and terminated at both ends. Walls (**306**), (**307**), (**309**) and flags (**308**) were all built onto firm natural boulder clay (**310**) at 48.46m AoD.

Plate 8: Wall 309, looking north

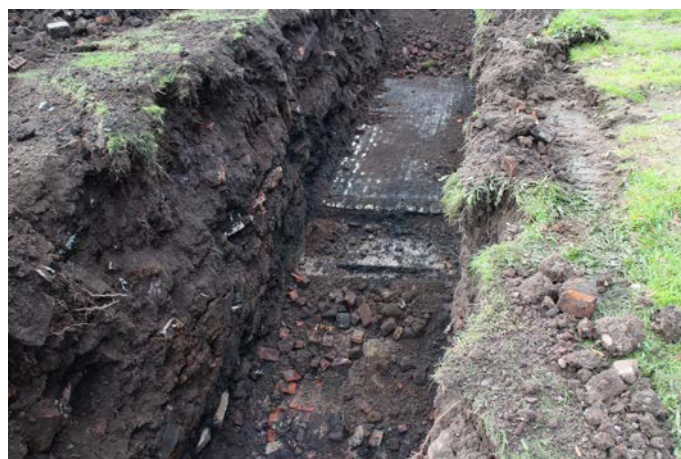
At the southwest end of the trench was a surface of sandstone sets (**404**) at 47.89m AoD. This began 5.3m from the southwest end of the trench and ran into the trench edges.

Plate 9: Sandstone set surface 404, looking southwest

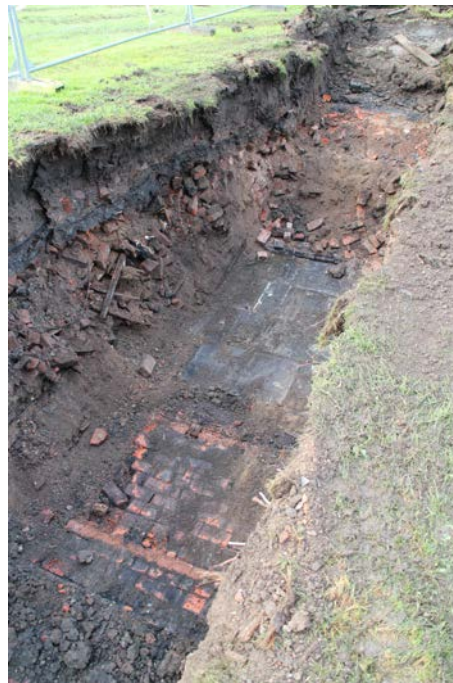
The northeast 5m of the trench were only excavated to 250mm depth due to the presence of fragments of corrugated chrysotile asbestos roof sheeting. Beyond this a brick wall (503) ran northwest/southeast across the trench. It comprised a single header course of handmade brick with white lime mortar. Beyond this wall was a 4.2m stretch of stone flag flooring (504) at 47.09m AoD. This ended at a brick wall (505) with an identical wall (507) running parallel 1m to the southwest and another identical wall (509) running parallel 1m southwest of that. All three walls comprised a single stretcher course of handmade brick with white lime mortar and were felt on excavation to be narrow passageways within the cellars of two terraced houses with the central wall (507) being the dividing wall between the buildings. Between the walls were handmade brick floor surfaces (508).

Plate 10: Walls 505, 507 and 509, brick floor 508 and flag floor 510, looking south

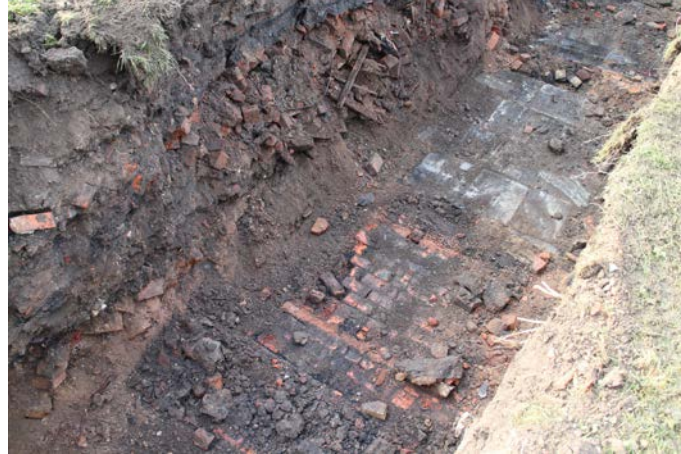
To the southwest of the passageways was a 3.5m stretch of stone flag flooring (510) which ended at a northwest/southeast brick wall (511) with a single stretcher course of hand bricks with white lime mortar. A second identical wall (512) ran parallel 0.8m to the north of this with the gap between the two being filled by loose demolition rubble (502). A 2.3m

long stretch of stone flag flooring (**513**) with 2.9m long stretch of handmade brick flooring (**514**) beyond it ending at a single stretcher course wide handmade brick wall (**515**) with white lime mortar. From this wall ran a 5.1m stretch of stone flag floor surface (**516**) which terminated at a brick wall (**517**), identical to wall (**515**), at the southwest end of the trench.

Plate 11: Walls 511, 512 and 515 brick floor 514 and flag floors 513 and 516, looking north

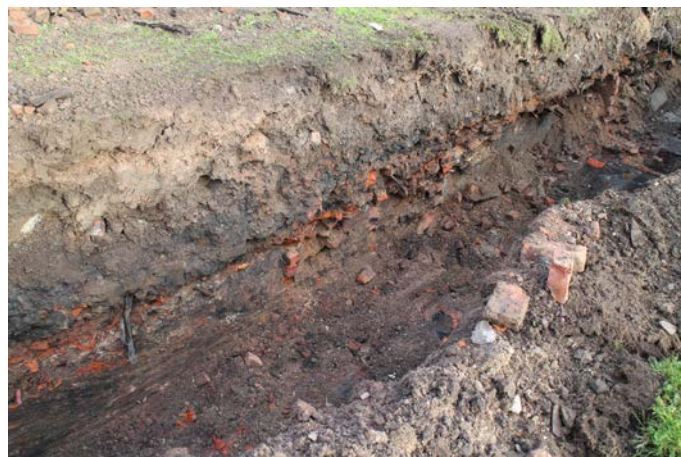
After the full excavation of the trench was completed part of the southwest end of the northwest trench edge collapsed revealing an in situ brick wall (**518**) set back 300mm from the trench edge. The top of this wall was 1.1m below the ground surface and it comprised handmade bricks in a stretcher bond with white lime mortar. Visible within the wall and corresponding with the break between flag surface (**513**) and brick surface (**514**) was a 1.5m wide doorway blocked with brick (**519**).

Plate 12: Wall 518 in trench section, with blocked doorway 519, looking north

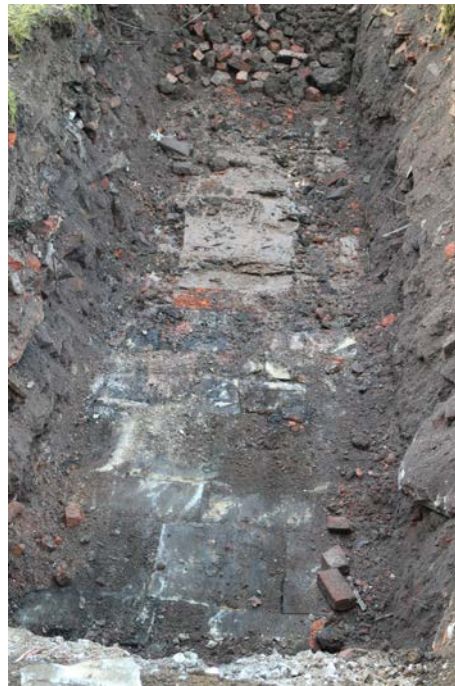
At the northeast end of the trench, at 46.48m AoD, was a stone flagged floor surface (**603**) which terminated 3.2m from the northeast end of the trench. Beyond this was a stretch of natural mid brown firm boulder clay (**604**). At 11m from the northeast end of the trench the natural had been cut into and filled with a compact clay and rubble material (**605**) which ran for 3m before disappearing beneath a 4m wide floor surface (**606**) of handmade brick at 47.00m AoD.

Plate 13: Flag floor 603 with brick floor 606 visible in background, looking southwest

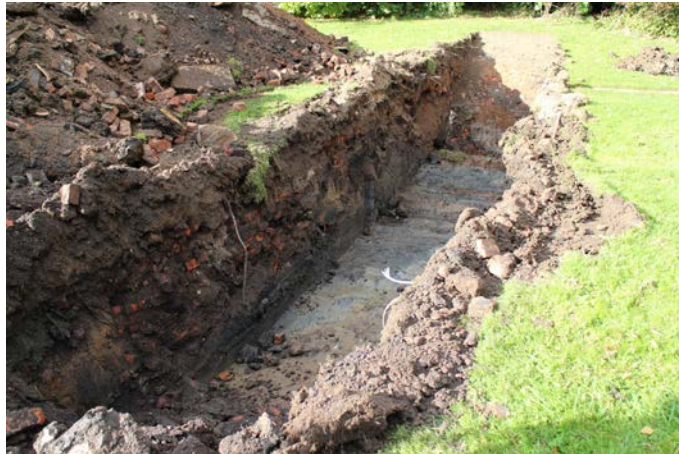
The trench was overlain by a 200mm to 300mm thick layer of turf and topsoil (**700**) which lay above a 400mm thick deposit of compact clay and rubble (**701**) above an 800mm to 900mm layer of loose clay and demolition rubble (**702**) containing brick, stone, cinders, clay, slate, wooden planking and plaster. Below this clay natural grey brown firm boulder clay (**703**) was visible across the whole trench rising from 46.58m AoD at the northwest to 47.13m AoD at the southeast. No features or structures were observed within the clay.

Plate 14: Trench 7, depth of natural clay, looking west

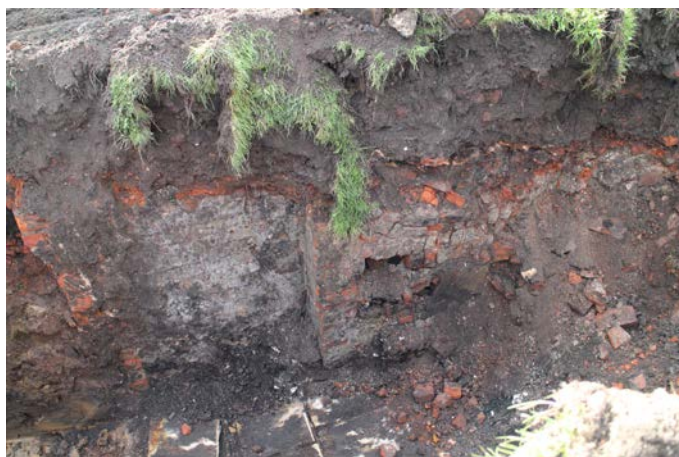
At a depth of c. 1m a brick wall (**803**) was observed within the southwest trench edge, running slightly offset from it for 4.3m and then turning northeast. This was two stretcher courses wide and of handmade brick with white lime mortar. The wall was also covered in a light blue/white plaster suggesting that the internal side of the cellar had been uncovered. Within the wall was the remains of a cellar hearth (**804**) set 400mm out for the wall and running back into the trench end. It is not at present known whether range had been built into the hearth as the depth of the trench and unstable nature of its sides precluded further investigation.

Plate 15: Wall 803 and hearth 804, looking southwest

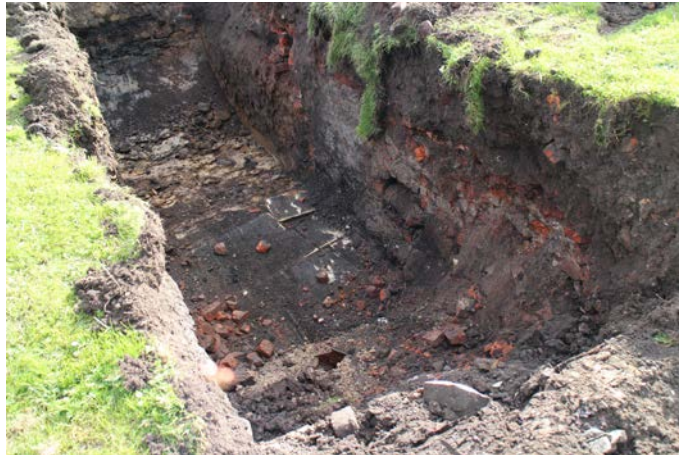
Within the interior of the walls, at 47.04m AoD, was a stone flagged floor surface (**805**). To the southeast of the cellar, presumably originally beneath the former road surface, was

natural mid brown firm boulder clay (806). No evidence of the road was observed during the excavation of the trench.

Plate 16: Internal flagged cellar floor 805, natural clay 806 in background, looking southeast

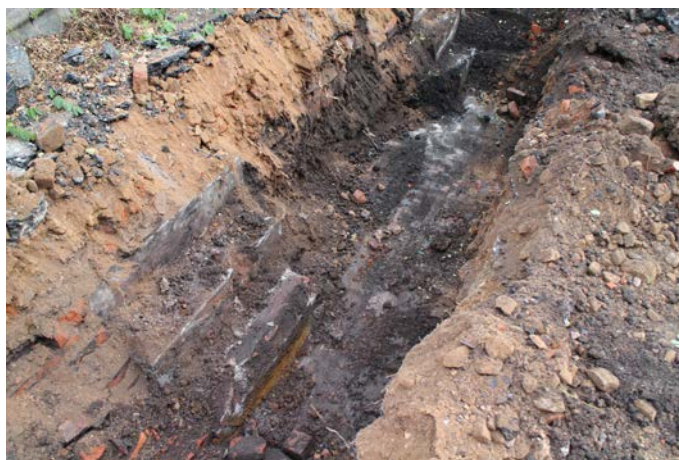
At the northwest end of the trench was a concrete column base (903). Only the southern corner was visible within the trench so the full size is not known but the base comprised three steps with a total height of 0.9m. A second column base (904) lay 3.2m to the southwest of this and was 1.2m in width. Base (903) sat upon a concrete floor surface (902) which extended 1.2m from the northeast trench edge, ending at a machine made brick floor surface (905) on which column base (904) sat.

Plate 17: Concrete bases 903 and 904, concrete floor 902 and brick floor 905, looking north

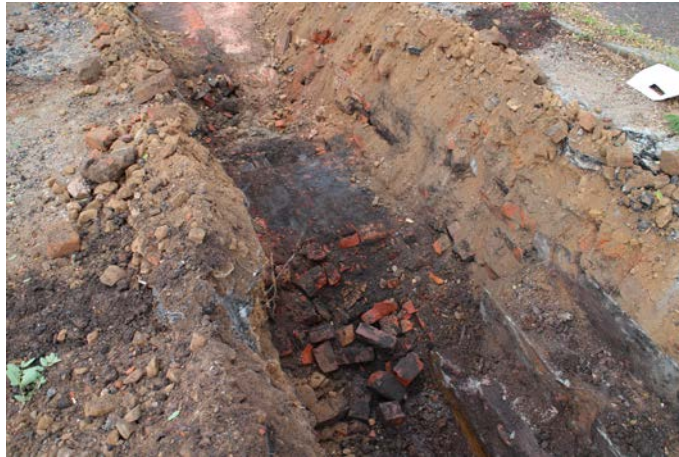
To the immediate southwest of brick floor (904) was a very substantial 2.1m wide brick plinth (906) raised 0.7m higher than the brick floor and having a flat upper surface. It was

built from 20th century brick with hard black cement. Between this structure and the brick and concrete structure to the southwest was a 0.9m gap filled with clay infill material (907).

Plate 18: Brick structure 906, looking southwest

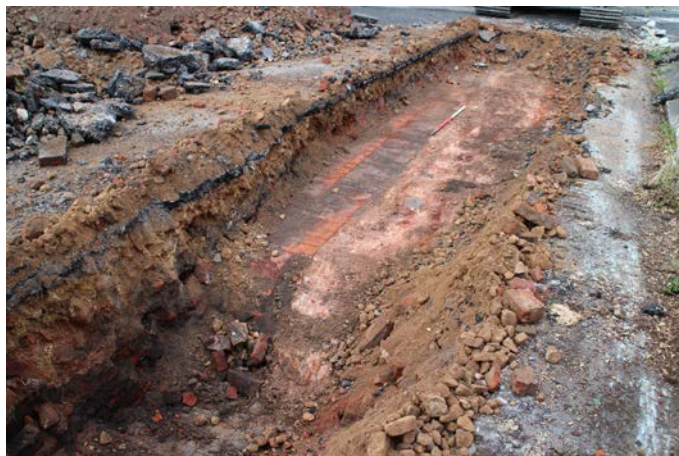
The southwest 8.1m of the trench comprised a substantial machine made brick retaining wall (908) running along the southeast edge of the trench and measuring over 0.8m in width. Against the retaining wall was an expanse of concrete (909) running the length of the wall. This may have contained a service.

Plate 19: Brick retaining wall 908 and concrete structure 909, looking southwest

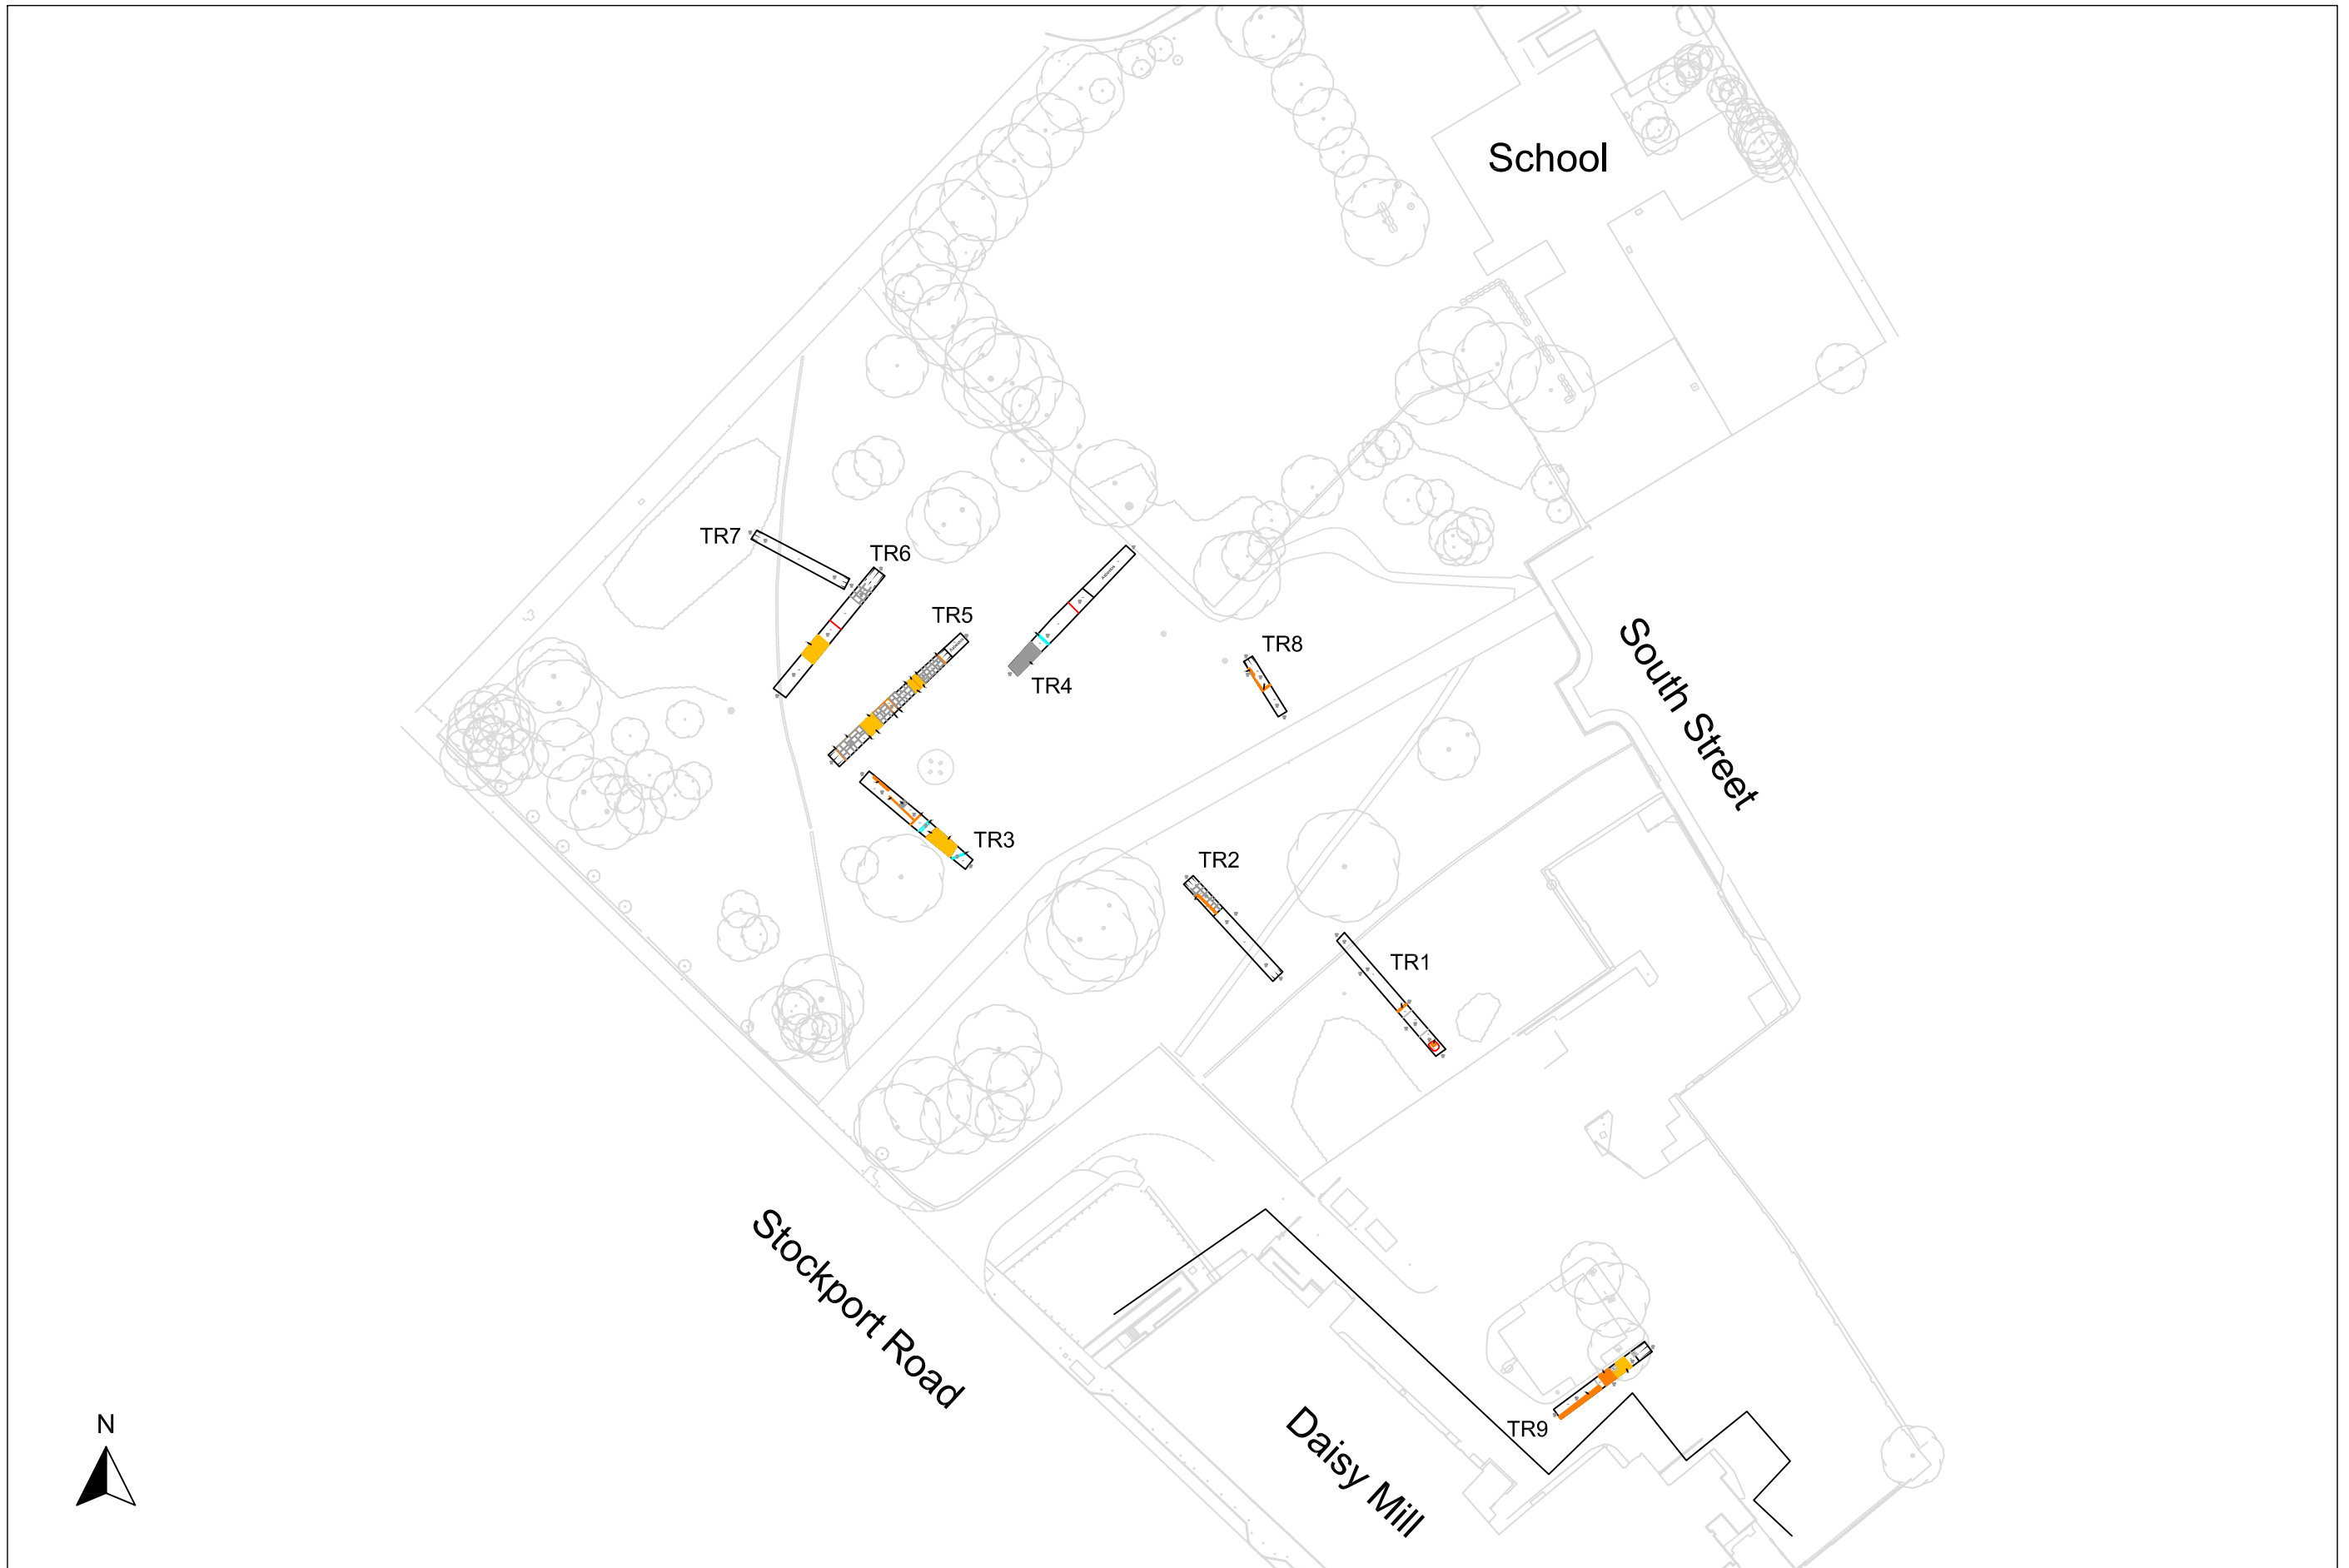
Fig 2: Trench location plan

Before excavation, the client provided Salford Archaeology with service plans for the area and all trenches and surrounding areas were scanned with an appropriate instrument to ensure that no live cables would be disturbed during the programme of works. The trenches were excavated using a tracked mechanical excavator with a 1.80m wide toothless ditching bucket down to archaeological features or natural geology. On occasions, a 0.60m wide bucket was used to excavate out narrower areas. The machine excavation was supervised by a professional archaeologist at all times. The locations of the trenches are shown on the trench location plan (*Fig 2*).

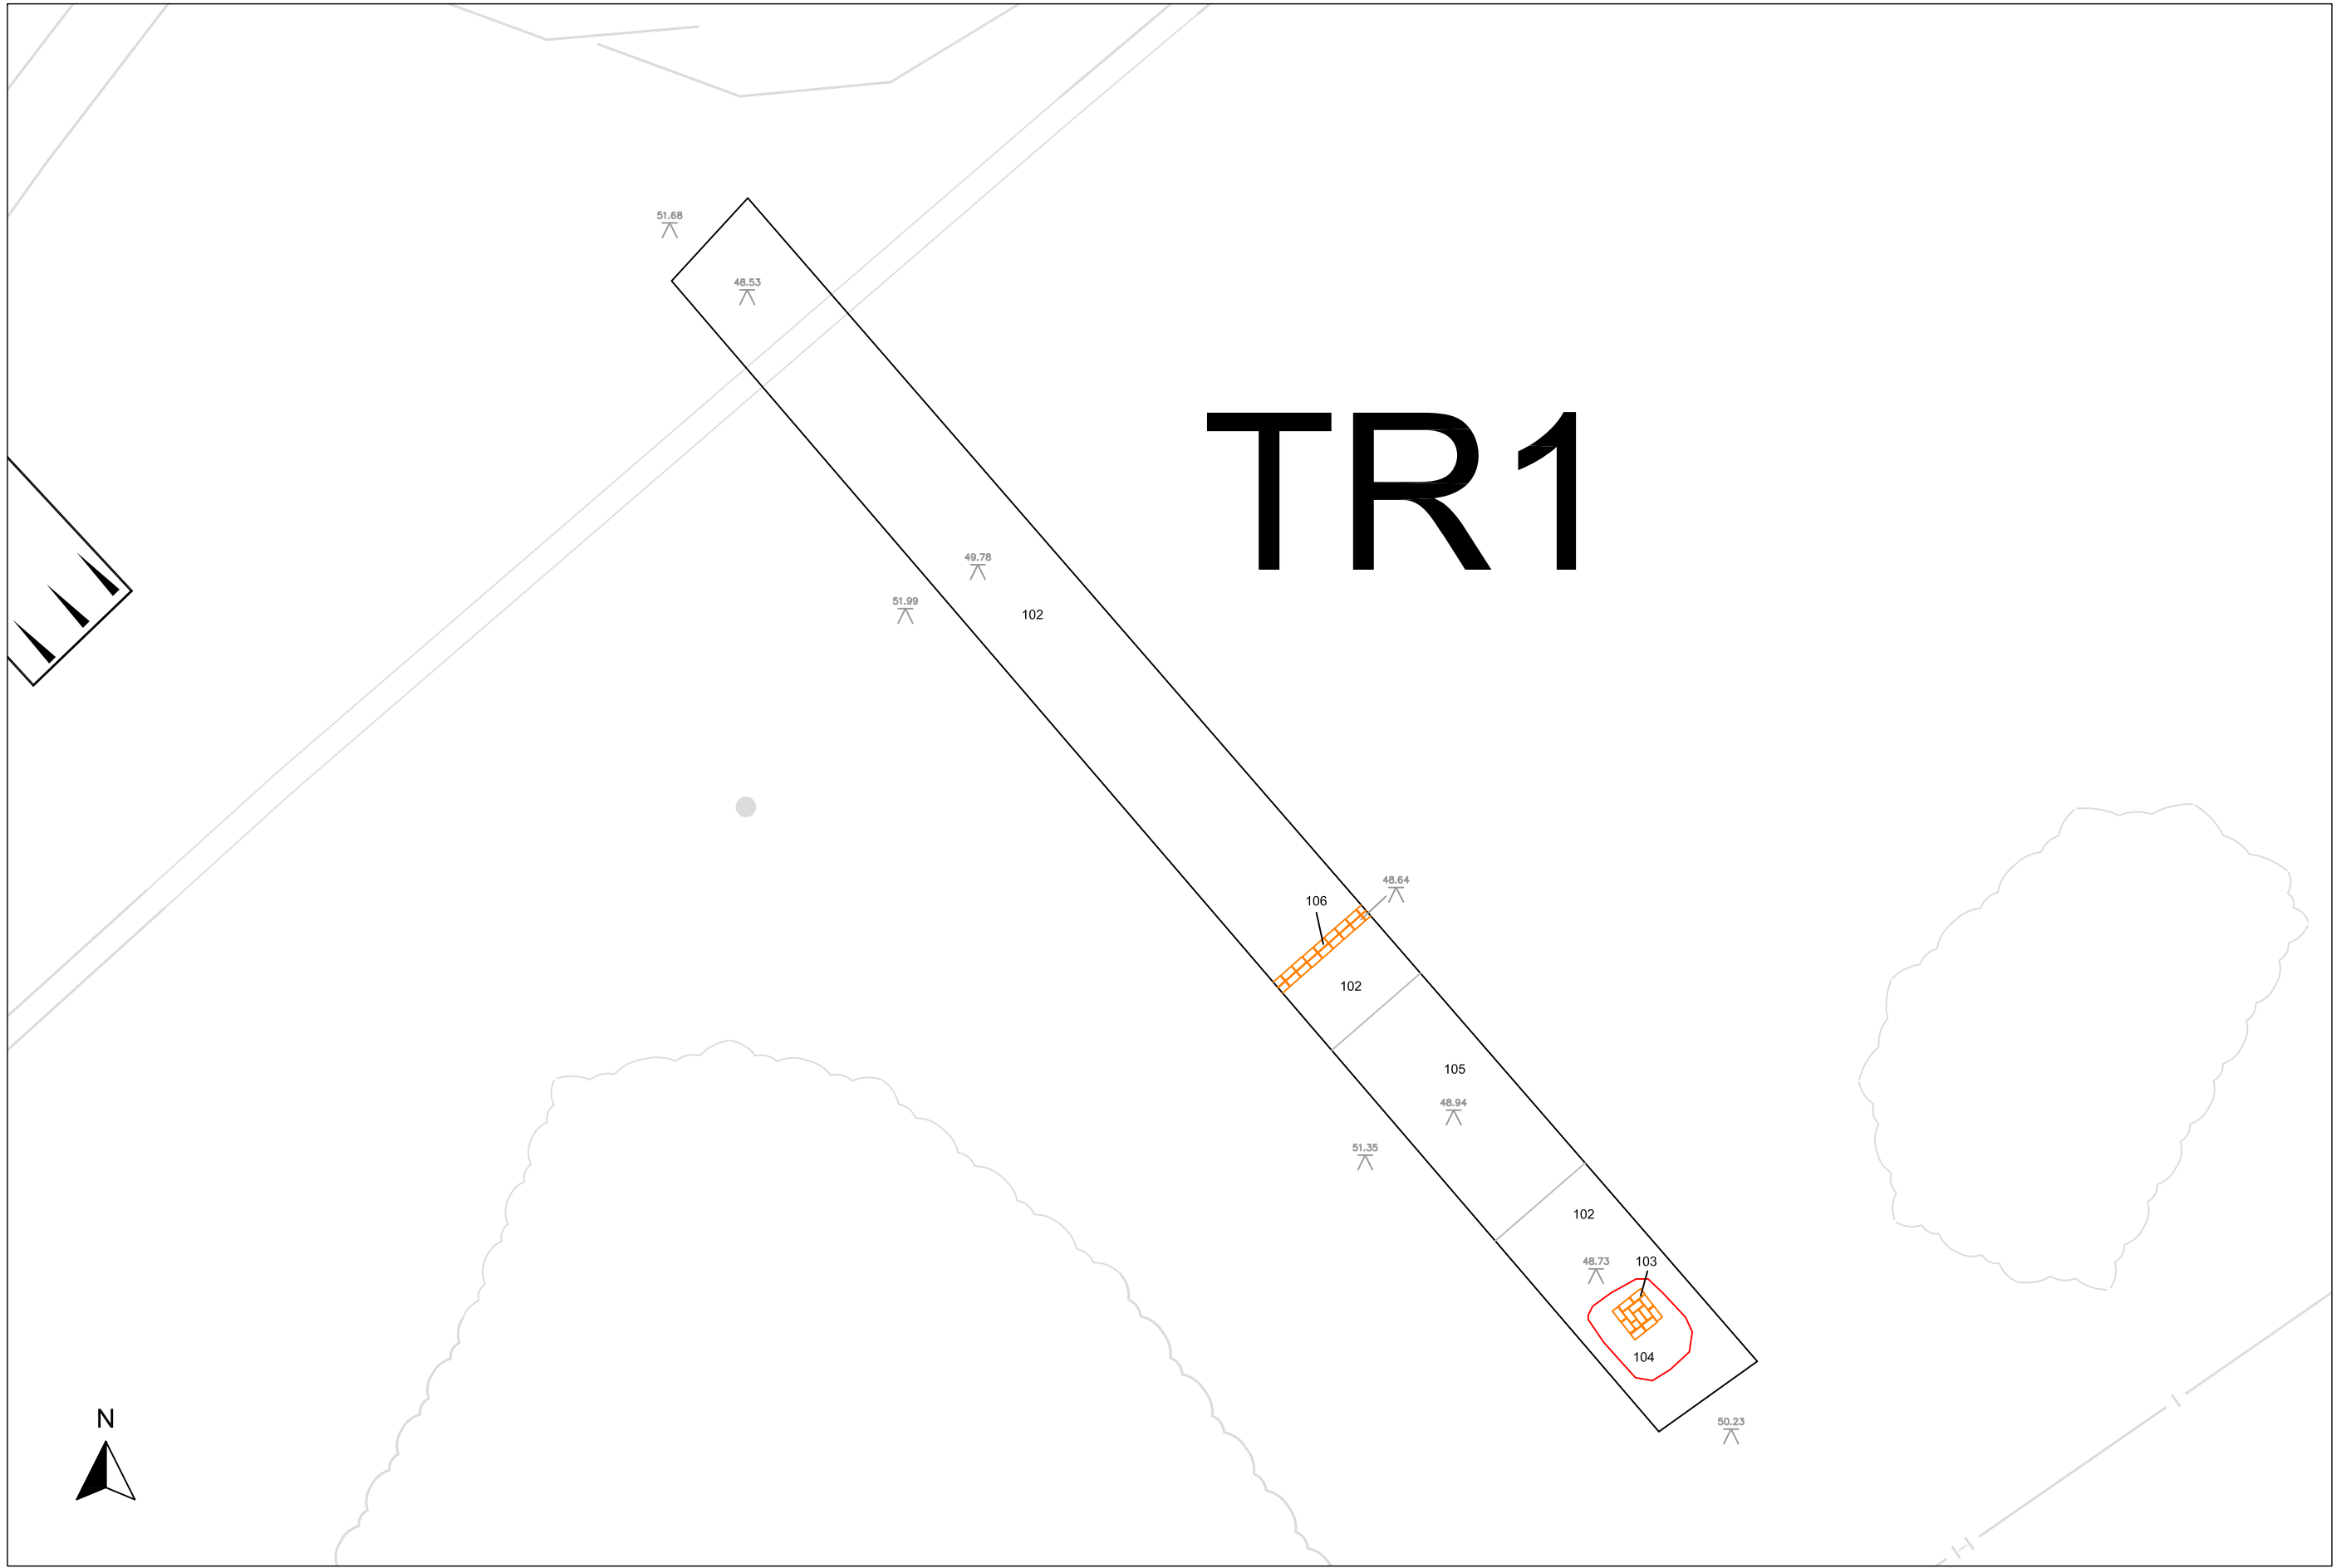
Fig 3: Trench 1 plan

This trench was located in the southeast part of the park area, beginning close to the fence separating the park from the rear yard of the mill, and running northwest. It measured 25m in length and 2m in width. It was excavated to a maximum depth 2.8m (*Fig 3*).

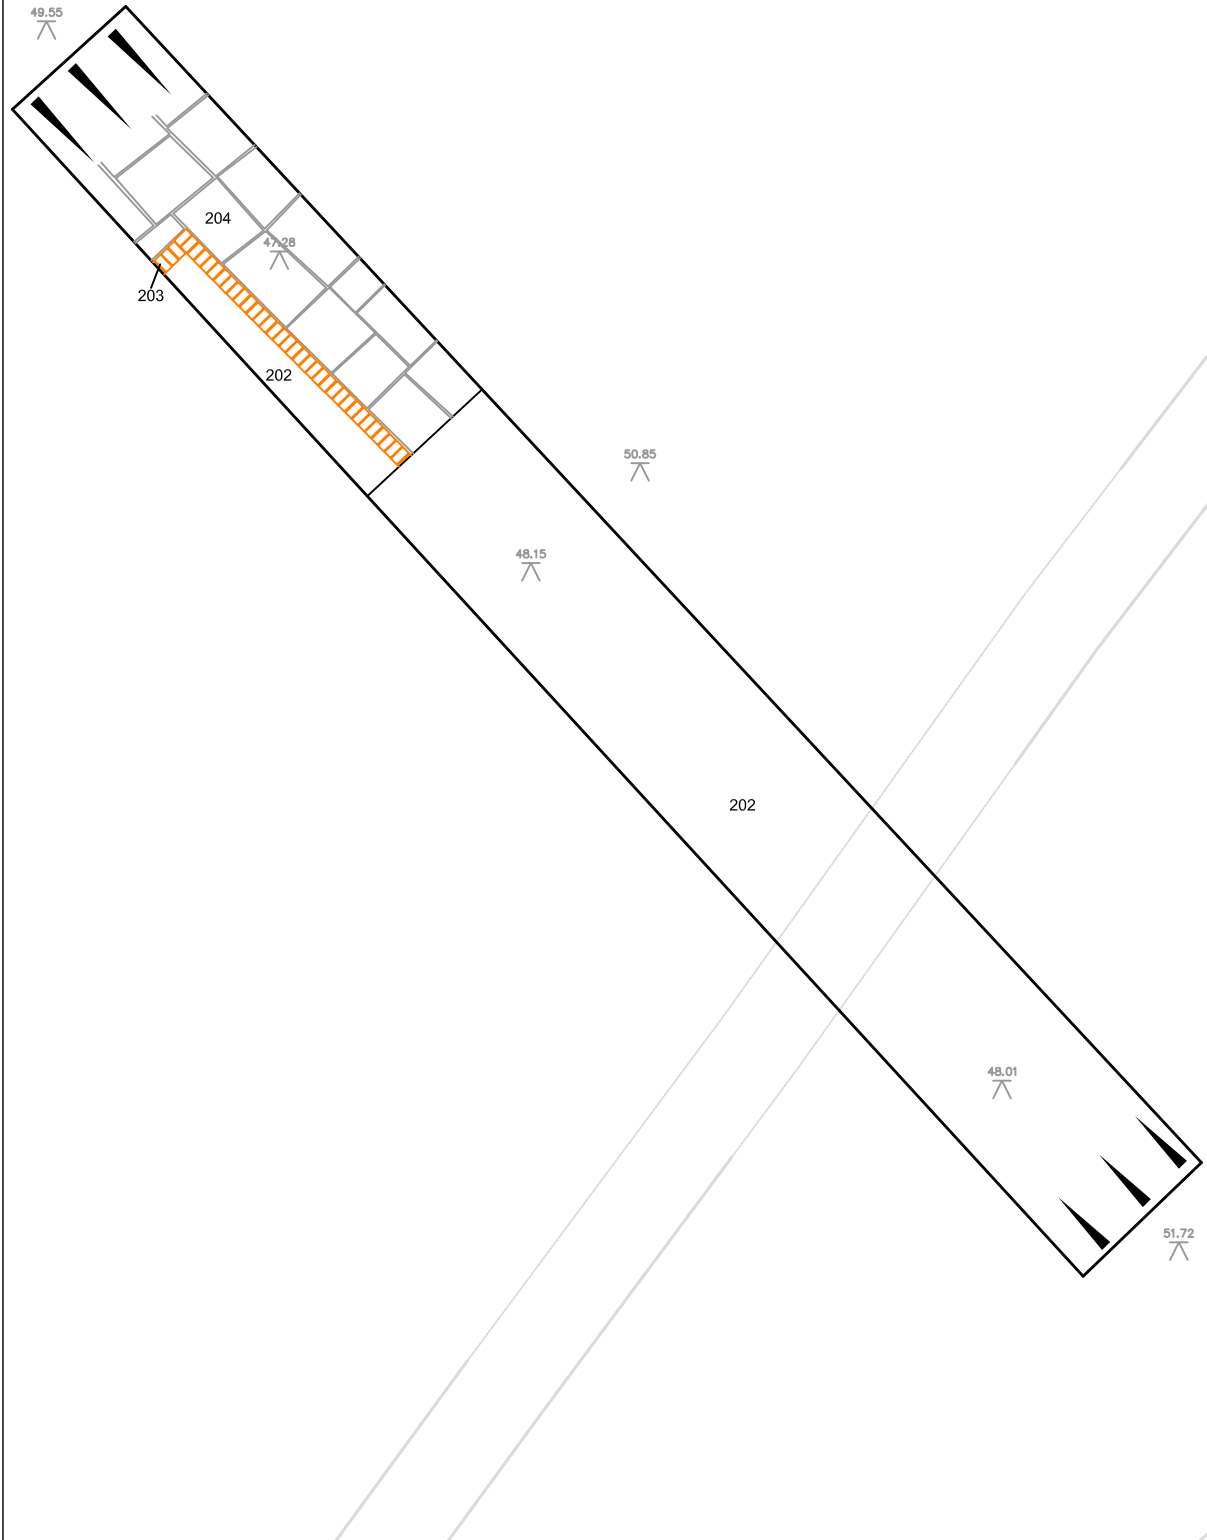
Fig 4: Trench 2 plan

This trench was located within the southeastern side of the park, at the southeast of the paved path and to the west of trench 1. It ran southeast/northwest, measured 21m by 2m and was excavated to a maximum depth of 3.7m. The trench was foreshortened at its northwest end due to the presence of a high pressure water main (*Fig 4*).

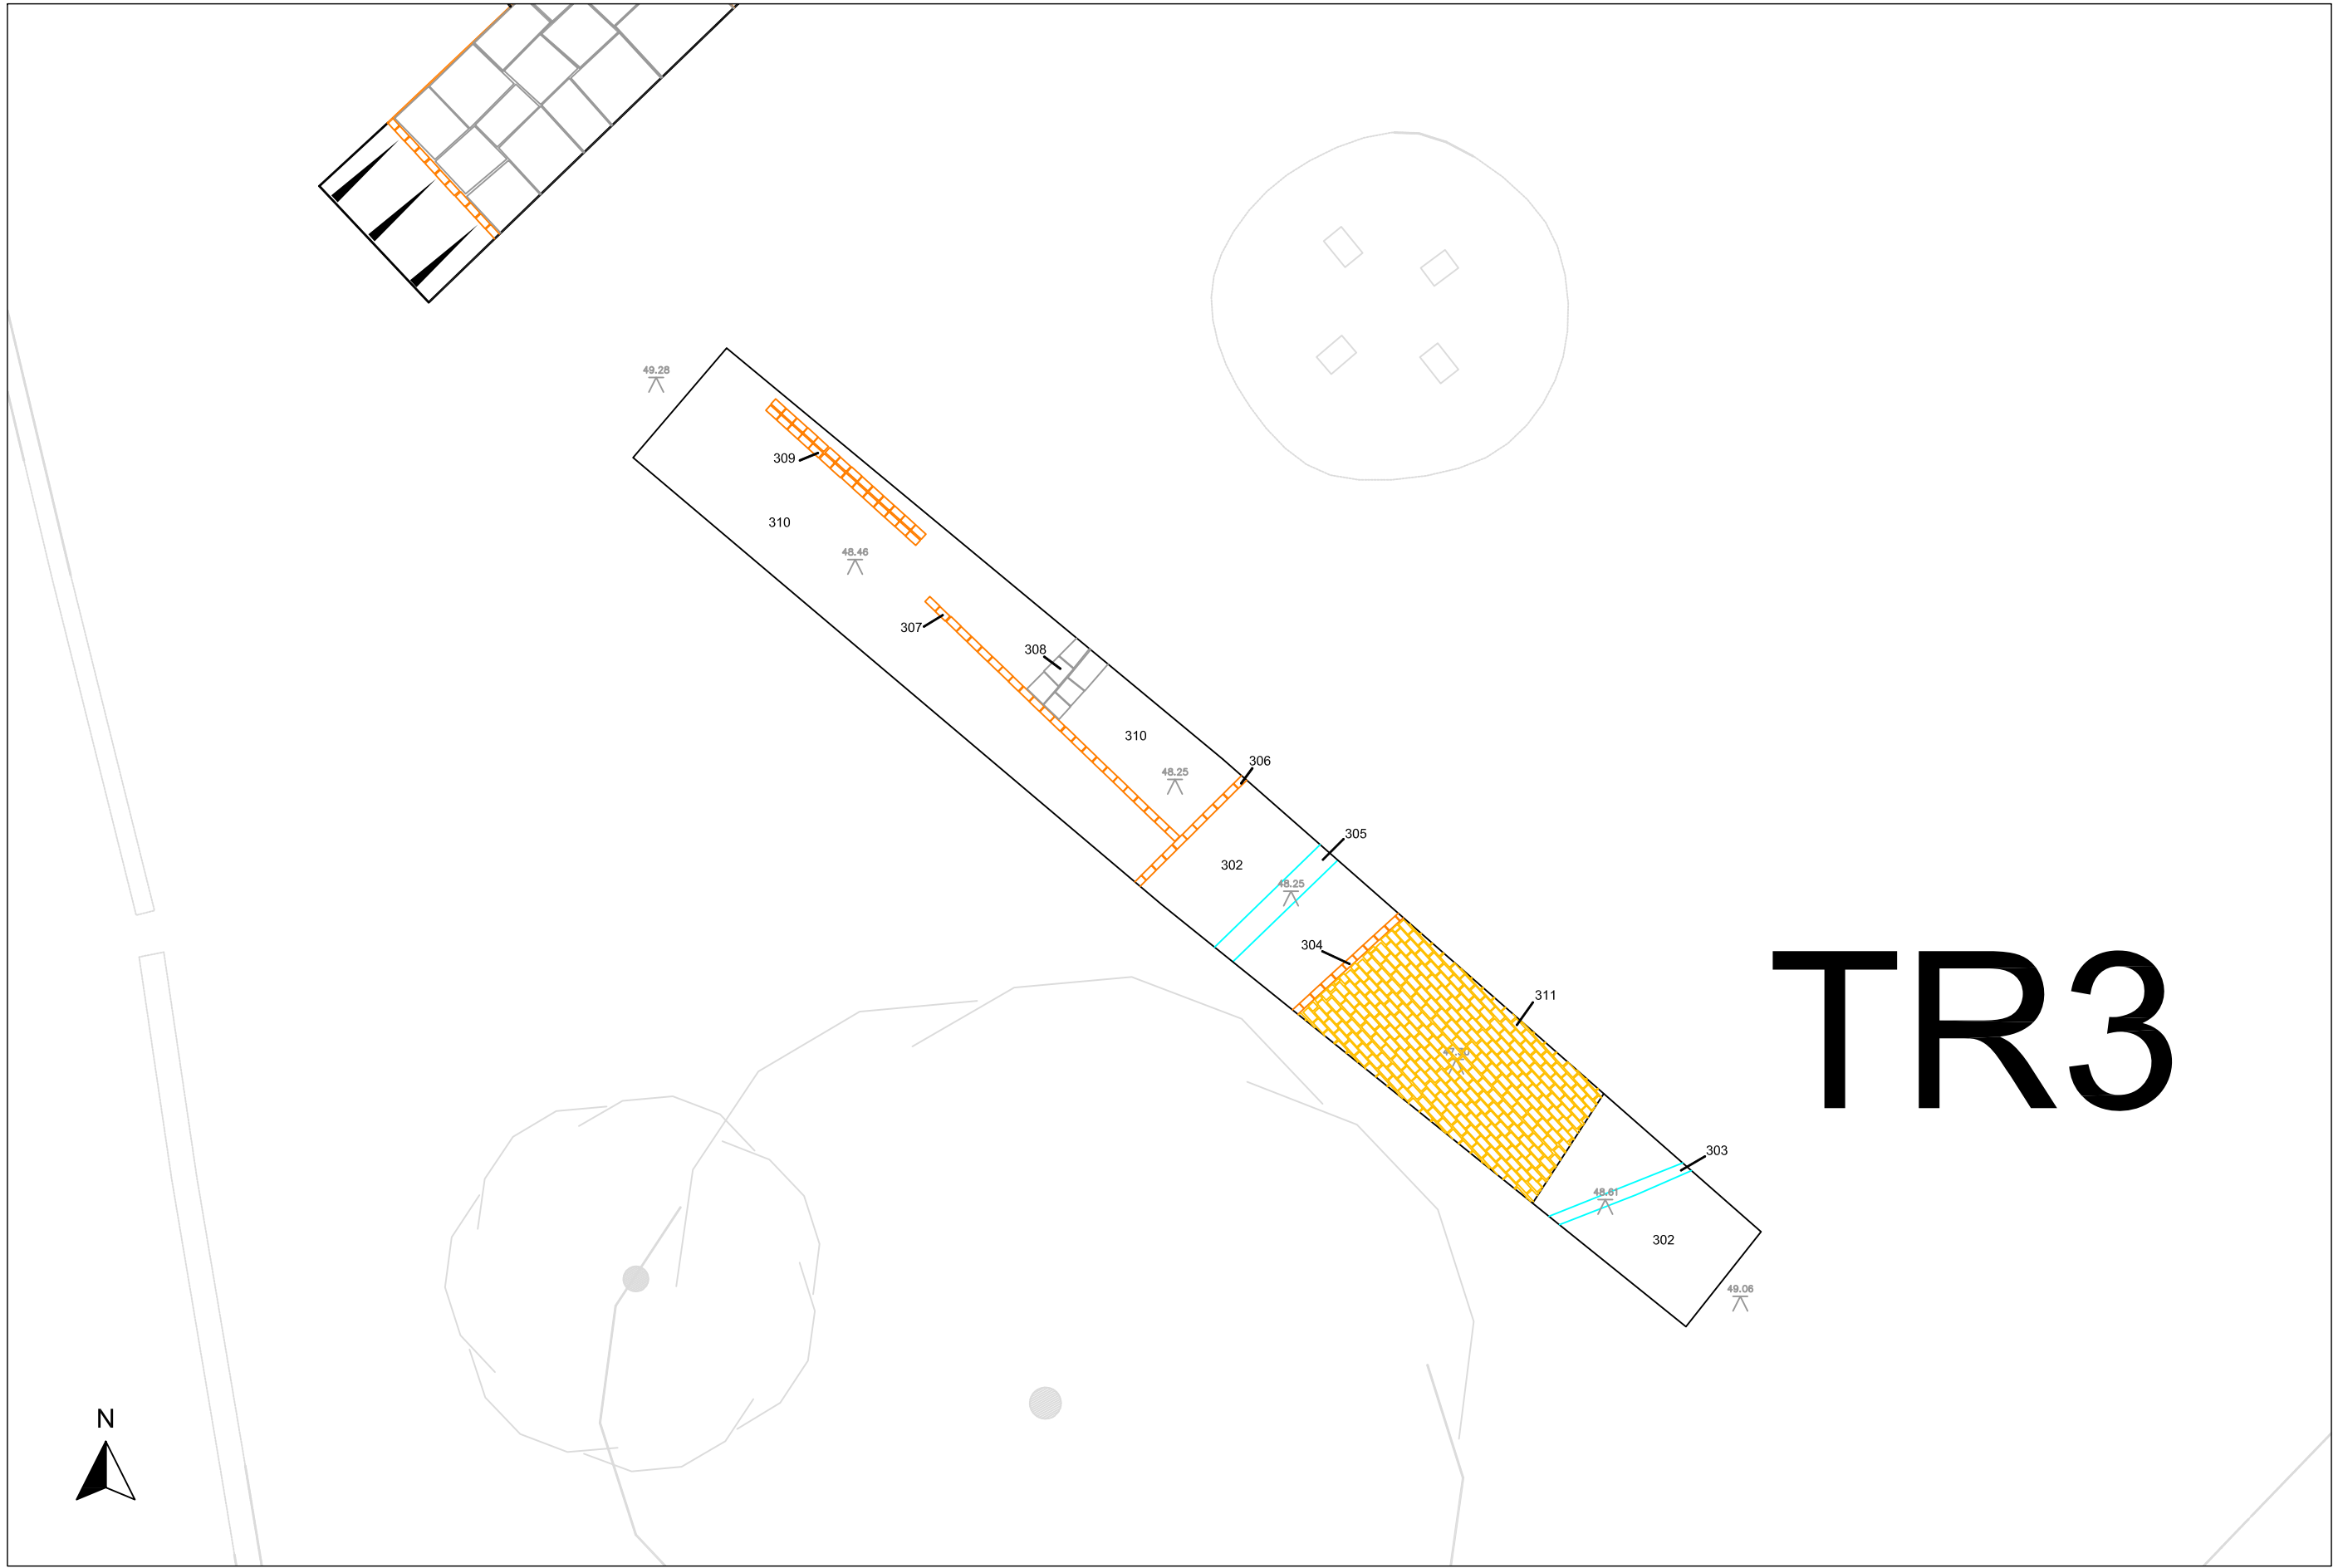
Fig 5: Trench 3 plan

This trench was located within the park, to the northwest of the paved path and to the southwest of the wooden sculpture. It ran southeast/northwest, measured 22m by 2m and was excavated to a maximum depth of 1.7m. The trench was foreshortened at its southeast end due to the presence of a series of live electricity cables (*Fig 5*).
