**Archaeological
Evaluation
Interim Report:**

Daisy Mill,
Longsight,
Manchester

Client: Laing
O'Rourke

Report No:
22/2015

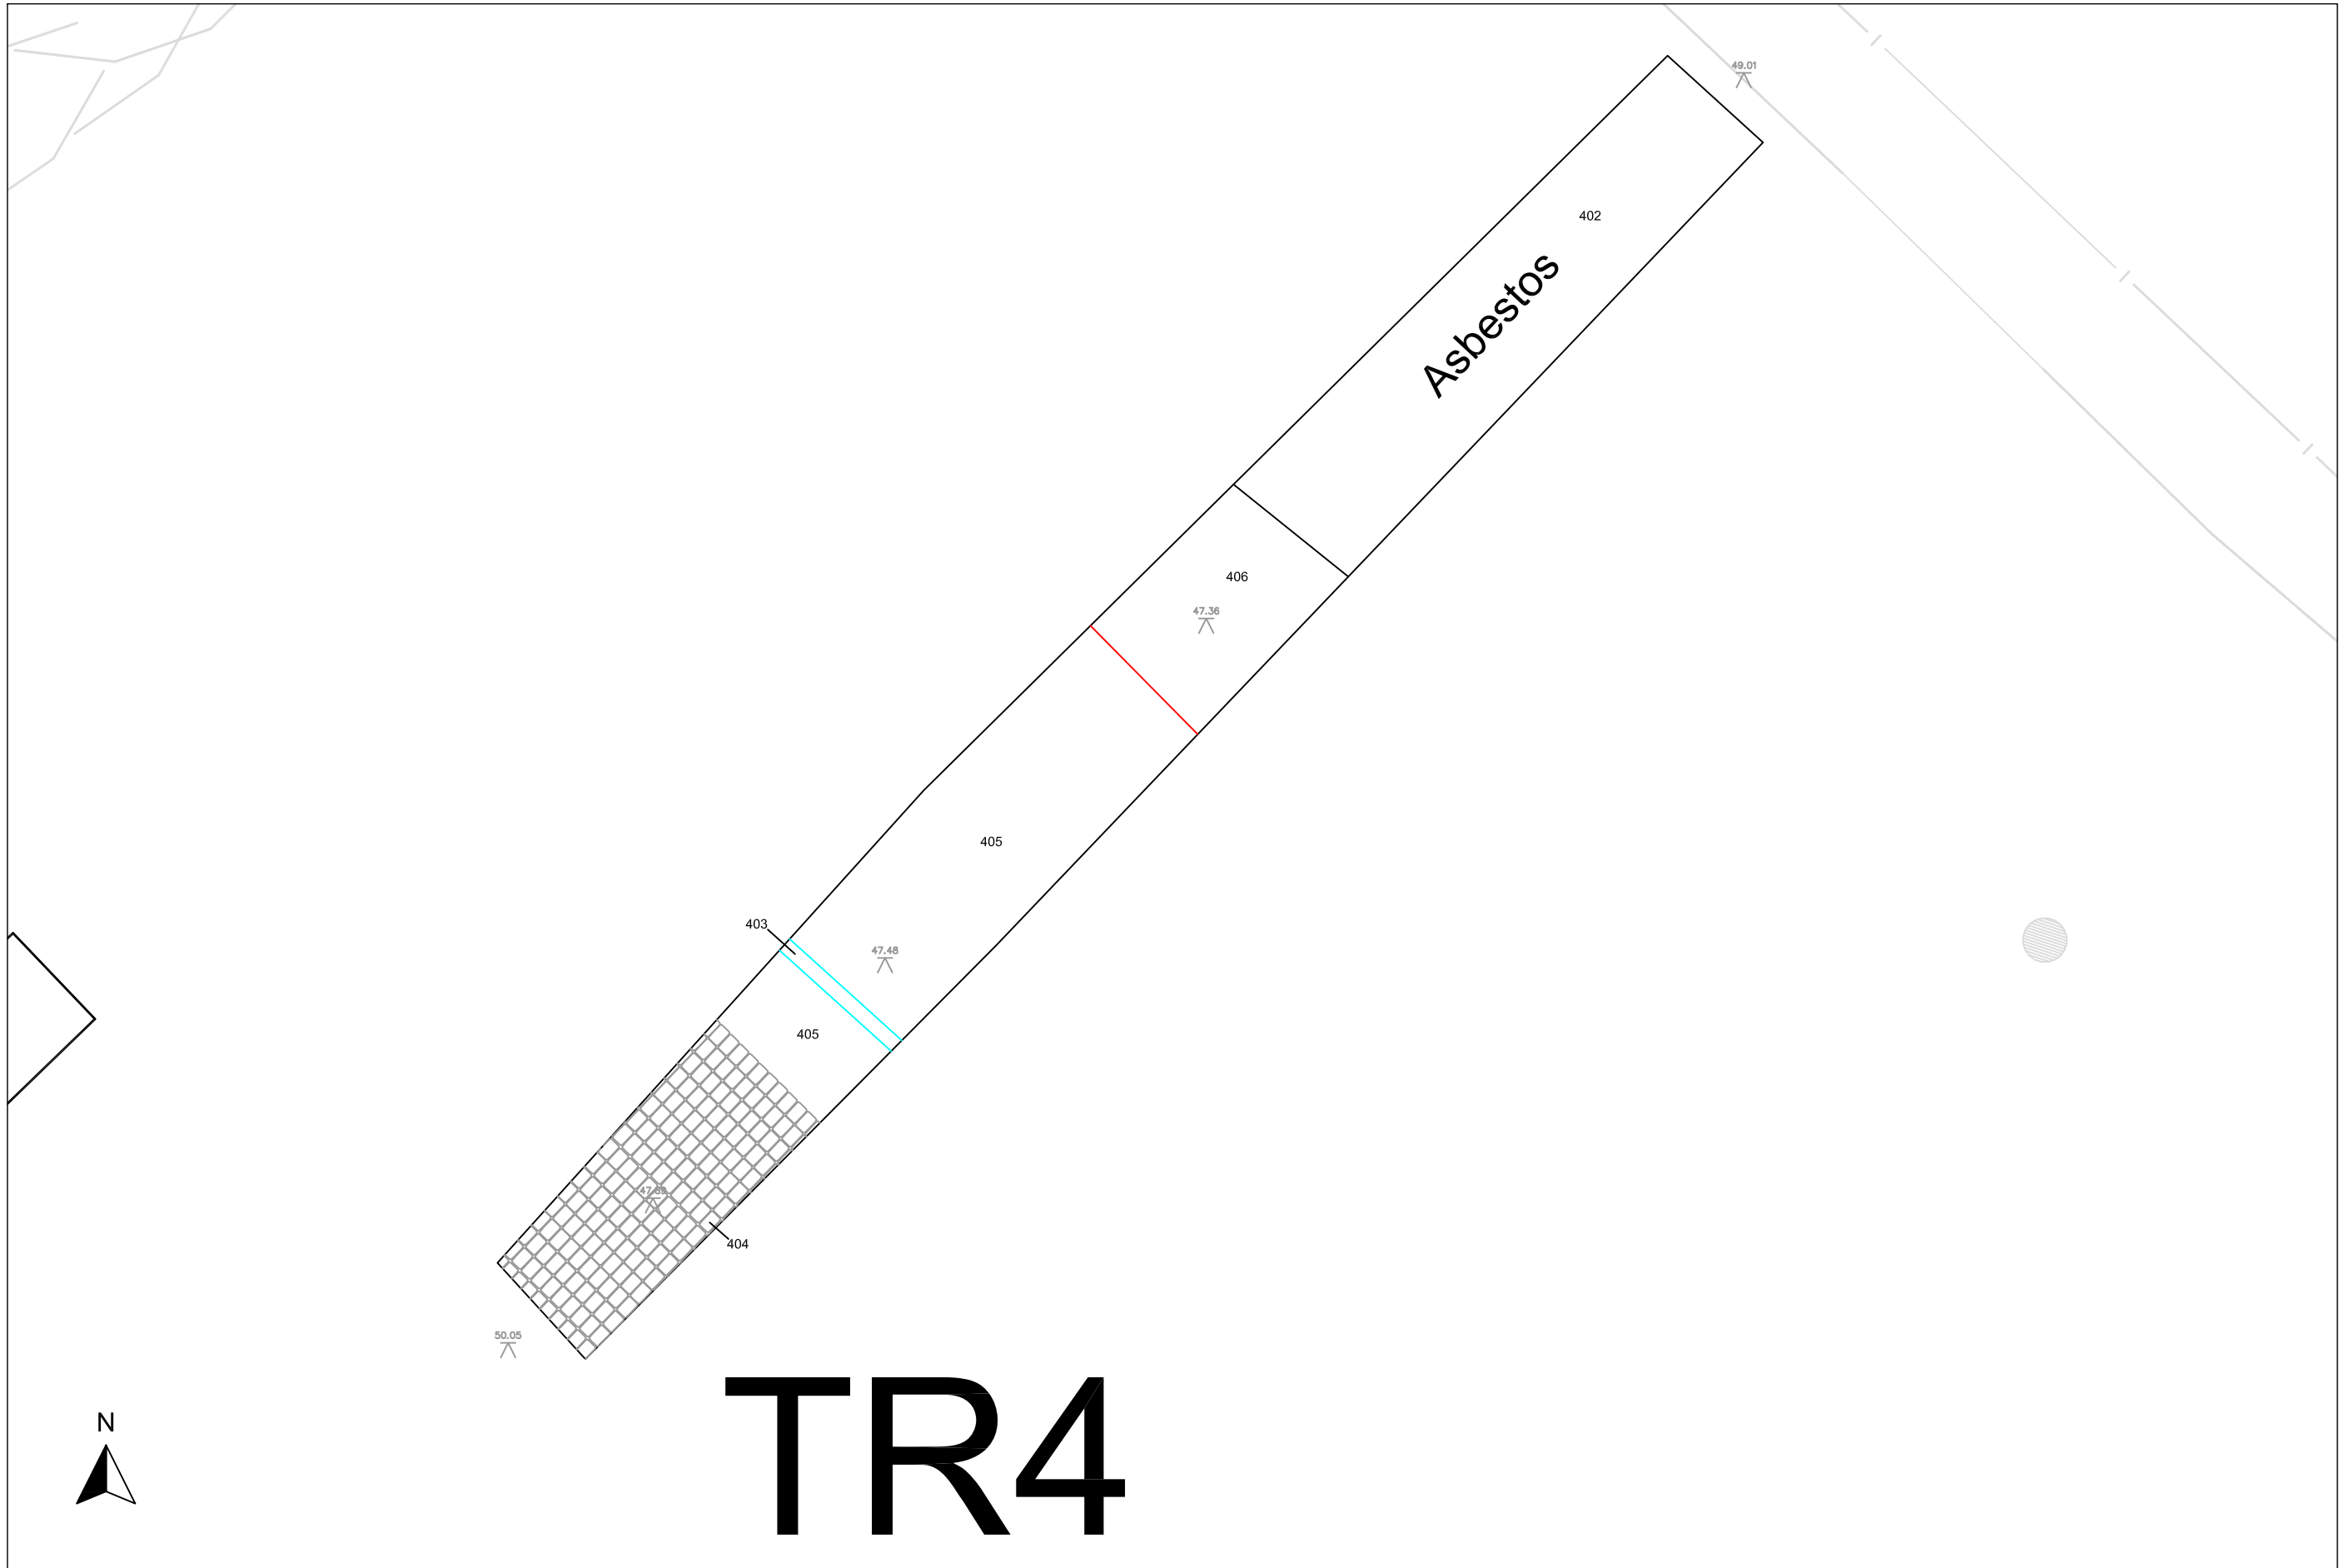
Fig 6: Trench 4 plan

This trench was located within the park, to the northwest of the paved path and to the immediate southwest of the school playing field fence. It ran southwest/northeast, measured 27m by 2.2m and was excavated to a maximum depth of 2.5m (*Fig 6*).

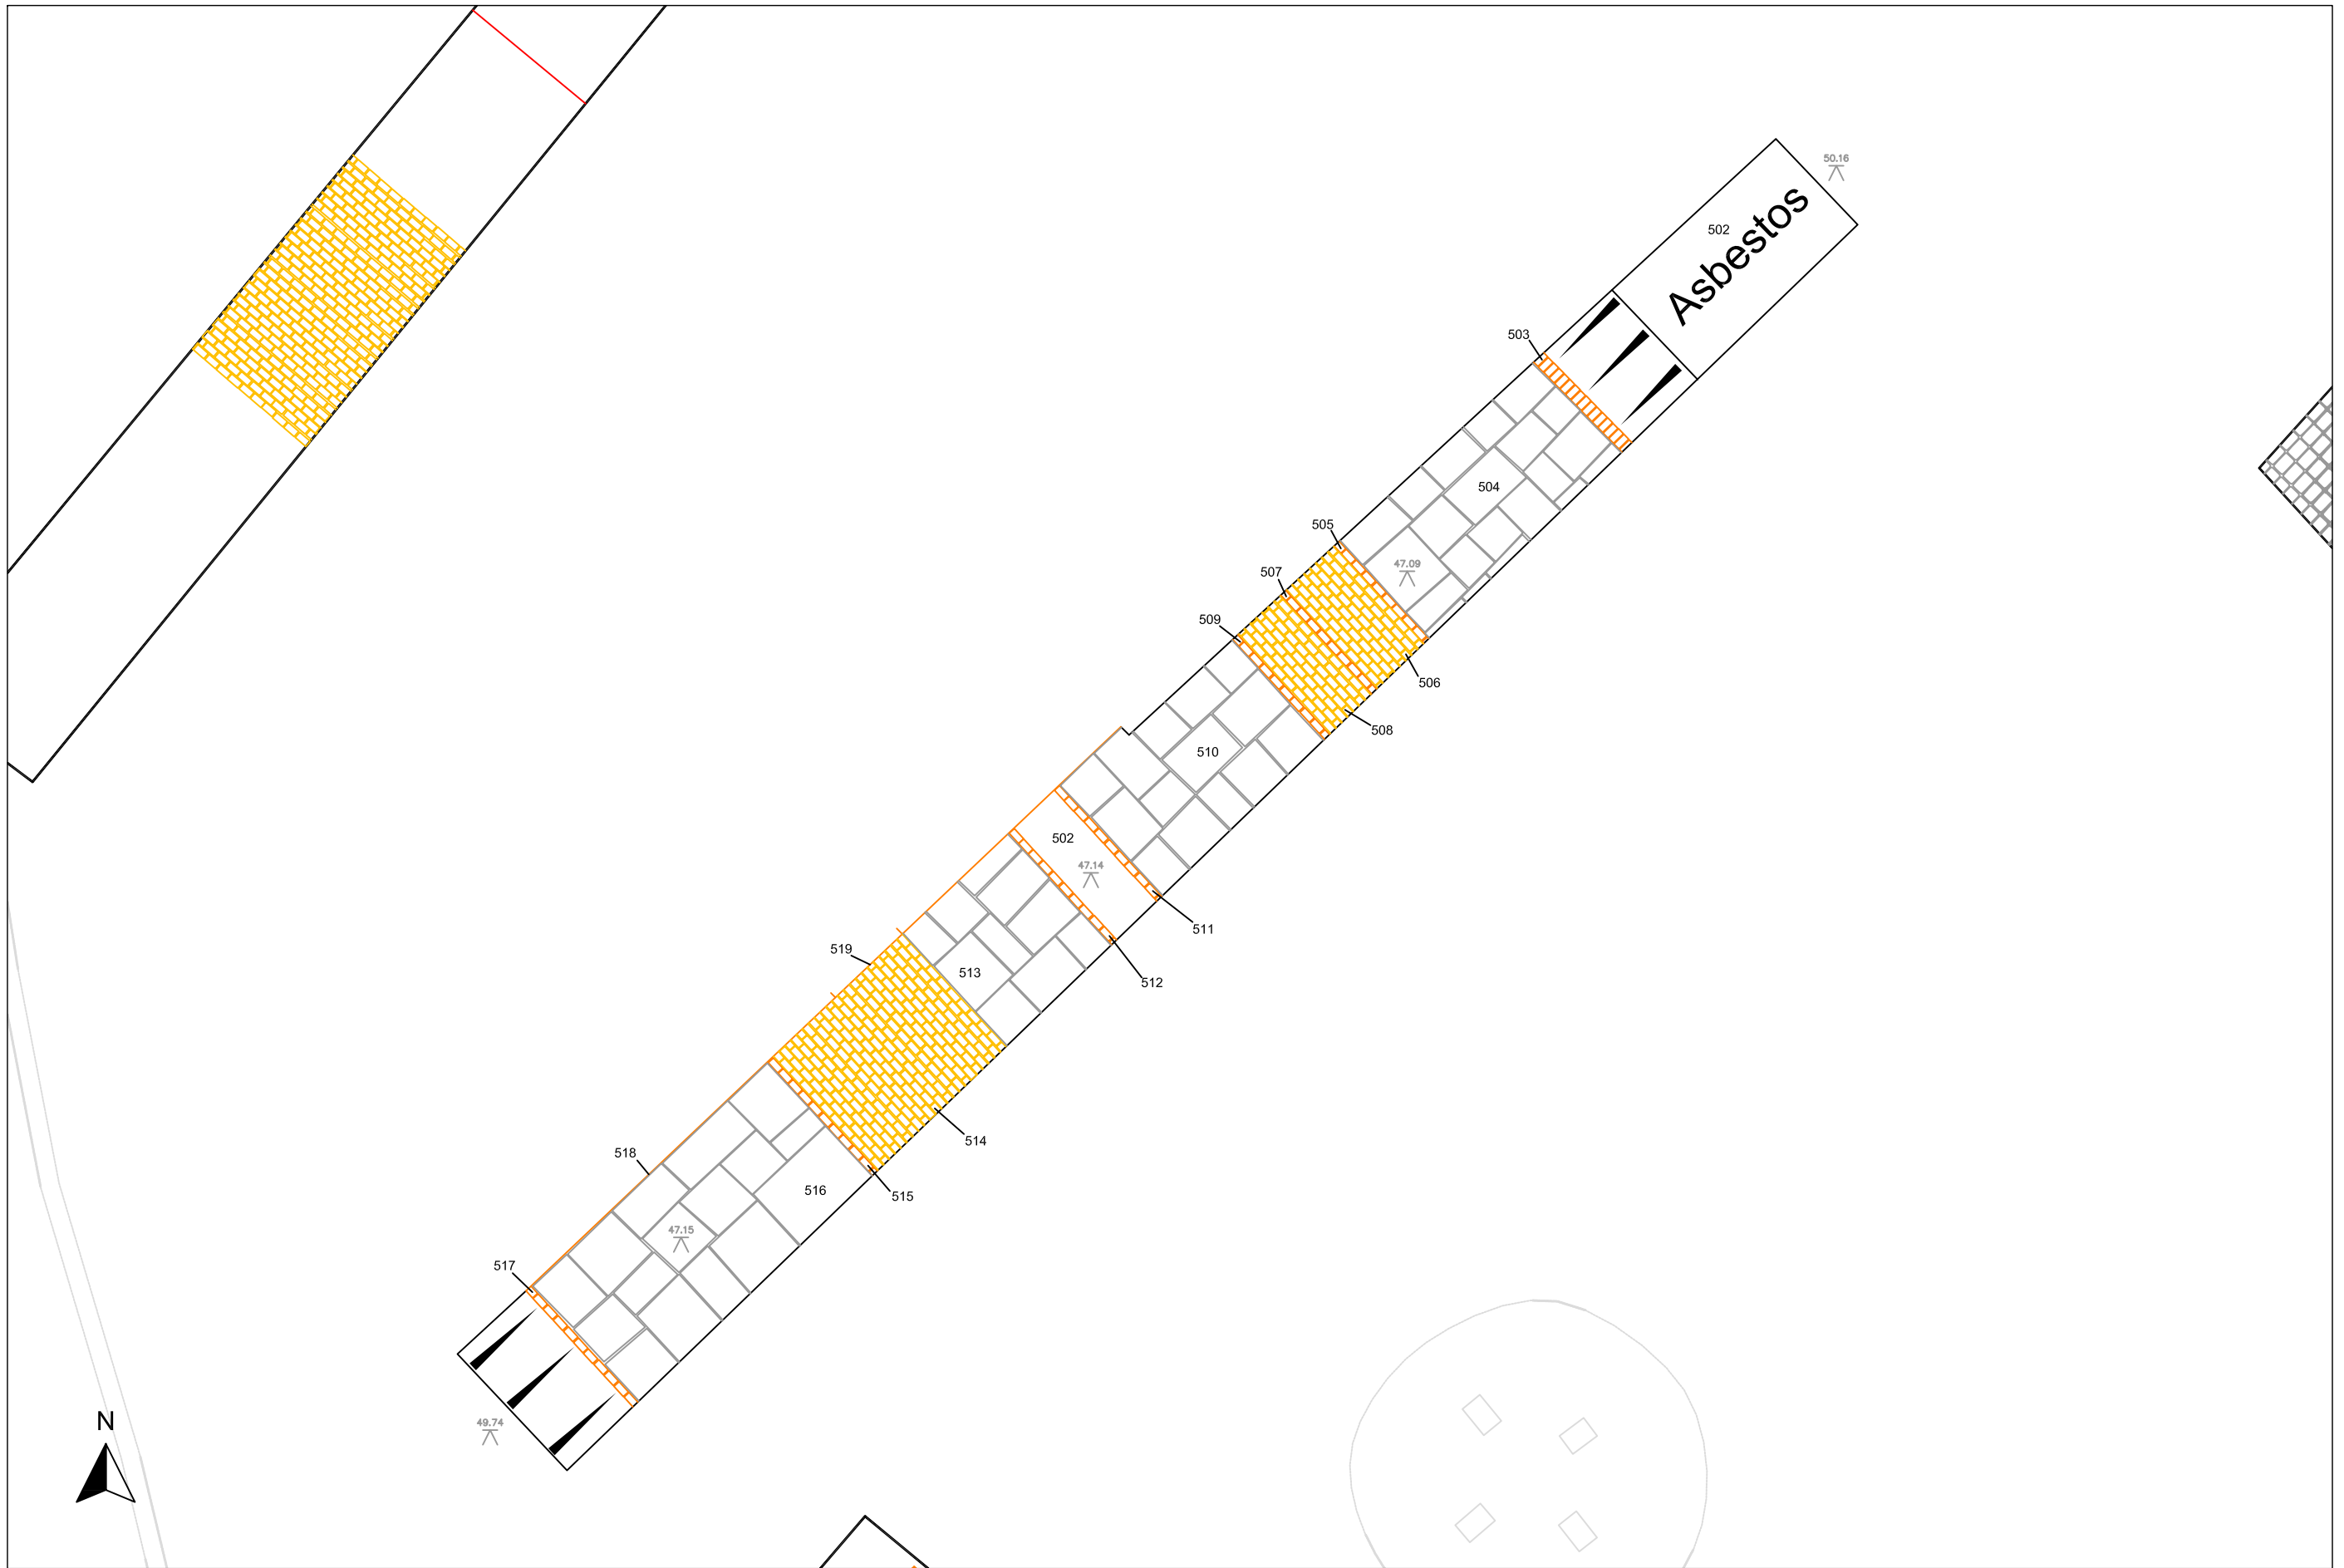
Fig 7: Trench 5 plan

This trench was located within the northwest side of the park to the northwest of trench 3. It ran northeast/southwest, measured 28.5m by 2m wide at the northeast end and 2.4m wide at the southwest end due to collapse. It was excavated to a maximum depth of 3m (Fig 7).

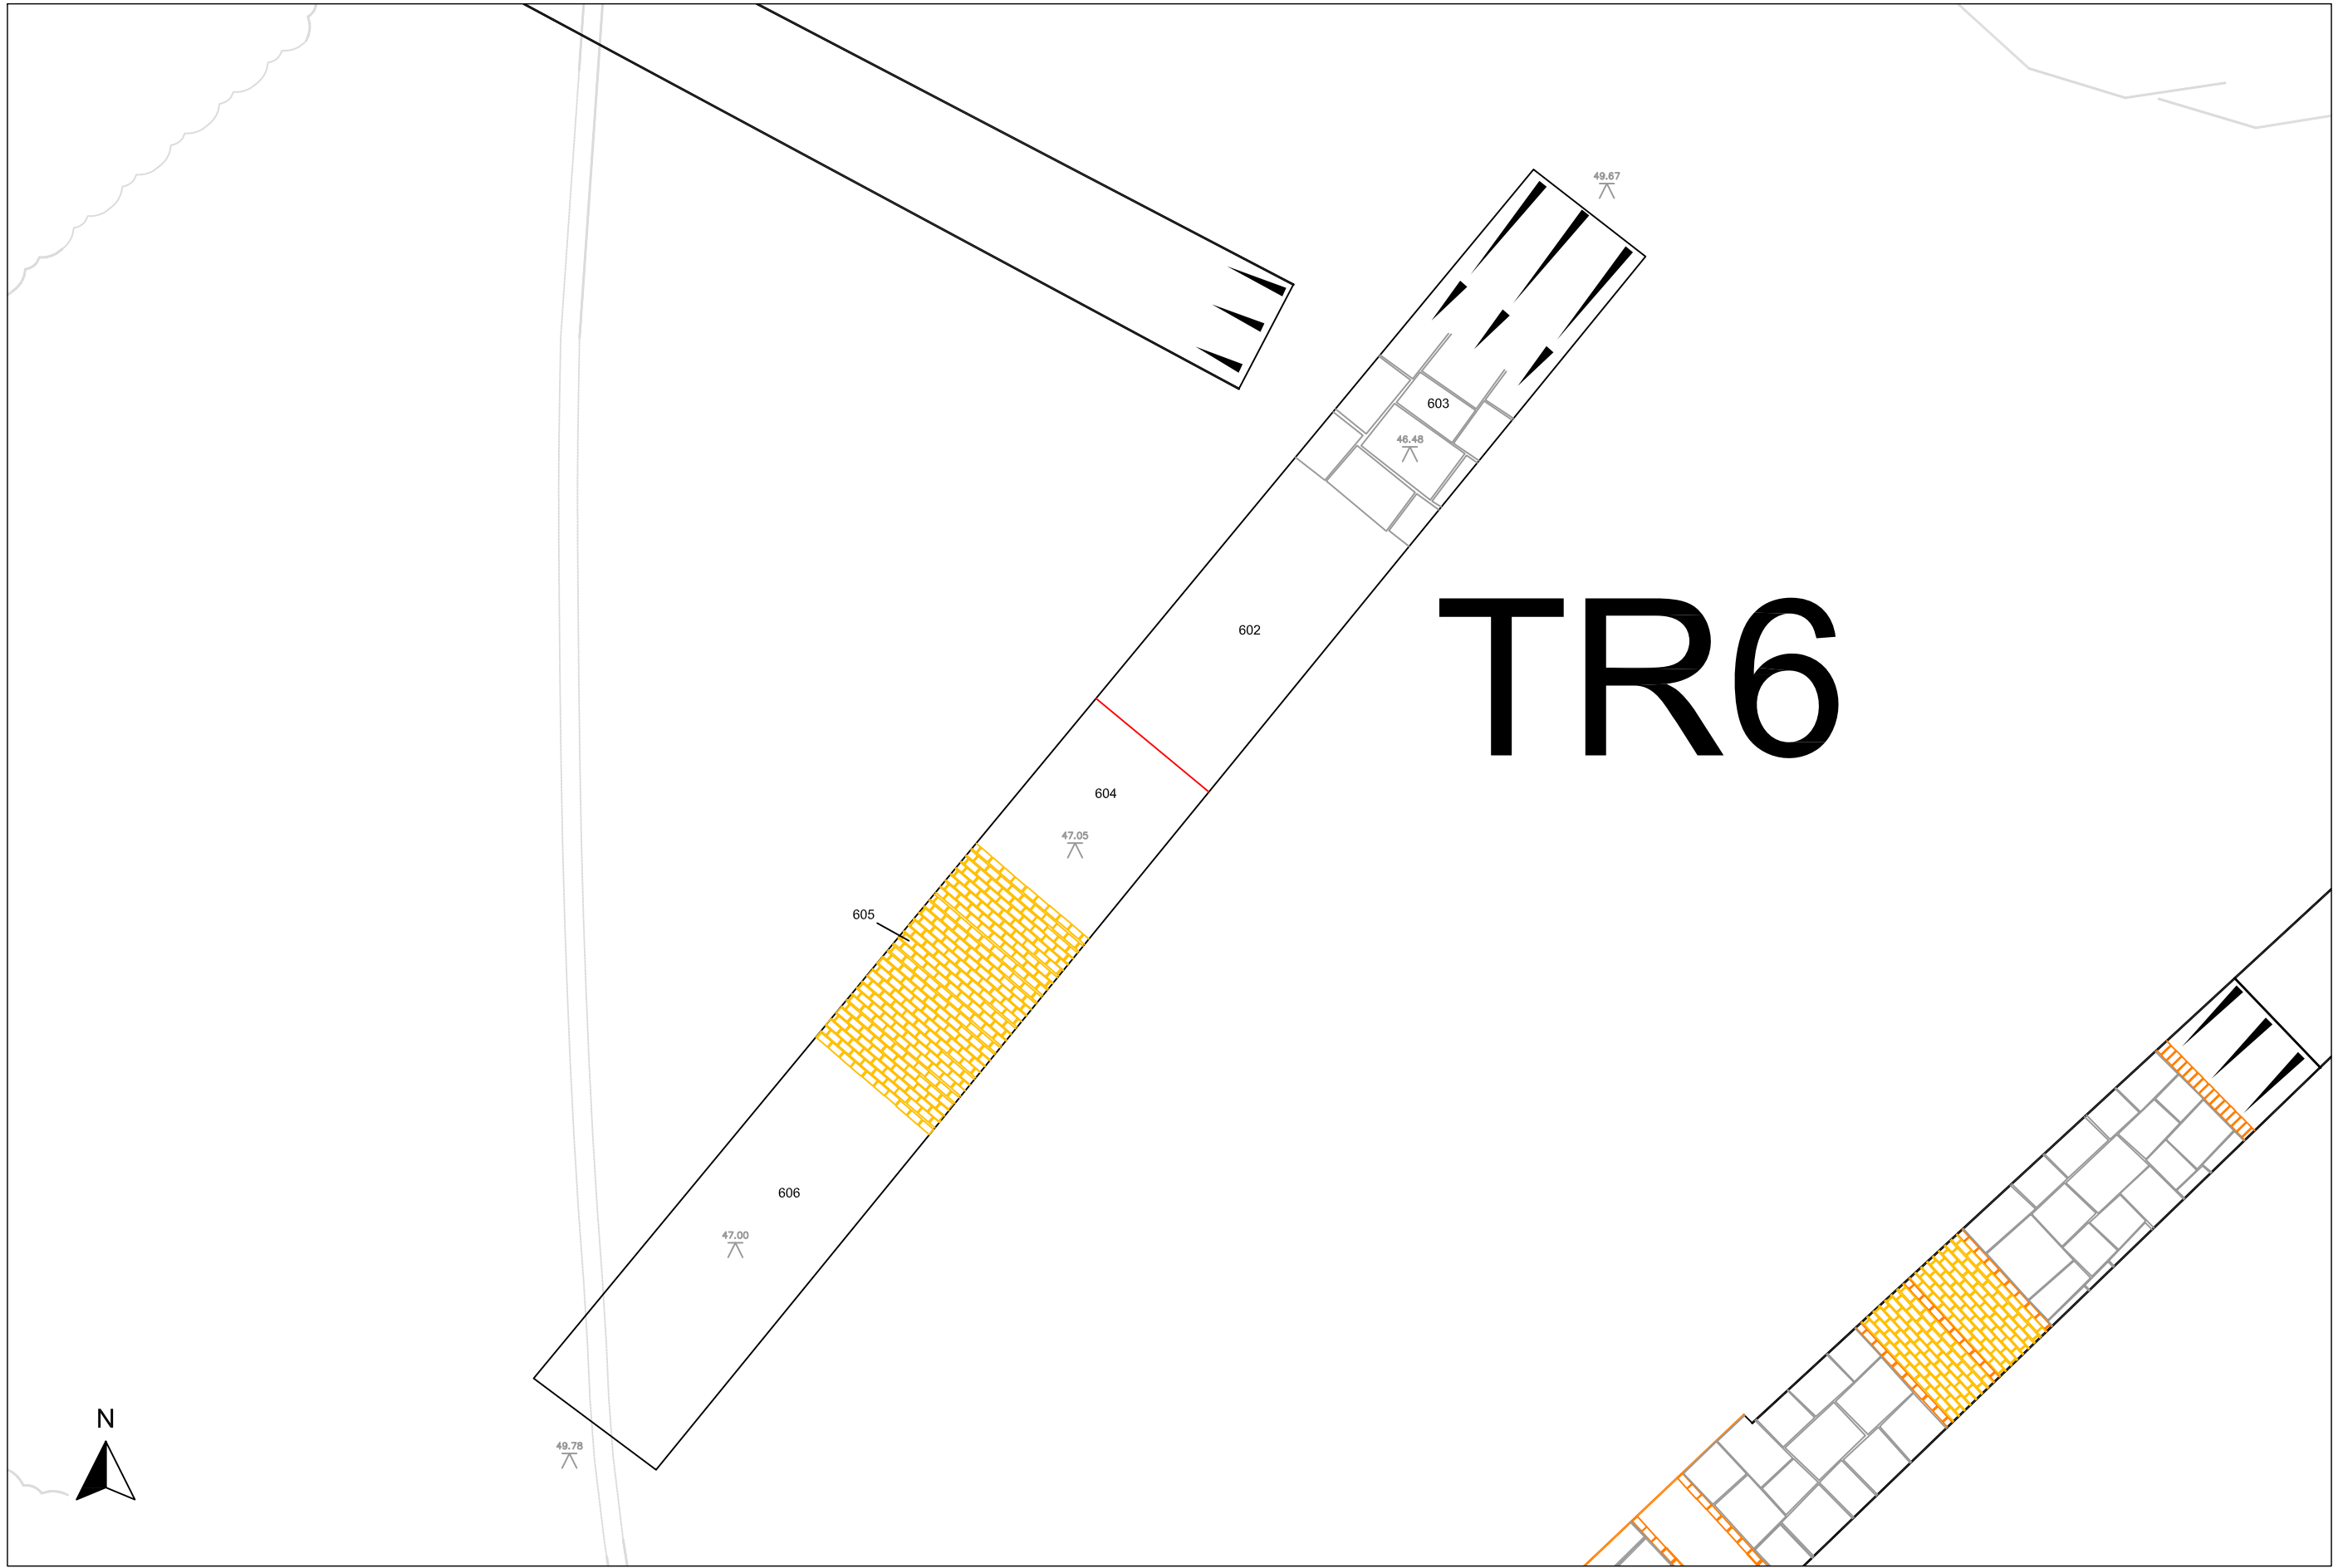
Fig 8: Trench 6 plan

This trench was located to the northwest of trench 5, running parallel to it. It measured 25m by 2m and was excavated to a maximum depth of 2.8m (*Fig 8*).

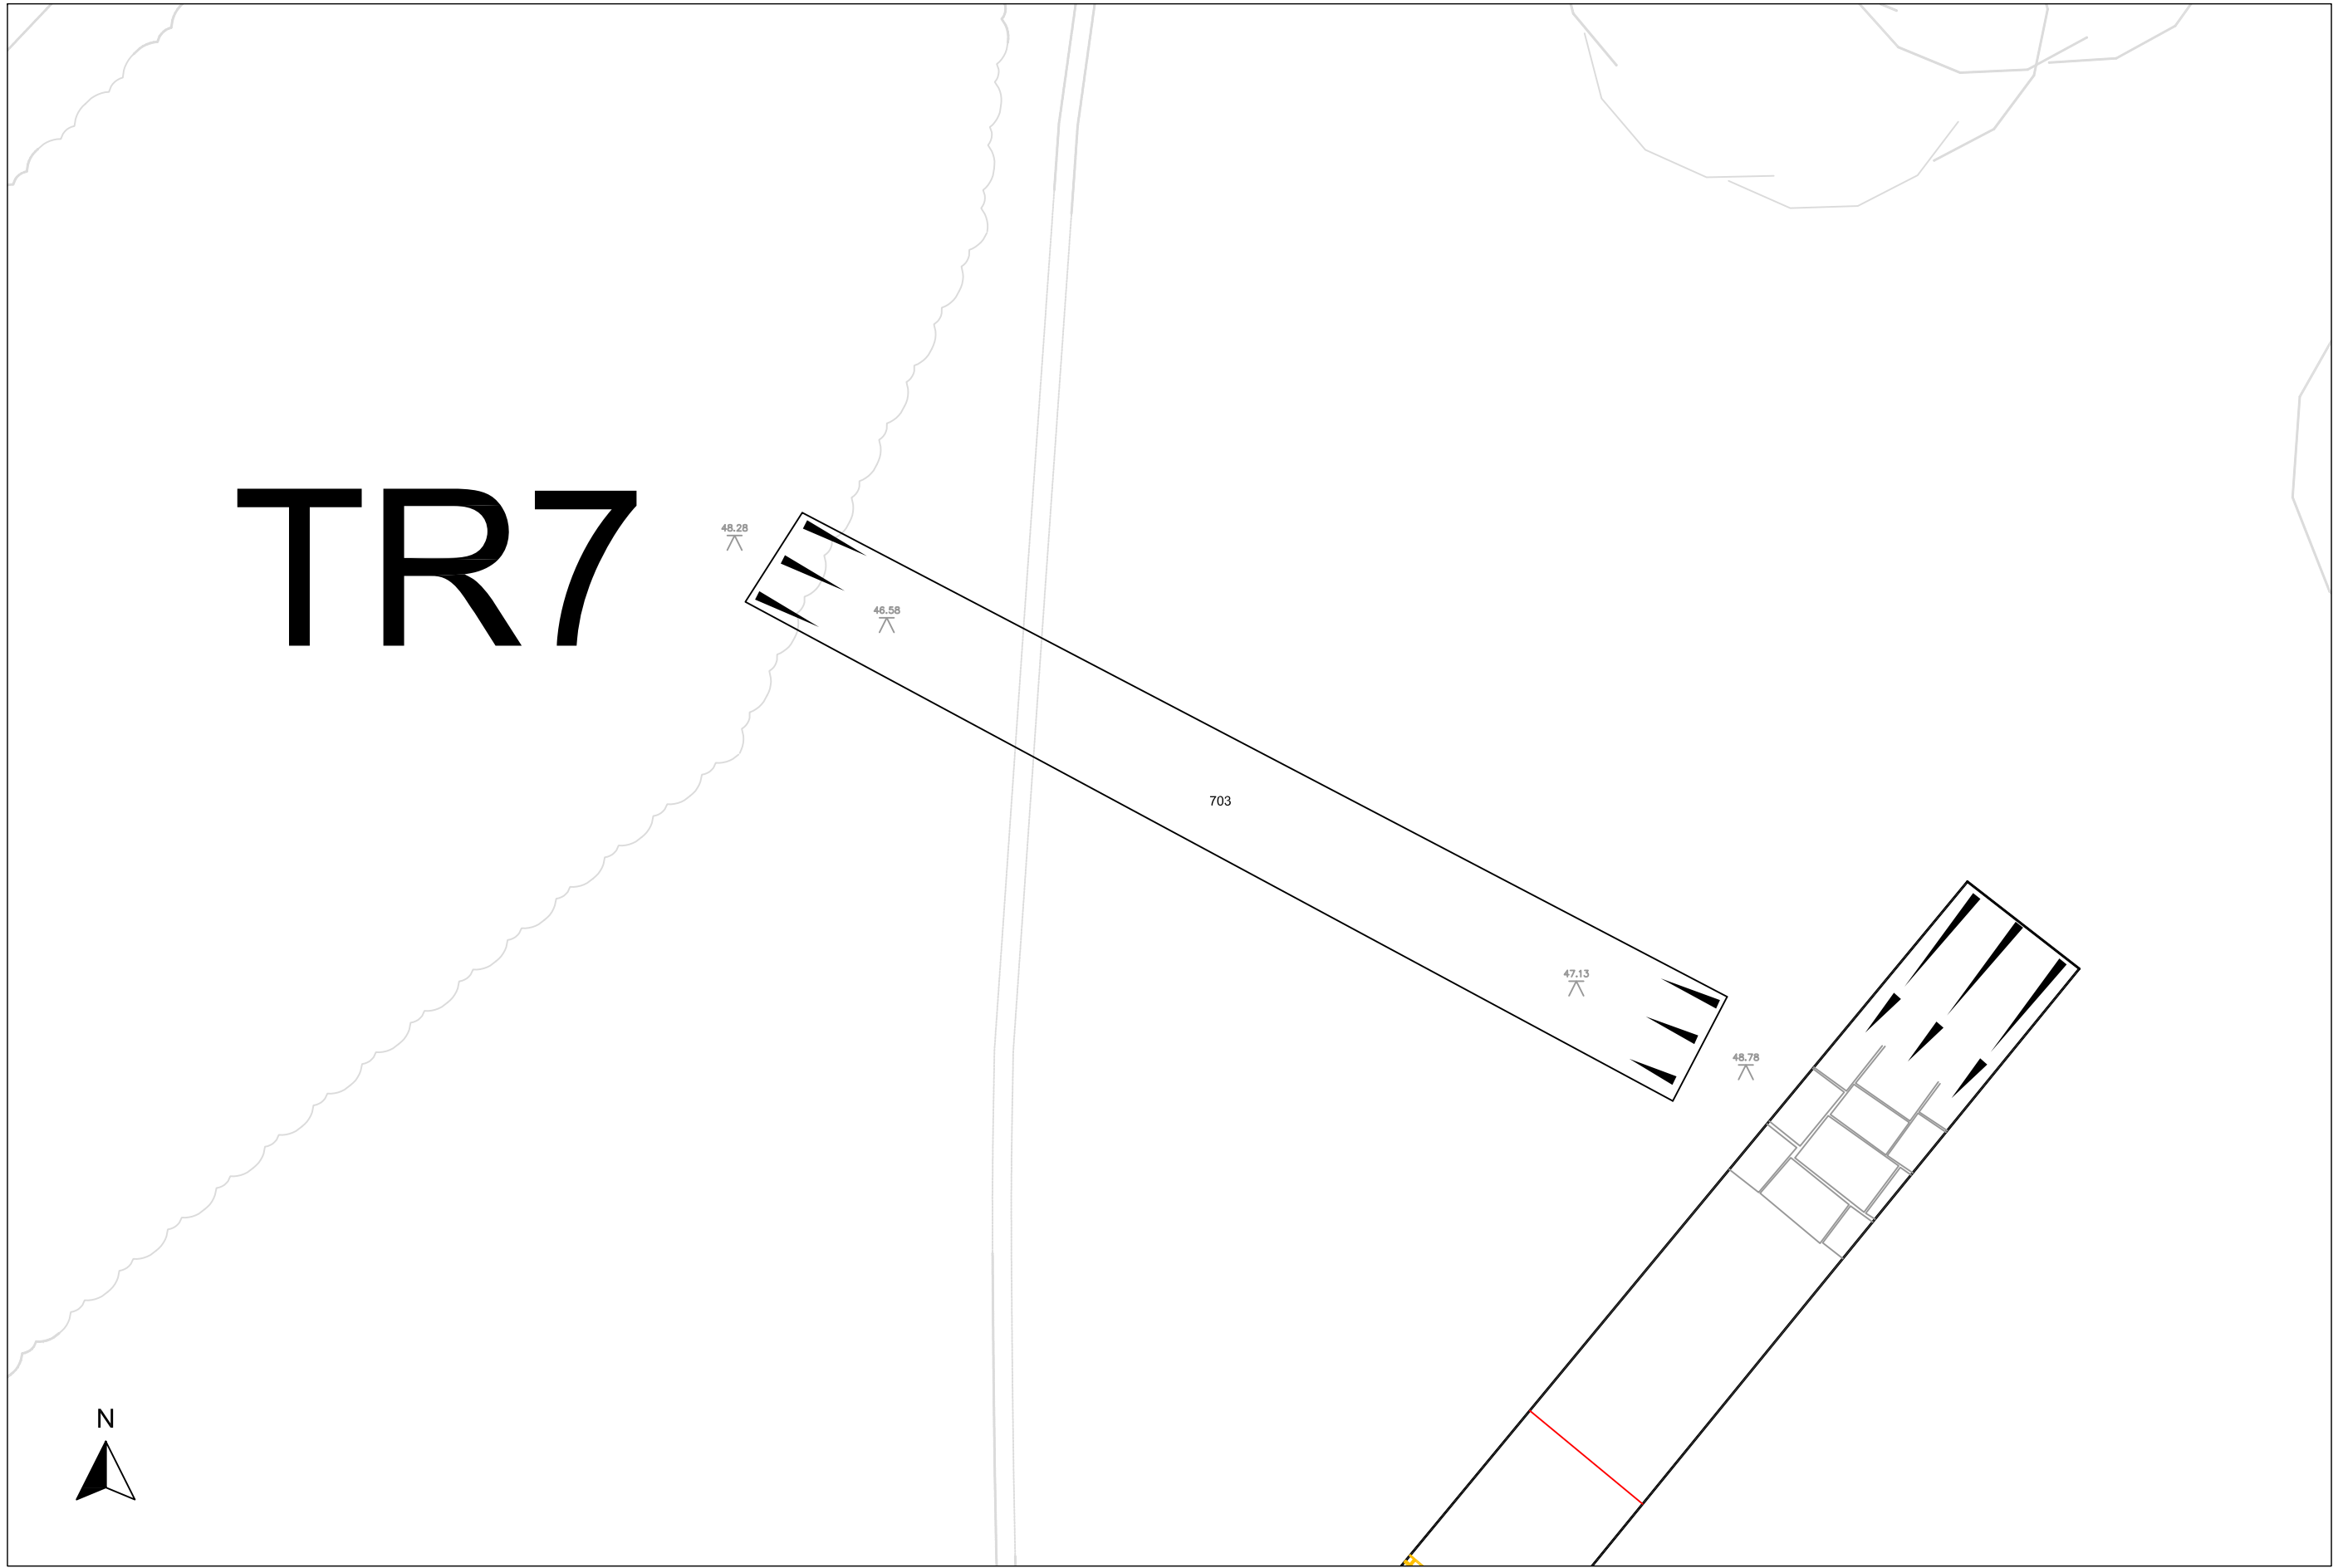
Fig 9: Trench 7 plan

This trench was located to the northwest of trench 6, running perpendicular to it to the northwest. It measured 16.7m by 2m and was excavated to a maximum depth of 1.6m (*Fig 9*).

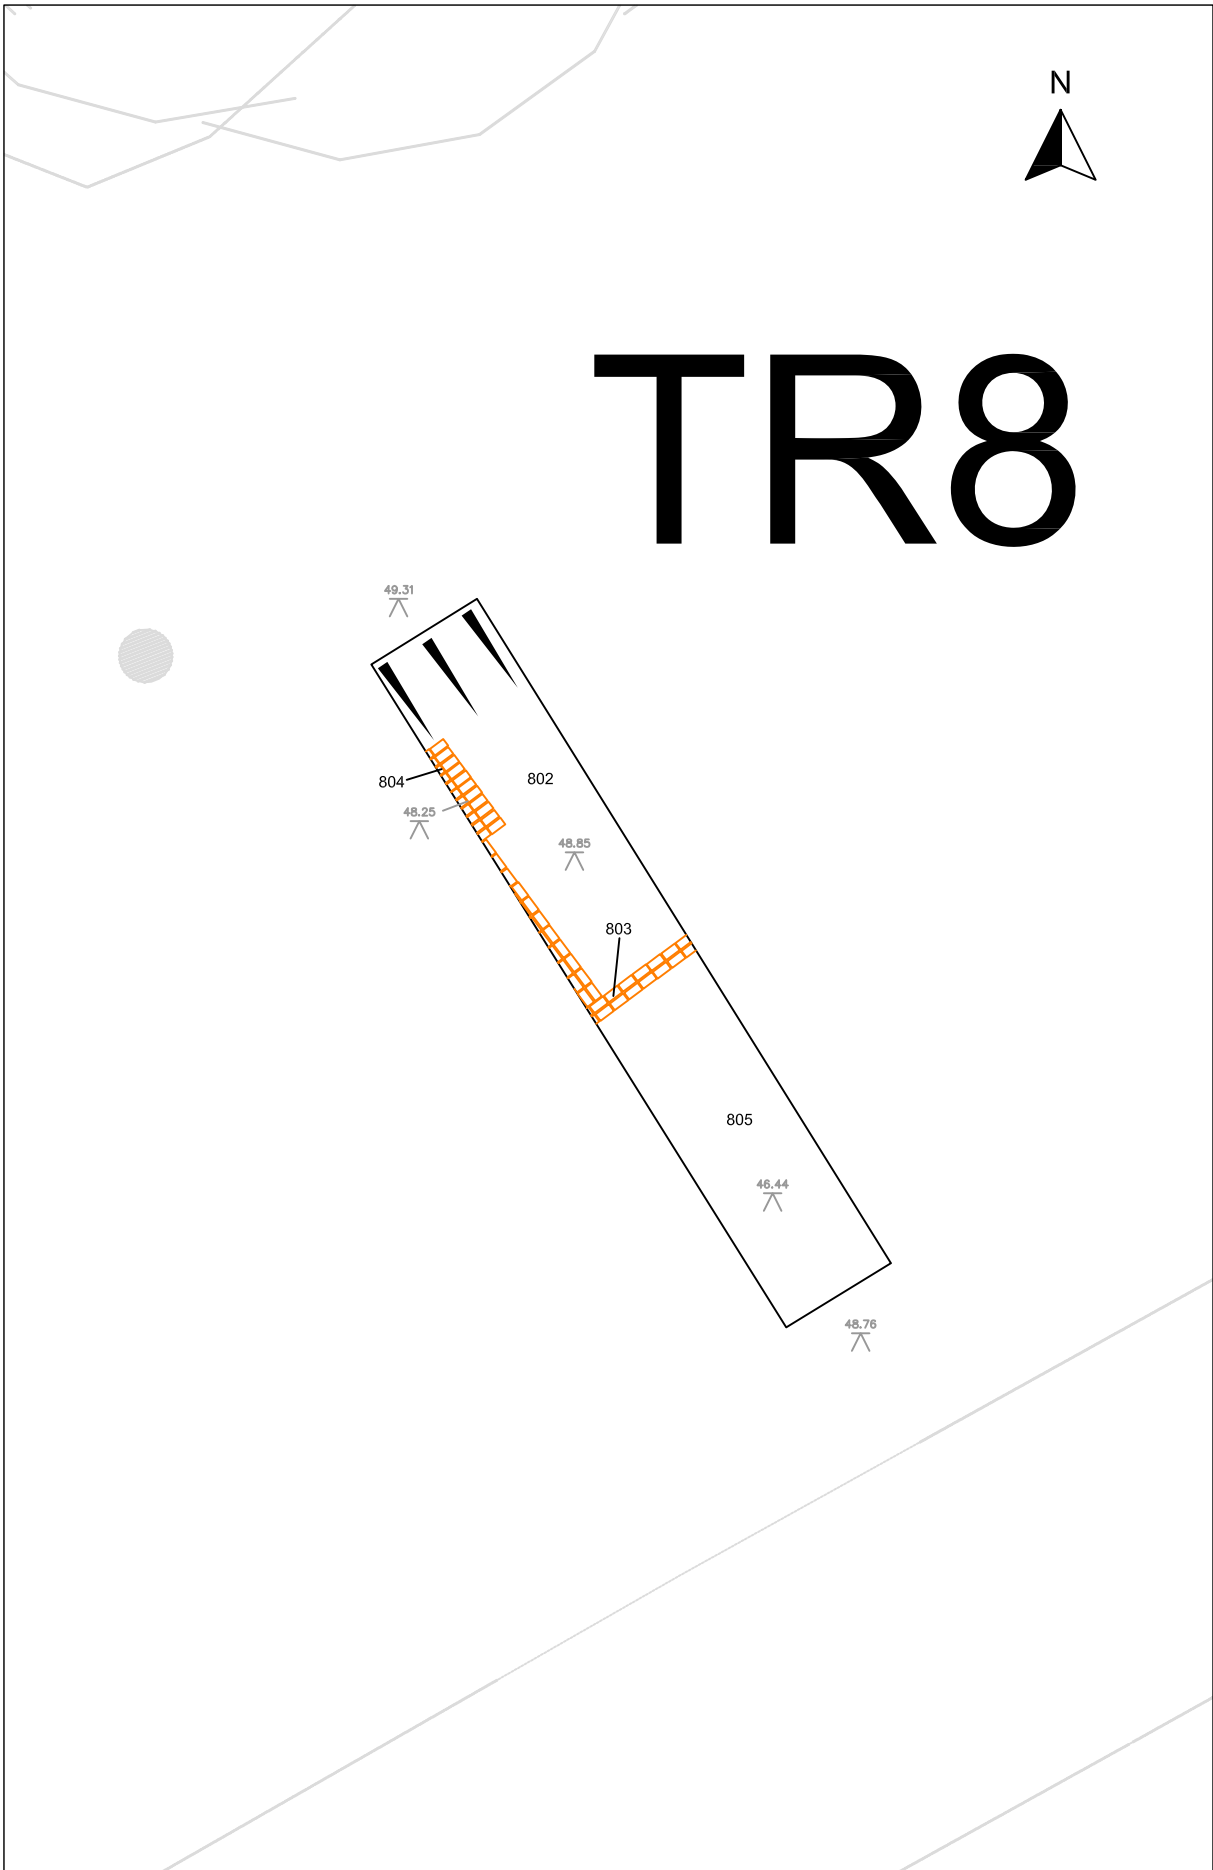
Fig 10: Trench 8 plan

This trench was located on the northwest side of the paved path, to the south of the primary school fencing and to the southeast of trench 4. It measured 10.4m by 2m and was excavated to a maximum depth of 2.34m. It was foreshortened at both ends due to the presence of potentially live services (*Fig 10*).

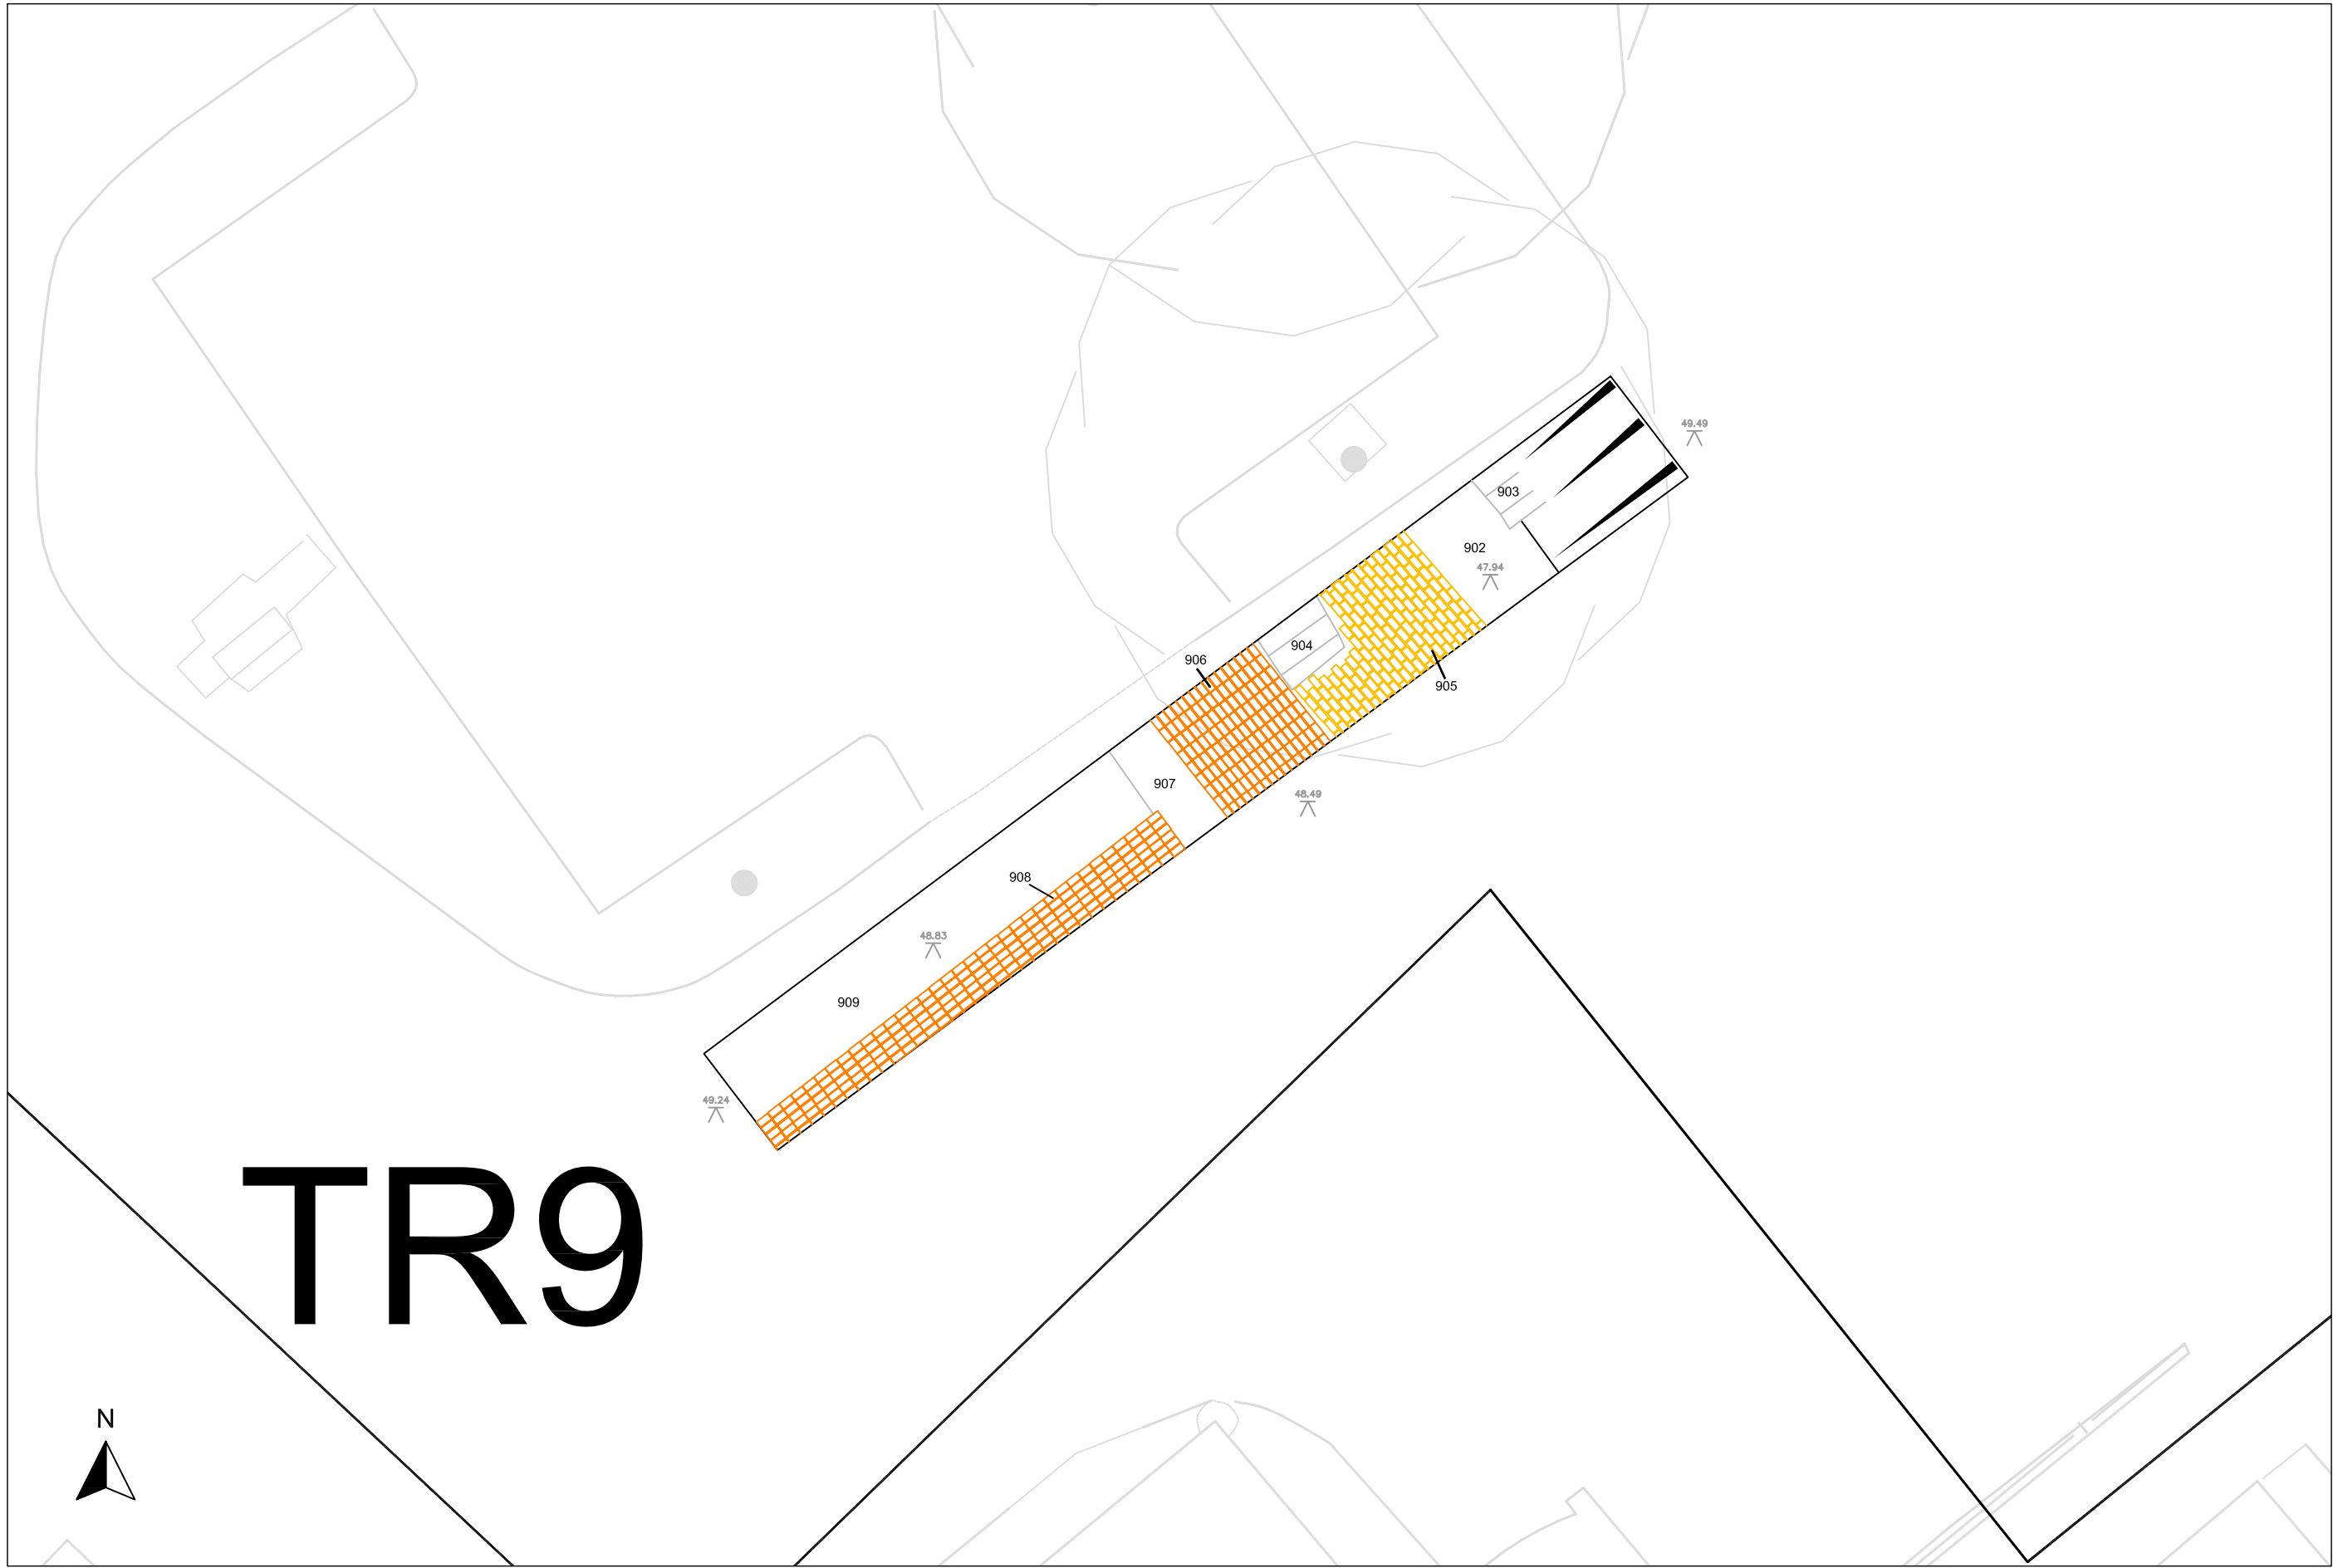
Fig 11: Trench 9 plan

This trench was located within the yard to the rear of Daisy Mill running northeast/southwest. It measured 18m by 2m and was excavated to a maximum depth of 1.5m. It was foreshortened at both ends due to the presence of live services (*Fig 11*).
