**Archaeological
Excavation**

Wellington Street,
Bury.

Technical Report:
Sarah Cattell

Report No: 20/2015

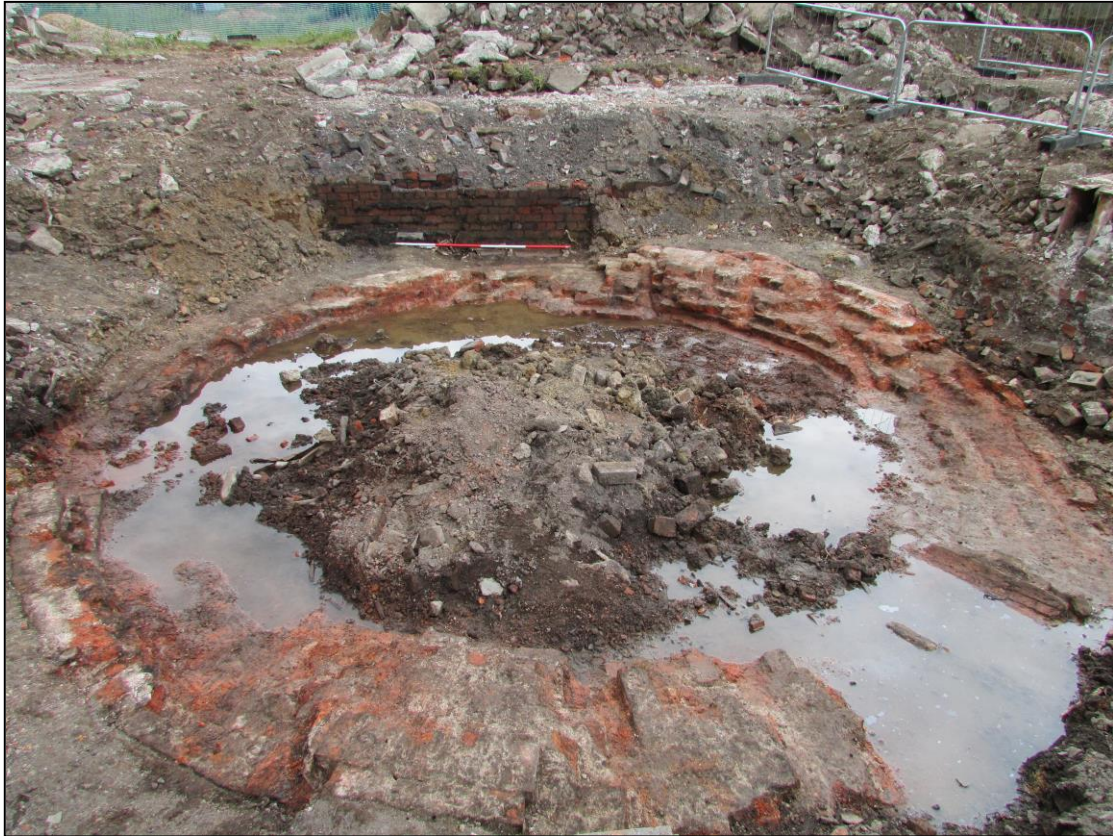
Fig.1. General view of Area 1 showing the remains of the chimney (075) and wall (073). Looking south.

This deposit lay against a large circular brick wall (075) with an external diameter of 7.00m and a thickness of 1.00m. This wall was identified during the evaluation phase of work within Trench 6 but was not excavated due to safety concerns. The wall was found to comprise of 5 courses of heavily degraded handmade brick laid with stretchers on the external and internal faces with the core made up of header courses. The internal face on the western section of the wall was heavily truncated leaving only 3-4 courses of brick visible. A rounded channel was identified running north-south across the south-eastern section of the wall which was constructed using stretchers laid on their sides, the base of which was found at a depth of c.0.25m. The central area within the wall was filled by (077).

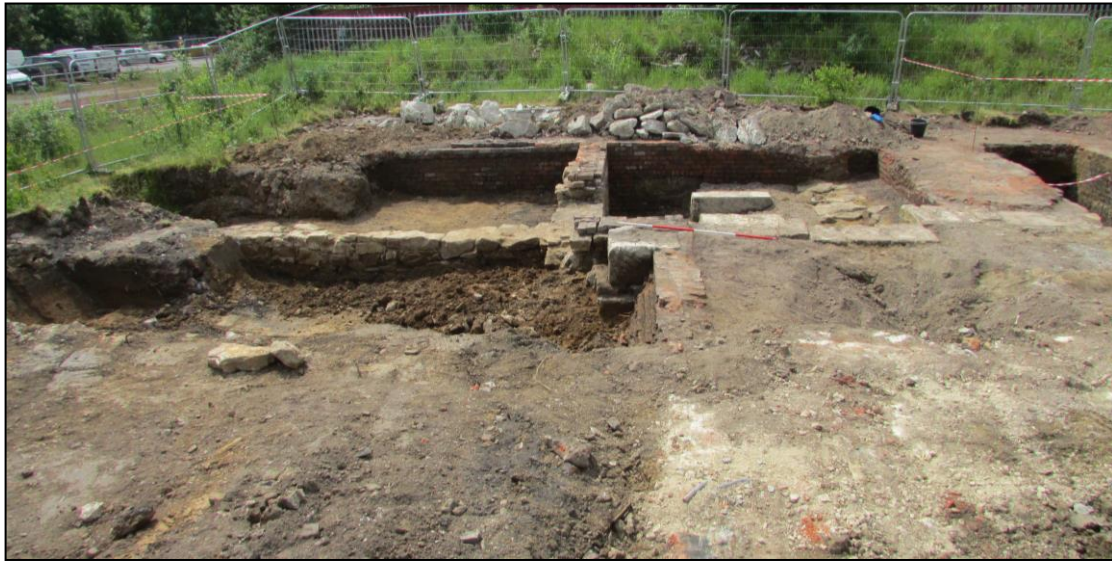
Fig. 3. General view of Rooms 1 & 2, Area 2. Looking south.

Two rooms were identified in the south-eastern corner of the area, elements of which were identified during the evaluation phase. Room 1 was found in the far south-eastern corner of the area and was bounded to the north by a rubble core stone wall (001), to the south by a handmade brick wall (002) which continued westwards into Room 2, and to the west by a stone wall with 2 courses of handmade brick added to the top (004). This wall appeared to have been cut by (002) and the join filled by brick fragments, possibly as part of the same phase as the top 2 brick courses. The eastern edge of the room was bounded by the eastern trench edge. No floor surface was identified within this room, although a light yellowish-brown sandy deposit (021) was found across the lower level of the room which was cut on the eastern side by a stone culvert (003) running northwest-southeast which was identified in the evaluation phase as context (050). Three deposits of (020) were identified within layer (021) which were found to be rich in bitumen fragments, brick and mortar.

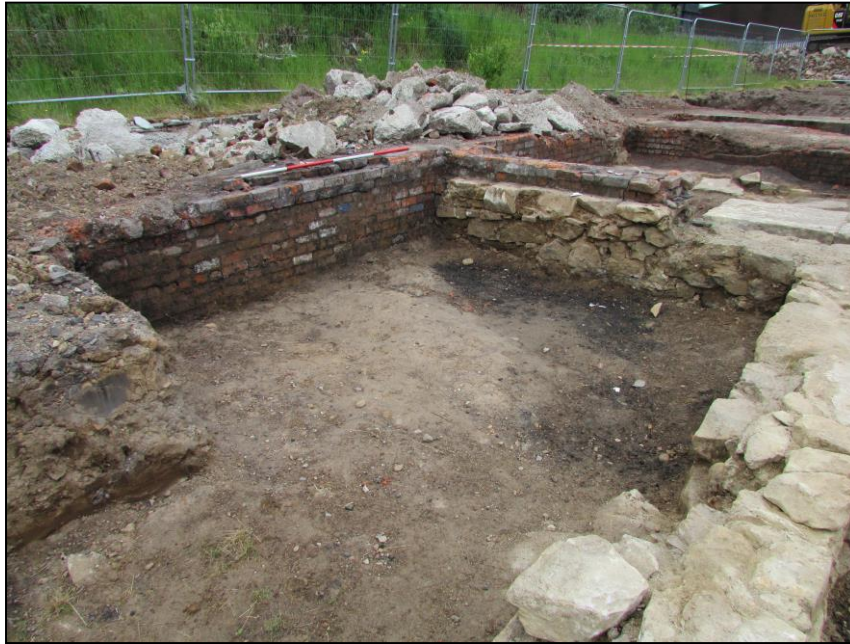
Fig 4. Western side of Room 1 showing walls (002) and (004). Looking west.

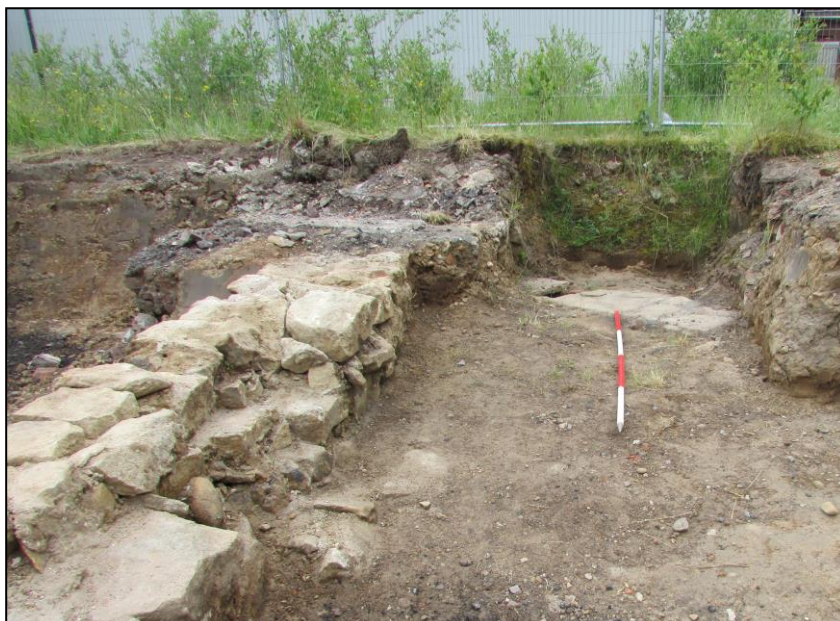
Fig. 5. Eastern side of Room 1 showing culvert found during the evaluation works. Looking east.

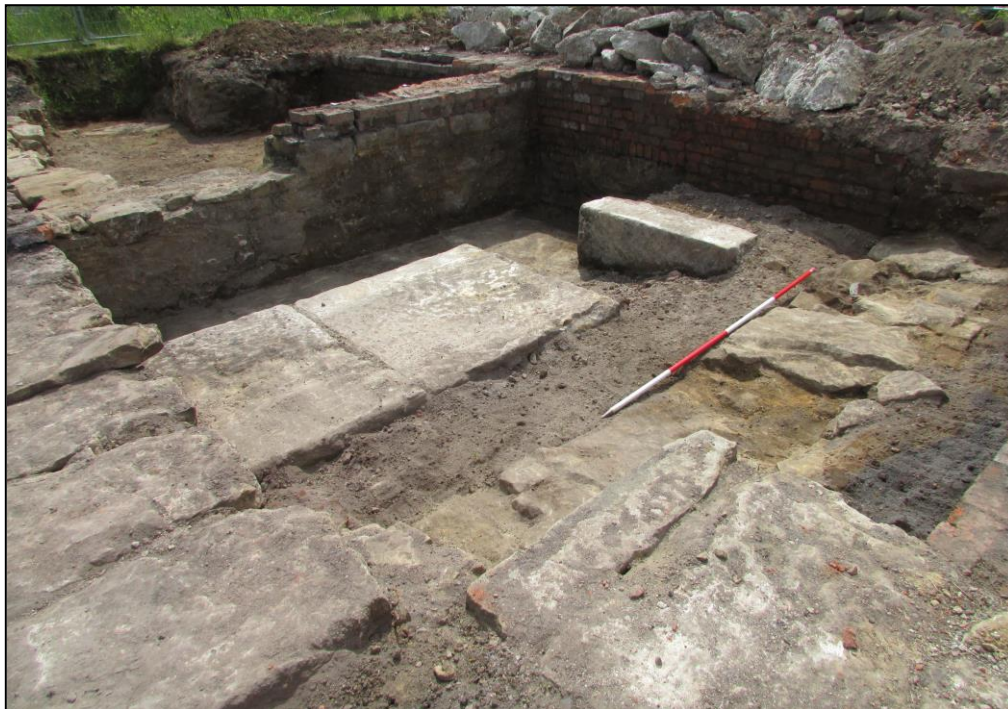
Fig. 6. General view of Room 2 showing stone beds in the centre. Looking southeast.

Room 2 retained the only evidence of the machinery which occupied this part of the mill during its earlier phase in the form of the two large stone engine beds. There was no evidence however of mountings or fixings on these stone blocks suggesting that upper blocks from this structure were missing, possibly removed prior to the brick building phase. The presence of an engine in this room also suggests the purpose of the opening in the lower part of the stone wall to the north, (005), which may have served as a drain for the engine.

archaeological evidence found in Area 2 does indicate two phases of engine bases, the earlier of which may be related to the pre-1871 mill. Documents from the sale of the mill site in 1871 lists two ‘60 horse boilers, one 30 horse beam engine and one 34 horse horizontal engine’ all unaffected by the fire and obviously in a saleable condition (Matrix, 2013). The advertisement appears to infer that the structural fabric of the engine houses was still intact following the fire, with the engines left *in-situ* inside. This fact would explain the well preserved condition of the features in Area 2 and the lack of evidence for heat/fire damage. The configuration of the stone engine blocks attributed to this original mill are more than likely the lower of several courses forming an engine bed for the advertised beam engine.

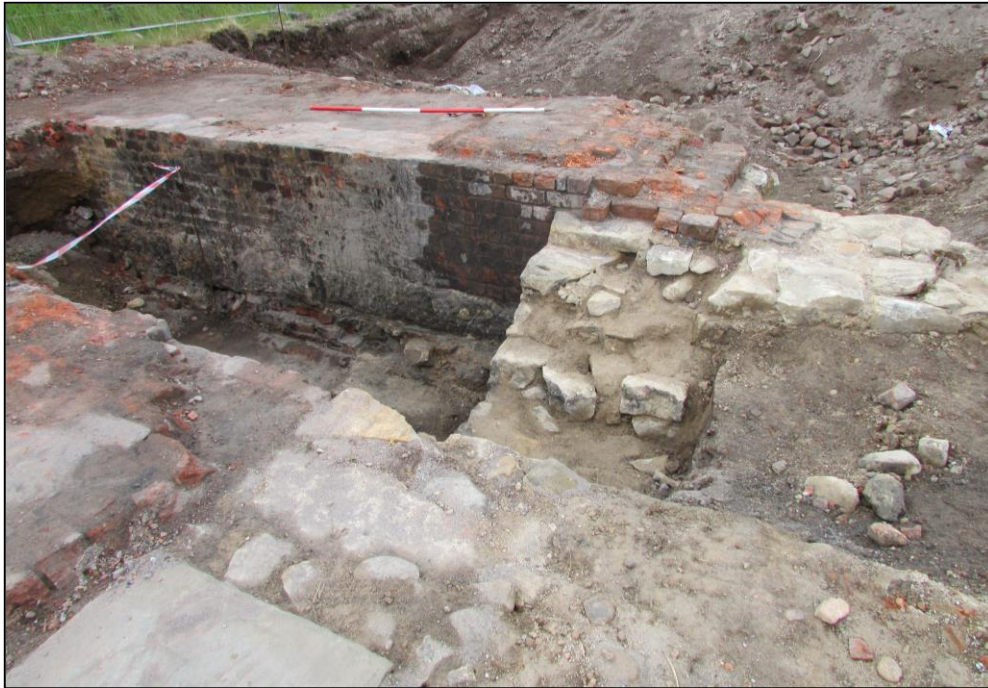
Fig. 7. Wall (019) in foreground with brick structure (009) to rear. Looking west.

Wall (019) measured 4.40m x 0.70m and ran between wall (007) in the east and (009) in the west which abutted it. The wall was constructed of both dressed and rough stone blocks laid with a yellow sandy mortar and stood to a height of 1.30m (7 courses). At its western extent the wall was abutted by an almost identical wall (**011**) which continued northwards before being truncated by the layer of concrete on this side of the site. Both walls appeared to be abutted to by (009) with some of the bricks from this structure even found to overlie the stone walls. Two similar stone walls were also revealed to the west of (009) which were of almost identical construction and bonding. Wall (025) lay against the northern end of (009) with some of the bricks from this structure obscuring its upper course, making it difficult to ascertain if this was a continuation of (019) or a separate wall. The wall measured 2.80m and stood to a height of 1.00m at its eastern end where it abutted (011), but was heavily truncated to the west where only one stone course was visible. Approximately 1.50m south of (025) lay the final stone wall found in this area. This wall was again constructed of dressed and rough stone blocks with a sandy mortar measuring 3.20m x 0.80m. the wall was aligned north- south and may have formed a return of wall (025) although both walls have been destroyed at the possible site of this junction.

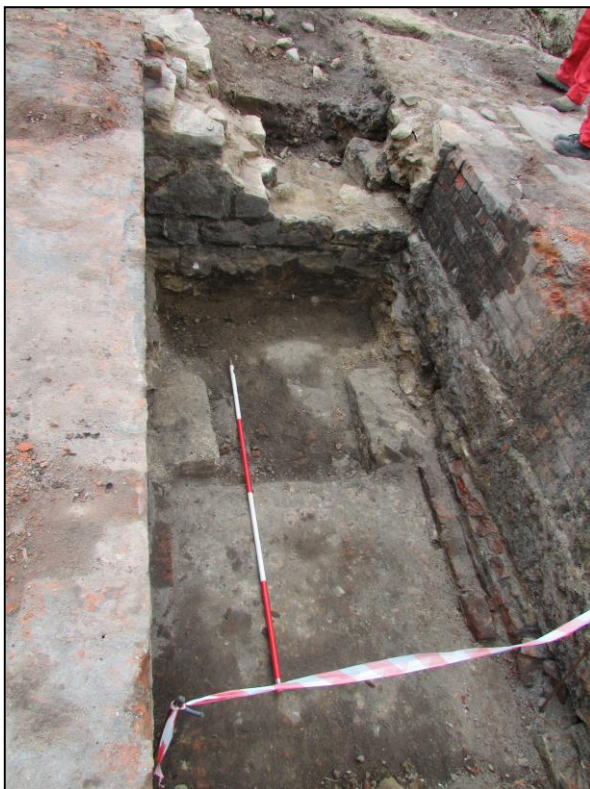
Fig. 8. Internal space between (008) and (009). Looking north.

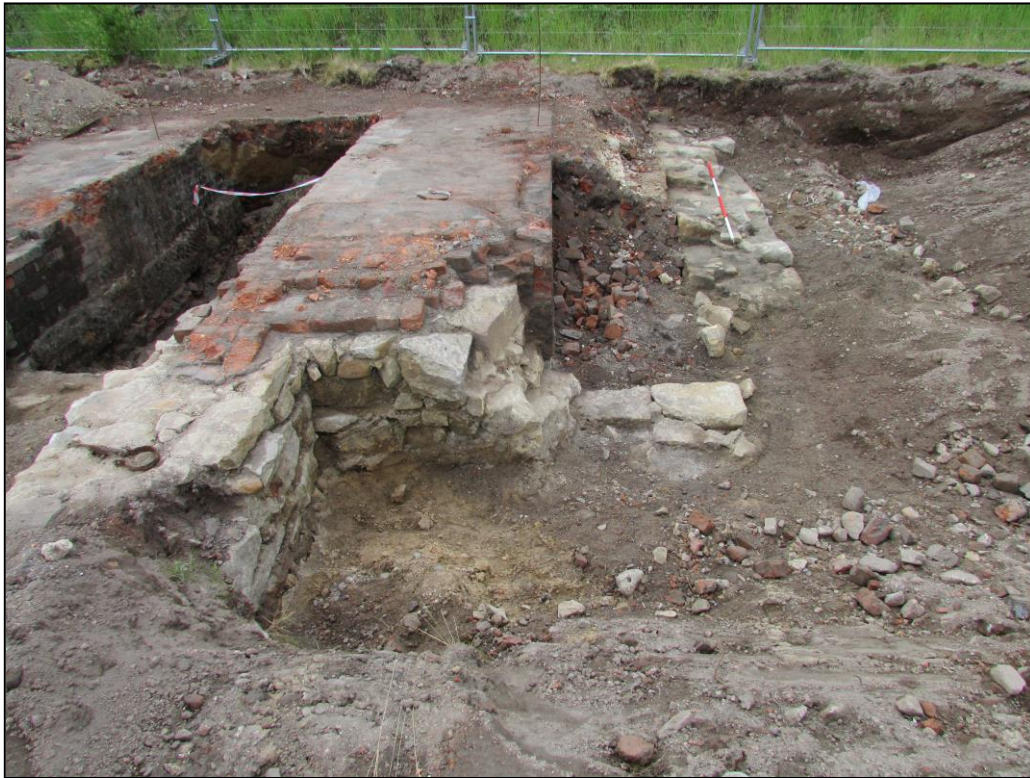
Fig. 9. Brick structure (009) and walls (011), (012) and (025). Looking south

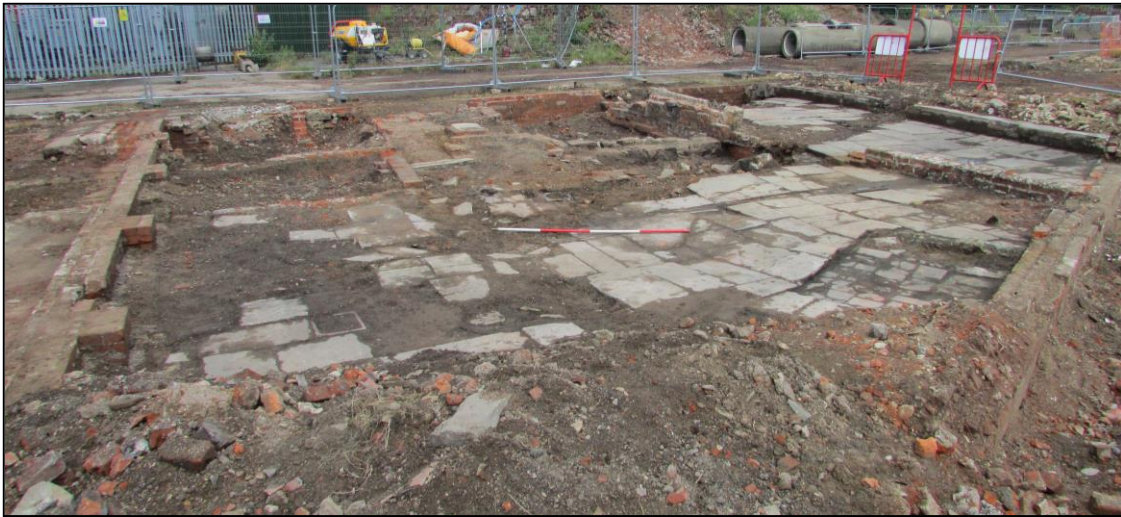
Fig. 10. General view of eastern side of Area 3. Looking north.

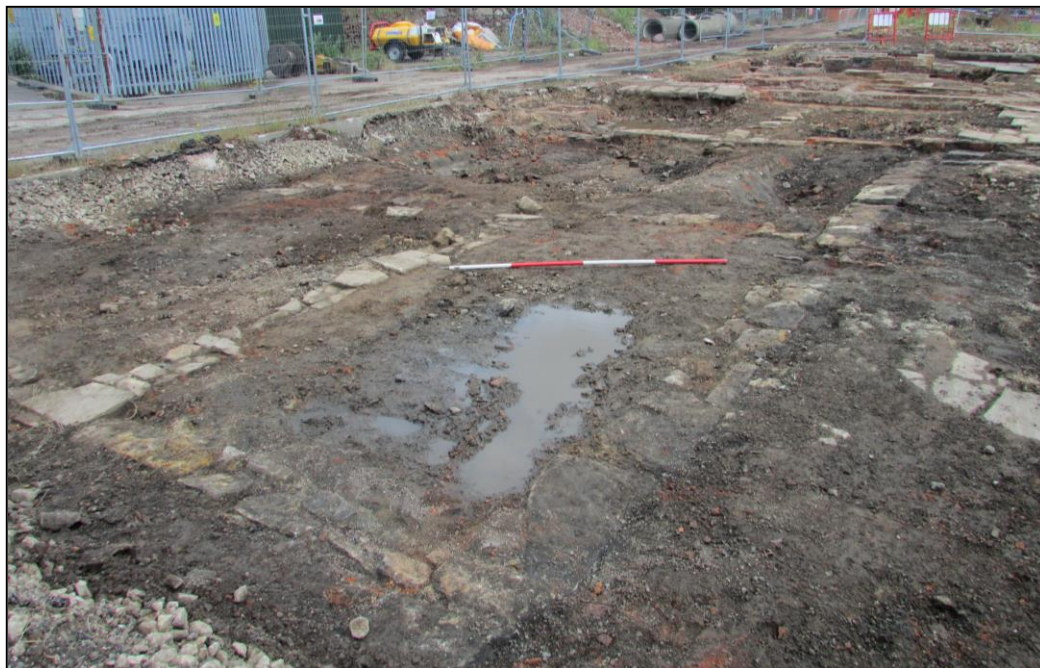
Fig. 11. General view of western side of Area 3. Looking northeast.

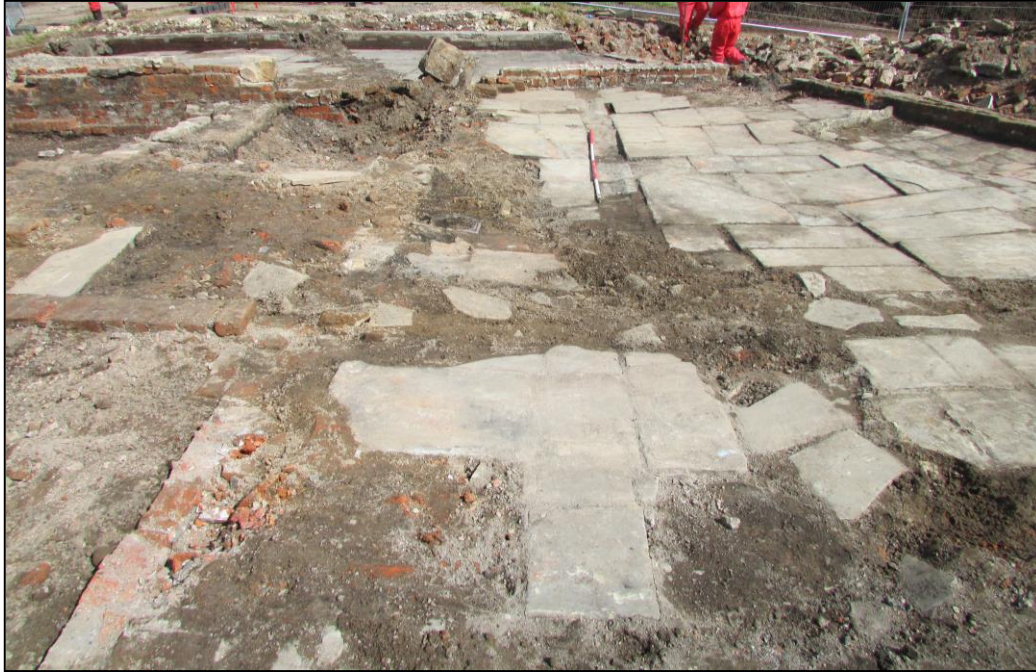
Fig. 12. Floor (044) showing drain and cut [039]. Looking east.

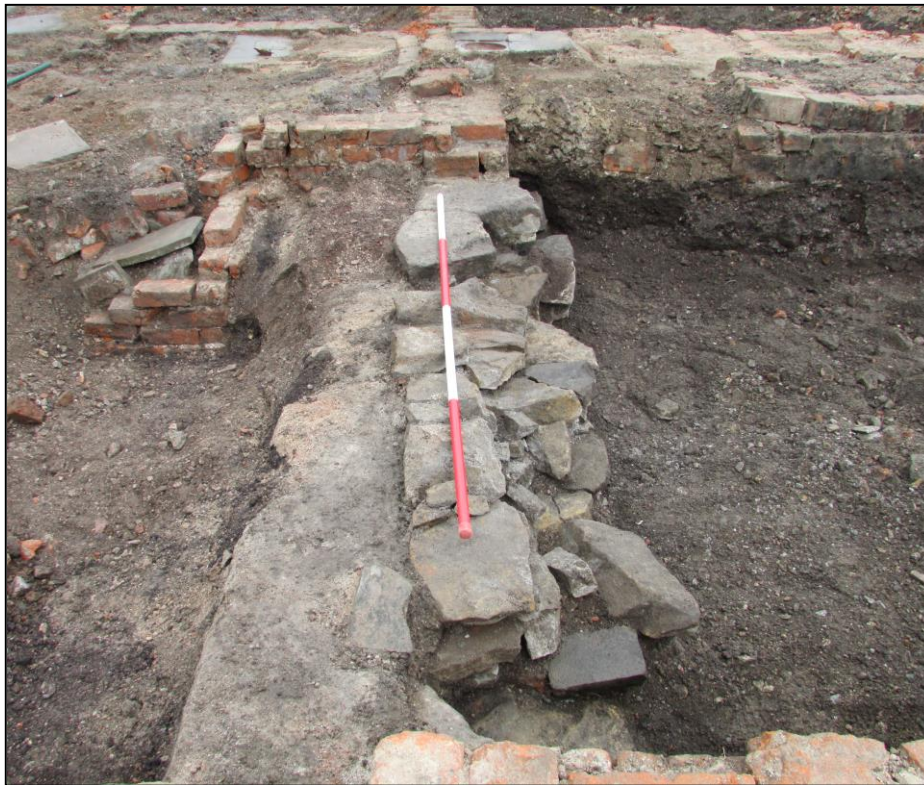
Fig. 13.
Wall (045)
showing (046)
and (047) at
rear. Looking
west.

Wall (047) abutted the western extents of both (064) and (046) was aligned north-south and measured 4.50m x 0.25m. The wall was composed of 2 courses of handmade brick laid with white mortar and possessed two spurs extending c.0.60m westwards c.1.20m apart with a 0.65m square brick feature between. Room 3 was identified to the west of this wall and was enclosed by (041) to the north, (048) and (063) to the south and (050) to the west. This room, like Room 2 was also filled with a dark ashy material containing fragments of brick, stone and mortar (055). A small machine made brick wall (072) was identified extending 1.20m south into the room from (041) which was laid 2 courses wide with white mortar. Wall (048) overlaid (063) both running east-west 4.00m south of (041). Wall (048) measured 1.85m x 0.30m and consisted of 2 courses of handmade brick laid with white mortar. Despite

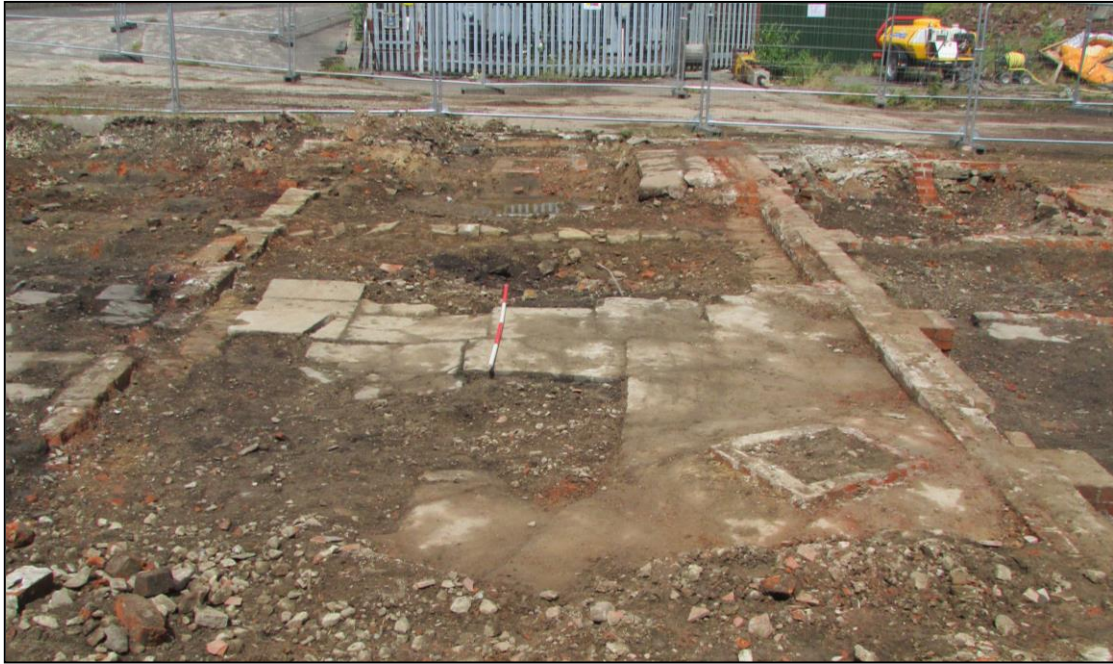
Fig. 14. Floor (051) with Rooms 5 and 6 behind. Looking north.

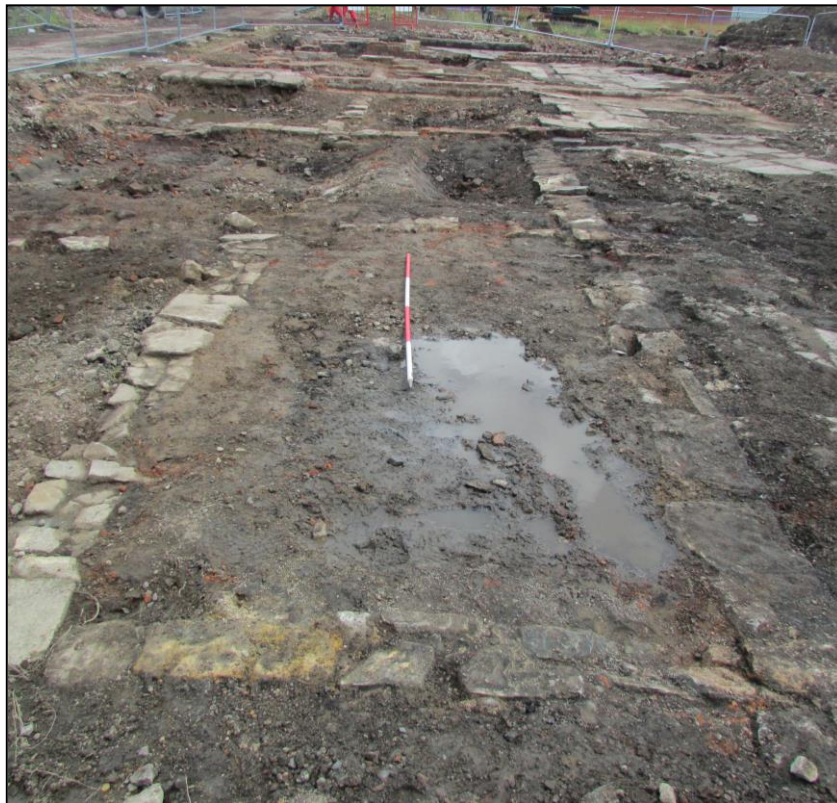
Fig. 15. Detailed view of Room 7. Looking east.

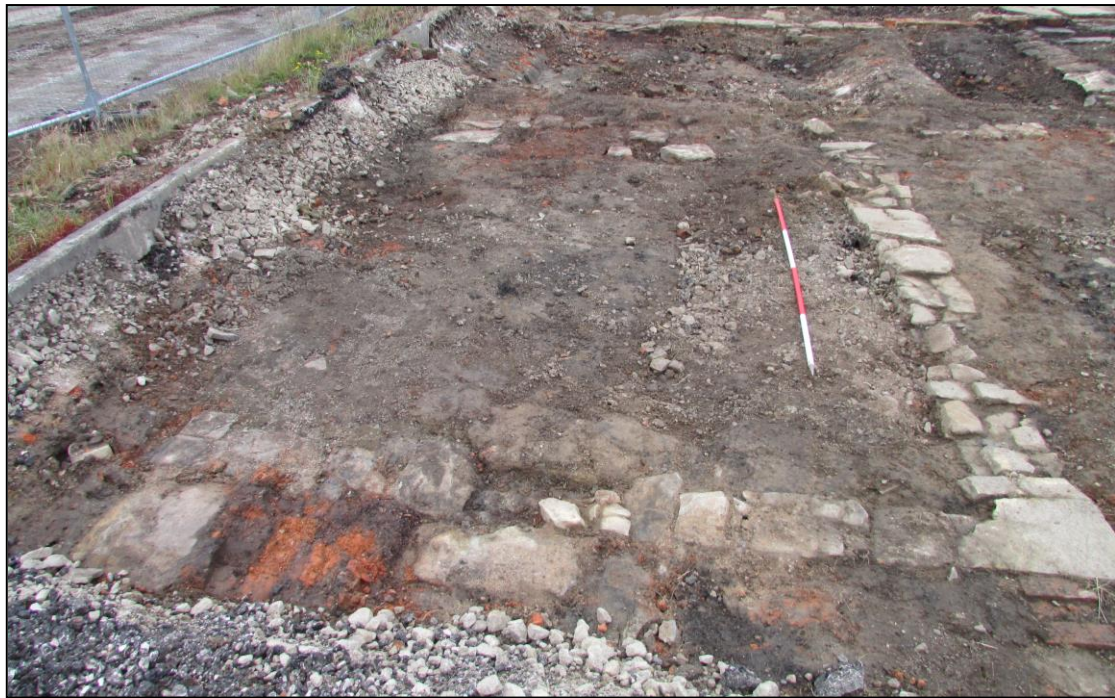
Fig. 16. Detailed view of Room 9. Looking east.

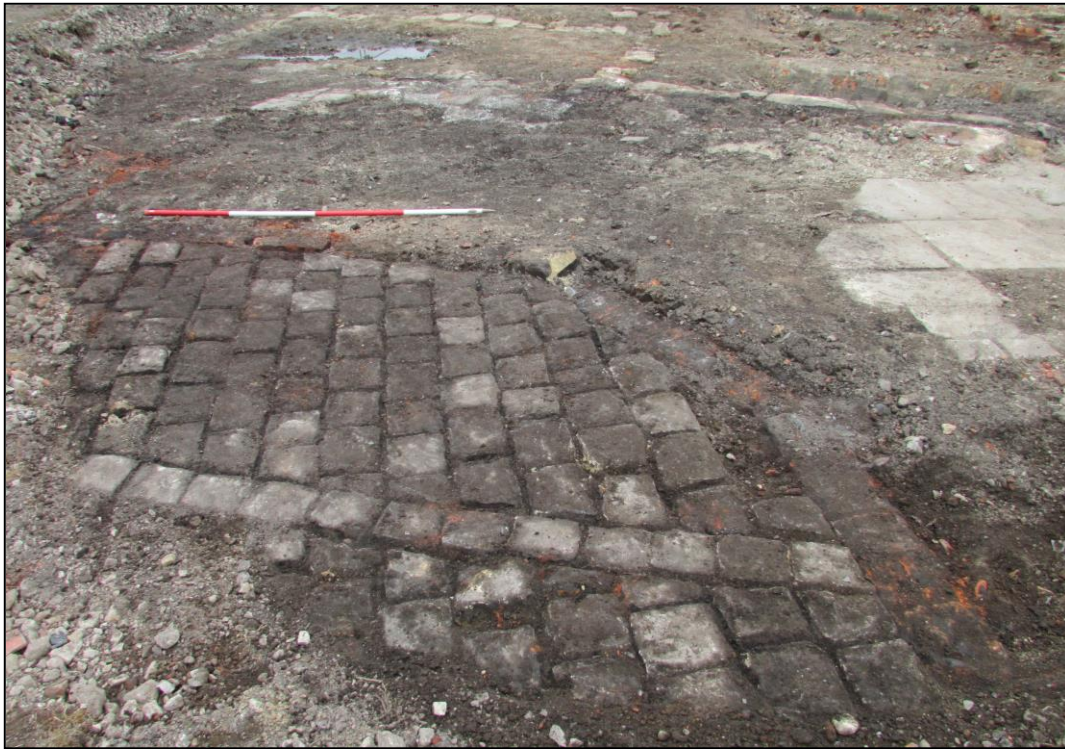
Fig. 17. Detailed view of surface (069) and (066). Looking north.

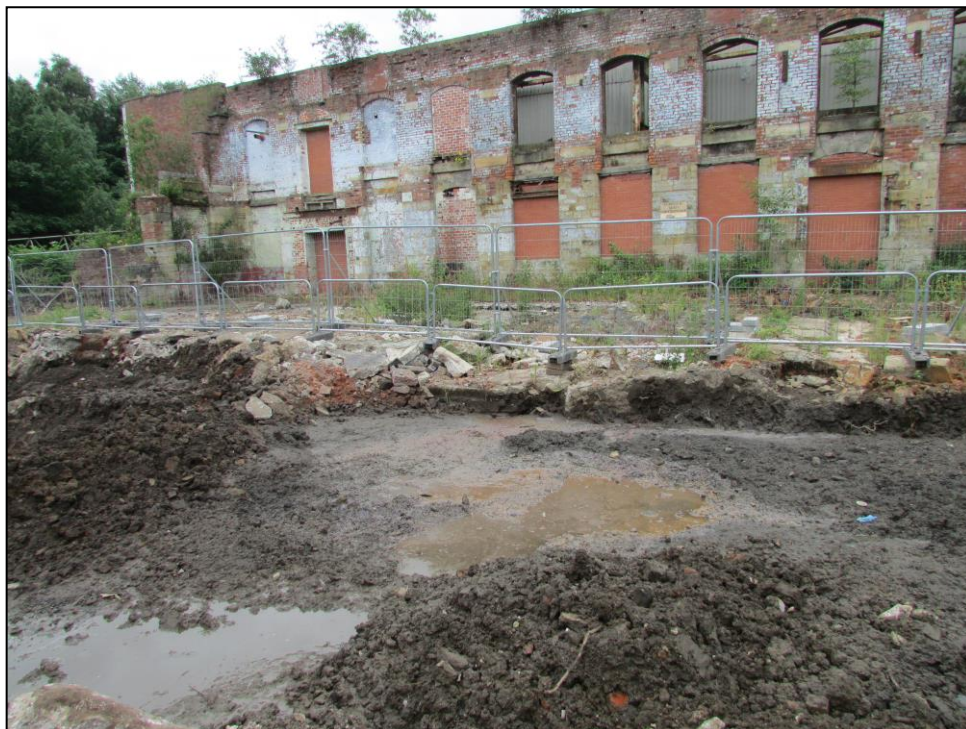
Fig. 18. Area of watching brief showing the lack of features below the concrete raft floor of the 20th century mill structure.

The purpose of the watching brief was to ascertain whether early 19th century features had been preserved further north below this concrete layer. The current works however found that this was not the case and that the concrete layer and associated foundation structures continued northwards and in places, were identified at depths exceeding 3.00m. In addition, a large culvert was found to form the northern boundary of the watching brief area which appears to have been constructed to link the Manchester, Bolton and Bury Canal with the River Irwell to the east. This had also removed all archaeological deposits. As a result the watching brief was only able to identify fragmentary remains of the later paper mill probably dating to no earlier than the 1950s.

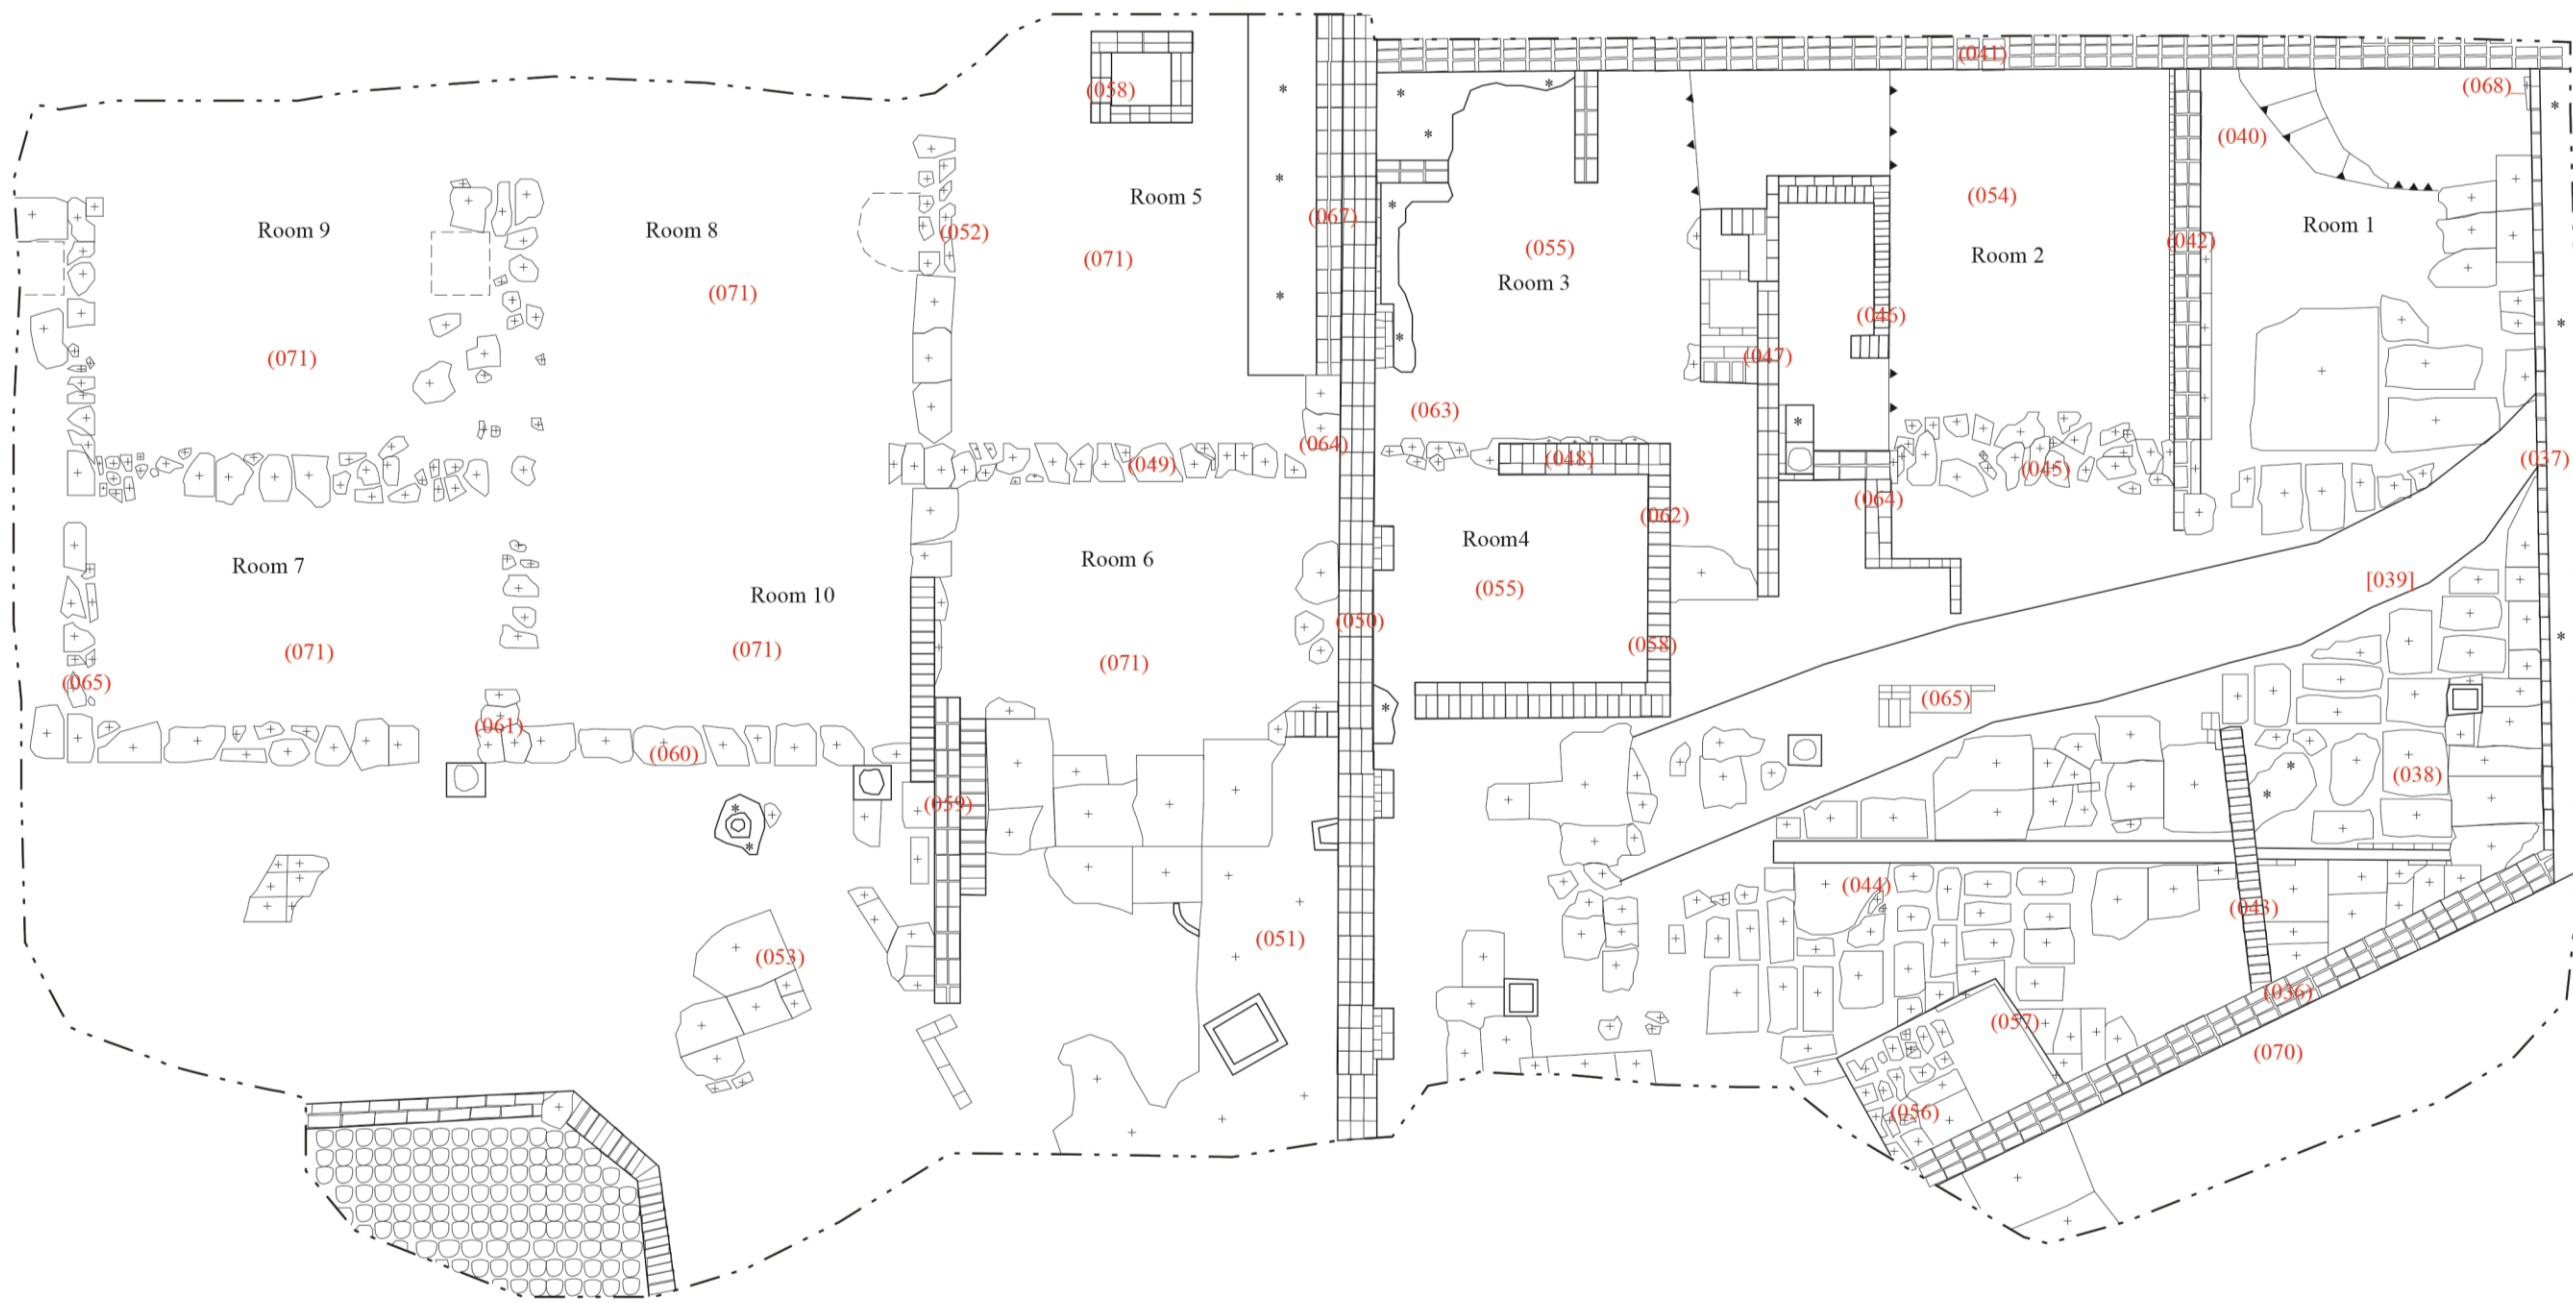
| | <p>Site Name: Wellington Street, Bury Site Code: WS15 Drawing Ref: WS-15-EX-28 Date Drawn: 12/06/15 Drawn By: EH & ES</p> | | |

| <p>The Centre for Applied Archaeology College of Science and Technology The Crescent Salford M5 4WU</p> | <p>Title: Phased plan of Area 3.</p> | <p>Key: + Stone * Concrete (051) Context no.</p> | |

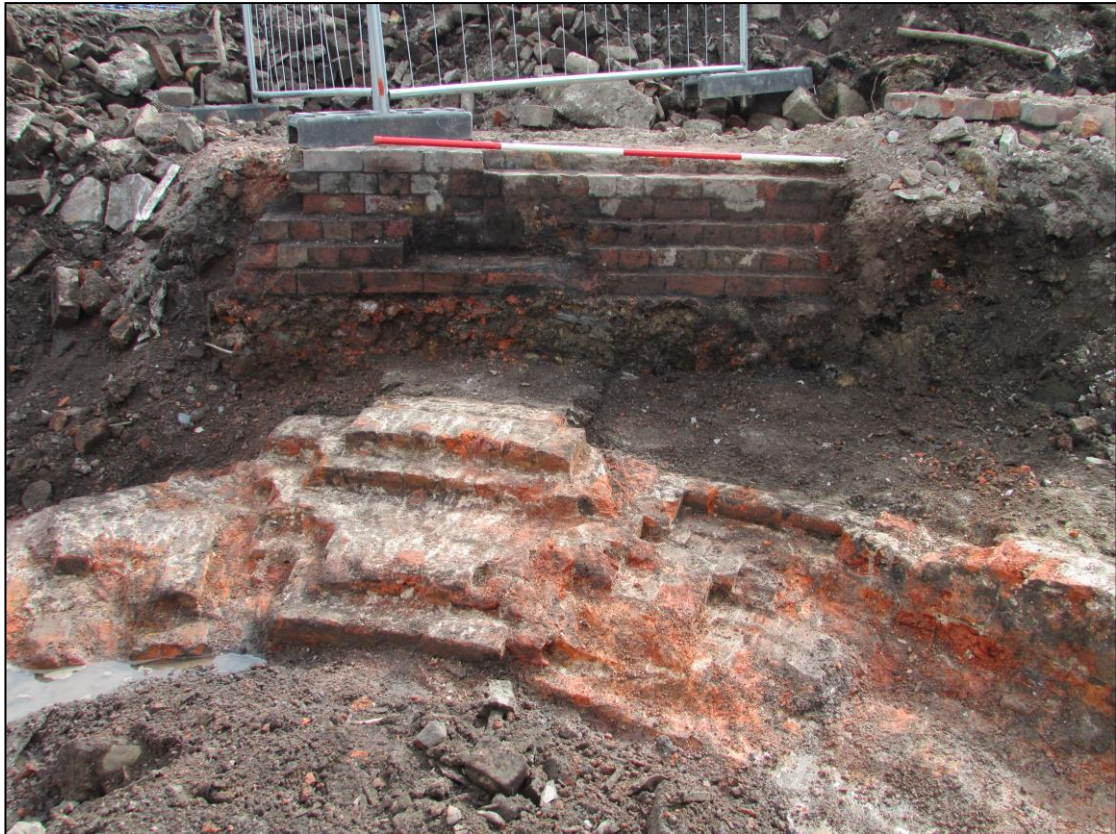
Fig. 30. Detail of wall (076) in Area 1. Looking south.

| (076) | 1 | Machine made frogged brick wall to south of chimney laid in stretcher bond with 3 foundation courses in header bond. |

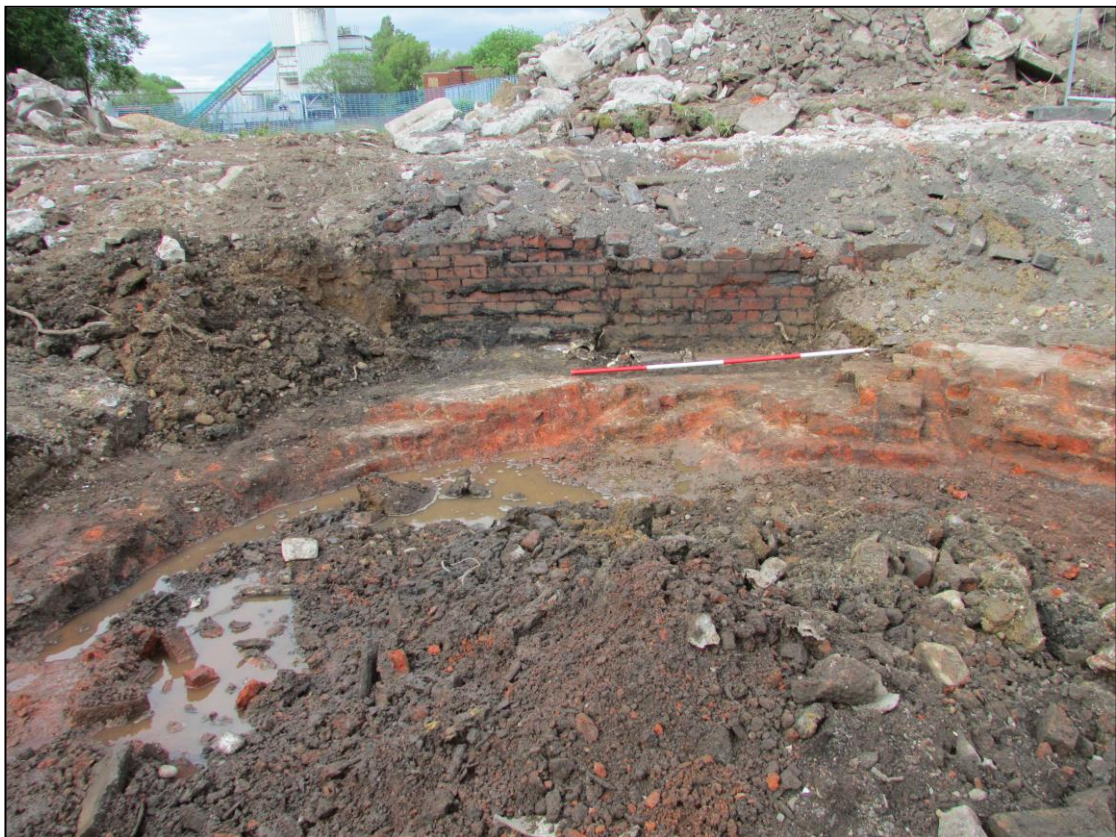
Fig. 31. Detail of wall (073) in Area 1. Looking north.

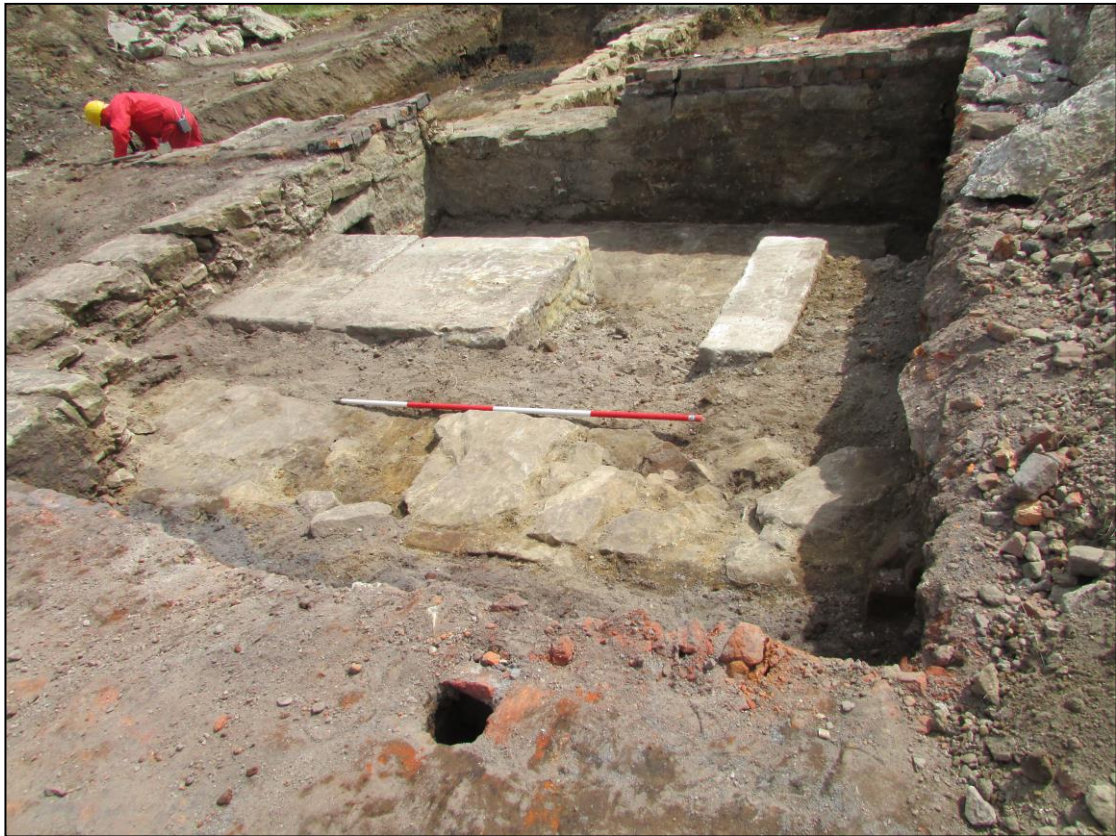
Fig. 32. Area 2, Room 2 showing detail of wall (007) and possible oil sump hole in (008). Looking east.

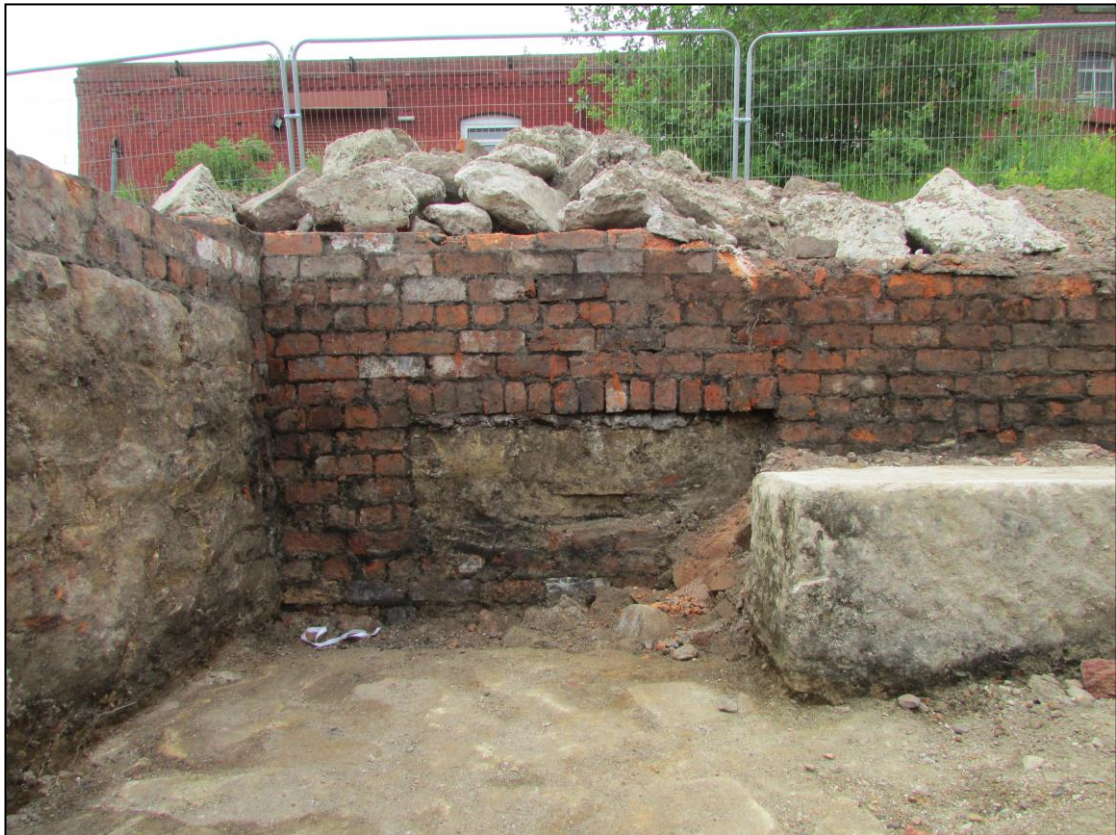
Fig. 33. Detail of stone block within wall (002), Room 2, Area 2. Looking south.

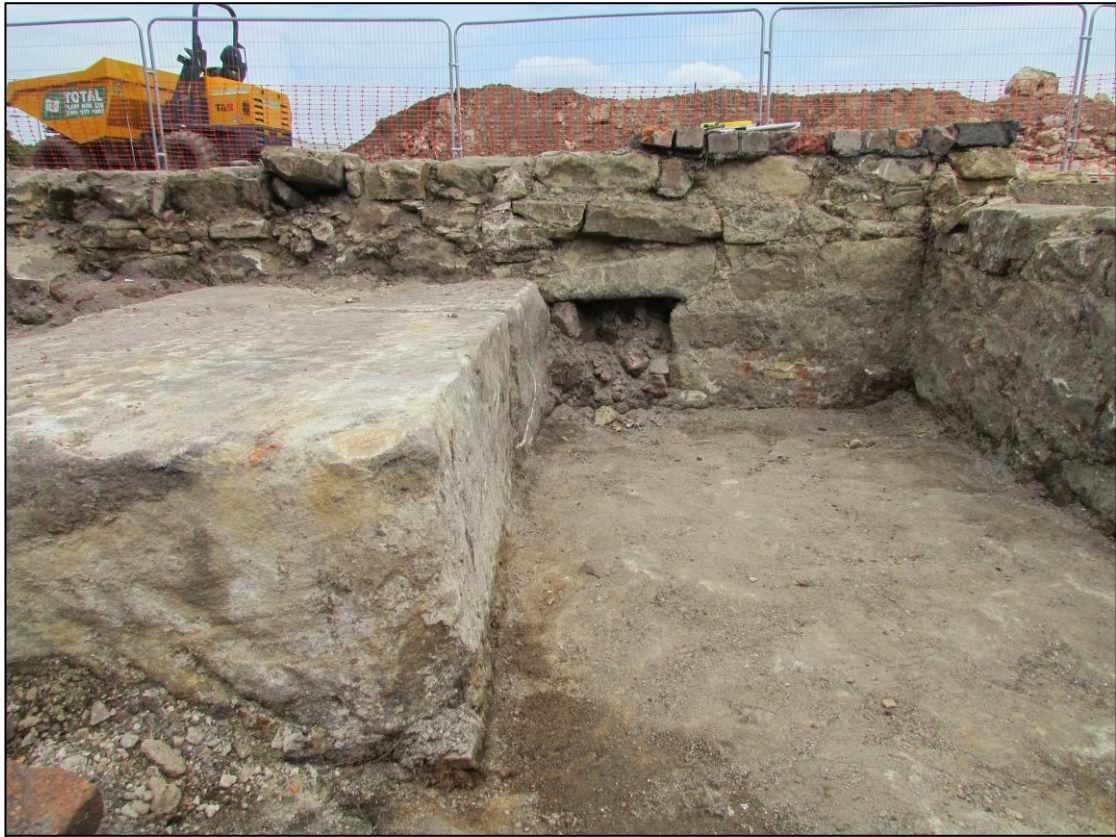
Fig. 34. Room 2, Area 2, detail of opening within wall (005). Looking north.

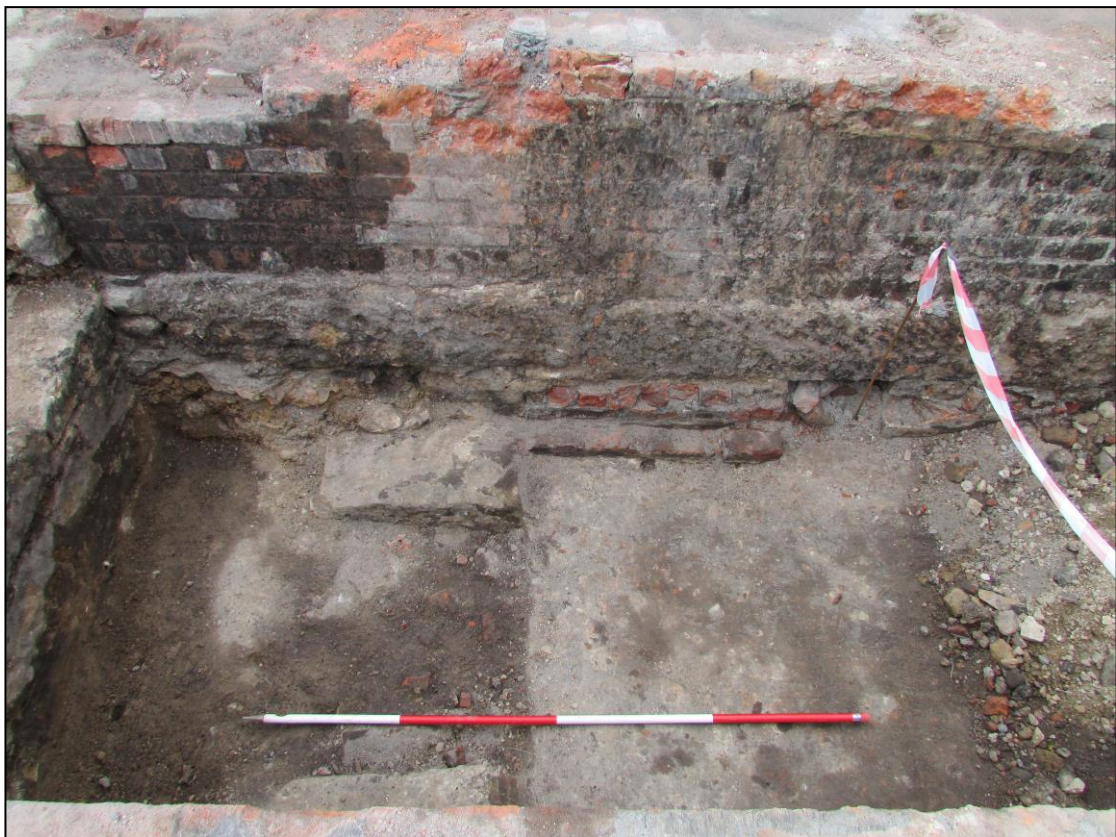
Fig. 35. Detail of space between (008) and (009) showing west facing section of (008). Looking east.
