**Archaeological
Excavation**

Wellington Street,
Bury.

Technical Report:
Sarah Cattell

Report No: 20/2015

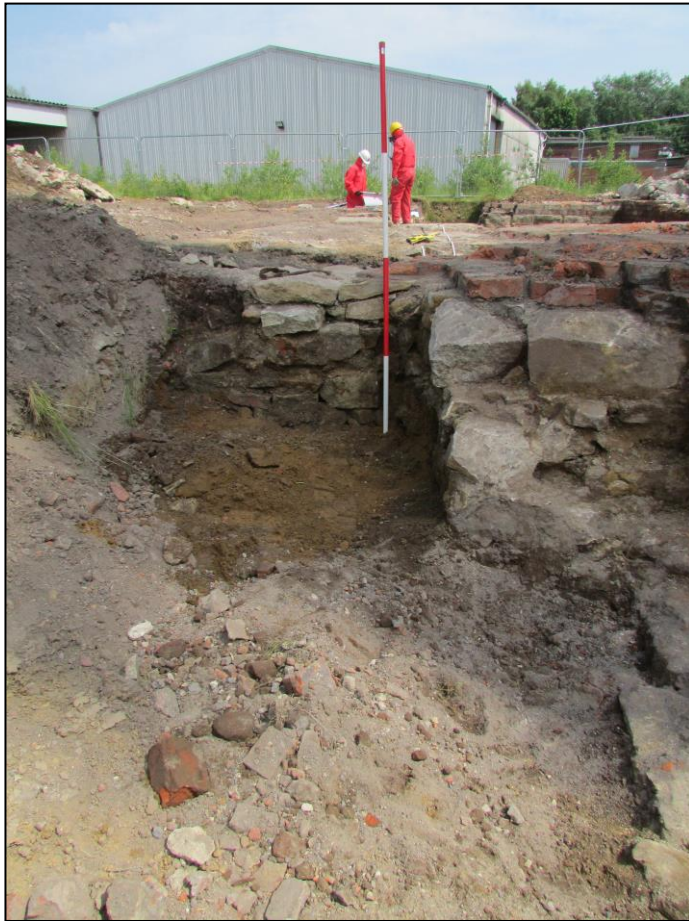
Fig. 36. Detail of wall (011).
Looking east.

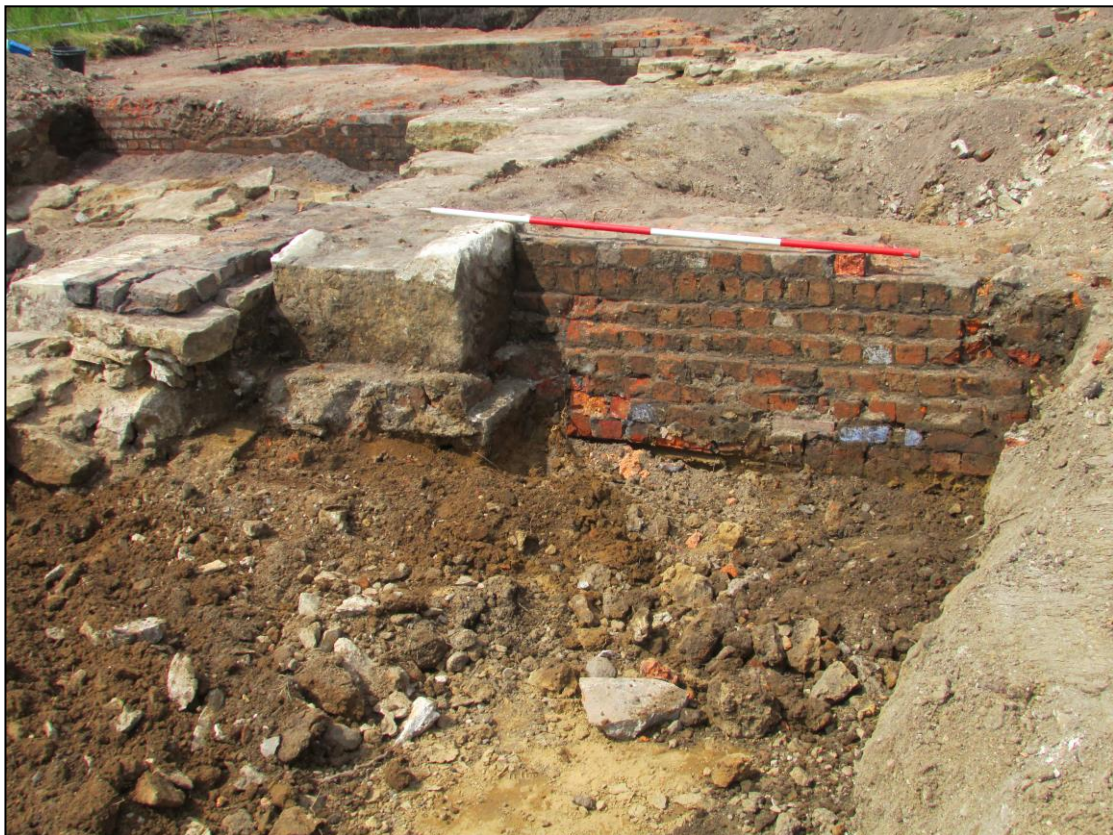
Fig. 37. Area 2 showing wall (006) with inset stone pillar base. Looking west.

| Context Number | Area | Description |
|---|---|--|
| (006) | 2 | Brick wall running N – S, continues N into baulk. Abuts (021) and (005). 5 projecting foundation courses and stone pillar base at the south with bolts. |

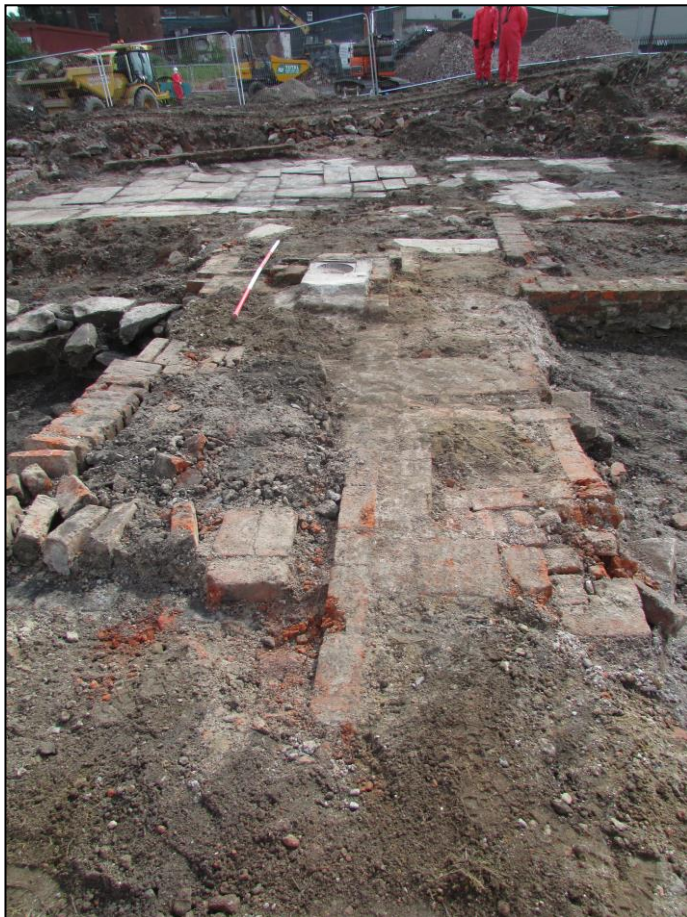
Fig. 38. Area 3 showing detail of (046). Looking south.

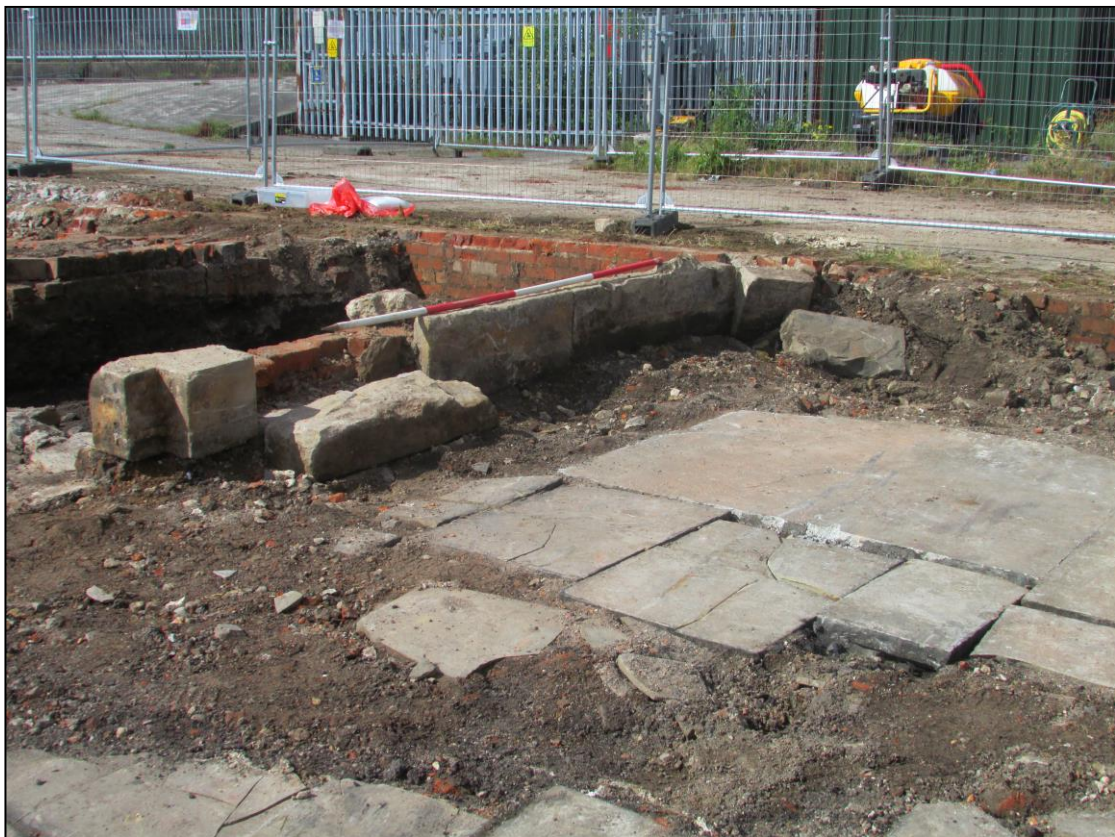
Fig. 39. Area 3 showing detail of wall (042). Looking northwest.

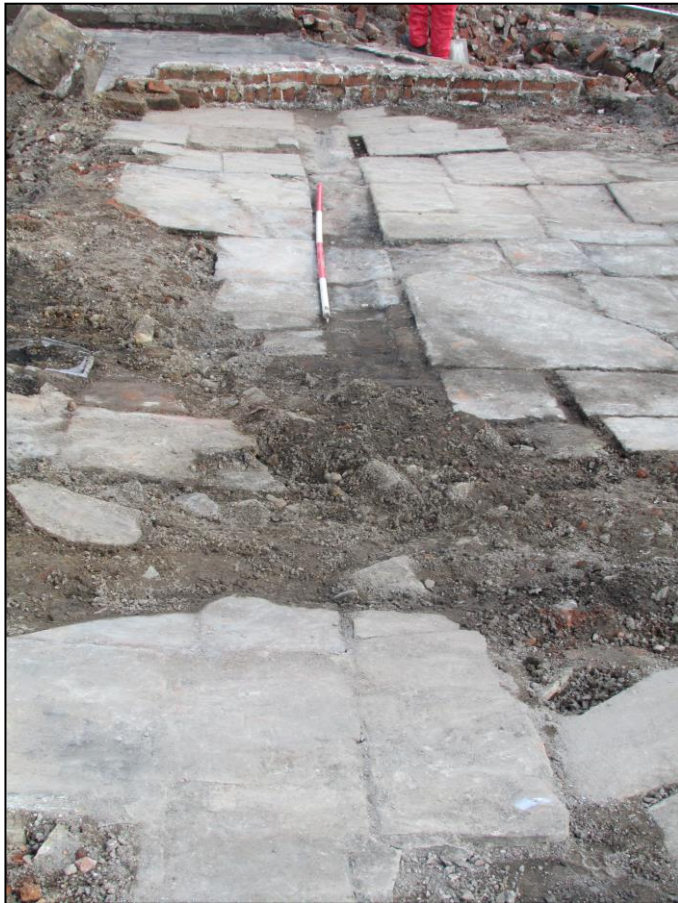
Fig. 40. Area 3 showing detail of drainage channel within floor (038). Looking east.

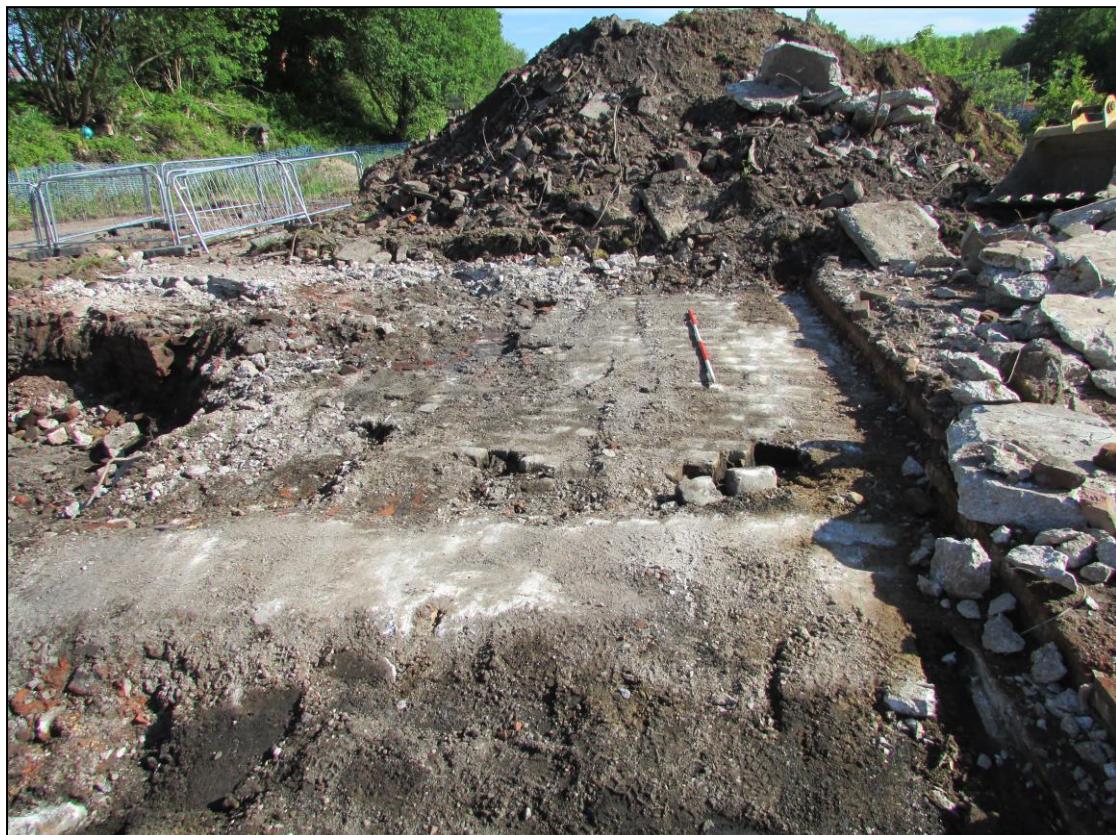
Fig. 41. Northern side of watching brief area showing an extension of the concrete floor revealed during the 2014 evaluation. Looking north.

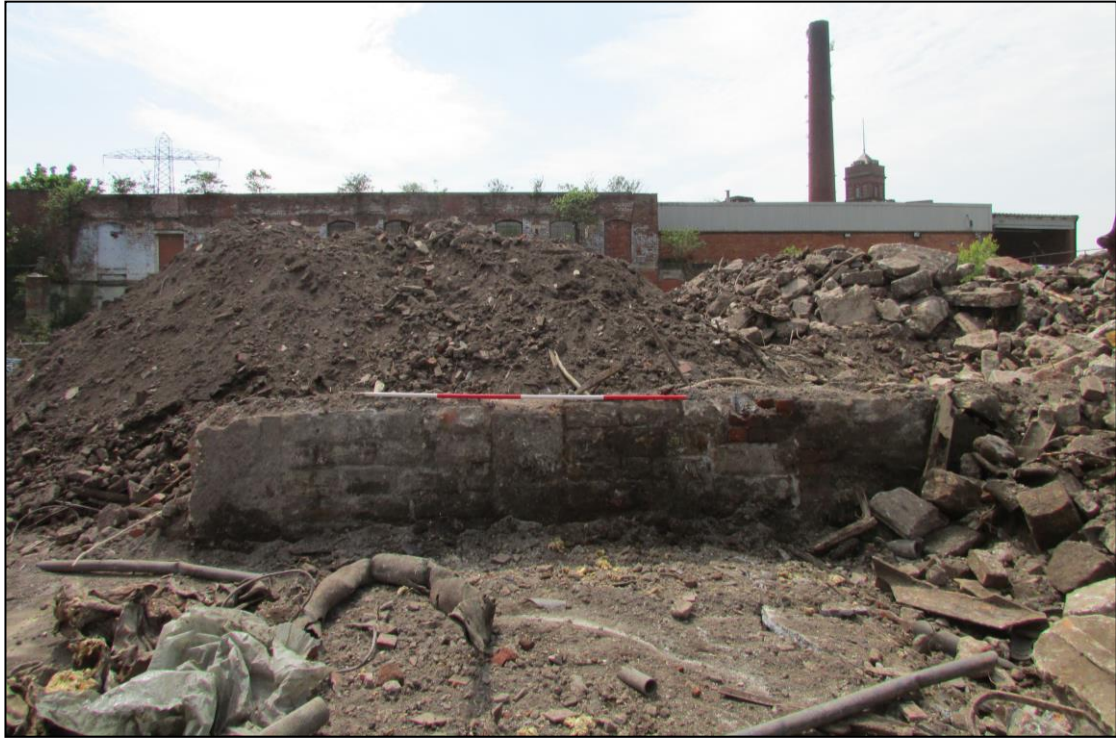
Fig. 42. Stone and concrete wall identified in the northern end of the watching brief area. Looking south.
