**Archaeological
Excavation Report**

Land off Stanley Street,
Central Salford: Plots
B5/6 (New Bailey
Prison)

Technical Report:
Rachael Reader

Report No:
2015/07

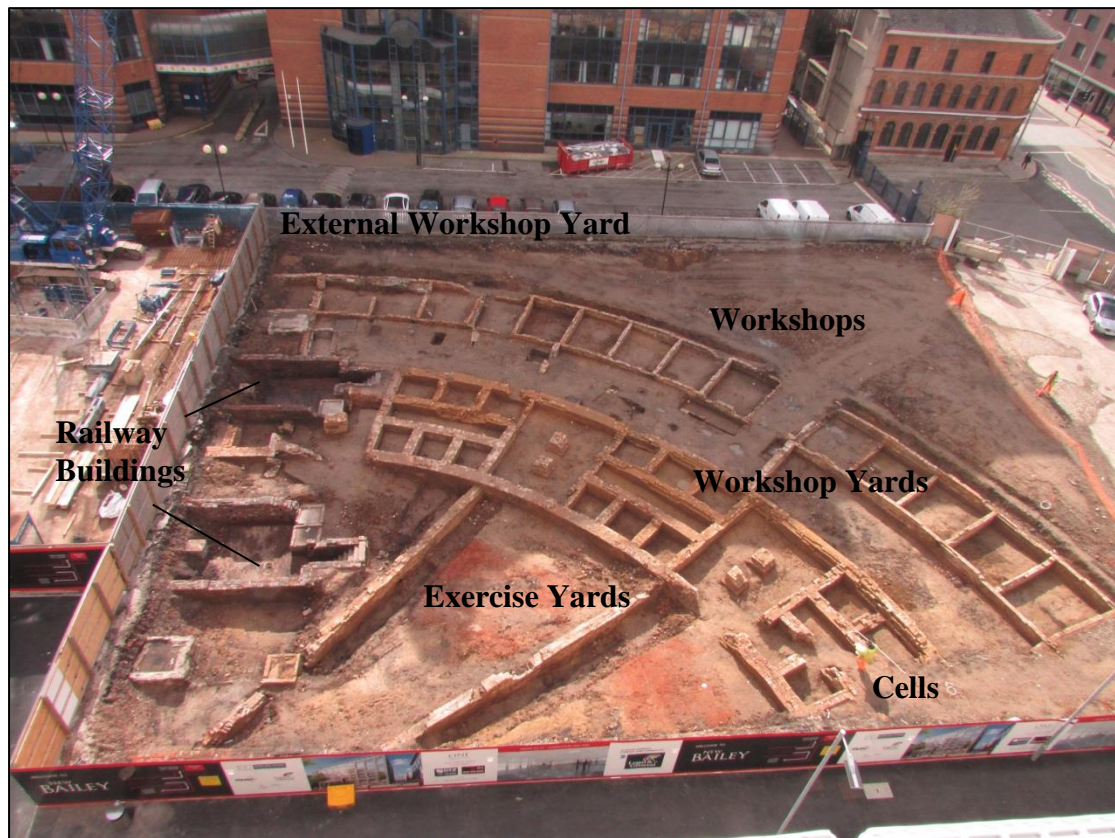
Fig. 2 Excavated area, showing main features referred to in the text

The excavation area was broadly rectangular and measured a maximum of 43.00m in length and 37.00m in width. The remains uncovered were the foundations of the prison buildings but the evidence suggests that they were at or close to the original floor level.

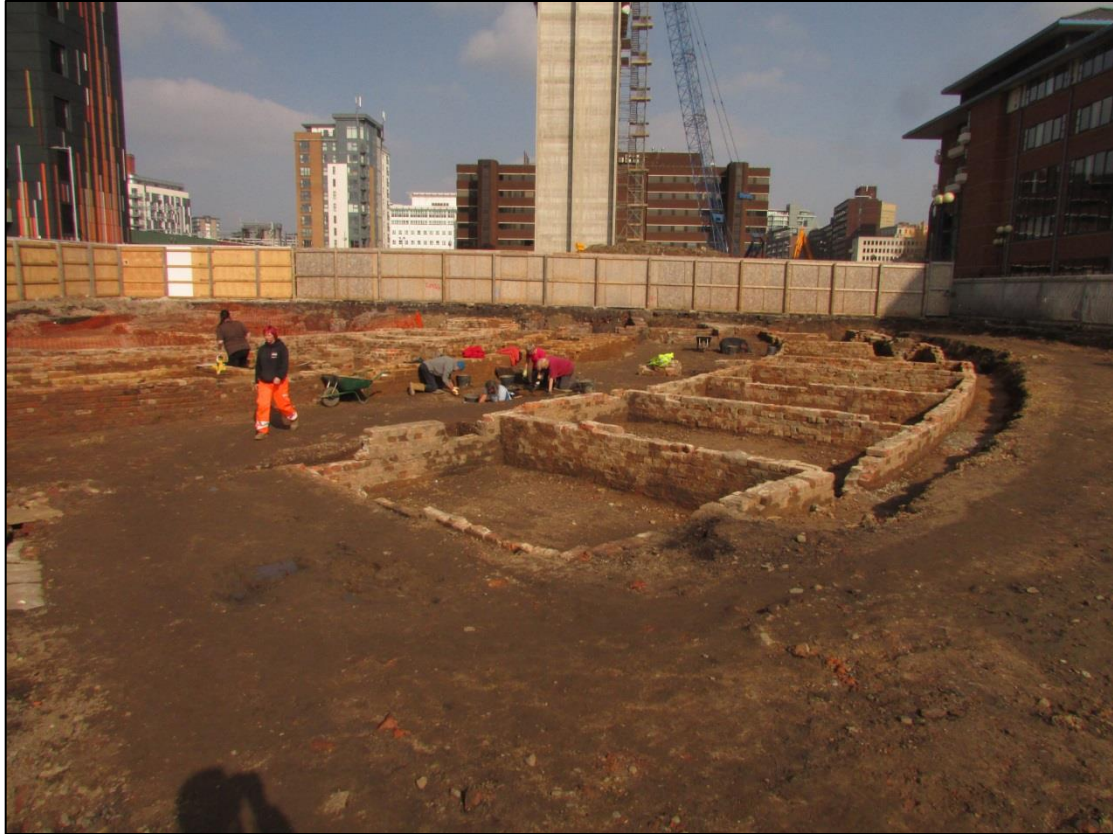
Fig. 3 Eastern part of the workshops, after excavation. Walls (008) and (009) define the workshop building (looking NE)

Linear cut [148] was visible truncating deposit (147) and measured 0.25m wide and a maximum of 1.50m deep. This was infilled by (008), a handmade brick wall, two courses wide curving round from NE to NW and bonded with a compact light brown mortar. The bond was broadly English with a step out either side measuring 0.07m. The wall was 0.24m wide and was excavated to a maximum depth of 2.00m. The cut and the wall was backfilled by (149), a friable light yellow brown silty clay with frequent inclusions of small rounded pebbles. This was infilling cut [148] to the same width and depth. (009) ran parallel with (008) and was a handmade brick wall, two courses wide and also curving round from the NE to the NW. The bricks were bonded with a compact light brown mortar and a mixed bond was visible. This wall was 0.24m wide and excavated to a maximum depth of 0.80m. No cuts were visible along the interior face of these walls (S of (008) and N of (009)) and deposit (150)

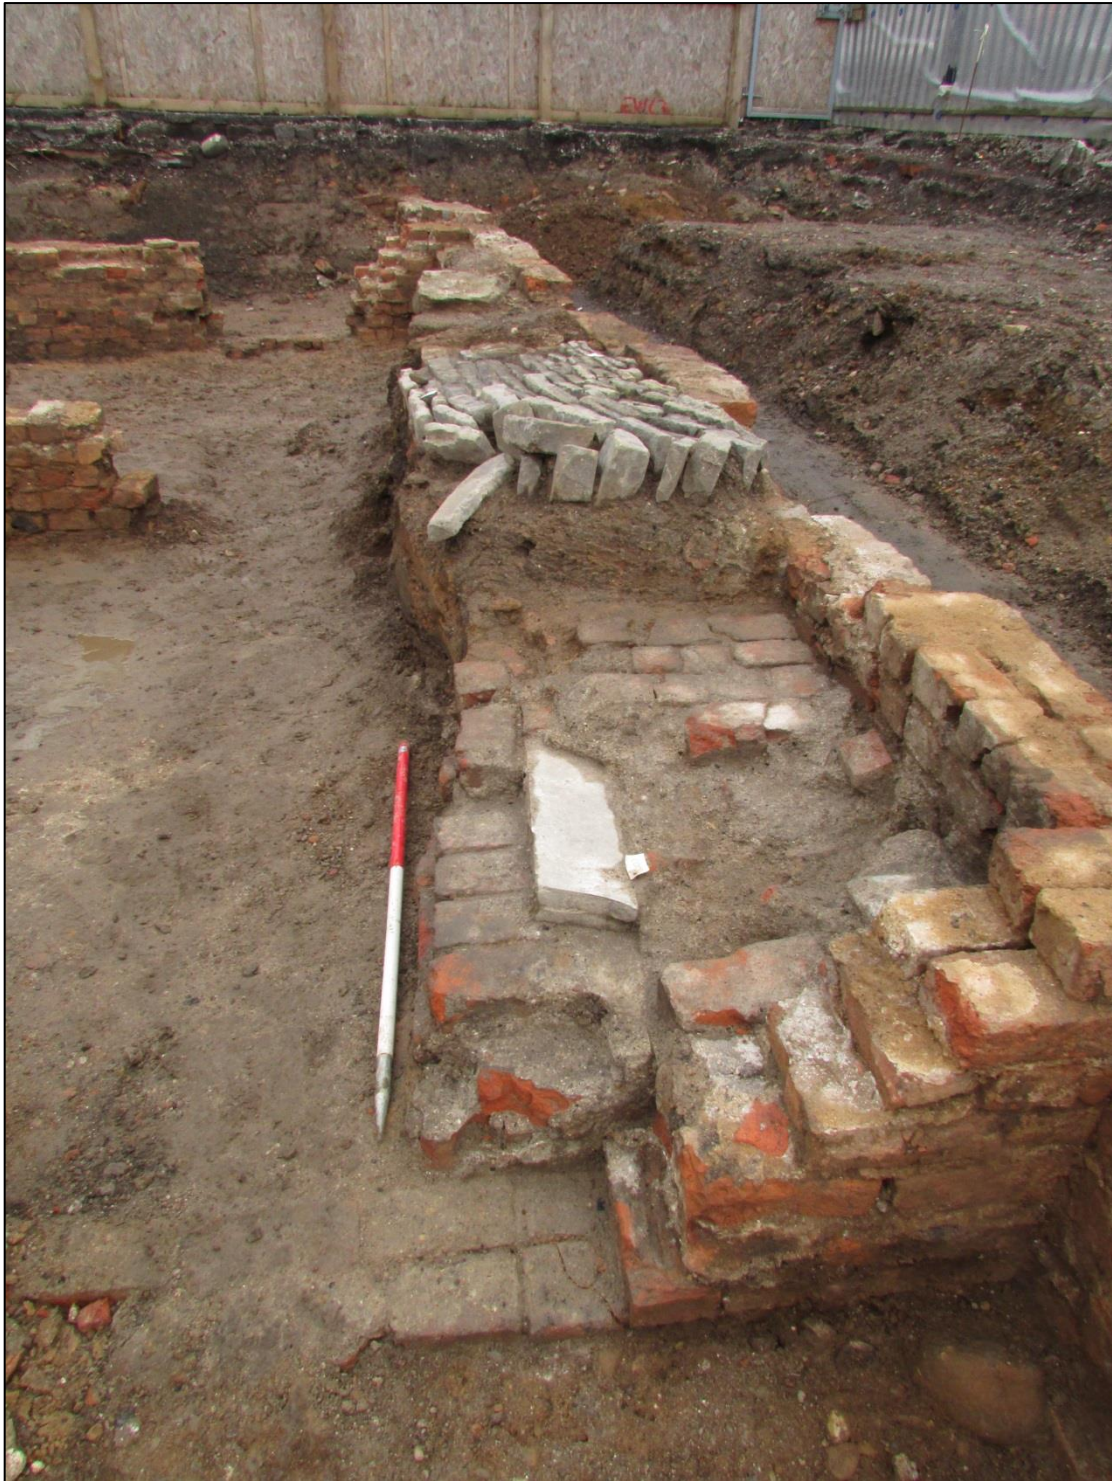
Fig. 4 Brick plinth (014) and surface (013) in the background

(008) and (009) had a series of walls keyed into them which split this curve into fifteen visible partitions and these are described from NE-NW. **(011)** is the first of these walls and was a handmade brick wall, two courses wide and orientated NW-SE. The wall was bonded with a mid-brown mortar and had a mixed bonding pattern. The wall measured 4.20 x 0.24 x 0.42m (excavated depth) and was keyed into walls (008) and (009) and was also sealed by (150), as were the other cross walls. **(014)** ran parallel with (011) was located 3.00m to the SW. This was a handmade brick wall, two courses wide, orientated NW-SE and mortared with a light brown compact material. This measured 4.30 x 0.24 x 0.70m (excavated depth), keyed into (008) and (009) and was abutted by **(013)**, a handmade brick plinth measuring 0.75 x 1.10 x 0.35m (excavated depth). This also abutted (009) and was mortared with a loose light whitish grey mortar, with a large stone flag (measuring 0.60 x 0.20 x 0.05m) constructed into it also. Immediately NE of (013) was **(012)**, a flagstone floor surface with the stones laid on side, covering an area measuring 1.80 x 0.90 x 0.15m. The stones were regularly laid and on average measured 0.19 x 0.04 x 0.15m and were set into (150) (see Fig. 4).

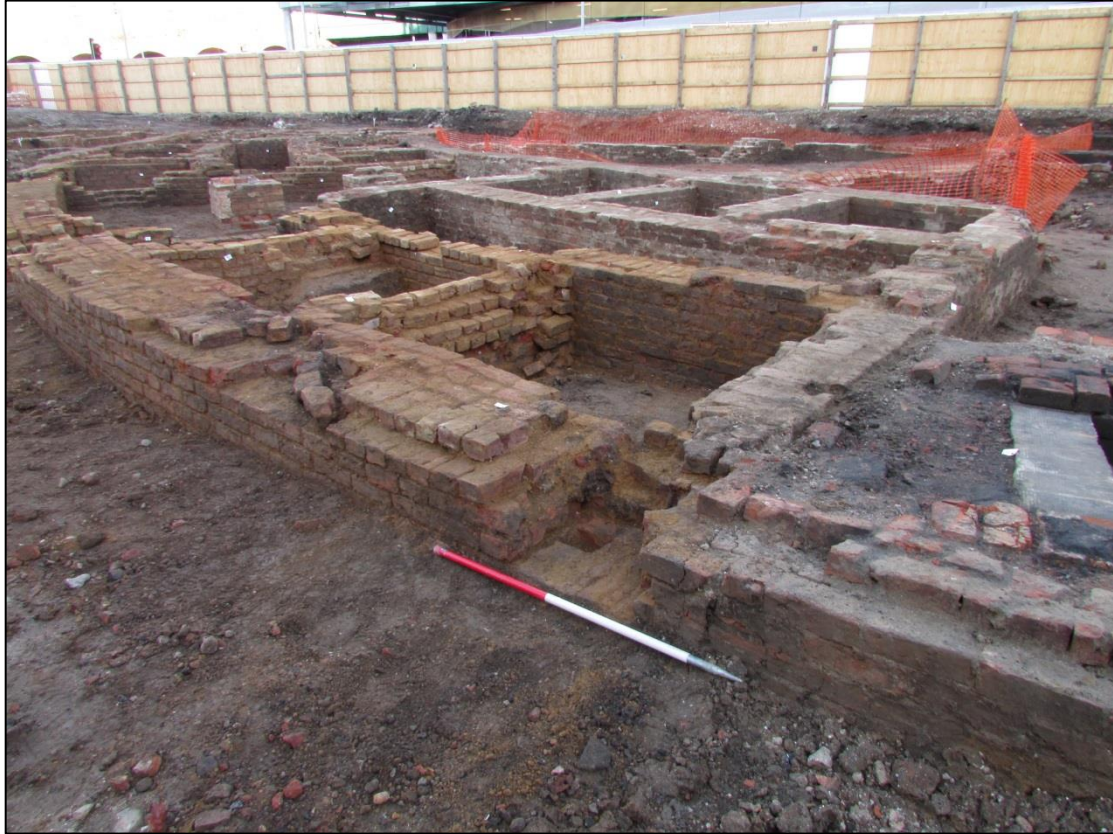
Fig. 5 Shot across part of the Male Felon Cell building, with wall (058) in the foreground

It was defined on its S side by (058), a handmade brick wall, six courses wide and curving from NE to NW. The wall was bonded in a mixed pattern with a fairly loose light yellowish brown mortar. This wall measured 37.50 x 0.75m and was visible across the length of the excavated area. The maximum depth excavated was 2.00m. (057) ran parallel with (058) to the N and was a handmade brick wall, six courses wide and curving from NE-SW. The wall was of a mixed bond with a compact light brown grey mortar, measuring 24.00 x 0.75m and excavated to a maximum depth of 2.30m. (057) was truncated to the NE however running along the same line was (054), a handmade brick wall, six courses wide and orientated NE-SW. The bonding was mixed with some rows of headers laid on side and the bricks were bonded with a compact light brown grey mortar. The overall dimensions were 2.00 x 0.80 x 0.85m (excavated depth) and was abutted by what appeared to be later walls to the NE (see below),

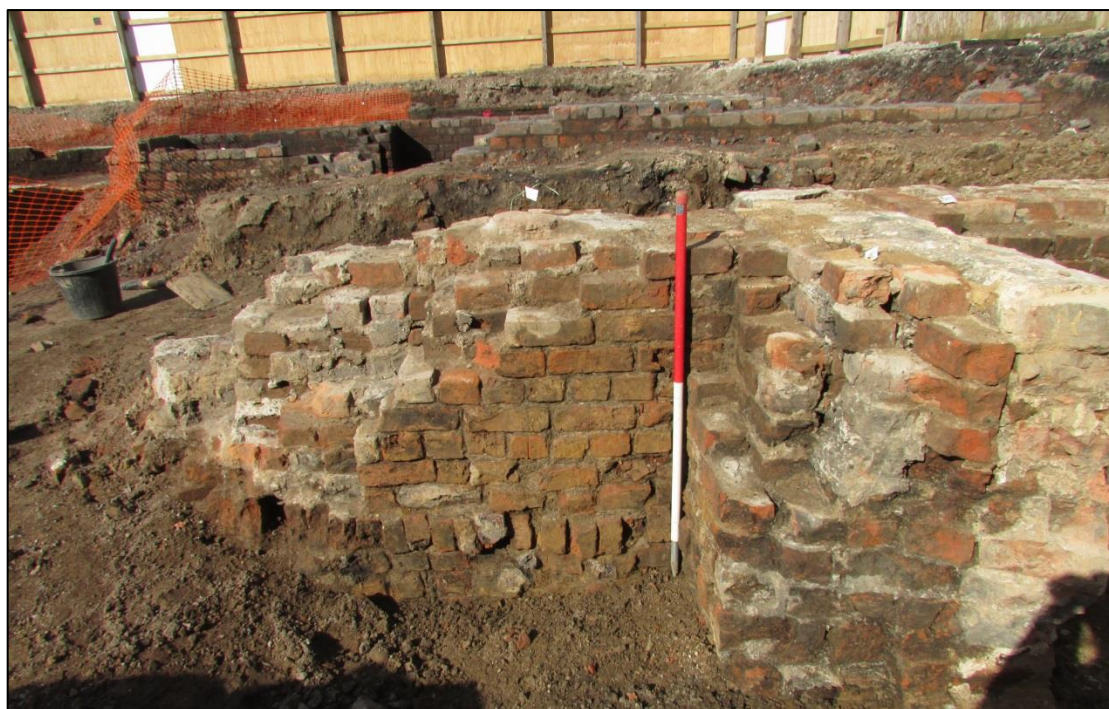
Fig. 6 Wall (054) with irregular bonding and possible later walls running off to the right

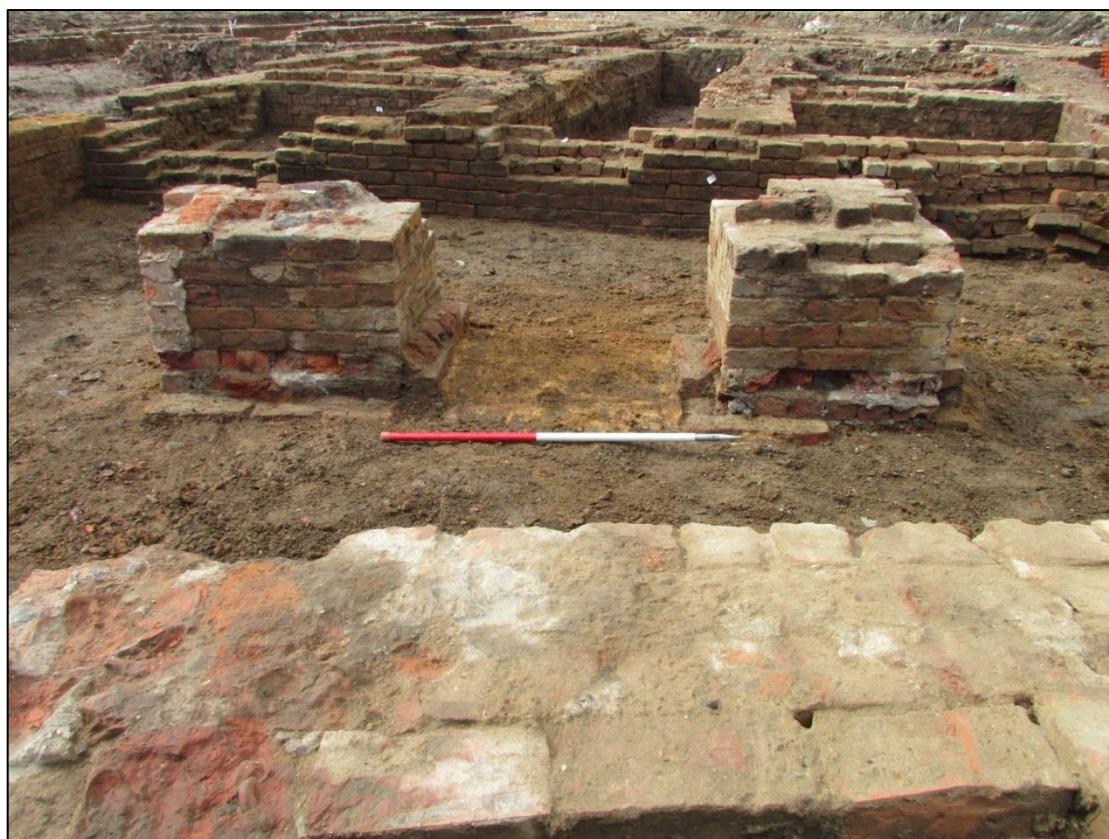
Fig. 7 Brick pillars (103) (on the left) and (104)

Located to the W of (097) was **(103)** and was a handmade brick pillar measuring 1.00 x 0.95 x 0.75m (excavated depth). The bricks were stretcher laid and bonded with compact mortar, which varied between a light brown grey and white grey material. There was possible evidence for rebuild or repair along the S side of this pillar but evidence for this was not conclusive. Located 1.00m to the N of (103) was **(104)**, a handmade brick pillar measuring 1.00 x 0.86 x 0.76m (excavated depth) with a one course wide plinth at the excavated depth limit. The bricks were stretcher laid and was bonded with compact mortar which varied between a light brown grey and white grey material (see Fig. 7).

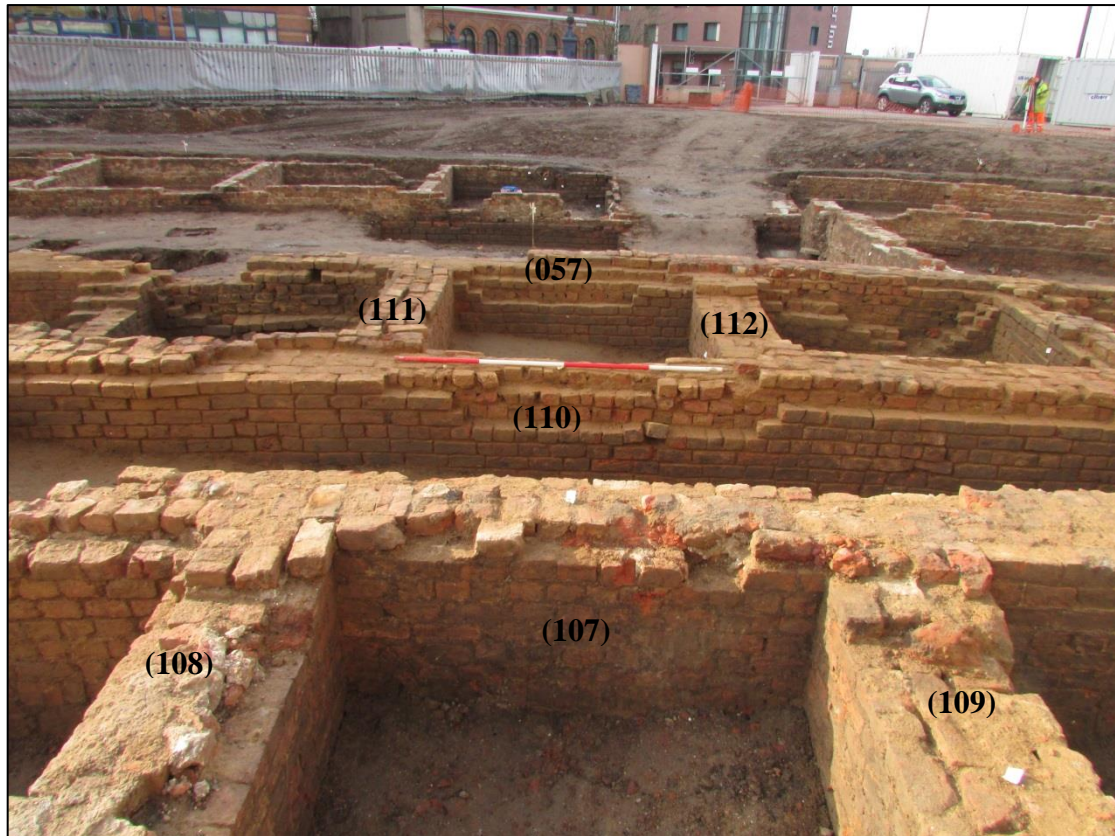
Fig. 8 General shot of cells and dividing corridor

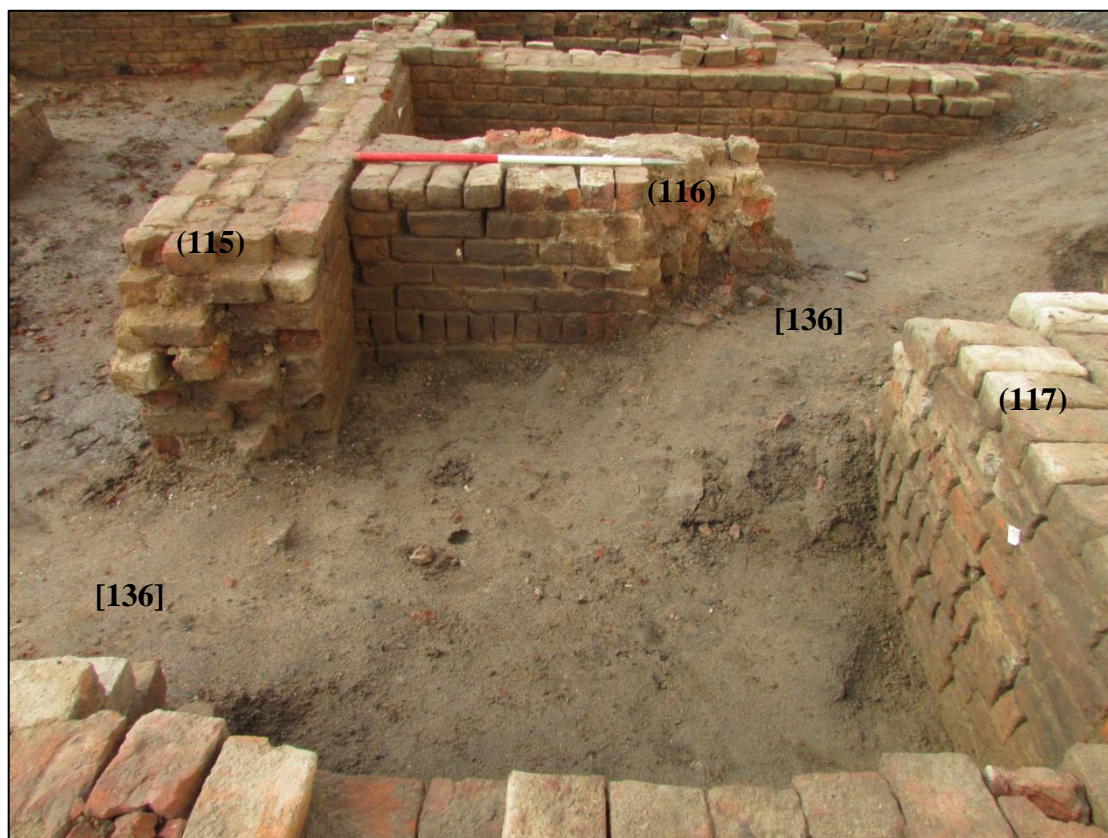
Fig. 9 Western part of Male Felon Cells showing later truncation

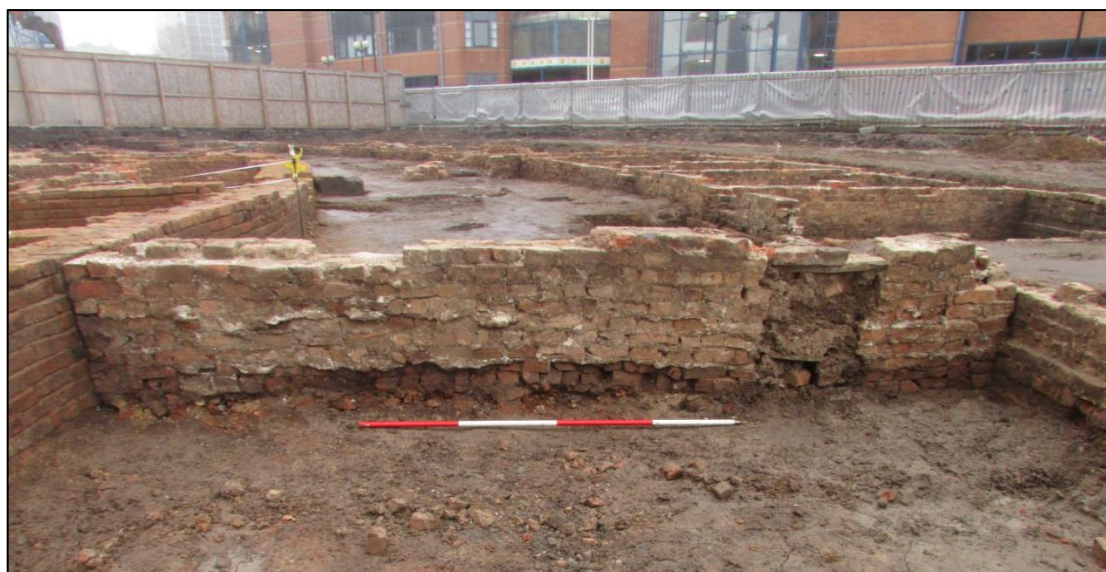
Fig. 10 Wall (074) within Workshop Yard

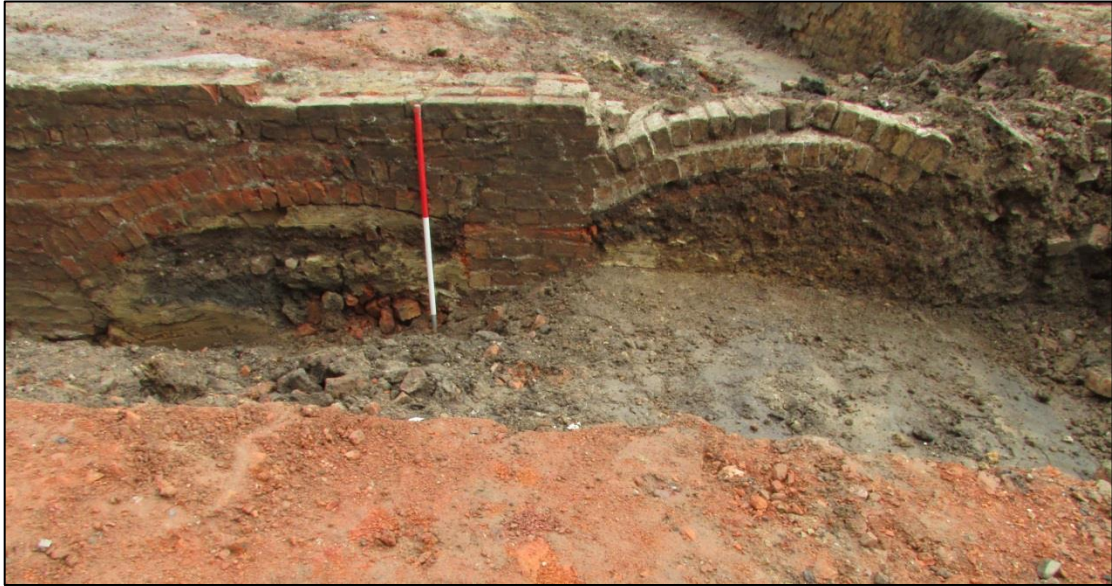
Fig. 11 Examples of the segmented arches within wall (094)

Running NE from wall (057) was (094), a handmade brick wall, four courses wide and orientated N-S. The bonding was mixed and the bricks were mortared with a compact white-grey mortar. Its overall dimensions were 12.90 x 0.48 x 1.50m although the wall was truncated at its SW end and four arches were constructed into this wall (see Fig. 11). These were segmental arches, consisting of two rows of headers laid on side. They appeared to be assymetrical and were cut into (146) and (147). The foundations for the wall consisted of mortar, brick and stone fragments. Physically above (147) and sealing wall (087) was (162), a mixed compact clay deposit with lenses of grey silty clay and loose red silty sand with inclusions of small brick fragments. This measured up to 0.30m in depth and was in turn sealed by

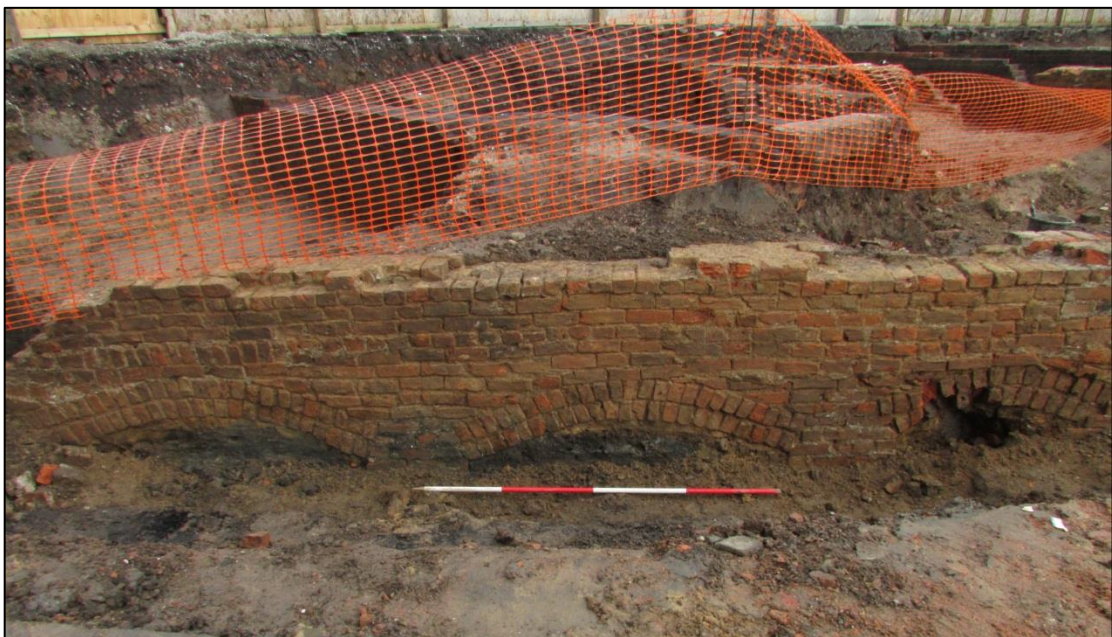
Fig. 12 Segmental arches within wall (087)

Running parallel with (094) to the NE and abutting wall (057) was (087), a handmade brick wall, four courses wide and orientated N-S. The bonding was mixed and the bricks were mortared with a compact white grey material. Its overall dimensions were 11.40 x 0.48 x 1.50m but was partially truncated at its N end and truncated (146) and (147). Five segmental arches were also constructed into this wall (see Fig. 12), consisting of two rows of headers laid on side and appeared to be broadly symmetrical. The foundations were partially revealed and were comparable to those observed for (094). Physically above (147) and sealing wall (087) was (162), which measured up to 0.50m in depth here.

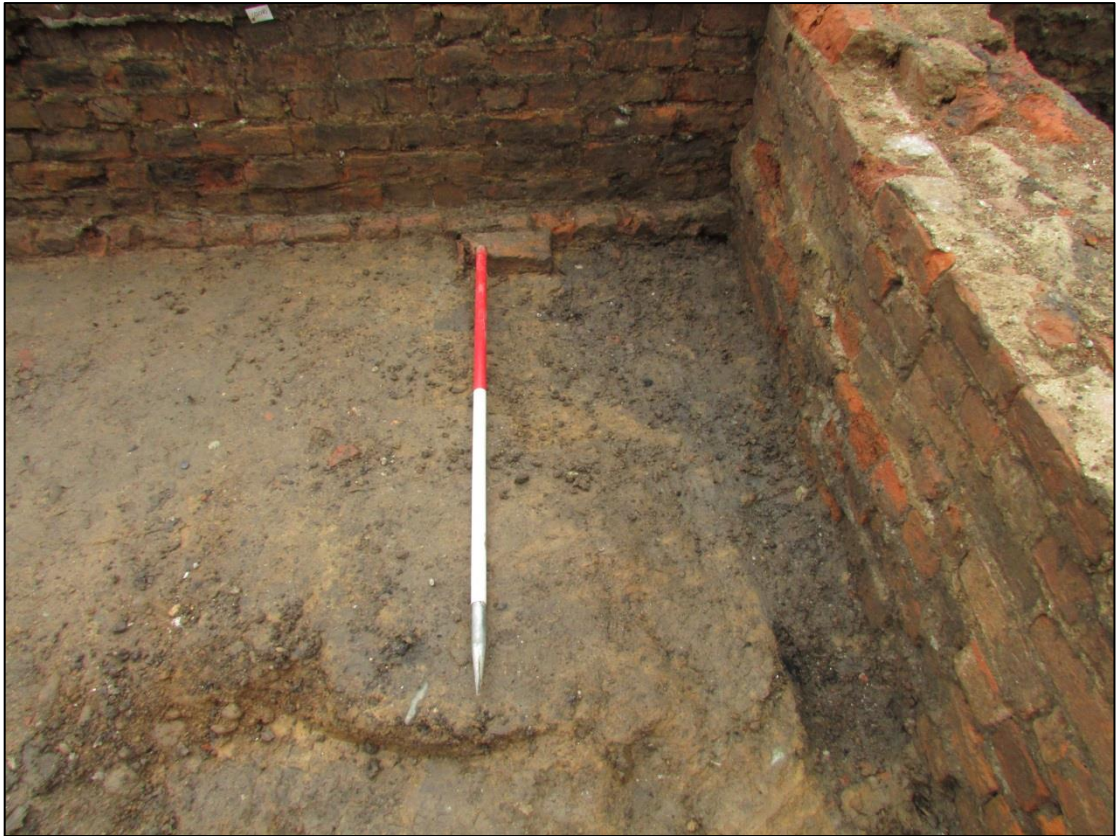
Fig. 13 Cut [166] for wall (010) (to the right)

There was evidence for a later extension to the E of the workshops, with cut [166] truncating deposit (150). This was broadly linear in shape and measured up to 0.35m in width. The cut was not excavated but was infilled with (167), a friable dark brown grey clayey silt with inclusions of small brick fragments. This deposit was left unexcavated and it was infilling the foundation of (010), a handmade brick wall, four courses wide and orientated NW-SE. Bonding of the wall was mixed and the bricks were bonded with a compact light brown mortar. Its overall dimensions were 4.40 x 0.40 x 0.80m (excavated depth) and it abutted (023) to the SW. (023) was a handmade brick wall, 3 courses wide and orientated NE-SW. The bonding pattern was broadly English and the bricks were mortared with a compact light white grey material. Its overall dimensions were 2.60 x 0.36 x 2.00m (excavated length) and the wall continued beyond the NE trench edge. It was built into (082), abutted (010) and ran parallel with (024), which ran to the SE. This was also a handmade brick wall, 3 courses wide and orientated NE-SW. The bonding pattern was mostly stretcher and the bricks were bonded with a compact light white grey mortar. The overall dimensions were 2.90 x 0.36 x 0.90m (excavated length and depth) and the wall continued beyond the NE trench edge.

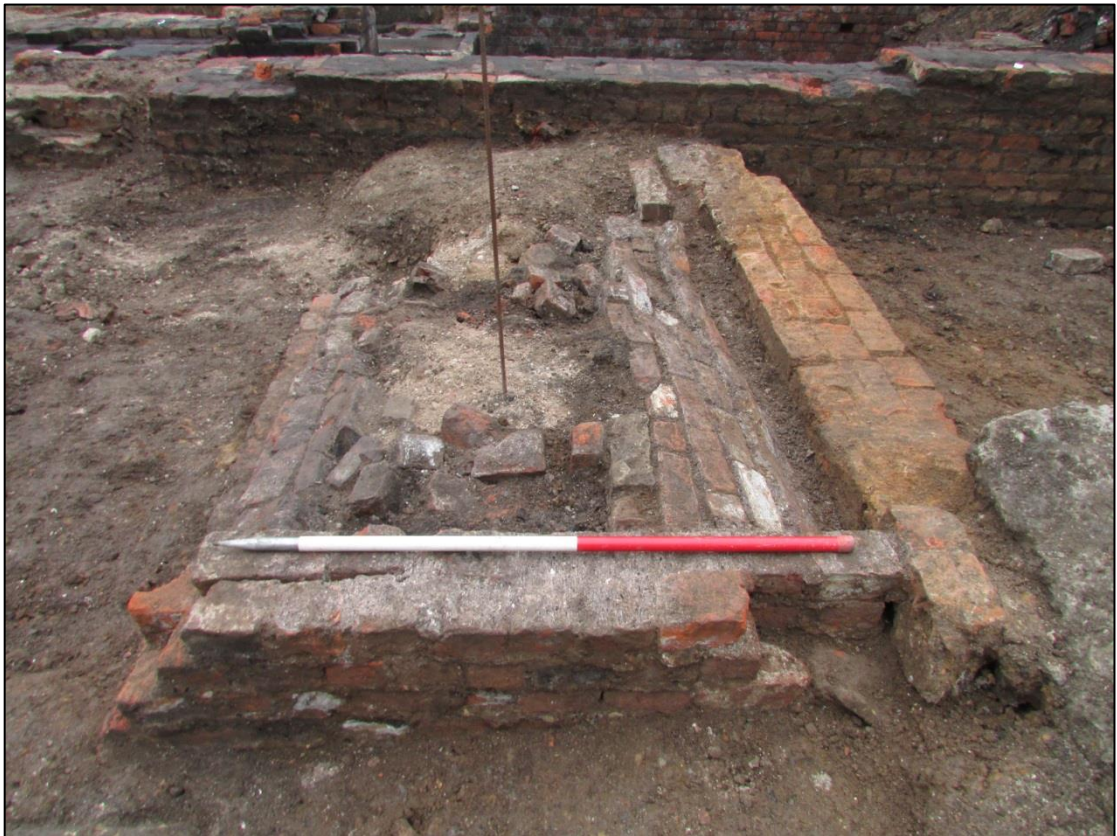
Fig. 14 Wall (082) (shown on the right) and possible 'tank' structure (082) – pre excavation

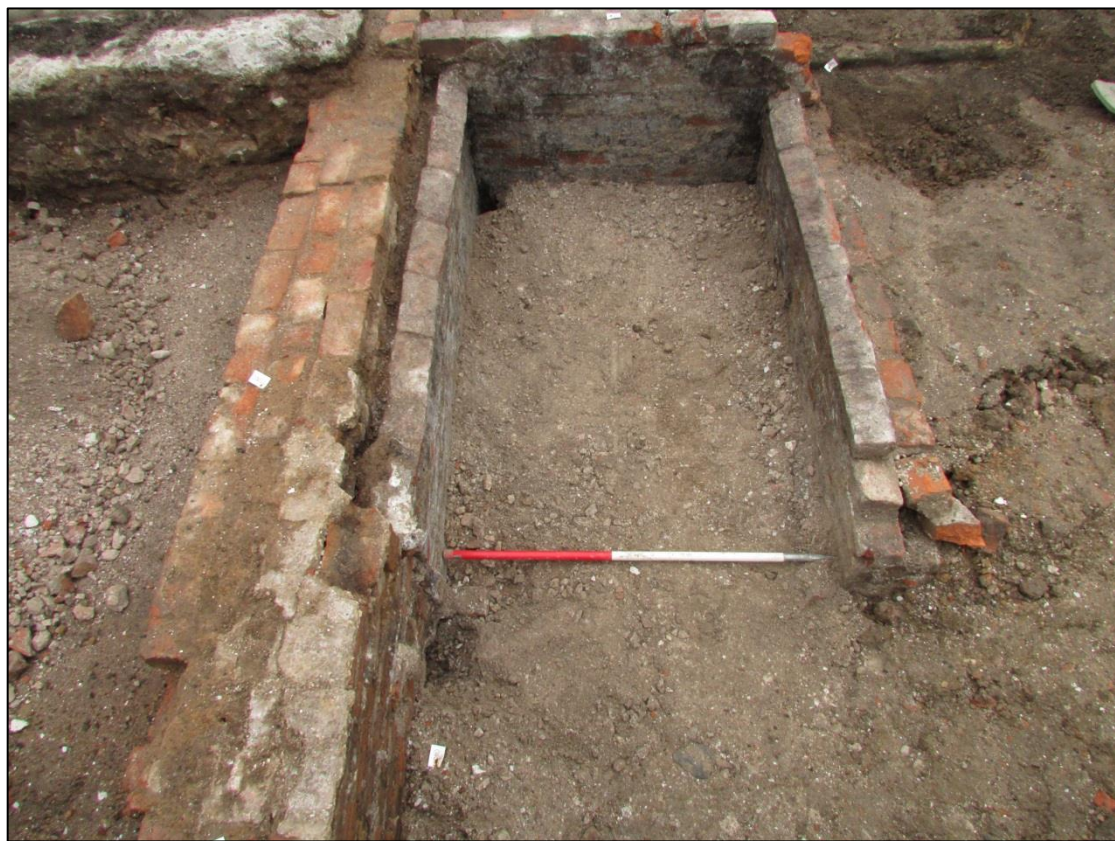
Fig. 15 Possible 'tank' (080) partially built into wall (082), after excavation

Within the workshop yard, wall (082) had been partially truncated along its SW face and (080) had been constructed against it. This feature consisted of three handmade brick walls, maximum two courses wide and built up against the W face of (082) (see Fig. 15). The interior faces were covered with remnants of limewash plaster and a partially preserved barrel vaulted ceiling (see Fig. 15). The overall dimensions were 3.00 x 1.65 x 2.00m and it also appeared to be cut into the uppermost visible yard deposit (155). A sondage was placed to the NW of this structure and there appeared to be remnants of a possible brick floor, or drain at a depth of 2.00m but due to the nature of infill and the extreme depth, this was recorded by photograph only. The infill (081) was a loose white brown silty sand with abundant inclusions of crushed mortar and plaster, as well as rare fragments of brick. This measured up to 2.00m deep.

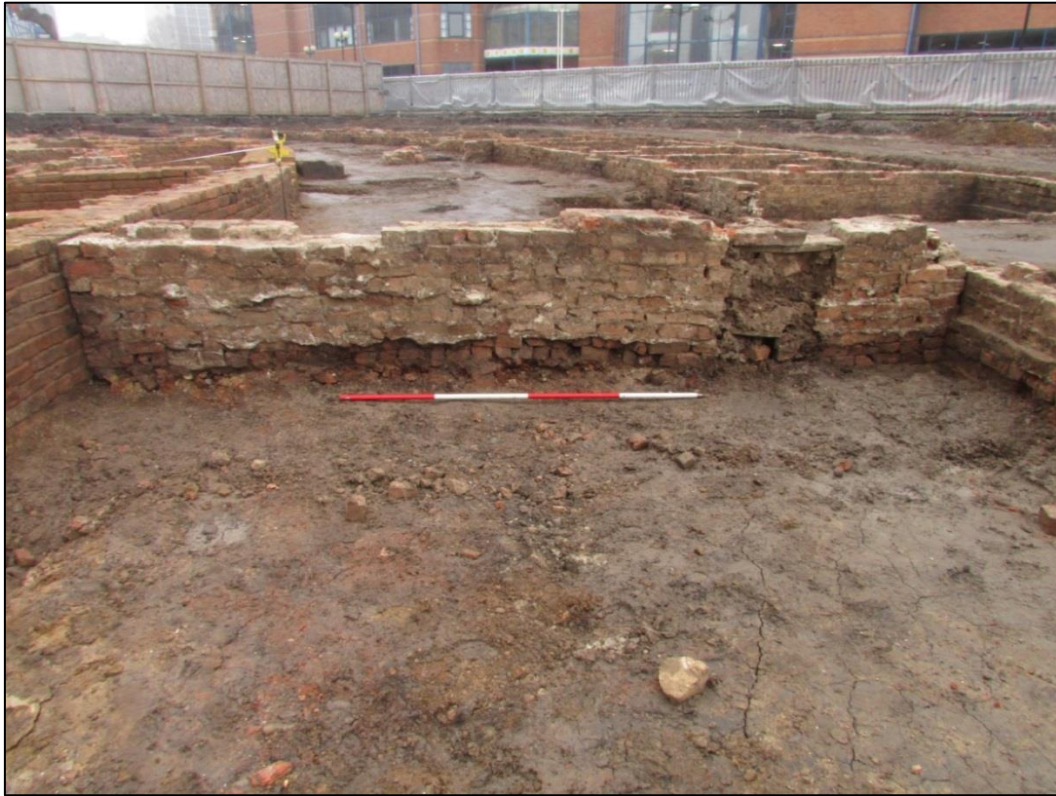
Fig. 16 Wall (074), showing cut [160] for later drain on the right and possible evidence for rebuild above deposit (161)

Stratigraphically later than walls (074) and (076) was [160], a steeply sided cut, measuring up to 0.50m wide at the top and 0.50m in depth. This also truncated deposit (155) and at the base was (073), a handmade brick drain with a stone flagged base and cap. This was revealed in several sondages across the Workshop yards and was broadly running parallel with wall (008), curving from NE-NW. It was 0.30m wide and survived up to 0.40m in depth. It was sealed by (161), a compact mid yellow brown silty clay with lenses of crushed mortar and small fragments of brick. This deposit measured up to 1.00m in depth, infilled cut [160] and sealed drain (073). Within wall (074) and sealing the later truncation, there was evidence for a partial rebuild of the wall (see Fig. 16).

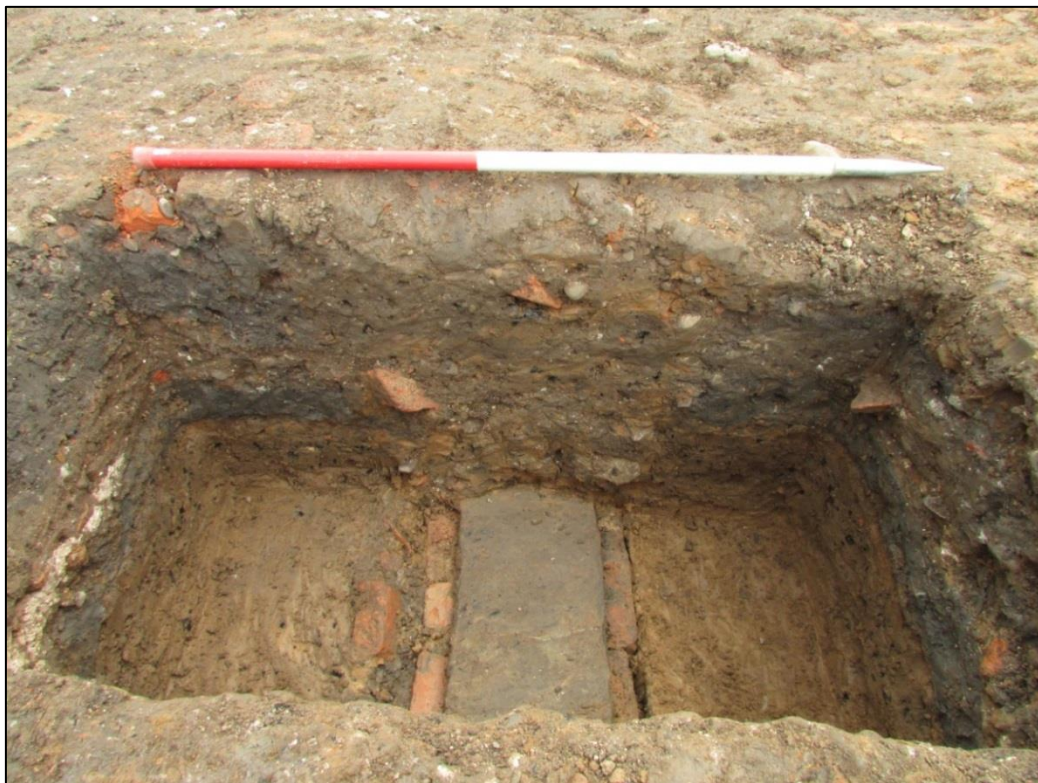
Fig. 17 Cut [160] is shown here in section along with drain (073)

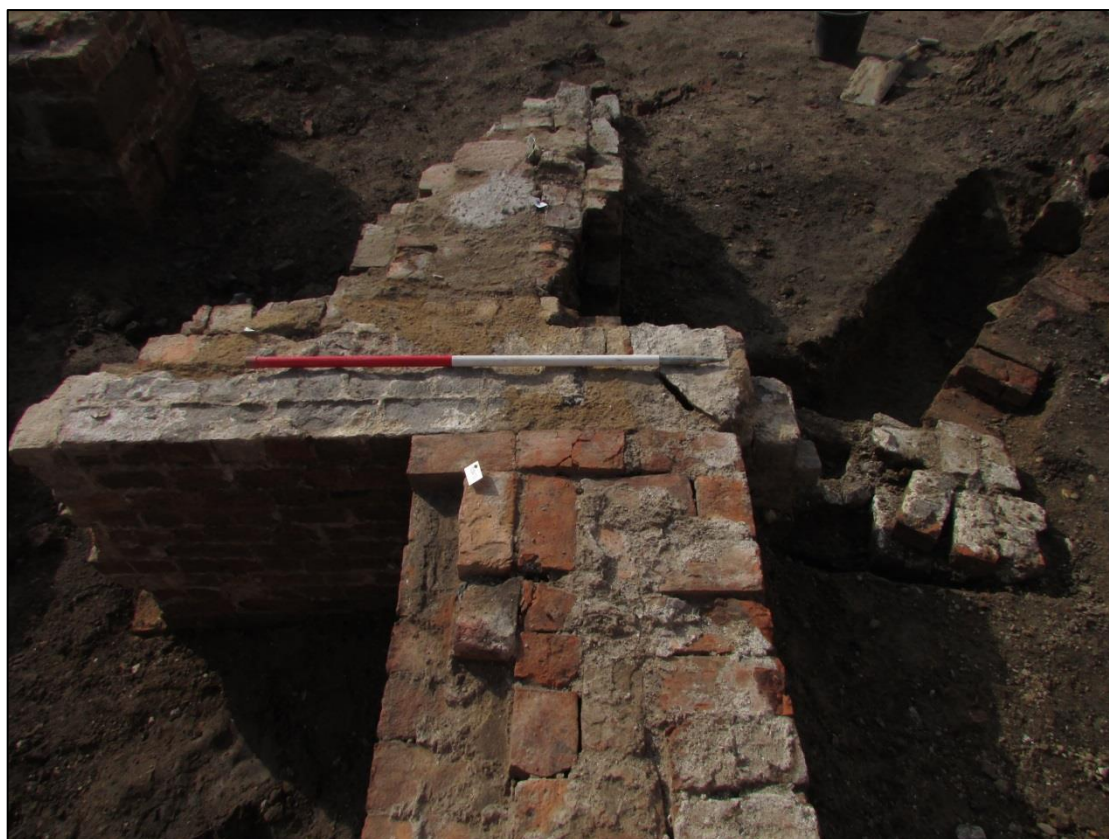
Fig. 18 Shot showing wall (047) in the foreground, which appears to have been added at a later stage

There was also evidence to suggest that the eastern part of the cells had also been extended in this direction (see Fig. 18). Abutting wall (054) was (049), a handmade brick wall up to six courses wide and orientated NW-SE. The bonding was mixed and the bricks were bonded with a compact light brown mortar. Its overall dimensions were 1.85 x 0.73 x 1.00m but it also continued slightly further SE for 0.60m as it had been truncated. It was keyed into (054) and abutted (047), a handmade brick wall, six courses wide and orientated NE-SW. The bonding was mixed and the bricks were mortared with a compact light grey brown material. Its overall dimensions were 2.90 x 0.74 x 0.93m (excavated length and depth) and as well as abutting (049), (048) was keyed into this wall. This was a handmade brick wall, four courses wide and orientated NW-SE. The bonding was mixed and the bricks were bonded with a compact light grey brown mortar. Its overall dimensions were 2.10 x 0.50 x 0.92m (excavated depth) and as well as being keyed into (047) it was also truncated at its SE end (see below).

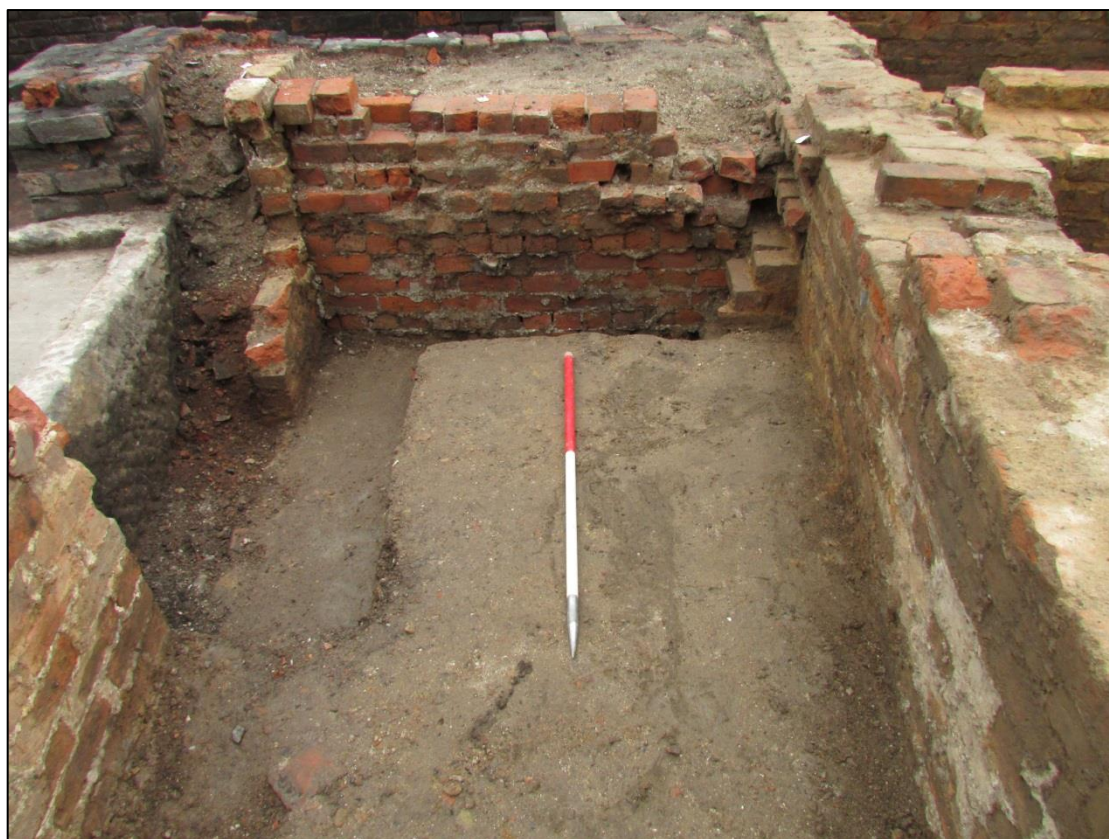
Fig. 19 Shot showing later truncation of wall (062)

Further evidence for truncation was found within wall (095). (062) was a handmade brick wall, five courses wide and orientated NE-SW. The bonding was unknown and the bricks were mortared with a light brown loose material. Its overall dimensions were 0.50 x 0.60 x 0.85m (excavated depth) and it was keyed into (095). However it was truncated at its NE end and (056) abutted it. This was a handmade brick wall, up to three courses wide and orientated NE-SW. The bonding was mixed and the bricks were bonded with a compact light grey mortar. Its overall dimensions were 1.70 x 0.30 x 0.90m (excavated) and it was also abutting (063).

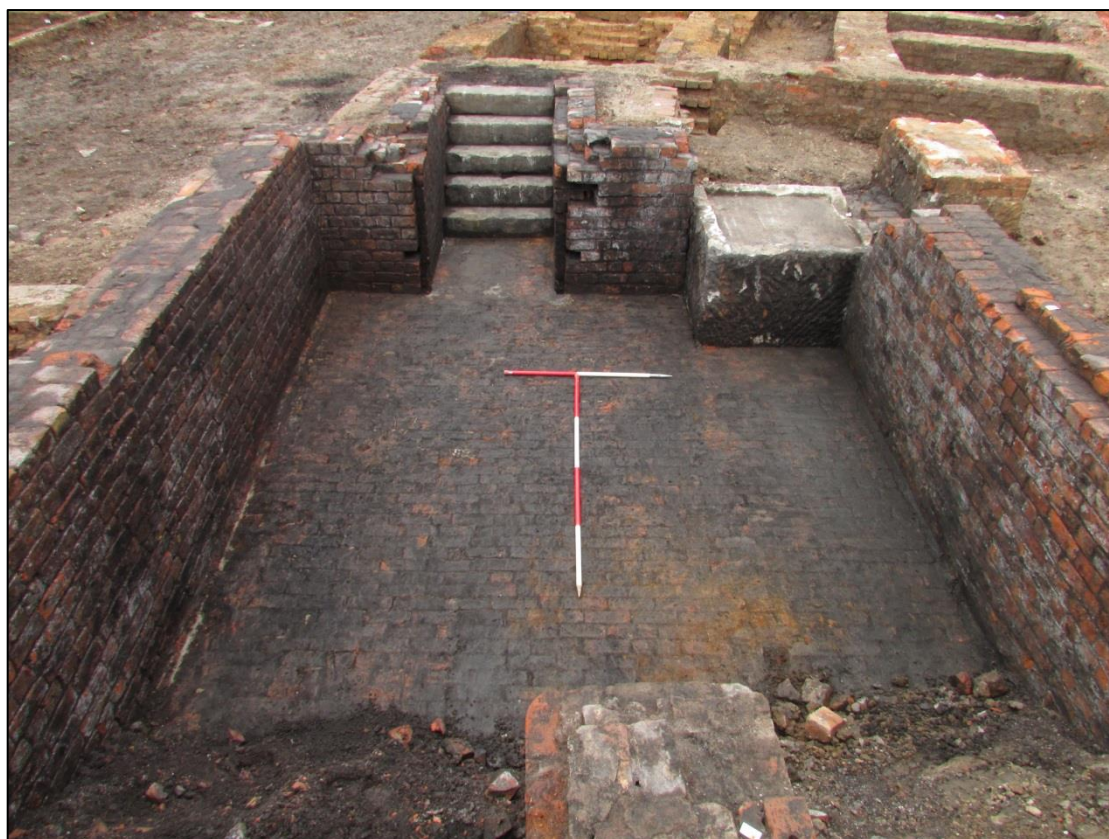
Fig. 20 General shot of Railway Building 1

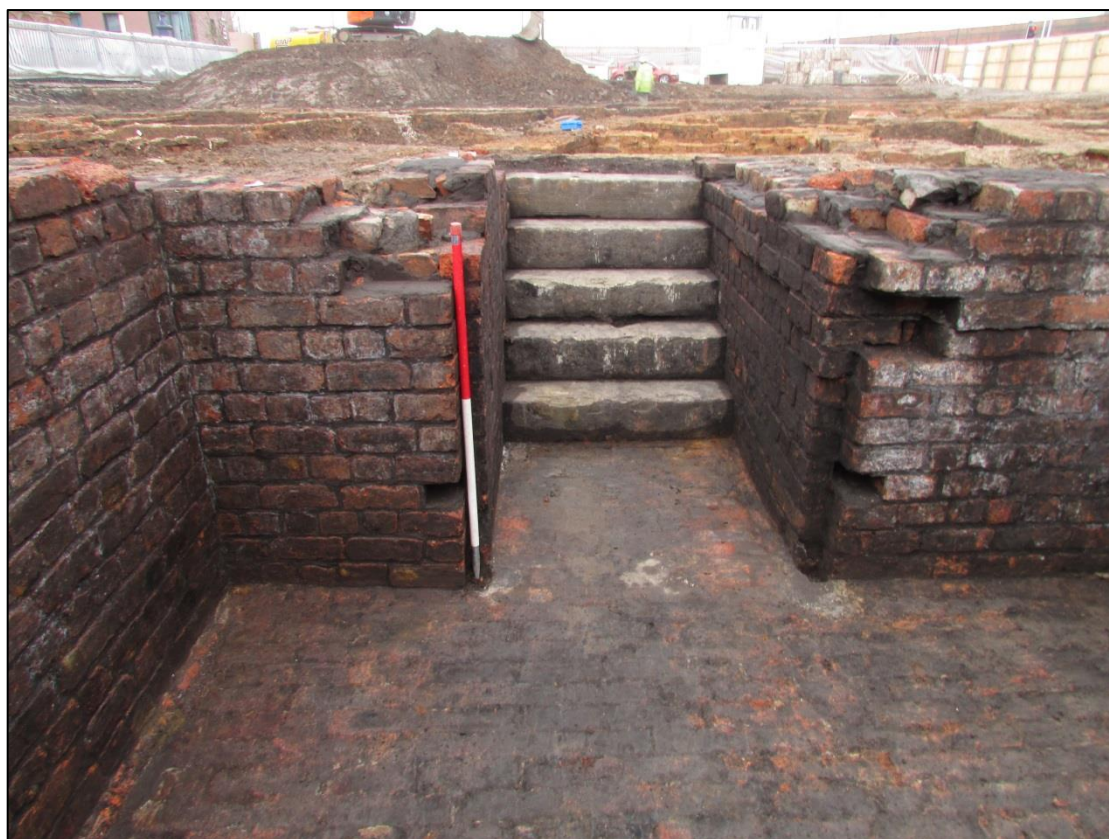
Fig. 21 The gaps deliberately built into the wall shown suggests the presence of a gate or door

Railway building 1 was defined by wall (035), a handmade brick wall, four courses wide and orientated NE-SW. The bonding was English pattern and mortared with a compact dark black grey material with traces of plaster on the NW face. Its overall dimensions were 6.00 x 0.49 x 1.40m (excavated length) and its cut [083] was visible at a distance of 0.25m to the SE and was a vertical sided cut running parallel with (035). It truncated wall (082) and the cut was infilled by (084), a compact light yellow brown sandy clay with inclusions of crushed plaster and mortar, as well as small fragments of brick. This also sealed (035). Wall (034) was keyed into (035) and was handmade, four courses wide and orientated NW-SE. The bonding was English pattern and the bricks were bonded with a compact dark black grey mortar with traces of plaster on the NE face. There was a gap as well to accommodate a possible door (Fig. 21).

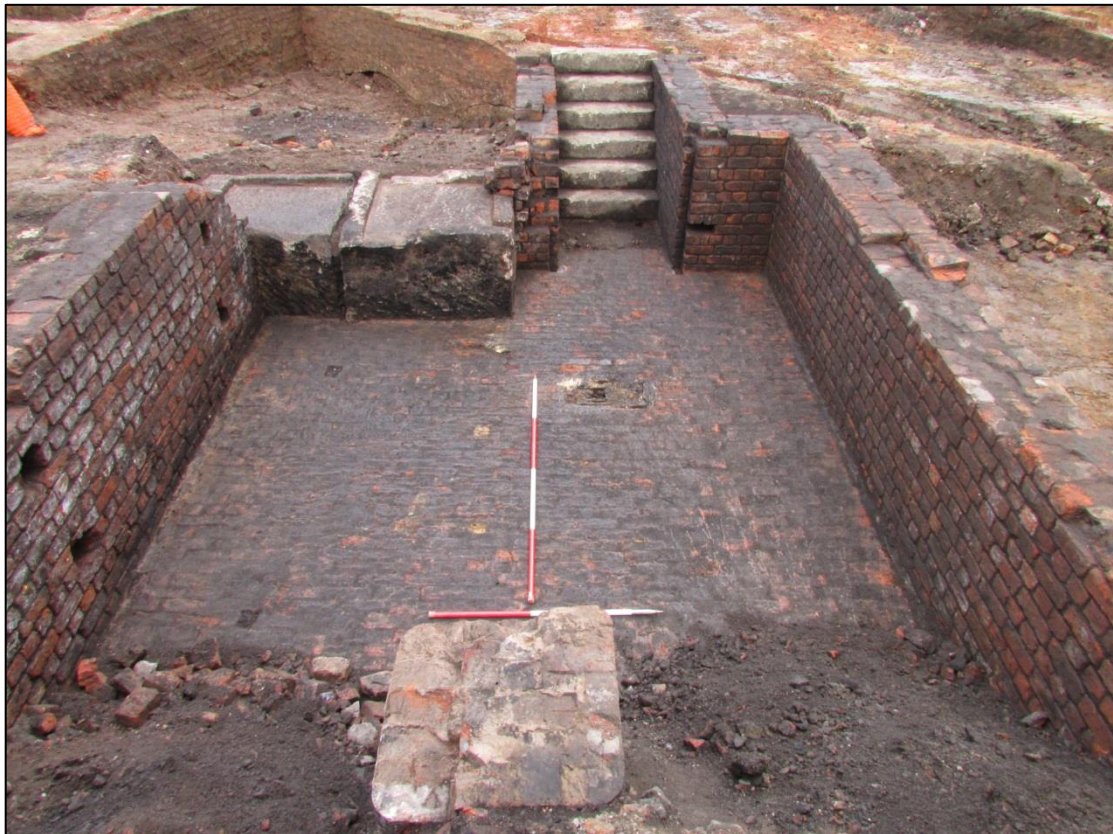
Fig. 22 General shot of Railway Building 2
