**Archaeological
Excavation Report**

Land off Stanley Street,
Central Salford: Plots
B5/6 (New Bailey
Prison)

Technical Report:
Rachael Reader

Report No:
2015/07

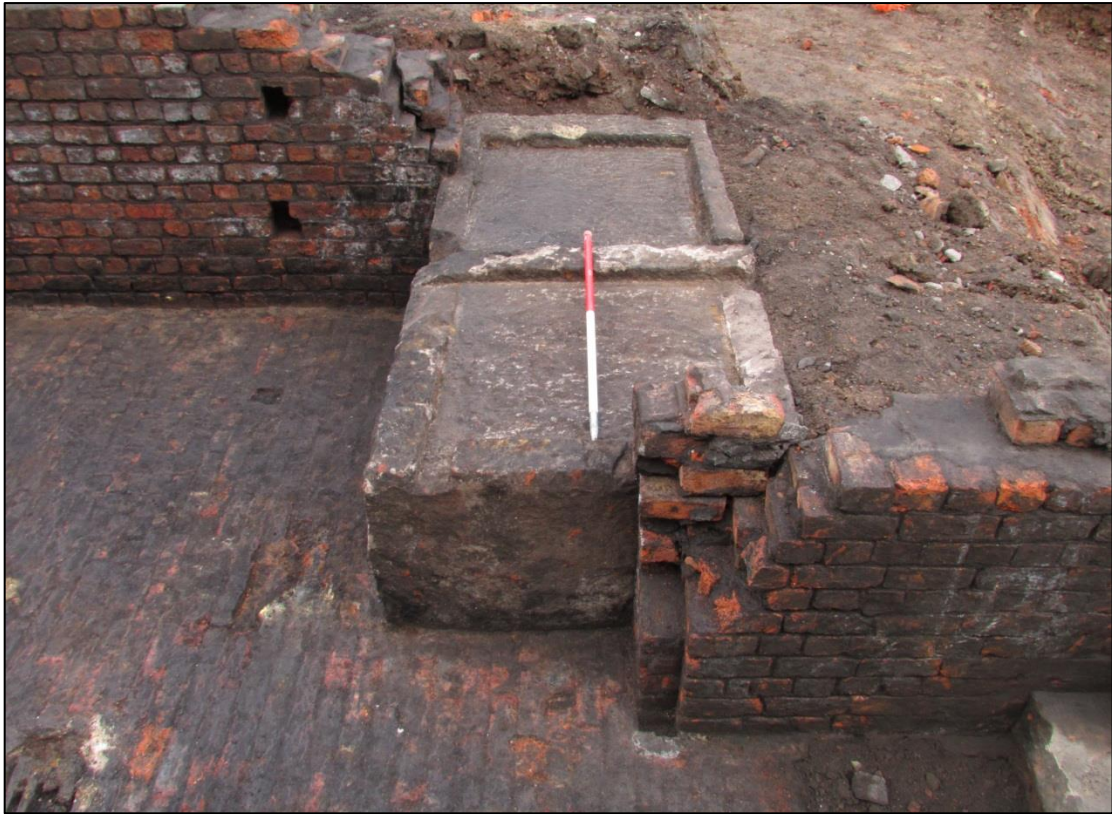
Fig. 23 Stone blocks (043) and (044) within Railway Building 2, with deliberately inserted slots also shown

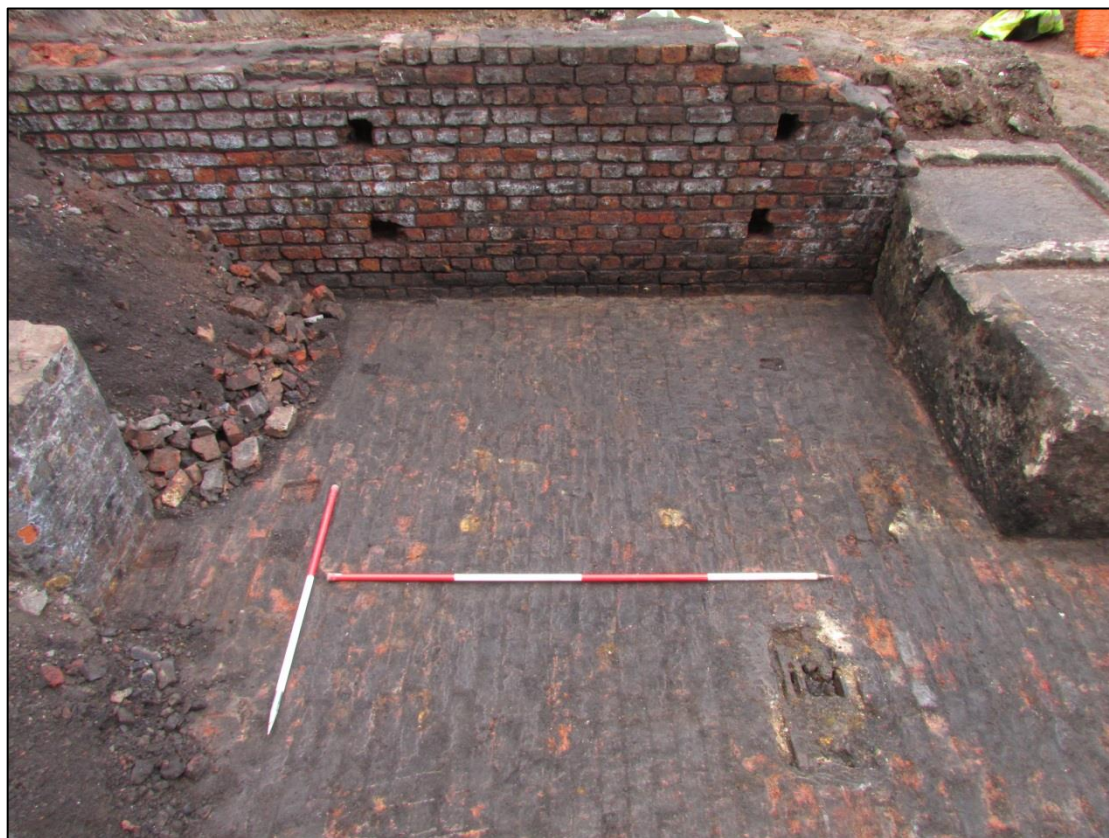
Fig. 24 A total of four slots within wall (042) and five within floor (041) were revealed in Railway Building 2, as shown

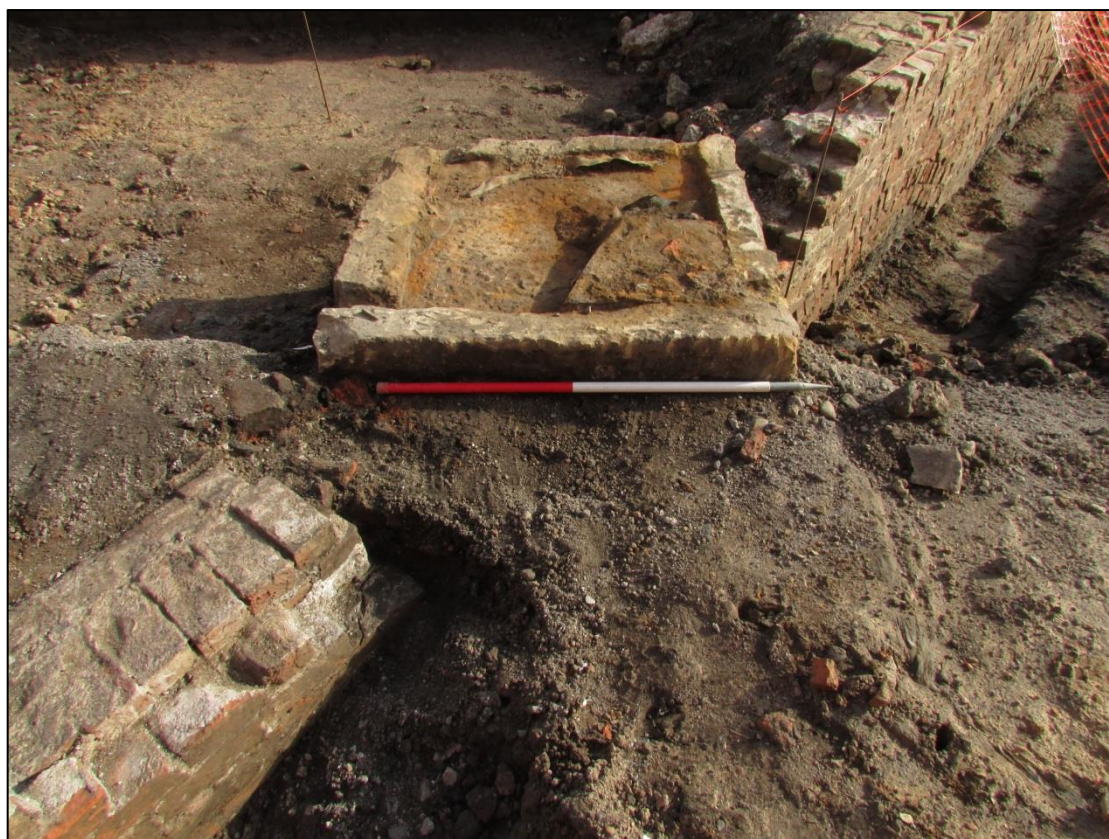
Fig. 25 Example of one of the stone blocks (in this case (089) related to the railway phase. This one also truncates wall (087)

There were also isolated features including (079), which was a large sandstone block measuring 1.25 x 1.25m and truncated (007). (089) was also a large sandstone block measuring 1.25 x 1.25 x 0.50m (excavated depth) with a small amount of metal preserved on the surface. This was infilling cut [088], which was a square feature, with almost vertical sides and slightly wider than (089). This truncated wall (087) within the Exercise Yard (see Fig. 25). Also truncating (087) to the NW was (090), a handmade brick wall, four courses wide and orientated NE-SW. The bonding was unclear but the bricks were bonded with a compact black grey mortar. Its overall dimensions were 5.75 x 0.48 x 0.40m (excavated depth) and it was abutted by (091) to the SW, which was a large rectangular stone block measuring 1.00 x 0.40 x 0.30m. (091) was in turn abutted by (092) to the SW which was another rectangular stone block, measuring 0.90 x 0.40 x 0.25m. Keyed into (090) was (093), a handmade brick wall, orientated NE-SW. The width was unknown as it was only visible within the NW trench edge however it was observed over a distance of 2.75m, running parallel with (091) and (092).

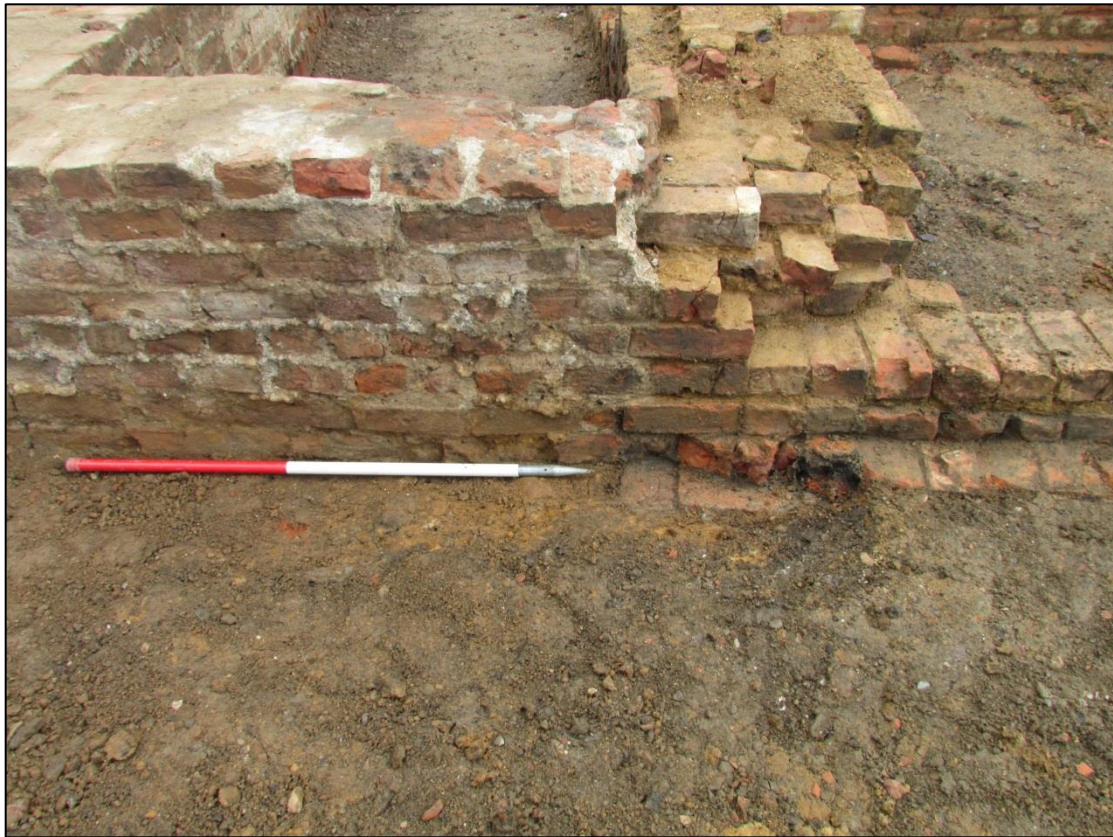
Fig. 26 Wall (097) is of one phase, however two different types of mortar are evident, suggesting that the construction process was carried out in specified stages

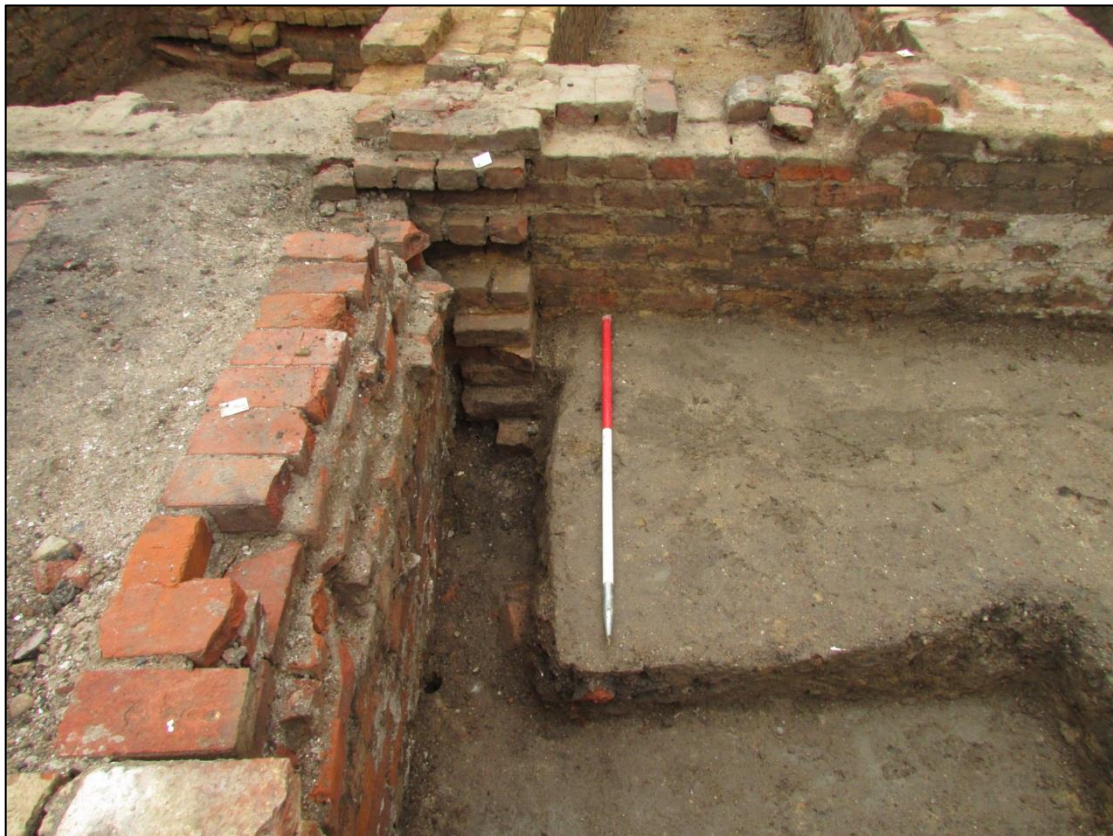
Fig. 27 Wall (062) appears to have once extended further but was at some stage dismantled and replaced with a poorly constructed wall

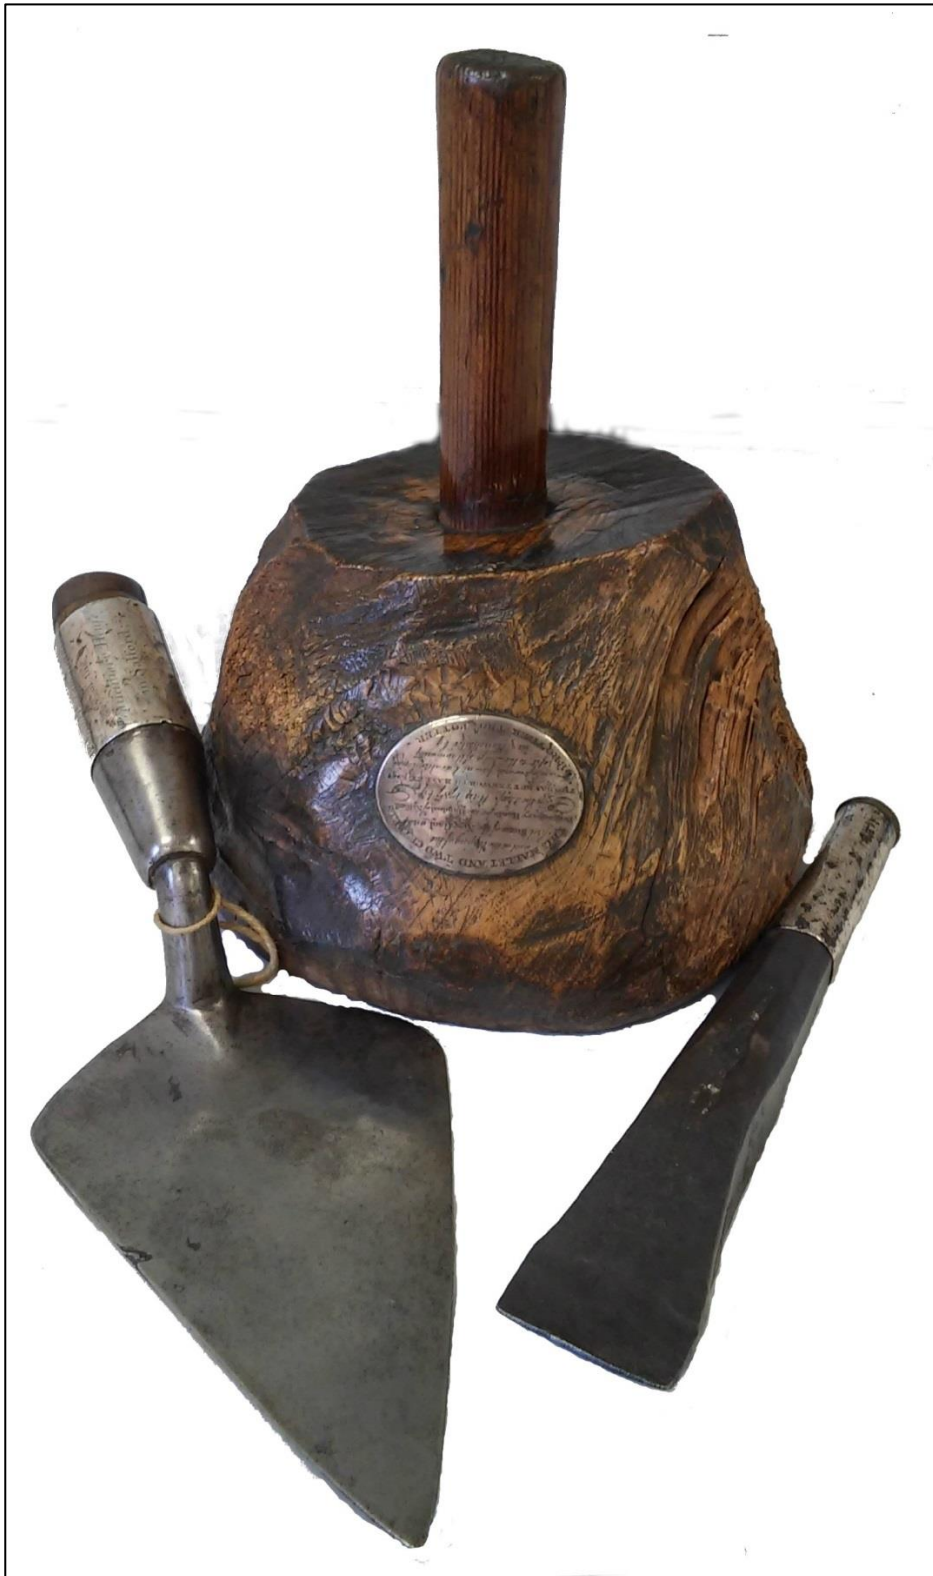
Fig. 28 The Ceremonial Tools used to lay the foundation stone of New Bailey Prison in 1787

However the Centre came into possession of three finds from an unexpected source. In February 2015, the Centre was contacted by Mr James Cale, the secretary of the Masonic Lodge of Unanimity No.89. They had in their possession the ceremonial chisel, trowel and maul used to lay the foundation stone of New Bailey in 1787. The three tools appear to have entered into the Lodge's possession at slightly different times. According to Mr Cale, Thomas Butterworth Bayley was a member of the lodge and the brothers who presented the items: Thomas Potter and John Howarth were prominent local figures. The Lodge kindly agreed to sell the items to the client and it

is hoped to display these as museum exhibits in the future. In accordance with CfAA's finds policy, these items have been catalogued and photographed by the Centre and further details are found in Appendix 5.

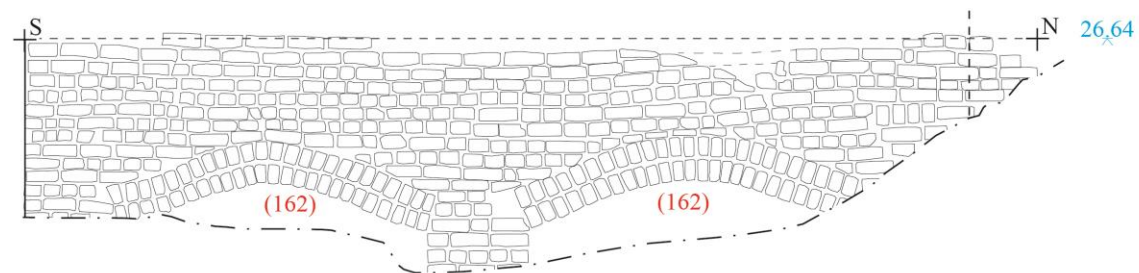
E facing section of (087)

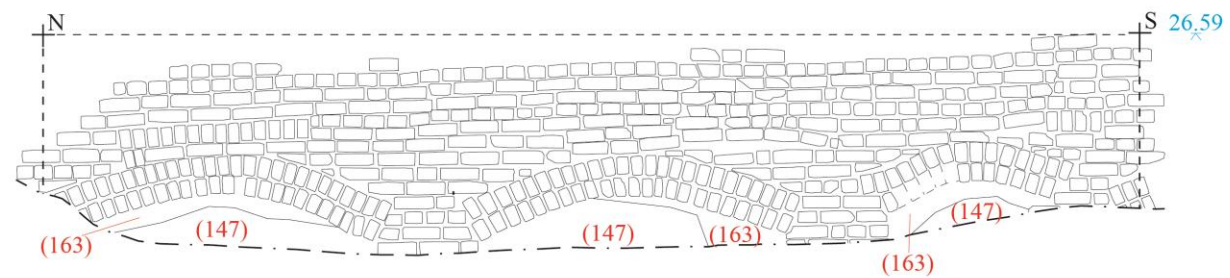
W facing section of (087)

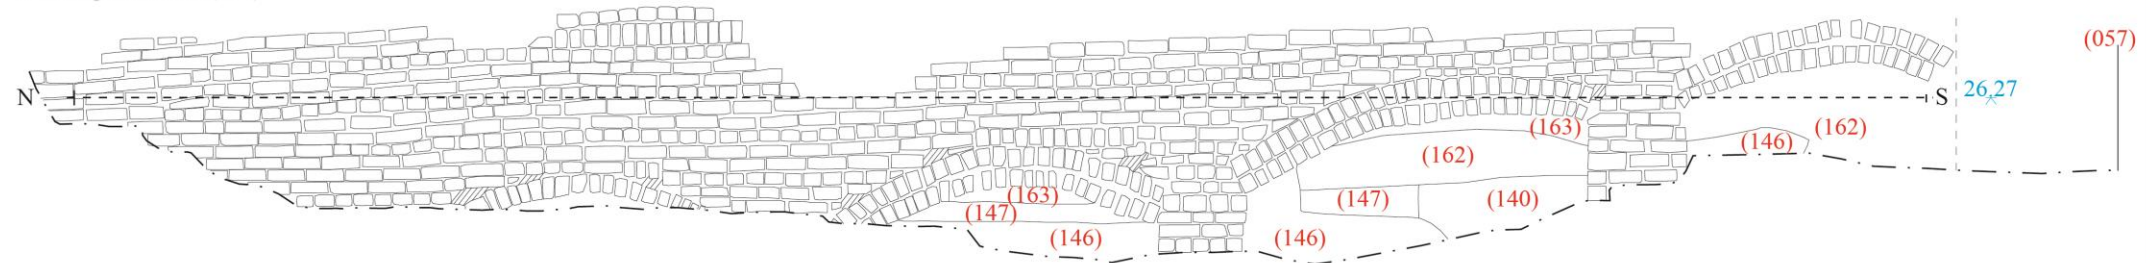
W facing section of (094)

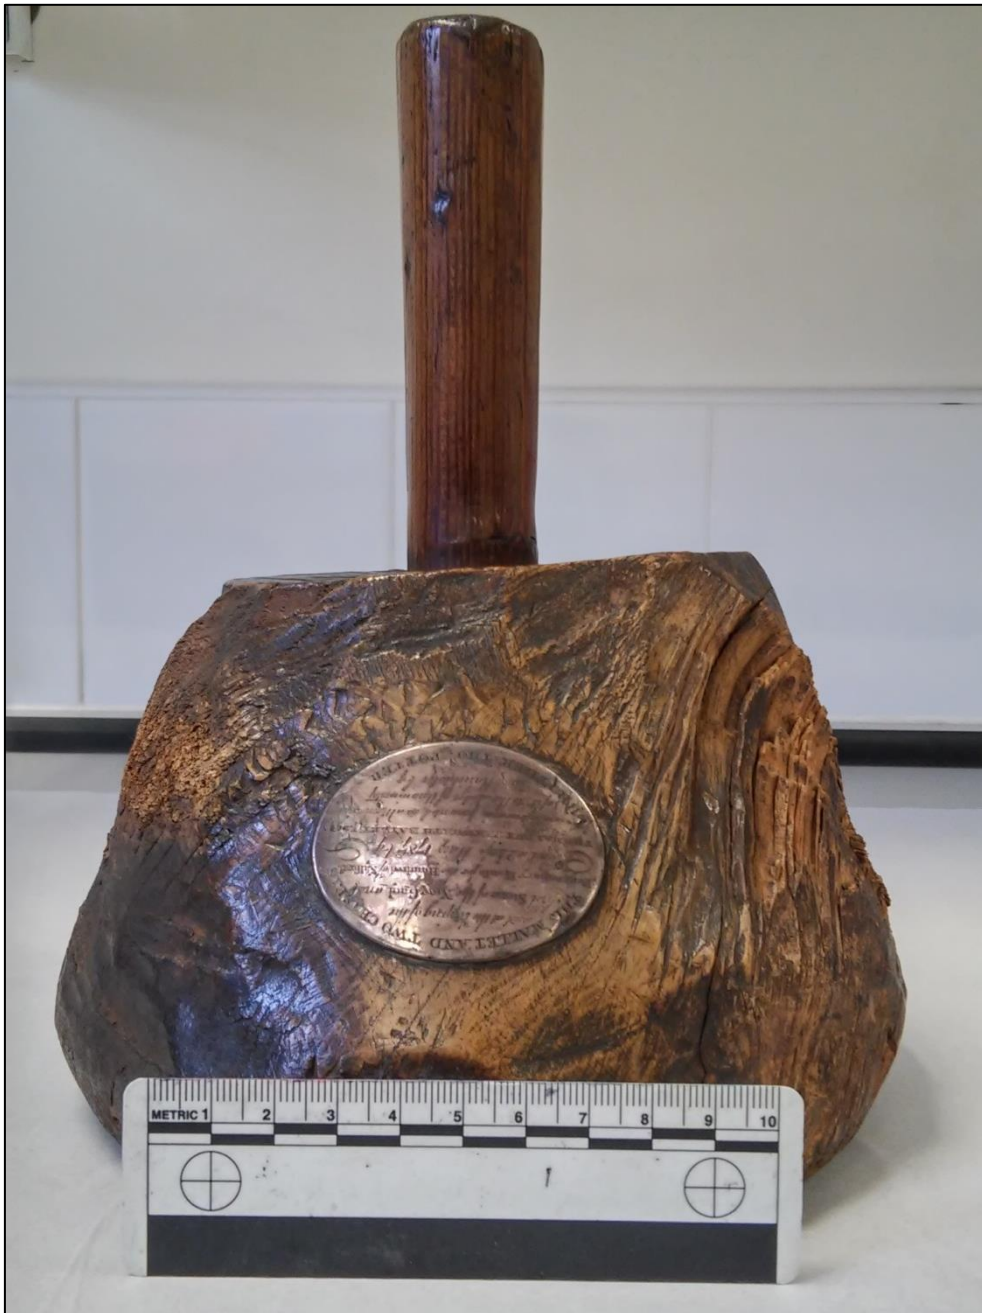
Maul

Fig. 46 Ceremonial maul, including inscription (transcribed below)

Hard wooden mallet, highly polished/varnished, double piece, handle is all the way through. Small Cu alloy or silver plaque reading:

Circumference: 550mm

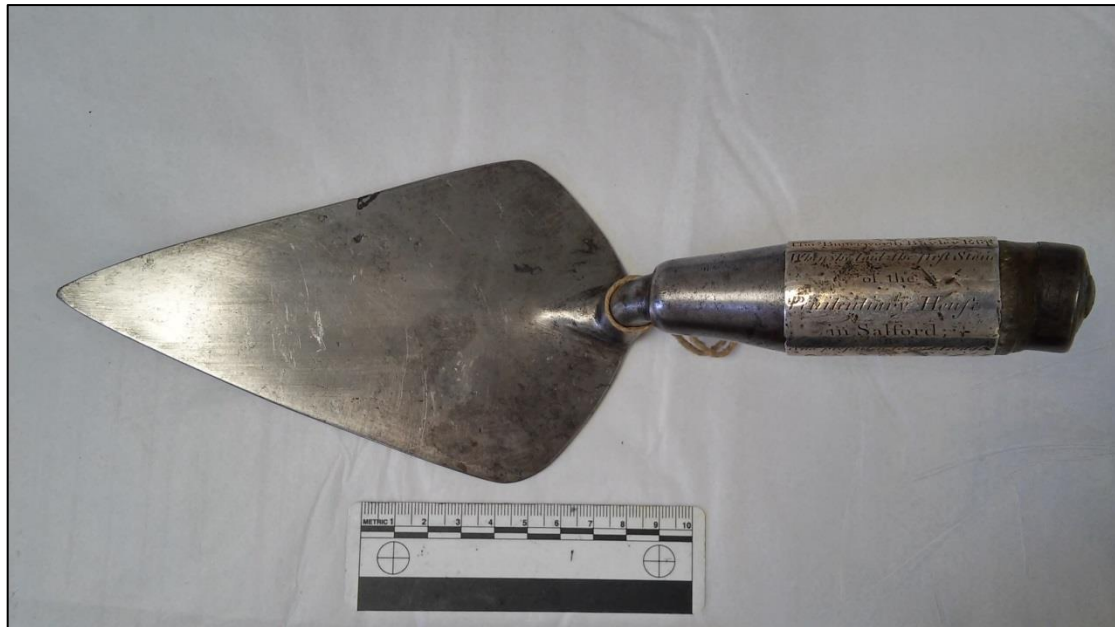
Trowel

Fig. 47 Ceremonial trowel

Not FE, possible Cu alloy or silver, welded handled masonry trowel, larger blade 5”, slight right curvature to tip (use markings) small plaque laid over wooden handle reading:

Length: 280mm

Width: 100mm

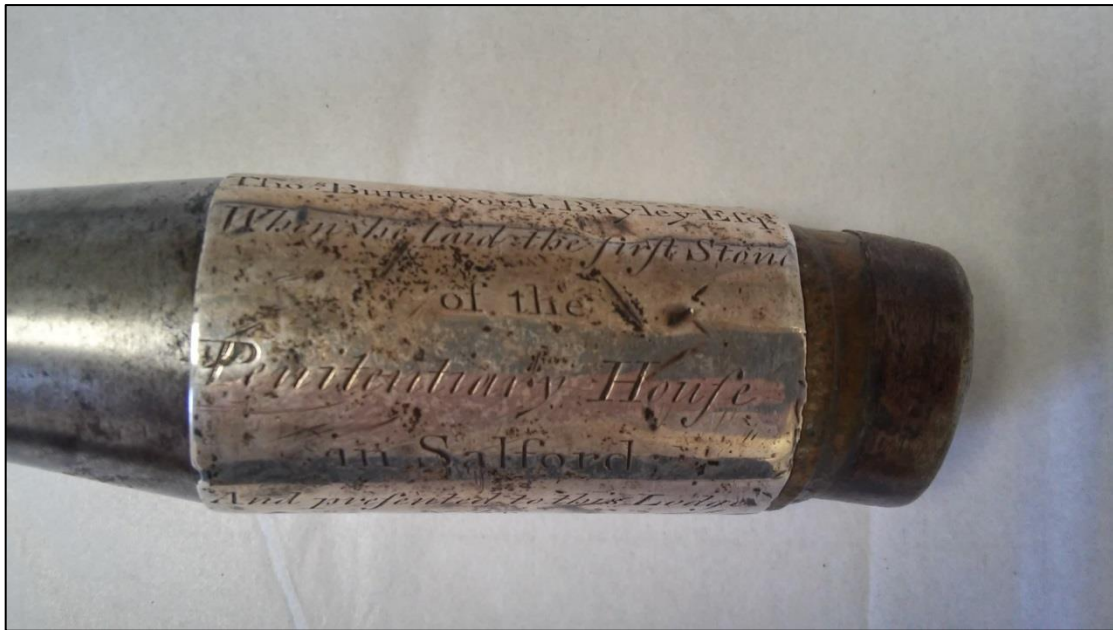
Fig. 48 Close up of inscription on the trowel

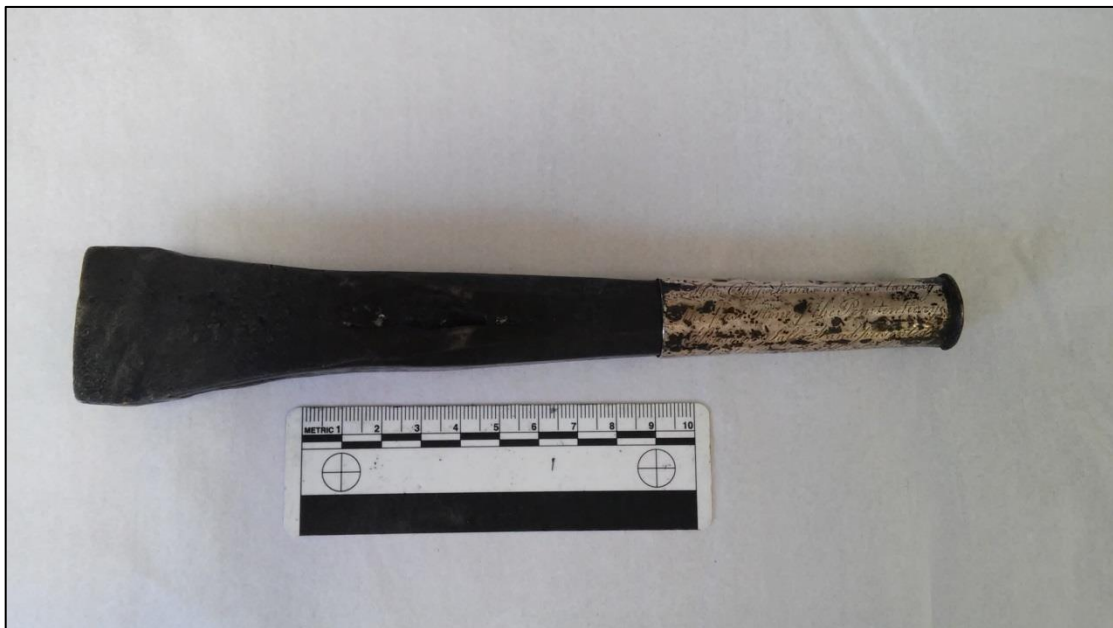
Chisel

Fig. 49 Ceremonial chisel

Fe construction, Ag plaque reading:

Length: 220mm

Width (at blade) : 40mm

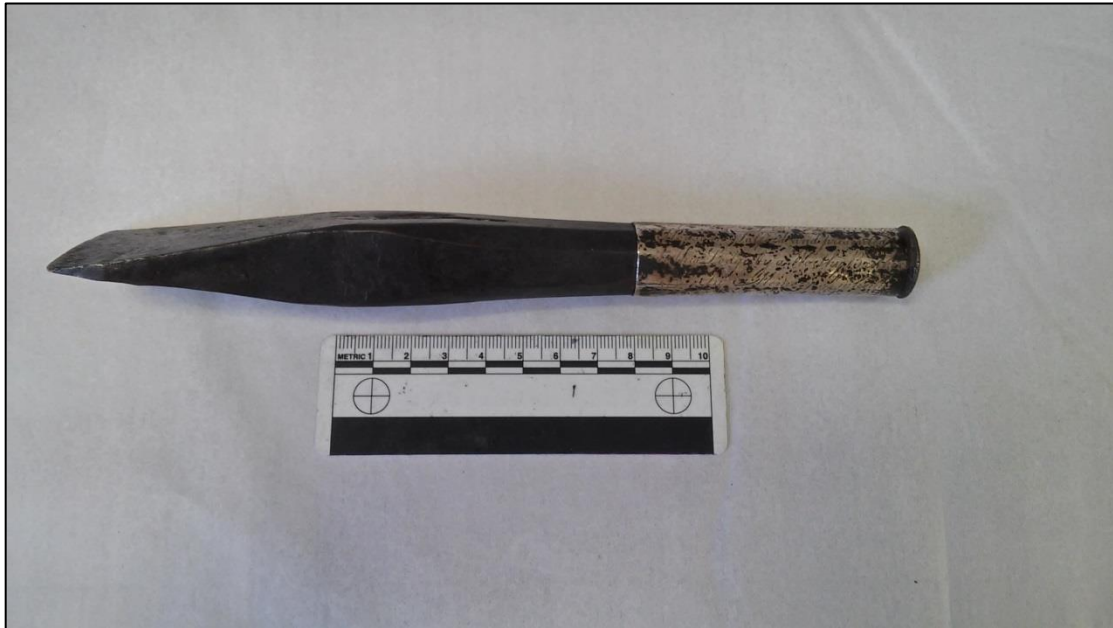
Fig. 50 Ceremonial chisel (side on)
