RISING DAMP EVALUATION AND TREATMENT A QUASI-EXPERIMENTAL CASE STUDY

Submitted in Partial Fulfilment of the Requirements of
the Degree of Doctor of the Built Environment, May 2017

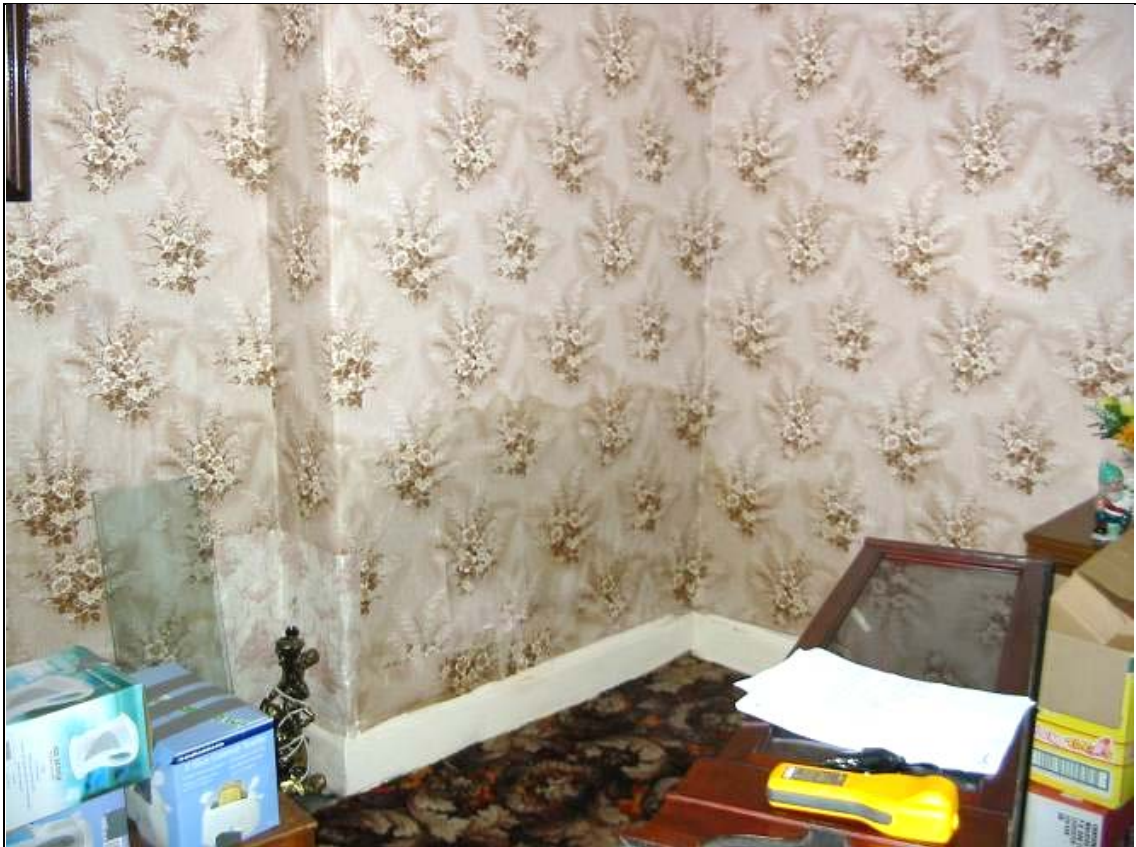
Figure 3: rising damp?

This photograph of damp staining affecting the base of a wall in an early nineteenth century, stone built house in Aberford, West Yorkshire aligns with the description of rising damp in BRE Digest 245, shown in Figure 4 below. I possess many similar photographs, some of which are provided in Chapter 2.

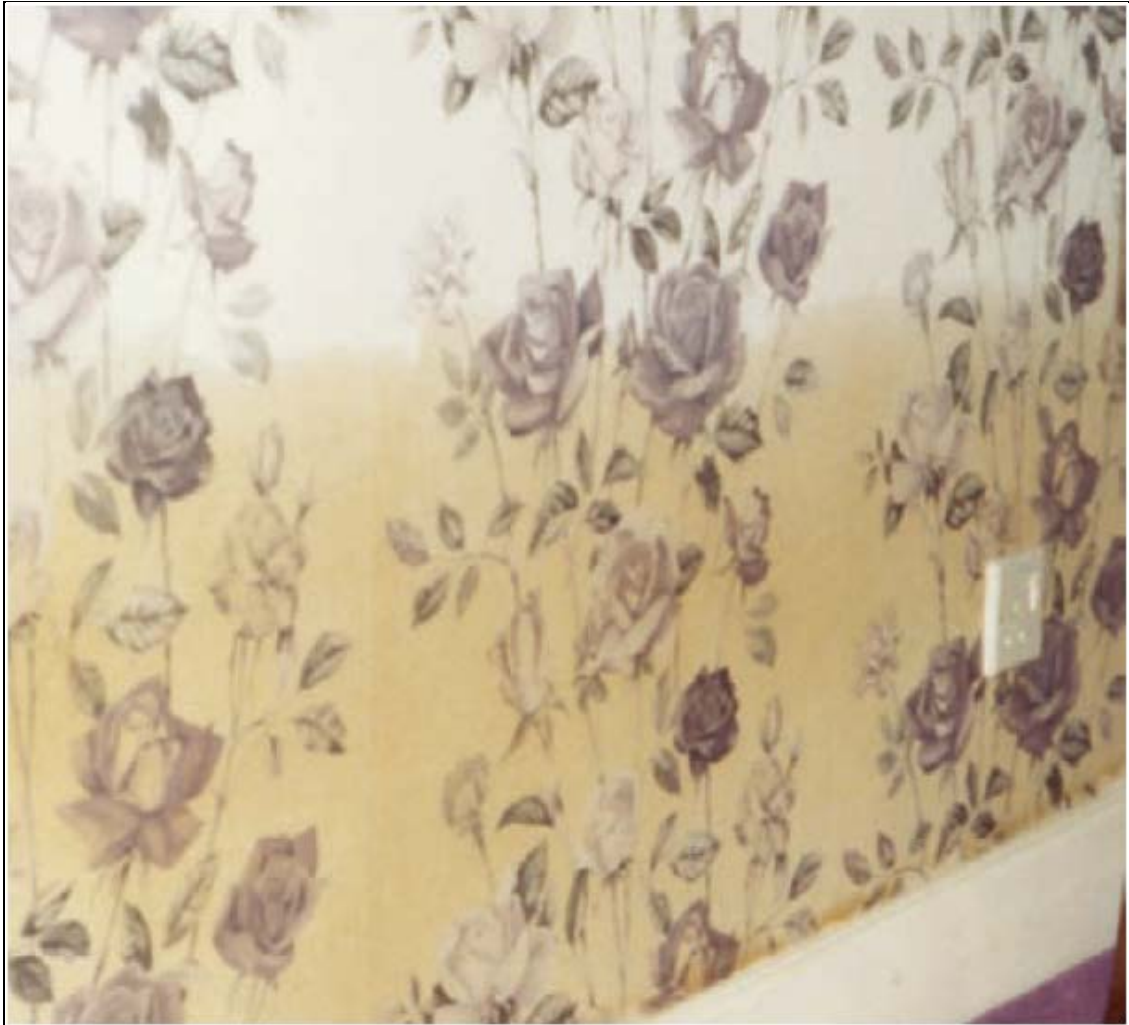
Figure 4: Staining to wall paper on a wall affected by rising damp (Adapted from Trotman, 2007, p. 1).

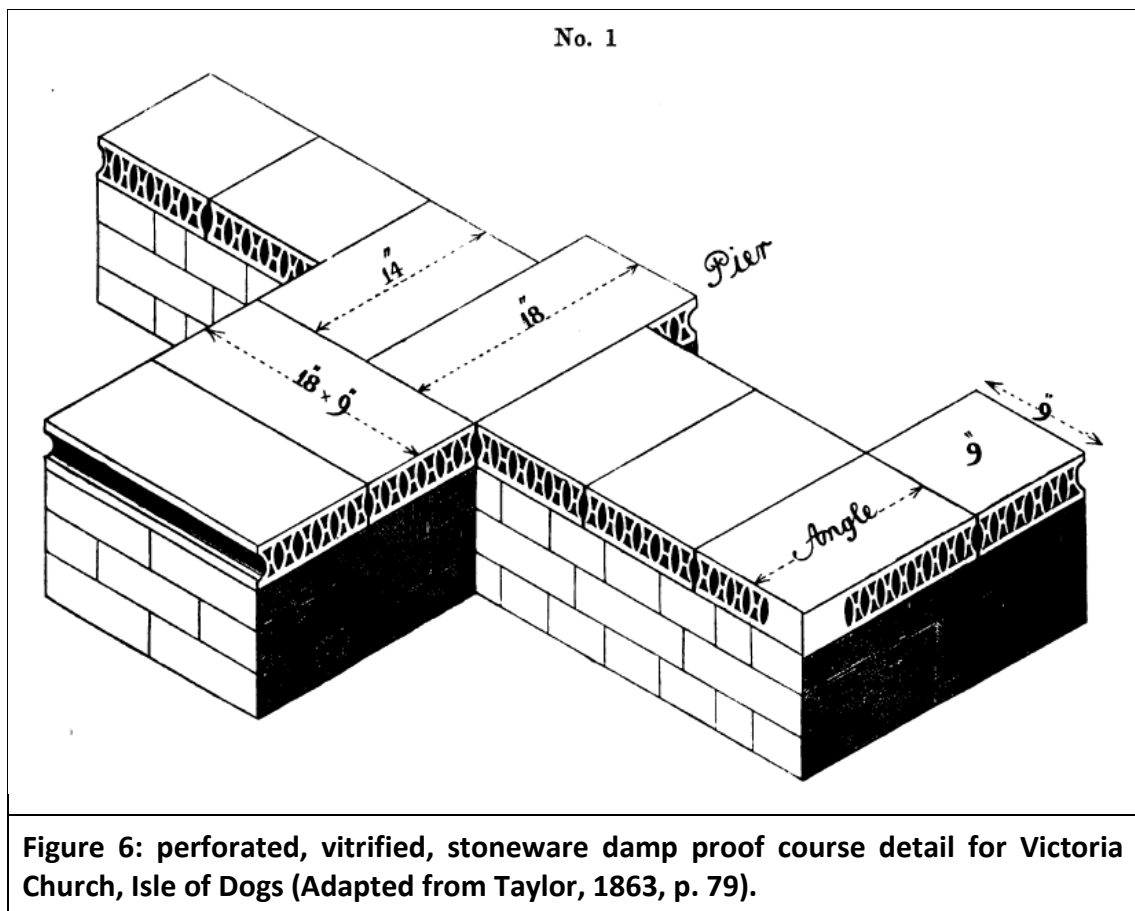
Figure 6: perforated, vitrified, stoneware damp proof course detail for Victoria Church, Isle of Dogs (Adapted from Taylor, 1863, p. 79).

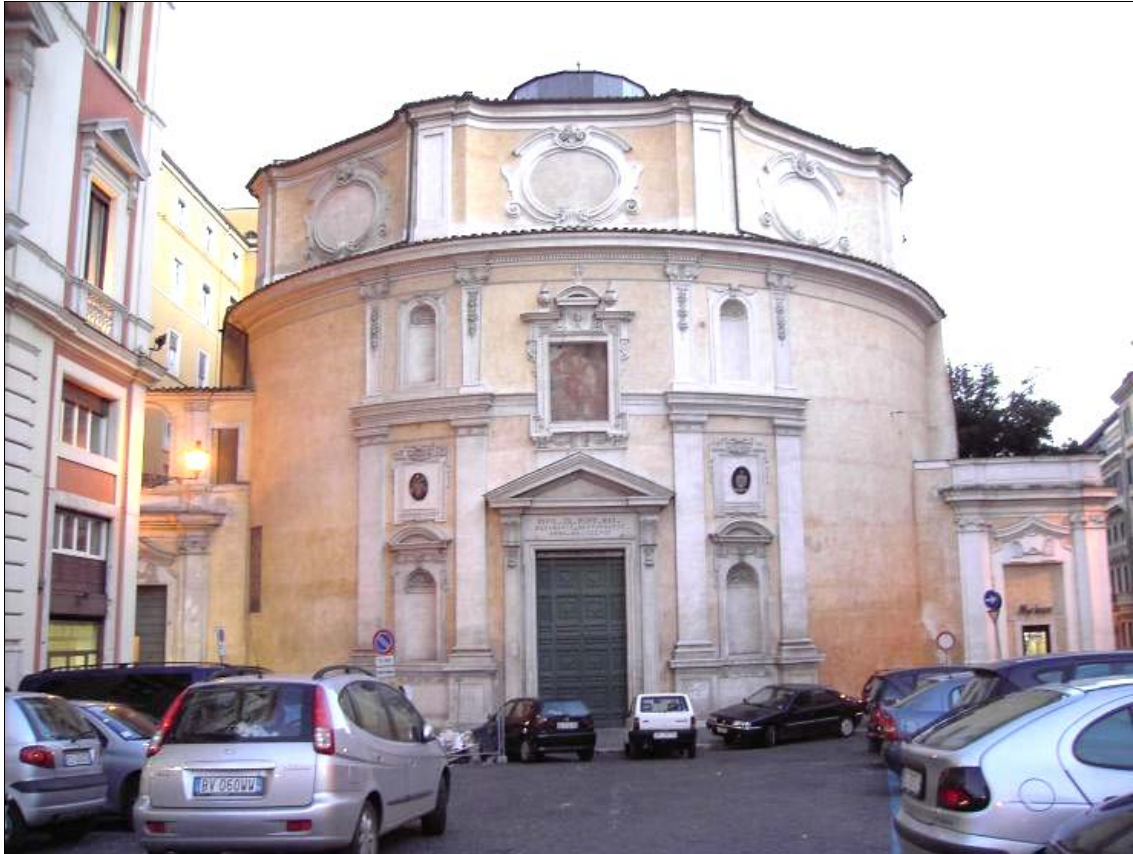
Figure 7: Church of San Bernardo (Français Wikipedia, 2010).

The church walls are 4.0 m thick. Rising damp is reported to have reached a height 5.3 m (Massari & Massari, 1993, p. 77).

In addition, because thicker walls require a larger surface area to attain a rate of evaporation equivalent to that of thinner walls, damp will rise higher in the former than it will in the latter (Rirsch & Zhang, 2010, p. 1816). This phenomenon is demonstrated by Massari and Massari with respect to the church of San Bernardo in Rome (1993, p. 77), shown in Figure 7 below, its 4.0 m thick walls enabling moisture to rise to the considerably height of 5.3 m (Massari & Massari, 1993, p. 77).

The mortar aging effect is significant. Over a one-hundred-year period, the height of damp rise in a wall can increase by seven-fold (Mason, 1974, p. 229). The church of San Bernardo, discussed earlier in this chapter and illustrated in Figure 7 above, is an example of rising damp reaching heights of 5.3 m (Massari & Massari, 1993, p. 77). The

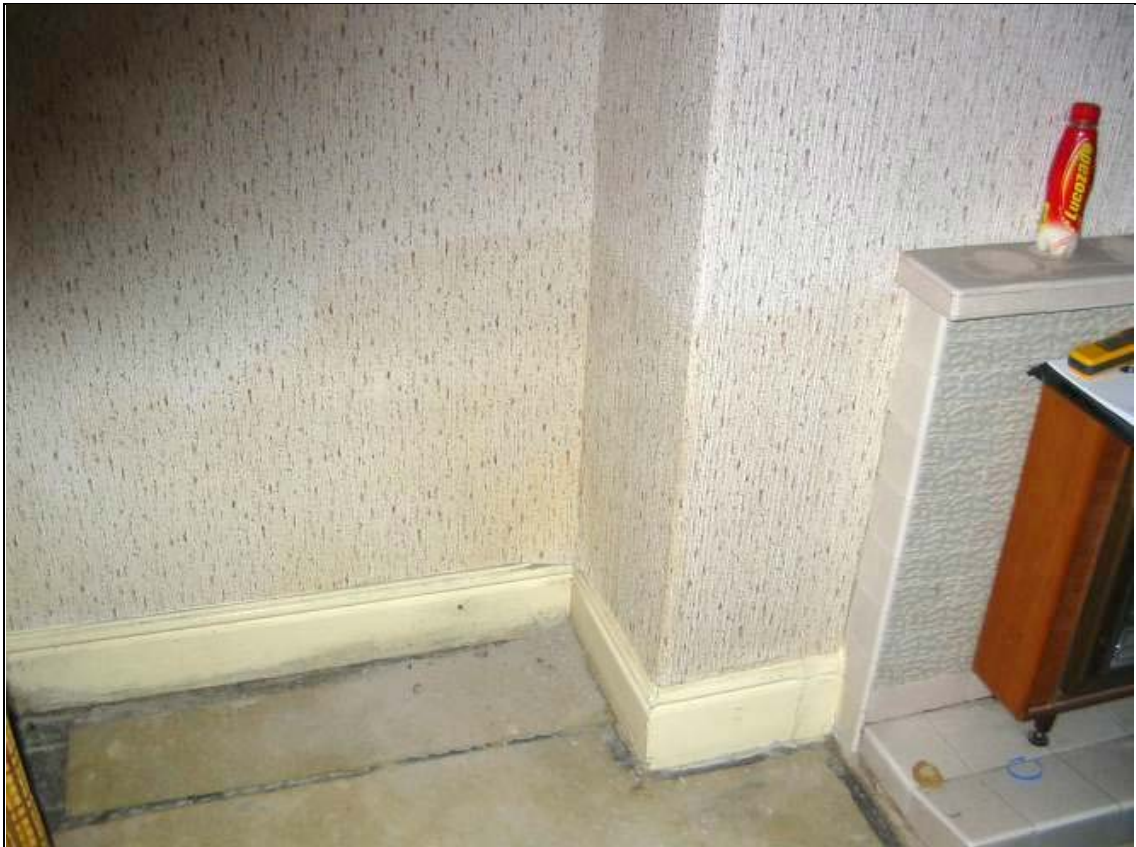
Figure 8: Wall base dampness aligning with the Sharp Front model (example 1).

Damp staining affecting the base of this wall of an early twentieth century, brick built house in York, North Yorkshire aligns with the characteristics describing rising damp and the Sharp Front model.

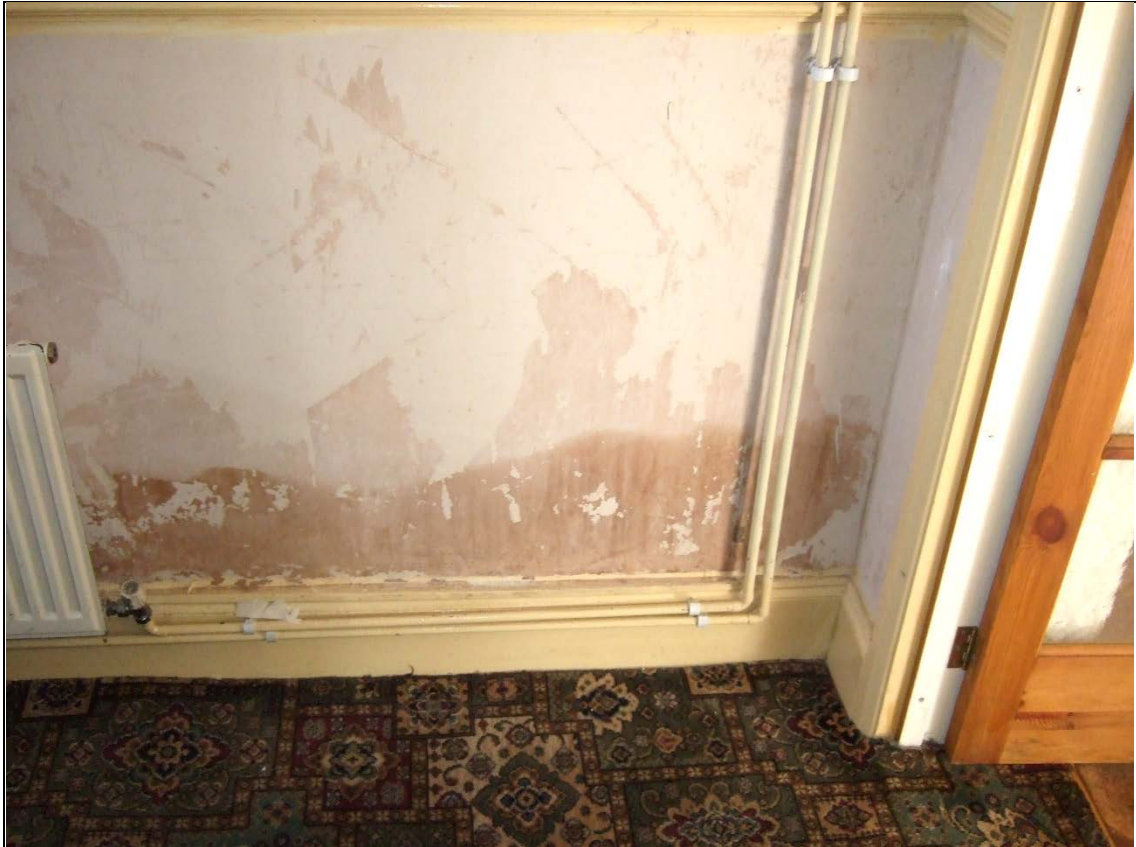
Figure 9: Wall base dampness aligning with the Sharp Front model (example 2).

Damp staining affecting the base of this late nineteenth century, brick built house in Howden, East Yorkshire aligns with the characteristics describing rising damp and the Sharp Front model.

Admittedly, this result is underpinned by a number of assumptions; yet, if the product of the calculation is representative of the height that rising damp may attain in the walls of Victorian terraced houses, then the Sharp Front model aligns with rising damp that I have seen many times in houses of this era, as illustrated in the examples shown in Figure 3, Figure 9, and Figure 10 below.

Clearly, there is some speculation that these three real world examples, and many comparable cases that I have witnessed, are categorically rising damp; nevertheless, given their seeming correlation with the Sharp Front model and similarity with the characteristics describing rising damp, that it may be the cause of this dampness cannot be ignored.

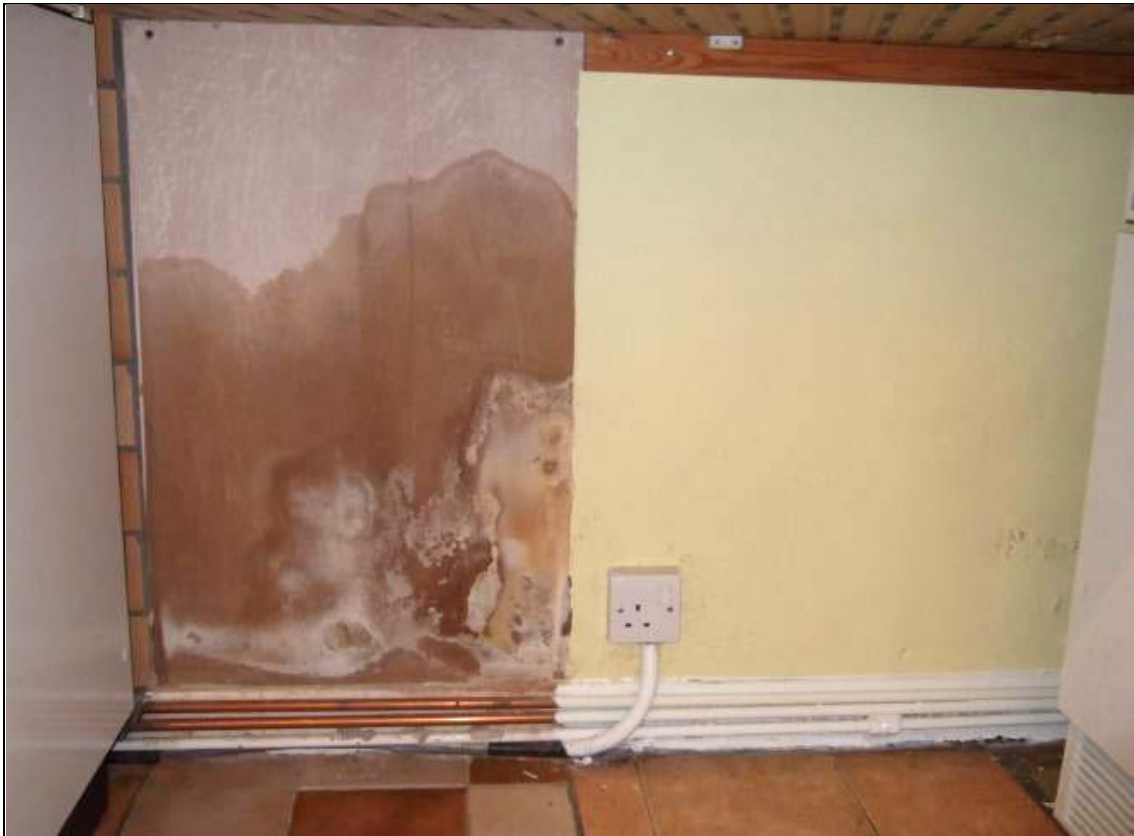
Figure 10: Wall base dampness aligning with the Sharp Front model (example 3).

Damp staining affecting the base of this early twentieth century, brick built house in Selby, North Yorkshire aligns with the characteristics describing rising damp and the Sharp Front model.

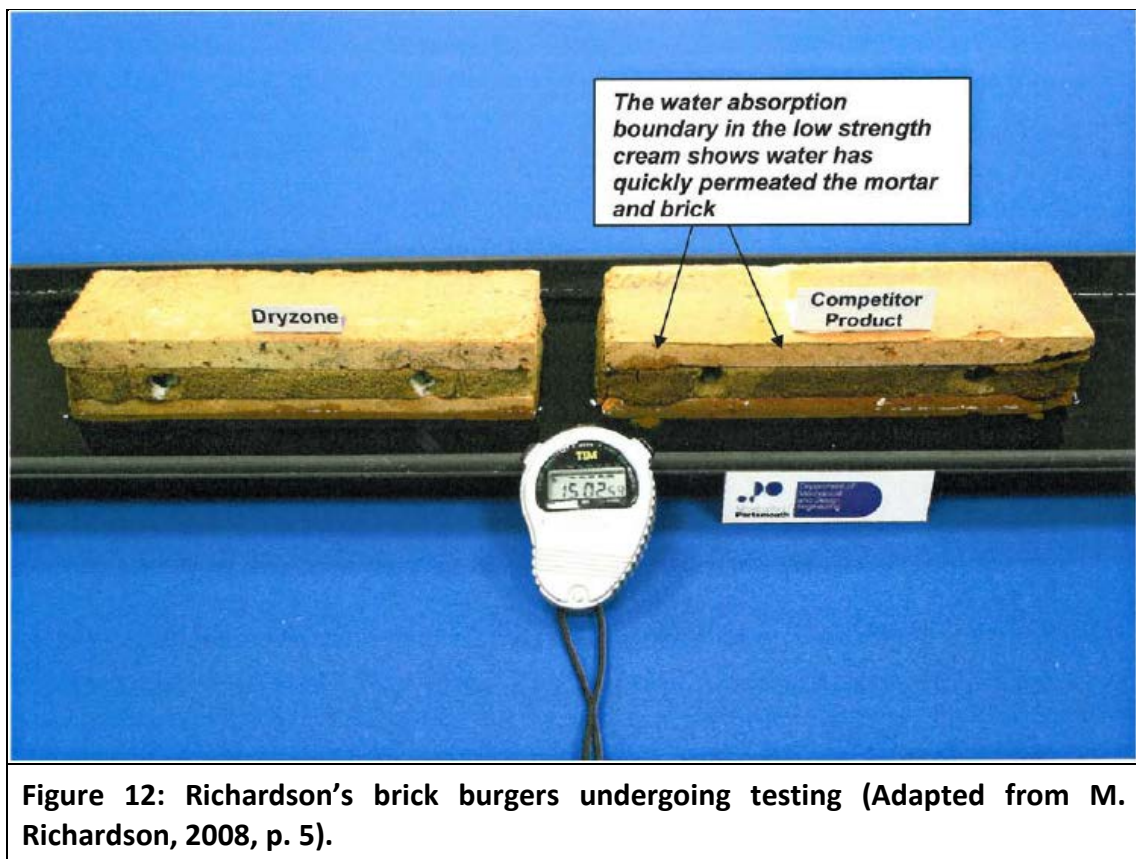
Figure 12: Richardson's brick burgers undergoing testing (Adapted from M. Richardson, 2008, p. 5).

Richardson's work was essentially aimed at comparing Safeguard Europe Ltd.'s Dryzone damp proofing cream with products manufactured by their competitors. His study involved the use of 'brick burgers'; each of these burgers comprised two thin pieces of common Fletton bricks sandwiching a centre filling of high porosity mortar. The damp proofing cream was injected into two 12 mm diameter holes, spaced at 120 mm centres, that had been formed in the mortar filling during construction (M. Richardson, 2008, p. 3). The treated brick burgers were subsequently placed in trays containing a shallow depth of water, as shown in Figure 12 below, and weighed at periodic intervals to measure the amount of water absorbed (M. Richardson, 2008, p. 4). From these results, the relative effectiveness of the damp proofing creams was determined.

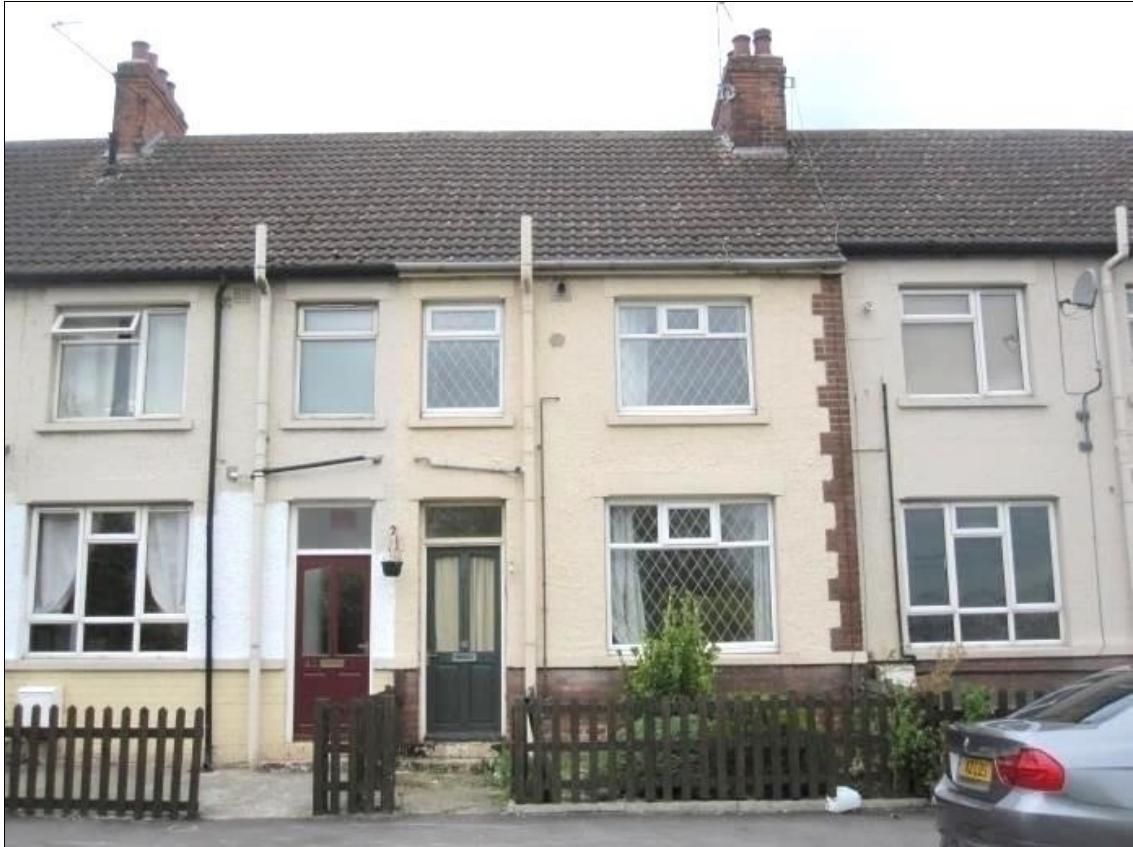
Figure 13: The case study house.

The house, shown in Figure 13 below, had ground floor living accommodation that comprised a small entrance lobby, a front living room, an understairs cupboard, a kitchen, and attached outbuildings. It was of a type that is susceptible to damp problems and for which surveys relating to dampness are often commissioned.

The front guttering comprised a half-round, grey plastic type, connected to a fall pipe at its left-hand end, as shown in Figure 13 above. However, the right-hand end of this gutter had sagged, as shown in Figure 28 below, and stains visible on the fascia board directly behind suggested that rain water had been discharging from it or from the roof.

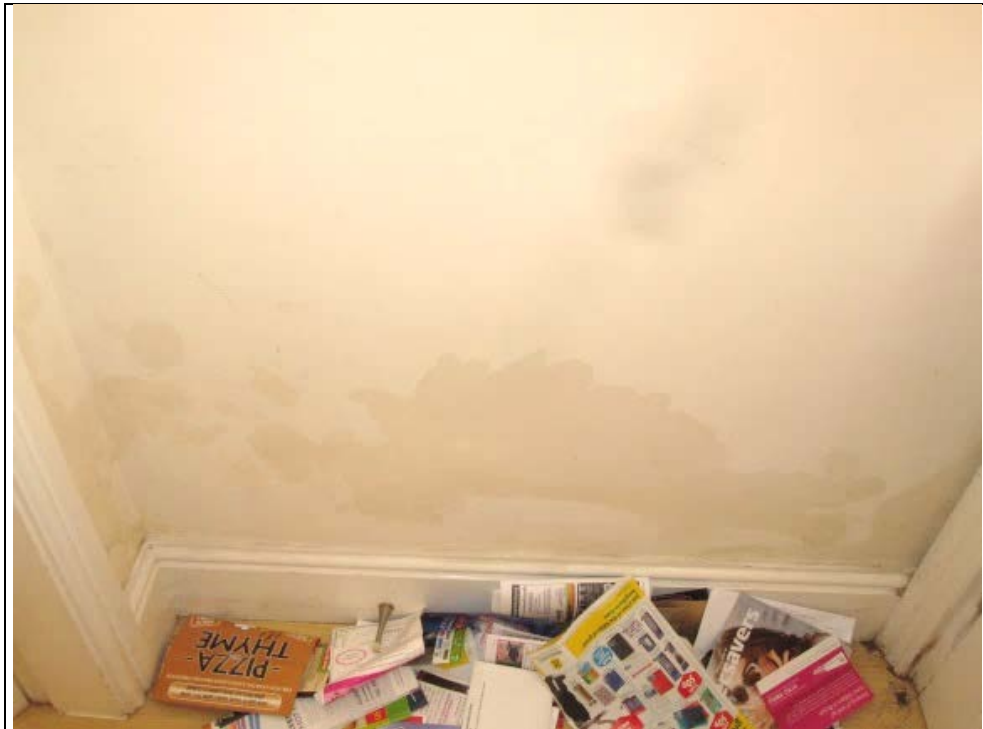
Figure 14: Entrance lobby right-hand side wall.
Damp staining extends to 550 mm above floor level.

The initial survey revealed damp staining to affect the base of the ground floor walls in the entrance lobby, living room, and kitchen that extended to heights of between 250 mm and 800 mm above internal floor level, as shown in Figure 14, Figure 15, Figure 16, Figure 17, Figure 18, Figure 19, Figure 20, Figure 21, and Figure 22 below.

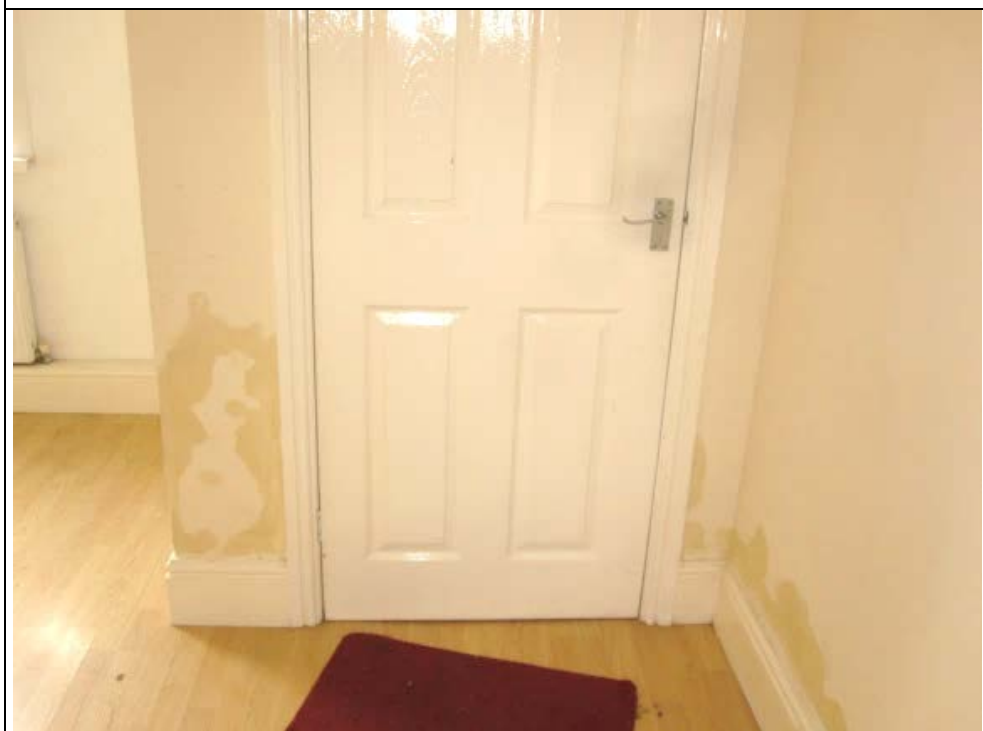
Figure 15: Living room dividing wall with entrance lobby.
Damp staining extends to 800 mm above floor level.

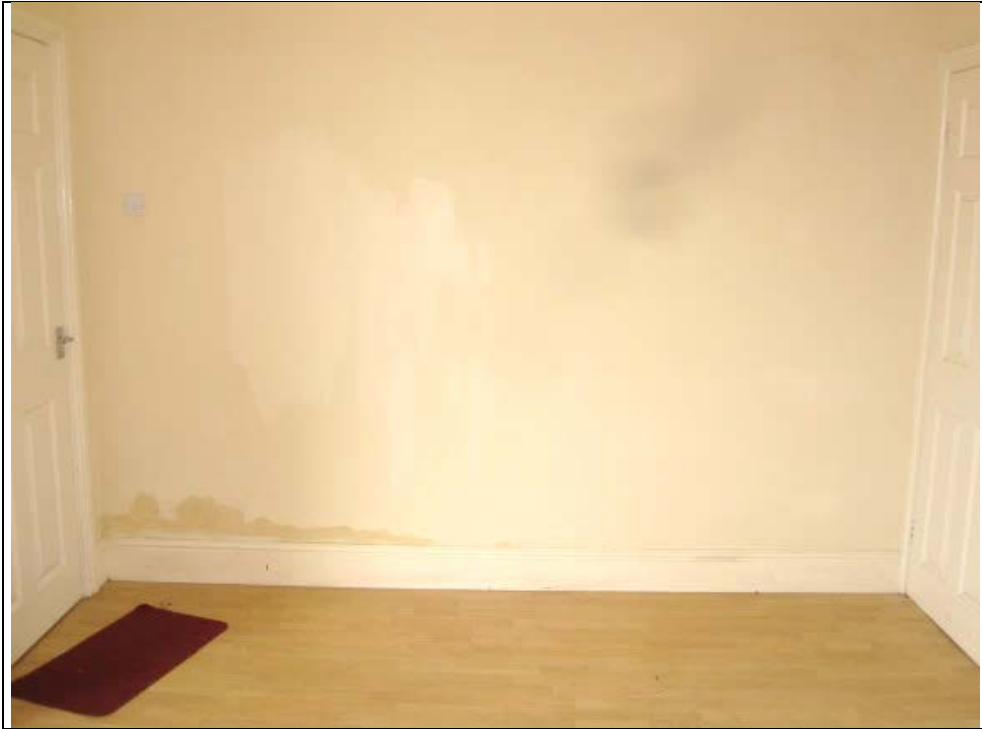
Figure 16: Living room left-hand side (party) wall.
Damp staining extends to 300 mm above floor level.

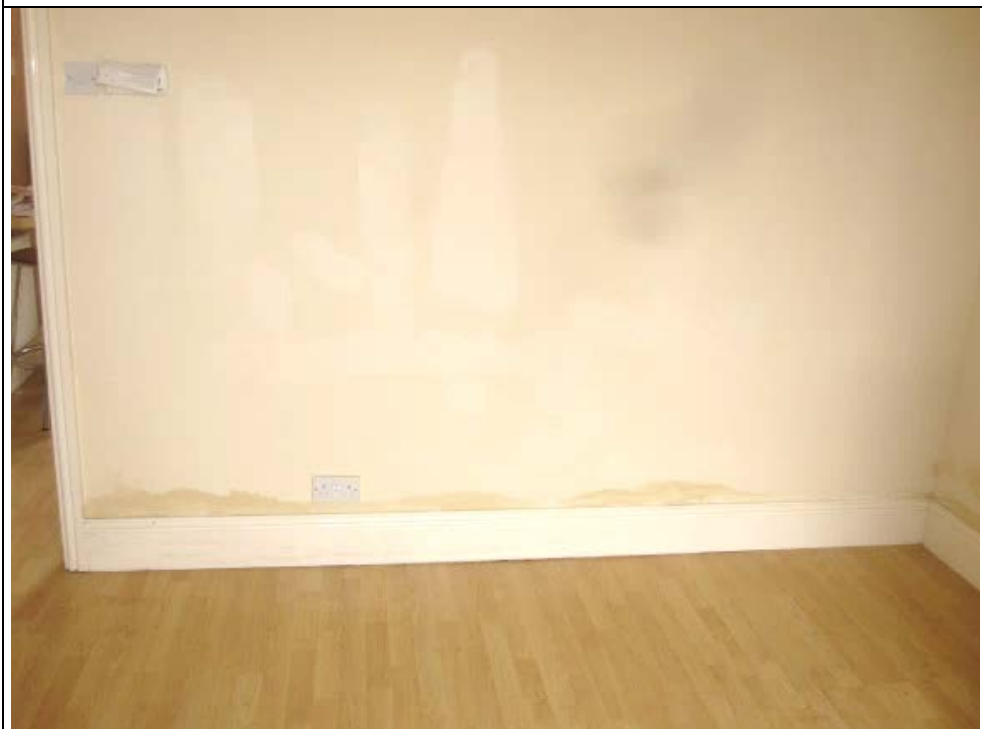
Figure 17: Living room rear wall.
Damp staining extends to 250 mm above floor level.

A Protimeter MMS meter was used to obtain measure-mode readings from the ground floor walls of the house. The distribution of high to low readings essentially aligned with the damp staining visible on the wall bases. For example, on the living room rear wall, illustrated in Figure 17 above, the following profile of measure-mode readings was recorded:

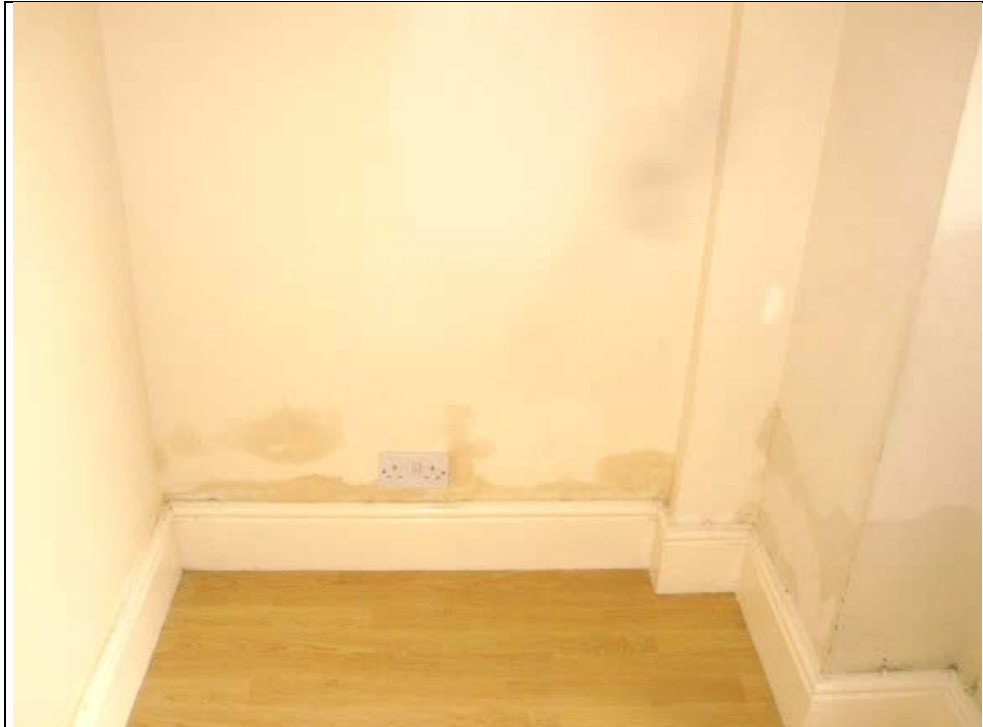
Figure 18: Living room right-hand side (party) wall; rear alcove.
Damp staining extends to 400 mm above floor level.

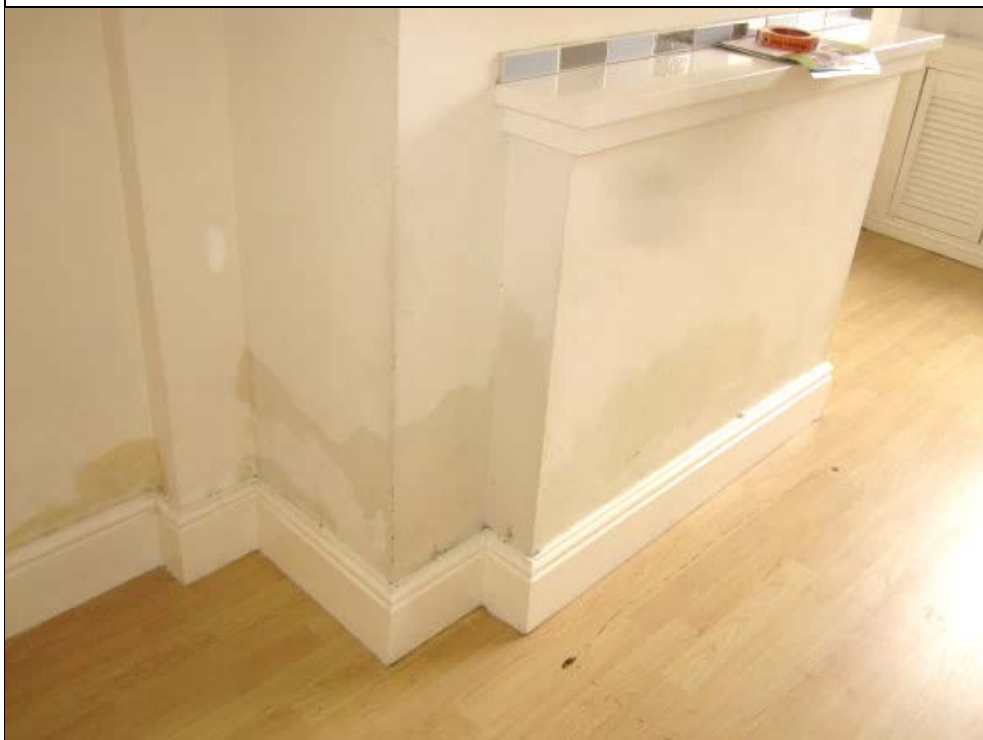
Figure 19: Living room right-hand side (party) wall; fireplace.
Damp staining extends to 650 mm above floor level.

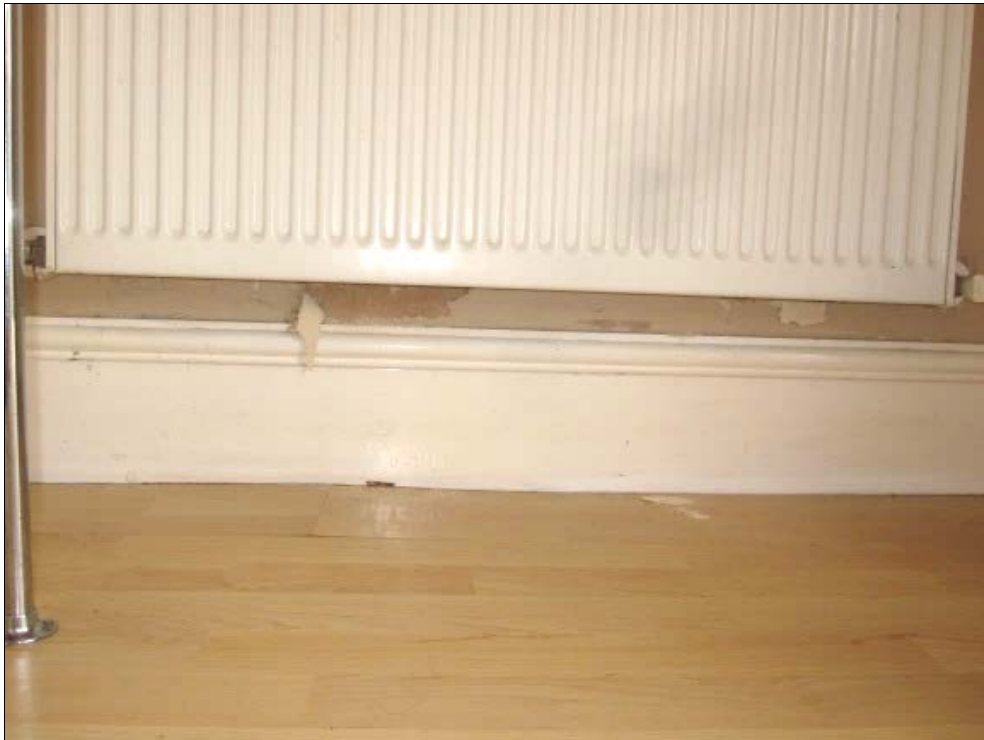
Figure 20: Kitchen left-hand side wall.
Damp staining extends to 350 mm above floor level.

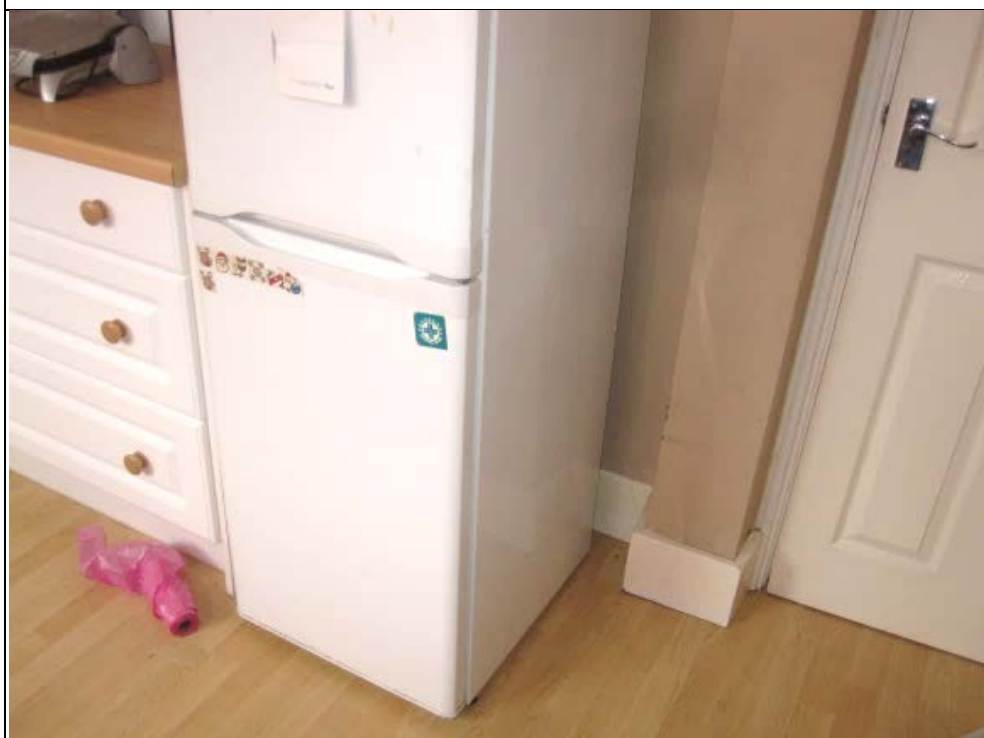
Figure 21: Kitchen front wall, nib wall to side of door.
Damp staining extends to 250 mm above floor level.

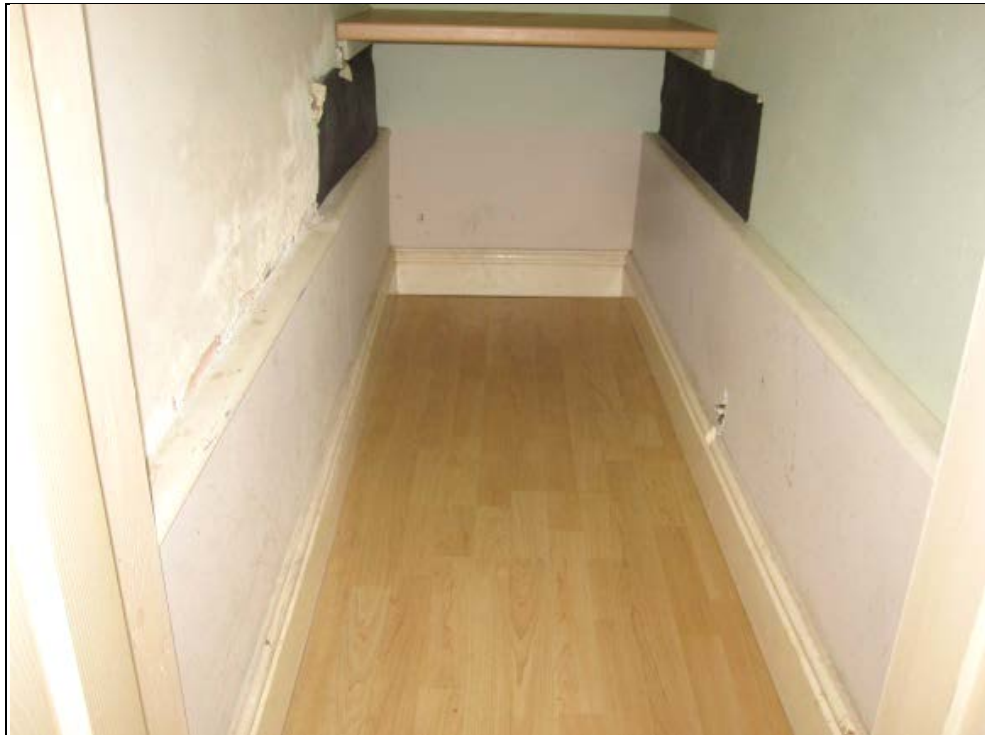
Figure 22: Understairs cupboard left-hand side and right-hand side walls.
Damp staining extends to 800 mm above floor level.

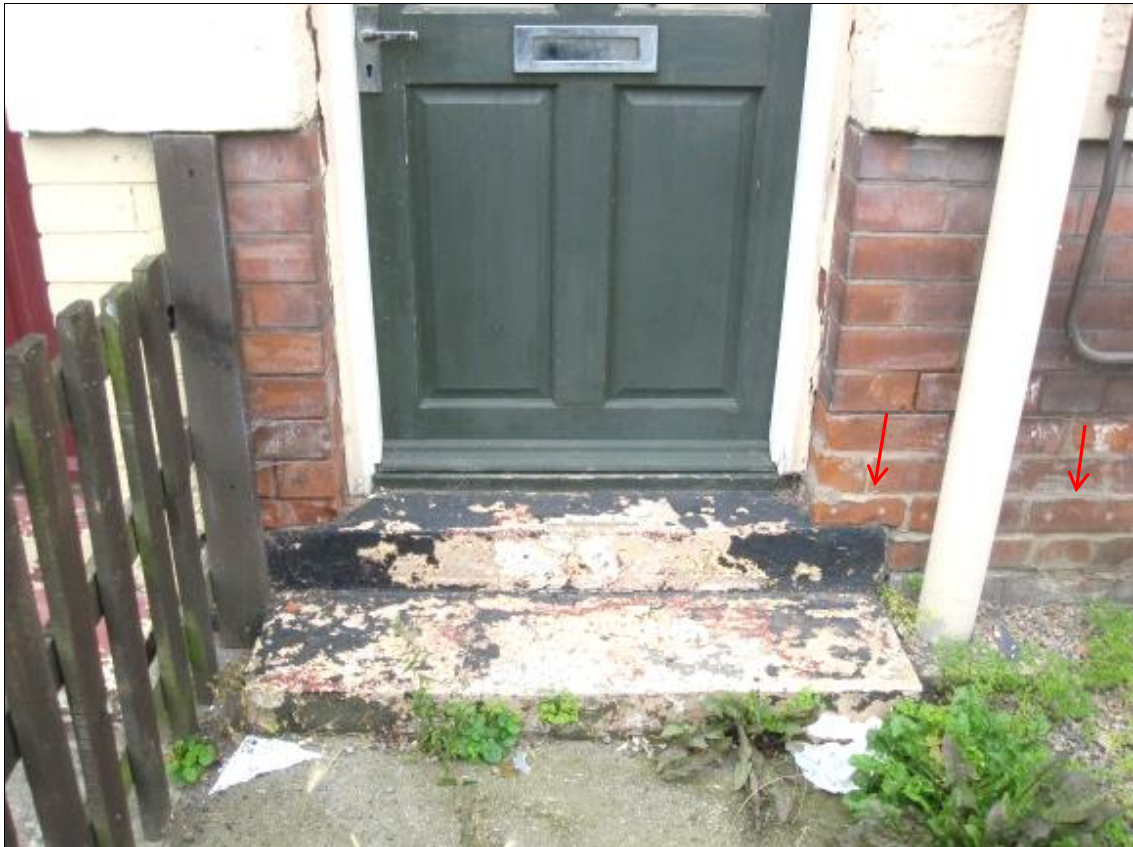
Figure 24: Front wall evidence of chemical injection damp proof course.

Drill holes in a pattern consistent with the installation of a chemical injection damp proof course were visible in the third brick course of the front wall (arrowed). Similar holes were found to have been drilled internally in the base of the walls.

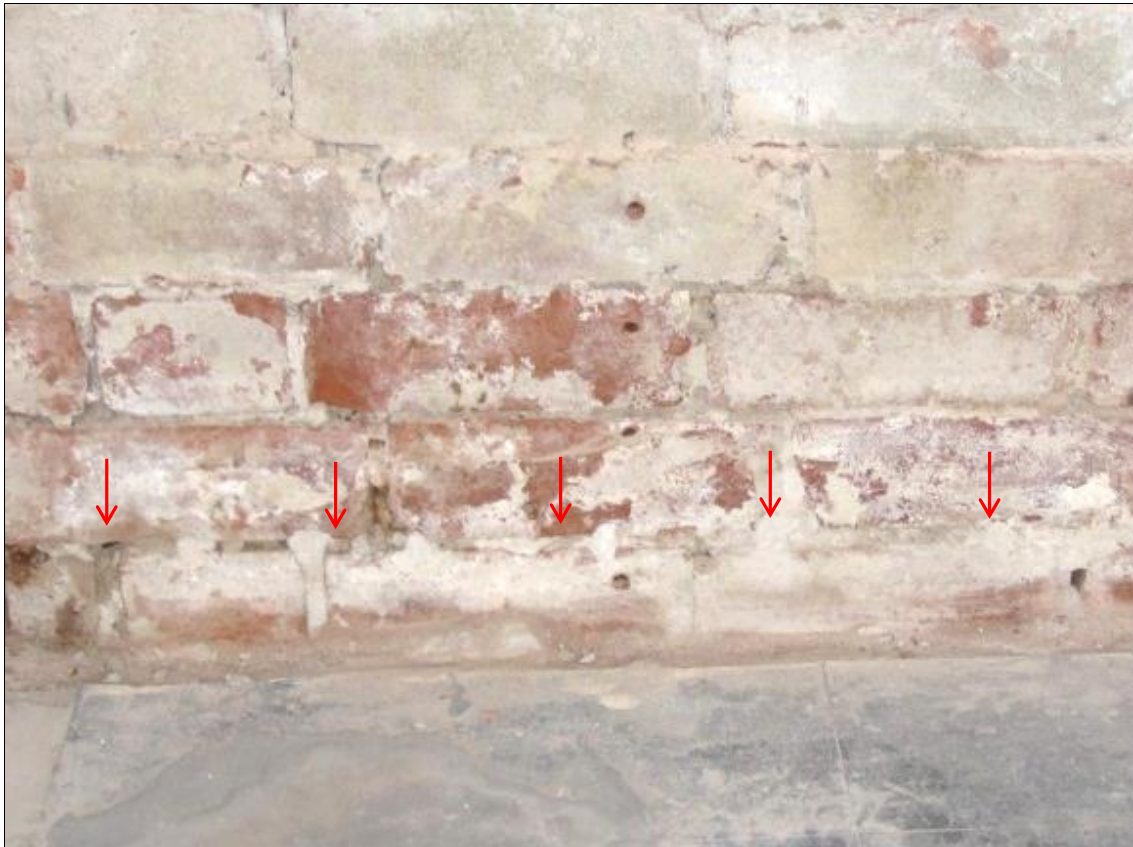
Figure 25: Living room rear wall evidence of chemical injection damp proof course.

Drill holes in a pattern consistent with the installation of a chemical injection damp proof course were visible in the horizontal mortar bed joint above the first brick course (arrowed). Note that the vertical row of holes is not associated with this damp proof course but was formed when the walls were drilled to obtain samples for gravimetric moisture analysis.

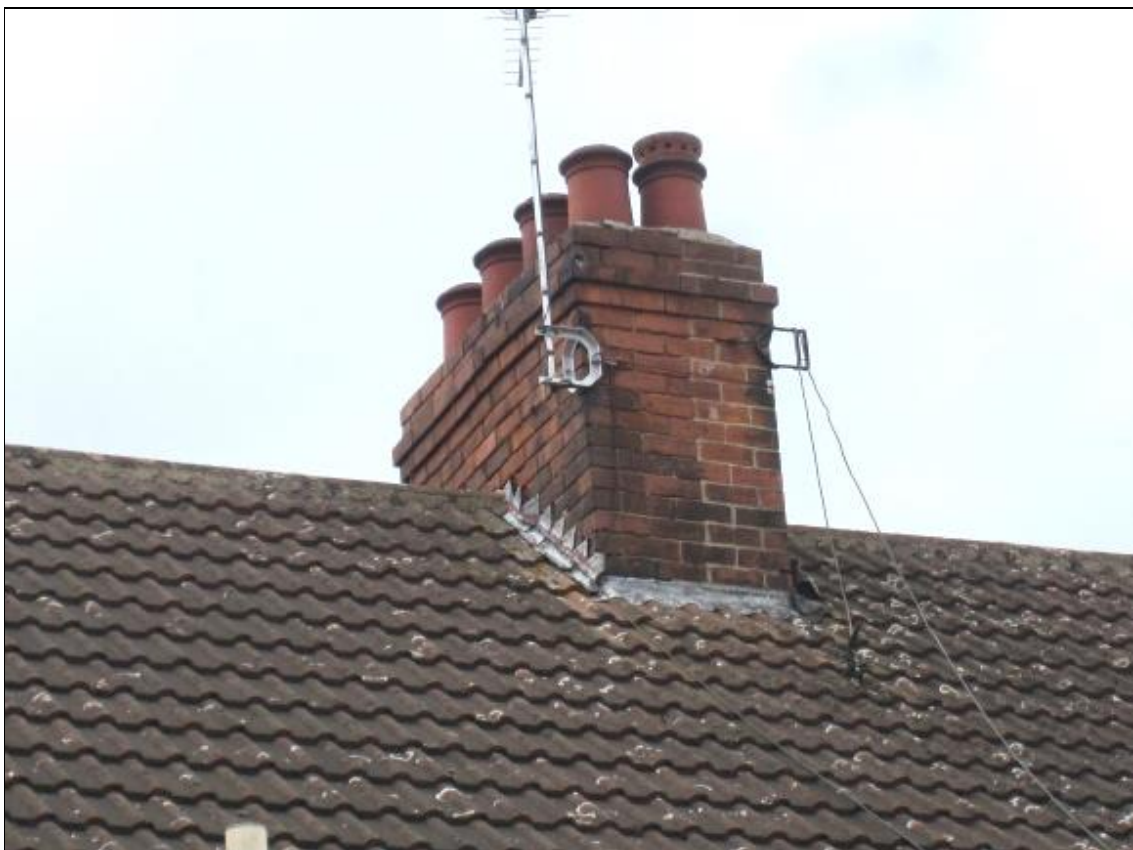
Figure 26: Chimney stack.

Damage to the flaunching and eroded pointing of the chimney stack, shown in Figure 26 below, could have allowed rain water to penetrate into the flue and to seep downwards and affect the living room chimney breast and fireplace.

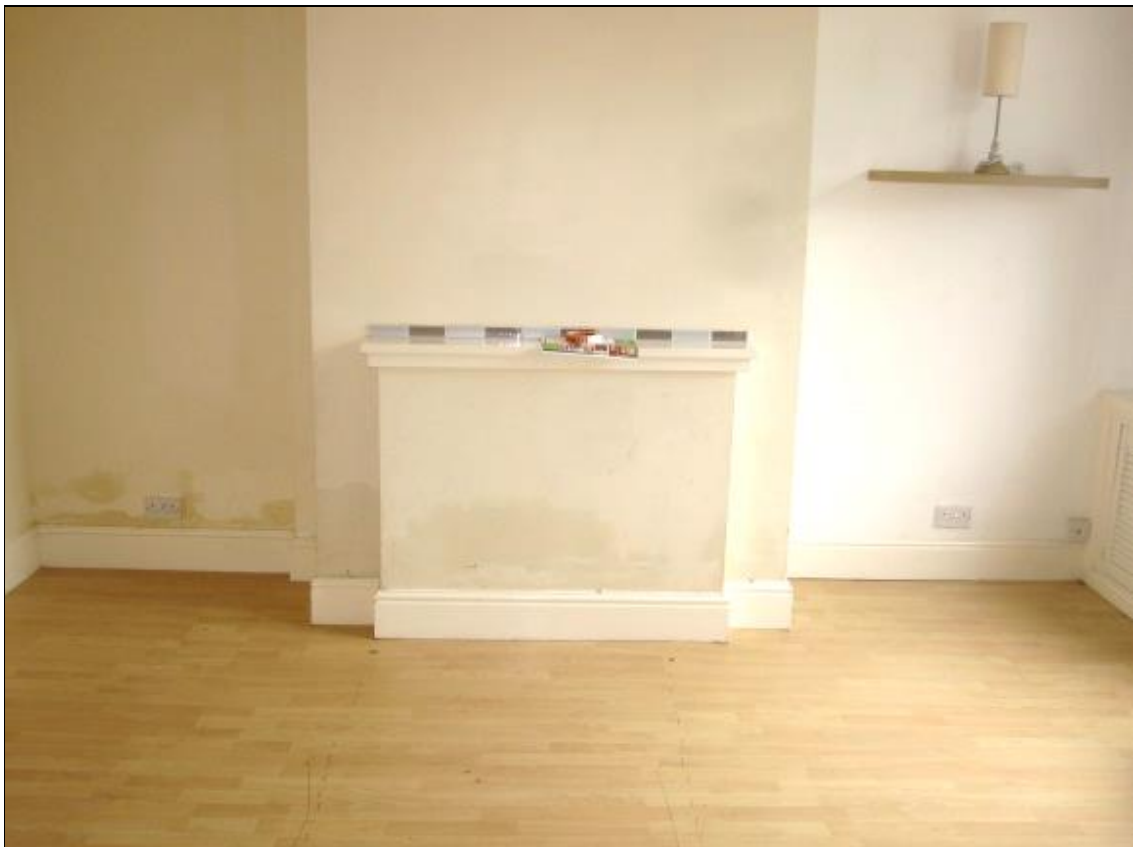
Figure 27: Living room fireplace and alcove walls.

Rain water entering the flue and penetrating downwards into the base of the chimney breast would therefore provide a mechanism, through evaporation, for these salts to migrate into the plasterwork, as shown in Figure 27 below, and be a contributory cause of dampness.

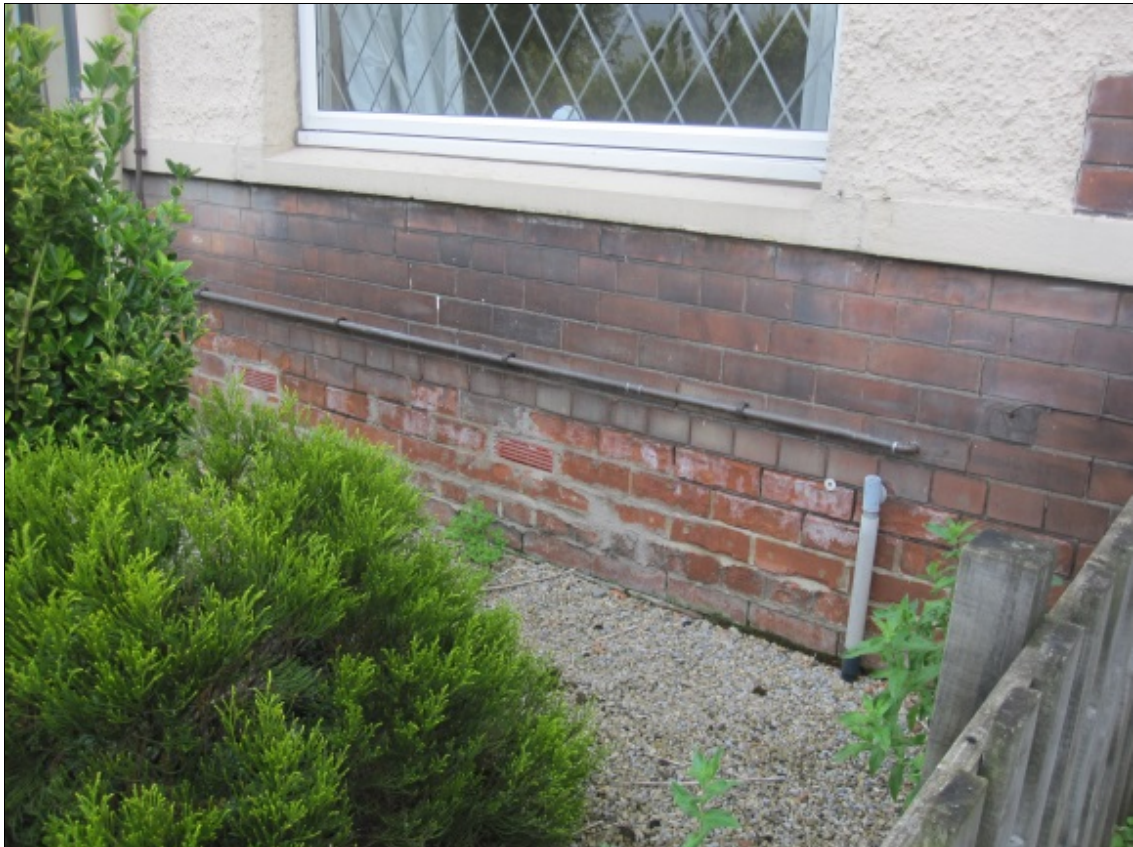
Figure 30: Front wall perished masonry.

Externally, the fourth and fifth brick courses at the base of the front wall were noticeable more perished and affected by greater deposits of efflorescent salts than the bricks in the adjacent courses, as shown in Figure 30 below.
