RISING DAMP EVALUATION AND TREATMENT A QUASI-EXPERIMENTAL CASE STUDY

Submitted in Partial Fulfilment of the Requirements of
the Degree of Doctor of the Built Environment, May 2017

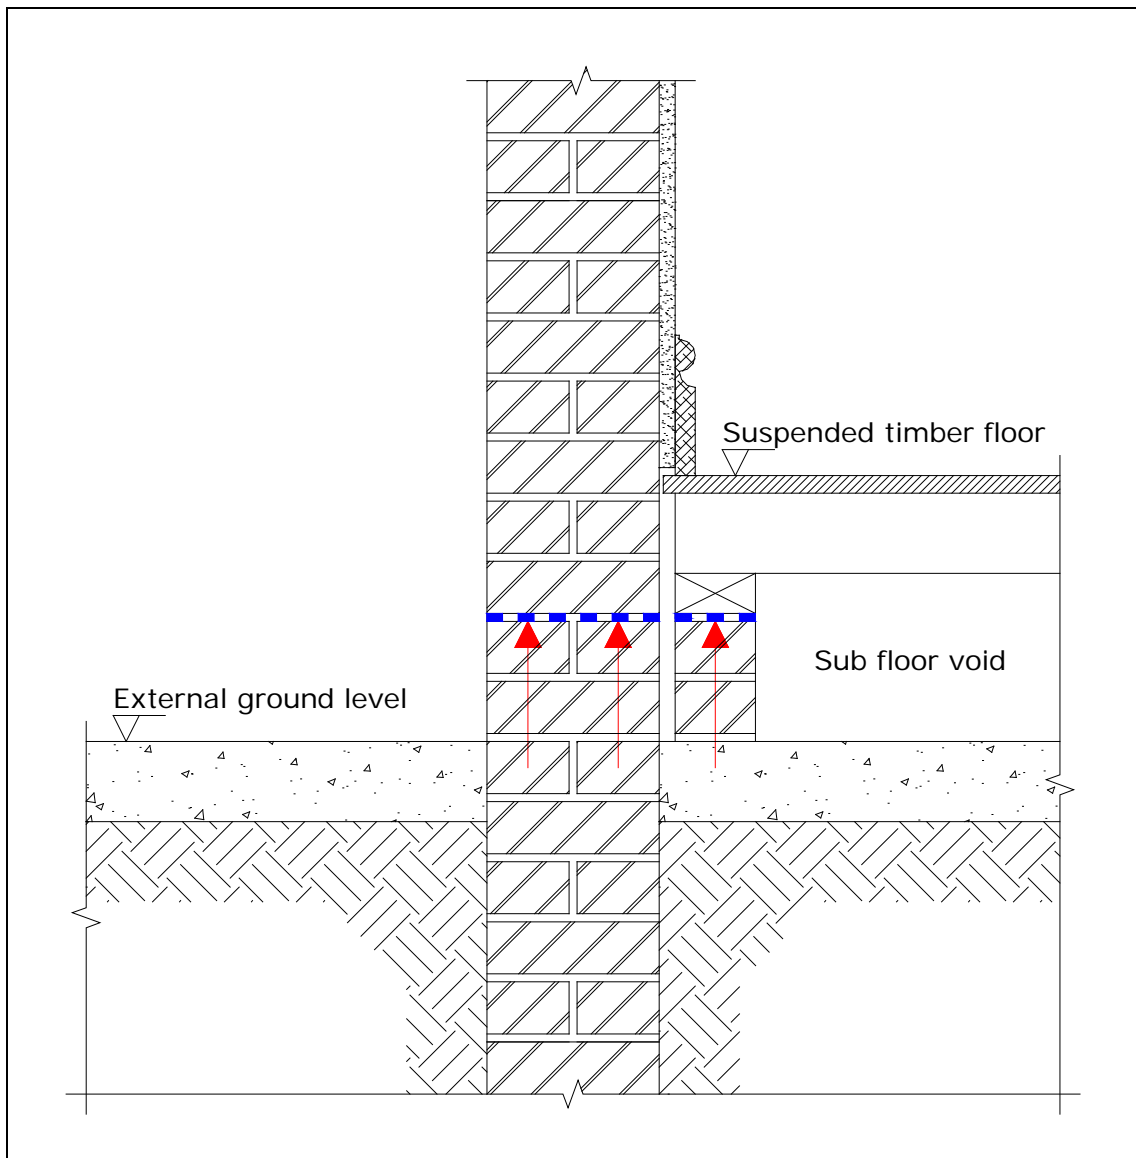
plate, as illustrated in Figure 31 below (Clay & Davis, 1977, p. 97; Oliver, Douglas, & Stirling, 1997, p. 144).

Figure 31: Indicative section through a solid external wall of a house with suspended timber floors.

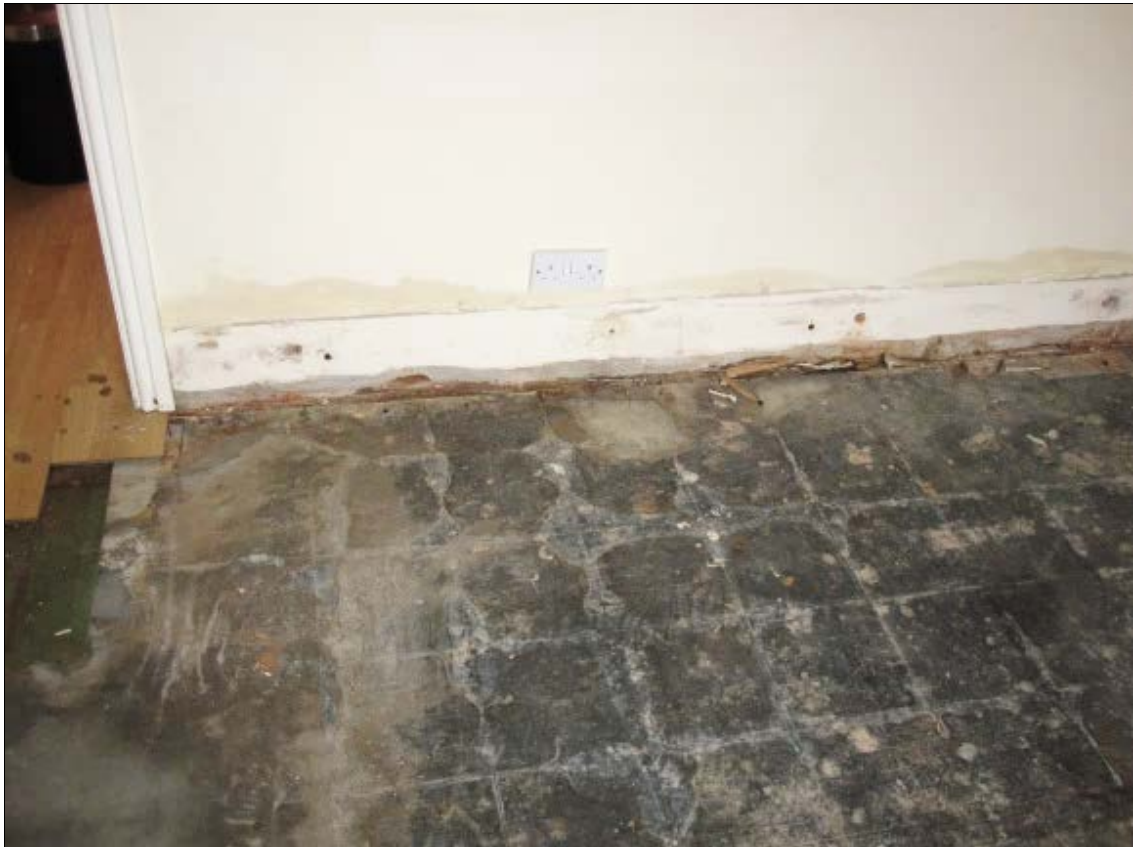
A chemical injection damp proof course had been installed in the ground floor walls. At the time of the initial survey, the only signs of this work were characteristic holes drilled into the bricks at the base of the external face of the front wall, along with evidence that the internal sides of the ground floor walls had been replastered with a cement rich render to a nominal height of one metre. Works undertaken at later stages of this study revealed the bottom edges of this render to have been taken down to meet the solid floors, as shown in Figure 33 below.

Figure 33: Base of the living room rear wall: plaster bridges the existing chemical injection damp proof course.

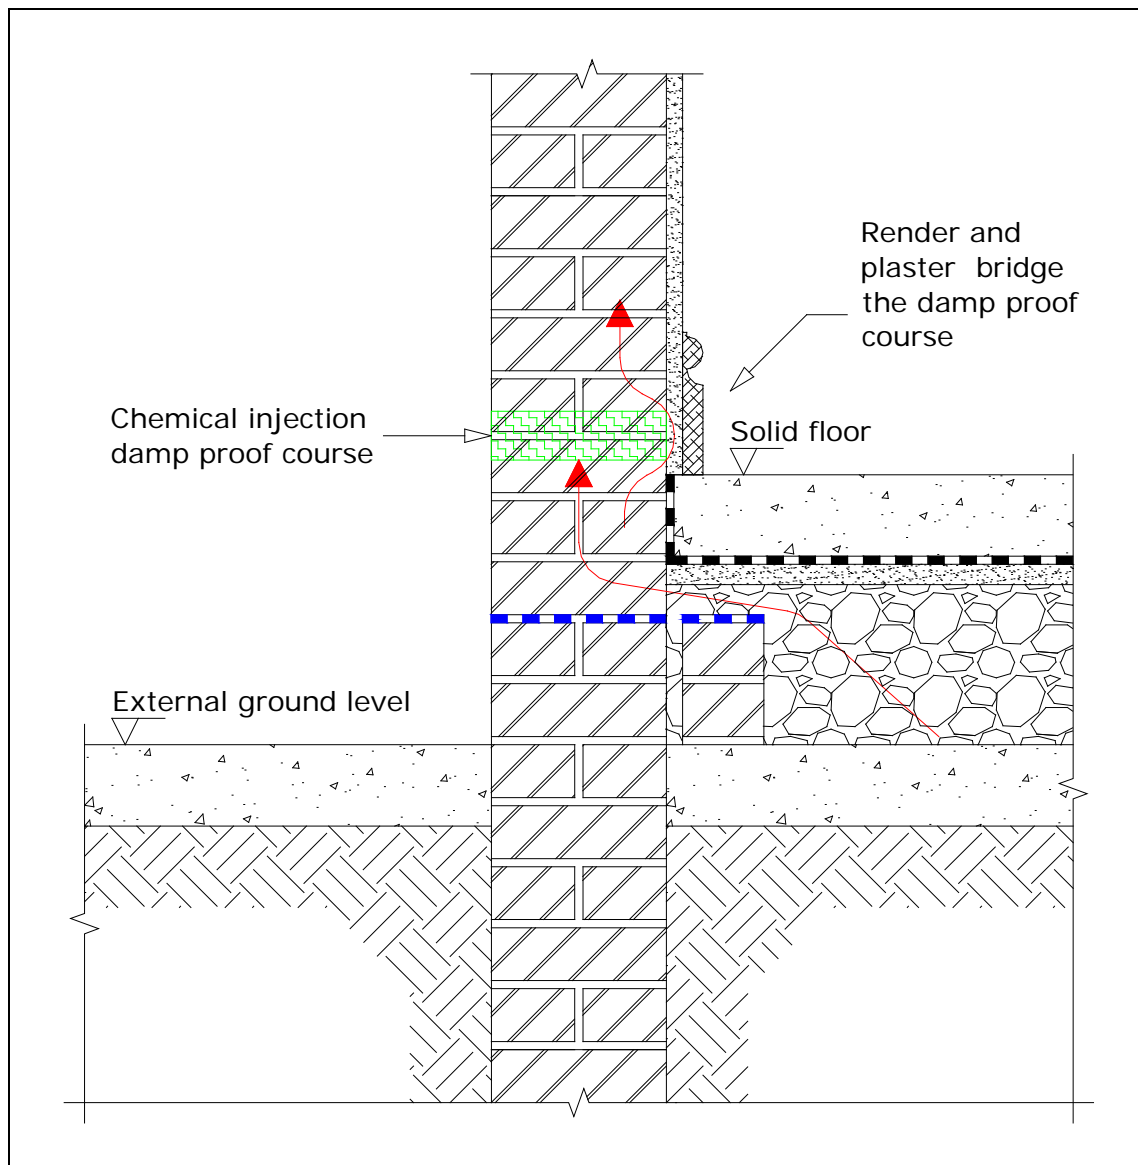
Allowing the internal plasterwork to touch the solid floor, or more explicitly to pass over the chemical injection damp proof course, provides a bridging mechanism that enables moisture in the masonry below the damp proof course to pass up into the wall above, as illustrated in Figure 34 below.

Figure 34: Indicative section through a solid external wall of a house with replacement concrete floors and a chemical injection damp proof course bridged by internal plasterwork.

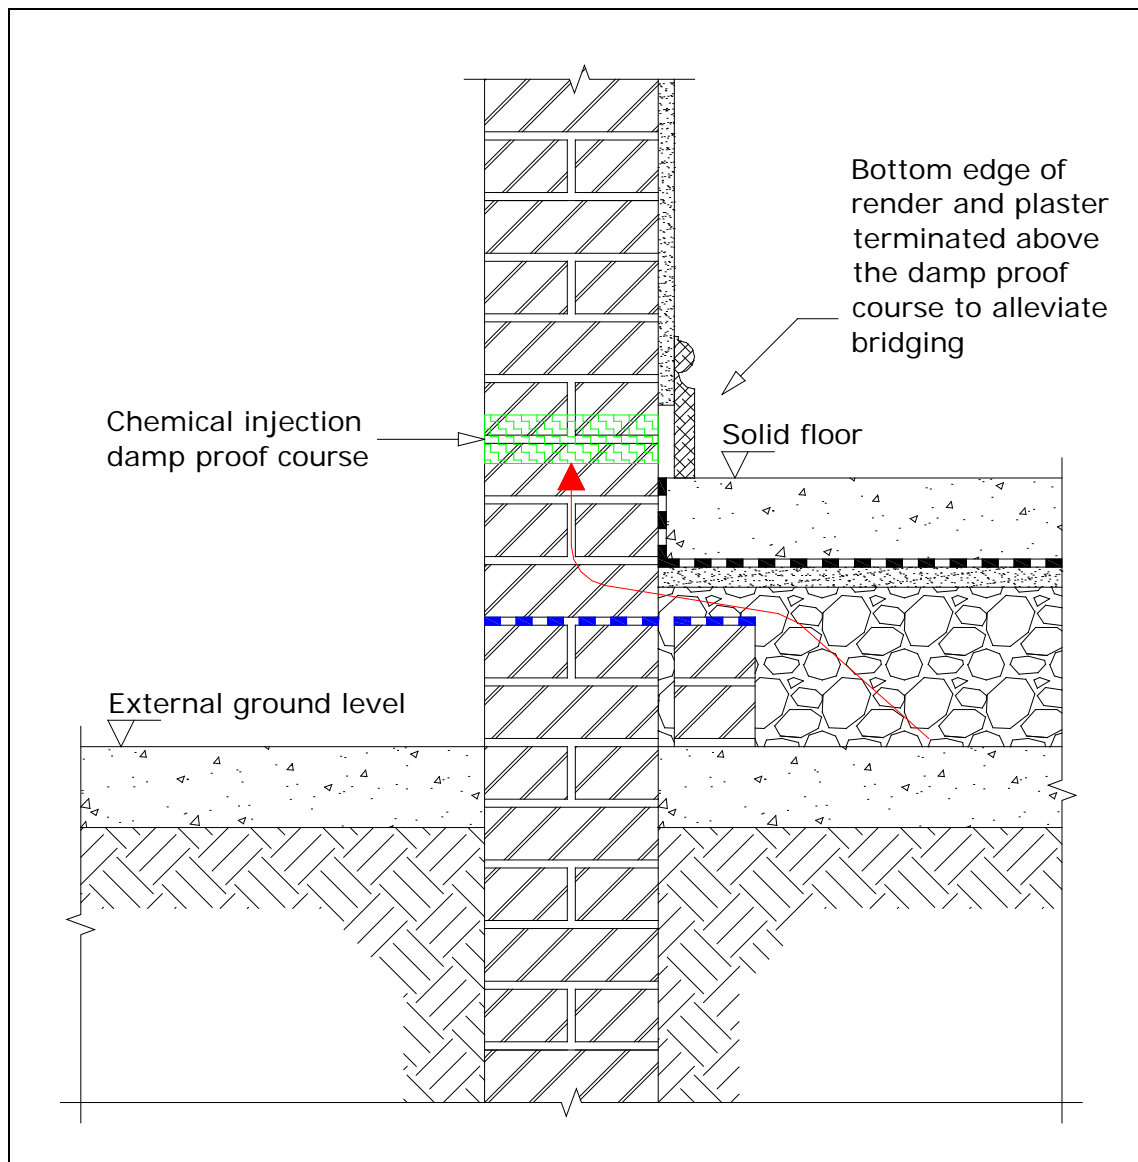
To prevent bridging requires the bottom edge of the plasterwork to be cut back or otherwise terminated above the damp proof course, as illustrated in Figure 35 below.

Figure 35: Indicative section through a solid external wall of a house with replacement concrete floors and a chemical injection damp proof course not bridged by internal plasterwork.

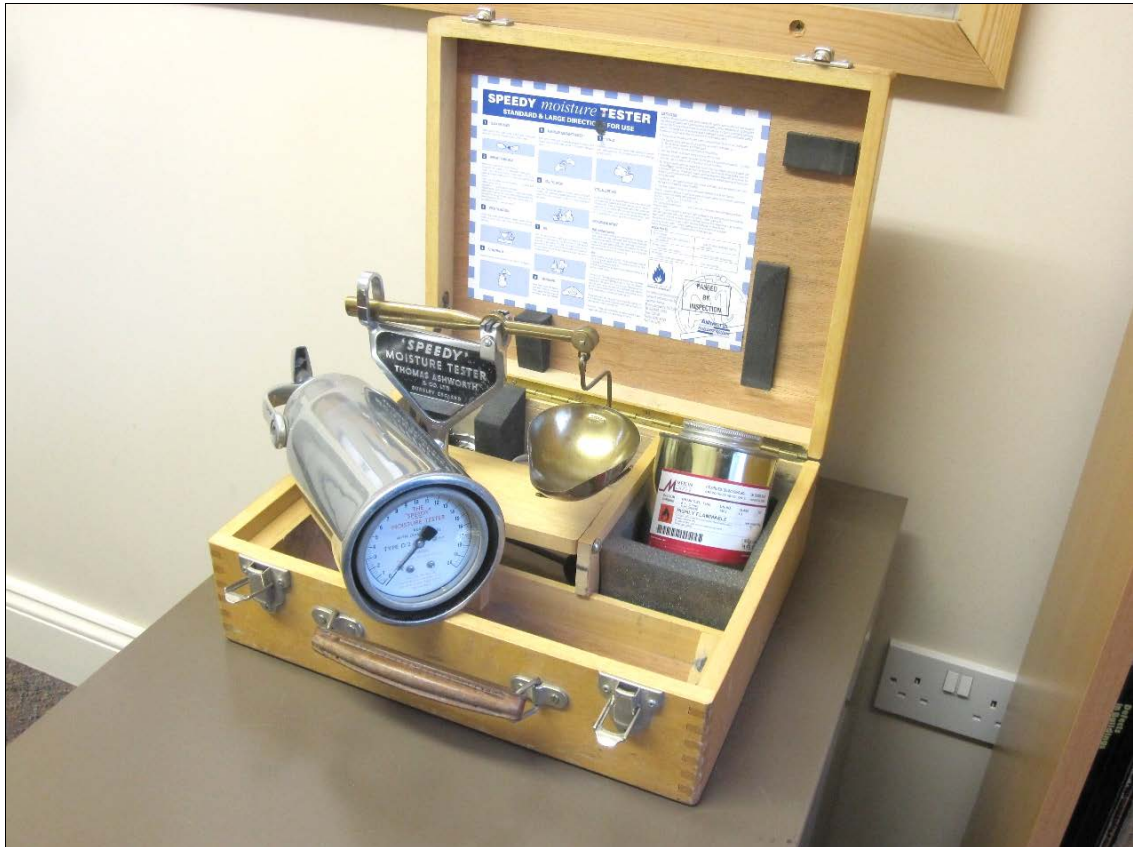
Figure 36: Carbide meter.

A carbide meter, which is shown in Figure 36 below, comprises a metal flask with a pressure gauge attached to its base. To use this meter, a sample of the mortar, plaster, or masonry to be tested is typically obtained by drilling. This sample is carefully weighed, placed in the flask with a measured quantity of calcium carbide reagent and the flask is then sealed and shaken to mix the contents (Hollis & Gibson, 2005, p. 411). The calcium carbide reagent reacts with moisture in the sample and this reaction produces acetylene gas (Burkinshaw & Parrett, 2003, p. 80). The gas increases the pressure within the flask and this pressure is converted into a percentage moisture content that can be read directly from the analogue dial of the gauge attached to its base. The reading obtained is therefore proportional to the amount of moisture present in the sample: the wetter the sample, the higher the reading (Hollis & Gibson, 2005, p. 411).

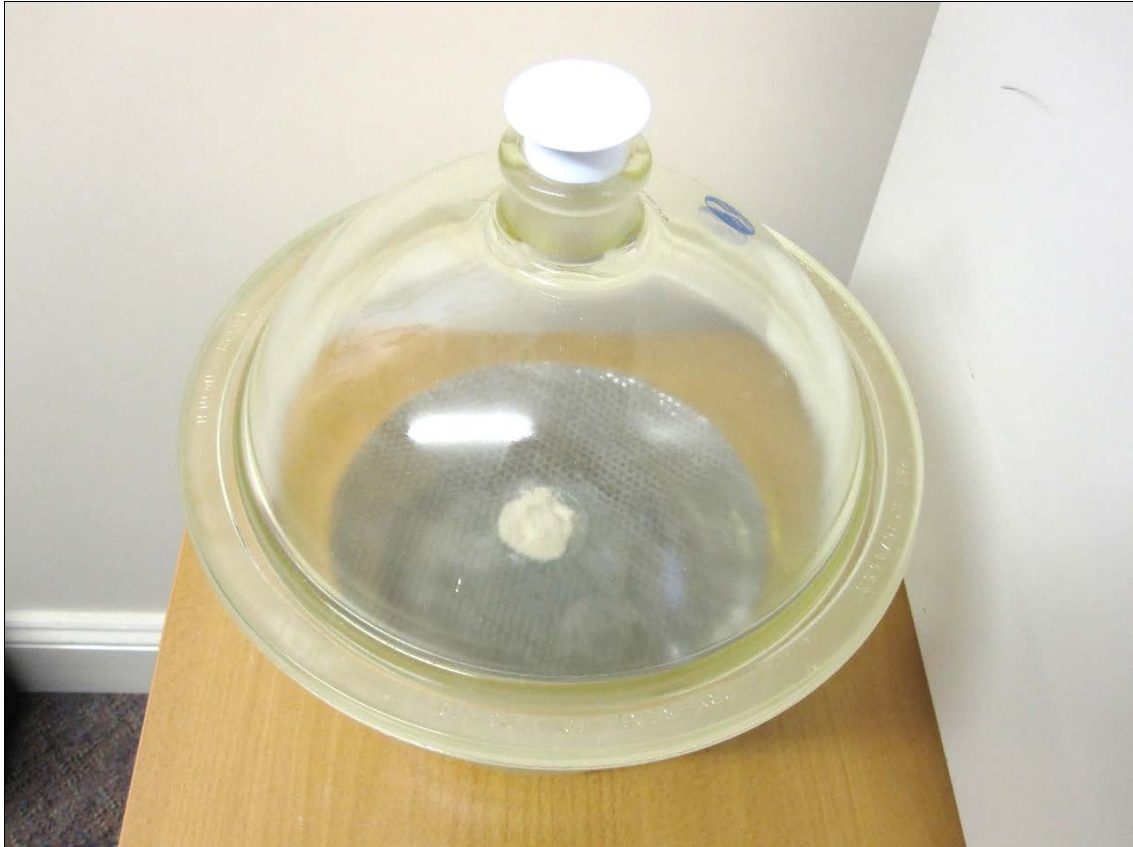
Figure 37: 75% humidity chamber.

Figure 37 below illustrates items 1 and 2 of the above list after a sample on a watch glass has been weighed and placed in a desiccator above a saturated solution of sodium chloride. When sealed, the air inside the desiccator equilibrates to 75.0% relative humidity (BSI, 2013a, pp. 4,5; Trotman, 2007, p. 11).

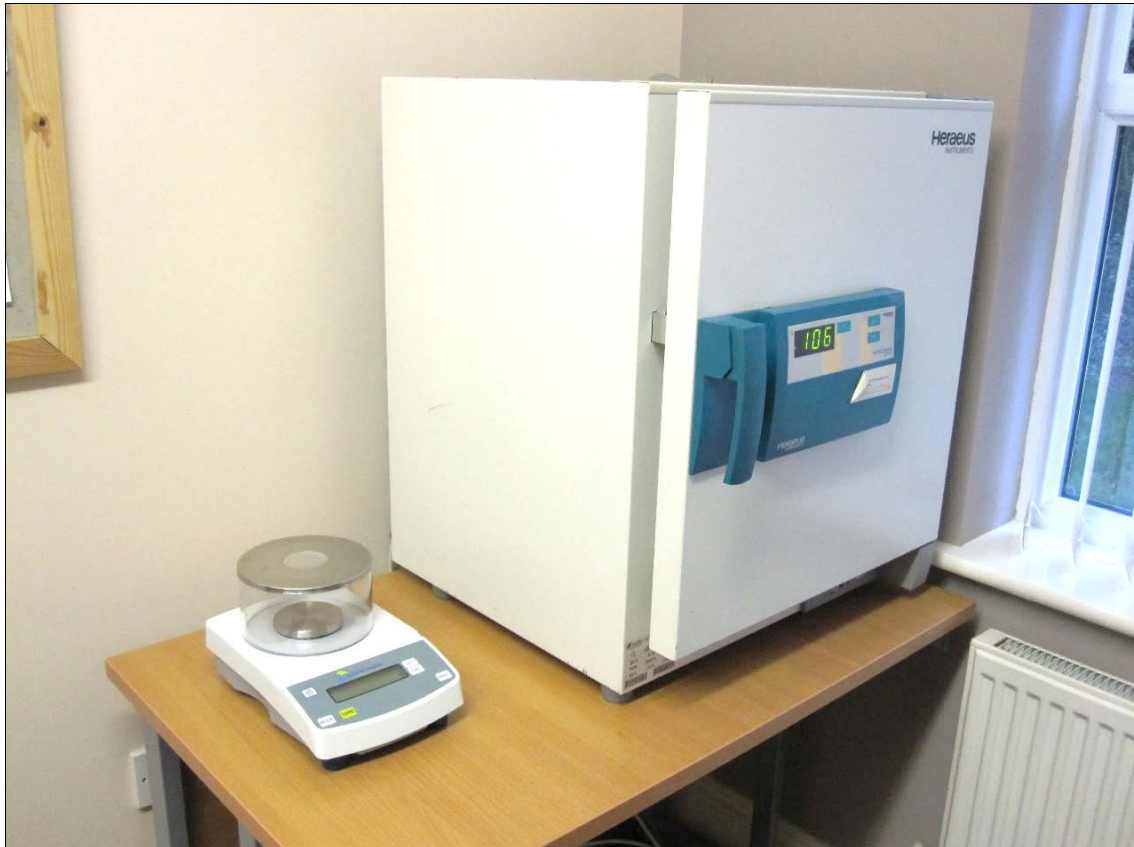
Figure 38: Drying oven and balance

Samples are conditioned by placing them in a sealed vessel above a saturated solution of common salt, thereby providing a controlled, 75% relative humidity environment. Once equilibrated, the moisture content of the sample is determined either using the gravimetric method or with a carbide meter to obtain its hygroscopic moisture content.

Items 3 and 4, the electronic milligram balance and laboratory drying oven, are illustrated in Figure 38 below.

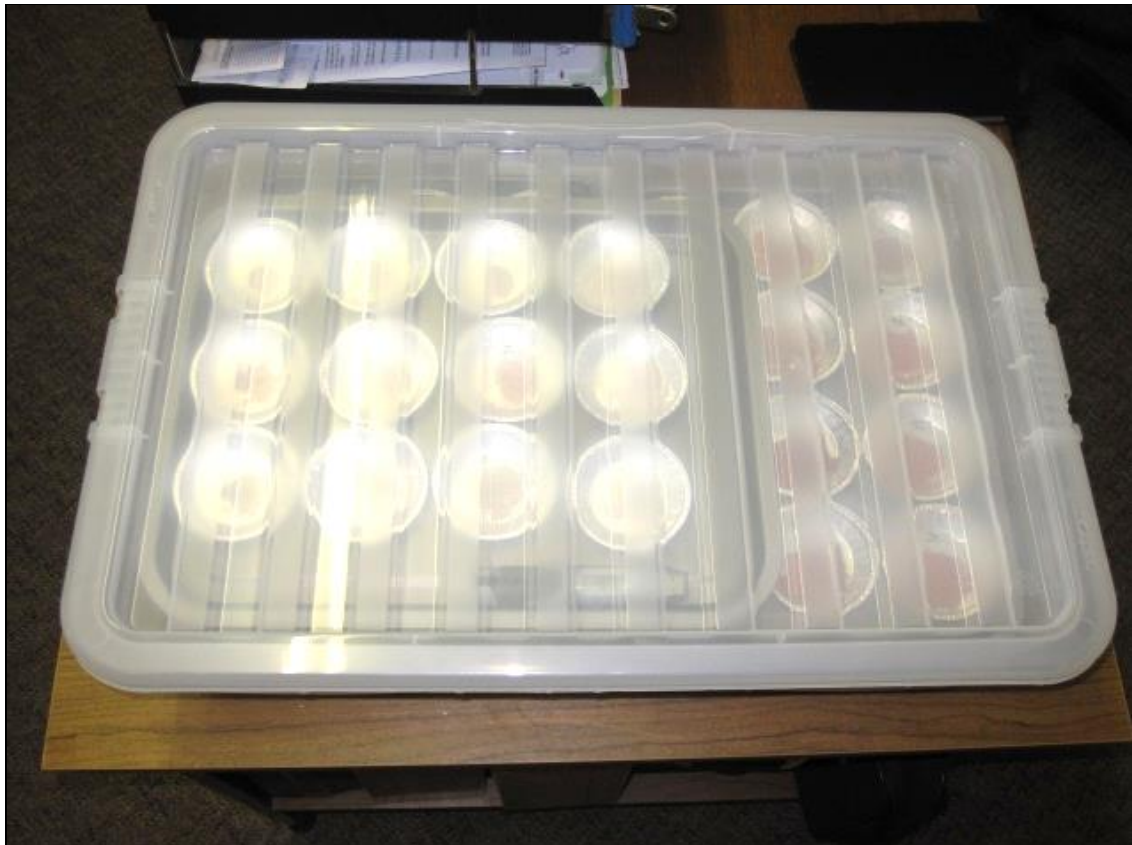
Figure 39: 75.0% relative humidity container for large batch processing.

conditioning. In contrast, the drying oven can accommodate eighty-two samples in a single batch. Thus, a larger 75.0% relative humidity chamber was constructed using a large plastic container with a sealable lid, as shown in Figure 39 below, in which up to eighty-two samples could be processed above a saturated salts solution at the same time.

Samples are placed on trays above a saturated salts solution in the base of this large, plastic container for batch processing at 75% RH. This container can accommodate eighty-two samples at the same time.

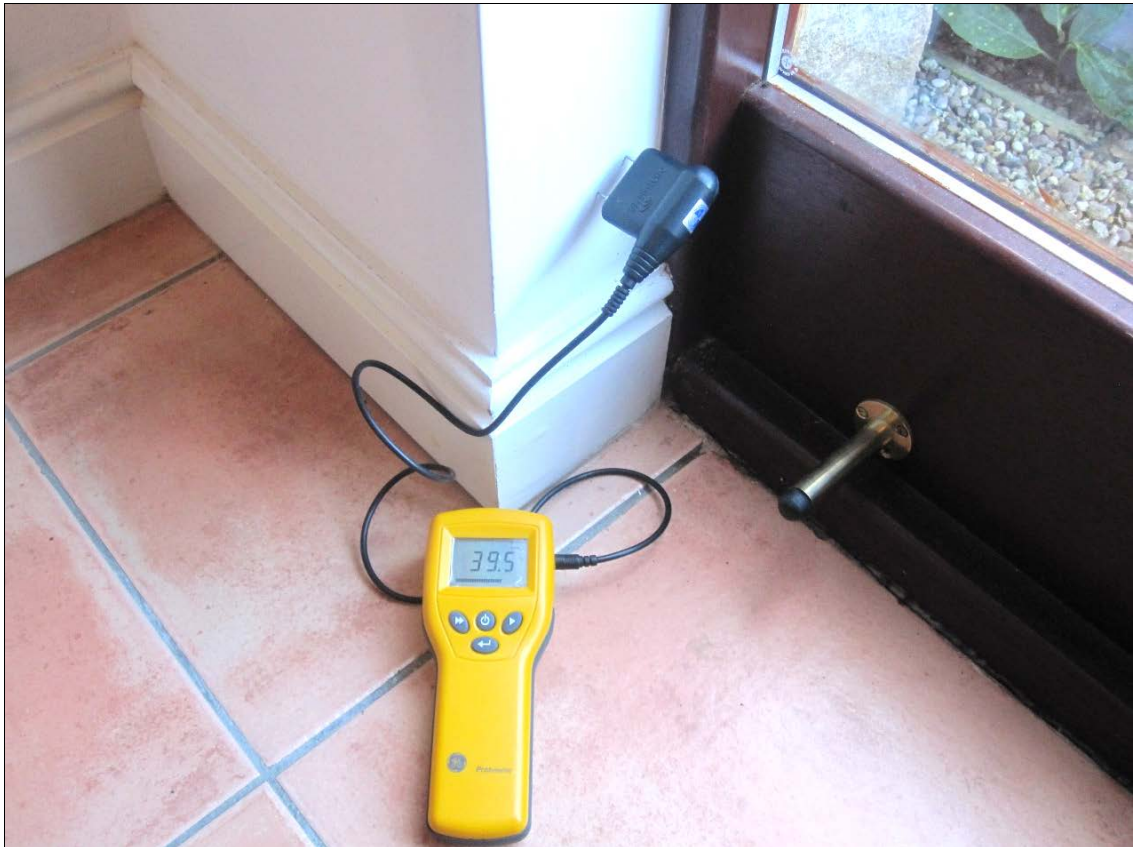
Figure 40: Protimeter MMS meter: measure-mode function using the Heavy Duty Probe.

For the Protimeter MMS meter, measure-mode readings are obtained using a Heavy Duty Probe attachment: the two-pins of the probe are pushed into the surface of the material to be sampled, as illustrated in Figure 40 below (GE Sensing, 2005, p. 7).

The measure-mode function enables the actual percentage moisture content of timber to be obtained within the range of 8%-29% (GE Sensing, 2005, p. 17; 2009, p. 6). Outside this range (i.e. >30-100%) measure-mode readings recorded on timber are not quantitative (GE Sensing, 2005, p. 17). The manufacturers of the Protimeter instruments claim that measure-mode readings obtained from materials other than timber are 'wood moisture equivalent' (WME) (GE Sensing, 2005, p. 7). However, because brick, stone, plaster, concrete, and other masonry materials are dissimilar, measure-mode readings recorded on them can only be considered relatively (Burkinshaw, 2002, p. 165; Burkinshaw & Parrett, 2003, p. 76).

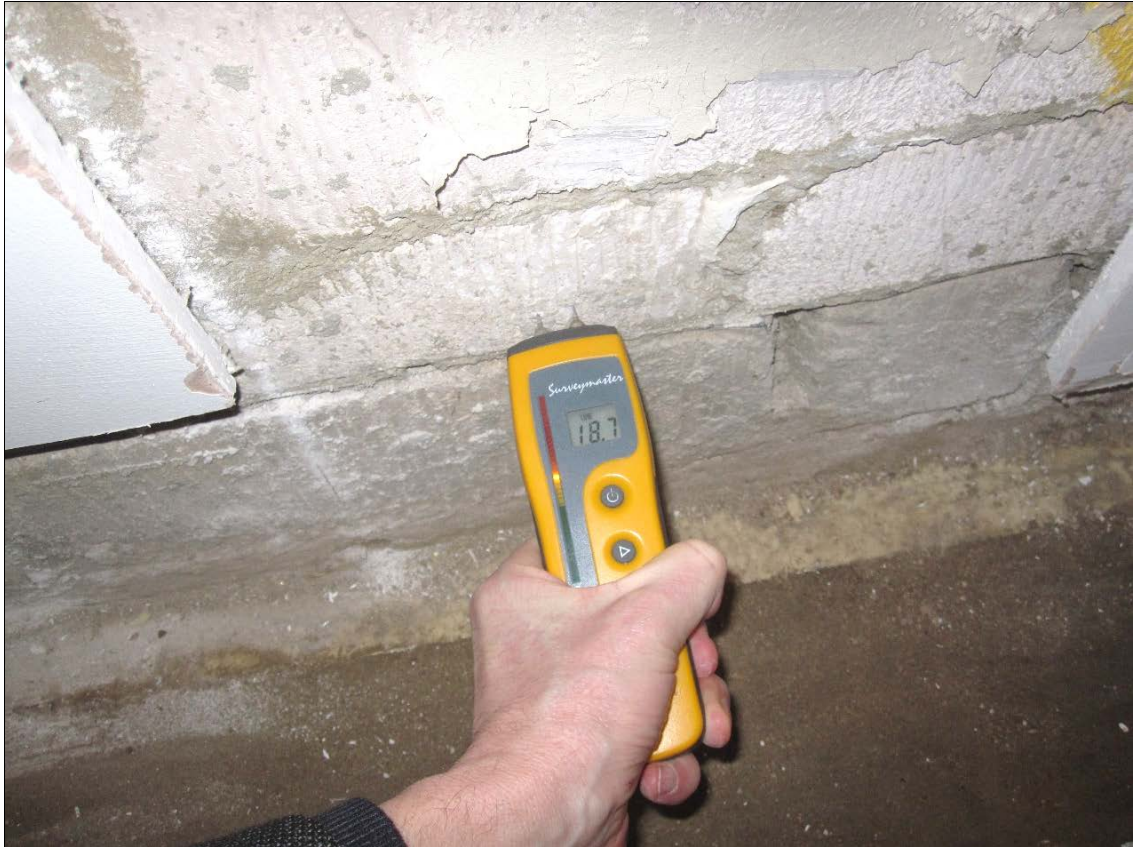
Figure 41: Protimeter Surveymaster meter: measure-mode function using the integrated pins.

The Heavy Duty Probe can be used with the Protimeter Surveymaster model, but this instrument is also fitted with two integral pins that can be pushed directly into the surface of the subject material hence replicating the probe's function, as shown in Figure 41 below (GE Sensing, 2009, p. 6).

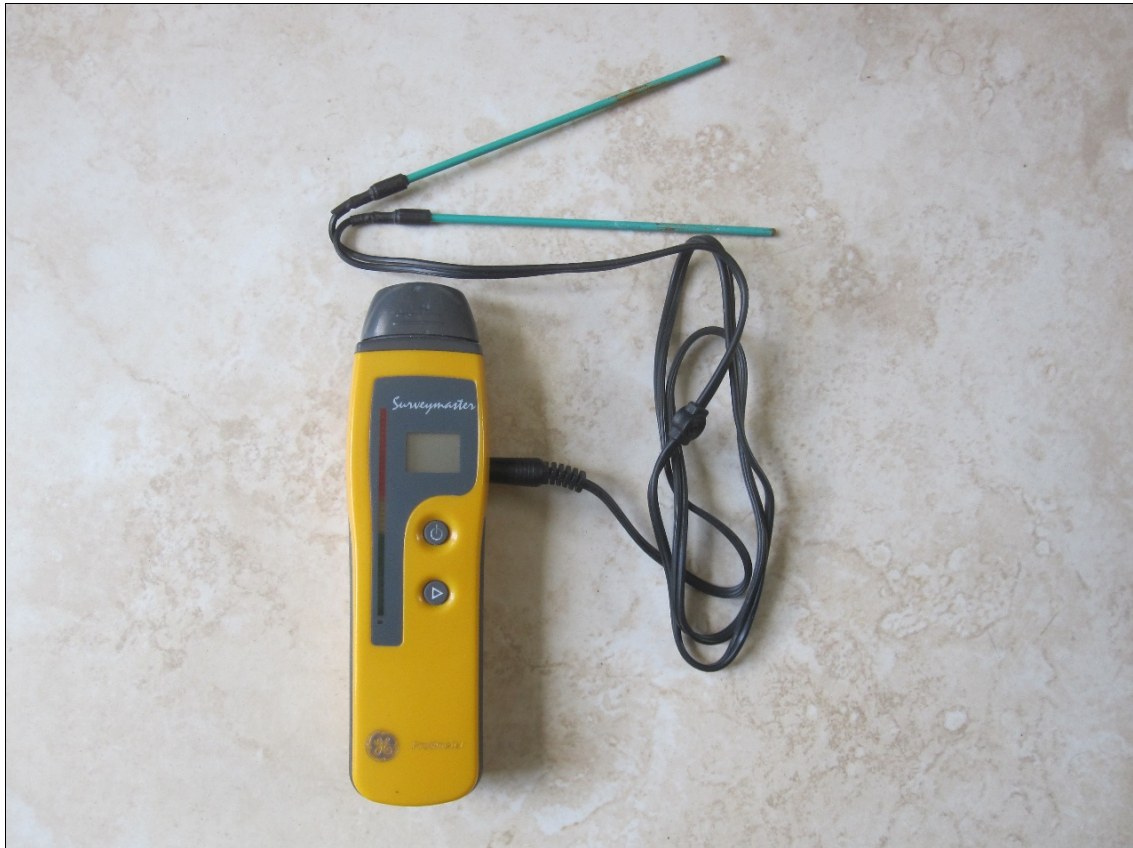
Figure 42: Protimeter Surveymaster meter: Deep Wall Probes attached.

As an alternative to the Heavy Duty Probe attachment, the measure-mode function can be used with Deep Wall Probes. These probes, shown in Figure 42 below, are 140 mm long and with the exception of their tips are insulated. By drilling small holes into a wall and

inserting the Deep Wall Probes, measure-mode readings can be obtained at depth. Interpretation of the readings obtained is identical to that of the standard two-pin probe.

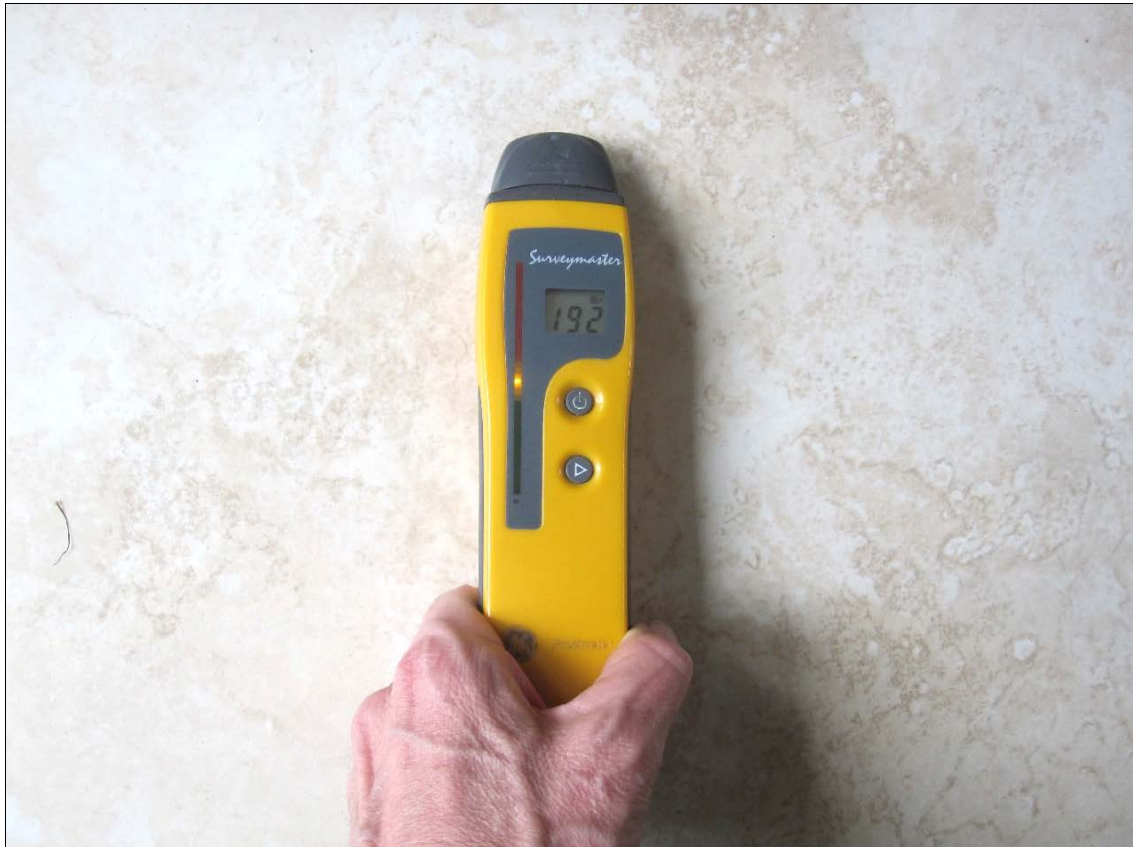
Figure 43: Protimeter Surveymaster meter: search-mode function.

Protimeter search-mode readings are obtained using a capacitive-coupled sensor located in the back of the instrument, which is placed against the material under test, as illustrated in Figure 43 below. When used on solid, homogenous materials, search-mode can scan to depths of 15 mm or 19 mm using the MMS or Surveymaster models respectively (GE Sensing, 2005, p. 5; 2009, p. 3). Search-mode readings are provided as integers in the range of 0-1000 or 60-999²⁴ but these values are not quantitative and can only be compared relatively (GE Sensing, 2005, p. 5).

Electronic meters offer a means of testing for moisture that is non-invasive, quick, and easily repeatable. Despite these advantages, there are two reasons why caution is required. Firstly, Protimeter electronic moisture meters are calibrated for use on timber: readings obtained from masonry and plaster materials are not quantitative and can only be considered relatively (Burkinshaw, 2002, p. 165; Oliver, Douglas, & Stirling, 1997, p. 264). Secondly, the meters are technically measuring electrical resistance and will therefore respond to any form of moisture or any electrical conducting substance (Burkinshaw, 2002, p. 162; Oliver, Douglas, & Stirling, 1997, p. 264).

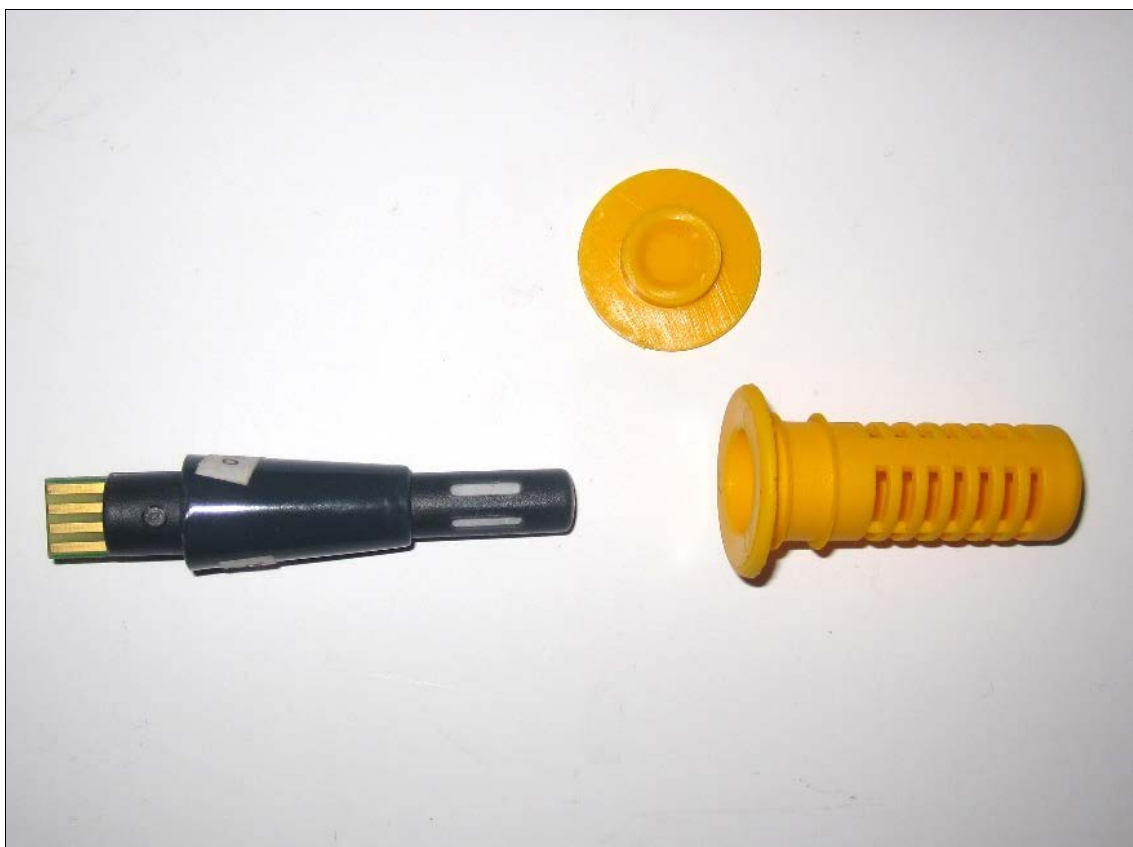
Figure 44: Protimeter Hygrostick, Humidity Sleeves and Humidity Sleeve's endcap.

Hygrosticks are not embedded directly into a wall but require the installation of proprietary Humidity Sleeves. A process that involves drilling a 16 mm diameter hole, approximately 45 mm deep, into the surface, inserting the Humidity Sleeve, and sealing its outer end with a removable, plastic cap (Burkinshaw, 2009, p. 190; GE Sensing, 2005, p. 20). The Protimeter Hygrostick and Humidity Sleeve, with its end cap removed, are shown in Figure 44 below.

The plastic body of the Humidity Sleeve is perforated by a series of slots. When its end cap is fitted, these slots enable moisture vapour evaporating from the surrounding masonry to equilibrate with the air inside the sleeve.

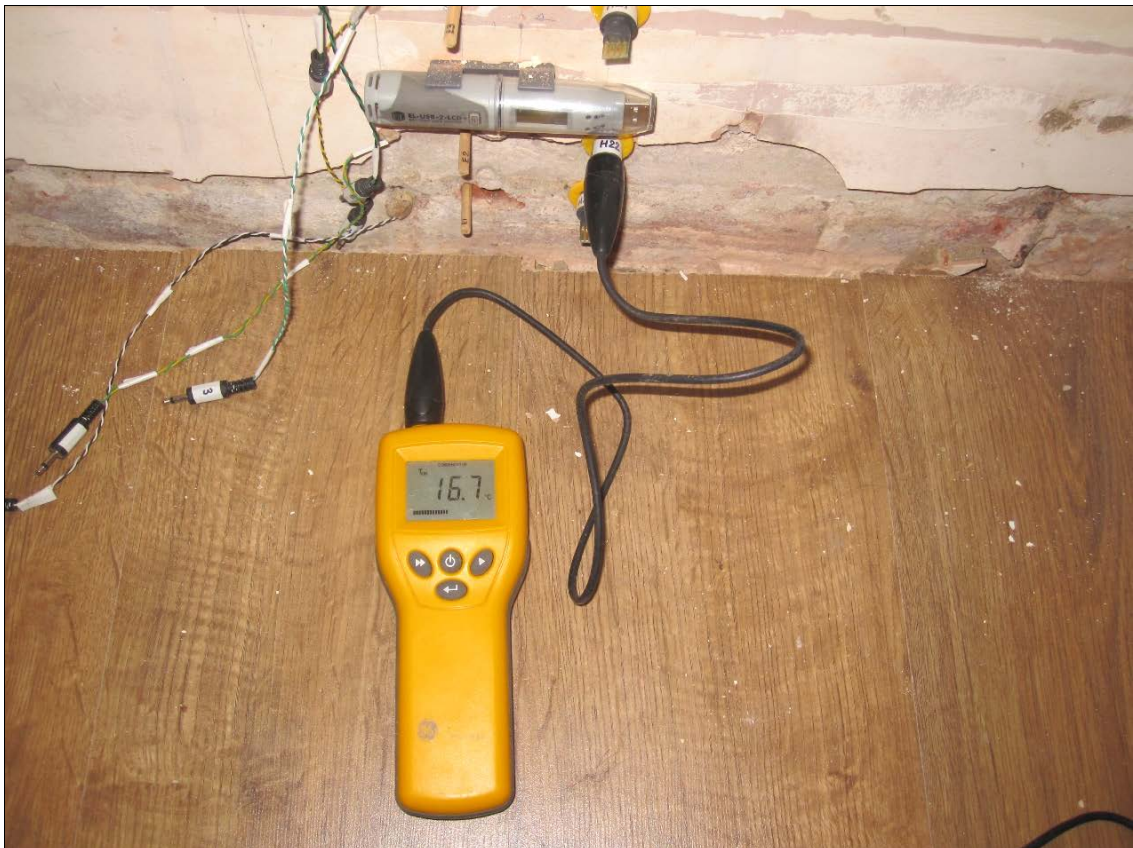
Figure 45: Protimeter MMS meter reading a Hygrostick inserted into a Humidity Sleeve embedded in a masonry wall.

temperature of this pocket of air, the Humidity Sleeve's end cap is removed, and a Hygrostick attached to the Protimeter MMS meter with a proprietary extension lead is inserted into it, as illustrated in Figure 45 below. Hygrosticks require time to equilibrate with the air in the Humidity Sleeve and are therefore required to be inserted thirty to sixty minutes before readings can be taken (Burkinshaw, 2009, p. 191; GE Sensing, 2005, p. 19).

Hygrosticks would appear to provide a mechanism for monitoring moisture change via variations to the ERH in the Humidity Sleeves; however, relative humidity is a function of temperature (BSI, 2011, p. 3; Burkinshaw, 2009, p. 190); consequently, there is a significant concern in using this method to extrapolate moisture contents, which is explained as follows.

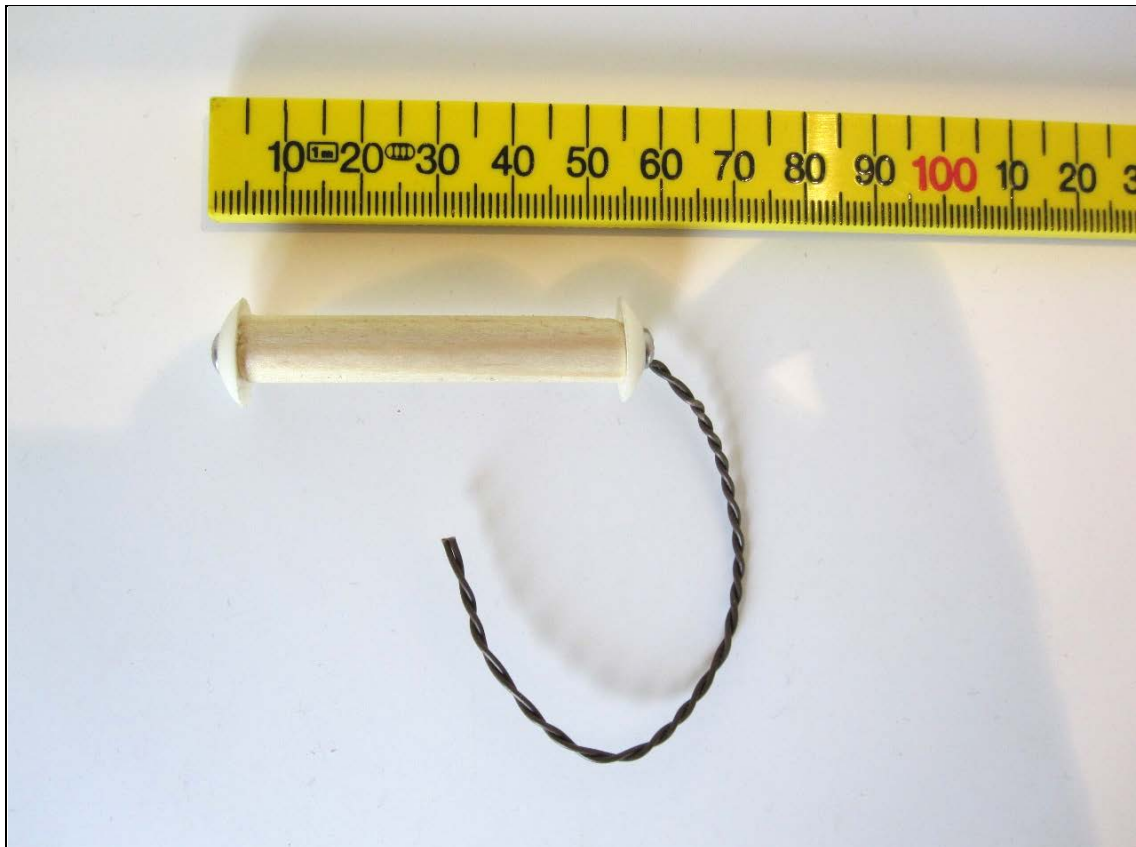
Figure 49: Timber Probe Type 3.

The plastic end spacers of the Type 3 probe ensure that its dowel body cannot directly contact the sides of the holes into which it is inserted. The attached wire is only to facilitate removal of the Type 3 probe from its accommodating hole for weighing.

Timber Probes Type 2 and Type 3 were designed to be installed into an oversized hole drilled into the wall surface. The ends of their dowel bodies had been fitted with plastic spacers, as shown in Figure 48 and Figure 49 below, to ensure that they did not directly contact the surrounding masonry and therefore that they only absorbed moisture from the pocket of air within their accommodating hole

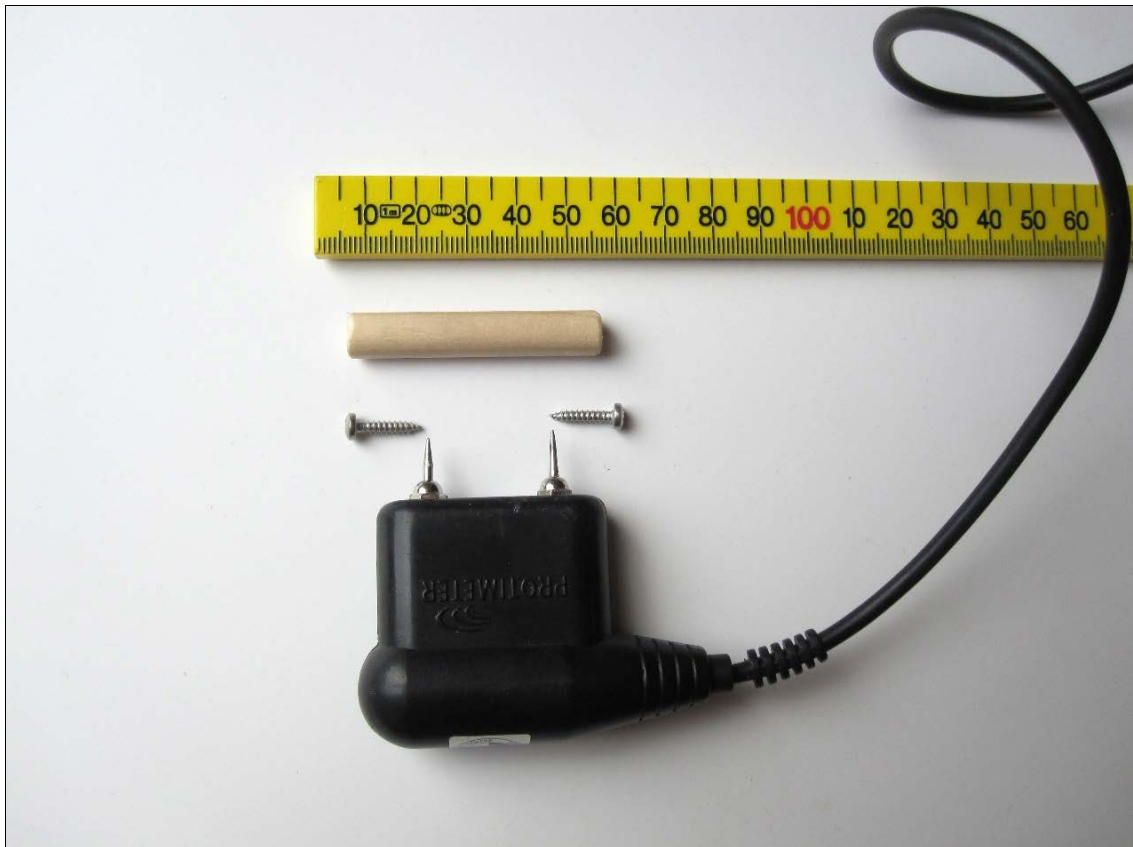
Figure 51: Timber Probes Type 1 & 2: screw configuration.

The moisture content of the Type 1 and Type 2 probes is obtained using the measure-mode function of the Protimeter. This was made possible by attaching an insulated electrical wire with 13 mm long, stainless steel screws (to avoid corrosion in the damp environment) to each end of their dowel bodies. The configuration of the screws meant that the distance between their internal ends was 25 mm, precisely replicating the spacing between the needles of the Protimeter Heavy Duty Probe, as illustrated in Figure 51 below. The outer ends of each wire pair was terminated with a standard 3.5 mm jack plug that can be plugged directly into a Protimeter.

This unassembled probe illustrates that, once inserted, the internal ends of the two 13 mm long, stainless steel screws, which secure the connecting wires (not shown), essentially replicate the 25 mm spacing of the needles of the Protimeter Heavy Duty Probe.

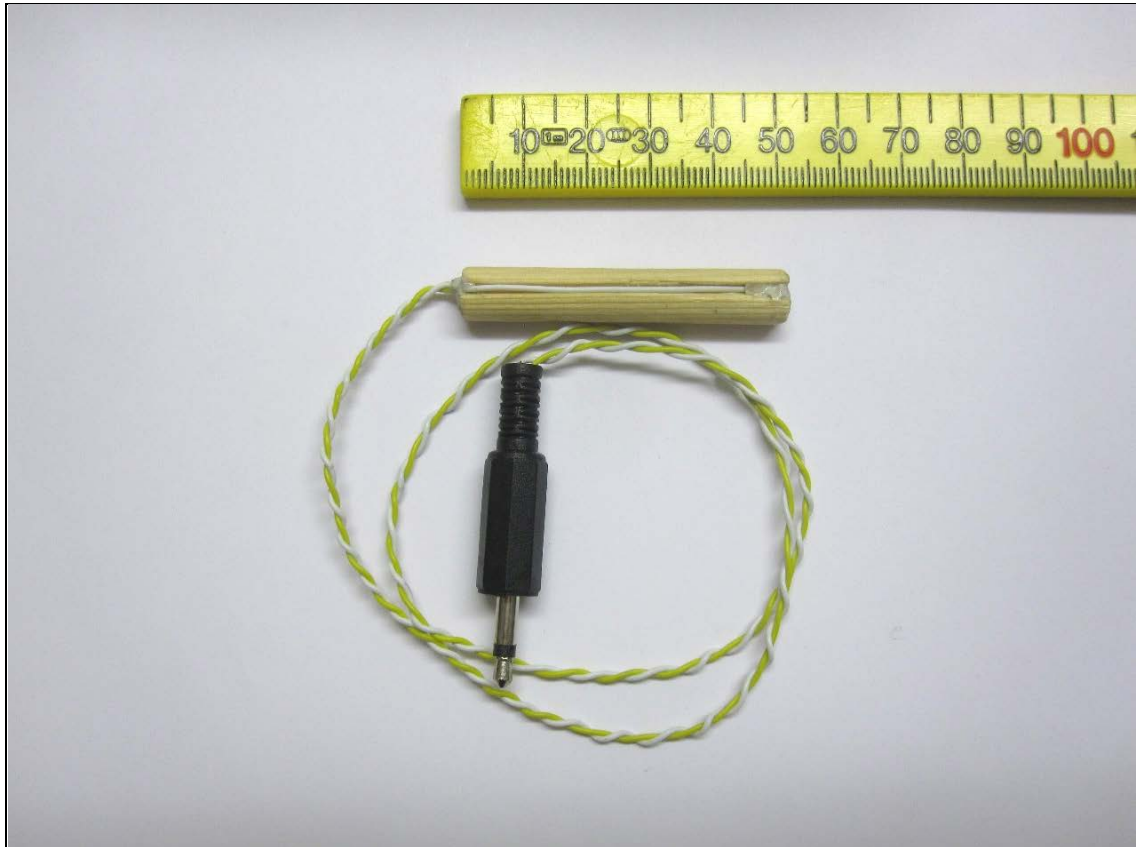
Figure 52: Timber Probe Type 1: final design.

In this final design, the stainless steel screws securing the wires to the dowel body are recessed and sealed with butyl tape to prevent inadvertent short circuits. The wires have been lengthened and twisted together for convenience and added strength. In all other respects, the final design of Timber Probe Type 1 is identical to the prototype.

The pilot study found Timber Probe Type 1 to provide the best results for monitoring moisture change. It is this probe that is used in this research project; however, the final version of the Type 1 probe did receive three minor modifications: the wires were lengthened to better facilitate attachment to a Protimeter; the wires were twisted to add strength; and the two screws securing the wires to the dowel body were

countersunk and covered with butyl rubber tape to ensure that they could not inadvertently make contact with the surrounding masonry. This final version of the Timber Probe Type 1 is shown in Figure 52 below.

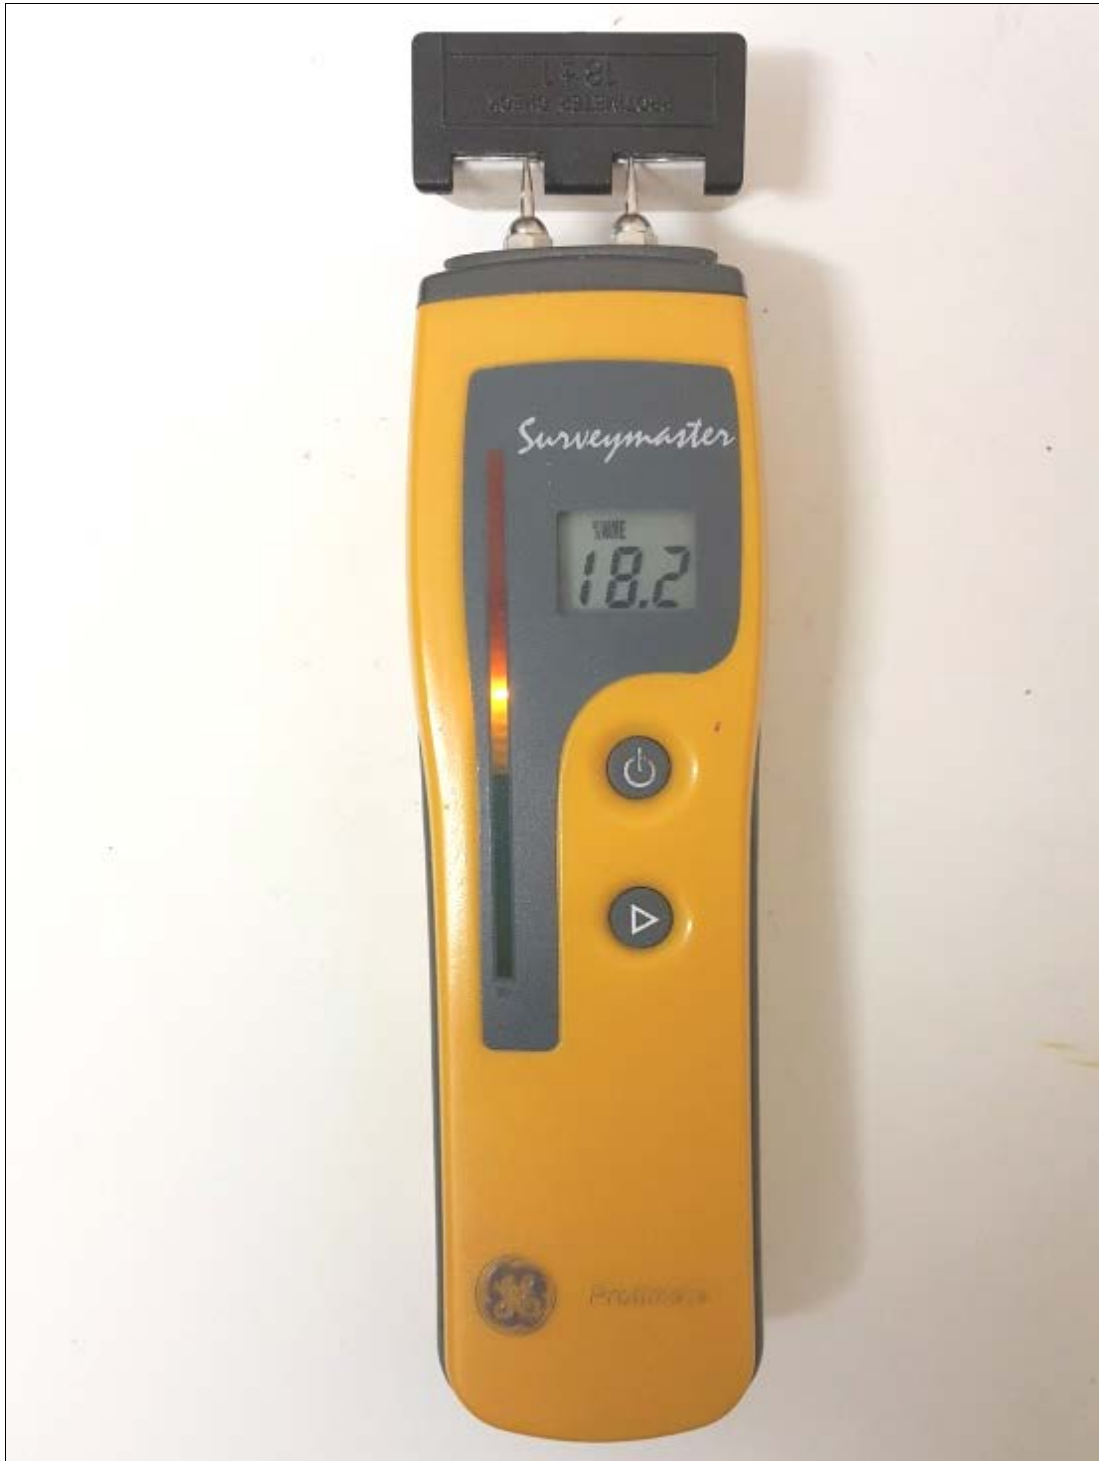
Figure 53: Protimeter Surveymaster meter: calibration using Calcheck tool.

Checking the calibration of the Protimeter Surveymaster using the proprietary Calcheck tool. The display readout is 18.2 which falls within the acceptable range of 18.2 ± 1.0 stipulated by the meter's manufacturers. Calibration checks carried out on the Protimeter instruments used for the study were consistently in the range of 18.1-18.3.

Protimeters are supplied with a proprietary calibration check device, a Calcheck, which comprises a metal wire secured in a small plastic holder. To test the Protimeter's calibration, the built-in needles or those of a connected probe are placed in contact with the metal wire of the Calcheck tool. The Protimeter is correctly calibrated if the displayed reading is in the range of 18.2 ± 1.0 , as illustrated in Figure 53 below (GE Sensing, 2009, p. 8). Thus, checking the accuracy of the Protimeter measure-mode function simply requires this test to be undertaken before each use.
